PHASE I ENVIRONMENTAL SITE ASSESSMENT

1300 ACRES – MURRIETA

MURRIETA HILLS

SUBJECT: Phase I Environmental Site Assessment for Thirteen Hundred Acres of Undeveloped Land in Riverside County, California.

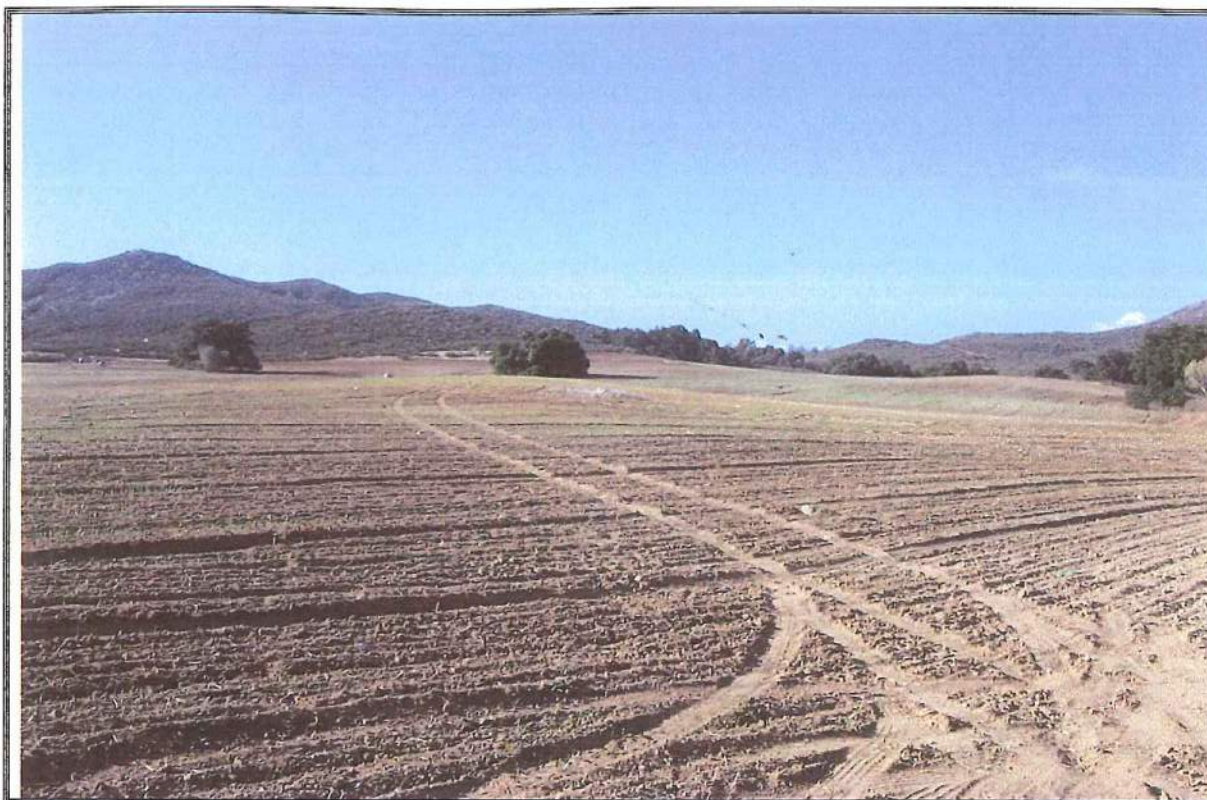
Photograph : Looking southwest at recently planted oat field located on the northeast corner of the site.

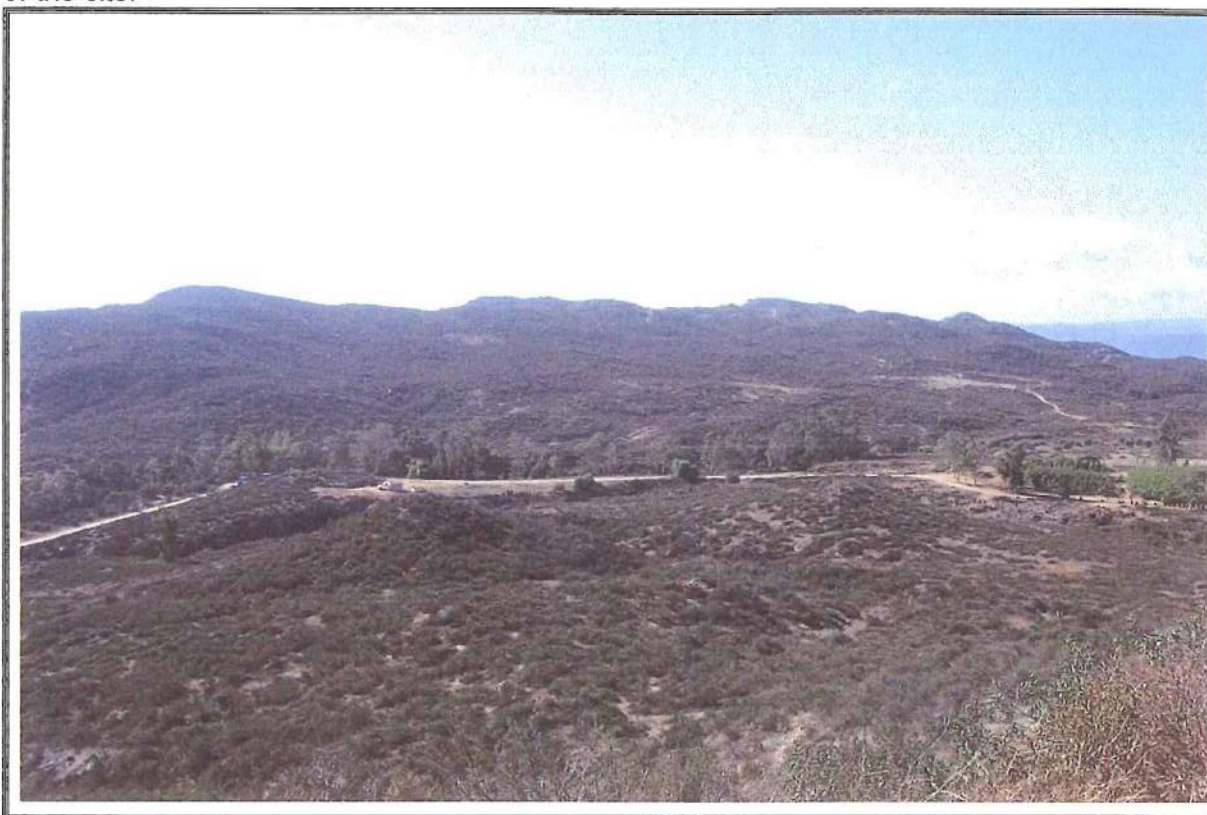
Photograph 2: Looking southwest at valley located in the middle portion of the site. Road pictured in middle is the primary access road to site. Ridge in background defines south border of site. Nursery located on right next to trees.

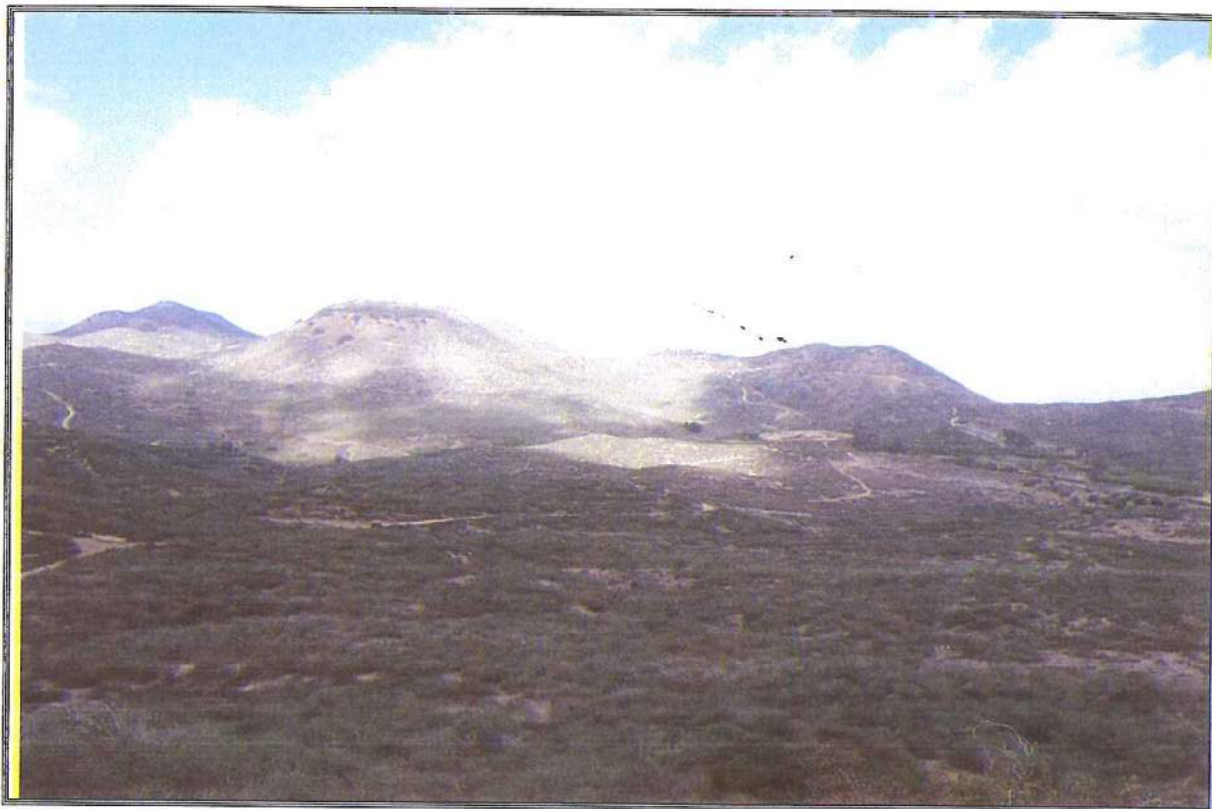
Photograph 3: Looking the north ridgeline of site from the south ridgeline south boundary of property. Nursery on site located on right. .

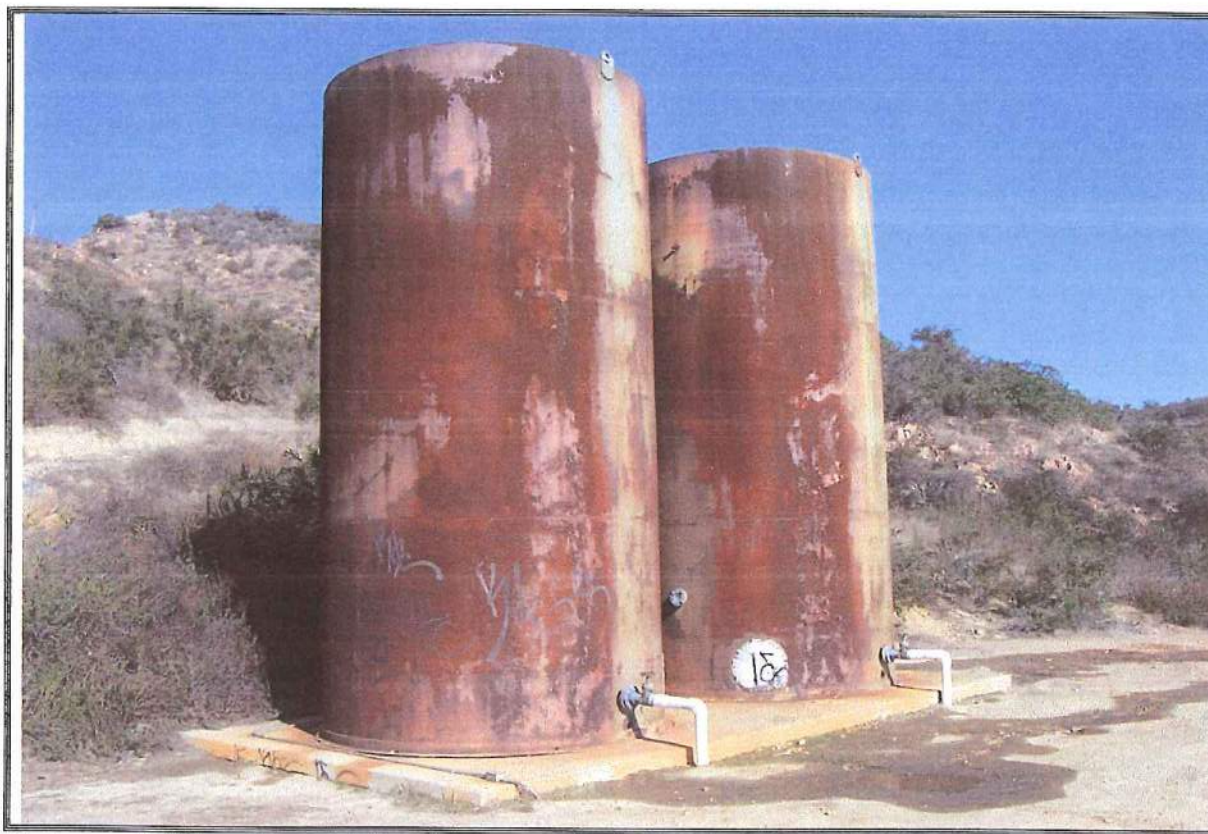
Photograph 6: Looking metal water storage tanks located above the nursery.

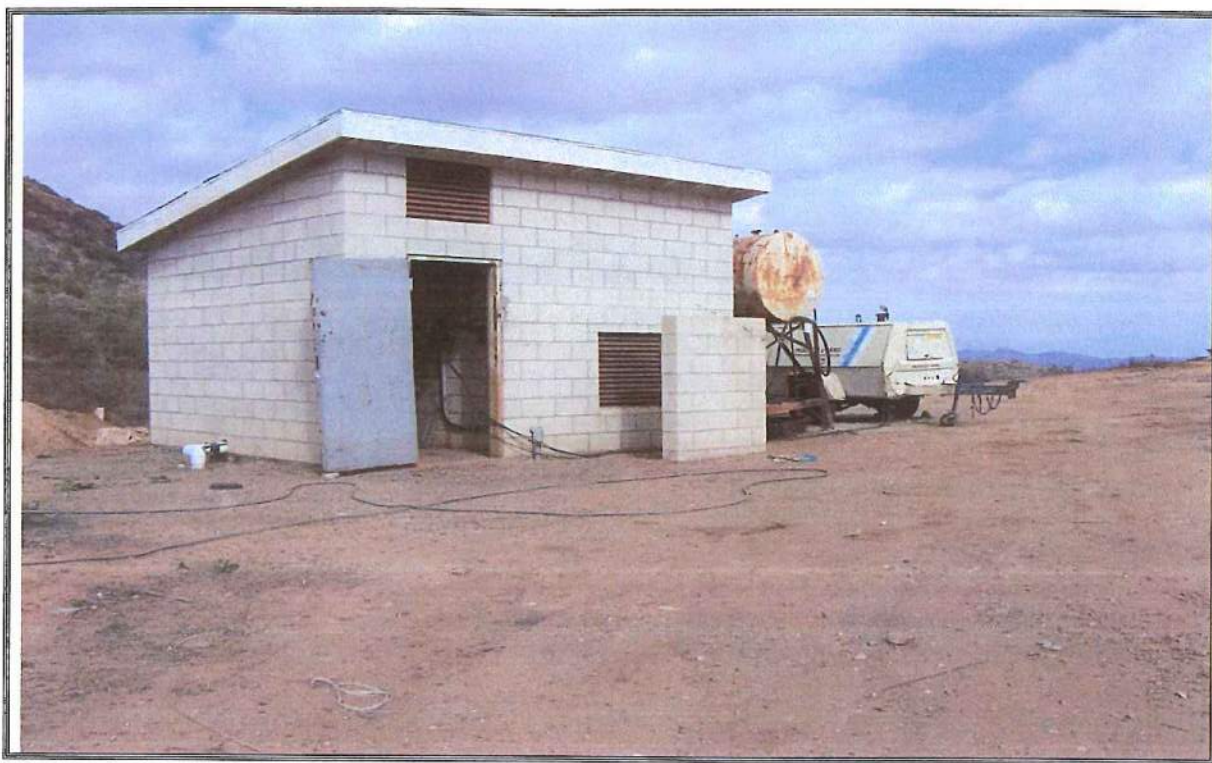
- Located approximately four hundred feet east of the nursery is a small single story brick building. (See Photo #: 7). Located in this building is the ground water well that supplies water for the nursery. Also located in this building is a generator that provides power to the pump. Located directly adjacent to the building to the east is a three hundred gallon diesel fuel tank and portable generator. There were minor stains of diesel fuel noted on the soil under the tank, and extending from the building (See Photo #: 8). The stains appeared to be surface stains only.

Photograph 7: Looking at brick building that contains the water well and generator utilized by the nursery. Diesel fuel tank and back up generator pictured on right of building.

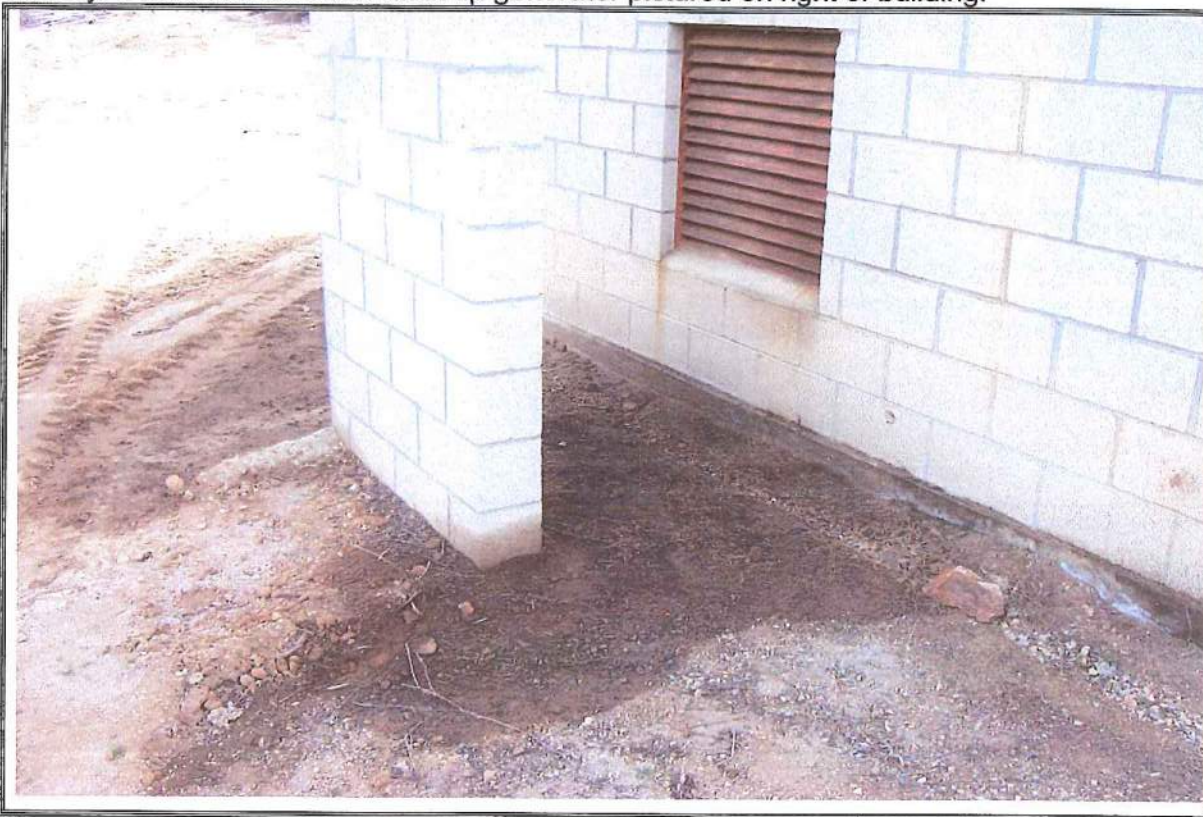
- Mr. Richard Greer indicated there have been minor leaks of diesel fuel from the generator and diesel fuel tank that supplies fuel to the generator. He believes most of the soil where the diesel fuel has impacted is surface stains only.

Photograph 8: Looking on back side of number 6 photograph at diesel fuel stained soil from generator and fuel tank.

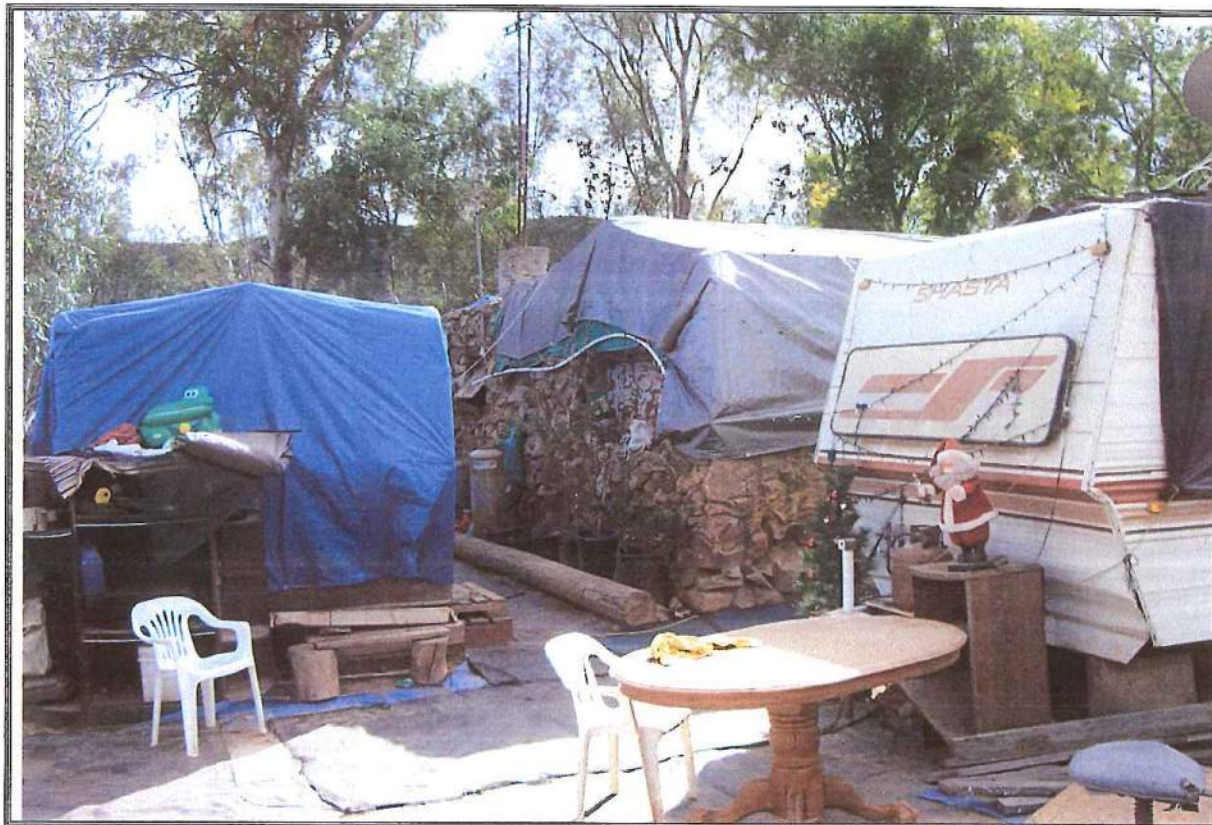
- Located in the center of the property is a single story rock/concrete house (See Photo #: 9). Based upon historical aerial photographs reviewed, the house was built prior to 1938. Currently the house is utilized as a residence for the workers for Murrieta Oaks Nursery. Several small trailers parked directly adjacent to the house are also used by the workers. Scattered trash and debris was noted around the house and trailers. There was no indication that hazardous materials were utilized or disposed of in this area of the property.

Photograph 9: Looking at rock house on site and trailers where workers at nursery live.

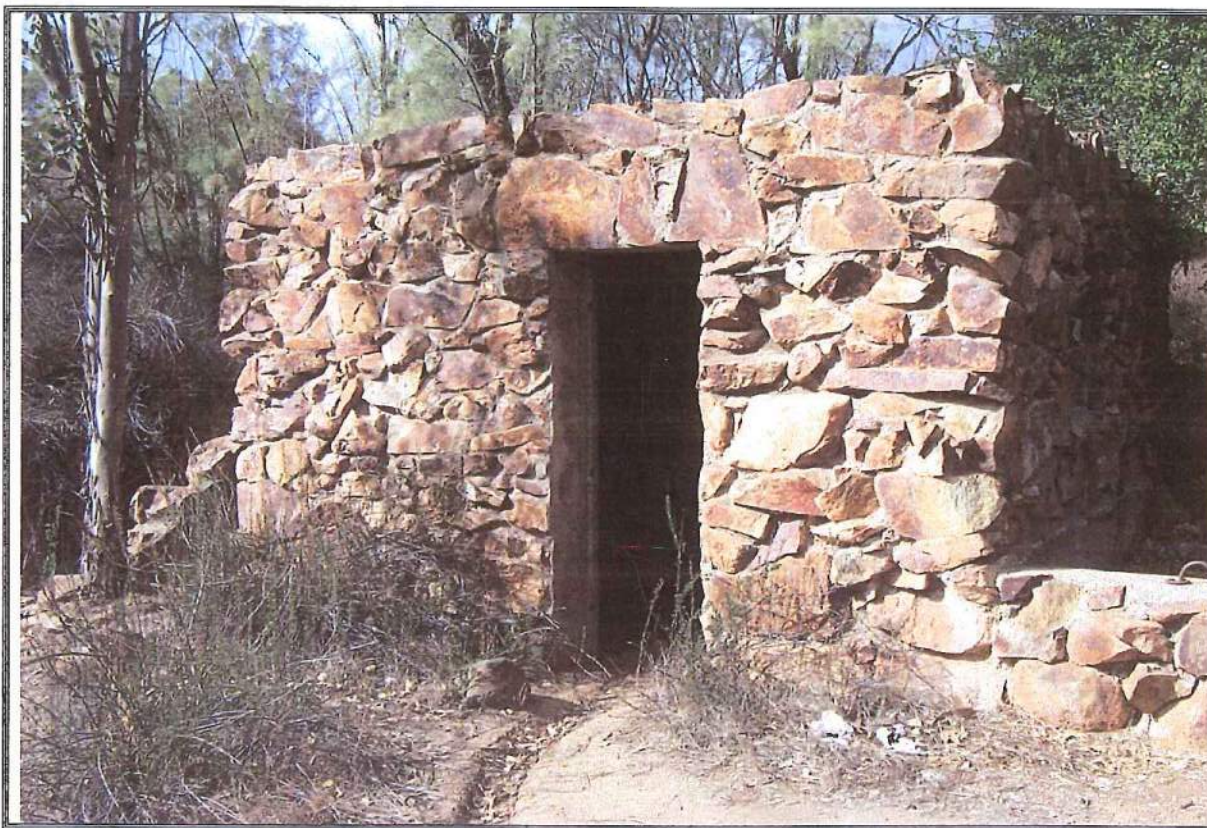
- Located approximately one hundred feet west of the house in a small ravine is a small single room one story rock/concrete structure (See Photo #: 10). Based upon its construction and design, it most likely was built at the same time as the house stated above. It appears it may have been used as a bath house. At the time of the inspection this structure was empty. No environmental concerns were noted in or near this structure.

Photograph 10: Looking on at bath house located 200 feet west of house in photo # 9 above.

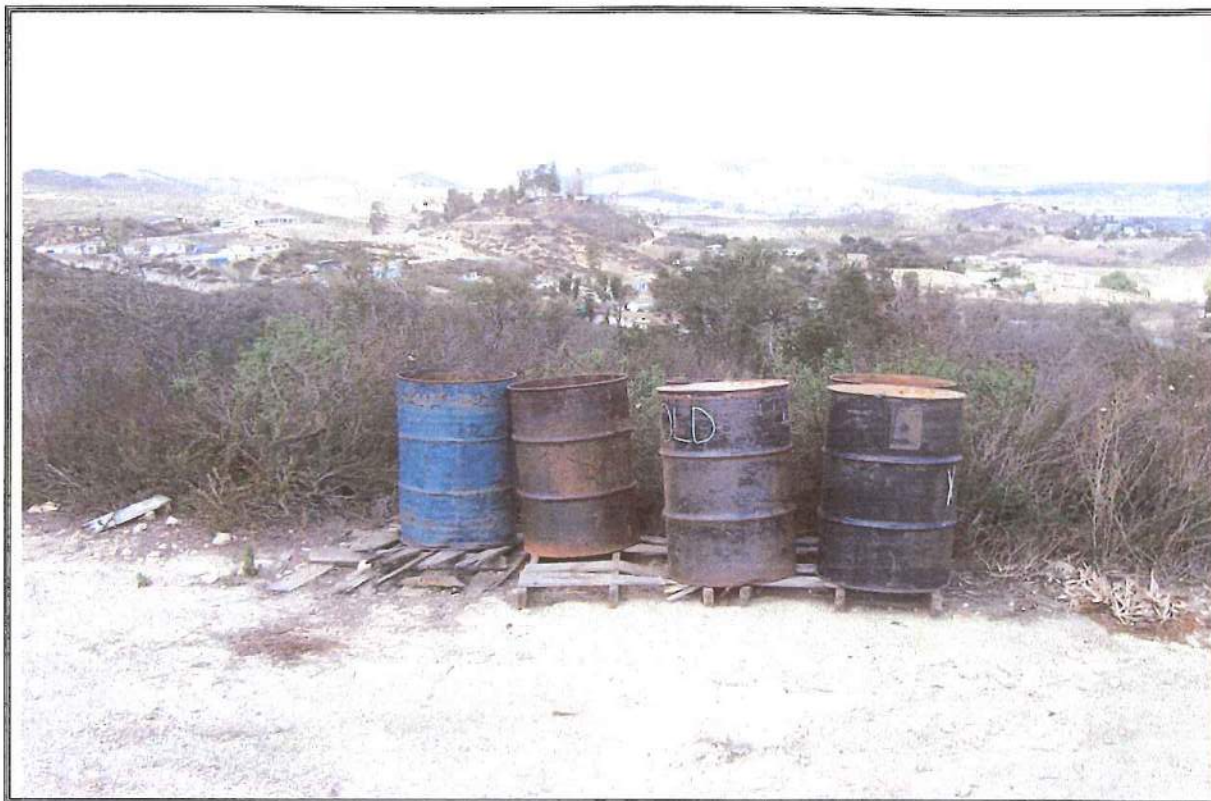
- Located atop a ridge road on the south portion of the site are six fifty-five gallon metal drums set on a wood pallets (See Photo#: 11,12). It appeared the drums had been there for some time as they were $\frac{3}{4}$ filled with rain water and were supporting plant growth and a vibrant bug population. There were no indications of stains under or near the drums or any labels on the drums identifying what the former contents may have been.

Photograph 11: Looking at metal drums located along dirt path on north ridgeline of site.

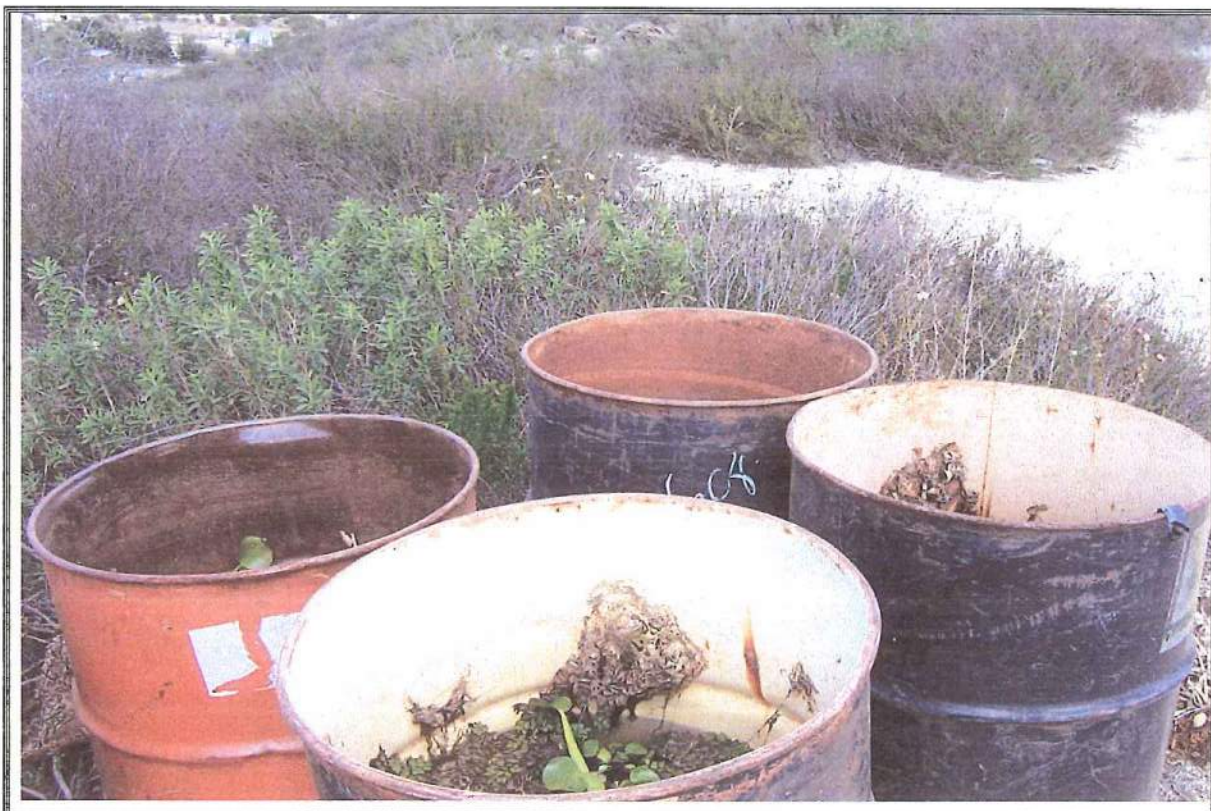
Photograph 12: Looking at contents of drums pictured in photo # 11 above. Contents consist of rain water, plants growth and bugs.

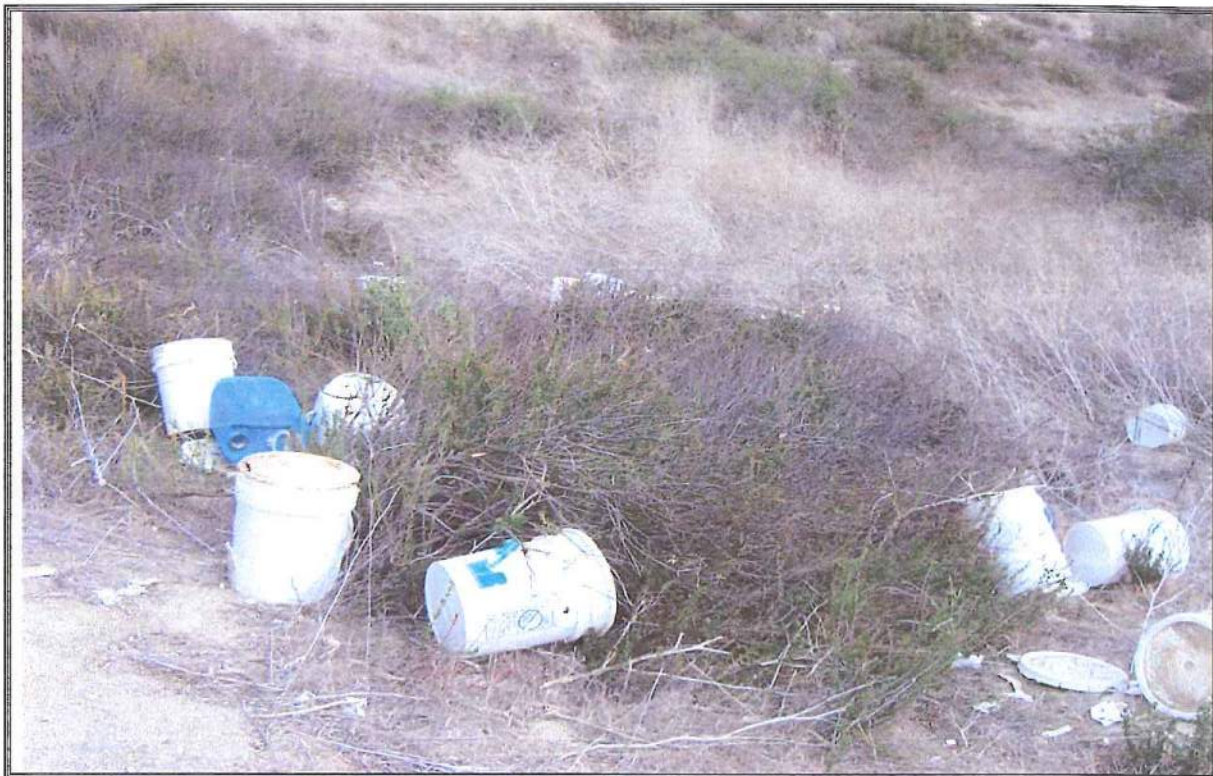
- Located approximately one hundred feet southwest of the drums along the same ridge line was a collection of five gallon plastic containers of discarded paint. Most of the containers were empty, however several had varying quantities left over. None of the containers appeared to be significantly leaking.

7. Piles of discarded debris were noted at several locations throughout the site. At one of the locations partially filled containers of used paint were observed. None of these containers of paint appeared to have significantly stained the underlying soil. Other debris included TV's, furniture, cloths, wood, gym equipment, landscaping debris, and a general collection of household junk.

Photograph 13: Looking at paint containers located on north ridgeline near drums in photo #11. Most containers were empty with a few having varying quantities of paint.

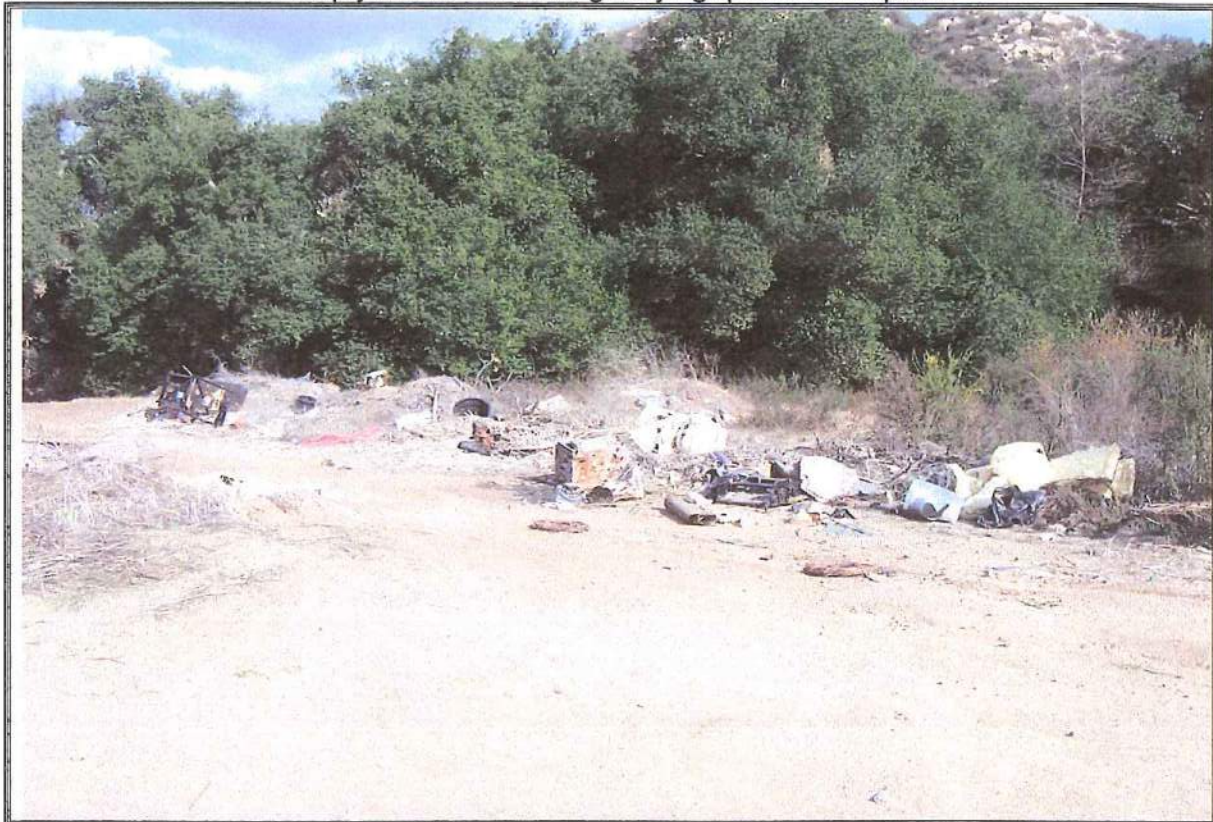
- A two lane dirt road identified as Shauna Charmain Lane acts as the primary access to the site. Easily accessible from Keller Road and suitable for normal vehicle traffic, areas abreast of this road serve as a natural "dumping ground" for debris. Additionally, Scenic View Drive which extends along the western portion of the site holds the same glamour for depositors of debris (See Photo#: 14). Each debris pile was inspected for the presence of any significant quantities of hazardous materials. The debris piles primarily consisted of old TV's, furniture, cloths, wood, gym equipment, and a general collection of household junk. Several of the piles contained empty plastic containers (pints, quarts, buckets), of motor oil, transmission fluid, and paint (See Photo#: 13). Only minor stains were noted in a few of the areas with no indication of any significant soil incursions.

Photograph 14: Looking at typically debris dumped on the site. This area located on eastern portion of the site.

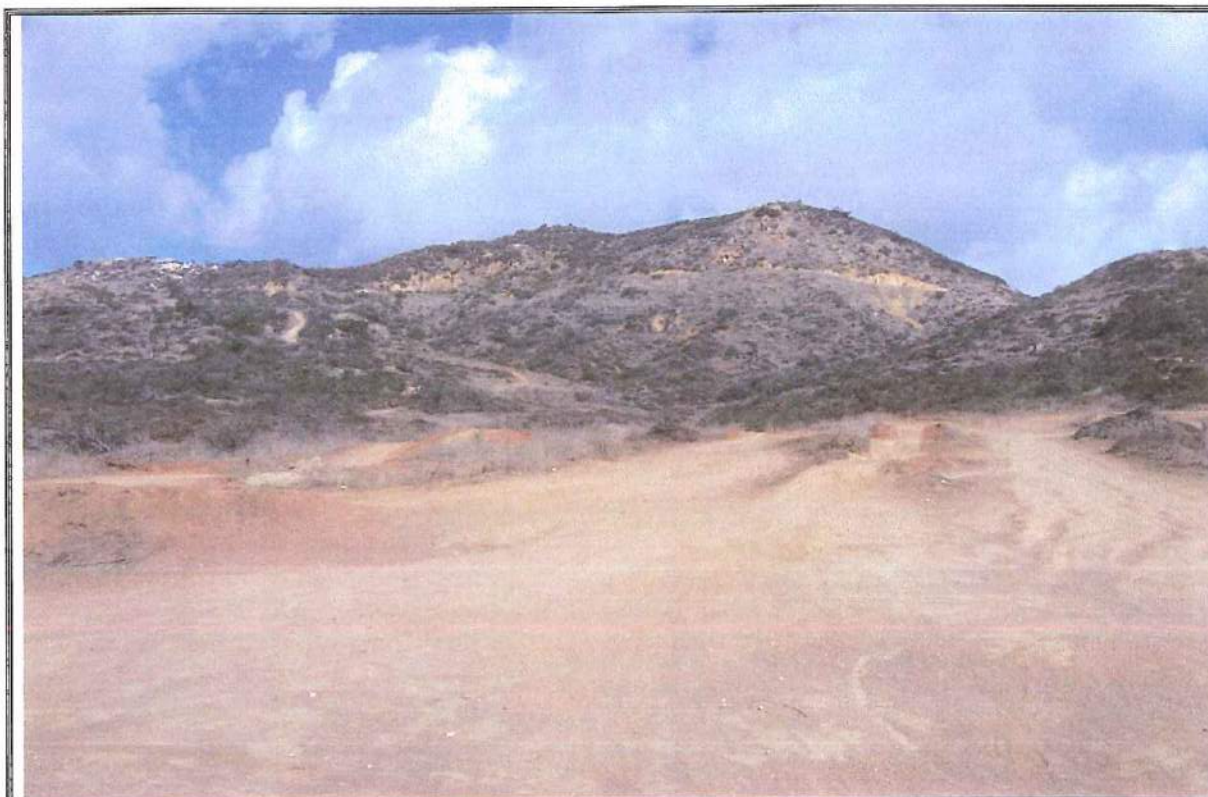
- Located approximately three hundred feet west of the nursery is an open area cleared of vegetation (See Photo #: 15). This area is marked with mounds of soil that appeared to be created by a bulldozer or other similar type of earth moving equipment. It is apparent that this area is used by motorcyclists as a type of race track or motocross course. There were no significant stains or other indications that hazardous materials have been stored or spilled in this area.

Photograph 15: Looking at area in middle portion of site used as motocross area. North ridge line of property pictured in background.

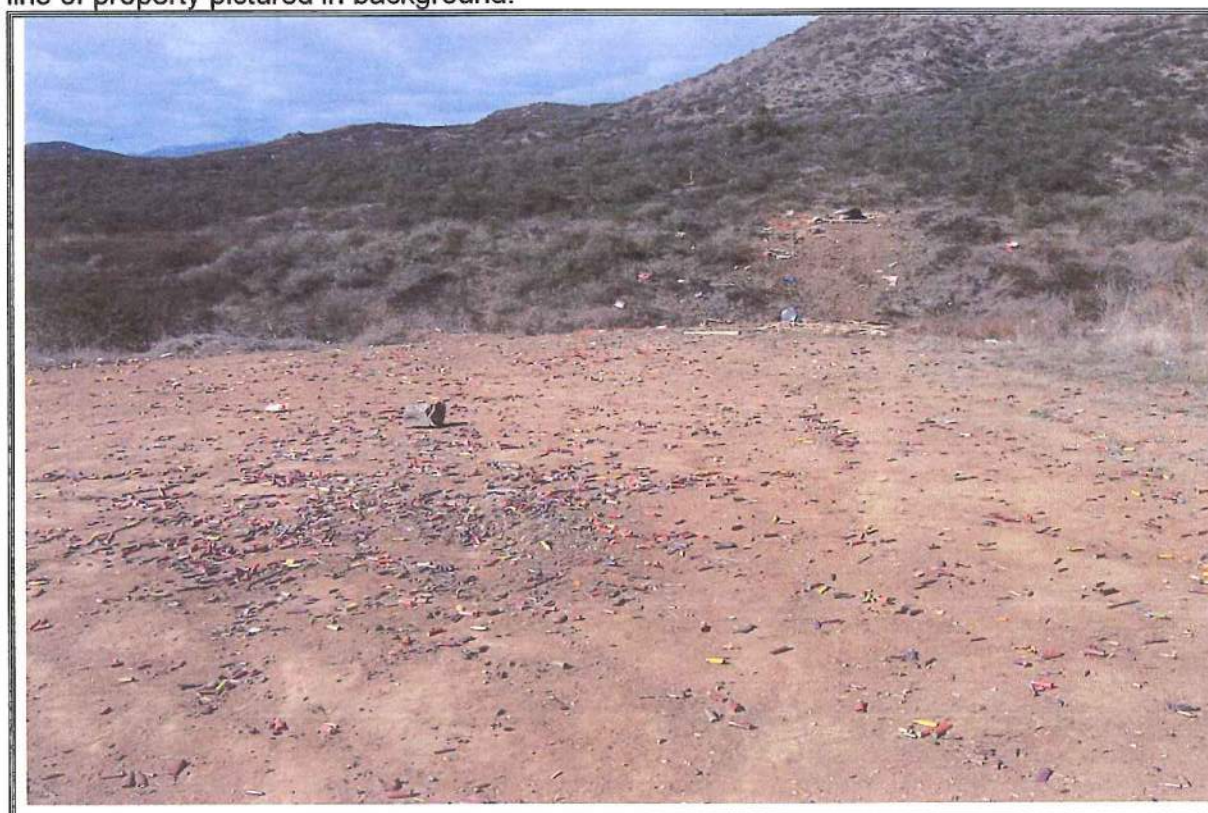
- Located directly adjacent to the above referenced motocross course is an area used as a weekend shooting range (See Photo#:16). Numerous shell casings (primarily shot gun casings) and aluminum beer containers were observed in this area.

Photograph 16: Looking at shooting area located directly south of motocross area in photo # 15 above. Most of the casings in picture are from shotguns.

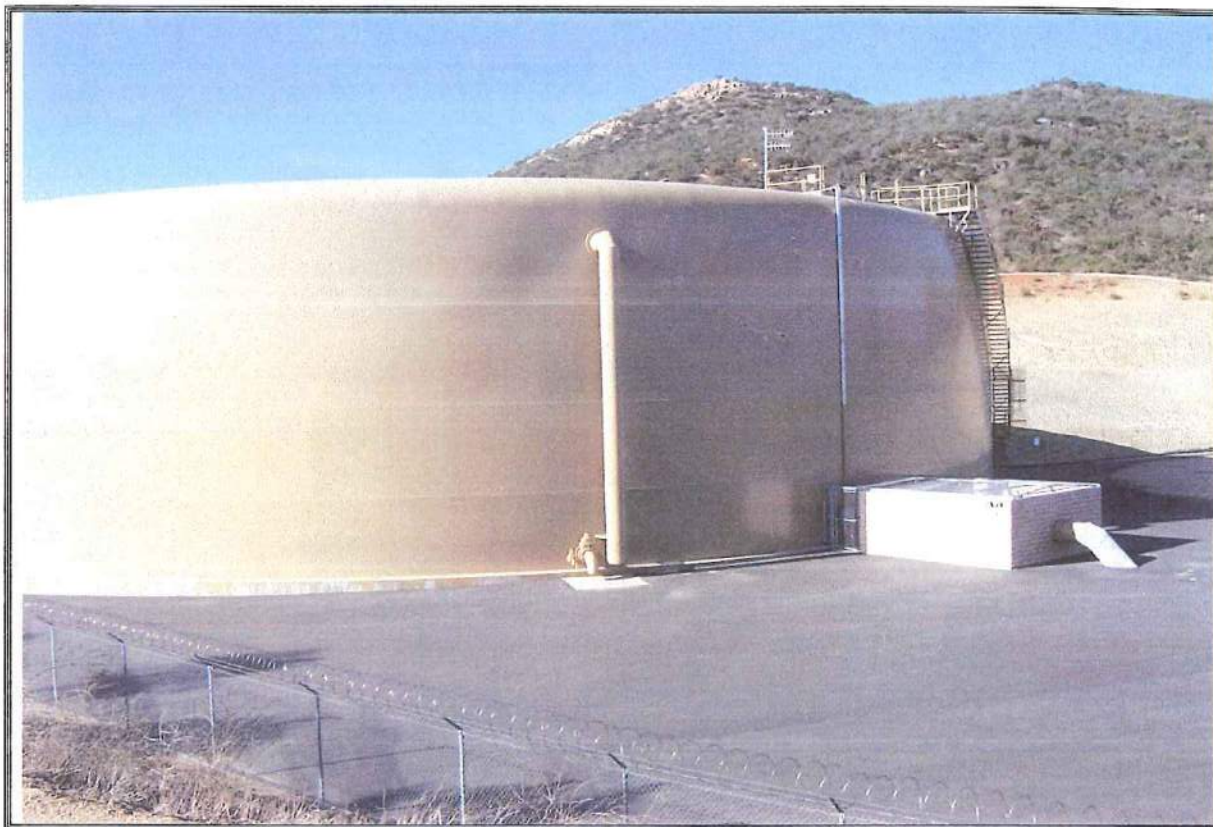
- Located on the northern portion of the site at Keller Road is a EMWD water storage tank (See Photo#: 17). The volume of the tank appears to be in the range of several million gallons. A fence with barb wire encloses this facility. There was no indication of the storage or use of any hazardous materials within this facility.

Photograph 17: Looking at EMWD water storage tank located on northern portion of site next to Keller Road

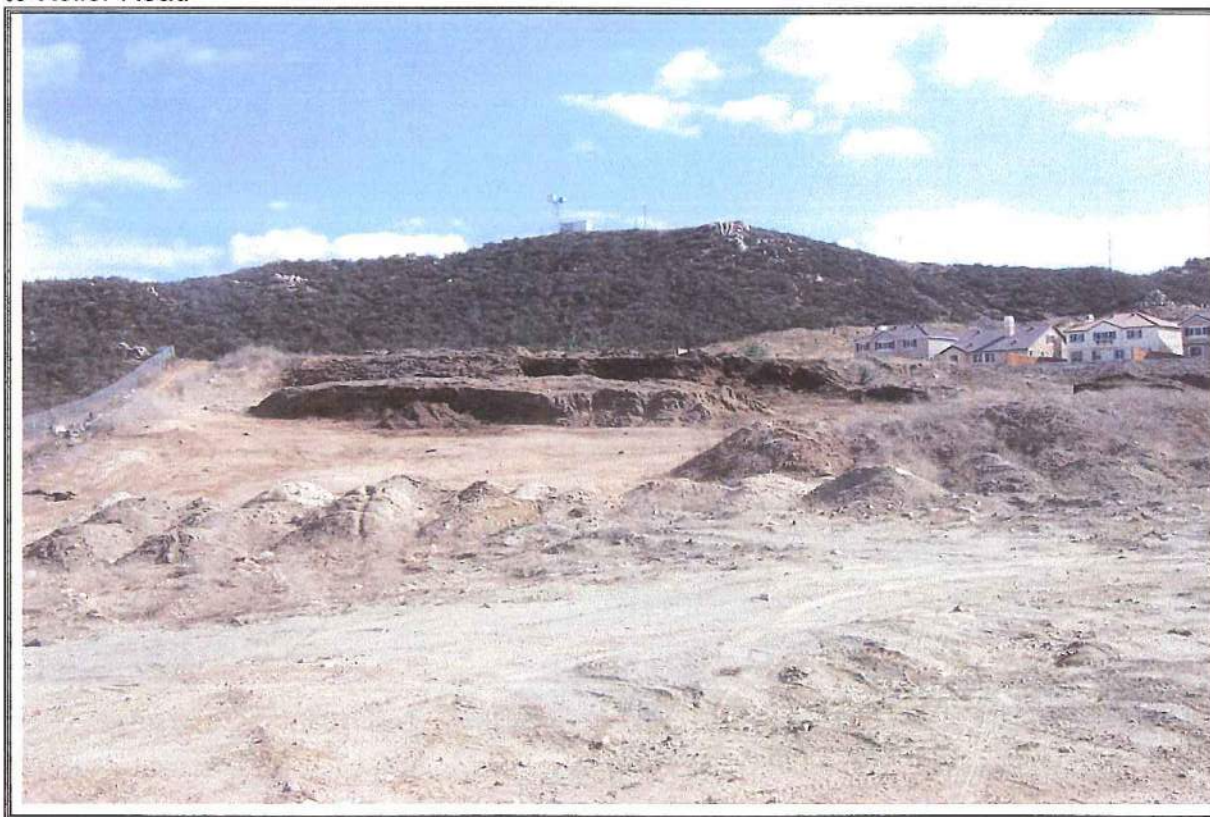
Photograph 18: Looking at piles of dirt spread out over a cleared area of located in the southeast portion of the site. Homes on right form the south boundary of the site..
