# **NORTH FORK RANCH FROST PONDS PROJECT SANTA BARBARA COUNTY, CALIFORNIA**

## **BIOLOGICAL RESOURCES ASSESSMENT**

*February 4, 2020*

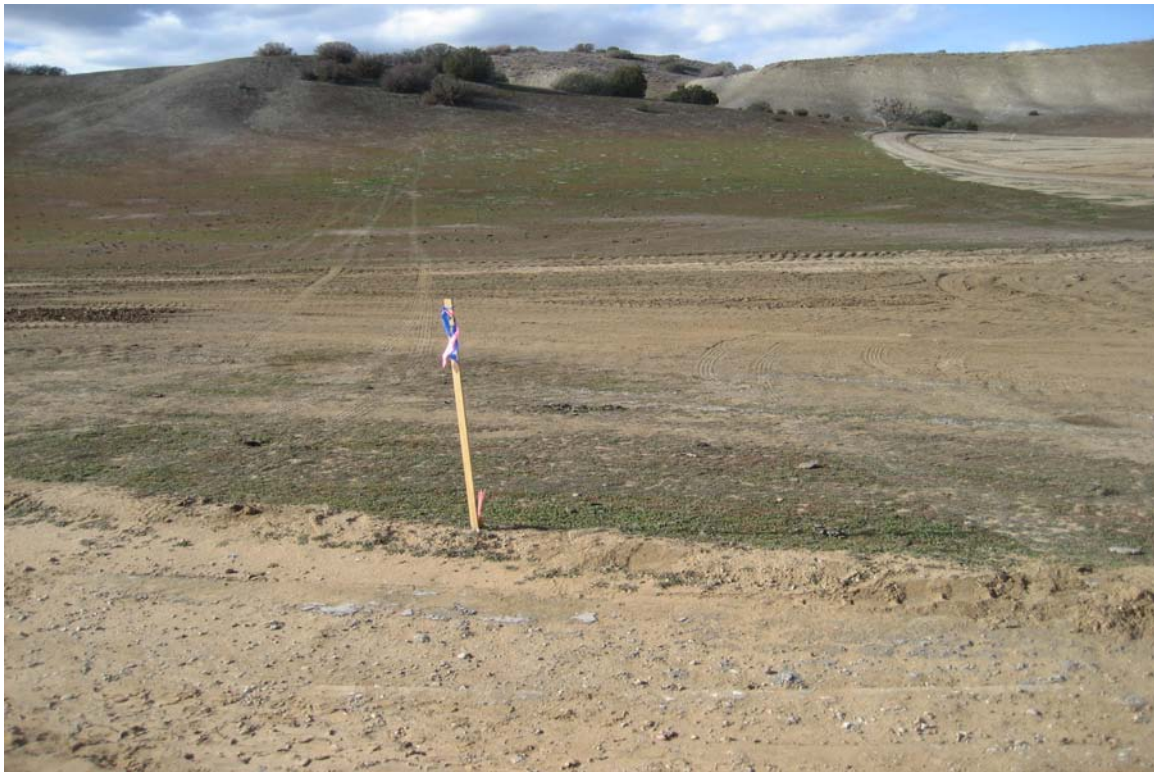
**Photo 1.** View of Reservoir 1 site looking northwest. Stake marks southeast corner of the reservoir. Surveys occurred prior to and after disking and site preparation activities.

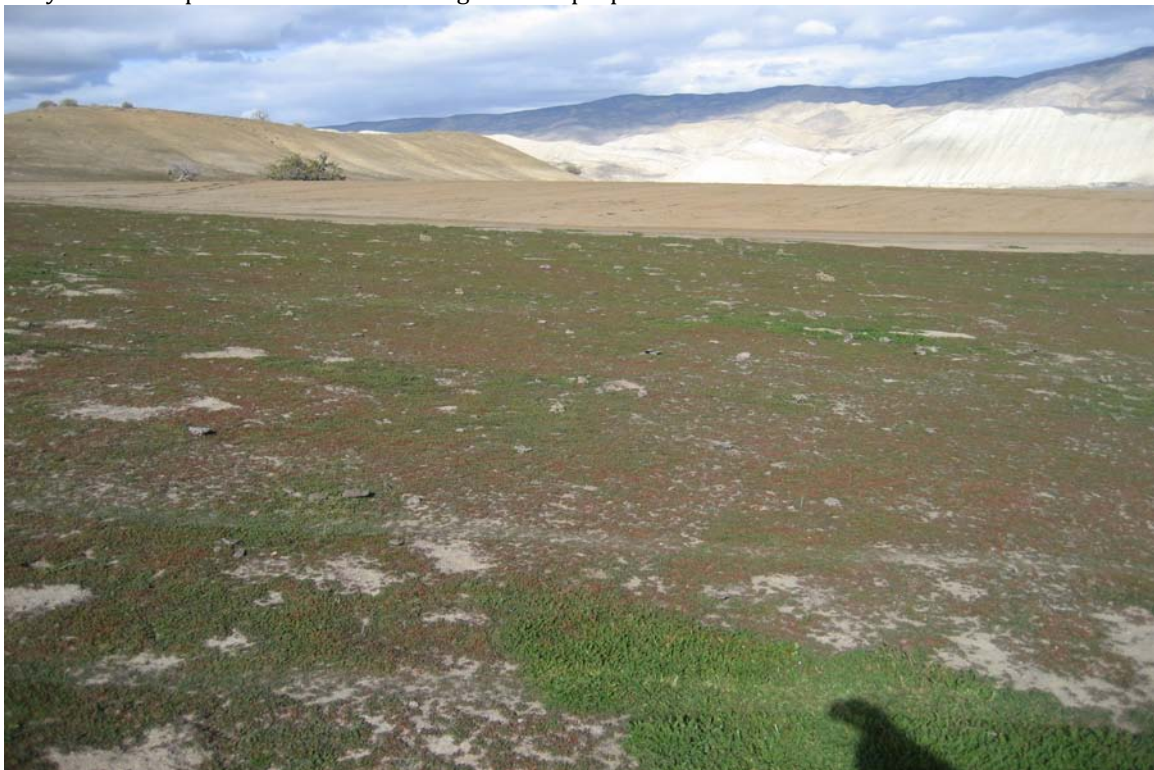
**Photo 2.** Overview of Reservoir 1 site, looking north toward Highway 166. Schoolhouse Canyon Road is located to the right of the picture. Area was composed of non-native weeds and bare soil that was being disked.

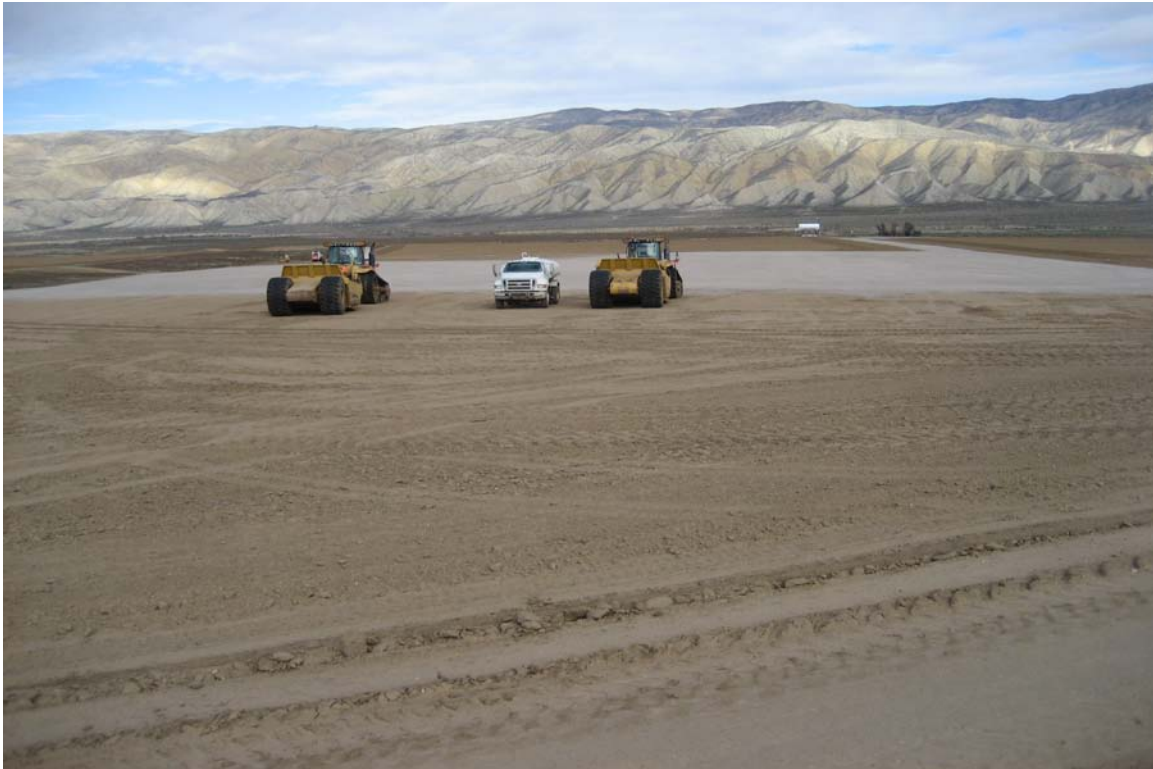
**Photo 3.** View of Operations Yard site looking northeast toward Highway 166.

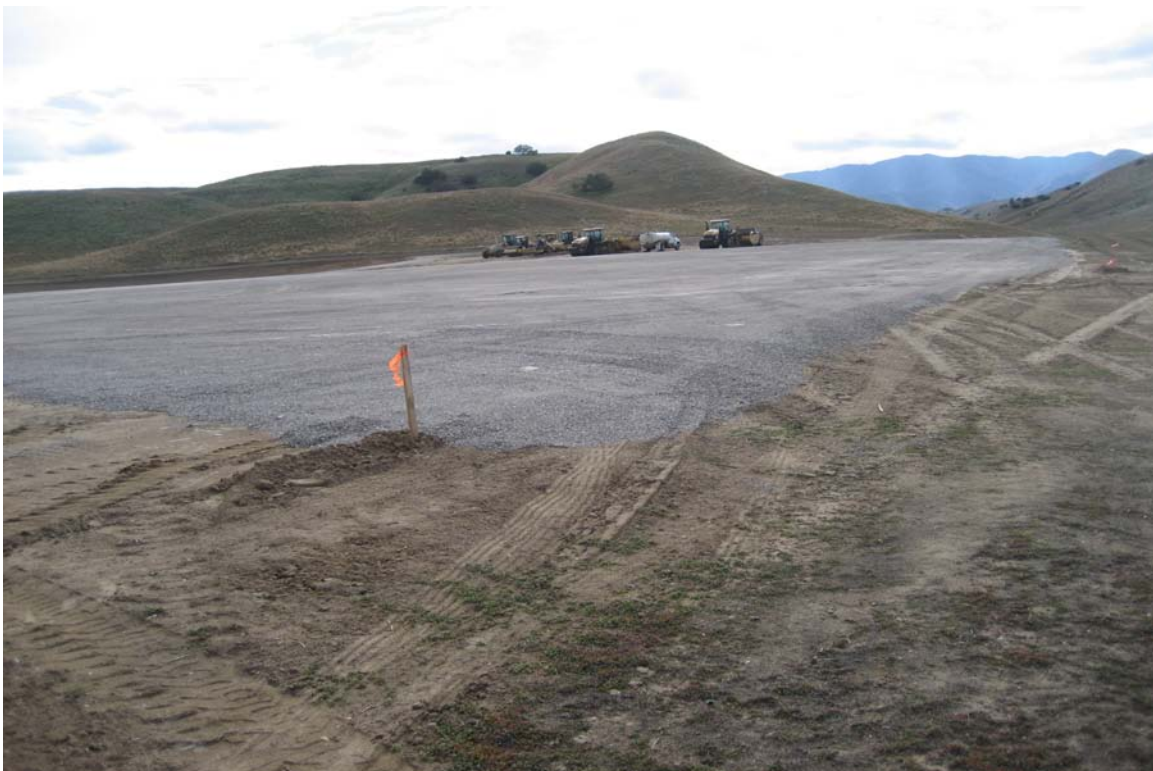
**Photo 4.** Easterly view of Operations Yard.

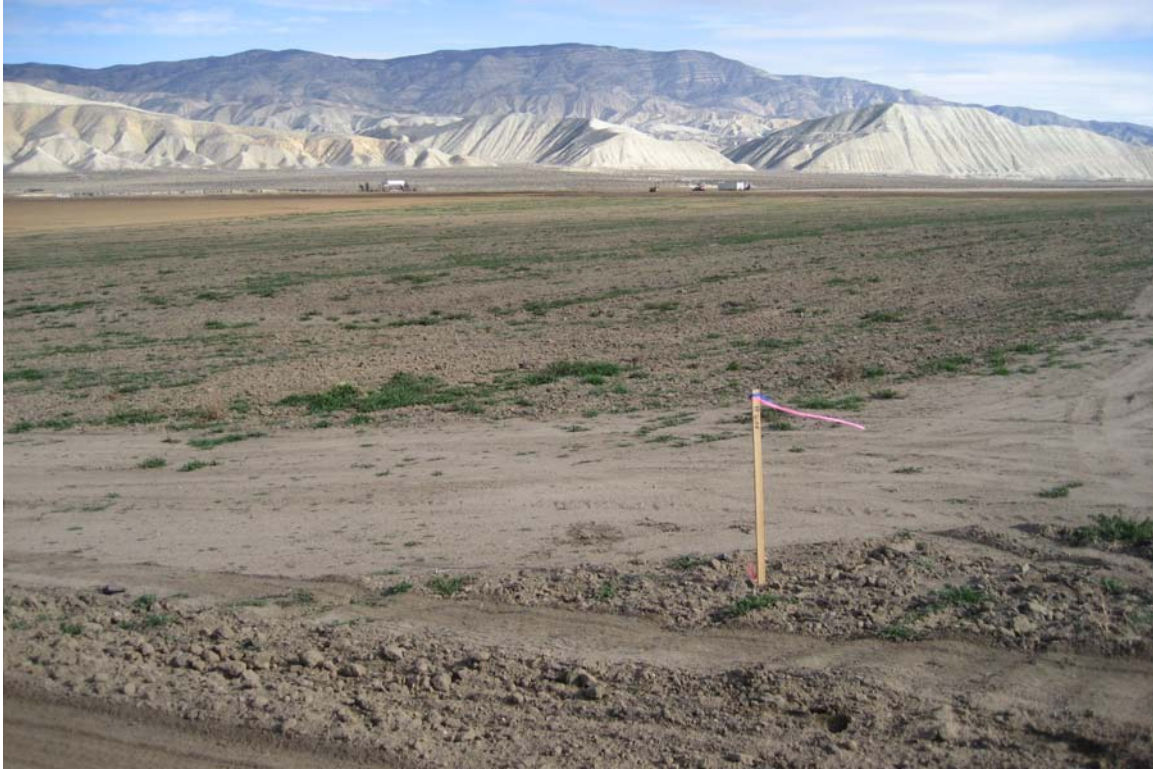
**Photo 5.** View of Reservoir #2 looking east. Stake marks western corner of the grading limits.

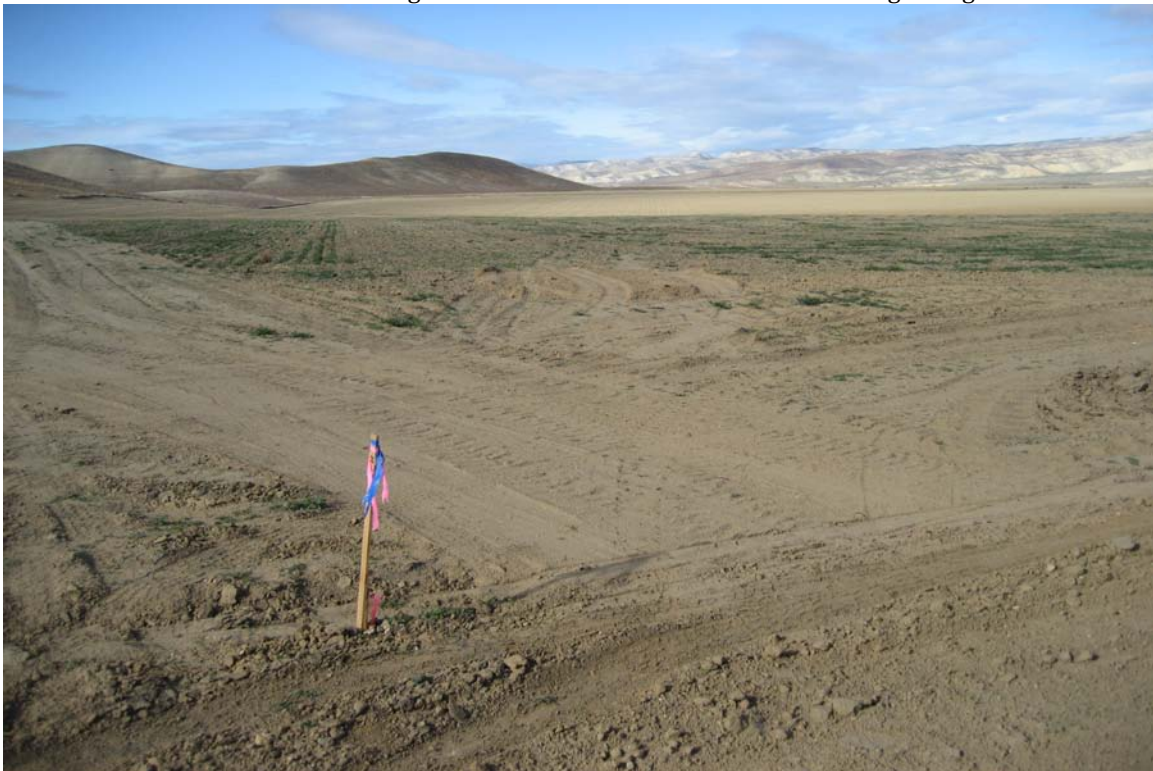
**Photo 6.** View of Reservoir #2 looking north. Stake marks eastern corner of the grading limits.

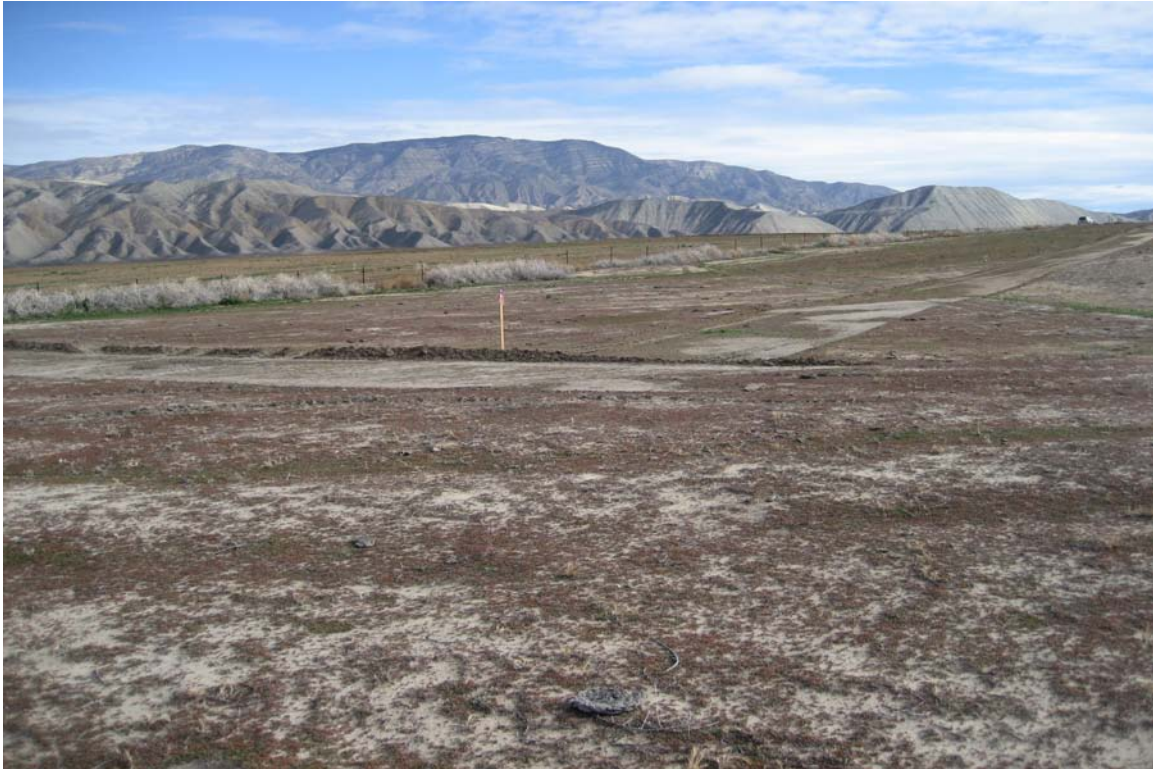
**Photo 7.** View of Reservoir #3 looking east. The site consisted of non-native weeds and bare soils prior to disking and site preparation. Russian thistle was also present and tumbleweeds can be seen along fenceline.

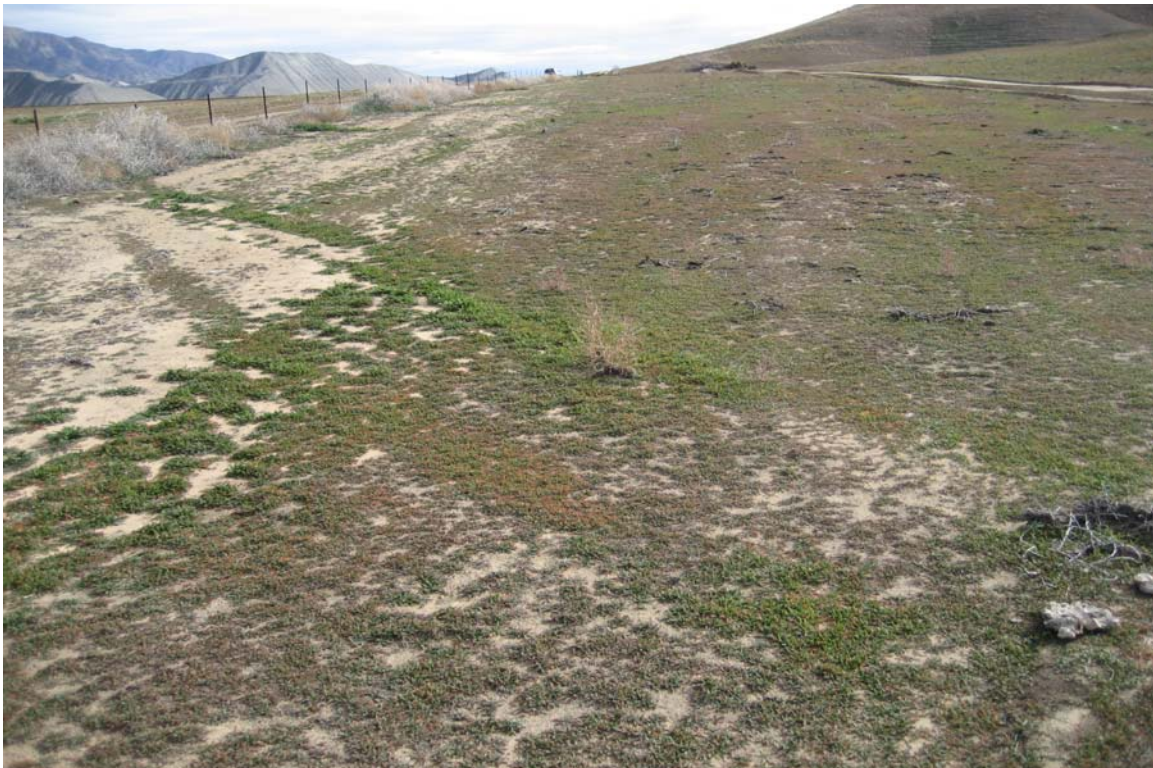
**Photo 8.** Closeup view of Reservoir #3 looking east. Photo taken prior to disking and site preparation activities showing dominant cover of non-native plants (primarily red-stemmed filaree) and bare soils.

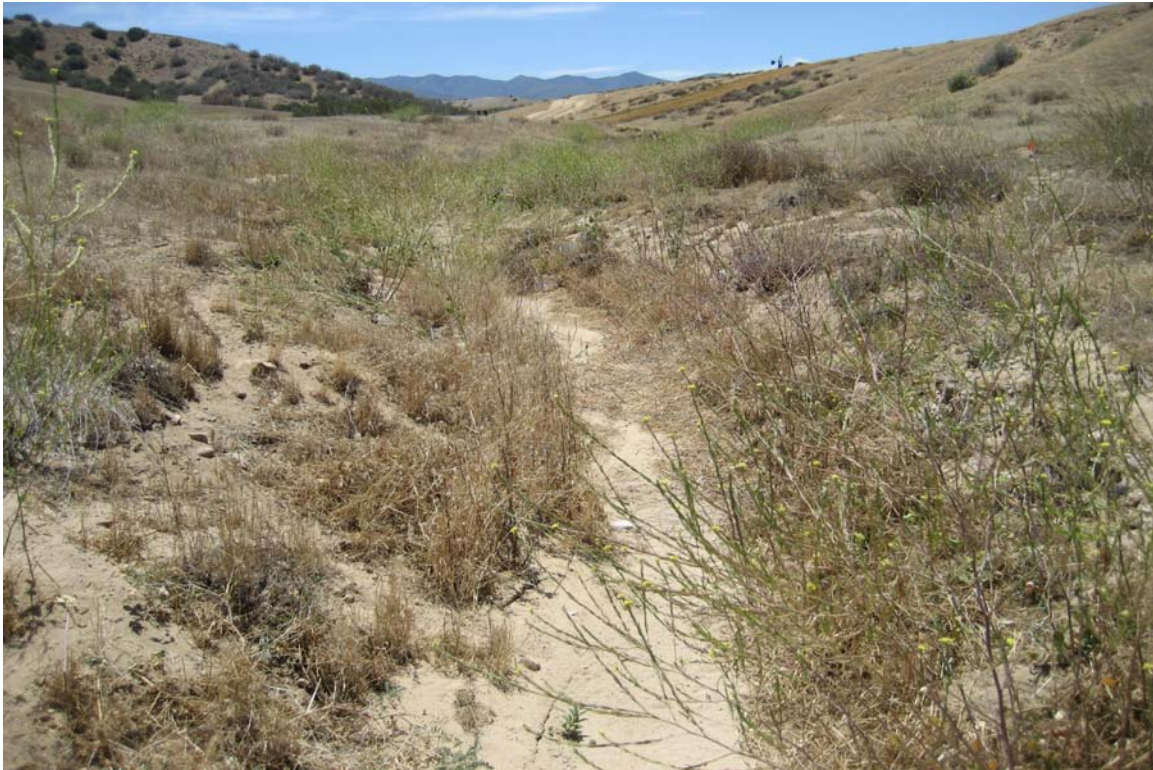
**Photo 1.** View of Crossing #1, looking upstream. Note narrow active channel section to be avoided by suspending waterlines above the banks.

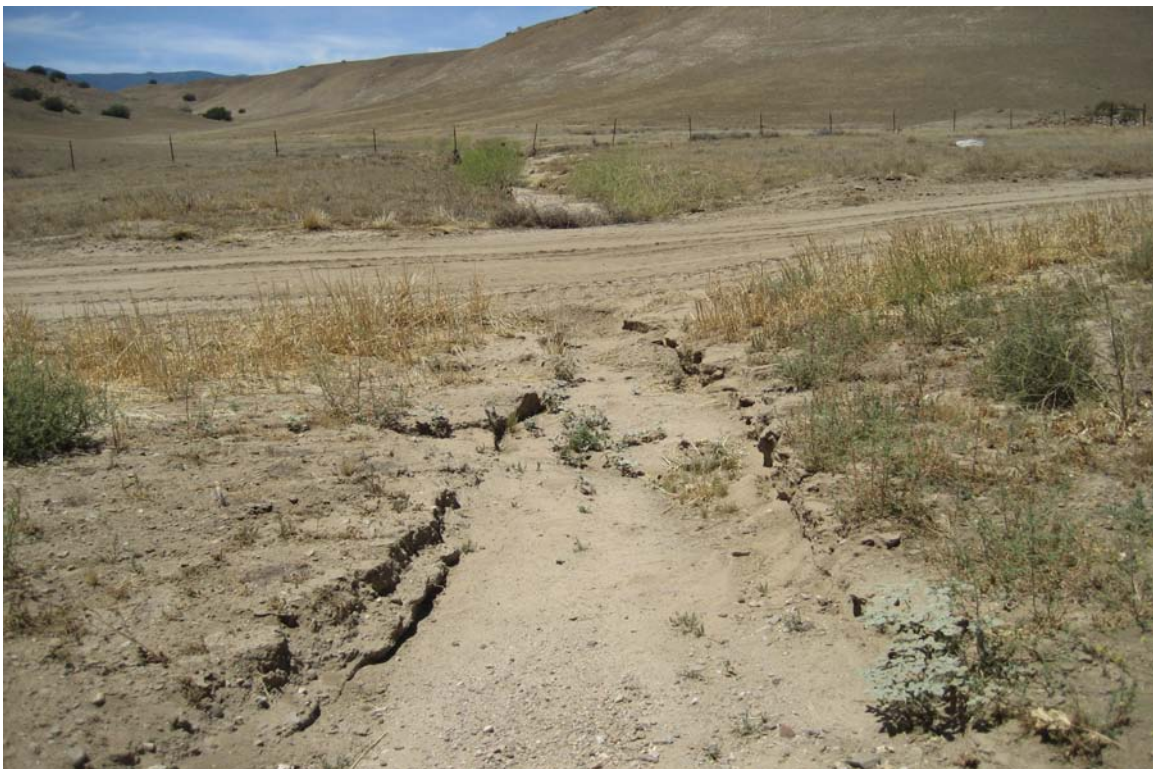
**Photo 2.** View of Crossing #2, looking upstream. Crossing alignment will be at downstream edge of road. Note flat, shallow channel configuration at this location.

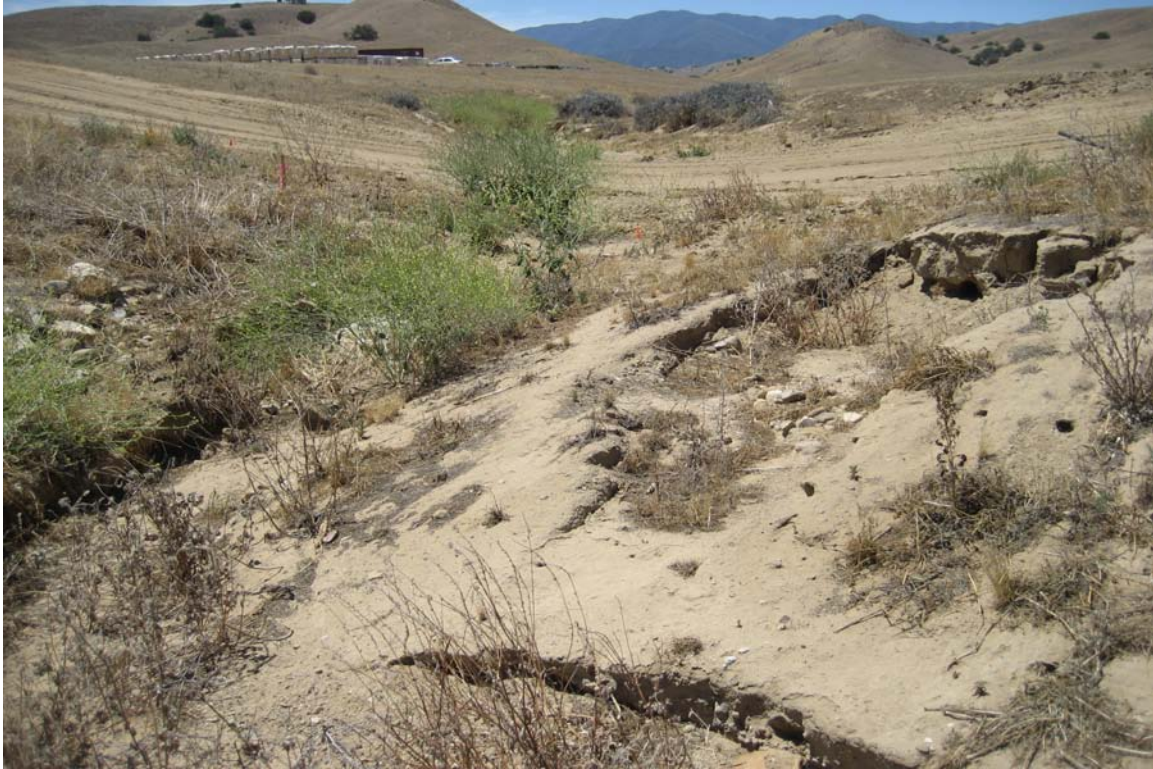
**Photo 3.** View of Crossing #3, looking upstream. Crossing alignment will be at downstream edge of road.

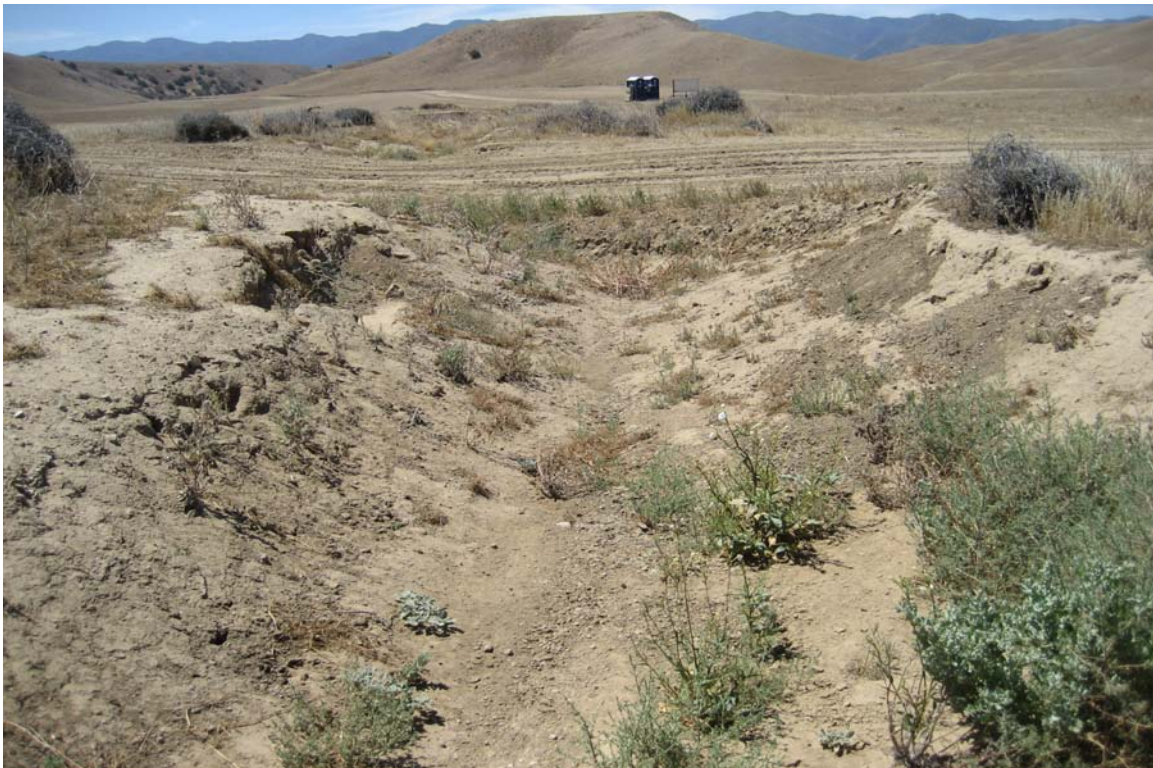
**Photo 4.** View of Crossing #4, looking upstream. Crossing alignment will be at downstream edge of road.

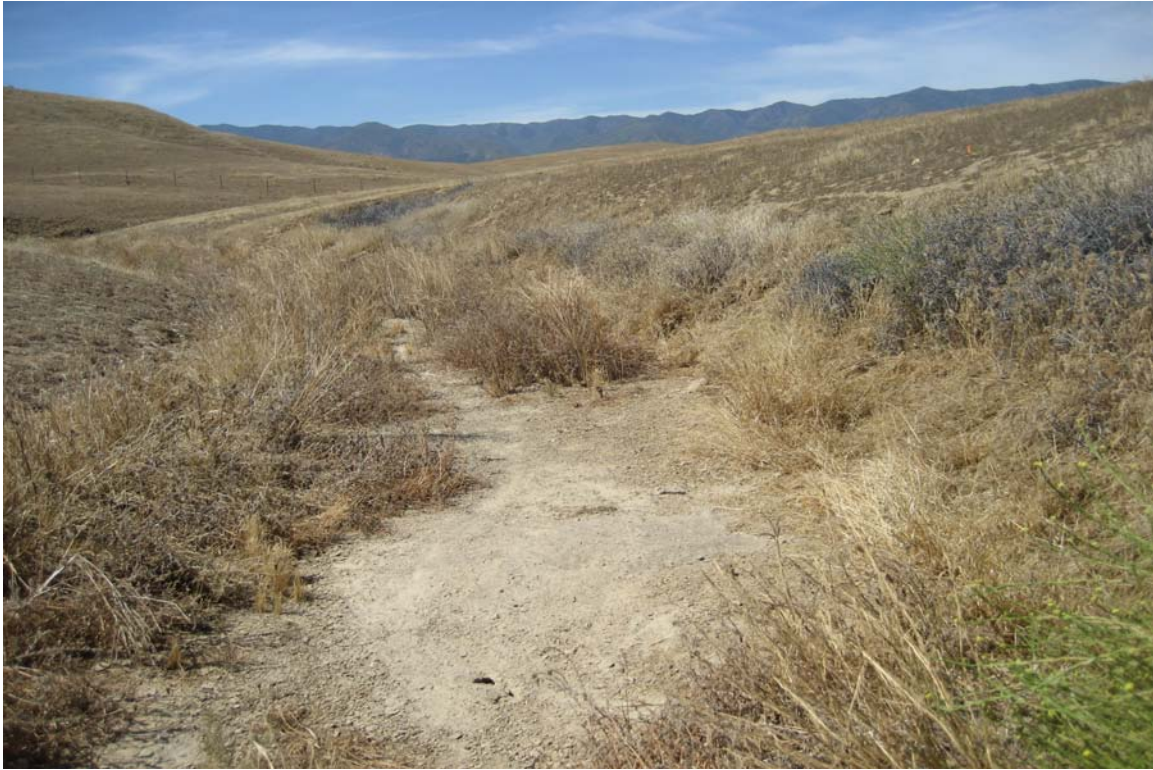
**Photo 5.** View of Crossing #5, looking upstream. Note flat, shallow active channel area and steep upper bank configuration.

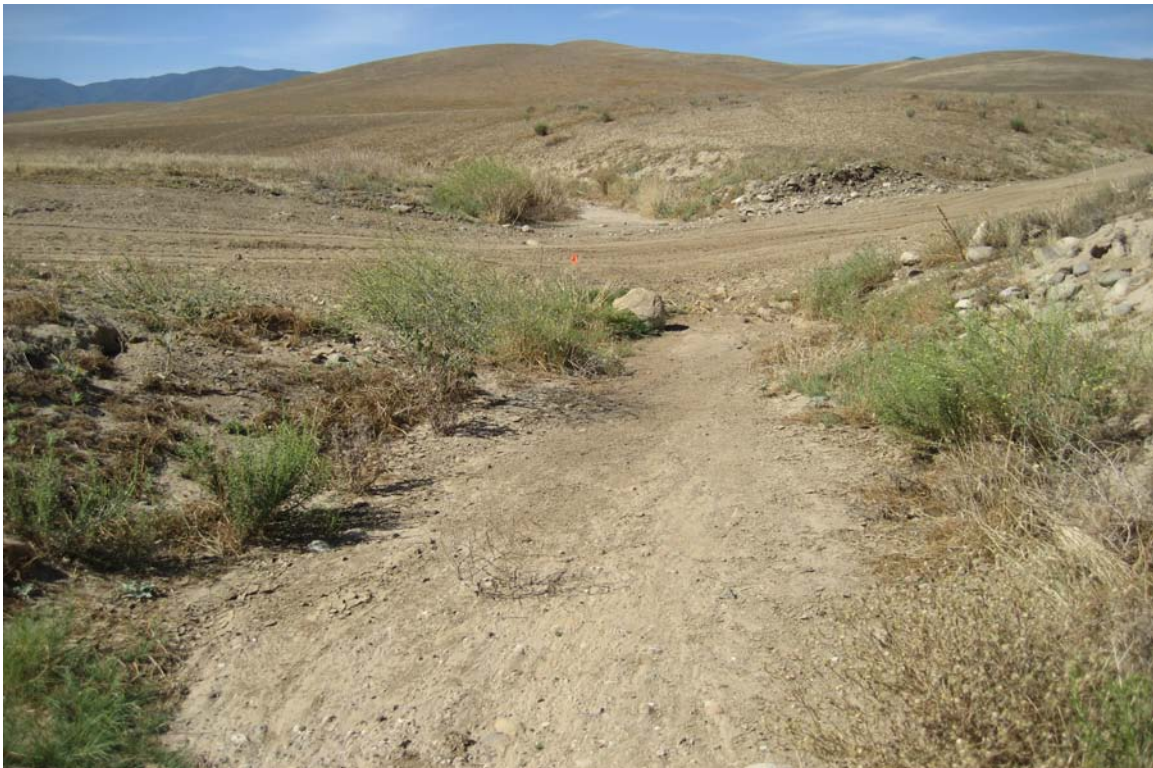
**Photo 6.** View of Crossing #6, looking upstream. Crossing alignment will be at downstream edge of road.

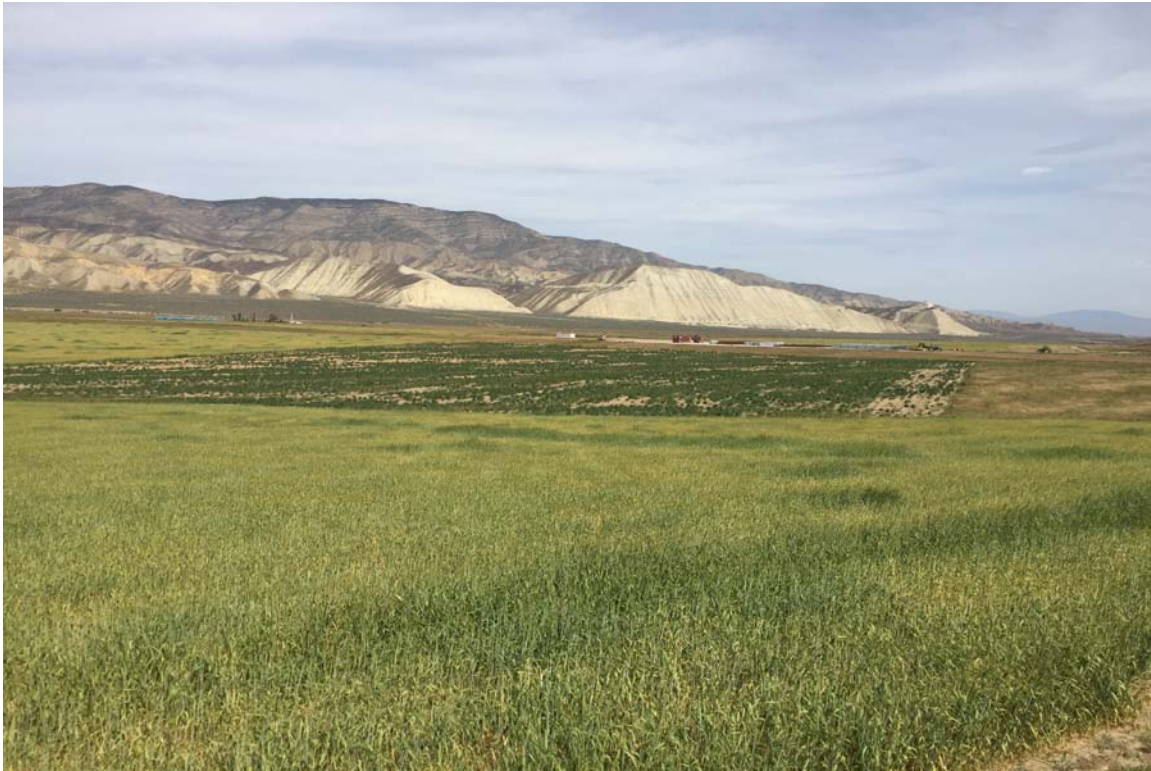
**Photo 7.** Overview of planted cover crop surrounding proposed Reservoir 2 with operations yard in the distance.

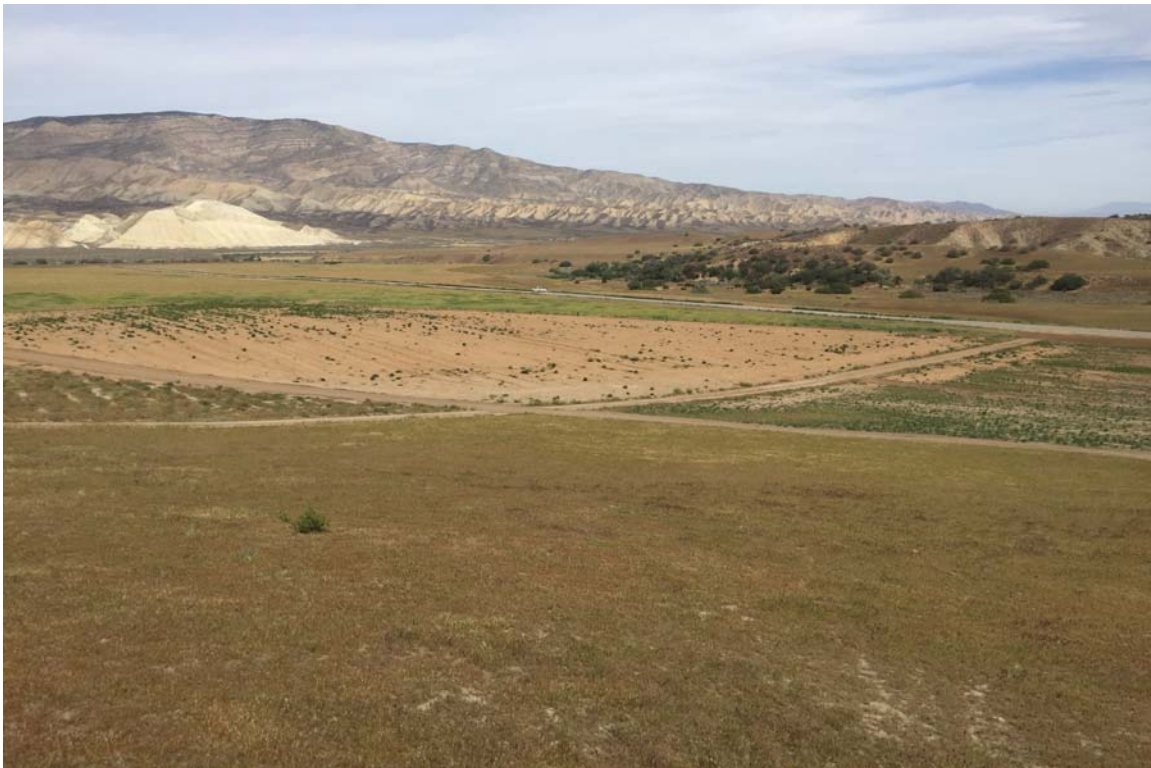
**Photo 8.** Overview of proposed Reservoir 3 (visible as bare soil area) with planted cover crop in flats and annual grassland on the slope in the foreground. Schoolhouse Canyon Road is visible in the distance.

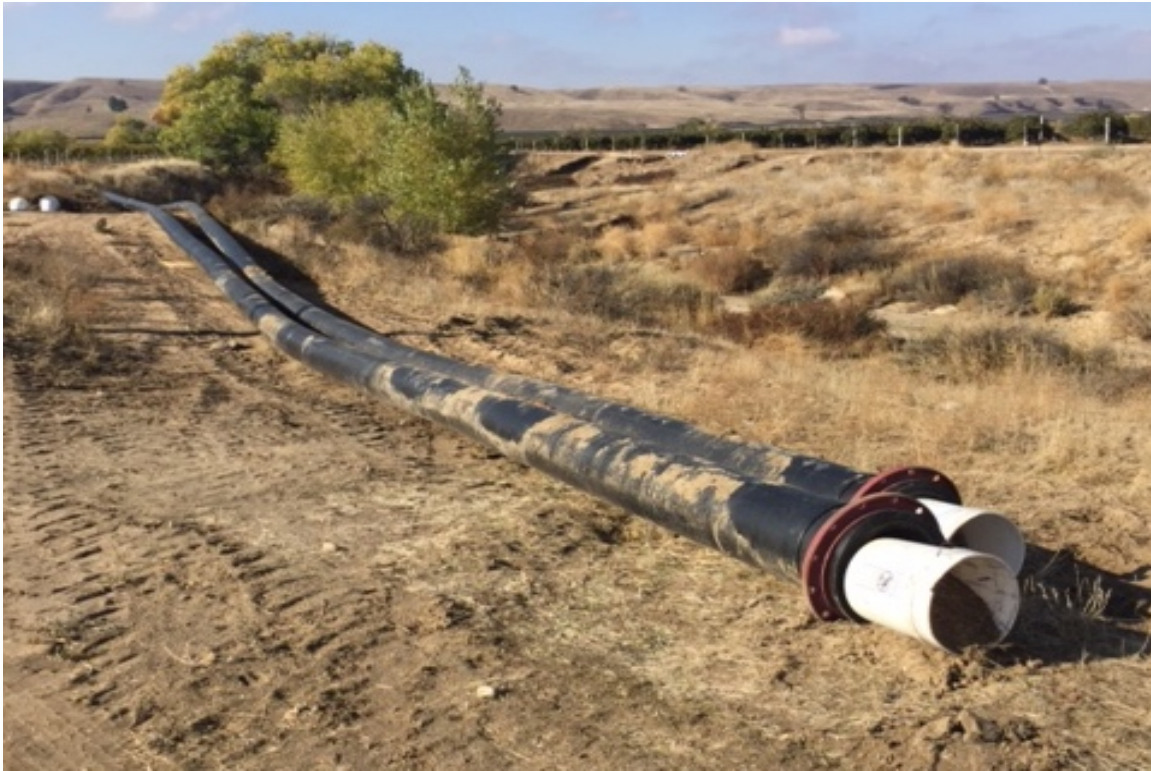
**Photo 9.** Representative photo from another site showing the flexible HDPE pipe to be laid above ground over the drainage features.

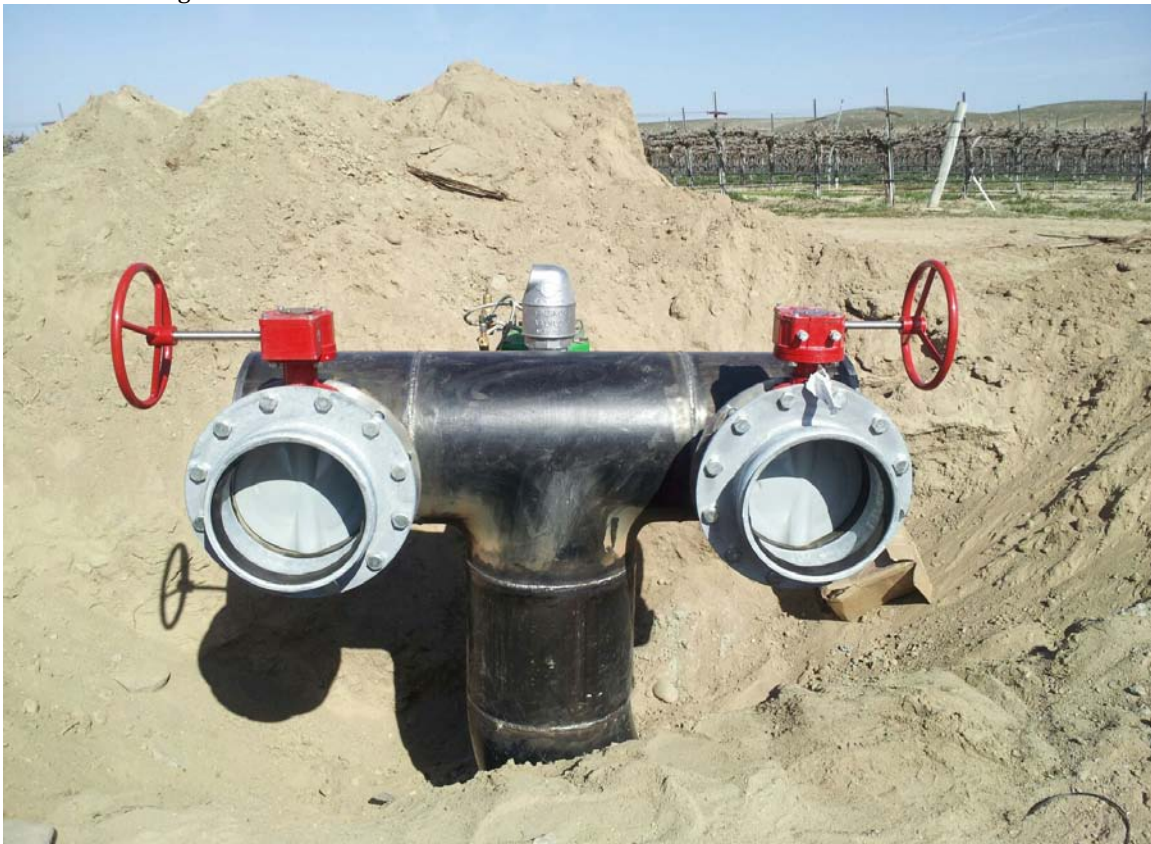
**Photo 10.** Representative photo of how waterline with valves will “daylight” outside top of bank of drainages. Flexible HDPE pipe will be attached and then run overland at drainage crossings.

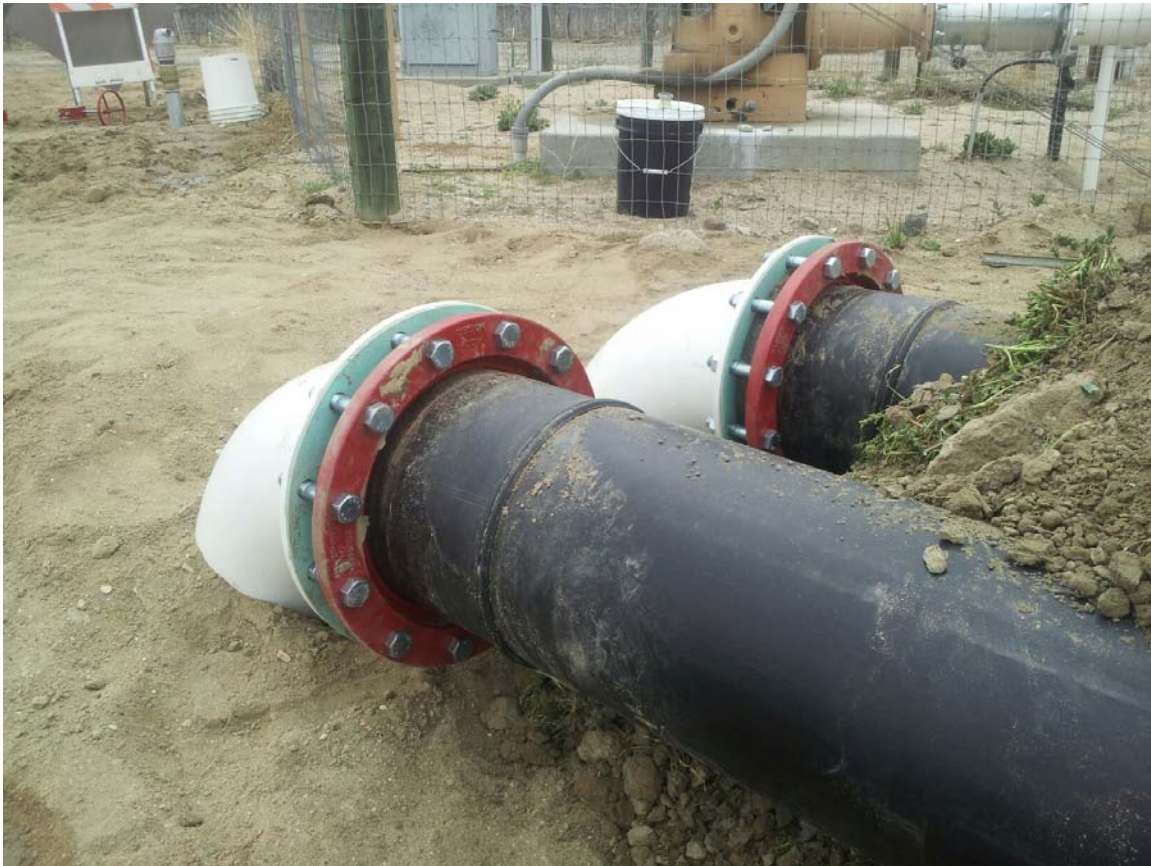
**Photo 11.** Representative photo illustrating connection of HDPE pipe and underground pipe.

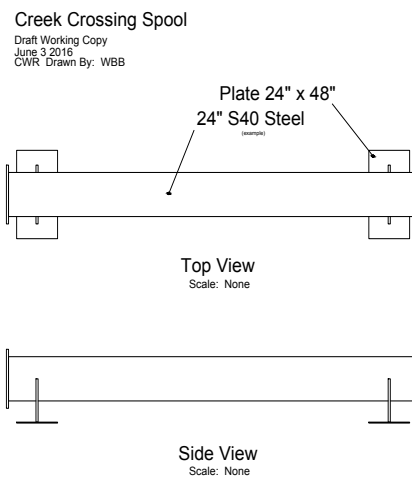
**Photo 12.** HDPE pipes will span active stream channels using the 20' long steel supports shown above.

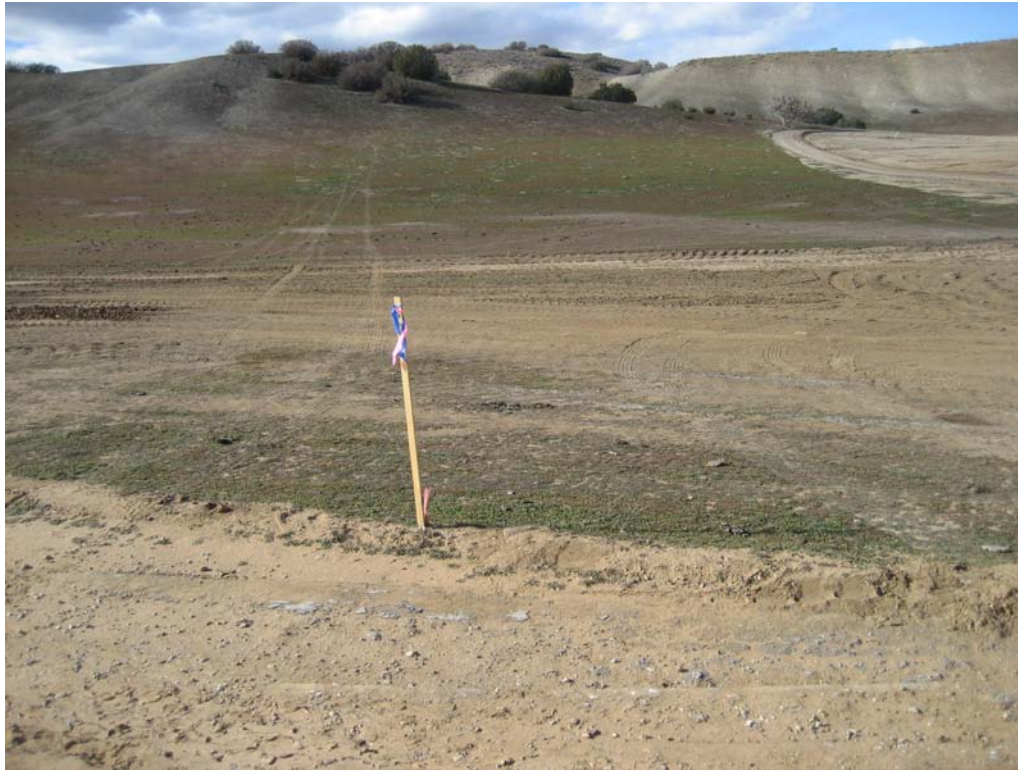
**Photo 1.** View of Reservoir 1 site looking westerly during surveys in 2016 when initial disking occurred showing filaree as dominant cover. Stake marks southeast corner of the reservoir.

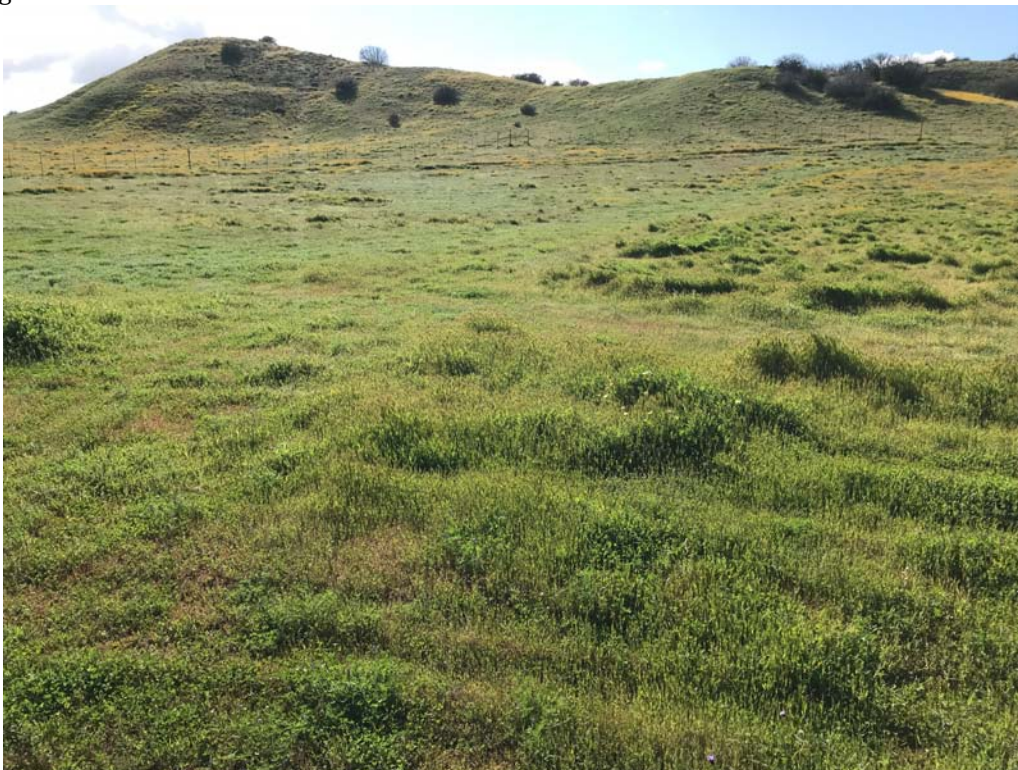
**Photo 2.** View of Reservoir 1 site in March 28, 2019 during an above average rainfall year with filaree and red brome forming dominant cover.

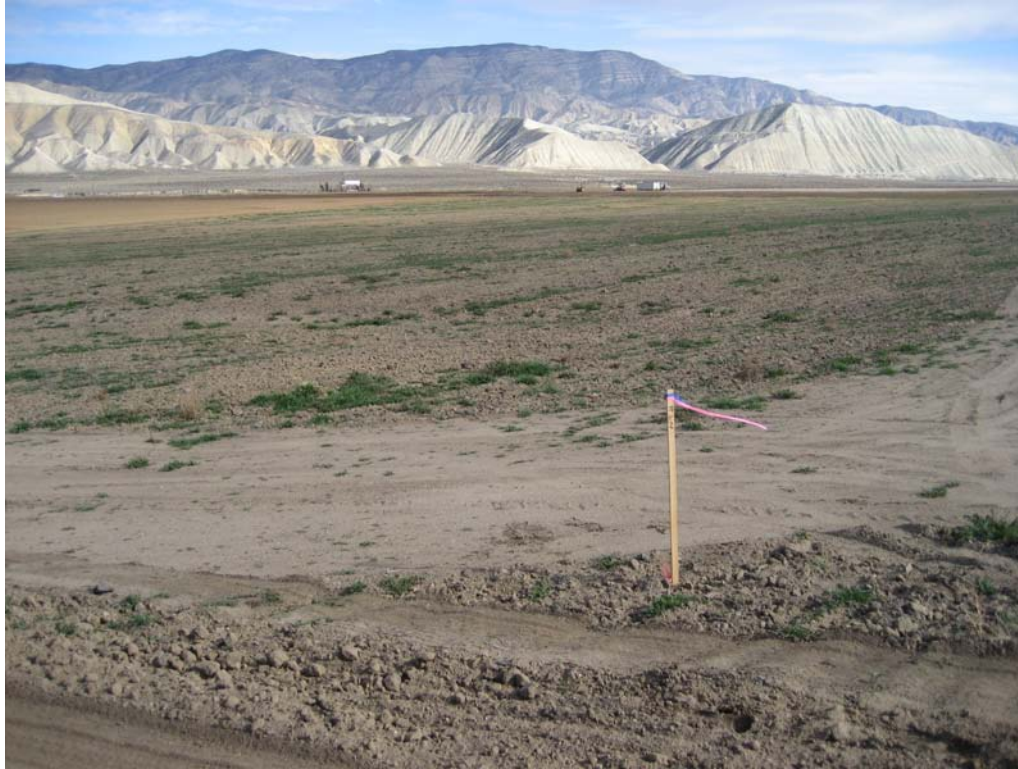
**Photo 3.** View of Reservoir #2 looking northeast in 2016 after initial disking activities. Stake marks western corner of the grading limits.

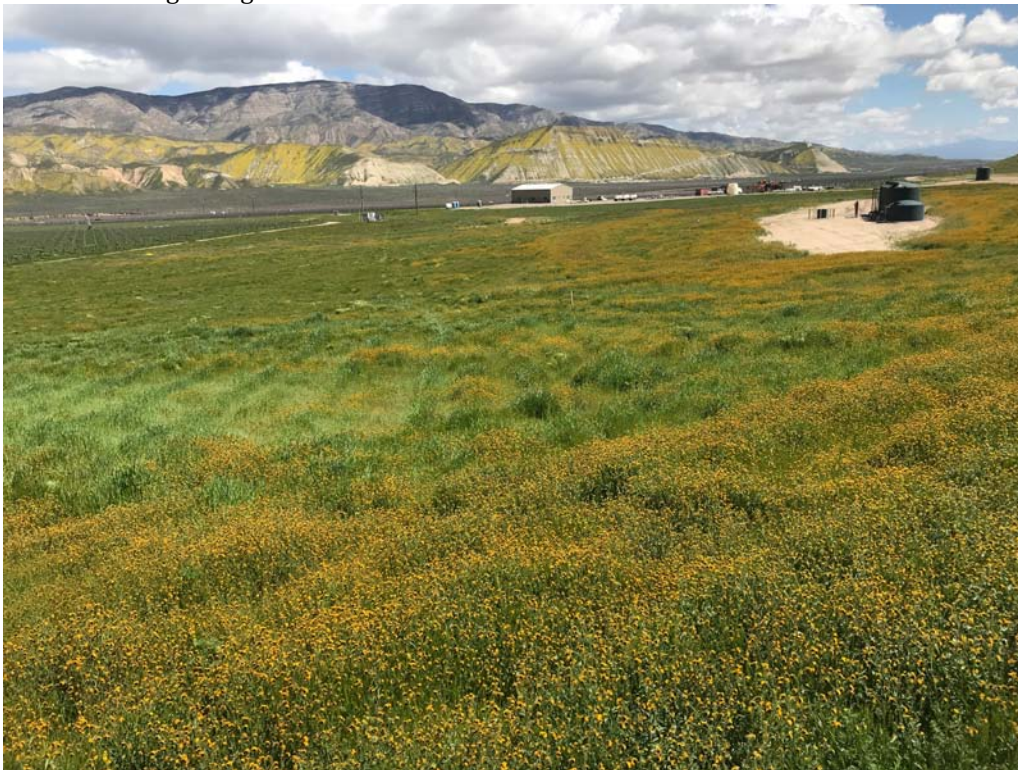
**Photo 4.** View of Reservoir #2 looking northeast in March 2019 showing fiddleneck and annual grasses. Note Operations yard in the distance and water tanks to the right.

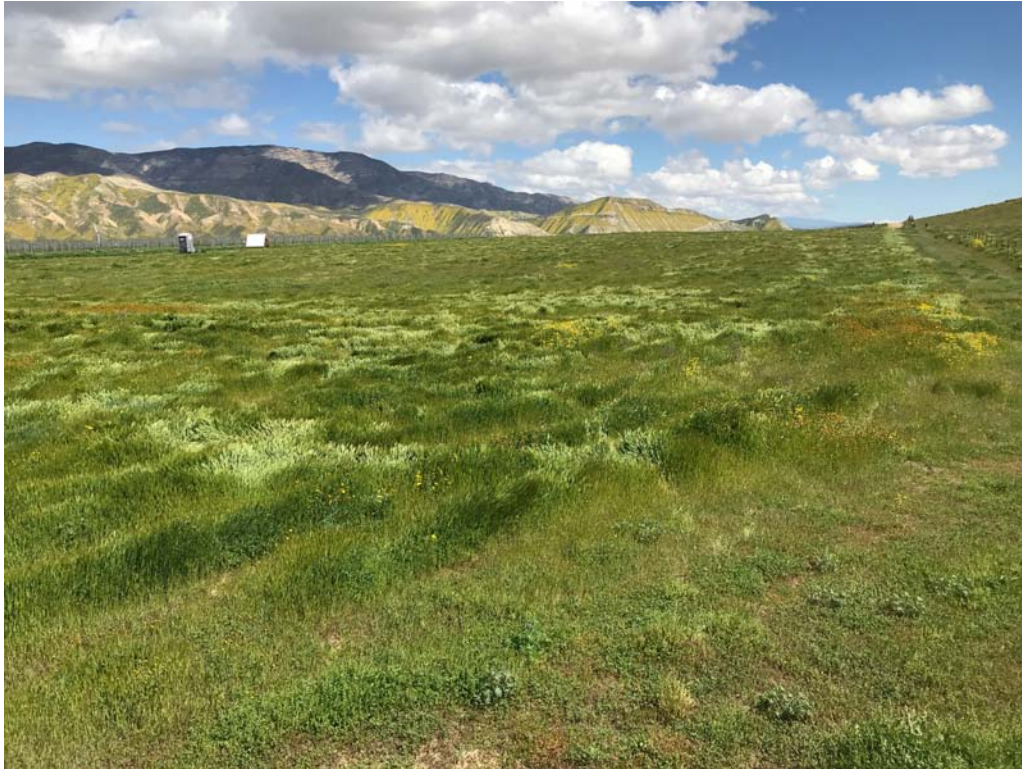
**Photo 7.** View of Reservoir #3 looking east on March 28, 2019 showing a mix of non-native annual grasses and fiddleneck along with a few patches of *Monolopia*.

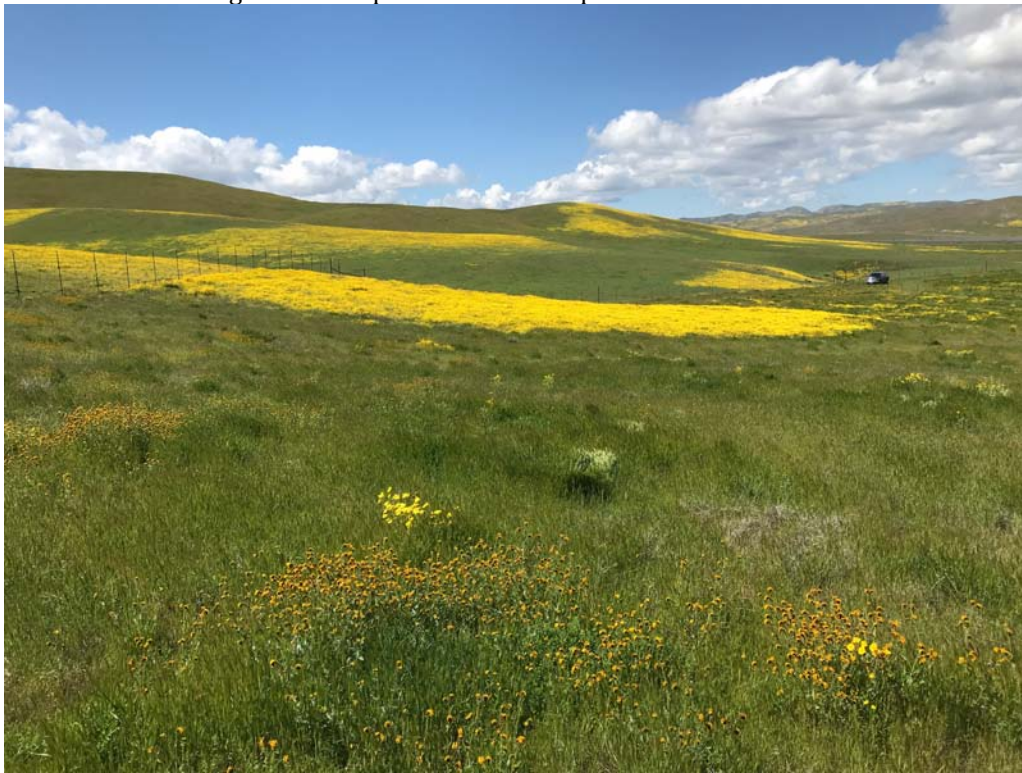
**Photo 8.** Photo of southwestern corner of Reservoir #3 study area in March 2019 showing curly bluegrass (native bunchgrass) and *Monolopia* (yellow patch) located just south of construction footprint. Refer to Figure 3C for further detail as the reservoir would be constructed in the flatter area to the right of the yellow wildflower patch.
