Appendix L-1

**Historical Resource Inventory
and Evaluation Report (2 of 2)**

*Resource Name or # 1725-1731 West 16th Street

c. Address: 1725-1731 W 16th City: Merced, CA Zip: 95348

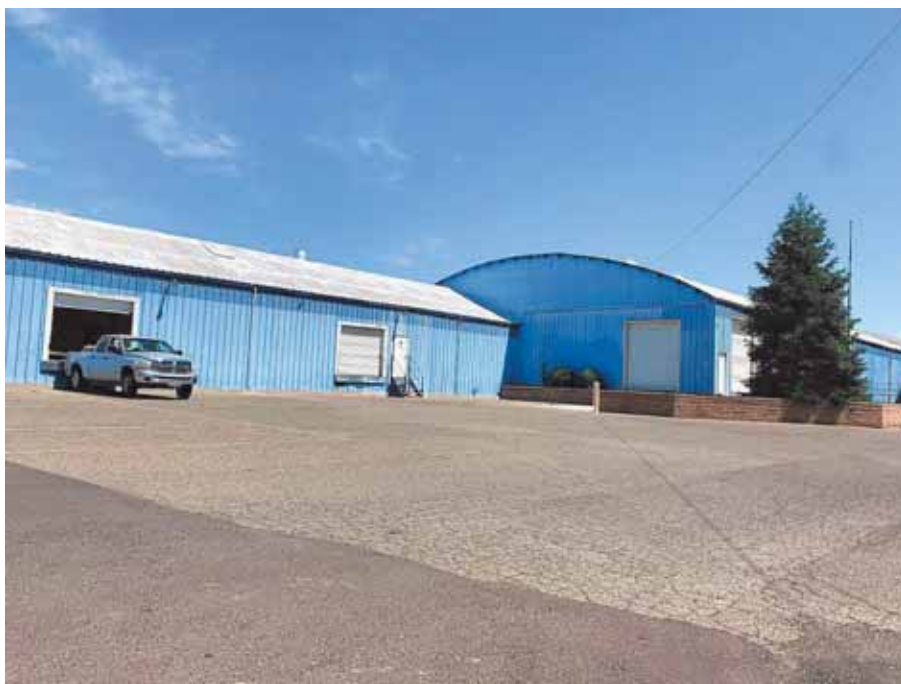
*P3a. Description: (Describe resource and its major elements. Include design, materials, condition, alterations, size, setting, and boundaries) 1725-1731 W 16th consists of a narrow, irregular shaped parcel northwest of the intersection of W 16th Street and Highway 59. It consists of a rectangular shaped, single-story warehouse building with two volumes, a vaulted roofed volume, and a gabled roof volume, both clad in corrugated metal sheeting on the walls and roofs. (See continuation sheet)

*P5b. Description of Photo: (View, date, accession #) 1725-1731 W 16th, Southeast elevation, looking northwest. January 2021. ICF.

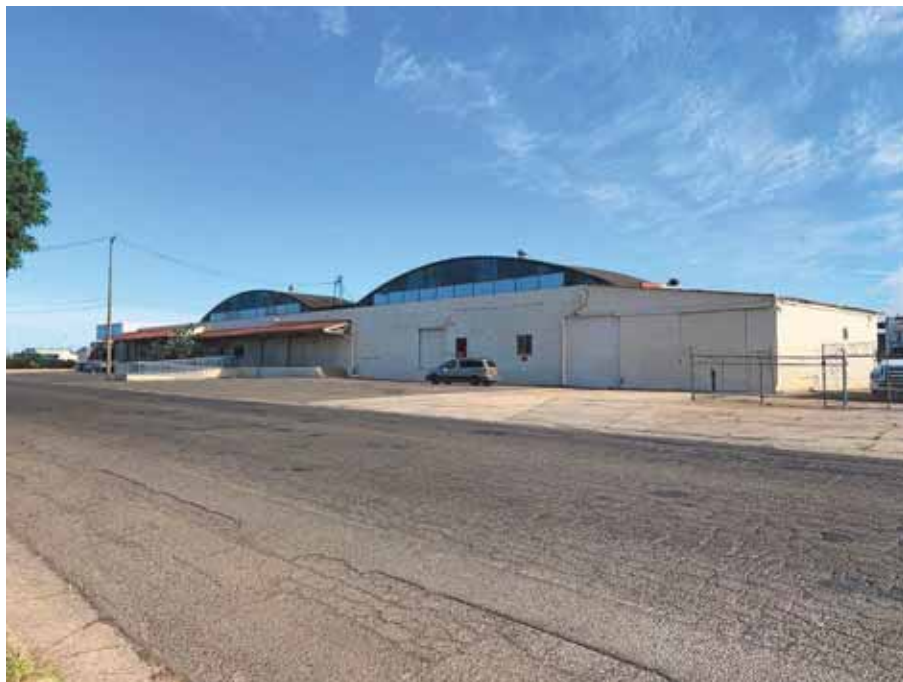
P5b. Description of Photo: (View, date, accession #) June 2020, south and east elevations, facing north. ICF. 2020.

The westernmost volume features a low-pitch side gable-roof and corrugated metal-clad volume with a concrete foundation and a covered loading bay facing West 15th Street. A small, fenced area and utility shed fronts this volume. The roof line features a distinct step down to the loading dock area moving east, where the roof transitions to a low-pitched shed-style angled down towards the east and center volume. The center volume appears as the oldest part of the building, featuring cinderblock construction with a combination flat and rainbow roof clad in black roofing material. Rows of windows clad in opaque material appear under the two arches on the façade, surrounding with corrugated metal sheeting on the walls. Six loading docks along the façade with roll-top style industrial doors. Windows along this elevation feature one multi-pane window with unknown frame materials near the loading bay doors, a large window just east of the main pedestrian entrance masked by opaque materials and having unknown features, and a small metal-framed two-light slider window along the eastern segment of this volume. A centrally located pedestrian entrance appears on the facade with signage labeling the building as a “Modesto City School District” property and that the building houses the Food Service and Print Shop departments and functions as a Warehouse. The sign notes the building address as 933 West 15th Street. A small secondary entrance appears along the easternmost area of this volume with cinderblock stairs and a metal guard railing. A prominent projecting canopy clad in rust-red corrugated metal sheeting projects from the façade towards West 15th Street, sheltering the main pedestrian entrance and five of the six loading back docks. A prominent wheelchair ramp runs from the parking lot at ground level to the main pedestrian entrance and the loading dock level.

A small cinderblock and corrugated metal, shed-style roofed volume, easternmost on the building, appears clad in corrugated metal sheeting and features a large horizontal-sliding metal doorway mounted to a track. A small, fenced parking area abuts the eastern border of the easternmost parcel. No other window features appear on the façade or the east elevation. The north elevation of this property features two additional loading bay doors and a second row of opaque windows along the arched roof, but no other secondary entrances or windows appear. Overall, the property is in good condition.

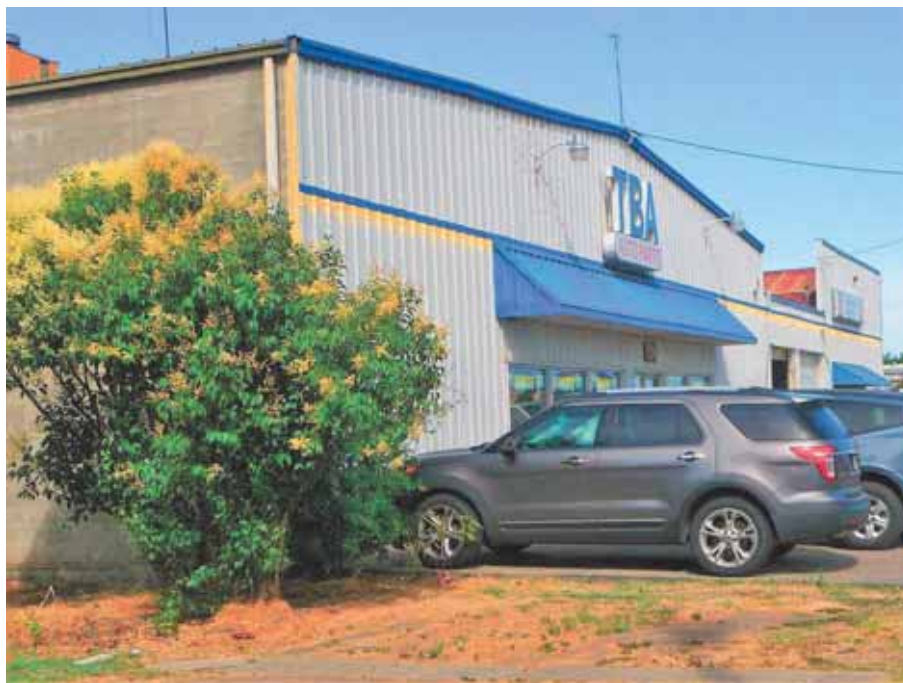
P5b. Description of Photo: (View, date, accession #) TBA Auto Parts, June 2020, view facing southwest, portions of the north and east elevations. ICF.

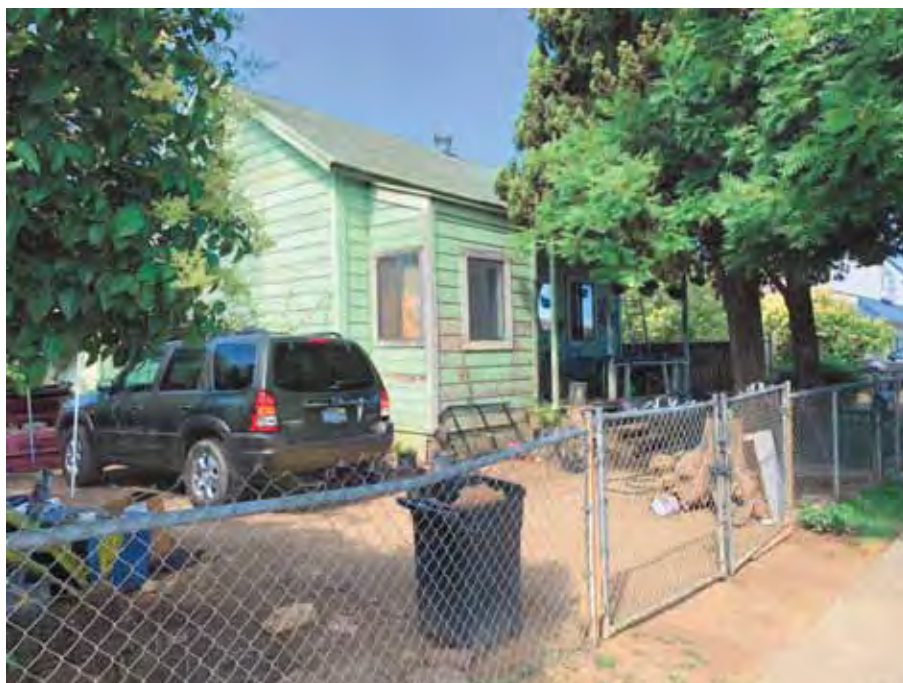
The house at 912 W. 15th Street is a single-story cottage, likely evolved from a simple Hall and Parlor style. The residence is on a raised wooden foundation with wooden clapboard siding and a gable roof of moderate pitch clad in composite shingle. Plain wooden posts support an inset porch, running 2/3 the length of the façade, with the main entry located within the porch. (not visible from right-of-way) and front window. To the west of the front door is a small protruding bay with a shed roof, facing northwest. The windows on all elevations have wooden casements but appear to be replacement aluminum windows likely dating from the second half of the twentieth century. The window type is consistent at all visible elevations, with two windows at the extension, one on the façade to the east of the entrance, and two on the southeast facing elevation. Aerial images indicate the house has a rectangular footprint. Mature trees and plants, including two Italian Cypress at the property line facing 15th Street, surround the property.

P5b. Description of Photo: (View, date, accession #) June 12, 2020, view facing east

*B6. Construction History: (Construction date, alteration, and date of alterations) Built in 1923. Ancillary building, likely a shed, at the rear of the property demolished c. 2014-2016. Roof, windows and doors all appear to be replacements circa mid-20th century.

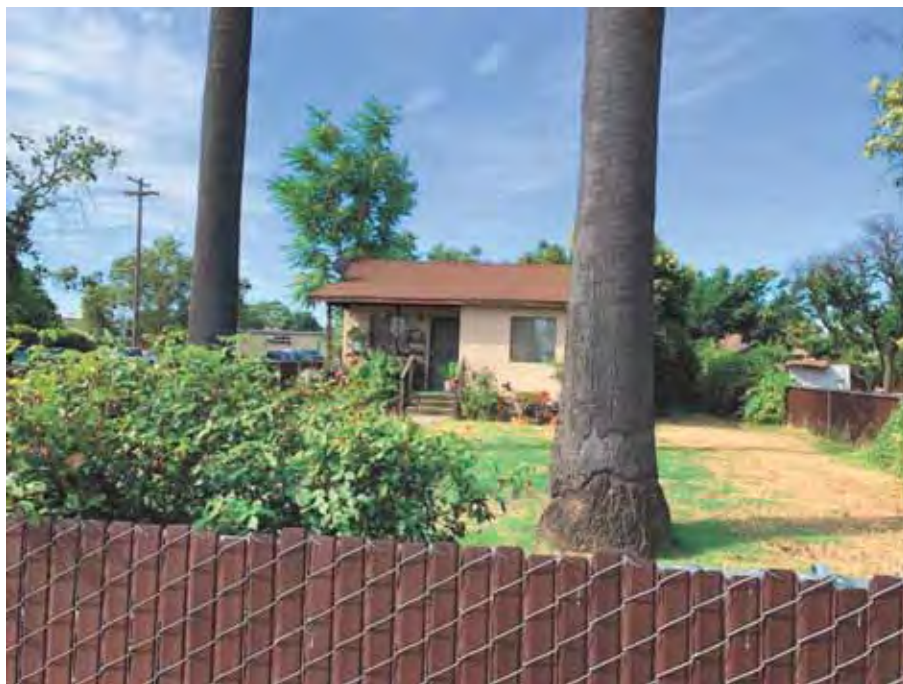
The property at 904 W 15th Street is a single-story style residence. The residence has a raised foundation, stucco siding, and a low-pitch cross gable roof clad in composite shingle. A shed-roof projection on the façade creates a small, covered porch and also covers the projecting front bay at the east side of the façade. The porch roof is supported by plain wooden columns, and there is a small wood and concrete staircase leading from the front lawn to the front door; the door is currently obscured by a modern-era metal security door. The two windows at the façade, one to the west of the front door and one on the projecting bay, are aluminum sliding windows, with narrow aluminum casements. The northwest elevation has two aluminum slider windows and an air conditioning unit obscures one of those windows. The rear elevation (northeast facing) has two similar aluminum slider windows, and a rear entrance door that is protected by a metal security door. The property has mature landscaping including two large palm trees at the façade and a mimosa tree at the rear, and the parcel is encircled with a chain link fence with vinyl slats.

P5b. Description of Photo: (View, date, accession #) June 12, 2020, view facing east

*B6. Construction History: (Construction date, alteration, and date of alterations) Built c. 1900 with an effective year of 1970, when roof was likely replaced, windows replaced with aluminum slider windows, and new security doors added. Chain link fence added c. 1970. Stucco siding likely redone in the second half of the twentieth century and possibly related to 1970 remodeling.

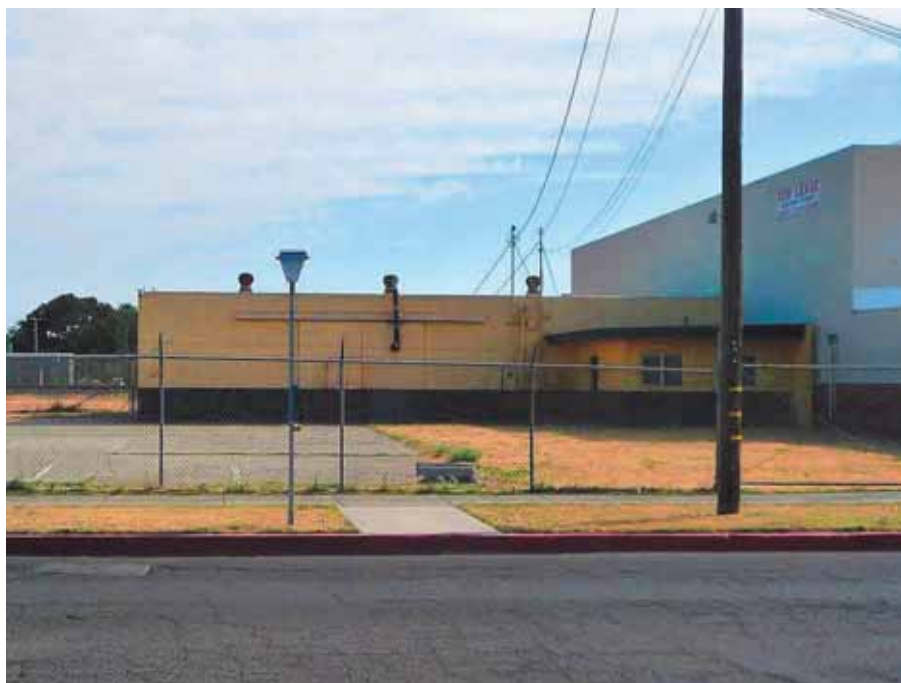
P5b. Description of Photo: (View, date, accession #) 863 West 15th Street abutting 855 West 15th Street, view facing north, south elevation. June 12, 2020. ICF.

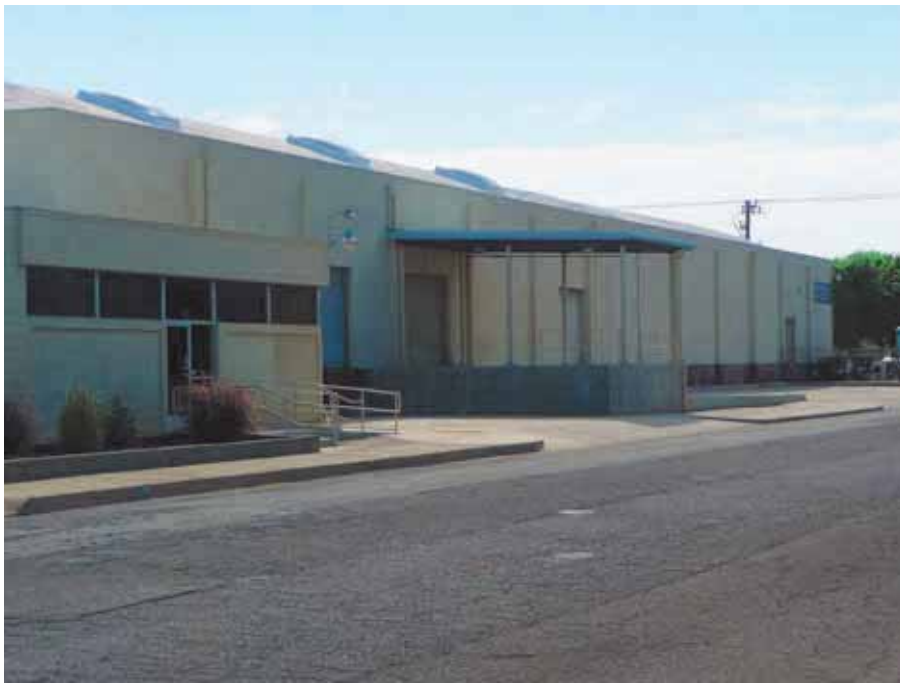
P5b. Description of Photo: (View, date, accession #) 855 West 15th Street, June 2020, view facing northeast, portions of the east elevation warehouse, loading dock, office space, and parking. ICF.

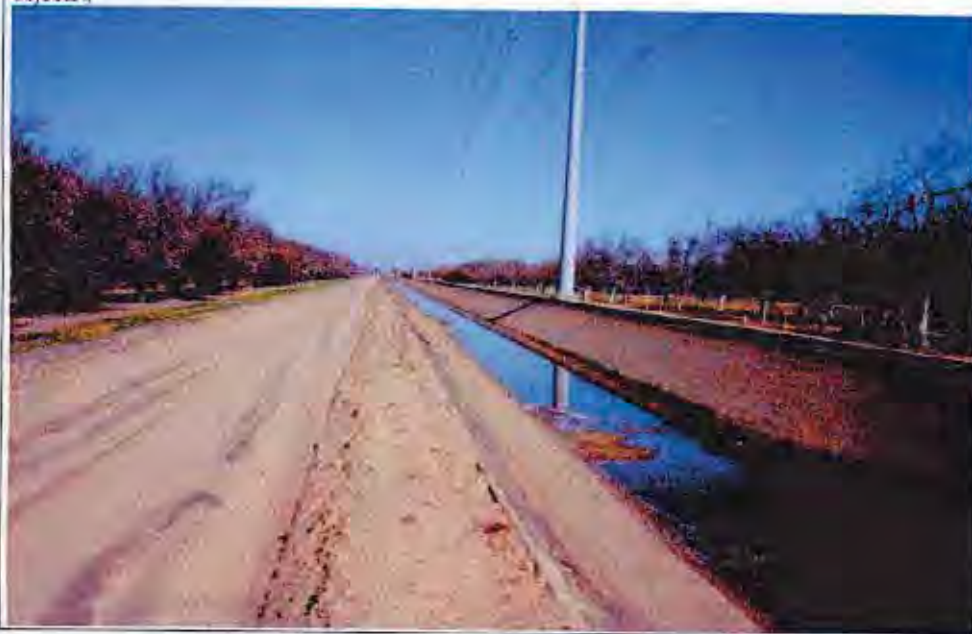
Turlock Irrigation District Main Canal in Ceres, Mitchell Road, view looking north, March 8, 2009.

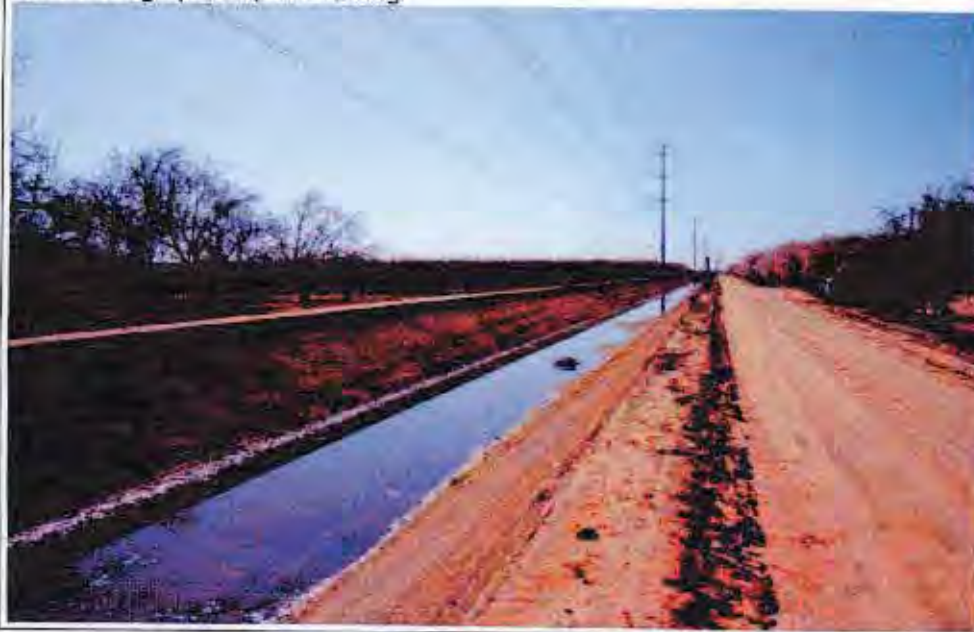
L8b. Description of Photo: Ceres Main Canal. View looking south along the unpaved section of Mitchell Road.

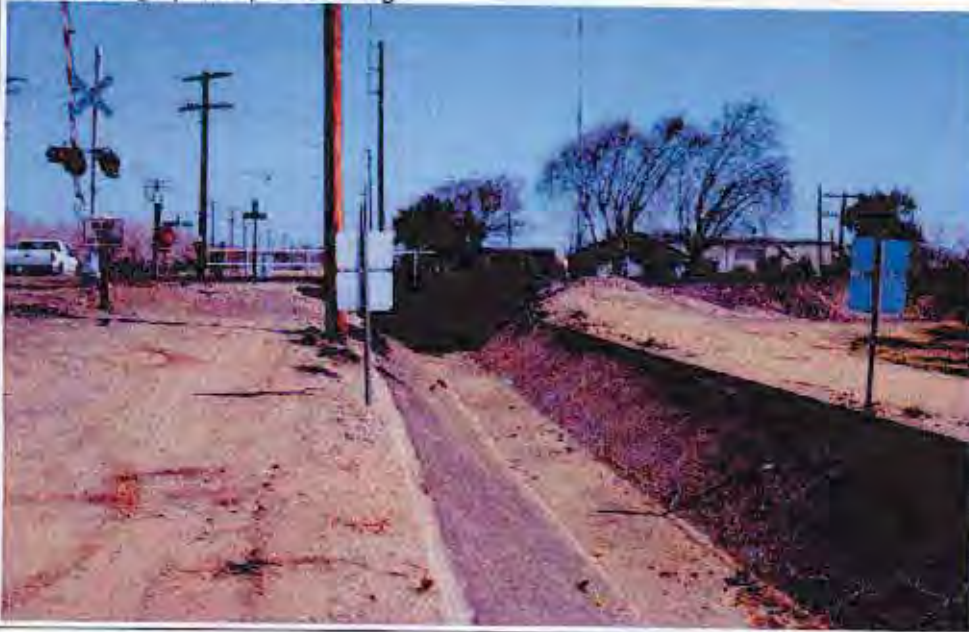
L7. Integrity Considerations: The lateral canal is still used as part of an active irrigation system that covers 307 square miles. Due to continual upkeep and maintenance, the canal has lost integrity in materials, design, setting and workmanship. This segment is not eligible for listing in the National or California Register.

Upper Lateral No. 2 where it intersects with the Burlington Northern Santa Fe Railroad line. View looking east, March 8, 2009.

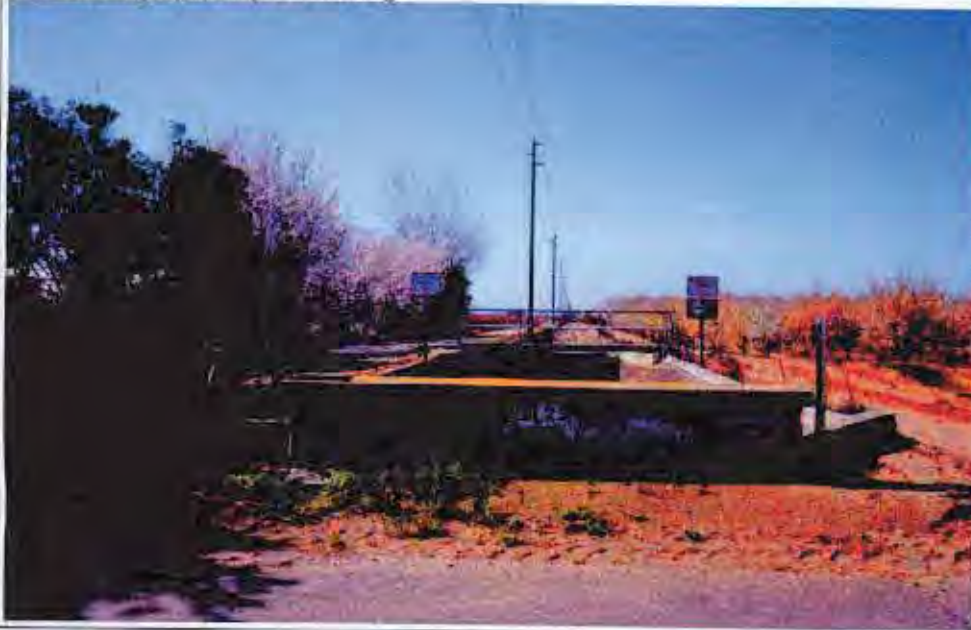
L7. Integrity Considerations: The lateral canal is still used as part of an active irrigation system that covers 307 square miles. Due to continual upkeep and maintenance, the canal has lost integrity in materials, design, setting and workmanship. This segment is not eligible for listing in the National or California Register.

Upper Lateral No. 2 where it intersects with Washington Road. View looking west March 8, 2009.

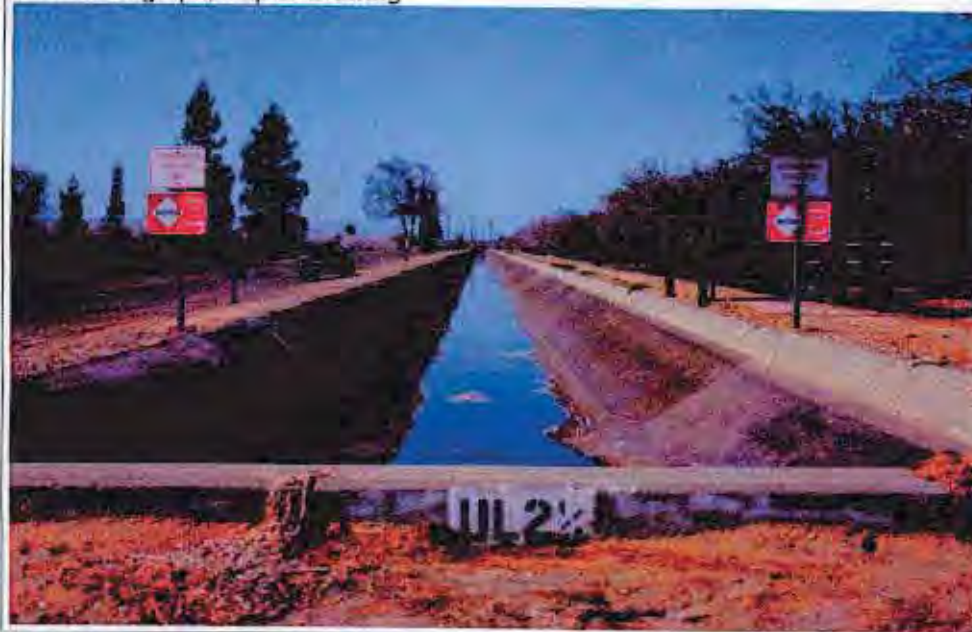
L7. Integrity Considerations: The lateral canal is still used as part of an active irrigation system that covers 307 square miles. Due to continual upkeep and maintenance, the canal has lost integrity in materials, design, setting and workmanship. This segment is not eligible for listing in the National or California Register.

Upper Lateral No. 2 ½ where it intersects with Prairie Flower Road. View looking west. March 8, 2009

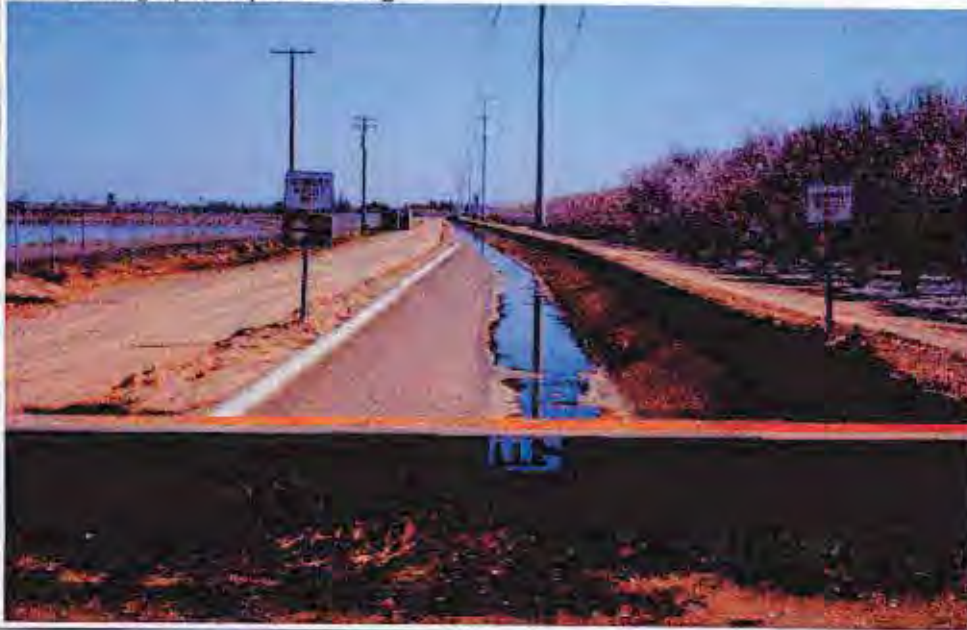
L7. Integrity Considerations: The lateral canal is still used as part of an active irrigation system that covers 307 square miles. Due to continual upkeep and maintenance, the canal has lost integrity in materials, design, setting and workmanship. This segment is not eligible for listing in the National or California Register.

Lower Lateral No. 2. View looking west from Morgan Road towards intersection of canal with railroad line. March 8, 2009.

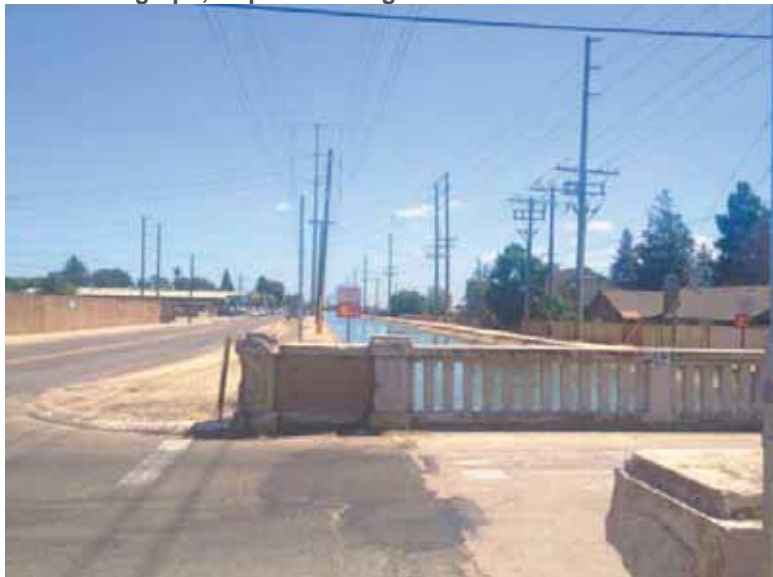
L7. Integrity Considerations: Originally an earthen-bermed canal, constructed with horses, graders, scrapers, and manual labor, the canal has been improved and maintained over the ensuing years by lining it with concrete, replacing original metal culverts and gates, checks, valves, etc. During the 1920s-1930s the canals were lined with concrete and have undergone periodic modifications to features since their construction. Although the Turlock Main Canal follows the same course as when completed in the early 1900s, it was lined with concrete in 1927, resurfaced with Gunitite in 1958 and 1985, and upgraded to modern standards. Consequently, it lacks integrity and is not eligible for the National Register.

Canal facing south with Caltrans Bridge 38C0245 in foreground.

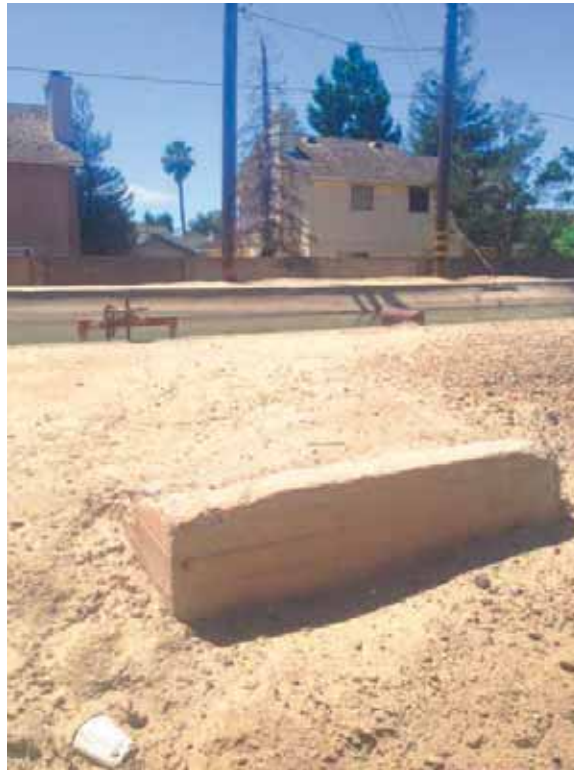
Feature A includes a broken concrete foundation in line with an intake valve. A metal pipe stand extending from the ground and pumping into the canal is adjacent to the intake valve. Feature B is a concrete box with a heavily corroded metal lid with two hinges. Feature B is adjacent to a dam.

Photo 753. Feature A – cement foundation and pipe (right background) on the east side of the canal in the berm, adjacent to an intake valve (left background). Facing west.

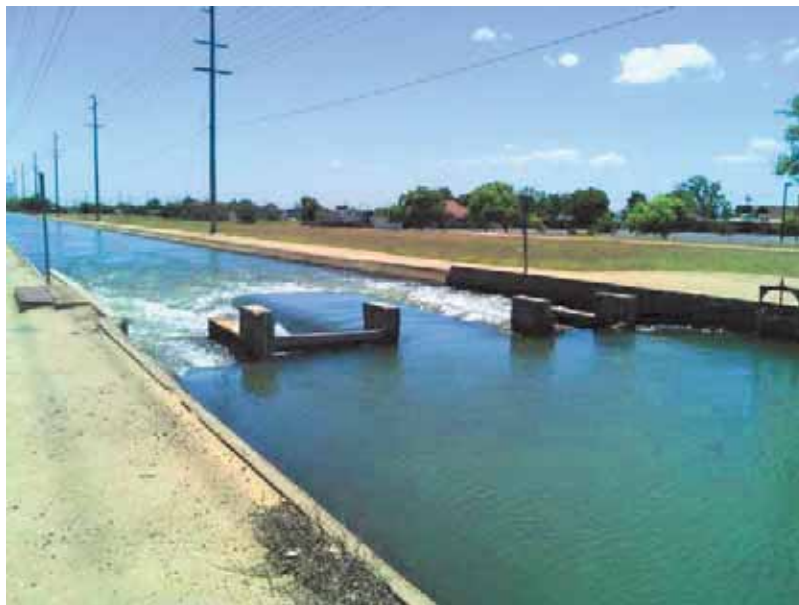
Photo 753. Feature B – metal box (left) on the eastern berm of the canal, associated with the dam. Facing southwest.

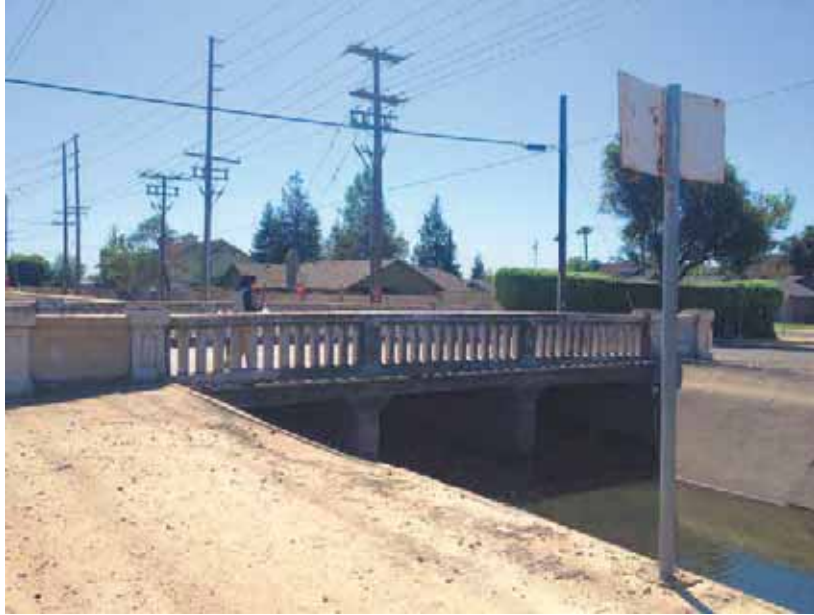
Caltrans Bridge #38C0245 facing south/southwest with T.I.D. berm in foreground.

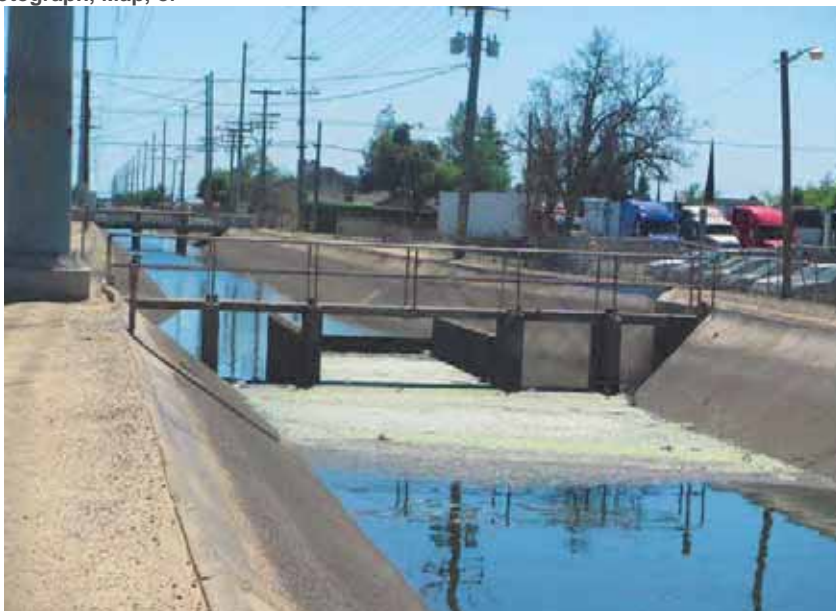
L7. Integrity Considerations: Originally an earthen-bermed canal, constructed with horses, graders, scrapers, and manual labor, the canal has been improved and maintained over the ensuing years by lining it with concrete, replacing original metal culverts and gates, checks, valves, etc. During the 1920s-1930s the canals were lined with concrete and have undergone periodic modifications to features since their construction. Although the Turlock Main Canal follows the same course as when completed in the early 1900s, it was lined with concrete in 1927, resurfaced with Gunite in 1958 and 1985, and upgraded to modern standards. Consequently, it lacks integrity and is not eligible for the National Register.

L8b. Description of Photo, Map, or Drawing (View, scale, etc.)
View south (3/25/2015)

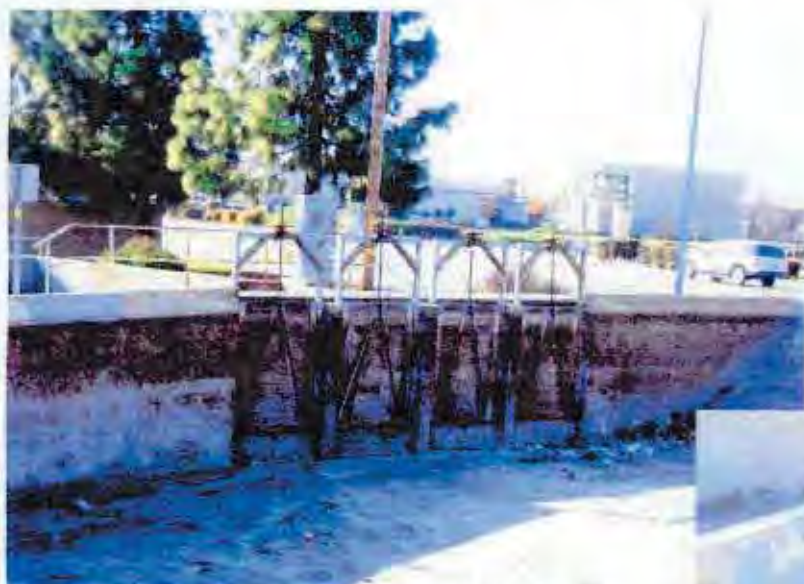
Four gates are located at the Head of Lateral One, constructed of board-formed concrete, with wood gates with metal bottoms, raised with Waterman valves and supported by square metal posts and rails, which divert water from the canal into Lateral One and the Main Canal. Lateral One, which continues west, conveys water through a concrete pipeline, accessed from the head drop through a trash gate (grizzly). Five concrete gates, with a central rectangular board-formed concrete water measuring weir, divert water due south into the Main Canal. A pedestrian bridge, constructed of concrete with board decking, crosses the canal at this point. Another pedestrian bridge, of more recent construction, has a concrete deck and a pipe rail. It provides access across the south branch of the Main Canal. Upstream from the diversion gates, a lateral (13-2) diverts water north through a gate with a Waterman valve, to the agricultural area north of the Main Canal. The age of the Waterman valves and improvements to the canal are unknown, as the TID does not keep historical records of replacements (Vanderpol 2009).

No. 1. Headgates, Head of Lateral One and Ceres Main Canal.

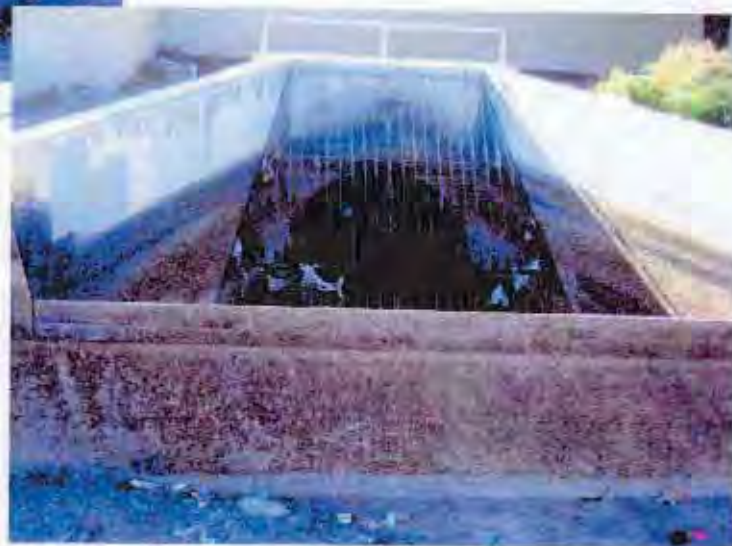
No. 2. Lateral 1 at Ceres Main Canal, view west.

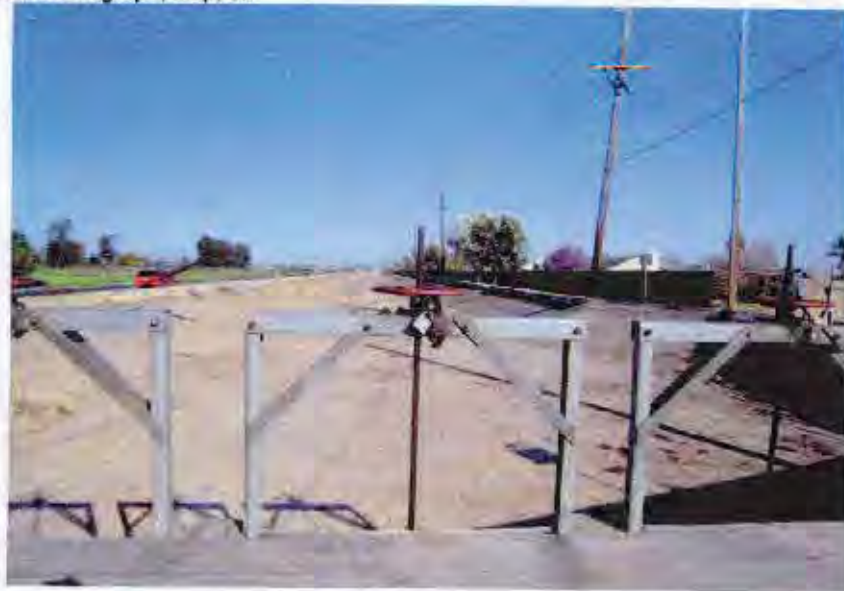
L7. **Integrity Considerations:** Originally an earthen-bermed canal, constructed with horses, graders, scrapers, and manual labor, the canal has been improved and maintained over the ensuing years by lining it with concrete, replacing original metal culverts and gates, checks, valves, etc. During the 1920s-1930s the canals were lined with concrete and have undergone periodic modifications to features since their construction. Although the Turlock Main Canal follows the same course as when completed in the early 1900s, it was lined with concrete in 1927, resurfaced with Gunite in 1958 and 1985, and upgraded to modern standards. Consequently, it lacks integrity and is not eligible for the National Register.

View east (3/12/09)

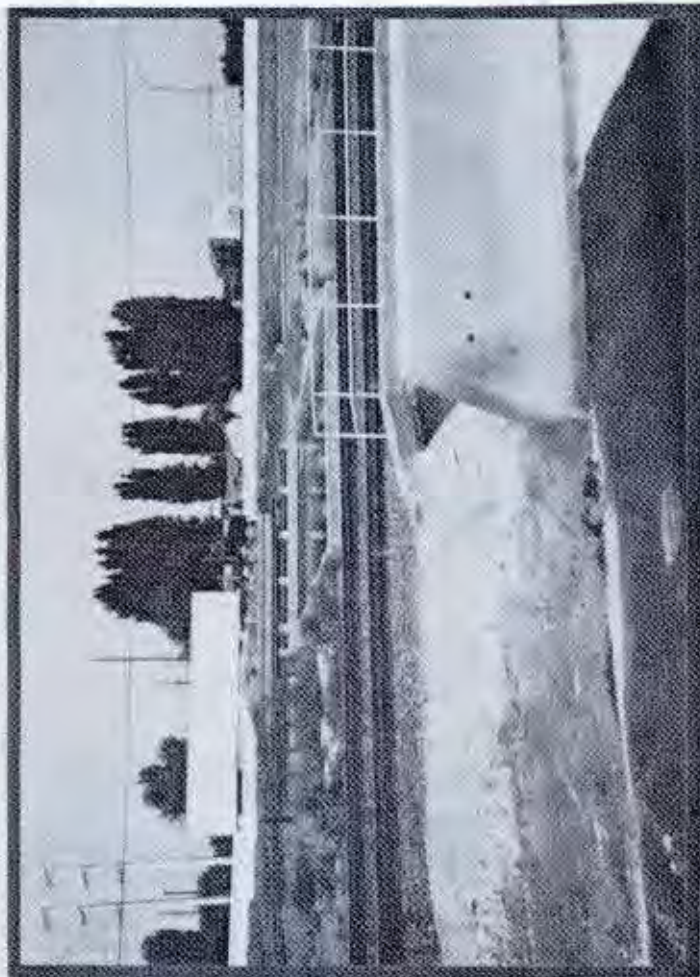
1. **Name of Feature:** Ceres Main Canal
2. **Location of recordation:** Where Upper Lateral 2 1/2 joins the Ceres Main Canal at the junction of Turner and Mitchell roads.
3. **Other locations for recording this feature:** KT-8 and KT-8(n)
4. **Structures at or near this location:** Mitchell Road extends parallel to the canal.
5. **Setting at this location:** Orchards completely surround this recordation point.
6. **Integrity considerations for this feature:** Concrete lining has replaced the original dirt canal.
7. **Attributes at this location (measurements in feet):**

Photograph Number: 1
 Site Number: KT-8
 Common Name: Ceres Main Canal
 Camera Facing: East

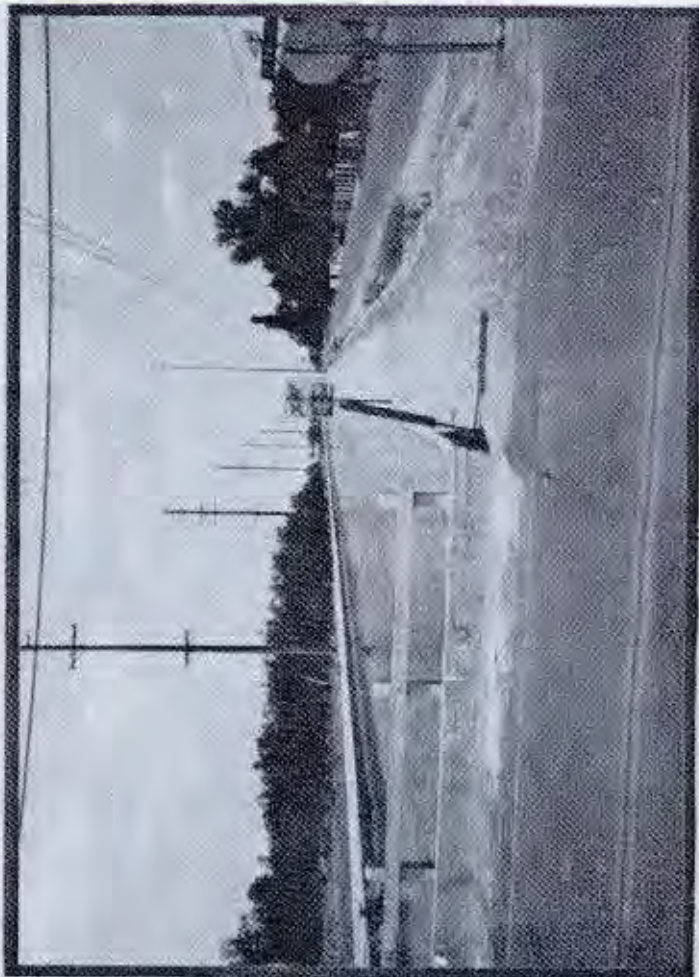
Photograph Number: 2
 Site Number: KT-8(n)
 Common Name: Ceres Main Canal
 Camera Facing: North

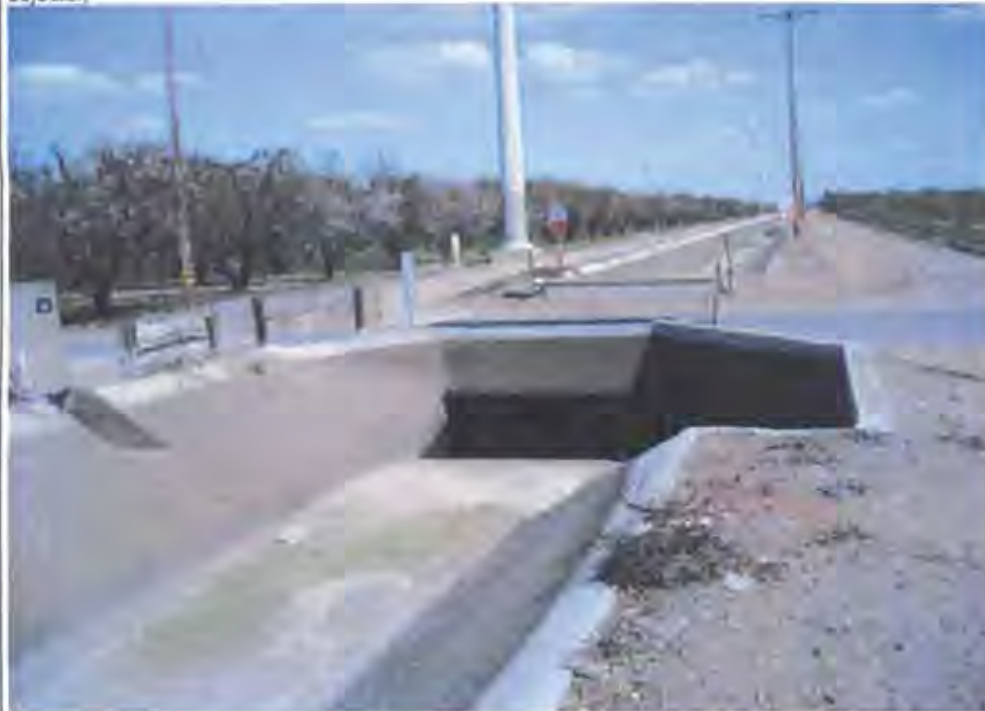
*P3a. Description: (Describe resource and its major elements. Include design, materials, condition, alterations, size, setting, and boundaries) Turlock Irrigation District's (TID) Lateral No. 2 connects at the eastern end to the Turlock Main Canal. The segment of the canal recorded begins where the Union Pacific railroad intersects Lateral No. 2 and continues west until Carpenter Road. This portion of Lateral No. 2 connects on the eastern end at the Ceres Main Canal and Laird Slough on the western end. At Crow's Landing, Lateral No. 2 is called Lower Lateral No. 2. Lateral No. 2 was completed in 1899 (Paterson 1989). Originally, Lateral No. 2 was an open dirt canal which was constructed by Fresno scrapers. Parts of the TID canals were lined with cobbles after initial construction to improve water flow. Beginning in the 1920's the TID began a long-term program of canal improvement that focused on the installation of concrete lining which would improve water flow, reduce loss from seepage, and reduce maintenance. The easternmost section of Lateral No. 2 that is recorded here is located between the Union Pacific Railroad line and Crow's Landing Road and was lined with concrete in 1953. Approximately one mile west of Crow's Landing Road at Ustick Road, the concrete lining was installed by 1961. Concrete lining was installed in Lateral No. 2 at Carpenter Road by 1964. Even with this concrete lining, irrigation canals require maintenance and repair on a periodic basis. Several patched cracks were observed along this lateral. In addition to the actual canal, the recorded segment of Lateral No. 2 includes several check dams: D7, D8, D9, D10, and D11.

P5b. Description of Photo: (View, date, accession #) March 16, 2009, View to the west.

Lateral No. 2 was originally an open earth canal that was later improved with concrete lining beginning in the 1950s and continuing through 1970. Over the decades, the concrete lining was repaired and maintained. Repairs and upgrades to the check dams and flow controls along the canal have occurred over the decades, as well. The canal segment recorded here possesses integrity of location, as it is in the same location as when it was originally constructed in 1899. However, the canal only retains some integrity of setting. Although a part of the area of the recorded canal segment remains predominately rural farmland, several post 1920 structures are located in the vicinity of the canal, including industrial and agri-business development. Additional roads cross the canal and The canal has sustained a loss of integrity of materials and workmanship as it is no longer an open earth canal, but rather lined with concrete which has been continually repaired and maintained. Also, although the check dams retain much of their original construction, all have been upgraded and modern metal bridges have been added at each dam. The canal segment does retain some integrity of association, as the canal segment is still used for irrigation. Since the materials and workmanship of this canal segment have been replaced with more modern materials, the canal no longer retains integrity of feeling of the TID area before 1920. This recorded segment does not retain the essential physical features that made up its character or appearance during the period of its association.

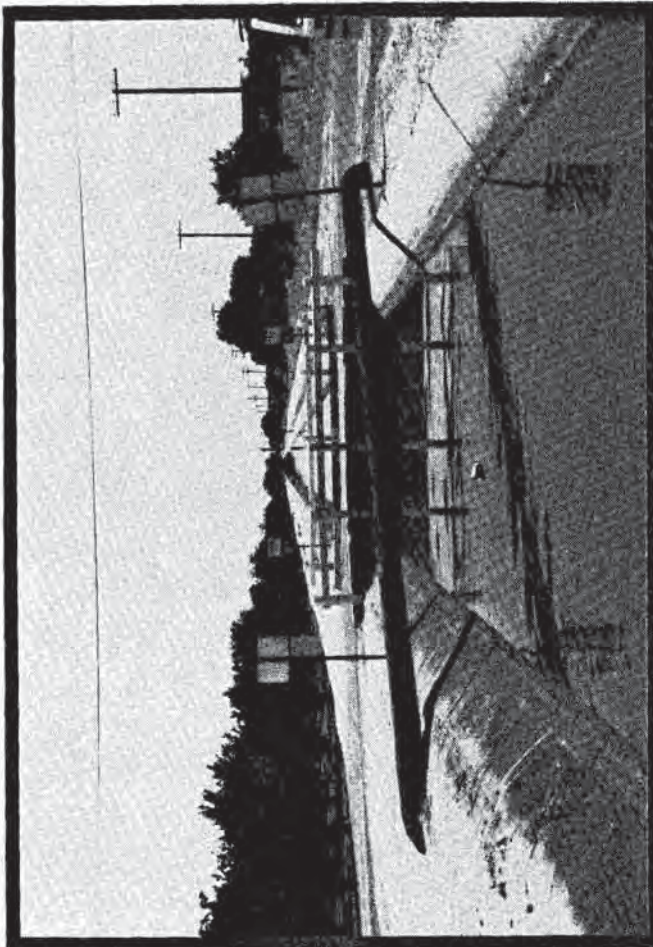
8. **Sketch, in cross section:** Looking east

Photograph Number: 1
Site Number: KT-6
Common Name: Upper Lateral 3
Camera Facing: West

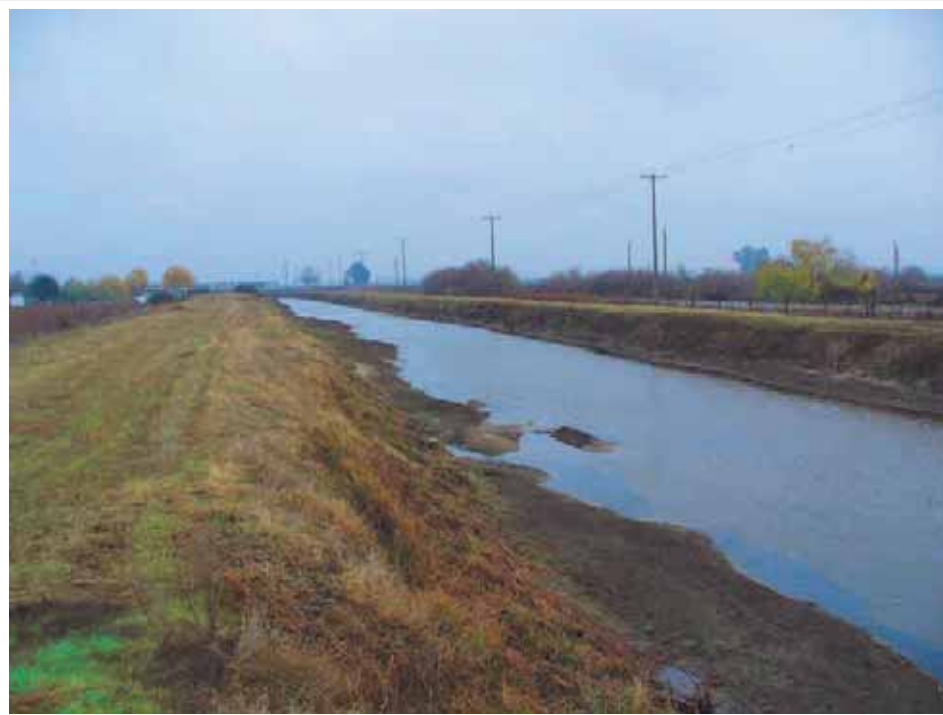
P5b. Description of Photo: (View, date, accession #) Photograph 1. Canal Creek, camera facing east. 12/12/07.

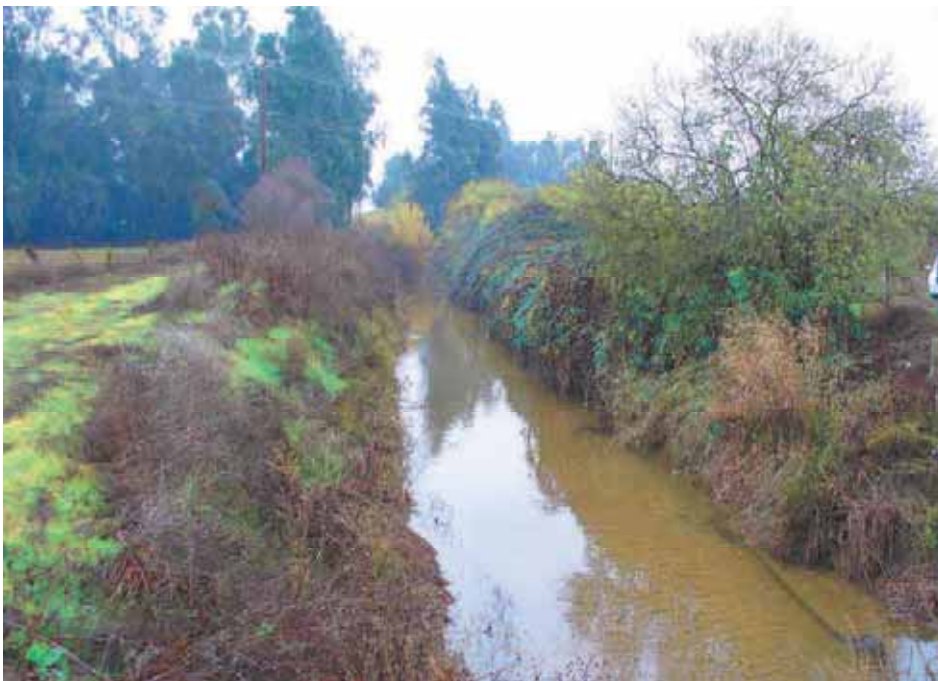
At this point the canal is approximately 48 feet wide (Photographs 4). The unlined channel is U-shaped with bramble and grasses growing on its banks. The Avenue One bridge crosses the canal at this point (Photograph 4).

L8b. Description of Photo, Map, or Drawing:
Photograph 4. Canal Creek from
Avenue One bridge, camera facing
northeast. 12/12/06.

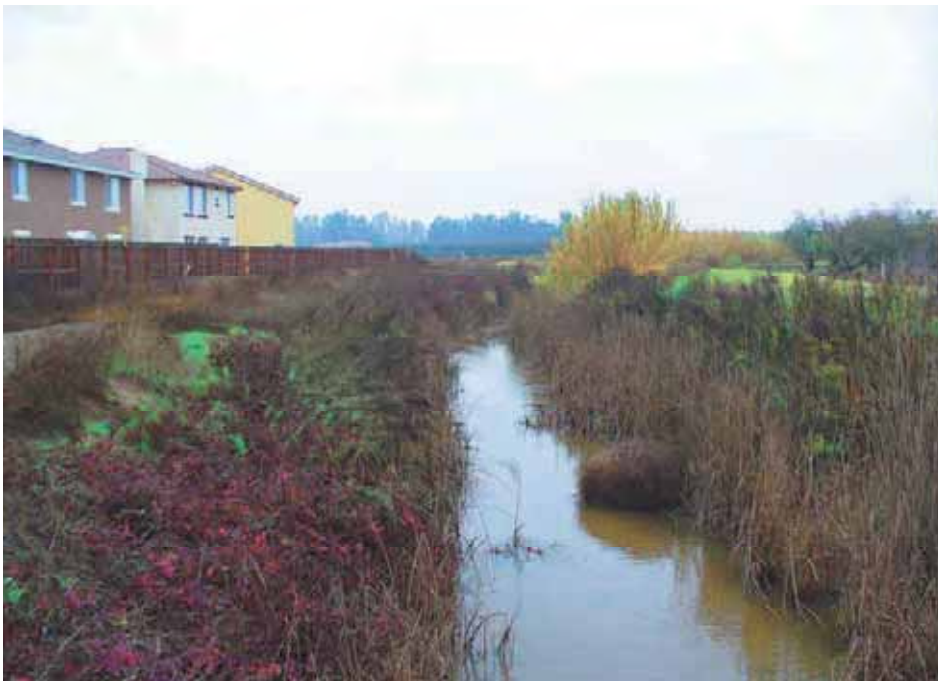
At this point the canal is approximately 110 feet wide. The unlined channel is U-shaped with bramble and grasses growing on its banks. There is an overgrown access road on the west side of the canal. The Ashby Avenue bridge and US 99 cross the canal at this point (Photographs 5).

L8b. Description of Photo, Map, or Drawing:
Photograph 5. Canal Creek from Ashby Avenue bridge, camera facing northwest. 12/12/06.

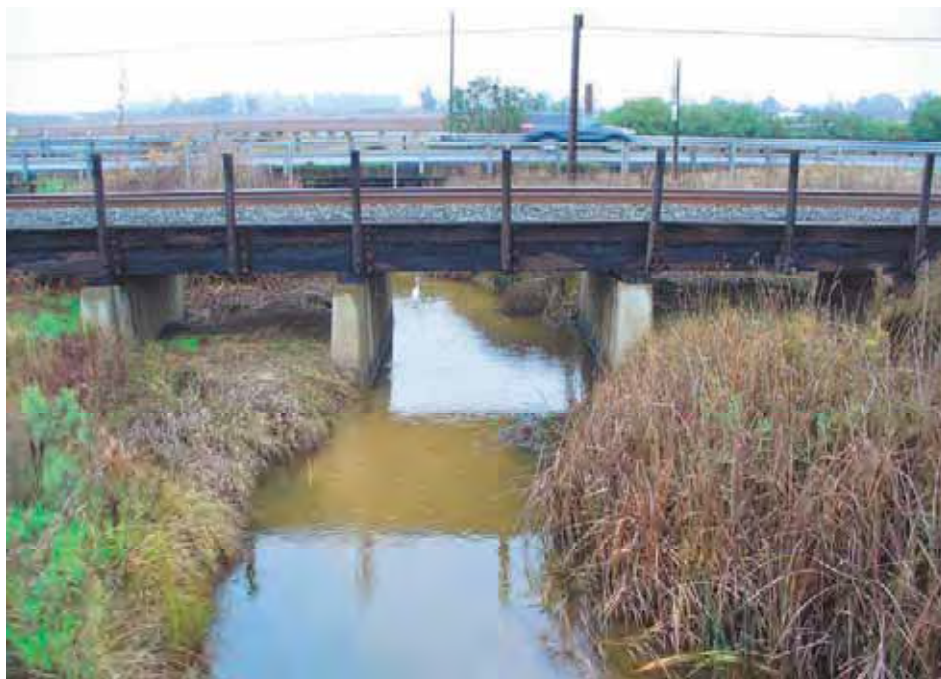
At this point the canal is approximately 80 feet wide. The unlined channel is U-shaped with bramble and grasses growing on its banks. There is an overgrown access road on the west side of the canal. A Union Pacific Railroad bridge and the SP Avenue bridge cross the canal at this point (Photograph 6).

L8b. Description of Photo, Map, or Drawing: Photograph 6. Canal Creek passing under US 99 and Union Pacific railroad tracks. Photo taken from Southern Pacific Avenue bridge, camera facing north. 12/12/06.
