Appendix L-1

**Historical Resource Inventory
and Evaluation Report (2 of 2)**

*Resource Name or # 1725-1731 West 16th Street

c. Address: 1725-1731 W 16th City: Merced, CA Zip: 95348

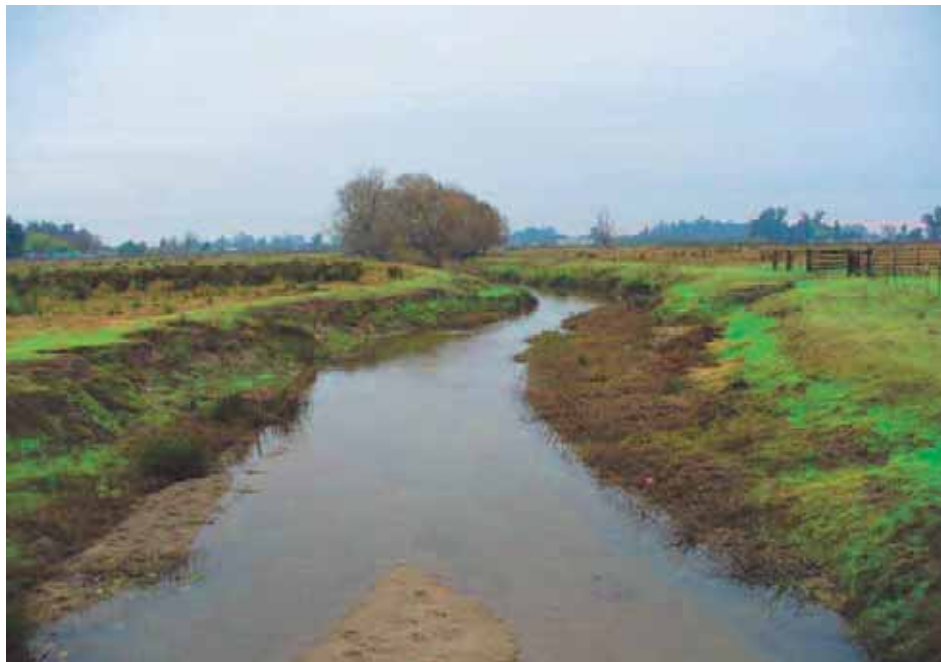
L8b. Description of Photo, Map, or Drawing:
Photograph 7. Canal Creek from Elliot Avenue bridge, camera facing south.
12/12/06.

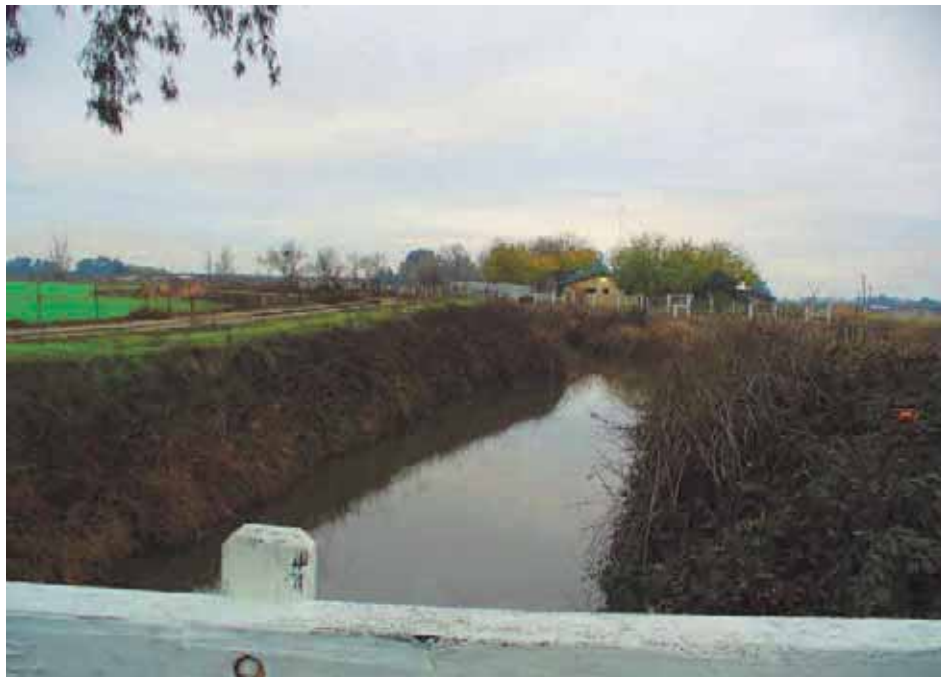
L8b. Description of Photo, Map, or Drawing:
Photograph 8. Canal Creek from
Landram Avenue bridge, camera facing
north. 12/12/06.

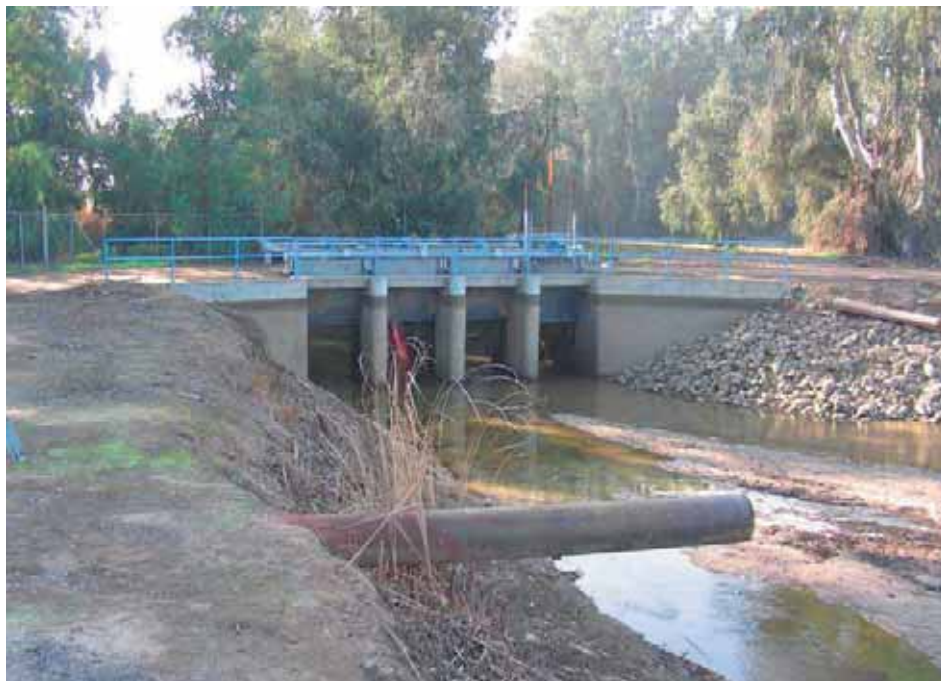
The section of Canal Creek contains the headgate for the Livingston Canal and also a headgate to control the flow of Canal Creek downstream from this point. The headgate has four metal gates set in a concrete structure. The entire structure is approximately thirty feet long and ten feet wide. On both the upstream and downstream faces are concrete wings. The top of the headgate functions as a bridge and there is a metal railing on both sides and a guardrail on the downstream side. Also present on top of the headgate is the gate operating equipment. The canal at this point is approximately 50 feet wide and 12 feet deep and is roughly U-shaped. It is unlined except for a small area the area between the two headgates lined with riprap. The steep banks are wide with little vegetation and show signs of erosion. Immediately upstream from the headgate the canal passes under the BNSF railroad and Santa Fe Drive. Two large drain pipes protrude from the south bank of Canal Creek at this point (Photograph 10, 49, 51).

L8b. Description of Photo, Map, or Drawing: Photograph 10. Canal Creek with flow control headgate, camera facing southwest. 1/22/07.

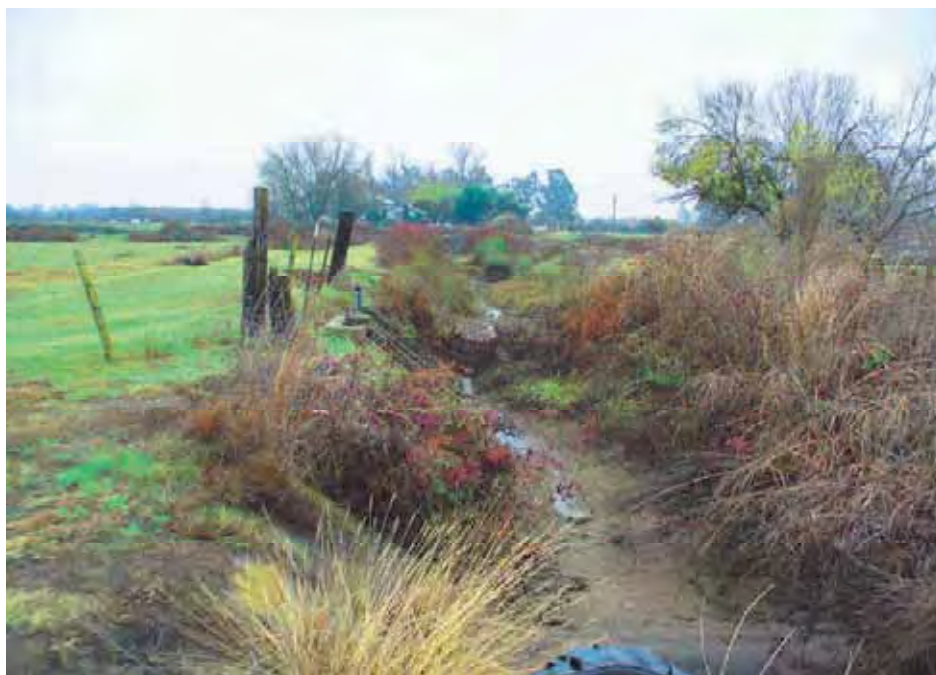
L8b. Description of Photo, Map, or Drawing:
Photograph 12. Main Ashe Lateral at
Avenue Two, camera facing southwest.
12/12/06

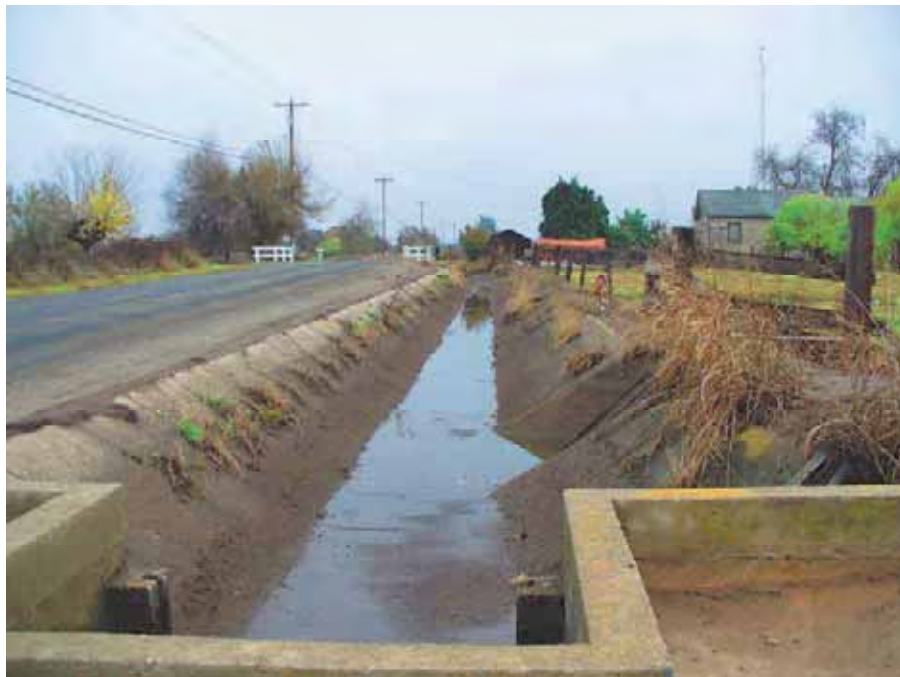
L8b. Description of Photo, Map, or Drawing:
Photograph 13. Main Ashe Lateral near
Avenue One, camera facing east.
12/12/06.

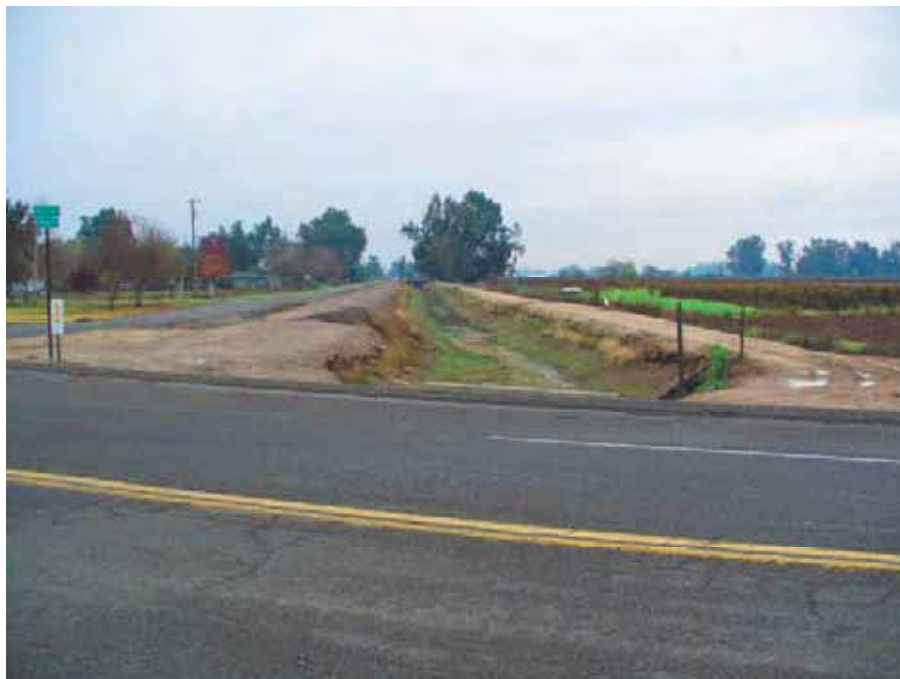
L8b. Description of Photo, Map, or Drawing:
Photograph 14. Main Ashe Lateral at SP Avenue and Gurr Road, camera facing south. 12/12/06

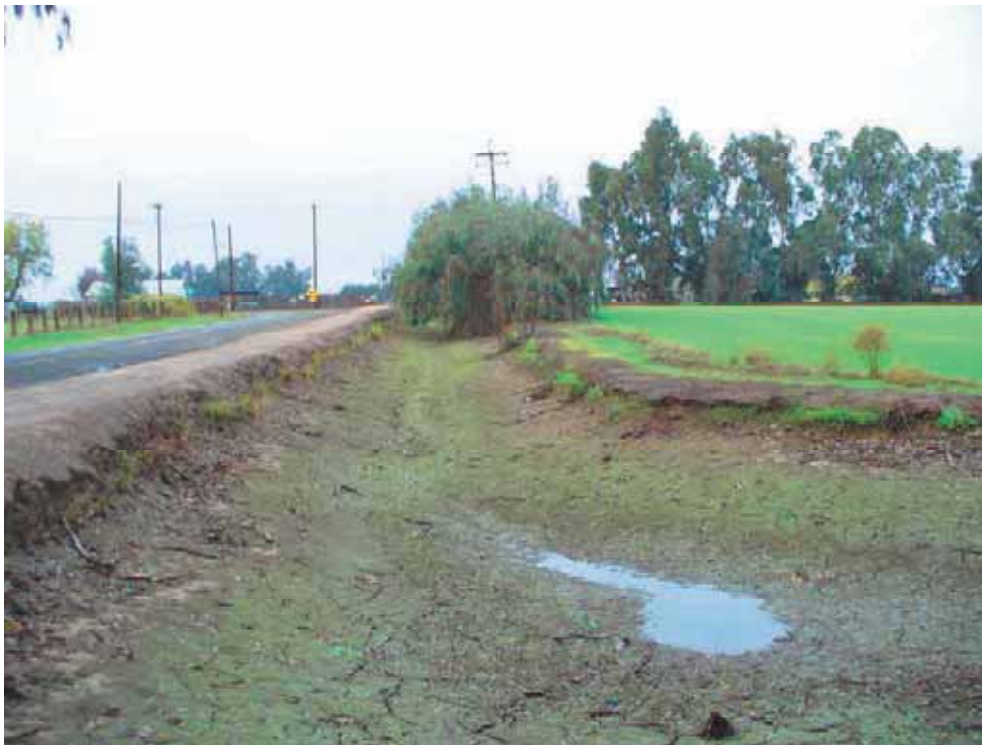
The East Ashe Lateral branches off the Main Ashe Lateral in the NE1/4 of Section 9, T7S/R13E MDBM. At this point the canal is approximately 18 feet wide and 3 feet deep. It is U-shaped, unlined and has gently sloping banks. Metal and concrete control gates are placed intermittently along the canal. The canal did not carry water at the time of the survey (Photographs 16, 36).

Photograph 16. East Ashe Lateral, camera facing southeast. 12/12/06.

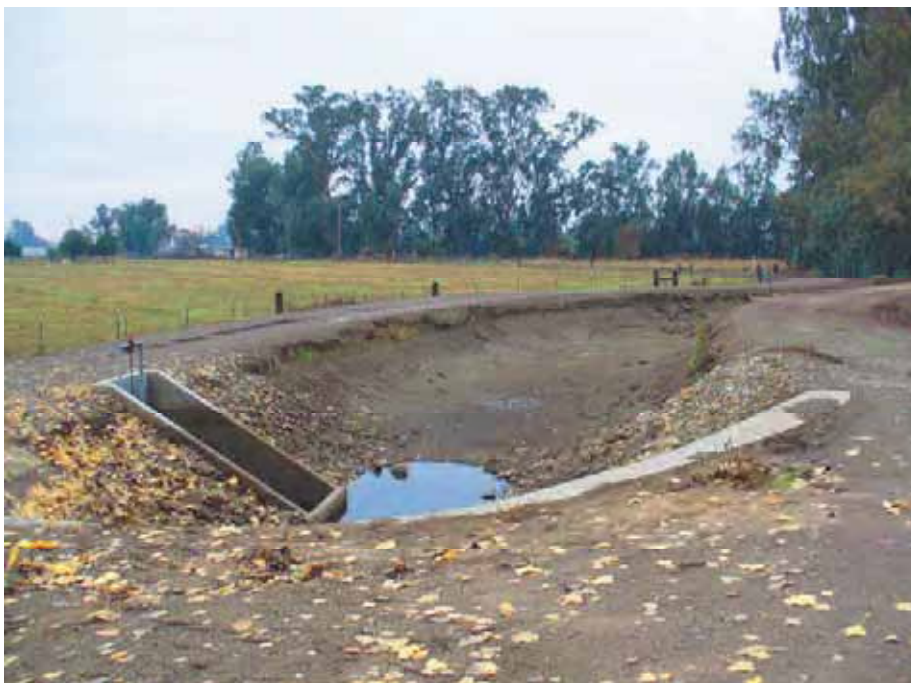
On the east side parallel to Bear Creek is the Meadowbrook Lateral canal constructed between 1946 and 1958. The lateral receives its water from the reservoir created by the Crocker Dam in Section 22 T7S/R13E MDBM. It is approximately 20 feet wide and four feet deep. It is unlined and U-shaped and its banks show signs of erosion. Both sides of the channel are built up above the surrounding land. It has concrete and metal gate structures and a concrete culvert passing under the highway. The lateral did not contain water at the time of the survey (Photographs 18, 37).

L7. Integrity Considerations: The Meadowbrook Lateral maintains its integrity to its period of significance defined as the era of its original construction.

Photograph 18. Meadowbrook Lateral, camera facing south. 12/12/06

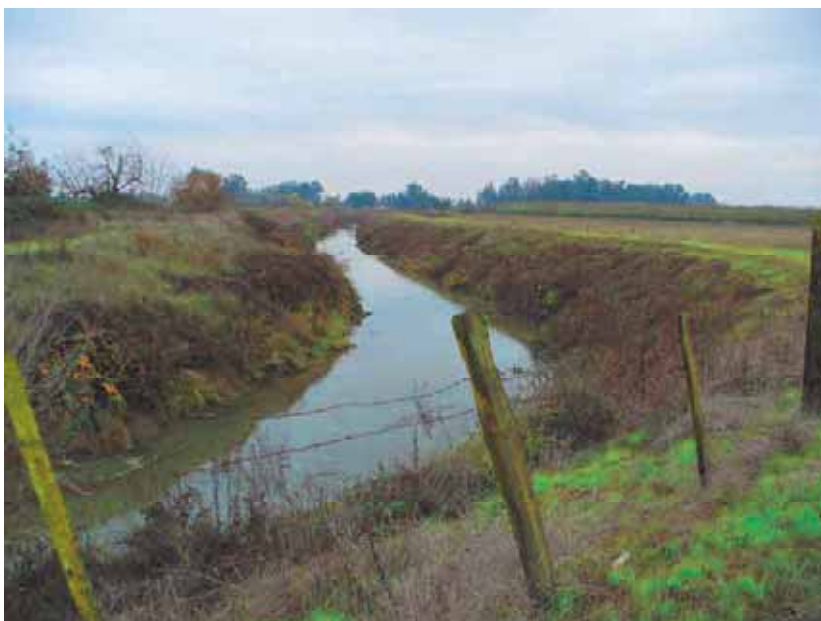
L8b. Description of Photo, Map, or Drawing:
Photograph 19. Black Rascal Creek from Landrum Road, camera facing south. 12/12/06.

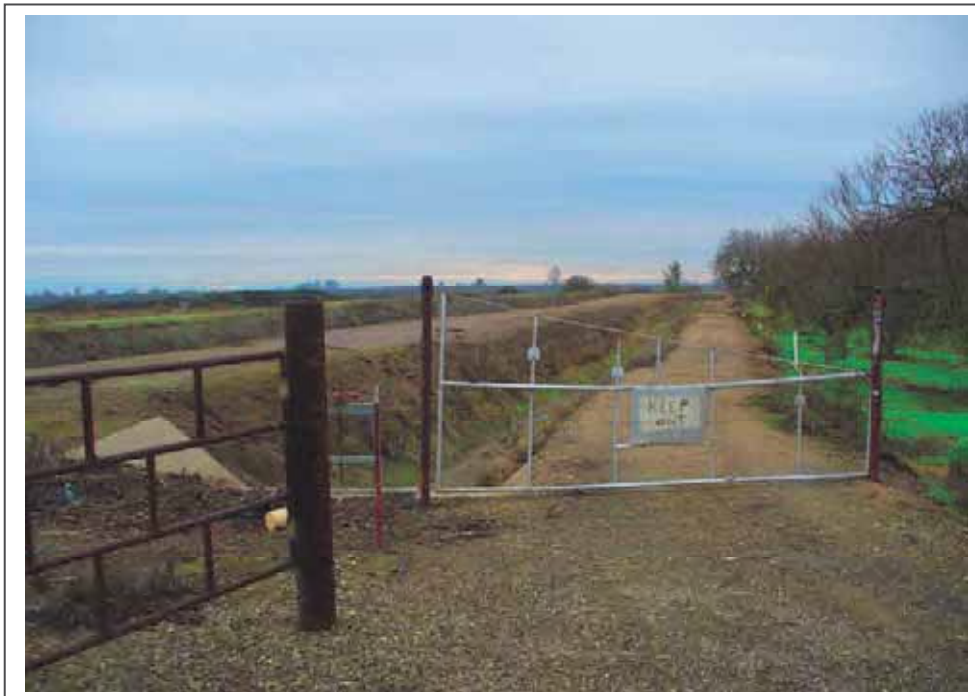
Photograph 20. Hess Lateral, camera facing east. 12/12/06.

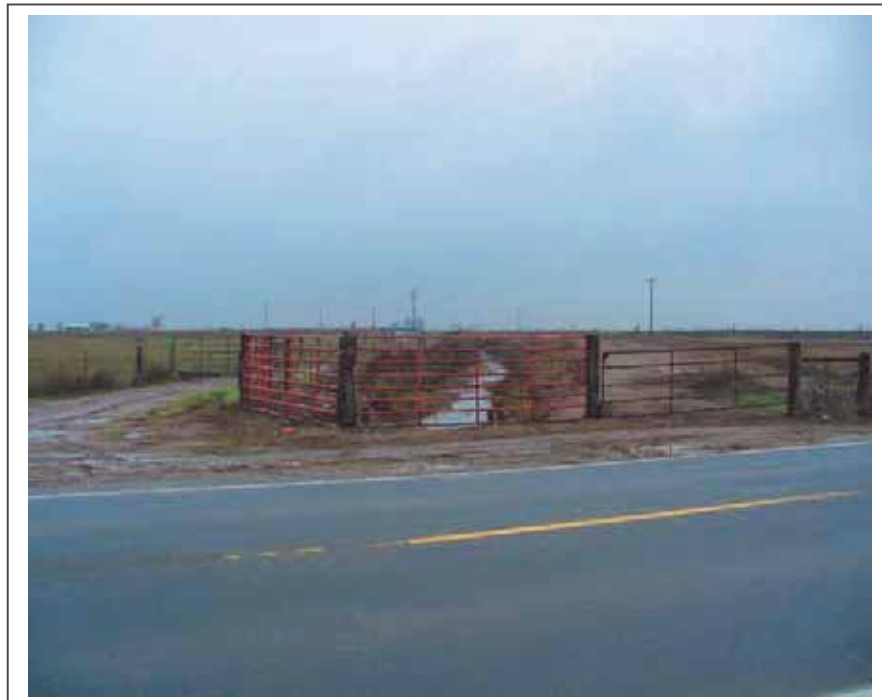
L3. Description: (Describe construction details, materials, and artifacts found at this segment/point. Provide plans/sections as appropriate.) At this point the canal is approximately 15 feet wide and four feet deep. It originates from the Main Canal in Section 18 T6S/R14E MDBM. The unlined channel is U-shaped and has vegetation growing on its banks. Some erosion and silting is evident. Access roads run on both sides of the canal. Where the canal intersects Bellevue Road, a culvert carries the water under the roadway. To the east of the canal is a circular holding basin fenced with black plastic. (Photographs 21, 39-42).

L8b. Description of Photo, Map, or Drawing:
Photograph 21. Henderson Lateral, camera facing south. 12/12/06.

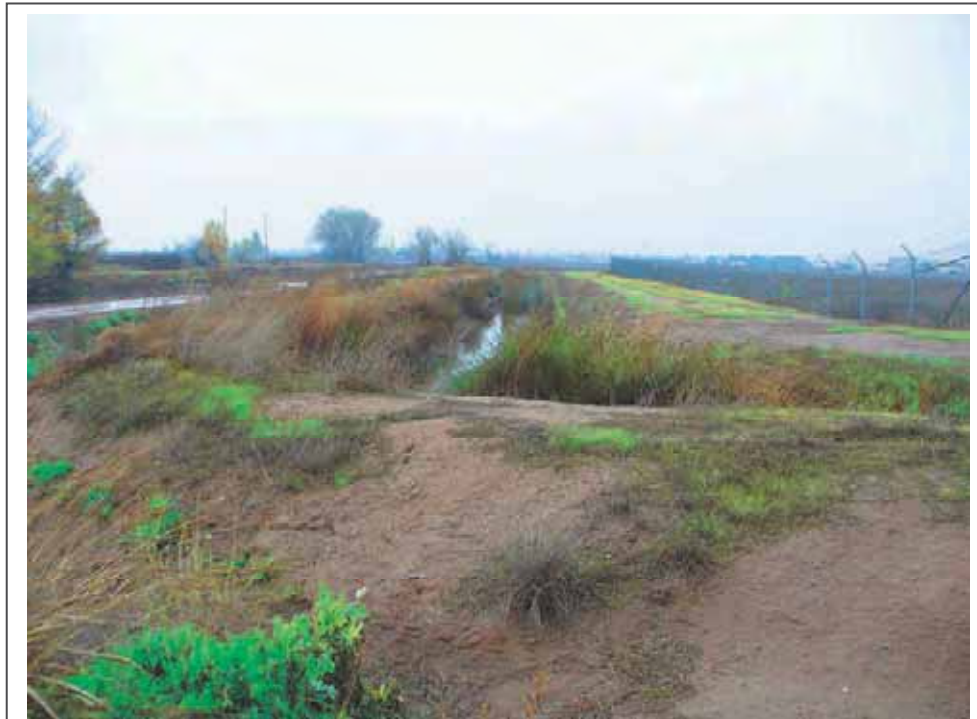
This is a small lateral canal that originates from the Henderson Lateral in Section 34 T6S/R13E MDBM. It is approximately 15 feet wide and four feet deep, U-shaped and unlined. Its banks are raised slightly above the surrounding landscape and are covered in vegetation. This section of the canal runs parallel to Fox Road, and then turns to parallel Canal Creek. The canal ultimately drains into Canal Creek (Photograph 23).

Photograph 23. Mason-Curtis Lateral, camera facing south, 12/12/06.

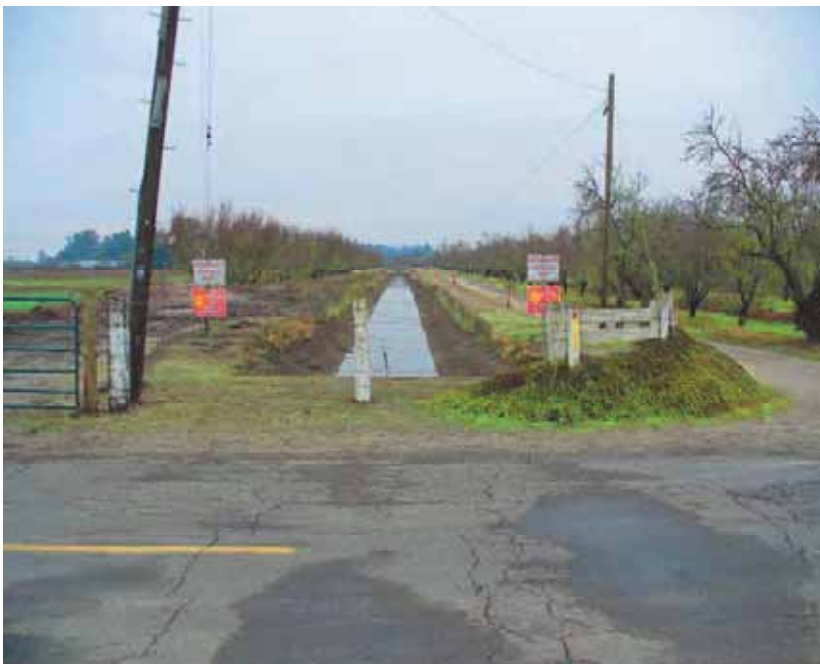
L7. Integrity Considerations: The Buhach Lateral was lined with concrete after World War II, and, therefore, lacks integrity to its period of construction.

Photograph 24. Buhach Lateral, camera facing south, 12/12/06.

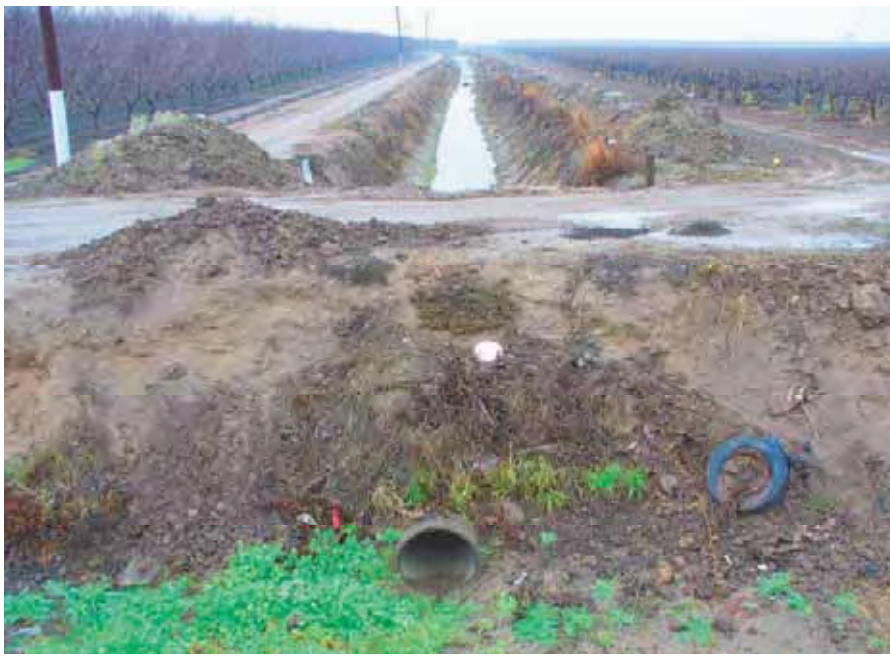
L8b. Description of Photo, Map, or Drawing:
Photograph 25. Drainage Ditch, camera facing north. 12/12/06.

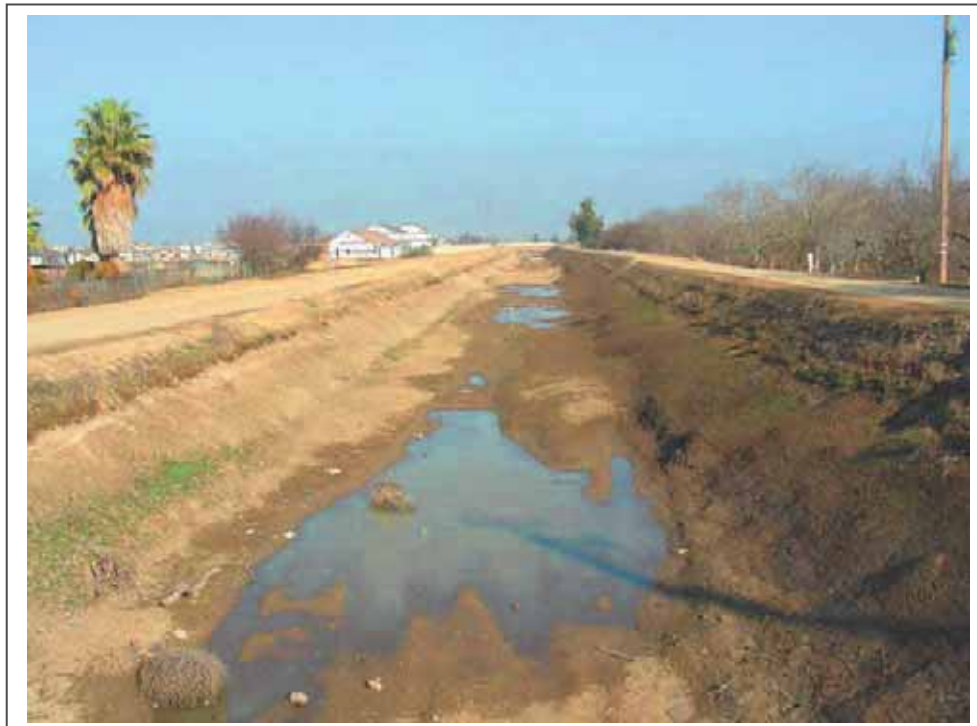
L3. Description: (Describe construction details, materials, and artifacts found at this segment/point. Provide plans/sections as appropriate.)
This section of the Livingston Canal is approximately 50 feet wide and 12 feet deep. It is trapezoidal in shape and unlined. There are service roads along both sides. The banks are smooth and shaped to a uniform angle. There is a gate on the south bank of the canal west of Buhach Road (Photograph 27).

Photograph 27. Livingston Canal, camera facing east. 1/22/07.

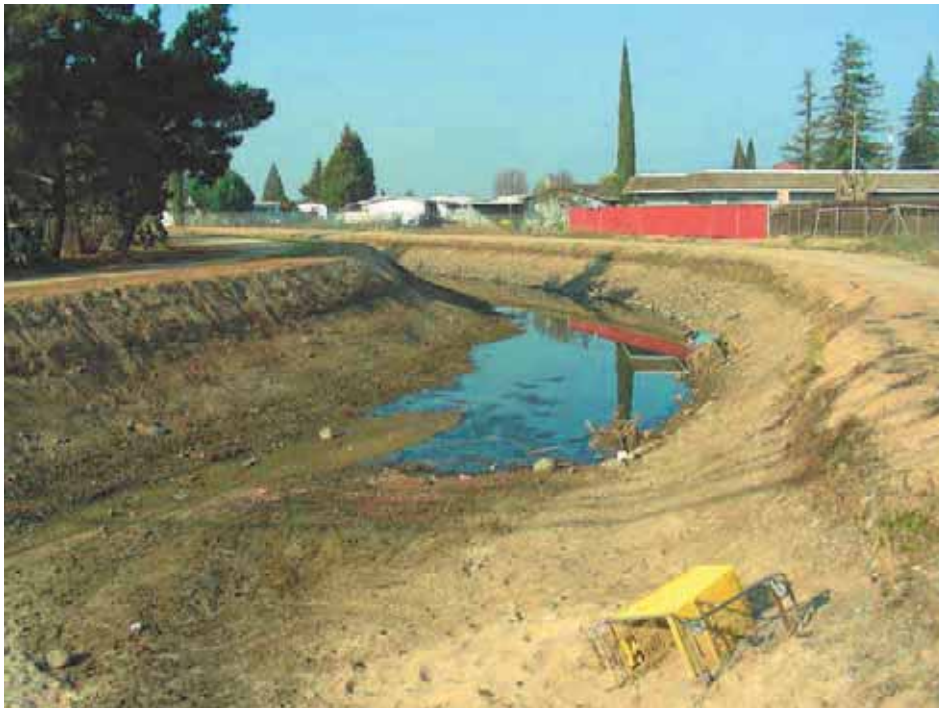
This section of the Livingston Canal is approximately 50 feet wide and 12 feet deep. It is trapezoidal in shape and unlined. There are service roads along both sides. The banks are smooth and shaped to a uniform angle. There is a drain and a vertical pipe on the east bank of the canal north of Bellevue Road (Photograph 28).

L8b. Description of Photo, Map, or Drawing:
Photograph 28. Livingston Canal,
camera facing north. 1/22/07.

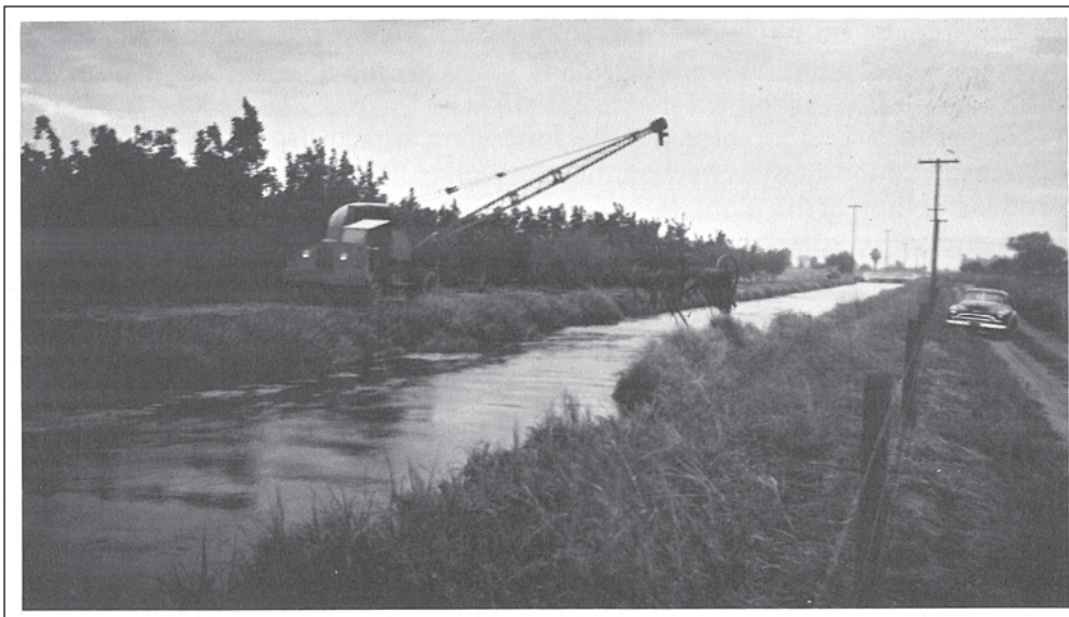
Figure 2. Crane cleaning weeds from an unknown canal in 1949. (McSwain 172)

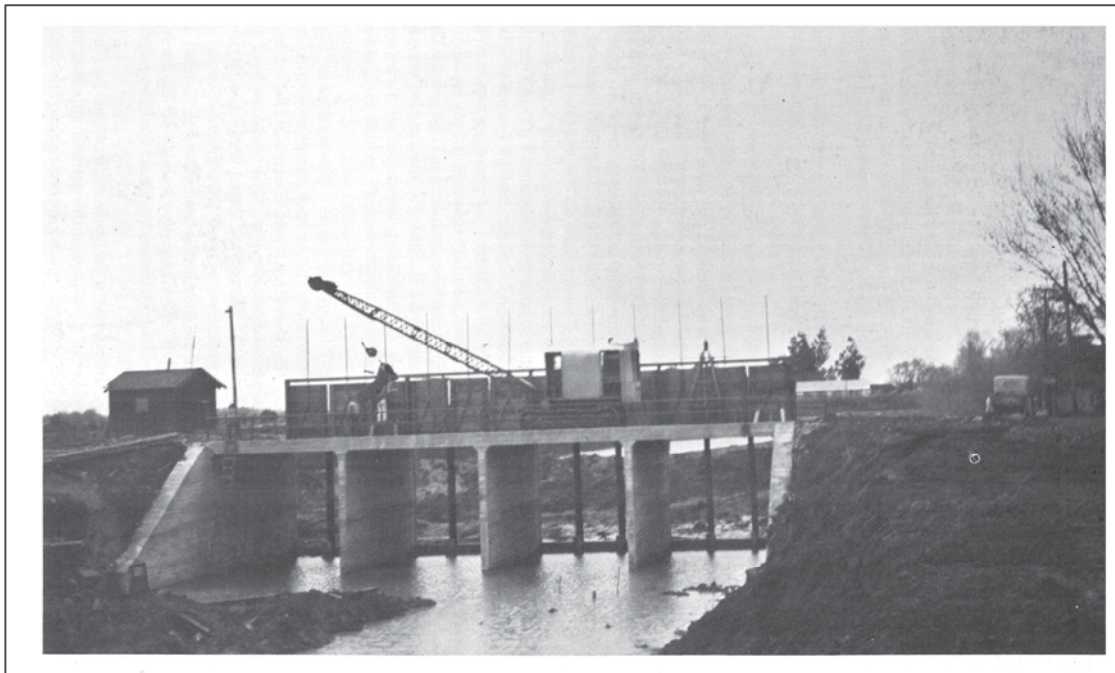
Figure 4. Bear Creek side of Crocker Dam as being rebuilt in 1940. (McSwain 145)

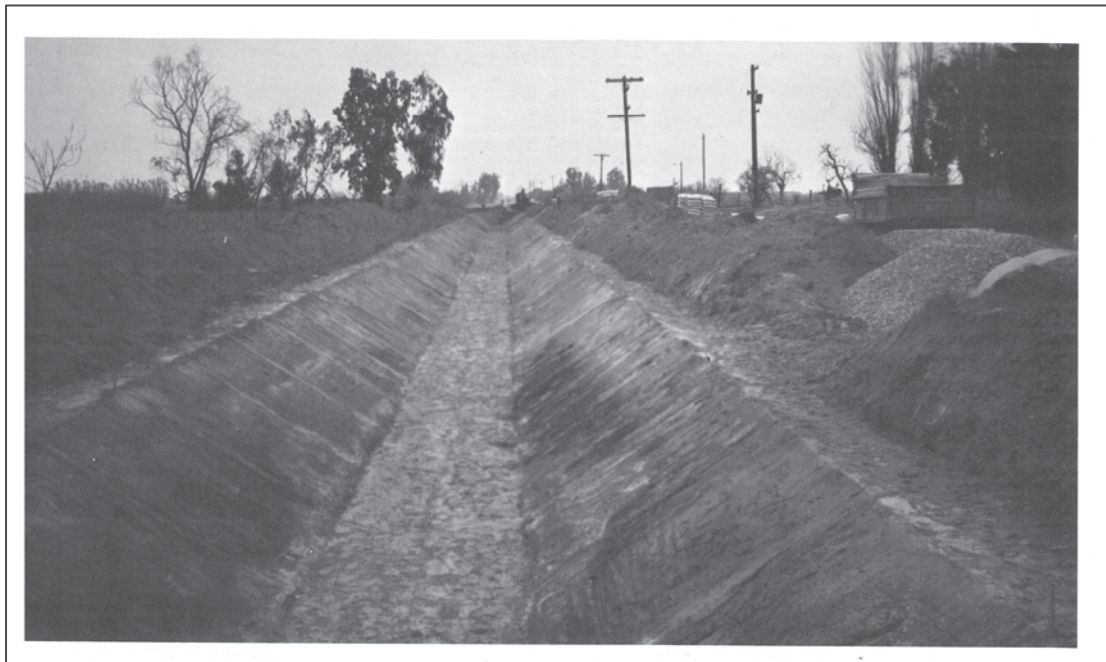
Figure 6. Arena Canal being shaped for concrete lining in 1950. (McSwain 174)

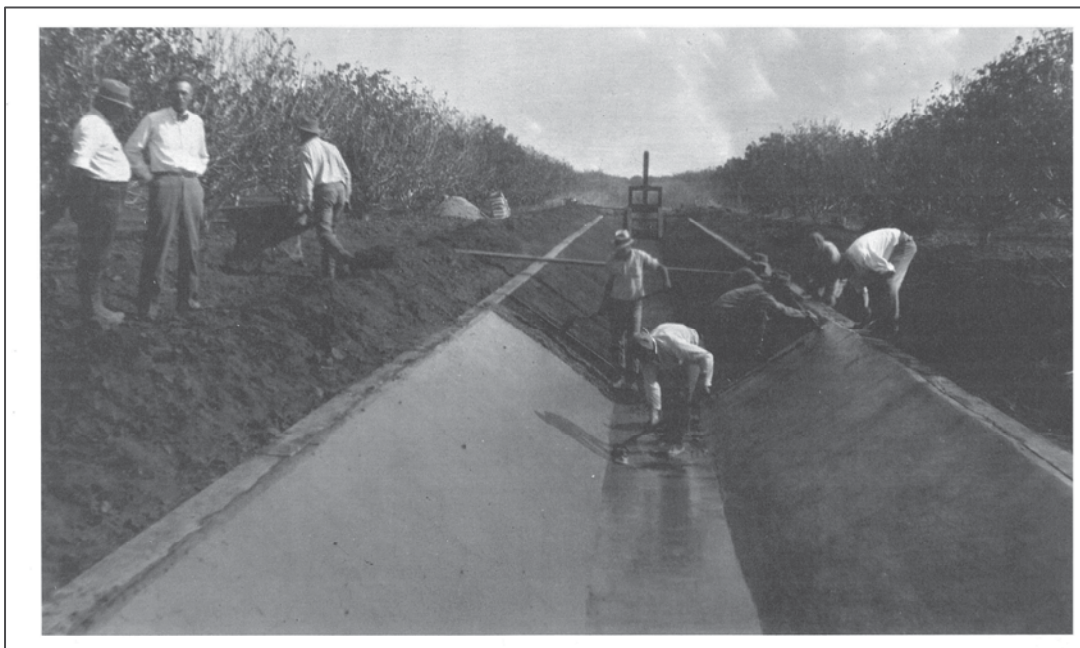
Figure 7. Concrete lining of unknown canal in 1930. (McSwain 105)

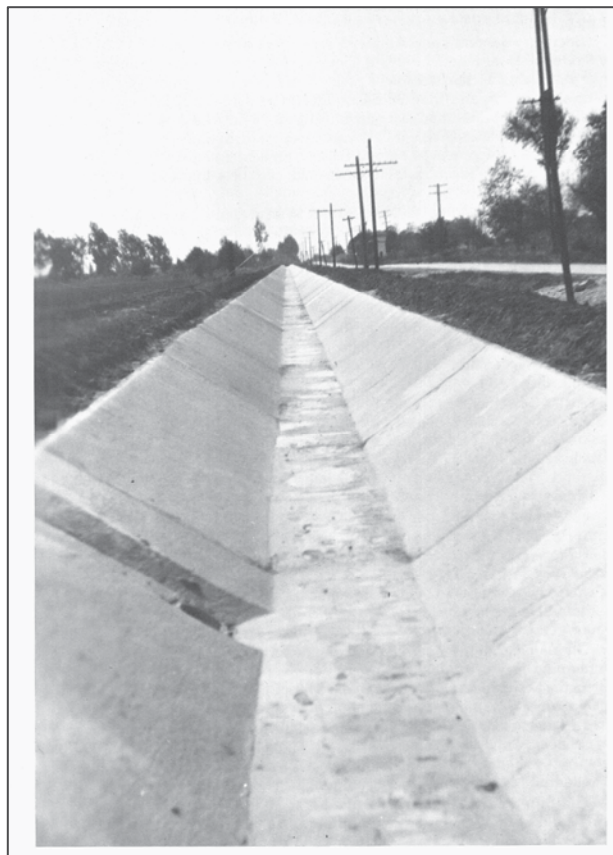
Figure 8. Newly lined McSwain Lateral in 1930.(McSwain, 102).

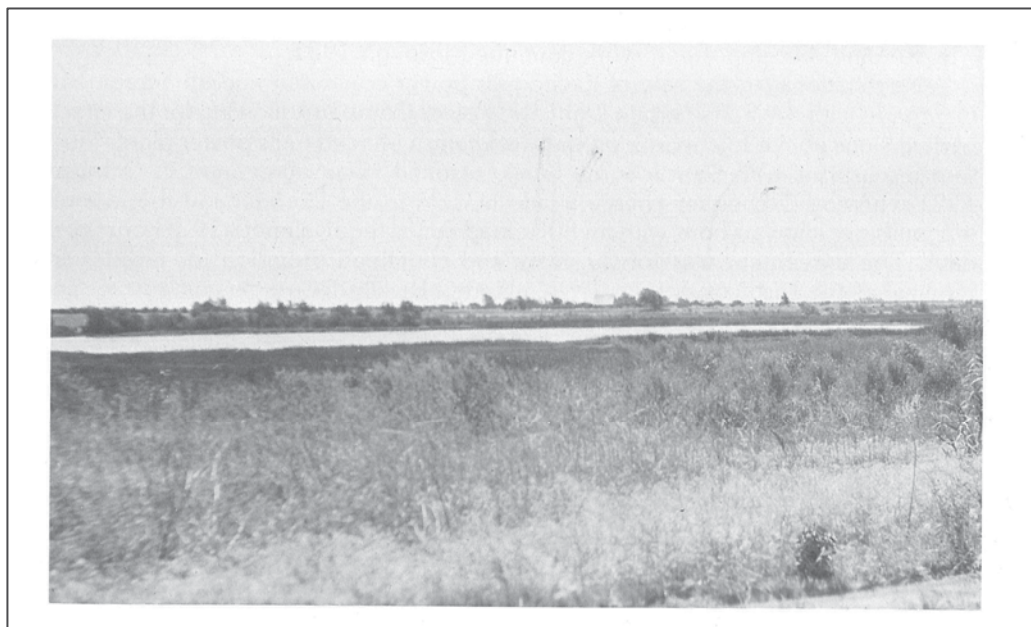
Figure 9. Photo from 1920 showing water-logged land north of Atwater. (McSwain, 33)

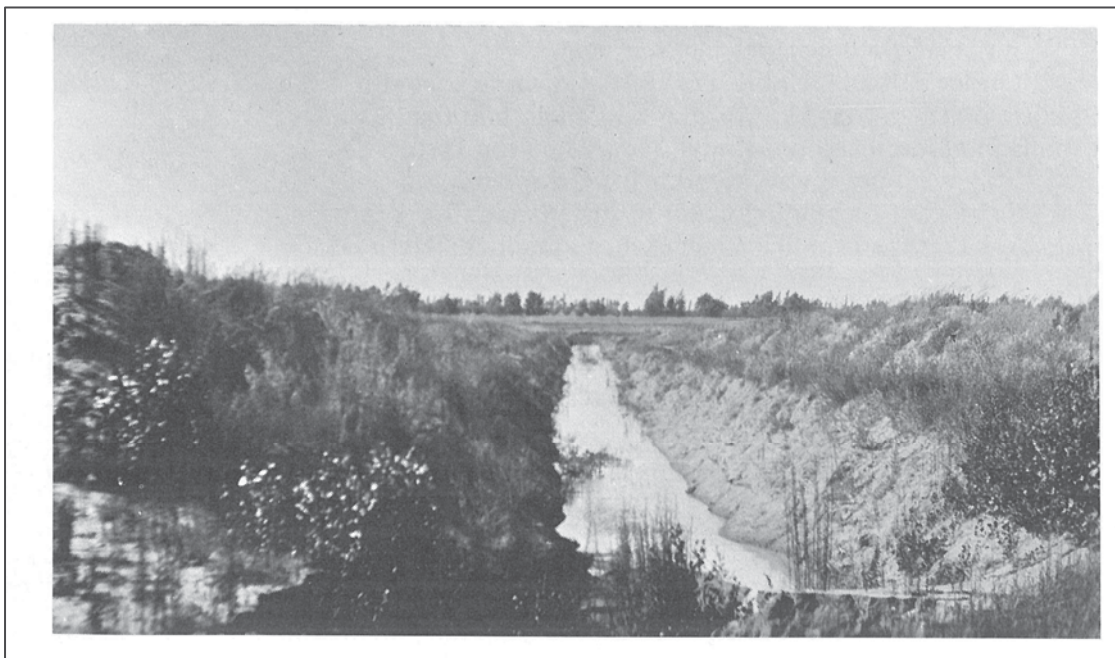
Figure 10. Photo from 1920 showing drainage ditch near Atwater. (McSwain, 35)

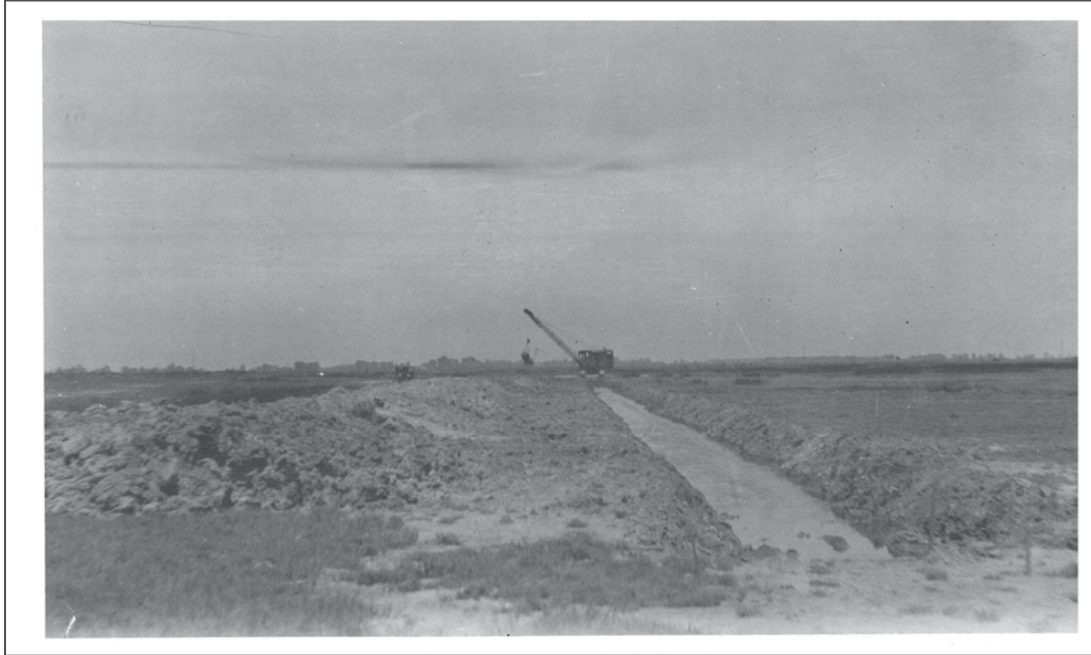
Figure 11. Dragline in 1929 digging a drainage ditch. (McSwain 95)

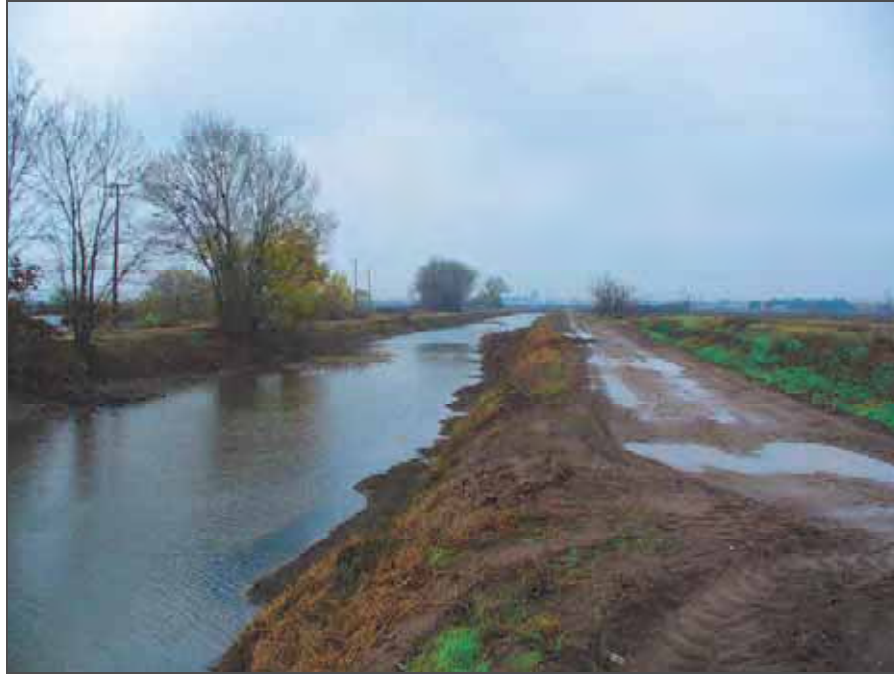
Photograph 29. Canal Creek at Fox Road (point CC1), camera facing west. 12/12/06

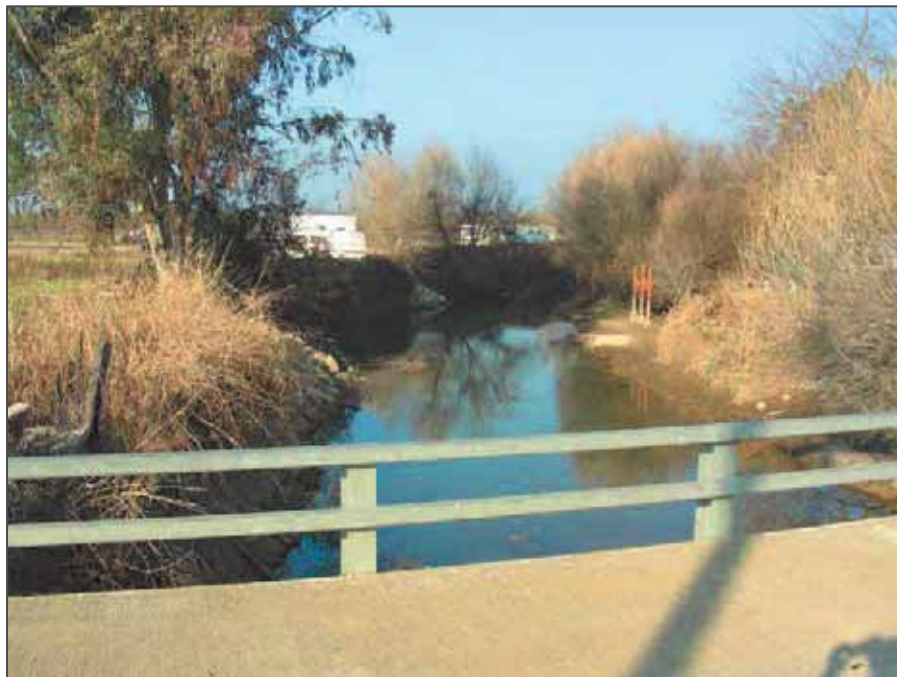
Photograph 30. Canal Creek at Ladino Road (point CC8), camera facing north. 1/22/07.

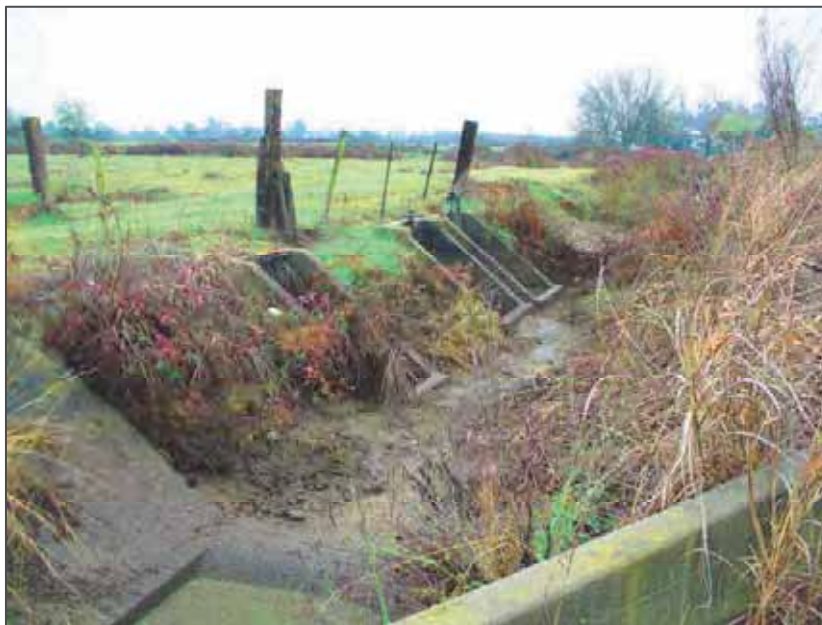
Photograph 31. Control gates on Main Ashe Lateral at point MA2, camera facing south. 12/12/06.

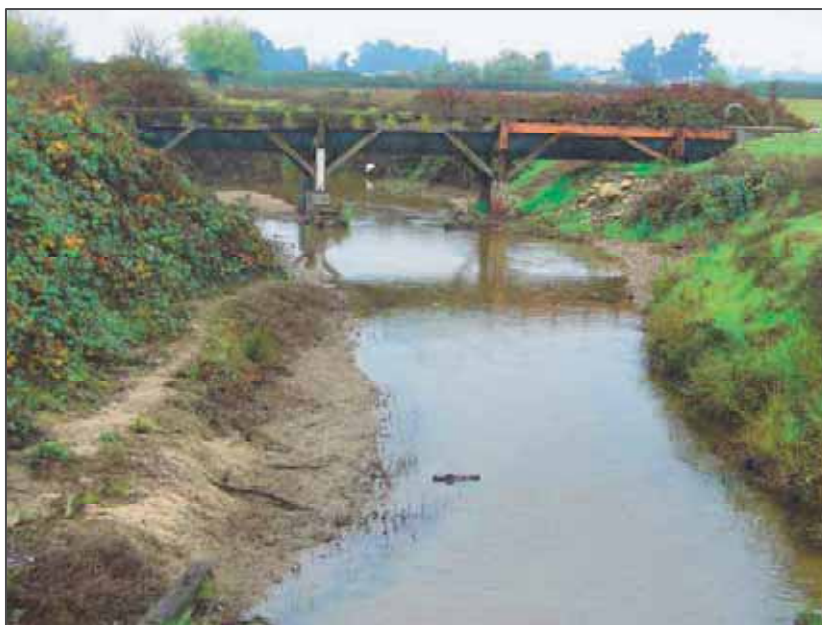
Photograph 32. Main Ashe Lateral Flume over Canal Creek at point MA2, camera facing south. 12/12/06.

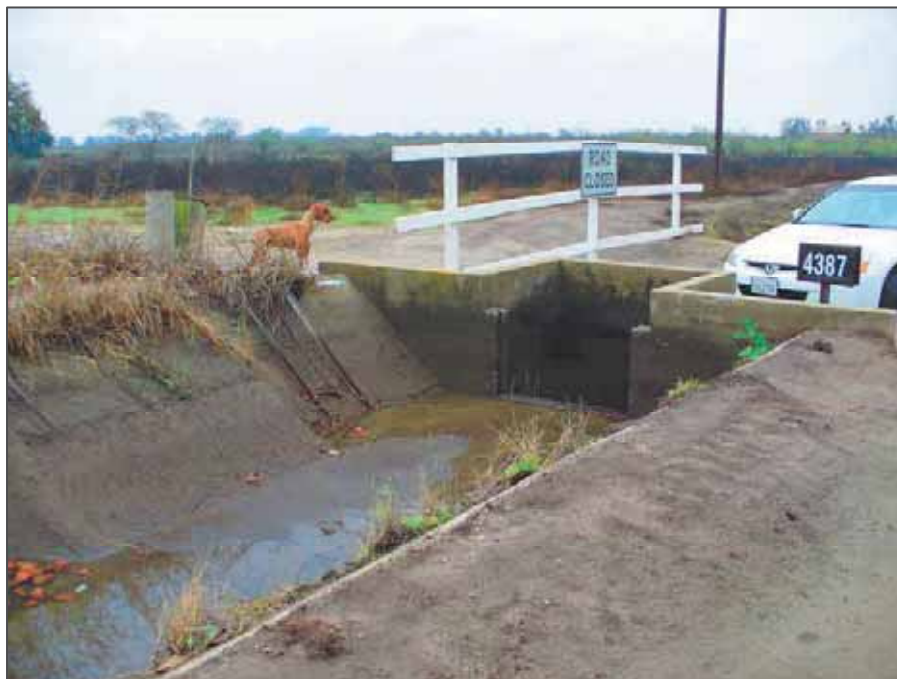
Photograph 33. Main Ashe Lateral showing slide gates at point MA3, camera facing southeast. 12/12/06.

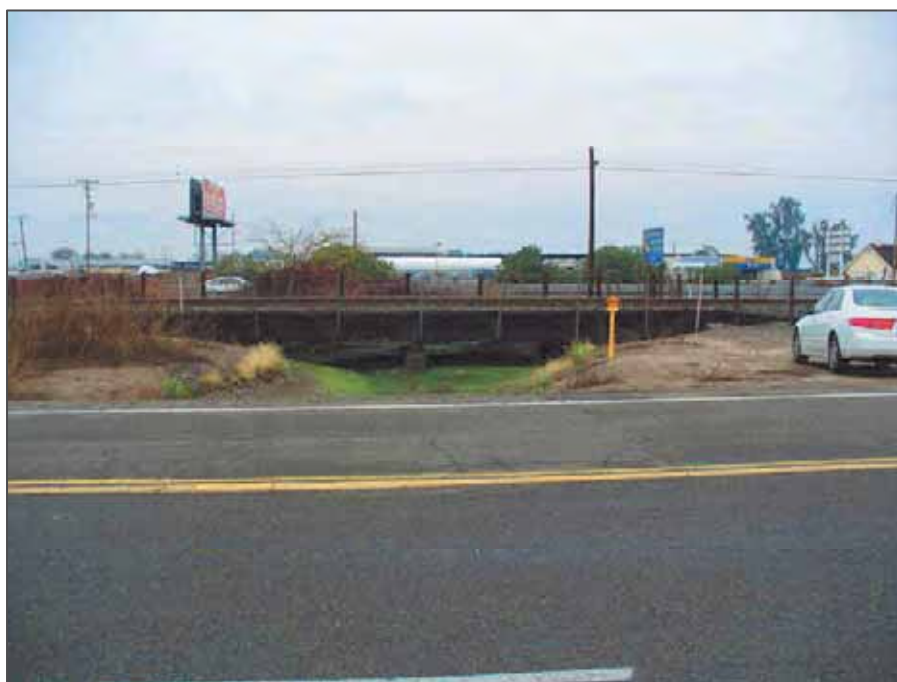
Photograph 34. Main Ashe Lateral at SP Avenue showing the canal passing under the UPRR at point MA4, camera facing north. 12/12/06.

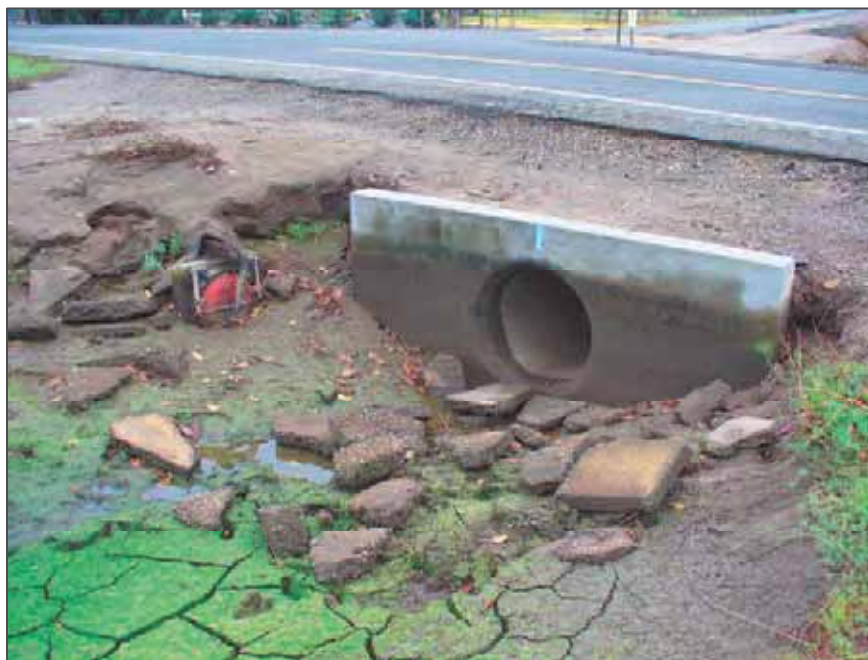
Photograph 35. Main Ashe Lateral at SP Avenue showing concrete culvert passing under SP Avenue at point MA4, camera facing southeast. 12/12/06.

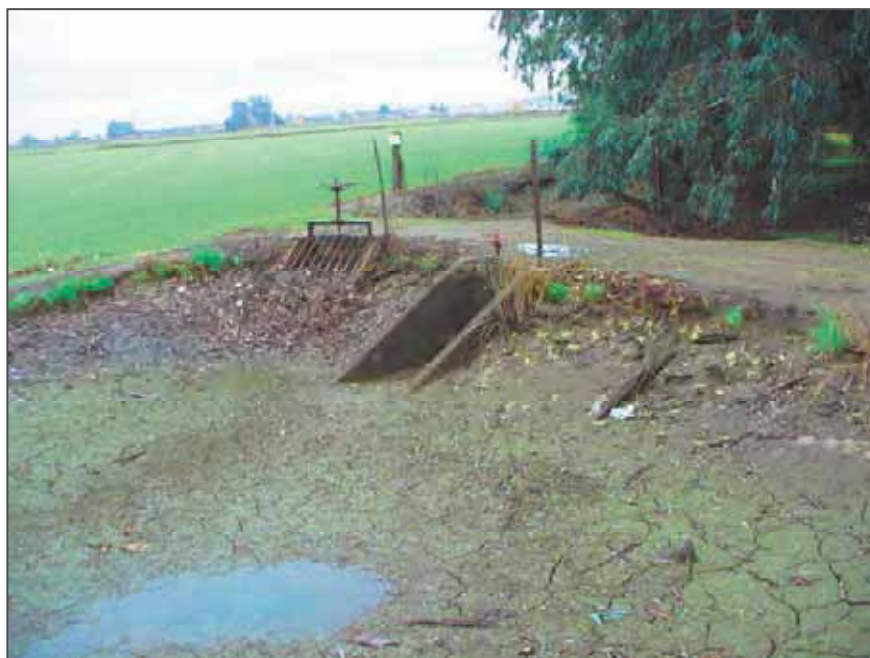
Photograph 36. East Ashe Lateral near Trinidad Road showing concrete and metal control gates at point EA6, camera facing southeast. 12/12/06

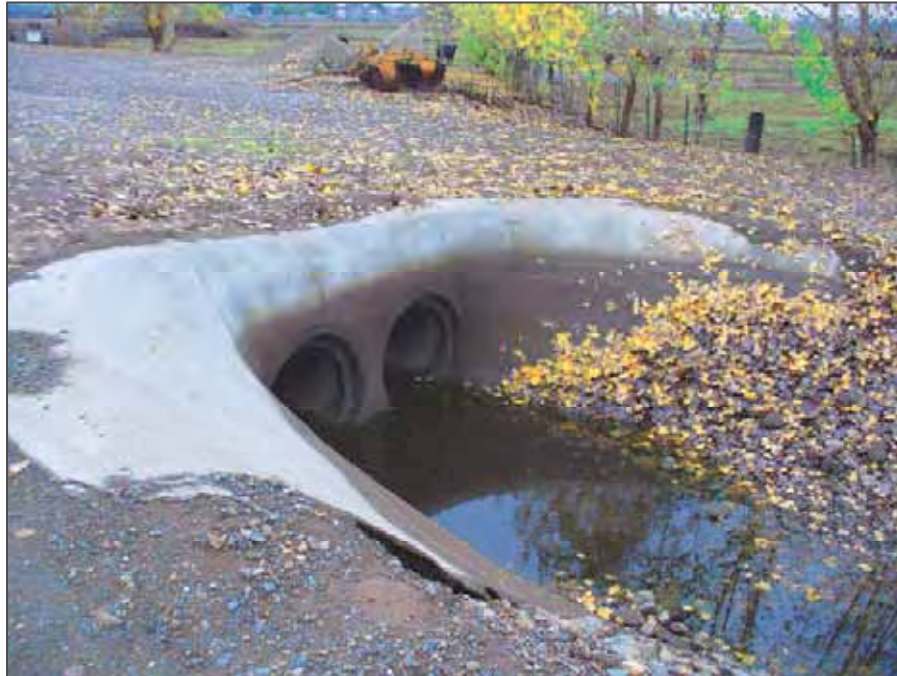
Photograph 37. Meadowbrook Lateral siphon pipes at point MB1, camera facing east. 12/12/06.

The Meadowbrook Lateral is an irrigation canal running adjacent to Bear Creek, paralleling its east side (Location Map 2). It is approximately 20 feet wide and four feet deep. It is unlined and roughly U shaped in cross section and its banks show signs of erosion. Both sides of the channel are built up above the surrounding land. It has concrete and metal gate structures and a concrete culvert passing under SR 140. This form addresses that portion of the creek intersecting SR 140 (See Linear Feature Record MR1-MB-1 and Photograph 37).
