Appendix L-1

**Historical Resource Inventory
and Evaluation Report (2 of 2)**

*Resource Name or # 1725-1731 West 16th Street

c. Address: 1725-1731 W 16th City: Merced, CA Zip: 95348

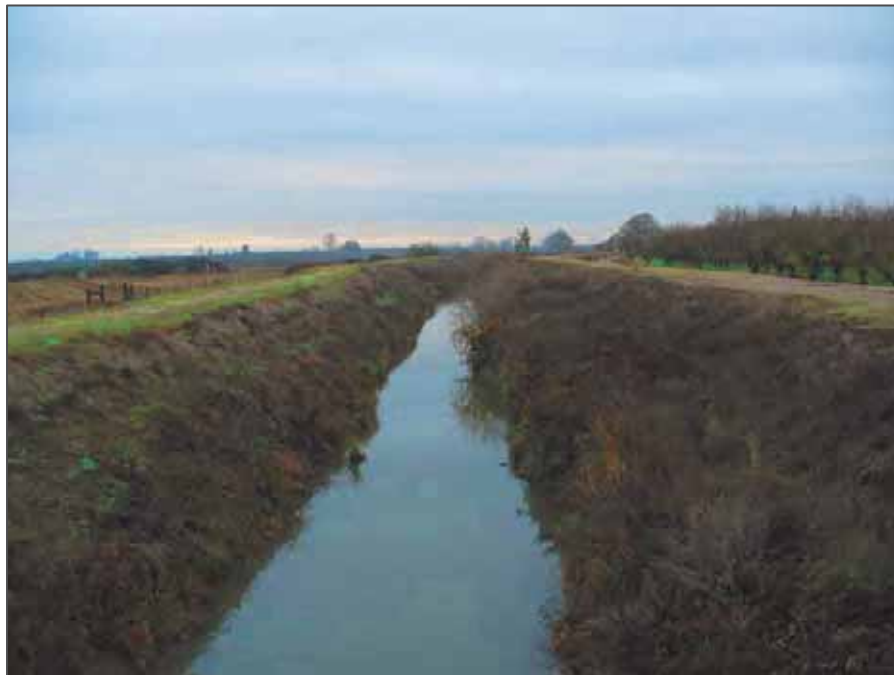
Photograph 38. Black Rascal Creek at point BR1, camera facing east. 12/12/06.

The role of this creek as a canal began around 1905 when the Crocker-Huffman Irrigation Company constructed the Livingston Canal, from which Black Rascal Creek drew water. This part of Black Rascal Creek is roughly U shaped in cross section and has vegetation growing along its unlined banks. Black Rascal Creek has a very regular, groomed appearance. Its banks have been raised above the surrounding farmland to form berms or levees and the banks have a uniform slope. The channel also appears straight and angular in alignment, within the segment addressed in this study. In this area the canal passes through agricultural land irrigating orchards, pastures, and row crops (See Linear Feature Record MR1-BR-1 and Photographs 38).

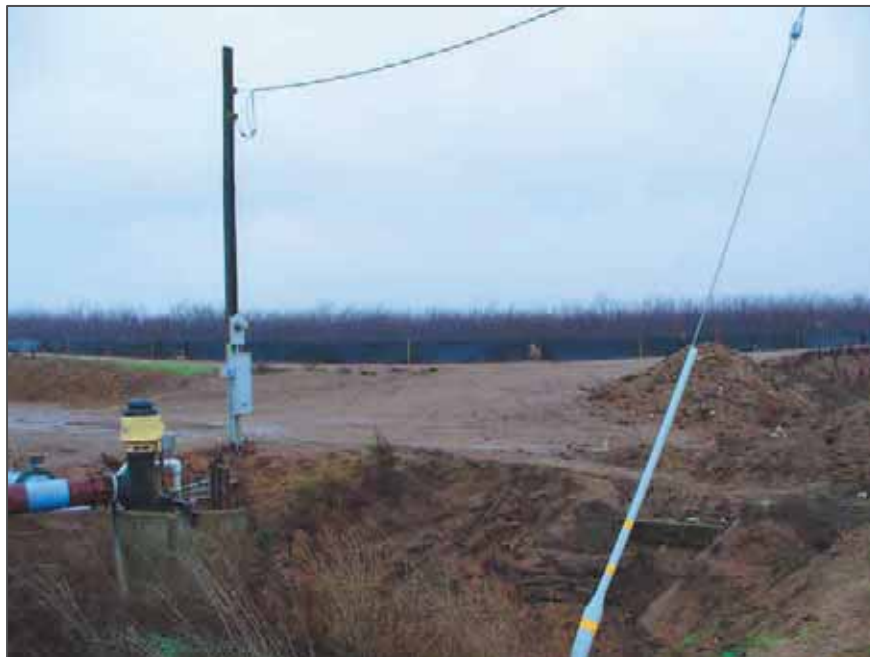
Photograph 41. Pump, lower left, timber supports for access road, lower right, fenced basin in background, camera facing northeast, near Henderson Lateral, point HN1. 12/12/06.

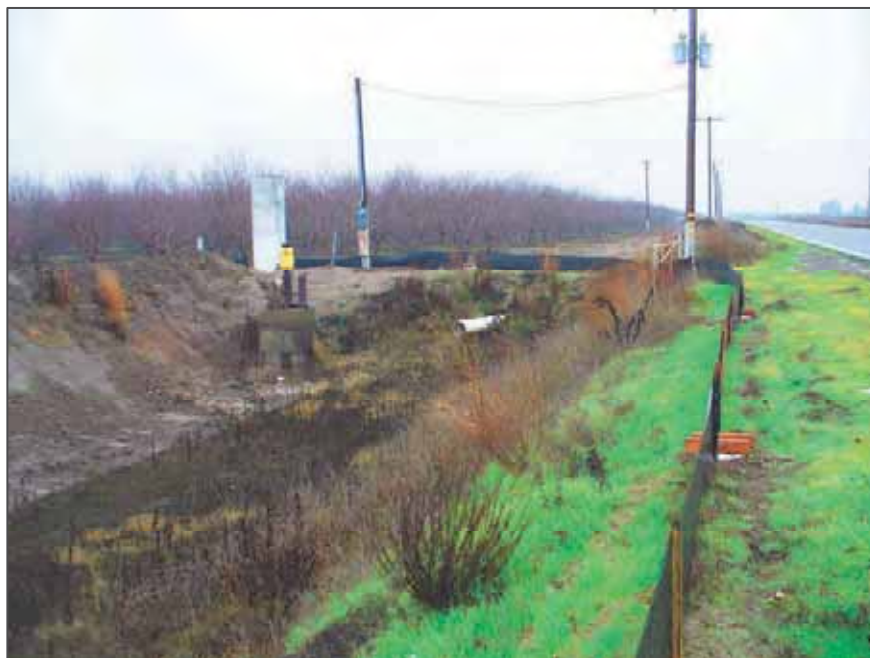
Photograph 42. Pump and vertical pipe near Henderson Lateral point HN1, camera facing northeast. 12/12/06.

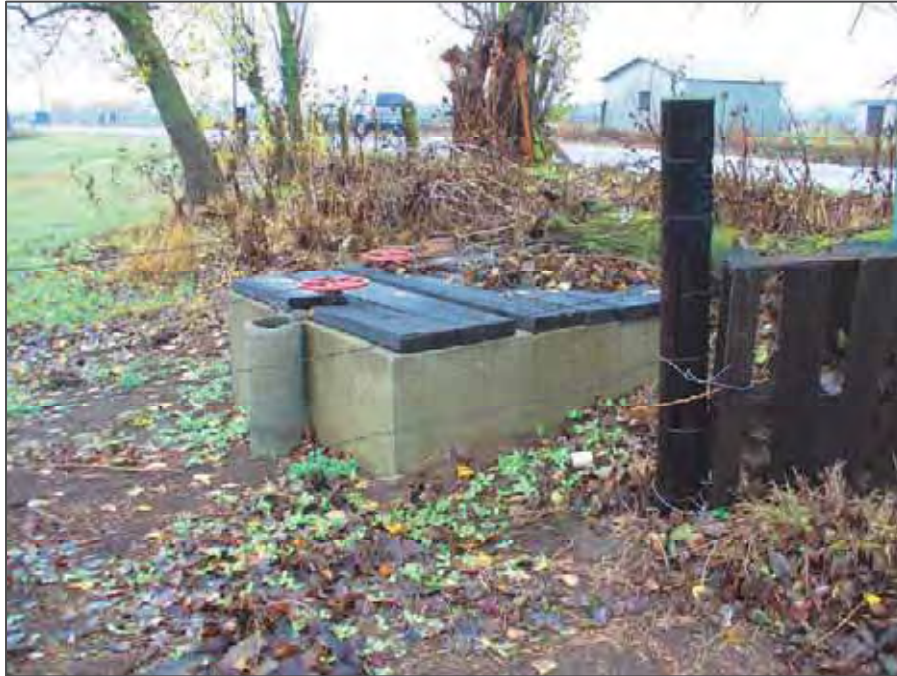
Photograph 43. Control Box at point HN2, camera facing northwest. 12/12/06.

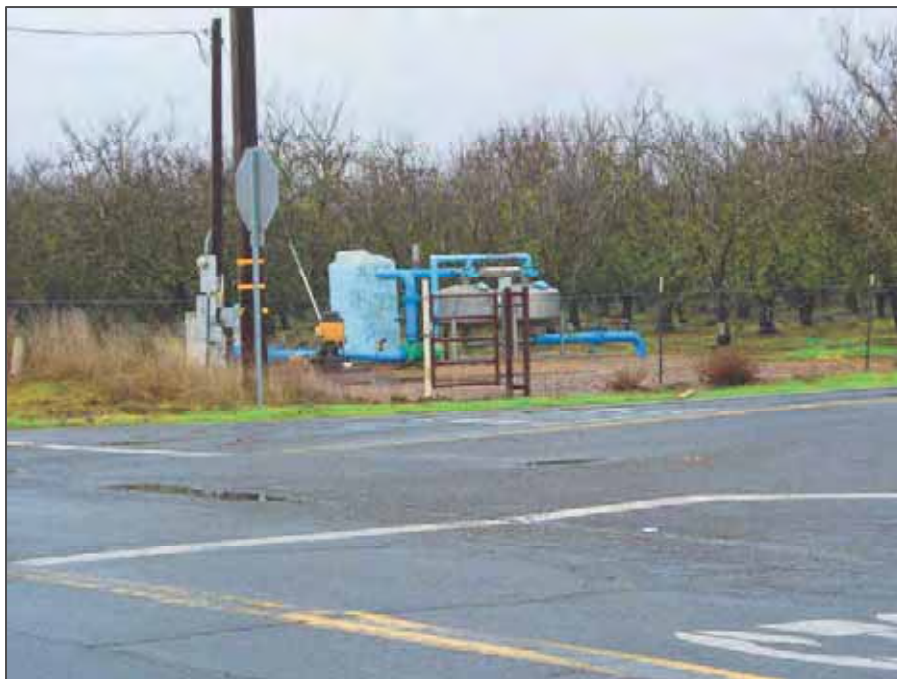
Photograph 44. Pump at point HN2, camera facing northeast. 12/12/06.

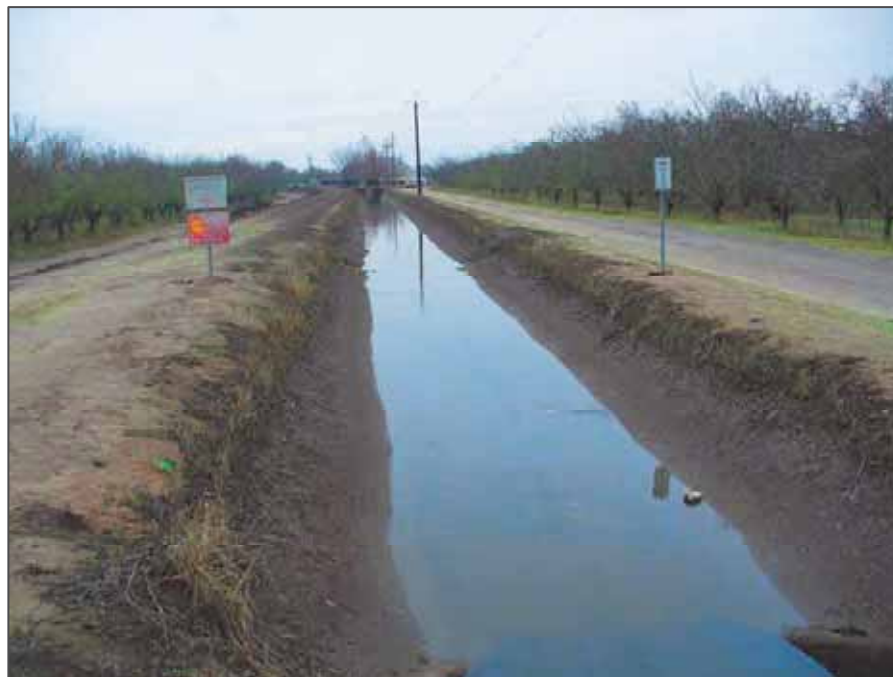
Photograph 45. Buhach Lateral at point BH1, camera facing north. 12/12/06.

The Buhach Lateral is an irrigation canal that runs roughly north-south from its origination point in Section 6 T7S/R13E MDBM where it branches off from the MID's Livingston Canal (Location Map 5). The Buhach Lateral was built in the 1890s to serve the Buhach agricultural colony. This form addresses that portion the lateral intersecting Elliot Road. This part of the canal is roughly trapezoidal in shape and lined with concrete. In this area the canal passes through agricultural land irrigating orchards, pastures, and row crops (See Linear Feature Record MR1-BH-1 and Photographs 45, 46).

L3. Description: (Describe construction details, materials, and artifacts found at this segment/point. Provide plans/sections as appropriate.)
At this point the canal is approximately 15 feet wide and four feet deep. It runs roughly north to south from its origination point in Section 6 T7S/R13E MDBM where it branches off from the MID's Livingston Canal. The channel is trapezoidal and lined with concrete. An access road runs on the east side of the canal. The canal passes under Elliot Road via a concrete culvert (Photographs 24, 45, 46).

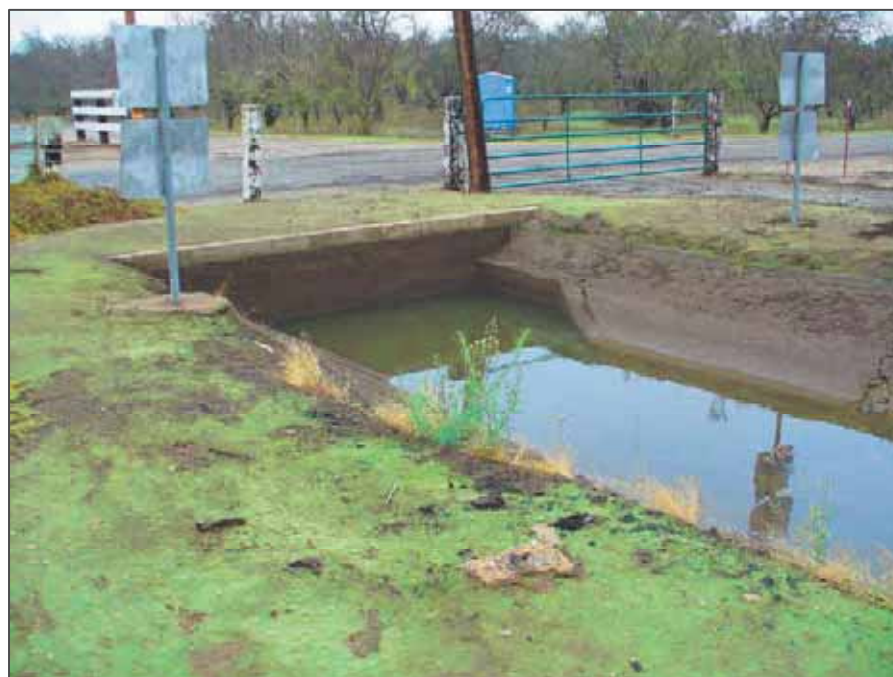
Photograph 46. Culvert under Elliot Avenue at point BH1, Buhach Lateral, camera facing northeast. 12/12/06.

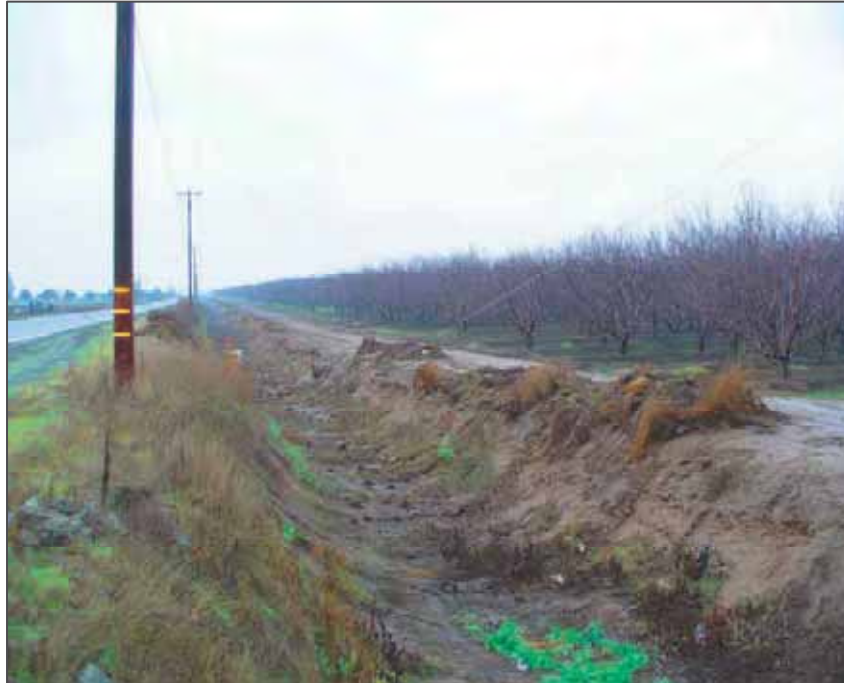
Photograph 47. Drainage Ditch at point DR1, camera facing west. 12/12/06

This drainage ditch, built between 1957 and 1960 borders farm land in Sections 25, 26, 34 and 35, T6S/13E MDBM and is about four miles in total length (Location Map 6). Ditches such as these are common in Merced County and drain irrigation water from fields. The ditch is approximately 14 feet wide at the top and four feet deep. It is unlined and has some vegetation on its banks and shows signs of erosion and of recent excavation. This form addresses that portion the ditch perpendicular and parallel to Bellevue Road. The ditch at this point runs north/south between two fields in Section 35 and east/west parallel to Bellevue Road. Maps and field observation indicate that a portion of the original ditch has been piped and covered recently. The terminus was undetermined, but generally such ditches drain into a natural waterway or canal (Linear Feature Record MR1-DR-1 and Photographs 47, 48).

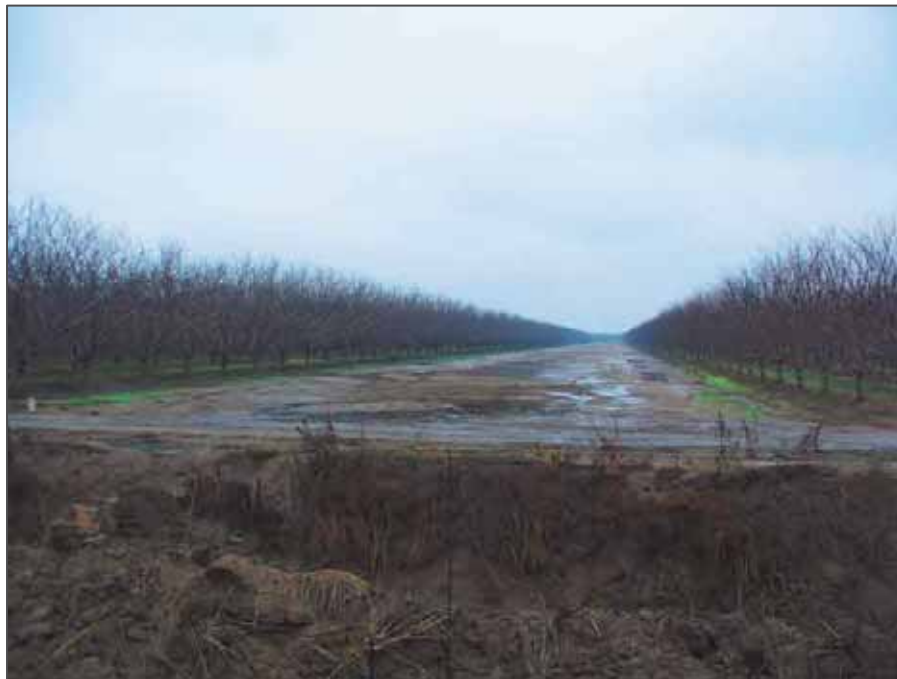
Photograph 48. Former site of an open drainage ditch that has been piped and covered (west of point DR1), camera facing north. 12/12/06.

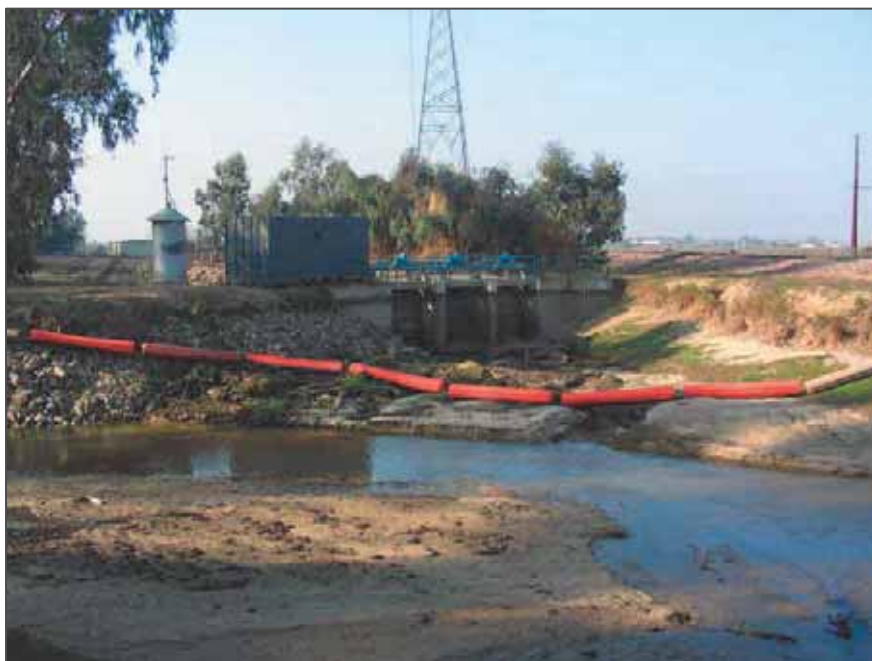
Photograph 49. Livingston Canal headgate (point LC1), Canal Creek in foreground camera facing west. 1/22/07.

lined with concrete or riprap, while others are unlined. The canal follows a circuitous route through residential areas in the city of Atwater as it runs northwest away from the study area. There are periodic metal gates along the canal's course (See Linear Feature Records MR1-LC and Photographs 49, 50).

The section of Canal Creek contains the headgate for the Livingston Canal and also a headgate to control the flow of Canal Creek downstream from this point. The headgate has four metal gates set in a concrete structure. The entire structure is approximately thirty feet long and ten feet wide. On both the upstream and downstream faces are concrete wings. The top of the headgate functions as a bridge and there is a metal railing on both sides and a guardrail on the downstream side. Also present on top of the headgate is the gate operating equipment. The canal at this point is approximately 50 feet wide and 12 feet deep and is roughly U-shaped. It is unlined except for a small area the area between the two headgates lined with riprap. The steep banks are wide with little vegetation and show signs of erosion. Immediately upstream from the headgate the canal passes under the BNSF railroad and Santa Fe Drive. Two large drain pipes protrude from the south bank of Canal Creek at this point (Photograph 10, 49, 51).

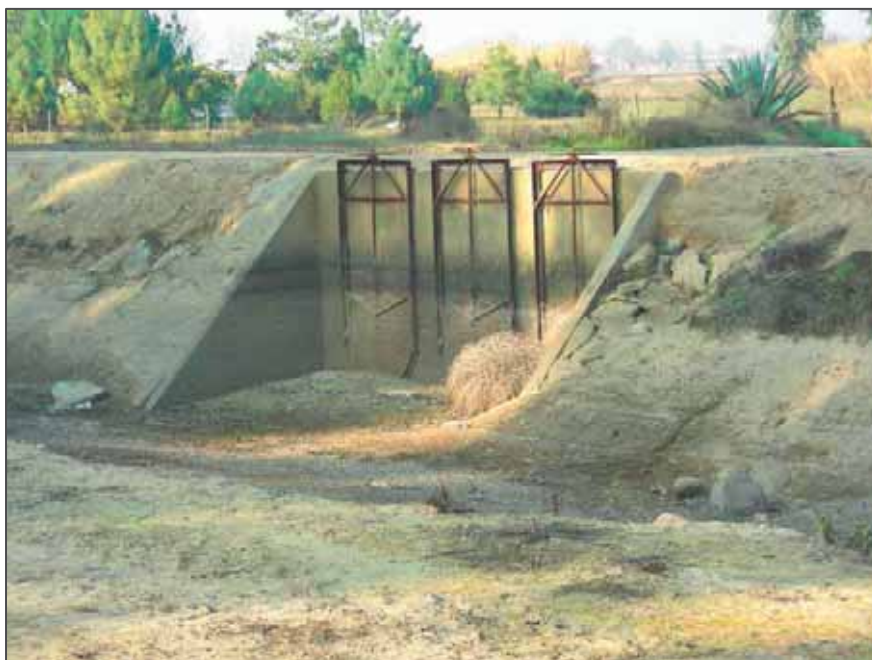
Photograph 50. Lateral gates off of Livingston Canal (point LC1), camera facing northwest. 1/22/07.

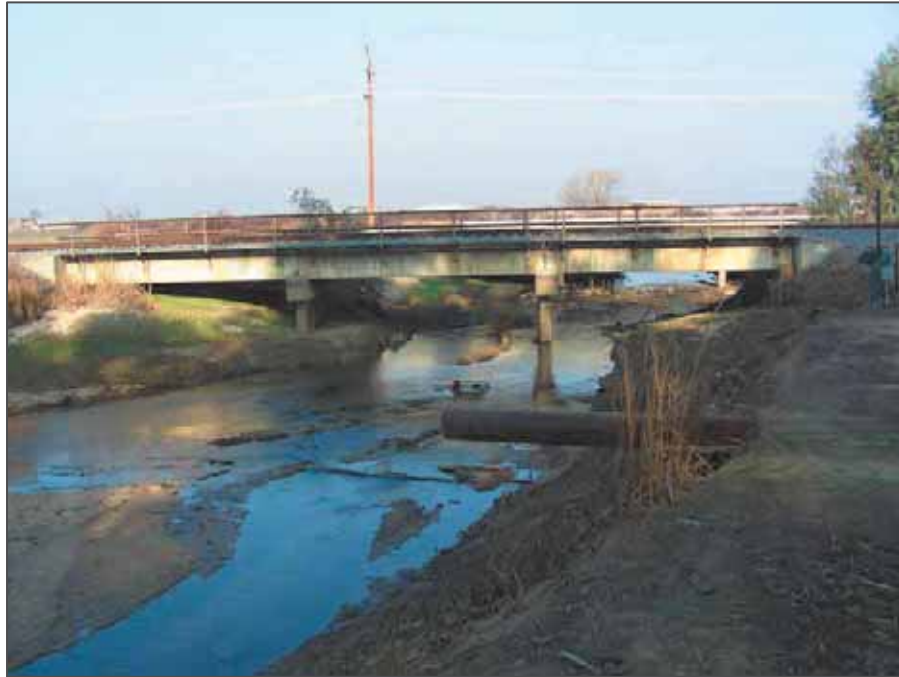
Photograph 51. Canal Creek passing at point CC9 passing under the SFBN railroad, camera facing northeast. 1/22/07.

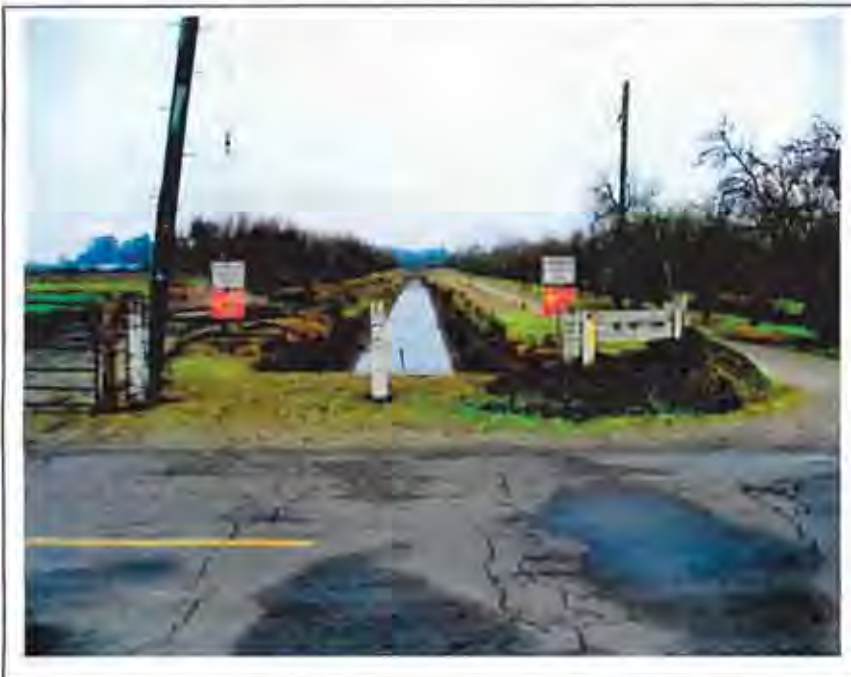
L7. Integrity Considerations: The Buhach Lateral was lined with concrete after World War II, and, therefore, lacks integrity to its period of construction.

Photograph 24. Buhach Lateral, camera facing south, 12/12/06.

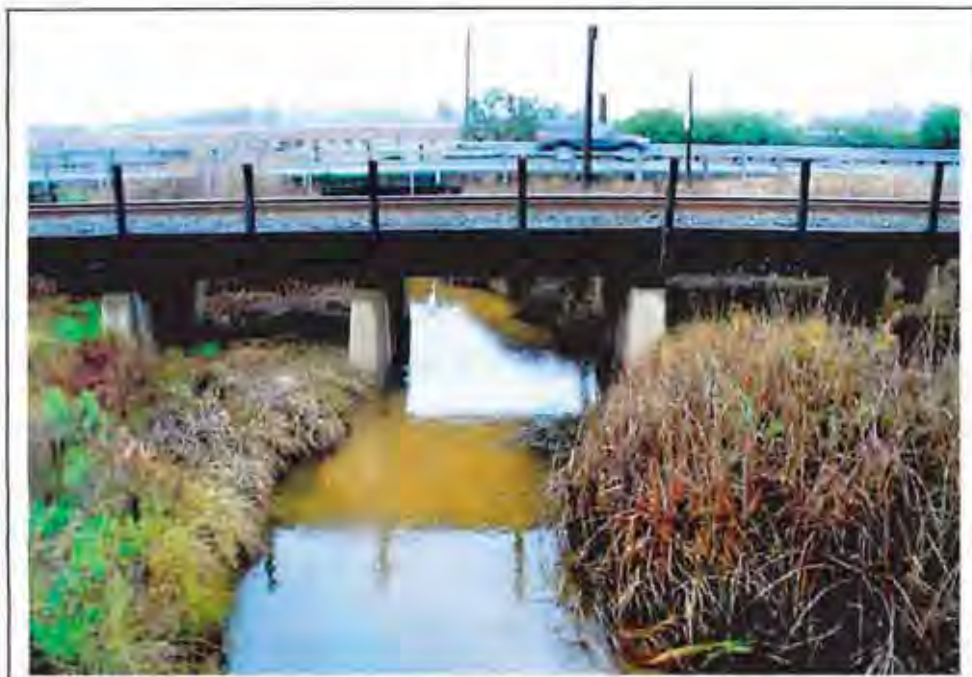
At this point the canal is approximately 80 feet wide. The unlined channel is U-shaped with bramble and grasses growing on its banks. There is an overgrown access road on the west side of the canal. A Union Pacific Railroad bridge and the SP Avenue bridge cross the canal at this point (Photograph 6).

L8b. Description of Photo, Map, or Drawing: Photograph 6. Canal Creek passing under US 99 and Union Pacific railroad tracks. Photo taken from Southern Pacific Avenue bridge, camera facing north. 12/12/06.

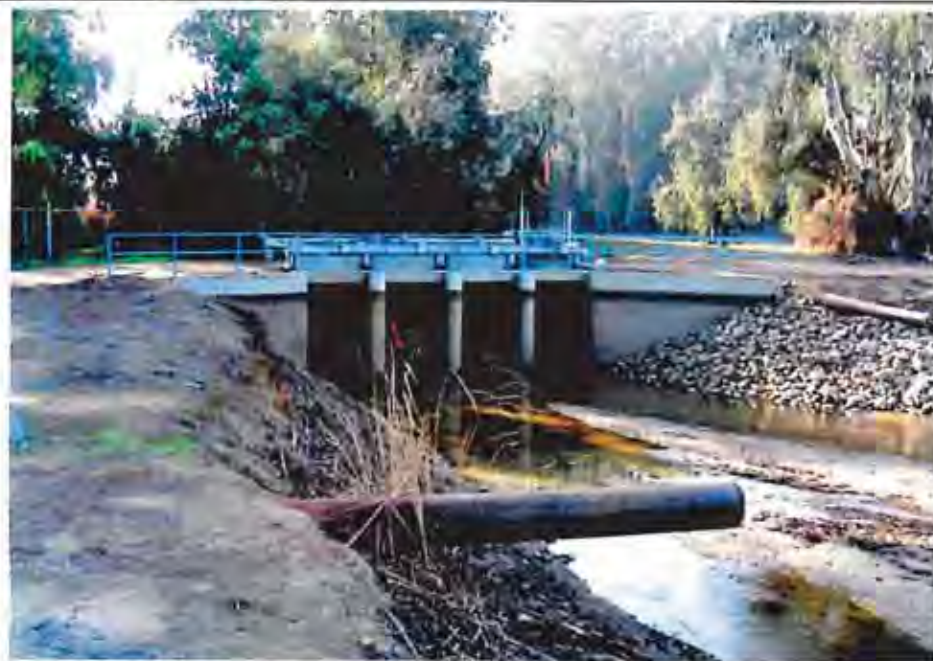
L8b. Description of Photo, Map, or Drawing:
Photograph 10. Canal Creek with flow control headgate, camera facing southwest. 1/22/07.

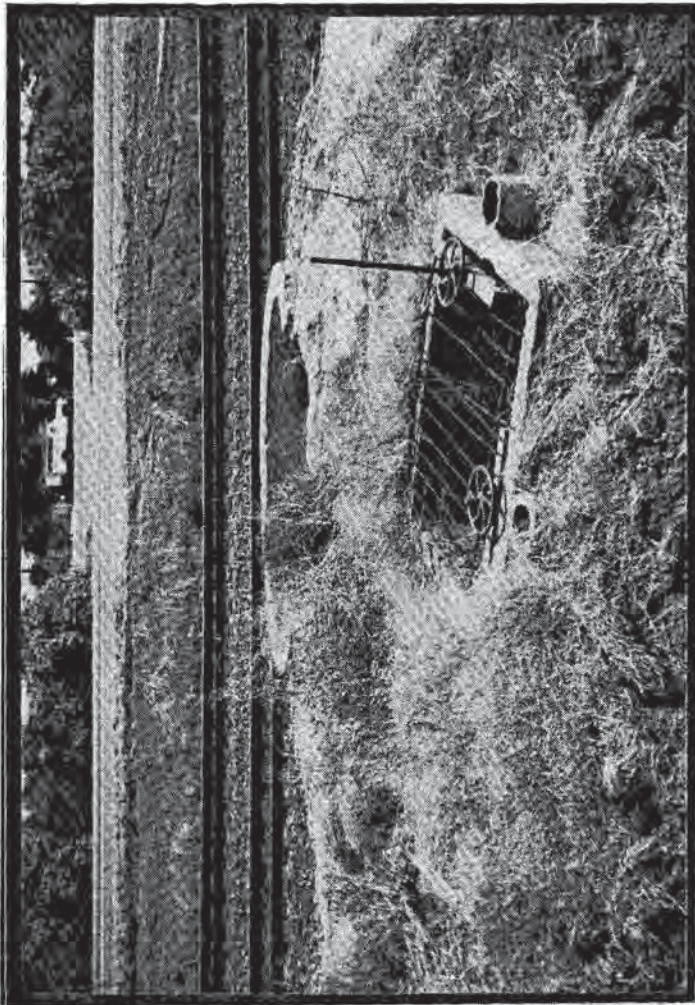
The siphon remnant is a semi-circle, built of brick with concrete plaster. The visible remnant is about 1' thick, 13' wide, and a little over 2' in height. The actual height of the unit would be much greater, extending to the bottom of the siphon. It may be presumed that the siphon itself was damaged or perhaps demolished when the pipeline was installed.

Photograph Number: 1
Site Number: LG-18
Common Name: Remnant of Ashe Lateral Inverted Siphon
Camera Facing: North

Although not documented through irrigation district records, it is quite likely that this siphon was replaced in the late 1940s when Highway 99 was constructed on its current alignment. The highway construction more than tripled the distance required for the under-crossing, forcing the irrigation district to install a deeper and longer conduit. The brick feature identified as LG-18, then, is an inoperable remnant of a turn-of-the-century engineering feature.

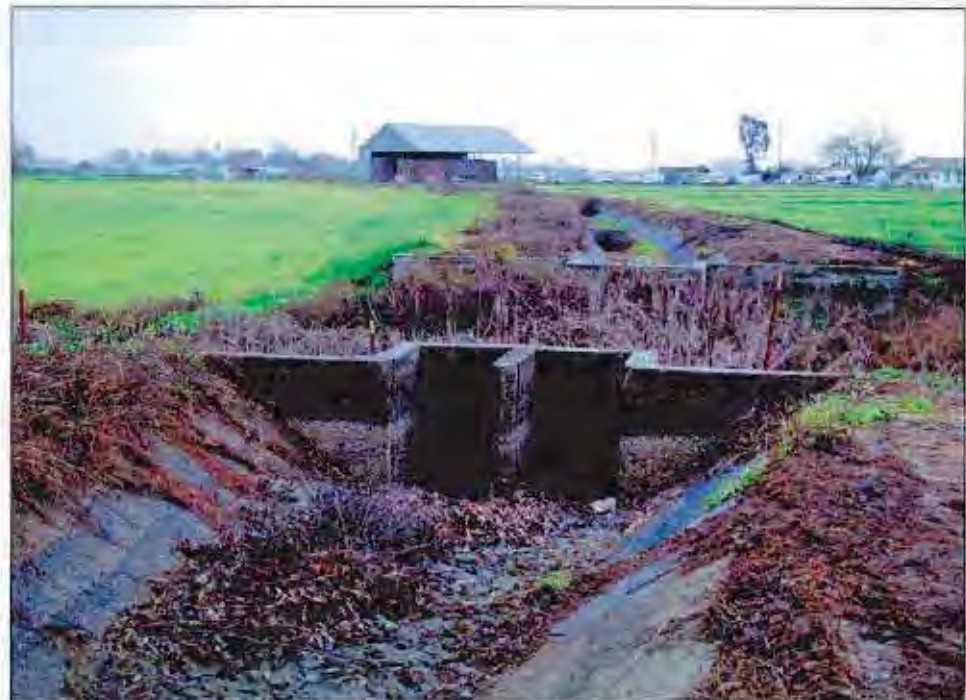
There are several features associated with the Main Ashe Lateral. At Point #2, the lateral passes underneath Avenue One in a double culvert reinforced by a concrete headwall with two parallel wingwalls. At Point #3 an inverted siphon carries the lateral underneath the Trindade Drain, a modified natural drainage feature. The siphon intake, in the north side of the drain, is composed of a double headwall with parallel wingwalls constructed of highly aggregated concrete. Two vertical intake pipes are nestled within the "U" created by the headwall and wingwalls. On the south side of the drain is a single headwall with parallel wingwalls that protect the embankment from the water that flows upward through the single vertical pipe. The water then continues through the canal to Point #4. At that point, the water again passes through a gate and culvert. The gate appears to make use of flash boards to raise or lower the level of the canal before it enters the culvert. The culvert, which carries water under an access road, is a single conduit and is reinforced with a headwall and 45-degree wingwalls. Point #5 is a headgate that appears to have fallen into disuse. The concrete portion of the gate structure was cast in two pieces. A groove present within each of the two pieces may have once held a large steel gate. These grooves are the result of setting the now nonexistent gate into the forms prior to pouring the concrete. A concrete walkway allows access over the canal at this gate. This gate also marks the point where the canal narrows, as described above. At the southern boundary of the current project area, the Main Ashe Lateral ends. The headwall at the terminus of the canal allows the water to be directed either southward through a gate to the Main Ashe Spill, or westward to the Weber Drain through a grate.

- P5. Photograph or Drawing (continued):** Main Ashe Lateral siphon (DSCN-2239), view to the southwest at Point #3.

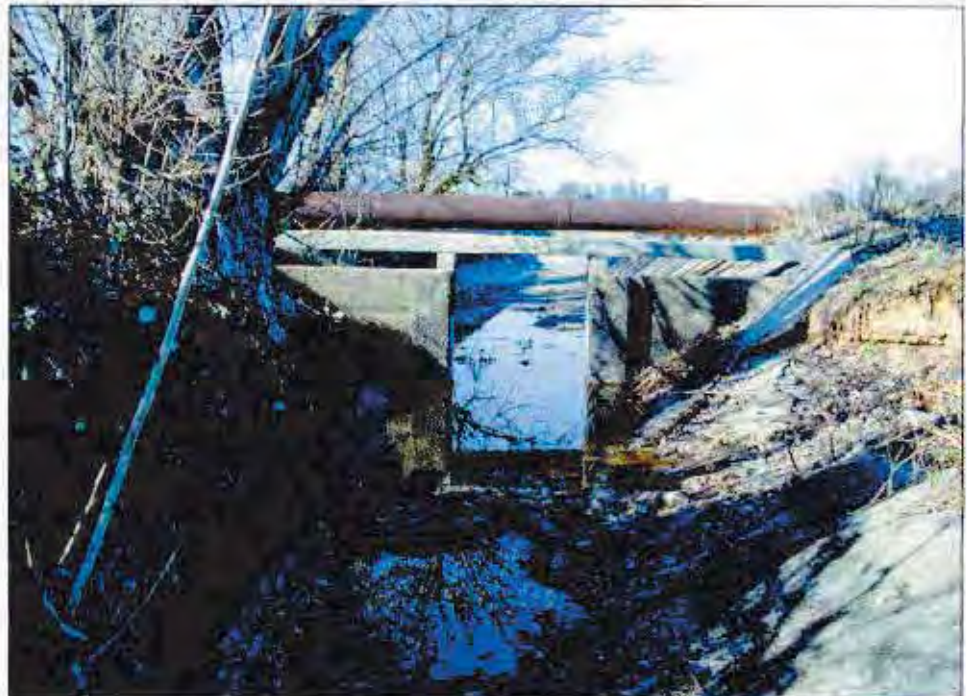
- Main Ashe Lateral gate
and crosswalk (DSCN-
2234), view to the north at
Point #5.

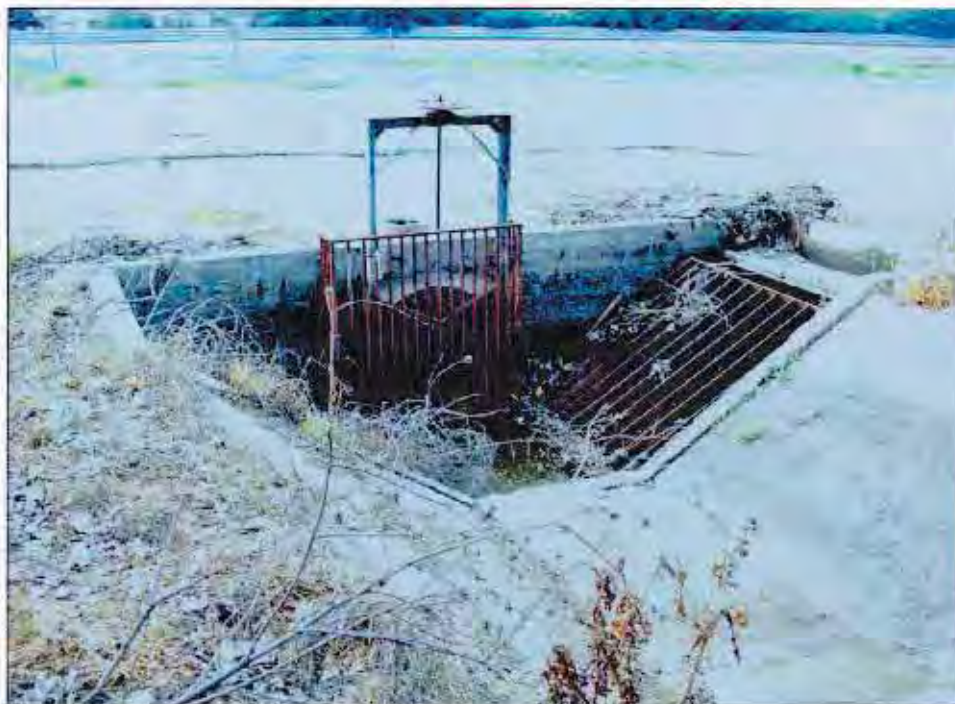
- P5. Photograph or Drawing
(continued): Main Ashe
Lateral culvert gate at
Ashe Road (DSCN-2273),
view to the south at
Point #6.

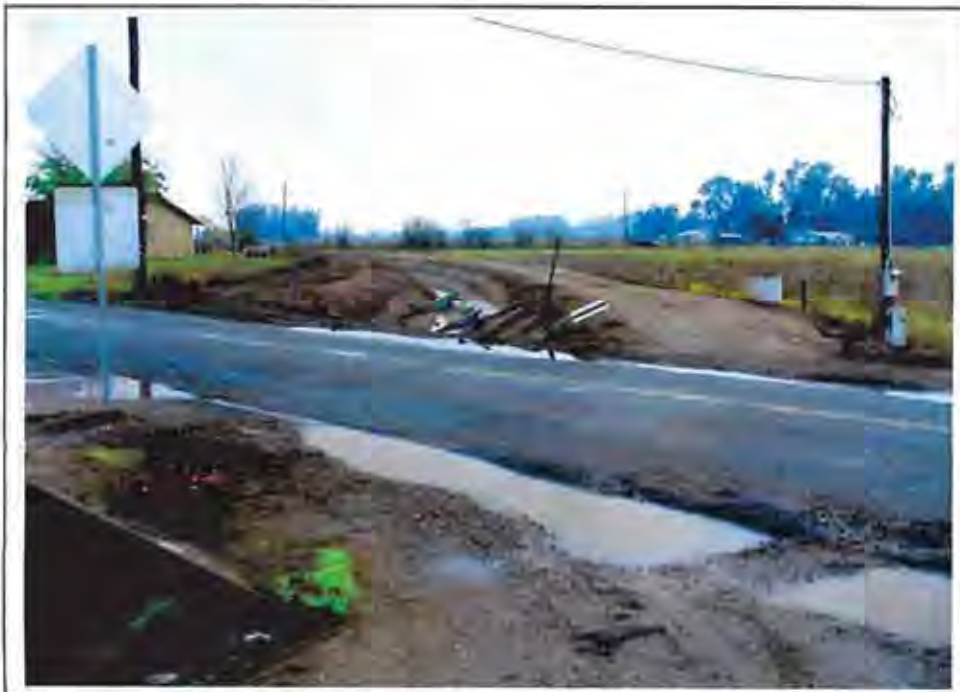
L3. Description: (Describe construction details, materials, and artifacts found at this segment/point. Provide plans/sections as appropriate.)
At this point the Main Ashe Lateral canal is approximately 20 feet wide and approximately four feet deep. It originates from Canal Creek in the SW1/4 of Section 4, T7S/R13E MDBM. It is trapezoidal and lined with concrete with metal control gates. Access roads are on both sides of the channel. The Avenue Two bridge crosses the canal at this point (Photograph 11).

Photograph 11. Main Ashe Lateral at Avenue Two, camera facing southeast. 12/12/06.

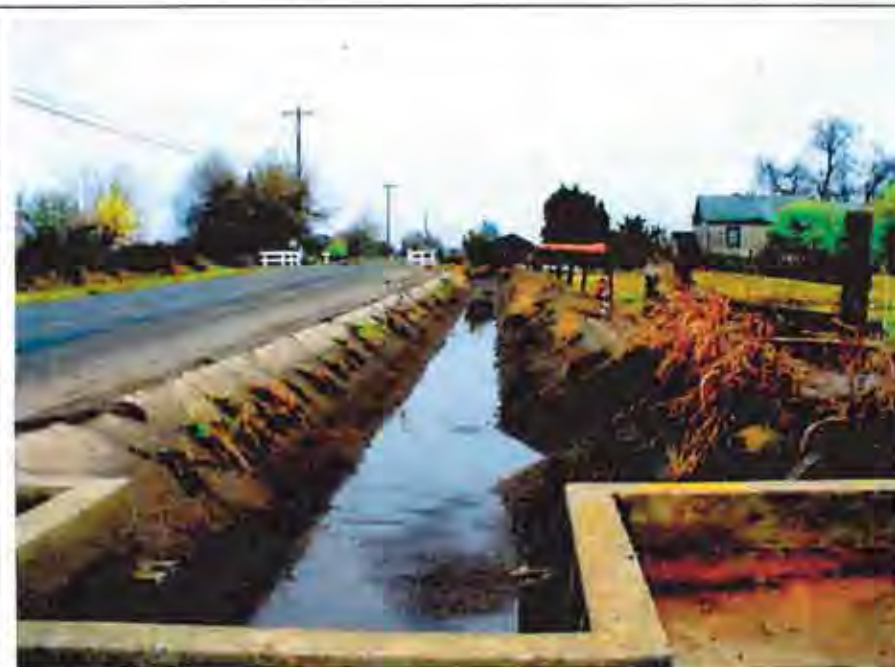
At this point the canal is approximately 15 feet wide and four feet deep. It is trapezoidal and lined with concrete. There are several concrete and metal slide control gates along this segment. It passes through farmland and a portion is adjacent to Avenue One (Photographs 13, 33).

L8b. Description of Photo, Map, or Drawing:
Photograph 13. Main Ashe Lateral near
Avenue One, camera facing east.
12/12/06.

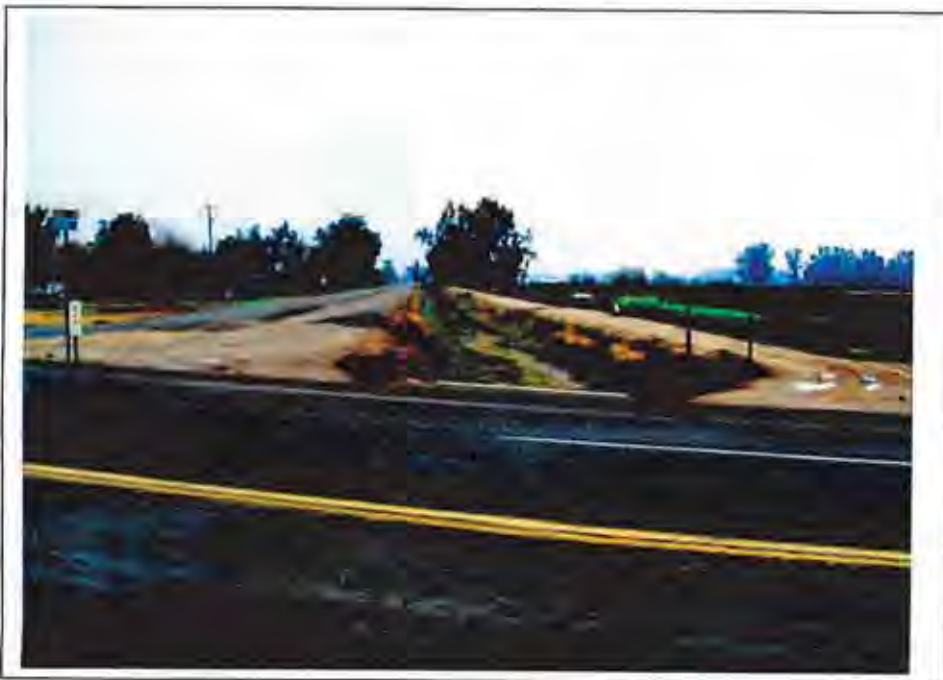
At this point the canal is approximately 15 feet wide and eight feet deep. It is U-shaped and unlined. There are concrete and metal control gates placed intermittently along this segment. The channel is heavily silted and the gently sloping banks show signs of erosion. The canal passes under SP Avenue via a concrete culvert. The Union Pacific railroad is carried over the canal via a bridge. Access roads are alone both sides of the canal to the south along Gurr Road. The canal did not carry water at the time of the survey (Photographs 14, 34, 35).

L8b. Description of Photo, Map, or Drawing:
Photograph 14. Main Ashe Lateral at SP Avenue and Gurr Road, camera facing south. 12/12/06

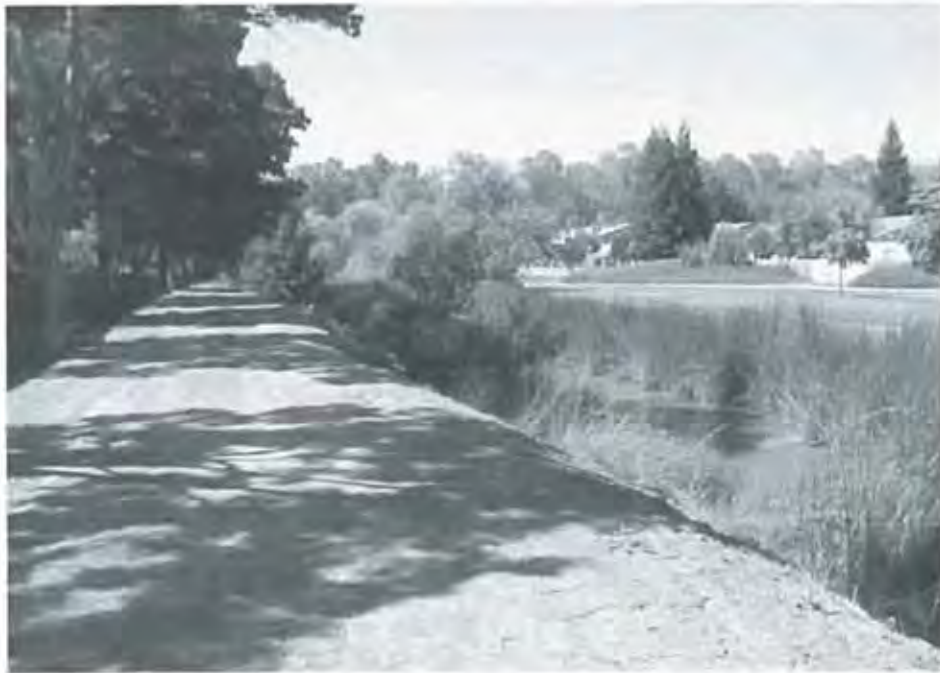
East section. About one-third mile east of S.R. 59, channelized section of creek

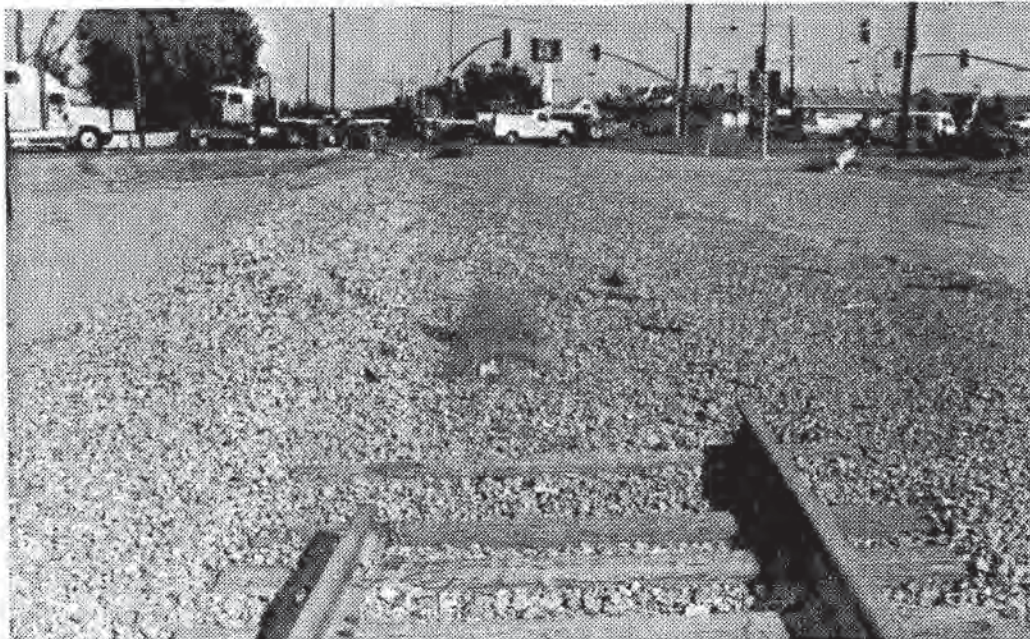
- e. ballast material: crushed granite (2" fragments)
- L7. Associated Features Observed: Rails, spikes, tie plates, and fasteners
- L8a. Photograph and Location Sketch (attached).

L8b. Date:
11/20/96
L8c. Camera
facing: S50E

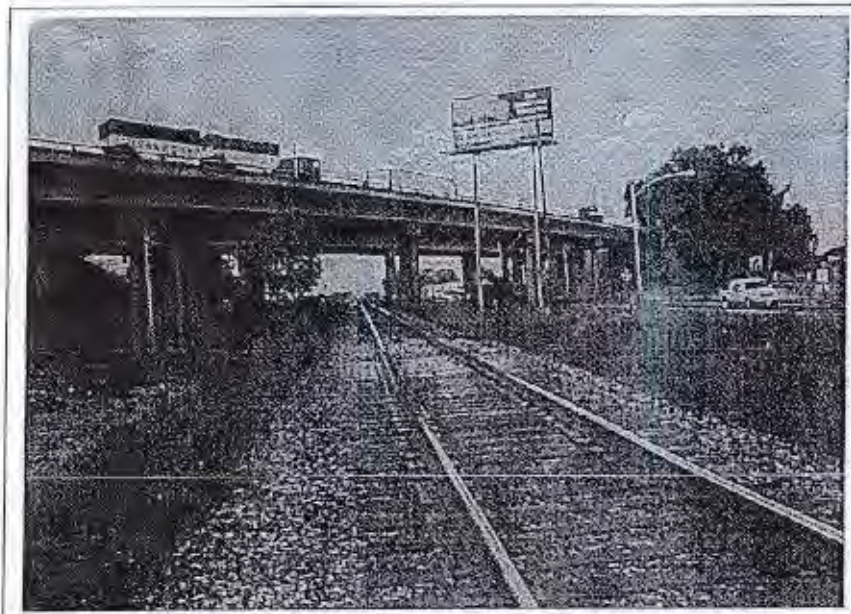
P5b Photo Date: September 19, 2005
View of railroad line and West Merced
Overhead looking northwest.

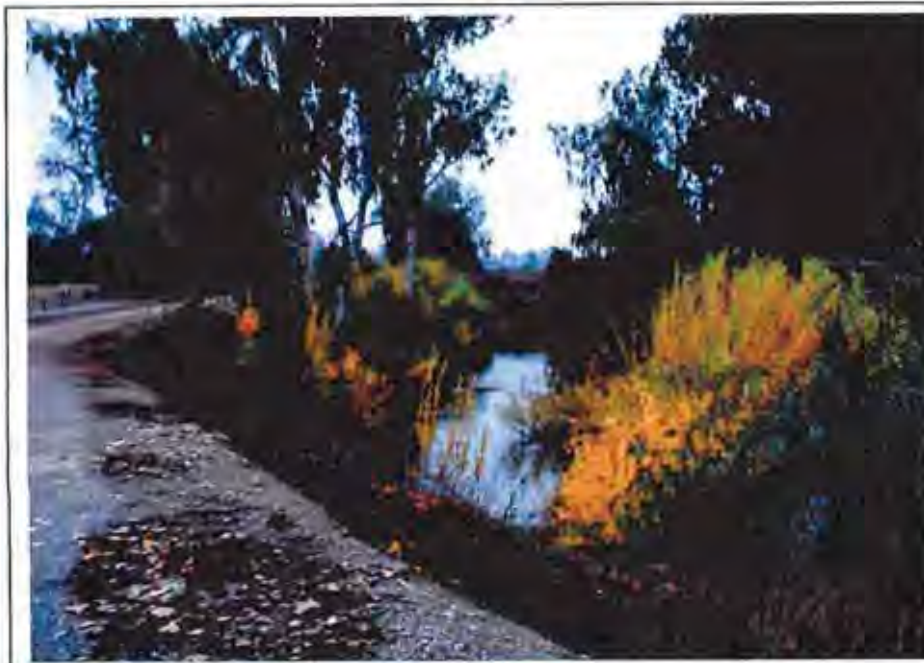
L3. Description: (Describe construction details, materials, and artifacts found at this segment/point. Provide plans/sections as appropriate.)
At this point the Bear Creek canal is approximately 60 feet wide. Water in the canal prevented an accurate depth measurement. The unlined channel is U-shaped and has vegetation growing on its steep banks. Both sides of the channel are built up forming levees on the banks. It is crossed by the SR 140 bridge. An access road runs on the east side of the canal. (Photographs 17).

L8b. Description of Photo, Map, or Drawing:
Photograph 17. Bear Creek passing under
SR 140, camera facing north. 12/12/06.

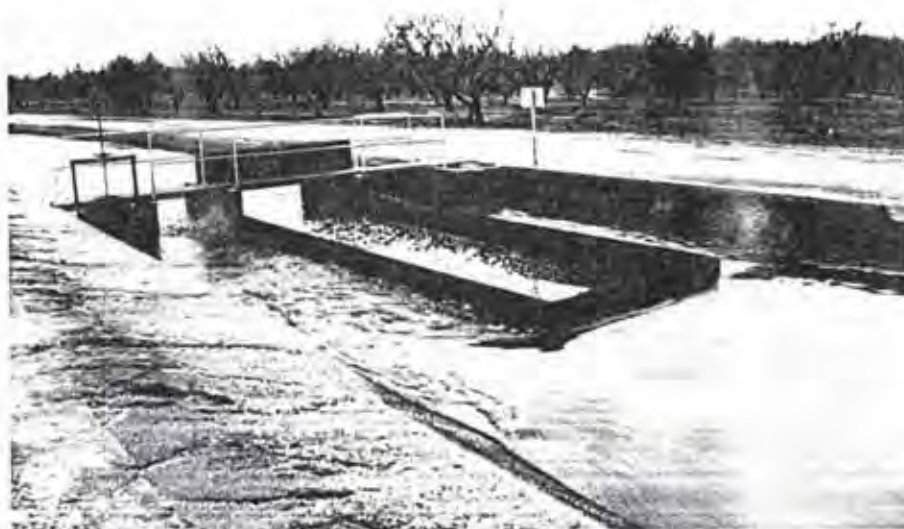
Three-cell canal drop marked "L6-D2," view looking southwest.

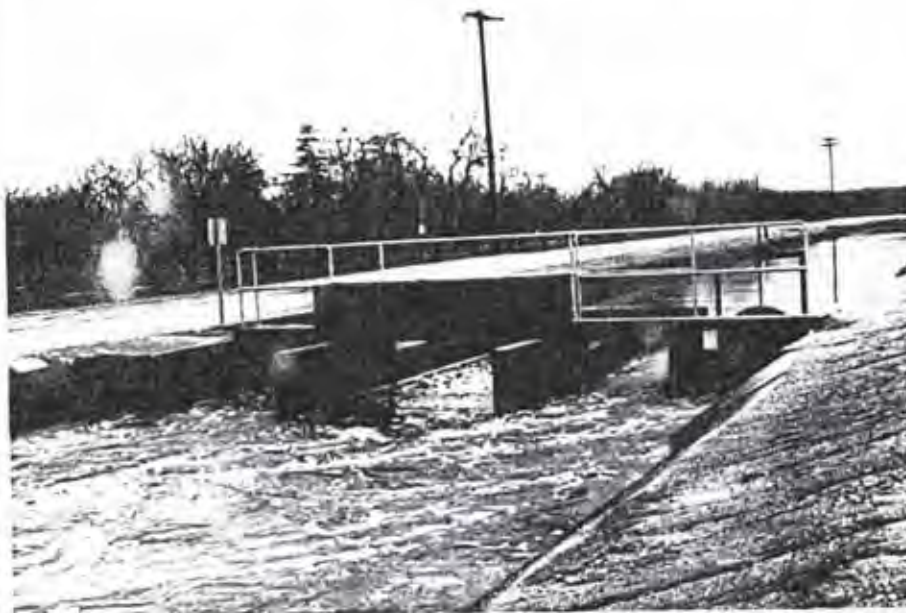
Three-cell canal drop marked "L6-D2," view looking north.

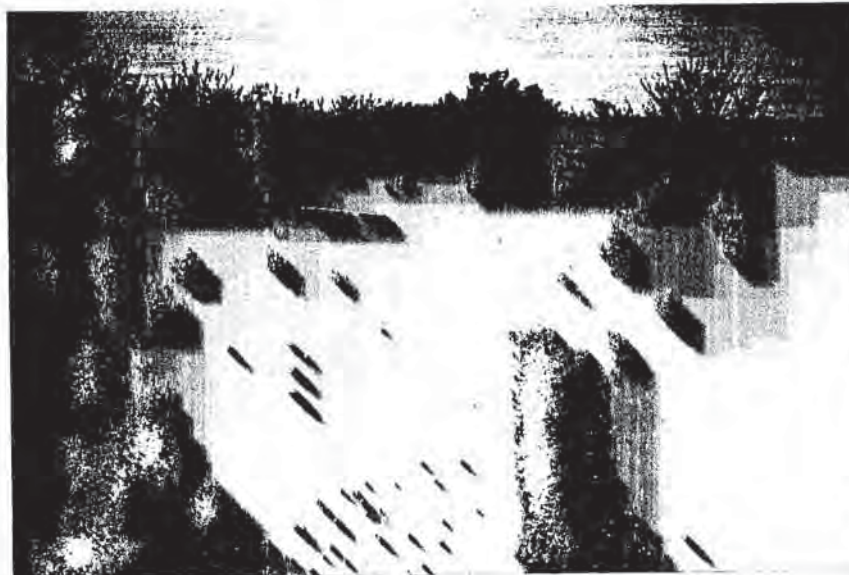
Culvert, view looking northwest.

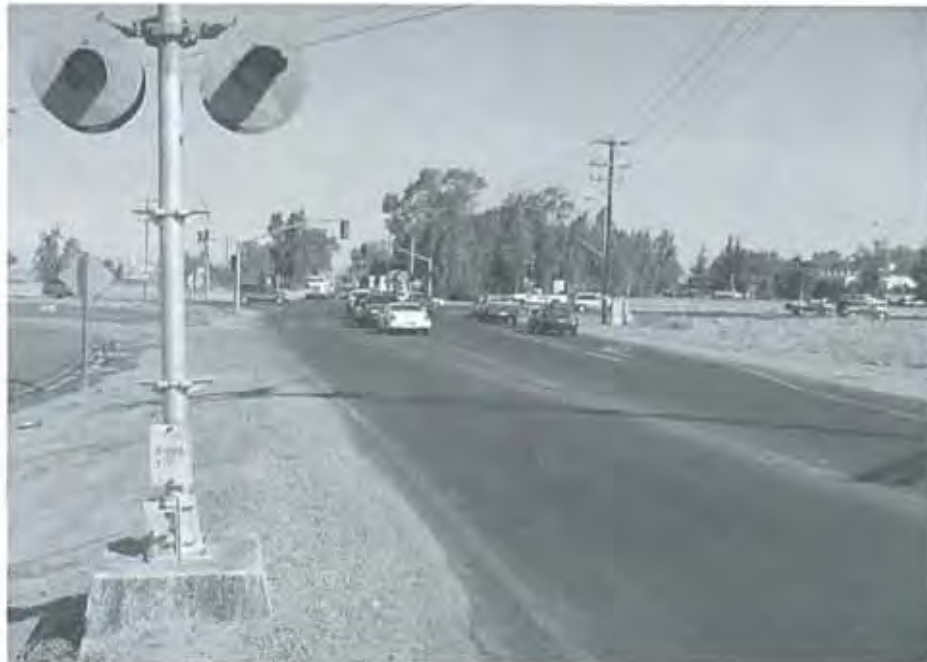
Looking north from Santa Fe tracks

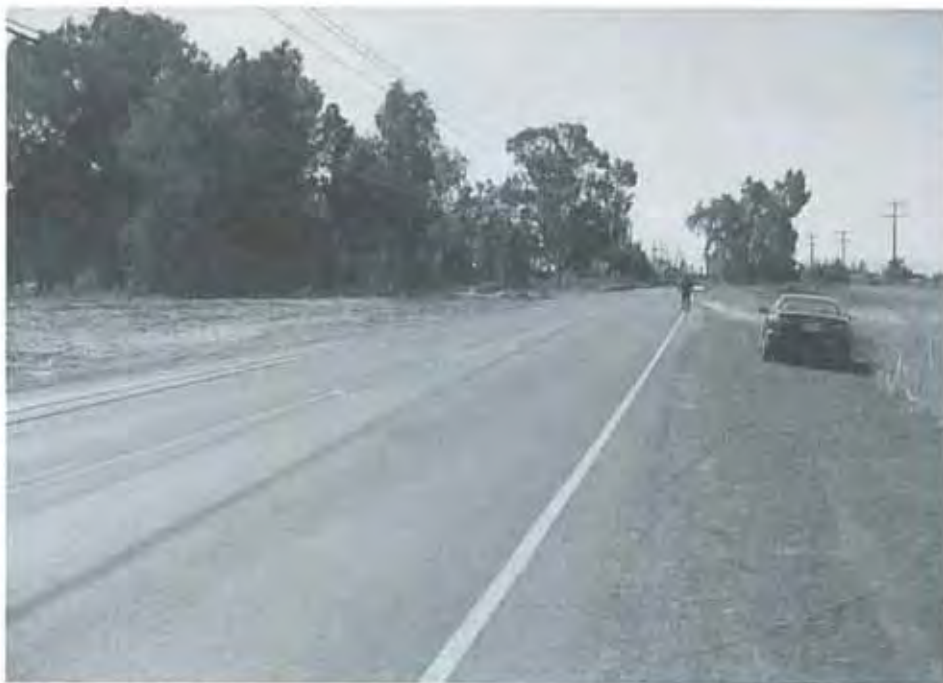
Looking south, 150 feet north of Black Rascal Creek

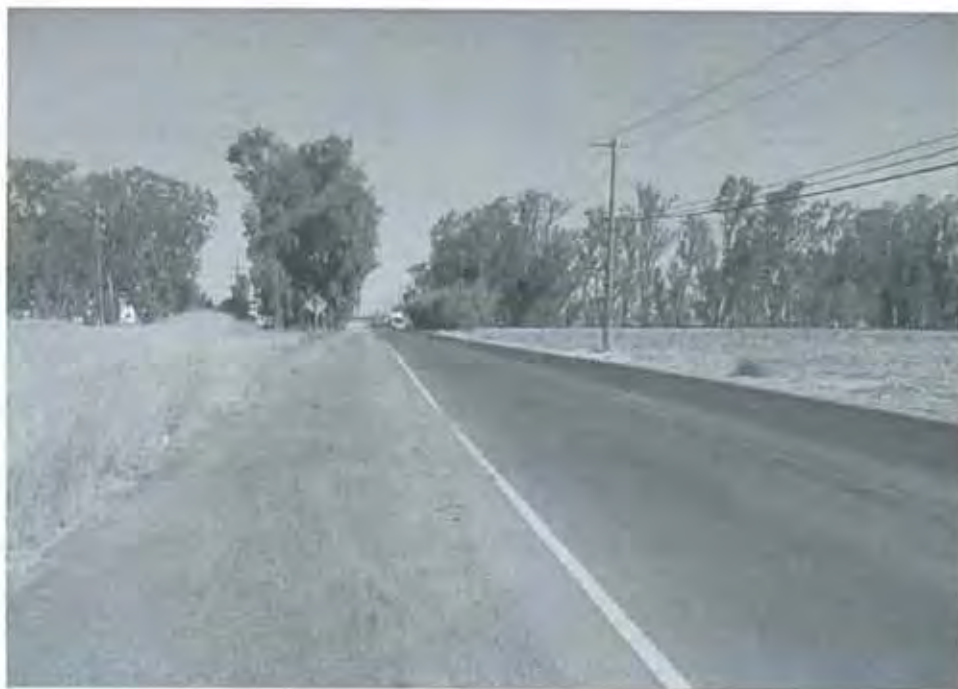
Looking north, 150 north from Black Rascal Creek
