Cambrian Park Plaza Historic Resource Evaluation

May 20, 2016

CAMBRIAN PARK PLAZA
Historic Resource Evaluation

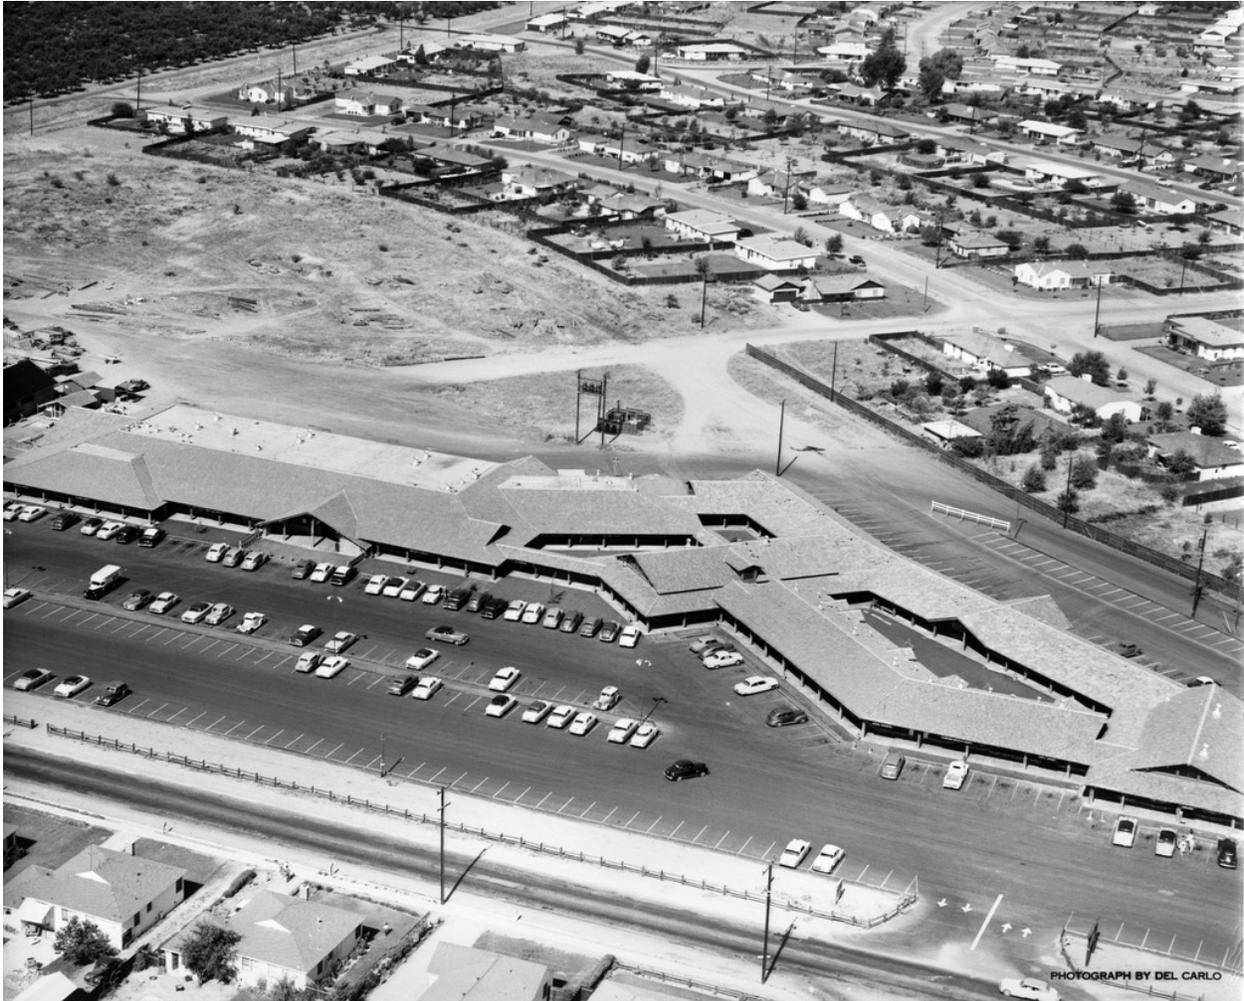
A c1956 aerial view of the property clearly shows the extent of the original 1953-54 building (fig.8). And a 1956 newspaper section advertising the Cambrian Park neighborhood also included an aerial view of the vicinity and the extent of its development (fig.9). That c1956 image also shows the completed western leg of the CPP fronting on Union, but as yet without any construction of the northern leg, with that portion of the site remaining open and segregated by a roadway.

Fig.8 – Cambrian Park Plaza – Aerial, c1956 (courtesy Sourisseau Academy for State and Local History, Arnold Del Carlo Collection)

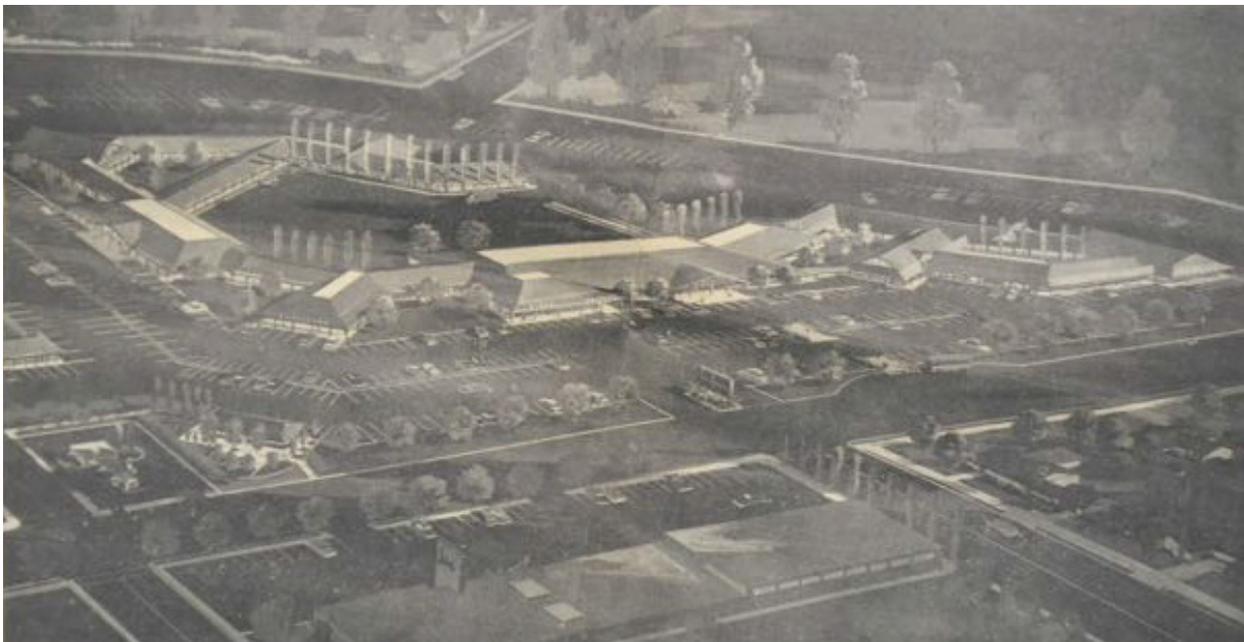
Additional images of and advertisements for the CPP were included in that newspaper section. One view was an undated architectural rendering of the CPP and which greatly differs from the realized project, especially the placement of its northern leg, which was envisioned to be aligned with Camden and to extend into an eastern leg (fig.9). As built, the northern leg was rotated to the southwest and the planned eastern leg was deleted from the project. Prominent stores were also shown at the several outside corners of the CPP, yet these did not come to fruition. A roadside pylon sign was indicated at the main entrance in the middle of the Union Ave. front, and an elevational sketch of the CPP also illustrated the Union Ave. frontage with a roadside pylon sign of modern design at its entry (fig.10). That second sketch more accurately illustrated the CPP as it stands today, its modest and rambling architecture lying under low sloping roofs in the middle distance. And the pylon sign depicted therein may have been representative of the original roadside sign which, in the early aerial views, is otherwise barely visible at the south entry to the CPP. Overall, the undated architectural rendering appears to present the CPP with a more modern character than the realized work.

Fig.9 – Cambrian Park Plaza – Rendering, c1956 (from Cambrian Weekly News, June 14, 1956)

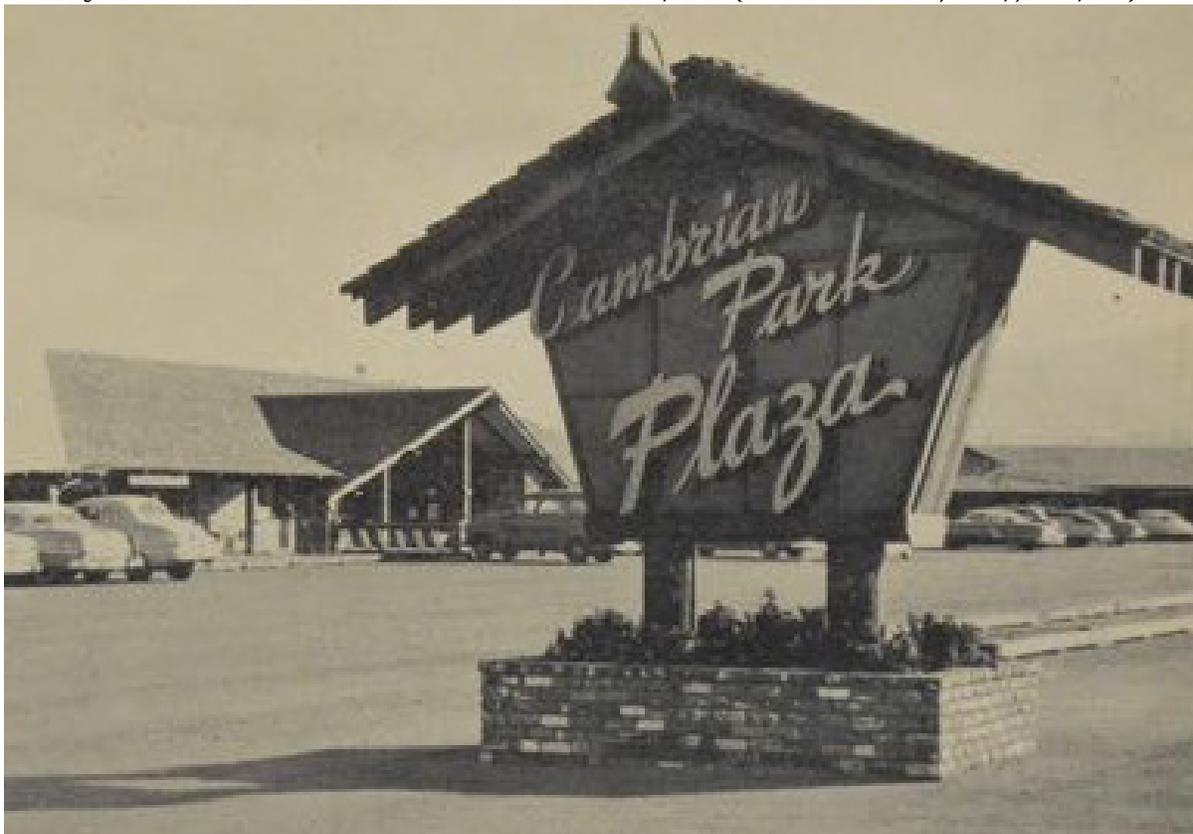
One of the photographic images in the 1956 article is of a low, freestanding Cambrian Park Plaza monument sign (fig.11). As is evident in the c1956 aerial, that sign stood not at the roadside or

entrance to the CPP but in the middle of the central entry drive off Union Ave. It was a low sign in character with the ranch-like architecture of the CPP. How long it lasted is not known, but that sign is again depicted in a 1963 advertisement, so probably stood at least until then (fig.12).

Fig.11 – Cambrian Park Plaza – Monument sign, c1956 (from Cambrian Weekly News, June 14, 1956)

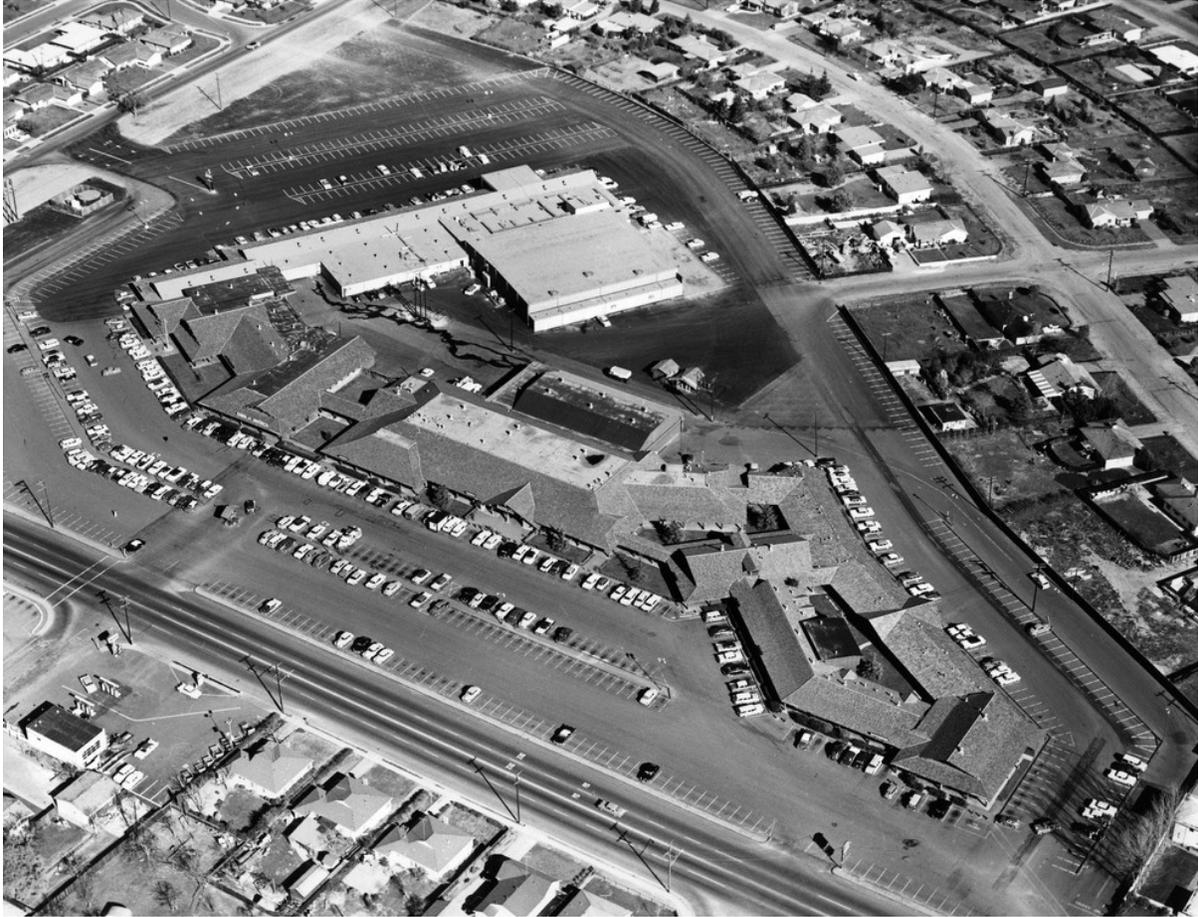
Another historic aerial view, c1960, documented the central CPP building consisting of both its western and northern legs, largely as it exists today yet without any freestanding buildings along Camden (fig.13). That aerial also shows that an addition was made to the rear of the original building, which was an extension to the supermarket housed in the space at the center of the western leg.

Fig.13 – Cambrian Park Plaza – Aerial, c1960 [courtesy Sourisseau Academy for State and Local History, Arnold Del Carlo Collection]

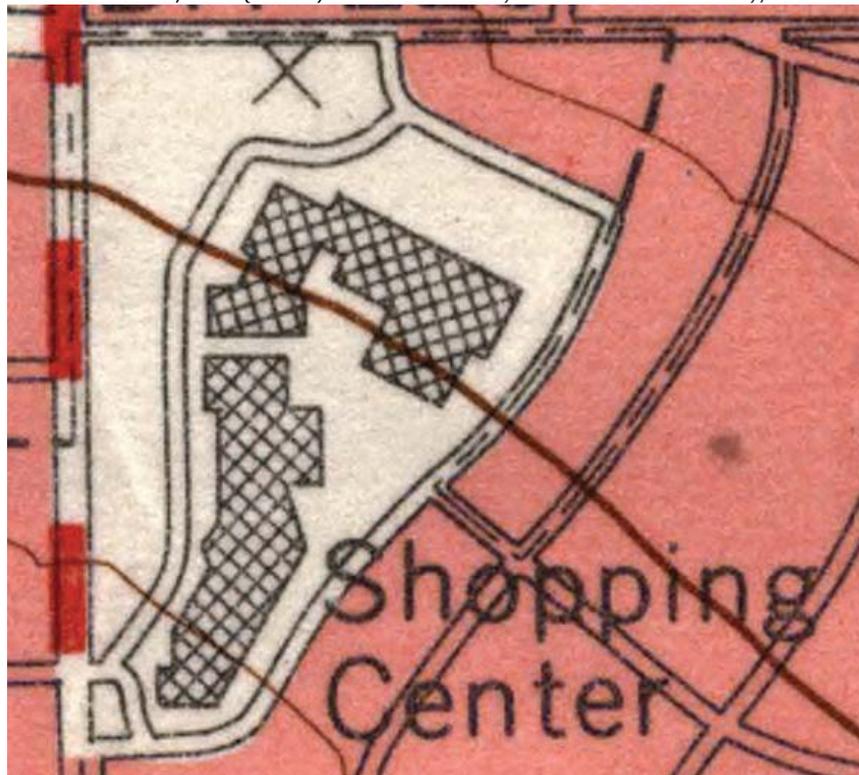
A 1961 USGS topographic map again depicted the completed overall building, clearly showing it as two buildings joined together (fig.14). That map appears to show the northeastern corner of the site as a separate parcel segregated from the northern leg of the CPP by a street or drive, the geometry of which appears to explain the curiously angled plan of the CPP's northern leg.

Fig.14 – Cambrian Park Plaza – USGS Map, 1961 (north is up)

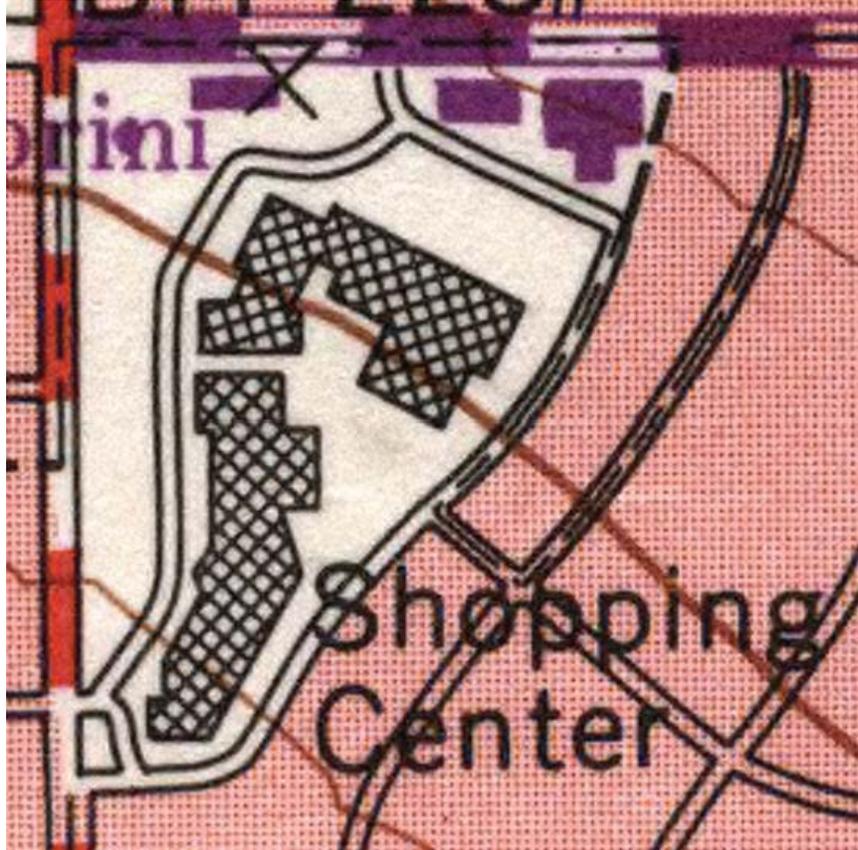
Based on a 1968 USGS map, three of the existing freestanding buildings were added along the Camden Ave. frontage during the latter 1960s (fig.15). The 1973 USGS map is the same (fig.16). In the 1980 USGS map (fig.17), it appears that the fourth freestanding building was added between 1973 and 1980.

Fig.15 – Cambrian Park Plaza – USGS Map, 1968 (north is up)

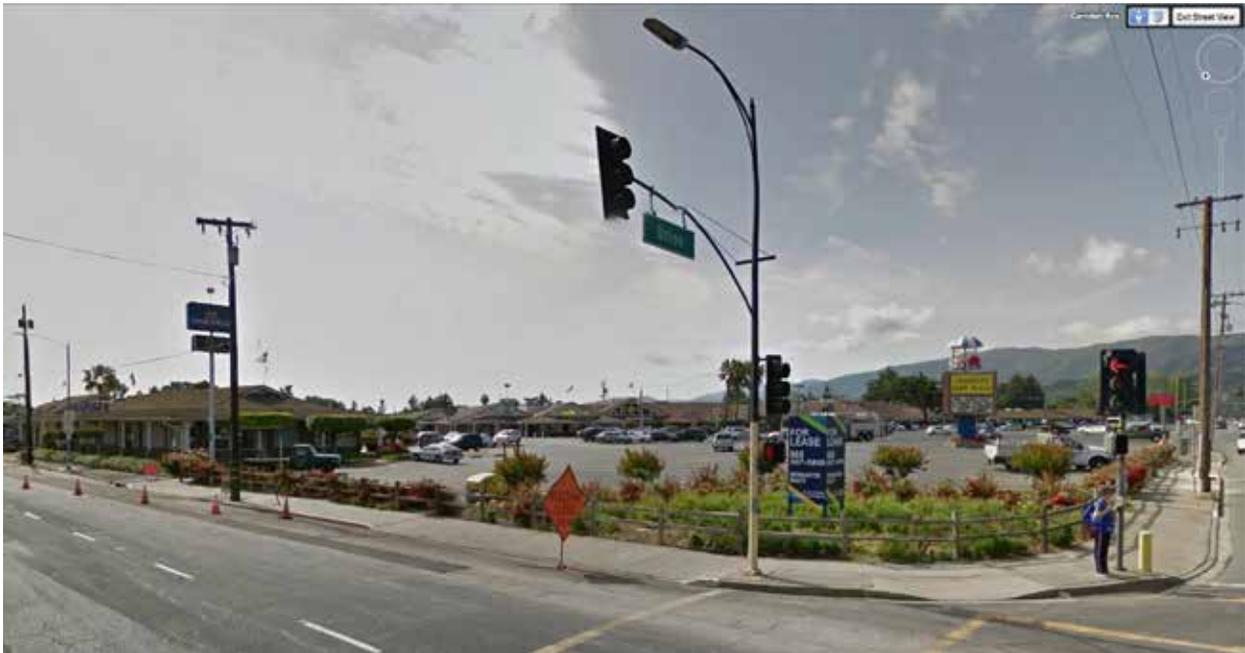
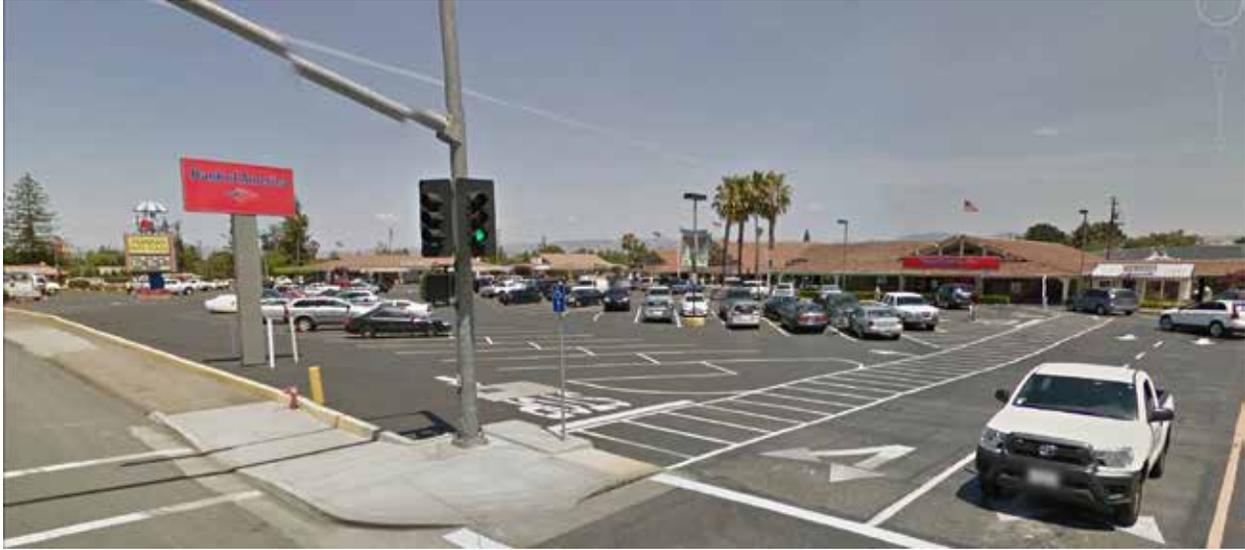
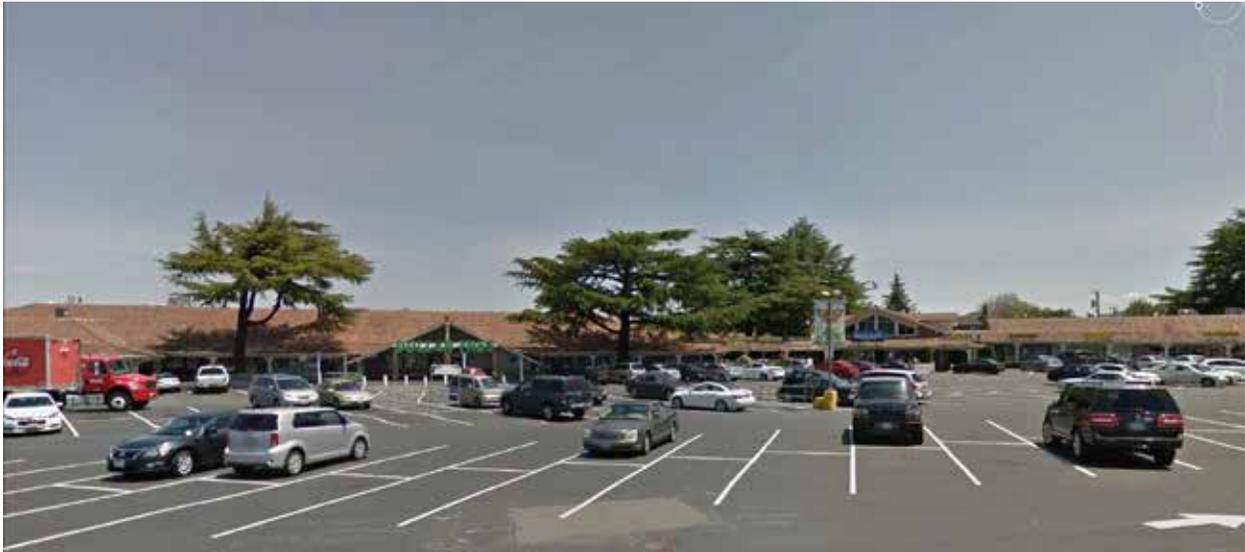
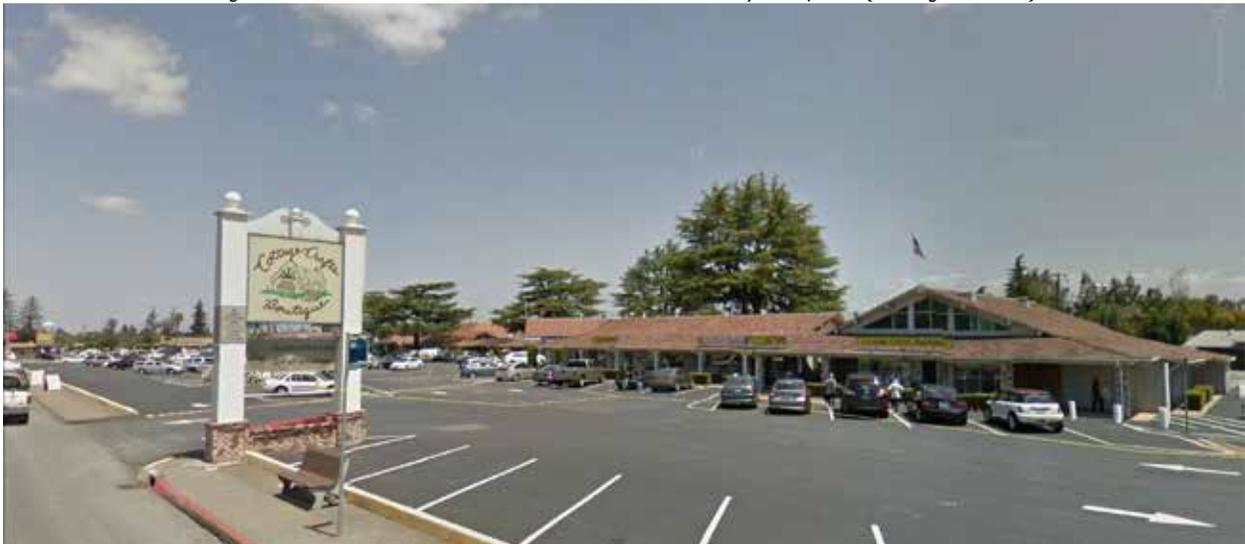
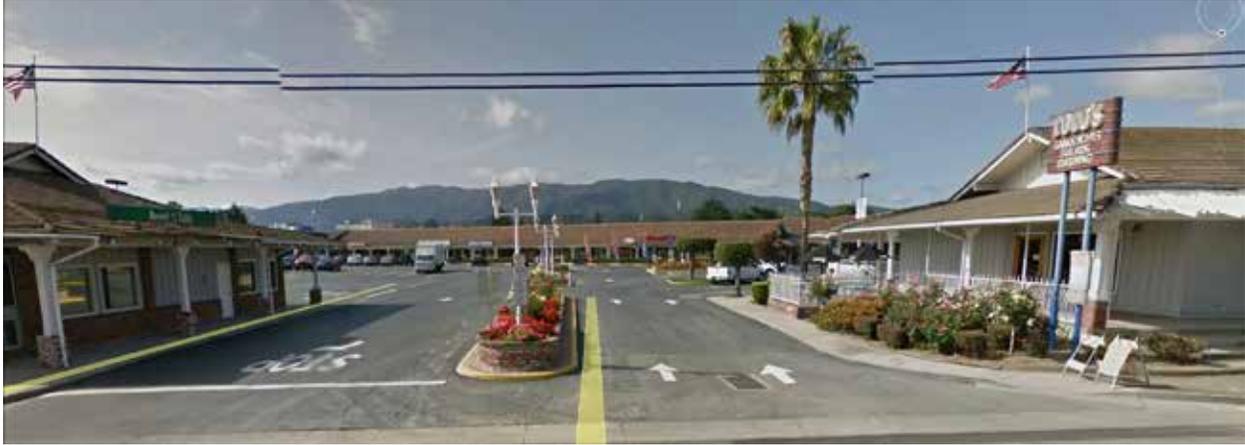
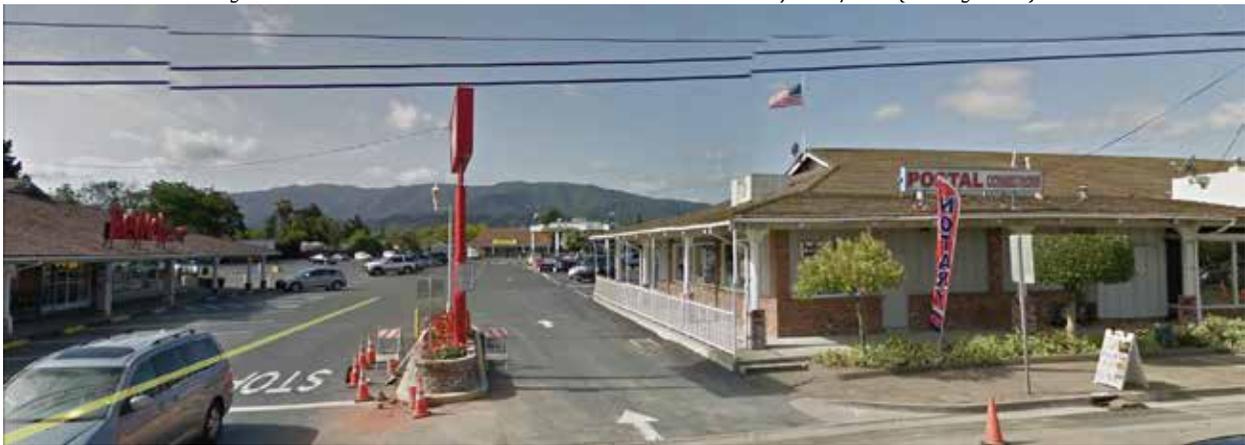
In a development pattern typical of its mid-century period, the original CPP buildings are set back on their lot behind auto circulation and parking areas (figs.18-23). The conjoined buildings are long, in a rambling rather than linear form, and tucked under continuously sloped roofs of varying heights.

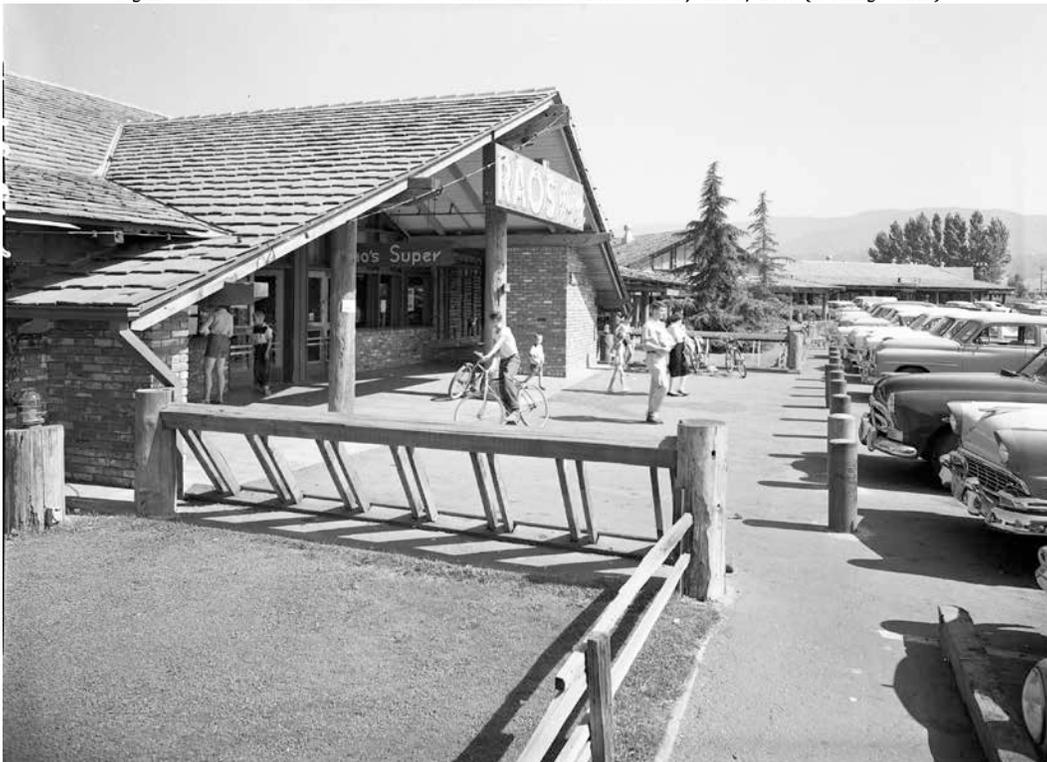
In two locations, the continuous roof lines are interrupted: by a low-gabled form along the Union Ave. front (fig.24); and by a projecting box-like form near the east end of the north leg (fig.25). Both are entry porticoes, the former to the original supermarket and the latter to the bowling alley.

Fig.24 – Cambrian Park Plaza – View of supermarket portal, 1960
(courtesy Sourisseau Academy for State and Local History, Arnold Del Carlo Collection)

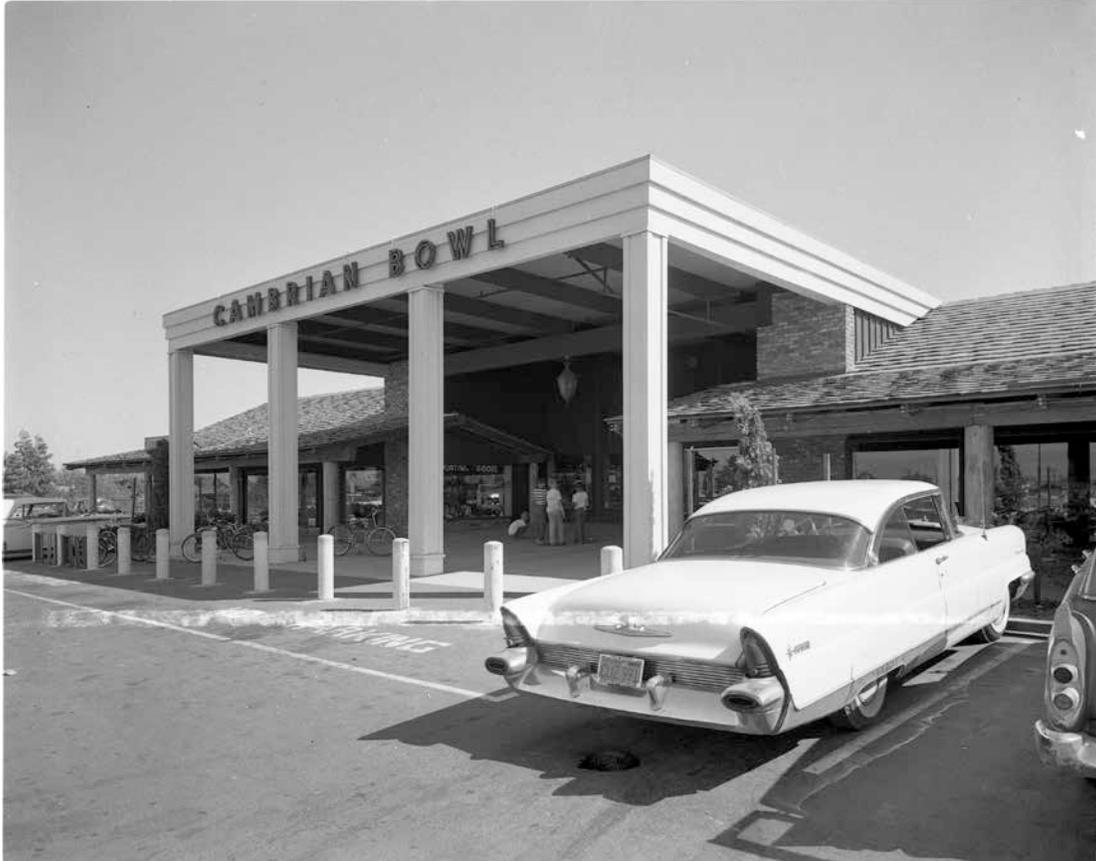
Fig.25 – Cambrian Park Plaza – View of bowling alley portal, 1960
(courtesy Sourisseau Academy for State and Local History, Arnold Del Carlo Collection)

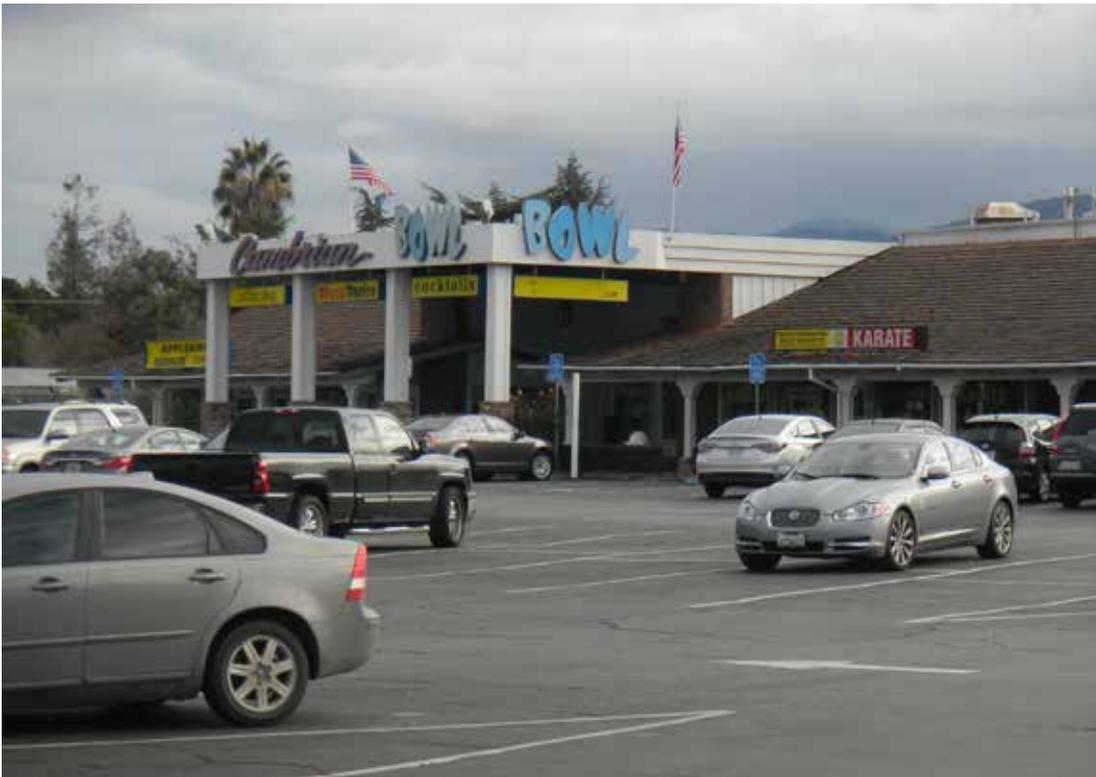
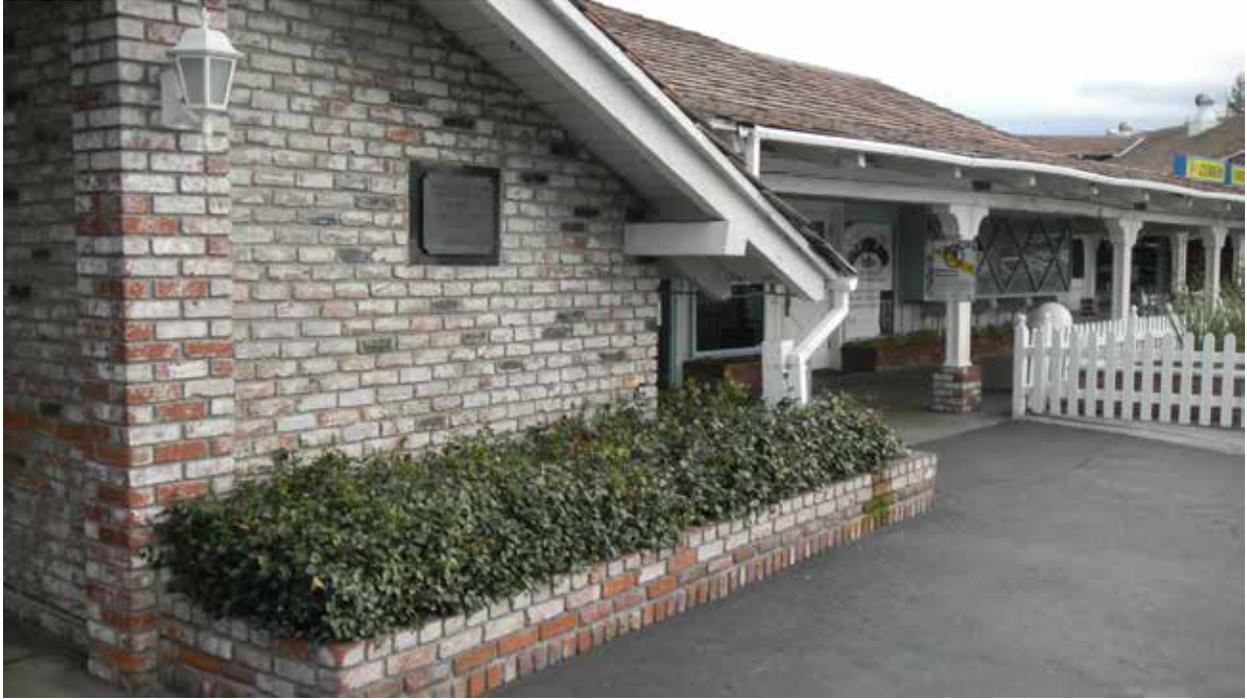
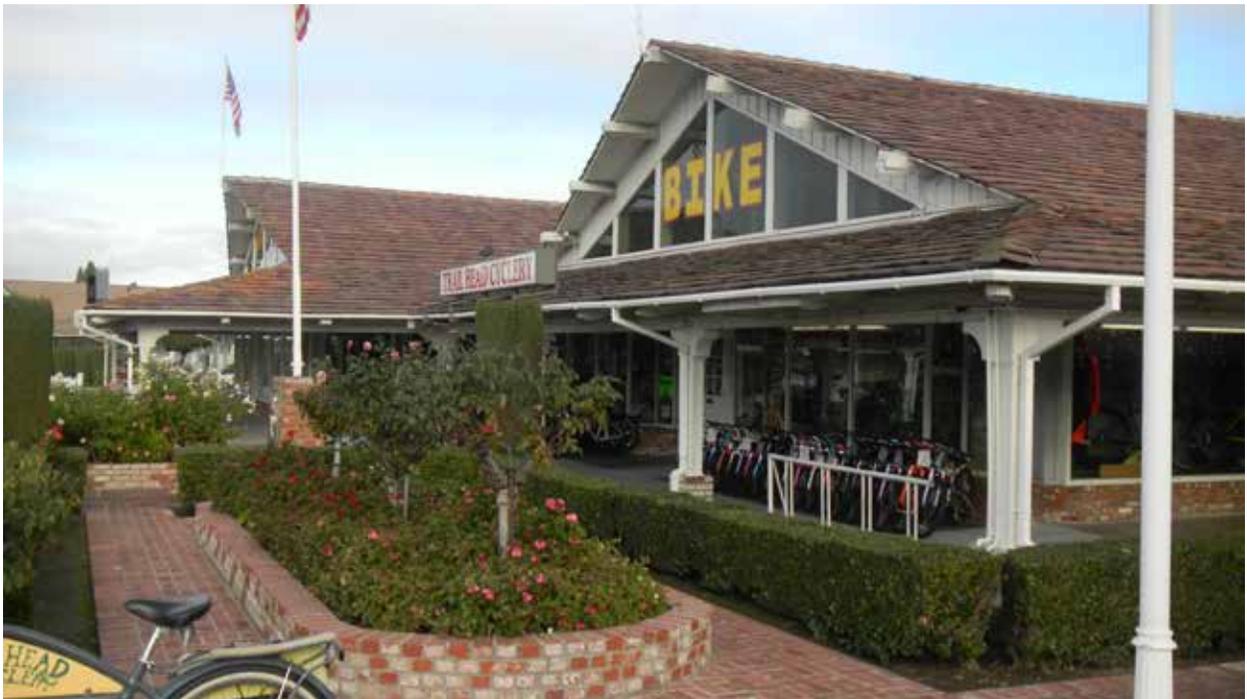
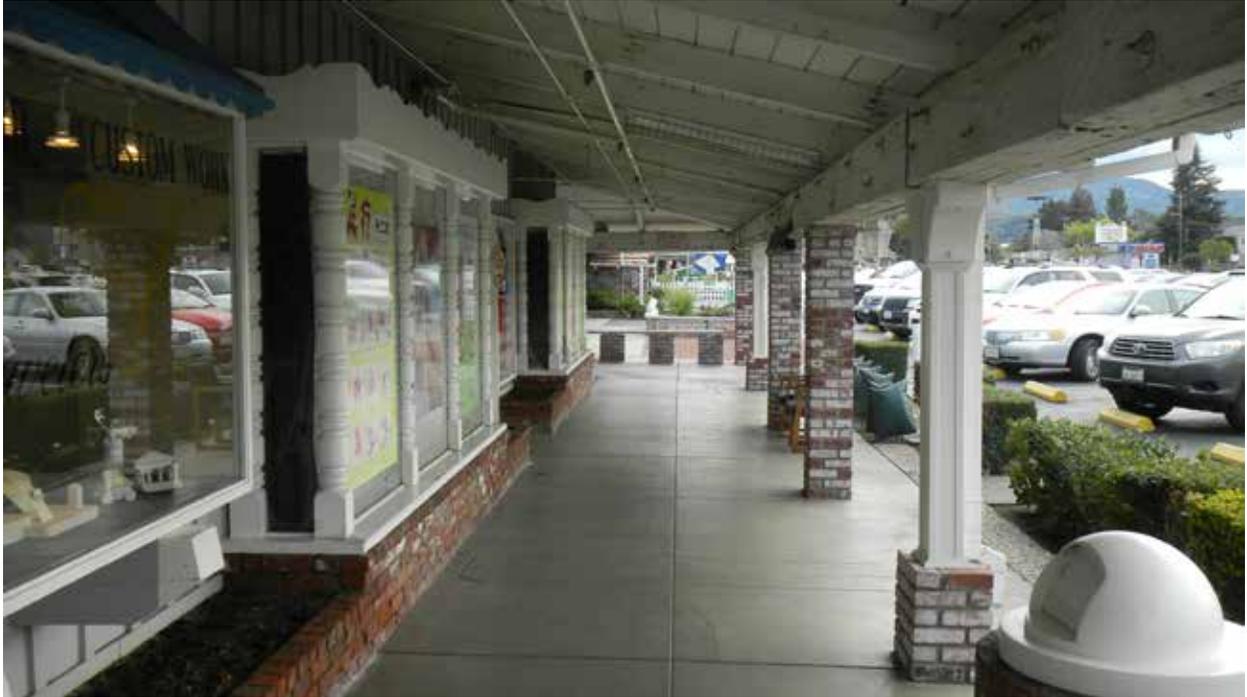
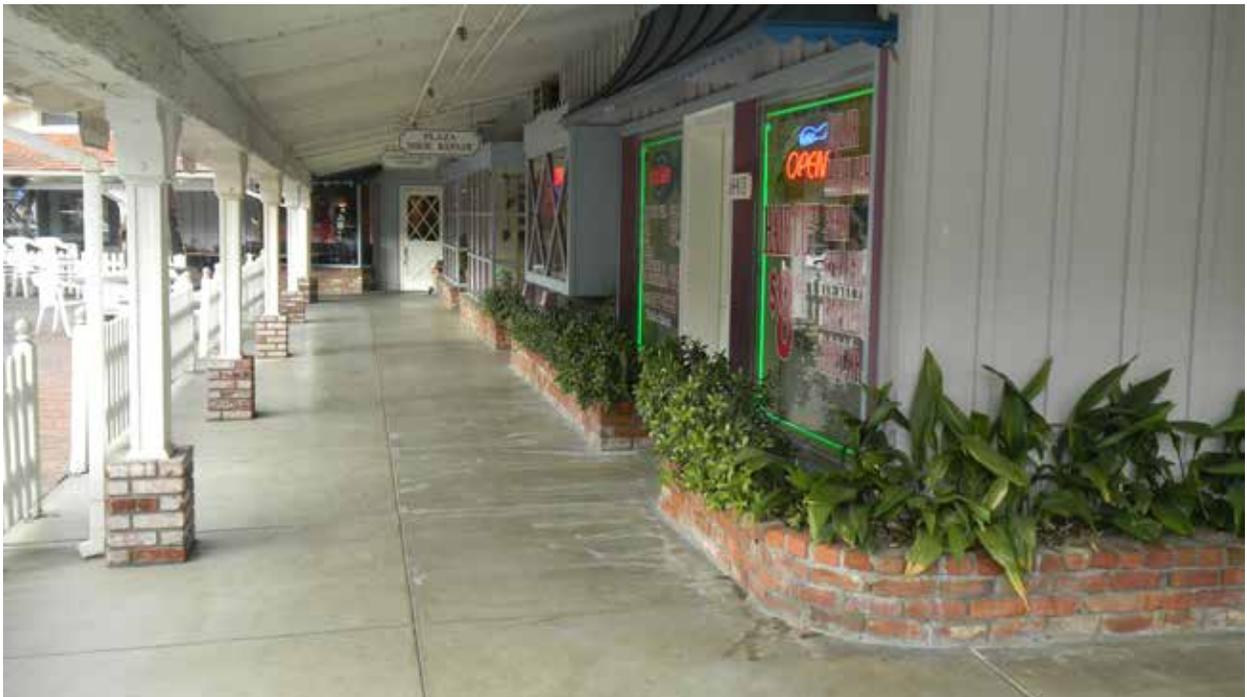
Principal exterior building elements are few: sloped, flat clay-tile roofs supported by a mix of timber and brick posts and timber beams at the perimeter; wood framed and trimmed gables projecting above the roofs, several with sets of large fixed windows; and individual signs standing at the roof edges (figs.26-30). Other building elements and materials include:

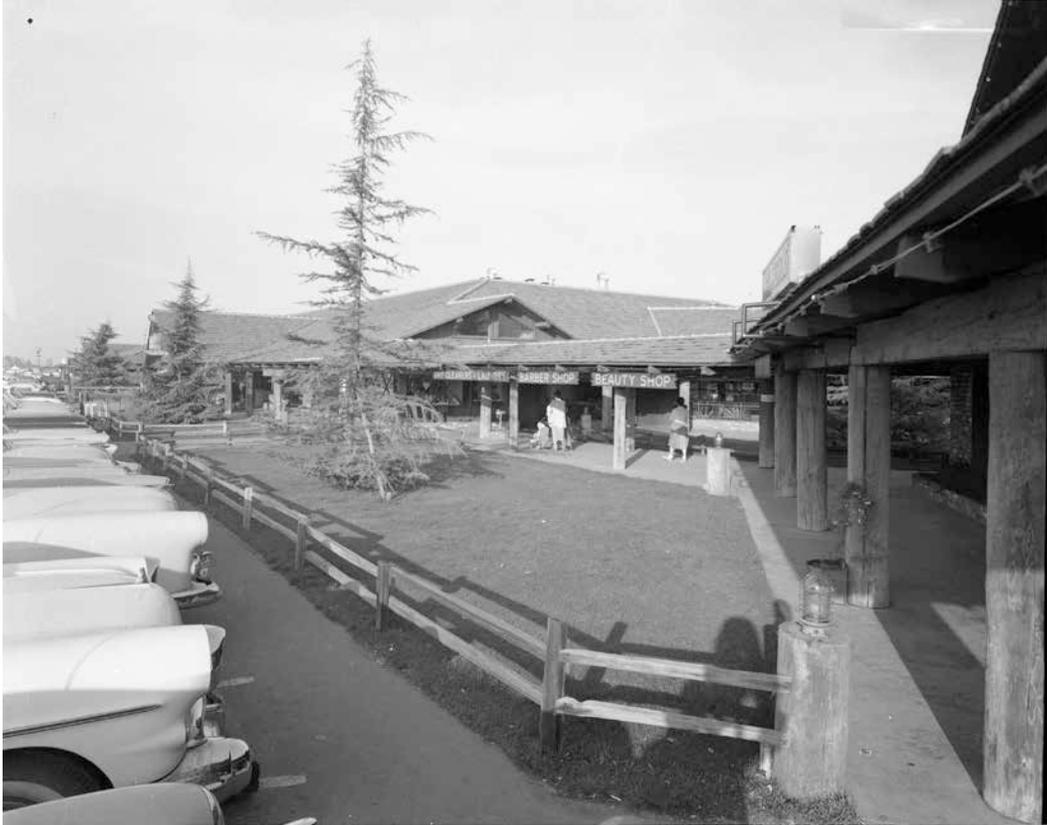
While the site at the building perimeter retains a semi-bucolic feeling, the original site had several generous yards as well as a large extent of split rail fencing (fig.35). The historic images therefore depict a far more bucolic and ranch-like setting at the building fronts. Signs for individual shops were also largely hung from the roof edge, rather than standing above the roof edge as they largely do today.

Fig.35 – Cambrian Park Plaza – View of south end, 1960
[courtesy Sourisseau Academy for State and Local History, Arnold Del Carlo Collection]
