La Jolla View Reservoir Project  
Environmental Impact Report  
SCH No. 2018041020 - Project No. 331101

Biological Technical Report

# LA JOLLA VIEW RESERVOIR REPLACEMENT PROJECT BIOLOGICAL TECHNICAL REPORT

## LA JOLLA VIEW RESERVOIR REPLACEMENT PROJECT JURISDICTIONAL DELINEATION REPORT

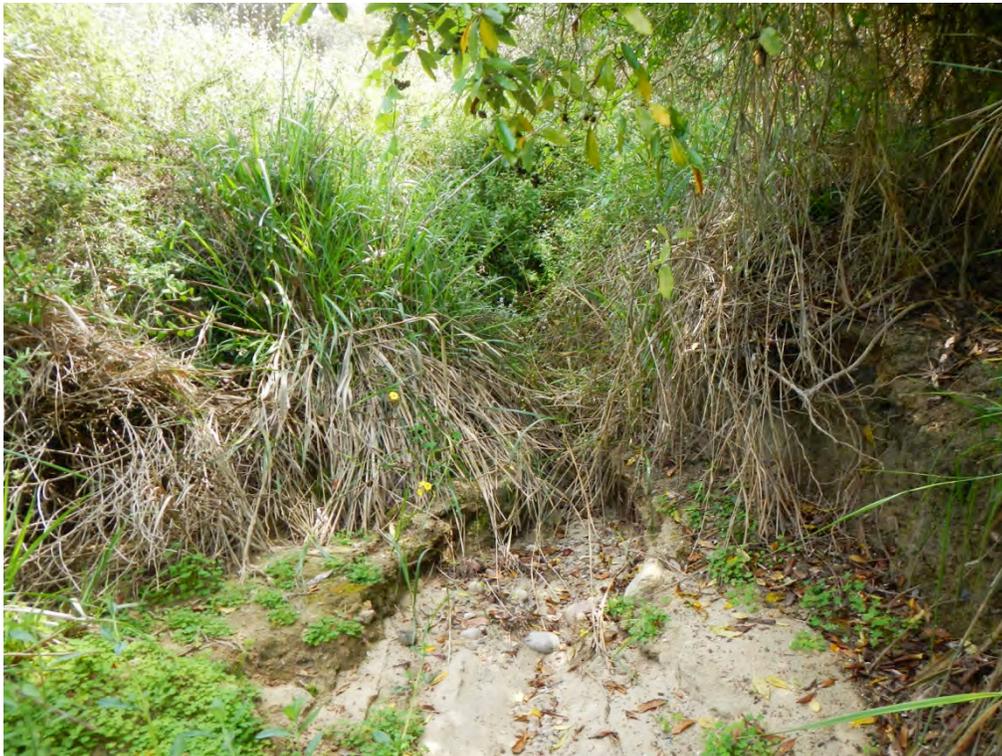
Photo 6. View of on-site channel ('Primary Drainage'). Note presence of upland, non-native species *Cortaderia selloana*, *Oxalis pes-caprae*, and *Myoporum laetum*.

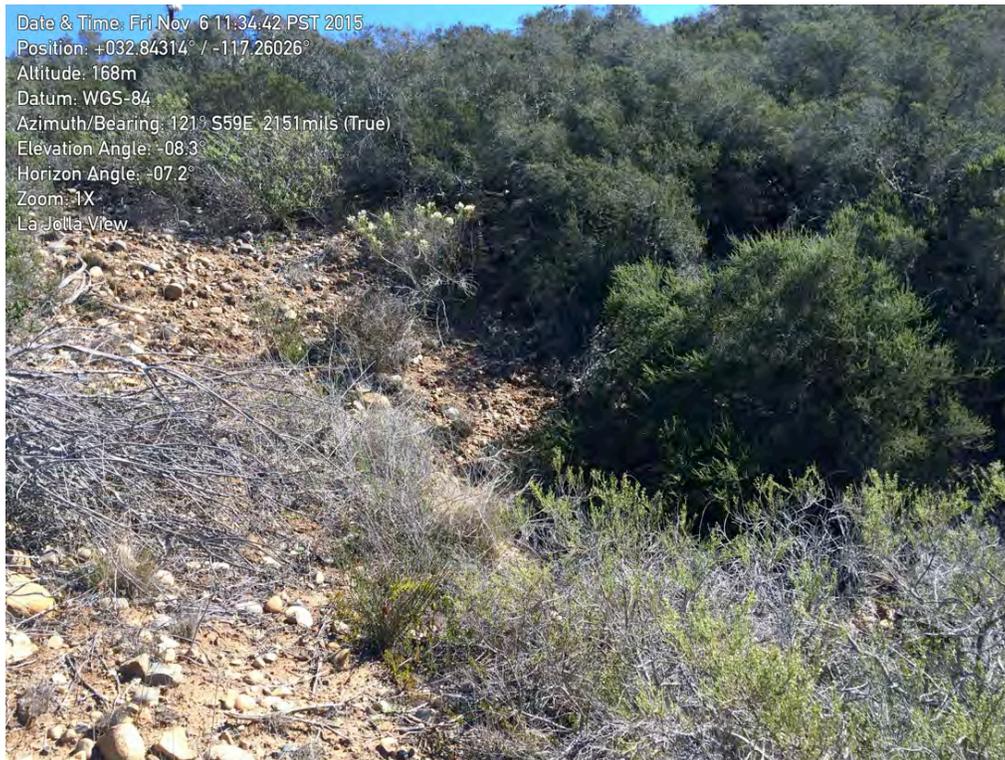
Photo 7. The start of the weak flow path within the Secondary Drainage.

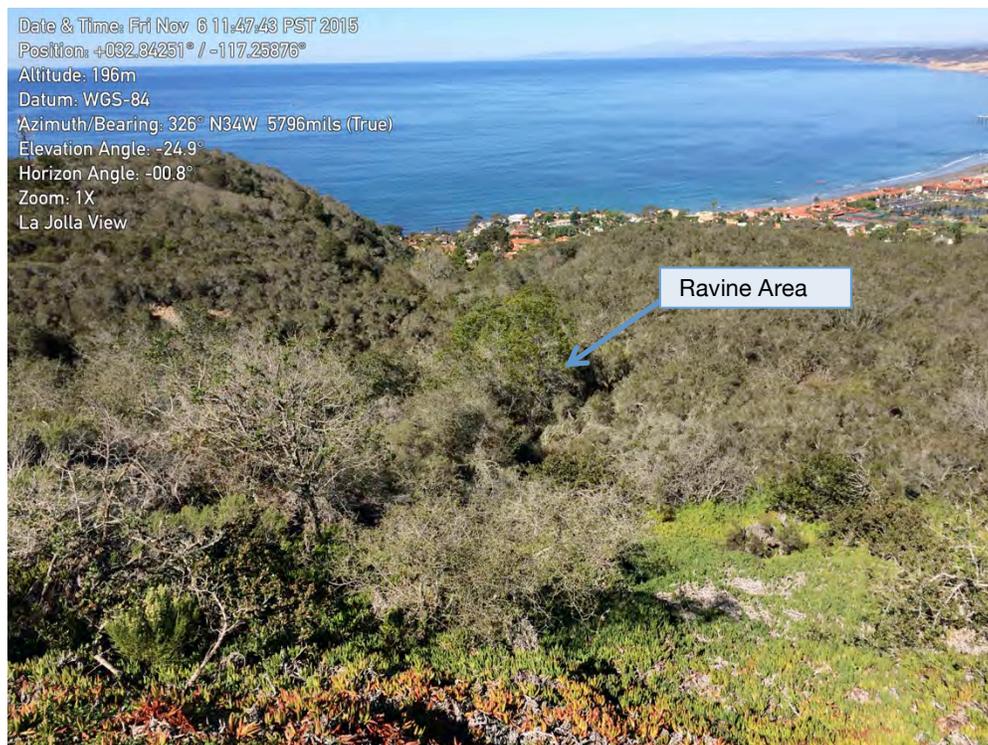
Photo 8. View of the non-jurisdictional ravine, facing west. This may drain a small amount of water from surrounding areas but it lacks soils, vegetation, and hydrology and is not shown in the USFWS wetlands inventory.

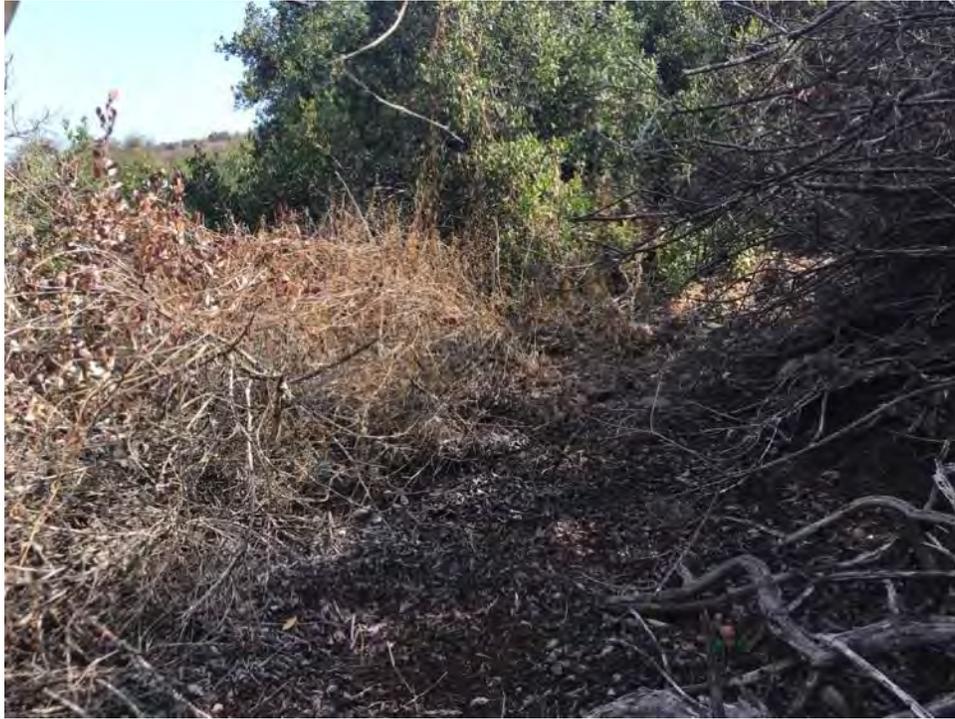
Photo 1. Downstream view of Feature 1 (F1) at its northeast bank (low terrace) where Ordinary High Water Mark (OHWM) Data Point 1 was taken. OHWM not pictured here.

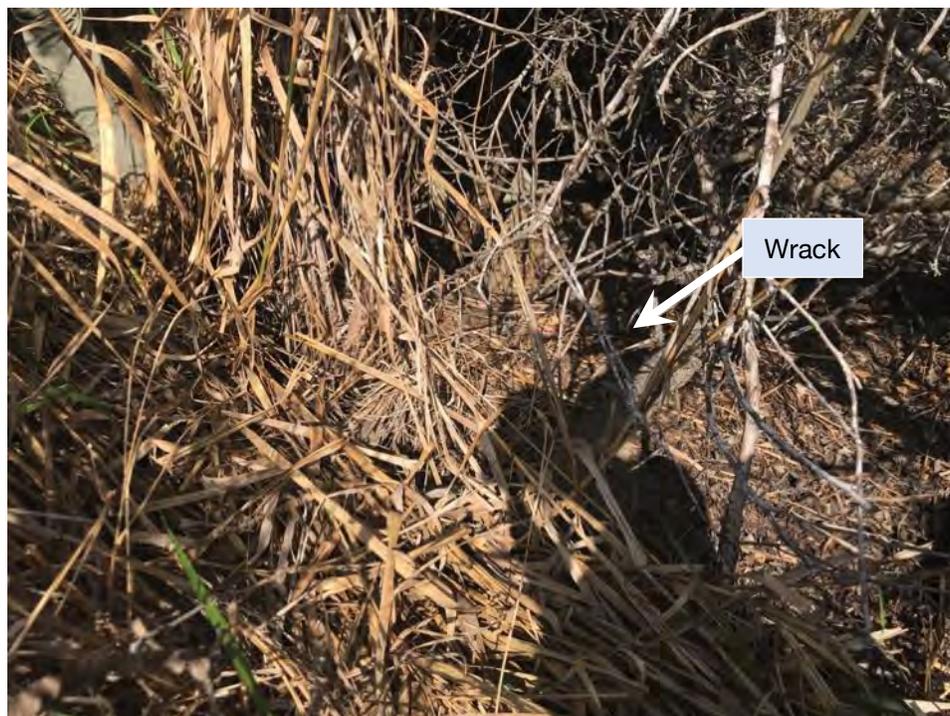
Photo 2. Downstream view of wrack accumulating along small patch of giant reed (*Arundo donax*) within OHWM of F1.

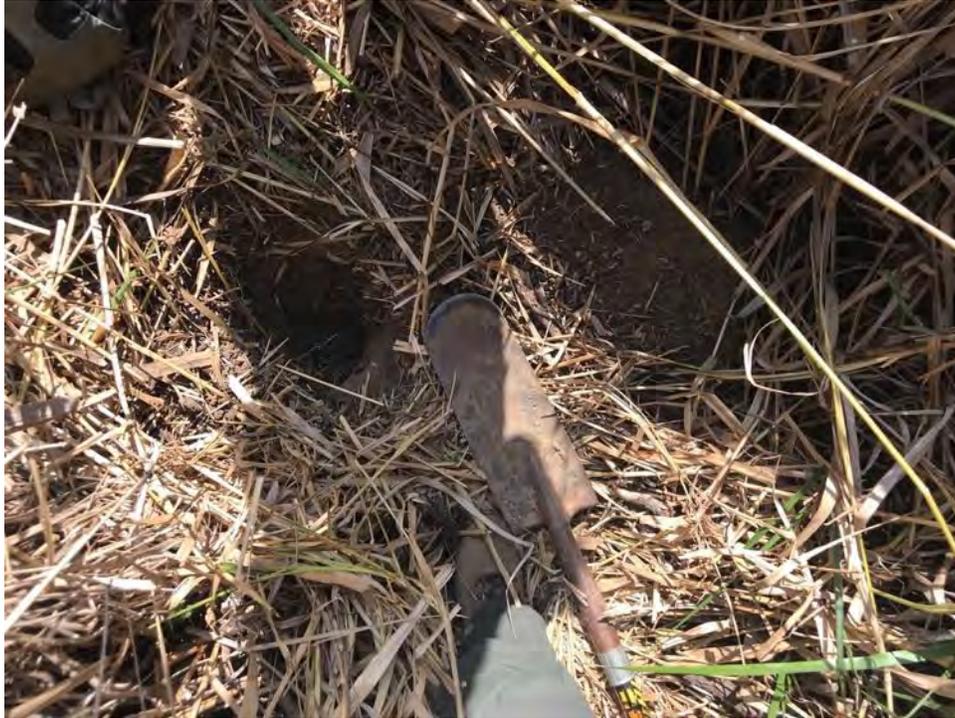
Photo 3. Wetland Sample Point (WSP) 1 taken within small giant reed patch within F1, in same area as OHWM Data Point 1. Wetland hydrology and hydrophytic vegetation parameters met; hydric soils not present.

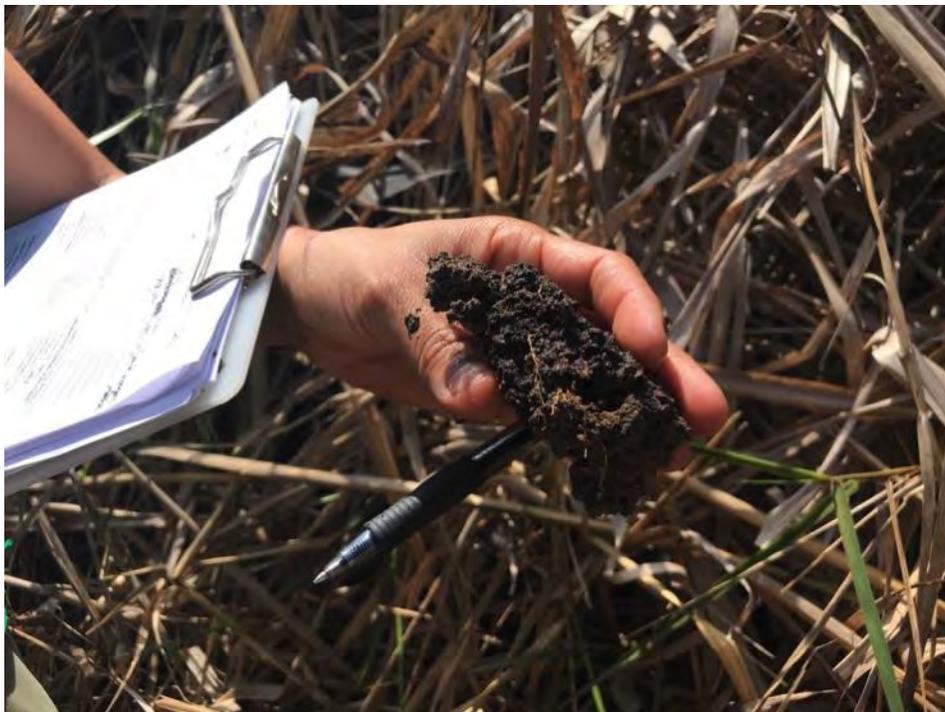
Photo 4. View of top layer of sediment at WSP 1, which field staff also observed as sediment deposits along the bases of giant reed culms as discussed on OHWM Data Point 1.

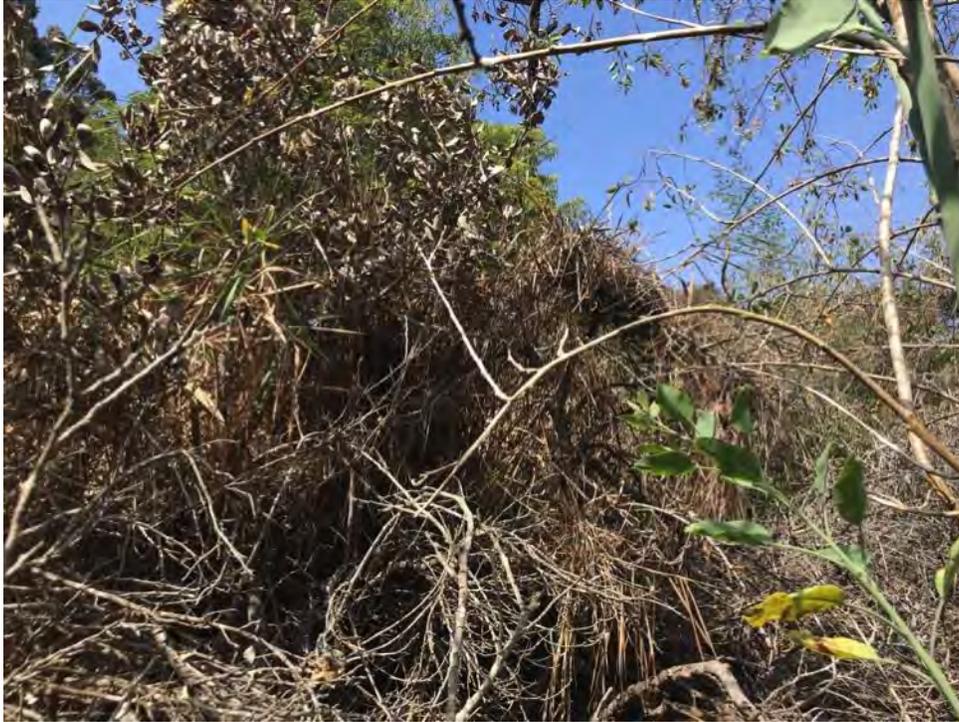
Photo 5. View of wrack accumulated within F1, collecting at the bases and higher on vegetation, located at the approximate location of the F1 OHWM (OHWM Data Point 1).  
Vegetation also bent in downstream direction.

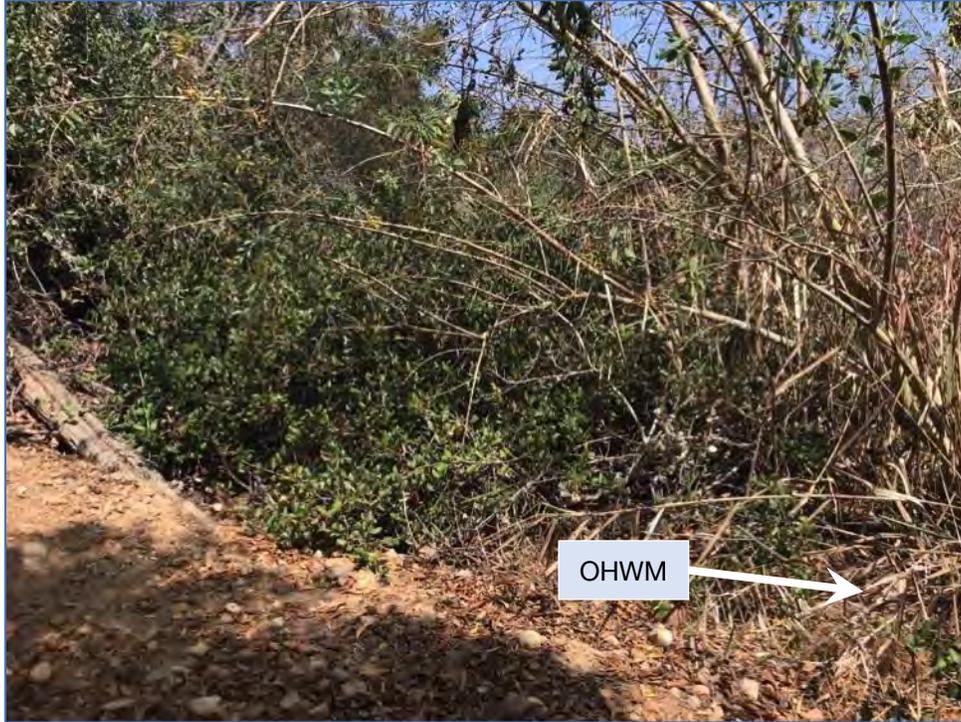
Photo 7. Downstream view of F1 at approximate location of south boundary of the OHWM and streambed with the adjacent uplands, where OHWM Data Point 1 and WSP 2 were taken.

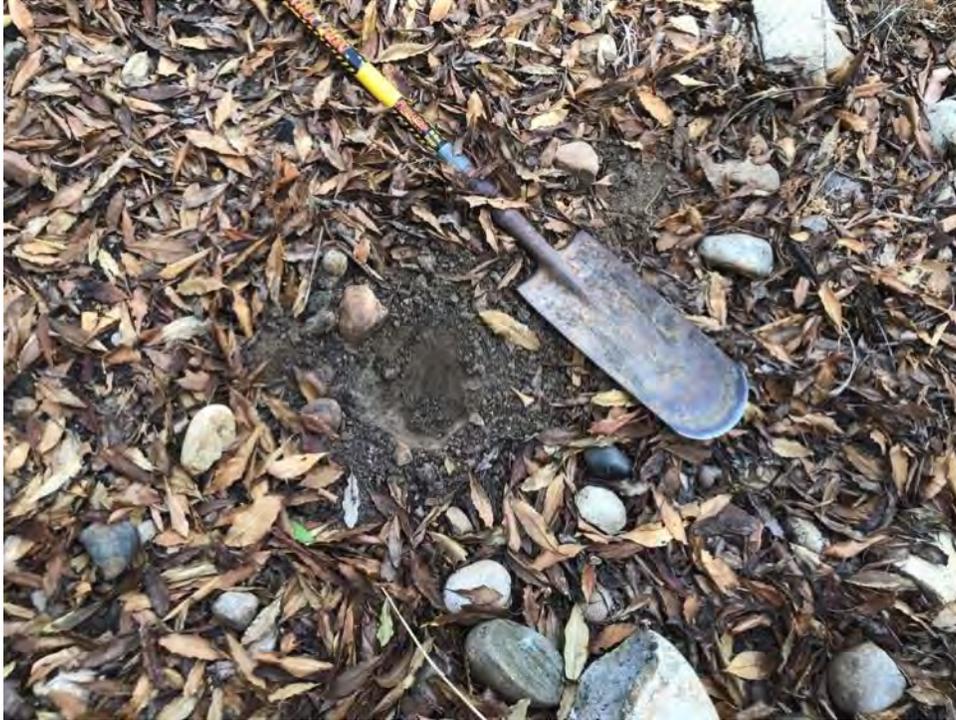
Photo 9. WSP 2 taken on the south bank (at bottom of canyon) of F1, which did not meet wetland (federal or state) parameters. WSP taken to compare findings at WSP 1.

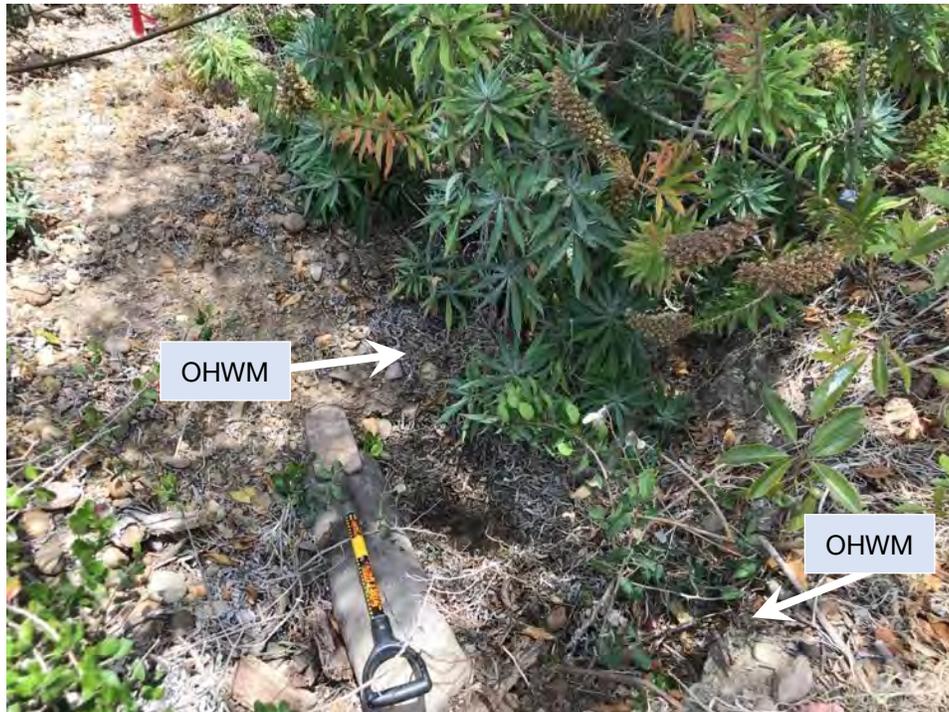
Photo 11. Upstream view of F1 showing the WSP 5 soil sample pit. Wetland hydrology parameter met; dominant or prevalent hydrophytic vegetation and hydric soils not present.

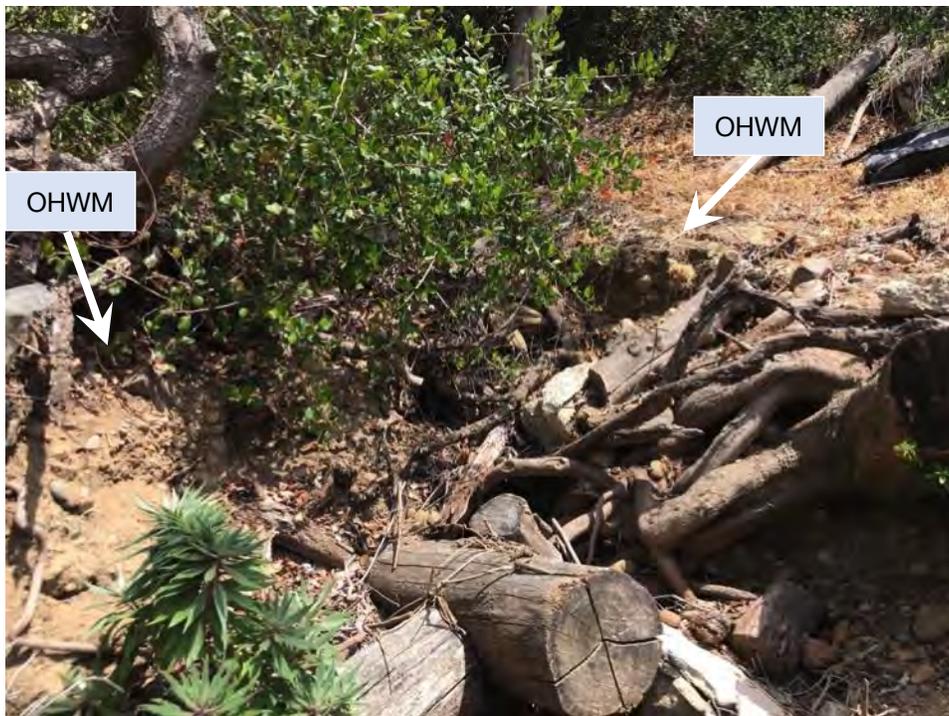
Photo 12. Upstream view of F1 at OHWM Data Point 4, where a bed and bank and change in vegetation cover and sediment between the active floodplain and uplands were observed.

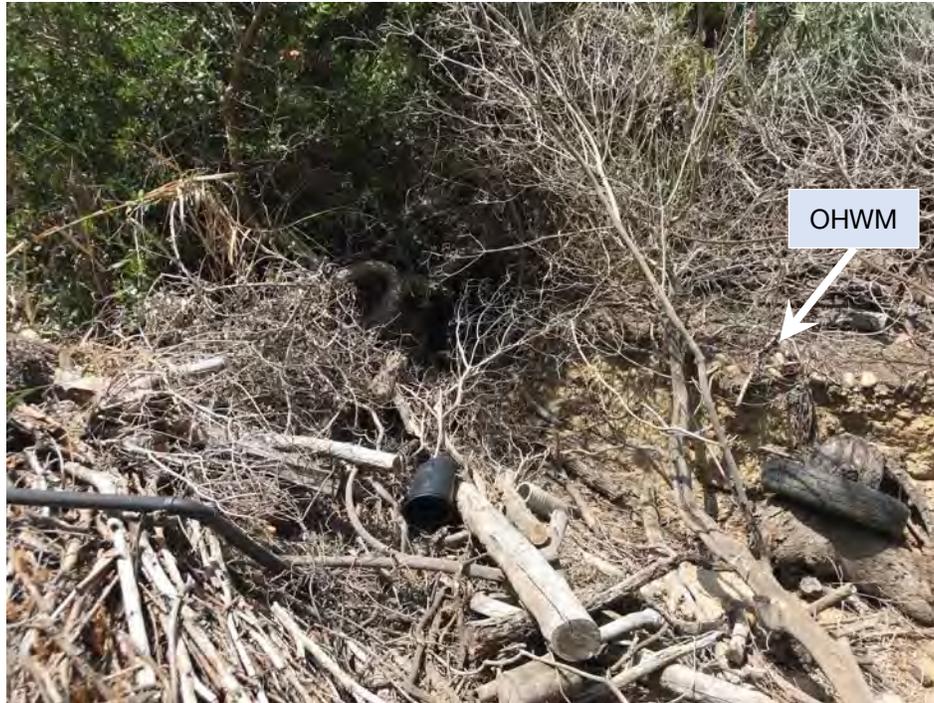
Photo 13. Downstream view of F1 at OHWM Data Point 4. Portions of the feature were littered with debris such as tree branches, pipes, concrete slabs, and cut logs which obscures the southwest bank.

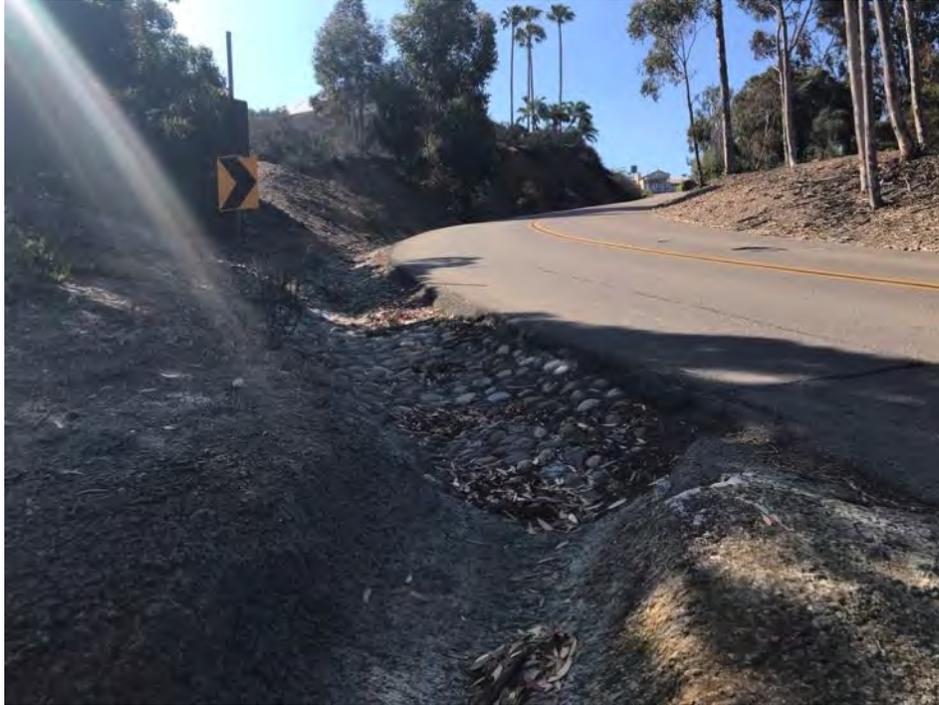
Photo 15. Upstream view of concrete-lined channel that runs along Country Club Drive and feeds into Feature 1A (F1A).

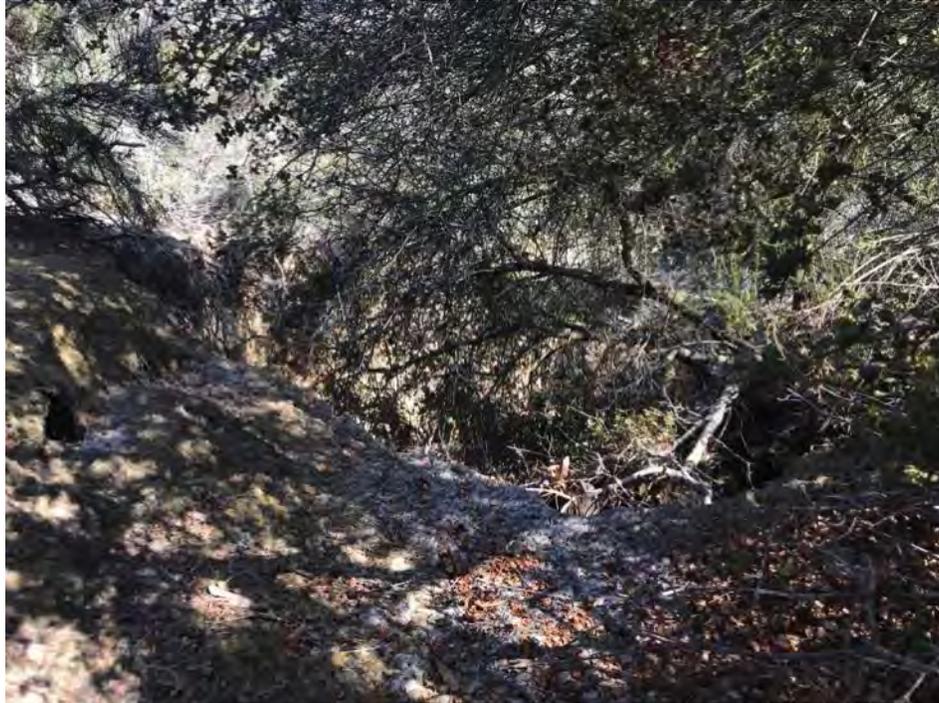
Photo 17. View of the location where the concrete-lined portion of F1A ends. The feature continues downstream as an eroded drainage, which drains into F1.

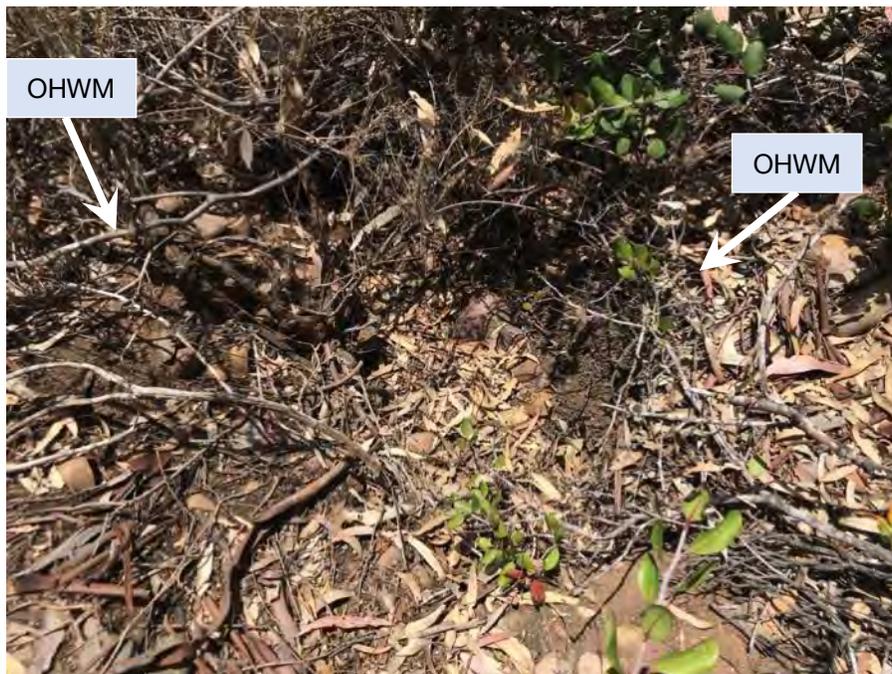
Photo 20. Downstream view of F1B at OHWM Data Point 5, where a bed and bank and change in vegetation cover and sediment between the active floodplain and uplands were observed.

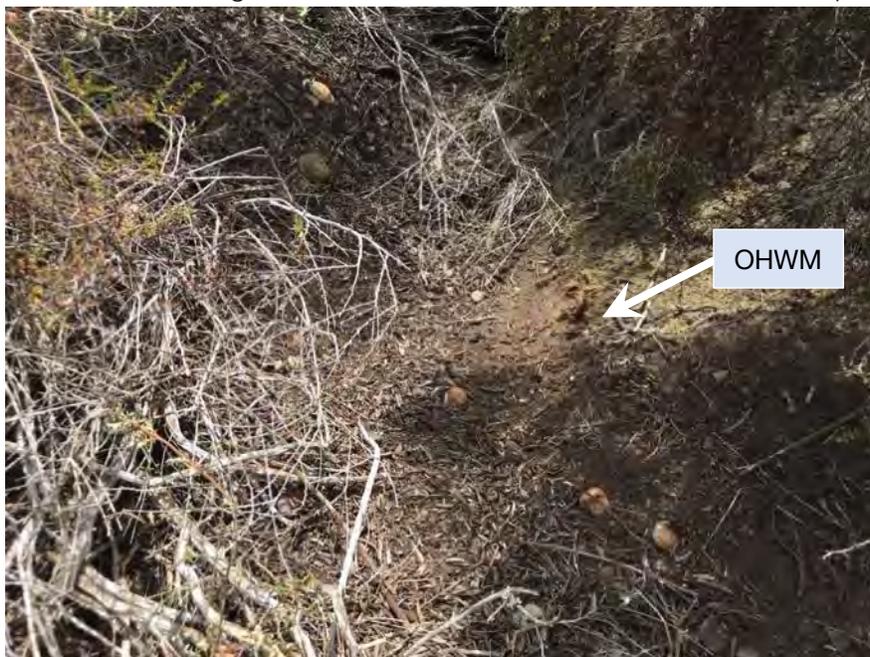
Photo 22. Upstream view of F2 at the location of OHWM Data Point 3 where a bed and bank (with a break in slope) and change in vegetation cover and sediment between the active floodplain and uplands were observed.

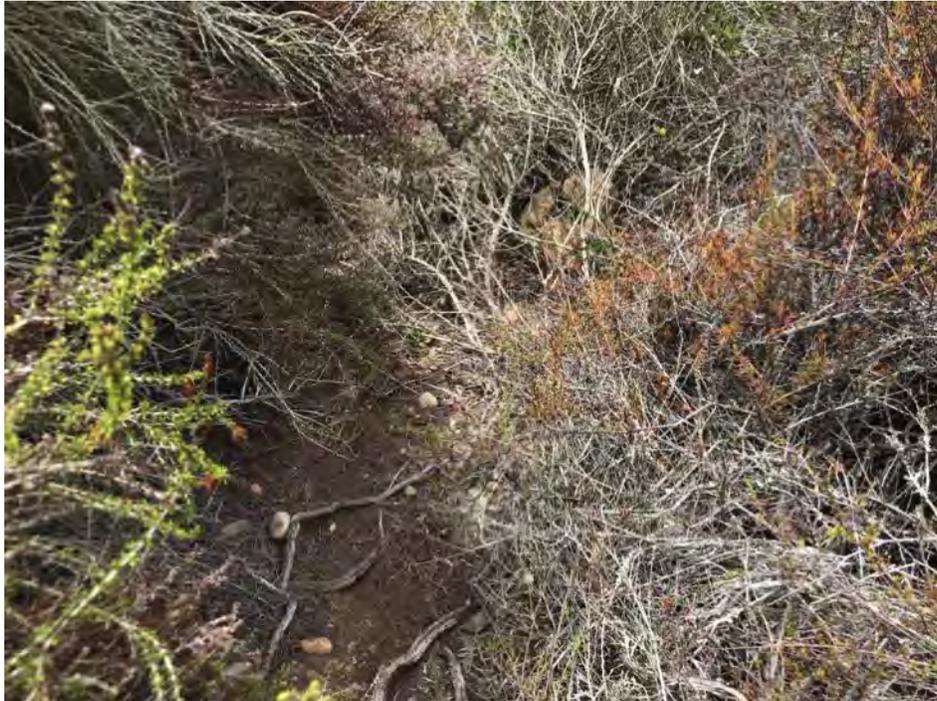
Photo 23. Downstream view of F2. OHWM obscured by upland vegetation story.

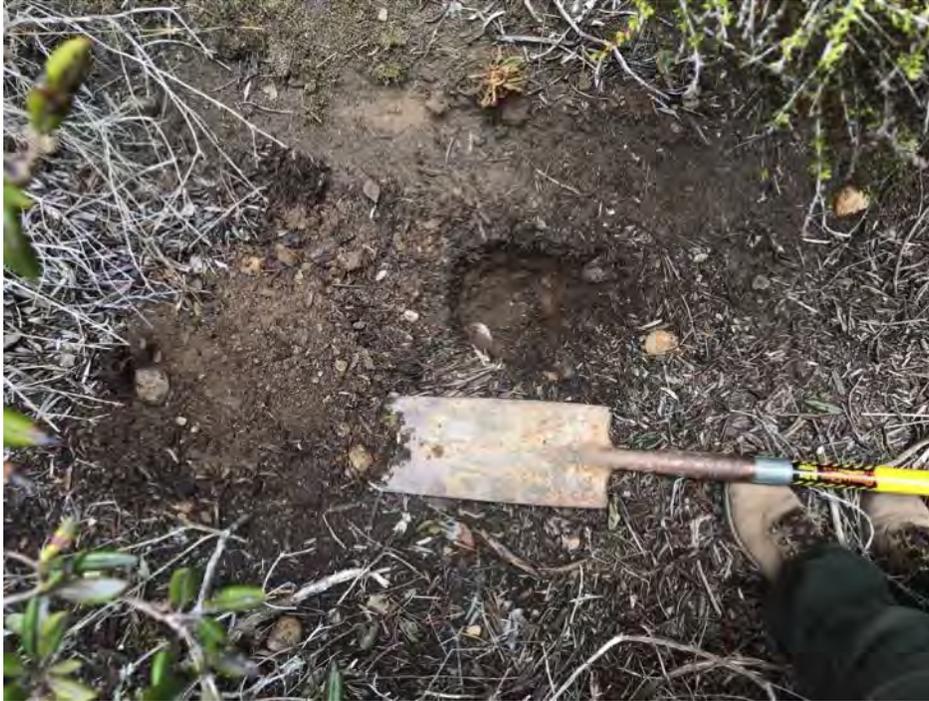
Photo 25. F2 at WSP 4; view of soil sample pit. WSP 4 met the wetland hydrology parameter but did not meet the hydrophytic vegetation or hydric soils parameters.

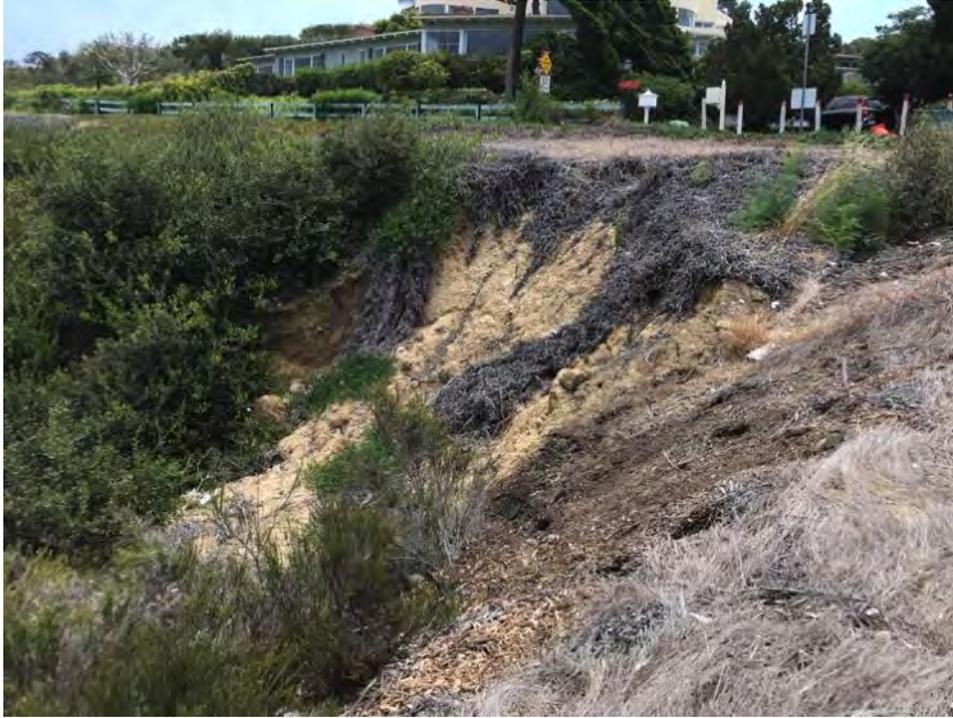
Photo 27. Upstream extent of F3. The feature appears to collect runoff from the adjacent residential development and driveway.

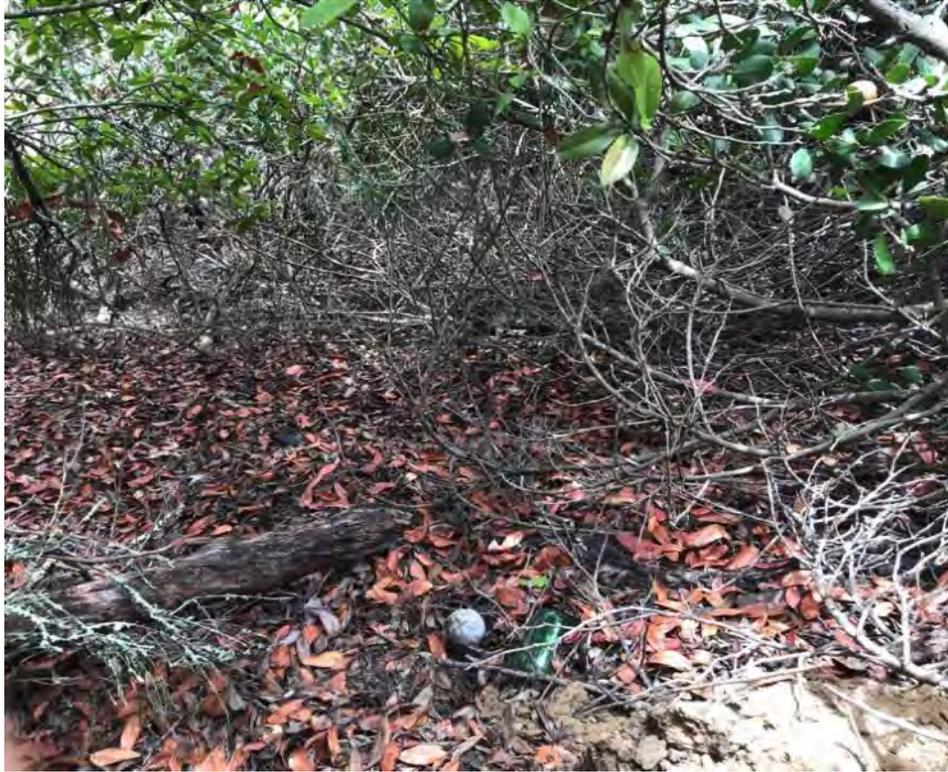
Photo 29. Downstream view of F3 at WSP 3 and OHWM 2. The feature did not show indicators of hydrology and appeared swale-like.

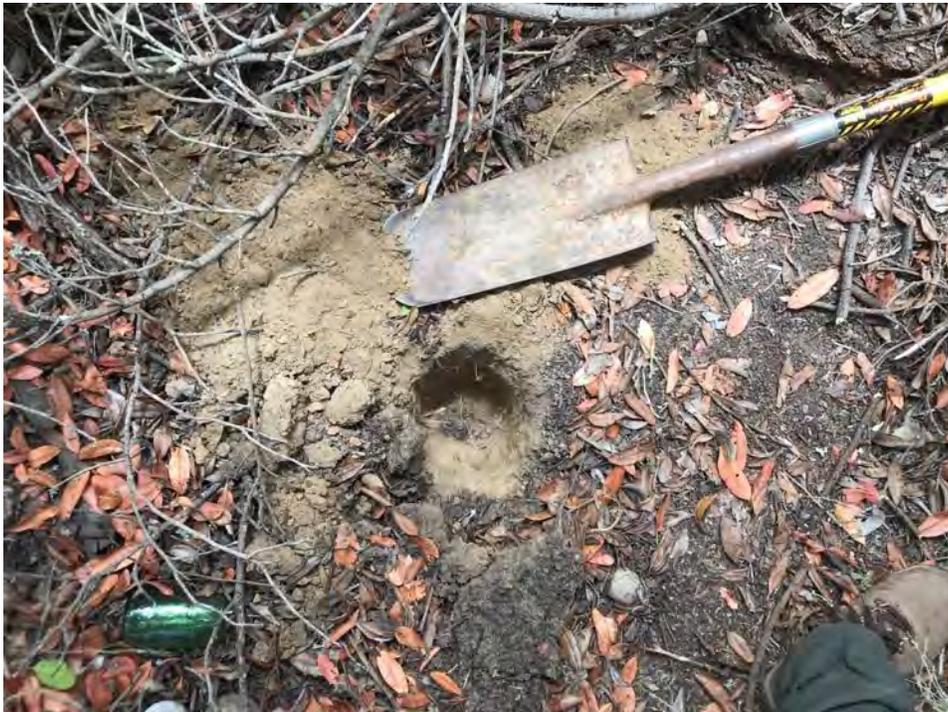
Photo 30. WSP 3, taken within F3. Observed soils within the feature were the same as observed on the vegetated slopes.

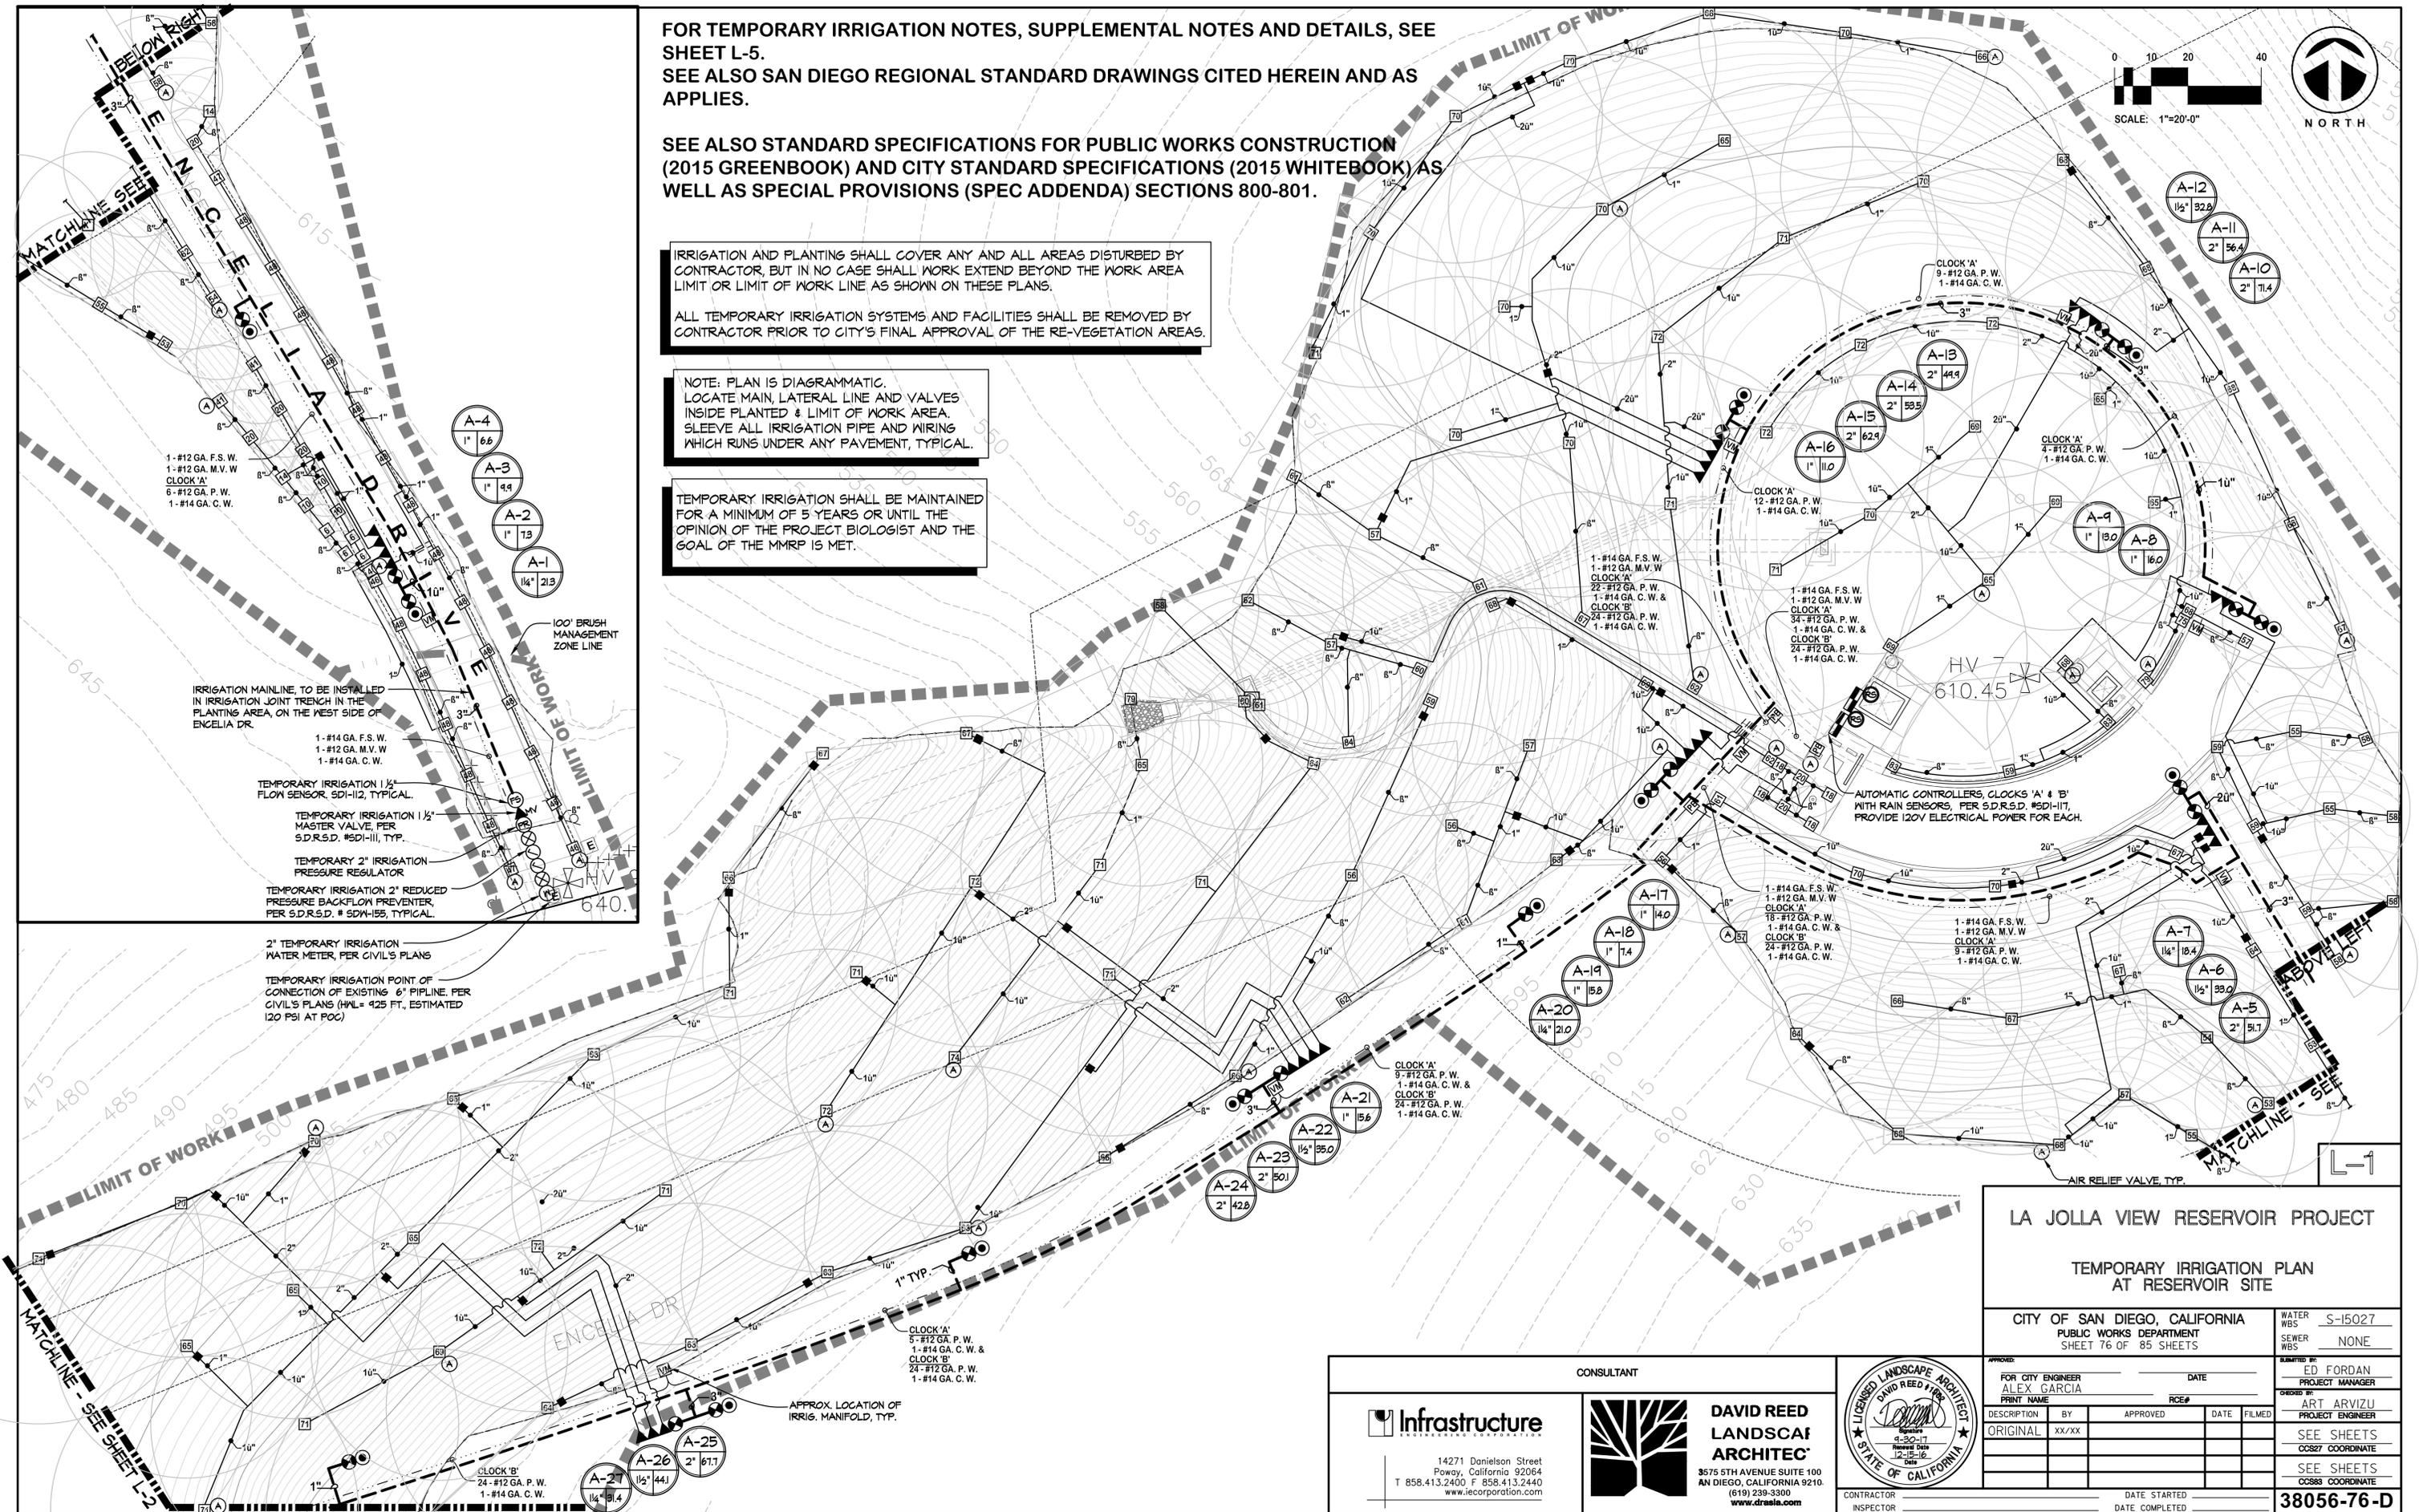
**LA JOLLA VIEW RESERVOIR PROJECT**  
**TEMPORARY IRRIGATION PLAN AT RESERVOIR SITE**

TEMPORARY IRRIGATION SHALL BE MAINTAINED FOR A MINIMUM OF 5 YEARS OR UNTIL THE OPINION OF THE PROJECT BIOLOGIST AND THE GOAL OF THE MMRP IS MET.

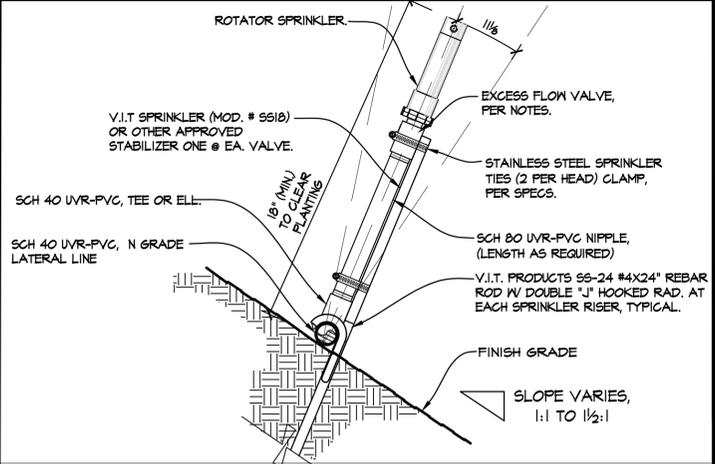
**"ON-GRADE" SPRINKLER** TEMPORARY **G**  
NOT TO SCALE SUPPLEMENTAL DETAIL, ALSO SEE S.D.R.S.D. #SDI-101

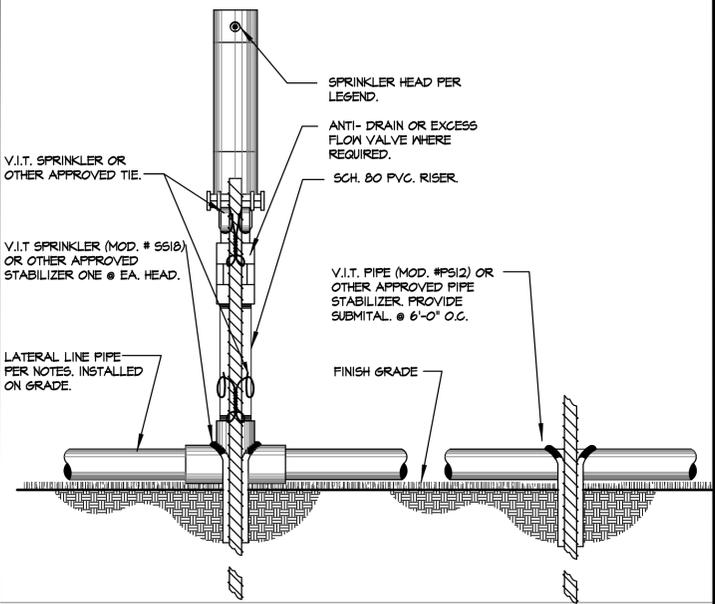
**"ON-GRADE" SPRINKLER** TEMPORARY **H**  
NOT TO SCALE SUPPLEMENTAL DETAIL, ALSO SEE S.D.R.S.D. #SDI-101, #SDI-120 & 123
