3Roots San Diego Project
Environmental Impact Report
SCH No. 2018041065; Project No. 587128

Jurisdictional Delineation Report

3Roots Project San Diego

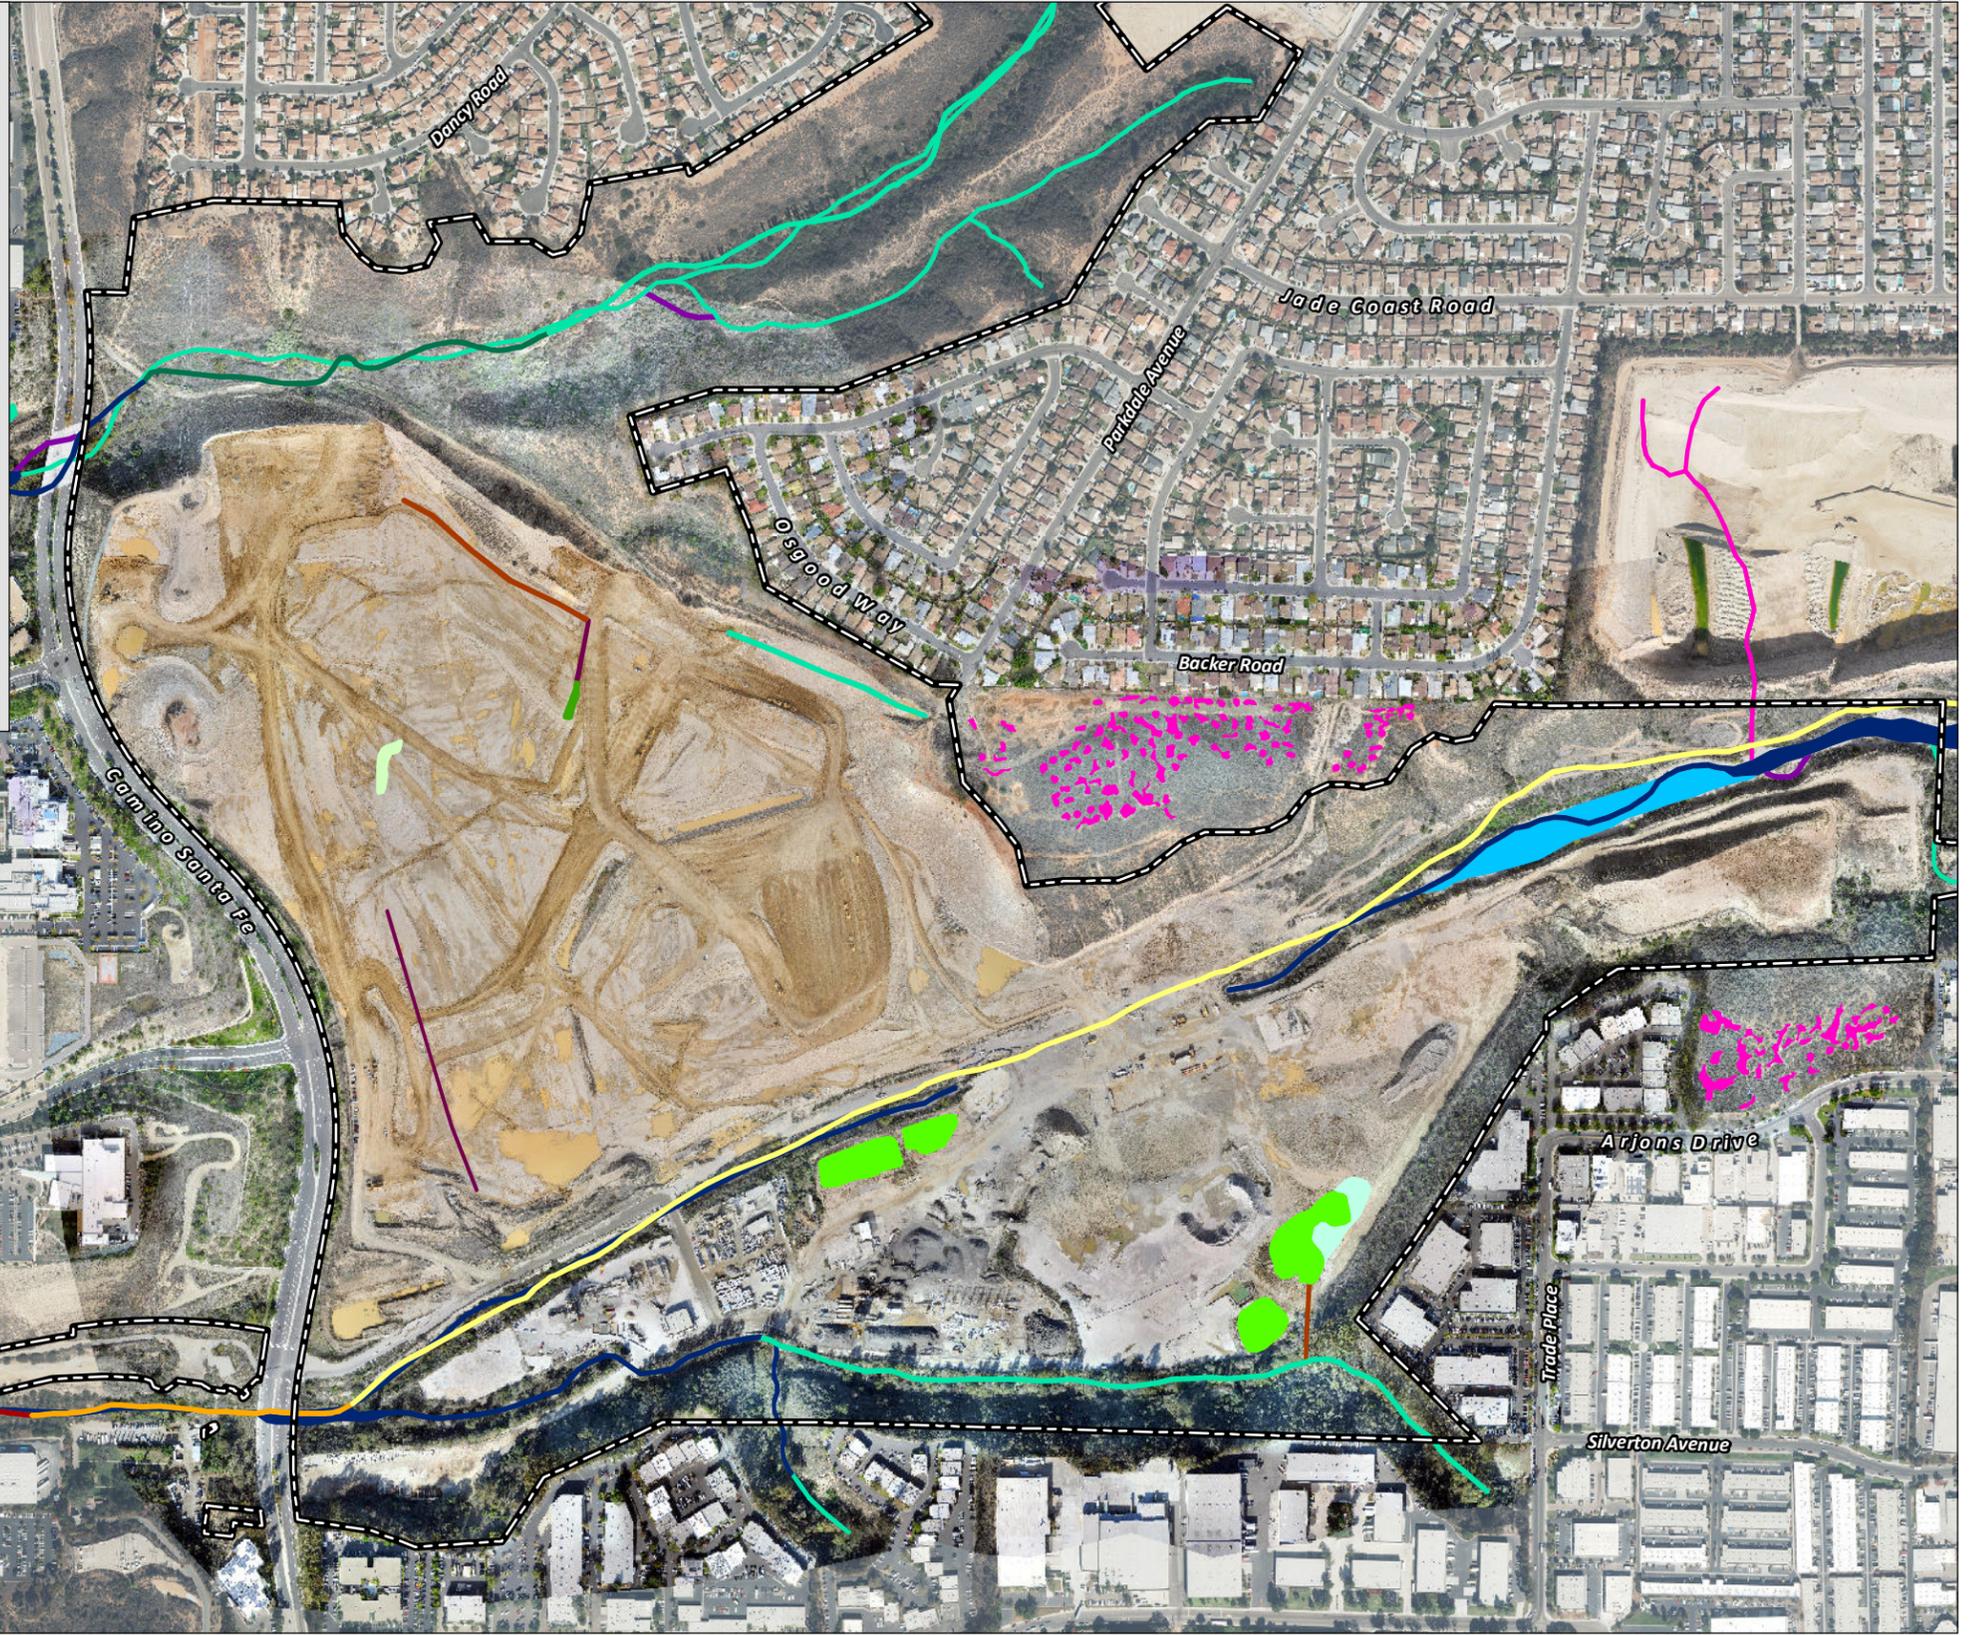
I:\PROJECTS\HAWAII\34 - Cantera\Map\JD\Fig6 - NWI.mxd CAH-02.01.6/6/2019 - SAB

- PUSAx - Palustrine, unconsolidated shore, seasonally flooded, excavated
- PUSCx - Palustrine, unconsolidated shore, temporary flooded, excavated
- R4SBA - Riverine, intermittent streambed, temporarily flooded

- R4SBAx - Riverine, intermittent streambed, temporary flooded, excavated
- R4SBC - Riverine, intermittent streambed, seasonally flooded
- R4SBCx - Riverine, intermittent streambed, seasonally flooded, excavated

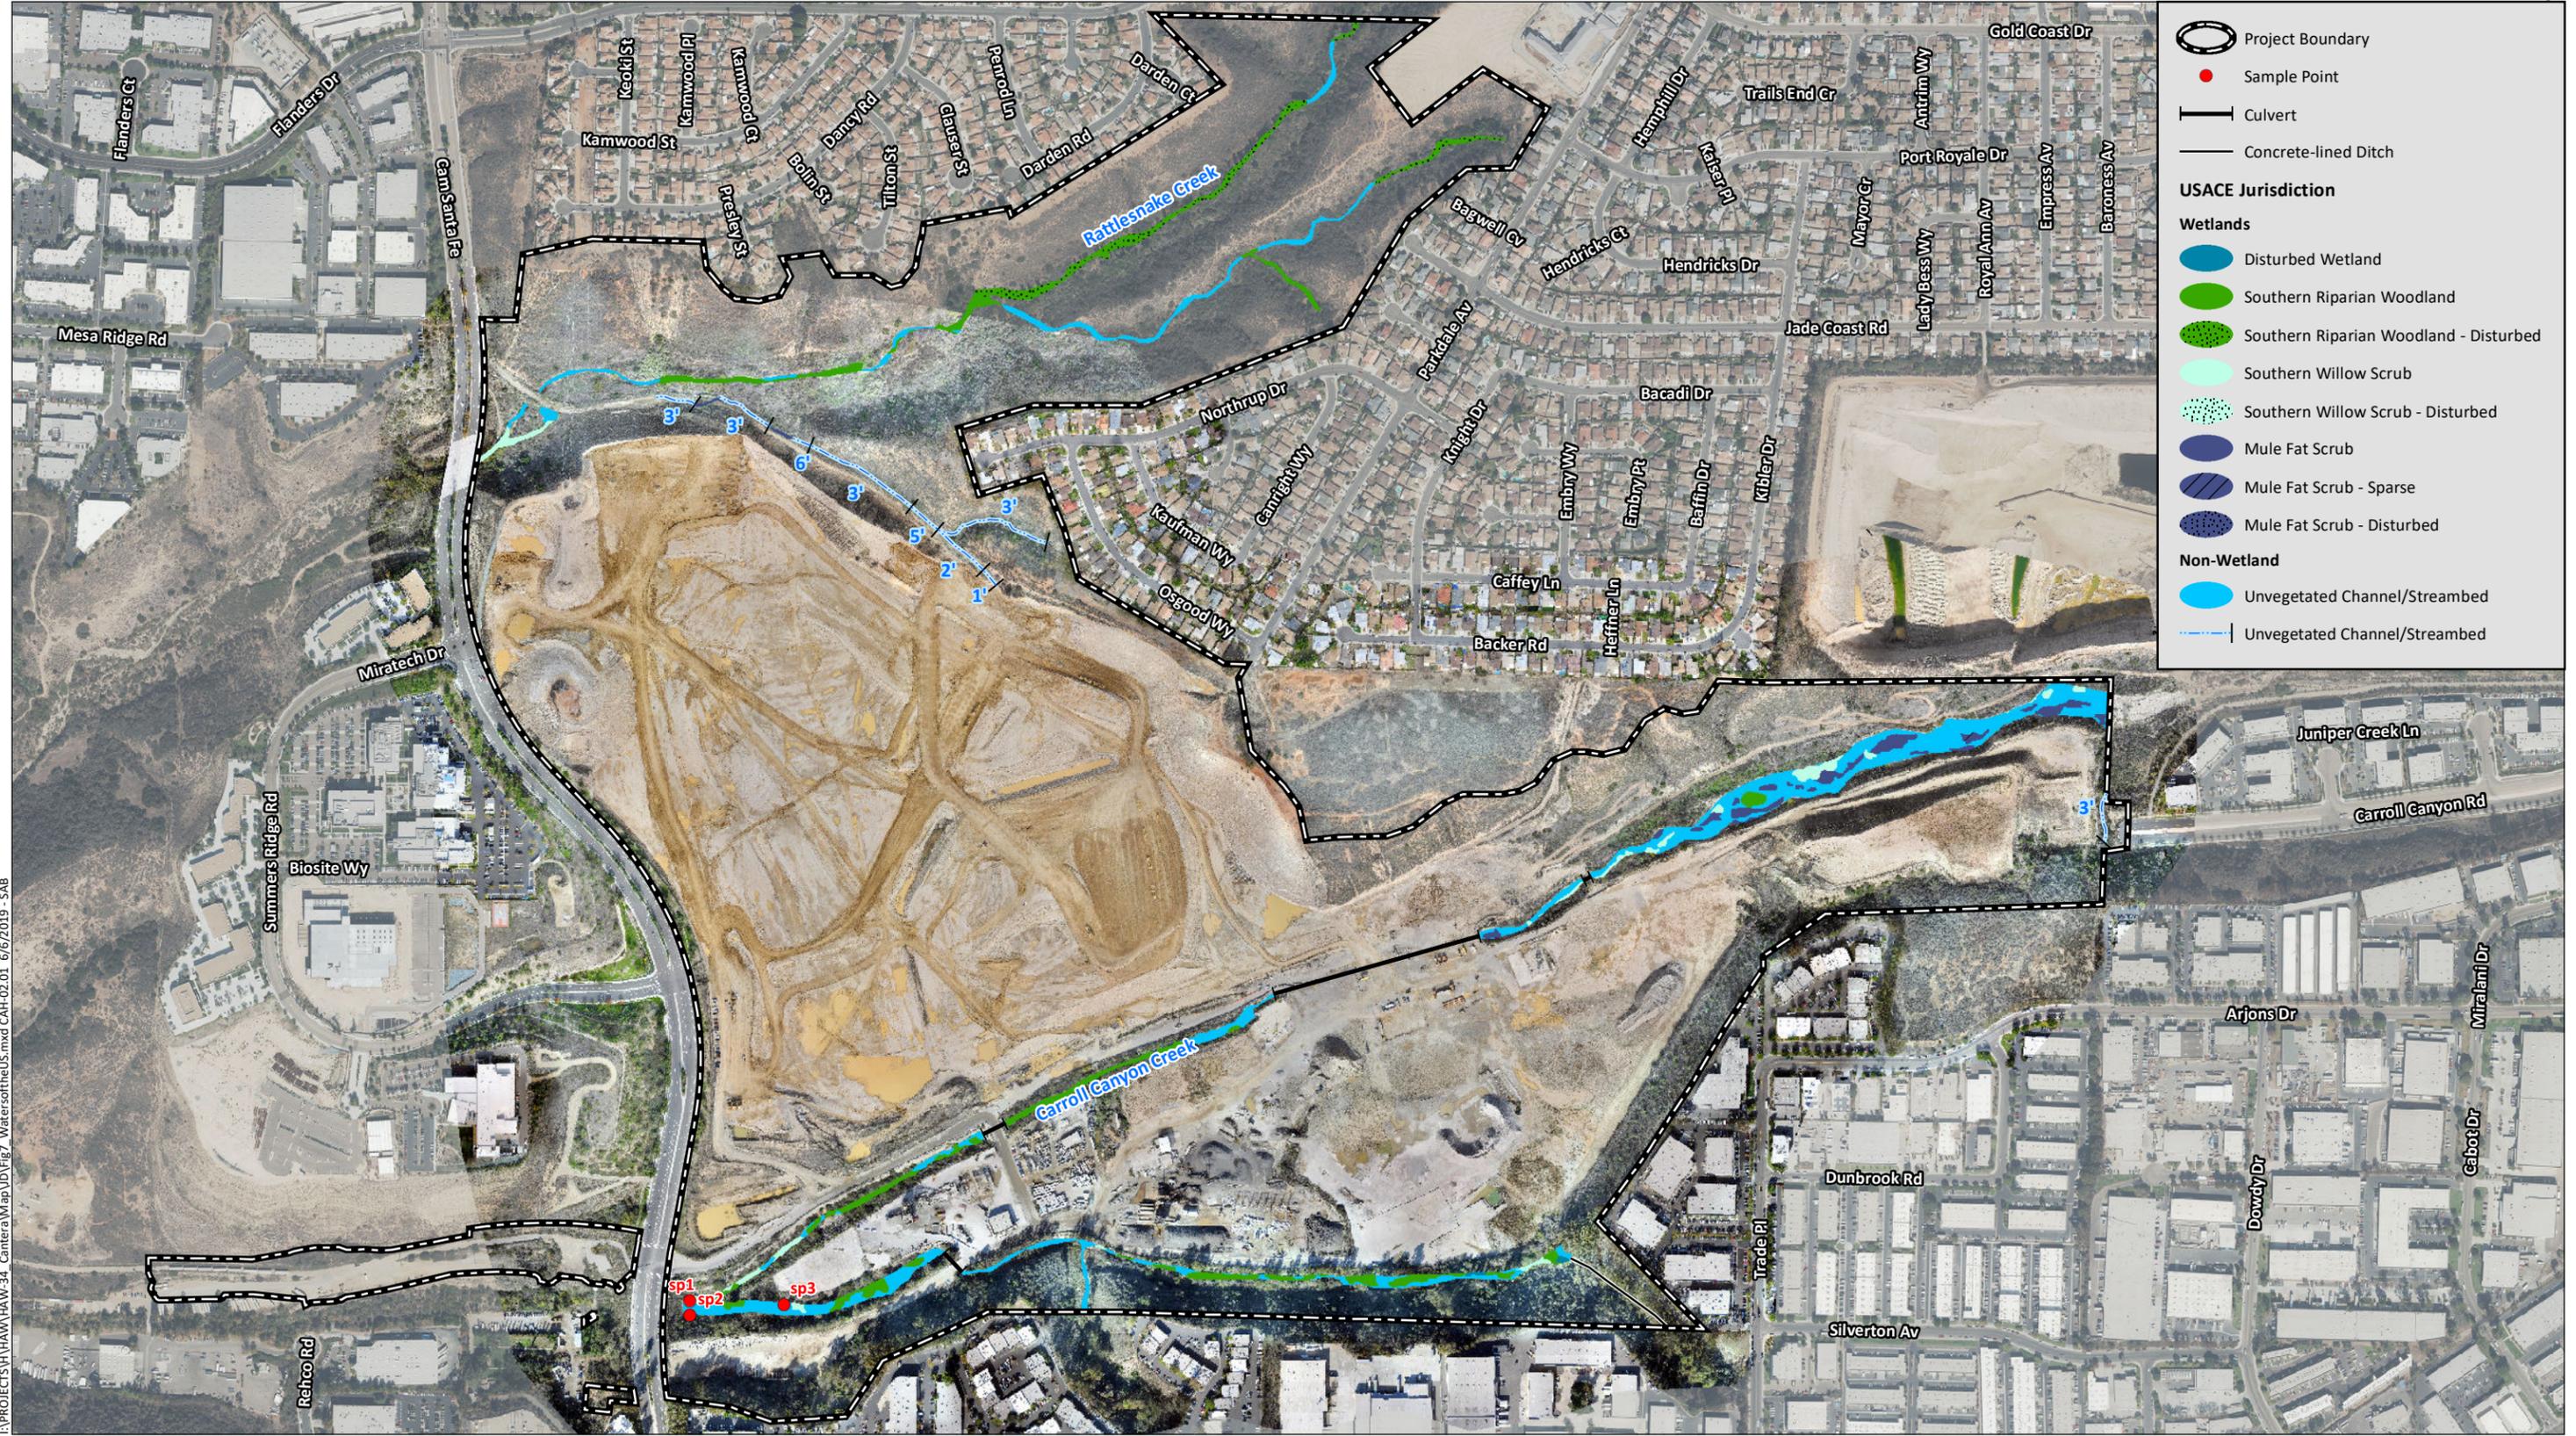
- Project Boundary
- Sample Point
- Culvert
- Concrete-lined Ditch

USACE Jurisdiction

Wetlands

Sample Point 1. This Sample Point was located on a sandbar adjacent to the unvegetated low-flow channel (Figures 7). The habitat at this location is shrubby, southern willow scrub. It is shown on the NWI as riverine, streambed, intermittent, temporarily flooded. Wetland vegetation, dominated by willows (*Salix lasiolepis* and *S. laevigata*), was present based on the Dominance Test. A soil pit excavated to a depth of 16 inches did not reveal any hydric soil indicators. However, the sample point appears to meet the circumstances for the vegetated sand and gravel bars within floodplains problem area of the Arid West Supplement (USACE 2008). Two secondary wetland hydrology indicators were present: drift deposits (B3; riverine) and the FAC-neutral Test, which is sufficient to conclude wetland hydrology. This location is a wetland WUS. The presence of wetland vegetation is also the basis for concluding that this location is also a CDFW jurisdictional habitat and a City wetland.

Sample Point 2. This Sample Point was located in the adjacent upland, in Diegan coastal sage scrub (Figures 7). Vegetation was dominated by two upland species (California sagebrush [*Artemisia californica*] and California buckwheat [*Eriogonum fasciculatum*]) and one facultative upland species (seloa pampas grass [*Cortaderia selloana*]), which failed the Wetland Dominance. The Prevalence Index

Sample Point 3. This Sample Point was located approximately 350 feet upstream of Sample Point 1 (Figure 7). The sample point was located on the floor of the drainage. The vegetation at this location was dominated by one upland species (Sydney golden wattle [*Acacia longifolia*]) and two facultative upland species—broom baccharis (*Baccharis sarothroides*) and western ragweed (*Ambrosia psilostachya*), which failed to meet the dominance test for hydrophytic vegetation. The Prevalence Index score for this sample point was 4.3, which is too high to conclude this is wetland vegetation. A soil pit dug to 16 inches did not reveal any hydric soil indicators. One secondary wetland hydrology indicator was noted—drift deposits (B3; riverine). While riverine drift deposits alone are insufficient for wetland hydrology, they are an OHWM indicator and are the basis for concluding that this location is non-wetland WUS. This location is also considered a CDFW jurisdictional streambed habitat.

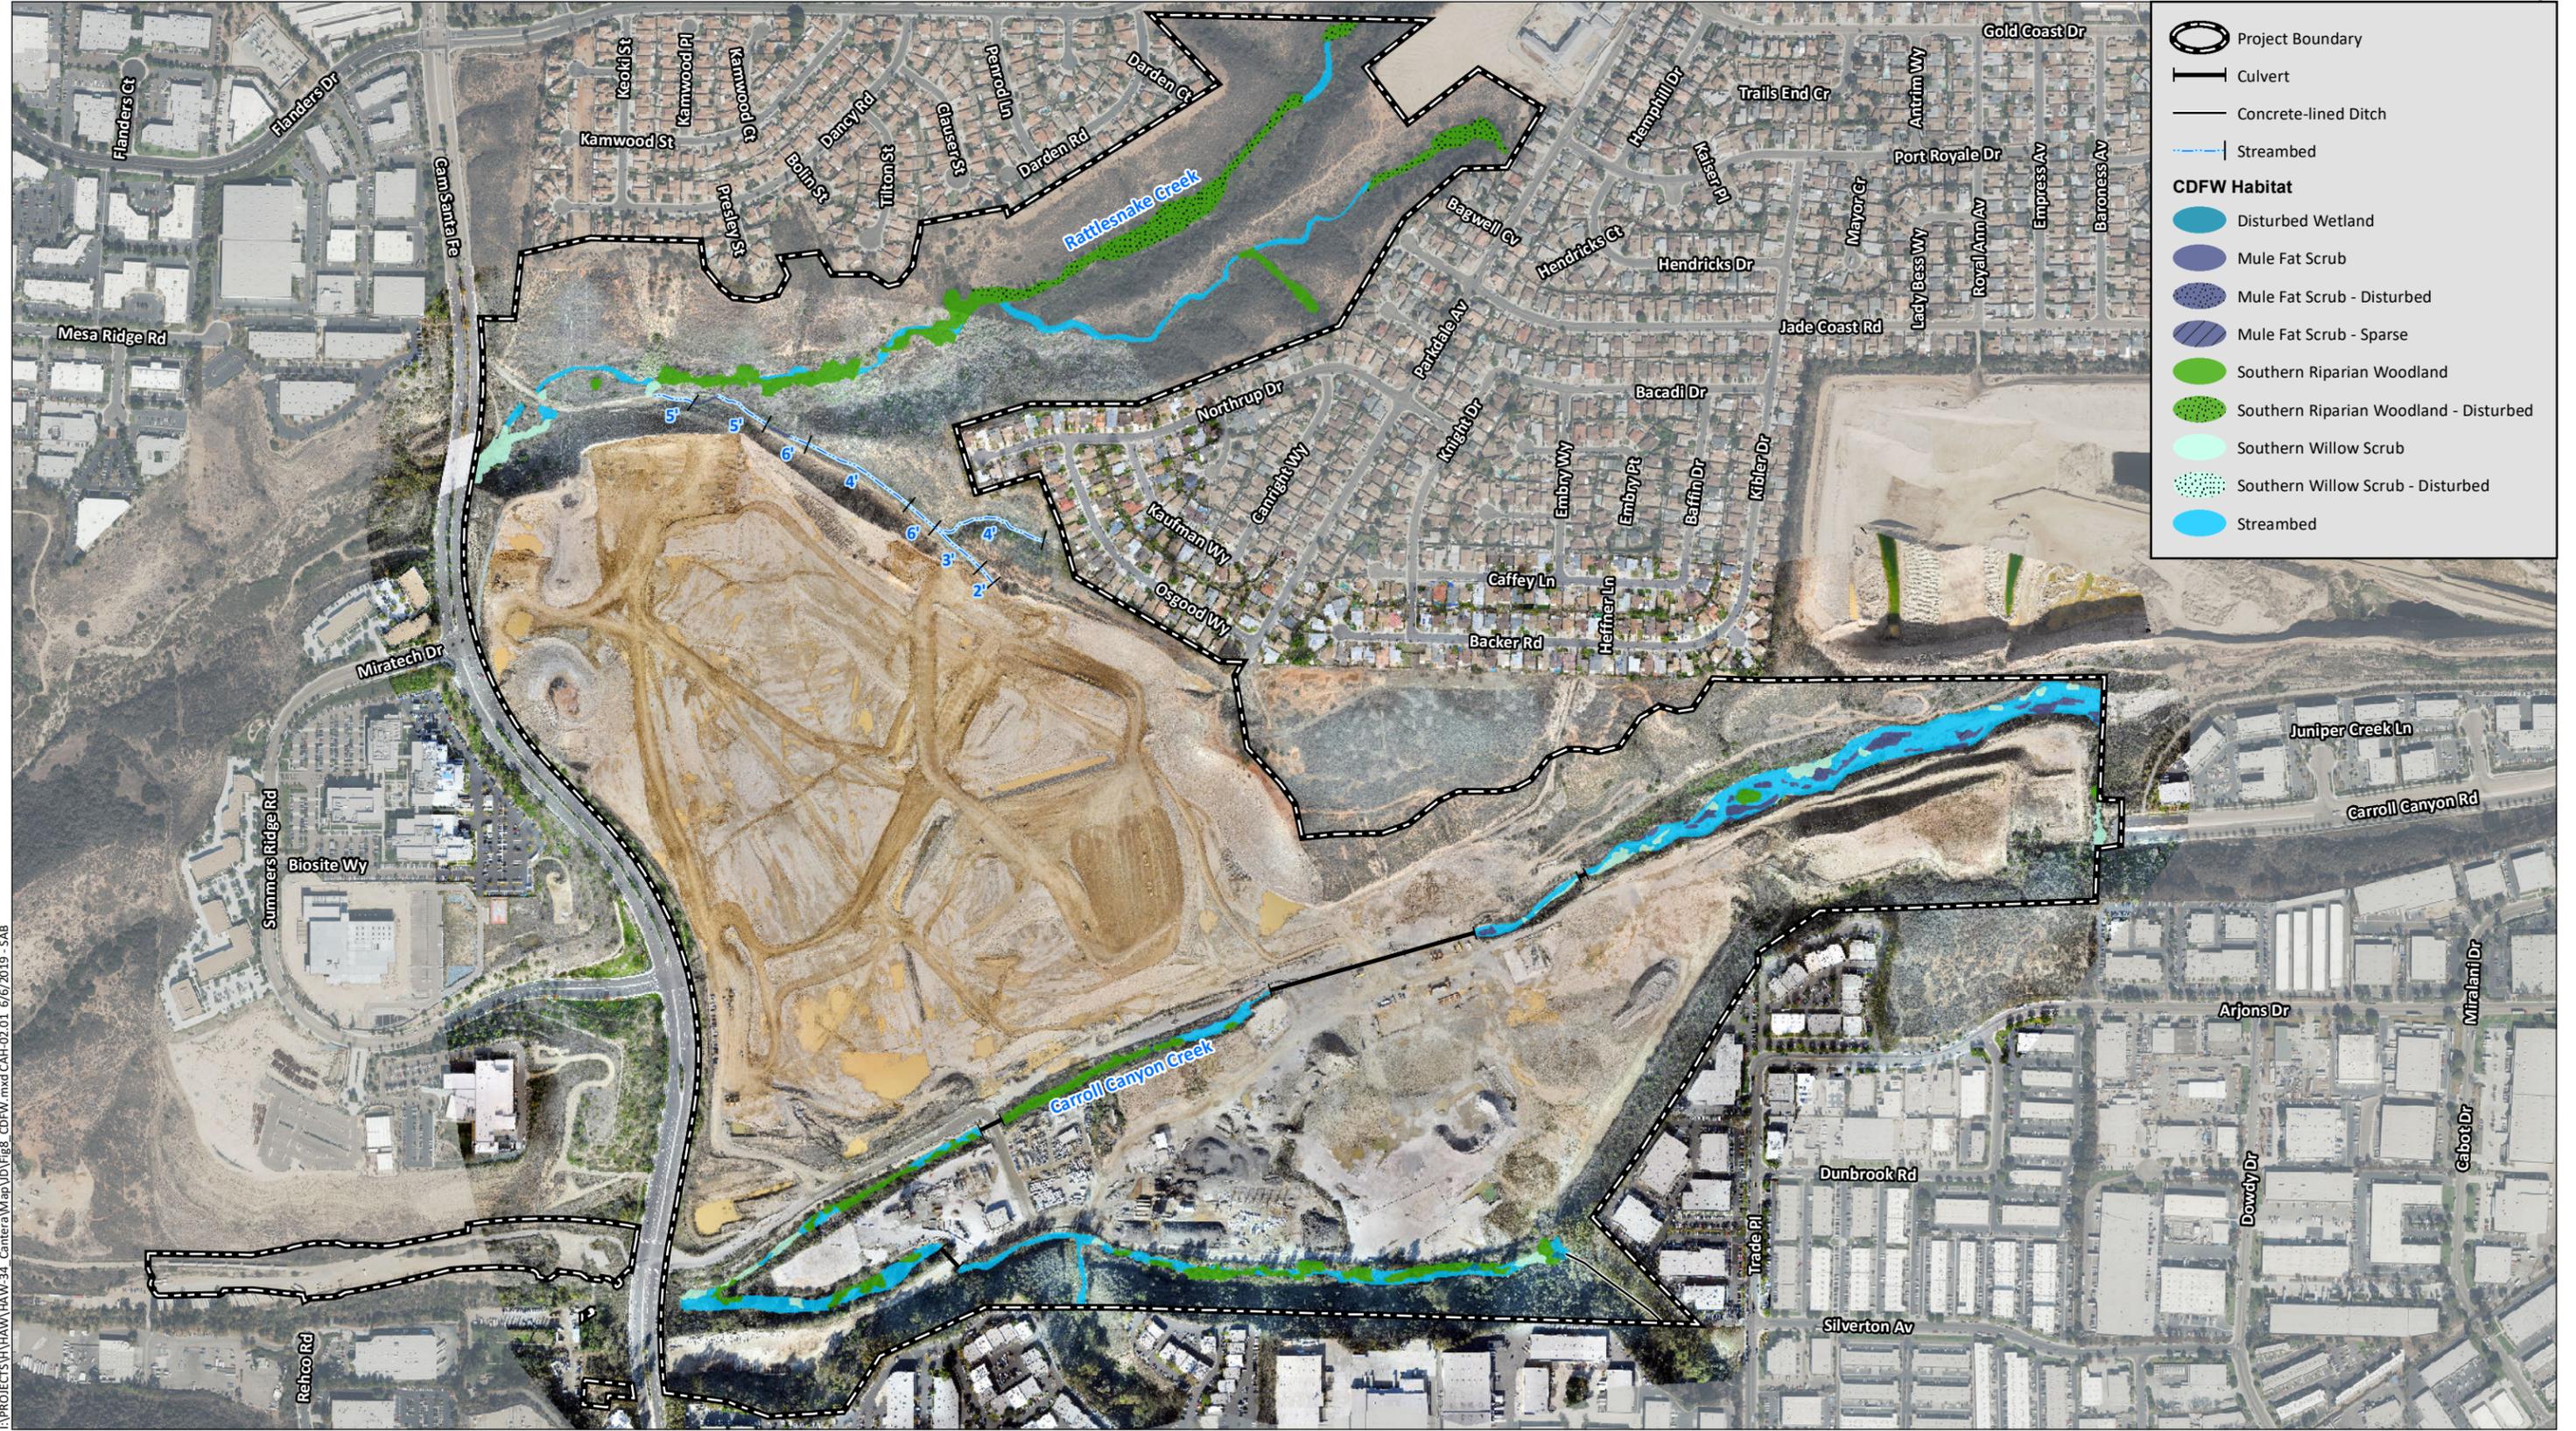
I:\PROJECTS\HAWAII\HAW-34_Cantera\Map\UD\Fig8_CDFW.mxd CAH-02.01_6/6/2019 - SAB

The CDFW jurisdictional habitats at the 3Roots project include 10.88 acres of riparian woodland, scrub, and herbaceous habitats, and 9.03 acres of unvegetated streambed (Figure 8; Table 3). The length of CDFW jurisdictional areas on site totals 19,283 linear feet. This includes the length of Rattlesnake Creek and Carroll Canyon Creek (to the edge of vegetation canopy) through the project site and their tributaries.

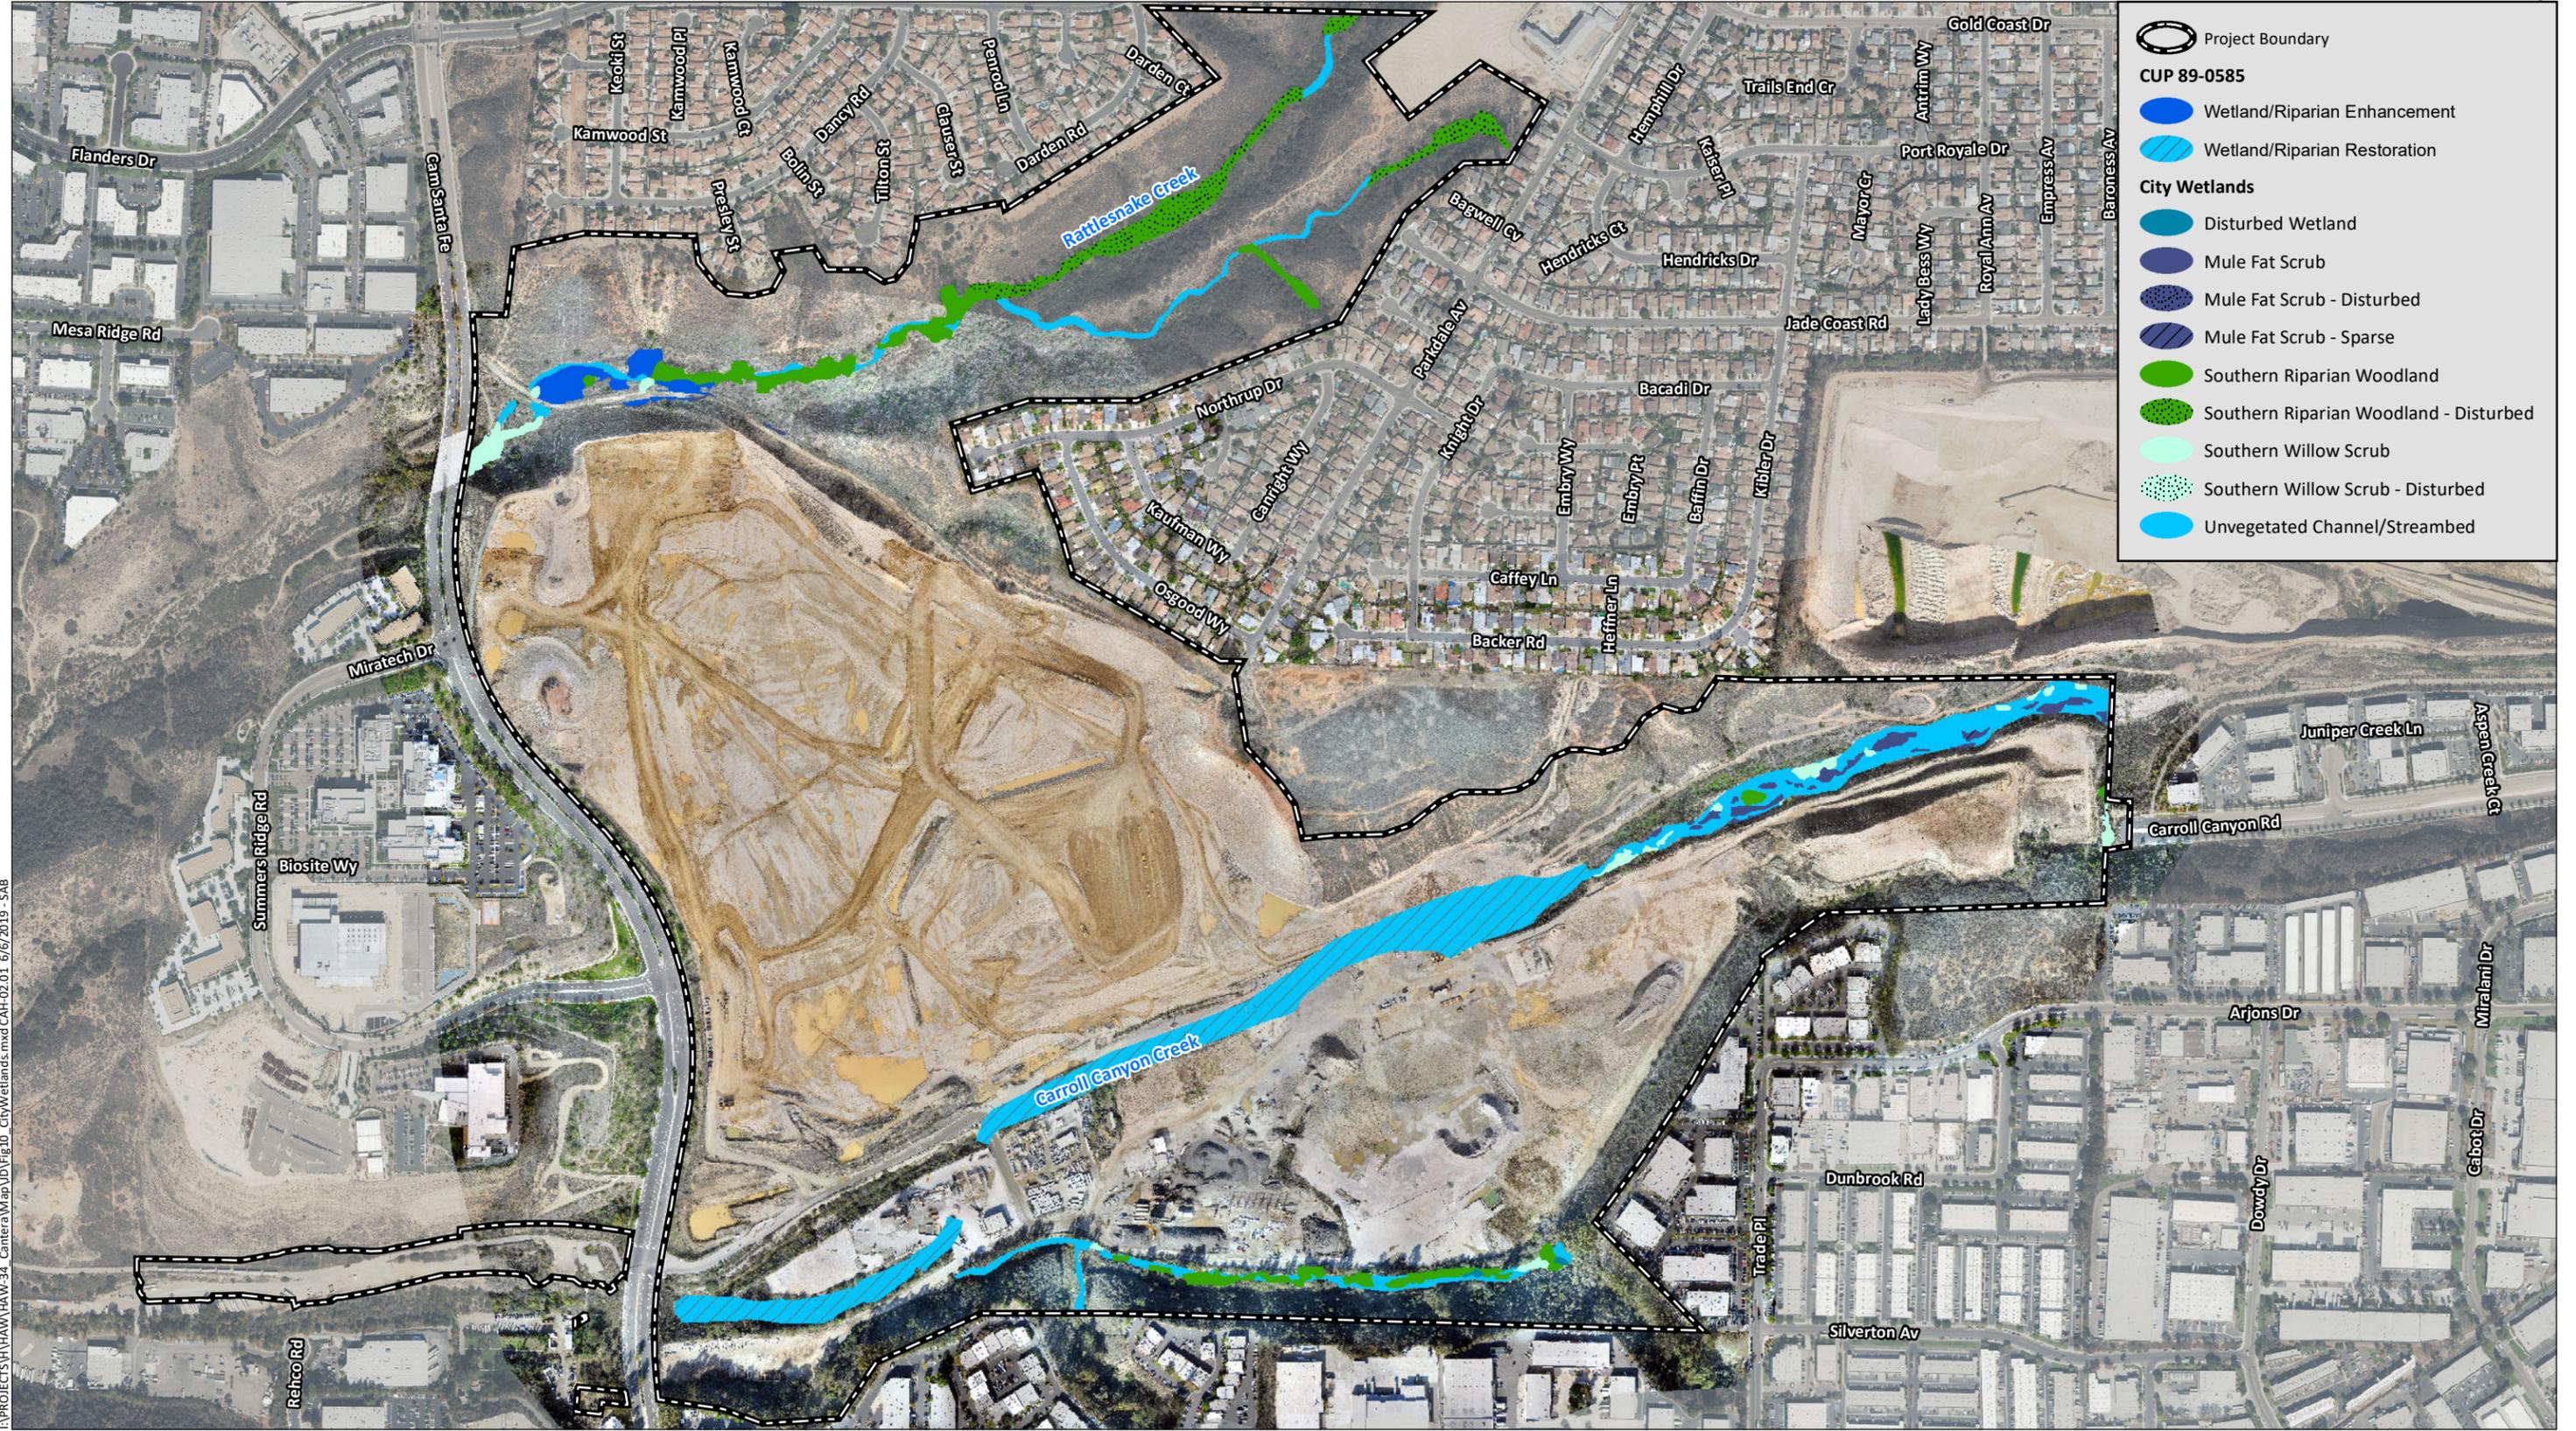
I:\PROJECTS\1\HAW\1\HAW-34_Cantera\Map\UD\Fig10_CityWetlands.mxd CAH-02-01_6/6/2019 - SAB

- Project Boundary
- CUP 89-0585**
- Wetland/Riparian Enhancement
- Wetland/Riparian Restoration
- City Wetlands**
- Disturbed Wetland
- Mule Fat Scrub
- Mule Fat Scrub - Disturbed
- Mule Fat Scrub - Sparse
- Southern Riparian Woodland
- Southern Riparian Woodland - Disturbed
- Southern Willow Scrub
- Southern Willow Scrub - Disturbed
- Unvegetated Channel/Streambed

The 3Roots project site includes a total of 27.47 acres of City wetland habitats (Figure 10; Table 5). The mapping for City wetlands was derived from what is currently on the ground and the extents of site restoration required as part of the Conditional Use Permit (CUP) reclamation requirements (CUP 89-0585). The restoration per CUP 89-0585 will be done at a later date.

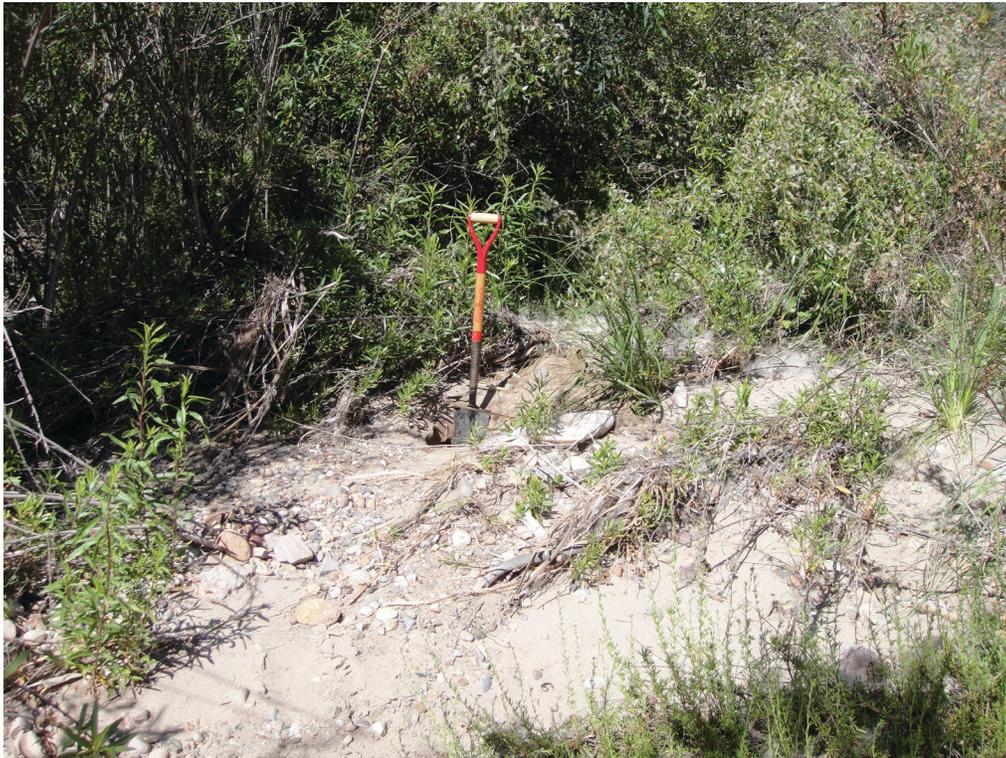
SP1. Sample Point 1 is located in Carroll Canyon Creek, near Camino Santa Fe. This location is a wetland.

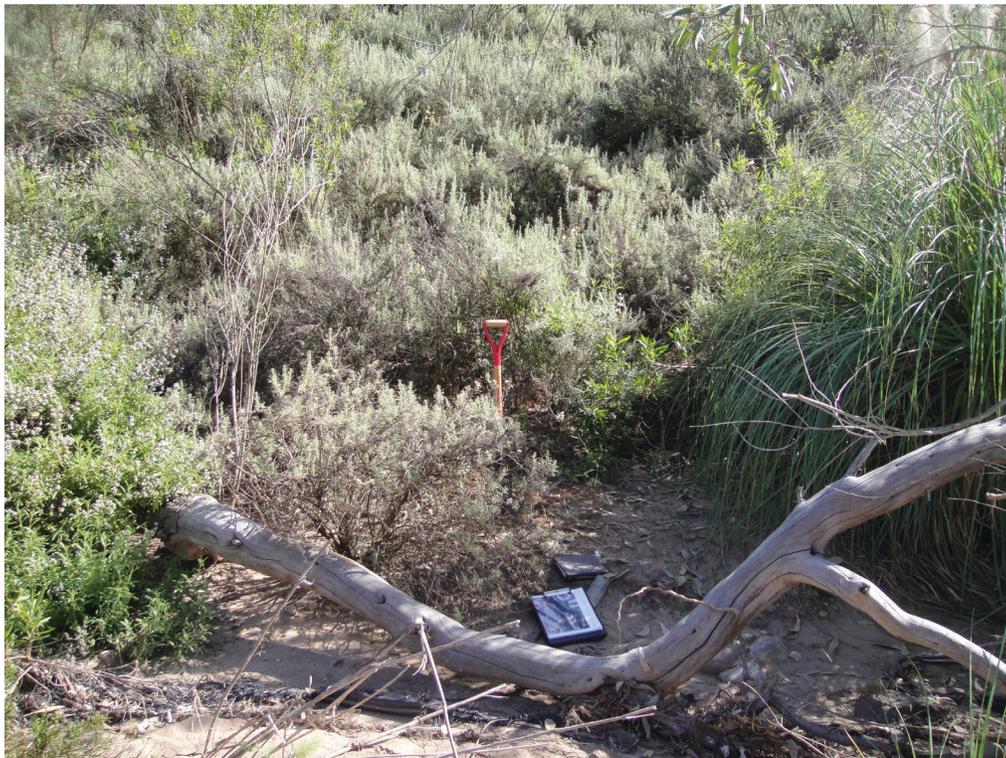
SP2. Sample Point 2 is located on a north facing slope above Carroll Canyon Creek. This location is an upland.

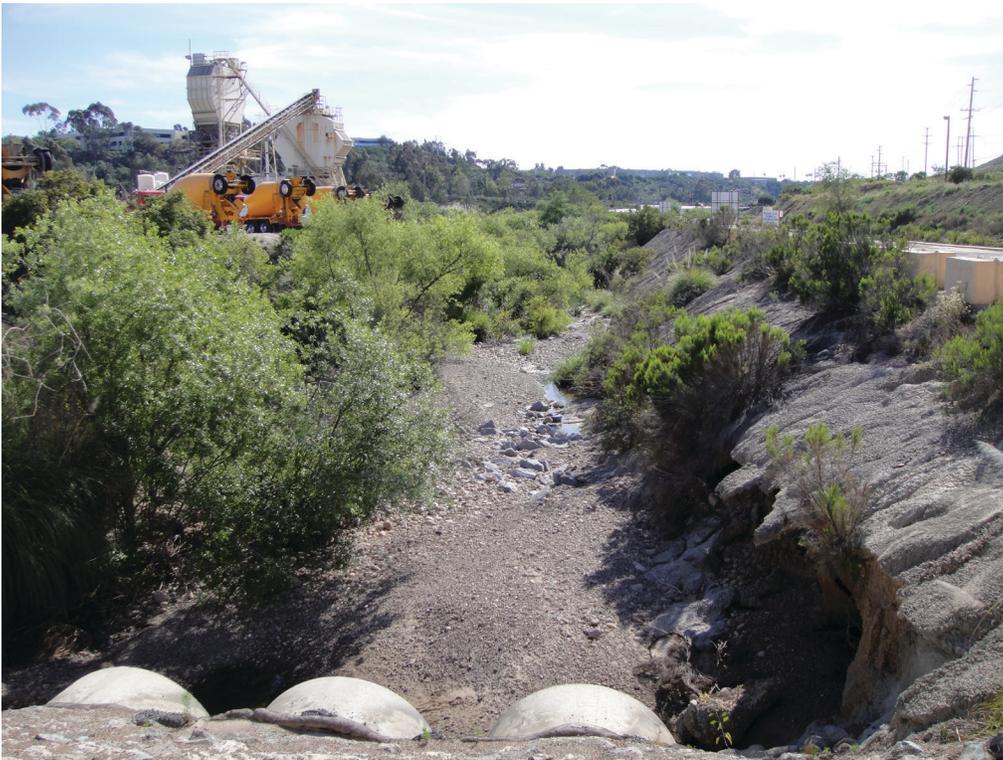
Photo 2. Western crossing of Carroll Canyon Creek. Looking west.

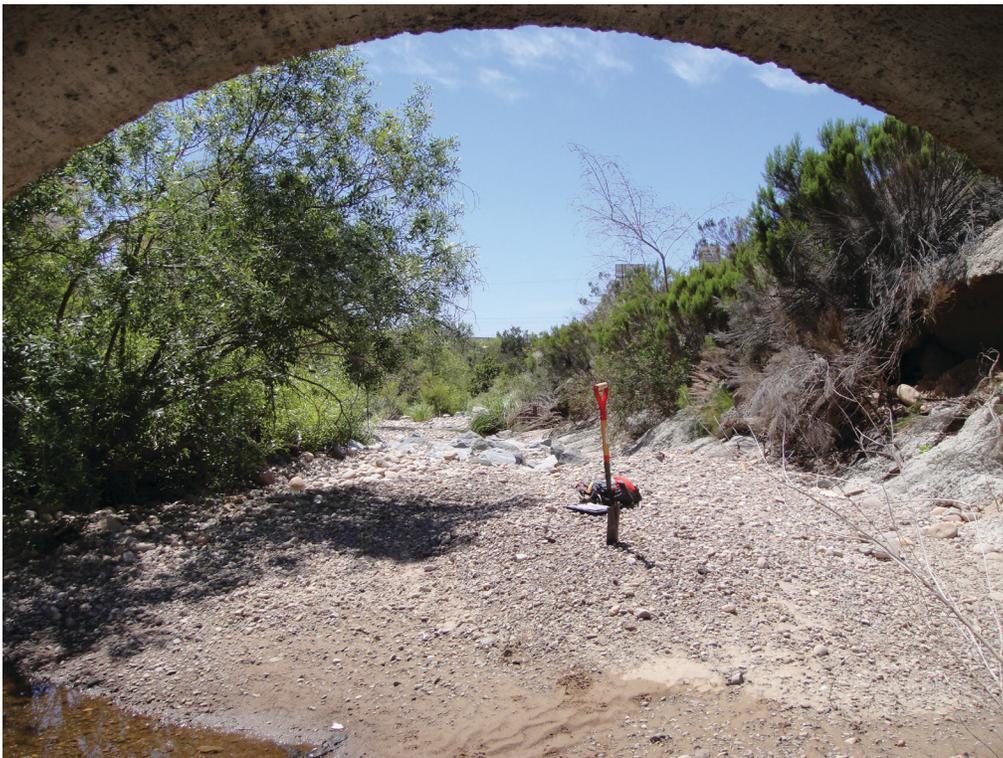
Photo 3. Western crossing of Carroll Canyon Creek. Looking west.

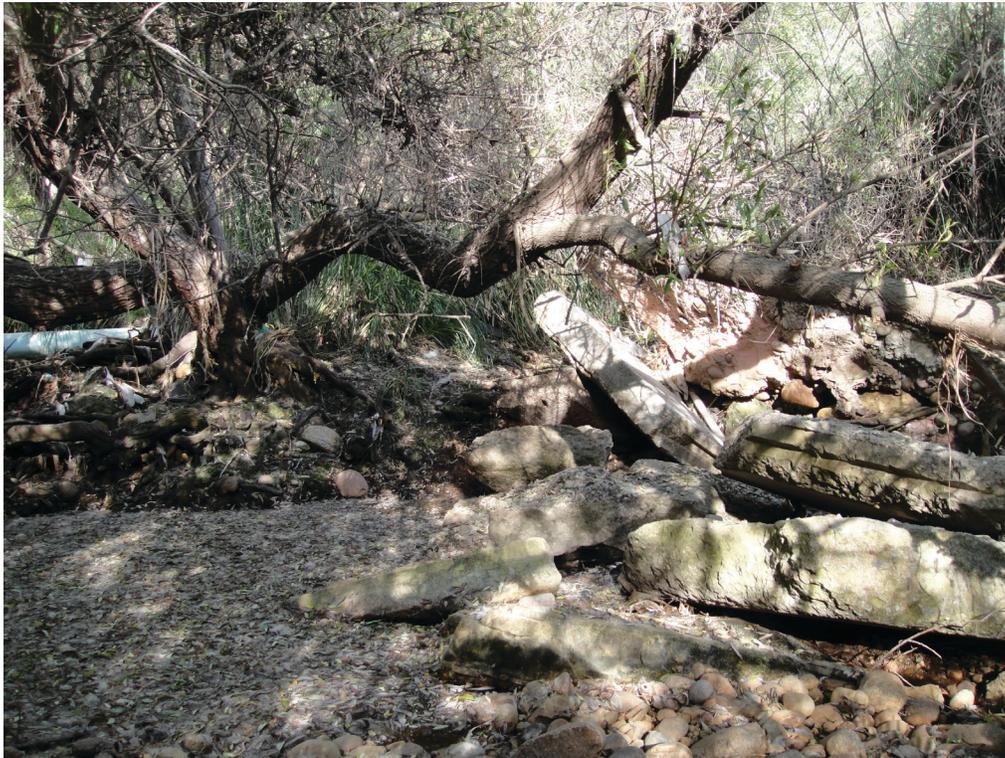
Photo 4. Streambed of Carroll Canyon Creek, east of western crossing. Note large pieces of concrete debris in left foreground. Looking east.

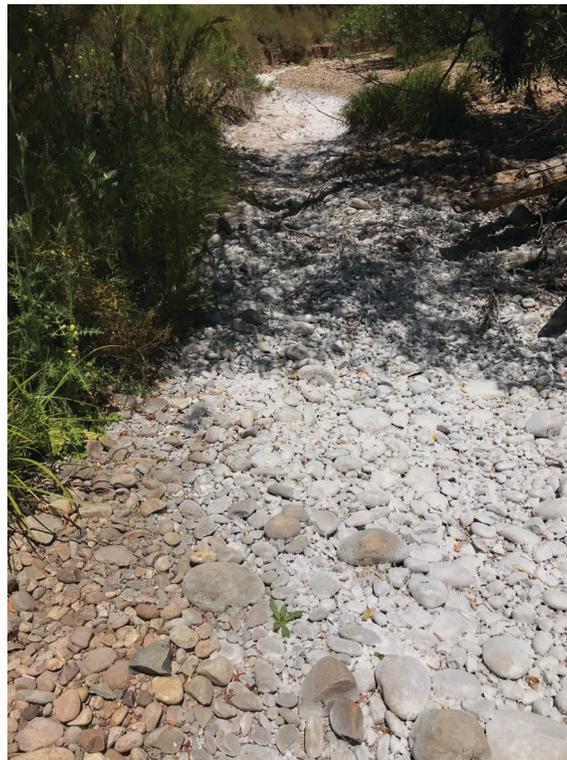
Photo 5. Rattlesnake Canyon Creek. Ash coloring of rocks is dried algae. Looking east.

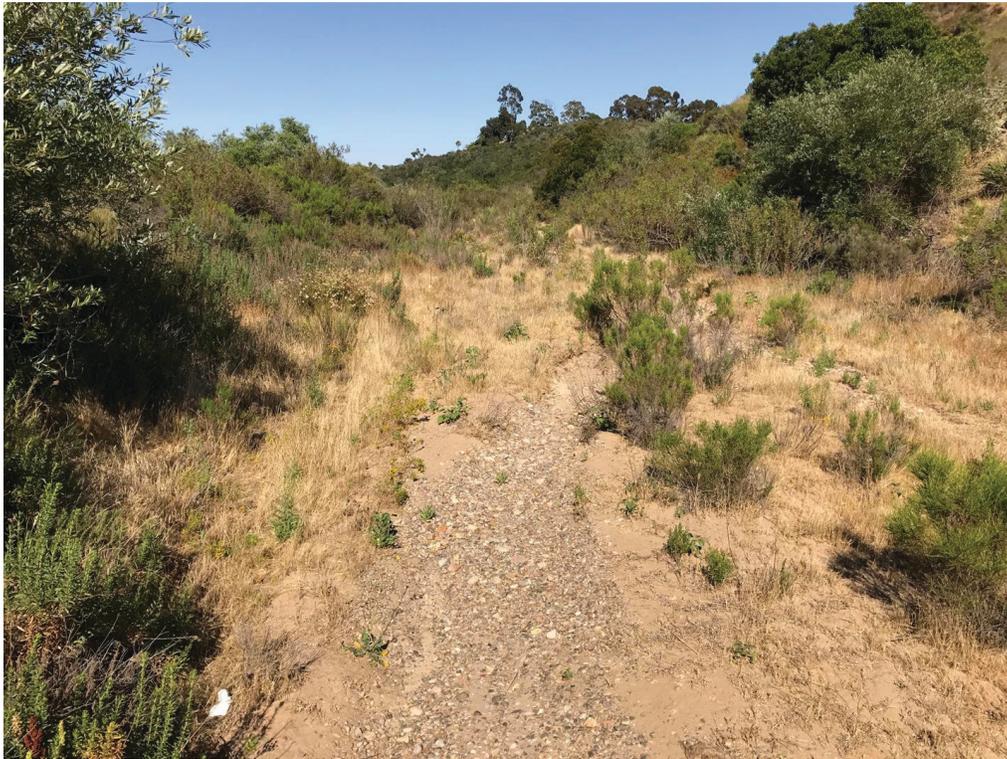
Photo 6. Southern tributary to Rattlesnake Canyon Creek. Looking east.

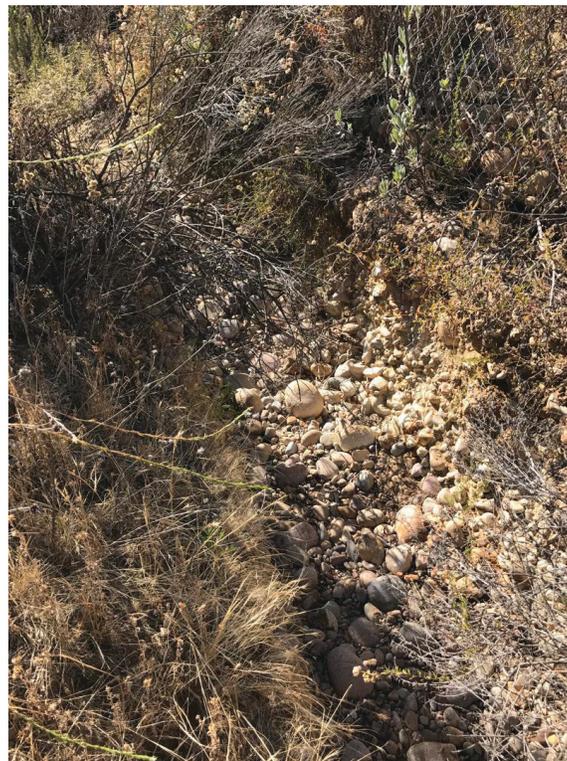
Photo 7. Southern tributary to Rattlesnake Canyon Creek, upstream of previous photo. Looking northwest.
