TYPE OF SERVICES	Phase I Environmental Site Assessment
LOCATION	Downtown Specific Plan Amendments and Specific Development Project Sunnyvale, California
CLIENT	David J. Powers & Associates
PROJECT NUMBER	118-97-1
DATE	September 24, 2018

Phase I Environmental Site Assessment
Downtown Specific Plan Amendments and
Specific Development Project
Sunnyvale, California

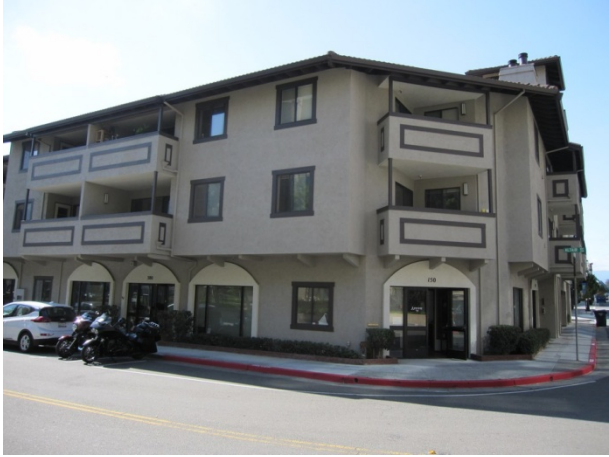
At the time of our visit, the 100 Altair Way parcel was developed with a three story mixed-use building on the western portion of the Site occupied on the ground floor for office uses (by Arrow Realty, Lore IO and Platform 9) and with 20 residential units on upper floors. The eastern portion of the parcel was developed with a building partially occupied as a post office by the USPS building; part of the building also was used by Platform 9 as office space. A hydraulic powered elevator was observed within three story mixed-use building. Mr. Kasik indicated that he was not aware of any maintenance issues with the elevator that would be indicative of hydraulic fluid releases. No other hazardous materials use or storage was observed at the parcel.

Photograph 1. Mixed-use building on Altair Way parcel.

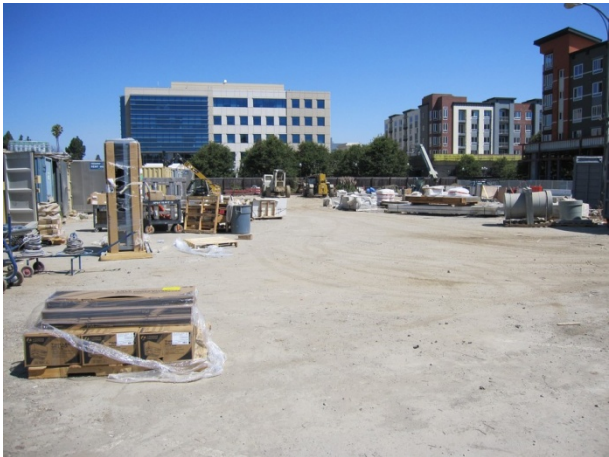
The 300 S. Mathilda Avenue parcel was observed to consist of an undeveloped lot used for construction staging purposes. Several temporary construction office trailers were present along with metal shipping containers of stored building materials and equipment. No hazardous materials use or storage was observed at the parcel.

Photograph 3. Construction staging area on 300 S. Mathilda Avenue parcel.

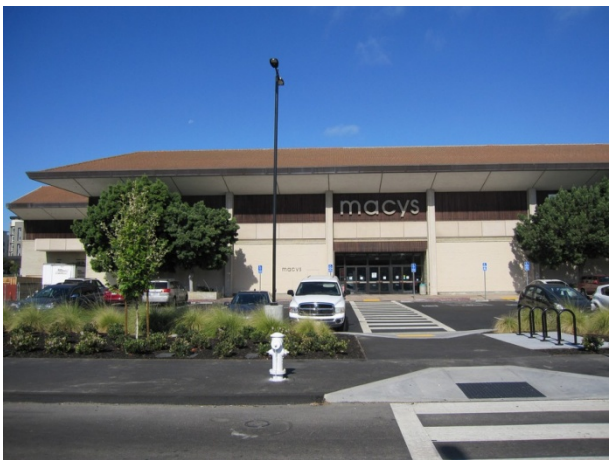
The parcel at 200 W. Washington Avenue was observed to be developed with a two-story Macy's department store consisting of typical retail display and customer service areas, stock rooms and administrative offices. A diesel-powered emergency generator was observed within the northeast portion of the building. Diesel fuel was stored within an adjacent 27 gallon above ground storage tank (AST). Three safety cans of diesel also were stored in a secondary containment tray near the generator. Other hazardous materials within the store were observed to be within metal flammable materials storage cabinets within the shoe department, a maintenance shop, and visual display department. These cabinets mainly contained various shoe cleaning products, building maintenance products, and paint related products that were stored in 1- and 5-gallon and smaller containers and aerosol cans. No evidence of significant spills was readily apparent. Shelving with plastic containers within a stockroom also was observed to be used for the collection of universal wastes (batteries, light tubes, etc.) and returned or damaged retail products, which were periodically disposed.

Photograph 5. Department store building on Macy's parcel

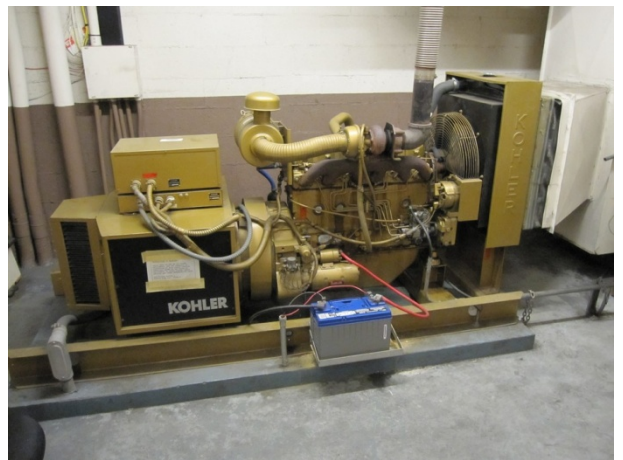
Photograph 6. Emergency generator at Macy's

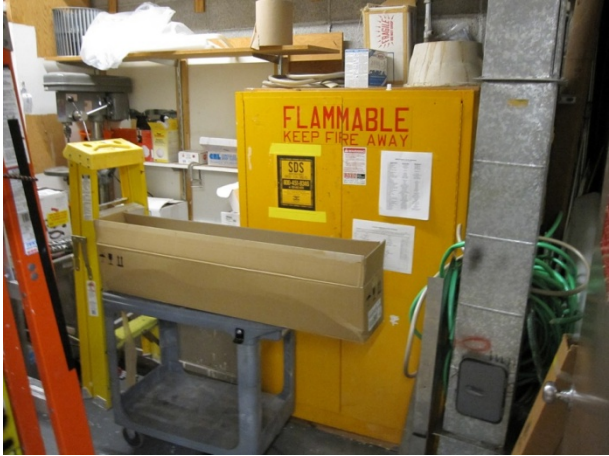
Photograph 7. Flammable material storage cabinet in maintenance shop at Macy's.

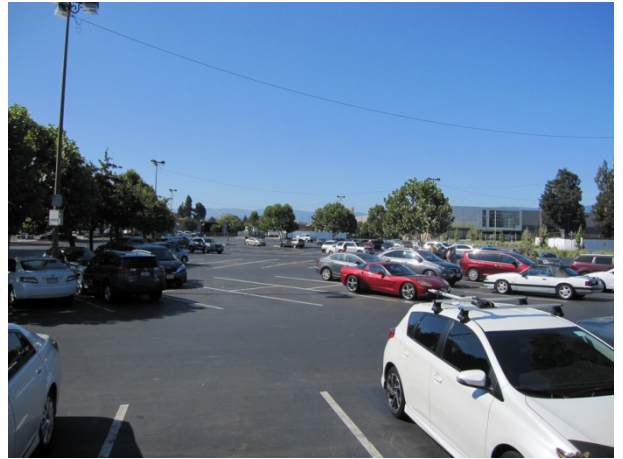
The Sub-block 6 parcel was observed consist mainly of an asphalt paved parking area used by customers of the westerly adjacent Macy's store. A fenced area on the southwest portion of the parcel was observed to be used for construction staging purposes, including temporary office trailers, and fenced area also contained soil vapor extraction equipment⁸. Several wells were observed on the parcel that presumably are used for soil vapor extraction or ground water monitoring. No hazardous materials were observed on the parcel.

Photograph 10. Parking lot on Sub-block 6, looking south.

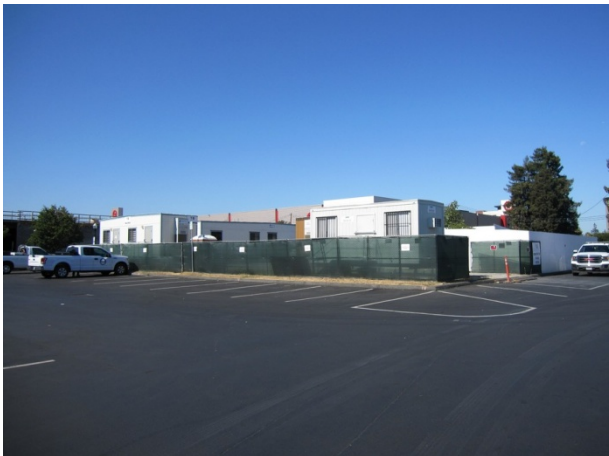
Photograph 11. Fenced construction trailers and SVE treatment system on Sub-block 6.
