Smith Basin Improvement Project

Smith Basin Improvement Project Biological Assessment, Orange
County Water District, October 2019

Smith Basin Improvement Project Biological Assessment

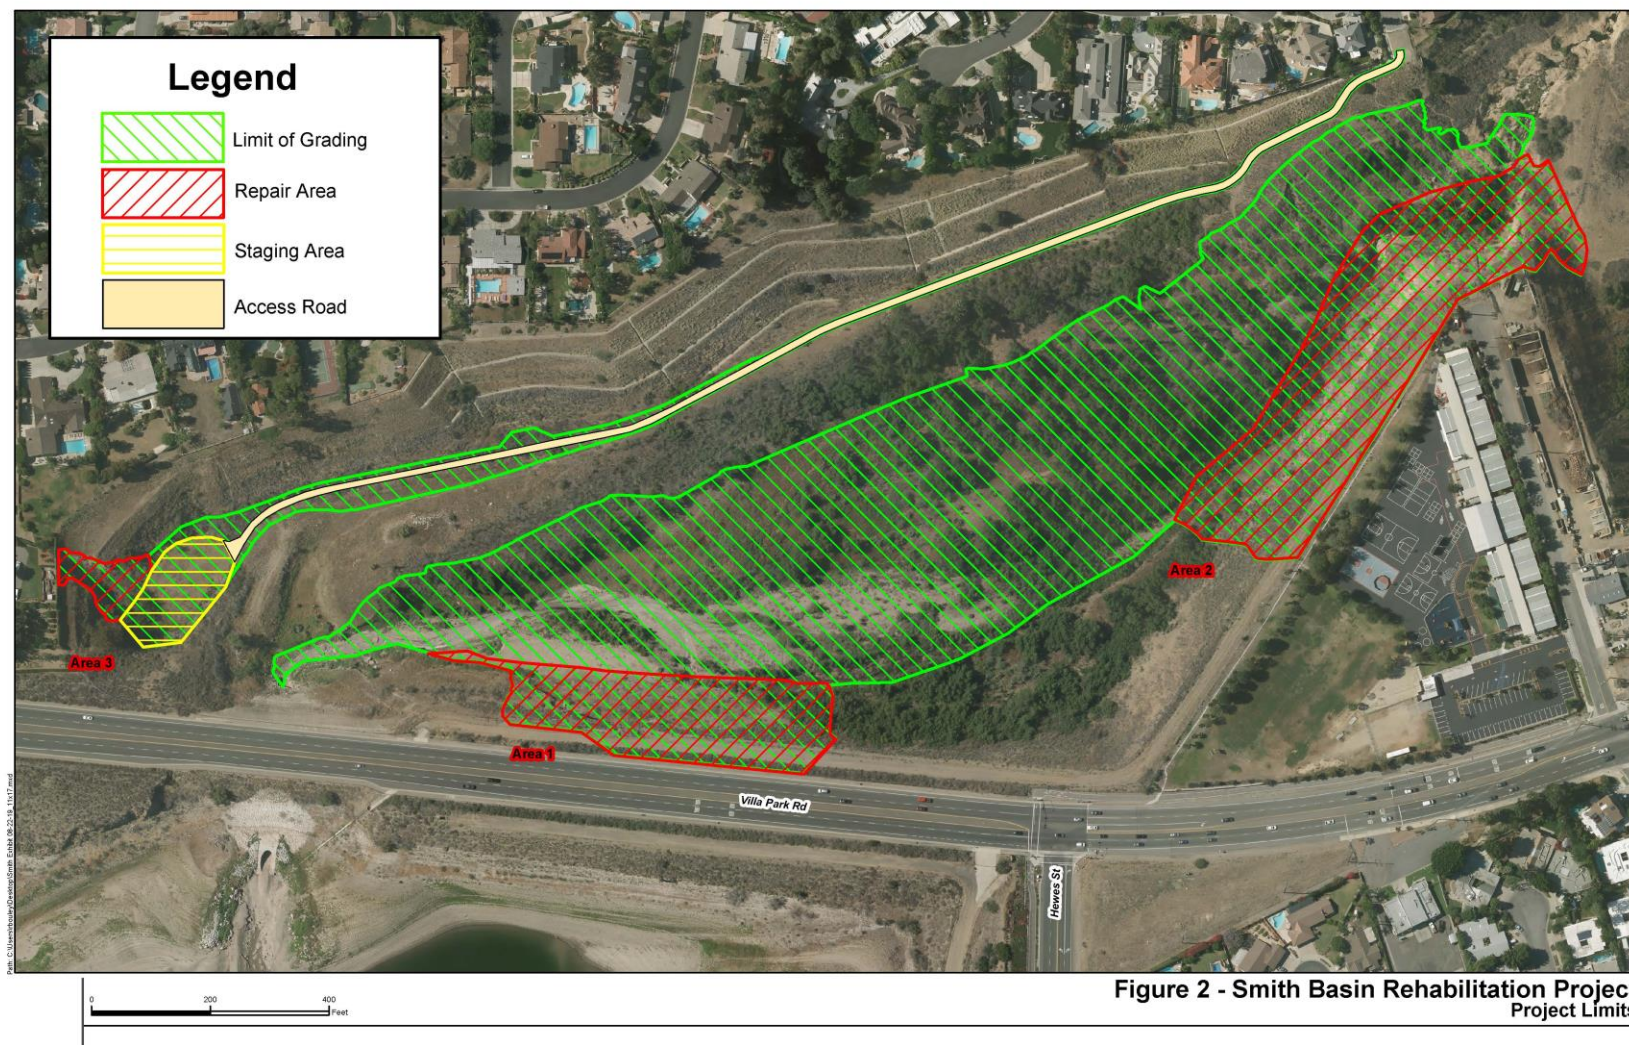
Figure 2: Smith Basin Improvement Project Limits

Figure 2 - Smith Basin Rehabilitation Project
Project Limits

Area 1 is located on the southern embankment slope adjacent to Villa Park Road (Figure 2); here an approximate 450-foot long area along the toe of the embankment slope has been progressively eroding during high water flow events since approximately 1981. The erosion has created a near-vertical scarp that is approximately 25 feet high. Some eroded talus is present near the base of the scarp, but most of the eroded material has been transported downstream. The primary cause of erosion to Area 1 would be undercutting of the toe of the embankment slopes from the southerly migration of Santiago Creek. Since approximately 1978, the flow line of Santiago Creek has been progressively migrating to the south resulting in erosive waters flowing against the base of the eastern and southern embankment slopes during high flow events. The primary concern for this severe erosion is the proximity to Villa Park Road. Without the project, future erosion is anticipated during significant rainfall and highwater flow events.

Area 2 is located on the eastern embankment slope which is adjacent to Oak Ridge Private School and the northern end of North Santiago Boulevard. The area of erosion is approximately 700 feet long along the toe of the embankment slope; it has been progressively eroding during flood events. This has created a near-vertical scarp that reaches a height of about 65 feet at the northeast end. Most of the eroded material has been transported downstream. As with Area 1, the primary cause of erosion to Area 2 has been undercutting of the toe of the embankment slope. The severity of the erosion raises concerns for the Oak Ridge Private School which is proximal. Future erosion is anticipated during significant rainfall and highwater flow events if the project is not constructed.

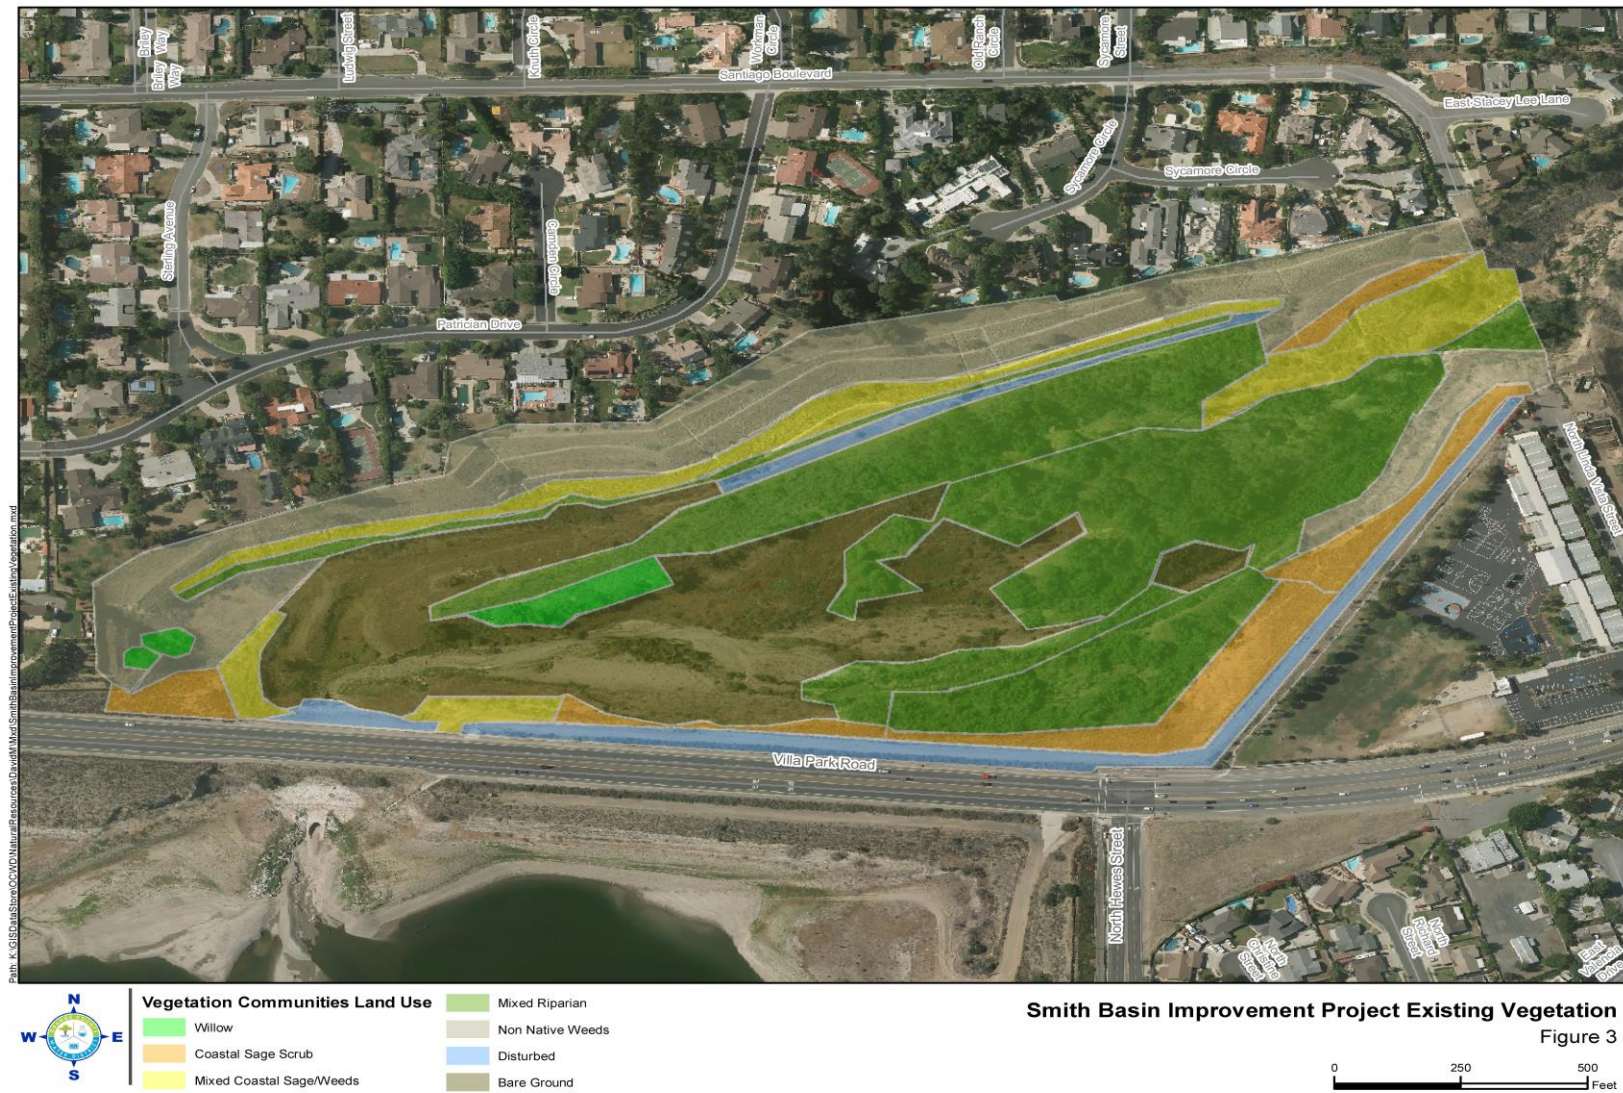
Figure 3: Smith Basin Improvement Project Existing Vegetation

The project site contains a diversity of vegetation and land covers (Figure 3; Table 1). For mapping purposes similar vegetation types were grouped together under one classification. The vegetation classifications identified within the project area includes willow, mixed riparian, coastal sage scrub, and mixed-coastal sage scrub. The remainder of the project site contains disturbed area, bare ground and the creek itself.

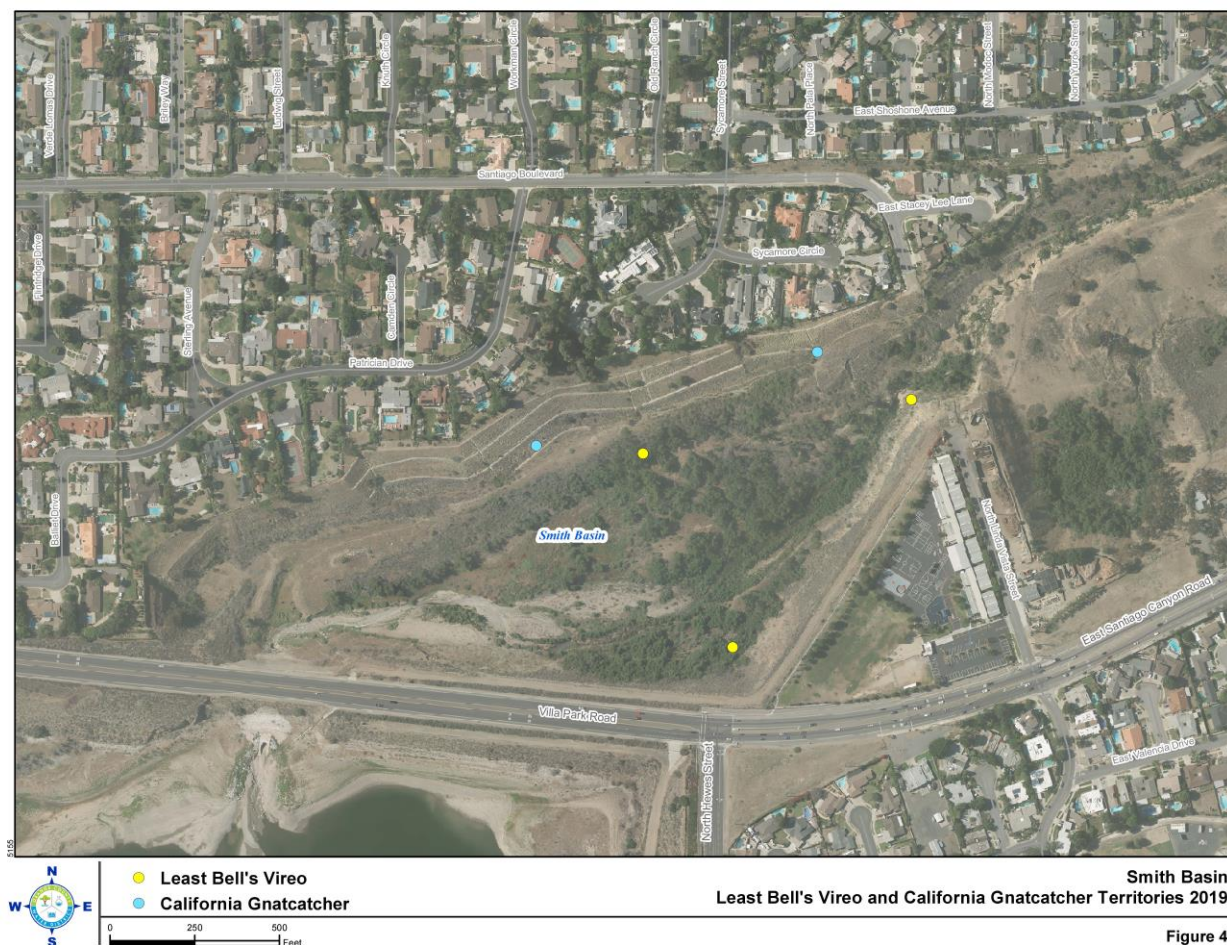
Figure 4: Least Bell's Vireo and California Gnatcatcher Territories 2019

The vireo is a listed Federal and State Endangered Species. The vireo is a small migratory songbird that historically was common in lowland riparian habitat, ranging from coastal southern California through Sacramento and San Joaquin Valleys with scattered populations in Coast Ranges of the Sierra Nevada, Mojave Desert and Death Valley. Presently, the species only occurs in riparian woodlands in southern California. Surveys conducted in 2019 identified four vireo territories in the project vicinity including one territory within the project site (Figure 4).

The California Gnatcatcher is a year-round resident of scrub dominated plant communities from southern Ventura County southward through Los Angeles, Orange, San Bernardino, Riverside, and San Diego counties. There are historical gnatcatcher territories in Smith Basin, but as of 2019 territories were documented outside of the limits of grading. Figure 4 shows the California Gnatcatcher territories documented in Smith Basin in 2019.
