Smith Basin Improvement Project

OCWD Smith Basin Geotechnical Improvements Project Noise and Vibration Technical Memorandum, Vista Environmental, February 2019

Subject: Orange County Water (OCWD) – Smith Basin Geotechnical Improvements Project Noise and Vibration Technical Memorandum.

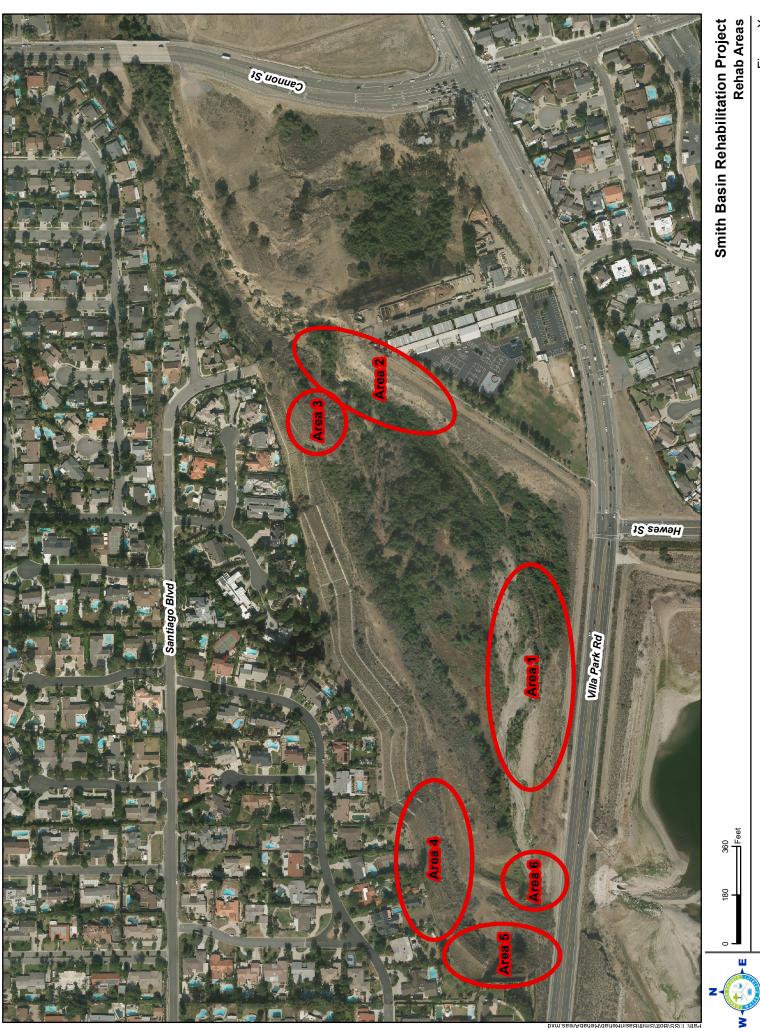
Figure X

The embankment slopes vary in height from 50 feet to 80 feet in height and vary in slope ratio from approximately 1:1 to 2:1, except near the southwest corner of the basin where the embankment slope is approximately 1:1. A portion of the north embankment slope has been improved with concrete v-ditch drainage improvements. A maintenance road is present along the top of the eastern embankment slope and the eastern portion of the southern embankment slope. Portions of the basin interior and lower areas of the southern and eastern embankment slopes are covered with dense vegetation. Erosion has resulted in near-vertical scarps in some areas. The locations where significant erosion has occurred are shown in Figure X. The proposed geotechnical improvements would take place in Areas 1, 2, and 5.

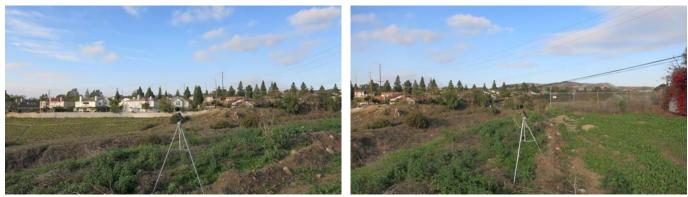
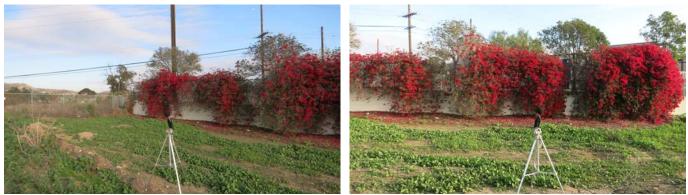
Noise Measurement Site 1 - looking north

Noise Measurement Site 1 - looking northeast

Noise Measurement Site 1 - looking east

Noise Measurement Site 1 - looking southeast

Approx 100 ft west of Santiago Bl CL at end of Road and approx 40 ft west of Oakridge Private School Noise from kids playing at School, equipment operating at Blue Ribbon Nursery, vehicles on Villa Park Rd and Aircraft 67 F, 29.69 in Hg, 57% Hu, no wind, partly cloudy

Site No.	Description	Primary Noise Sources	Start Time of Measurement	Noise Level (dBA Leg/Lmax)
1	Located approximately 100 feet west of the Santiago Boulevard centerline at the end of the road and approximately 40 feet west of Oakridge Private School.	Kids playing at Oakridge Private School, equipment operating at Blue Ribbon Nursery, vehicles on Villa Park Road, and aircraft	3:00 p.m.	51.4/64.3
2	Located in the front of the single-family home at 10422 Balliet Drive approximately 40 feet east of the Balliet Drive/Marion Way centerline.	Vehicles on Villa Park Road and aircraft	3:26 p.m.	46.7/57.3
3	Located in the center of Santiago Boulevard at the southern edge of the old road and approximately 230 feet south of Stacey Lee Lane.	Vehicles on Villa Park Road and Canon Street, kids playing at Oakridge Private School, and aircraft	3:46	52.8/63.1

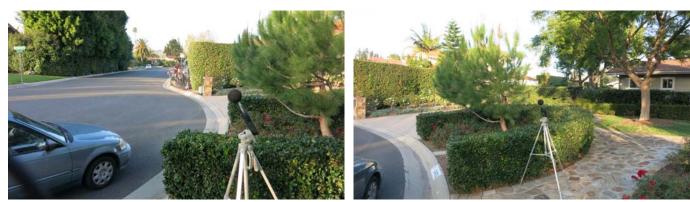
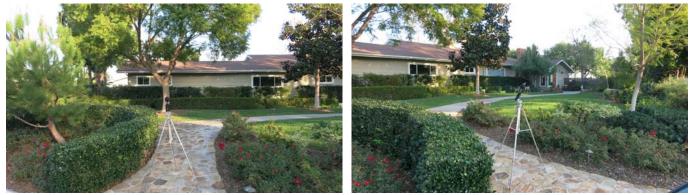
Noise Measurement Site 2 - looking north

Noise Measurement Site 2 - looking northeast

Noise Measurement Site 2 - looking east

Noise Measurement Site 2 - looking southeast

In front yard of home at 10422 Ballier Dr, approx 40 ft east of the CP of Ballier Dr and Marion Way 67 F 29.69 in Hg, 60% hu, no wind, partly cloudy

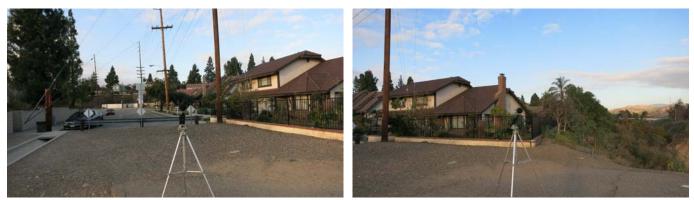
Noise Measurement Site 3 - looking north

Noise Measurement Site 3 - looking northeast

Located in center of Santiago Bl at southern edge of old road, approx 230 ft south of Stacey Lee Ln Noise from Villa Park Rd and Cannon St, kids playing at School, and Aircraft 67 F, 29.69 in Hg, 63% Hu, no wind, partly cloudy
