Re: Impact Assessment for Historic Resources included in the Proposed Mount San Antonio College
2018 Educational and Facilities Master Plan

2018 Educational and Facilities Master Plan (EFMP)

Cultural Resource Evaluation Report for Mt. SAC SEIR for 2015 Facilities Master Plan Update and Physical Education Projects, Walnut, Los Angeles County, California

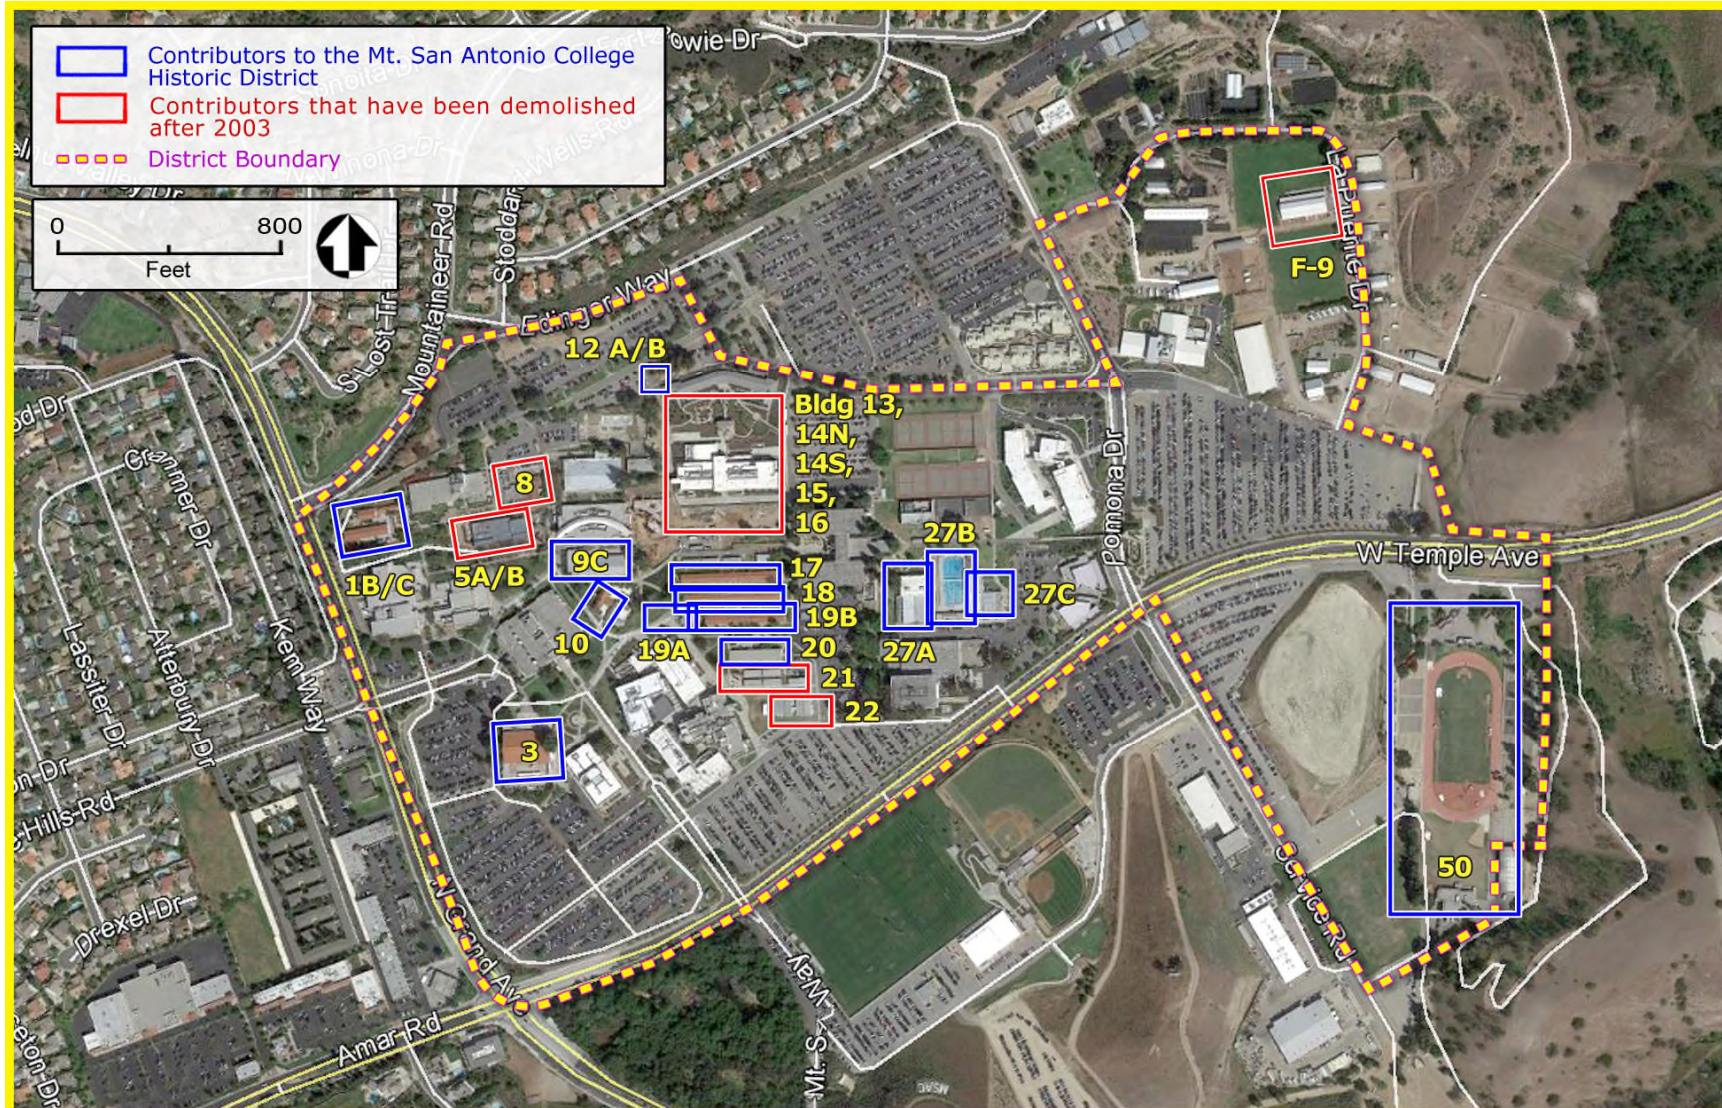
Figure 4. Mt. SAC Historic District identifying contributing resources and demolished contributors, as of November 2015.

The district was previously recommended as eligible for the CRHR under Criterion 1 at the local level, under the theme of Education, for its association with the development of Walnut, California, and its surrounding communities. The college served 10 different communities and thousands of residents and is today the largest community college in the San Gabriel Valley and one of the largest in California. Mt. SAC was one of the first junior colleges in California and the San Gabriel Valley to be established as independent from a high school campus. The period of significance for the district is 1946-1972, reflecting the date the present site of the college became its permanent residence, its early years of development and growth, and ending with the construction of the last major campus facility (the Marie T. Mills Aquatic Facility) to be built until the 1990s, before the growth of the college plateaued (only two buildings being constructed between 1972 and 1990). The college was built to accommodate the increased need for an independent community college (not located on a high school campus) in the area after World War II, and became one of the largest and most significant junior colleges in the San Gabriel Valley. Mt. SAC is the largest of six junior colleges in the San Gabriel Valley, with more than 35,000 students enrolled. The Student Life Center, Aquatic Facility, Women's Locker Facilities, and the Exercise Science/Wellness Center each reflect the college's long-standing efforts to foster student participation in extracurricular and recreational activities during the first 25 years of its establishment. Each building/structure contributes to the educational theme of the historic district and was built during the period of significance. Additionally, the resources maintain good integrity in all seven aspects.

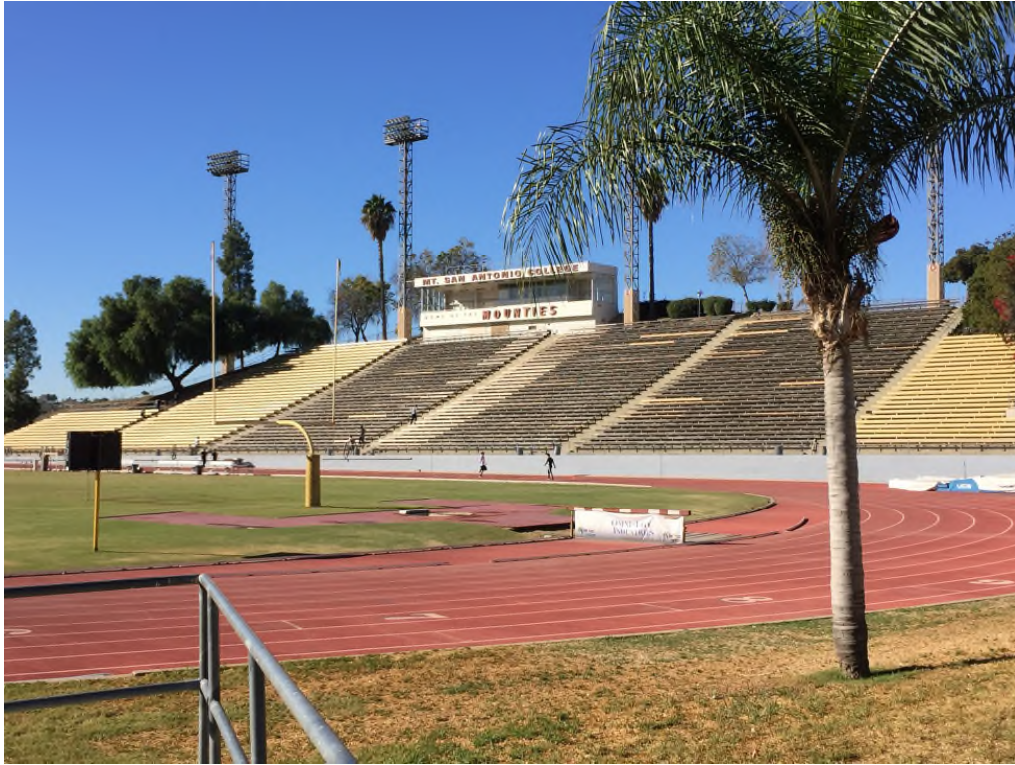
Figure 5. View looking southwest at Hilmer Lodge Stadium, including the track, western bleachers, and press box (50D).

Hilmer Lodge Stadium (consisting of Buildings 50A-H as well as other related elements built prior to 1973) is a contributor to the Mt. SAC Historic District.

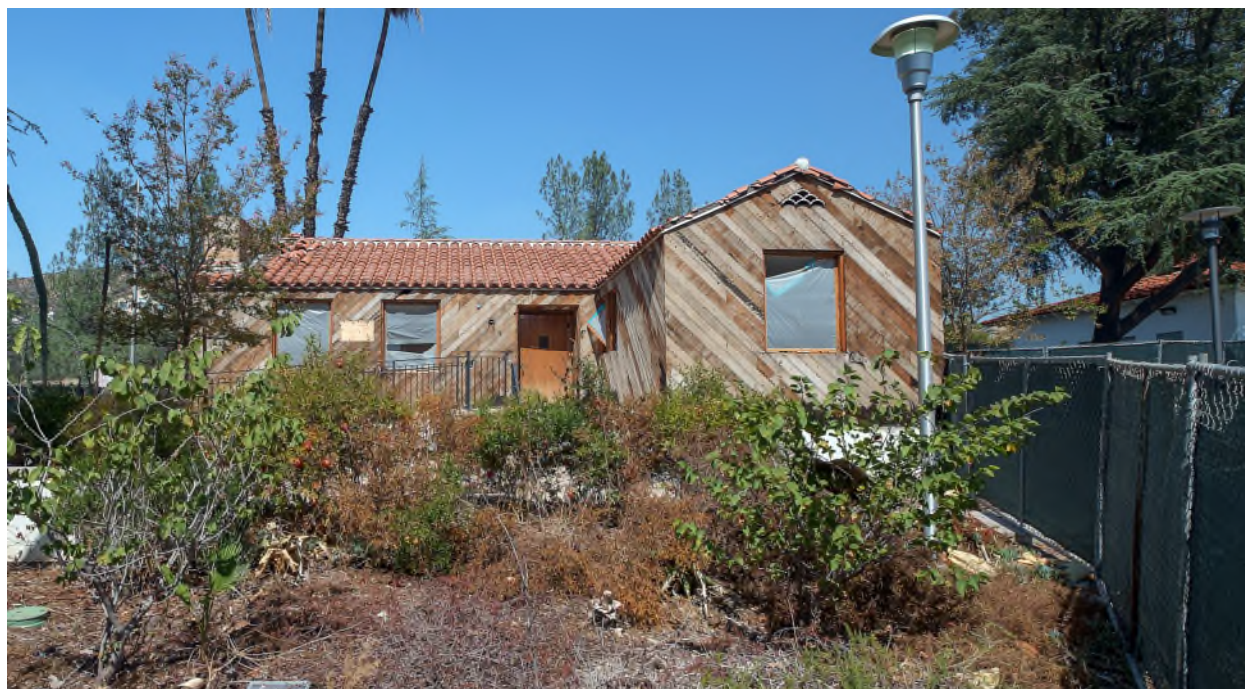
Figure 11. Oden House (12A) and garage (12B) to the right, view looking north at south façade.

Buildings 12A/B were constructed in 1947 as a single-family residence in the Spanish Colonial Revival style (Figure 11). They served as the residence for the college's first campus maintenance supervisor. According to the 2003 Gregory DPR form, the building is referred to as the "Oden House," presumably named after the first college maintenance supervisor; however, no other documentation or mention of this name is given in the report or DPR (Gregory 2003). Building 12A is the residence. Building 12B is believed to have served as a garage for the residence, but unusually contains a vented cupola at the top of the hipped roof that housed a siren.

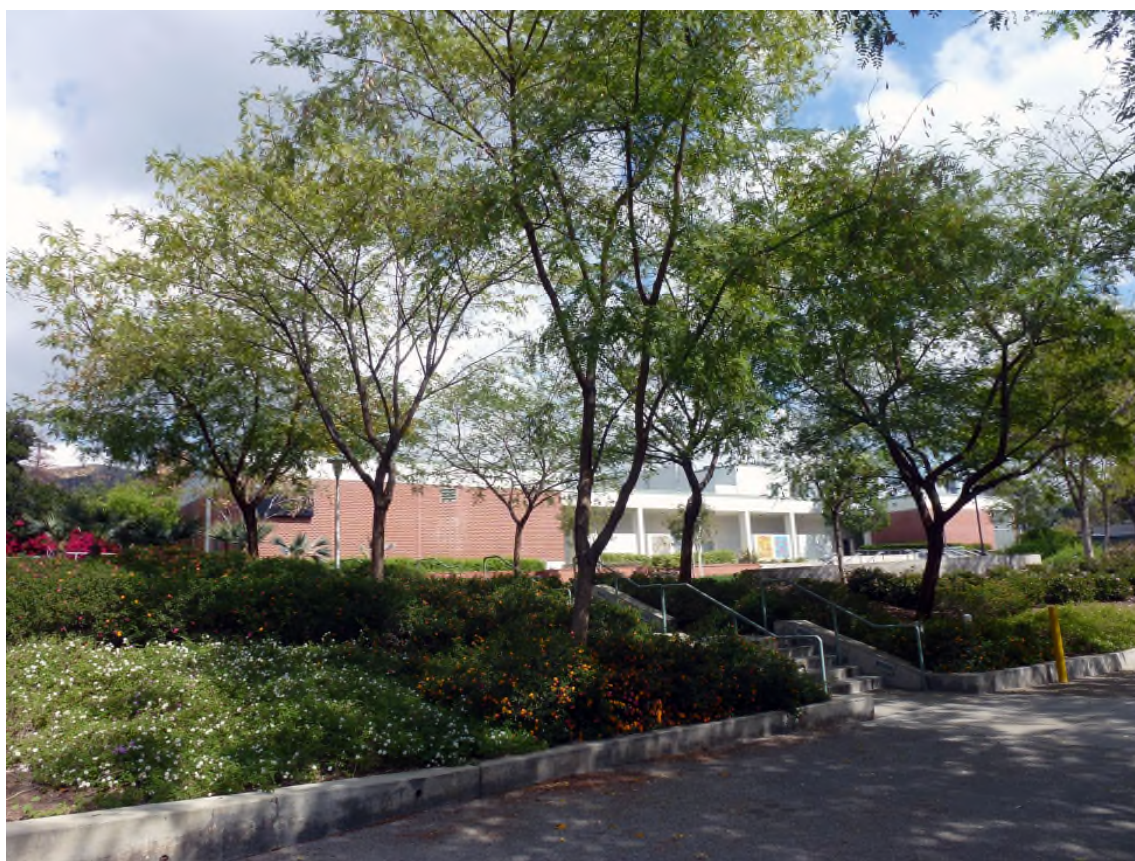
Figure 12. View of the south façade of Building 1A.

Building 1A, the Art Center, was constructed in 1972 (Figure 12). The Modern single-story building has a rectangular floor plan and concrete foundation. The educational building has brick and poured concrete siding and a flat roof. The windows are primarily fixed steel and are located on the north façade. Concrete steps with metal railings lead to the primary entrance on the south façade that consists of a partial-width arcade with rectangular concrete columns. At the center of the walkway within the arcade is a large glass display case flanked by walls of built-in lockers. In between the columns of the arcade are large concrete bulkheads adorned with geometric mosaics facing south; the north sides of the bulkheads have built-in lockers. Within the arcade are five entrances consisting of flush metal doors, some with partial glazing.

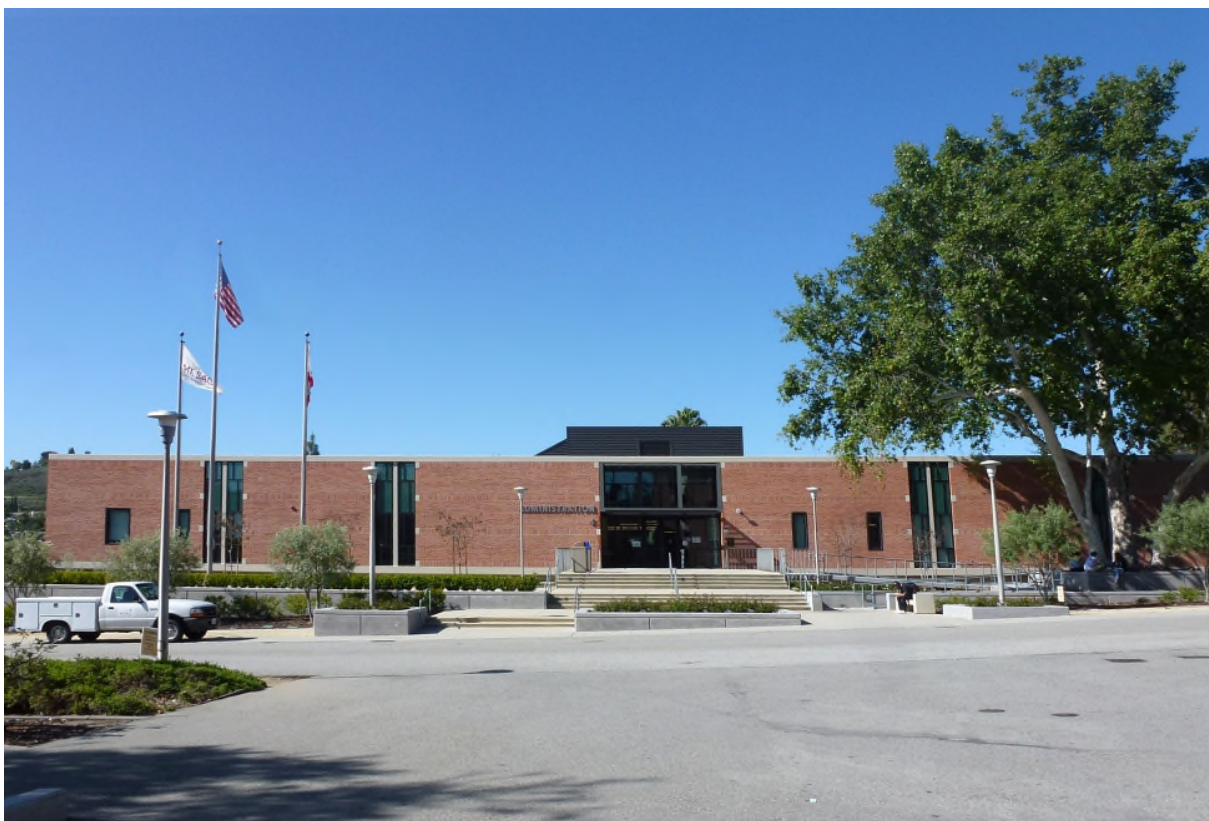
Figure 13. View of the primary (west) façade of Building 4.

Building 4, the Administration building, was constructed in 1965 in the Modern style (Figure 13). It is a two-story building located on the northeast of Temple and Grand avenues on the southwest side of the Mt. SAC campus. The administration building has a rectangular footprint with a concrete foundation. The upper portion of the building's exterior is clad in brick with scored concrete siding on the lower portion of the building. The brick is laid in three sections of running bond with a single sailor course in between each section. The concrete on the lower portion of the building is scored in a grid pattern. The roof is flat and has a poured concrete parapet cap. There is a penthouse on the roof that houses mechanical equipment. The primary entrance is located on the east façade and consists of a centrally-located recessed aluminum and glass entryway with a steel canopy over the double doors that have steel beams and screens to shade the entrance. The recessed entrance has been framed-in with steel posts and beams and accommodates lighting fixtures at the ceiling of the entryway. A secondary entrance is located on the north façade where a non-original steel canopy has also been installed. The south and west façades also have secondary entrances located within the lower portion of the building that has scored concrete siding. These entrances, like the east and north, consist of aluminum-framed glass entryways.

Building 4 was originally constructed to function as the administration center for registration, admission counseling, and other auxiliary services. The architectural firm Austin, Field, & Fry designed the building and the Steed Brothers Construction Company of Alhambra were the building contractors.

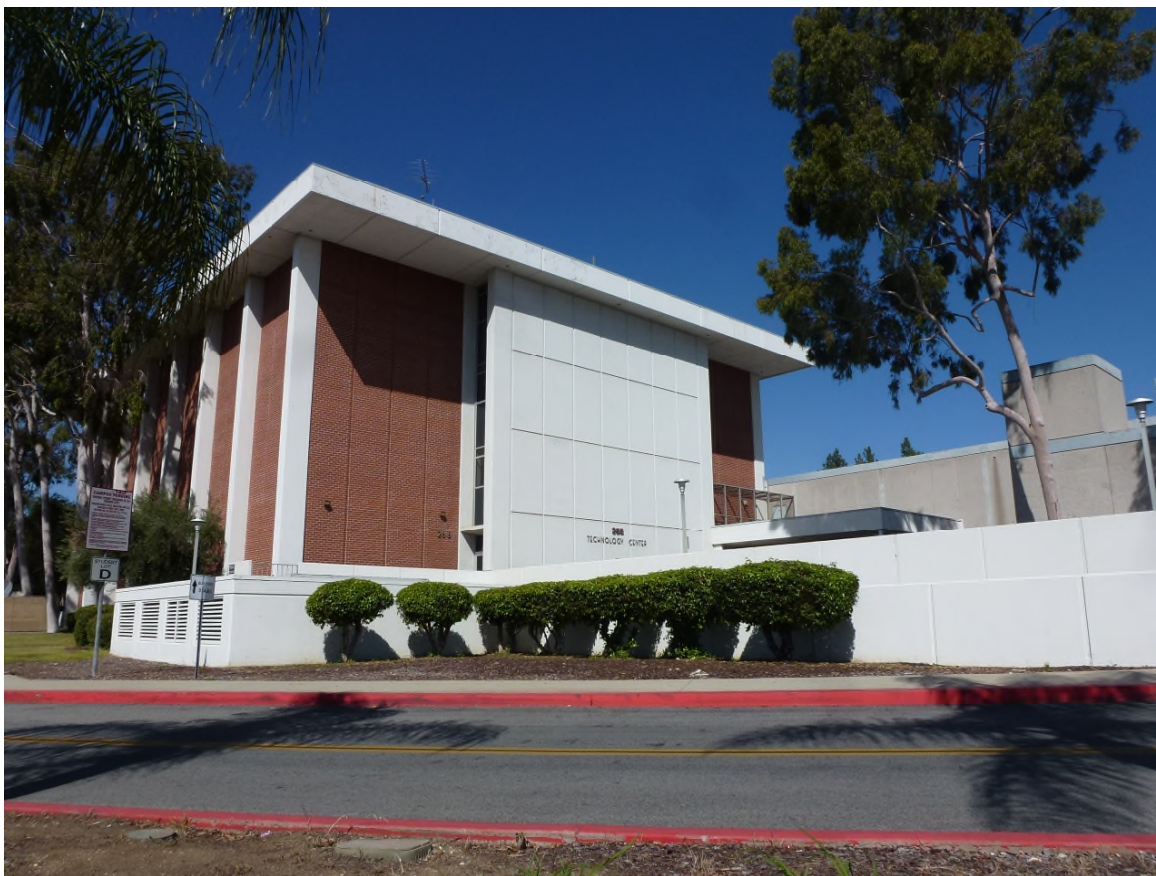
Figure 23. Oblique view of south and east facades of Building 28 A/B.

Buildings 28A and 28B appear to be minimally altered, although some of the corrugated concrete sections toward the northeast appear to have been added later. The buildings retain high integrity in all seven aspects.

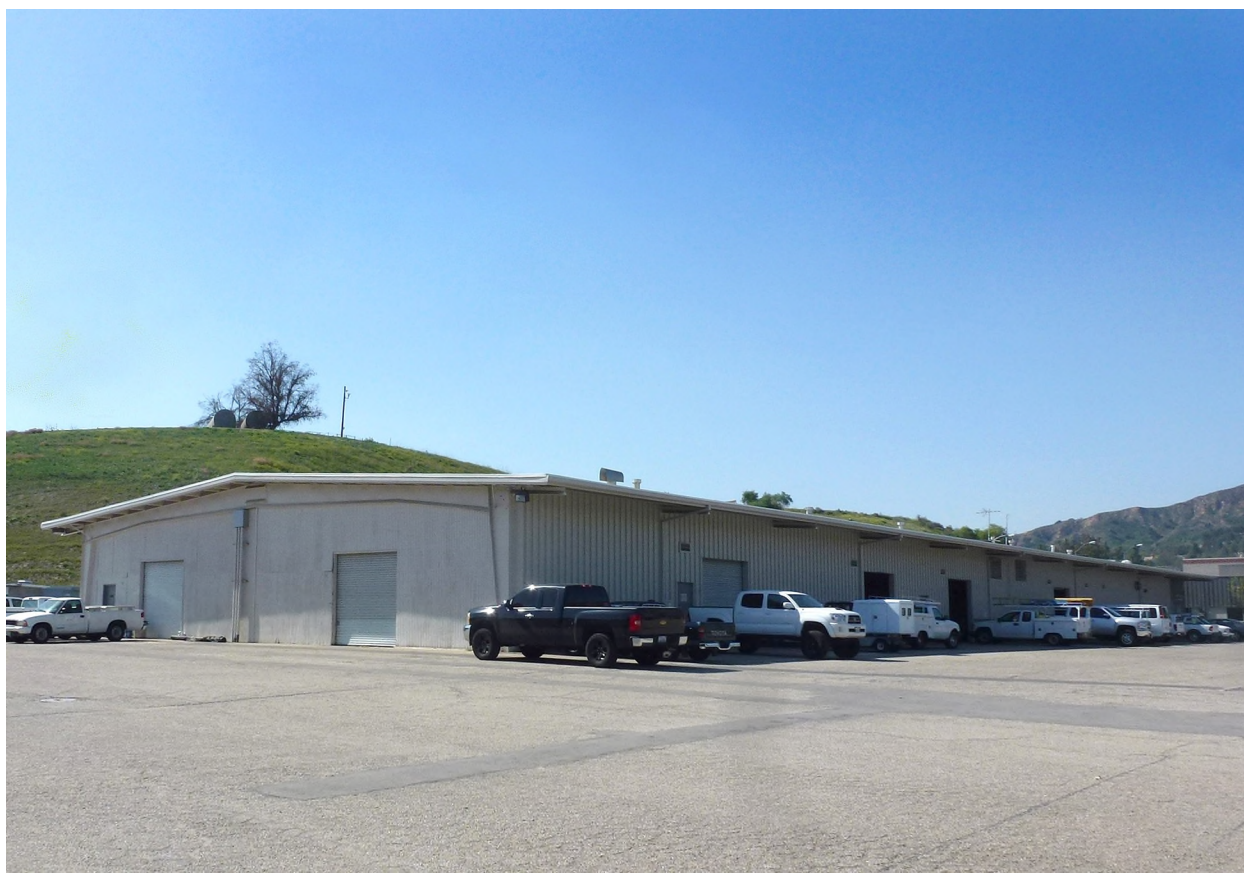
Figure 24. Oblique view toward the west of the northeast and southeast façades of Building 47.

Constructed as the Maintenance and Operations building, it was designed to house five offices and shops for carpenters, electricians, plumbers, general maintenance, painters, and gardeners. It was part of a larger complex which included Building 48 to consolidate facilities, maintenance, operations, receiving-distribution, and transportation departments in a single modern complex called the College Service Center. The cost was \$1.1 million, including outdoor storage areas and the construction of Bonita Drive. The complex was designed by Mt. SAC campus architects Austin, Field & Fry as an element of the college master plan, with Hartman Construction Company of San Bernardino as contractor. The modern concrete block-and-steel buildings are Type V-N construction. Groundbreaking for the center was August 1967, with completion on August 2, 1968 (Mt. SAC c. 1948).

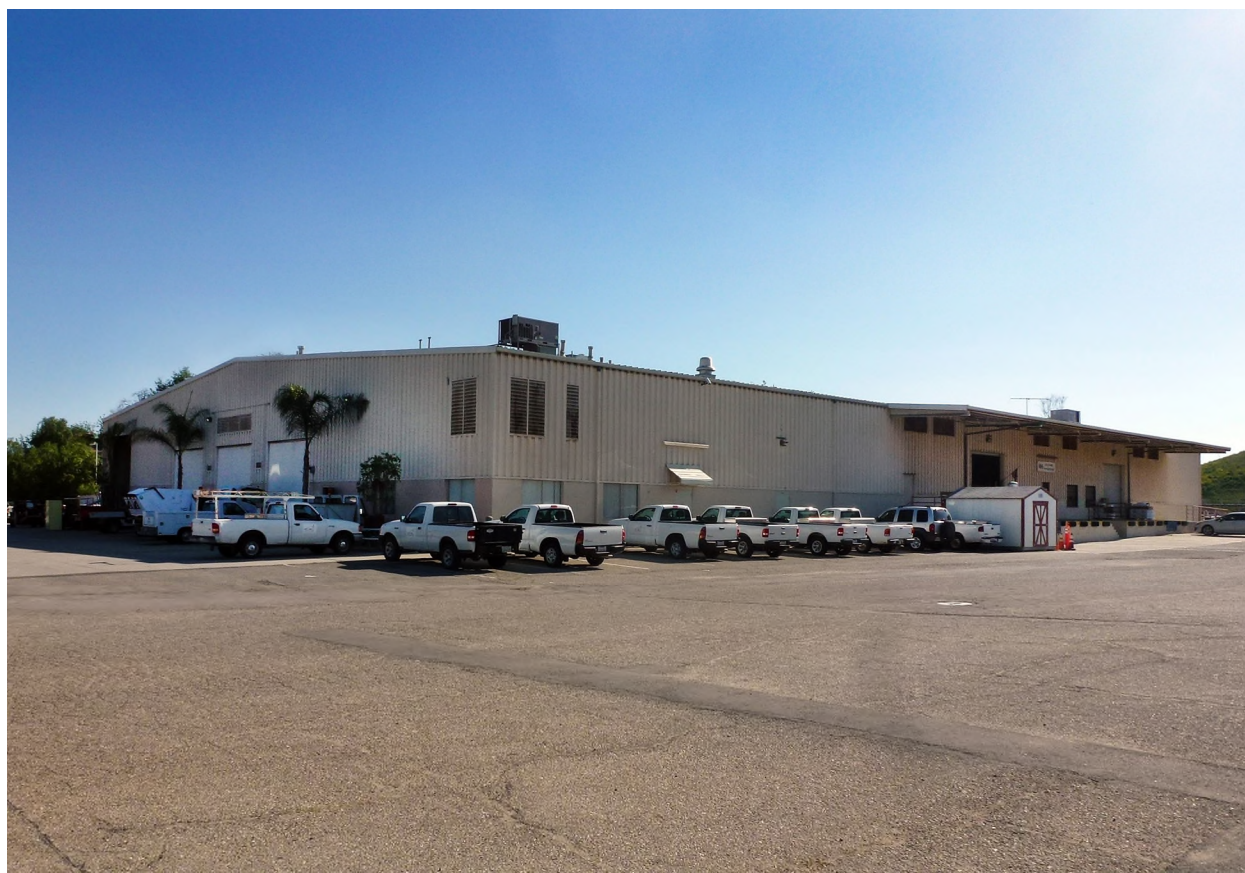
Figure 25. Oblique view toward the south of the northwest and northeast façades of Building 48.

Building 48, the Warehouse and Transportation building, was constructed in 1968 in no particular architectural style (Figure 25). It is a single-story maintenance building located on the southwest side of Temple Avenue and Service Road on the east side of the Mt. SAC campus. The building has a rectangular floor plan with a concrete foundation. The exterior is clad in vertically-oriented steel siding with a concrete block bulkhead. The roof is a low-pitched side gable roof with overhanging eaves and clad in metal. The primary entrance is located on the north façade. The windows are primarily multi-light steel security windows. The building also has metal louvered vents under the roofline and over the roll-top metal garage doors. There is no ornamentation on the building. The interior of the building includes bays for equipment and vehicles as well as a large warehouse space with a concrete floor, a tall exposed metal frame ceiling, and metal shelving for storage.

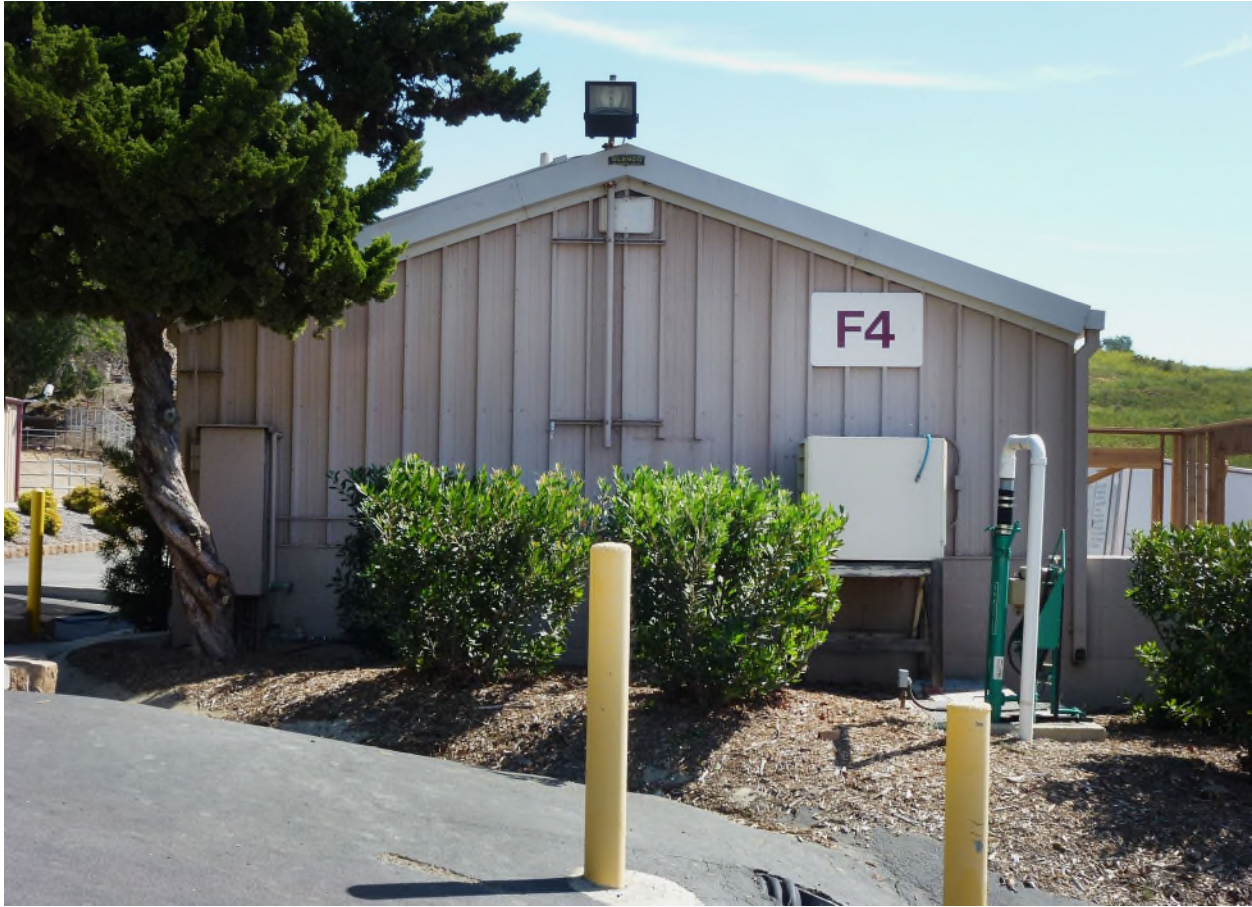
Figure 31. View of the west façade of Building F5.

Building F5, the Vivarium, was constructed in 1971 in no particular architectural style (Figure 31). It is a single-story agricultural building located on the southeast side of Farm Road and Bonita Drive on the east side of the Mt. SAC campus. The building has a rectangular floor plan with a concrete foundation. The exterior is clad in corrugated metal sheet siding. The primary entrance is located on the west façade and consists of a single flush wood door. There is a secondary entrance on the south façade and consists of a single flush wood door next to double partially-vented doors. The east end of the building is open on the south façade. Modifications include replacement siding and possible alterations in fenestration. The building retains integrity of materials, design, workmanship, location, setting, feeling, and association.

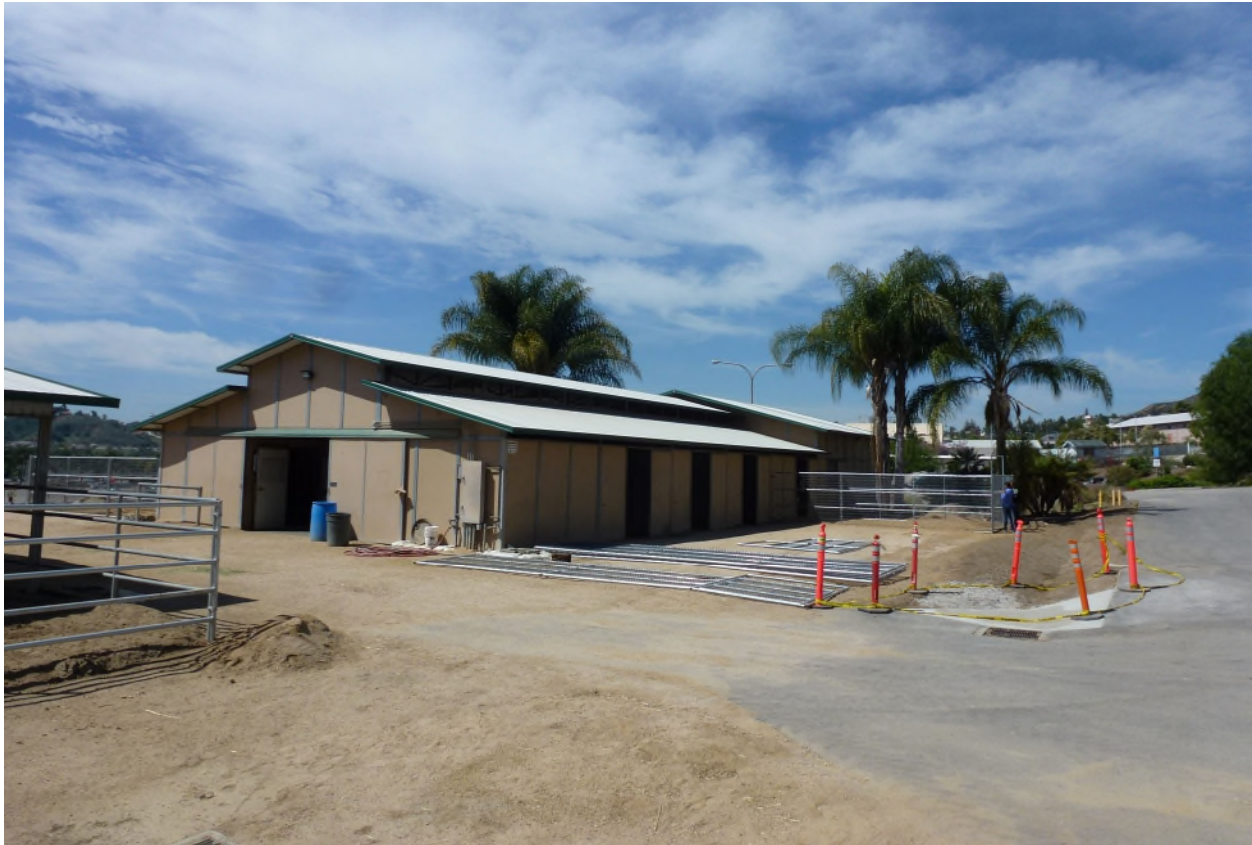
Figure 32. Oblique view of the east and north façades of Building F6A.

Building F6A, the Breeding Barn, was constructed c. 2000 in no specific architectural style (Figure 32). It is a single-story agricultural building located on the southeast side of Farm Road and Bonita Drive on the east side of the Mt. SAC campus. The building has a rectangular floor plan with a concrete foundation. The exterior is clad in metal shed siding. The roof is a front gable roof with shed roof extensions that are clad in standing seam metal sheets. The primary entrance is located on the east façade and consists of a top-hinged sliding metal door. A row of metal-framed windows line the south and north façades that sit underneath the overhanging eaves of the front gable roof. There are secondary entrances on the north and south façades and a corral on the south end of the building. The interior is made of metal-framed horse stalls with a concrete tile floor.
