PHASE I ENVIRONMENTAL SITE ASSESSMENT FOR

KAISEP FOUNDLTION HEALTH PLAN. INC. Moreno Valley Community Hospital 27300 Ins Avenus Moreno Valley, California 92536

April 11, 2007 SECOF PM: 370T.20930.00

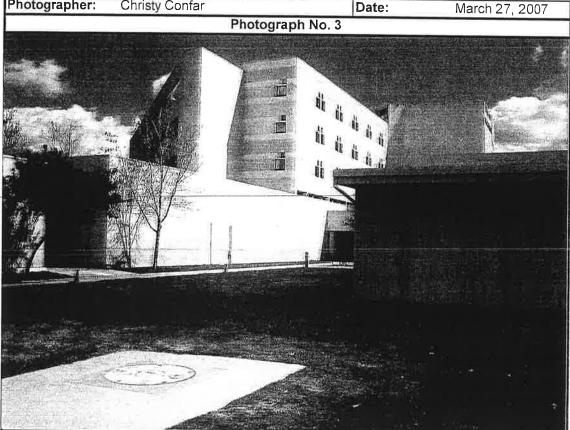
Modular Records building (right), main building (background), and UST area (foreground).

Access ports associated with a 12,000-gallon diesel UST were observed during the Site reconnaissance (Appendix A — Photographs 3 and 5). The UST was located outside the Modular Records Building on the west-central portion of the Site in a grassy landscaped area. Mr. Williamson indicated the subsurface piping for the UST extended to the east toward the

hospital building, and then directed north toward the generator room. No visual, olfactory, or other signs of releases from the UST were observed at the ground surface during the reconnaissance.

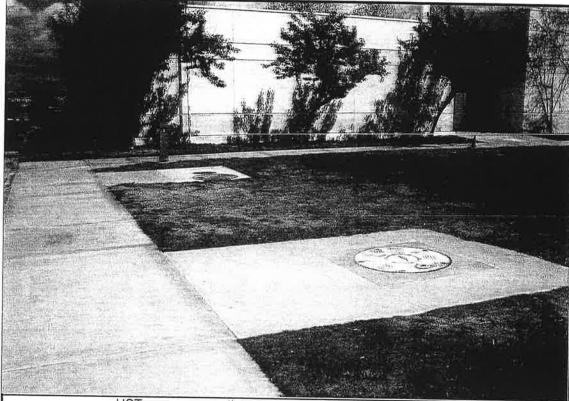
SECOR INTERNATIONAL INCORPORATED PHOTOGRAPHIC RECORD Client: Kaiser Foundation Health Plan, Inc. Job Number: 37OT.20930.00 Subject Name: Location: 27300 Iris Avenue Moreno Valley Community Hospital Moreno Valley, CA 92586 Photographer: Christy Confar Date: March 27, 2007 Photograph No. 5

UST area near southwest corner of main hospital building.

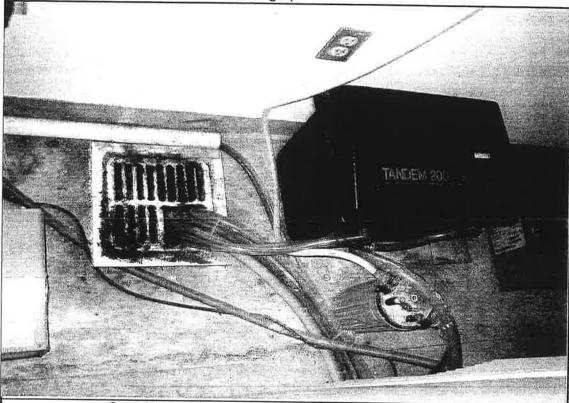
One of the two floor drains receiving photo machine effluent.

- Two photo processing machines are currently located on the Site in the first floor of the main building. The machines have been in use since hospital construction, and include photo fixer and developer processes. Both machines discharge effluent through a silver recovery unit, to floor drains, which then discharge to the sanitary sewer. Both drains were replaced 6 years ago when an underground pipe sleeve apparently broke, causing sediment to back up into both drains. Riverside County records indicate that on-site treatment of silver-bearing photo processing hazardous waste historically occurred on the Site. Based on the reported pipe damage, there is a potential for silver-bearing photo process effluent to have impacted subsurface soils beneath the first floor of the hospital building. Therefore, the presence of the two photo processing machines with direct discharge to subsurface piping is considered to be a REC. It is recommended that soil samples be collected from soil beneath the two photo processing machines to evaluate the potential for elevated concentrations of silver in subsurface soils.

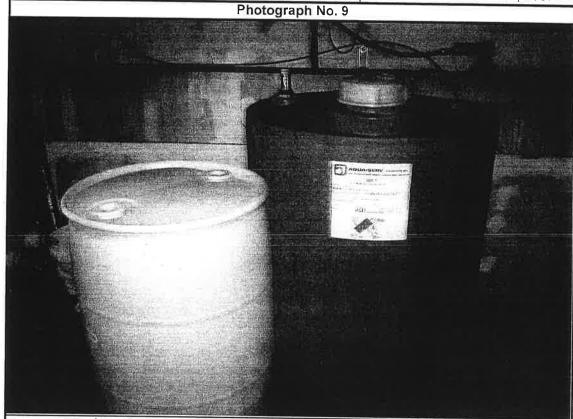
Aqua Serve water treatment chemical containers in the boiler room.

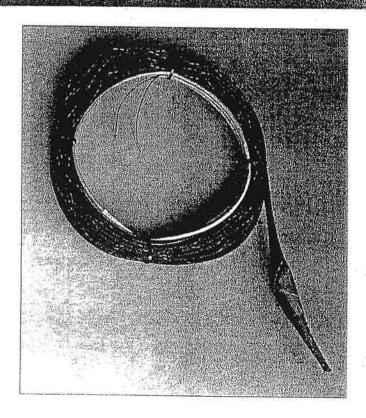
- Positive alarm indication of any liquid in double-wall fiberglass tanks.
- System indicators pinpoint alarm location.
- ► Simple to install.
- ► Two-wire connection to system monitor.
- Fast action helps prevent serious safety and environmental problems.

The Veeder-Root Interstitial Sensor for use in Fiber-glass Tanks detects the presence of liquid in the interstitial space of a double-wall fiberglass tank. Liquid in the annulus could mean a dangerous leak. When liquid is detected, the sensor sends an alarm signal to a TLS-350R, TLS-350, ILS-350, TLS-300i, TLS-300C, TLS-250i or ILS-250 monitor. The monitor's visual and audible built-in alarm indicators immediately tell you where the problem is, so you can quickly take action to help prevent serious safety and environmental problems.

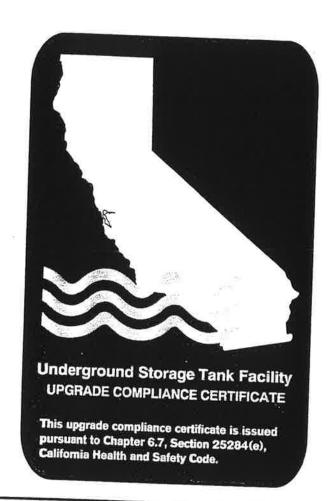
3		the second of th
	_	Diesel tank
99	7	Engineering Department
	3	Emergency Generator
	4	Building (Hospital)
	S	Tank Fill
	9	Pipe Sump
	7	Annular sensor
		landing
		Repair of one fill manhole
	V	Approved by:

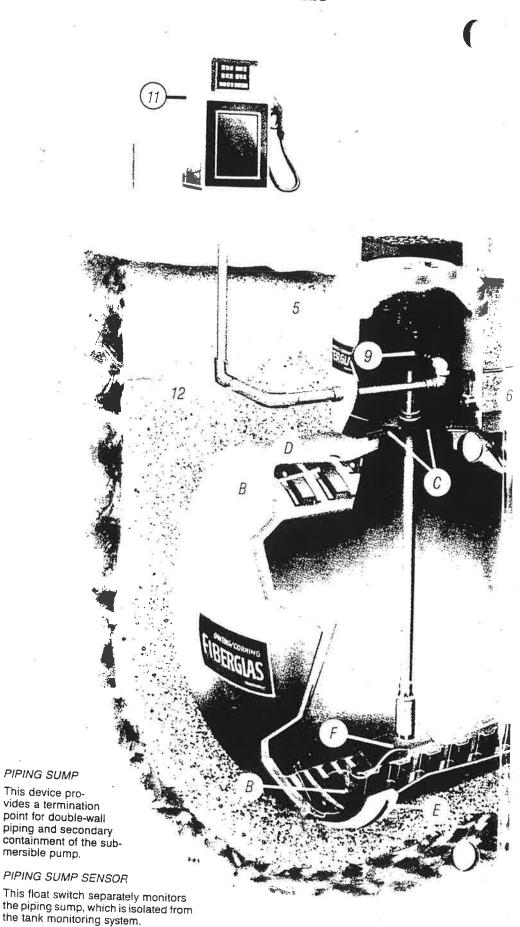
Typical double-wall tank installation with double-wall piping on the product lines, tank overfill prevention, overspill containment, and independent tank and pipe monitoring.
