***Appendix B***  
***Biological Survey Reports***

## **Biological Constraints Study**

Reference: Biological Constraints Study for the Reconfigure TL 674A at Del Mar and Remove from Service TL 666D Project (RECON Number 7203-1)

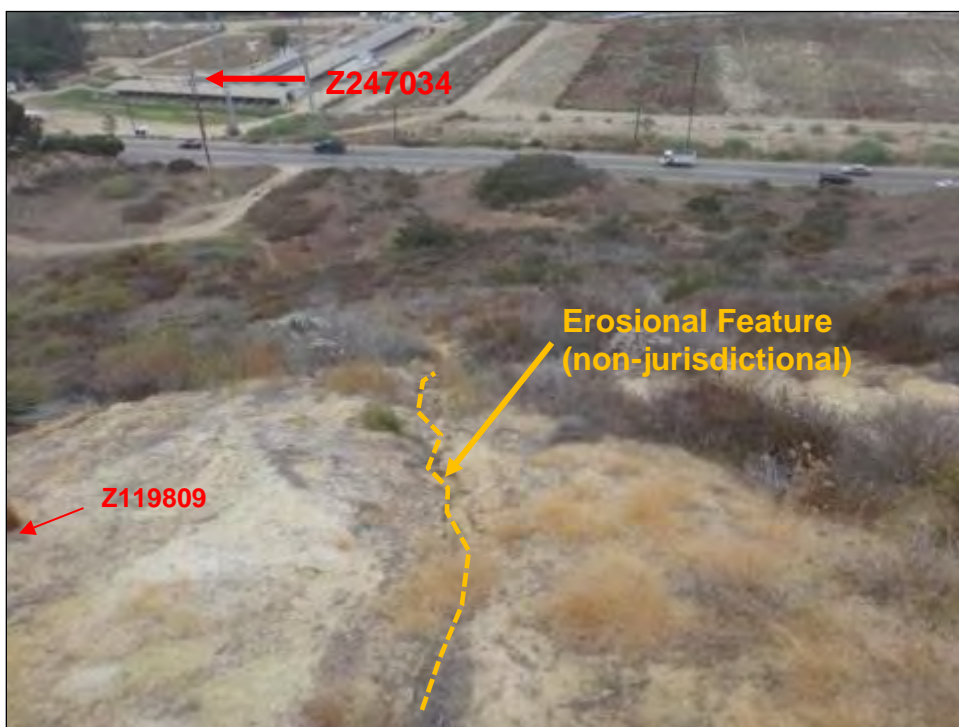
PHOTOGRAPHS (sheet 1 of 18)

PHOTOGRAPH 1: Hydrologic Feature 1: Non-jurisdictional erosional feature near Z119809, facing south.

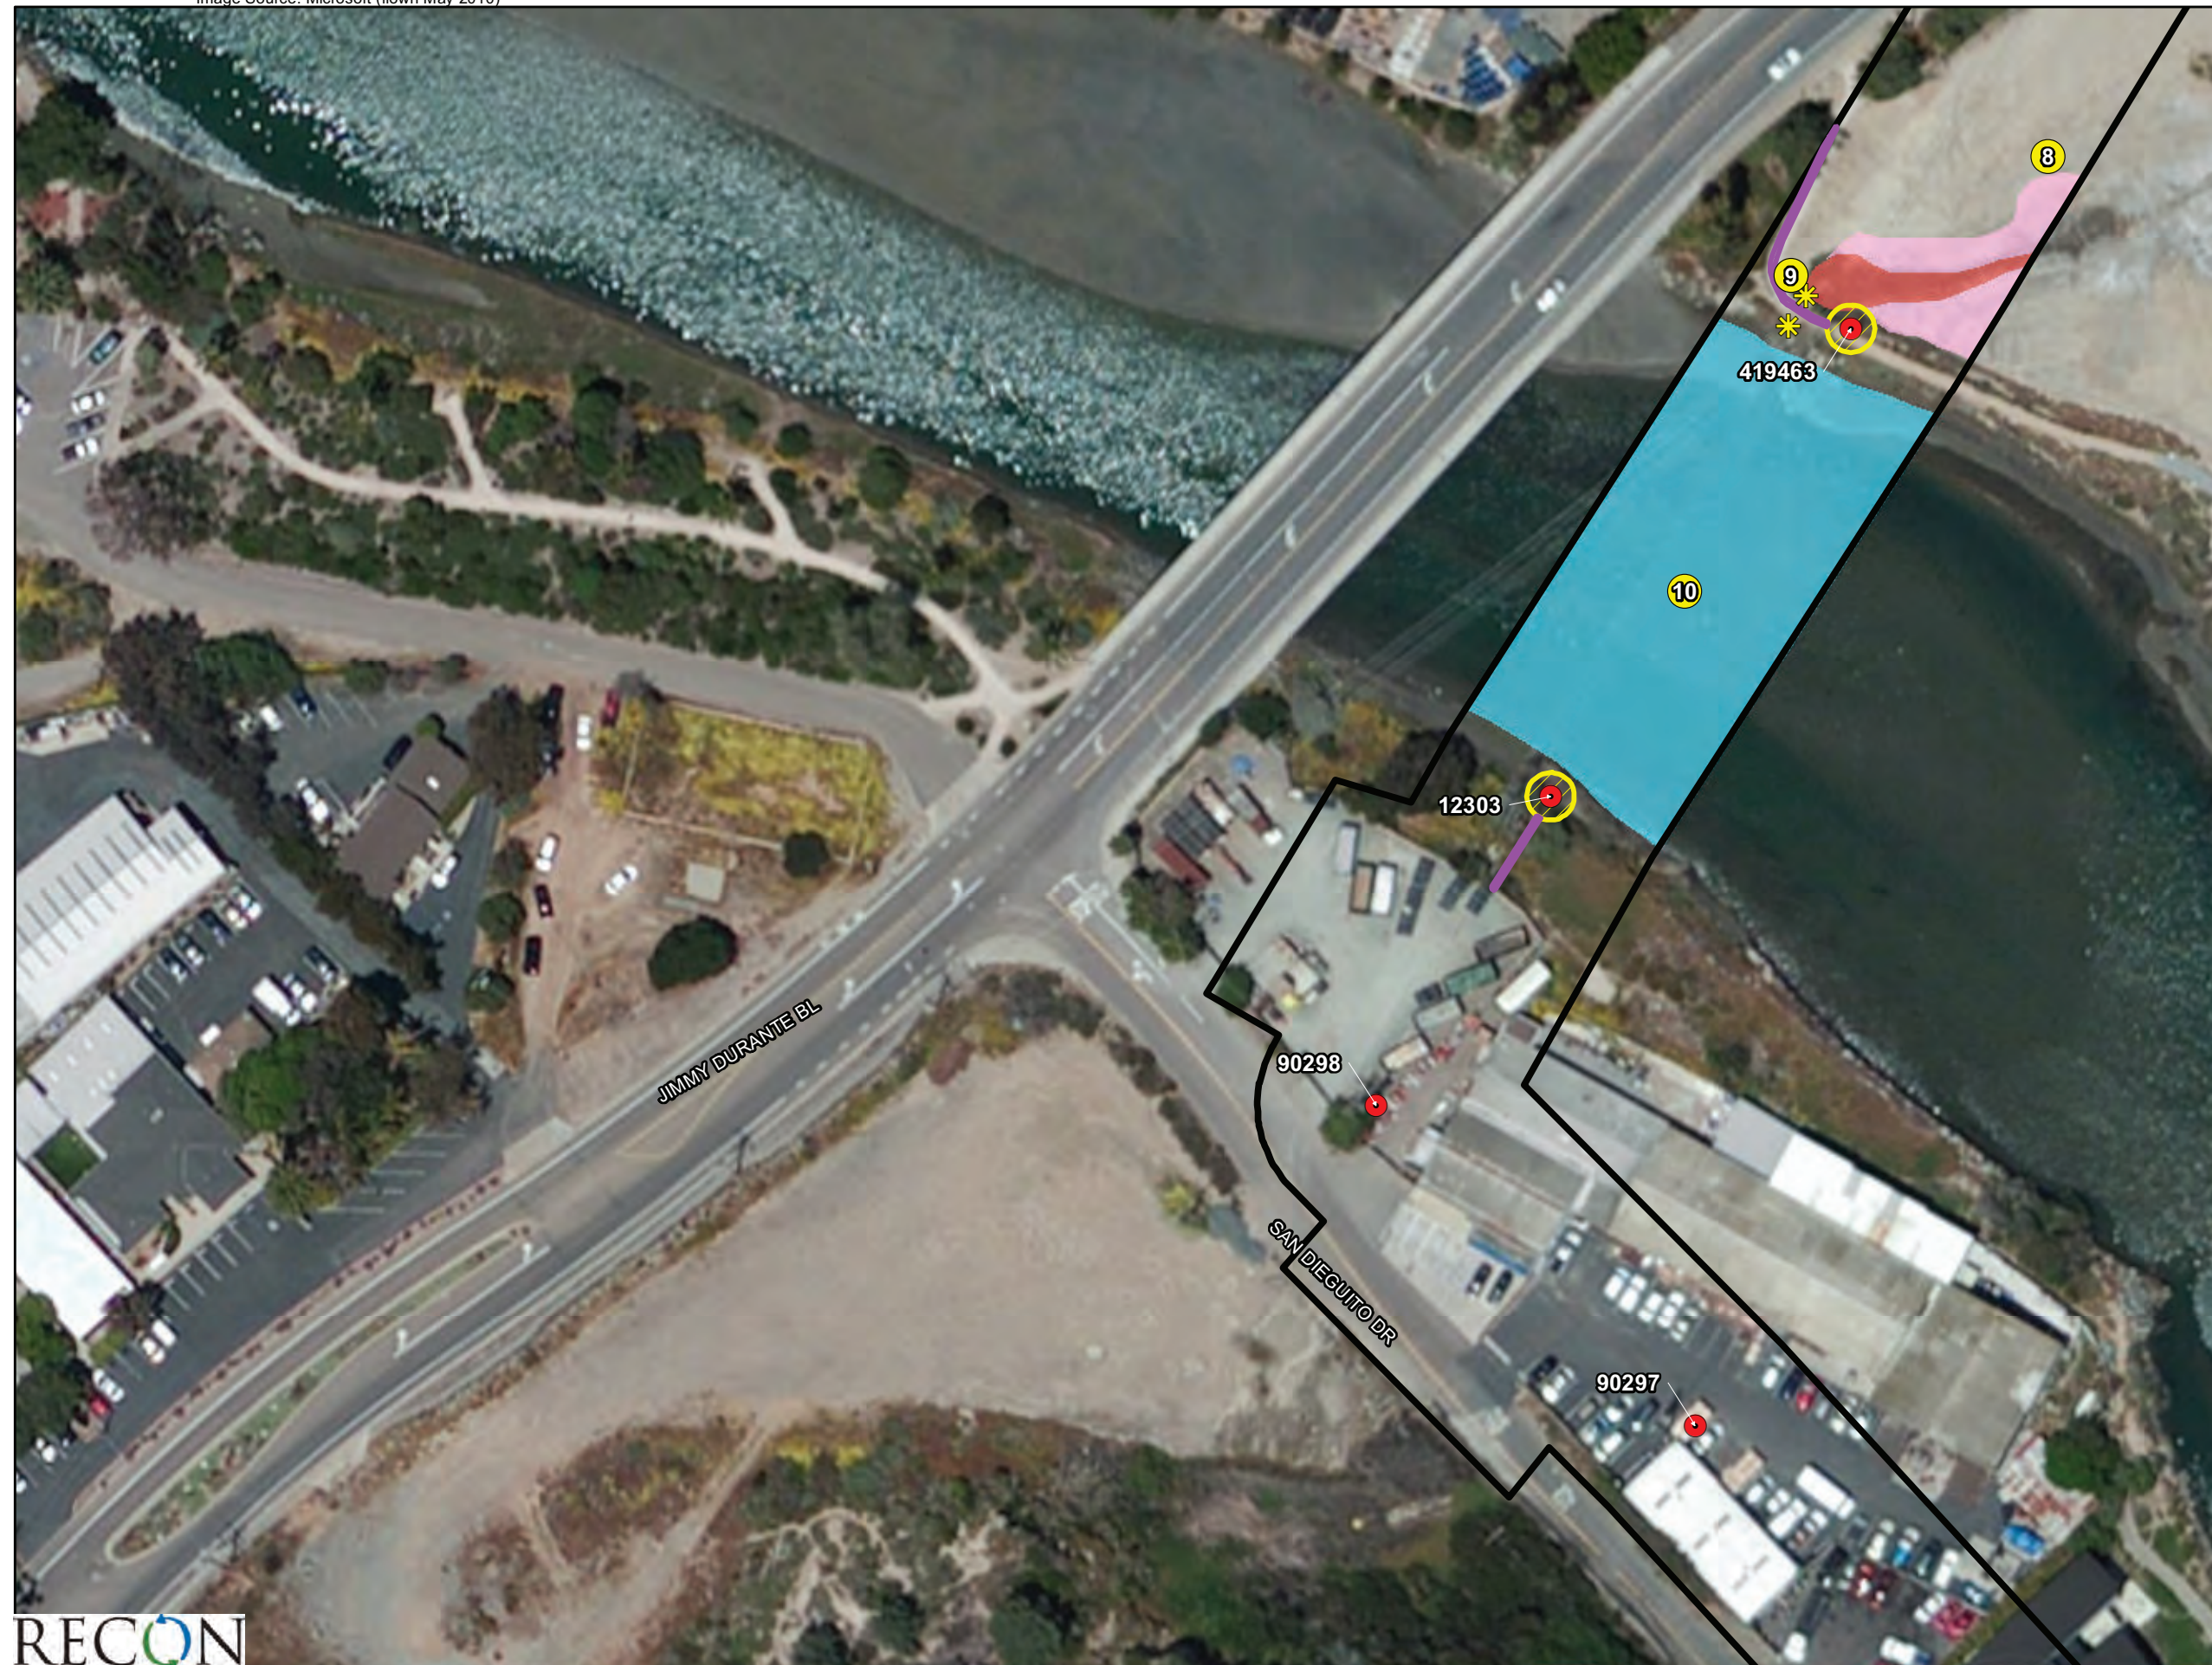
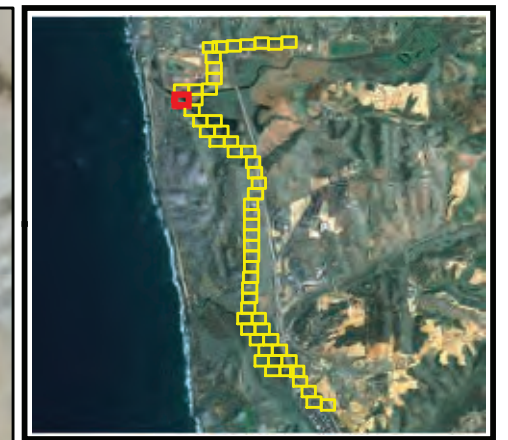
FIGURE 1-14  
Jurisdictional  
Resources on TL666

**Feature 8** is a jurisdictional salt panne associated with a restoration area north of Z419463 (Photographs 8 and 9, Figure 1-14). Extensive salt crusts were observed throughout a topographical depression connected to the Pacific Ocean via tidal water movement through a culvert to the south. As this feature is below the high tide line, it is likely considered an ACOE non-wetland water of the U.S., RWQCB water of the state, and CCC wetland. Construction activities may potentially impact this feature. Pole removal impact avoidance and minimization measures are recommended (Table 1).

**Feature 9** consists of coastal salt marsh dominated by pickleweed (*Salicornia pacifica* — Obligate [OBL]) (Photographs 8 and 9, Figure 1-14). Feature 9 is three feet east and downslope of Z419463. Z419463 is located on an upland berm which crosses over the top of a culvert which connects the feature to the Pacific Ocean via tides. This feature is likely considered an ACOE wetland water of the U.S., CDFW wetland, RWQCB water of the state, and a CCC wetland. Construction activities may potentially impact this feature. Pole removal impact avoidance and minimization measures are recommended (Table 1).

**Feature 10** is open water within the San Dieguito River channel (Photographs 10 through 17, Figure 1-14). This feature drains into a culvert beneath Via de la Valle and is likely considered an ACOE non-wetland water of the U.S., CDFW streambed, RWQCB water of the state, and CCC wetland. As this feature is outside any proposed project activities, no impacts are anticipated.

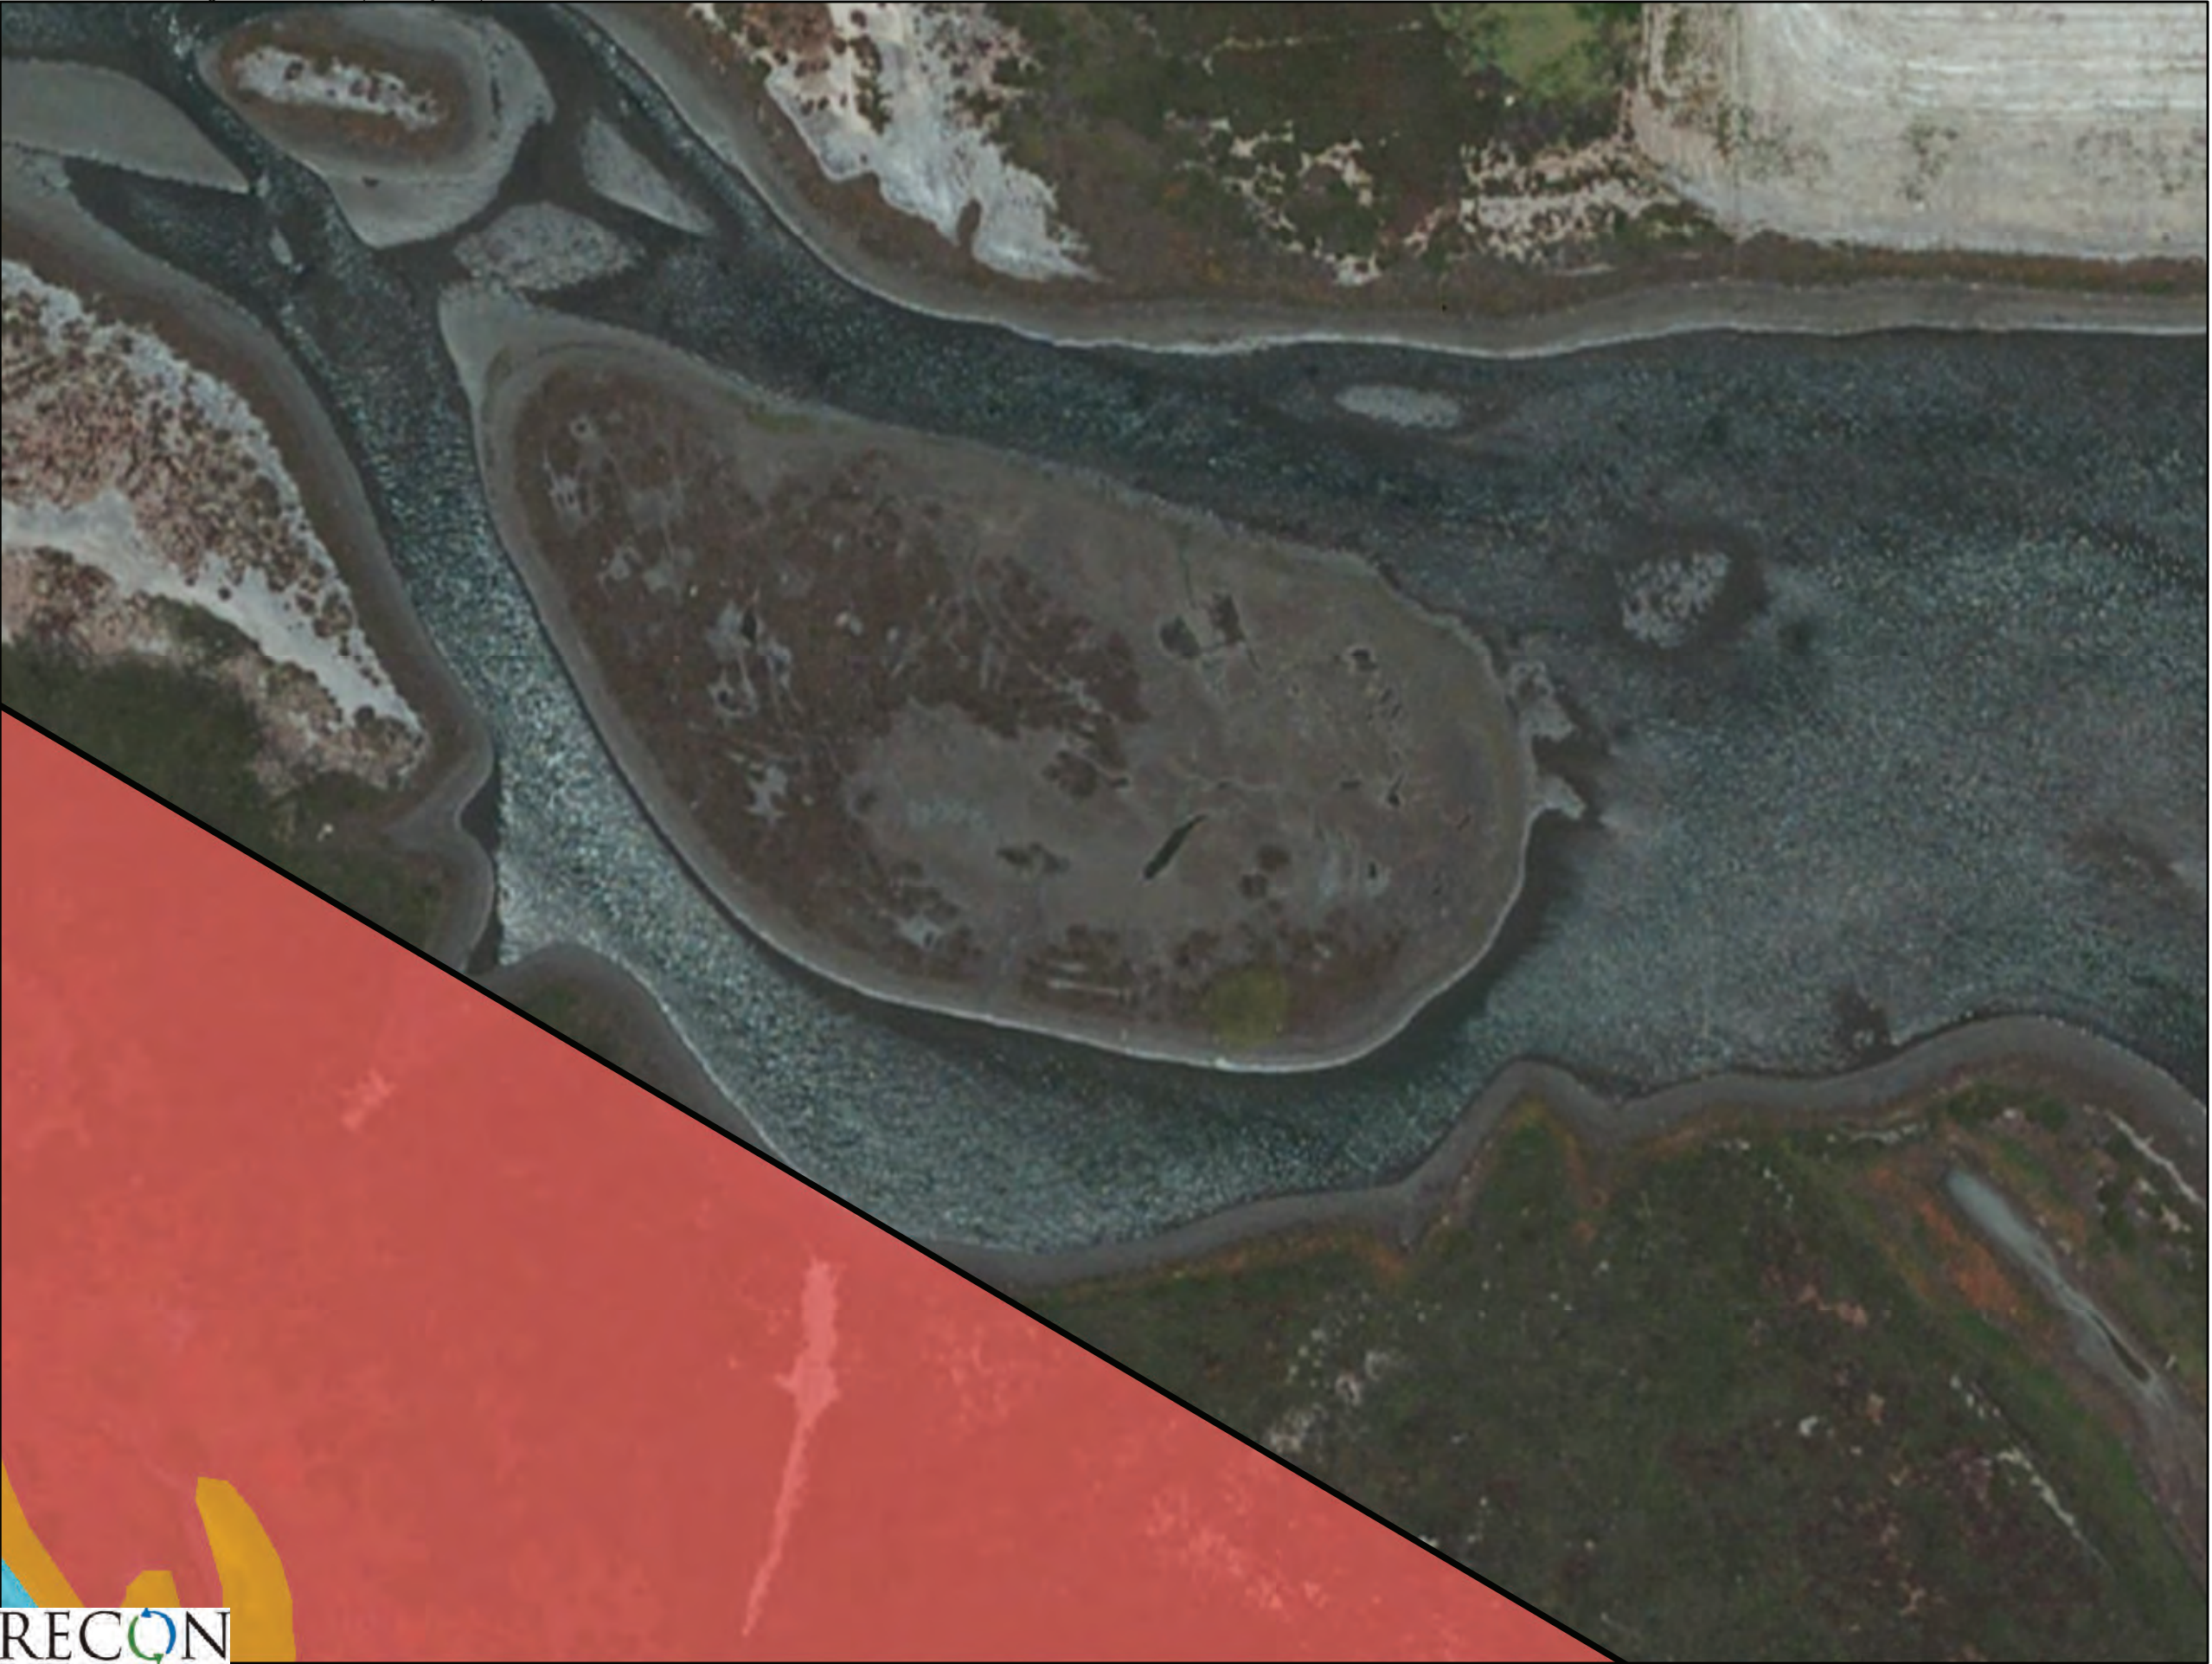
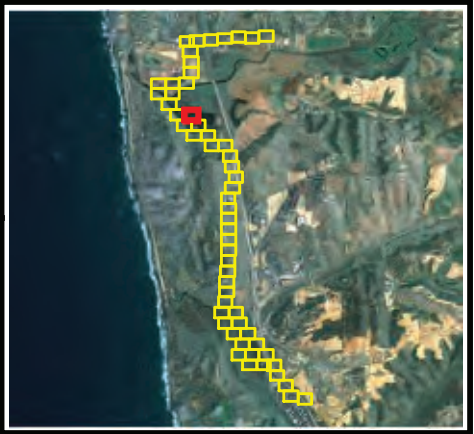
**FIGURE 1-17**  
Jurisdictional  
Resources on TL666

Utility poles Z90294, Z90293, and Z90292 are located within salt marsh vegetation (Figure 1-17, Photographs 15, and 16). Pedestrian access overland through jurisdictional wetlands is available via San

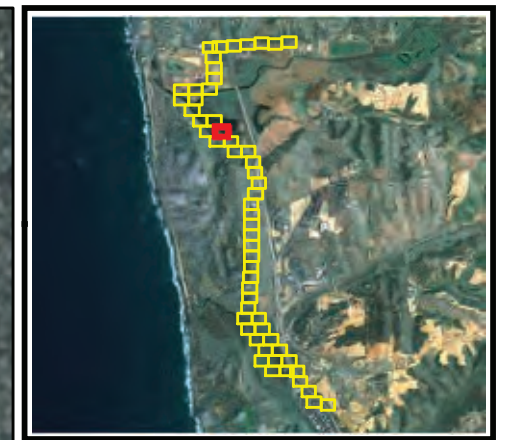
Jurisdictional Resources on TL666

Utility pole Z90291 is surrounded by jurisdictional salt marsh vegetation and is located on a small island in the estuary (Photograph 17, Figure 1-19). As the island is separated from the mainland by an approximately 70-foot-wide tidal inlet, direct pedestrian access is not available. Pole removal impact avoidance and minimization measures are recommended (Table 1).

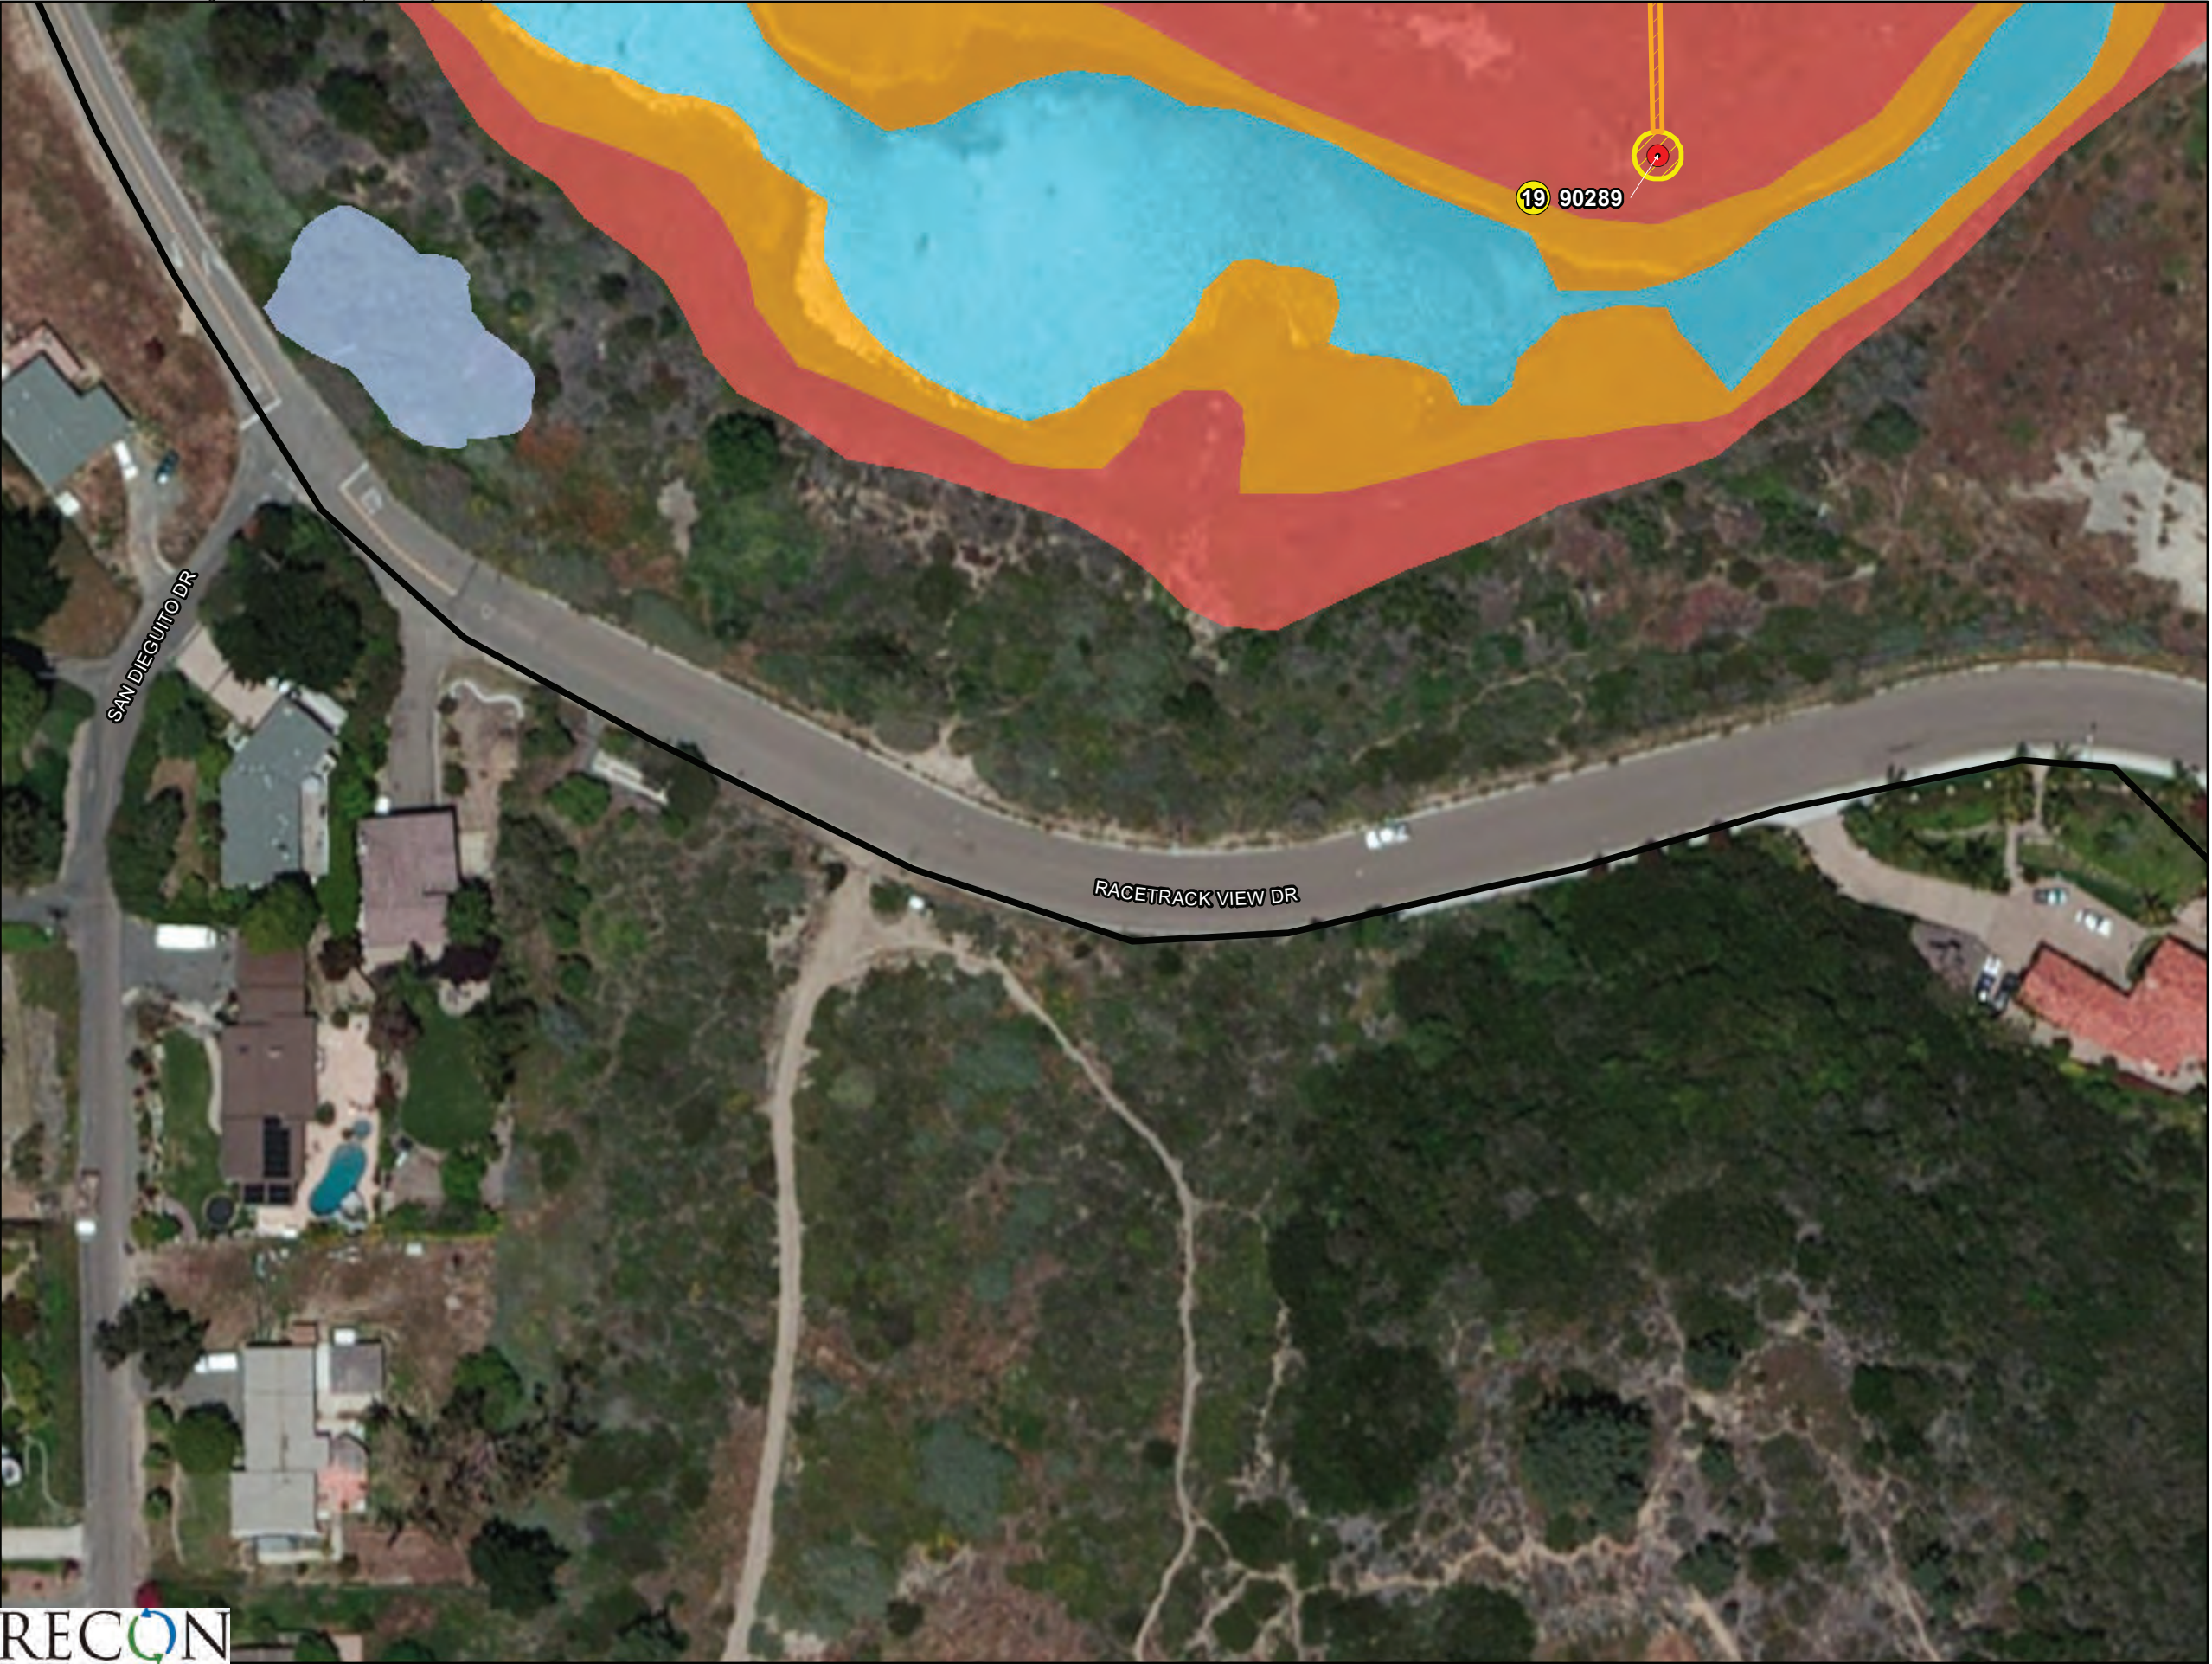
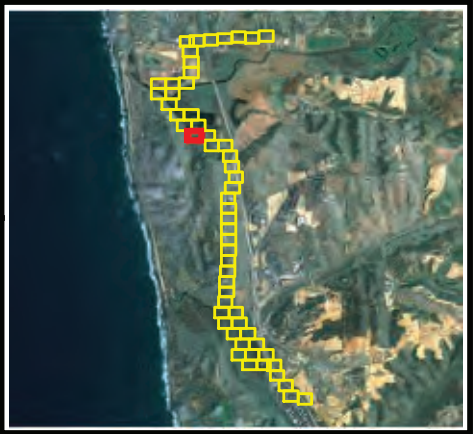
FIGURE 1-20  
Jurisdictional  
Resources on TL666

Utility poles Z90290 and Z90289 are located within the jurisdictional salt marsh fringe of a small island within the estuary (Photographs 18 and 20, Figures 1-20 and 1-21). As the island is separated from the mainland by an approximately 100-foot-wide tidal inlet, direct pedestrian access is not available. The center of the island is, however, at a relatively high elevation, dominated by non-native upland vegetation, is outside of tidal influence, and may make an appropriate non-jurisdictional landing zone for any potential helicopter use. Pole removal impact avoidance and minimization measures are recommended (Table 1).

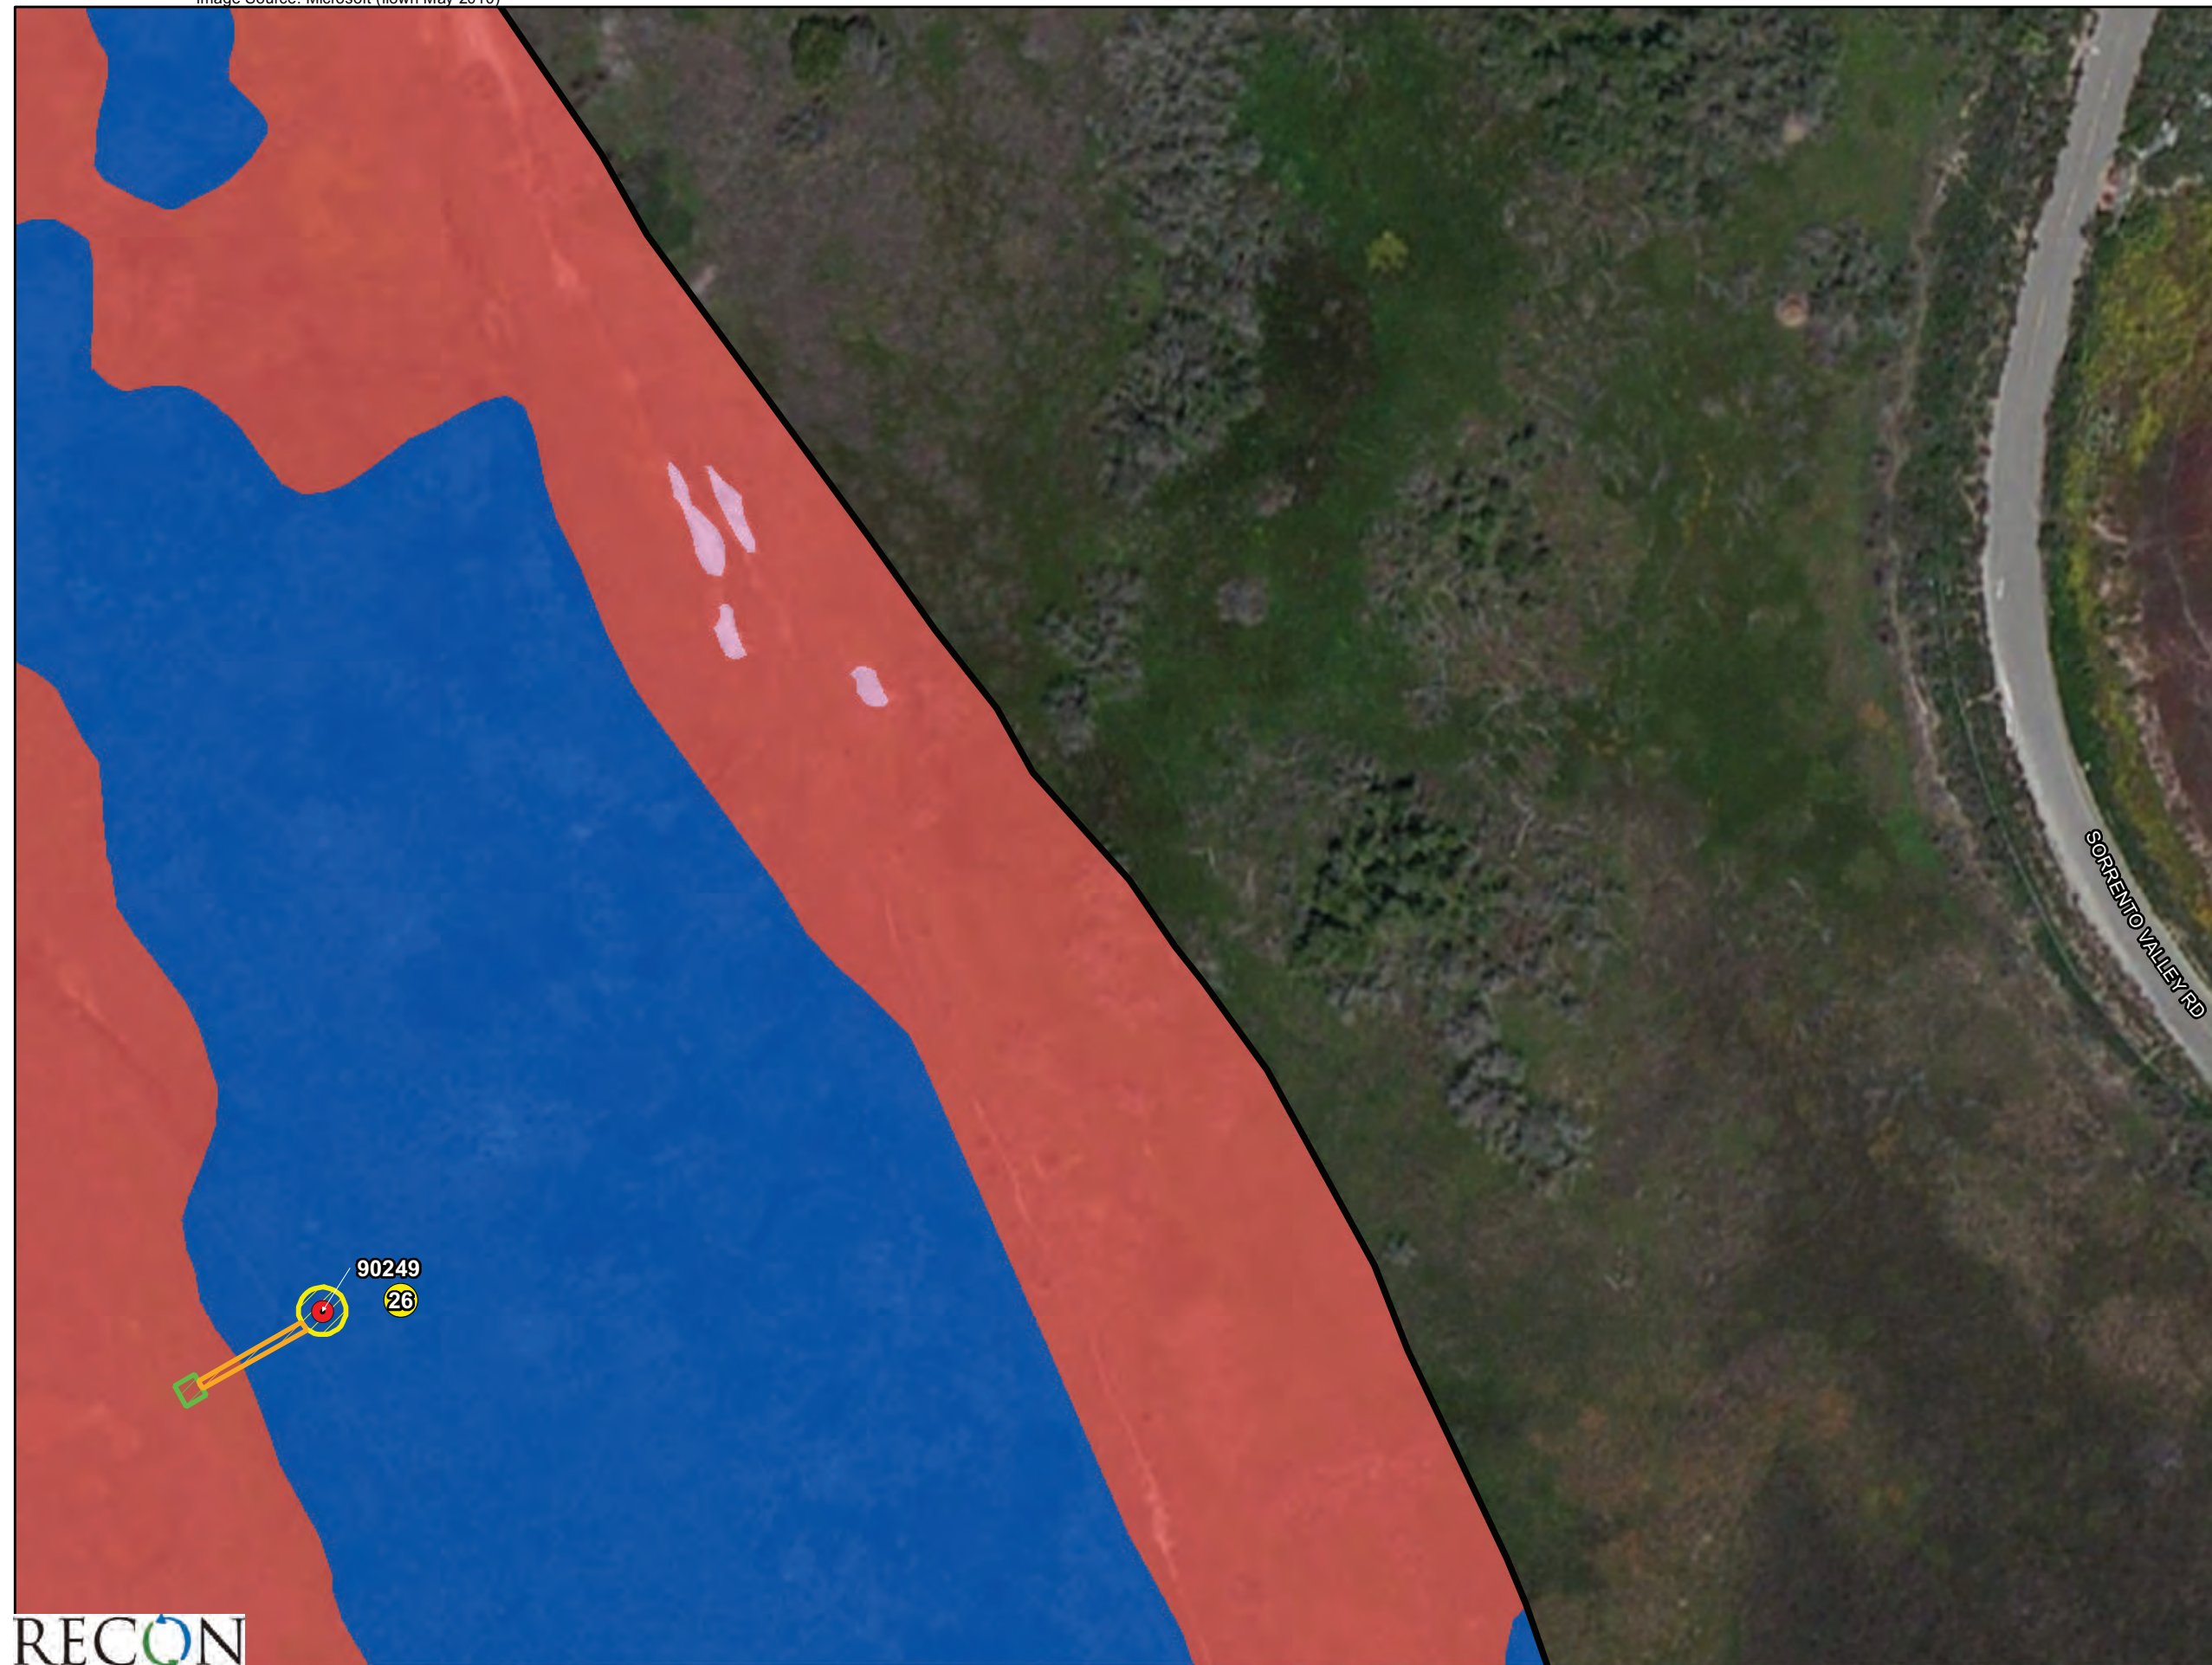
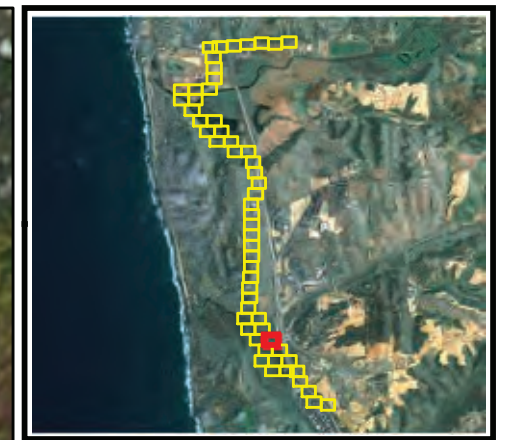
**FIGURE 1-44**  
Jurisdictional  
Resources on TL666

Utility pole Z90250 is located adjacent to a salt panne within freshwater emergent marsh vegetation (Photograph 25, Figure 1-44). Access to this pole is available from the south overland through jurisdictional salt marsh vegetation. A total 25 feet of 8-foot-tall jurisdictional emergent marsh vegetation will need to be walked through in order to access the pole. Temporary impacts to jurisdictional vegetation (salt marsh trampling, emergent freshwater marsh access trimming) are anticipated in order to access these poles. Pole removal impact avoidance and minimization measures are recommended (Table 1).

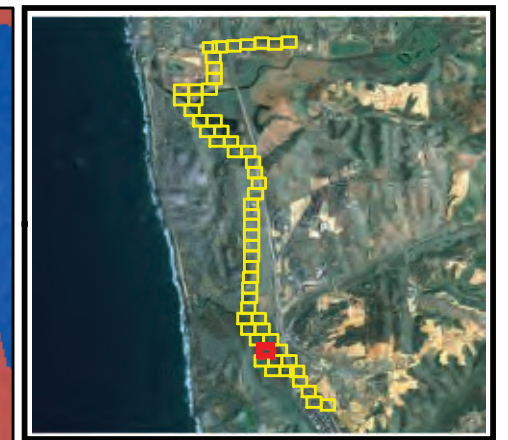
FIGURE 1-45  
Jurisdictional  
Resources on TL666

Utility pole Z90249 is located within freshwater emergent marsh vegetation (Photograph 26, Figure 1-45). Access to this pole is available from the south overland through jurisdictional salt marsh vegetation. Approximately 15 feet of 8-foot-tall jurisdictional emergent marsh vegetation will need to be walked through in order to access the pole. Temporary impacts to jurisdictional vegetation (salt marsh trampling, emergent freshwater marsh access trimming) are anticipated in order to access these poles. Pole removal impact avoidance and minimization measures are recommended (Table 1).

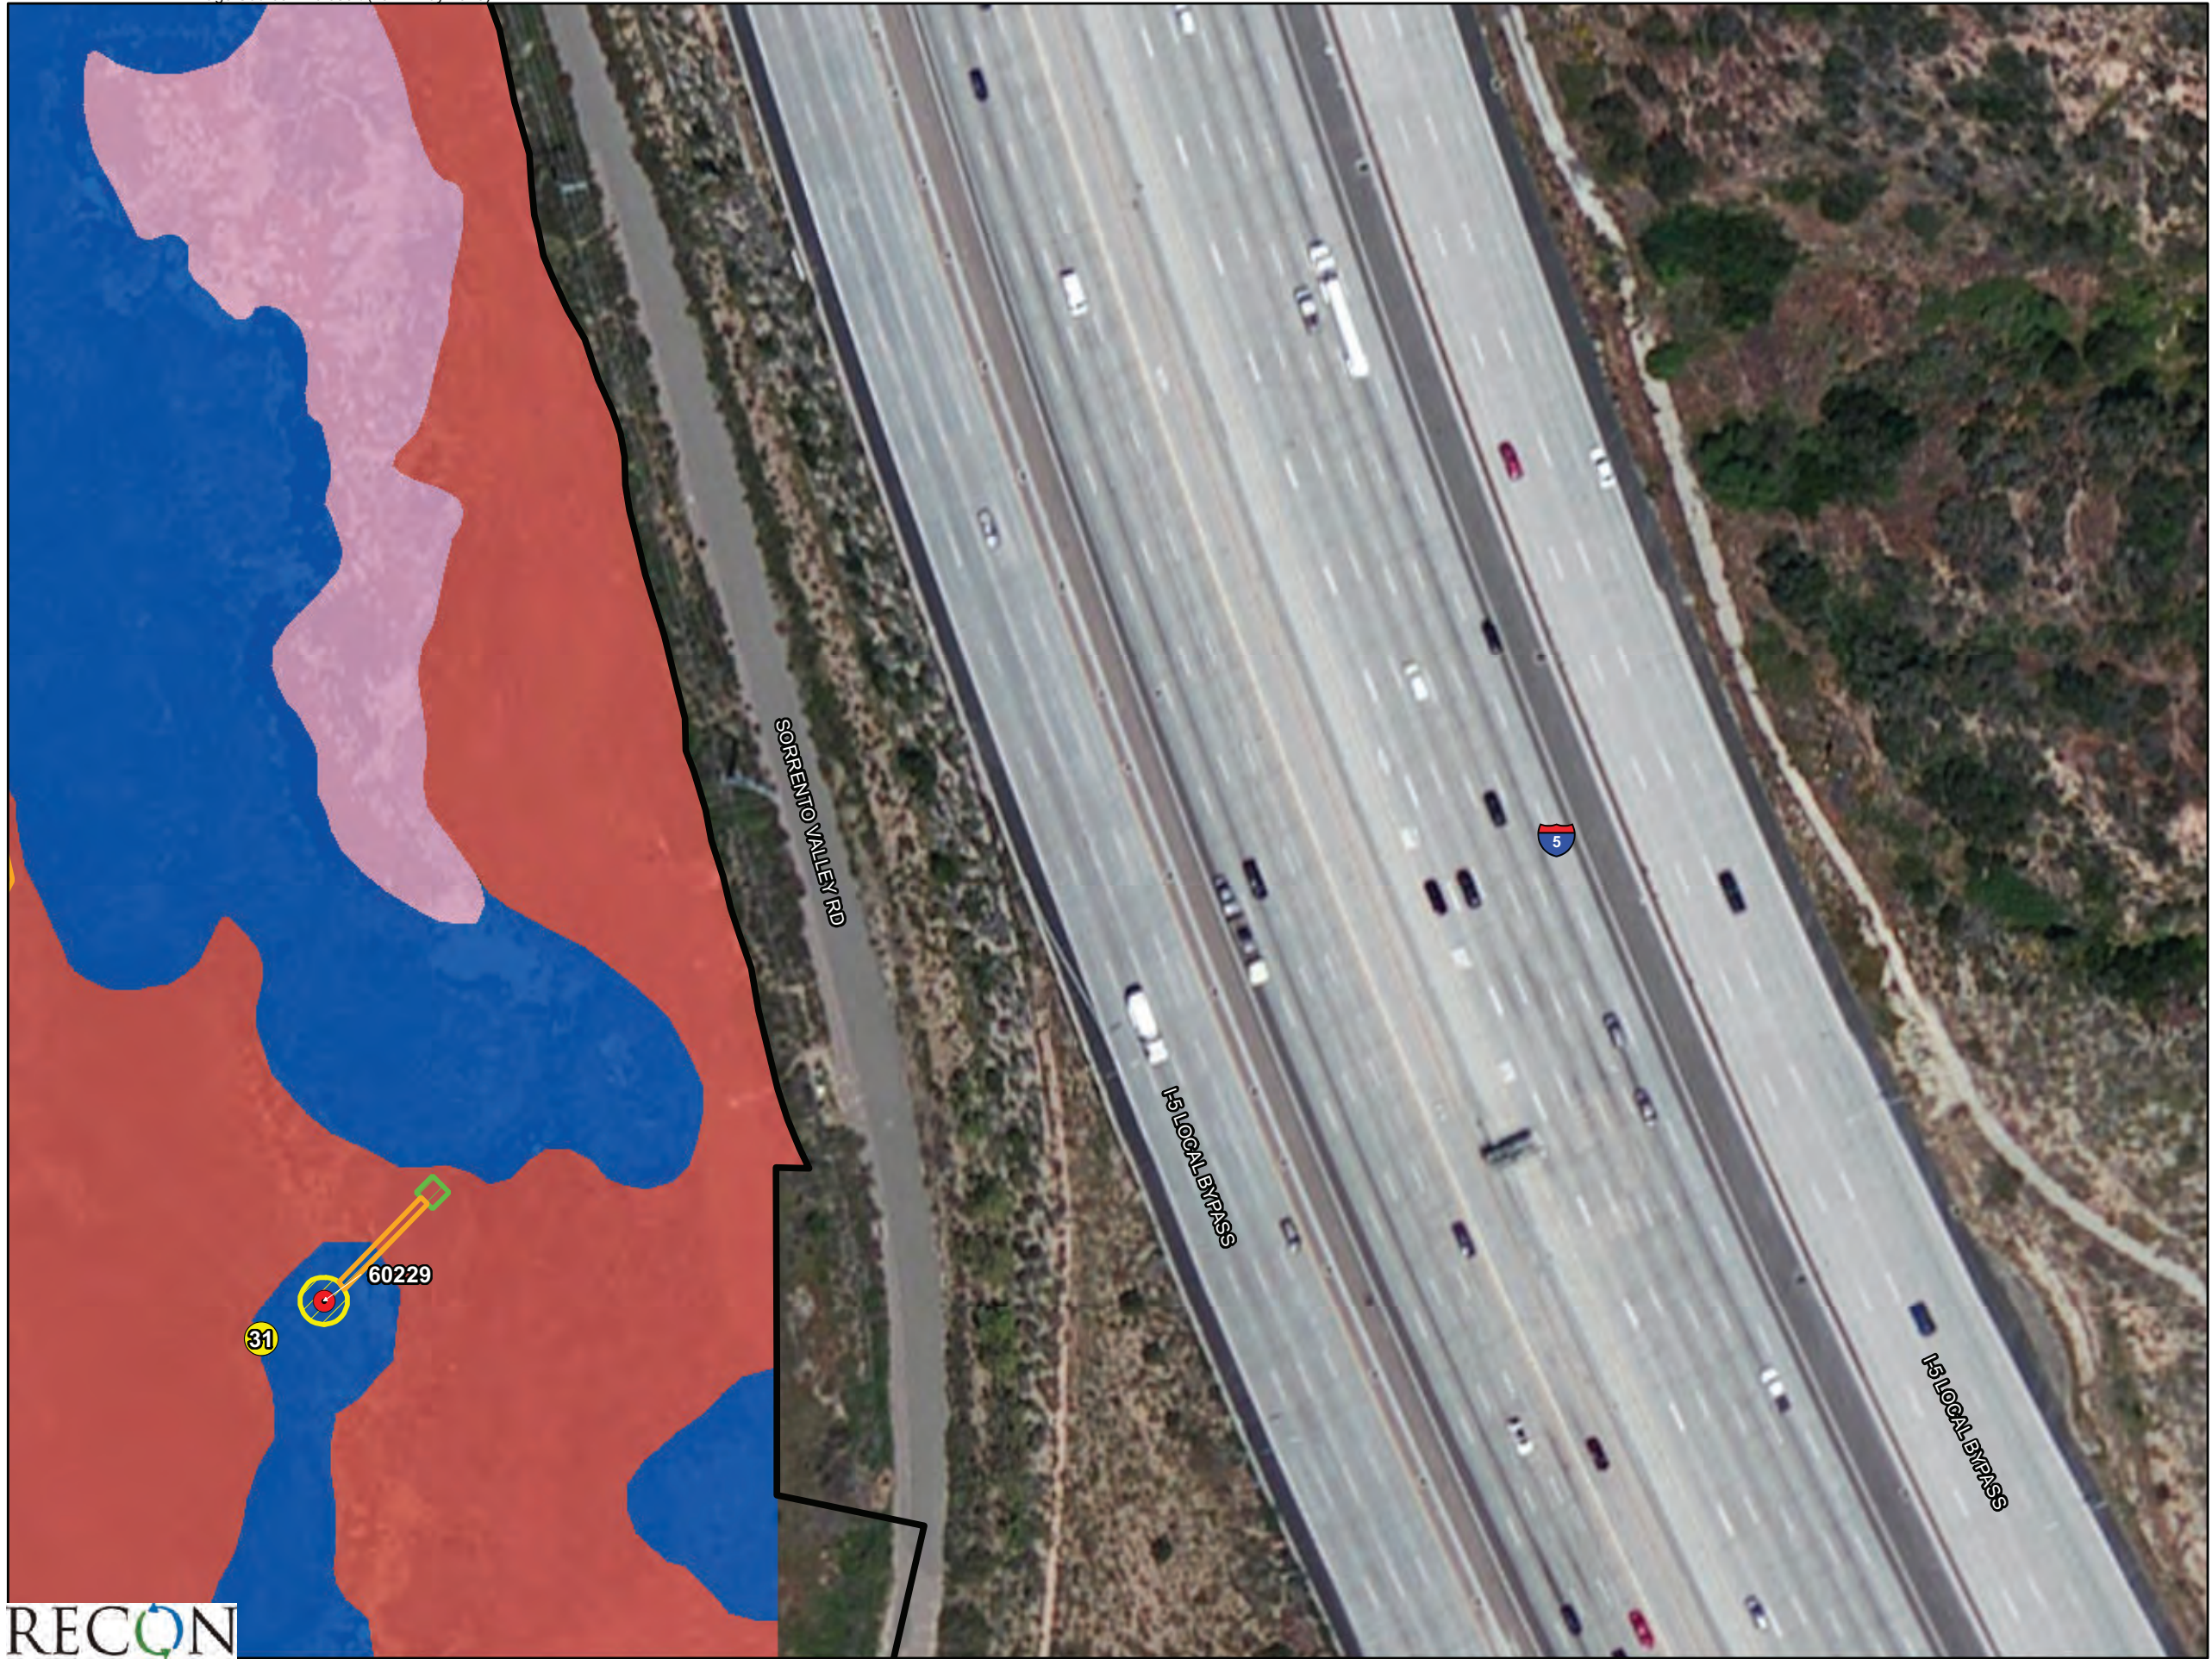
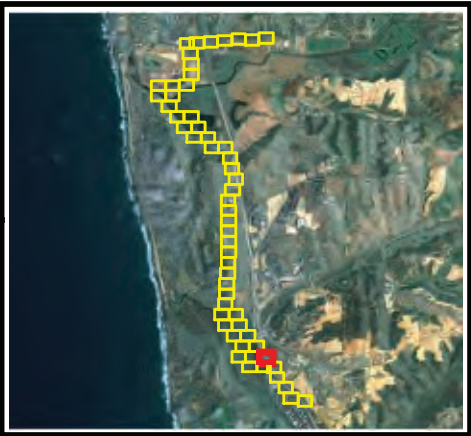
**FIGURE 1-49**  
Jurisdictional  
Resources on TL666

Utility pole Z90244 is located within salt marsh vegetation (Photograph 30, Figure 1-49). Access to this pole is available from the southeast overland through jurisdictional salt marsh vegetation from Sorrento Valley Road. Temporary impacts (vegetation trampling) to jurisdictional salt marsh vegetation are anticipated to access this pole. Pole removal impact avoidance and minimization measures are recommended (Table 1).
