***Appendix B***  
***Biological Survey Reports***

## **Biological Constraints Study**

Reference: Biological Constraints Study for the Reconfigure TL 674A at Del Mar and Remove from Service TL 666D Project (RECON Number 7203-1)

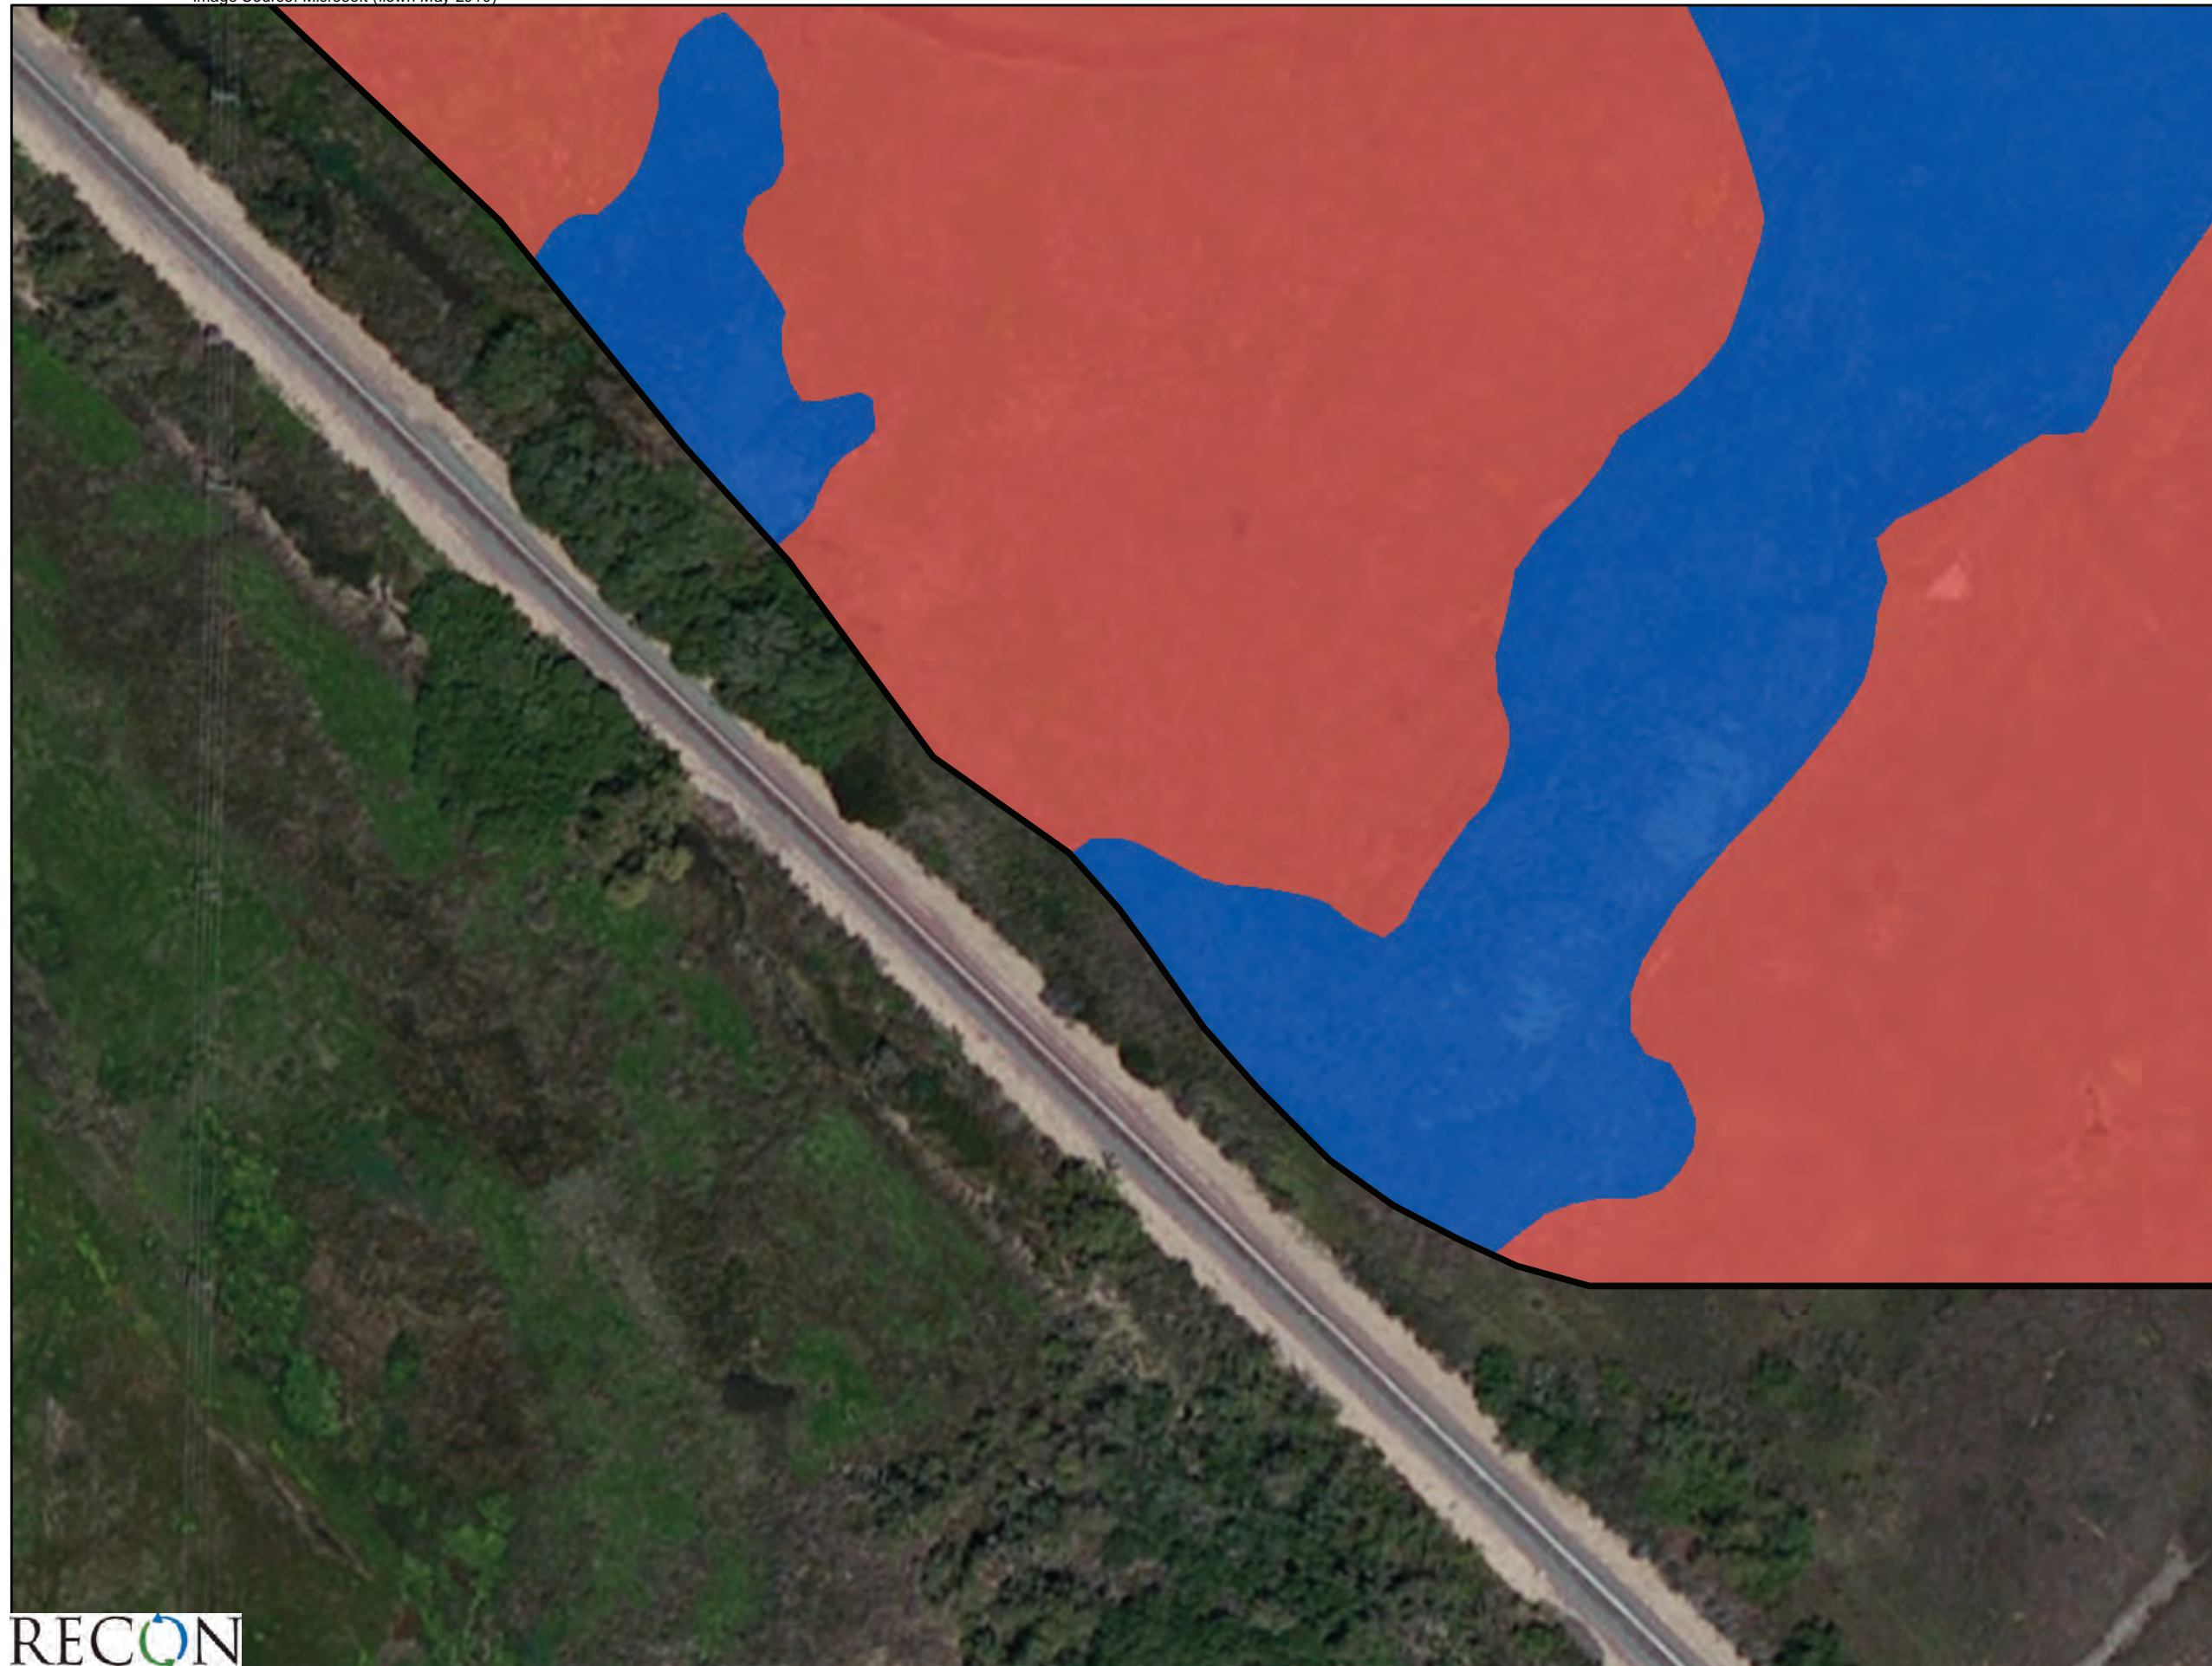
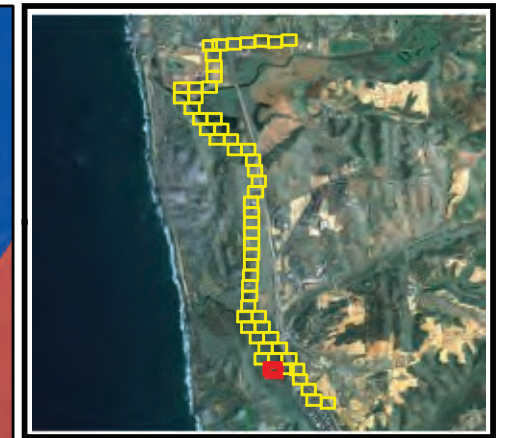
**FIGURE 1-50**  
Jurisdictional  
Resources on TL666

Utility pole Z60229 is located within emergent freshwater marsh vegetation (Photograph 31, Figure 1-50). Access to this pole is available from the southeast overland through jurisdictional salt marsh vegetation from Sorrento Valley Road. Temporary impacts (vegetation trampling) to jurisdictional salt marsh vegetation

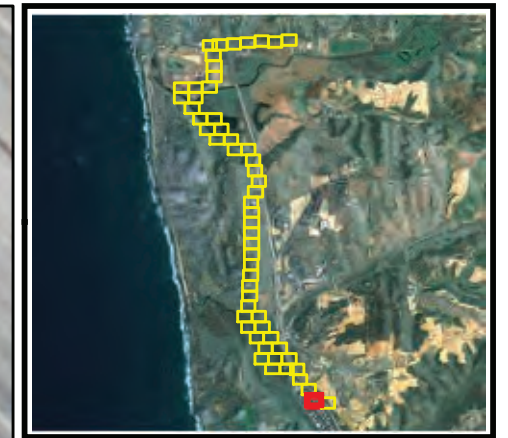
FIGURE 1-55  
Jurisdictional  
Resources on TL666

**Feature 32** is a concrete-lined drainage approximately 45 feet south of Z191293 (Photograph 32, Figure 1-55). This feature drains west into the Peñasquitos estuary and is likely considered an ACOE non-wetland water of the U.S., CDFW streambed, RWQCB water of the state, and CCC wetland. As this feature is outside any proposed project activities, no impacts are anticipated.

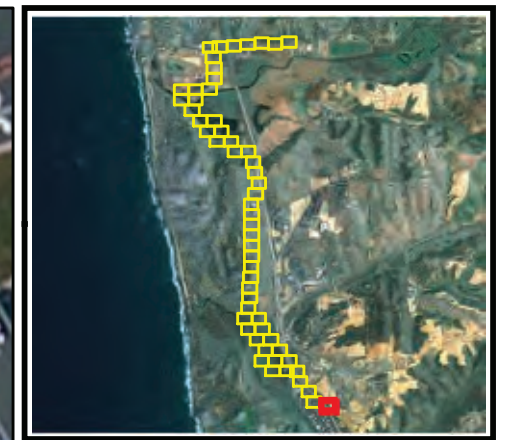
FIGURE 1-56  
Jurisdictional  
Resources on TL666

**Feature 33** is a concrete-lined drainage that flows approximately 20 feet south of poles Z191289, Z191288, and Z191287 (Photograph 33, Figure 1-56). This feature drains west into the Peñasquitos estuary and is likely considered an ACOE non-wetland water of the U.S., CDFW streambed, RWQCB water of the state, and CCC wetland. As this feature is outside any proposed project activities, no impacts are anticipated.

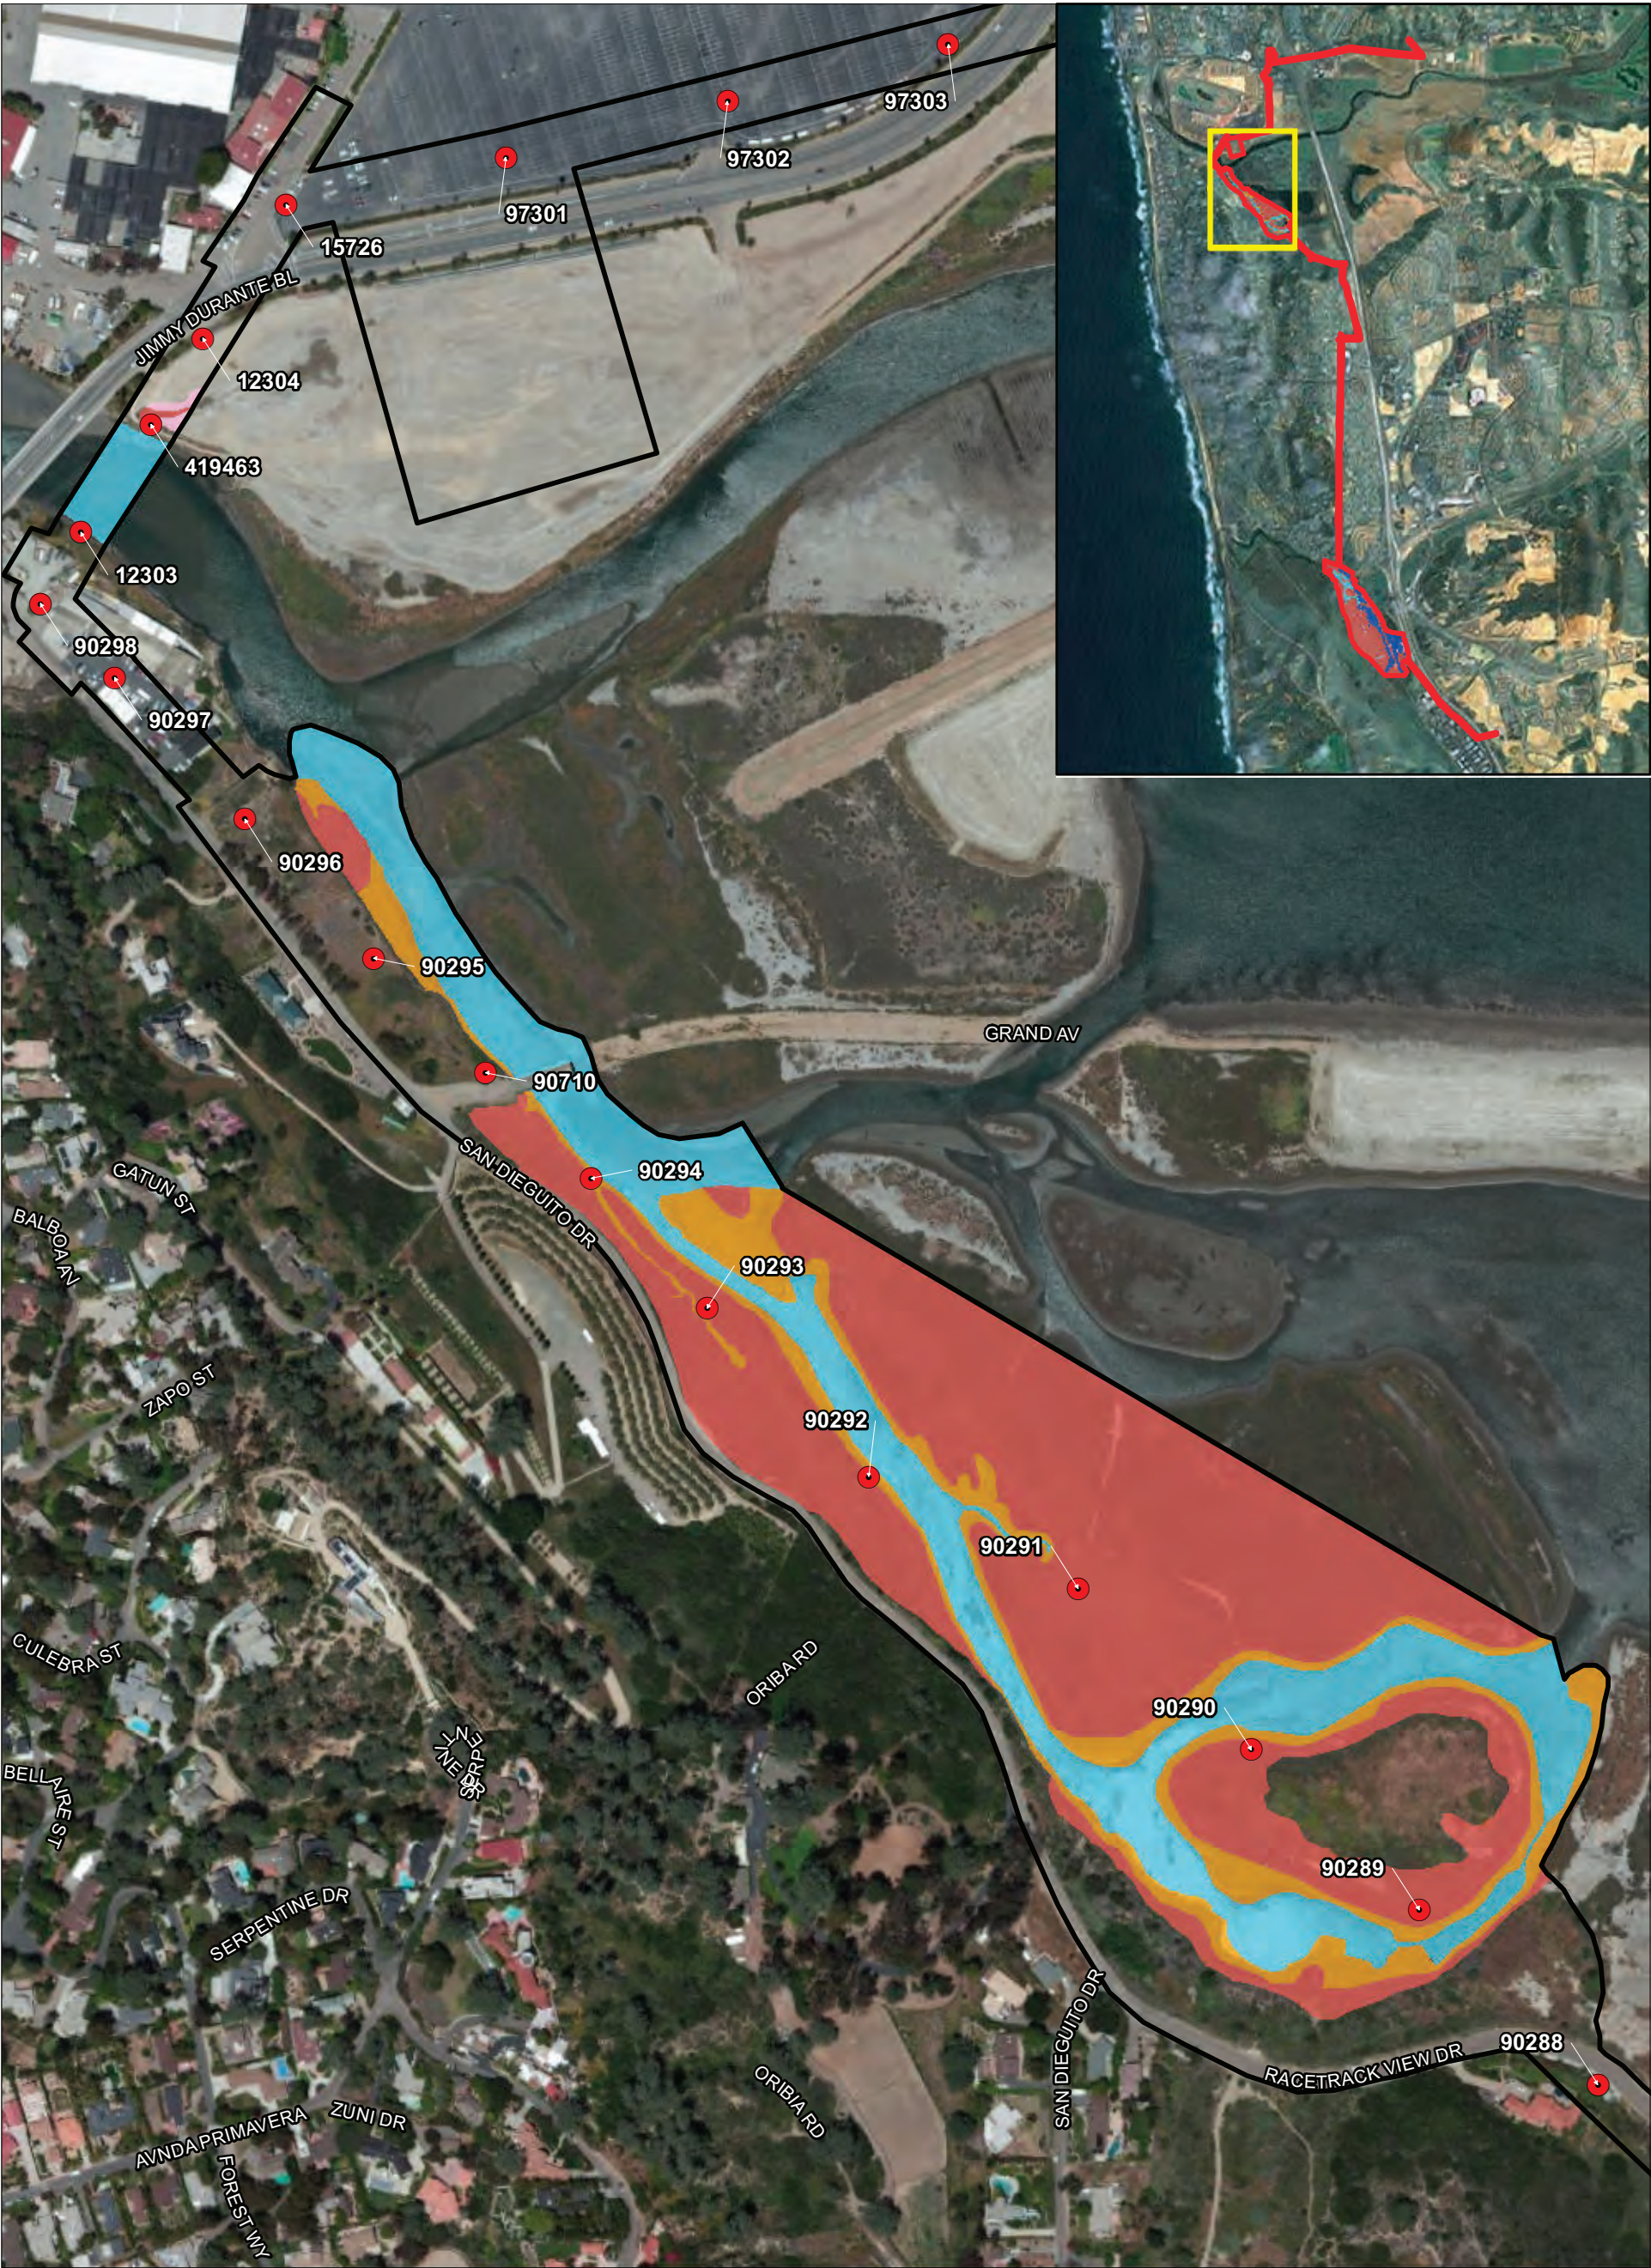
FIGURE 1-57  
Jurisdictional  
Resources on TL666

**Feature 34** is a non-jurisdictional brow draining a cut slope east of the Interstate 5 freeway approximately 10 feet north of pole Z164283 (Figure 1-57). This brow ditch is located on and drains an upland fill slope, and is therefore exempt from aquatic resource agency jurisdiction.

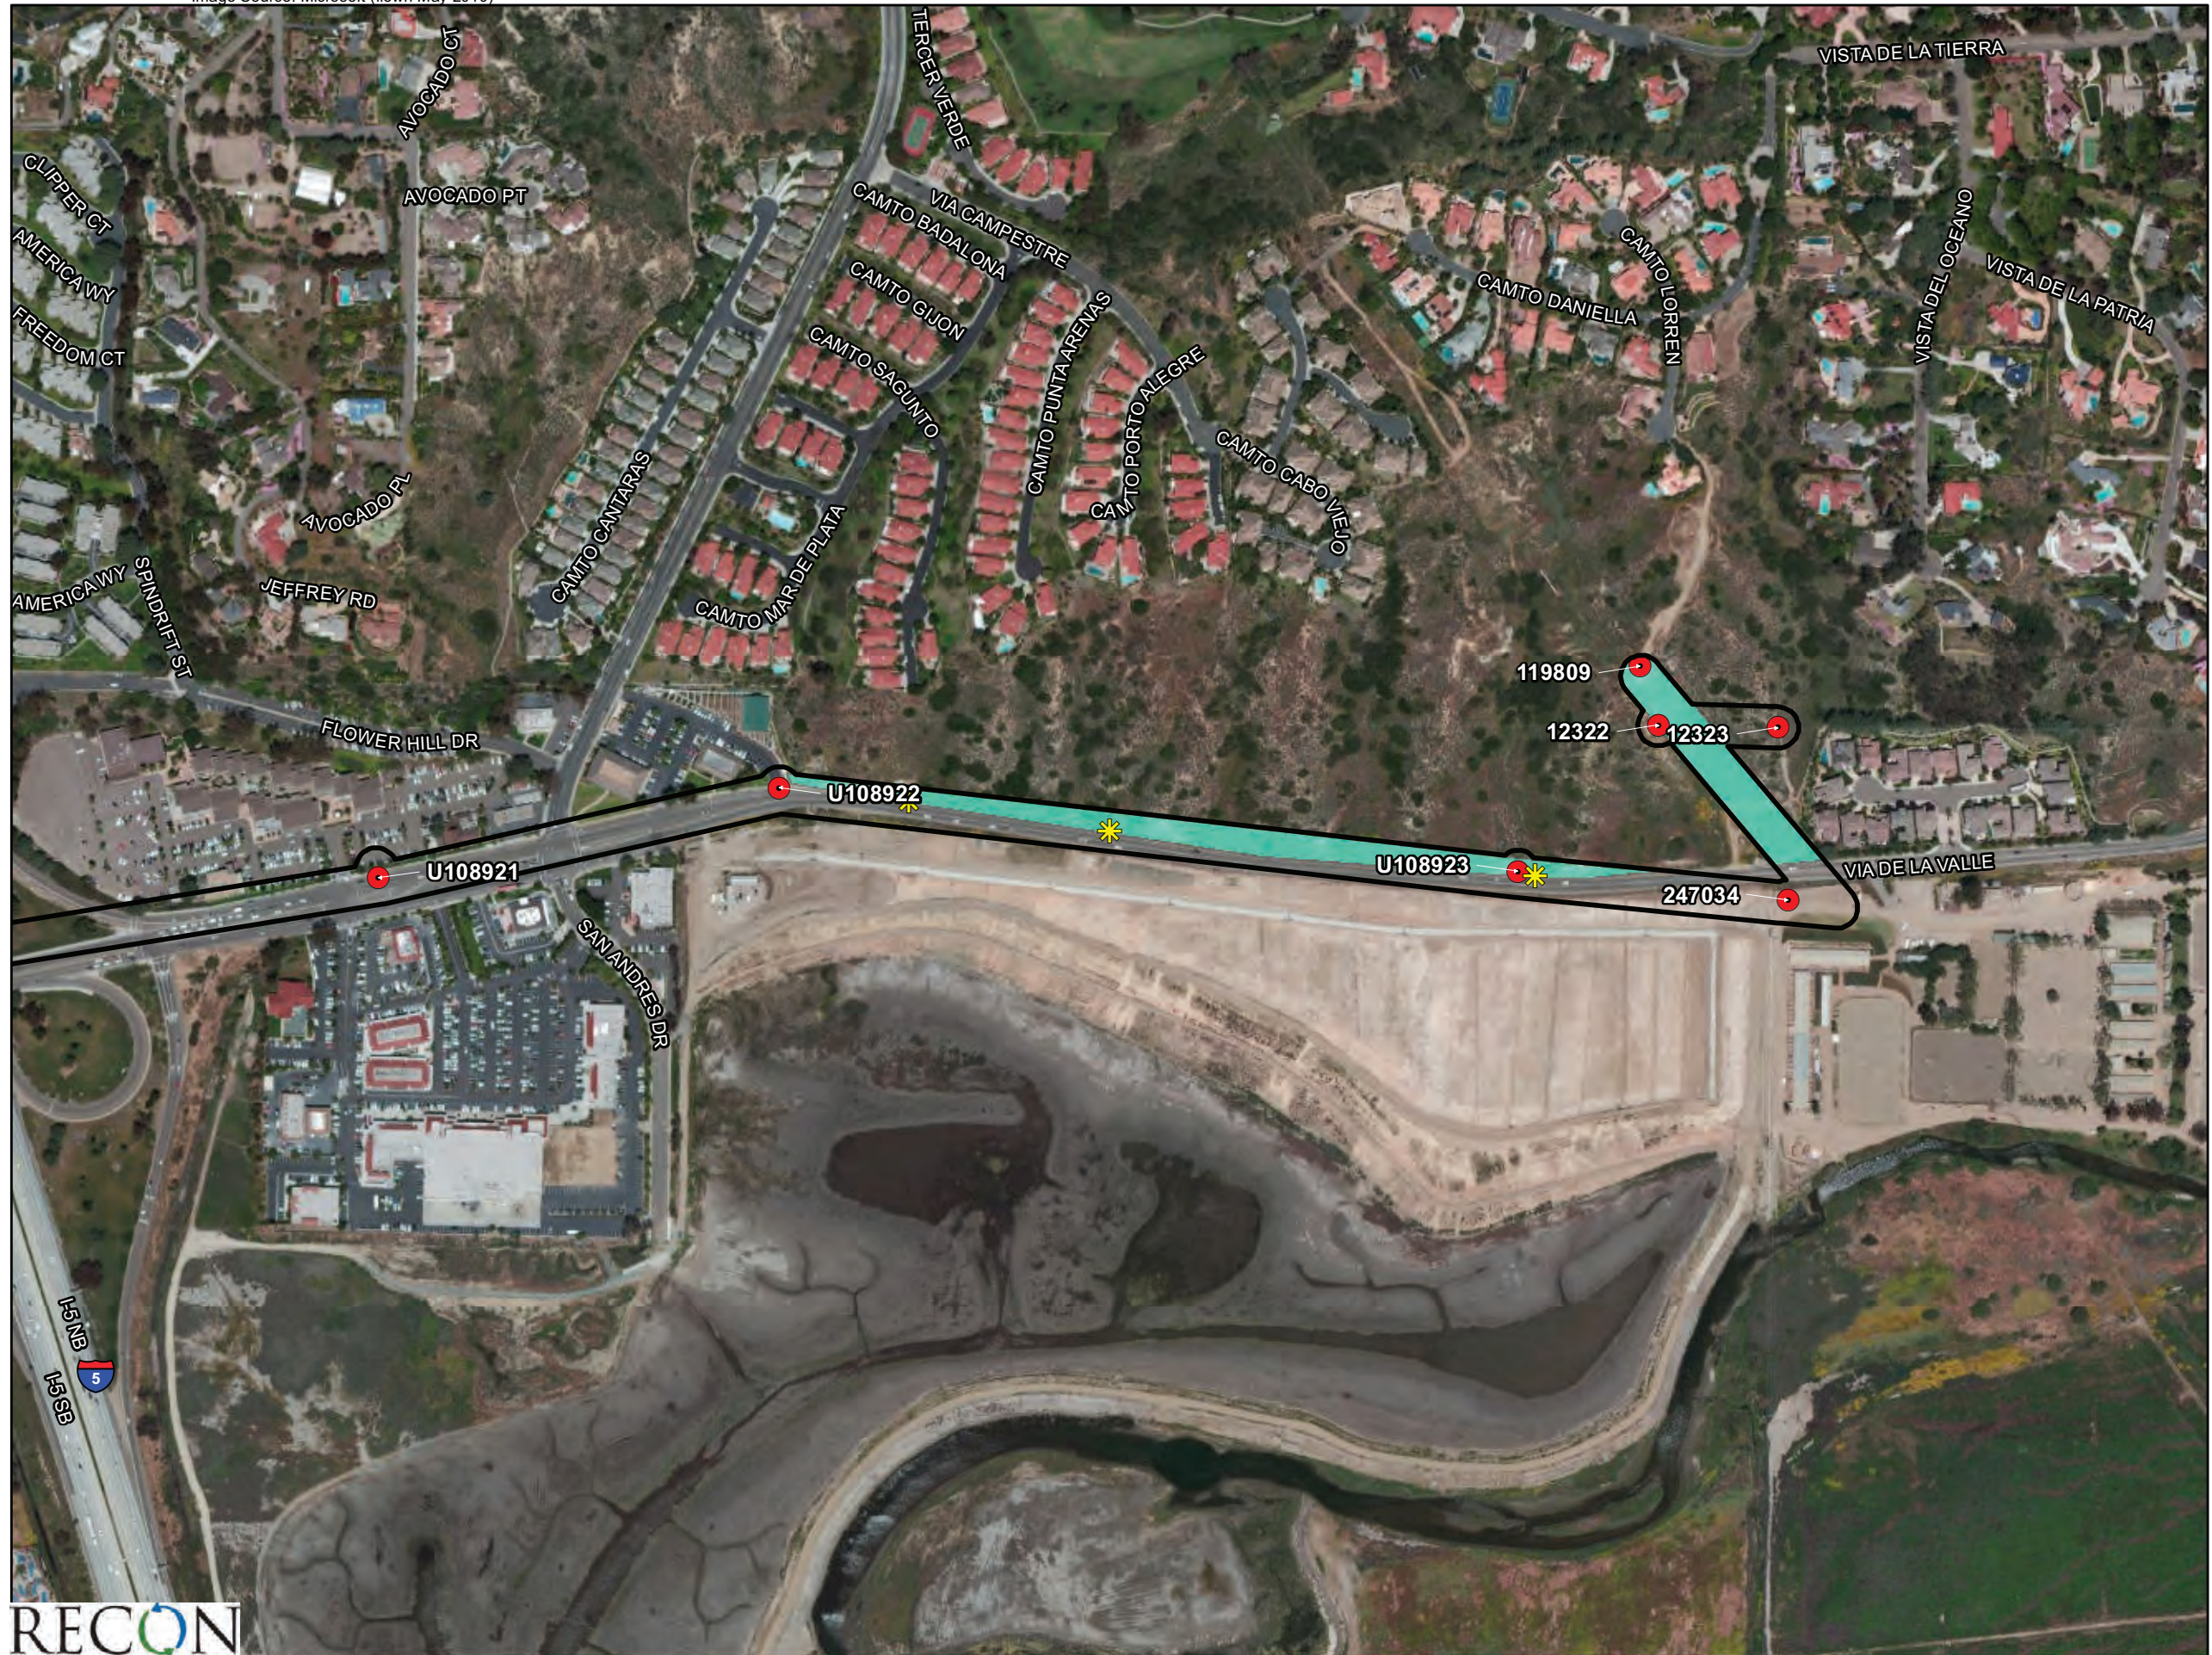
FIGURE 4-1

California Coastal Commission  
(CCC) Environmentally  
Sensitive Habitat Areas (ESHA)  
within TL666 Project Area

Approximately 180 individuals of San Diego County viguiera were observed within survey area in Diegan coastal sage scrub, maritime succulent scrub, and disturbed habitat along Via de la Valle (see Figures 4-1 and 4-2), San Dieguito Drive (see Figure 4-6), I-5 (see Figure 4-13), and El Camino Real (see Figure 4-16).

Approximately 100 individuals of Orcutt's pincushion were observed within the survey area in Diegan coastal sage scrub, maritime succulent scrub, and disturbed habitat along Via de la Valle (see Figures 4-1 and 4-2) and on a hillside southeast of Los Peñasquitos marsh (see Figure 4-14).

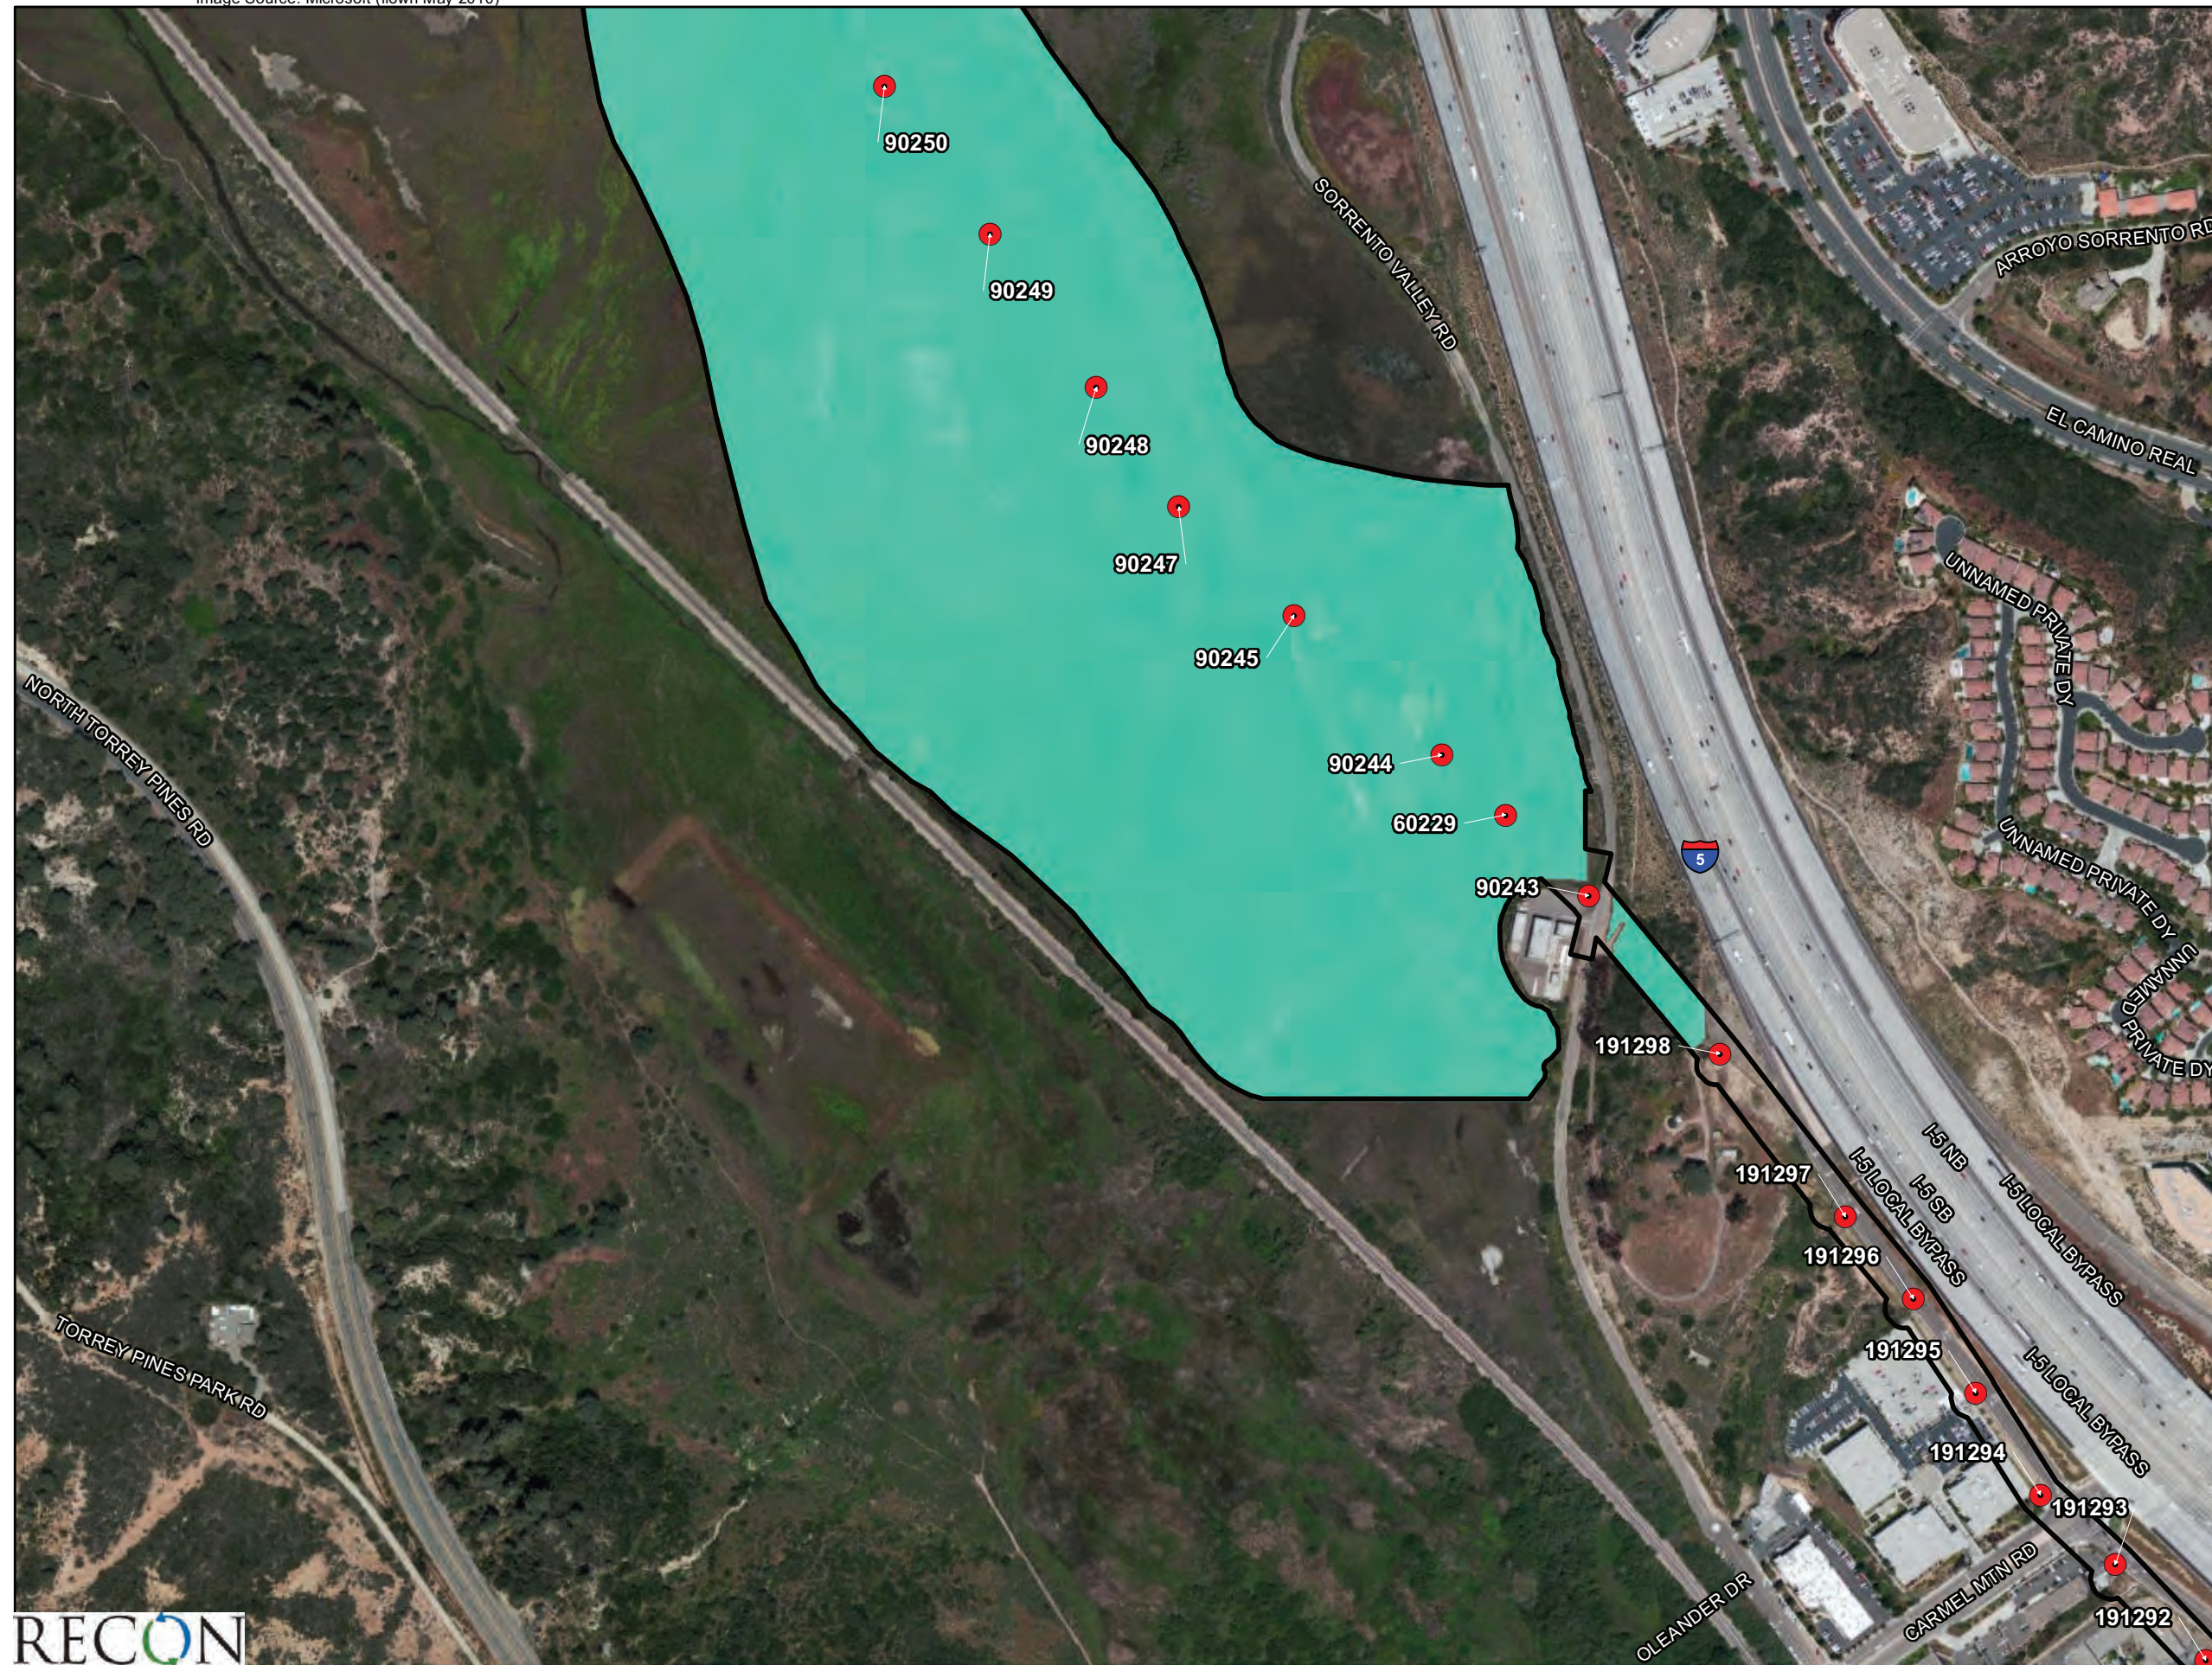
FIGURE 4-6

California Coastal Commission  
(CCC) Environmentally  
Sensitive Habitat Areas (ESHA)  
within TL666 Project Area

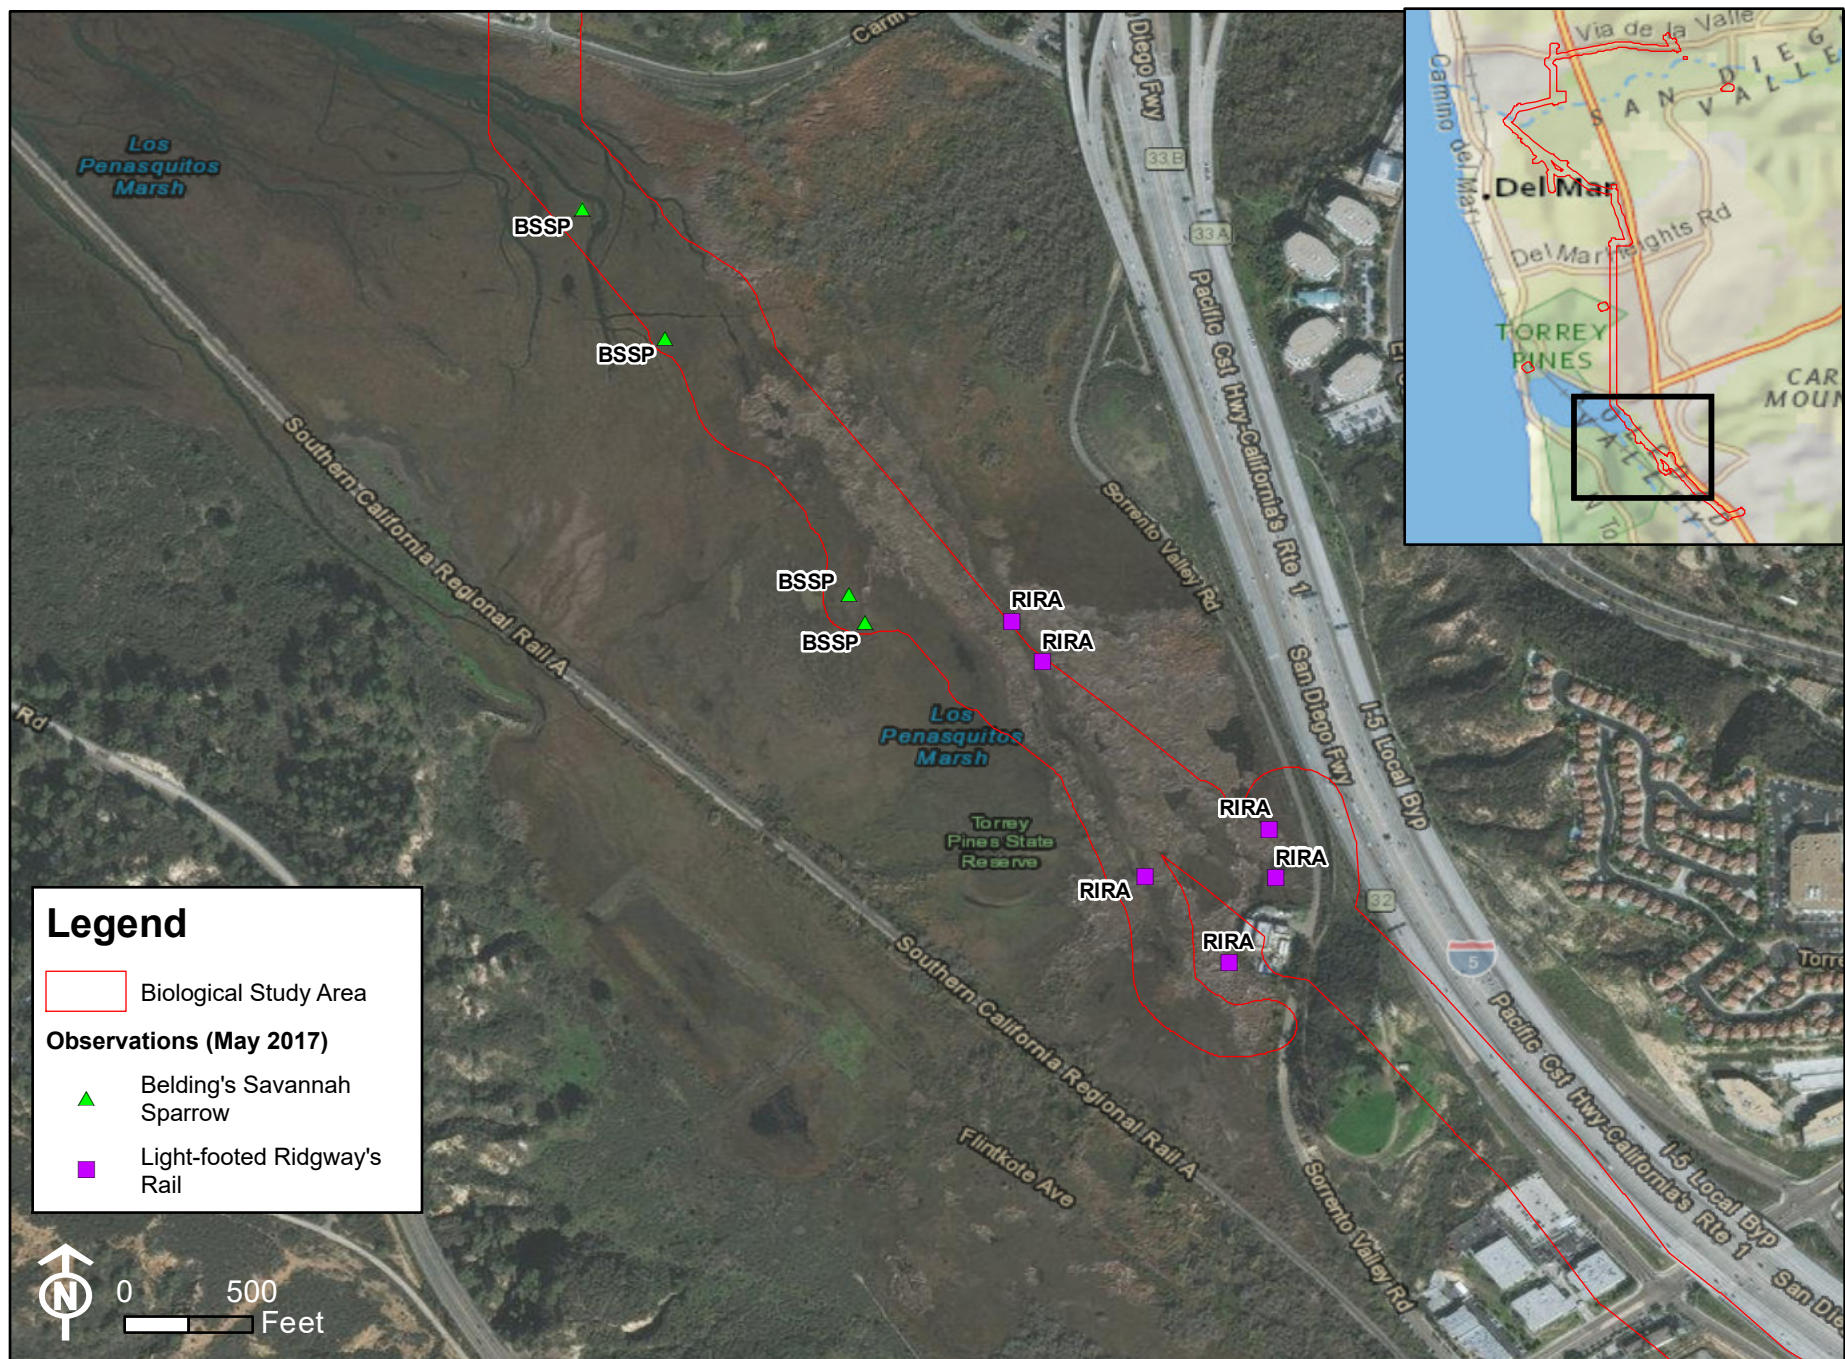
Figure 3  
Light-footed Ridgway's Rail and Belding's Savannah Sparrow  
Los Penasquitos Lagoon

Four BSSP territories were consistently detected within the southern coastal saltmarsh habitat (Figure 3). All of these observations were singly perched, singing males. During survey two, the lagoon was flooded, and four additional BSSP singly perched, singing males were observed in the northern portion of the alignment in areas of inundated southern coastal salt marsh. These birds were not detected in these areas again during any of the other surveys and were not counted as additional territories. No BSSP were detected within the BSA boundary for the proposed staging area at the Los Peñasquitos Reserve parking lot; however there was one BSSP adjacent to the survey area singing and perched in the coastal salt marsh along the southern border.

In Los Peñasquitos, the coastal salt marsh habitat is of high quality for BSSP, due to its large, undisturbed, mature characteristics, with regular tidal flow regimes. Most of this BSSP-suitable habitat is located in the eastern and central portions of the BSA and have previously supported BSSP (Konecny 2014). The BSSP territories that were detected for 2017 were found on the edges of the BSA in lower-quality coastal salt marsh habitat (Photograph 2). The use of these new areas was likely due to the coastal salt marsh being completely or partially inundated up until survey five. The mouth of the lagoon was intermittently closed to the ocean up until survey 5, when the mouth of the lagoon was being actively dredged. During the flooded conditions, BSSP were displaced and observed in areas where the highest shrubs were above the waterline within and adjacent to the BSA. If there is consistent maintenance to keep the lagoon mouth open, it is likely that BSSP will reestablish in the areas centrally located within the BSA and should eventually set up territories in the coastal salt marsh in the eastern portion of the site.

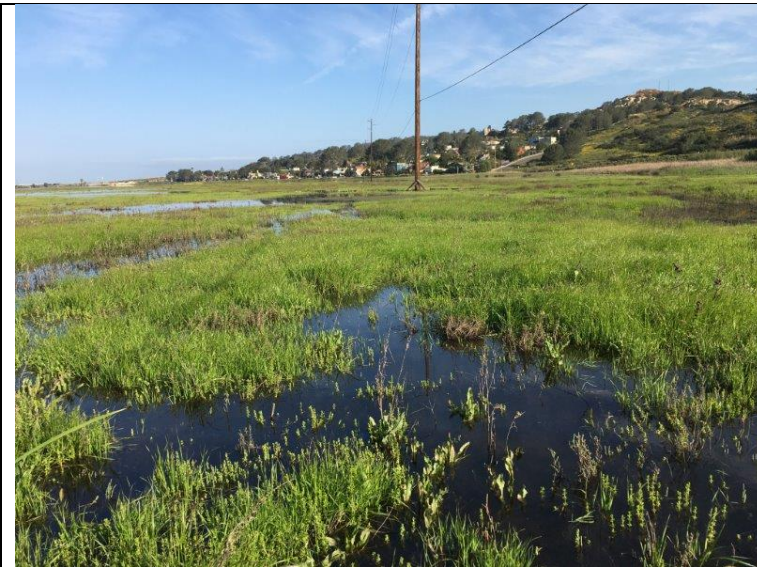
**Photograph 1.** Los Peñasquitos site. Coastal salt marsh in flooded conditions (taken April 11, 2017; facing northwest).

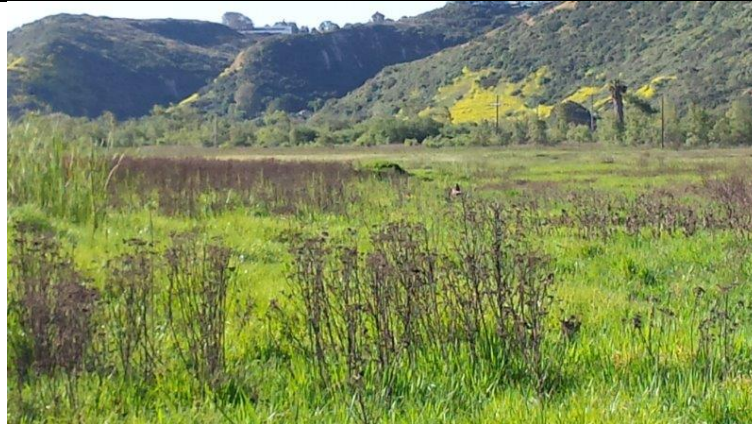
**Photograph 2.** Los Peñasquitos site. BSSP perched and singing at the edge of disturbed coastal salt marsh habitat at the edge of the BSA (taken April 30, 2017; facing east).

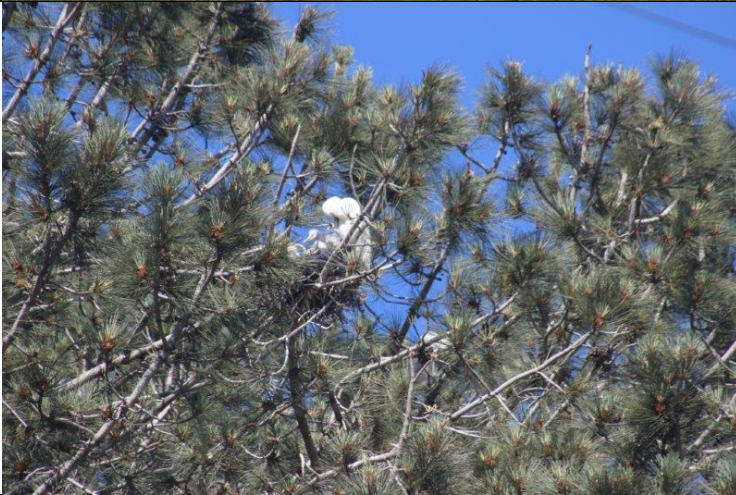
**Photograph 5.** San Dieguito site. SNEG and GREG nesting colony (taken April 29, 2017; facing west).

Also notable was the nesting colony of great blue herons (*Ardea herodias*; GBHE) and great egrets (*Ardea alba*, GREG) at the edge of the BSA in the northwestern part of the San Dieguito site (Figure 4; Photograph 5). Nesting behaviors at the nest colony were observed throughout the RIRA and BSSP surveys with nestlings observed by survey 4. At least four GBHE nests and four GREG nests were observed. Personal communications from the homeowner where the nest colony is located indicated that snowy egrets (*Egretta thula*) occupy the nest colony in the summer months after the GBHE and GREG have vacated the nests.
