***Appendix B***  
***Biological Survey Reports***

## **Biological Constraints Study**

Reference: Biological Constraints Study for the Reconfigure TL 674A at Del Mar and Remove from Service TL 666D Project (RECON Number 7203-1)

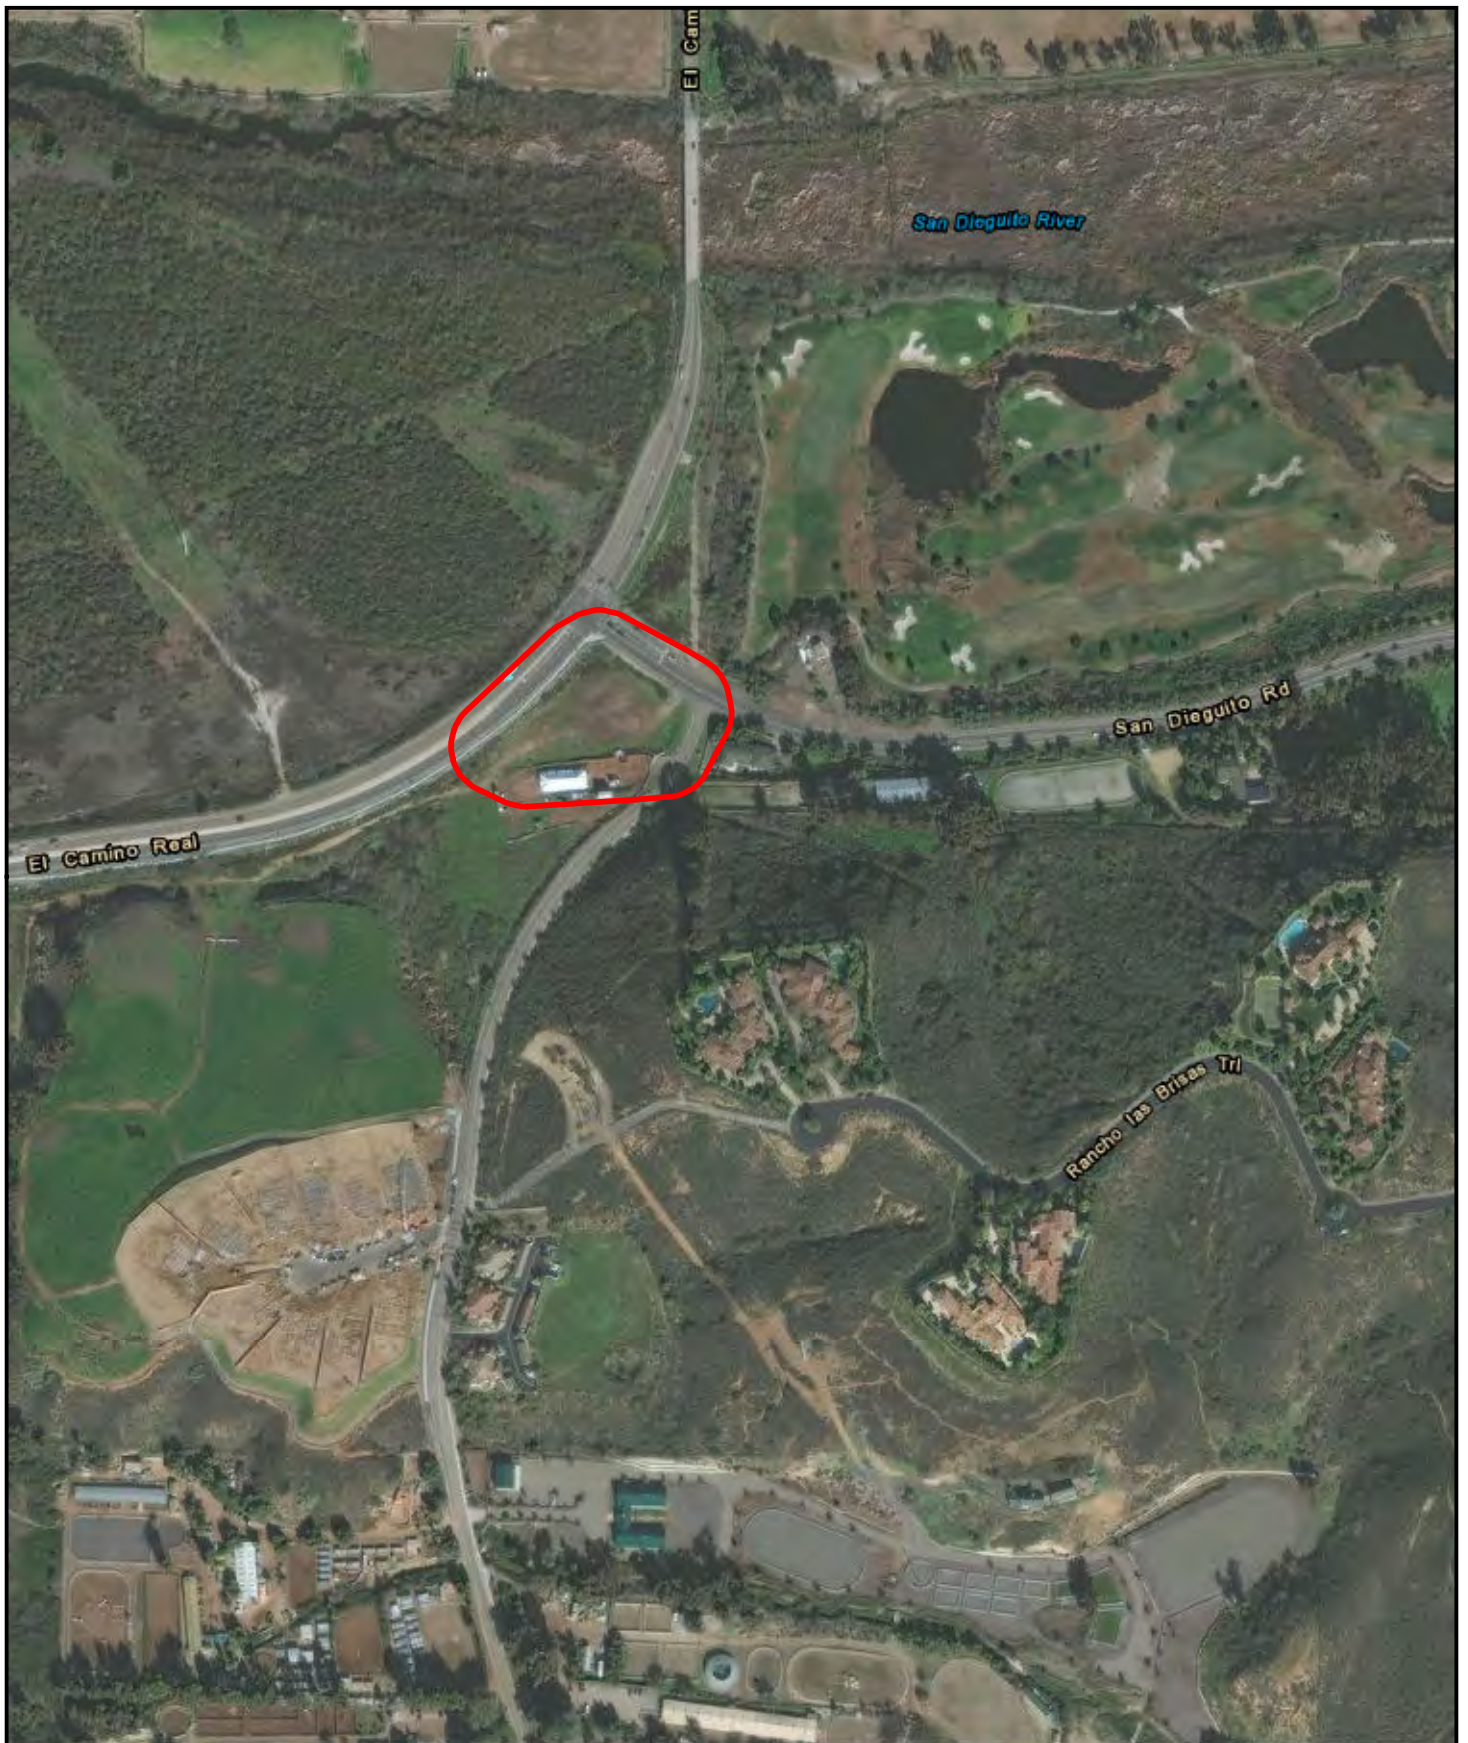
**Figure 2**  
California Gnatcatcher Survey Results  
Results Map 1 of 10

- ▭ Biological Study Area
- ▲ CAGN Nest
- ▭ CAGN Territory
- ▨ CAGN Suitable Habitat

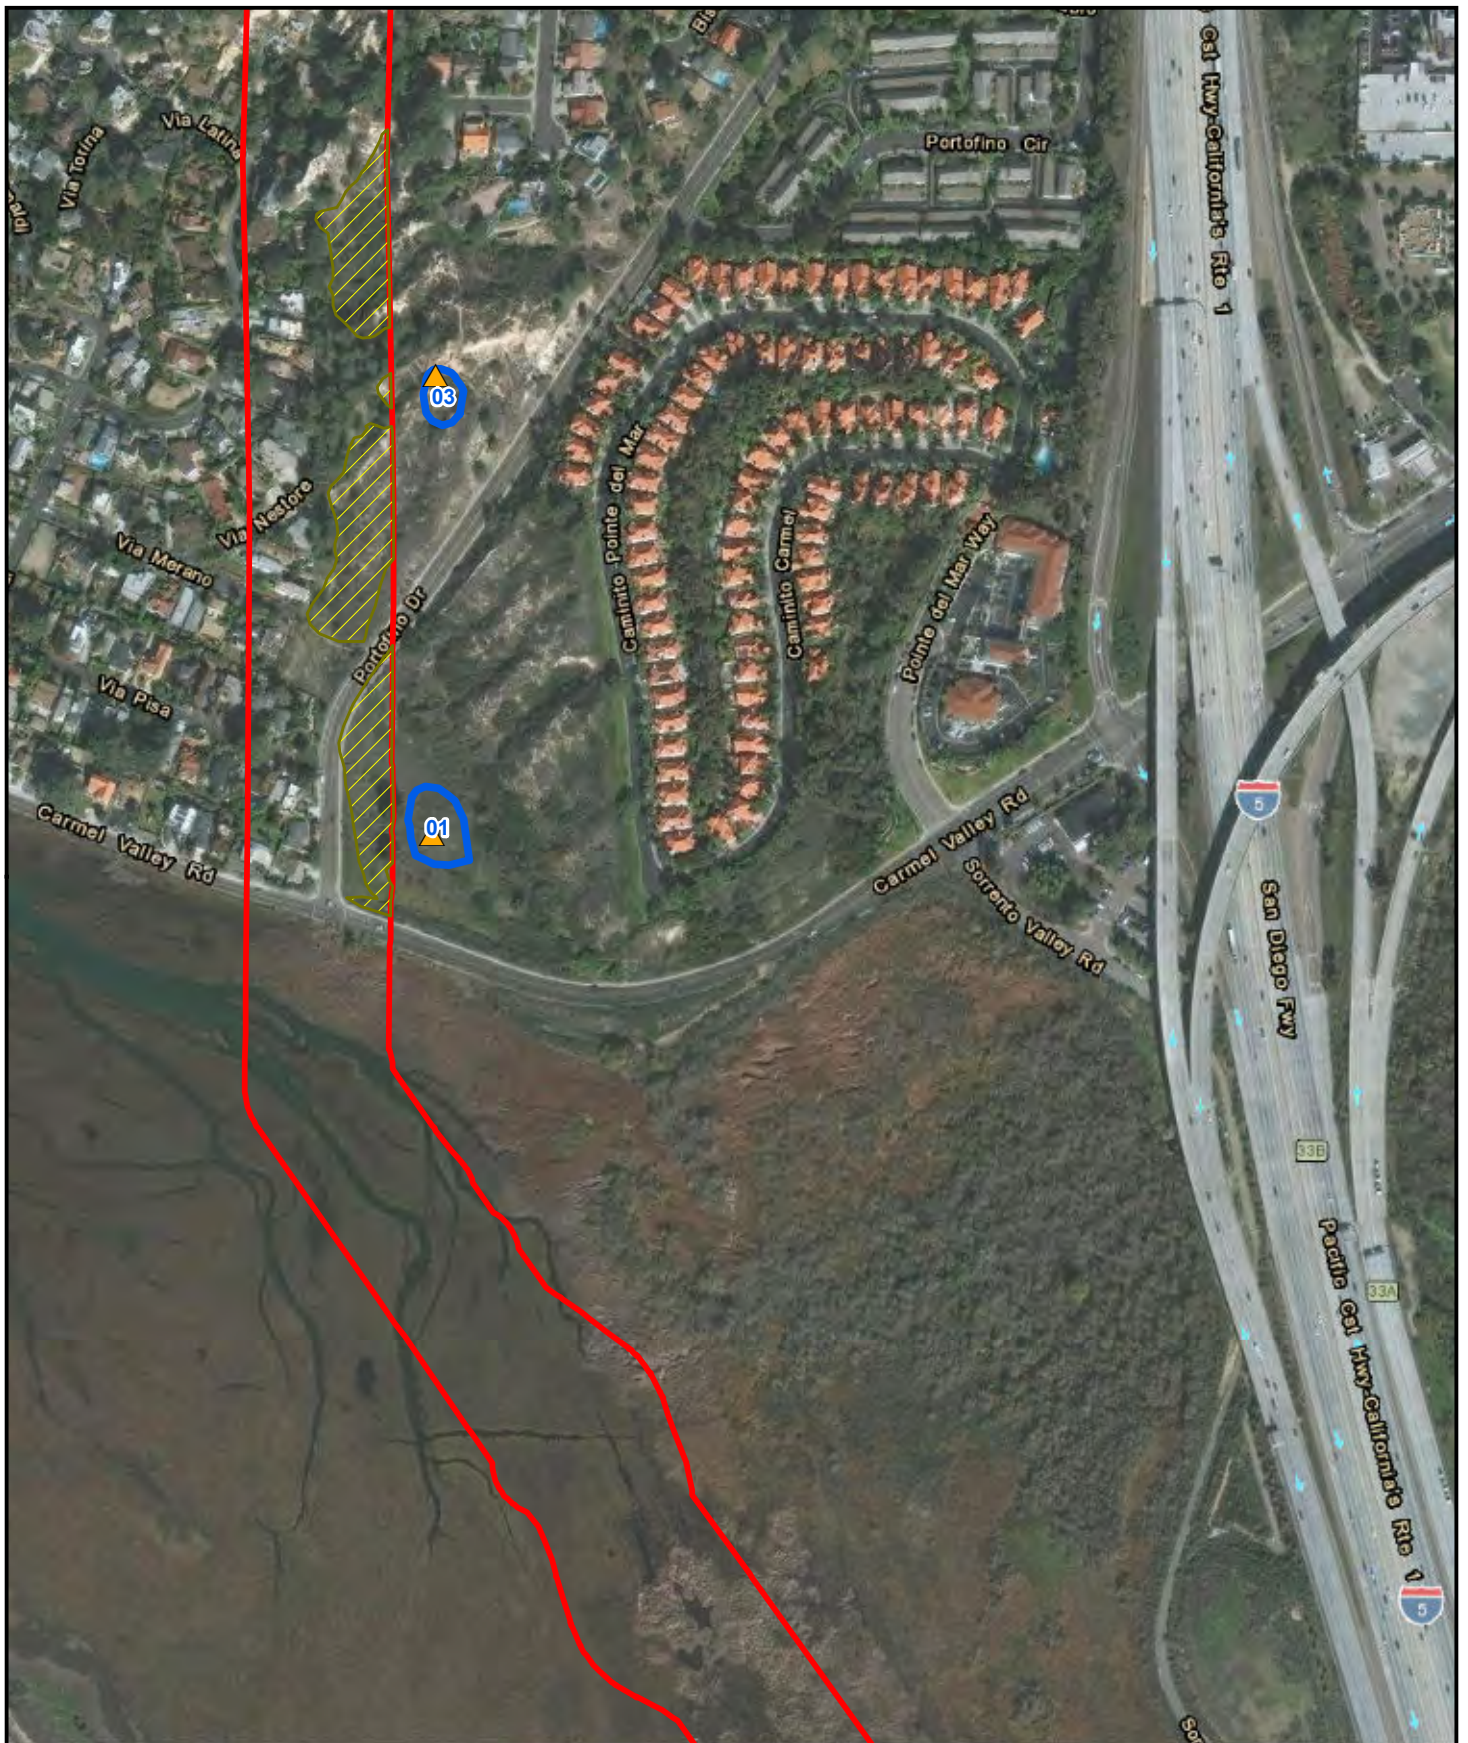
**Figure 2**  
California Gnatcatcher Survey Results  
Results Map 9 of 10

- ▬ Biological Study Area
- ▲ CAGN Nest
- CAGN Territory
- ▨ CAGN Suitable Habitat

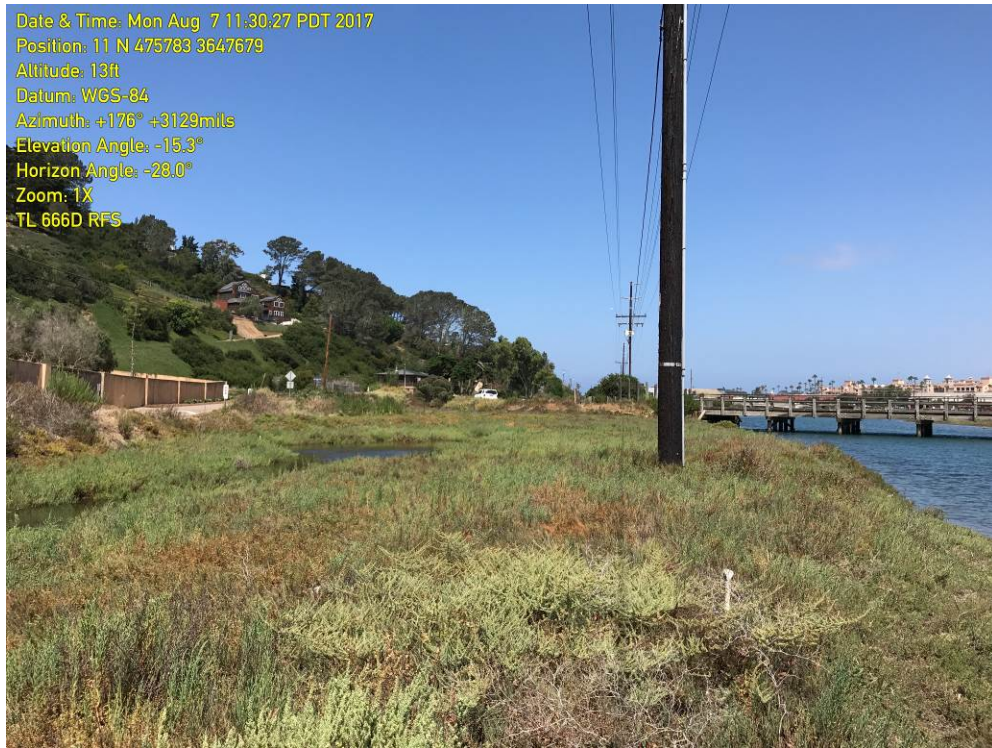
**Image 1:** View west of San Dieguito Lagoon east of San Dieguito River Walk pier showing saltgrass habitat for wandering skipper. Wandering skipper was observed in this area.

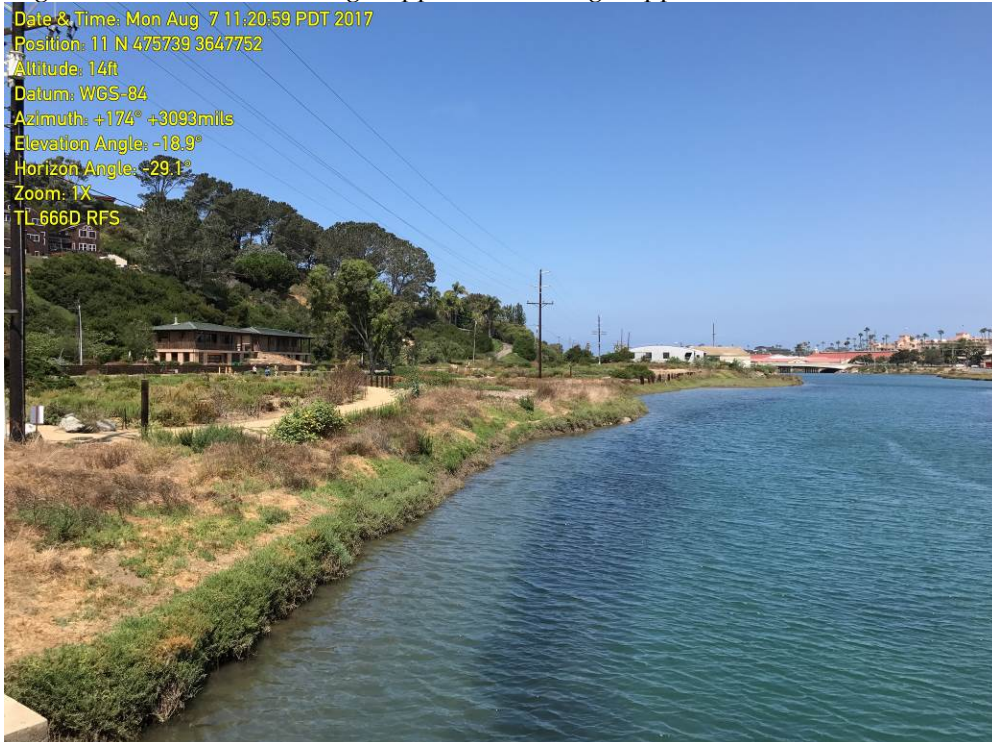
**Image 2:** View west of San Dieguito Lagoon showing saltgrass habitat for wandering skipper along margin of San Dieguito River Walk. Wandering skipper was observed in this area.

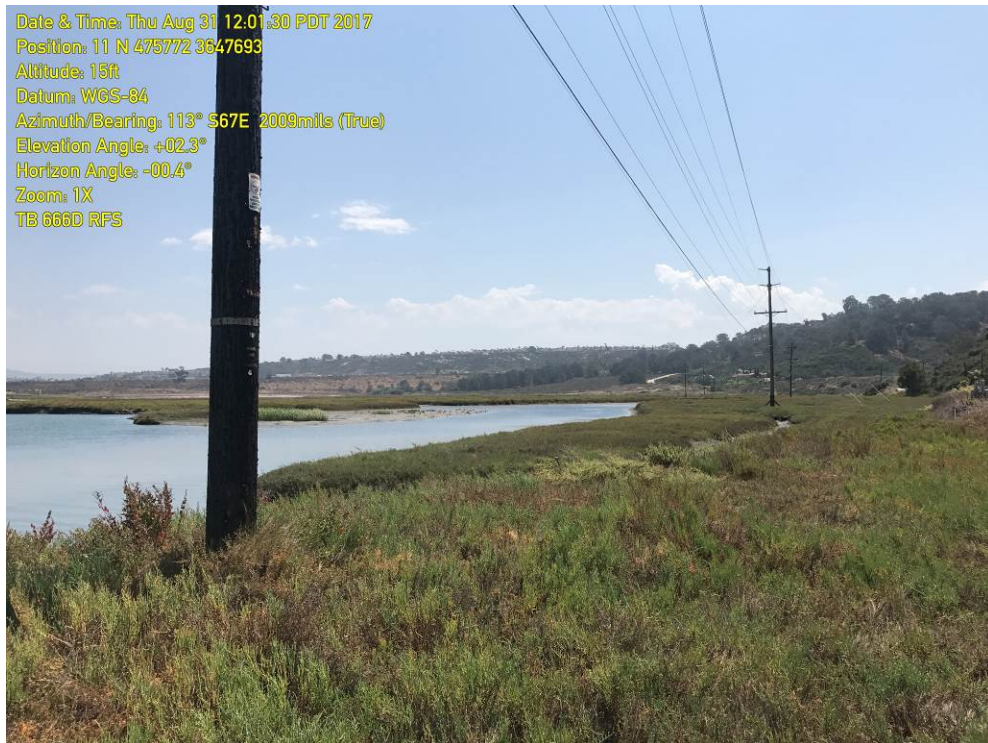
**Image 3:** View east of San Dieguito Lagoon showing habitat for wandering skipper. Tidal flow prevented access to some pole sites east of this location.

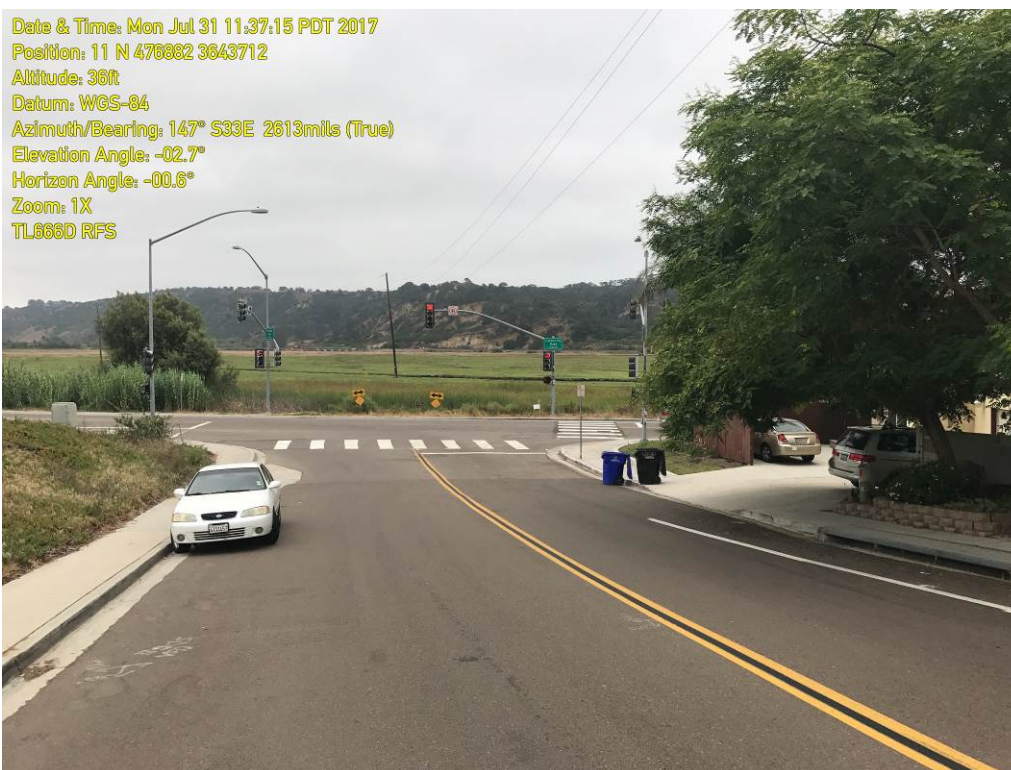
**Image 8:** View of Los Peñasquitos Lagoon from Portofino Drive and Carmel Valley Road. Wandering skipper was observed just south of this intersection. An undeveloped lot (left) with Diegan coastal sage scrub and potential nectar resources was included in surveys.

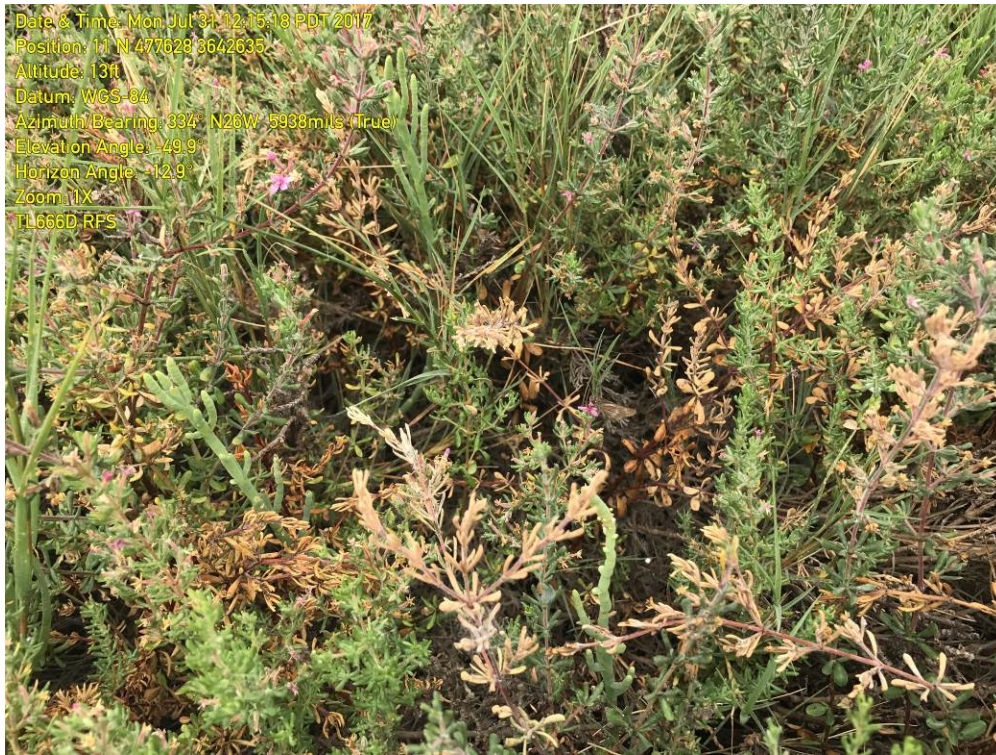
**Image 9:** Wandering skipper nectaring on alkali heath (*Frankenia salina*) in saltgrass habitat just north of Pump Station 65 at the east end of Los Peñasquitos Lagoon.
