FINAL INITIAL SITE ASSESSMENT REPORT

I-80/Gilman Street Interchange Improvement Project

Caltrans District 04
04-ALA-80-PM 6.38/6.95
EA 04-0A7700 / Project ID 0400020155
May 2018

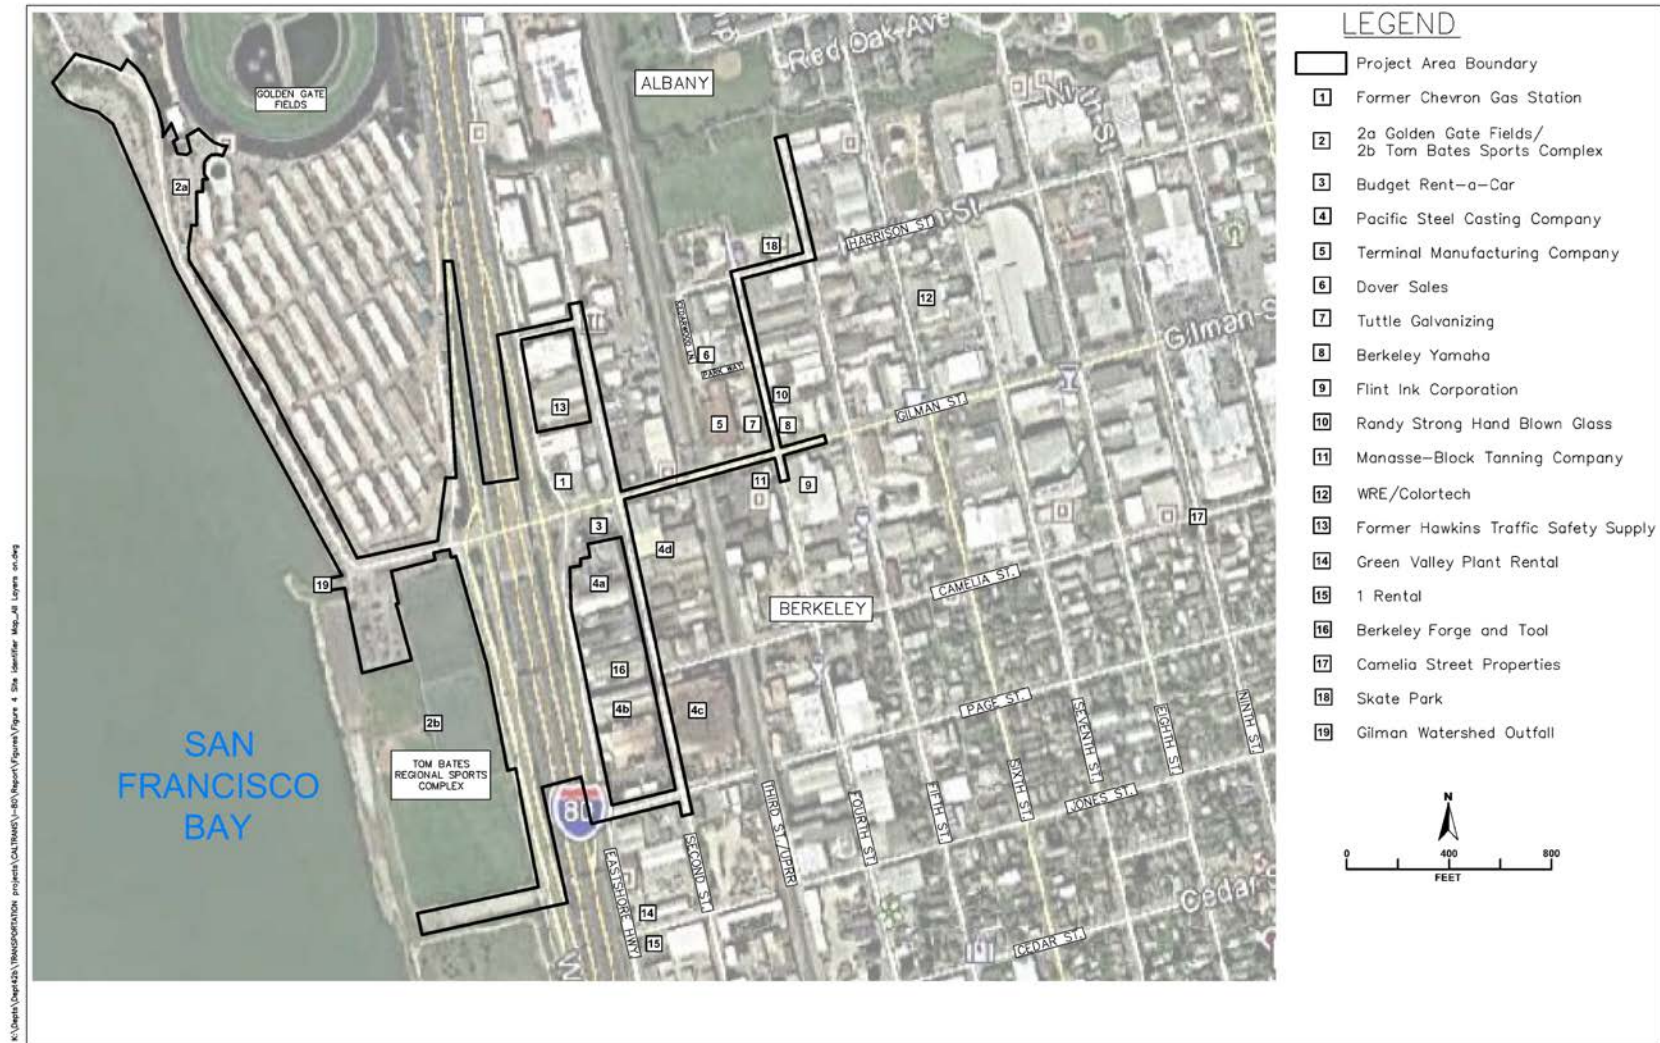
Figure 4: Site Identifier Map

Brief descriptions of the regulatory status of these sites based on information available on Geotracker and Envirostor is provided below (DTSC and State Water Resources Control Board databases accessed in 2018). The locations of these properties are shown on Figure 4.

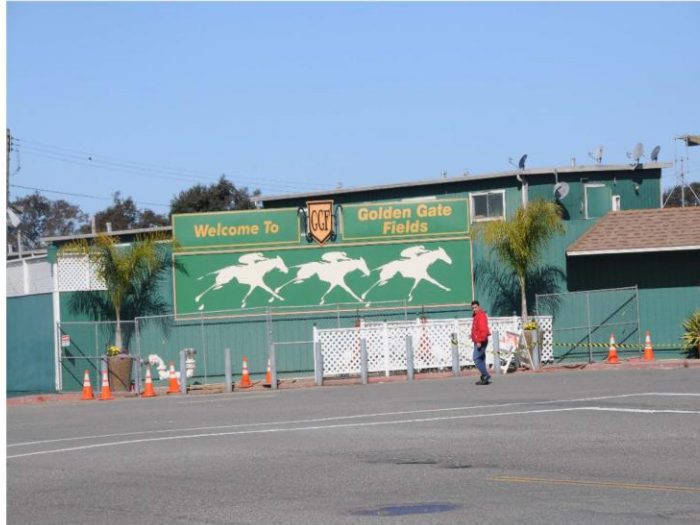
Photograph 1

Description: Entry to Golden
Gate Fields stables

West of Eastshore Highway. The area within the project site west of the I-80/Gilman Street interchange is occupied by the TBSC, paved and gravel parking lots, and Gilman Street Extension, adjacent to the west side of the stable area of the Golden Gate Fields horse racing facility (Photographs 1 through 10 in Appendix F). According to the Golden Gate Fields website, the horse racing track opened in 1941 (Golden Gate Fields 2018). Its initial operations were truncated by World War II, during which the facility was reportedly used as a naval amphibious landing craft base. Horse racing recommenced in 1946 and has continued until the present. The TBSC was opened in September 2008. Prior to development as playing fields, the land was used by Golden Gate Fields for storage and parking (East Bay Times 2008).

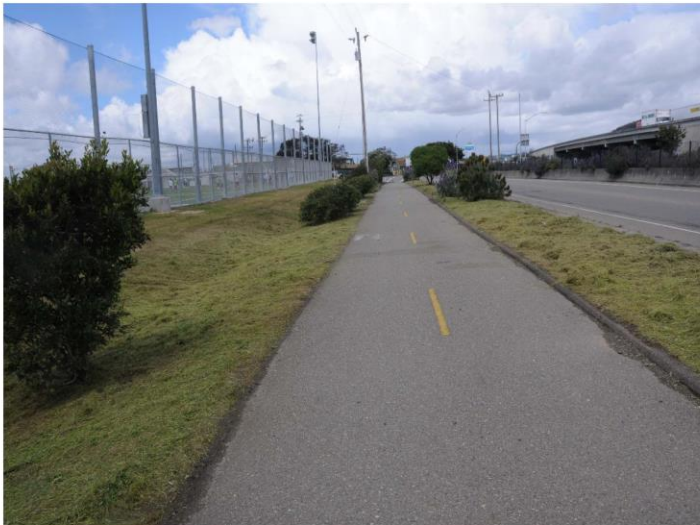
Photograph 2

Description: Bike path (San
Francisco Bay Trail) located
between Tom Bates Regional
Sports Complex and West
Frontage Road

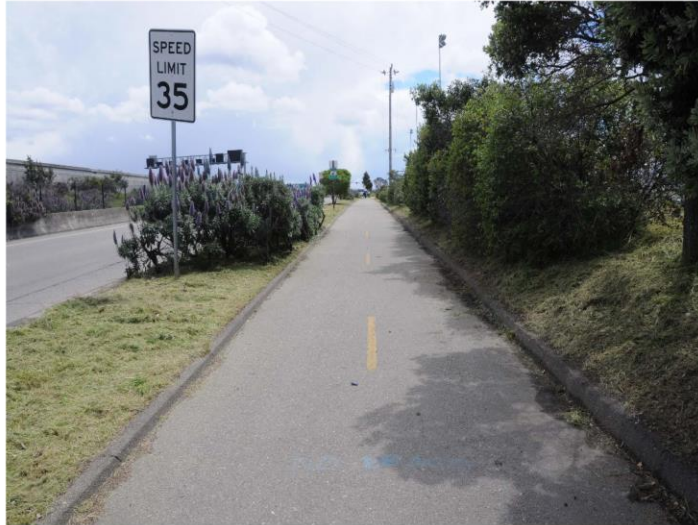
Description: Approximate location of proposed bicycle/pedestrian overcrossing of I-80

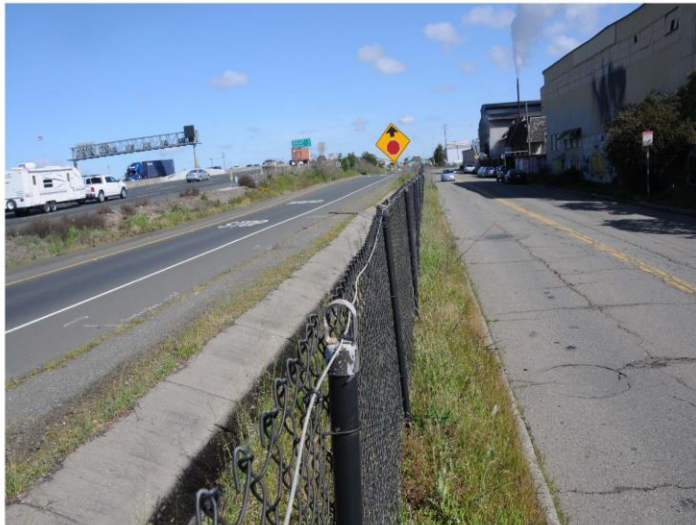
Photograph 4

Description: Approximate location of proposed bicycle/pedestrian overcrossing of I-80

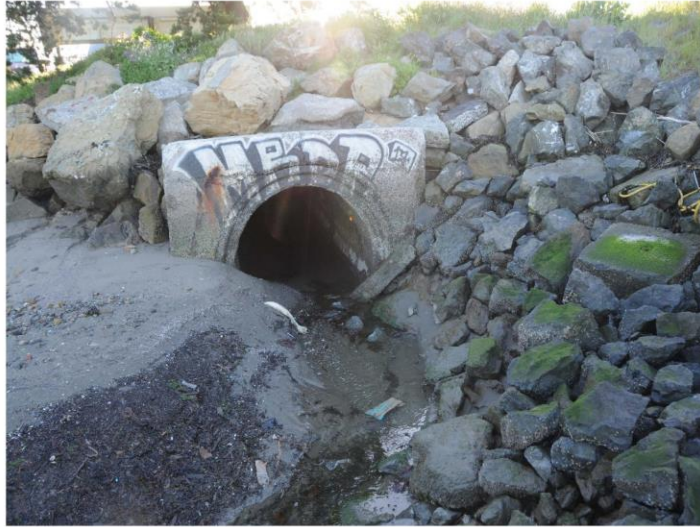
Description: Outfall (during low tide) from Gilman watershed into San Francisco Bay.

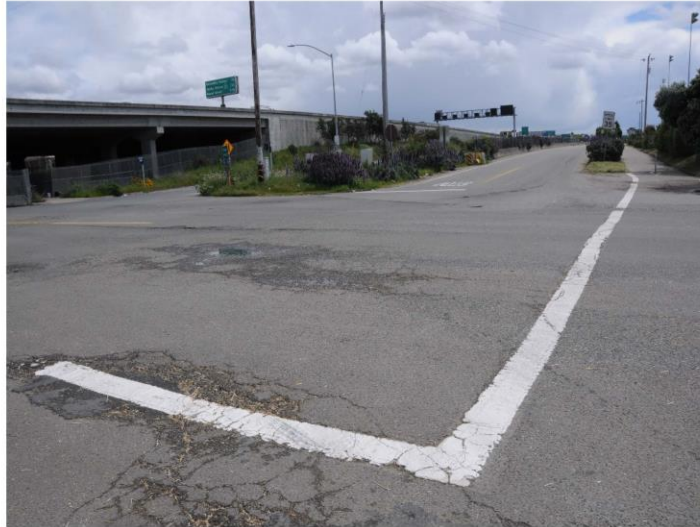
Description: Electrical control boxes in median strip between roadways, in area of utility pole relocations

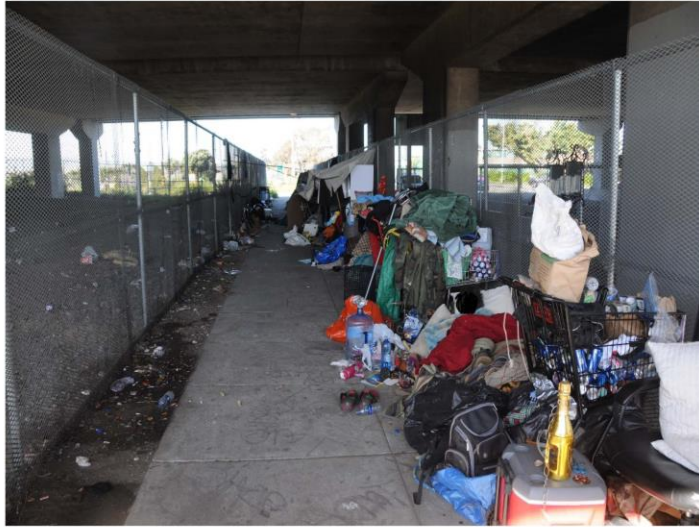
Description: Homeless encampment under southern side of I-80 Gilman Street overcrossing, near proposed multi-use path

Bridges built between approximately 1950 and 1982 may contain asbestos in features such as expansion joints, girders, and joints at the abutments. A concrete bridge comprises the Gilman Street undercrossing of I-80 (Photographs 11 through 15 in Appendix F). Expansion and abutment joints were observed from the public ROW during the site survey but were not inspected closely due to difficult access (fencing, homeless encampments, and traffic). The compounds in the joints may be asbestos-containing materials. Caltrans SSP 14-11.02 includes guidance for when asbestos is discovered on the work site (2015a).

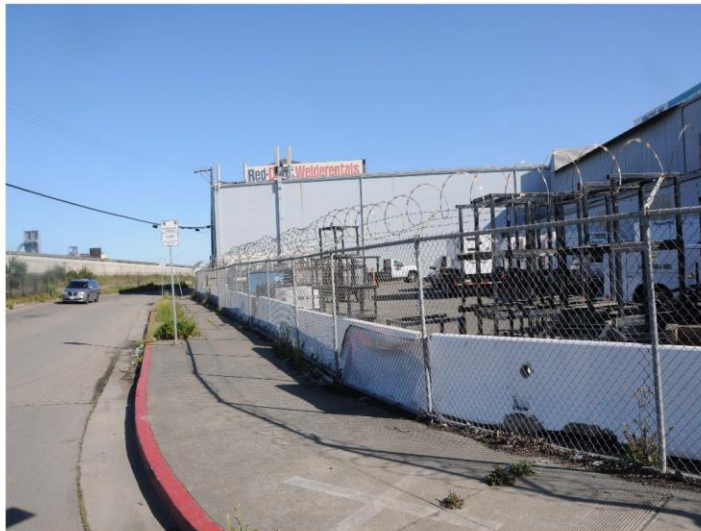
Photograph 16

Description: Former Chevron gas station site (1285 Eastshore Highway, right foreground), Red-D-Arc equipment storage and Red-D-Arc (635 Gilman, background)

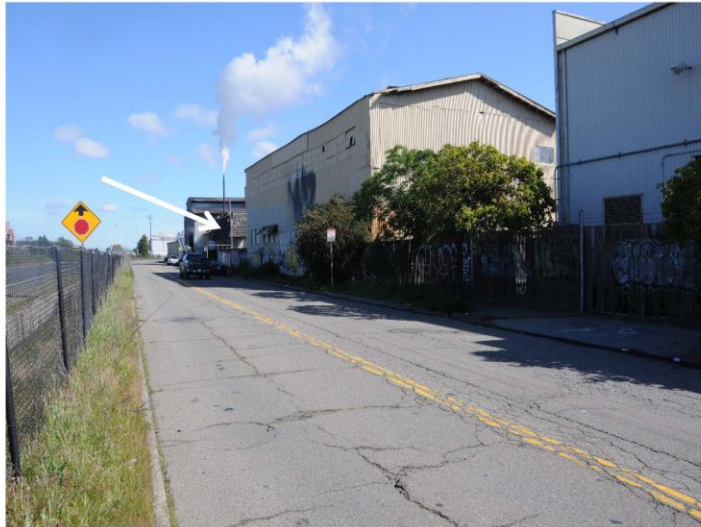
Description: Berkeley Forge and Tool (arrow) with Pacific Steel Casting Company in background

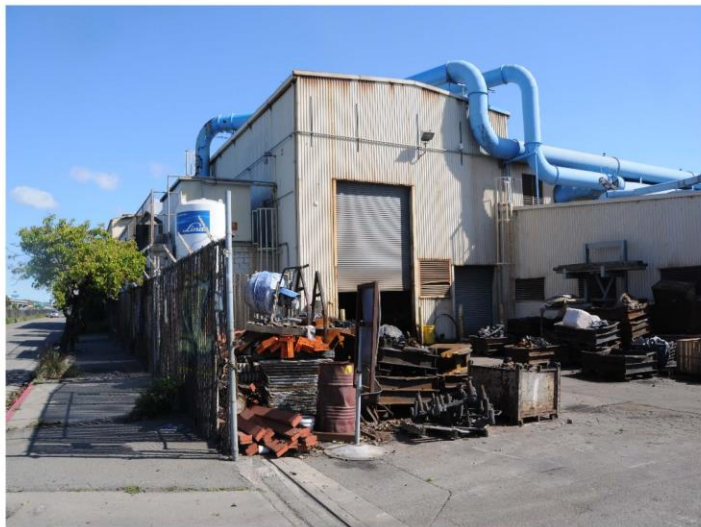
Photograph 18

Description: Materials and equipment storage on corner, Pacific Steel Casting Company manufacturing facility

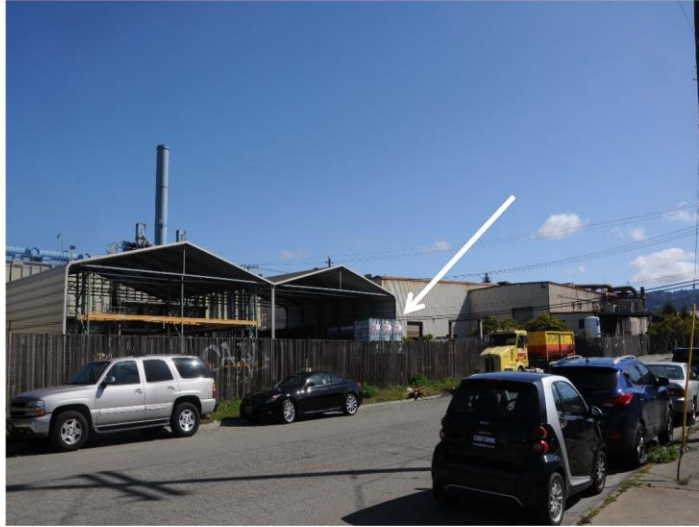
Description: Materials and
chemical tote storage.

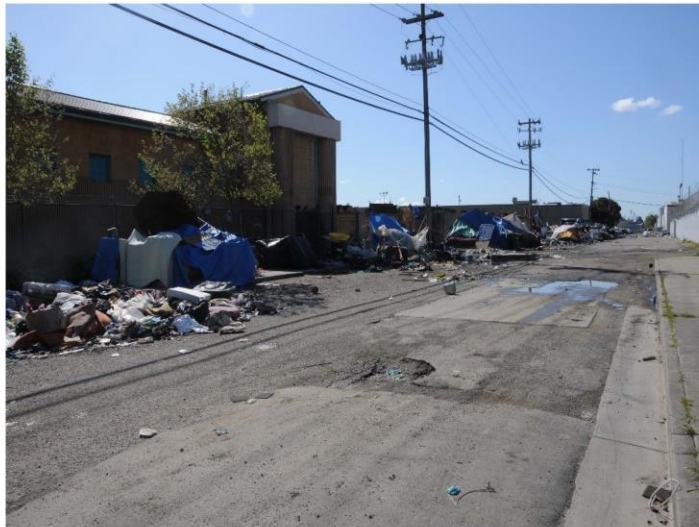
Photograph 20

Description: Poor conditions

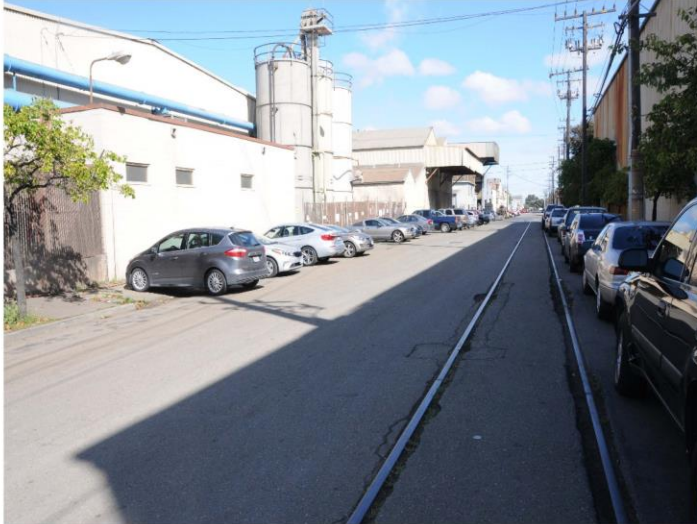
Description: Pacific Steel Casting Company Plant 2 on west side, abandoned railroad spur north/south on east side of 2nd Street

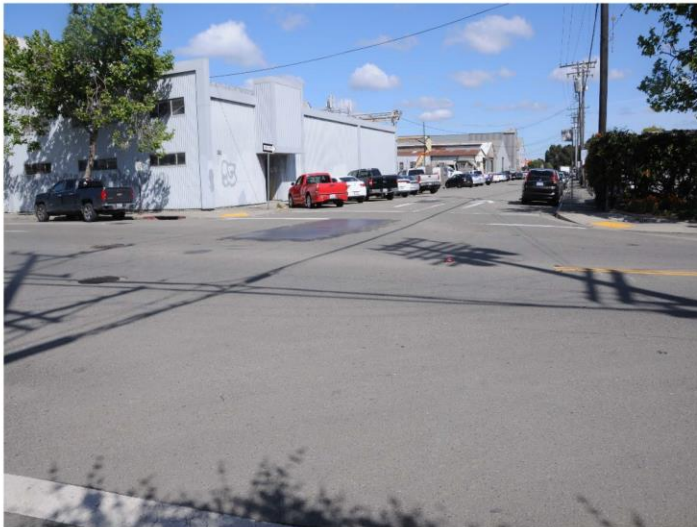
Photograph 22

Description: Red-D-Arc/AirGas /NESCO (635 Gilman Street, northwest corner) and Berkeley Recycling / Solid Waste Management Center (1235 2nd Street, northeast corner)

Eastshore Highway to 2nd Street, North of Gilman Street. The block bound by Eastshore Highway, Gilman Street, 2nd Street and Harrison Street was wetland in 1915 and vacant (possibly agricultural) until at least 1939, based on its appearance in the 1939 aerial photograph. By 1946, buildings are visible along Eastshore Highway, Gilman Street and 2nd Street adjacent to the project site. Sanborn Maps from 1950 indicate that a “gas and oil” facility (likely a gas station based on the facility’s configuration and city directories in Appendix D) was present on the corner of Gilman Street and Eastshore Highway (noted as 1285 Eastshore Highway), and a “mach[in]e shop & welding” facility was present on the corner of Gilman and 2nd Streets. Structures listed with uses including “spray paint booth,” “metal wkg,” and “industrial equipt. rental” indicate the type of facilities that were present. These former operations are depicted at these properties on the 1970 and 1980 Sanborn Maps. In 1980, the facility at the corner of Gilman and 2nd Streets (1285 Eastshore Highway) is identified as a “fill’g sta.” This is the location of the former Chevron gas station. The property is currently (in 2018) used for equipment storage by Red-D-Arc, Welderentals (635 Gilman Street), which occupies the buildings at the corner of Gilman and 2nd Streets (Photographs 22 and 23 in

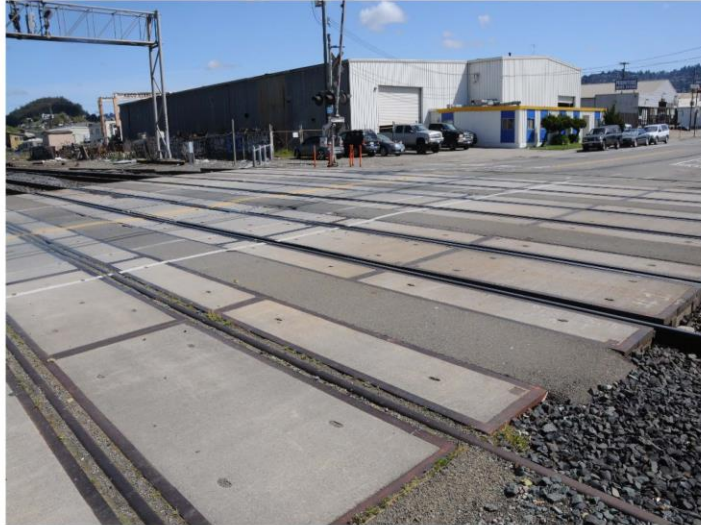
Description: Terminal
Manufacturing Company and
Union Pacific Railroad mainline
crossing

Environmental releases may have occurred within the UPRR mainline ROW (Photograph 25 in Appendix F) or the abandoned segment of railroad track that runs down 2nd Street (Photographs 21, 35 and 36 in Appendix F). Chemicals or hazardous materials may have previously leaked or spilled from tanks or cars transported by the railroad. Releases may also have occurred due to failure or breakage of brake lines or other equipment over the many years that the rail line has been in use. Railroads used chemicals to control vegetation growth and burrowing animals that could undermine the railroad tracks, residues of these chemicals might persist. One report reviewed during this investigation noted that a Kinder Morgan pipeline runs parallel to the rail line through the project site (SES 2016). Historical leaks from the pipeline are a potential source of contamination within the project site.

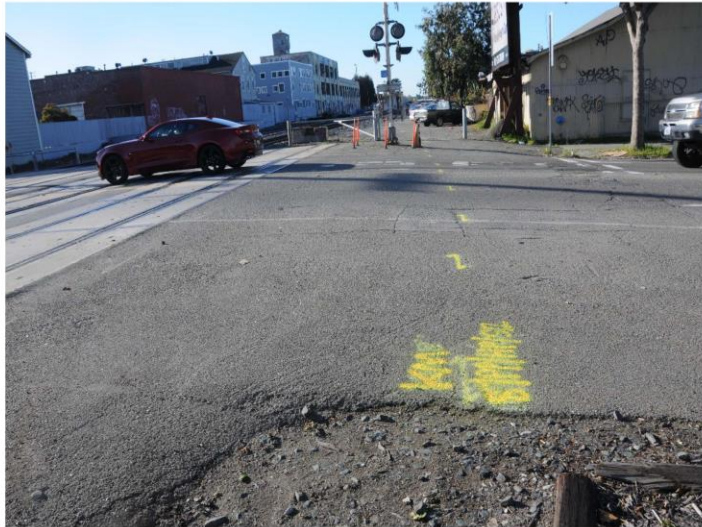
Description: Marked Kinder Morgan fuel line along west side of UPRR tracks

The report states that a Kinder Morgan gas line runs parallel to the UPRR tracks, 5 feet west of the western boundary of the facility. Paint markings on the pavement during the site reconnaissance on April 16 and 17, 2018, were observed trending parallel to the east and west sides of the UPRR tracks (Photograph 31, Appendix F).

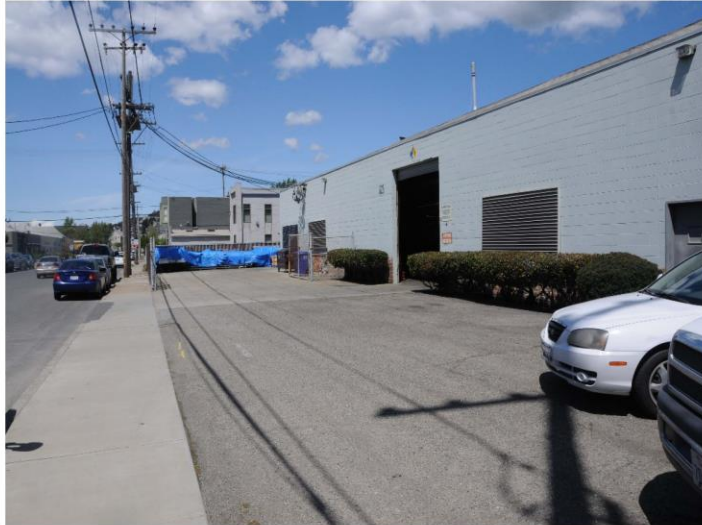
Description: WRE/Colortech west
side of property

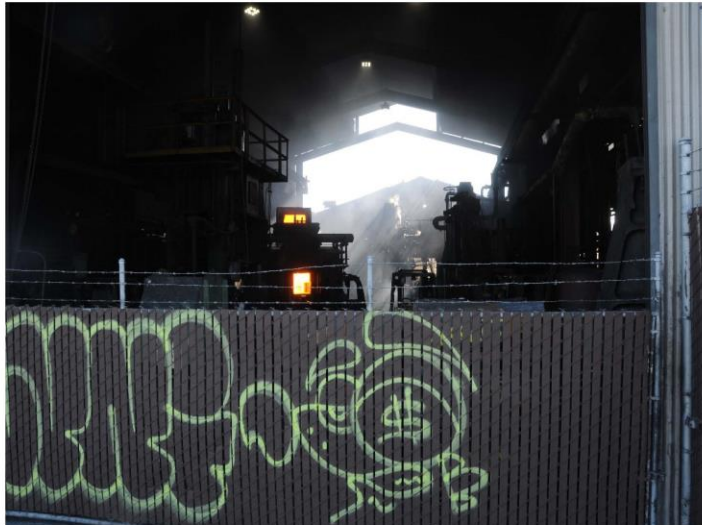
Photograph 34

Description: Pacific Steel casting
conducting operations

(trifluoromethyl)-benzene, heptane, petroleum distillates, waste gasoline, diesel fuel. Solids such as no bake paste and friable asbestos have also been used. Various USTs are documented to have been present on the PSC property. Records indicate that PSC operations resulted in an unleaded UST leak in the 1990s which resulted in more than 15,000 gallons of fuel-impacted groundwater being treated. The former UST was located on the property at Plant No. 2 (1333 2nd Street), approximately 60 feet north of Page Street along Eastshore Highway. Photographs of the area during the site reconnaissance on April 16 and 17, 2018, are provided in Appendix F (Photographs 17, 18, 21, 34 and 35).

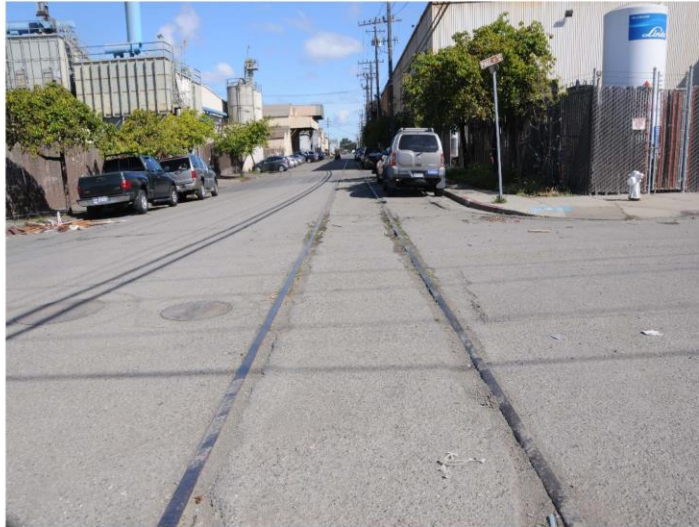
Description: Abandoned rail tracks trending on 2nd Street.

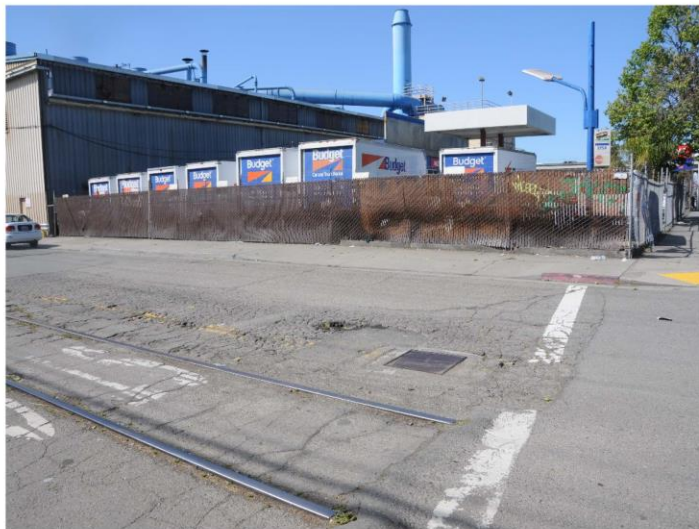
Description: Current Budget Rent-a-Car facility

Budget / Avis Rent a Car, 600 Gilman Street. The Budget Rent-A-Car facility is at the southwest corner of Gilman and 2nd Streets (Photograph 36, Appendix F). This property is within the project footprint (see Figure 2). The facility is reported to have formerly had a fuel dispensing operation (TRC 2013, Integral Consulting, Inc. 2014). Three USTs were removed in 1989, and one was removed in 2014. The USTs removed in 1989 included one 10,000-gallon unleaded gasoline UST, a 10,000-gallon diesel UST, and a 550-gallon used oil UST. Closure of these USTs was approved by the City of Berkeley Toxics Management Division (BTMD) in May 1999. Shortly after the three USTs were removed in 1989, a new 8,000-gallon UST was installed. This UST was removed in February 2014 (Integral 2014). During the removal of this tank, petroleum hydrocarbons in the gasoline and diesel ranges were detected in soil and groundwater samples collected from excavations; benzene and other volatile organic compounds (VOCs) were detected in some samples as well (Appendix G-3 contains a summary table of the analytical results associated with the tank removal). The petroleum hydrocarbon concentrations were reportedly comparable to those observed in the 1990s subsequent to removal of the three former USTs in 1989. The BTMD issued a closure letter for the UST removal in April 2015.
