Phase I Environmental Site Assessment

Proposed Kaiser Permanente Site

Southwest Corner of Escondido Avenue and Major Place

Terracon Project No. CB177179

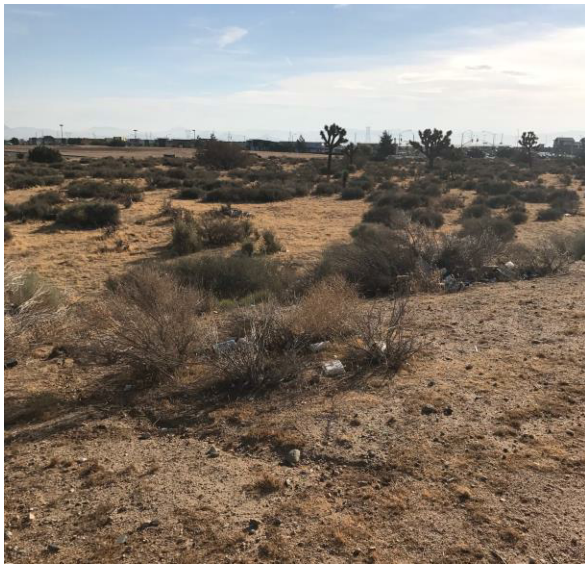
Scattered miscellaneous household trash and debris were observed throughout the site during the site reconnaissance, particularly in the southwestern portion of the site. Based on visual observation (only of surface materials), less than one cubic yard of debris, which consisted of household materials was observed. Leakage, spills or other releases from these materials were not observed during the visual reconnaissance. The debris materials did not appear to be hazardous in nature. Based on site observations, the trash and debris does not constitute a REC to the site.

Photo #3 View of scattered trash in southwestern portion of site.

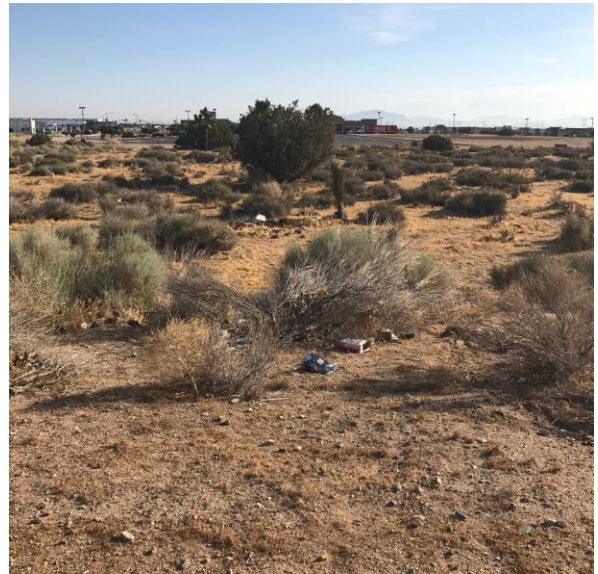
Photo #4 View of scattered trash in southwestern portion of site.

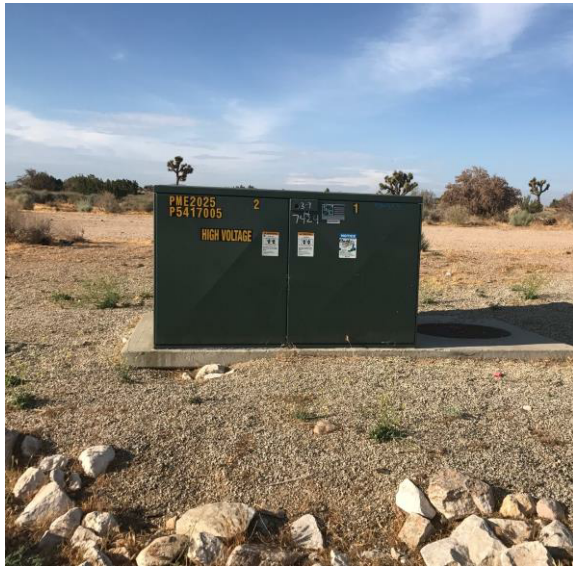
During Terracon's site visit, one pad-mounted transformer, owned and serviced by SCE, was observed along the driveway in the north-central portion of the site. An additional underground SCE vault was located in the northwest corner of the site. No information with regard to PCB content of the transformer fluids was observed. Some transformers contain mineral oil which may contain PCBs.

SCE maintains responsibility for the transformer, and if the transformer was "PCB contaminated," SCE is not required to replace the transformer fluids until a release is identified. However, evidence of current or prior releases was not observed in the vicinity of the electrical equipment during the site reconnaissance.

Photo #5 Pad-mounted transformer in north-central portion of site.

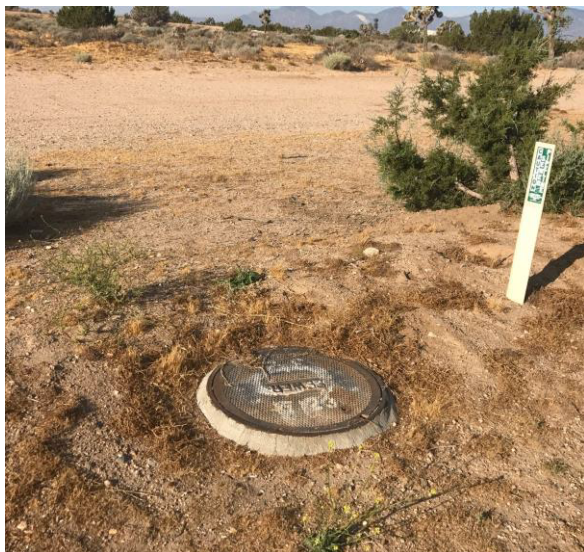
Sewer pipeline placards and Hesperia Sewer manholes were observed along the northern property line. Natural gas line placards indicating a Southwest Gas Corporation pipeline were located along Escondido Avenue. Based on available parcel overlays, the natural gas line appears to be located on an adjacent portion of the public road right of way.

Photo #7 Sewer pipeline placard and manhole in northern portion of site.

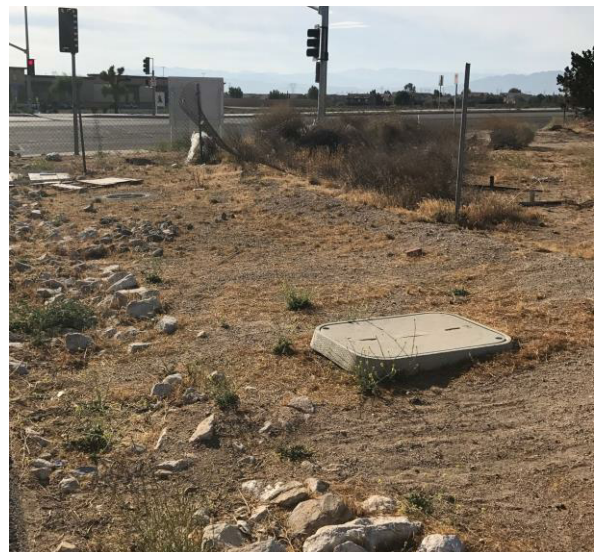
Photo #8 View toward east of northeastern portion of site; cable TV box in view.
