# Appendix G

## **Hydrology, Water Quality, and Utilities**

RE: **HYDROGEOLOGIC REPORT**  
**UNDER CANVAS – GROVELAND, CALIFORNIA**

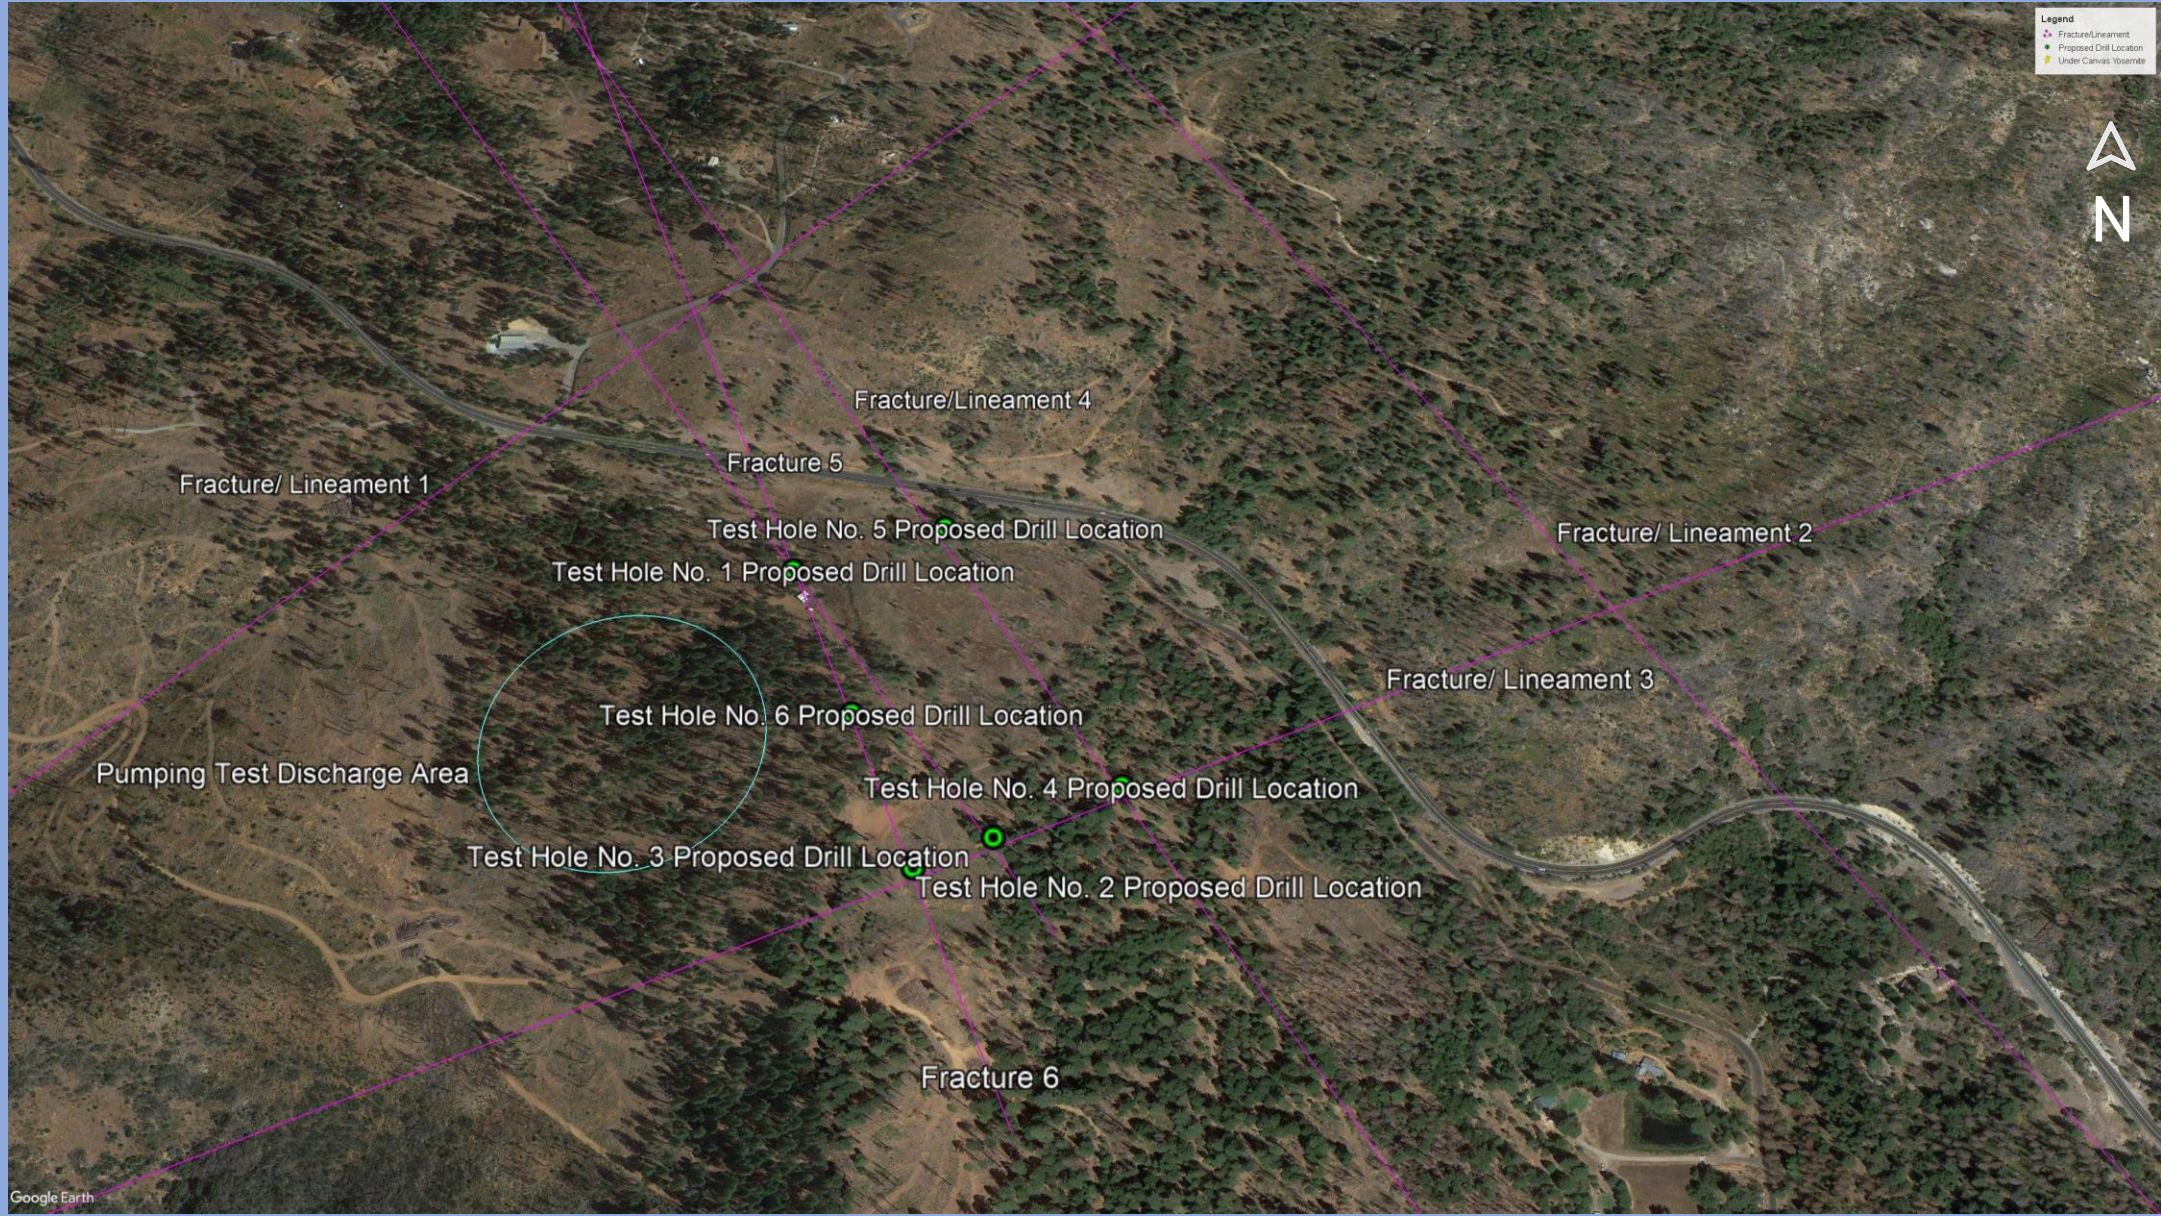
Figure 4  
Proposed Discharge Area  
Water Resources Associates, Inc.

Based on the ground truthing and field mapping, four locations were selected, out of the six, and three were considered most promising for the previously stated reasons. Figure 4 shows the locations of the six original and final four locations. Well siting involved a more in-depth review of each site, and assessing proximity to the inferred fracture system. Figure 5 indicates the results of the well siting effort, and the three most promising are numbered in the order of precedence for drilling.
