Appendix E: Biological Resources Report

#### Dublin Boulevard-North Canyons Parkway Extension Project Biological Resources Report

Project #3922-01

## Preliminary Delineation of Wetlands and Other Waters

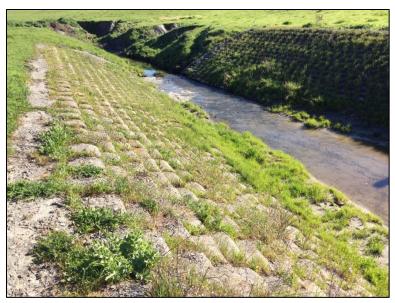
Cottonwood Creek is a perennial stream with a connection to groundwater and flows overland through the eastern portion of the BSA (Photo 1). It originates 4 mi north of the BSA in the Diablo Mountains

Photo 1. Perennial stream habitat within Cottonwood Creek.

near Collier Canyon Road, and flows southward to exit the BSA through a double box culvert beneath I-580, and then empties to Arroyo Las Positas after just 0.15 mi. Arroyo Las Positas flows into Arroyo Mocho, and historically, this watercourse went underground shortly thereafter, exhibiting no overland connection to the San Francisco Bay. During the present day, Arroyo Mocho flows through an aboveground engineered channel, draining into Alameda Creek and ultimately reaching the Bay, a traditionally navigable water. The main stem of Cottonwood Creek is split into two low flow channels just upstream of the BSA, and these channels converge in the central portion of the BSA. Although historical aerial photos indicate that this section of Cottonwood Creek generally conveys water year-round, it is possible that in periods of drought, sections of the stream may dry up or retreat underground. The inner stream banks are sharply incised and generally lined with exposed soil, providing little stabilization. As a result, numerous erosional features, such as headcuts and gullies, were apparent during surveys.

The reach of Cottonwood Creek in the BSA is shallow, steeply incised, unshaded, and contains little to no instream vegetation, which limits its value for fish and aquatic wildlife. No fish were observed within Cottonwood Creek during reconnaissance surveys, and the creek's shallow waters and lack of large pools make it unsuitable for most fish species. Small fish adapted to warm waters, such as the native California roach

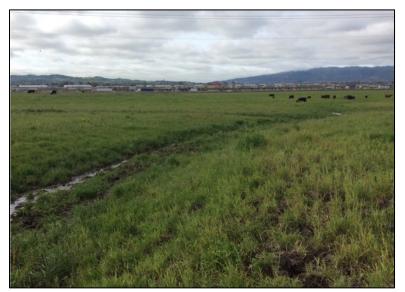
Vegetation. Three ephemeral streams occur in the BSA (Figure 3). These streams convey water during and immediately following rain events, and dry out during the summer months. As a result of heavy rains occurring just prior to the March 2017 reconnaissance survey, flowing water was present in sections of all ephemeral streams. But, no flowing water was present in any of these ephemeral streams during the surveys conducted in April and May 2018 (Photo 2).

Photo 2. A typical ephemeral stream in the Study Area.

A rocked area occurs in one ephemeral stream in parcel F. Otherwise, the majority of the ephemeral stream banks were vegetated with plants found in the surrounding California annual grasslands described below.

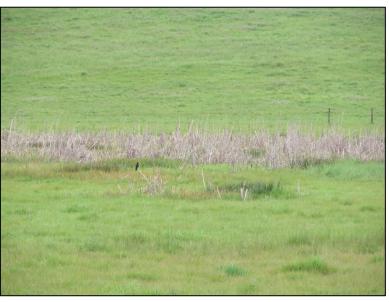
Vegetation. The perennial marsh habitat in the BSA supports strongly hydrophytic, emergent plants, and the marsh within the BSA is within the OHWMs of the perennial stream along Fallon/Croak Road. This features contained surface water and was codominated by Mexican rush (Juncus mexicanus) and iris-leaved rush (Juncus xiphioides), although some patches of hardstemmed bulrush (Schoenoplectus acutus) were also observed (Photo 3). Surface water was evident during all survey dates. Along the fenceline, dominant vegetation included alkali bulrush (Bolboschoenus maritimus), water parsnip (Berula creeping erecta),

Photo 3. Dead narrowleaf cattails within the large perennial freshwater marsh in parcel A.

Historically, narrowleaf cattails (*Typha angustifolia*) dominated the central portion of the seasonal wetland in parcel A. However, these cattails had entirely died back at the time of reconnaissance level surveys in 2017, possibly from the disruption of the hydrological source to this feature (Photo 3). Historical aerials show that the cattail stand had only recently developed in the past approximately 8 years, and seems to have represented a temporary condition (Google 2018). Further changes in the site's hydrology were noted during the 2018 wetland delineation, and signs of marsh rewetting and some cattail regeneration were observed in April 2018; however, by May 2018 these areas were drying again and the area exhibited seasonal hydrology.

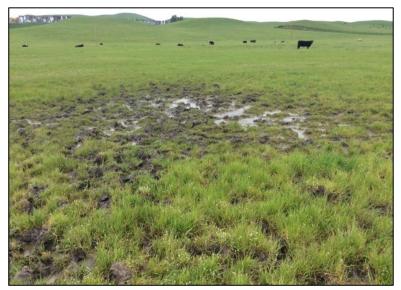
Photo 4. Seasonal wetland in Parcel A.

Seasonal wetland vegetation in the parcel A was dominated by native forbs and grasses. Plants such as popcorn flower (*Plagiobothrys sp.*), bird's eye speedwell (*Veronica persicaria*), alkali pepperweed, annual semaphore grass, alkali barley, bristled downingia (*Downingia bicornuta* var. *bicornuta*), woolly marbles (*Psilocarphus brevissimus* var. *brevissimus*), and meadow barley (*Hordeum brachyantherum* subsp. *brachyantherum*) were observed during spring surveys.

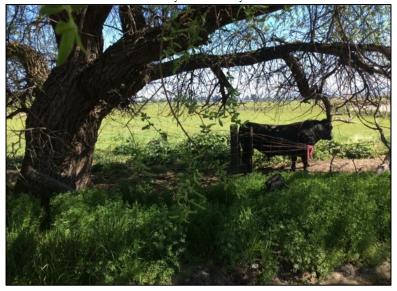
**Vegetation.** Mixed riparian woodlands in the BSA are composed of stands of mature trees rooted in the banks of perennial streams (Photo 5). Tree species include red willow and valley oak. Valley oaks in and near the BSA

Photo 5. Mixed riparian woodland habitat along Croak Road and parcel A.

that occur along Cottonwood Creek are very large (up to 4.8 ft dbh). Additionally, about 3.09 acres of riparian grassland occur within the top of the bank of Cottonwood Creek and the unnamed perennial stream to the west of Croak Road. The understory of mixed riparian woodlands intergrades with that of the surrounding habitats, and the areas of riparian grassland lacking tree cover support similar species to the surrounding California annual grassland, with species such as soft chess (*Bromus hordeaceus*) and Italian ryegrass.

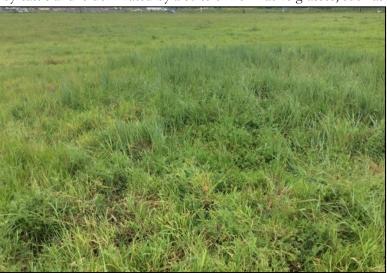
**Vegetation.** The majority (121.31 ac) of the BSA consists of California annual grassland habitat (Photo 6). Much of this grassland is currently grazed by cattle and is dominated by a suite of non-native grasses, such as

Photo 6. California grassland habitat in the BSA.

seaside barley (Hordeum marinum ssp. meadow gussoneanum), barley (H. murinum), soft chess, wild oat (Avena sp.), and Italian ryegrass. Common weedy (and non-native) forbs include various species of filaree and geranium (Erodium spp. and Geranium spp., respectively), bristly ox tongue (Helminthotheca echioides), and wild radish (Raphanus sativus). Large monocultures of bull thistle and black mustard (Brassica nigra) were also scattered across the BSA within the California annual grasslands.

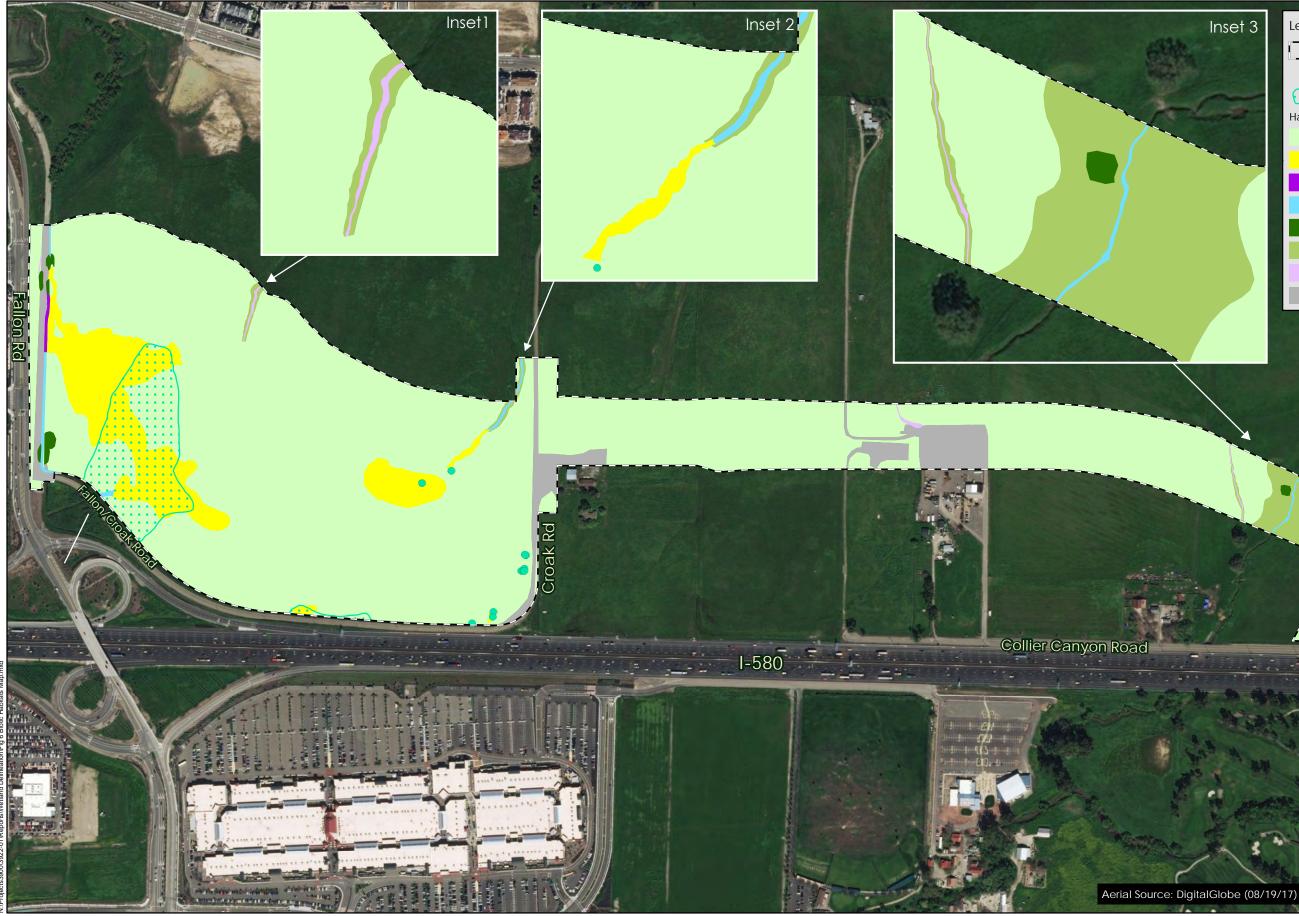
Four perennial streams comprise the perennial stream habitat in the BSA (0.33 acres) (**Figure 6**). These are the existing floodplain of Cottonwood Creek in the east and three additional unnamed streams in the western half of the BSA.

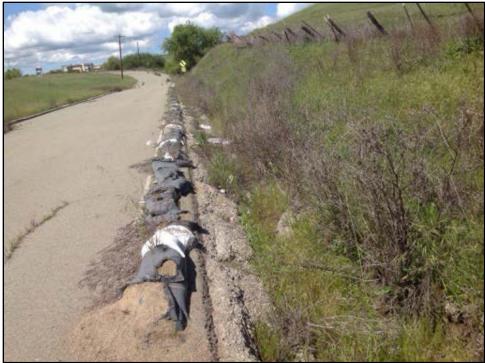
Photo 1. Concrete lined section of perennial stream PS1 that runs parallel to Croak Road and parcel A.

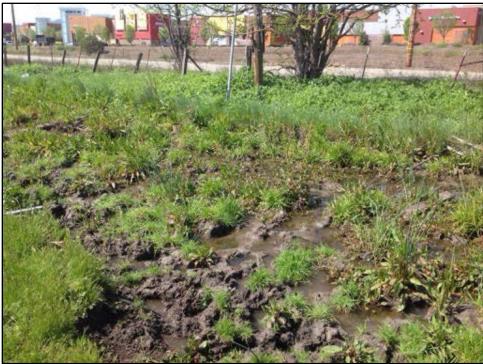
Photo 3. Perennial marsh (PM1) habitat with pooled water and extensive cow punches.

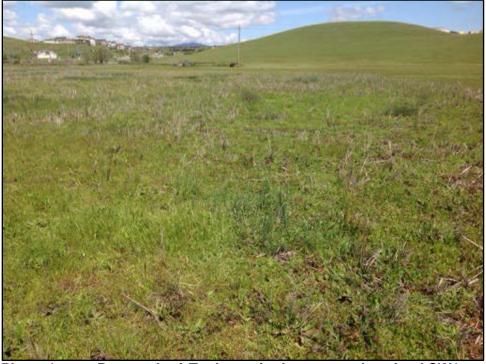
Photo 4.

Regrowth of *Typha* sp. in the seasonal wetland SW1.

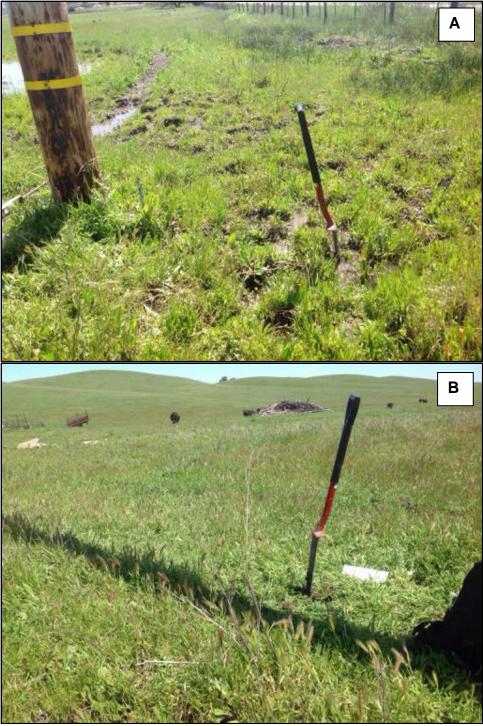
Photo 5A. Wetland sample point, SP5, representing seasonal wetland habitat with several inches of ponding and
Photo 5B. Paired upland sample point, SP4, where conditions are mesic but not wetland.

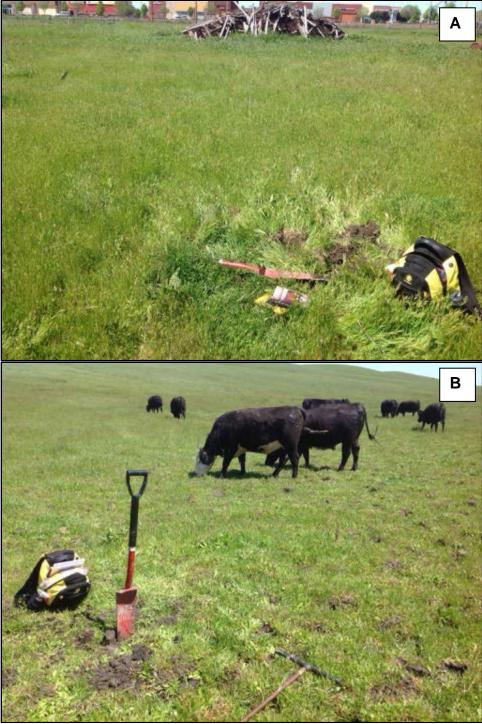
Photo 6A. Wetland sample point (SP3) for seasonal wetland (SW1) with more saturation than ponding and several cow punches and Photo 6B. Paired upland sample point (SP2) where conditions are mesic but not wetland.

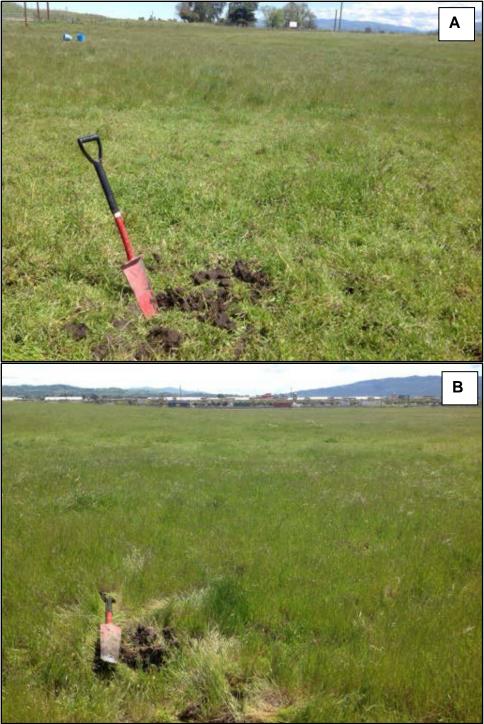
Photo 7A.Wetland sample point, SP7, in the floodplain swalewetland of SW4 formed by the perennial stream PS3 andPhoto 7B.Paired upland boundary sample point, SP8, for SW3.

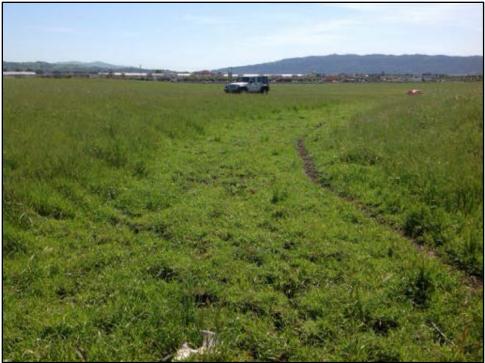
Photo 8. Unnamed perennial stream (PS3) showing the ordinary high water mark and the top of bank as defined here by the distinct change in vegetative cover and composition.

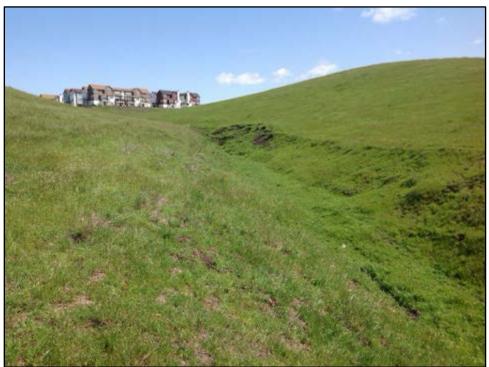
Photo 9. Ephemeral stream (ES1) in the northwestern part of the project area as defined by change in slope and topography and no flowing water.

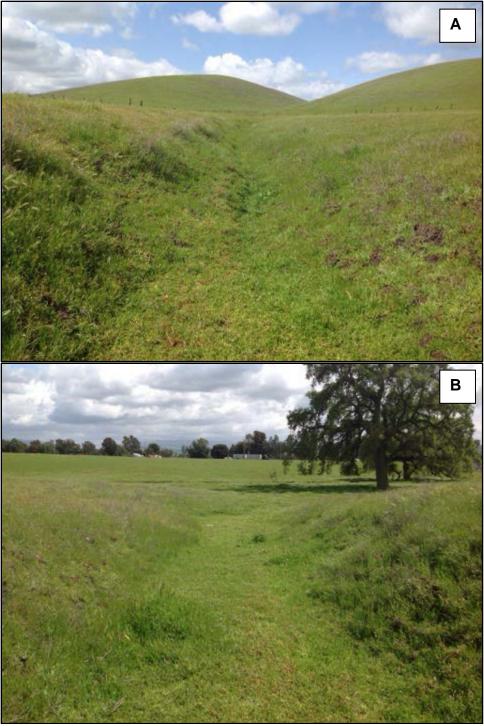
Photo 10A. The upstream portion of ephemeral stream ES3 with more incised banks and

Photo 10B. The downstream swale forming portion of PS3.

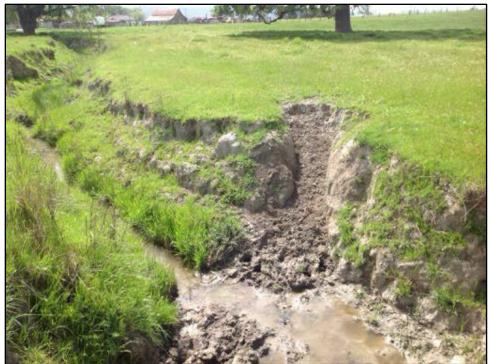
Photo 11. Cottonwood creek perennial stream (PS4) habitat showing cattle crossing, cow punches, and the ordinary high water mark as defined by the incised banks.

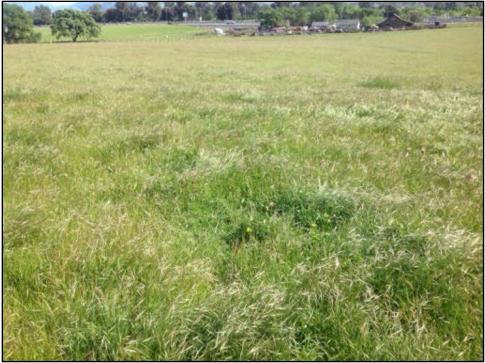
Photo 13. Typical California annual grassland habitat dominated majority of the BSA.

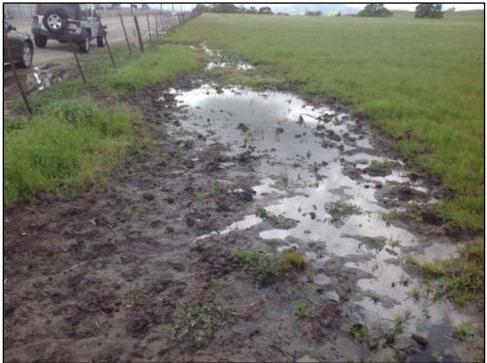
Photo 14. Location of sampling point 9 in April 2018 showing water pooled at the southeastern corner of the BSA. However, this was determined to be ephemeral ponding and did not display any wetland characteristics such as hydrophytic vegetation. This area was dry in both March 2017 and May 2018.
