Santiago Basin Saddle Repair Project

Santiago Basins Saddle Repair Project Description and Biological Assessment

Orange County Water District Santiago Basins Saddle Repair Project

November 2018

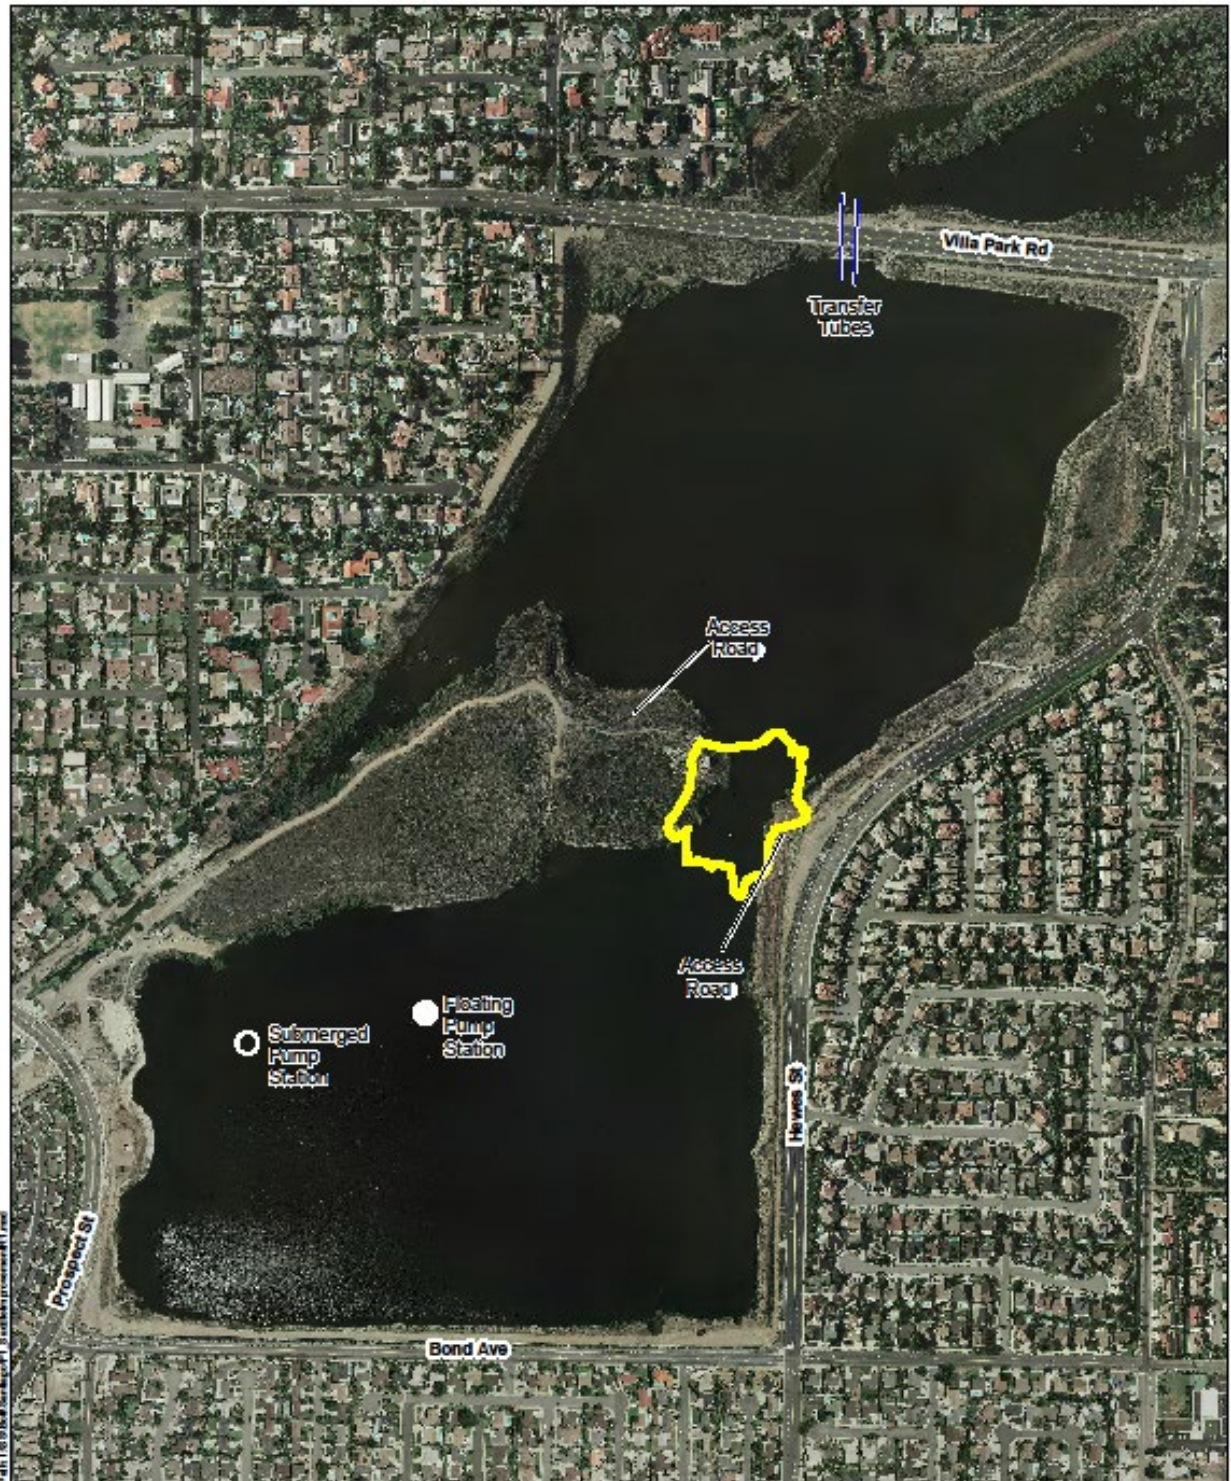
**Santiago Basins
Saddle Repair Project
Project Area**

The proposed saddle repair activities would occur in the area between Blue Diamond Basin and Bond Basin at the Santiago Recharge Basins, in the City of Orange in Orange County. As shown in Figure 1, the Santiago Basins are bounded by Prospect Avenue to the west, Hughes Avenue to the east, Bond Avenue to the south and Villa Park Road to the north. The site can be regionally accessed by State Route 55 via the Chapman Avenue exit. The Santiago Basins are located downstream of Santiago Reservoir and receive incoming flows from Santiago Creek which drains into and out of the basins. The project site is located at Township T4 South, Range R9 West on U.S.G.S. Quad Map for Orange.

As shown in Figure 1 access to the construction work site would be from existing roads that are currently used during maintenance activities. All construction equipment would be staged in an upland location above the wetted area. The project would be constructed in four phases:

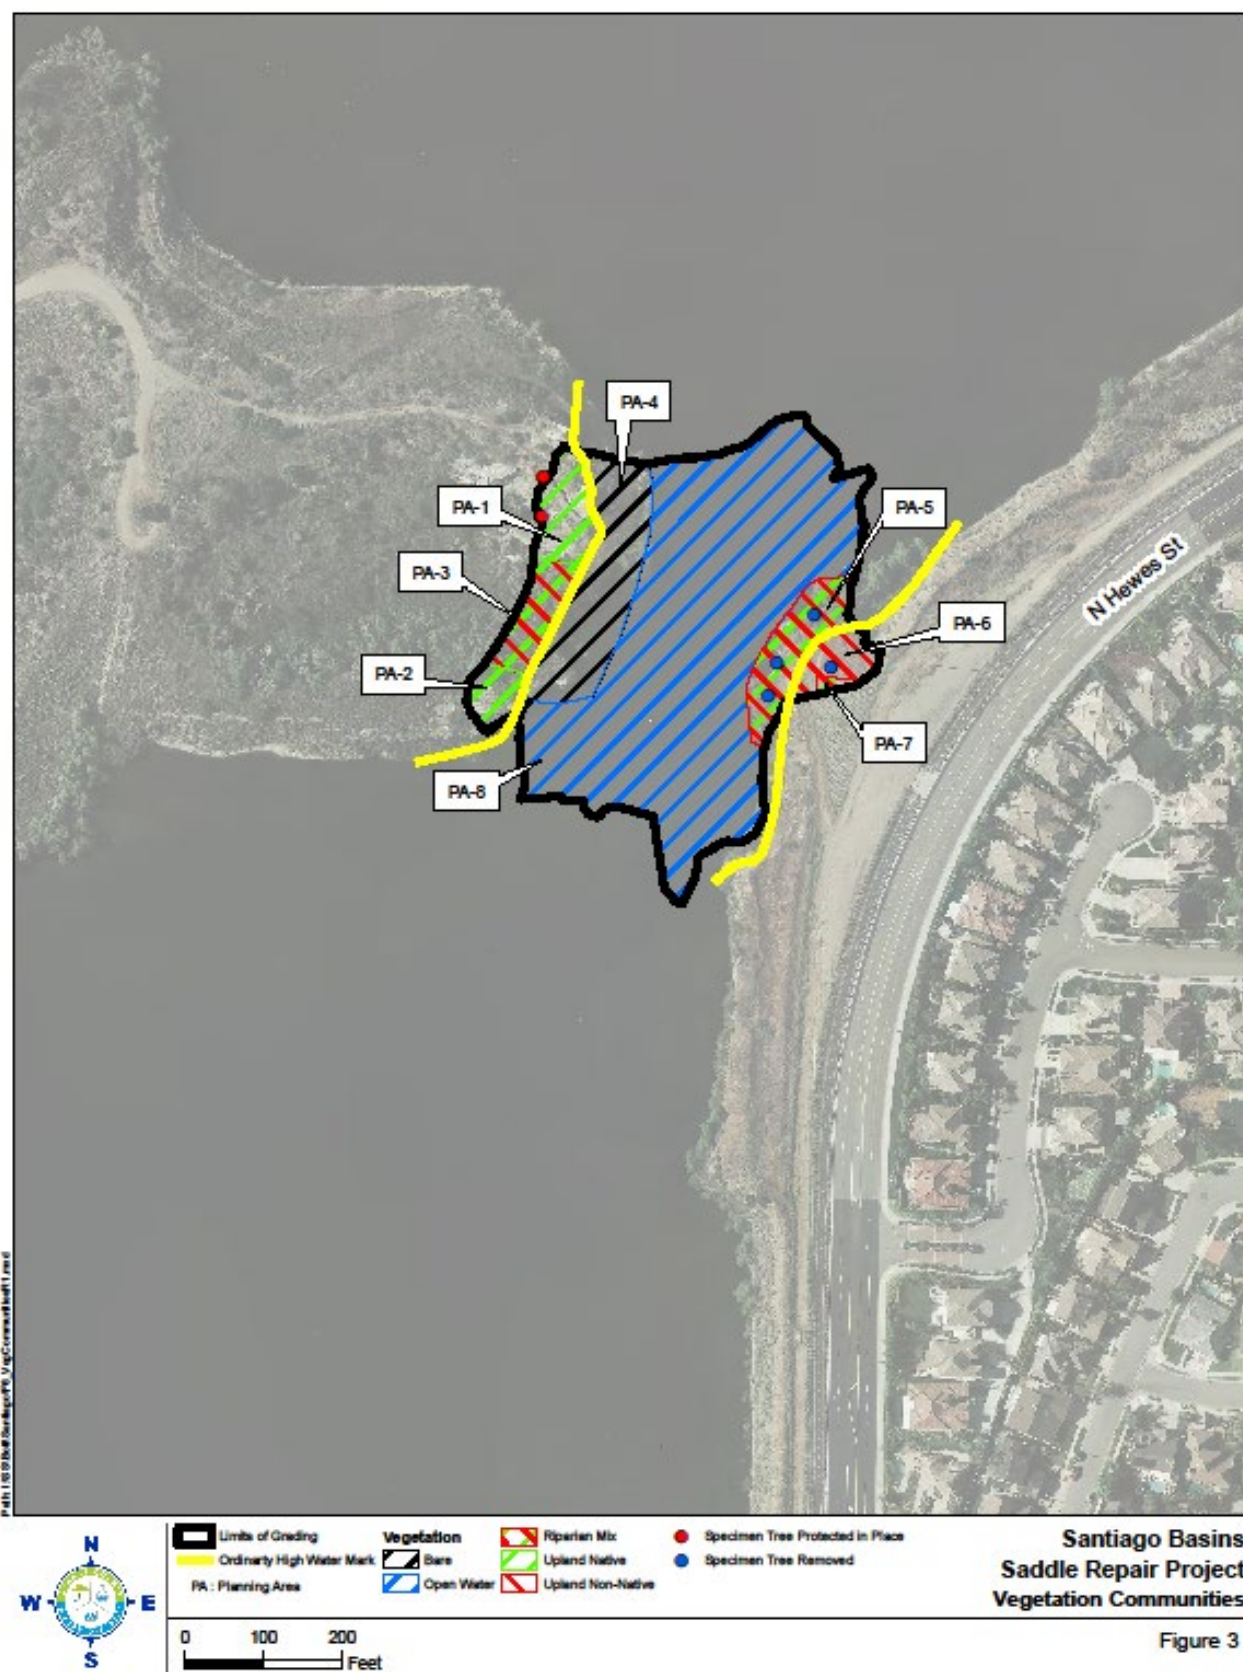
The vegetation community classifications at the project site include Upland Native, Upland Non-Native, Mixed Upland/Riparian, Bare lands and Open Water. The vegetation communities within the footprint of the construction site are shown in Figure 3 and a quantitative summary of the vegetation communities is shown in Table 5.

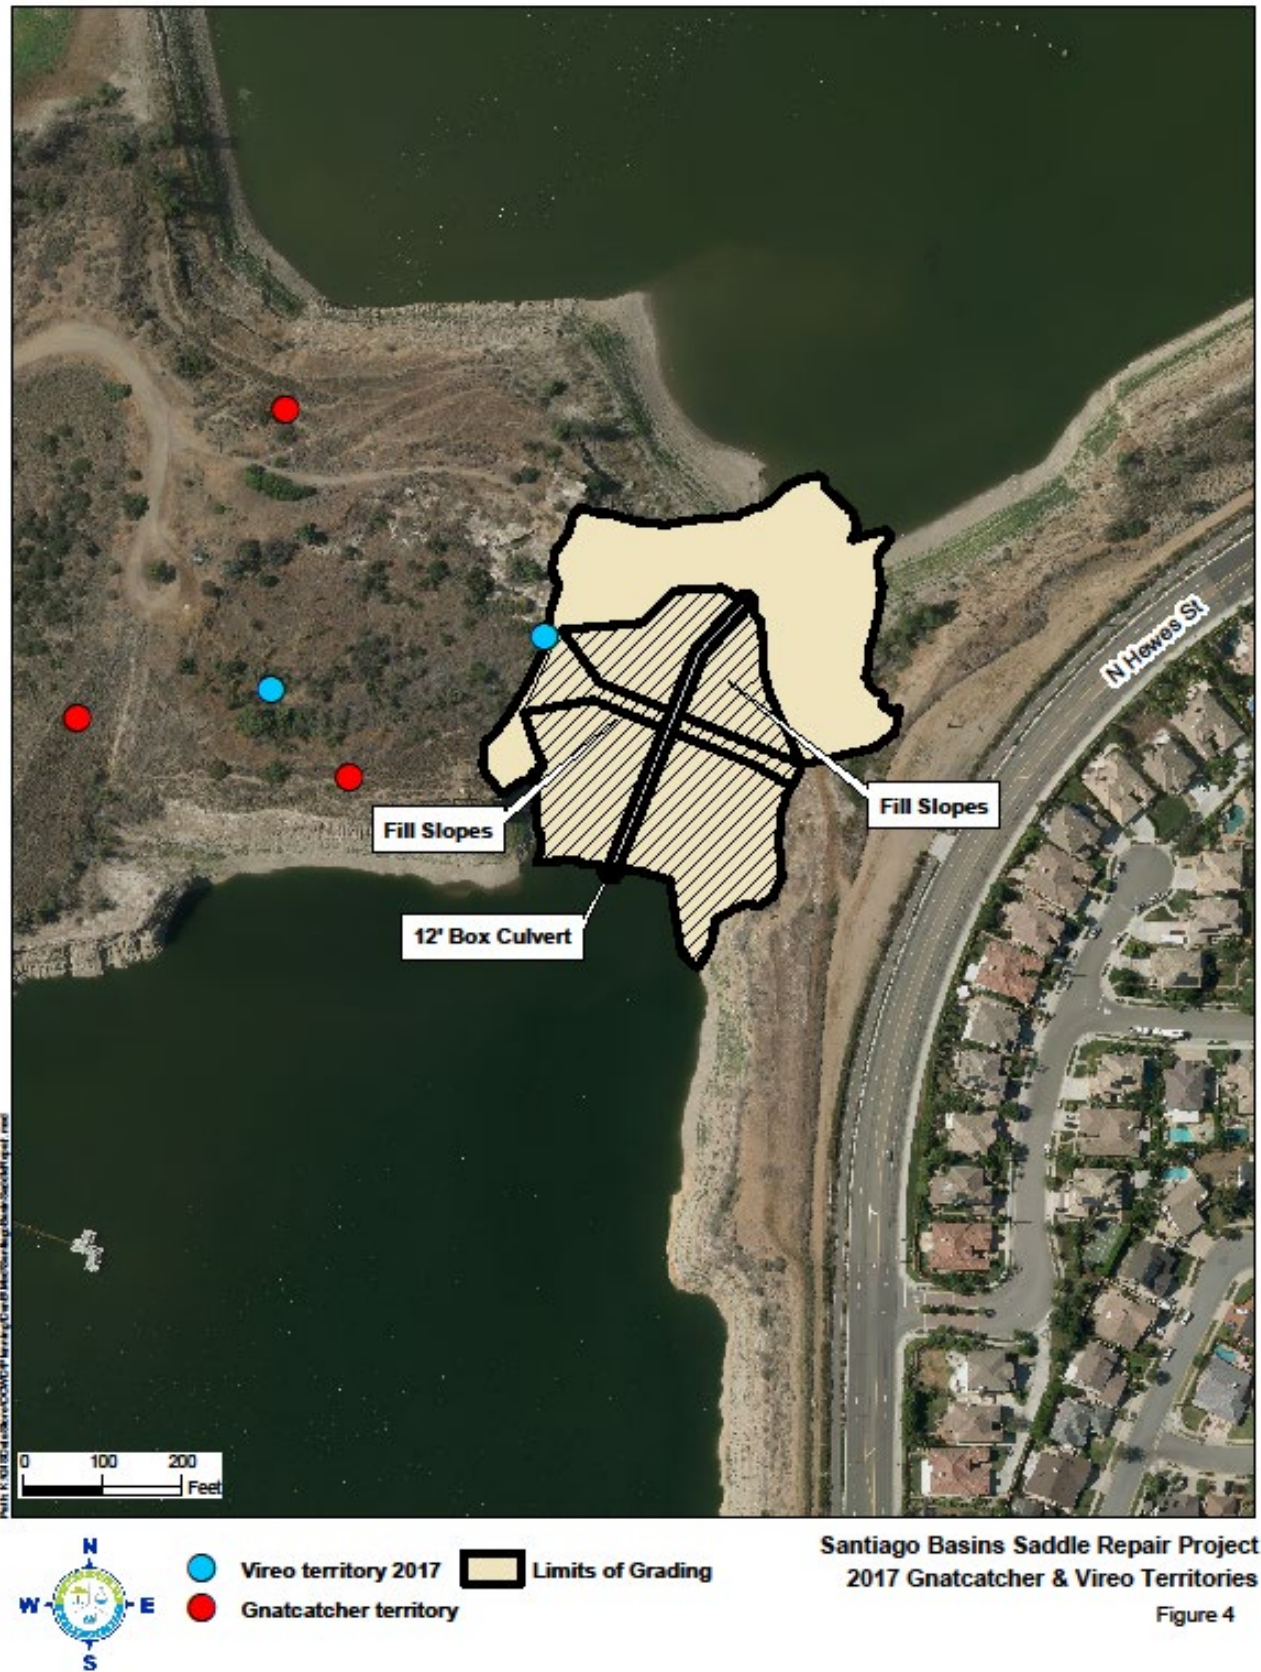
The Vireo occurs in riparian habitats along watercourses that contain dense growth of willow trees, cottonwood trees, mulefat and other dense riparian vegetation. At Santiago Basin the riparian habitat is fragmented and mixed with high amounts of non-native vegetation. Even though the quality of the habitat is marginal, there would be the potential that vireos could occur. As shown in Figure 5, in 2017 a single vireo territory was identified within the project limits of grading.

The upland areas in Santiago Basin contain pockets of coastal sage scrub. The Gnatcatcher both inhabits and nests in coastal sage scrub habitat. As shown in Figure 4 there are no known Gnatcatcher territories on the project site. Therefore, no direct construction impacts would occur. Additionally, to avoid direct impacts and indirect construction noise impacts, construction activities would occur when birds are no longer nesting. Additionally, prior to the removal of vegetation the project site would be surveyed by a qualified biologist. If the habitat is occupied, no vegetation removal activities would occur until such time the habitat is no longer occupied. With implementation of Conservation Measures BIO-1 potential significant impacts to the Gnatcatcher would be avoided.
