APPENDIX E: JURISDICTIONAL DELINEATION LETTER

SUBJECT: Jurisdictional Delineation for the Approximately 116-Acre Palomino Business Park Project, Located in Norco, Riverside County, California.

PALOMINO BUSINESS PARK PROJECT

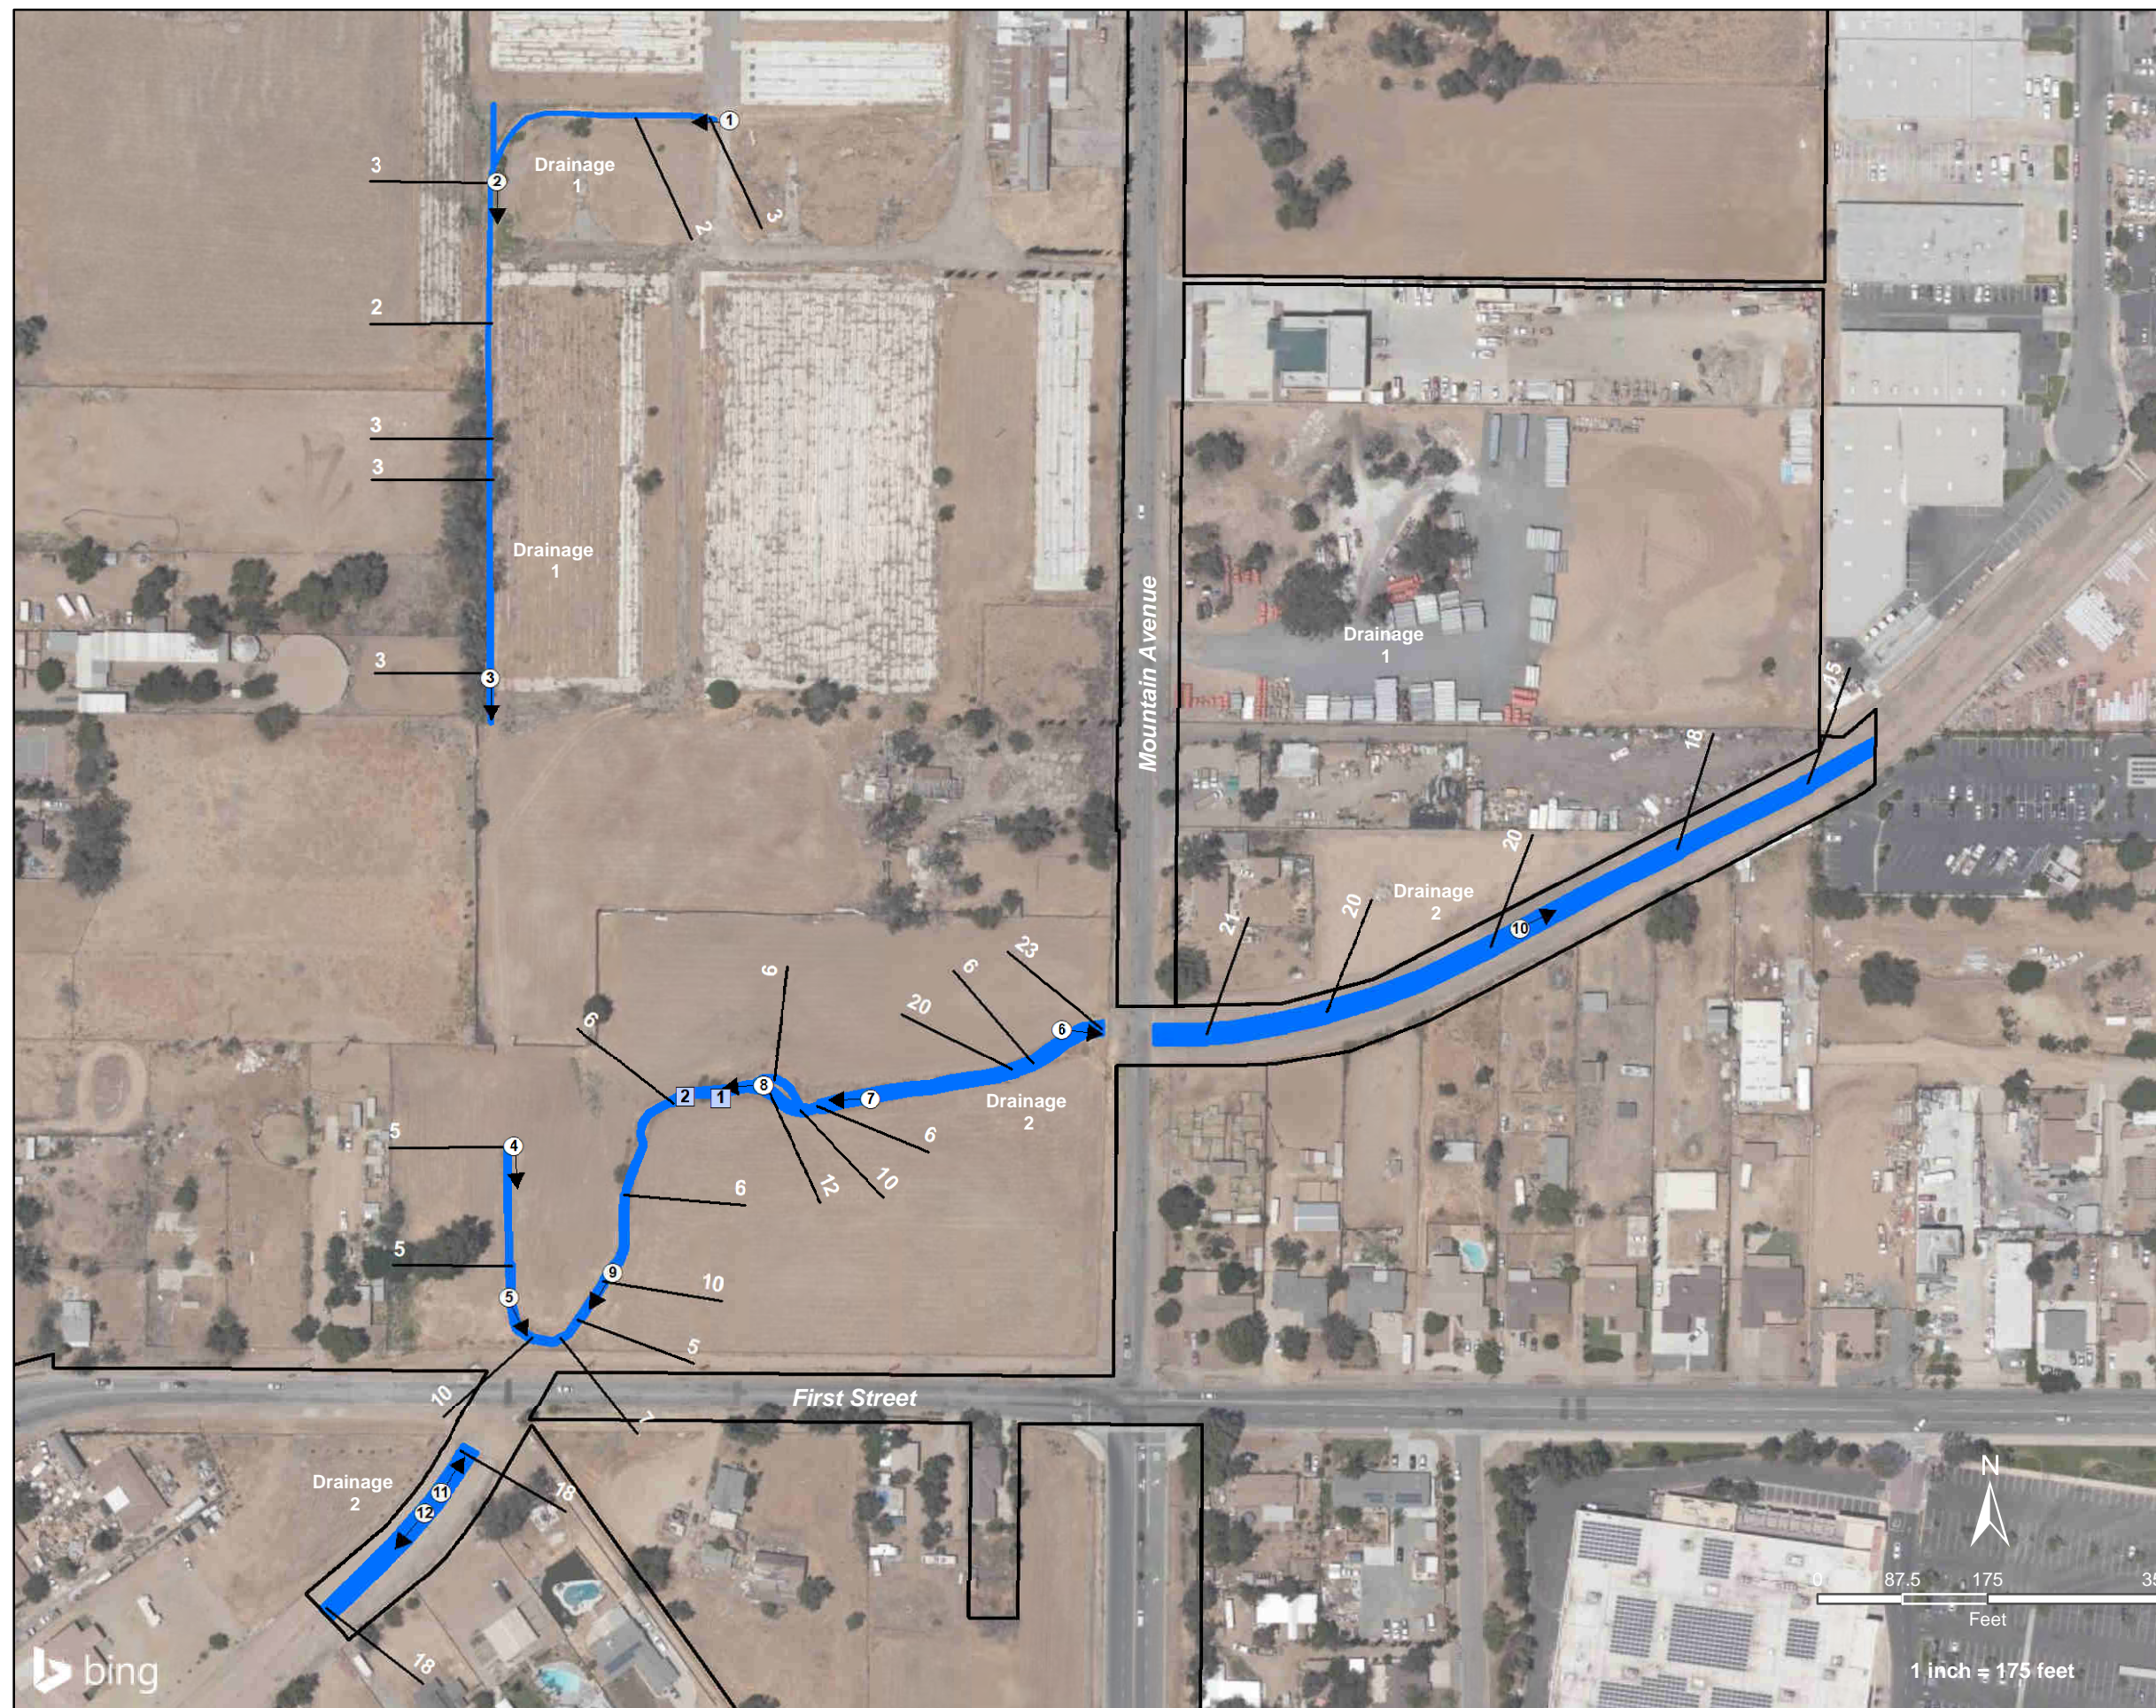
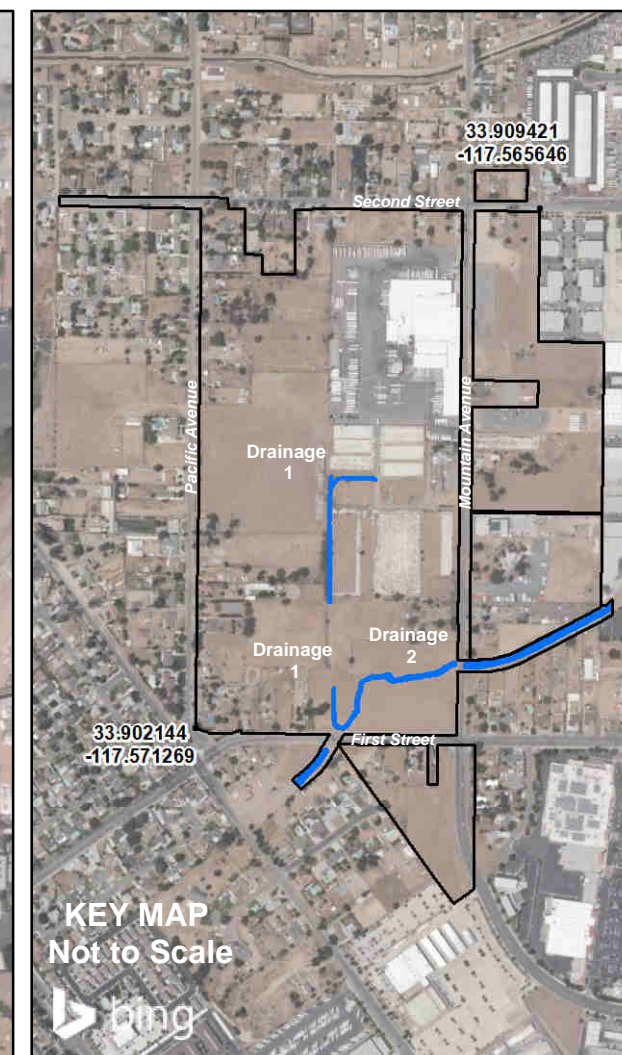
GLENN LUKOS ASSOCIATES
 Exhibit 3A

Corps jurisdiction within the Project site totals approximately 0.71 acre (2,992 linear feet) associated with two drainage features, none of which consists of wetland waters [Exhibit 3A – Corps/RWQCB Jurisdictional Delineation Map].

Corps/RWQCB Jurisdictional Delineation Map

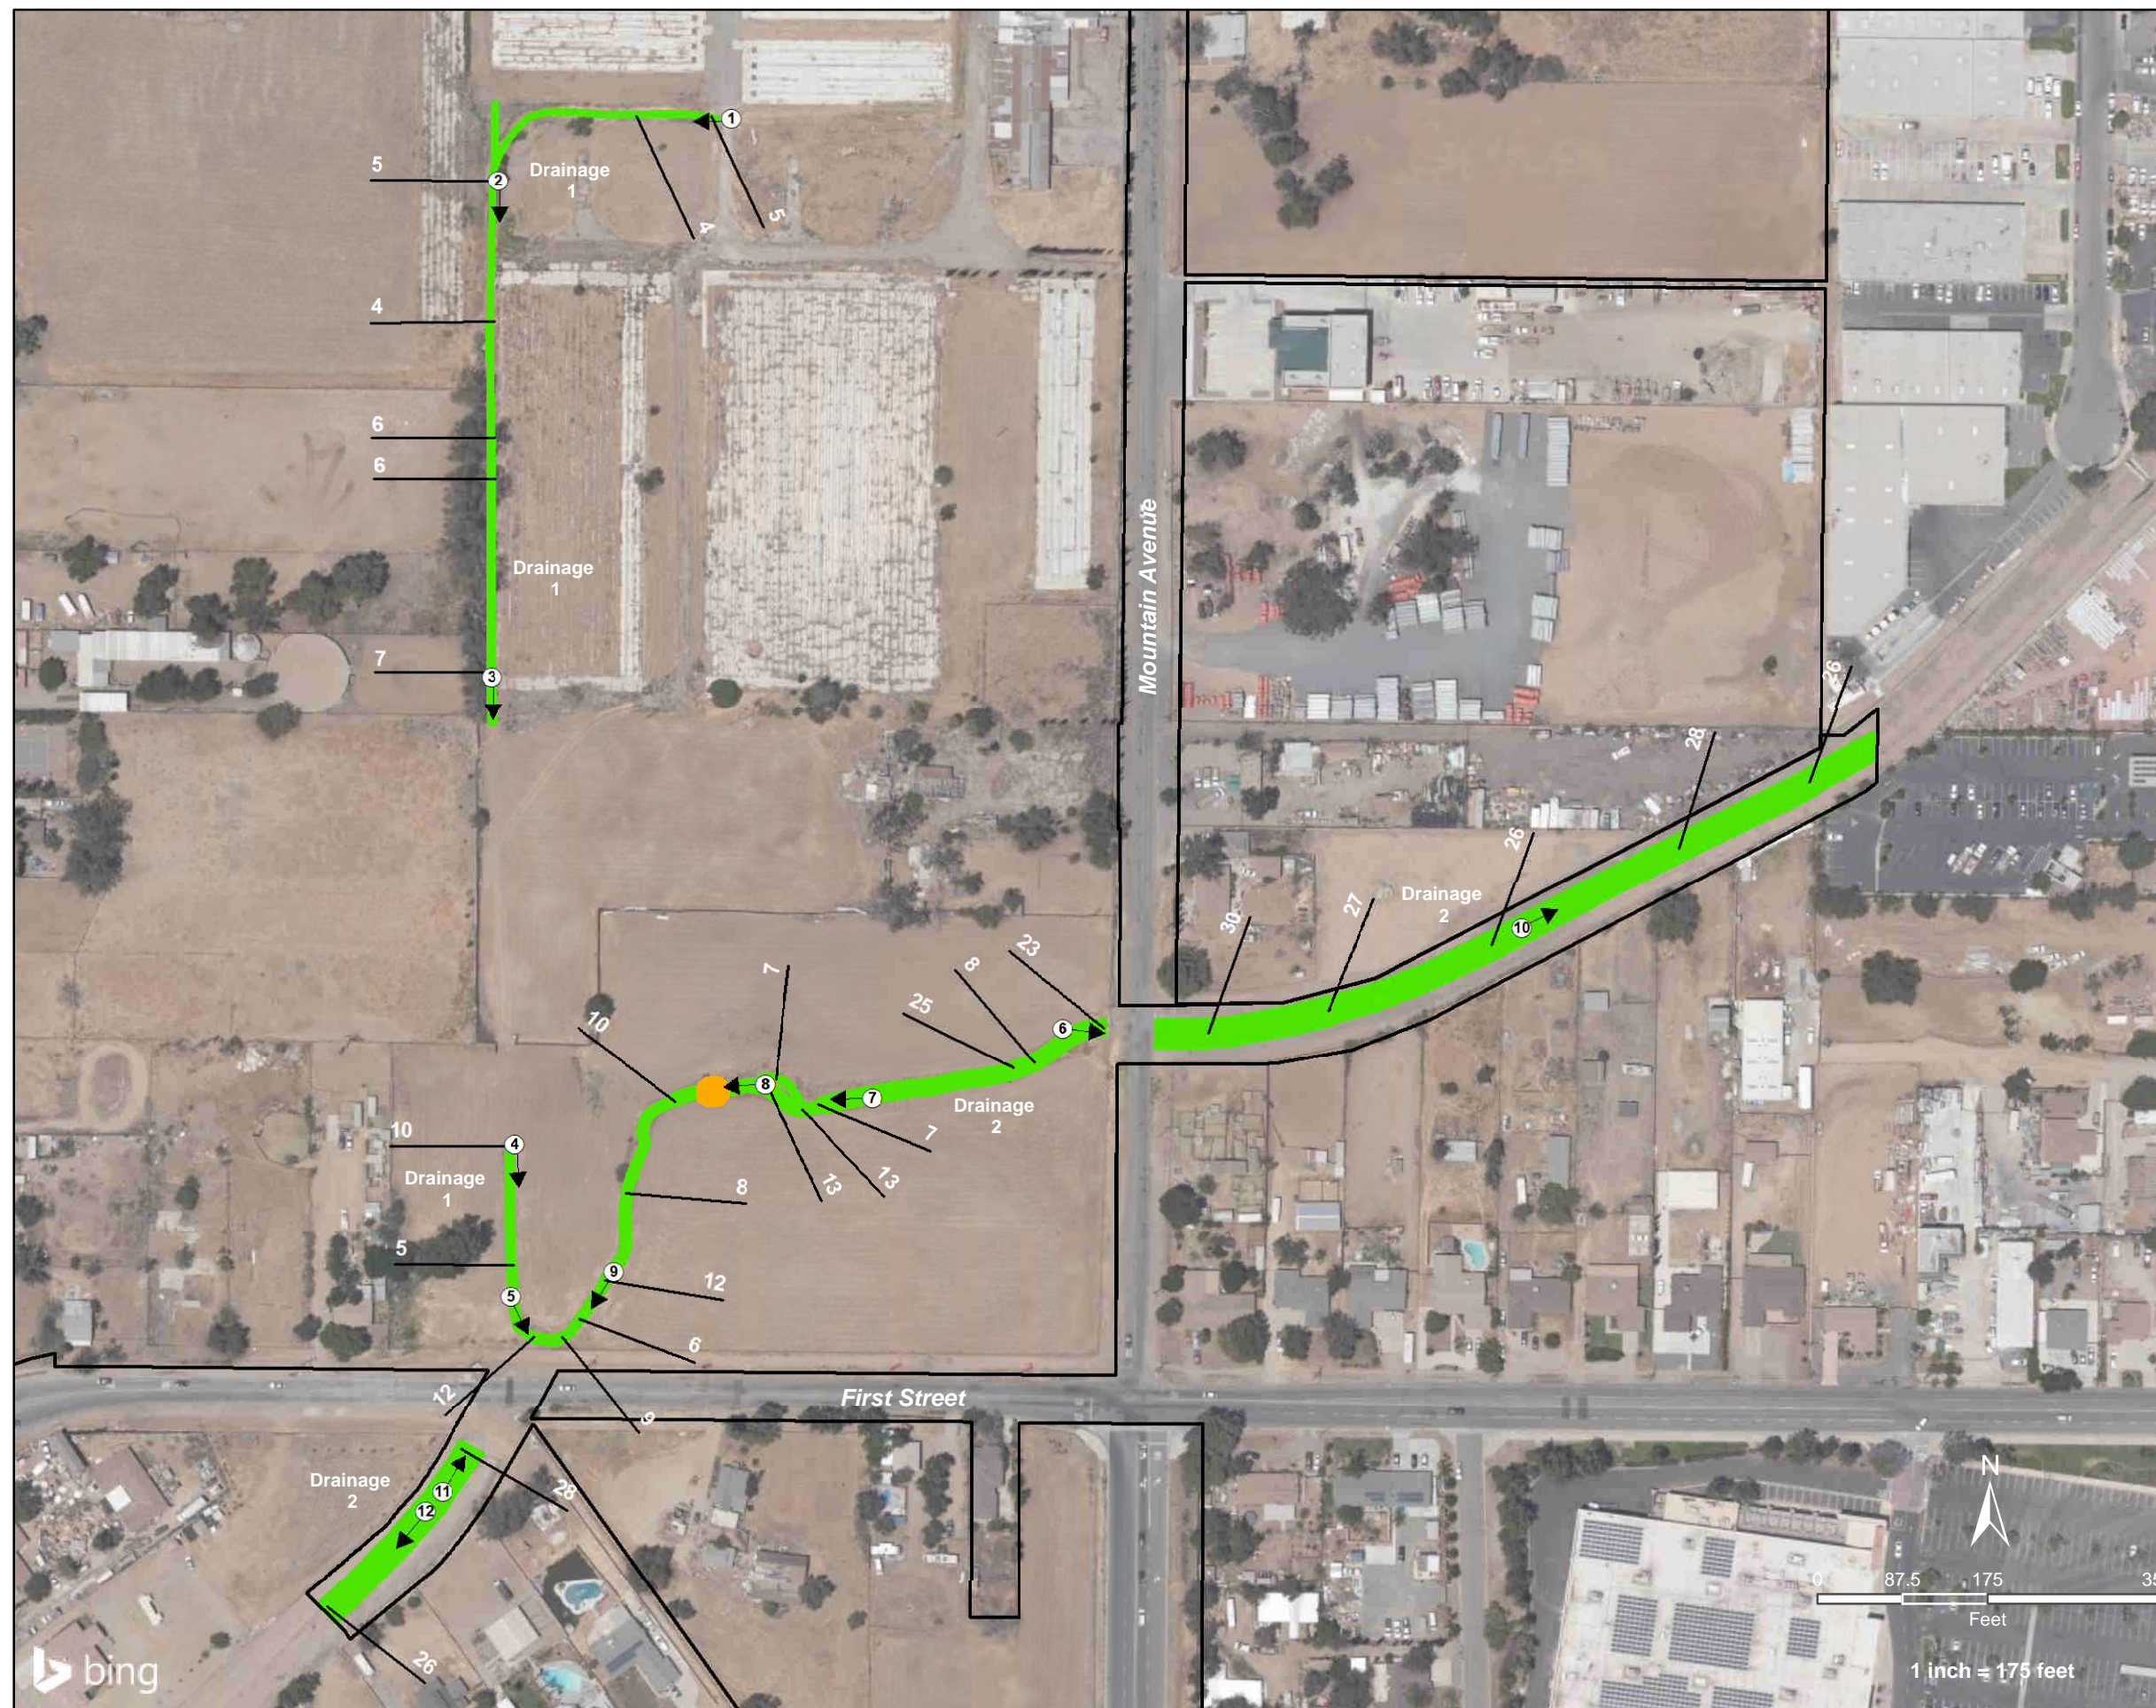
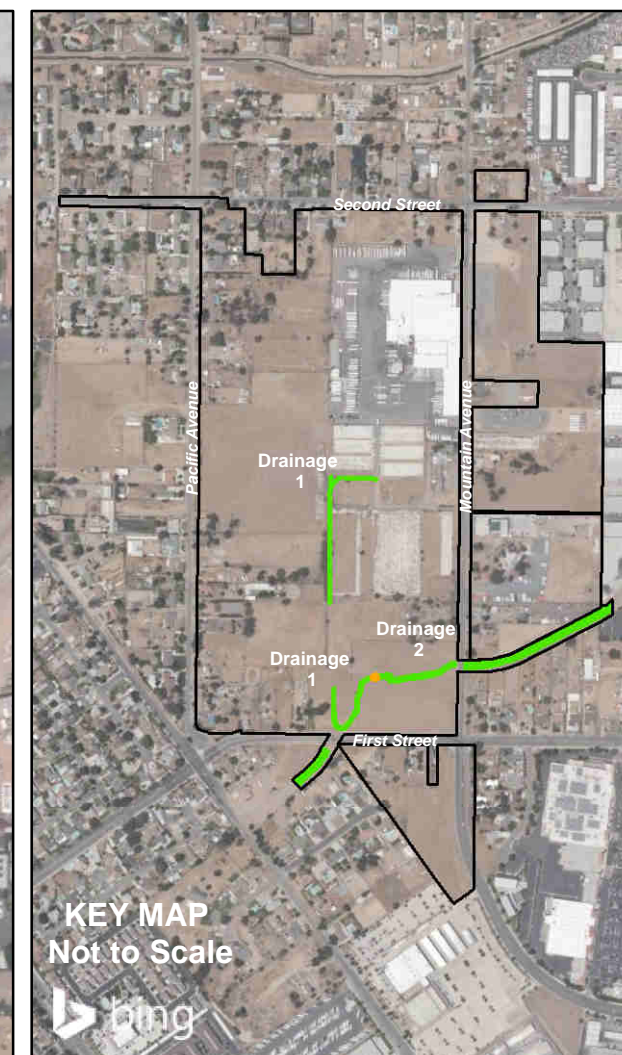
CDFW jurisdiction within the Project site totals approximately 1.03 acre (2,992 linear feet) associated with two drainage features, of which 0.02 acre consists of riparian vegetation [Exhibit 3B – CDFW Jurisdictional Delineation Map].

CDFW Jurisdictional Delineation Map

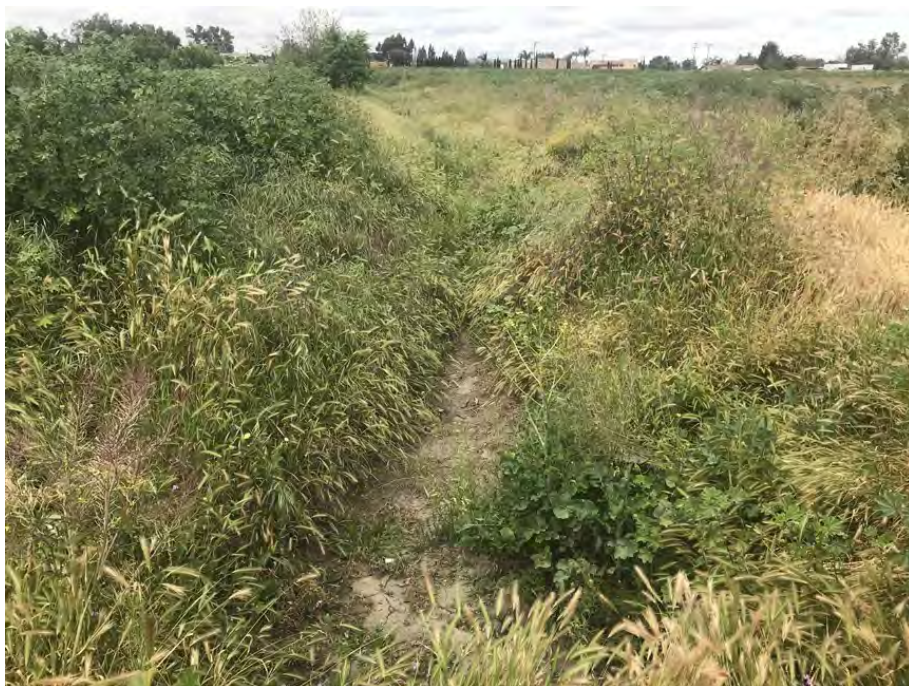
Photograph 1: View of ephemeral Drainage 1 facing west/downstream. Feature is dominated by non-native herbs. Photo date: 4/5/19.

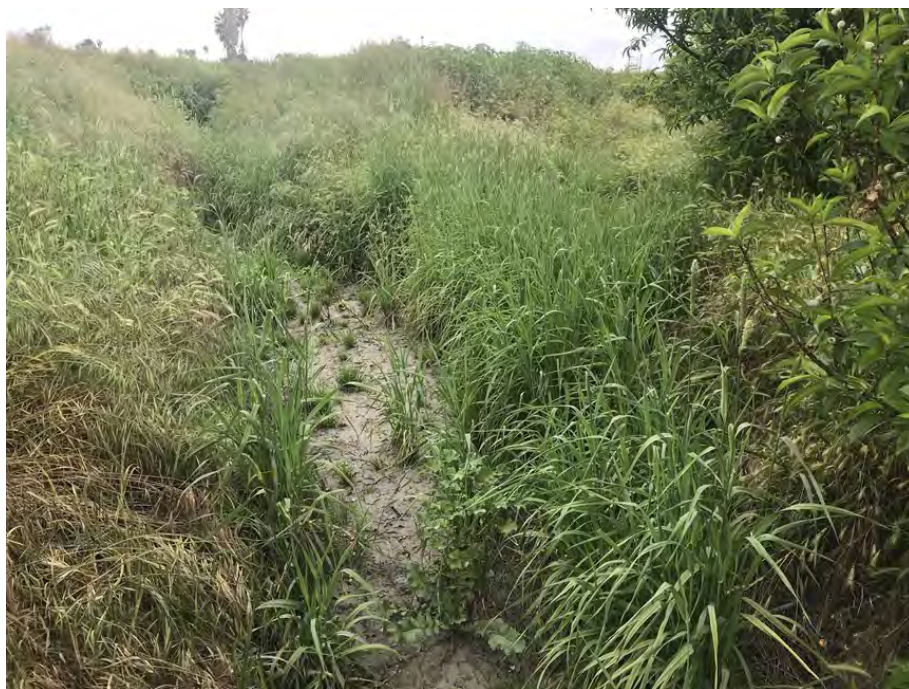
Photograph 2: View of ephemeral Drainage 1 facing south/downstream. Feature is dominated by non-native herbs. Photo date: 4/5/19.

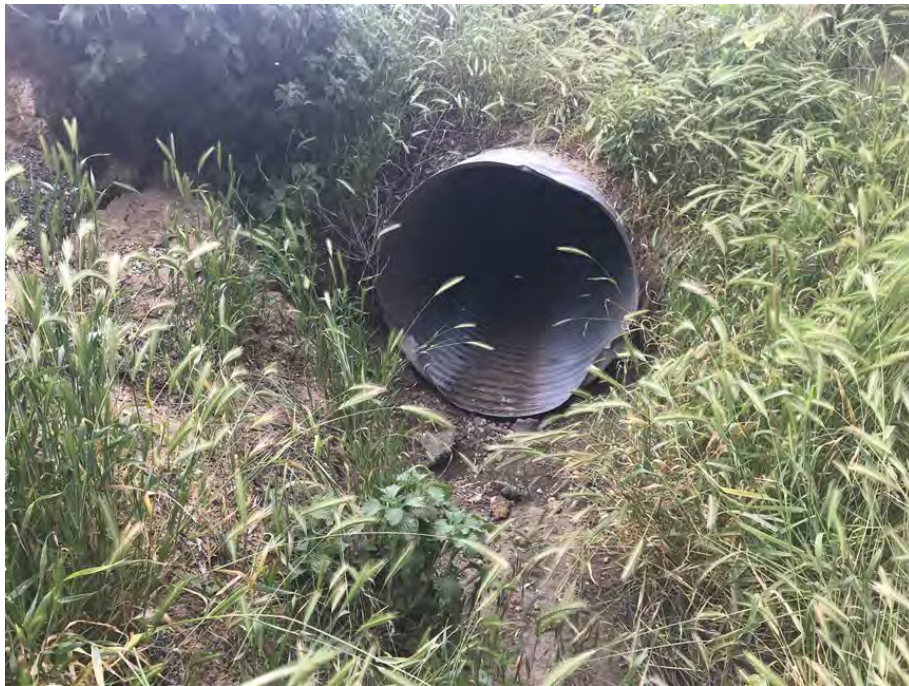
Photograph 3: View of ephemeral Drainage 1 entering an underground pipe facing south/downstream.
Photo date: 4/5/19.

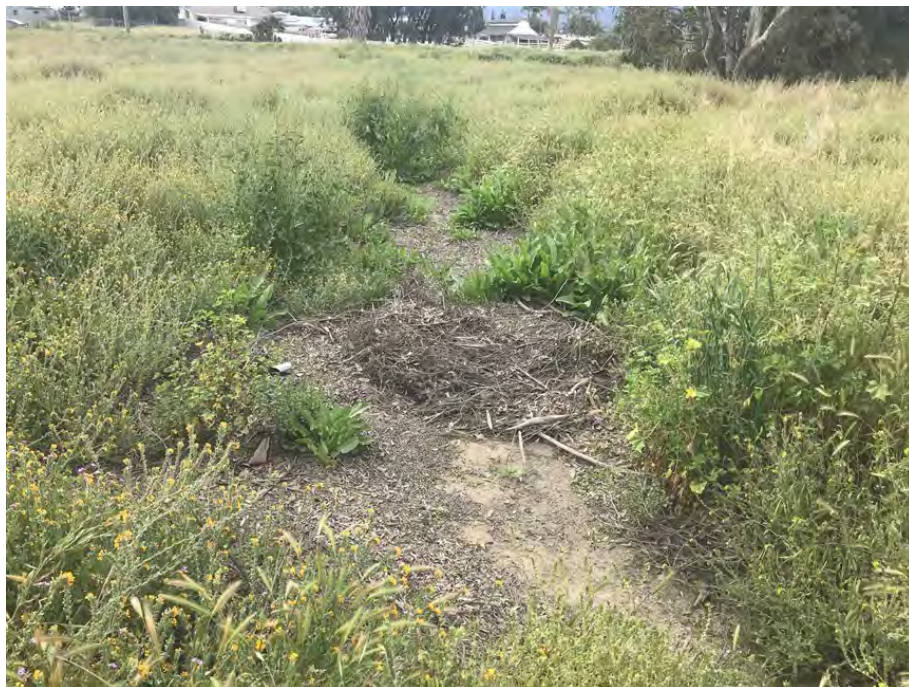
Photograph 4: View of continuation of ephemeral Drainage 1 facing south/downstream. Feature is dominated by non-native herbs.
Photo date: 4/5/19.

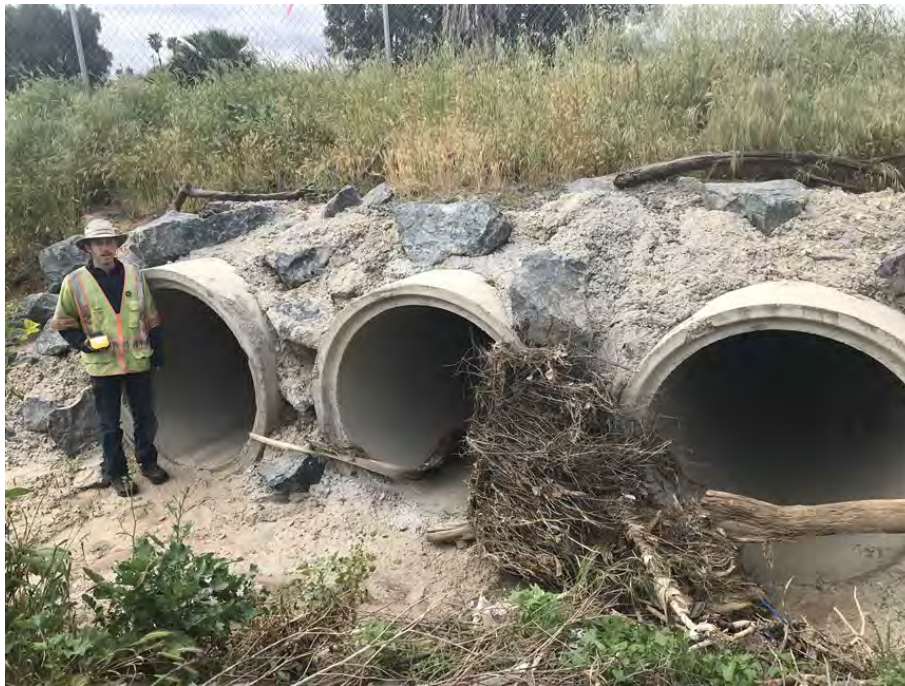
Photograph 5: View facing south/downstream of confluence of Drainage 1 and 2 where they enter three large pipe culverts and exit the site just north of First Street. Photo date: 4/5/19.

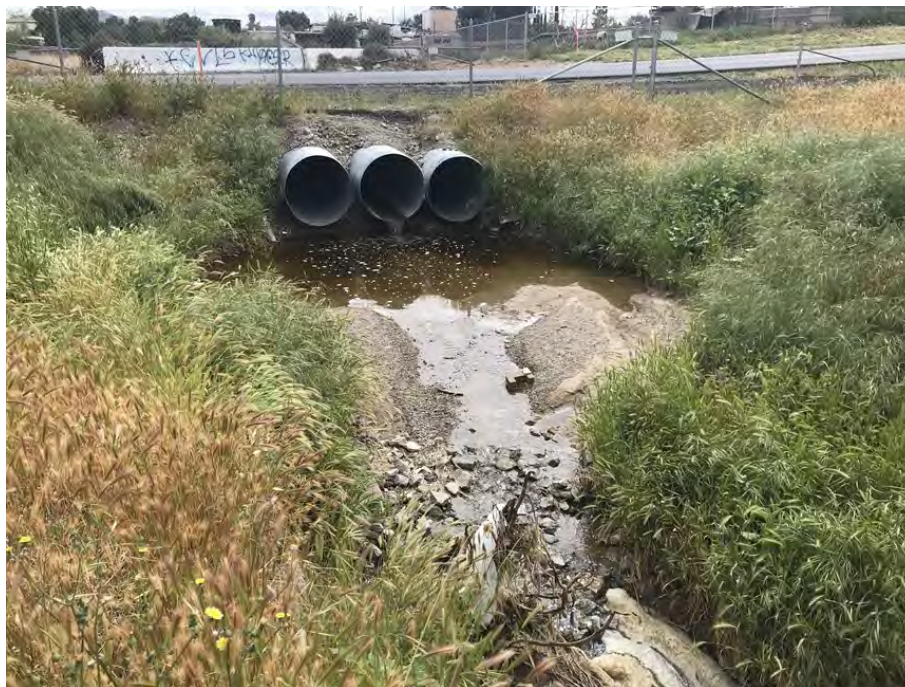
Photograph 6: View facing east/upstream of Drainage 2 entering the site via three pipe culverts. Feature is dominated by non-native herbs. Photo date: 4/5/19.

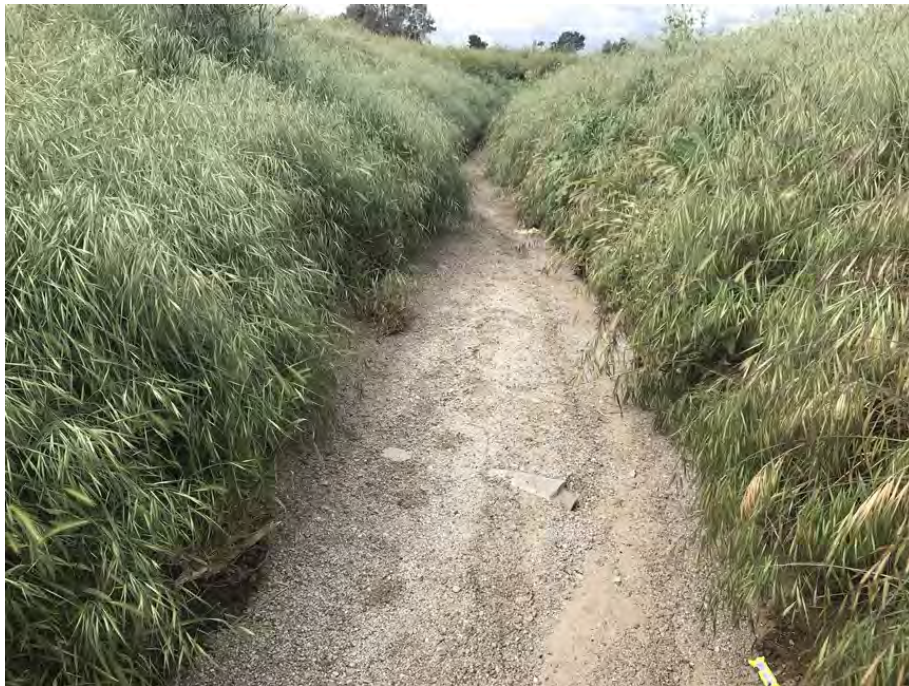
Photograph 7: View of Drainage 2 facing west/downstream. Drainage has a sandy bottom and the banks are vegetated with non-native herbs. Photo date: 4/5/19.

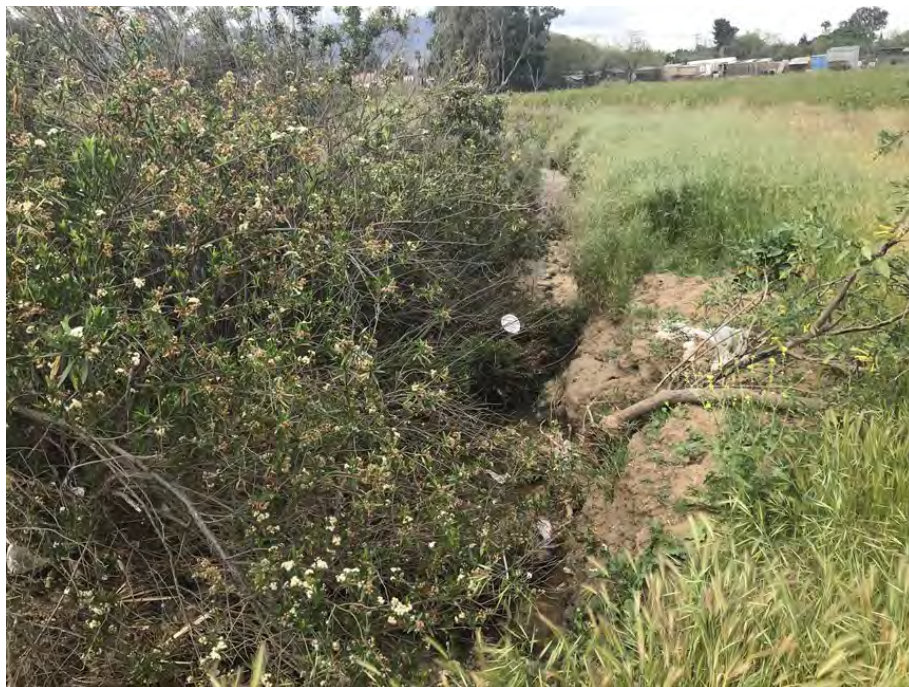
Photograph 8: View of Drainage 2 facing west/downstream. Note mulefat (*Baccharis salicifolia*) in the channel. Photo date: 4/5/19.

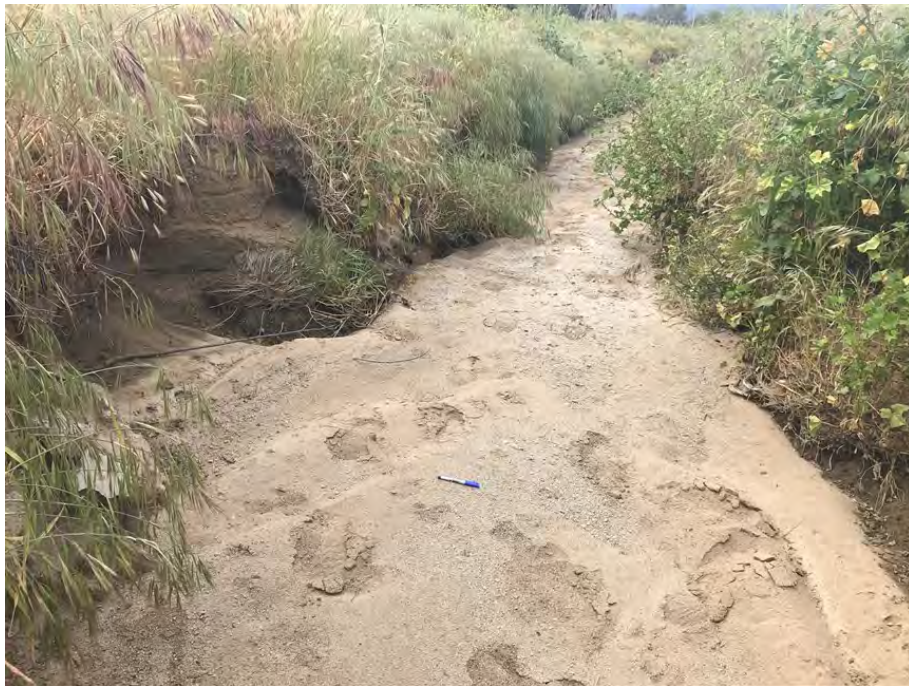
Photograph 9: View of Drainage 2 facing south/downstream. Drainage has a sandy bottom and the banks are vegetated with non-native herbs. Photo date: 4/5/19.

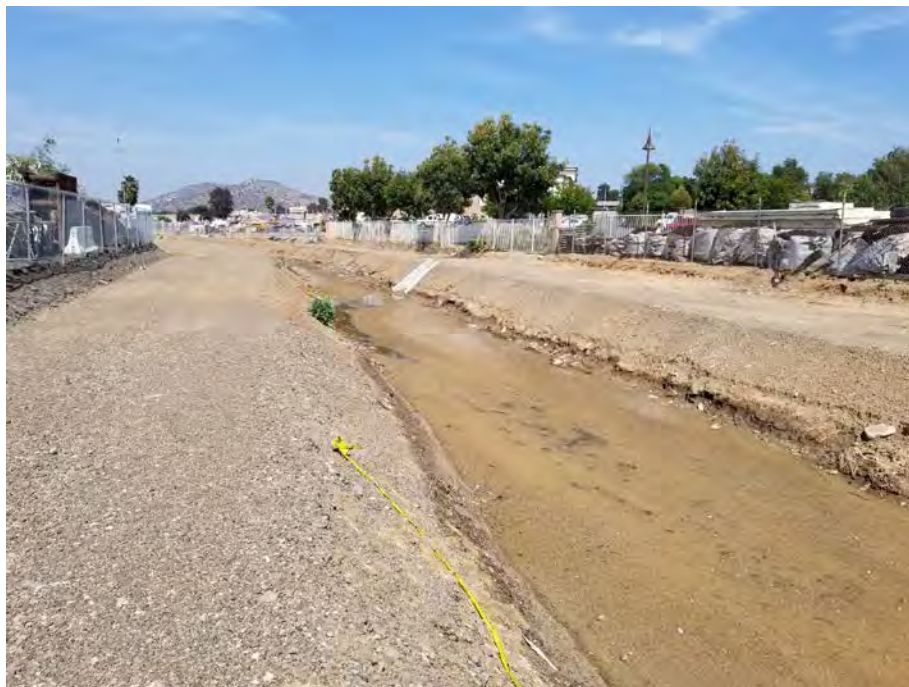
Photograph 10: View of Drainage 2 east of Mountain Avenue facing northeast/upstream. Drainage has sandy bottom and is unvegetated. Photo date: 5/13/19.

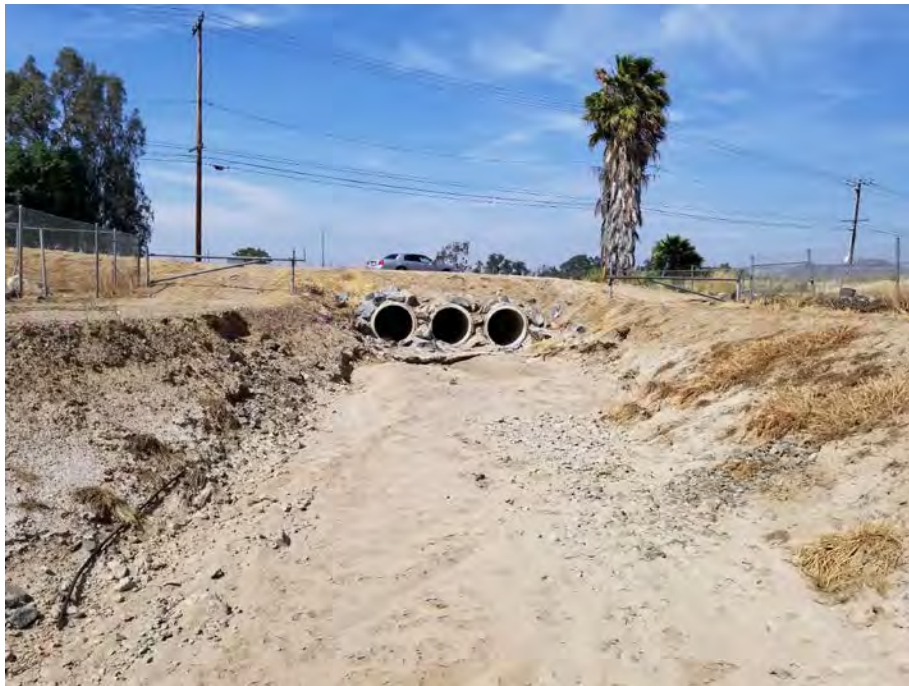
Photograph 11: View of Drainage 2 south of 1st Street facing northeast/upstream. Drainage has a sandy bottom and is unvegetated. Photo date: 5/13/19.

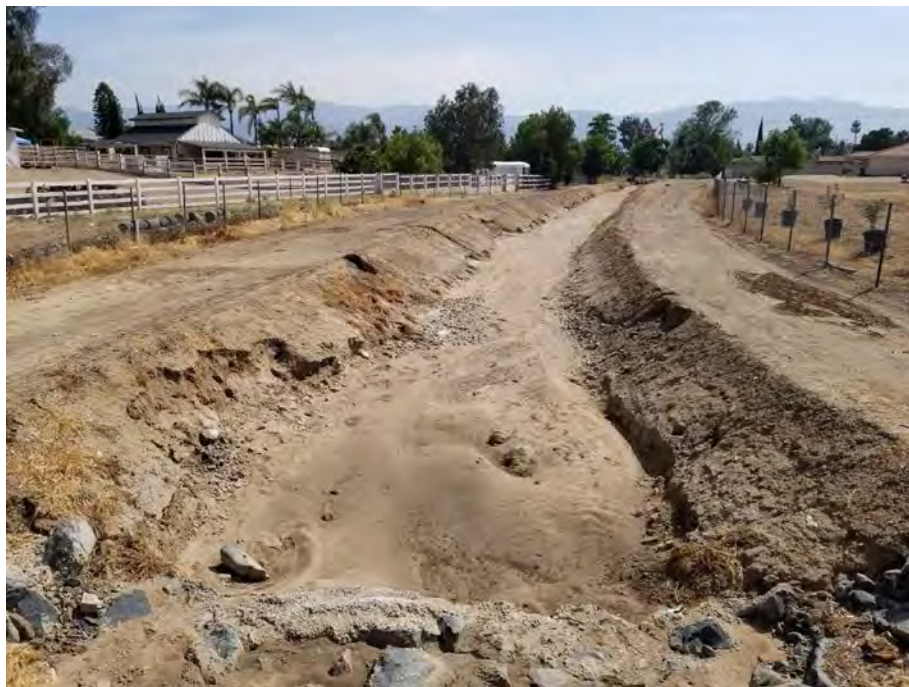
Photograph 12: View of Drainage 2 south of 1st Street facing southwest/downstream. Drainage has a sandy bottom and is unvegetated. Photo date: 5/13/19.

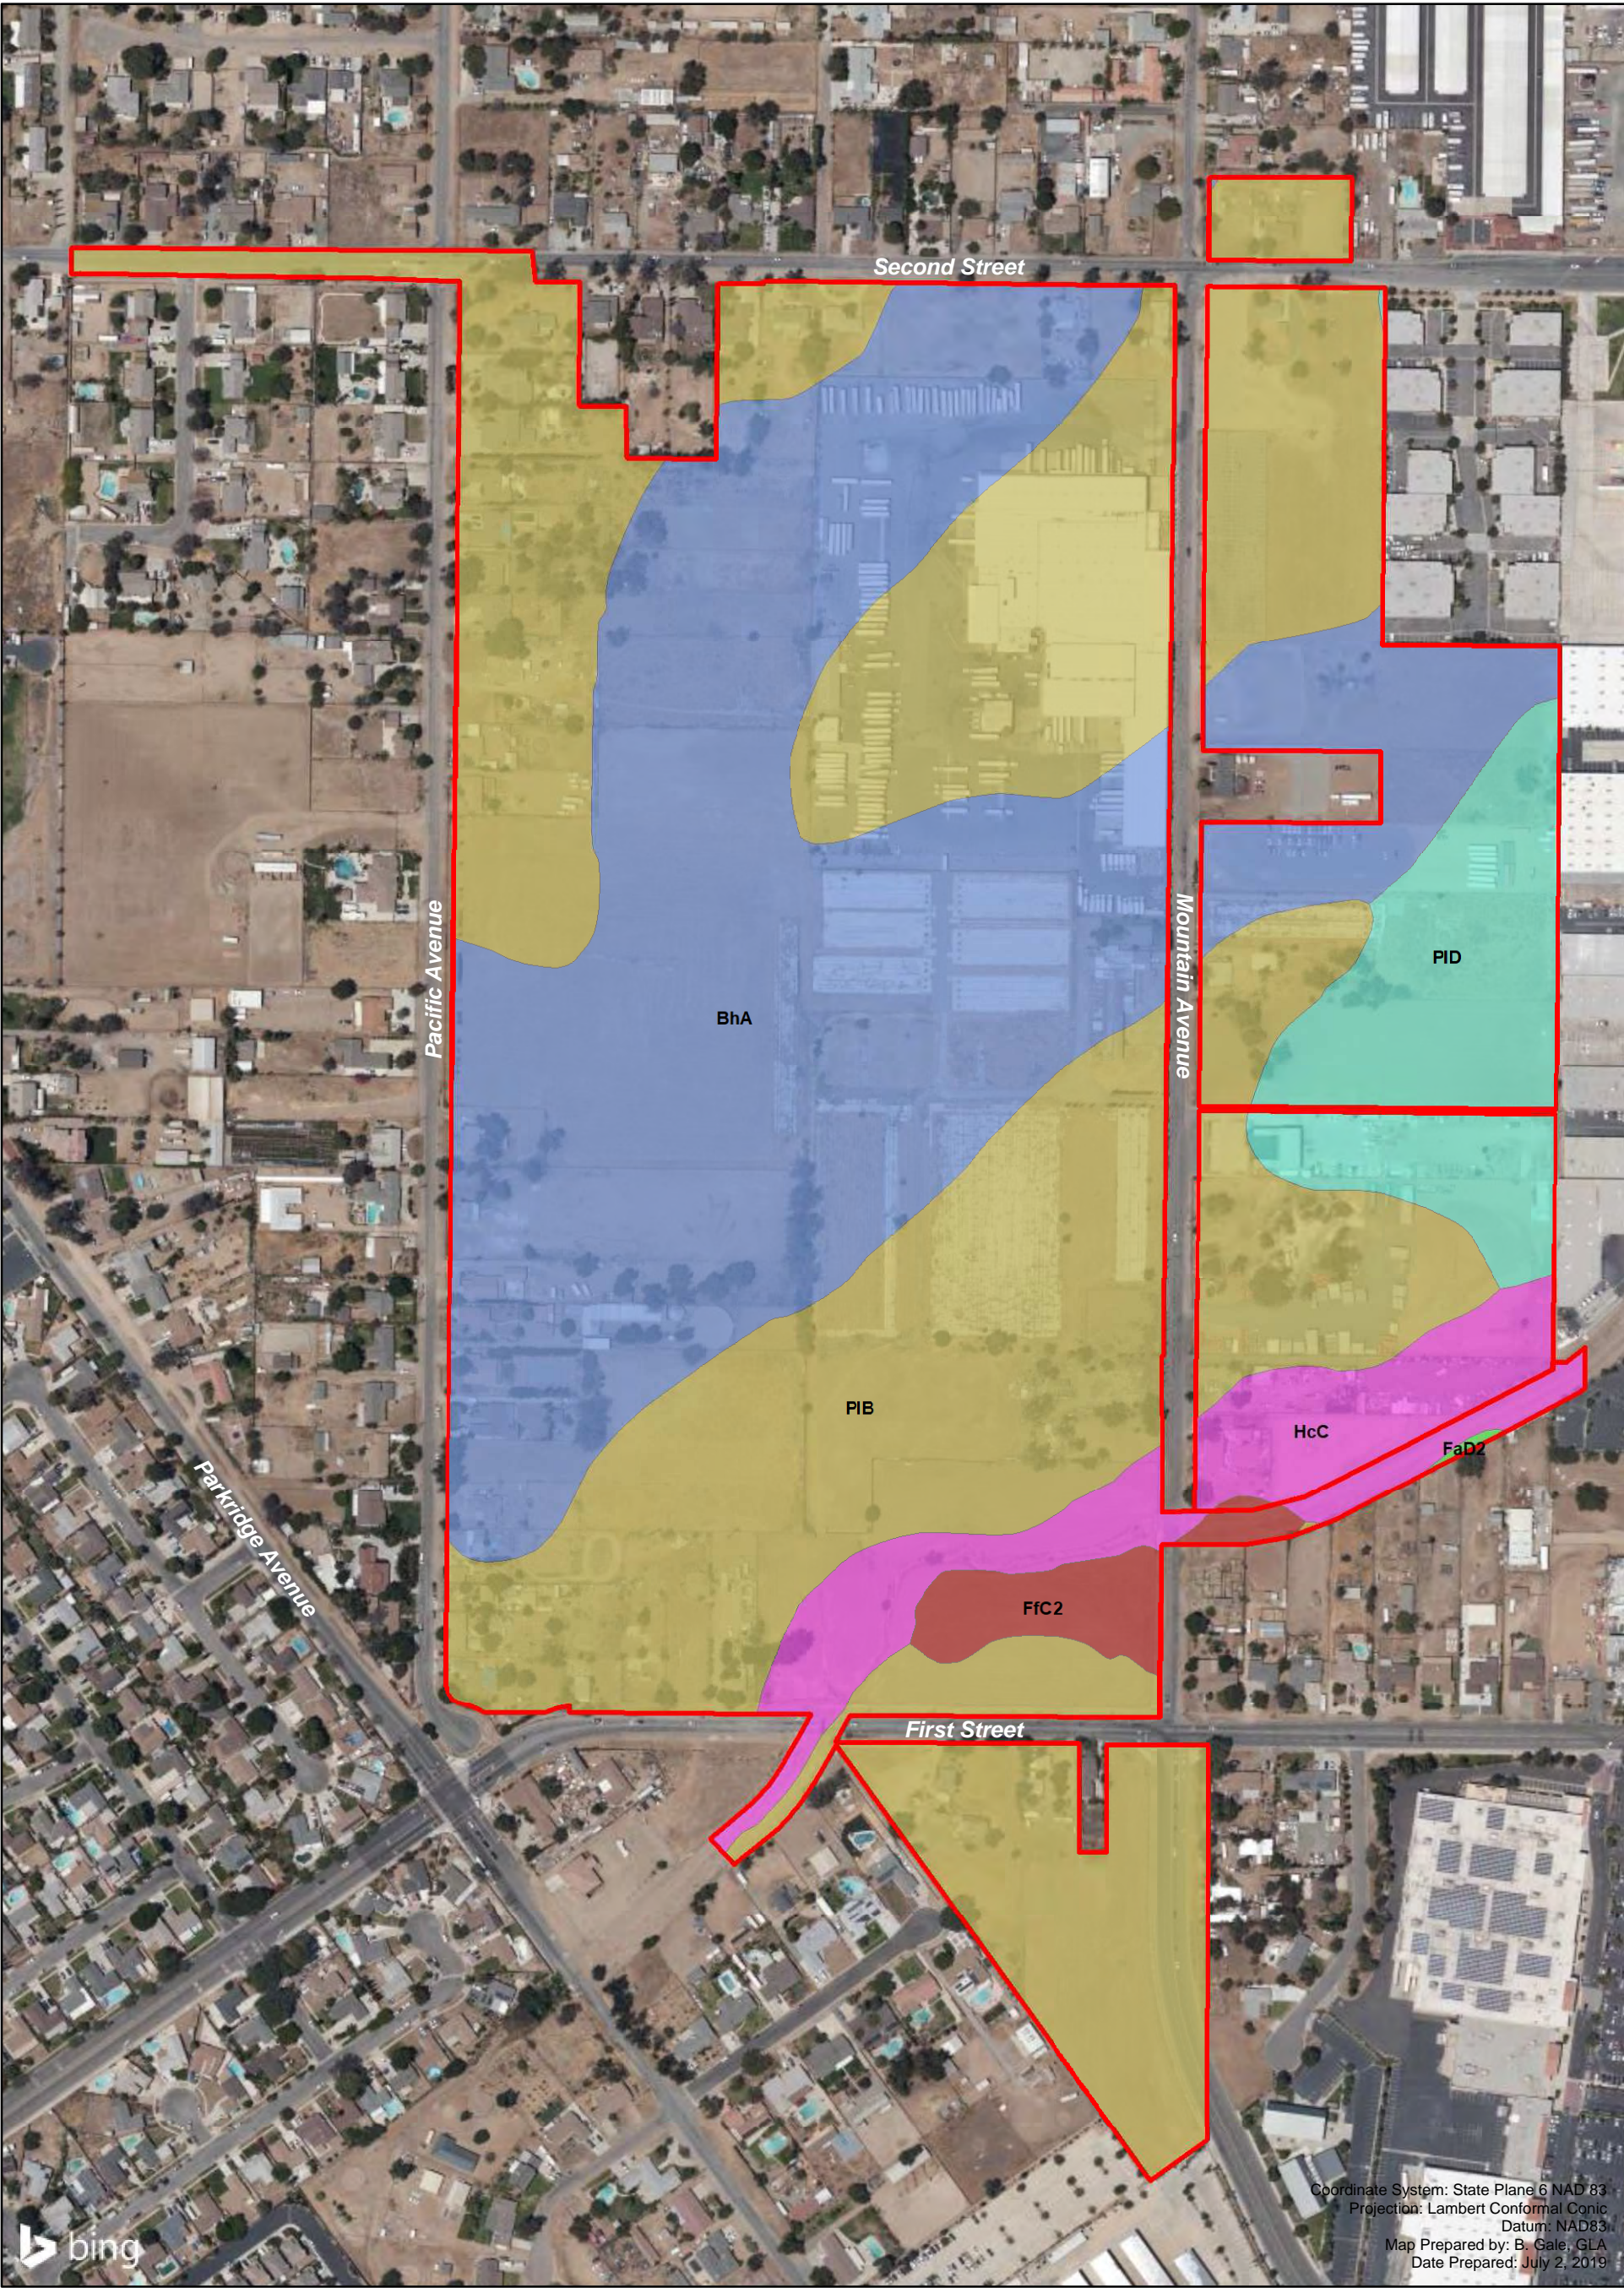
Exhibit 5

- Project Boundary
- BhA - Buchenau loam, slightly saline-alkali, 0 to 2 percent slopes
- FaD2 - Fallbrook sandy loam, 8 to 15 percent slopes, eroded
- FfC2 - Fallbrook fine sandy loam, 2 to 8 percent slopes, eroded
- HcC - Hanford coarse sandy loam, 2 to 8 percent slopes
- PIB - Placentia fine sandy loam, 0 to 5 percent slopes
- PID - Placentia fine sandy loam, 5 to 15 percent slopes

Soils Map
