Biological Resources Assessment, including Jurisdictional and Wetlands Delineation

City of Monterey Storm Drainage Maintenance Plan Project

Biological Resources Assessment

March 2019

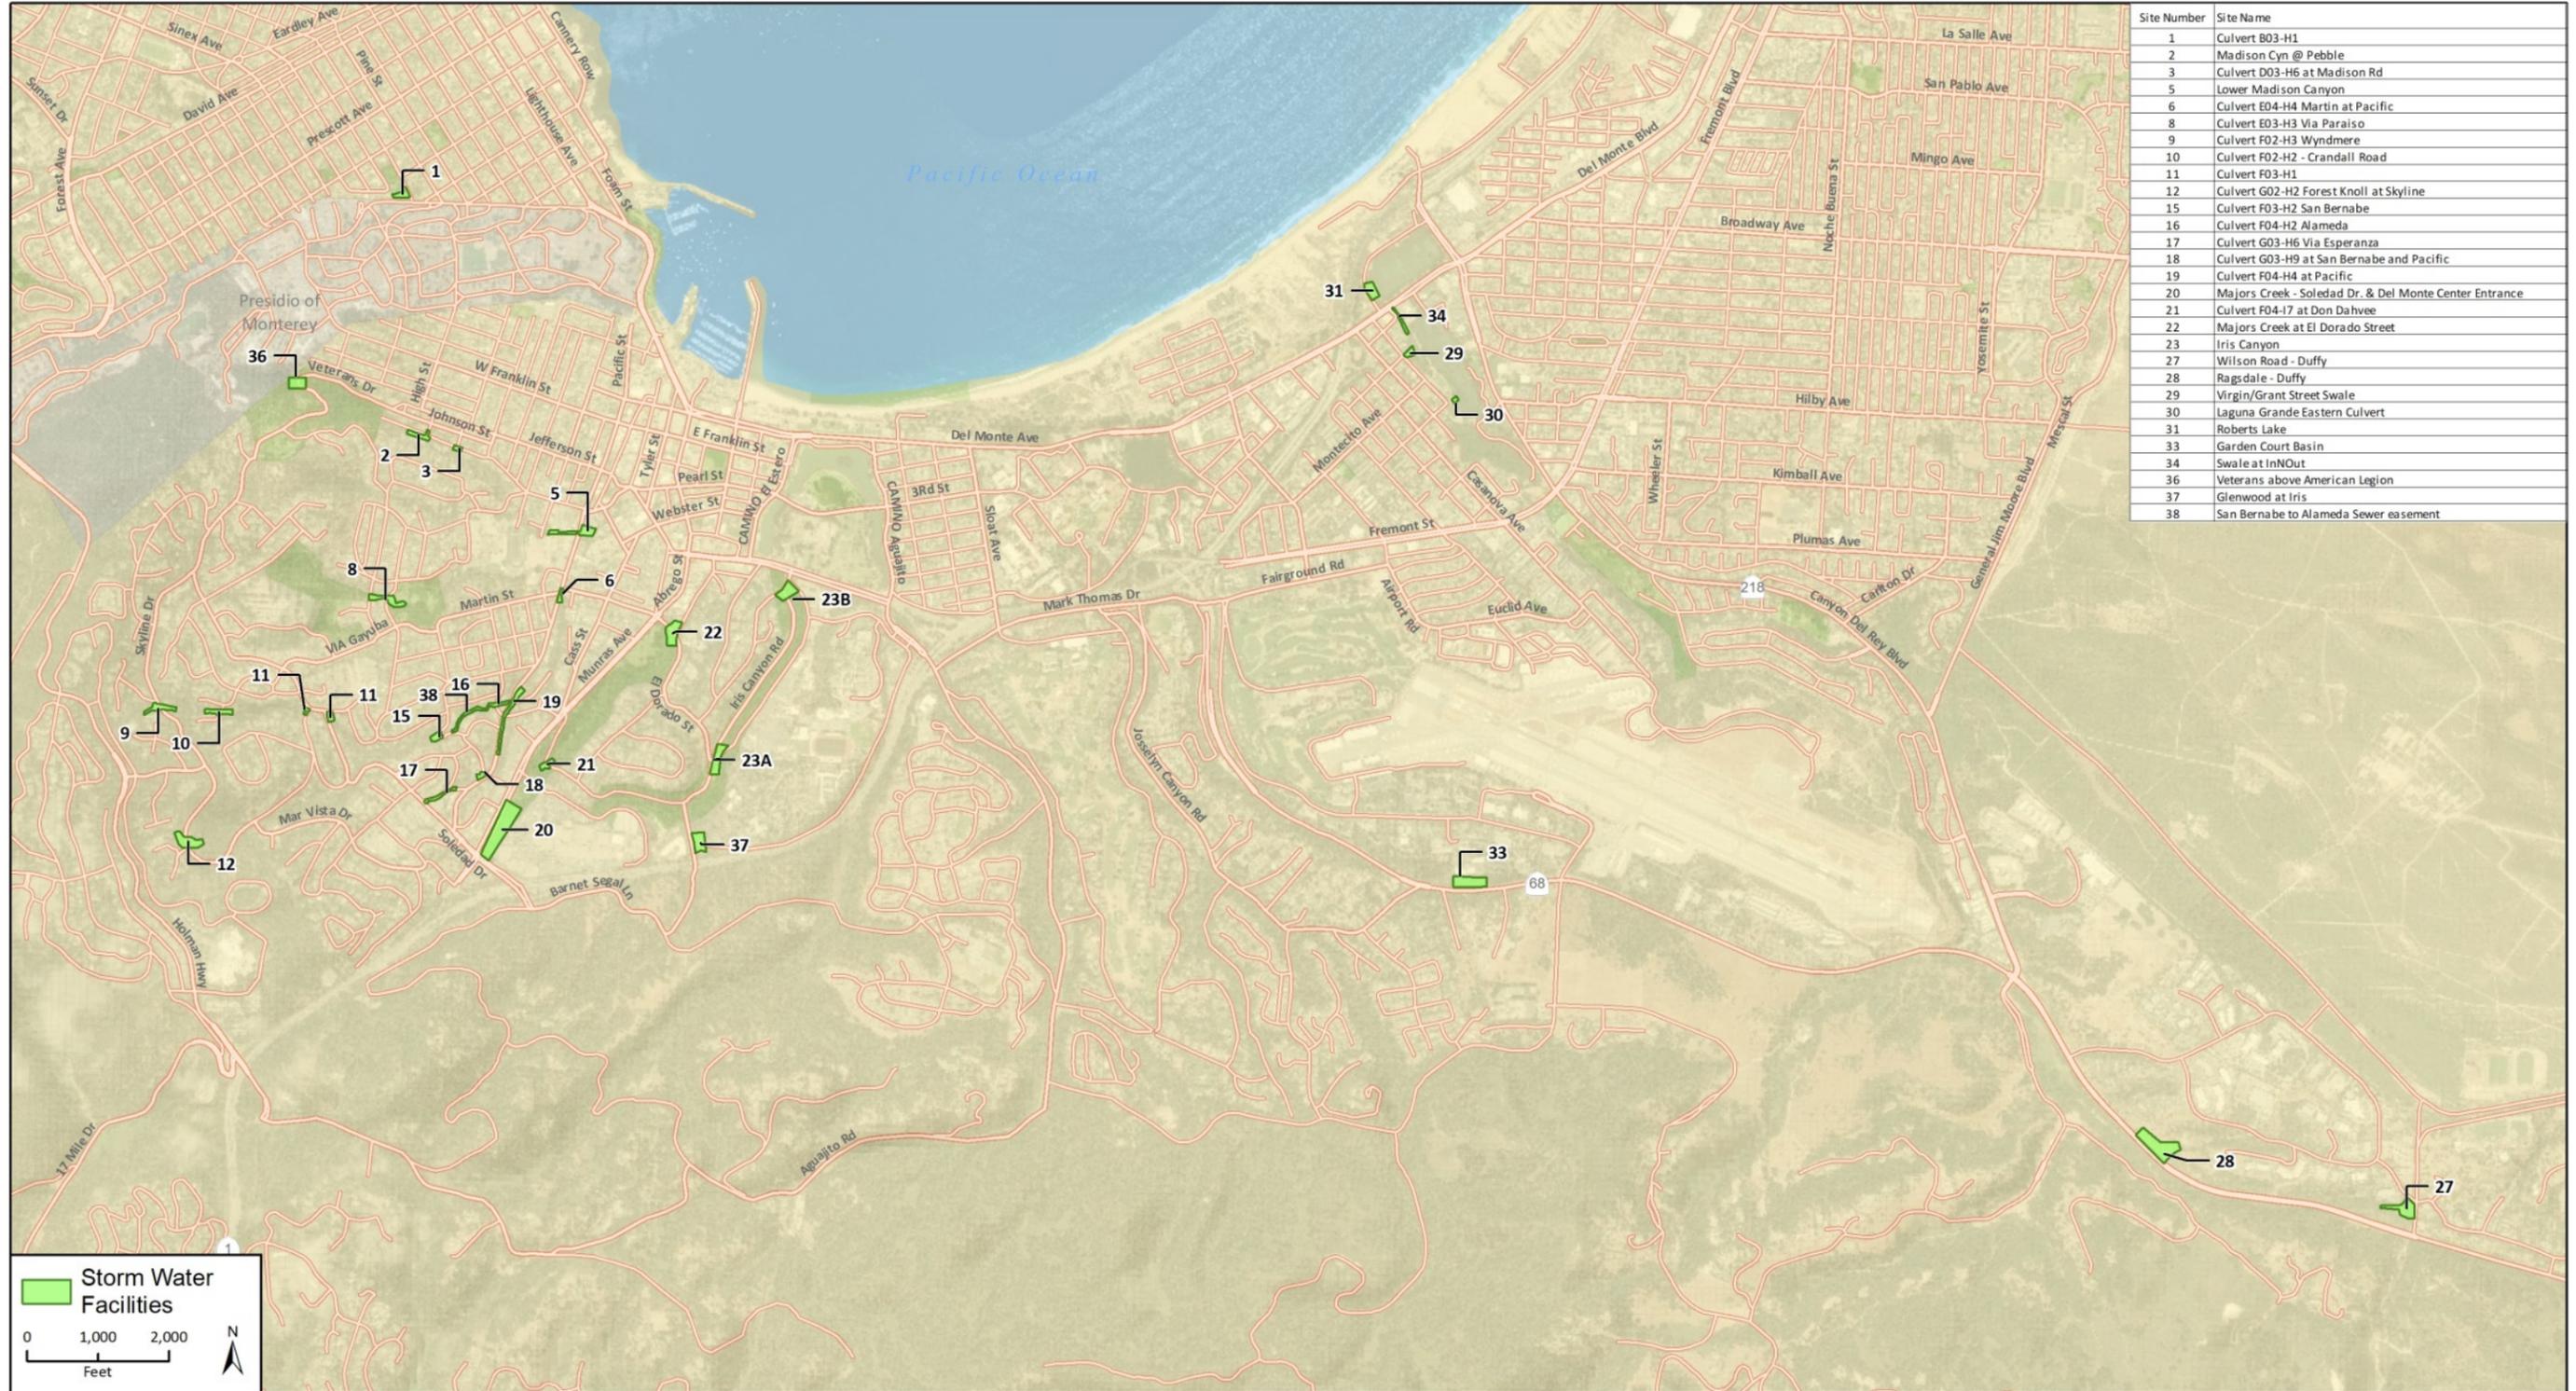
Figure 2 Project Area Map

Site Number	Site Name
1	Culvert B03-H1
2	Madison Cyn @ Pebble
3	Culvert D03-H6 at Madison Rd
5	Lower Madison Canyon
6	Culvert E04-H4 Martin at Pacific
8	Culvert F03-H3 Via Paraiso
9	Culvert F02-H3 Wyndmere
10	Culvert F02-H2 - Crandall Road
11	Culvert F03-H1
12	Culvert G02-H2 Forest Knoll at Skyline
15	Culvert F03-H2 San Bernabe
16	Culvert F04-H2 Alameda
17	Culvert G03-H6 Via Esperanza
18	Culvert G03-H9 at San Bernabe and Pacific
19	Culvert F04-H4 at Pacific
20	Majors Creek - Soledad Dr. & Del Monte Center Entrance
21	Culvert F04-17 at Don Dahwee
22	Majors Creek at El Dorado Street
23	Iris Canyon
27	Wilson Road - Duffy
28	Ragsdale - Duffy
29	Virgin/Grant Street Swale
30	Laguna Grande Eastern Culvert
31	Roberts Lake
33	Garden Court Basin
34	Swale at InNOut
36	Veterans above American Legion
37	Glenwood at Iris
38	San Bernabe to Alameda Sewer easement

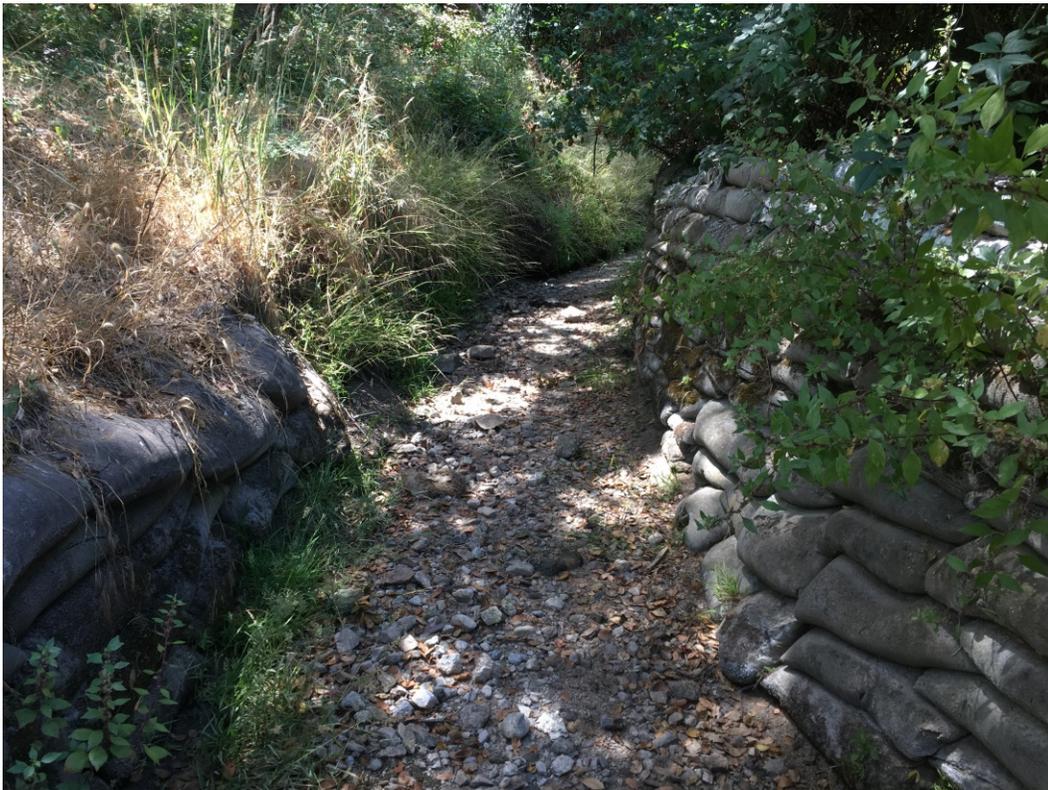
Site 2. Upstream reach, facing upstream, from culvert. North bank (right side in photo) adjoins private property.

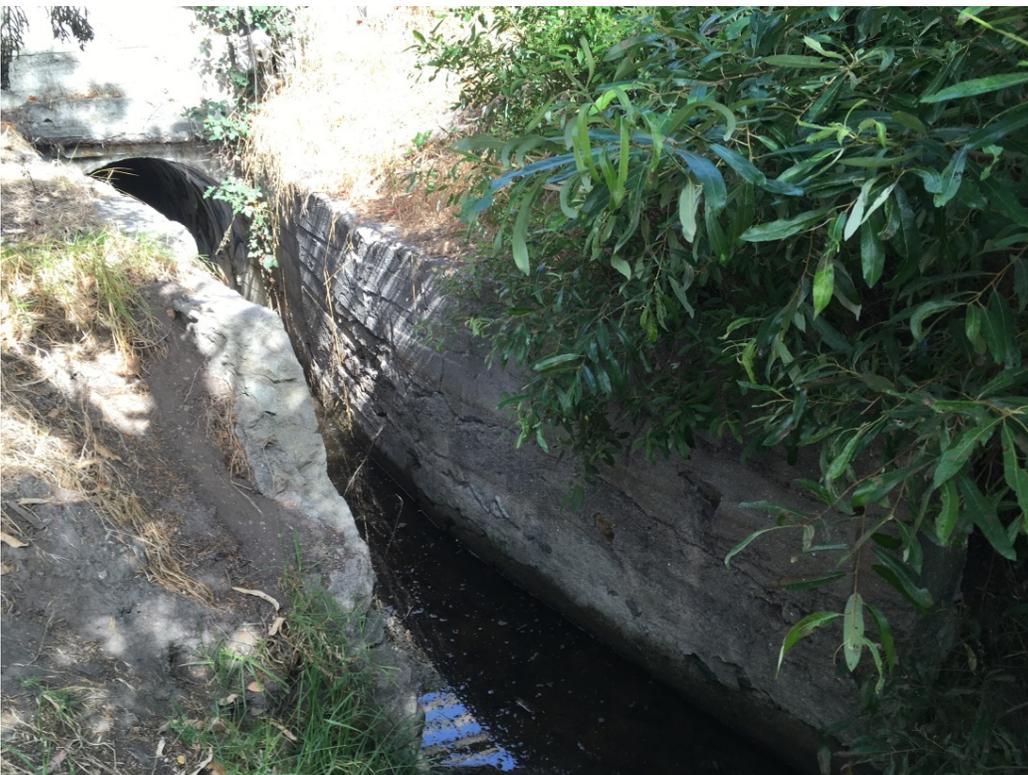
Site 5. Culvert outlet east of Pacific near library, facing structure. The outlet is armored for about 20 feet.

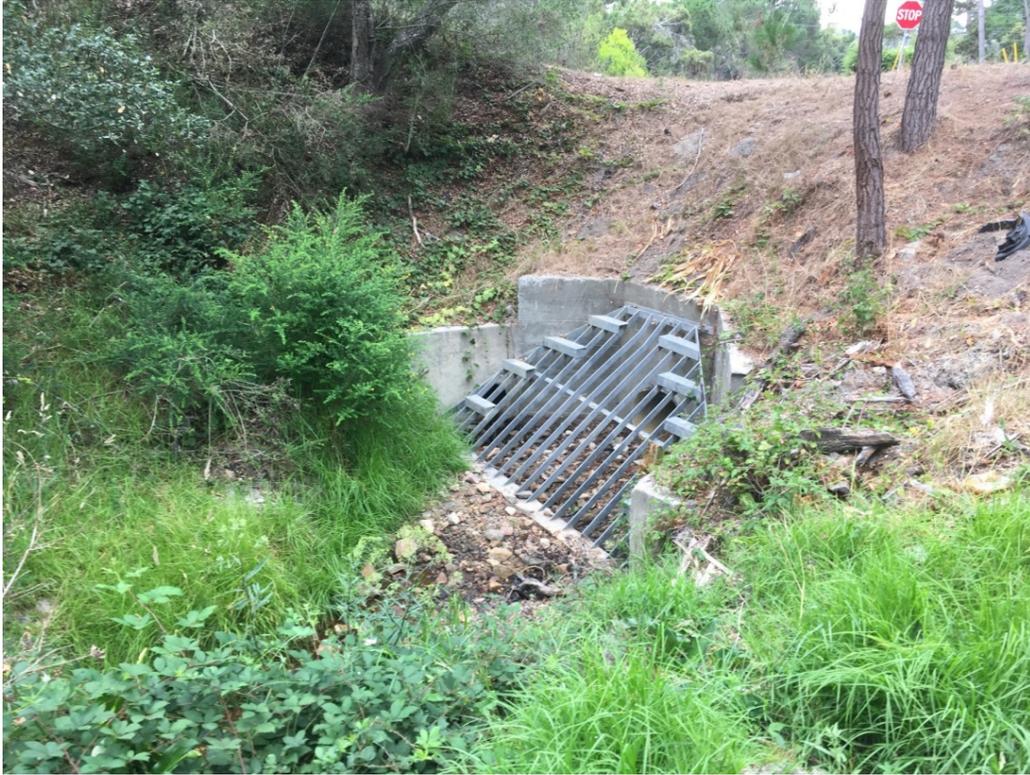
Site 11. Inlet at F03-H1.

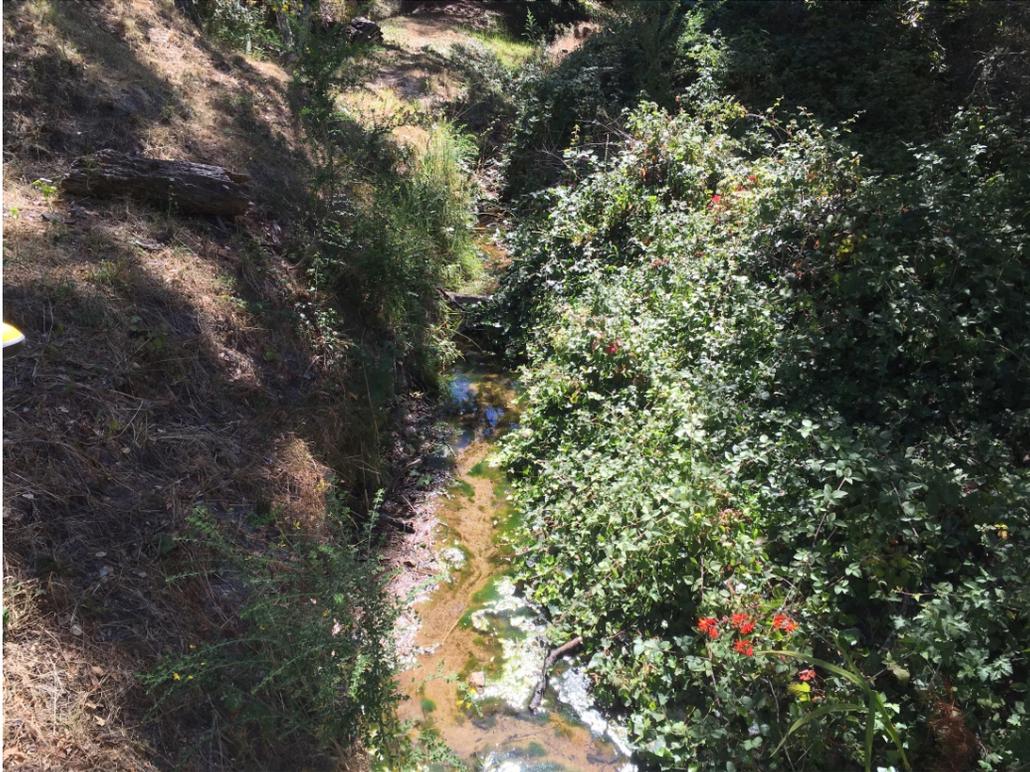
Site 15. Channel condition upstream of culvert F03-H2 inlet, facing upstream.

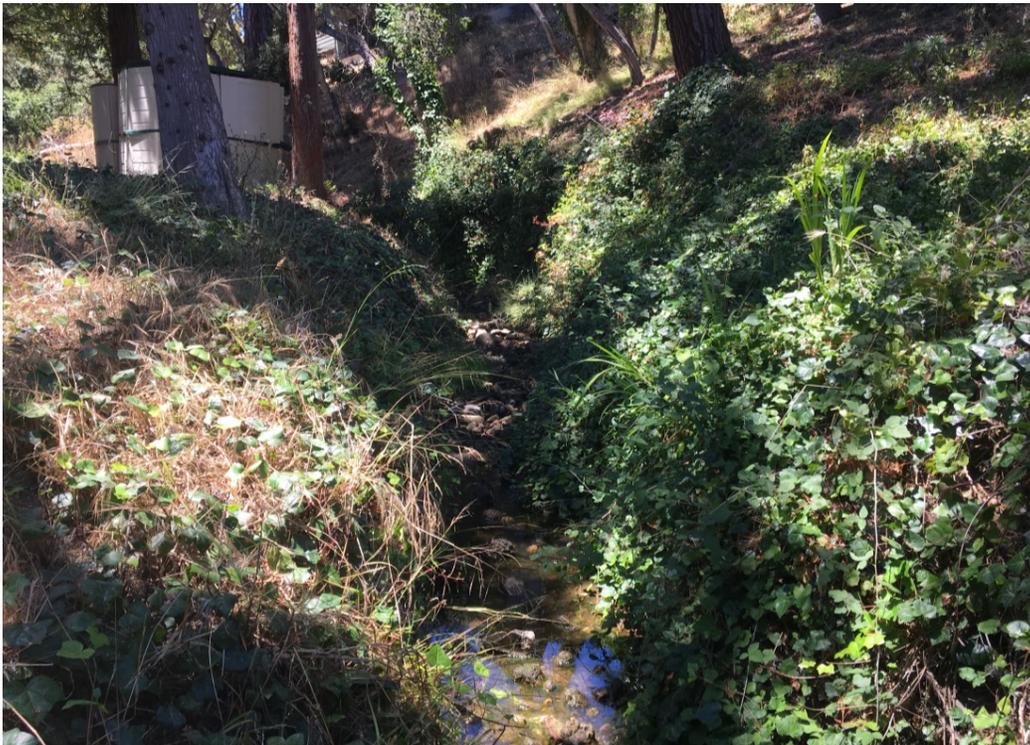
Site 16. Channel condition facing upstream from culvert at Alameda.

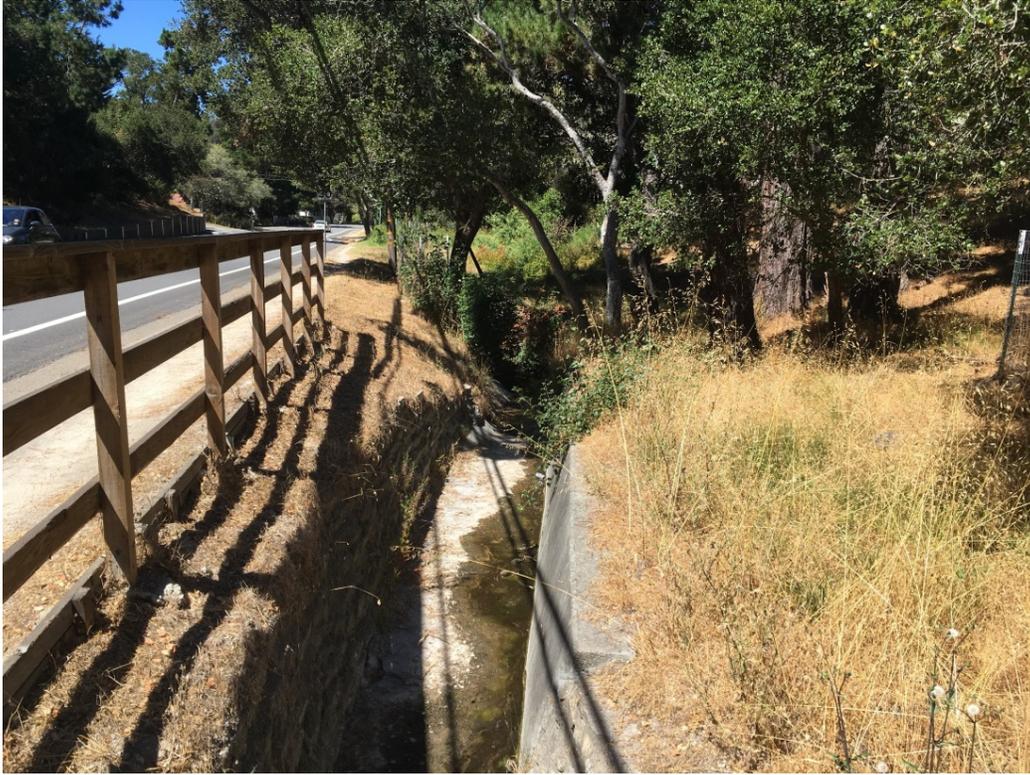
Site 19. Channel below outlet of Structure F04-H4 facing downstream.

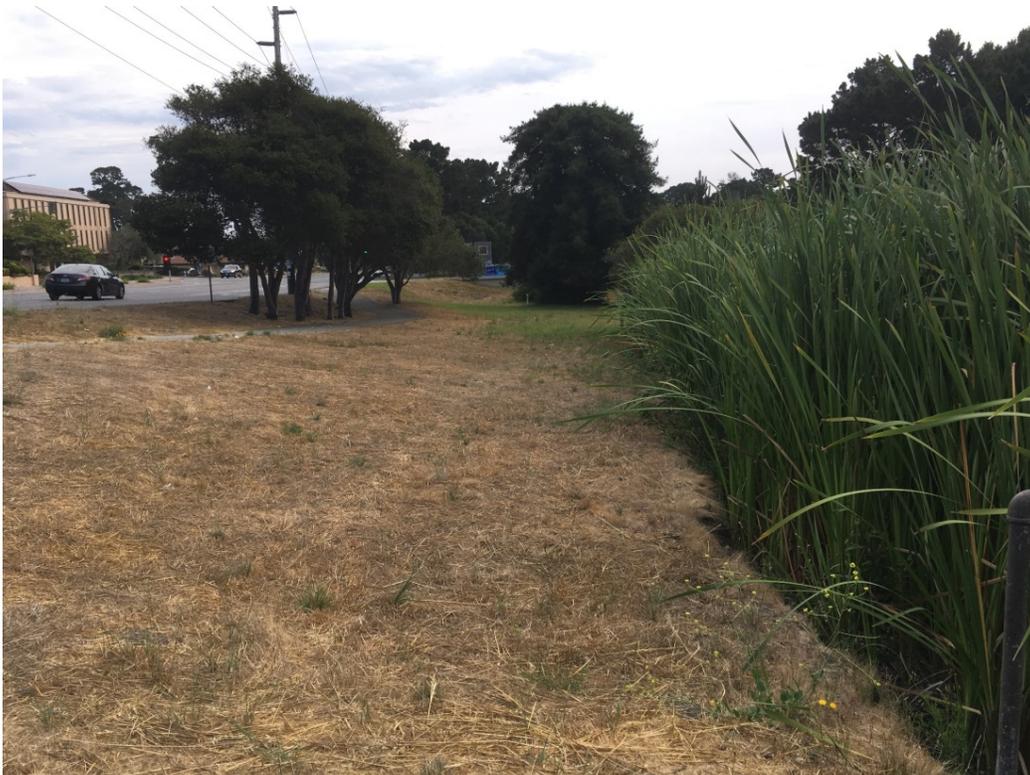
Site 20. The southern reach of Major Sherman Creek at Del Monte Center supports wetland vegetation. Viewed facing north.

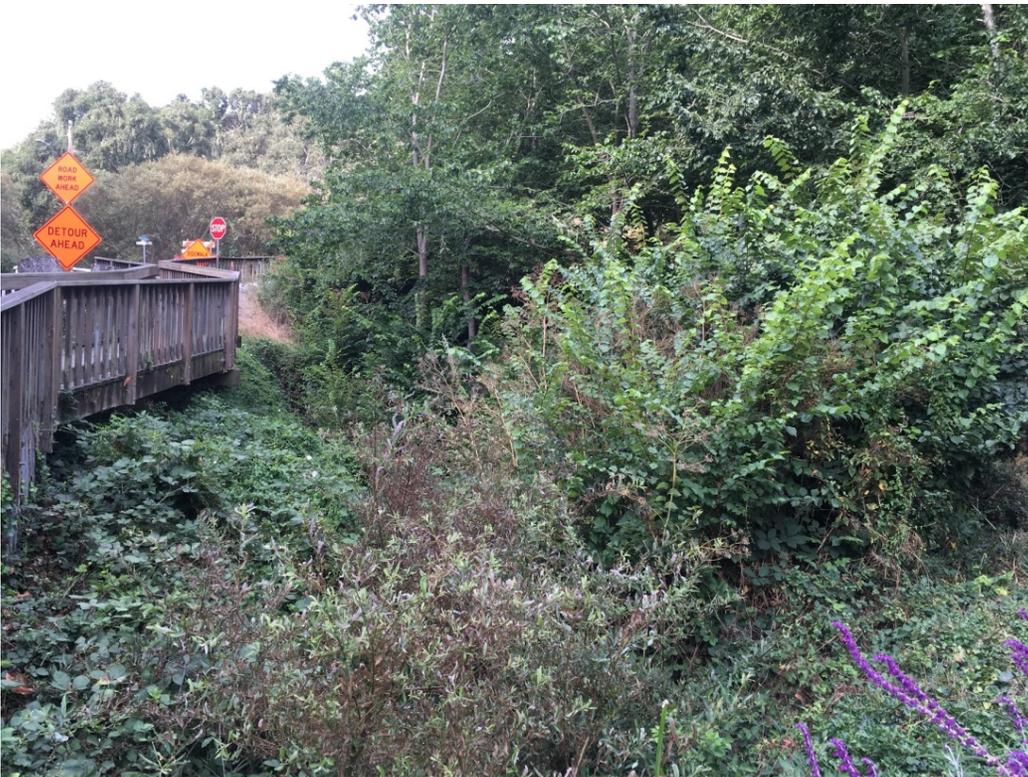
Site 22. Downstream reach, viewed looking upstream from structure E05-H1.

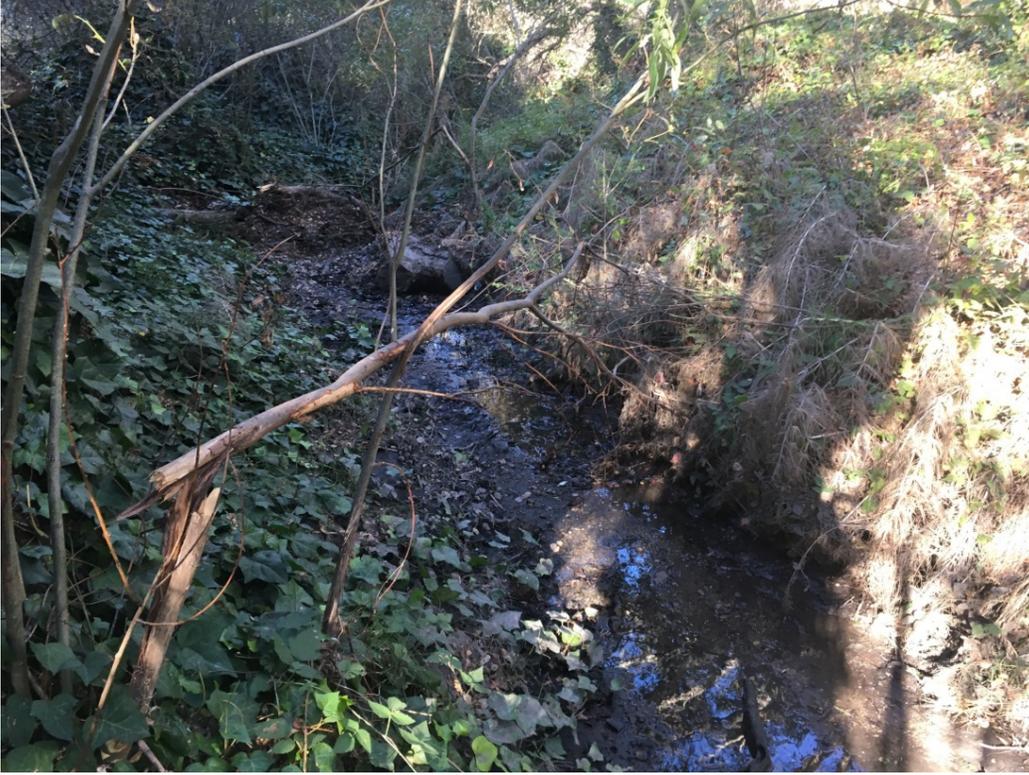
Site 23. Reach upstream of Via Mirada, looking upstream from structure E05-H4.

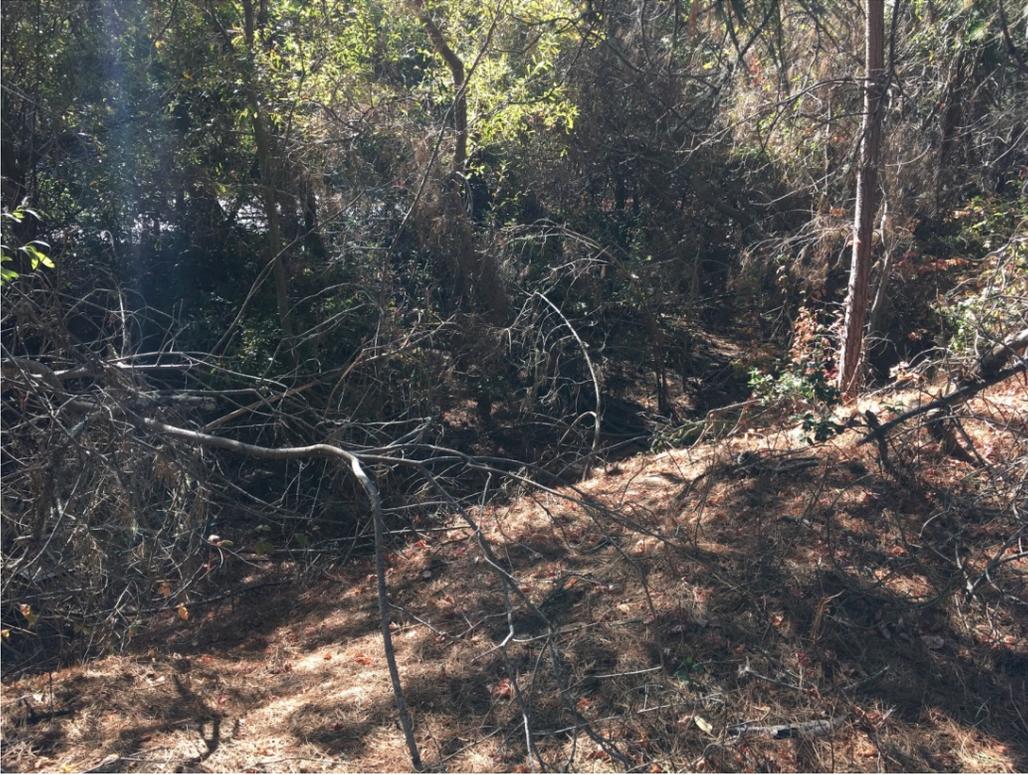
Site 33. Garden Ct. Basin - looking toward Hwy 68.

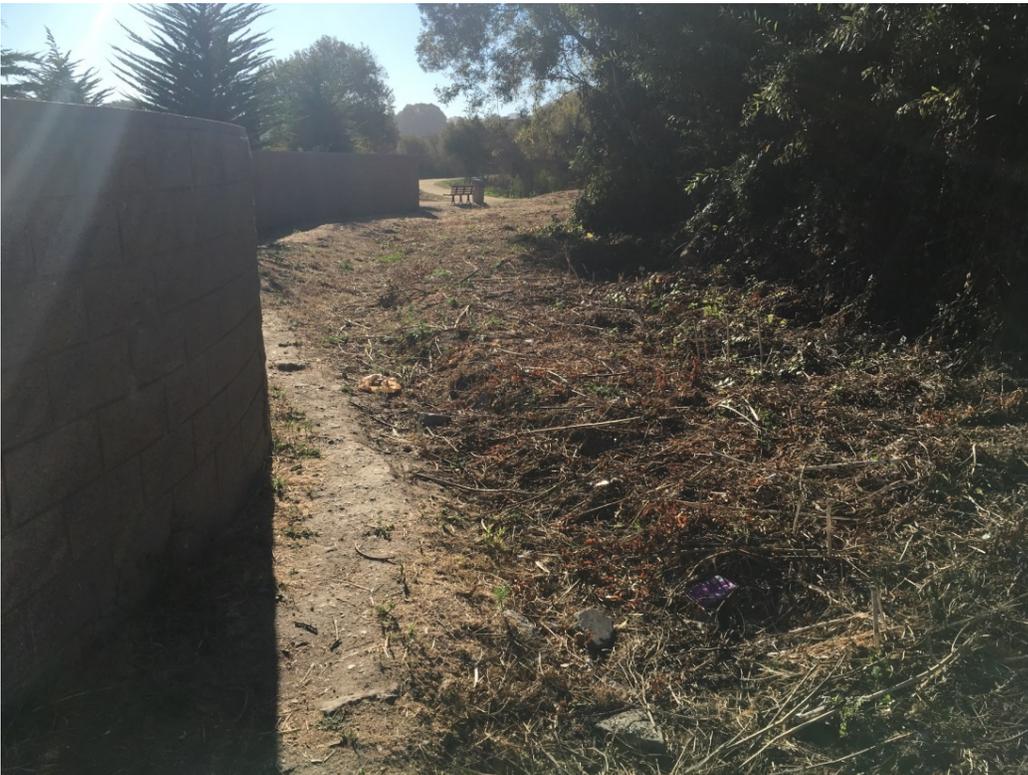
Site 34. Swale, looking toward Laguna Grande.

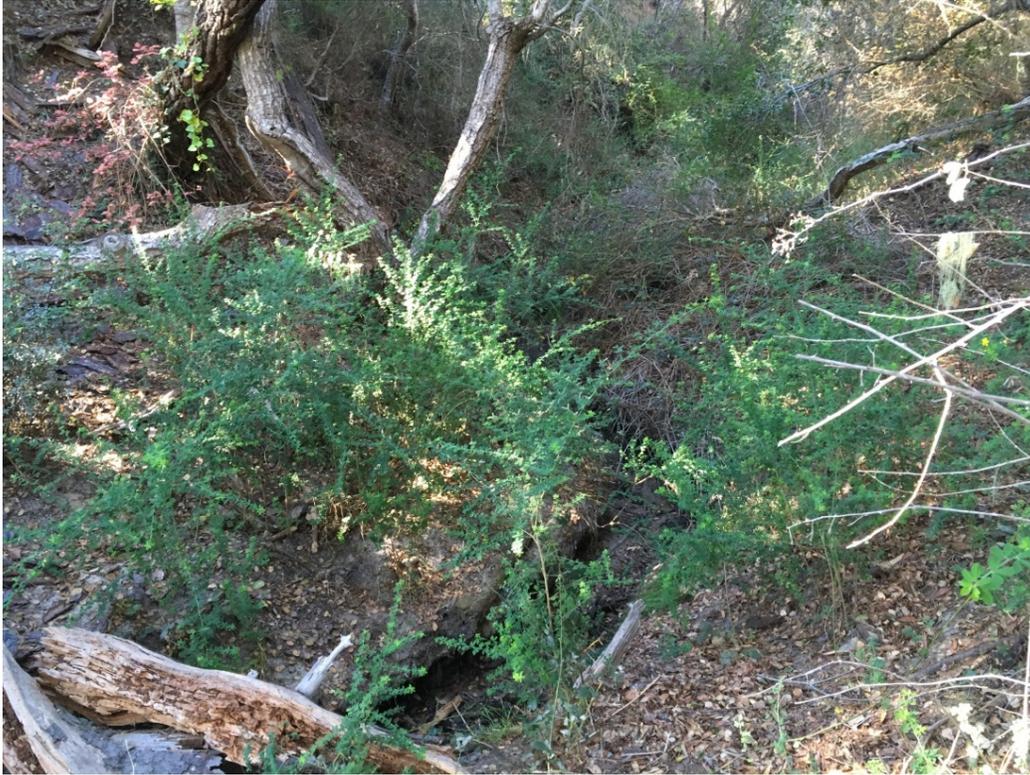
Site 36. Upstream reach near road, looking upstream.

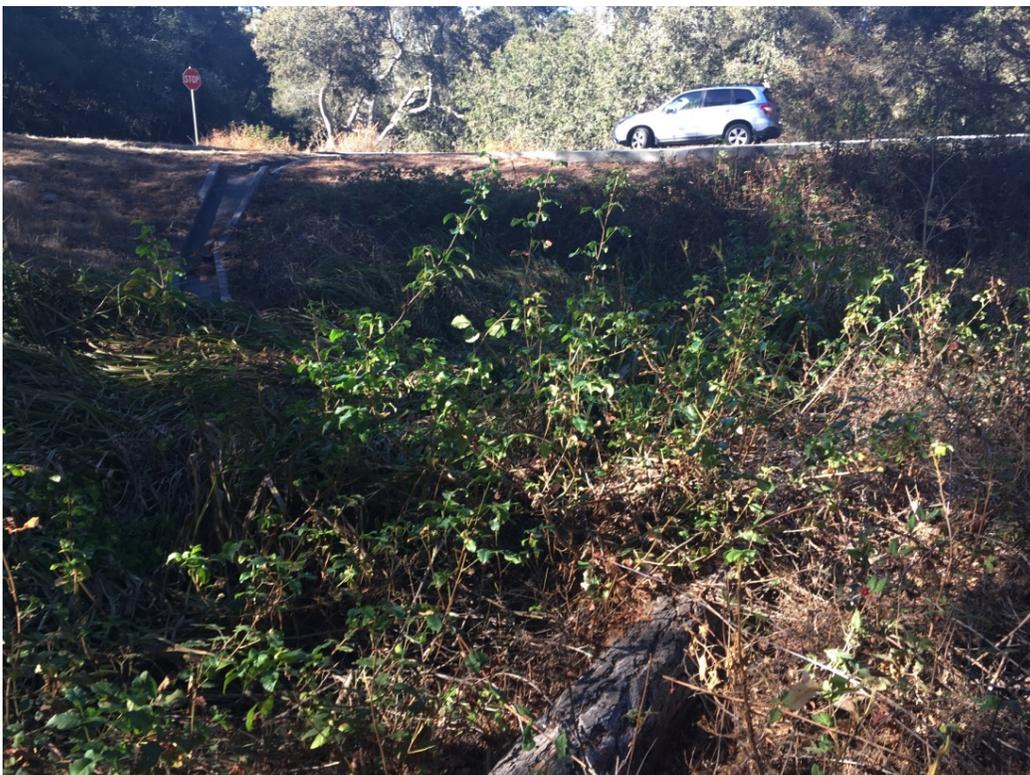
Site 37. Upstream reach, looking toward Glenwood Circle. Vegetation obscures channel. Sewer easement also present.

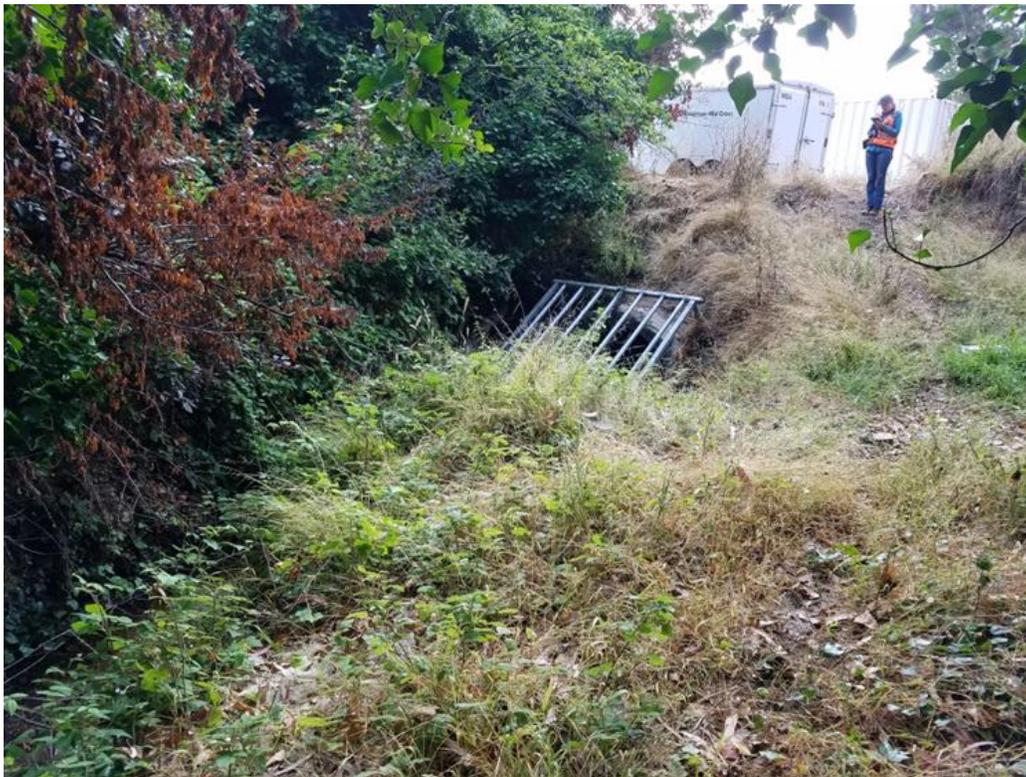
Photograph 6. Site 5, Culvert E04-H3 inlet, viewed facing downstream (east).

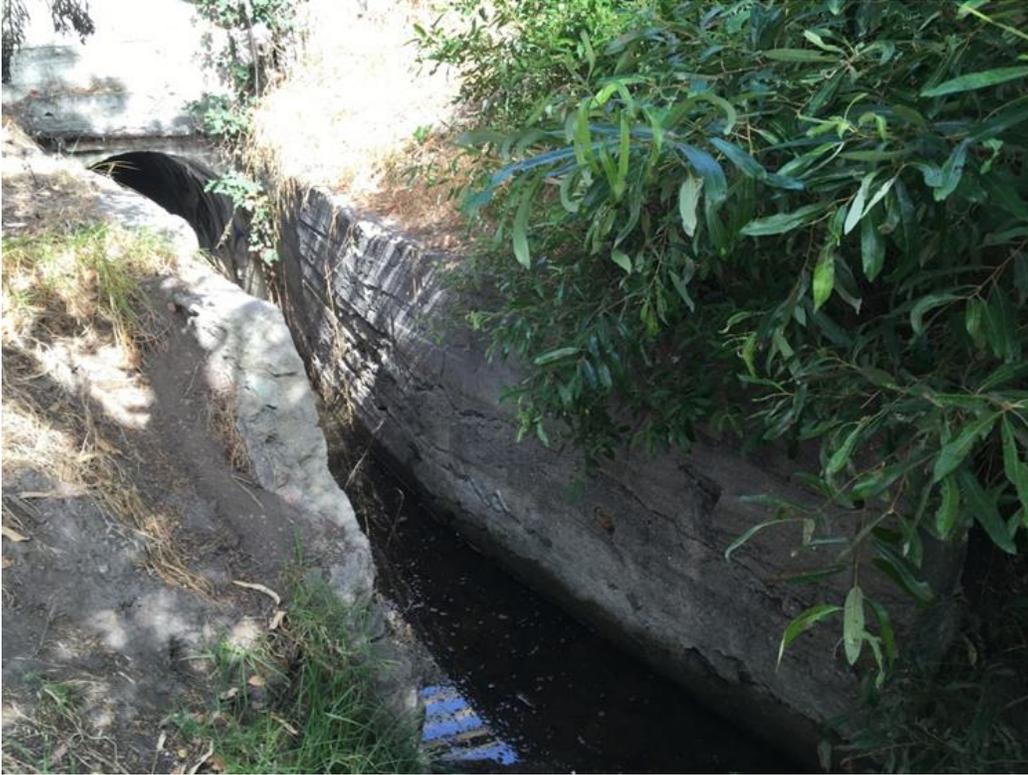
Photograph 7. Site 5, Armored culvert outlet east of Pacific St, facing northwest.

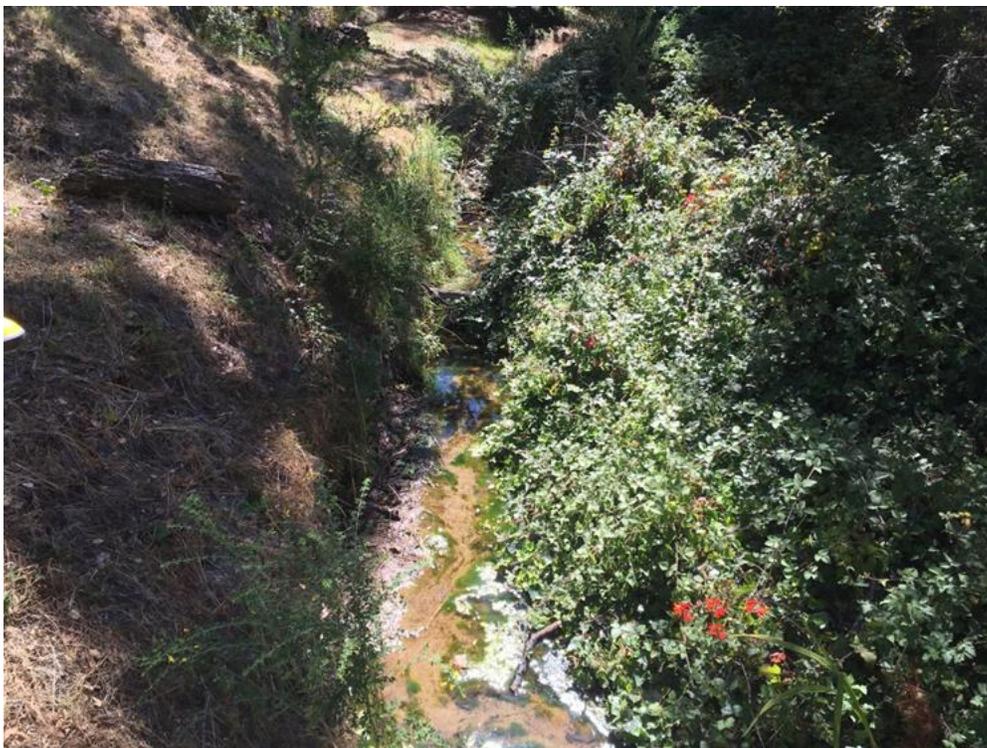
Photograph 17. Site 15, Channel condition upstream of culvert F03-H2 inlet, facing upstream (southwest).

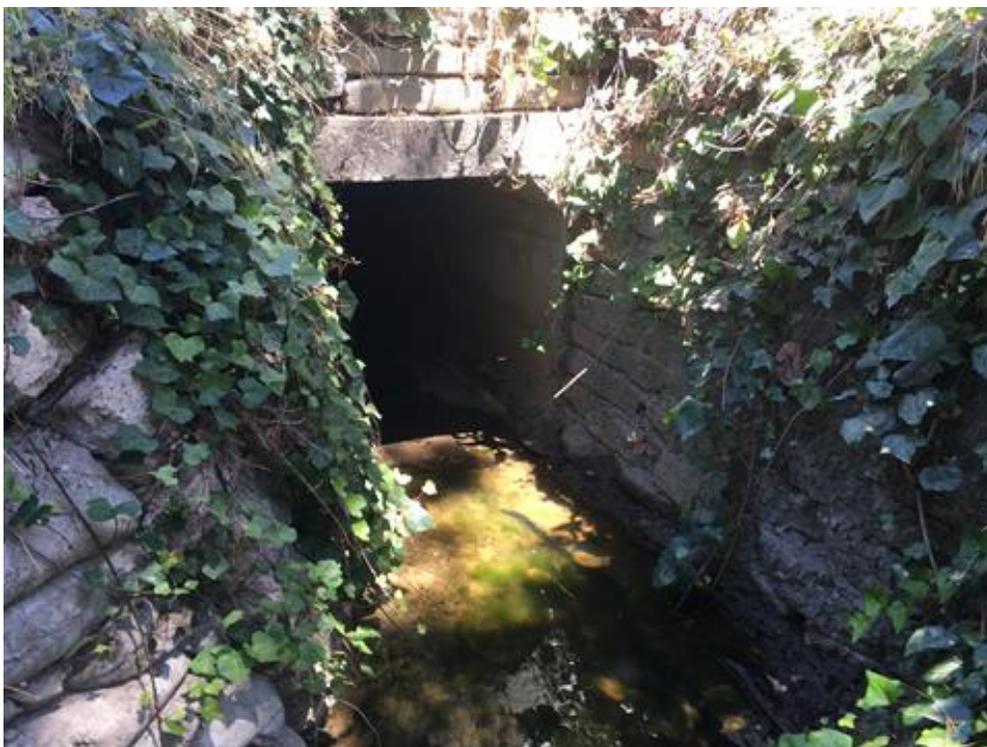
Photograph 18. Site 16, Culvert inlet on upstream side of Alameda Road, facing east.

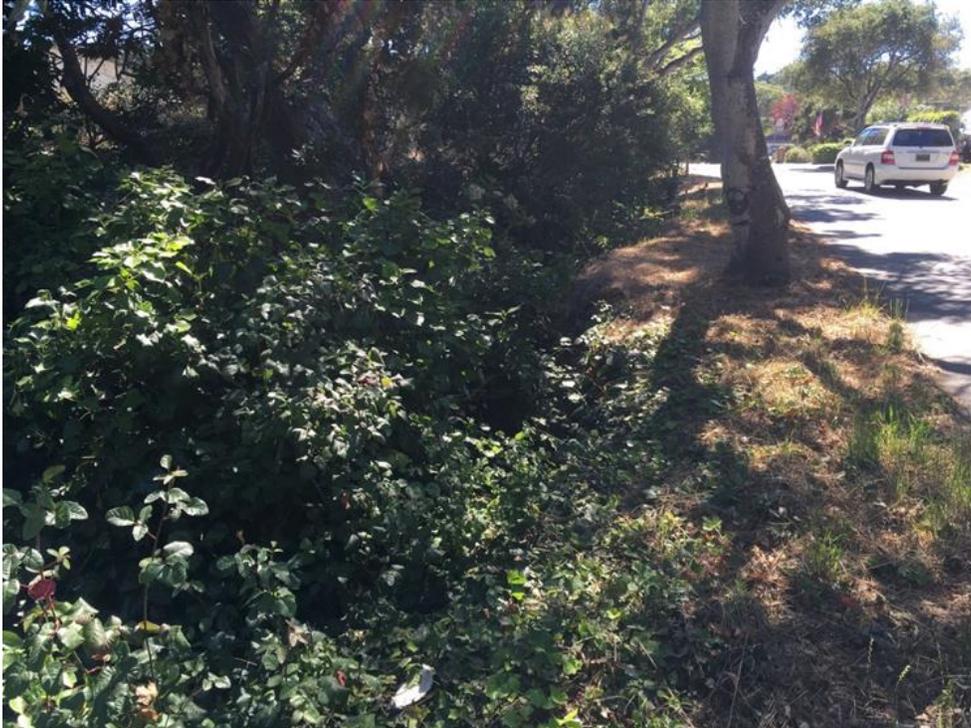
Photograph 19. Site 17, Channel condition just upstream of G03-H6, looking upstream, facing northwest.

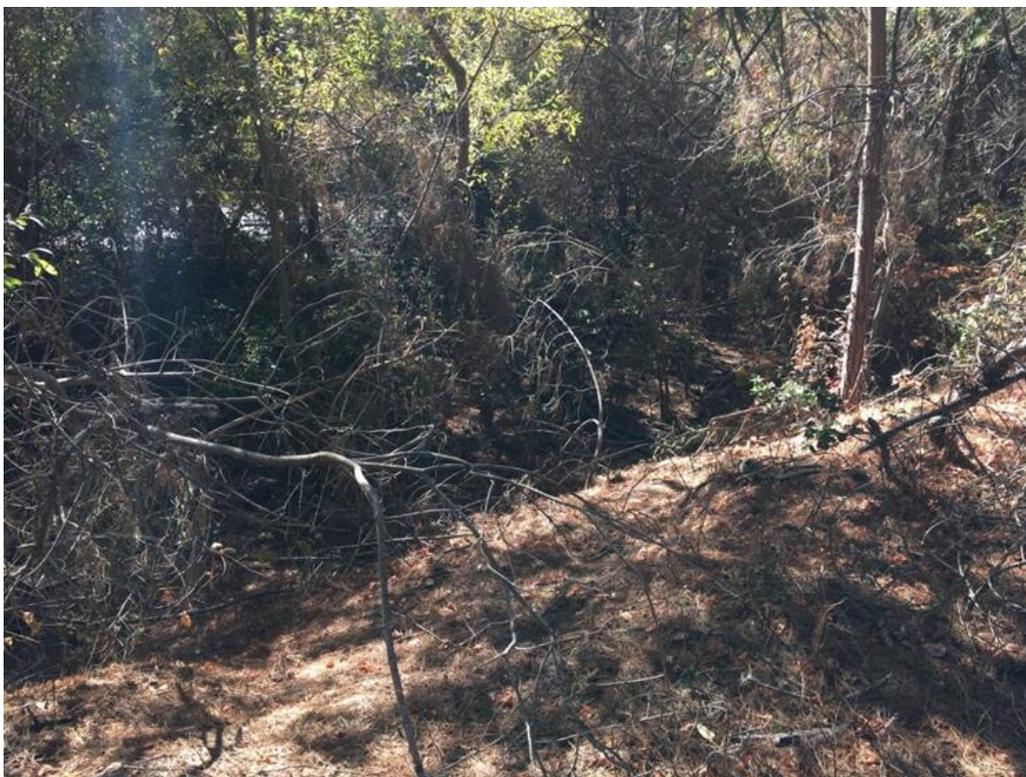
Photograph 36. Site 33, Garden Ct. Basin - looking toward Hwy 68, facing south.

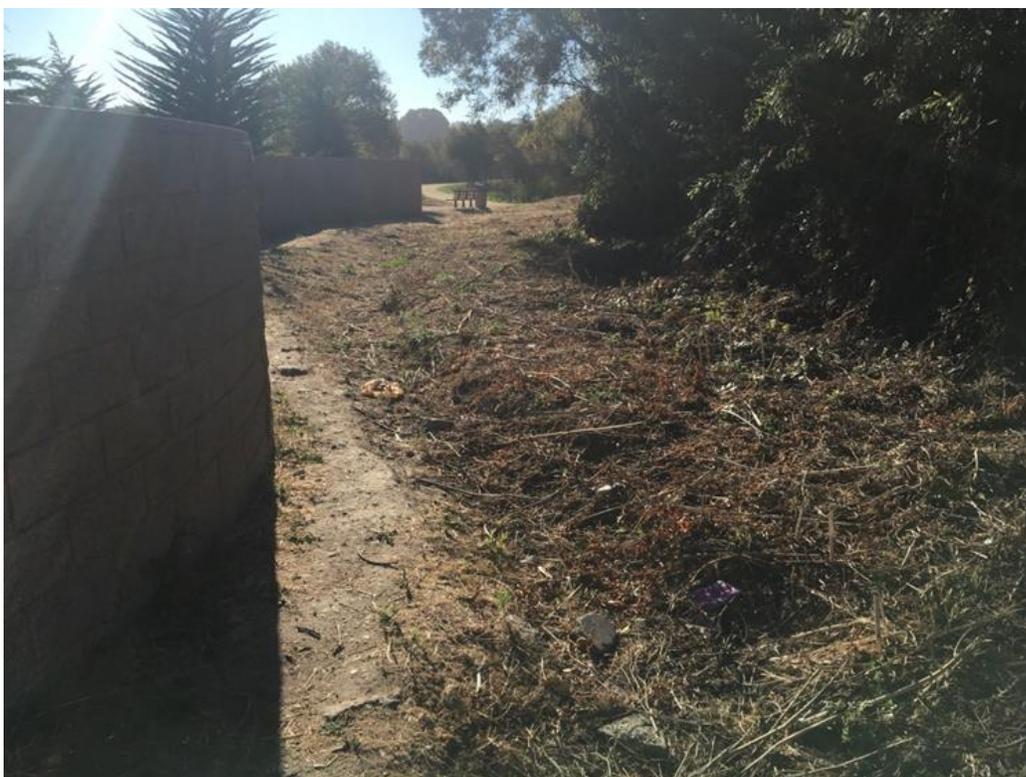
Photograph 37. Site 34, Swale, looking toward Laguna Grande, facing south.
