Site Circulation Report

LAUSD COMPREHENSIVE MODERNIZATION PROJECT -
92ND STREET ELEMENTARY SCHOOL

Prepared by:
LIN Consulting, Inc.

For:
ESA
Los Angeles Unified School District

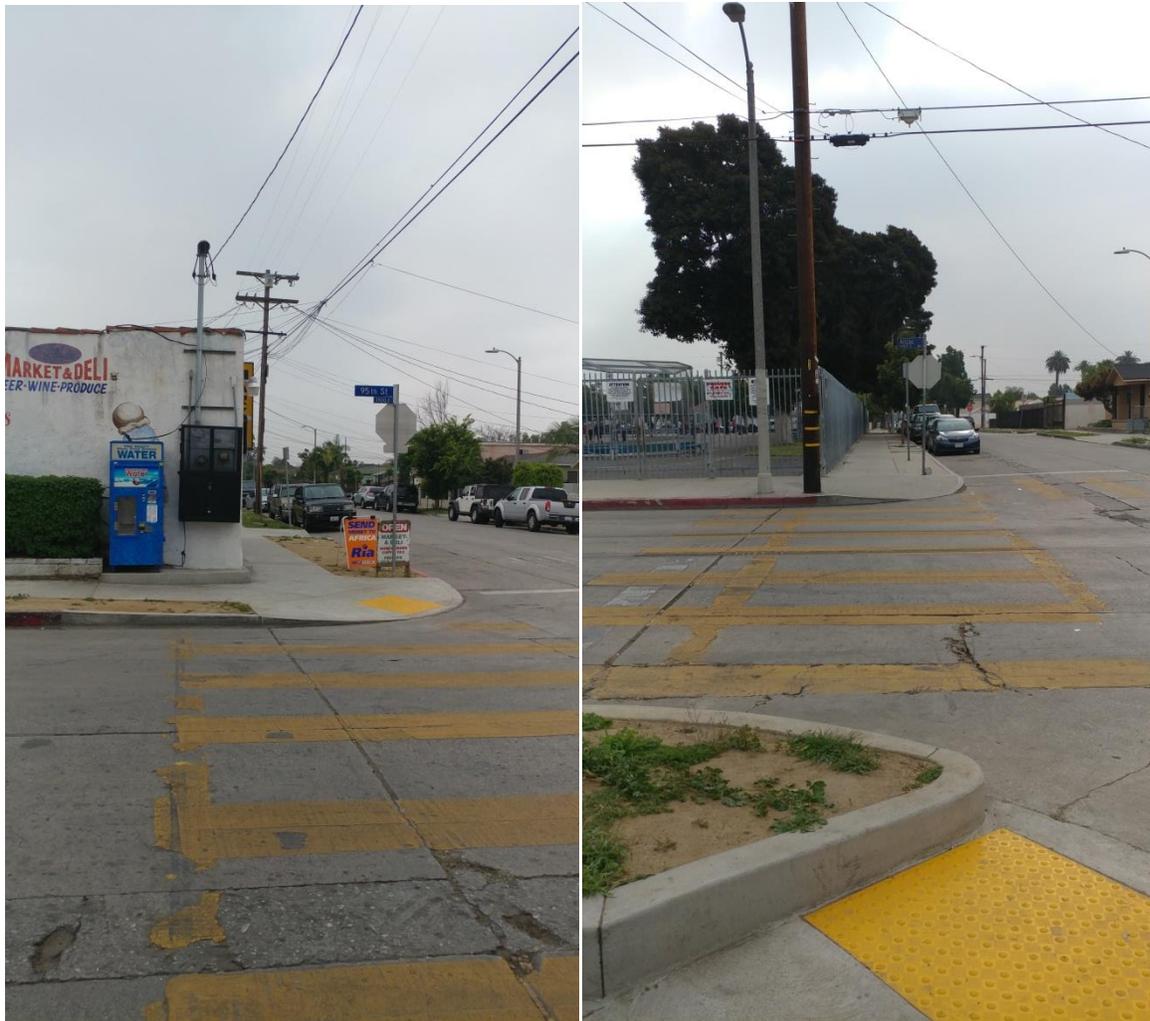
- Anzac Avenue & 95th Street
 - Crosswalk striping missing for the south leg of the intersection, despite heavy pedestrian use
 - Worn crossing pavement markings along the east leg of the intersection

- Worn and uneven crossing pavement on the north leg of the intersection
 - Street lighting is only provided on the northeast corner of the intersection

Crosswalk striping worn at the east leg (left) and crossing pavement worn and uneven at the north leg of the intersection of Anzac Ave and 95th Street

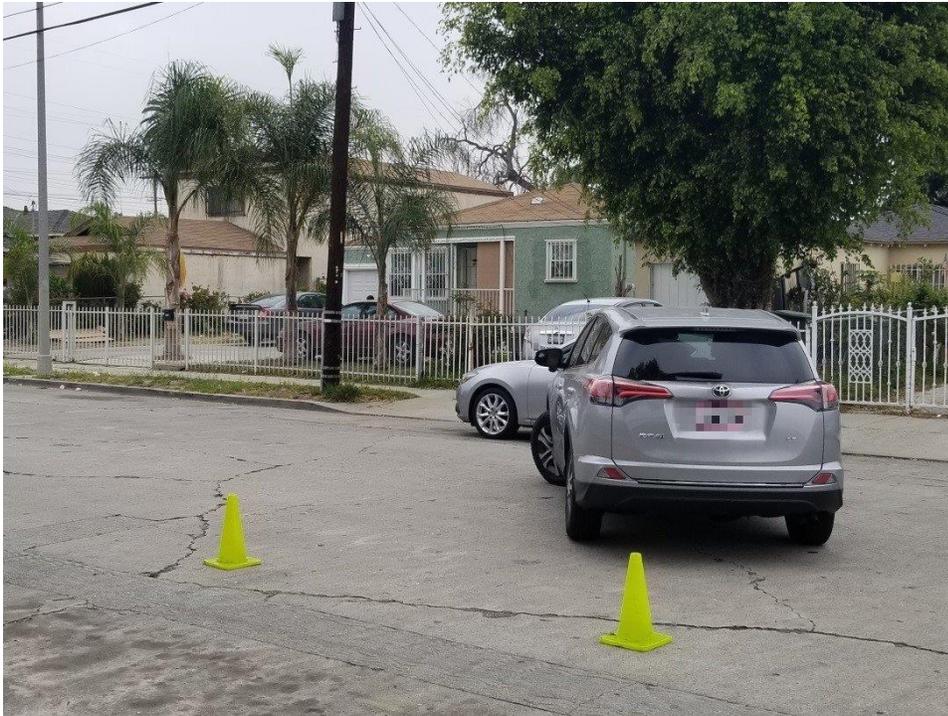
As mentioned previously, parents frequently attempt U-turns after the pick-up or drop-off to return to 92nd Street, which involves crossing a traffic cone line, which is a violation of California Vehicle Code. This maneuver often instead requires a 3-point turn and blocks oncoming northbound traffic. Principal Currie noted that despite occasional enforcement activity from the Los Angeles Police Department (LAPD), the problem continues to occur.

Parents make illegal U-turns on Grape Street to return to 92nd Street

- While off-site improvements are not within LAUSD's jurisdiction, in order to facilitate two-way heavy traffic flow on 95th Street, Grape Street, and Anzac Avenue, one side of curb parking could be removed, or additional pavement width could be provided on each street
- Alternatively, another off-site improvement may entail converting the previously mentioned streets into a one-way couplet, where traffic enters southbound on Anzac Avenue, turns left at 95th Street, then turns left again to northbound Grape Street; one-way travel northbound on Grape Street would eliminate the need for illegal U-turns

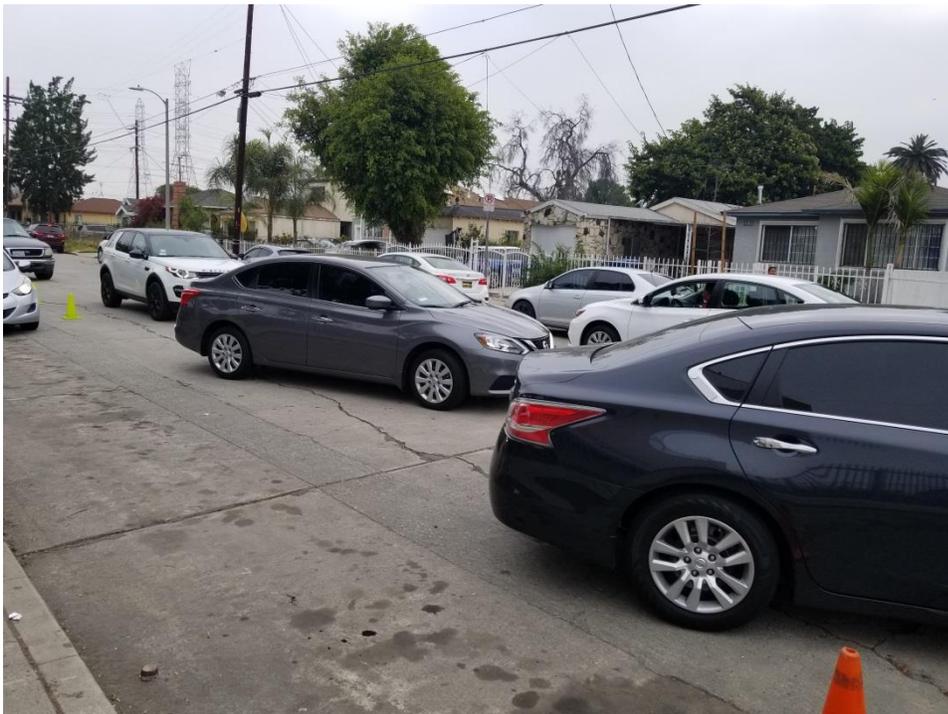
Parents double park and leave their cars in the middle of Grape Street

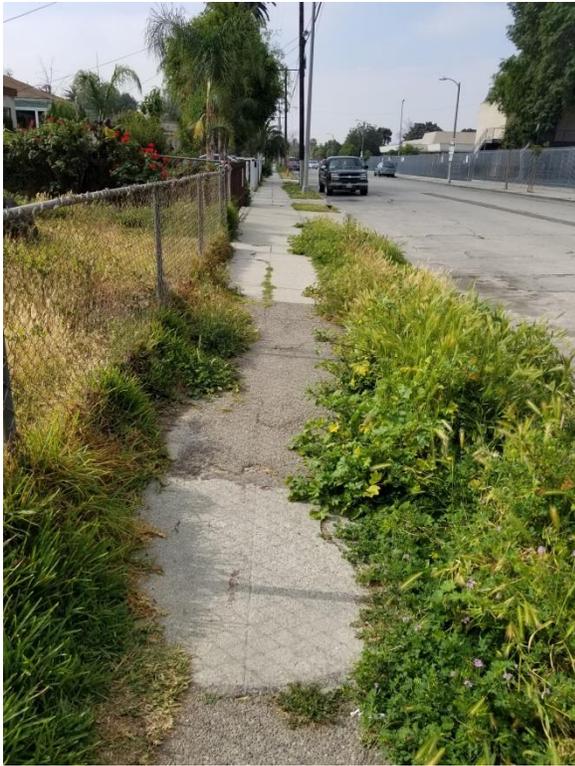
- Grape Street & 92nd Street
 - Crossing 92nd Street is not allowed, and nearest eastern crossing is 300 feet away
 - Sidewalk on east side of Grape Street near alley is overgrown with brush, and uneven surface/deteriorated pavement

Grape Street looking south; deteriorated sidewalks with overgrown brush make use impossible for disabled students or faculty

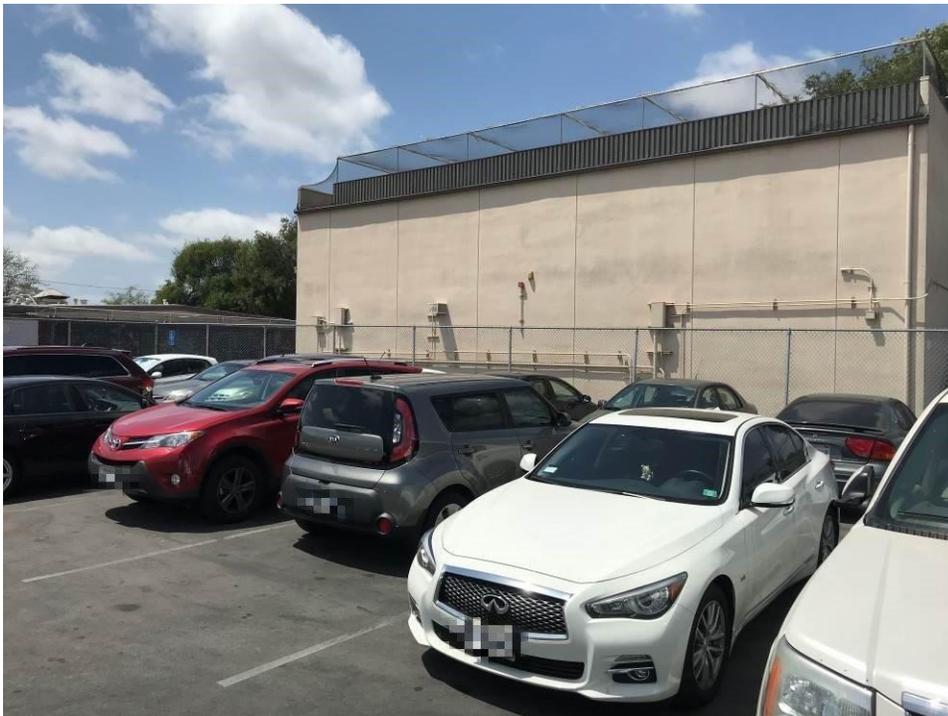
Principal Currie indicated that there is currently considerable shortage of parking available on-site for faculty and staff. On street sweeping days, the utilization of curb parking was observed to be above 95%, and per Principal Currie, faculty and staff often double-park or otherwise park in undesignated spaces on campus.

Faculty and staff double park due to lack of available parking

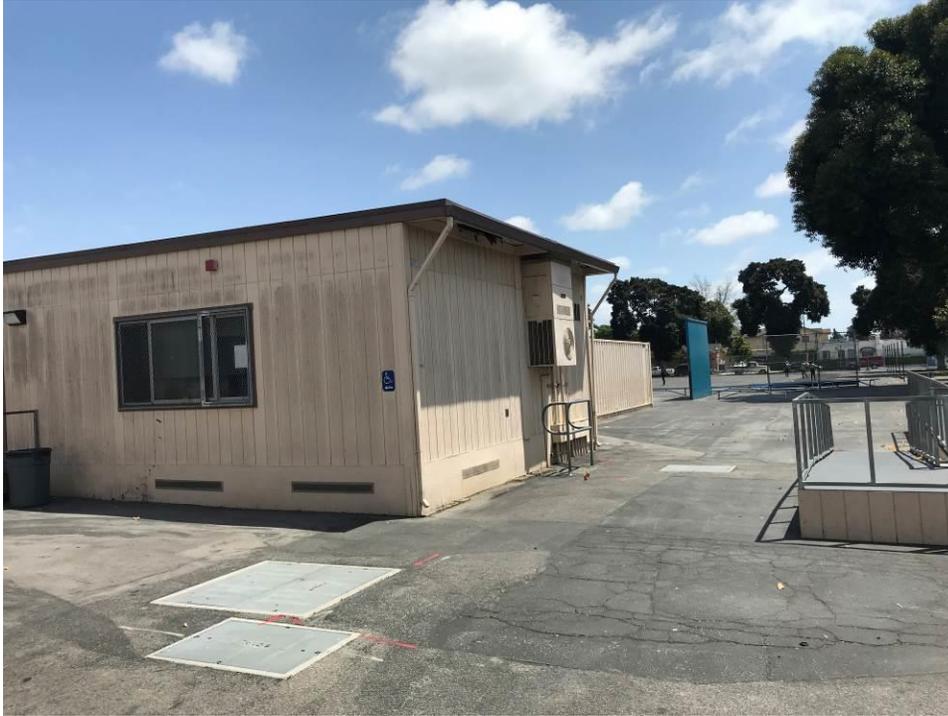
Modular temporary classroom units sit on top of largely paved over open space

- Removal of portable classrooms and large open space, particularly on south side of campus, may be well suited for additional parking or pick-up/drop-off area
- Large amounts of available paved open space on campus that may be underutilized (i.e., not used during the school day) may also present an opportunity for additional parking or pick-up/drop-off area

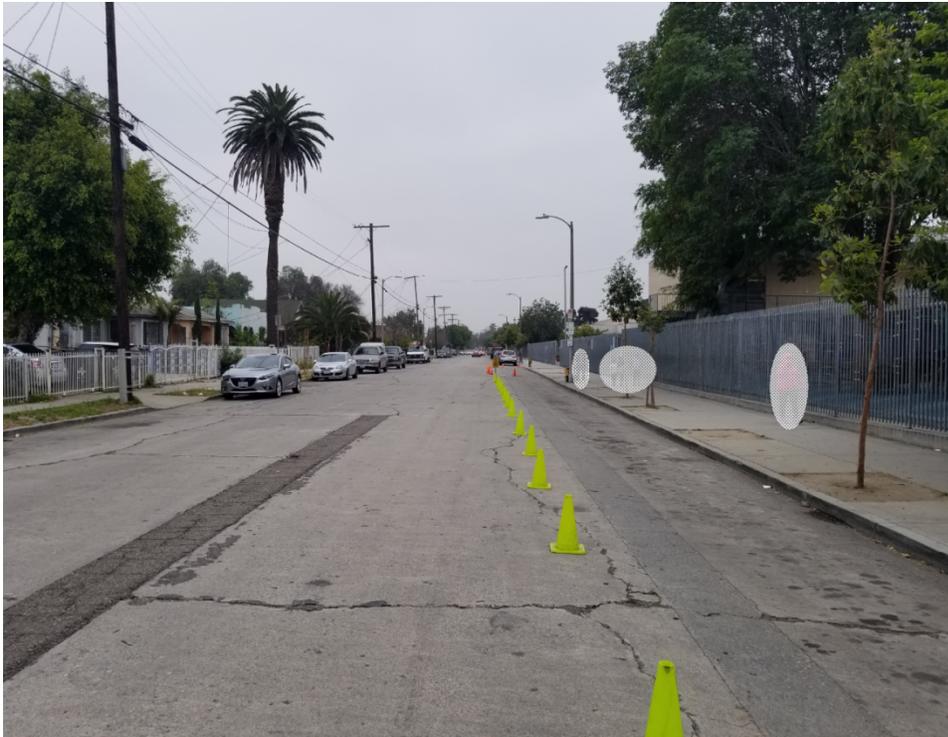
A passenger loading zone of roughly 200 feet exists near the main pedestrian gate, which is located on Grate Street, approximately halfway between 95th Street and 92nd Street. At this location, the school has instituted a “valet” program and policy to help organize the morning bell period. This operation runs southbound along Grape Street, and involves setting up and removing traffic cones once per day. A separate lane is formed along the west curb of Grape Street, intended for brief loading and unloading. There are two volunteers at main pedestrian gate (sometimes referred to as the kindergarten entrance) for opening/closing car doors, and for guiding children into the school. However, there is no signage that exists permanently, nor was any temporary signage observed, which would indicate specific instructions to the driver other than “Stop and Drop Here”.

Loading zone/15-minute parking zone is coned off to provide a “valet” curbside service for pick-ups/drop-offs on west side of Grape Street; volunteers open car doors and guide children into the gate

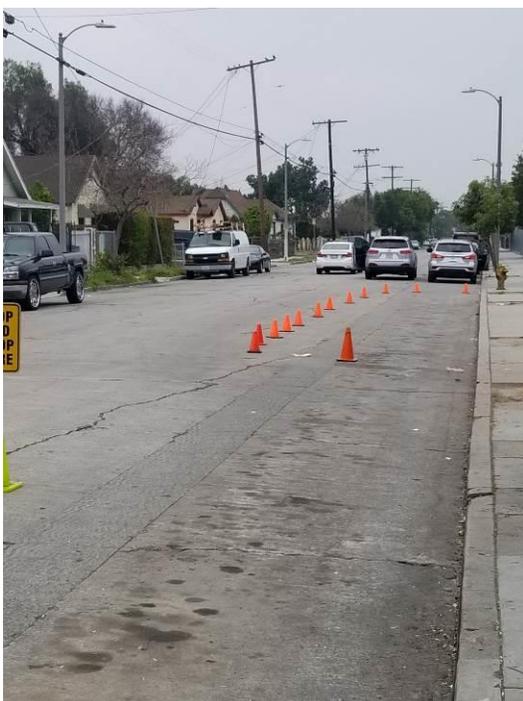
Parents frequently double park to drop children off, despite the “valet” service
