LOS ANGELES COUNTY DEPARTMENT OF PUBLIC WORKS

Limited Hazardous Materials Survey

Little Tujunga Canyon Road Bridge Replacement over Buck Canyon Creek Project

Prepared by
Los Angeles County Department of Public Works
Construction Division
Environmental Compliance Unit
November 14, 2017

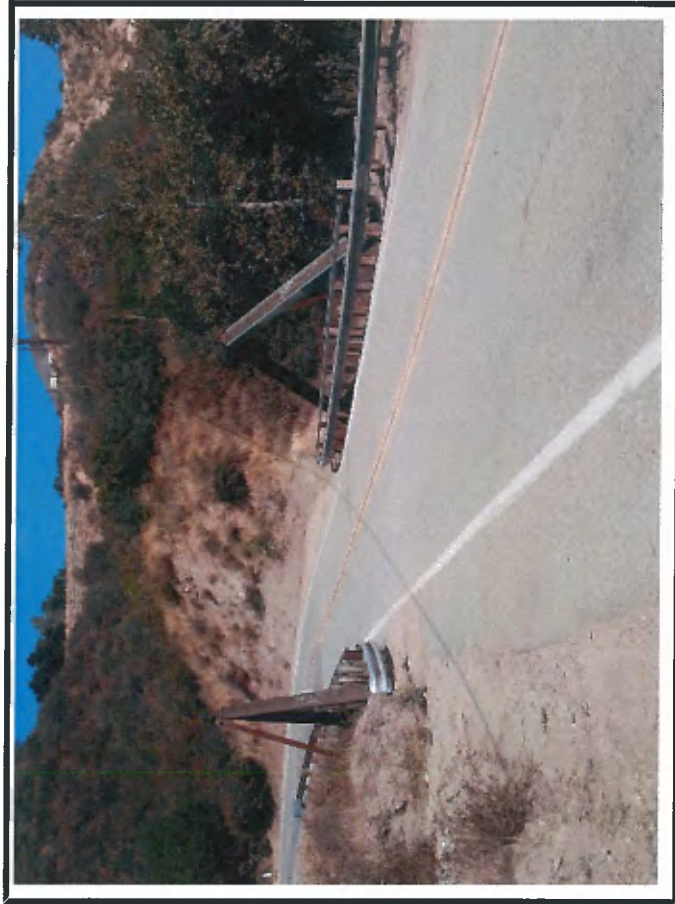
PROJECT PHOTOGRAPHIC NUMBER		1	
DESCRIPTION	View of the bridge looking toward the northwest.		
PHOTOGRAPHED BY	D. Simon	DATE	09/20/2017

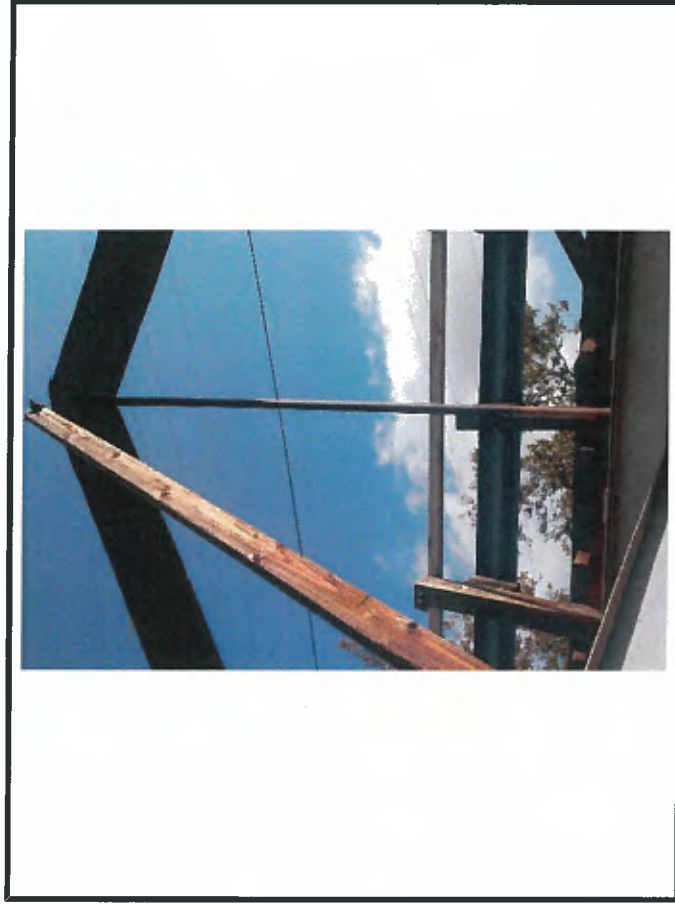
PROJECT PHOTOGRAPHIC NUMBER		2
DESCRIPTION	View looking up at the bridge from the bed of Buck Canyon Creek.	
PHOTOGRAPHED BY	D. Simon	DATE 09/20/2017

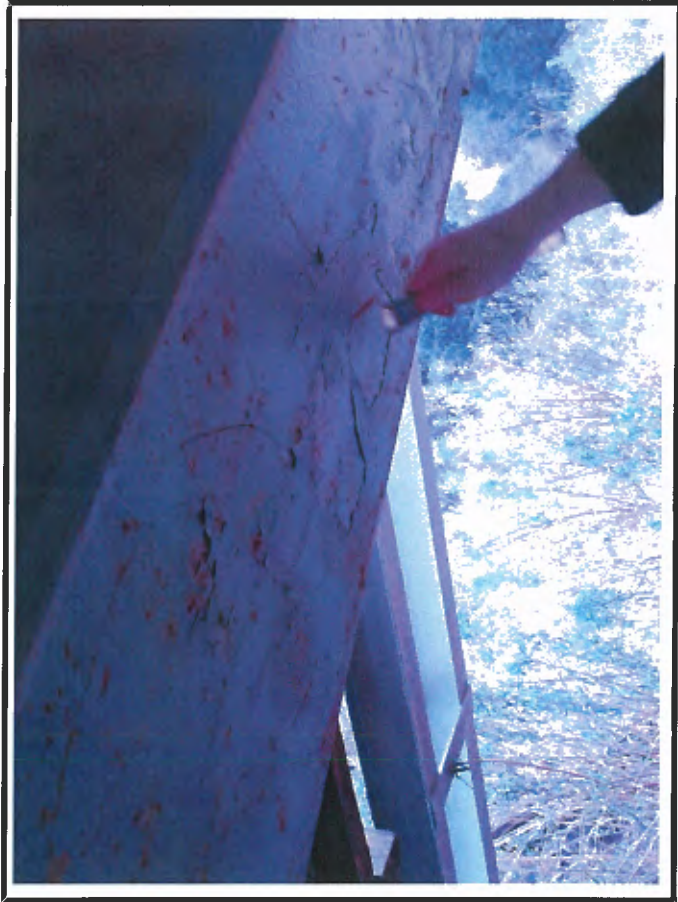
Sample No. 103101 (Photo No. 3) and Sample No. 103103 (Photo No. 5) had detectable lead concentrations below 5,000 ppm. These samples were collected from the grey paint on the metal beams supporting the bridge and the grey paint on the metal beams of the "A" frame on the sides of the bridge.

PROJECT PHOTOGRAPHIC NUMBER		3
DESCRIPTION	Underside of beam with grey paint under bridge.	
Lead Paint Sample No. 103101. 290 ppm, LCP		
PHOTOGRAPHED BY	D. Simon	DATE
		10/31/2017

The grey paint on the metal beams supporting the bridge and the grey paint on the metal beams of the “A” frame on the sides of the bridge contain detectable levels of lead below 5,000 ppm. Although these paints did not meet or exceed the level of 5,000 ppm for LBP, these surface coatings contain detectable levels of lead and are regulated by Cal/OSHA. Any areas of peeling or deteriorating paint shall be stabilized to prevent loose and flaking paint from becoming detached and impacting the surrounding environment. The paint shall be abated in any areas that may require cutting.

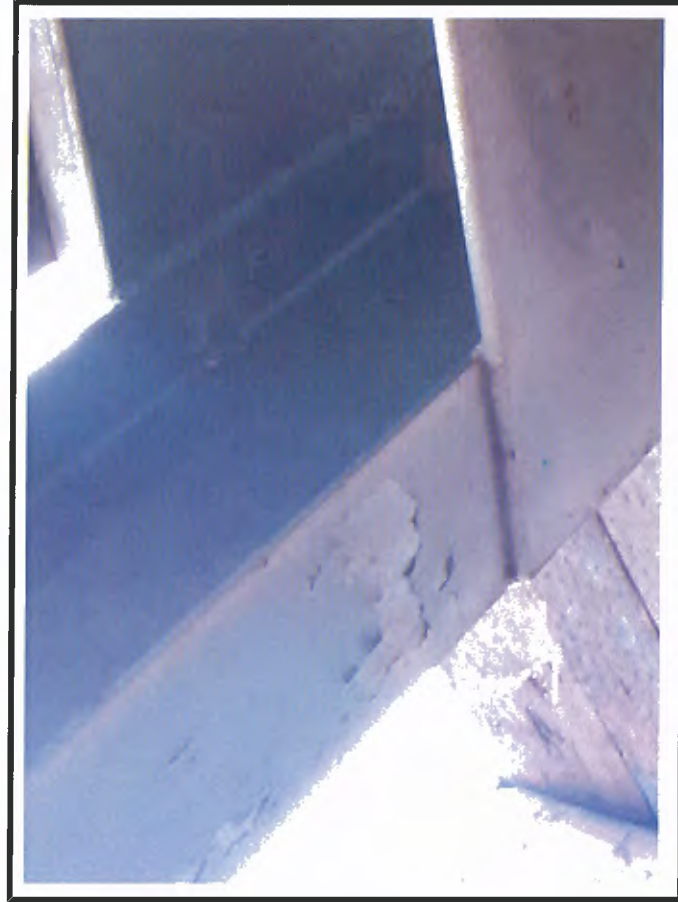
Sample No. 103102 (Photo No. 4) and Sample No. 103104 (Photo No. 6) had lead concentrations that met or exceeded the 5,000 ppm threshold to be defined as a LBP. These samples were collected from the grey (shiny) paint with orange under layer on the metal beams supporting the bridge and the black paint with the orange under layer on the metal poles at the apex of the timber "A" frame on the sides of the bridge.

PROJECT PHOTOGRAPHIC NUMBER		4
DESCRIPTION	Underside of beam with grey (shiny) paint with orange under layer. Lead Paint Sample No. 103102. 170,000 ppm, LBP	
PHOTOGRAPHED BY	D. Simon	DATE 10/31/2017

The grey (shiny) paint with the orange under layer on the metal beams supporting the bridge and the black paint with the orange under layer on the metal poles at the apex of the timber

“A” frame on the sides of the bridge contain concentrations of lead greater than the regulatory level of 5,000 ppm of lead and are considered LBP.

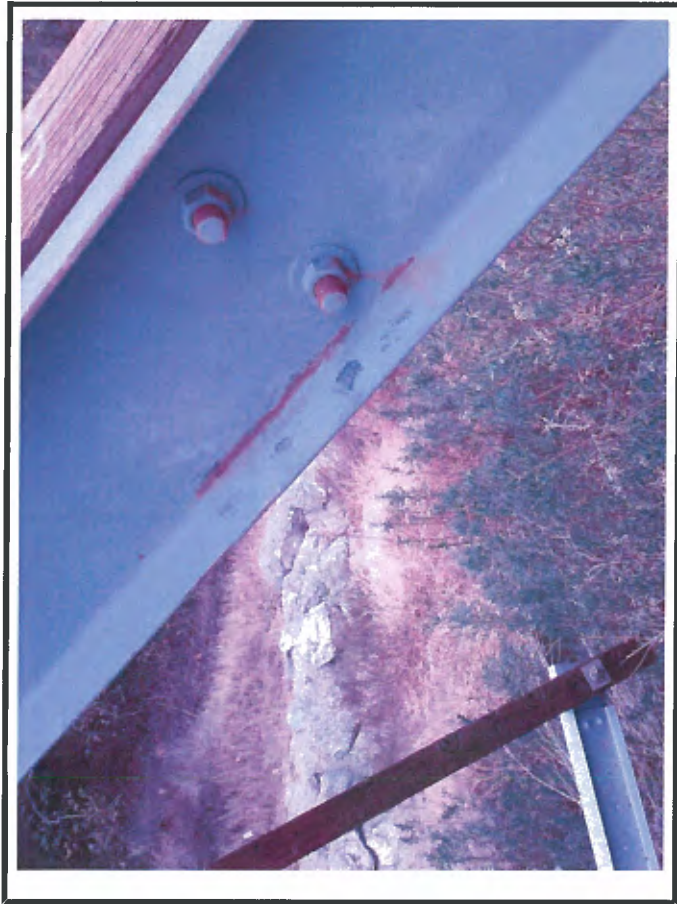
PROJECT PHOTOGRAPHIC NUMBER		5
DESCRIPTION	"A" Frame Beam with grey paint. Lead Paint	
Sample No. 103103. 160 ppm, LCP.		
PHOTOGRAPHED BY	D. Simon	DATE
		10/31/2017

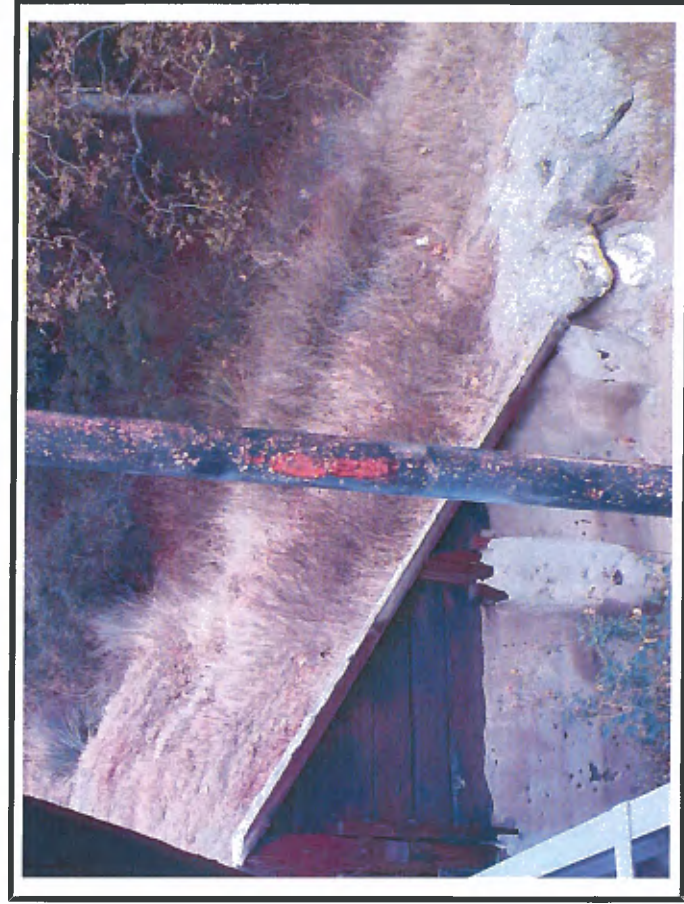
PROJECT PHOTOGRAPHIC NUMBER		6
DESCRIPTION	Black paint with orange under layer on metal pole at apex of "A" Frame. Lead Paint Sample No. 103104. 89,000 ppm, LBP.	
PHOTOGRAPHED BY	D. Simon	DATE 10/31/2017

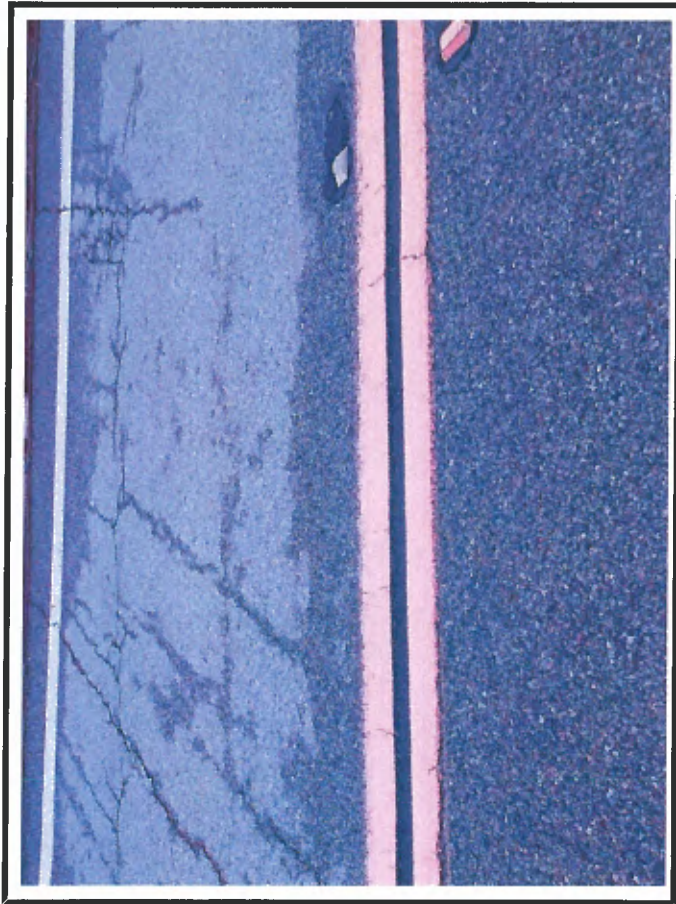
No lead was detected in Sample No. 103105 (Photo No. 7) and Sample No. 103106 (Photo No. 8) which were collected from the yellow and white paint striping on the road surface of the bridge based on the limitations of the analysis method.

PROJECT PHOTOGRAPHIC NUMBER		7
DESCRIPTION	Yellow Road Striping. Lead Paint Sample	
No. 103105. No lead detected.		
PHOTOGRAPHED BY	D. Simon	DATE
		10/31/2017

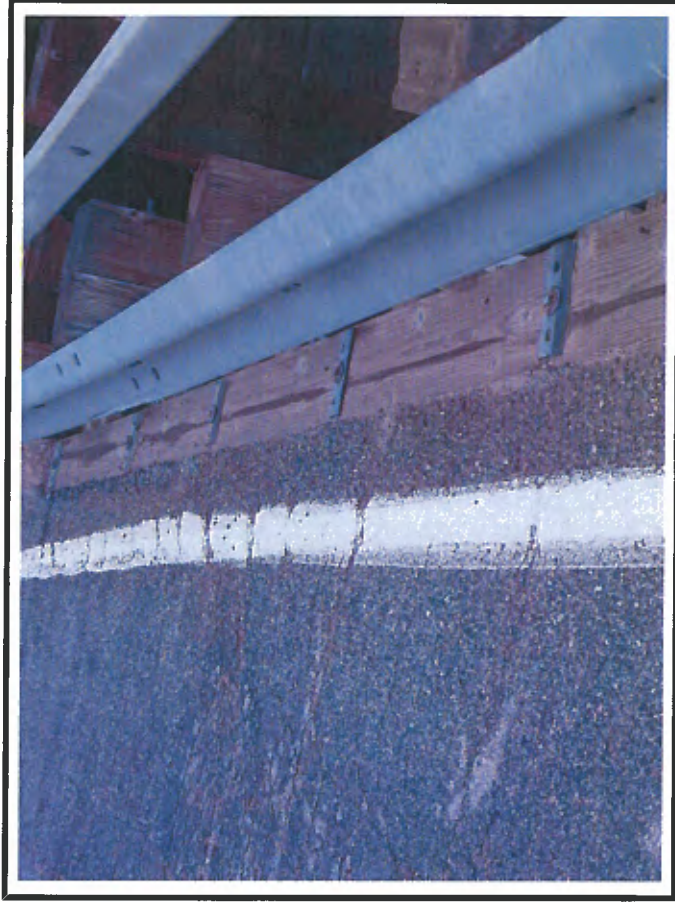
PROJECT PHOTOGRAPHIC NUMBER		8
DESCRIPTION	White Road Striping. Lead Paint Sample No. 103106.	
No lead detected.		
PHOTOGRAPHED BY	D. Simon	DATE
		10/31/2017

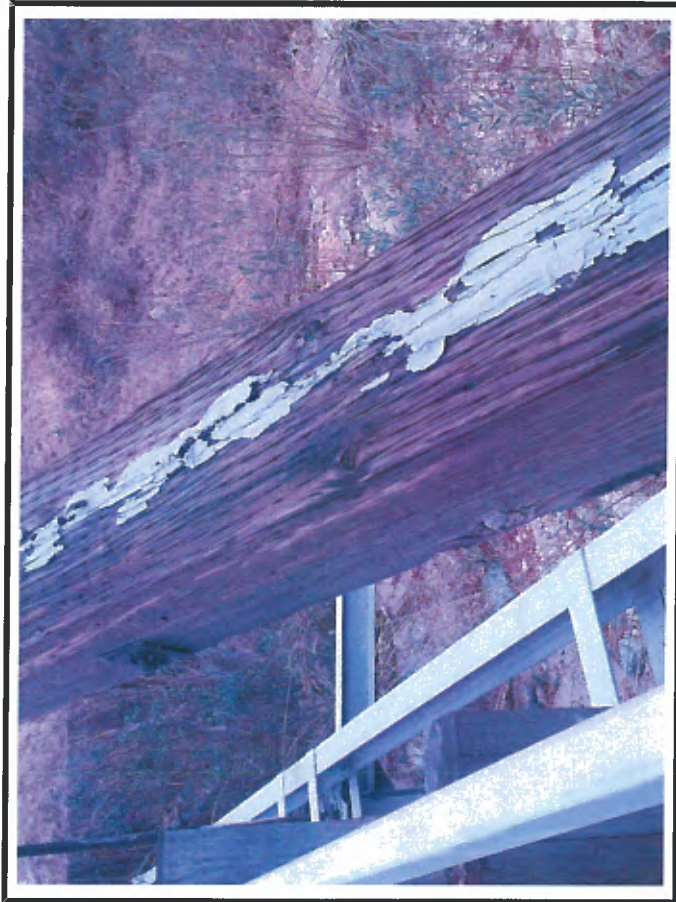
Sample No. 103107 (Photo No. 9) which was collected from the grey mastic on the "A" frame timber was found to contain asbestos at a concentration that defines this material as ACM. The analytical laboratory report and chain of custody record are included as Attachment 3.

PROJECT PHOTOGRAPHIC NUMBER		9
DESCRIPTION	Grey Mastic. Asbestos Sample No. 103107.	
10% chrysotile asbestos, ACM.		
PHOTOGRAPHED BY	D. Simon	DATE
		10/31/2017

The grey mastic on the “A” frame timber contains asbestos and is considered to be ACM. Suspect asbestos materials in areas not accessible at the time of the hazardous materials survey, and which were not tested for asbestos content, cannot be presumed to be free of asbestos. Therefore, if renovation or demolition activities reveal suspect asbestos materials that were not sampled, additional sampling would be required prior to activities that would disturb the suspect asbestos materials unless those surfaces are presumed to contain asbestos.

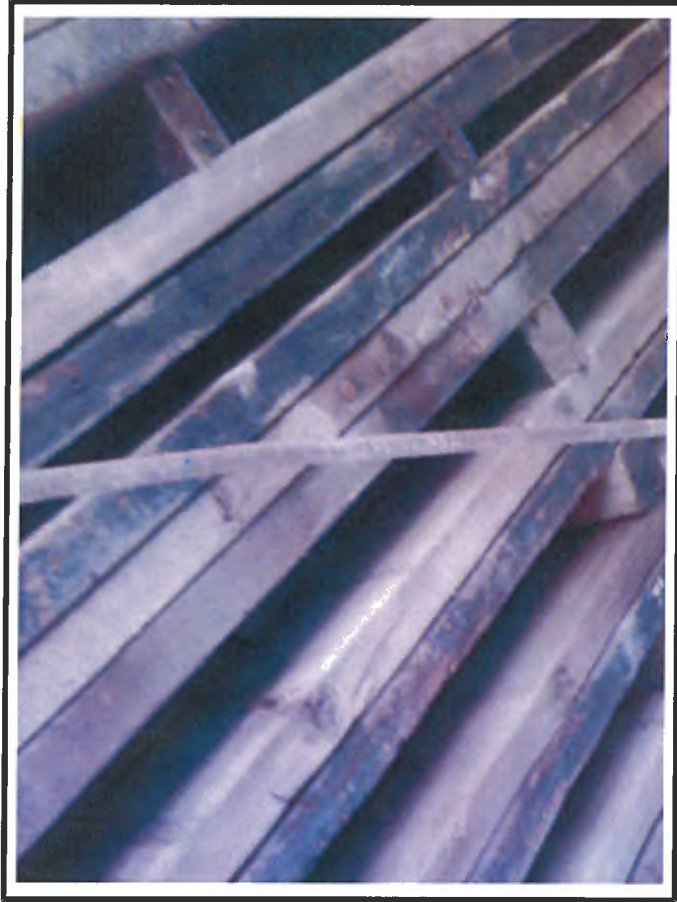
The pressure treated timber observed on the exterior of the Headworks structure is assumed to contain creosote (Photo Nos. 9, 10, and 11). Based on this assumption the timber is regulated under Title 22, CCR, Section 67386 "Alternative Management Standards for Treated Wood Waste".

PROJECT PHOTOGRAPHIC NUMBER		10	
DESCRIPTION	Treated Wood Timber at underside of bridge.		
PHOTOGRAPHED BY	D. Simon	DATE	09/20/2017

The existing timber to be removed from the bridge structure is categorized as TWW and shall be removed and disposed of per Title 22, CCR, Section 67386 "Alternative Management Standards for Treated Wood Waste". This regulation also requires the employer to provide training for all employees handling TWW and all employees that may reasonably be expected to contact TWW.

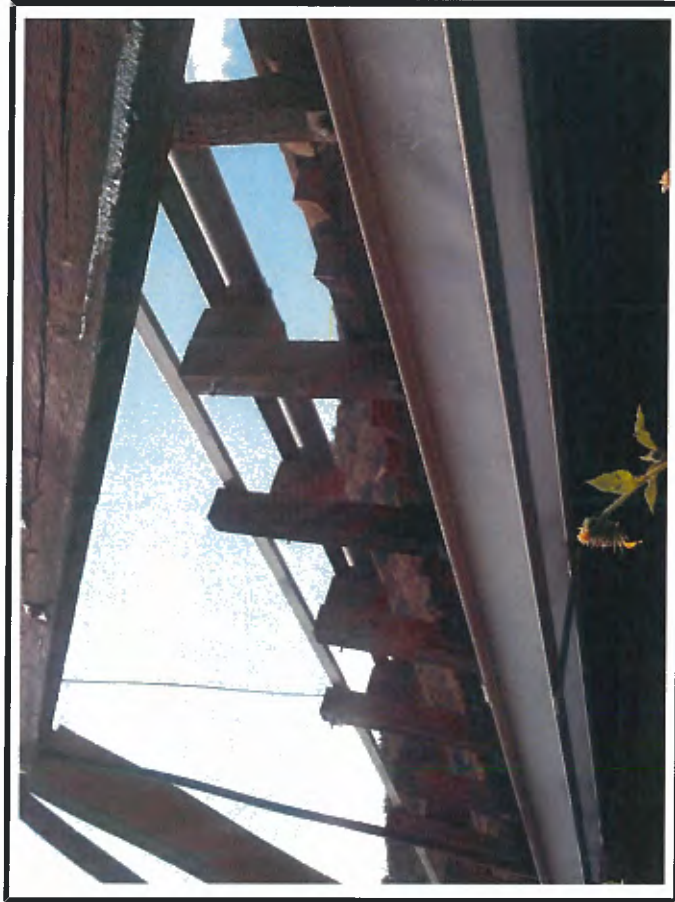
PROJECT PHOTOGRAPHIC NUMBER		11
DESCRIPTION	Treated Wood Timber railing.	
PHOTOGRAPHED BY	D. Simon	DATE
		09/20/2017

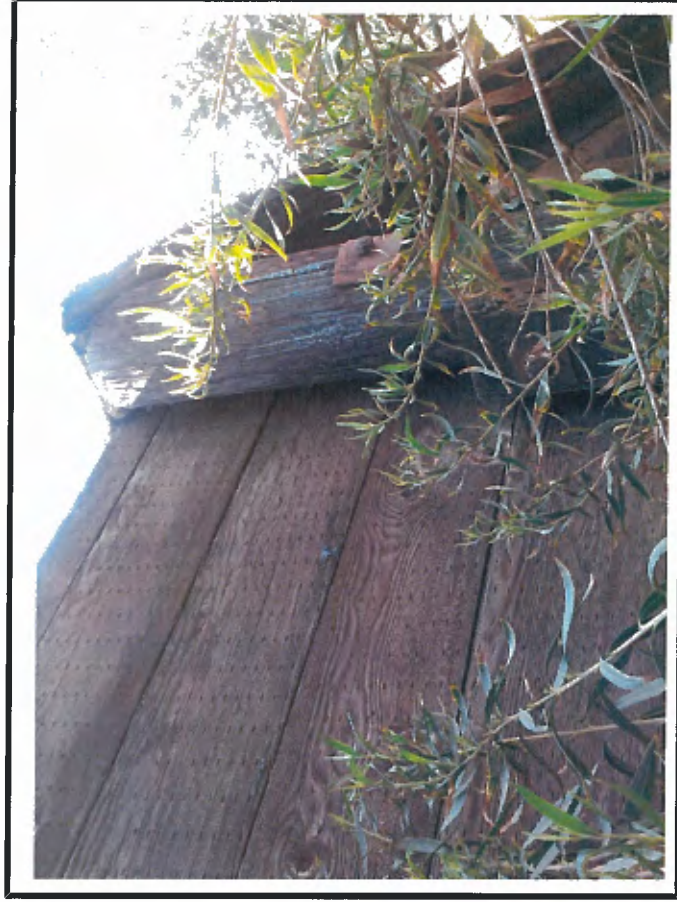
PROJECT PHOTOGRAPHIC NUMBER		12	
DESCRIPTION	Treated Wood Timber at bridge abutments.		
PHOTOGRAPHED BY	D. Simon	DATE	09/20/2017
