Re: CITADEL Project No. 0611.1053.0
Methane Survey Report
Pietersma Dairy Site
7233 Eucalyptus Avenue
Ontario, California 91762

Methane Survey Report

Citadel Project Number 0611.1053.0

Pietersma Dairy Site 7233 Eucalyptus Avenue Ontario, California 91762

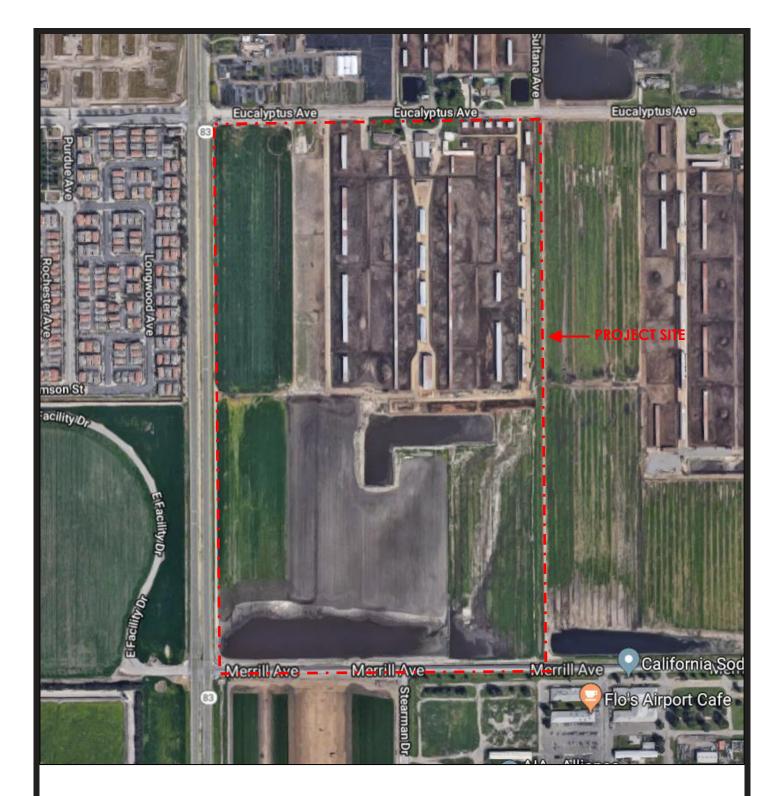
7233 Eucalyptus Avenue Ontario, California Figure 2

Site Map

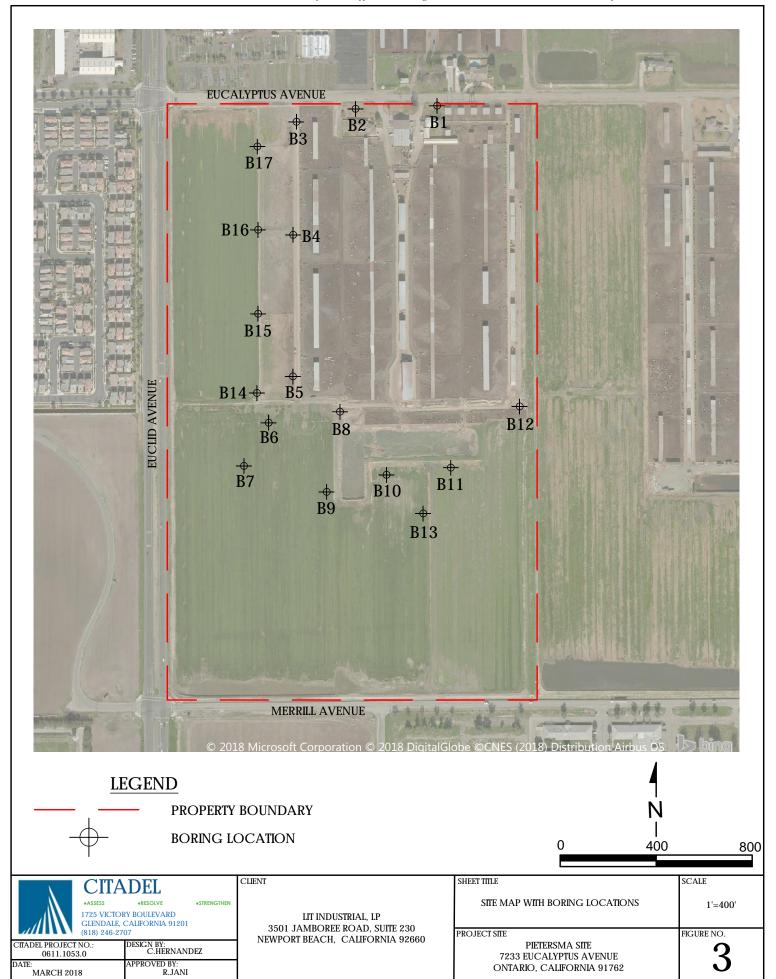
Figure 3 Site Map with Boring Locations

On March 26, 2018, Citadel advanced shallow borings identified as B1 to B17 at 17 locations across the Site for the purpose of collecting soil vapor samples at a depth of approximately five feet below ground surface (bgs) using a hand auger. Citadel's original scope of work for this project was to use a limited access direct push rig to advance the soil vapor borings. However, many of the boring locations were observed to be in areas of the Site that had wet soil and/or in areas with difficult accessibility. Therefore, the scope of work was modified to using a hand auger so as to avoid potential delays from using the rig in these areas. A Site Map showing soil vapor sampling locations is included as Figure 3.

Methane was not reported to be present above the pql in the soil vapor samples, except for samples B8 and B9, which were reported to have methane concentrations of 210 ppmv and 5,470 ppmv, respectively.

Boring locations B8 and B9 are located in the southern portion of the investigated area, south of the cattle pens. B8 is located immediately south of the cattle pens, and B9 is located further south in the field west of the retention pond. The locations are near each other and also immediately adjacent to the retention pond. Other borings near the retention pond did not have detectable concentrations of methane. Based on the methane detection locations it is not clear if the methane concentrations detected were related to the proximity to the retention pond or other factors specific to the western end of the retention pond.

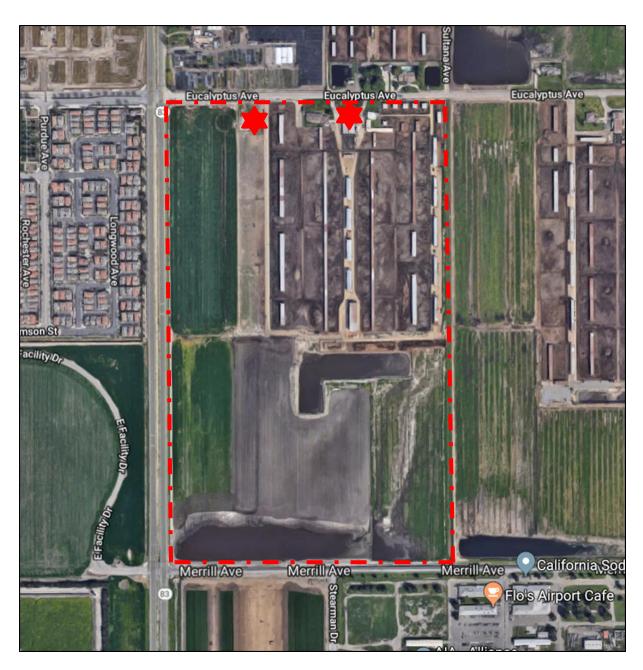
FIGURE 1.0 - EVACUATION ROUTE AND REFUGE AREAS

The SSO will designate evacuation routes and refuge areas to be used in the event of an emergency. Site personnel will stay upwind from vapors or smoke and upgradient from spills. Workers should exit through the established decontamination areas wherever possible. If evacuation cannot be done through an established decontamination area, site personnel will go to the nearest safe location and remove contaminated clothing there. Personnel will assemble at the predetermined refuge following evacuation and decontamination. The SSO will count and identify site personnel to verify that all personnel have been evacuated safely. Please refer to Figure 1.0 for the evacuation route and refuge location.
