RE: Cultural Resources Records Search for the 8<sup>th</sup> Street and Haven Avenue Project, Rancho Cucamonga, California

### **CALIFORNIA HISTORICAL RESOURCES INFORMATION SYSTEMS RECORDS SEARCH**

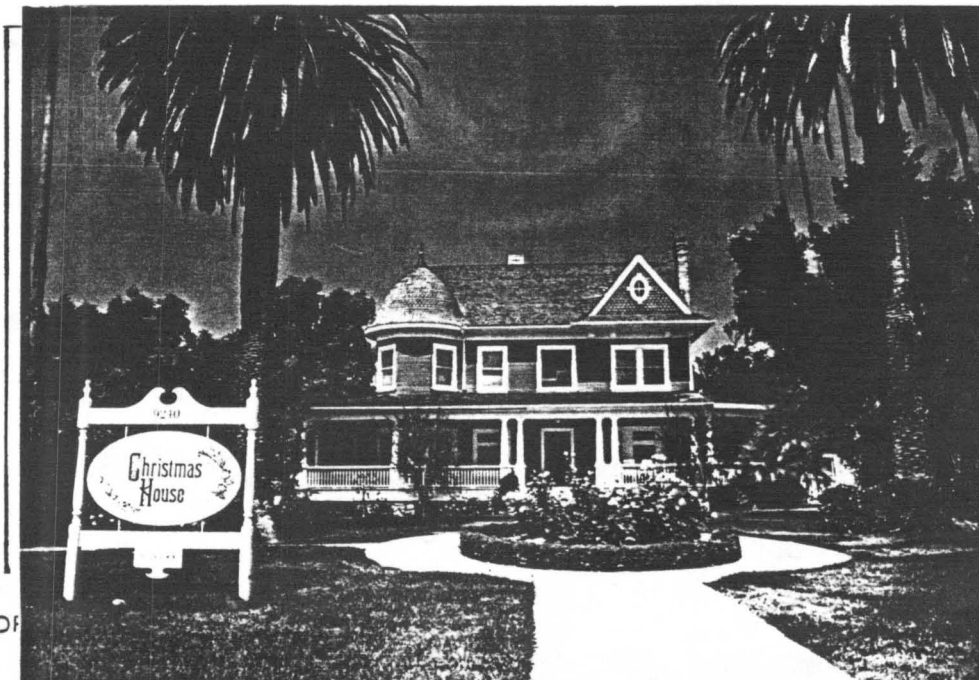
A two story rectangular wood structure of the free classic Queen Anne style. Roof is cross gable with wood shake shingles. A polygonal tower with S shaped curved roof is located on the south east corner. Tower roof has decorative fish scale shingles and finial. Front gable has oval window with decorative molding and shingle siding. Upper windows are double hung, lower are rectangular fixed with twin transoms. Transoms have "X" pattern. Siding is flush board. A full length single story porch extends along front of house paired columns on pedestal with turned spindle balustrade. Front steps are of concrete and straight run. Foundation material is field stone. Interesting landscape features two mature palm trees on eith side of entrance walk and two rows of windmill palms on both the north and south sides of property.

8. Construction date: Estimated  Factual 1904
9. Architect unknown
10. Builder H.D. Cousins
11. Approx. property size (in feet)  
Frontage 135 Depth 115  
or approx. acreage
12. Date(s) of enclosed photograph(s)  
July 1987

- P36-004200  
SBR-4200N
13. Condition: Excellent ☒ Good \_\_\_\_\_ Fair \_\_\_\_\_ Deteriorated \_\_\_\_\_ No longer in existence \_\_\_\_\_
14. Alterations: None Apparent
15. Surroundings: (Check more than one if necessary) Open land \_\_\_\_\_ Scattered buildings \_\_\_\_\_ Densely built-up ☒  
Residential ☒ Industrial \_\_\_\_\_ Commercial \_\_\_\_\_ Other: \_\_\_\_\_
16. Threats to site: None known ☒ Private development \_\_\_\_\_ Zoning \_\_\_\_\_ Vandalism \_\_\_\_\_  
Public Works project \_\_\_\_\_ Other: \_\_\_\_\_
17. Is the structure: On its original site? ☒ Moved? \_\_\_\_\_ Unknown? \_\_\_\_\_
18. Related features: \_\_\_\_\_

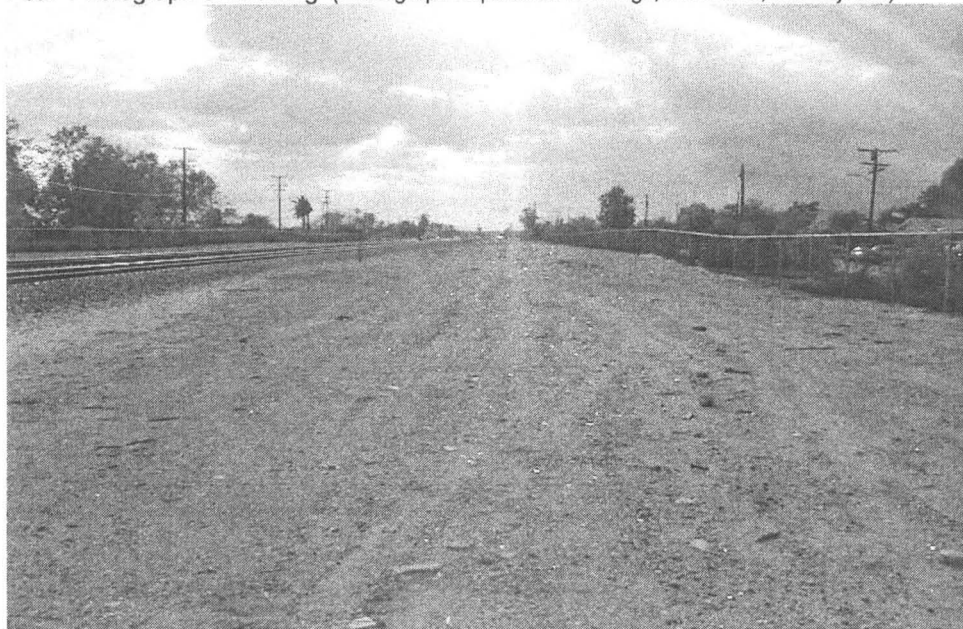
P5a. Photograph or Drawing (Photograph required for buildings, structures, and objects.)

P5b. Description of Photo: (view, date, accession #)  
Overview of the northern portion of the site (north side of the railroad tracks); view to the west.

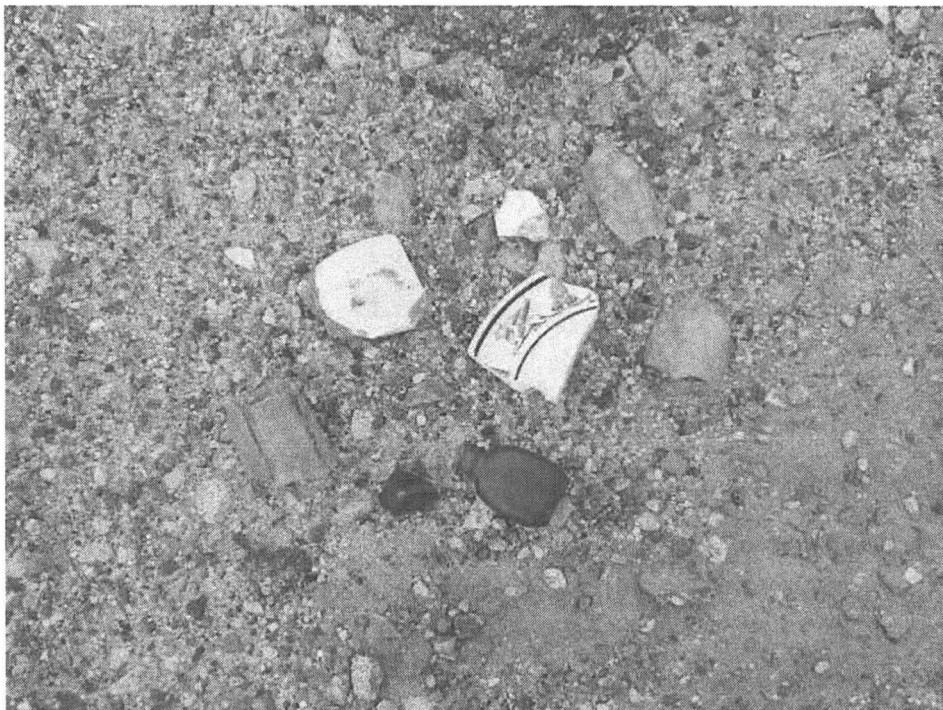
Figure 1: Representative sample of artifacts from the east end of the site, along the north side of the SCRRA railroad tracks. Note: the intact cobalt glass bottle included in the picture.

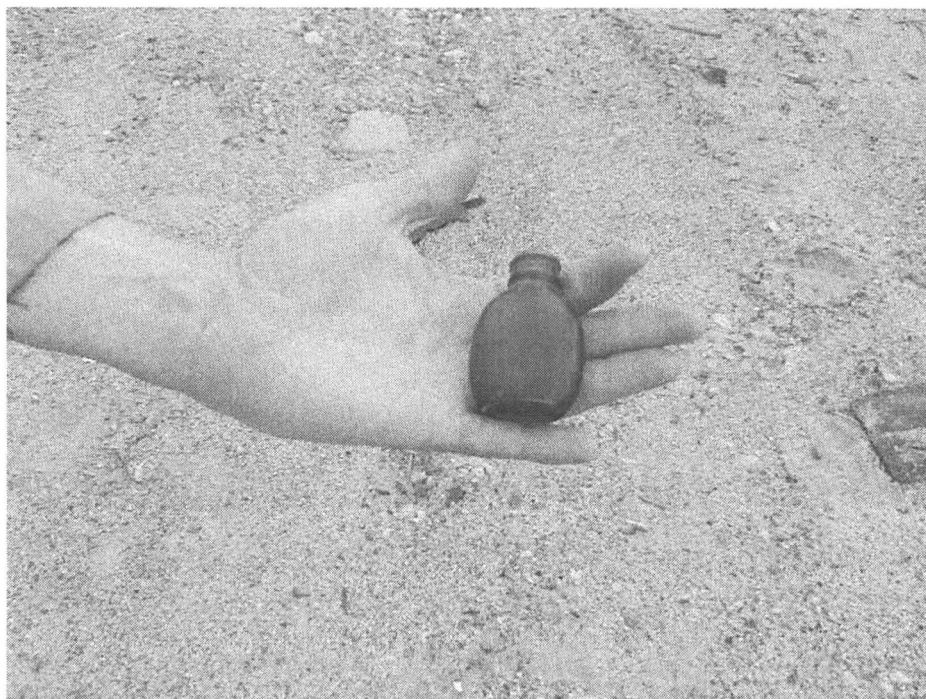
Figure 2: Intact cobalt glass bottle discovered at the east end of the site, along the north side of the railroad tracks.

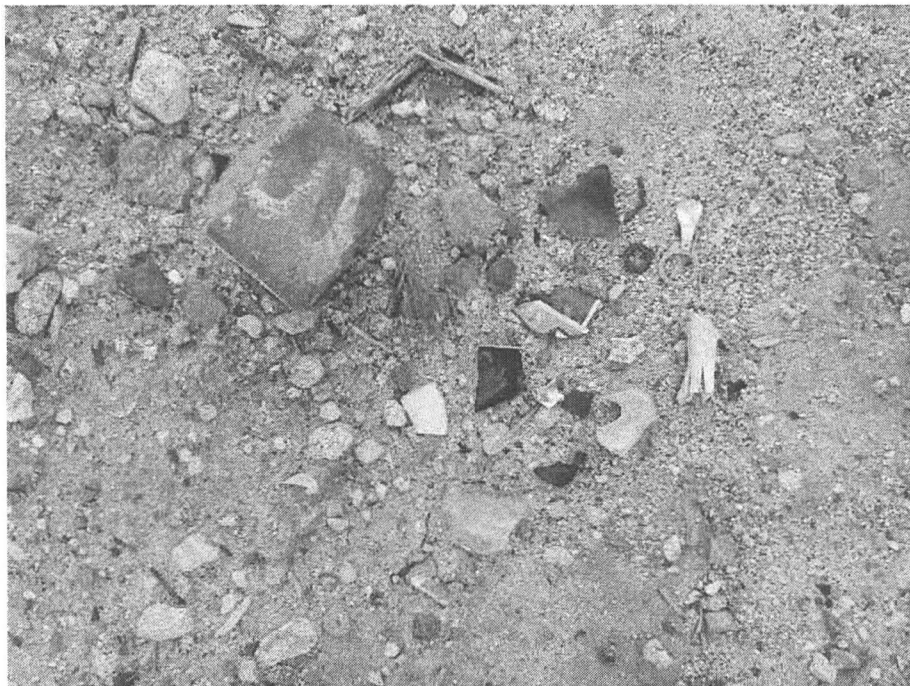
Figure 3: Representative sample of artifacts from the western portion of the site, along the north side of the SCRRA railroad tracks. Note: the amethyst glass fragments included in the picture.

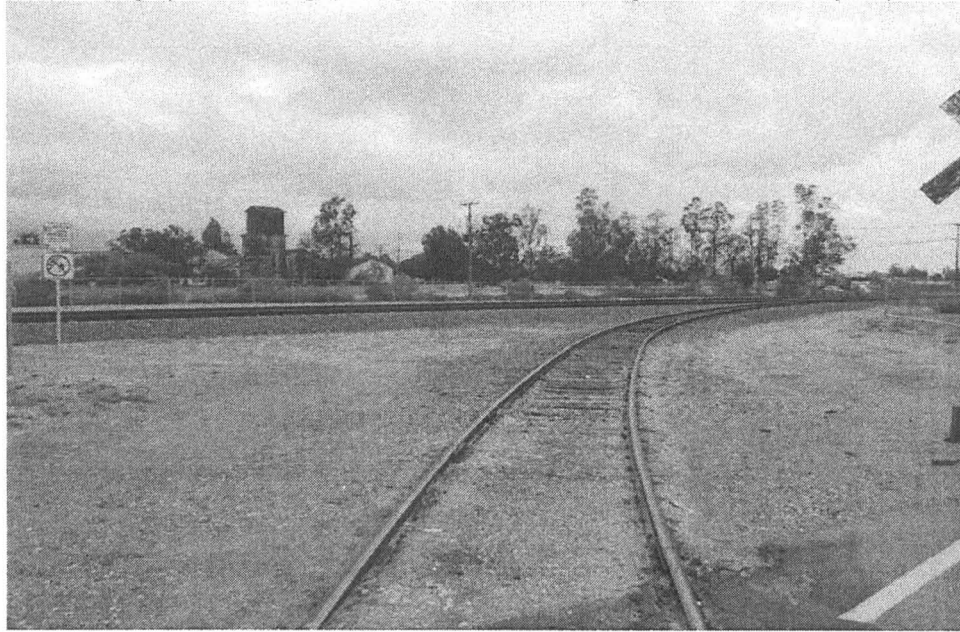
P5a. Photograph or Drawing (Photograph required for buildings, structures, and objects.)

Overview of railroad spur and tie-in with main SCRRA track. View to the northeast from 8<sup>th</sup> Street. Note: Cucamonga Pioneer Winery is located in the background.

- L7. **Integrity Considerations:** The recorded (northern most) segment of the spur features rail sections from 1903, 1913, 1915, 1917, 1919, 1924, 1925, 1952, and 1992. This suggests that the rails have been added over time and that many of the original rails have been replaced. The track appears to be in good condition, but it is not known if it is still in use.

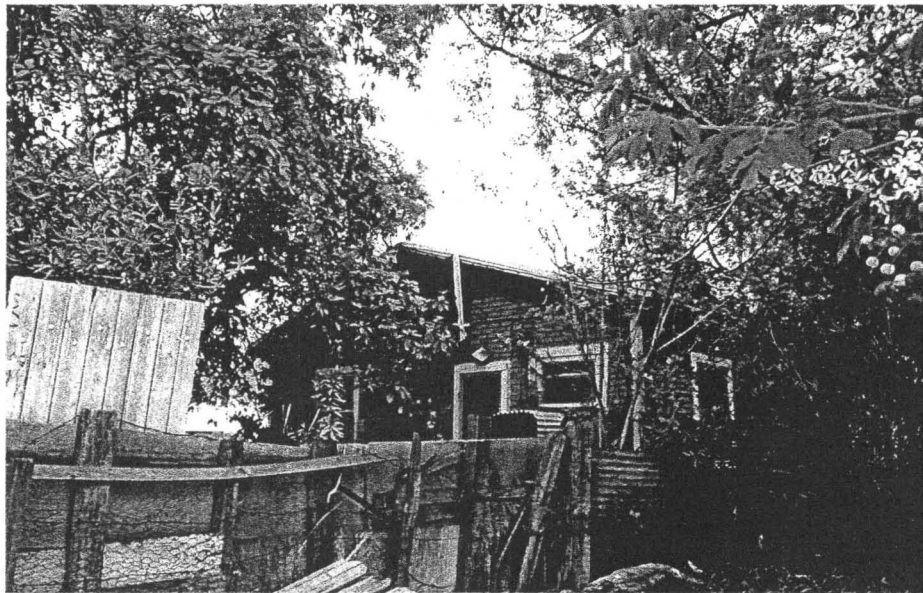
P5a. Photo or Drawing

The one story, wood frame house faces north and has a concrete foundation. There are composition shingles on both the exterior wall surface and the front gable roof. The roof has boxed eaves. The single entry front door is wood with a wood surround. The windows are wood framed, one-over-one light, double hung windows with wood sills and surrounds. There are three windows on the west and east sides. The rear of the house was not accessible. A wood frame garage is located to the east of the house.

P5b. Description of Photo: (View, date, accession #) View southeast, 21 April 2003

- B1. Historic Name: None  
 B2. Common Name: None  
 B3. Original Use: Residence B4. Present Use: Residence  
 \*B5. Architectural Style: Vernacular  
 \*B6. Construction History: (Construction date, alterations, and date of alterations)  
 Built in 1920. Composition shingles added to exterior wall, possible addition to rear, and window and door replacements. Building permit records and dates of alterations were not available. A garage has been constructed on the east side of the house.

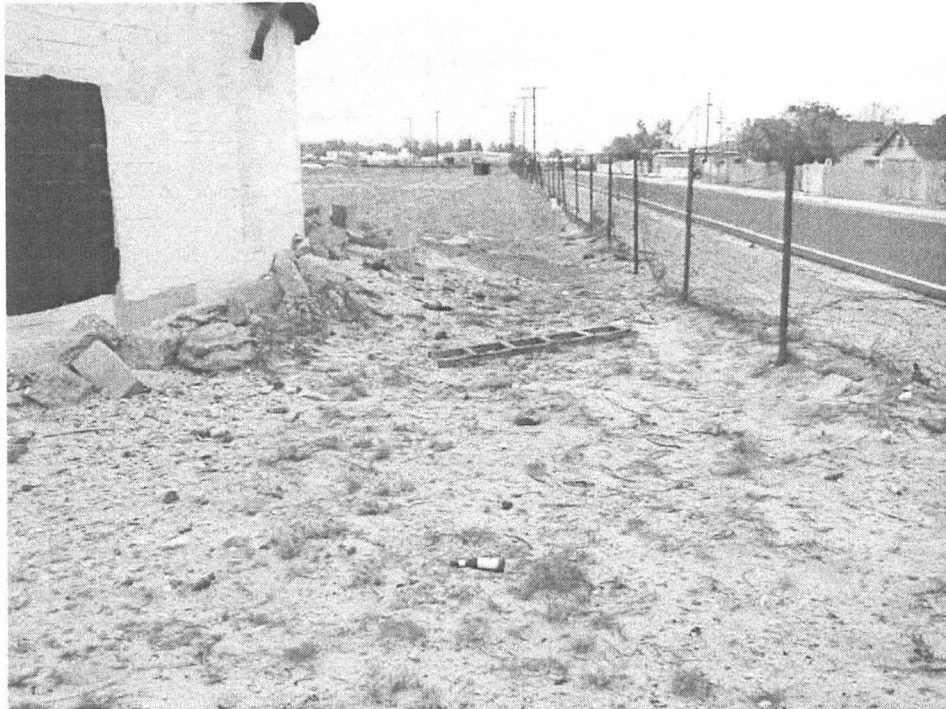
Figure 7: Overview of Locus 2, view to the south

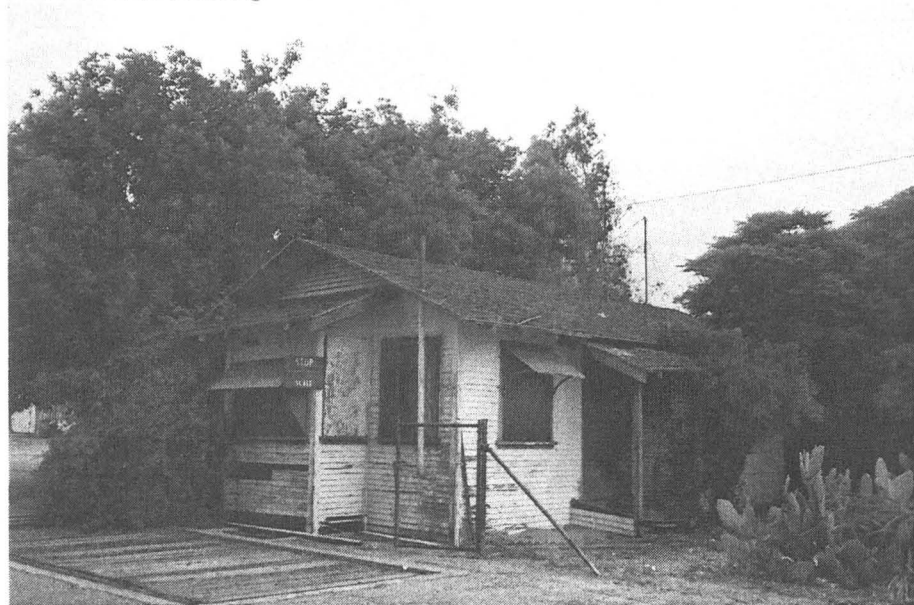
P5a. Photo or Drawing

The scale house is a one-story, wood frame building with a concrete slab foundation. The building faces east and has a rectangular shape. The exterior wall surface is horizontal wood siding and the side gable roof has exposed rafter ends and is clad with composition shingles. The single entry on the front of the building has a wood surround and has been boarded over. There is a shed roof porch over the door that has a wood floor and a shed roof supported by wood posts. The windows are wood framed double hung and casement windows with wood sills and surrounds. Several of the windows have been boarded over. There are metal awnings over some of the windows.

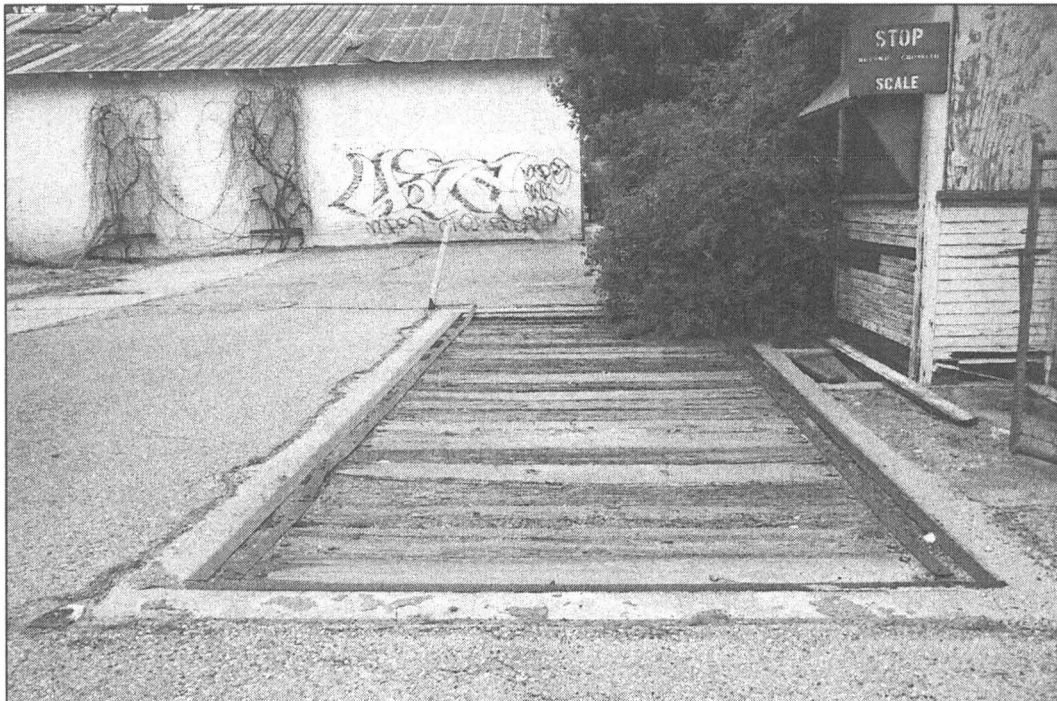
The Scale House is depicted on the 1913 Sanborn Fire Insurance Map, indicating it was constructed by the CWA in 1905. The scale house likely served as an administrative area, as well as the place where truck weights were recorded.

Truck Scale (view west)

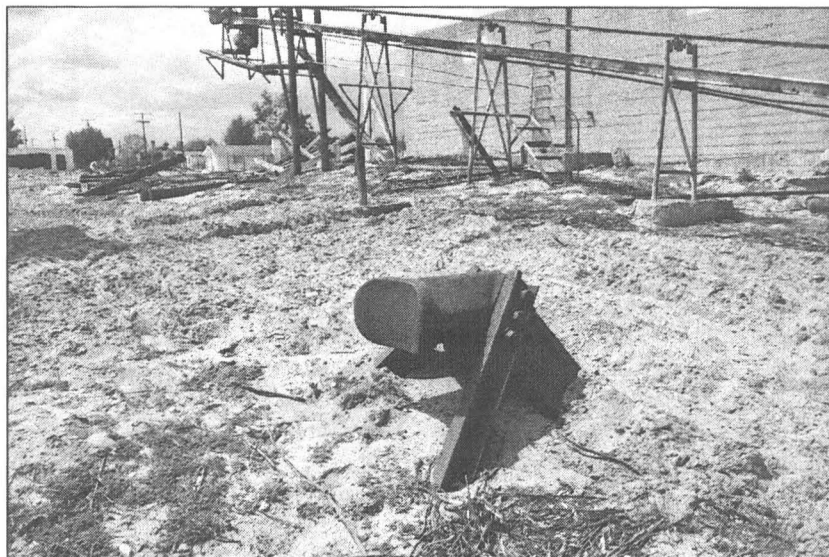
Bumper for Railroad Cars (view west)

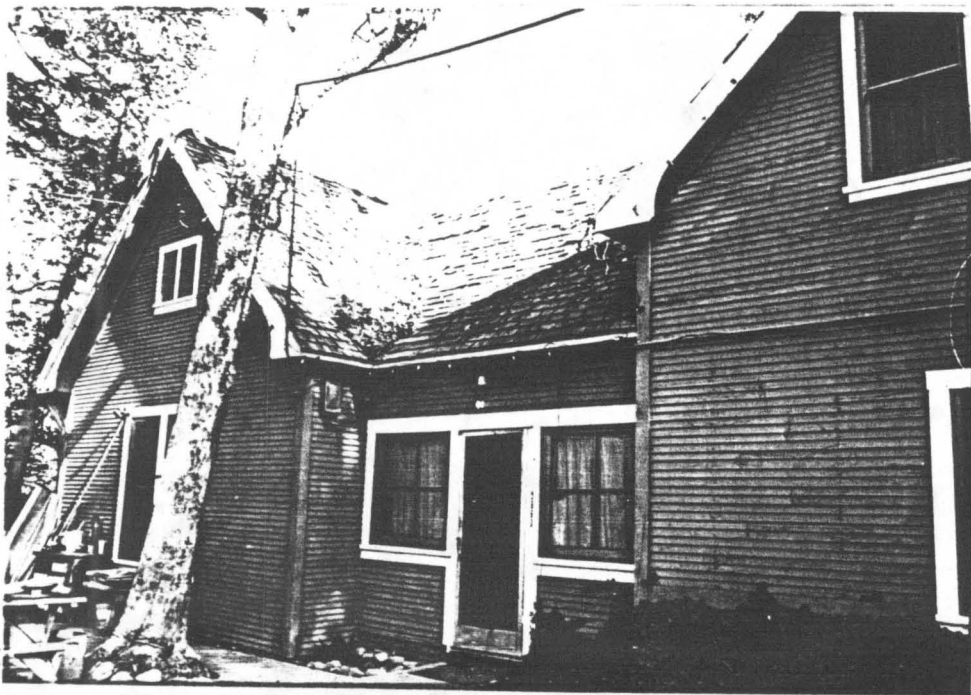
- 7a. Architectural style: N/A
- 7b. Briefly describe the present *physical appearance* of the site or structure and describe any major alterations from its original condition: A two story, irregular shaped structure of wood construction. Roof is cross gable with shake cedar shingles. Rafters are exposed. Siding is triple milled clapboard. Windows are double hung of wood construction. An extension on west side of structure with shed type roof and tar and gravel. Front door is unknown, aluminum screen over door. An interior brick chimney is located on the west portion of structure. Foundation is concrete. Structure is surrounded by a complex of buildings, consisting of barns and open air sheds used for storage of agribultural equipment and animals. Landscaping includes large pepper and eucalyptis trees. The site is surrounded on the south and west of the structure with vineyards.

- Construction date: Pre  
Estimated 1910 Factual \_\_\_\_\_
- Architect Unknown
- Builder W. N. De Berard
- Approx. property size (in feet)  
Frontage \_\_\_\_\_ Depth \_\_\_\_\_  
or approx. acreage 18.388
- Date(s) of enclosed photograph(s)  
July 1987

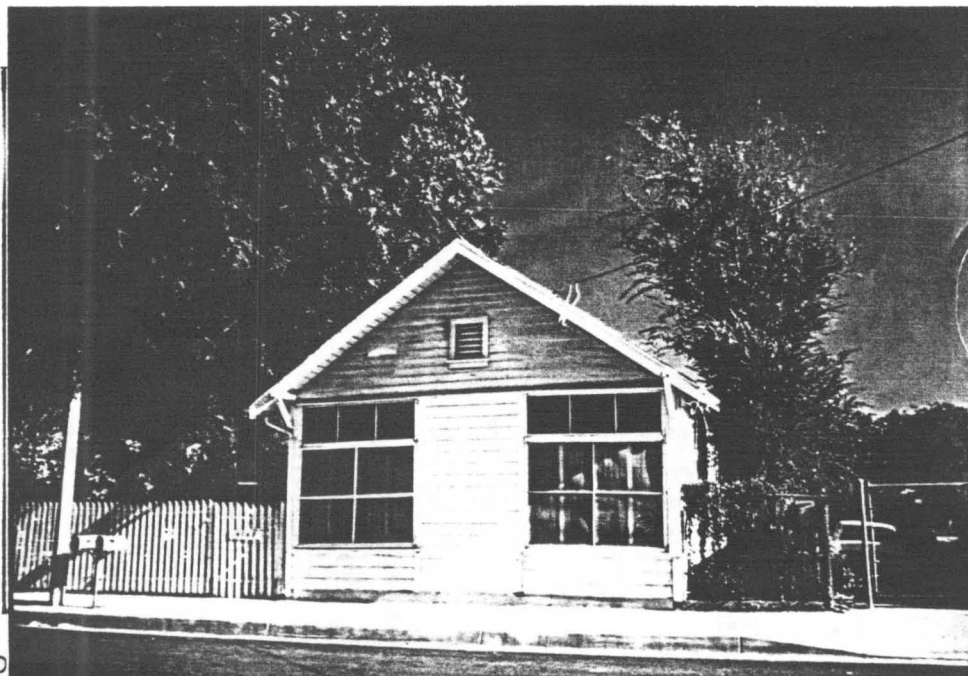
- 7a. Architectural style: N/A
- 7b. Briefly describe the present *physical appearance* of the site or structure and describe any major alterations from its original condition: A single story rectangular shaped structure of wood construction. Roof is medium front gable with composite shingles. Eaves are exposed with knee braces and exposed rafters. Siding is wood clapboard. Windows are multiple panel with rectangular, multipane transoms. These windows are similar to a storefront. A front entrance on this structure has been boarded over with narrow flush boards. A rectangular attic vent is located in the front gable. Sidewalk is located immediately in front of the structure. A side yard is located to the east of the structure, with several large trees and a white picket fence completing the scene.

8. Construction date:  
Estimated 1915 Factual
9. Architect unknown
10. Builder unknown
11. Approx. property size (in feet)  
Frontage 50 Depth 75  
or approx. acreage
12. Date(s) of enclosed photograph(s)  
July 1987

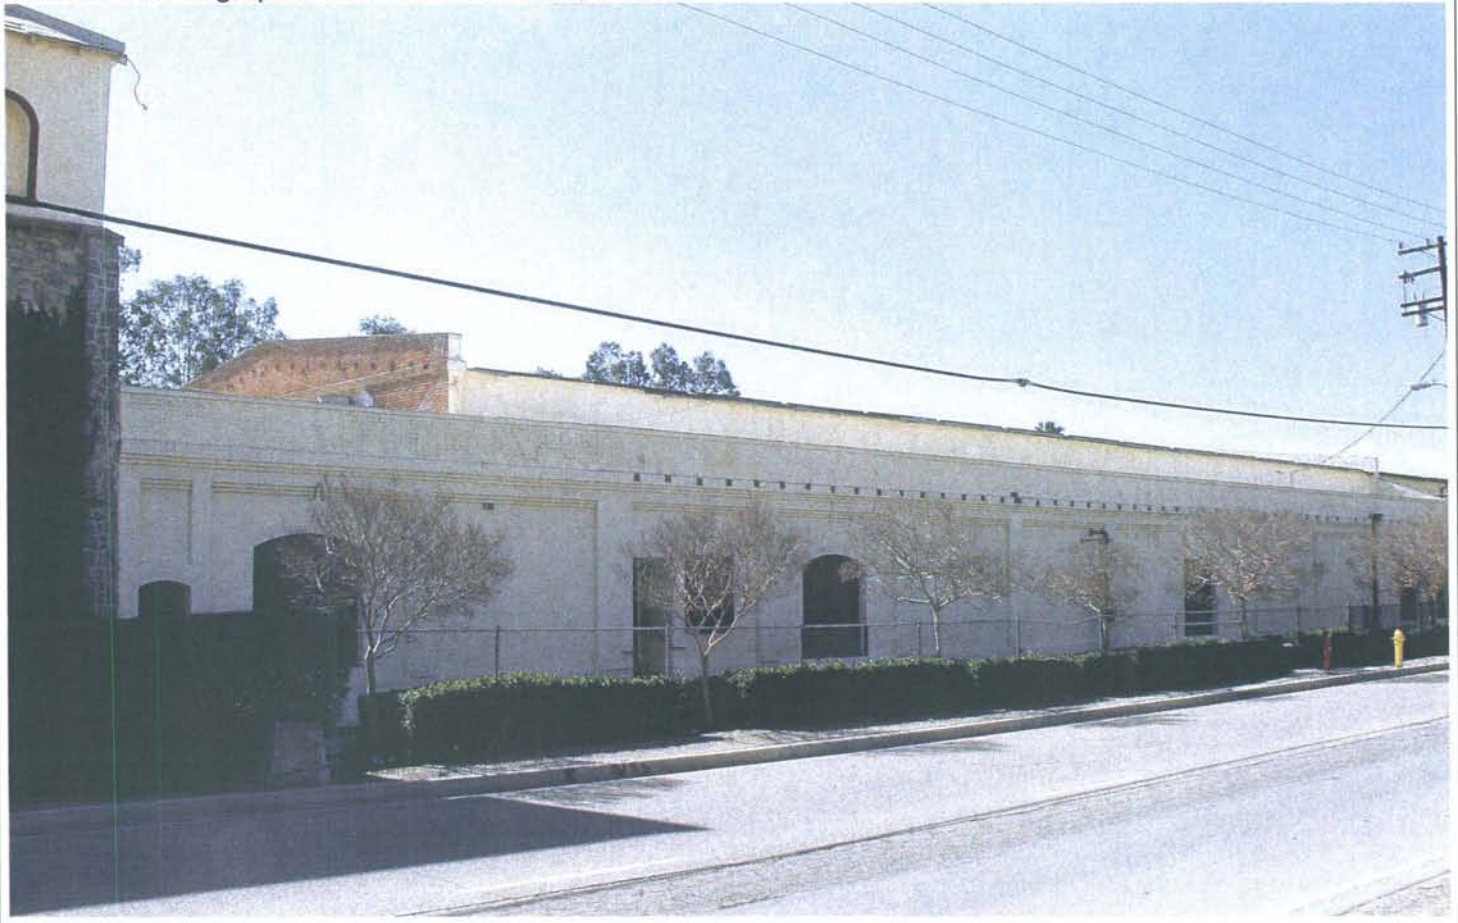
The rear elevation is utilitarian in design, with a partial-width raised concrete loading dock sheltered by a wood truss roof supported by two wooden partitions. A concrete ramp and two sets of stairs provide access from the ground. The western  $\frac{2}{3}$  of the dock is sided in corrugated metal panels, while the western  $\frac{1}{3}$  is painted brick. The brick side has two arched openings, one framed with a wooden doorway and the other boarded up. The corrugated metal side has three large rectangular bays fit with metal roll-up doors and a rectangular opening with a gridded wooden door with wood-framed side-lights.

Additional Photographs: View to the southwest, 2/13/08.

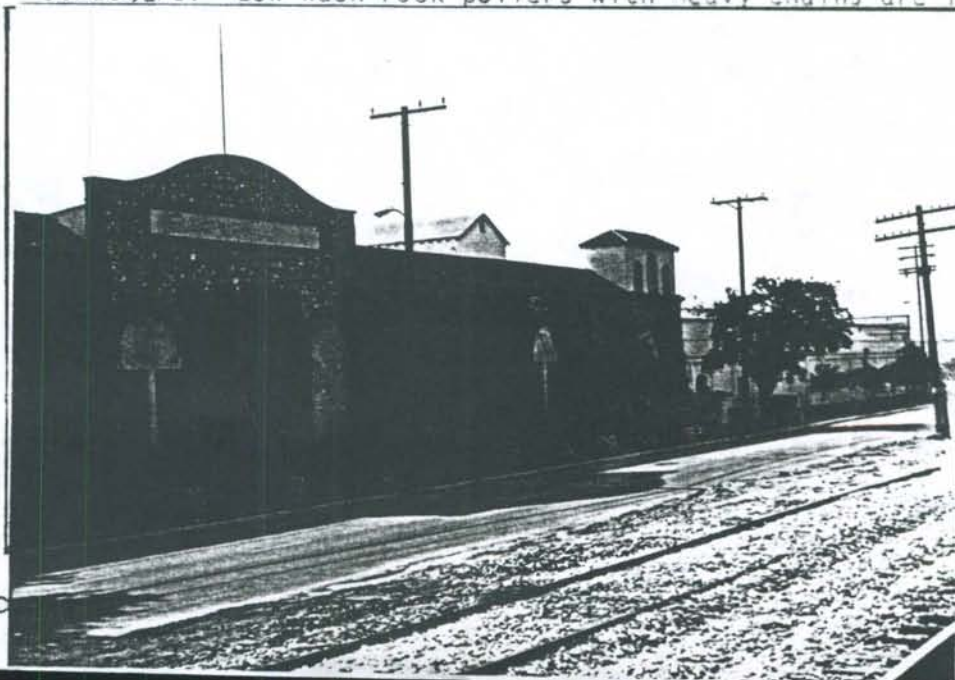
Structure 1: A rectangular shaped single story structure of cast concrete. Concrete grape loading pits are located on north and south sides, with a metal conveyor belt extending into the building. Standard industrial doors and windows. Structure was used as grape crushing building.

Structure 2: A large, irregularly shaped structure of wood concrete and wash rock. Roof is shed roof, with red tile with mission style castellated parapets. Several recessed openings with arches are located within the parapets. Siding is concrete with wash rock facing. Large, arched openings appear to have been reduced in size and fitted with standard rectangular industrial windows of multipane construction. Several large industrial doors are located along the front designed to service a railroad spur extending the length of the structure. Located centrally on the facade is a large arched parapet. Above the windows are faded advertisement of various wine brands. The west side of this structure has been modified with stucco, diagonal wood siding and large wine casks. Ivy covers a significant portion of the structure. Low wash rock pollers with heavy chains are located between the road and

13. Condition: Excellent ☒ Good ☐ Fair ☐ Deteriorated ☐ No longer in existence ☐  
Various windows and door have been sealed. West side of structure
14. Alterations: two has been stuccoed and modernized. Other buildings have been converted to various industrial uses.
15. Surroundings: (Check more than one if necessary) Open land ☐ Scattered buildings ☐ Densely built-up ☒  
Residential ☒ Industrial ☒ Commercial ☐ Other: ☐
16. Threats to site: None known ☐ Private development ☒ Zoning ☐ Vandalism ☐  
Public Works project ☐ Other: ☐
17. Is the structure: On its original site? ☒ Moved? ☐ Unknown? ☐
18. Related features: Various equipment and machinery from the winery is located around the complex.

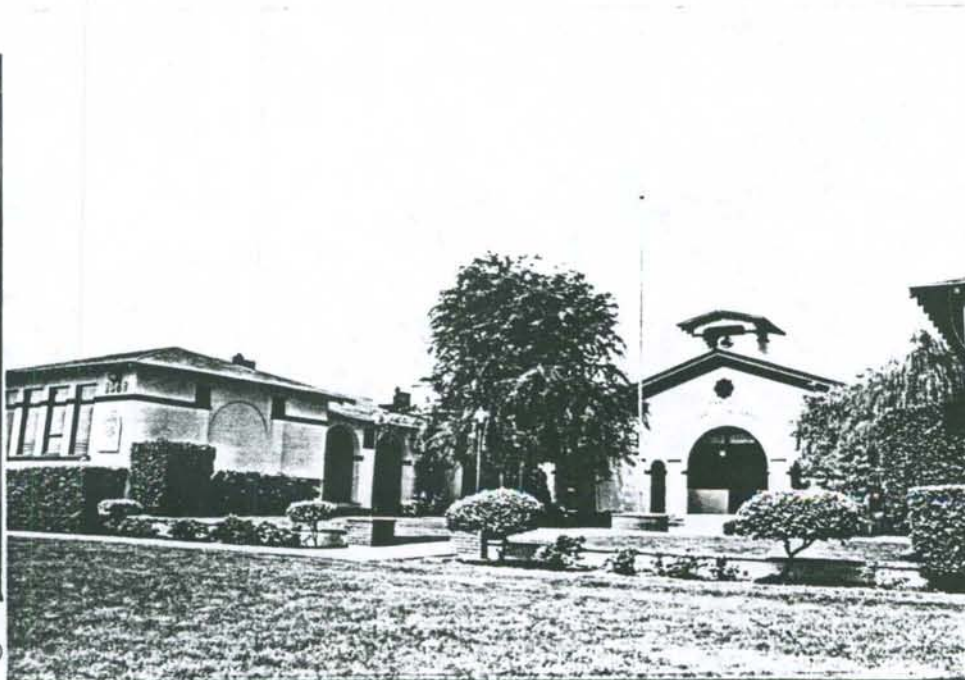
A single story complex of buildings of wood construction in the Mission Revival Style. This complex consists of three rectangular buildings, joined by arcades. Roofs are low hipped and gables, with exposed rafters and composite shingles, siding is stucco. A wood molding is located one quarter of the way down the walls. Windows are alluminum and smoked glass. Original windows were removed. Doors are solid wood with multiple panels. Several groupings of windows have been walled in on the southern side of building. A unique feature of this structure is the Bell Tower located on the gable of the central building. Original pictures indicate that this was not original but was added later by the school district.

13. Condition: Excellent ☒ Good \_\_\_\_\_ Fair \_\_\_\_\_ Deteriorated \_\_\_\_\_ No longer in existence \_\_\_\_\_
14. Alterations: Original windows replaced/some windows blanked out P36-016436
15. Surroundings: (Check more than one if necessary) Open land \_\_\_\_\_ Scattered buildings \_\_\_\_\_ Densely built-up ☒  
Residential ☒ Industrial \_\_\_\_\_ Commercial ☒ Other: \_\_\_\_\_
16. Threats to site: None known ☒ Private development \_\_\_\_\_ Zoning \_\_\_\_\_ Vandalism \_\_\_\_\_  
Public Works project \_\_\_\_\_ Other: \_\_\_\_\_
17. Is the structure: On its original site? ☒ Moved? \_\_\_\_\_ Unknown? \_\_\_\_\_
18. Related features: None

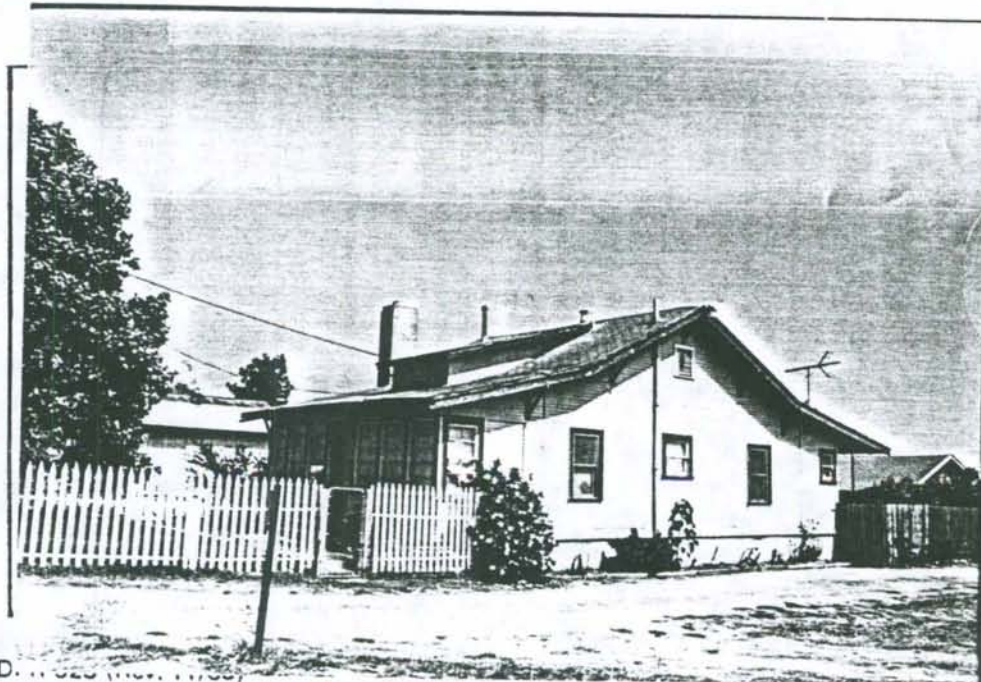
- 7a. Architectural style: Craftsman Bungalow
- 7b. Briefly describe the present *physical appearance* of the site or structure and describe any major alterations from its original condition:  
A single story irregularly shaped structure of wood construction. Roof is medium bellcast gable with composite shingles. Eaves are enclosed with knee braces. A shed roof dormer is located centrally over the entrance. An exterior chimney of brick construction is located on the east side of the structure. Siding is wood clapboard. A bay window with shed roof is located on the east side of the structure. Windows are double hung with narrow wood lintel and sill. Porch has been enclosed with glass and wood windows at some point after construction. Front door is multiple panel of wood and glass construction. Foundation appears to be brick. A separate garage is located to the rear of fence surrounds the front yard, with a large tree and several smaller fruit trees along the east side.

13. Condition: Excellent \_\_\_ Good X Fair \_\_\_ Deteriorated \_\_\_ No longer in existence \_\_\_
14. Alterations: Front porch enclosed with multiple pane windows.
15. Surroundings: (Check more than one if necessary) Open land \_\_\_ Scattered buildings X Densely built-up X  
Residential X Industrial \_\_\_ Commercial X Other: \_\_\_
16. Threats to site: None known \_\_\_ Private development X Zoning \_\_\_ Vandalism \_\_\_  
Public Works project \_\_\_ Other: \_\_\_
17. Is the structure: On its original site? X Moved? \_\_\_ Unknown? \_\_\_
18. Related features: Located next to the Santolucito Italian Market

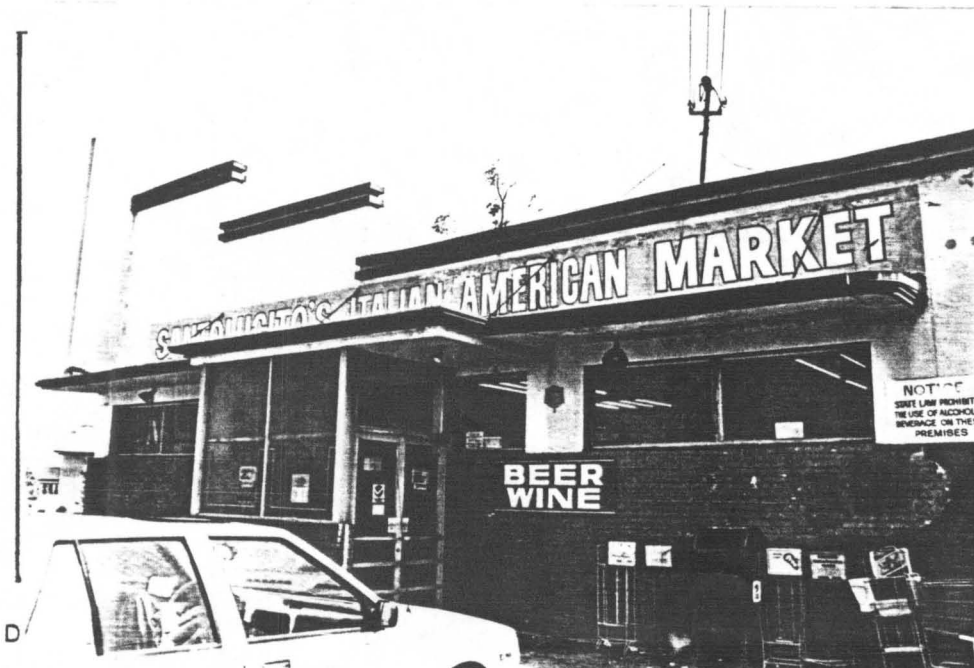
A single story rectangular structure of wood and brick construction. Flat roof with unknown roofing material. Stepped parapet with twin red brick moldings located on northeast corner of structure. A vertical sign rises up from the parapet on the same corner. Siding material is stucco with brick veneer extending halfway up the siding. Northwest corner has been rounded. Windows are glass and aluminum and do not appear to be original. An extension located on the northside of the structure contains the aluminum and glass vestibule doors. A flat gabled roof extends along the facade with decorated molding. This is secured with chains as opposed to wire. There is a small addition on east side of structure with a shed roof, composit rolled tarpaper. On west side of structure, there are two wood and glass doors covered with an awning and several double hung windows. All these windows are covered with wrought iron bars. There are no significant landscape features surrounding this structure. To the west of this structure are several warehouse type buildings.

13. Condition: Excellent \_\_\_\_\_ Good X Fair \_\_\_\_\_ Deteriorated \_\_\_\_\_ No longer in existence \_\_\_\_\_
14. Alterations: Replacement of wood framed windows with aluminum. Addition of vestibule on front with aluminum doors.
15. Surroundings: (Check more than one if necessary) Open land \_\_\_\_\_ Scattered buildings X Densely built-up \_\_\_\_\_  
Residential X Industrial \_\_\_\_\_ Commercial X Other: \_\_\_\_\_
16. Threats to site: None known \_\_\_\_\_ Private development \_\_\_\_\_ Zoning X Vandalism \_\_\_\_\_  
Public Works project \_\_\_\_\_ Other: \_\_\_\_\_
17. Is the structure: On its original site? X Moved? \_\_\_\_\_ Unknown? \_\_\_\_\_
18. Related features: N/A
