# **APPENDIX F-1**

## **Phase I Environmental Site Assessment**

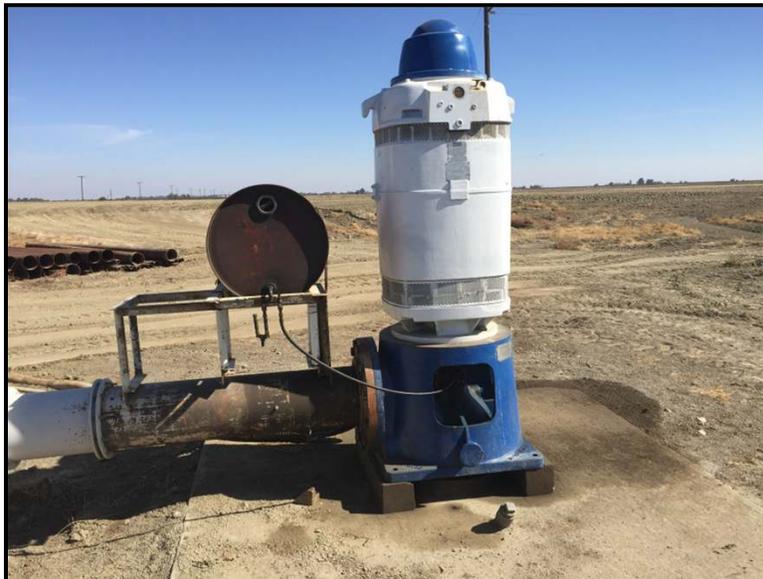
Hydraulic pump with staining in eastern portion of Site.

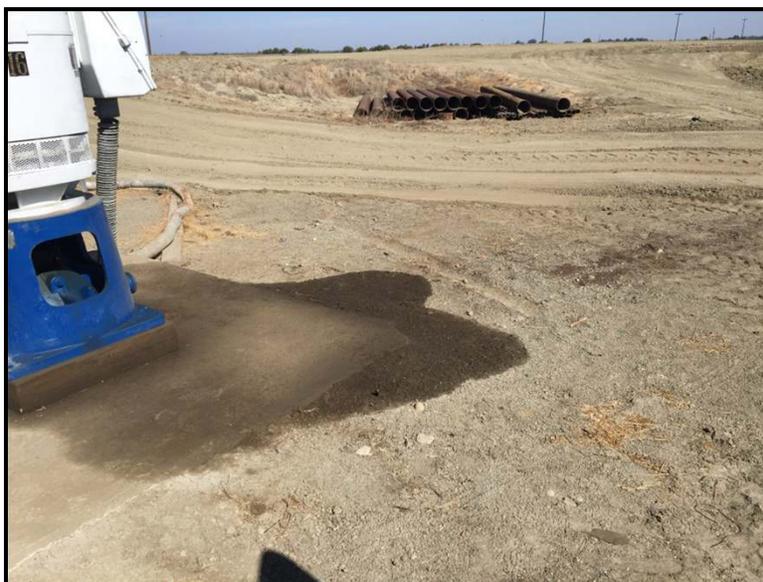
Staining from hydraulic fluid in eastern portion of Site.
