**CULTURAL RESOURCES INVENTORY AND  
EXTENDED PHASE I REPORT  
for the  
ROHNERT PARK WATER TANK PROJECT, SONOMA  
COUNTY, CALIFORNIA**

**City of Rohnert Park**  
130 Avram Avenue  
Rohnert Park, California 94928  
*Contact: Vanessa Marin, Senior Engineering Technician*

**DUDEK**  
853 Lincoln Way, Suite 208  
Auburn, California 95603  
*Adam Giacinto, MA, RPA,*  
*William Burns, MSc, RPA*  
*And*  
*Angela Pham, MA, RPA*

OCTOBER 2016

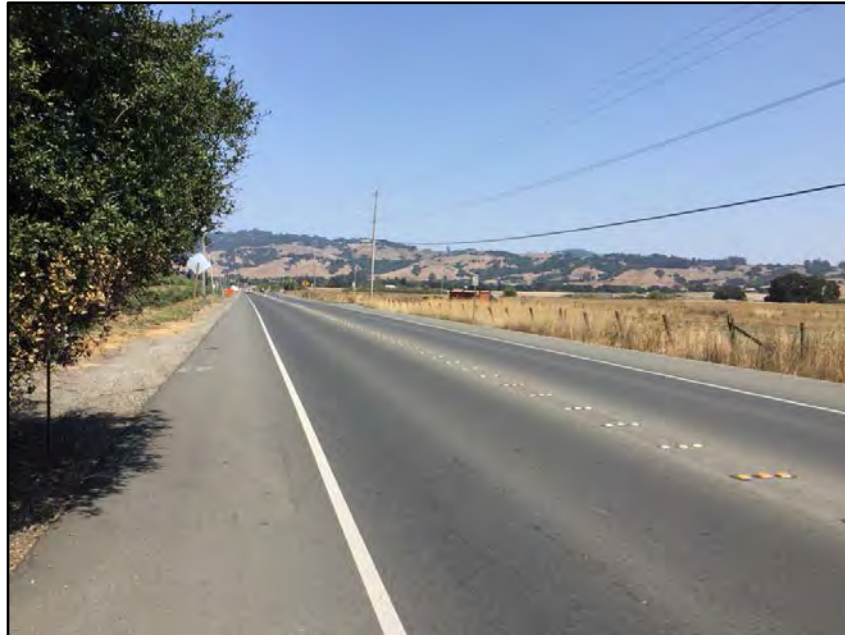
Figure 4. Project overview photo, view north along Petaluma Hill Road

The surface of this area was observed to be highly obscured by low-laying grasses on this initial site visit (see Figures 4-6). Evidence for buried cultural deposits was opportunistically sought through inspection of natural or artificial erosion/excavation exposures and the spoils from rodent

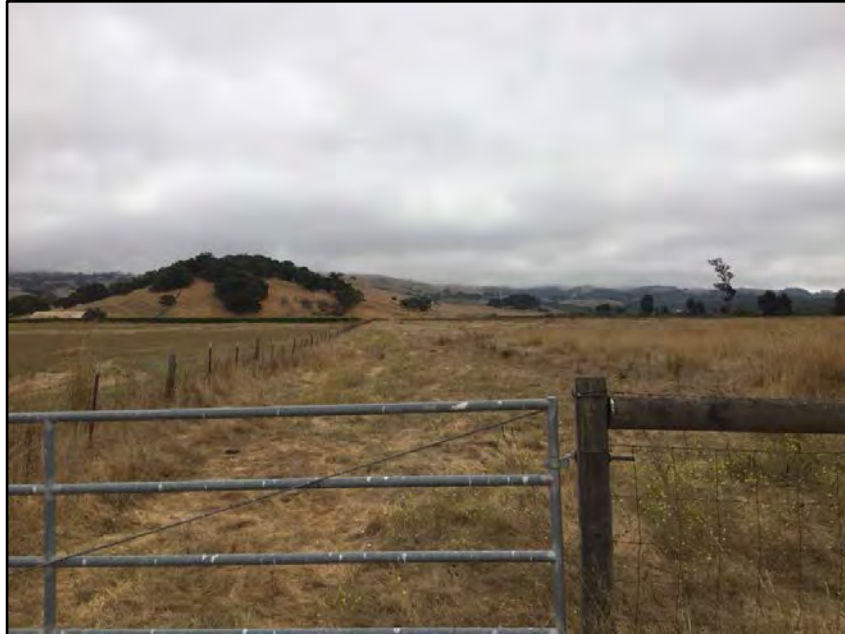
Figure 5. Project area overview photo, view east from Petaluma Hill Road

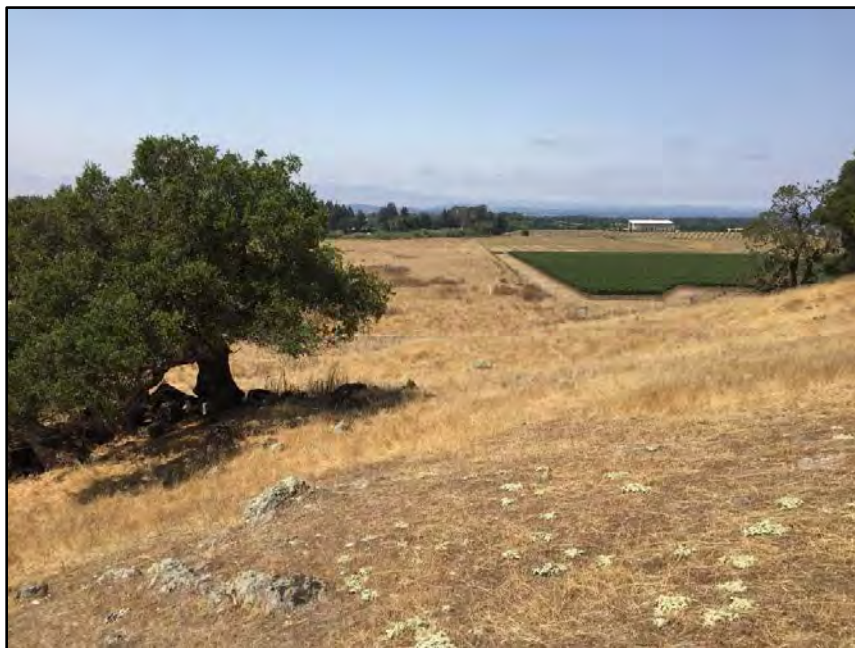
Figure 6. Project area overview photo, view west from water tank site

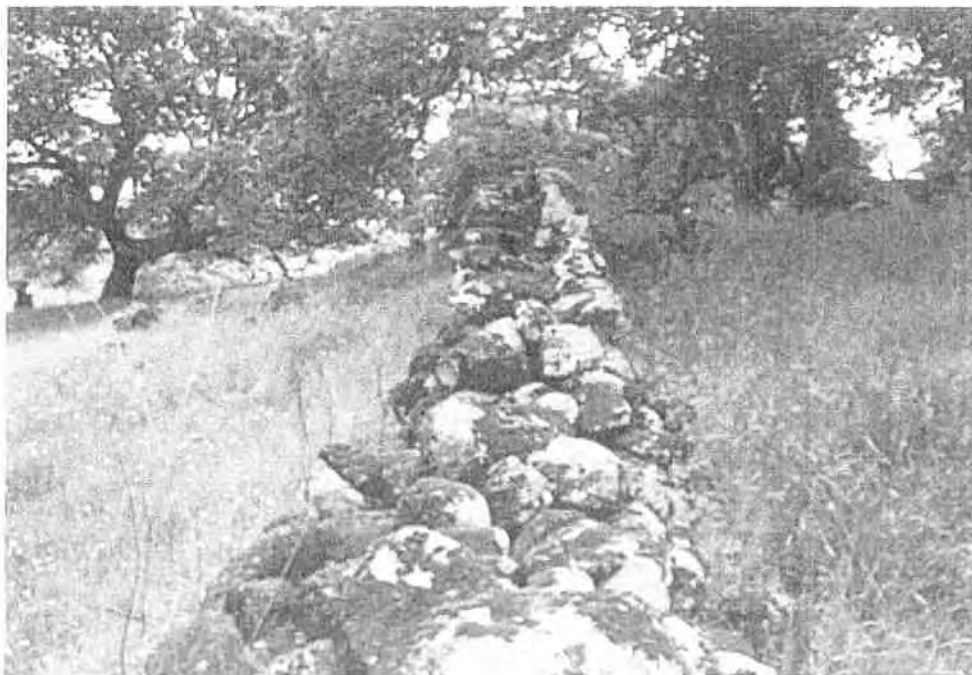
**L7. Integrity Considerations:** Most of this segment of the stone fence appears to have fair to good integrity. Several areas of the rock fence segment have been breached by the livestock present at the ranch. Mr. Anderson stated that very small remnants of the fence are visible to the east for another mile.

**L8b. Description of Photo, Map, or Drawing:** Break in fence, looking east.

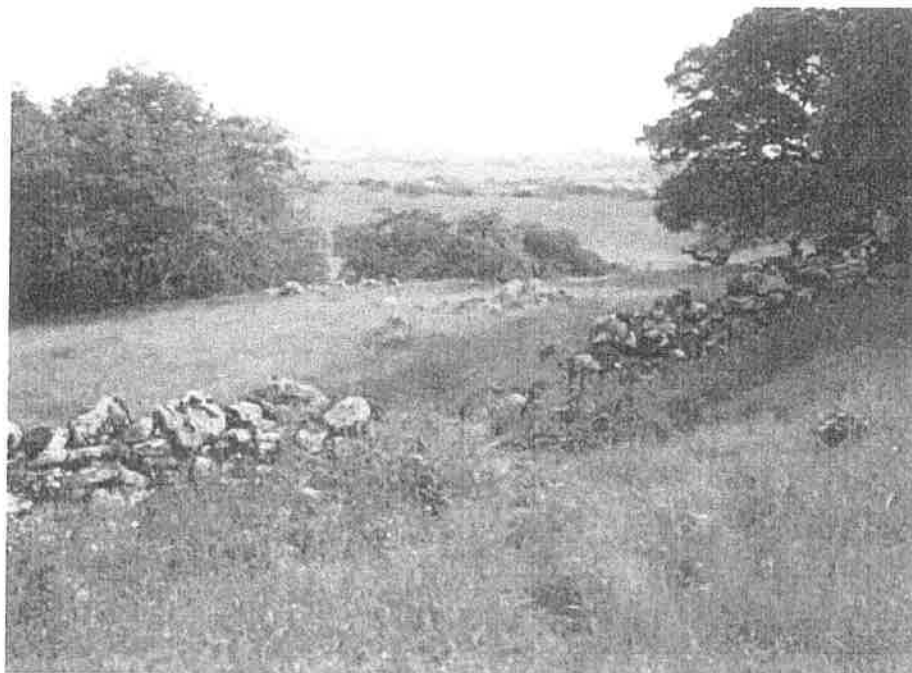
Break in E/W-oriented fence segment, looking northeast

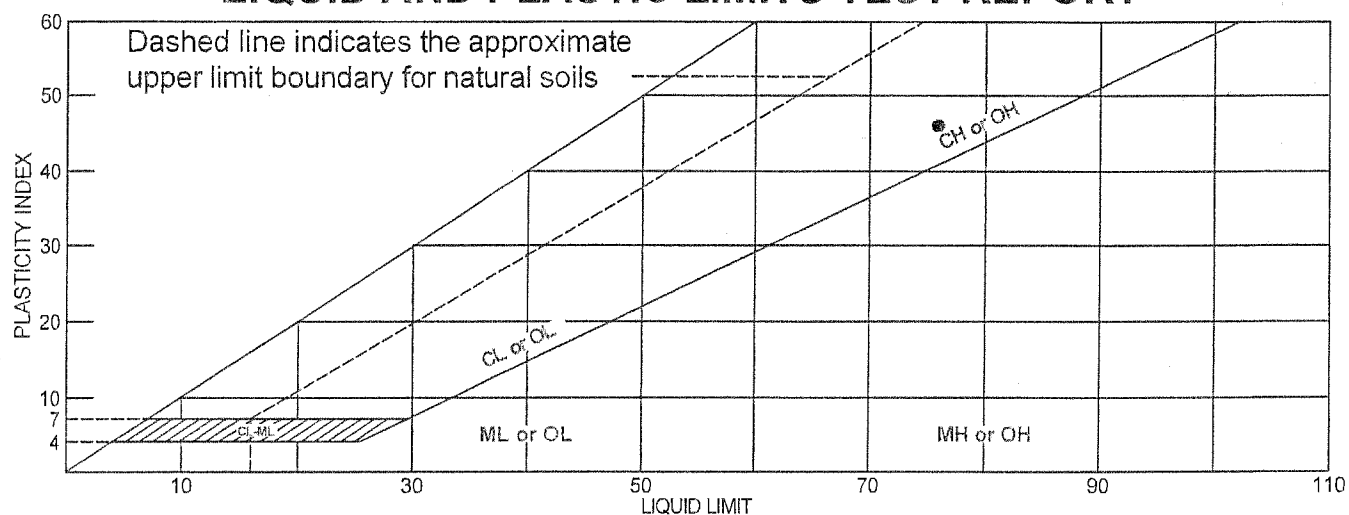
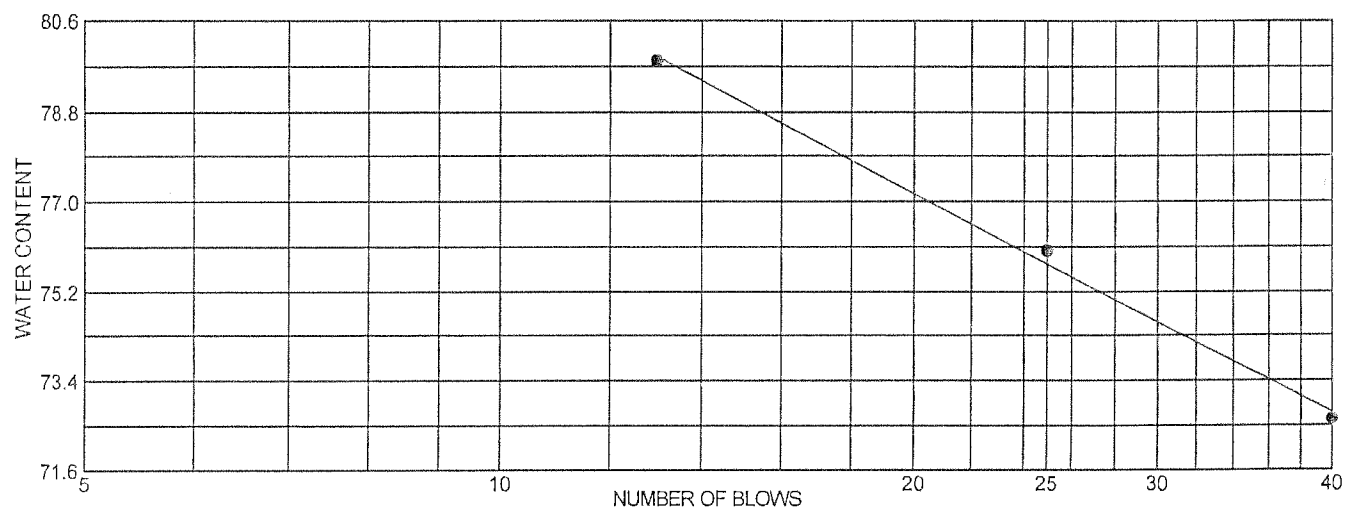
# LIQUID AND PLASTIC LIMITS TEST REPORT

MATERIAL DESCRIPTION	LL	PL	PI	%<#40	%<#200	USCS
●	Reddish brown sandy tuffaceous Clay	76	30	46			CH
