RE: PHASE I ENVIRONMENTAL SITE ASSESSMENT REPORT

SOMO - SONOMA MOUNTAIN VILLAGE 1212 VALLEY HOUSE DRIVE ROHNERT PARK, CALIFORNIA 94928

**NOVA PROJECT NO. R16-5878**

### PHASE I ENVIRONMENTAL SITE ASSESSMENT

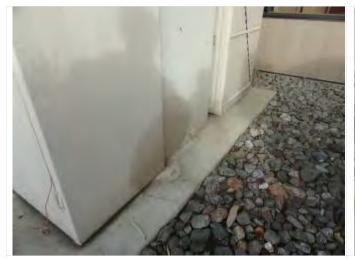
- Minor staining was observed at the base of the pad-mounted electrical transformer located adjacent to the south of Building 1300. This transformer is labeled as owned and maintained by PG&E. No obvious evidence of impact to unpaved surfaces was observed by Nova during the Site reconnaissance, and based on initial development of the Site (1983), the unit does not likely contain PCBs. As such, this constitutes a *de minimis* environmental condition, which should be reported to and mitigated by PG&E.

19. Transformer staining (adjoining 1300)

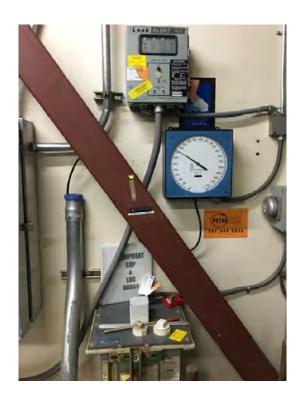
The electronic leak detection and inventory equipment for the underground storage tank behind Building 1400.
