# **PHASE I ENVIRONMENTAL SITE ASSESSMENT**

**1388 – 1420 SOUTH BASCOM AVENUE  
SAN JOSE, CALIFORNIA 95128**

**STELLAR ENVIRONMENTAL SOLUTIONS, INC.  
2198 SIXTH STREET  
BERKELEY, CALIFORNIA 94710**

**PROJECT NUMBER 2017-36**

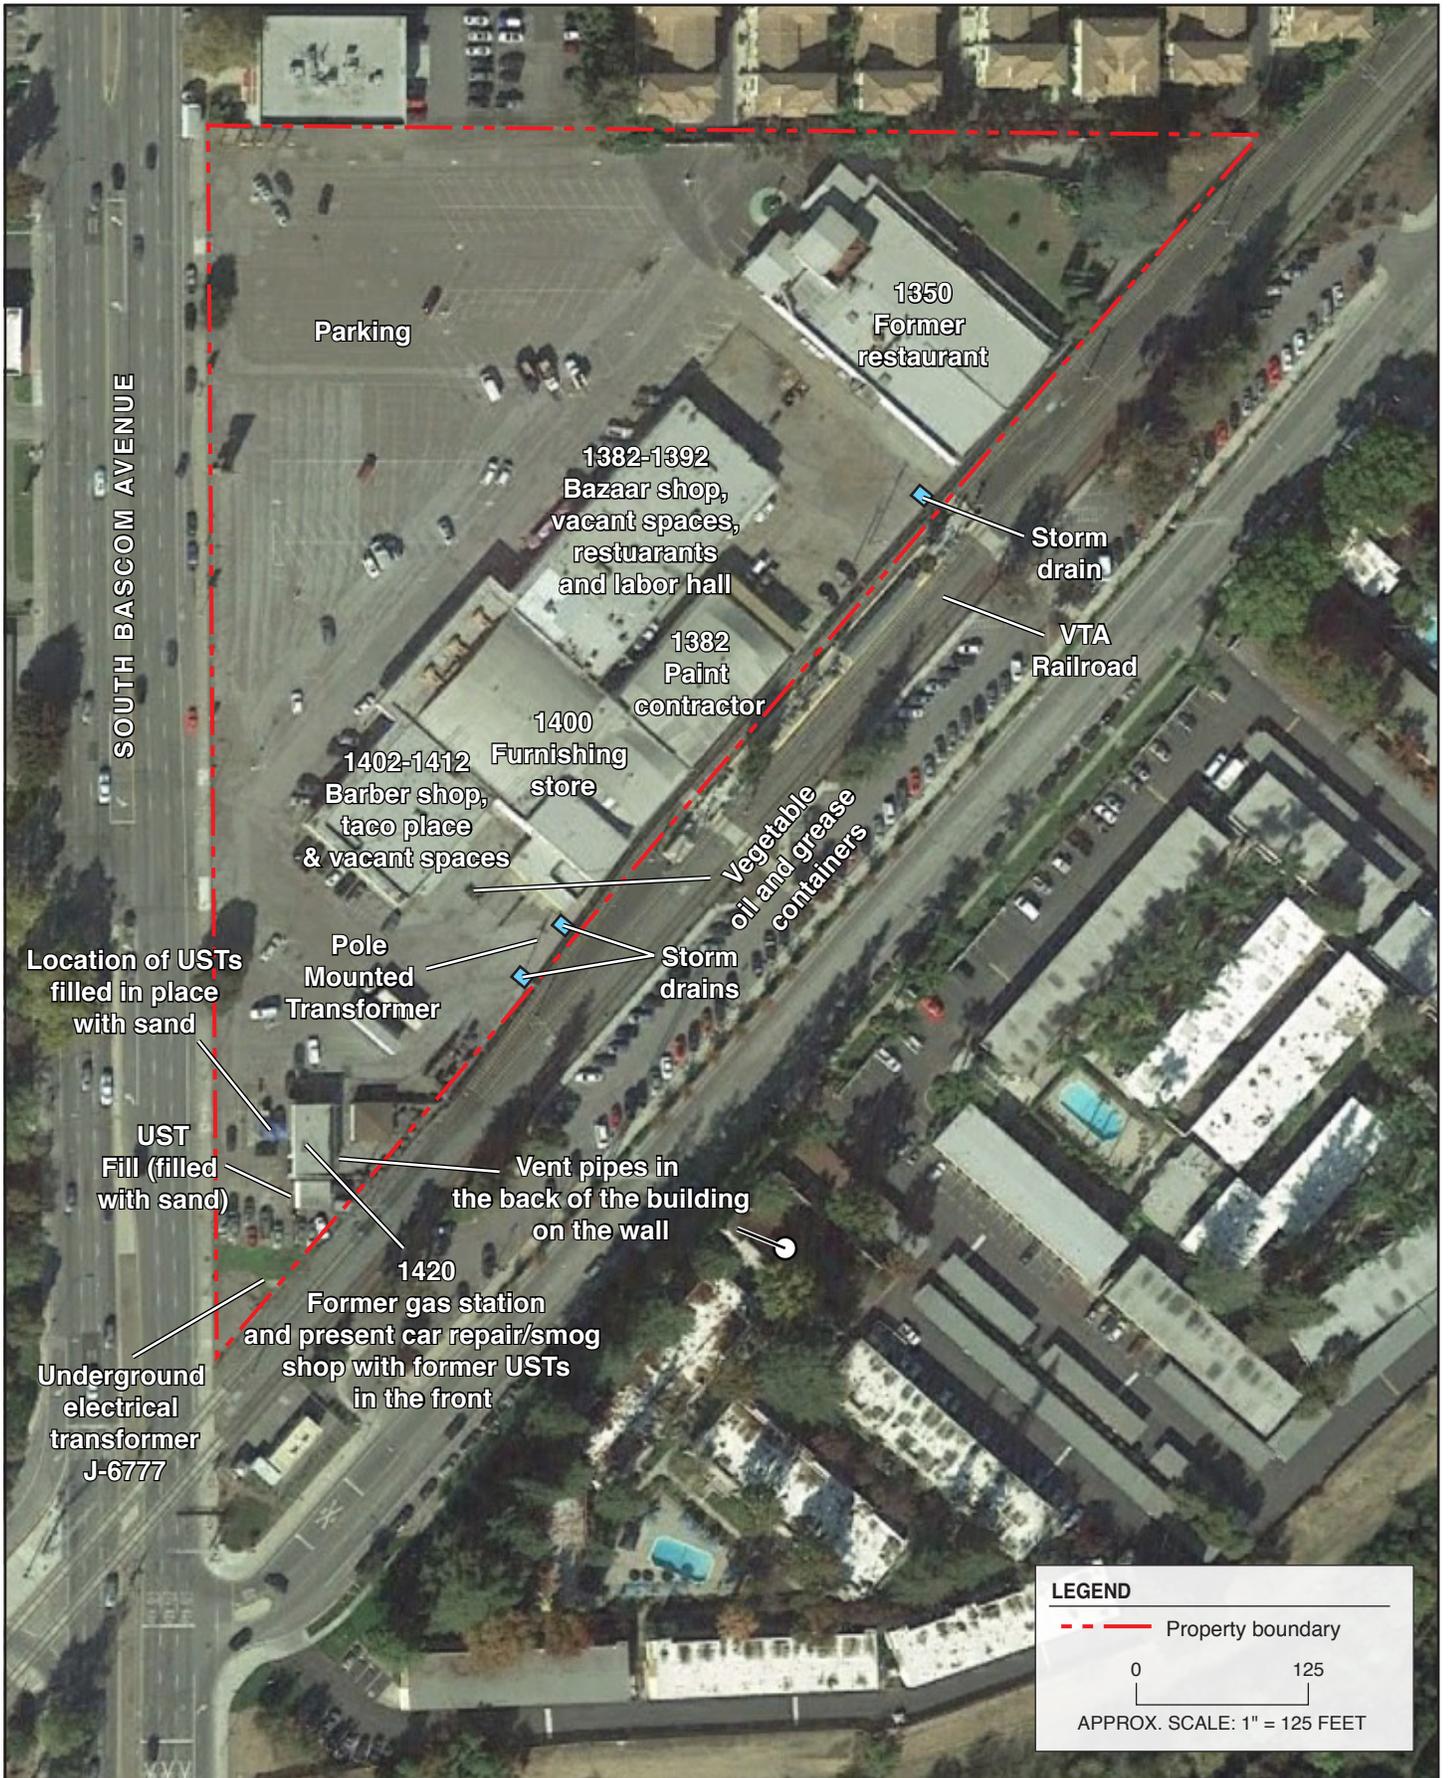
**SITE PLAN**

Several storm drains and sewer manholes were observed at the subject property (Figure 3), located in the back of the subject property and near the border with SCVTA railroad. The storm water is expected ultimately to drain into Los Gatos Creek.

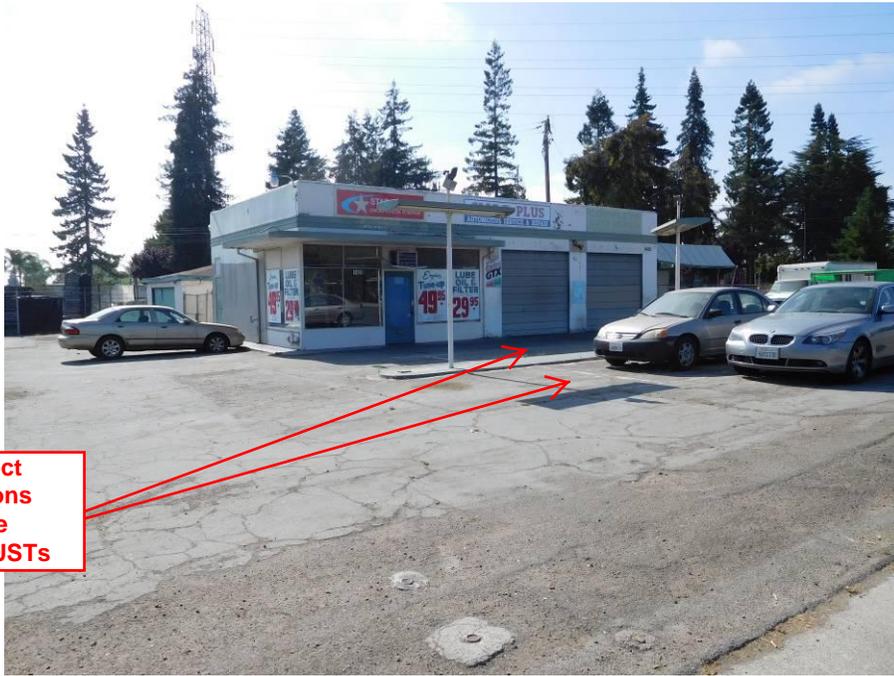
**Suspect Locations of the Former USTs**

- 1420 South Bascom Address, the Smog Shop and car maintenance facility has the signs of a gasoline service station. A remaining pad of former dispenser island was observed in the front of the building (Photos 1 and 2) and four vent pipes, signs of use of fuel USTs were observed in the back of the building (Photo 03). Fill spout for a UST was observed near the building at the Smog Shop (see Photos 16, 17, and 18 in Appendix C). The fill pipe was full of sand. No surface release or leak was observed at this location.

Subject: Subject Property south side, 1420 South Bascom Avenue, former gas station and present Smog/Car Repair Shop

- Searching and locating all underground fuel storage tanks (USTs).
- Removal of these USTs to accommodate the new site development foundations.
- Proper sampling and analysis of the soil after removal of the USTs to ensure the remaining soil underneath is not impacted with petroleum hydrocarbons.
- Including in the SMP measures, a health and safety plan and dust control

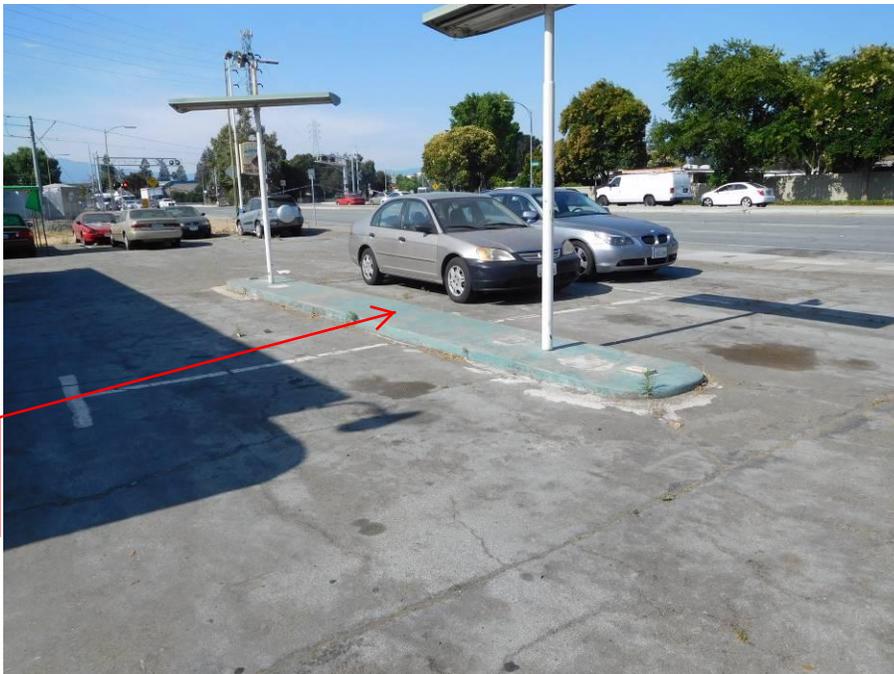
Photo No.: 03

**Former Gasoline Dispenser Island**

Subject: Subject Property, former dispenser island at the former Gas Station, 1420 South Bascom Avenue

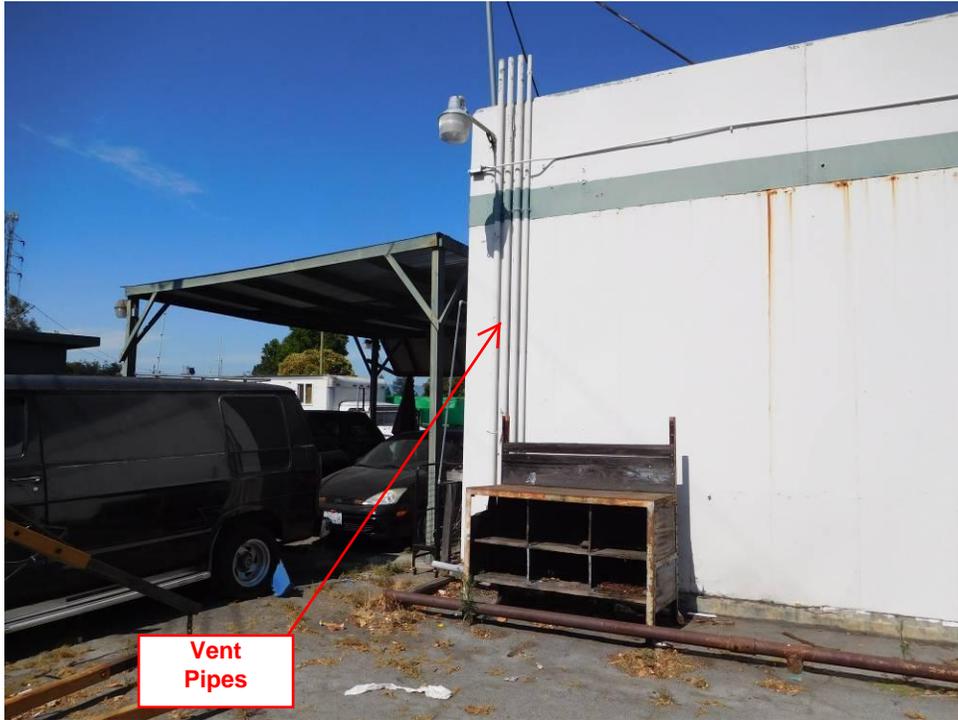
Photo No.: 02

Subject: Subject Property south side, 1420 South Bascom Avenue, Vent Pipes Behind the building

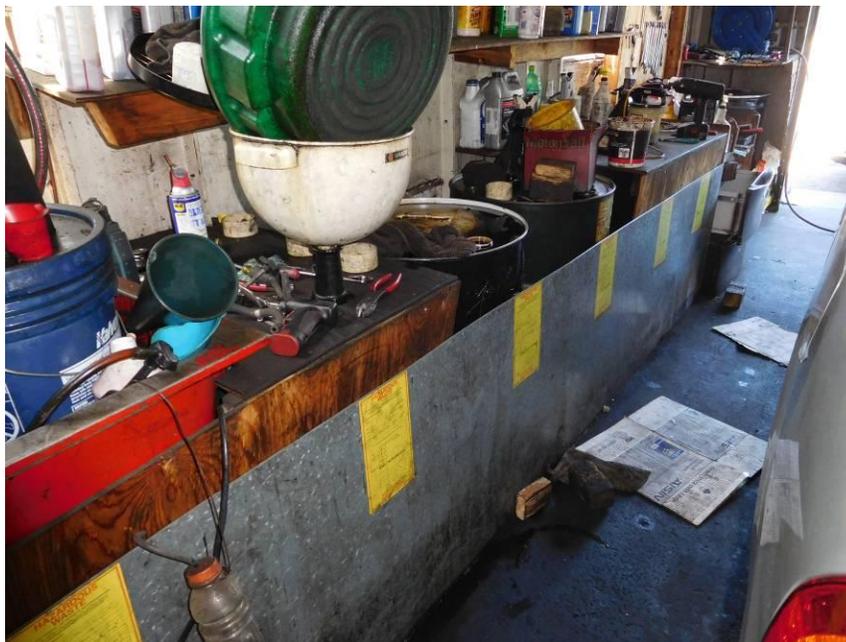
Photo No.: 04

Subject: Subject Property, former Gas Station, 1420 South Bascom Avenue, storage of waste oil in a secondary containment

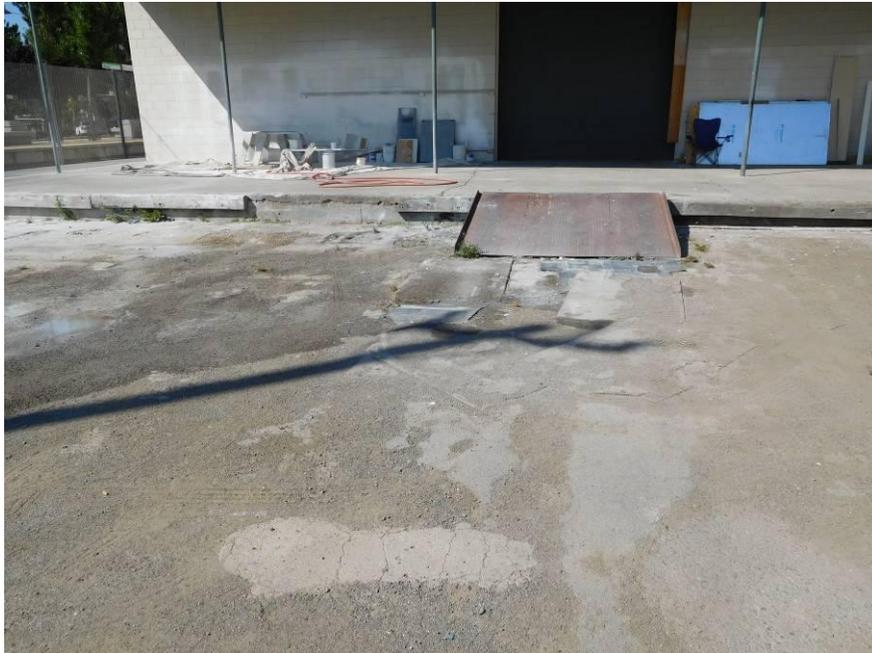
Photo No.: 11

- Minor staining of water and what appears to be gray calcium and caustic stains were observed in front of building marked with the address 1382A.

Subject: Subject Property, Some Stain near Building , 1382 South Bascom (paint contractor Occupy this address)

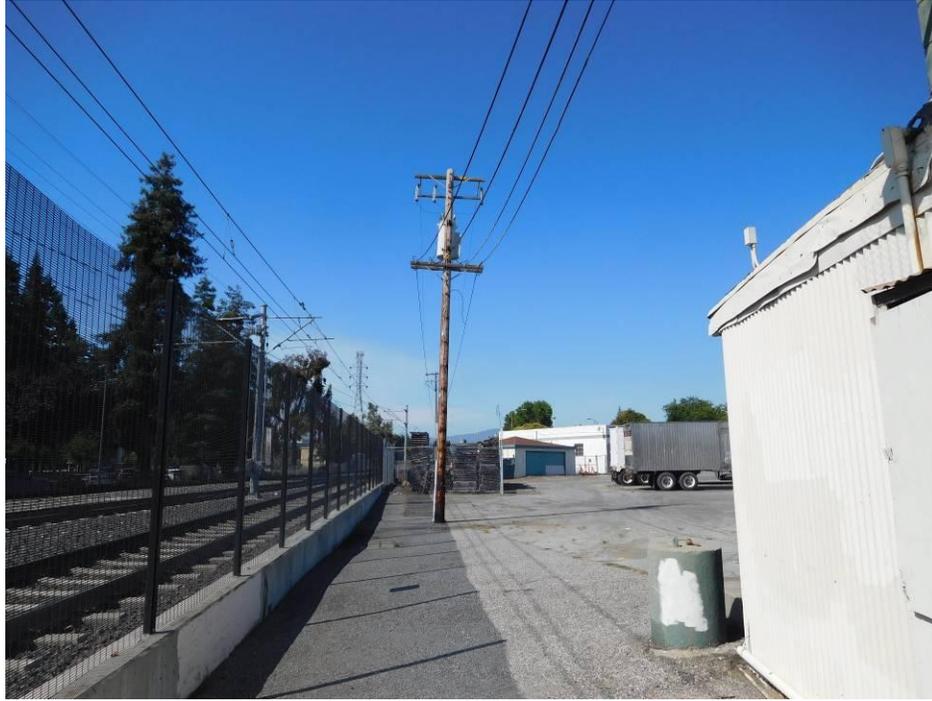
Photo No.: 12

Subject: Subject Property, Back Side, Pole Mounted Electrical Transformer onsite, serving the subject property

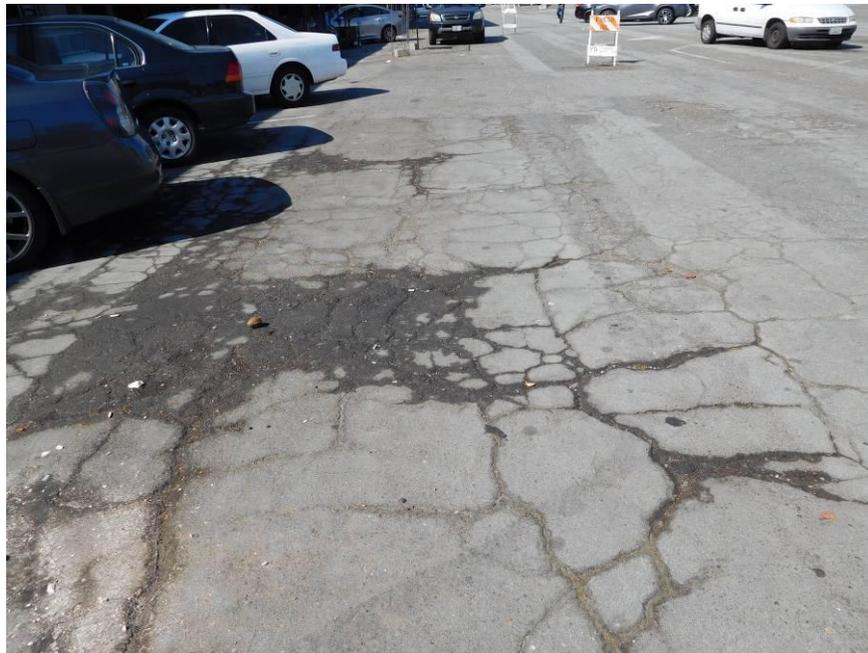
Photo No.: 14

Subject: Subject Property, Asphalt cover in the parking lot needs some repaving

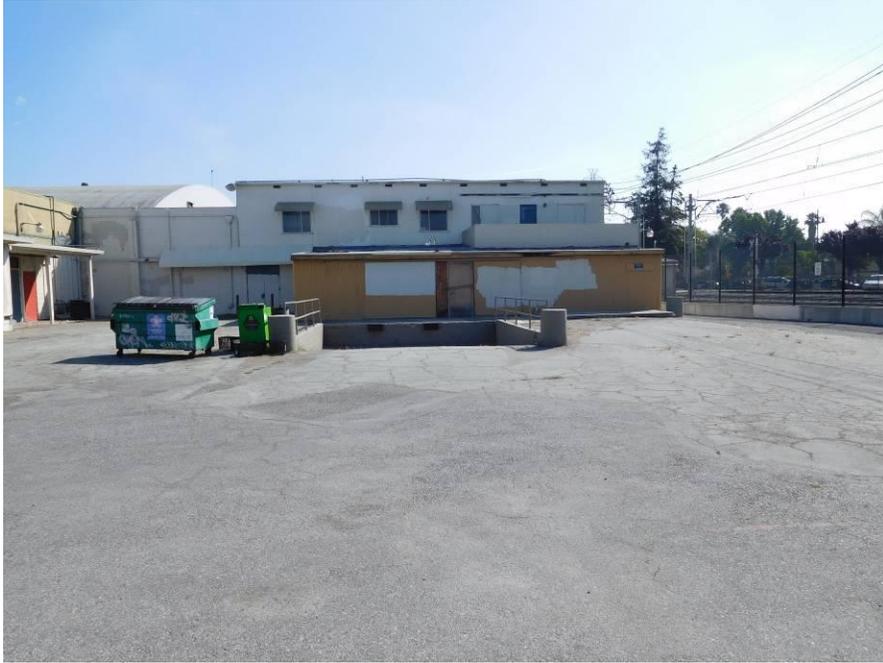
Subject: Subject Property, Oil and grease storage (full 550gallon drum, locked dumpster, and another green oil and grease container)

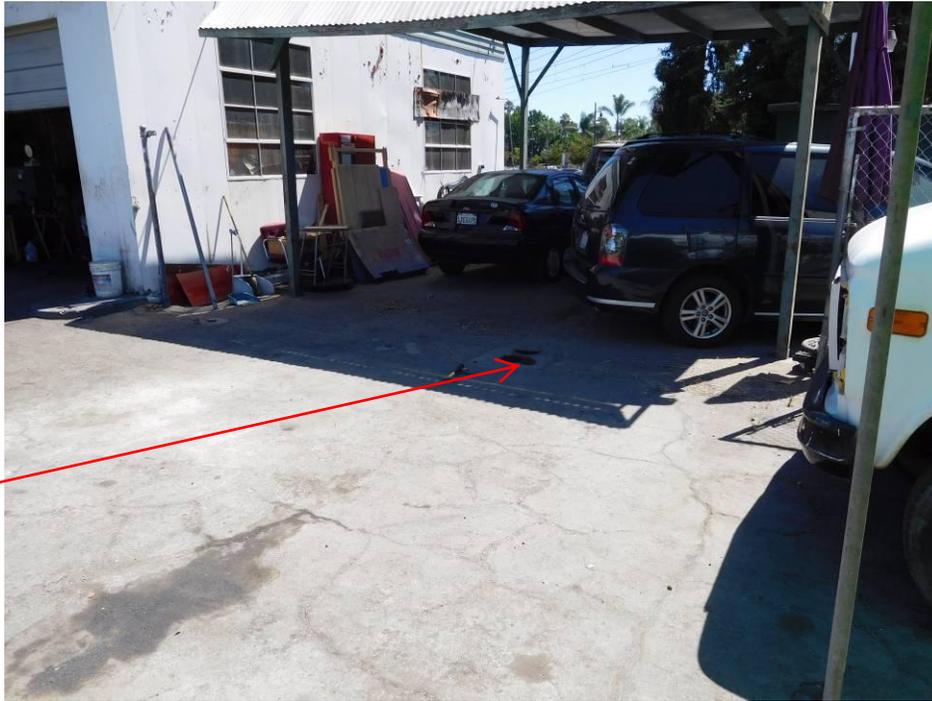
Photo No.: 16

**Location  
of the  
Suspect fill  
Box**

Subject: Subject Property, Location of the Fill Box observed on the south side of 1420 South Bascom (the Smog Testing Shop)

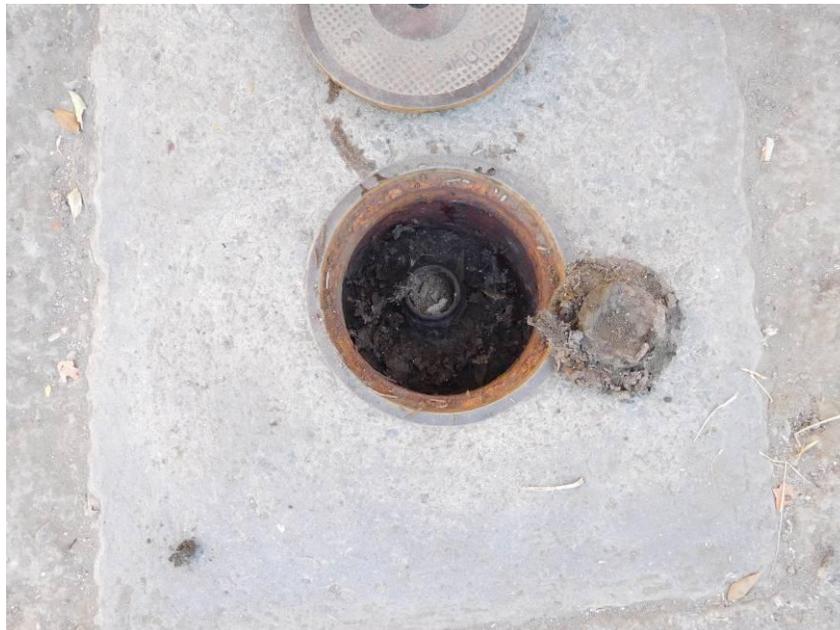
Photo No.: 17

Subject: Subject Property, Fill Box observed on the south side of 1420 South Bascom (the Smog Testing Shop), It appears to be a fill spout for an underground storage tank (UST), filled with sand

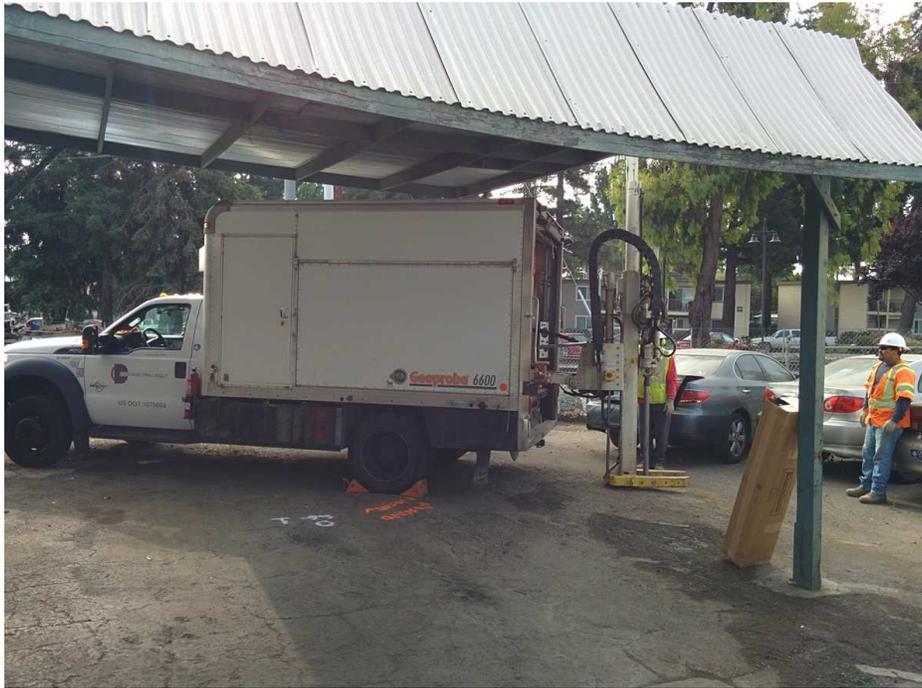
Photo No.: 01

Subject: Set up to drill Boring B4 in the area of the fuel USTs.

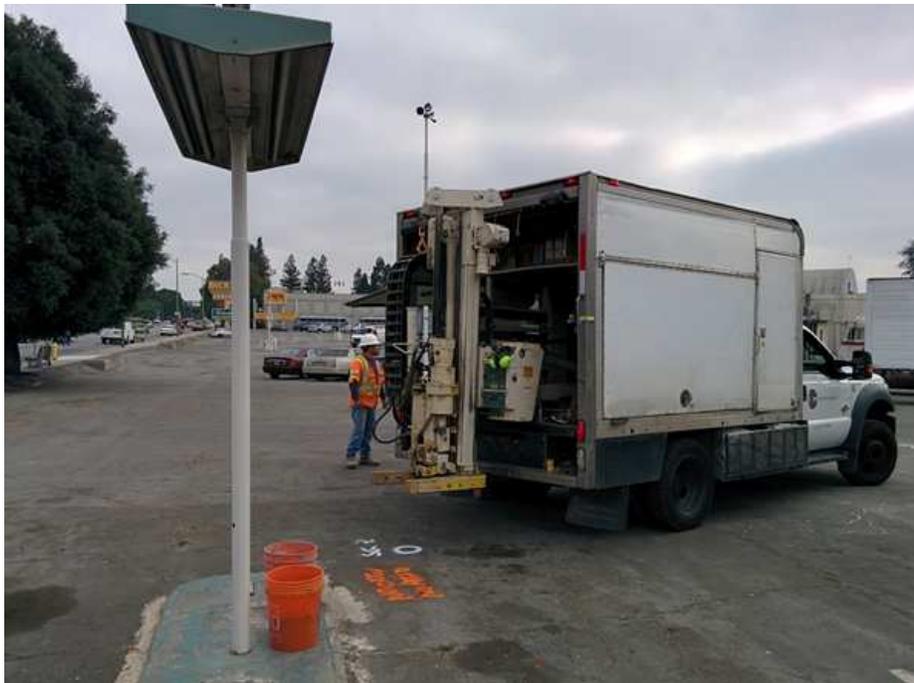
Photo No.: 02

Subject: Preparing to drill boring for soil gas sample SG-2.

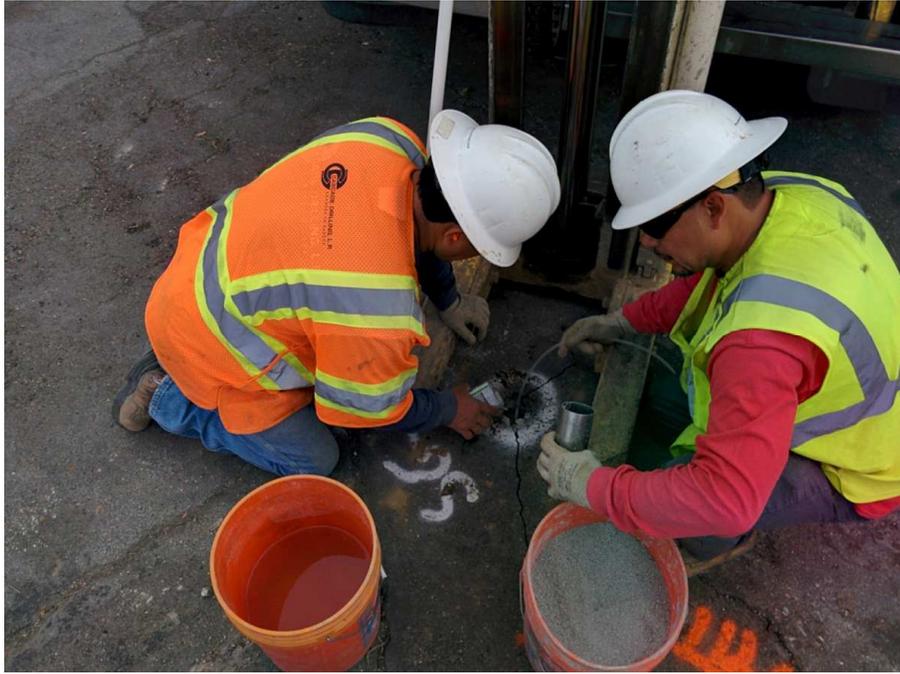
Subject: Typical installation of sacrificial probe for soil gas sampling.

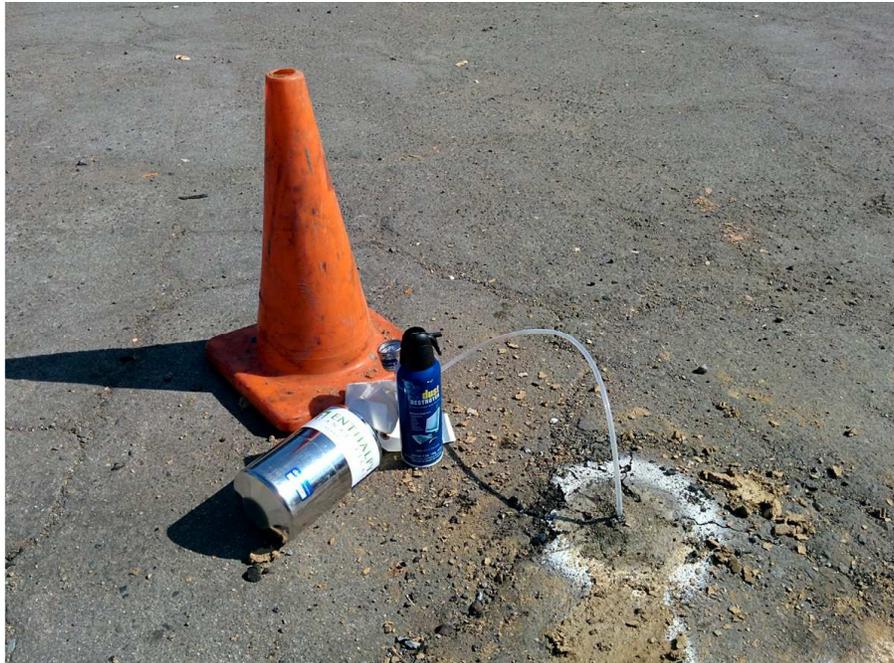
Photo No.: 03

Subject: Soil gas sample collection using Difluorochloroethane (DFA) as a leak detection compound.

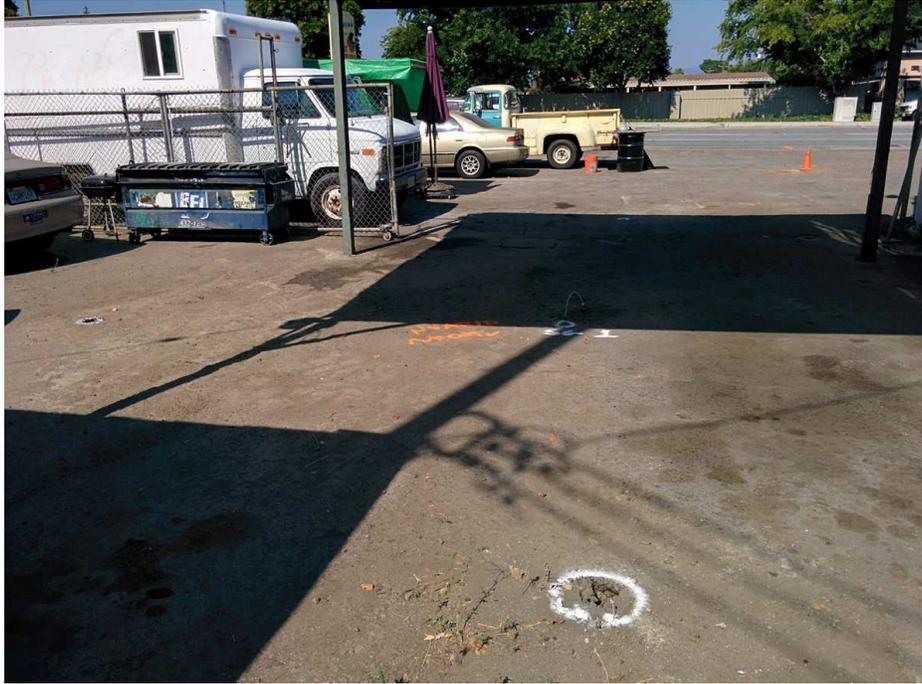
Subject: View of the boring locations around the abandoned in-place fuel USTs.

- Searching and locating all underground fuel storage tanks (USTs).
- Removal of these USTs to accommodate the new site development foundations.
- Proper sampling and analysis of the soil after removal of the USTs to ensure the remaining soil underneath is not impacted with petroleum hydrocarbons.
- Including in the SMP measures for a health and safety plan and dust control.

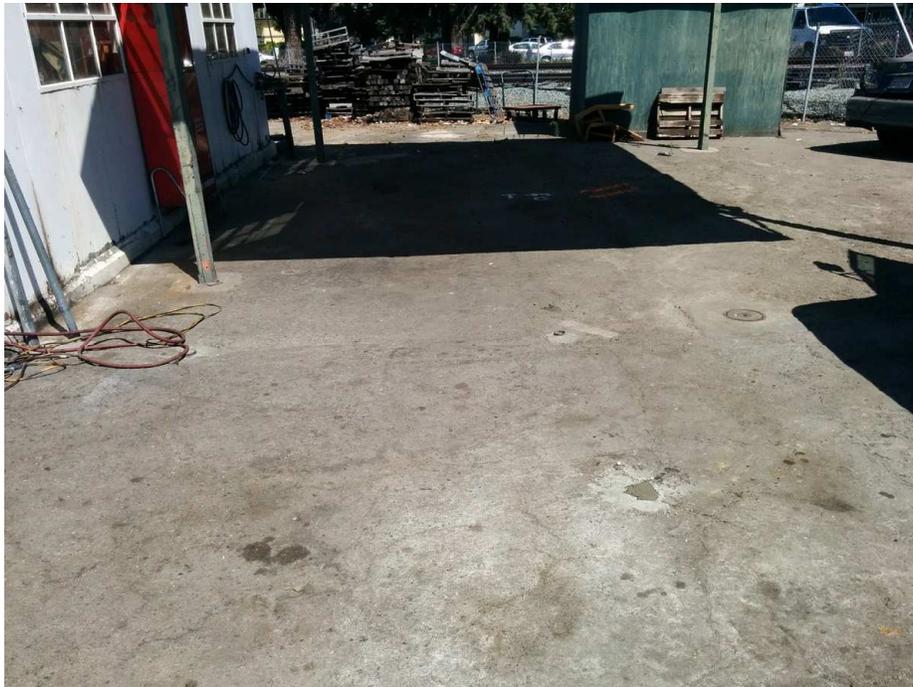
Photo No.: 05

Subject: Borings backfilled, surface repaired (typical).

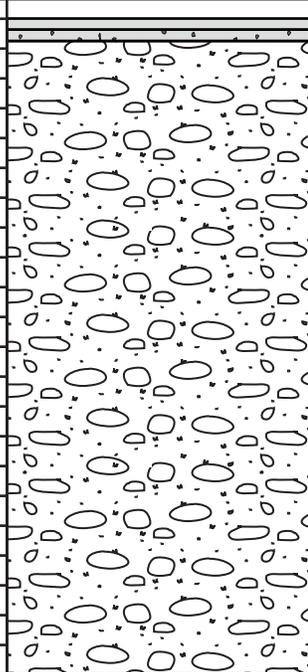
2017-40-09

DEPTH (feet)	GRAPHIC LOG	PID INSTRUMENT READING	DESCRIPTION/SOIL CLASSIFICATION	REMARKS
0			2" asphalt 3" baserock	
2

0.0	GW, Sandy gravel, grey brown, dry, loose	
4				
6				
8				
10				
12				
14				
16				
18				
20				
12	B2-11.5-12	0.0	CL, Silty clay, brown, damp, soft	
			Total drilled depth = 12'
