Camarillo Springs Golf Course Development Project

Cultural Resources Assessment

June 2020

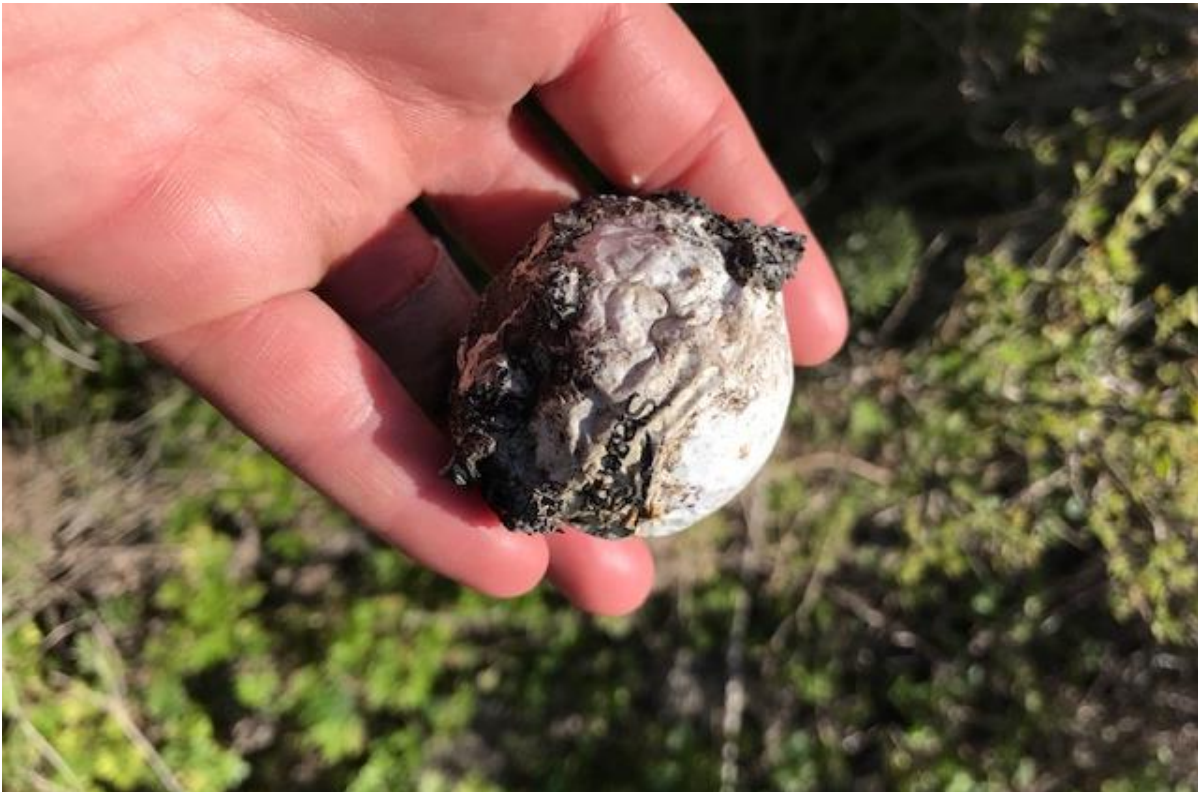
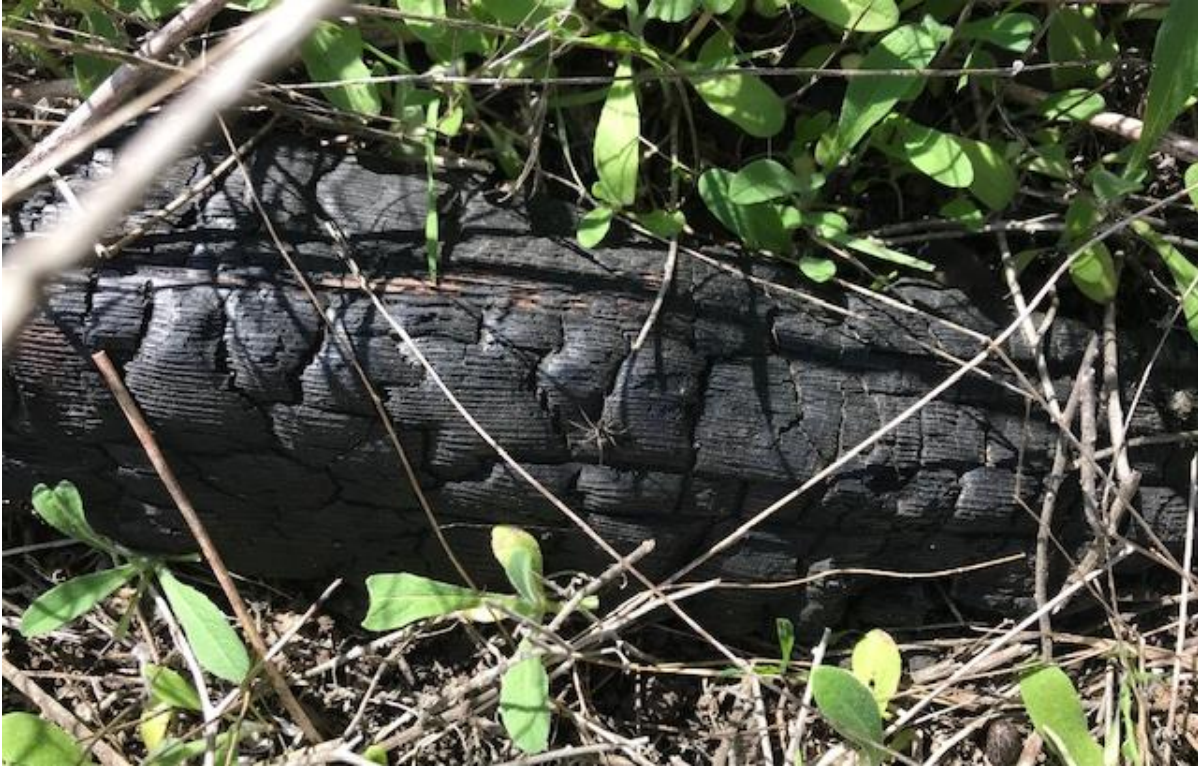
Figure 11 Evidence of Recent Wildfire

Figure 12 Evidence of Recent Wildfire

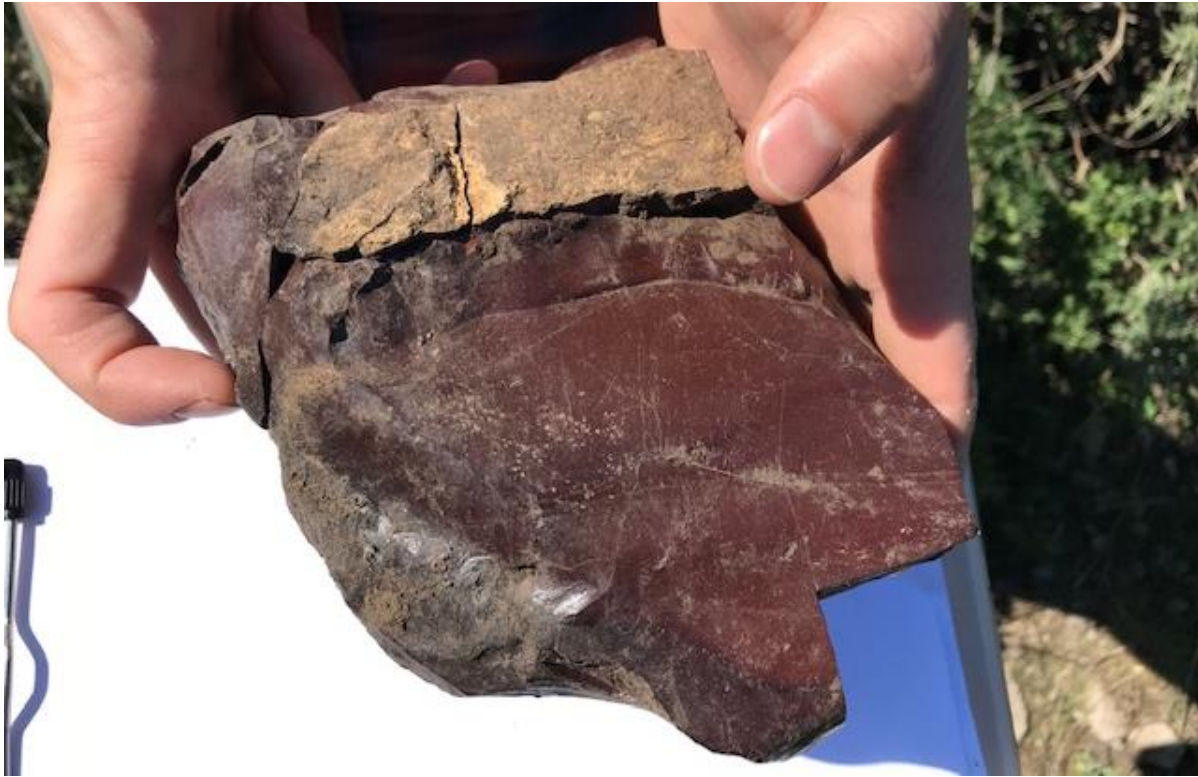
Figure 18 Jasper Core Refits

CSGC-Iso 1 is a red jasper core with one associated core fragment and two waste flakes. The core fragment and two waste flakes refit to the core. Isolates are typically ineligible for CRHR listing as their data potential is exhausted during the initial recording. Therefore, Rincon recommends CSGC-Iso-01 as ineligible for the CRHR. This isolate is not discussed further here.

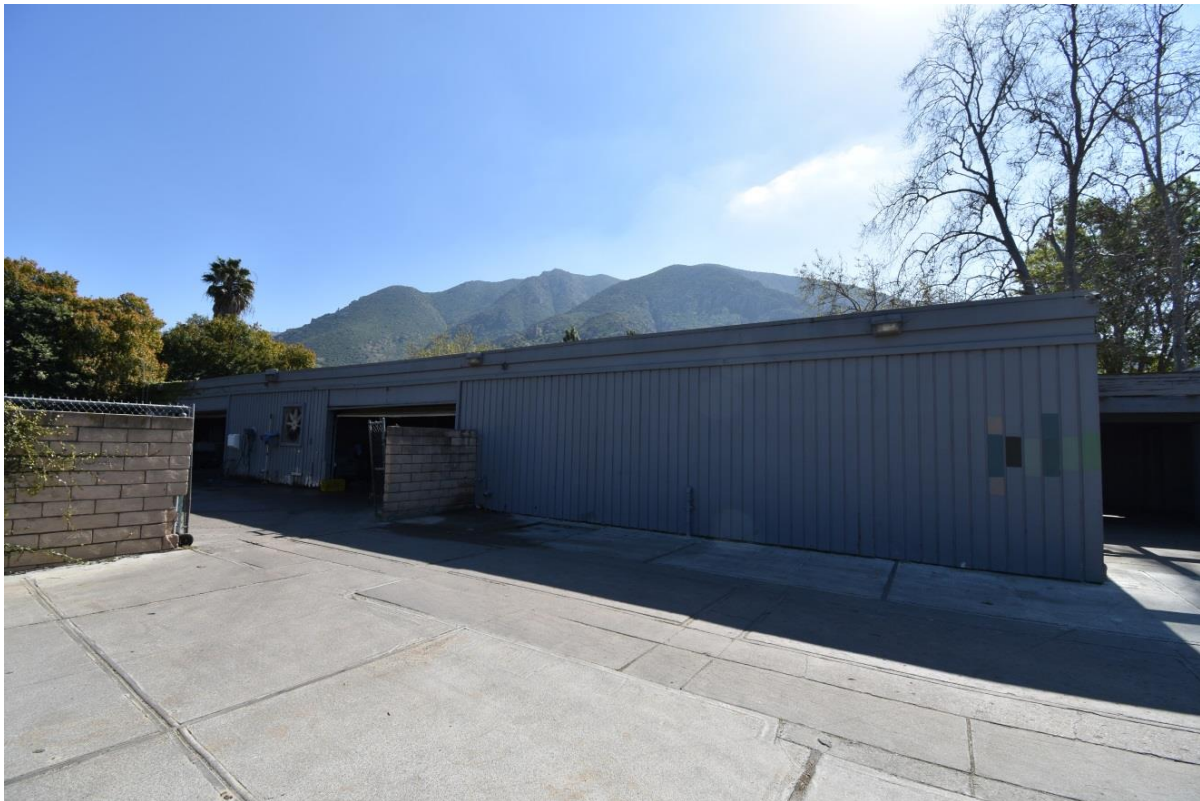
Figure 19 Golf Cart Building, North Elevation

The golf cart building is located in the central region of the golf course immediately to the west of the parking lot. The building does not exhibit the markings of an architectural style. It features a rectangular footprint, concrete foundation, and exterior of vertical wood tongue-and-groove siding. The building's flat roof features a parapet demarcated with horizontal wood planks over varying sizes and interspersed security lights. At least two garage entrances are located along the north elevation and provide vehicular entrance with roll-up modern doors. A concrete masonry unit (CMU) wall with a chain link gate restricts entrance to these garages (Figure 19).

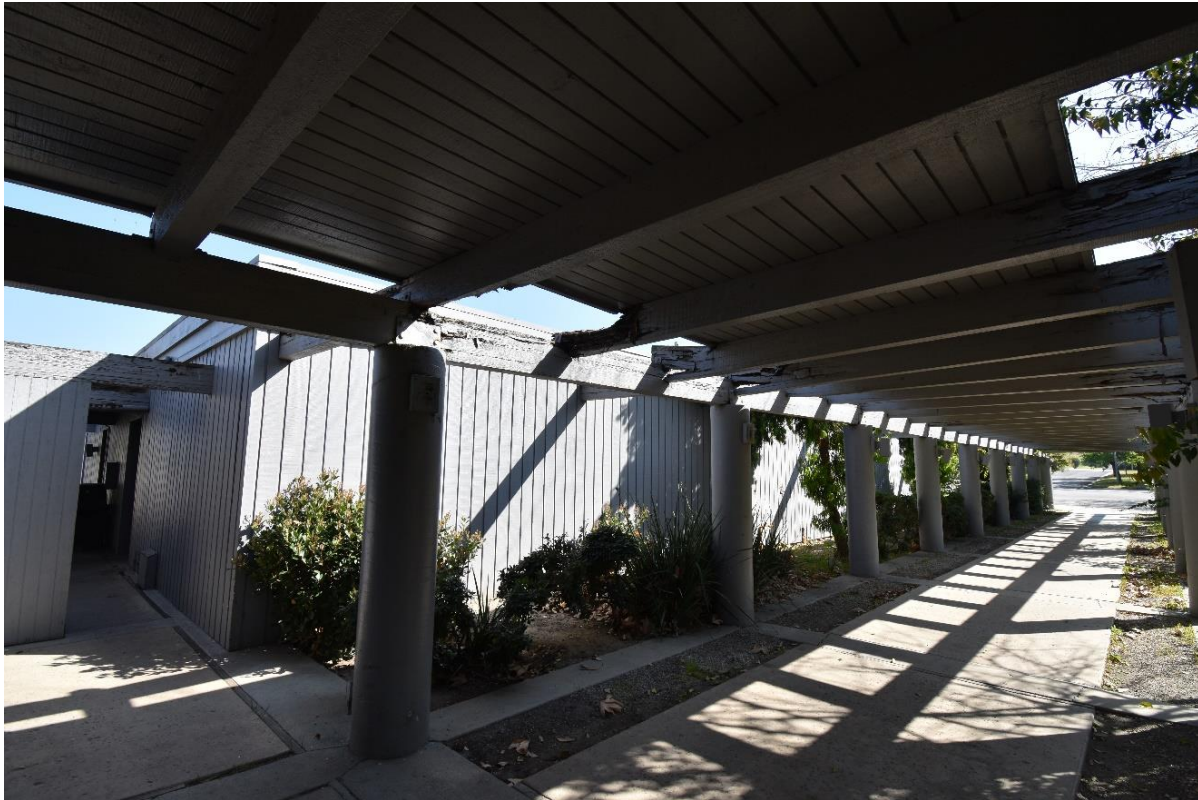
Figure 20 Detail of Entry Pergola with Golf Cart Building to the Rear

Along the south elevation of the golf cart building is the entry pergola with concrete slab walkway. Cylindrical concrete posts uphold interlaced wood beams and rafters capped with wood planks. Many of the wood beams and rafters are in poor condition and have experienced extensive water damage. This has resulted in splintering and rot (Figure 20).

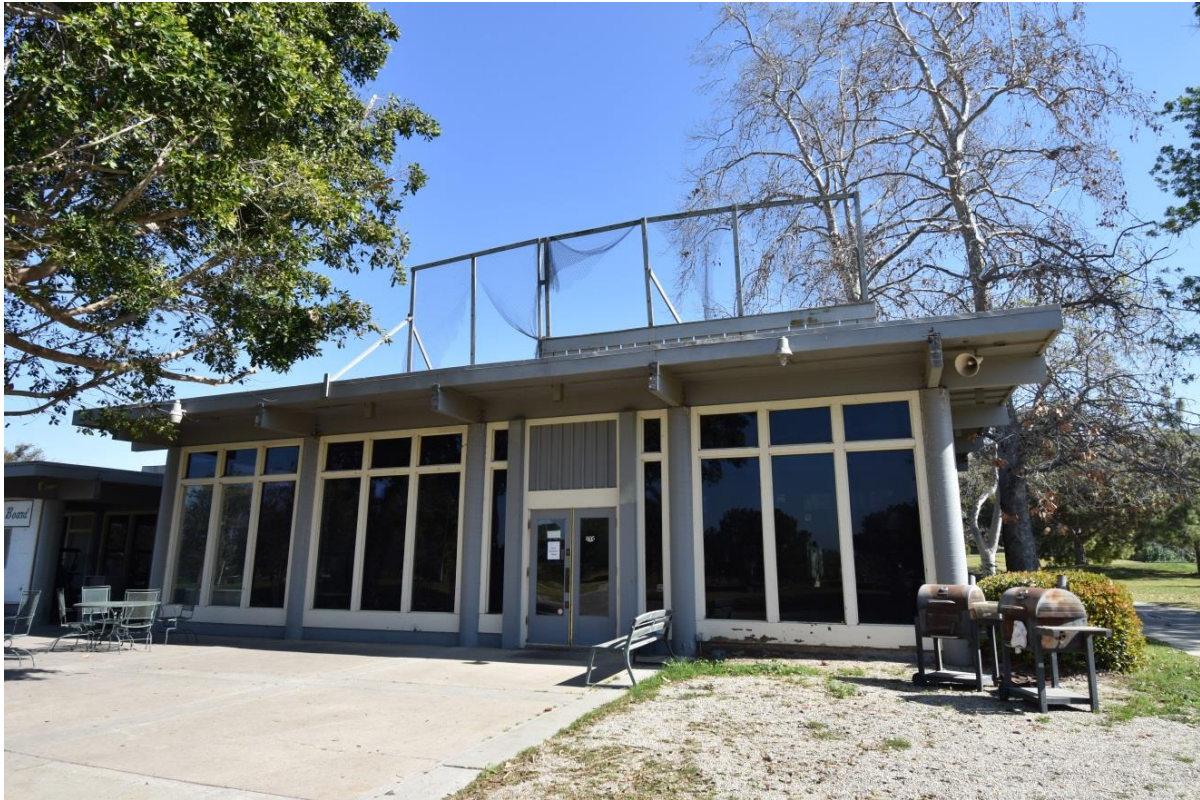
Figure 21 Clubhouse/Restaurant Building, West Elevation

The clubhouse/restaurant building is situated to the southwest of the golf cart building. It has an 'L'-shaped footprint, concrete foundation, and is designed in a style similar to that of the pro shop building. With an exterior of fixed ribbon lights set between partially recessed cylindrical concrete posts, the building is Modern and comprised of repeating geometries. It has a flat roof with a widely overhanging boxed eaves and exposed rafters. A net for catching stray golf balls is situated on the roof. The primary entrance on the west elevation features paired glazed, industrial doors set beneath a panel of board and batten wood (Figure 21).

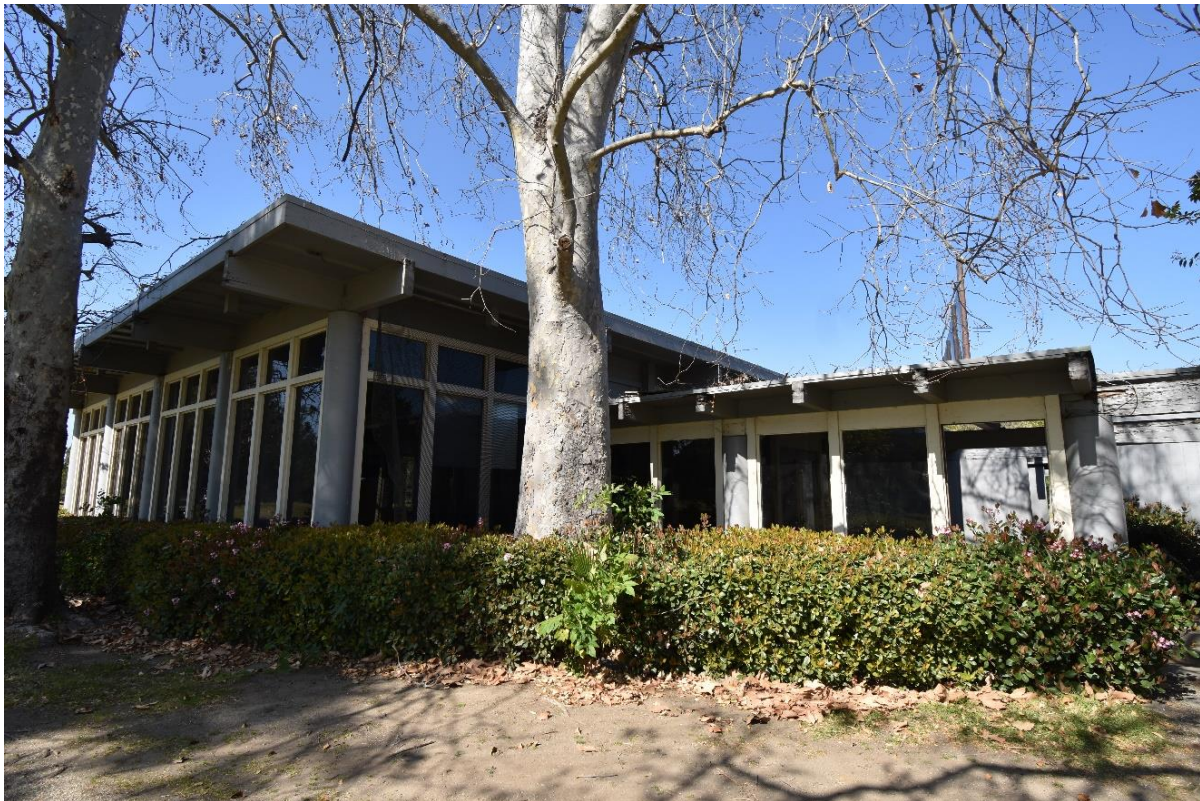
Figure 22 Clubhouse/Restaurant Building, East Elevation

The east elevation includes an entrance to which the pergola is attached (Figure 22). The verticality of the entrance bay is not quite as dramatic as the rest of the building, but rather lowers its exaggerated height. The entrance features paired glazed doors set between two fixed windows with wood surrounds and board detailing. Three fixed windows provide shelter from the elements. The clubhouse/restaurant building appears to be in poor condition. It has cracked concrete posts and rotten wood rafters along the west and east elevations.

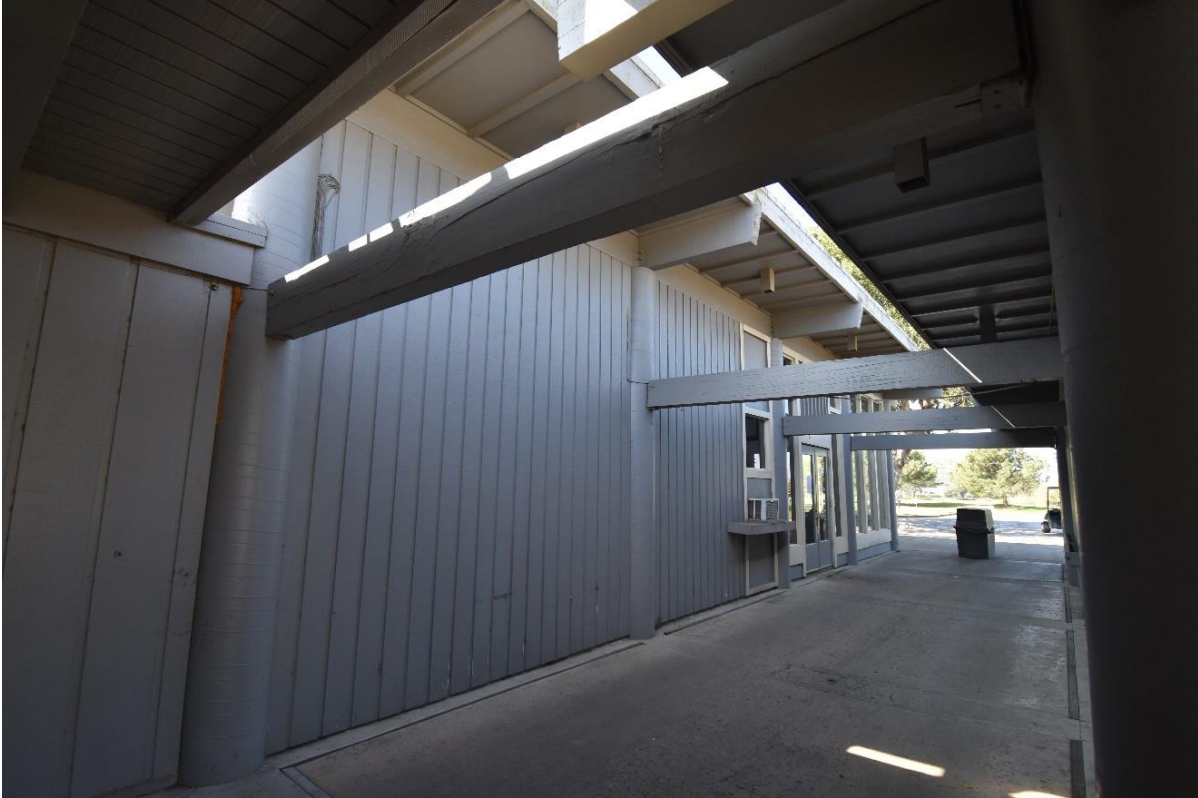
Figure 23 Breezeway

The breezeway at the rear (east) of the clubhouse/restaurant building is comprised of wood beams that span the distance between the clubhouse/restaurant building, golf cart building, and pro shop building; the breezeway does not have its own roof but is rather mostly projected by two of the buildings' overhanging, boxed eaves (Figure 23).

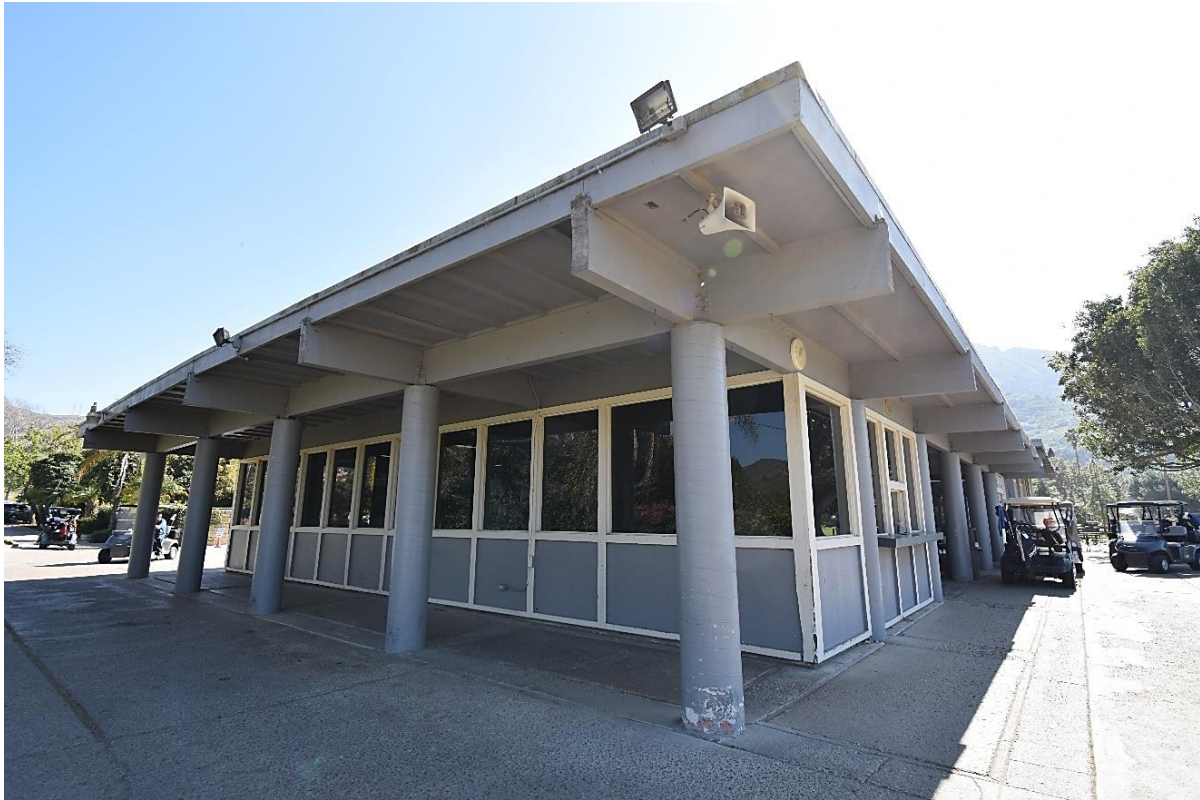
Figure 24 Pro Shop Building, North Elevation

The pro shop building is situated northwest of the golf cart building; it shares a breezeway with it and the clubhouse. Featuring a rectangular footprint, concrete foundation, and flat roof with a widely overhanging boxed eaves and exposed rafters, the building is a modest example of the Modern style of architecture. The underside of the roof shows interlaced beams upheld by large cylindrical concrete posts that create an arcade along the north and west elevations (Figure 24). The east elevation features these concrete posts as well, but they are sunken here to resemble pilasters.

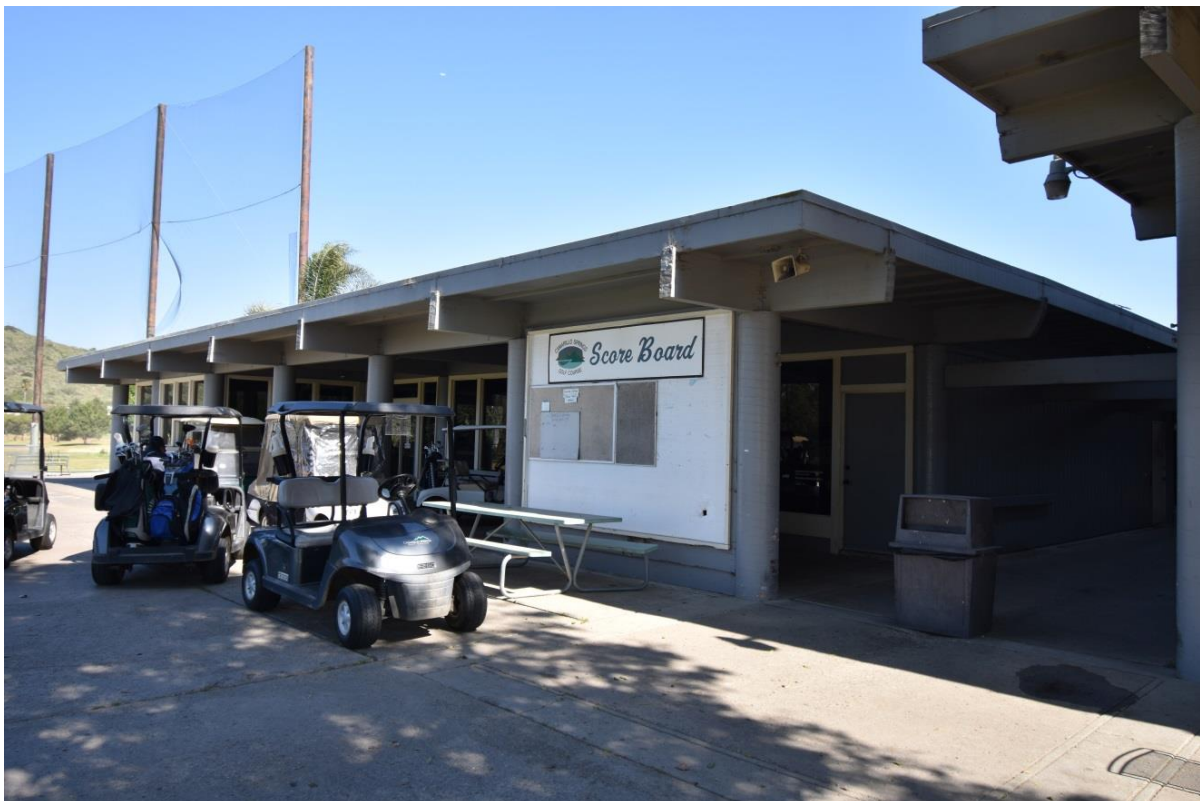
Figure 25 Pro Shop Building, West Elevation

The building's exterior has a ribbon of large, fixed windows with wood surrounds that extend to panels below each window. Fenestration is relatively dramatic, further emphasizes the building's many repeating geometries, and characterizes almost all elevations of the building. There are various entrances, including a paired glazed door and wood door with a boarded transom light on the east elevation. The west elevation features the main entrance with an industrial door, as well as three wood doors with boarded transom lights (Figure 25).

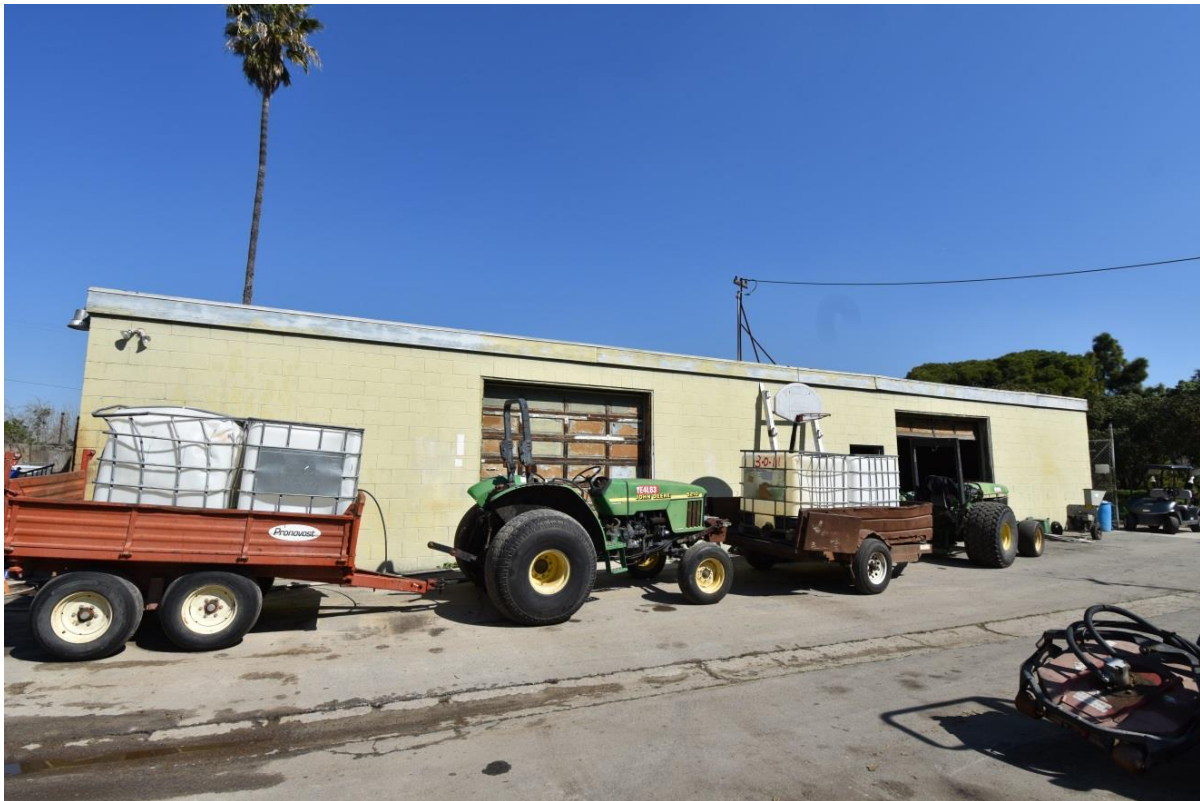
Figure 26 Maintenance Building No. 1, South Elevation

Maintenance building No. 1 is situated in the northwesternmost reaches of the golf course. With a rectangular footprint, concrete foundation and CMU exterior the 1-story building is generally utilitarian in nature and has no discernible style. The building's flat roof features a horizontal wood board around the parapet. Two rolling wood-paneled garage doors are evenly placed on the south elevation and provide vehicular entrance to the building (Figure 26). A wood door is situated to the west of the garage doors.

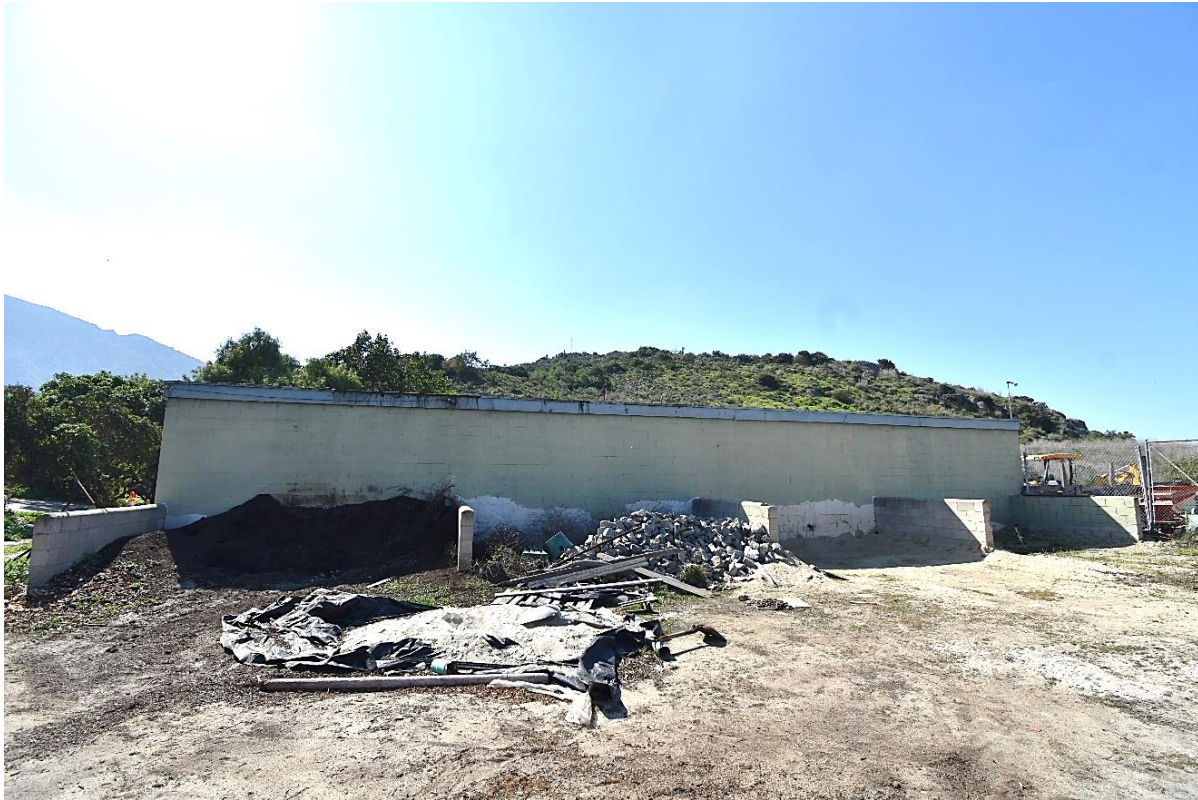
Figure 27 Maintenance Building No. 1, North Elevation

An additional vehicular entrance on the west elevation of the building appears to be boarded off and is no longer in use. Parking areas are generally located to the west of the building. The north elevation is characterized by five projecting waist-high CMU walls that appear to serve as storage spaces for various materials, including dirt and gravel (Figure 27). Security lights are situated on the corners of the building.

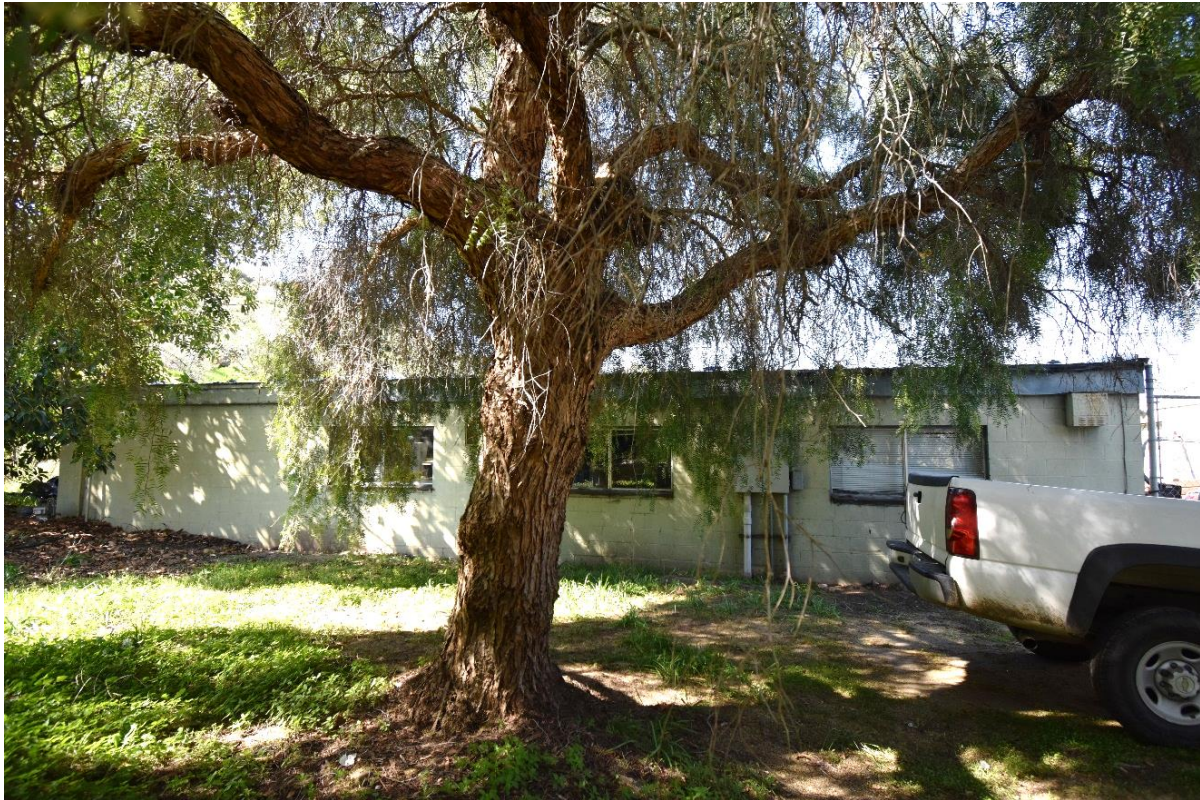
Figure 28 Maintenance Building No. 2, East Elevation of East Bay

Maintenance building No. 2 is utilitarian and mostly used for vehicular and storage purposes. The U-shaped building is comprised of a central bay and two projecting bays; the central bay is approximately one foot taller than its flanking ells. Besides four sliding aluminum windows, three on the east and one of the north elevations of the east bay, all windows and doors are limited to the interior courtyard of the building. An electrical box is situated on the east elevation of the east bay (Figure 28).

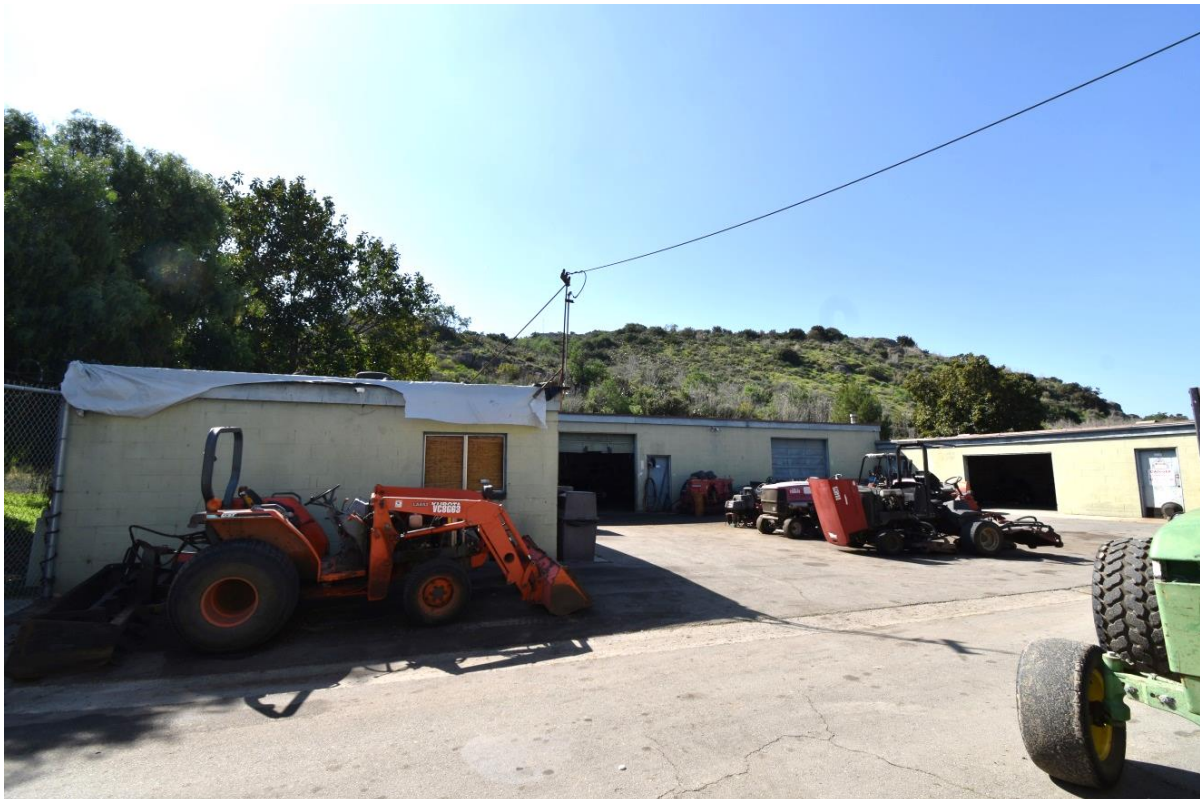
Figure 29 Maintenance Building No. 2, North Elevation

The building's three garage entrances feature rolling wood paneled garage doors; two of these are situated on the central bay and one is on the west bay (Figure 29). Two wood doors flank the garage door on the west bay, which otherwise lacks ornamentation. An additional pedestrian door is situated between the two garage doors on the central bay. The east bay is accessible via two wood pedestrian doors. This bay also features an air conditioning unit and a fixed jalousie window.

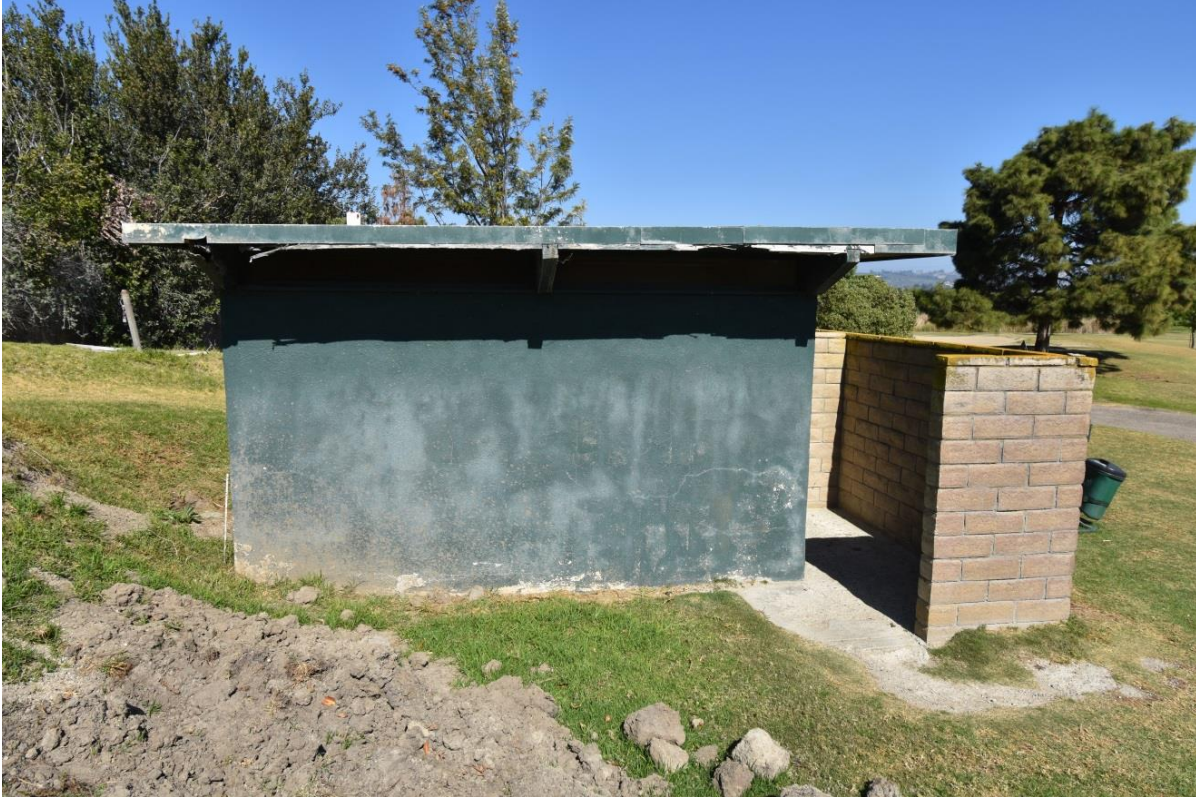
Figure 30 Restroom Building No. 1, South Elevation

Restroom building No. 1 is situated just southeast of the maintenance buildings near the cul-de-sac on Margarita Avenue. Constructed of concrete CMUs and featuring a flat roof with projecting eaves upheld by triangular braces, the building is utilitarian in nature (Figure 30). A thin screen panel beneath the roof provides passive air flow and a 'U'-shaped CMU wall creates privacy corridors into each restroom. The restrooms feature wood doors and stalls and tile floors. A portable water station is installed outside. The building is in poor condition.

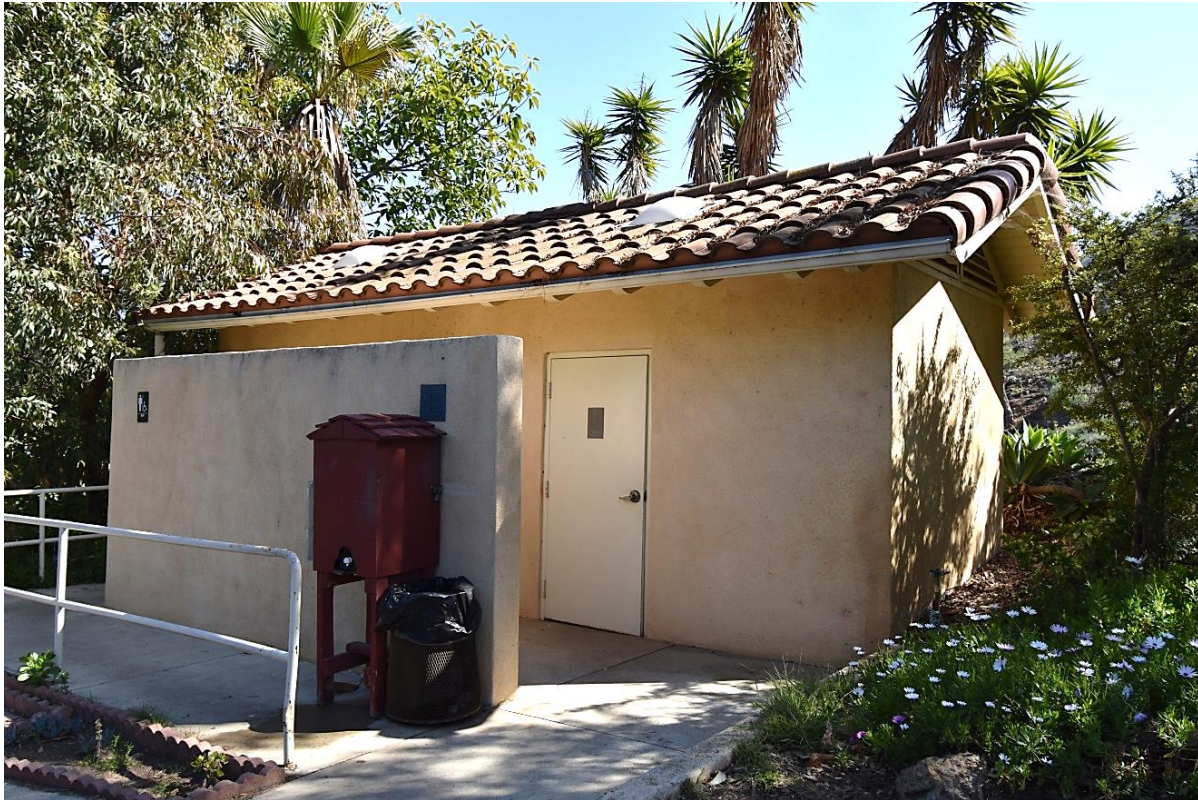
Figure 31 Restroom Building No. 2, West and South Elevations

With its smooth stucco exterior and gable roof clad in clay tiles, the building is designed in a modest iteration of the Spanish Revival style of architecture. It features two skylights and louvered vents beneath the gables for natural light and airflow. A detached stucco wall provides privacy for restroom entrances. Wood doors provide entry to the restroom (Figure 31).

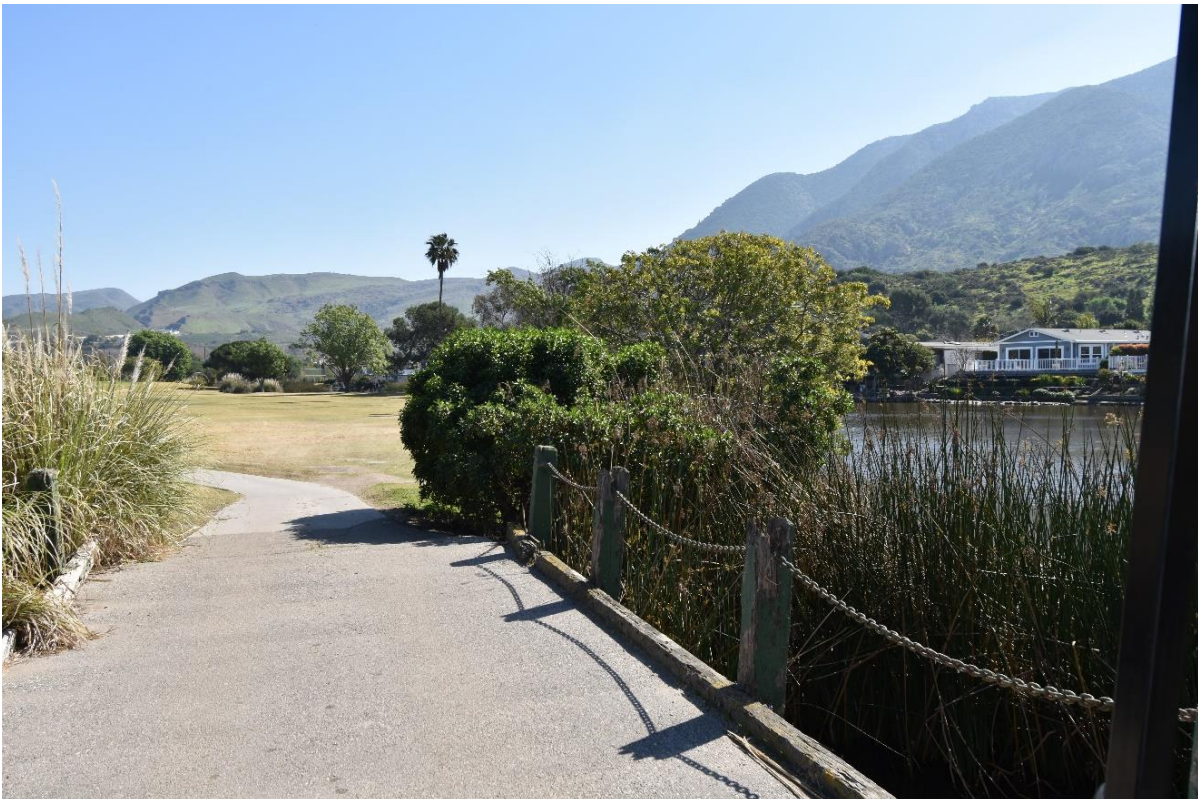
Figure 33 Delapidated Bridge

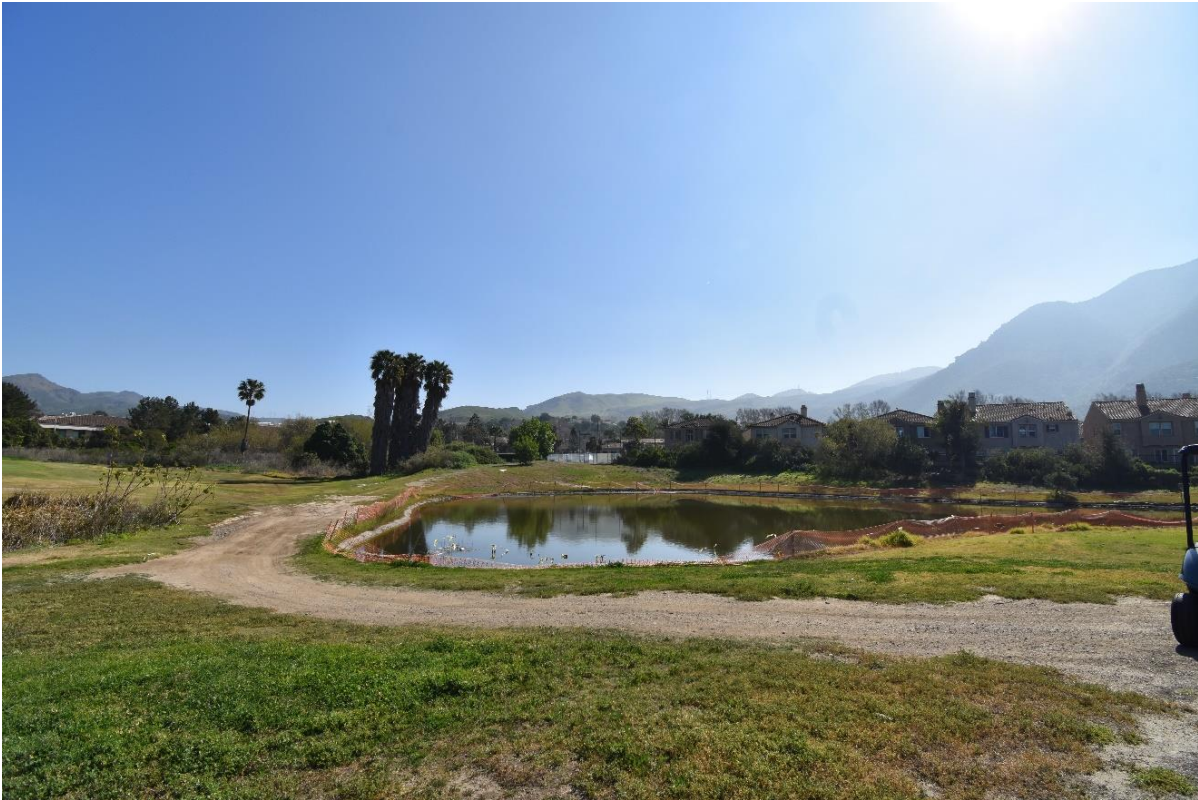
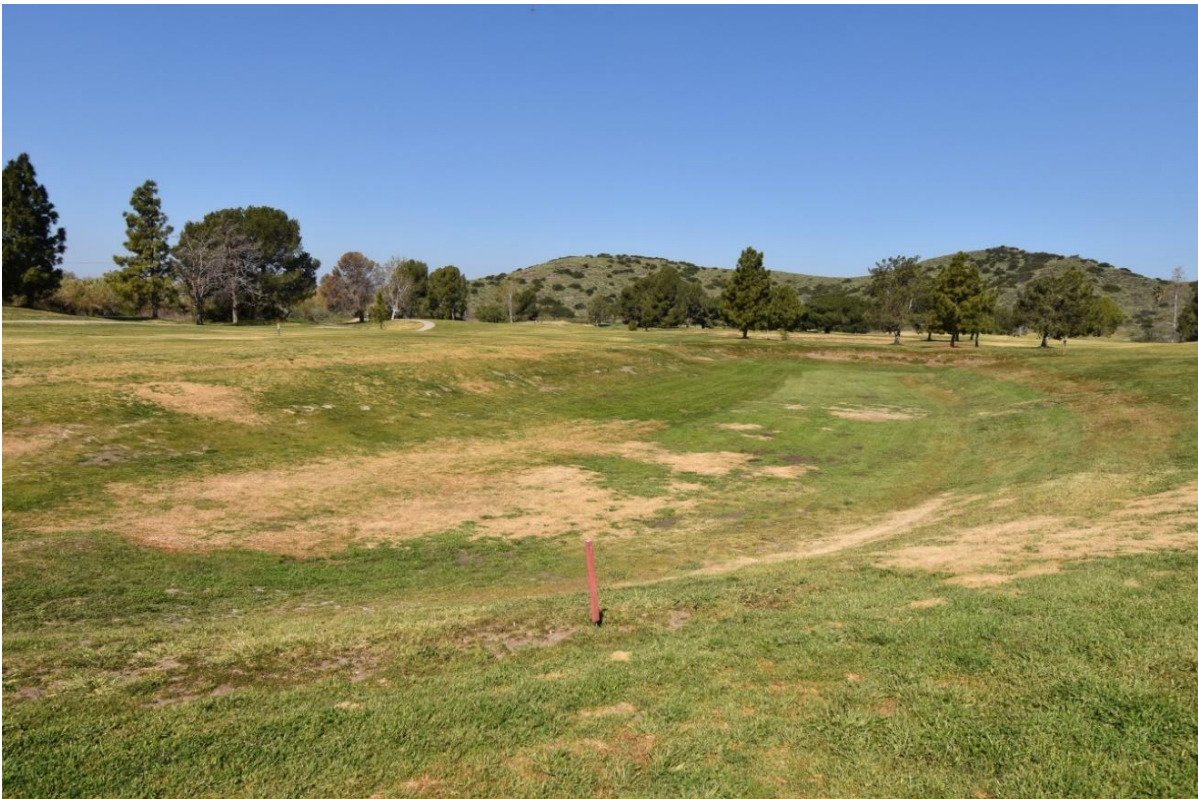
The entrance to the golf course is characterized by mature trees and planters, exhibiting a more maintained and ornamented area. Other areas of the golf course exhibit the winding drive through dry, scorched grassy lawns that are not consistently maintained. Some sand pits are patchy and no longer clearly defined (Figure 32). A bridge located in the central region of the golf course exhibits low little the area has been maintained with incredibly rotted piers and overgrown grasses (Figure 33). There are also several water features onsite, however these are seasonal, man-made irrigation ponds that are dry in the summer months. To conserve water, not all golf course water hazards remain operational and instead are now playing areas that are still distinguishable by their sunken, unique shapes (Figure 34; Figure 35).

Figure 34 Extant Water Hazard

Figure 35 Example of Water Hazard That Has Been Infilled

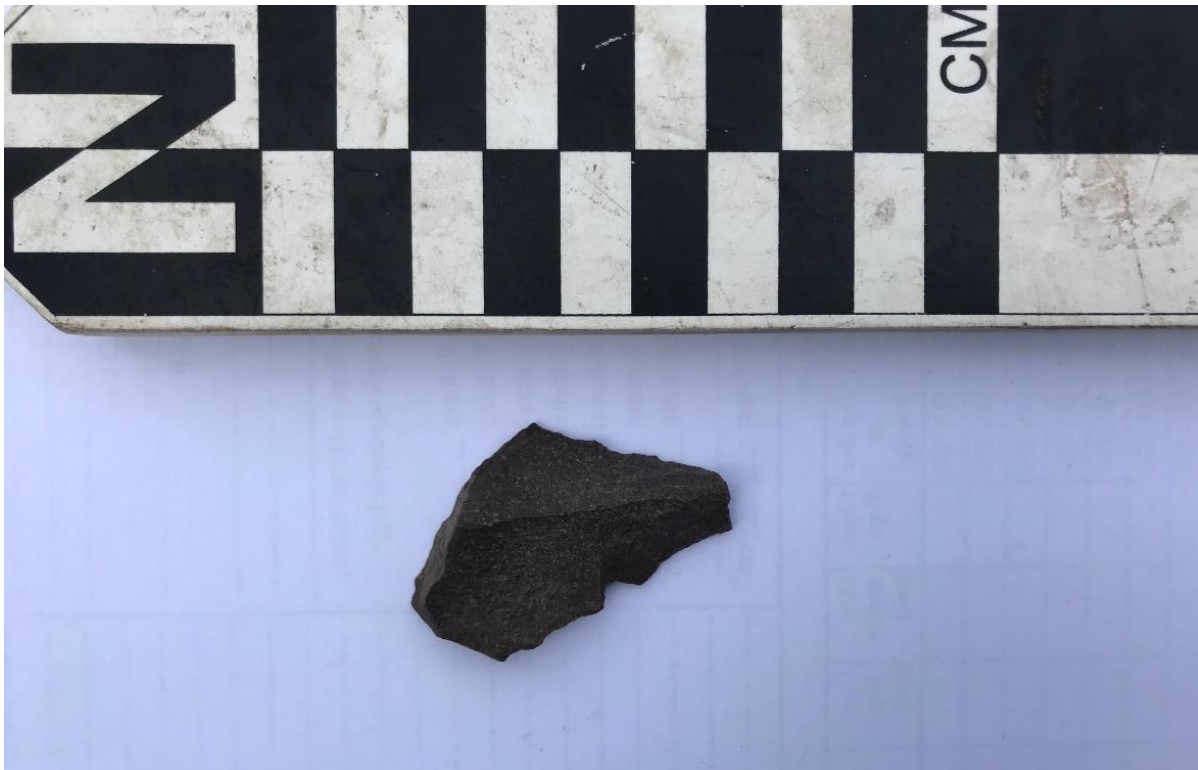
Soils within TU1 were comprised of silty sandy clay and clay with charcoal mixed throughout. One purple rhyolite tertiary flake (Figure 46) was recovered from the 30-40 cmbs level. Charcoal found throughout TU1 until 80 cmbs and is not considered to be cultural as there were no other indications that a feature was present. Several fires have occurred within the area during recent years (Camarillo Springs Fire 2013, Thomas Fire 2017-2018, Woolsey Fire 2019), suggesting that the abundance of burnt material may be the result of recent wildfire activity. No additional cultural deposits were recovered during the Phase II investigation. Modern disturbances were noted within levels two (10-20 cmbs) through five (40-50 cmbs), indicating a high level of disturbance within the tested area of the project site. A summary of TU1 is detailed in Table 5 below.

Figure 46 Flake Recovered from TU 1, 30-40 cmbs

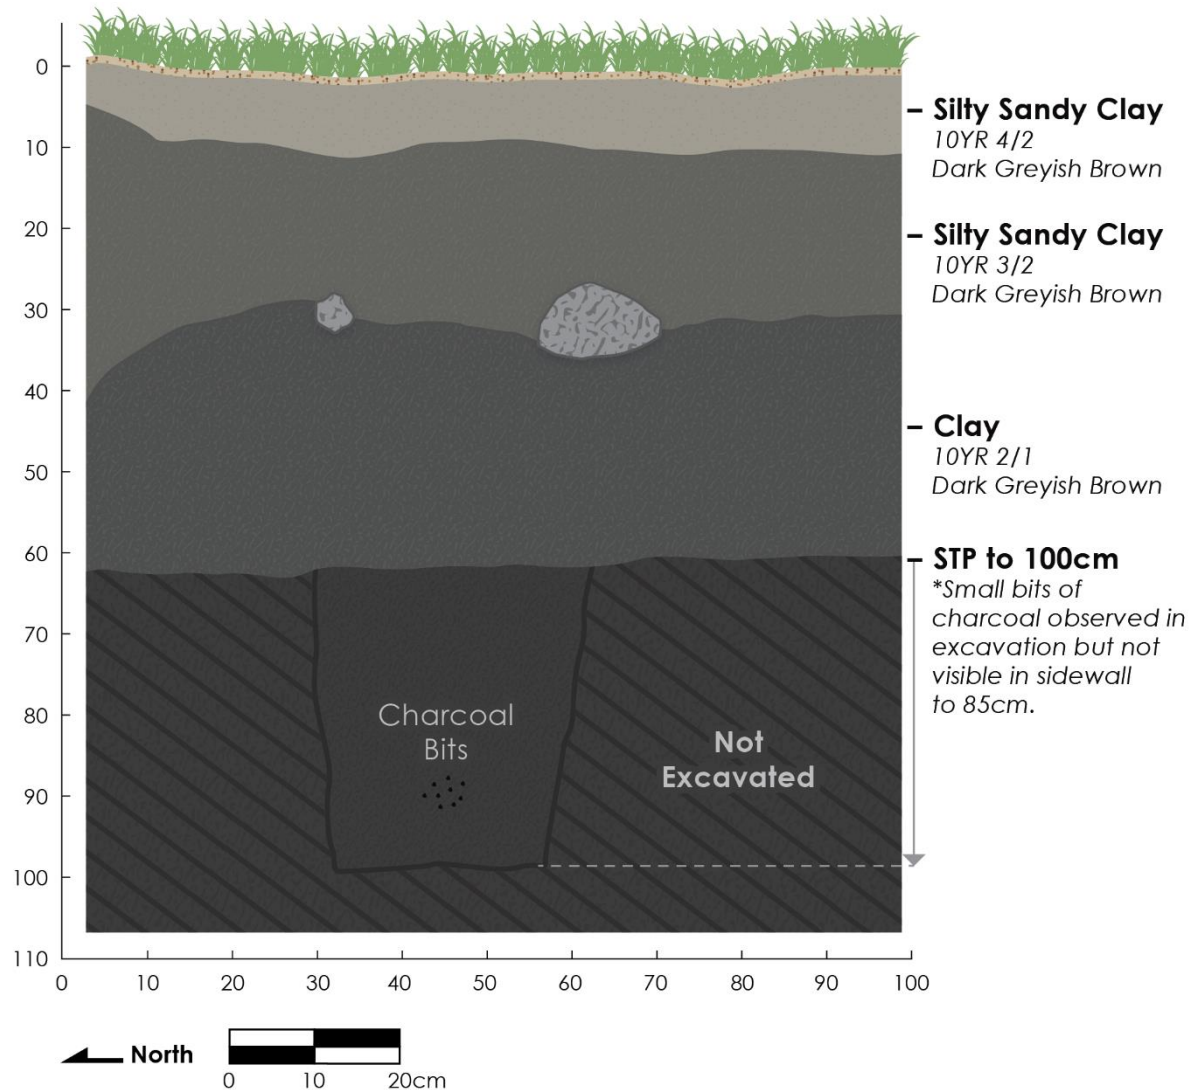
Figure 47 Eastern Wall Profile of TU1
