PLANNING PUBLIC HEARING – APPLICATION
ARCHITECTURAL & SITE REVIEW BOARD/PLANNING COMMISSION

Restoration of Creek Bank in two location, along Redwood Creek within the Menlo Country Club property

**Wetland and Riparian Habitat Restoration Plan
Menlo Country Club Bank Stabilization Project, Woodside, CA**

CONCEPTUAL CREEK BANK RESTORATION AND BENCHING DETAIL

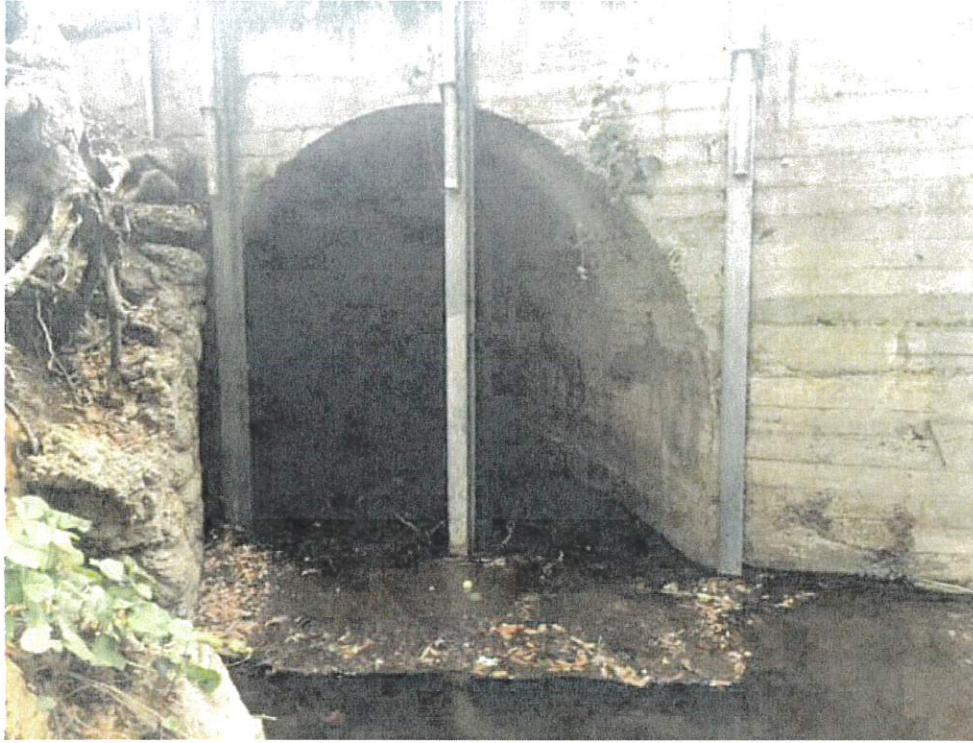
Appendix C-9. The downstream reach of Redwood Creek, where it exits the study area through a concrete culvert under Alameda de las Pulgas.

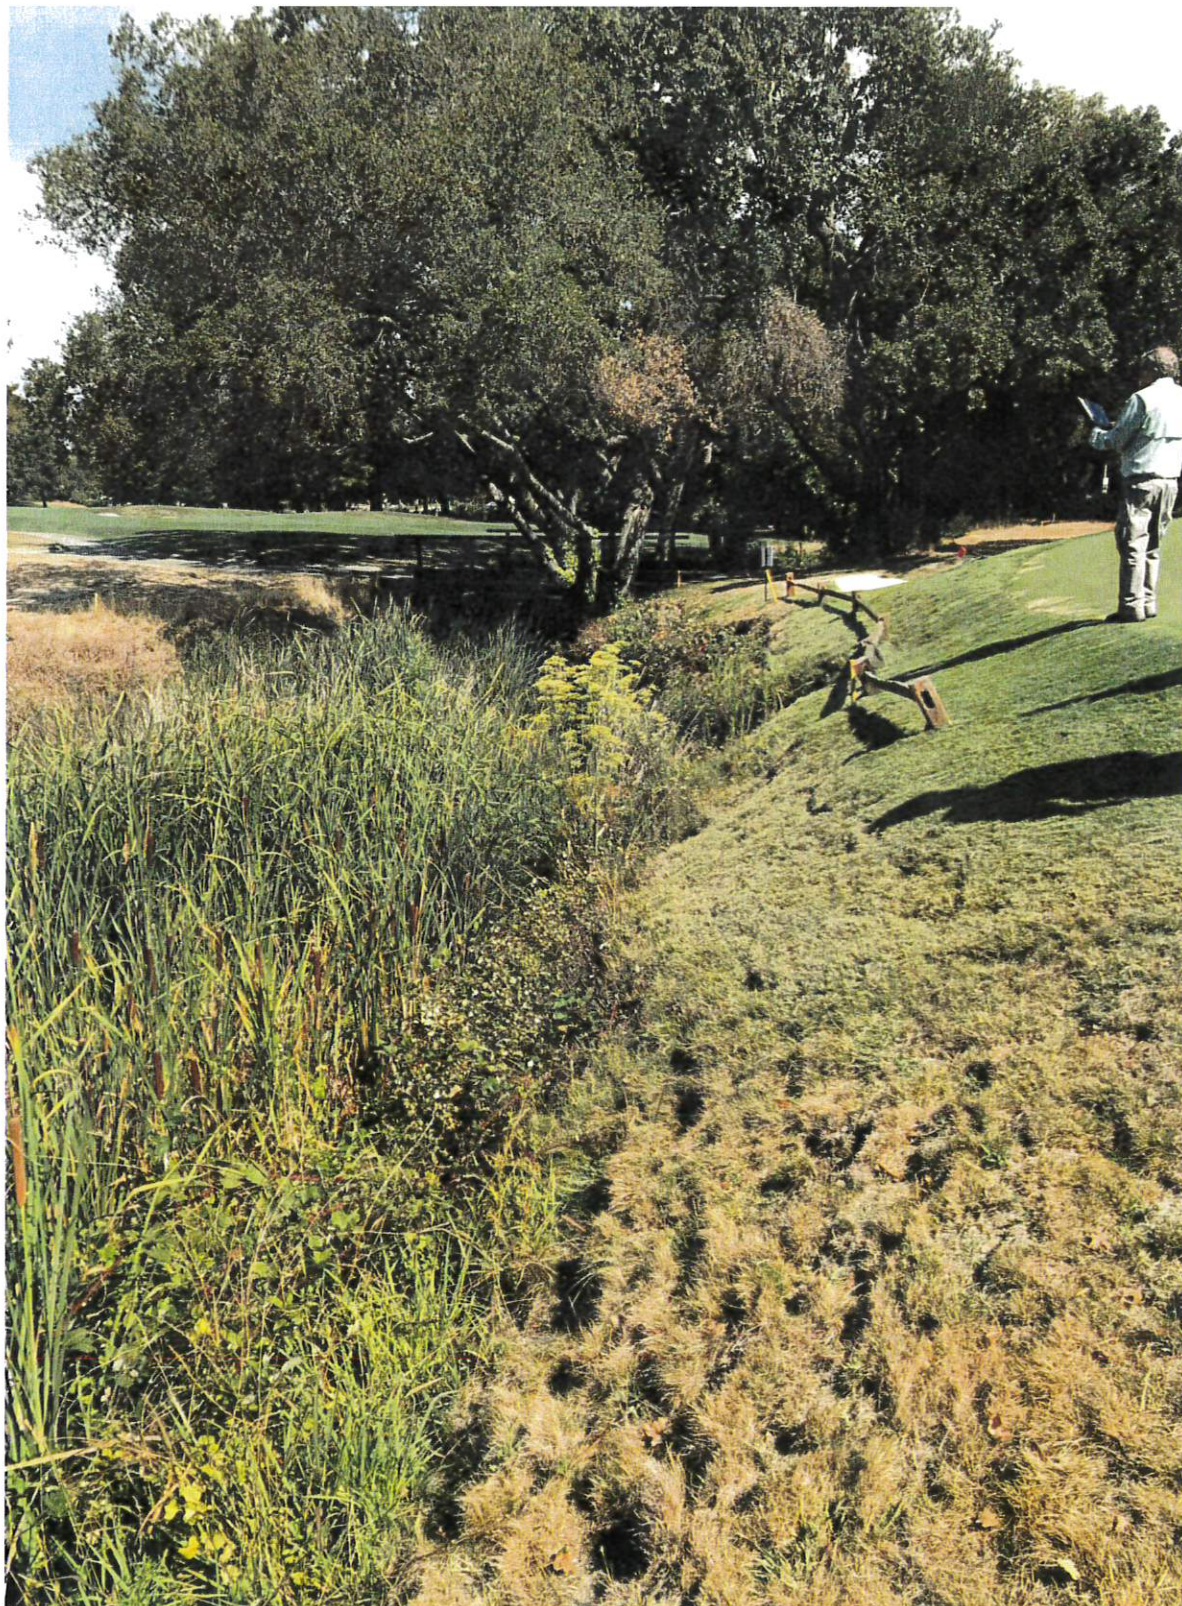
Photo 1. Hole 3, looking north. Cattail-dominated wetlands in Redwood Creek. Note pocked soil in foreground and tilting fence, with bank failure below in upper right (8/27/2018).

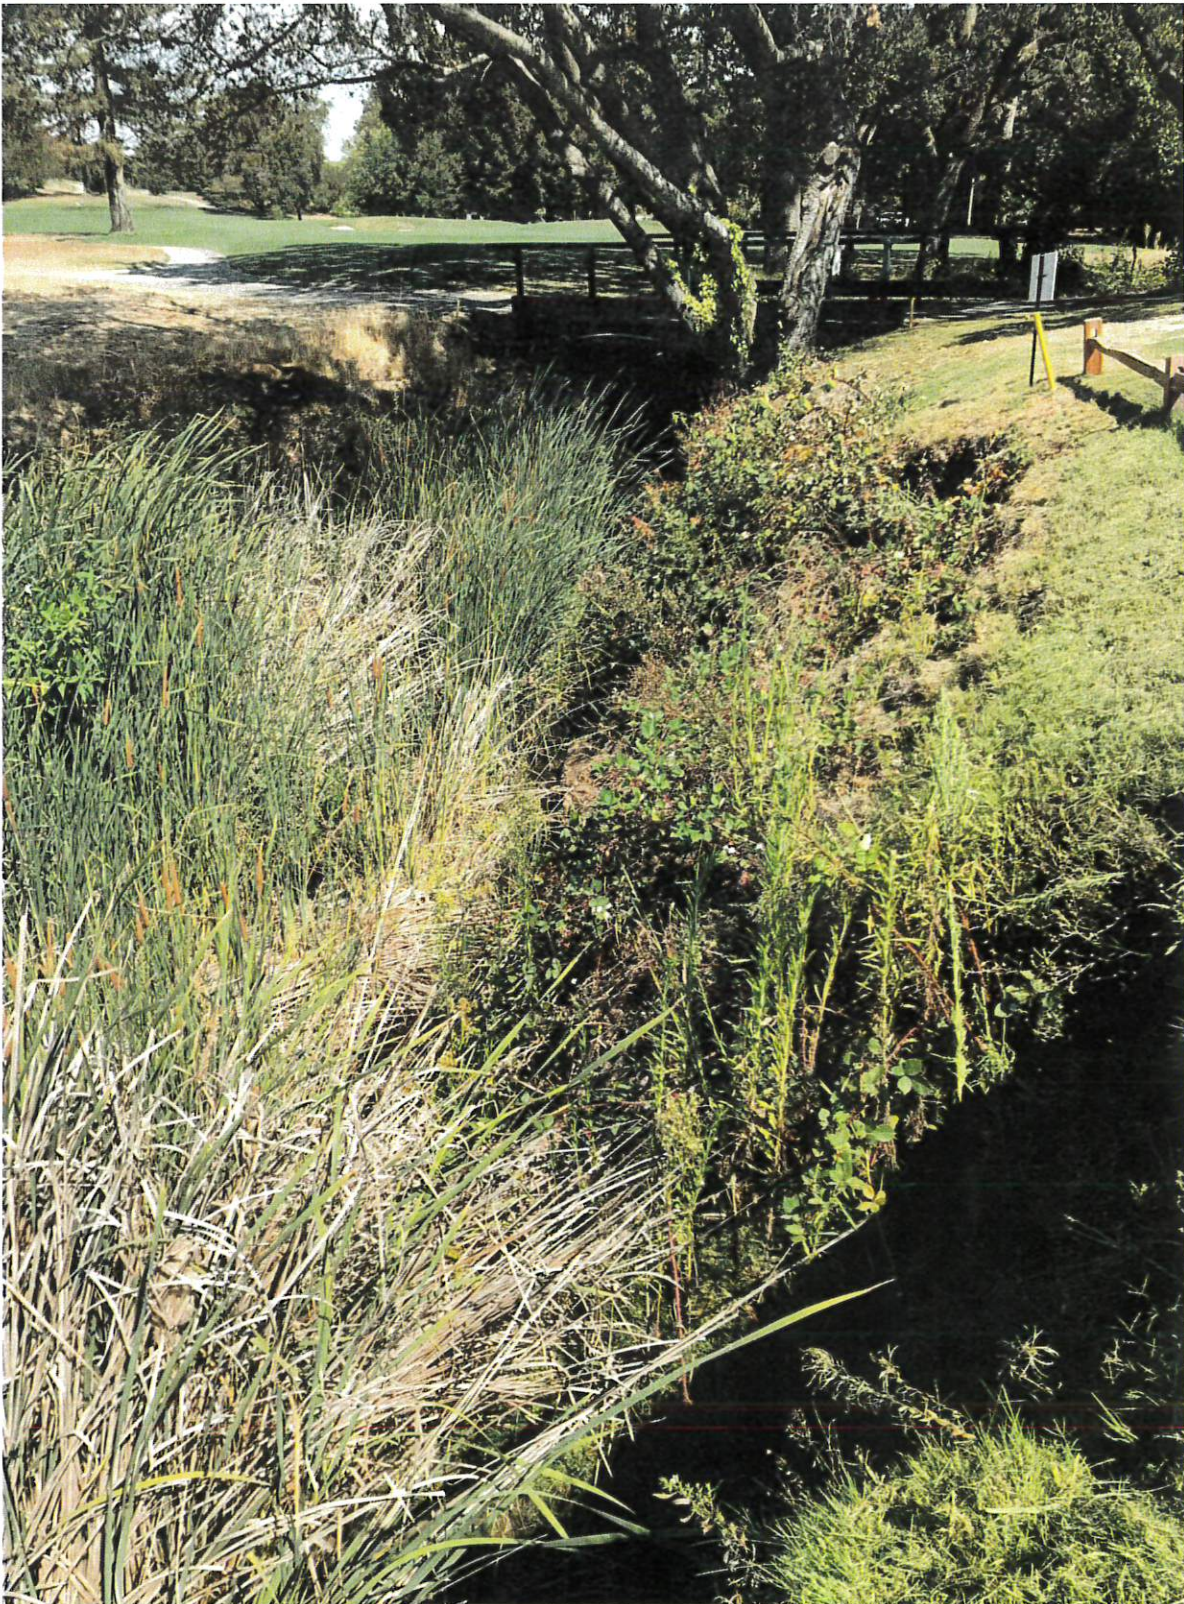
Photo 2. Hole 3 bank failure (8/27/2018), view to the north.

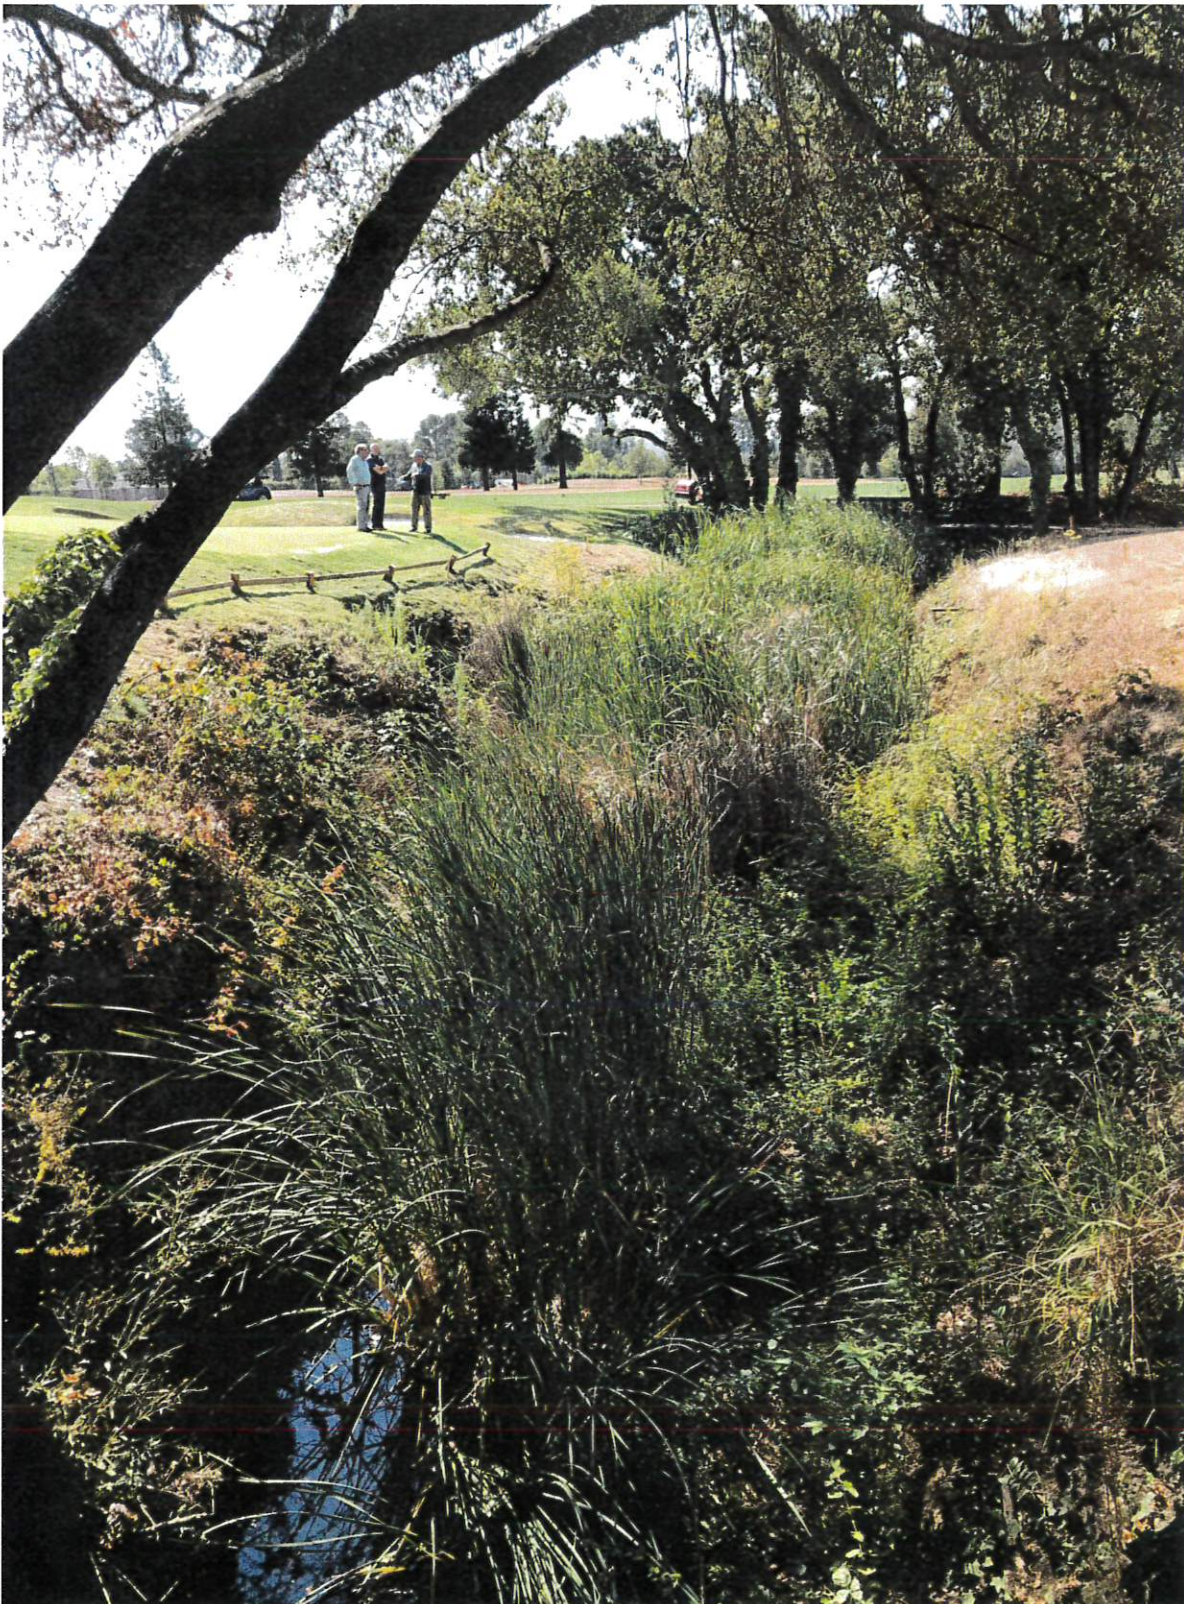
Photo 3. Hole 3, view of Redwood Creek and failing bank looking south (8/27/2018).

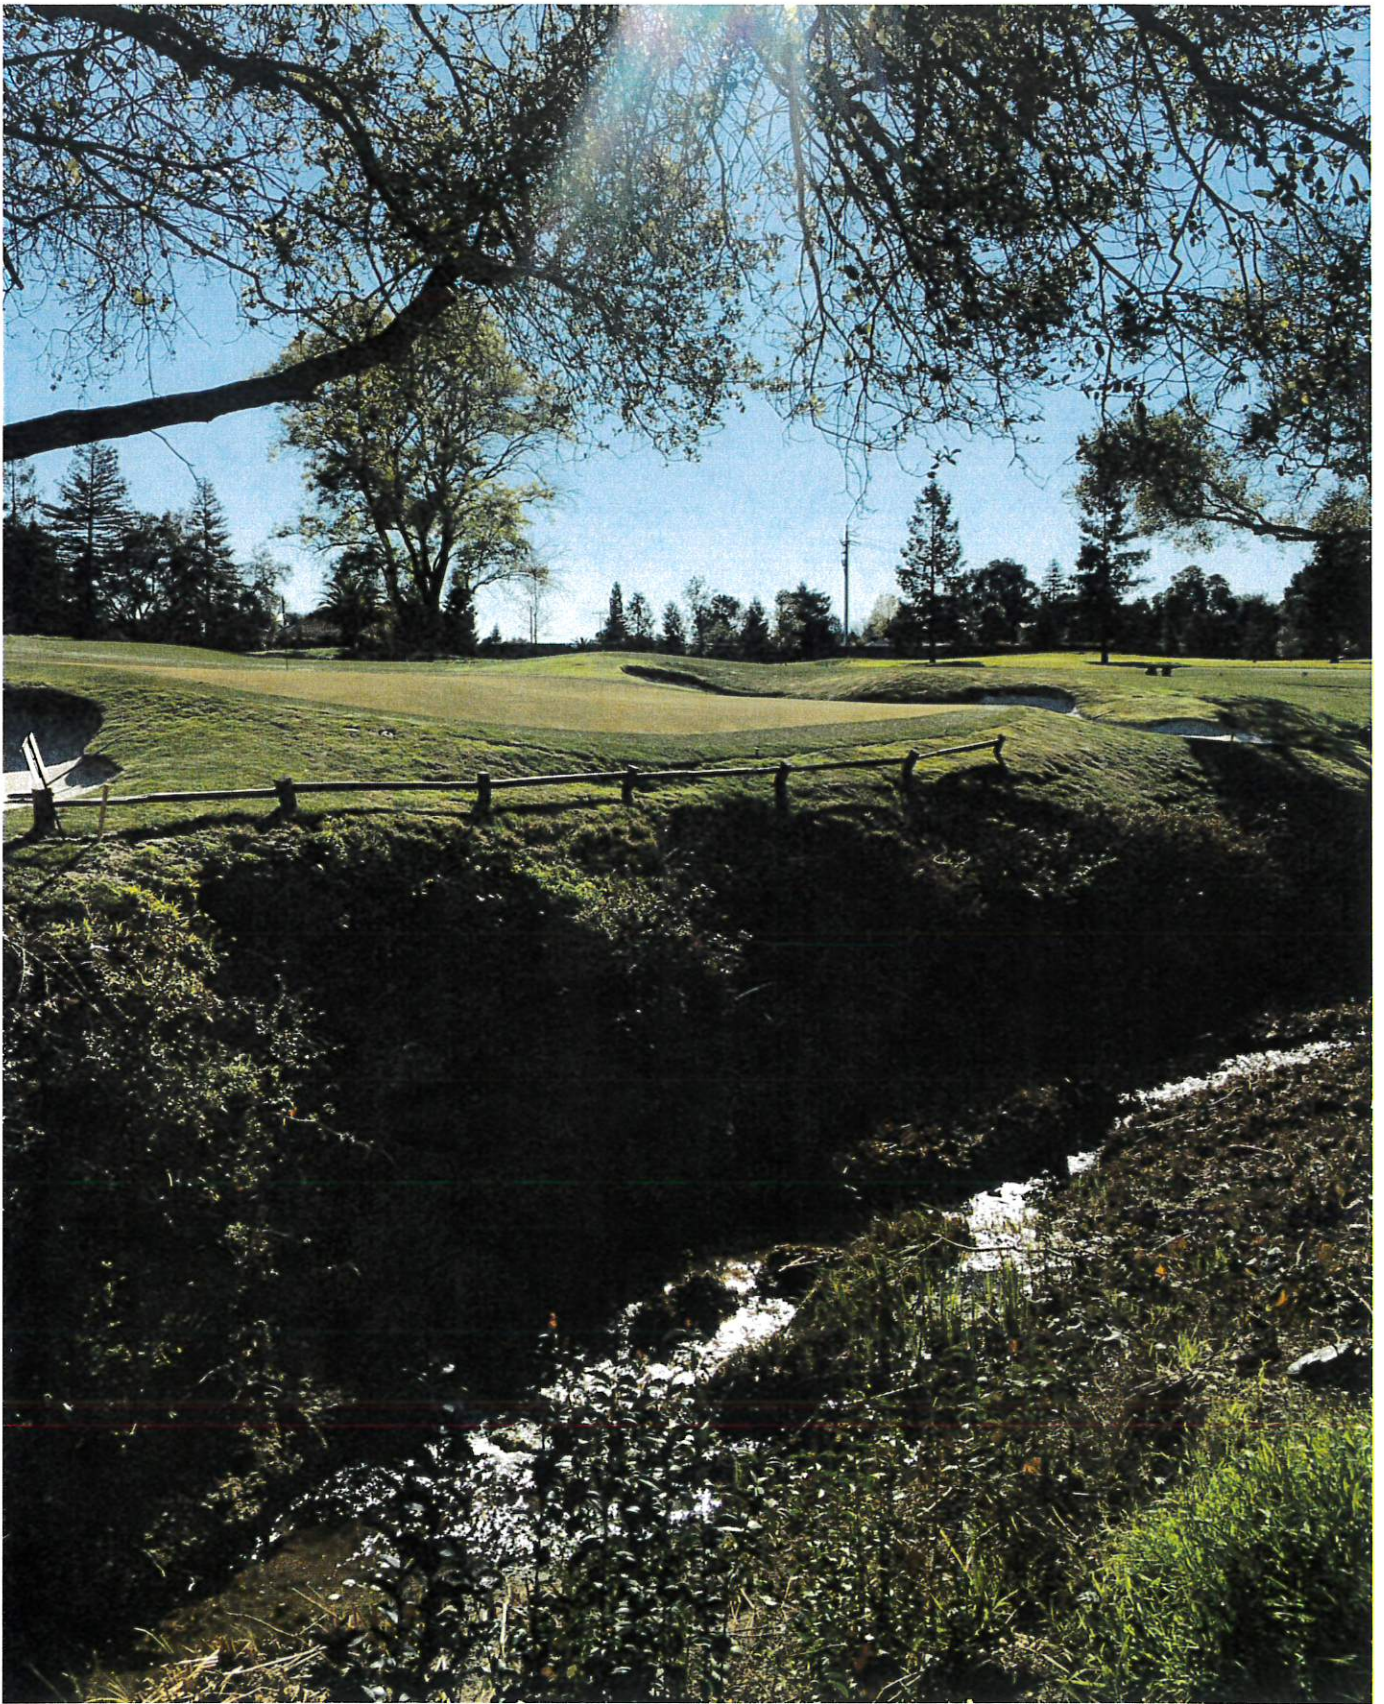
Photo 4. Hole 16 bank erosion is nearing fencing installed to protect golfers (March 2019), view to the southeast.

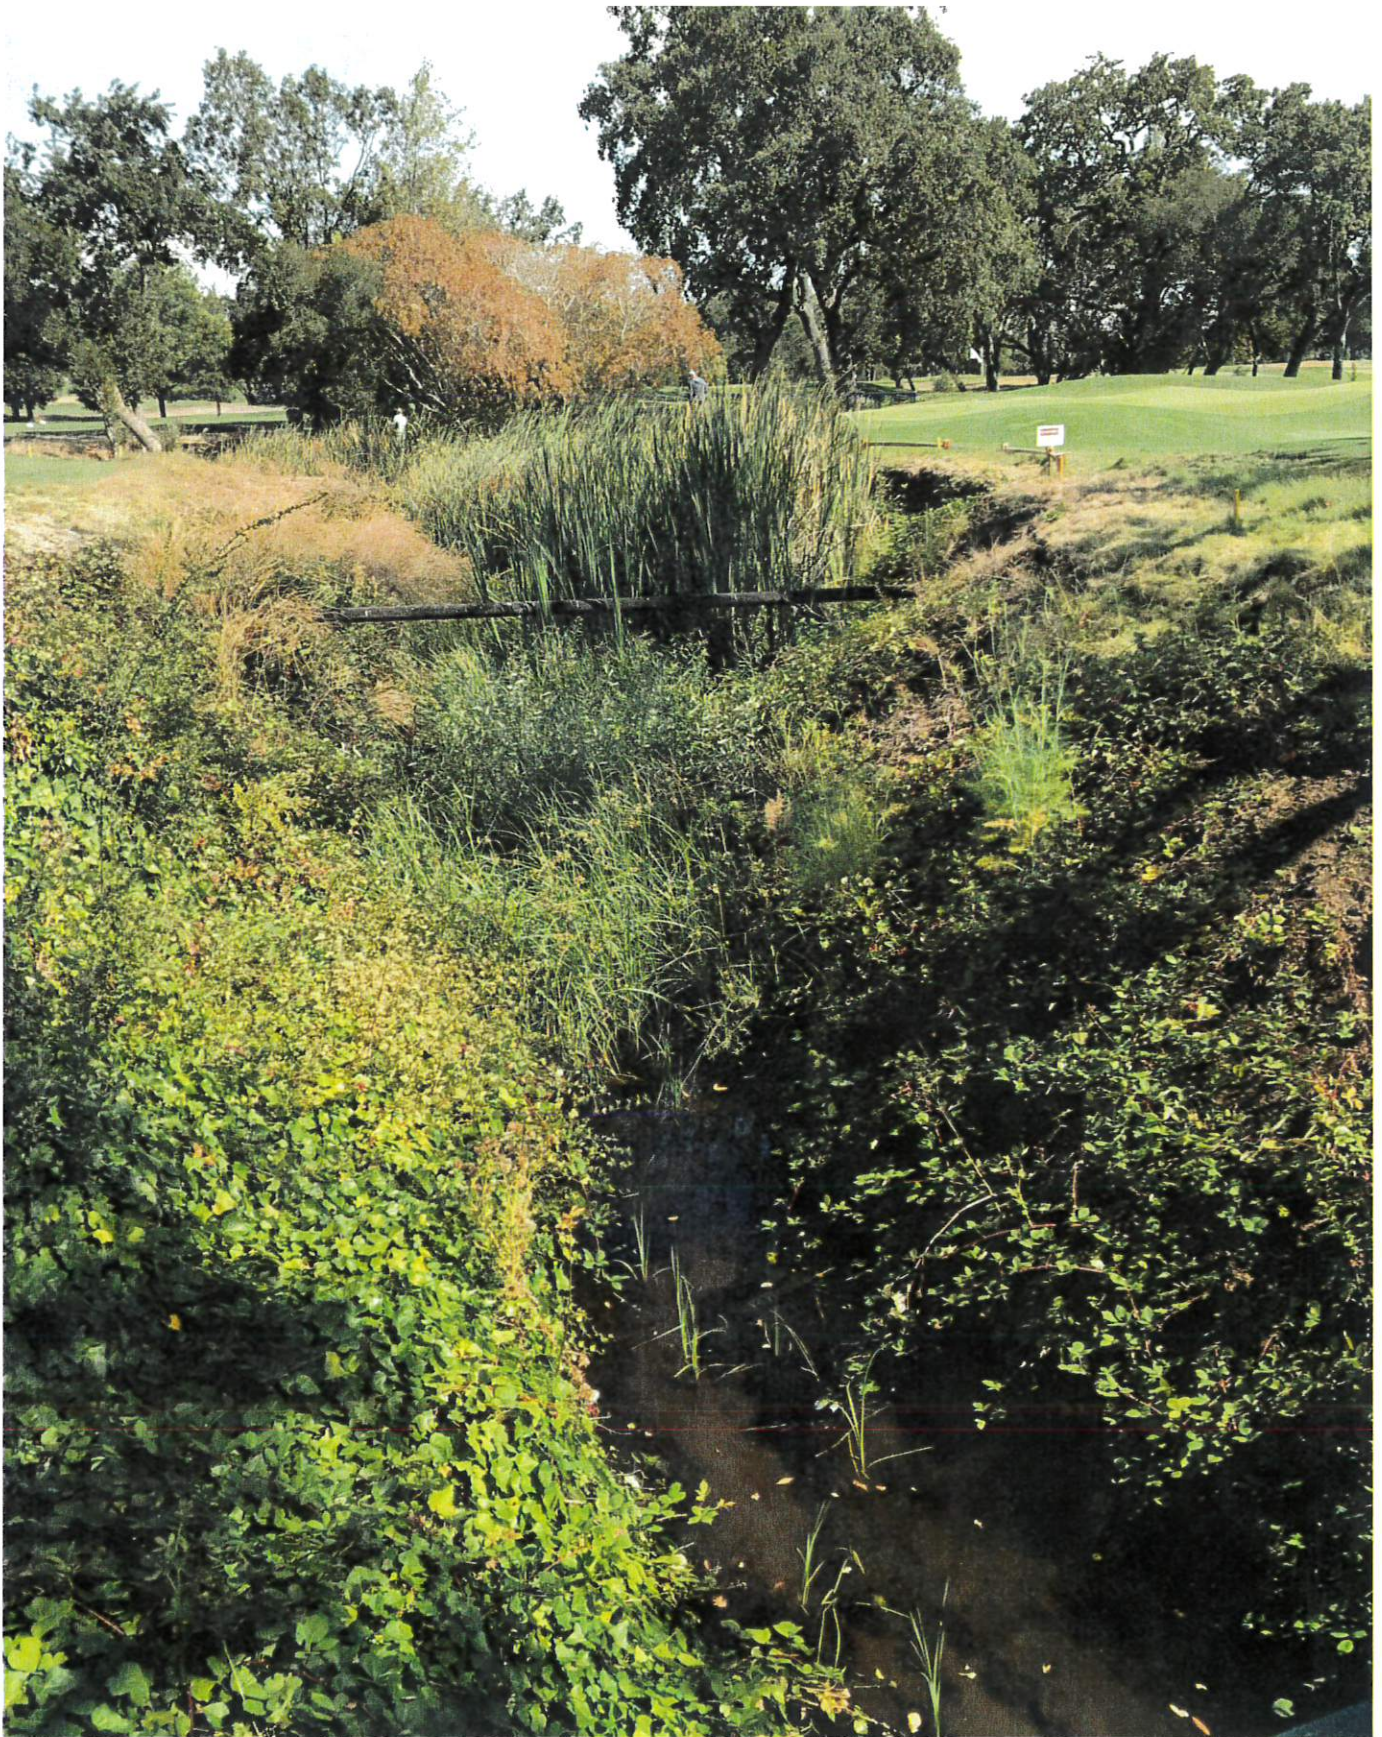
Photo 5. Hole 16. Redwood Creek and eroding bank, looking south (8/27/2018).

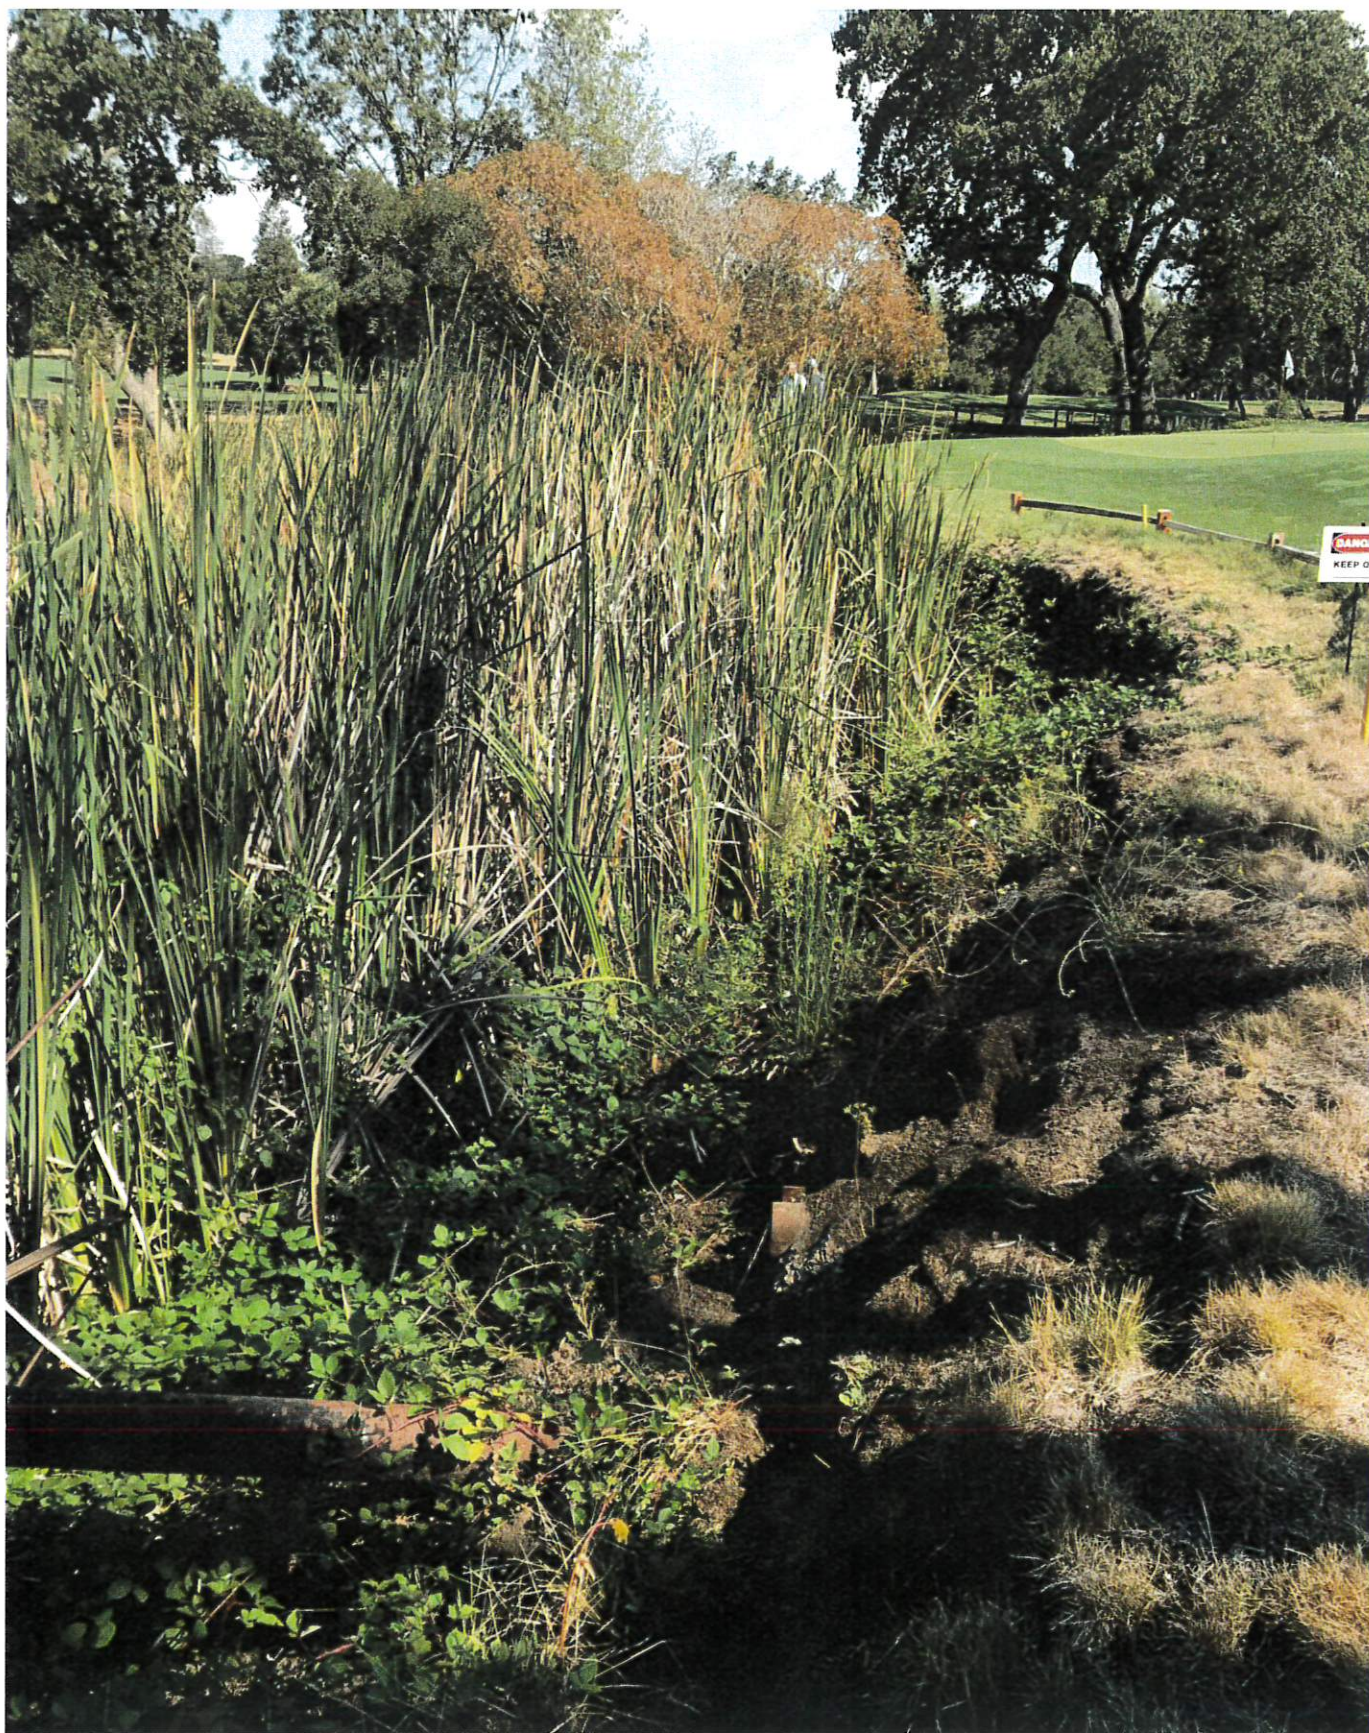
Photo 6. Hole 16, failing east bank, view to the north (8/27/2018).
