OFF-CHANNEL MINING AND RECLAMATION APPLICATION

CACHE CREEK HYDRAULICS STUDY for SHIFLER MINING REACH

CACHE CREEK HYDRAULICS STUDY – SHIFLER REACH

Subject: Shifler Off-Channel Mining and Reclamation Application
Cache Creek Channel Stability Analysis

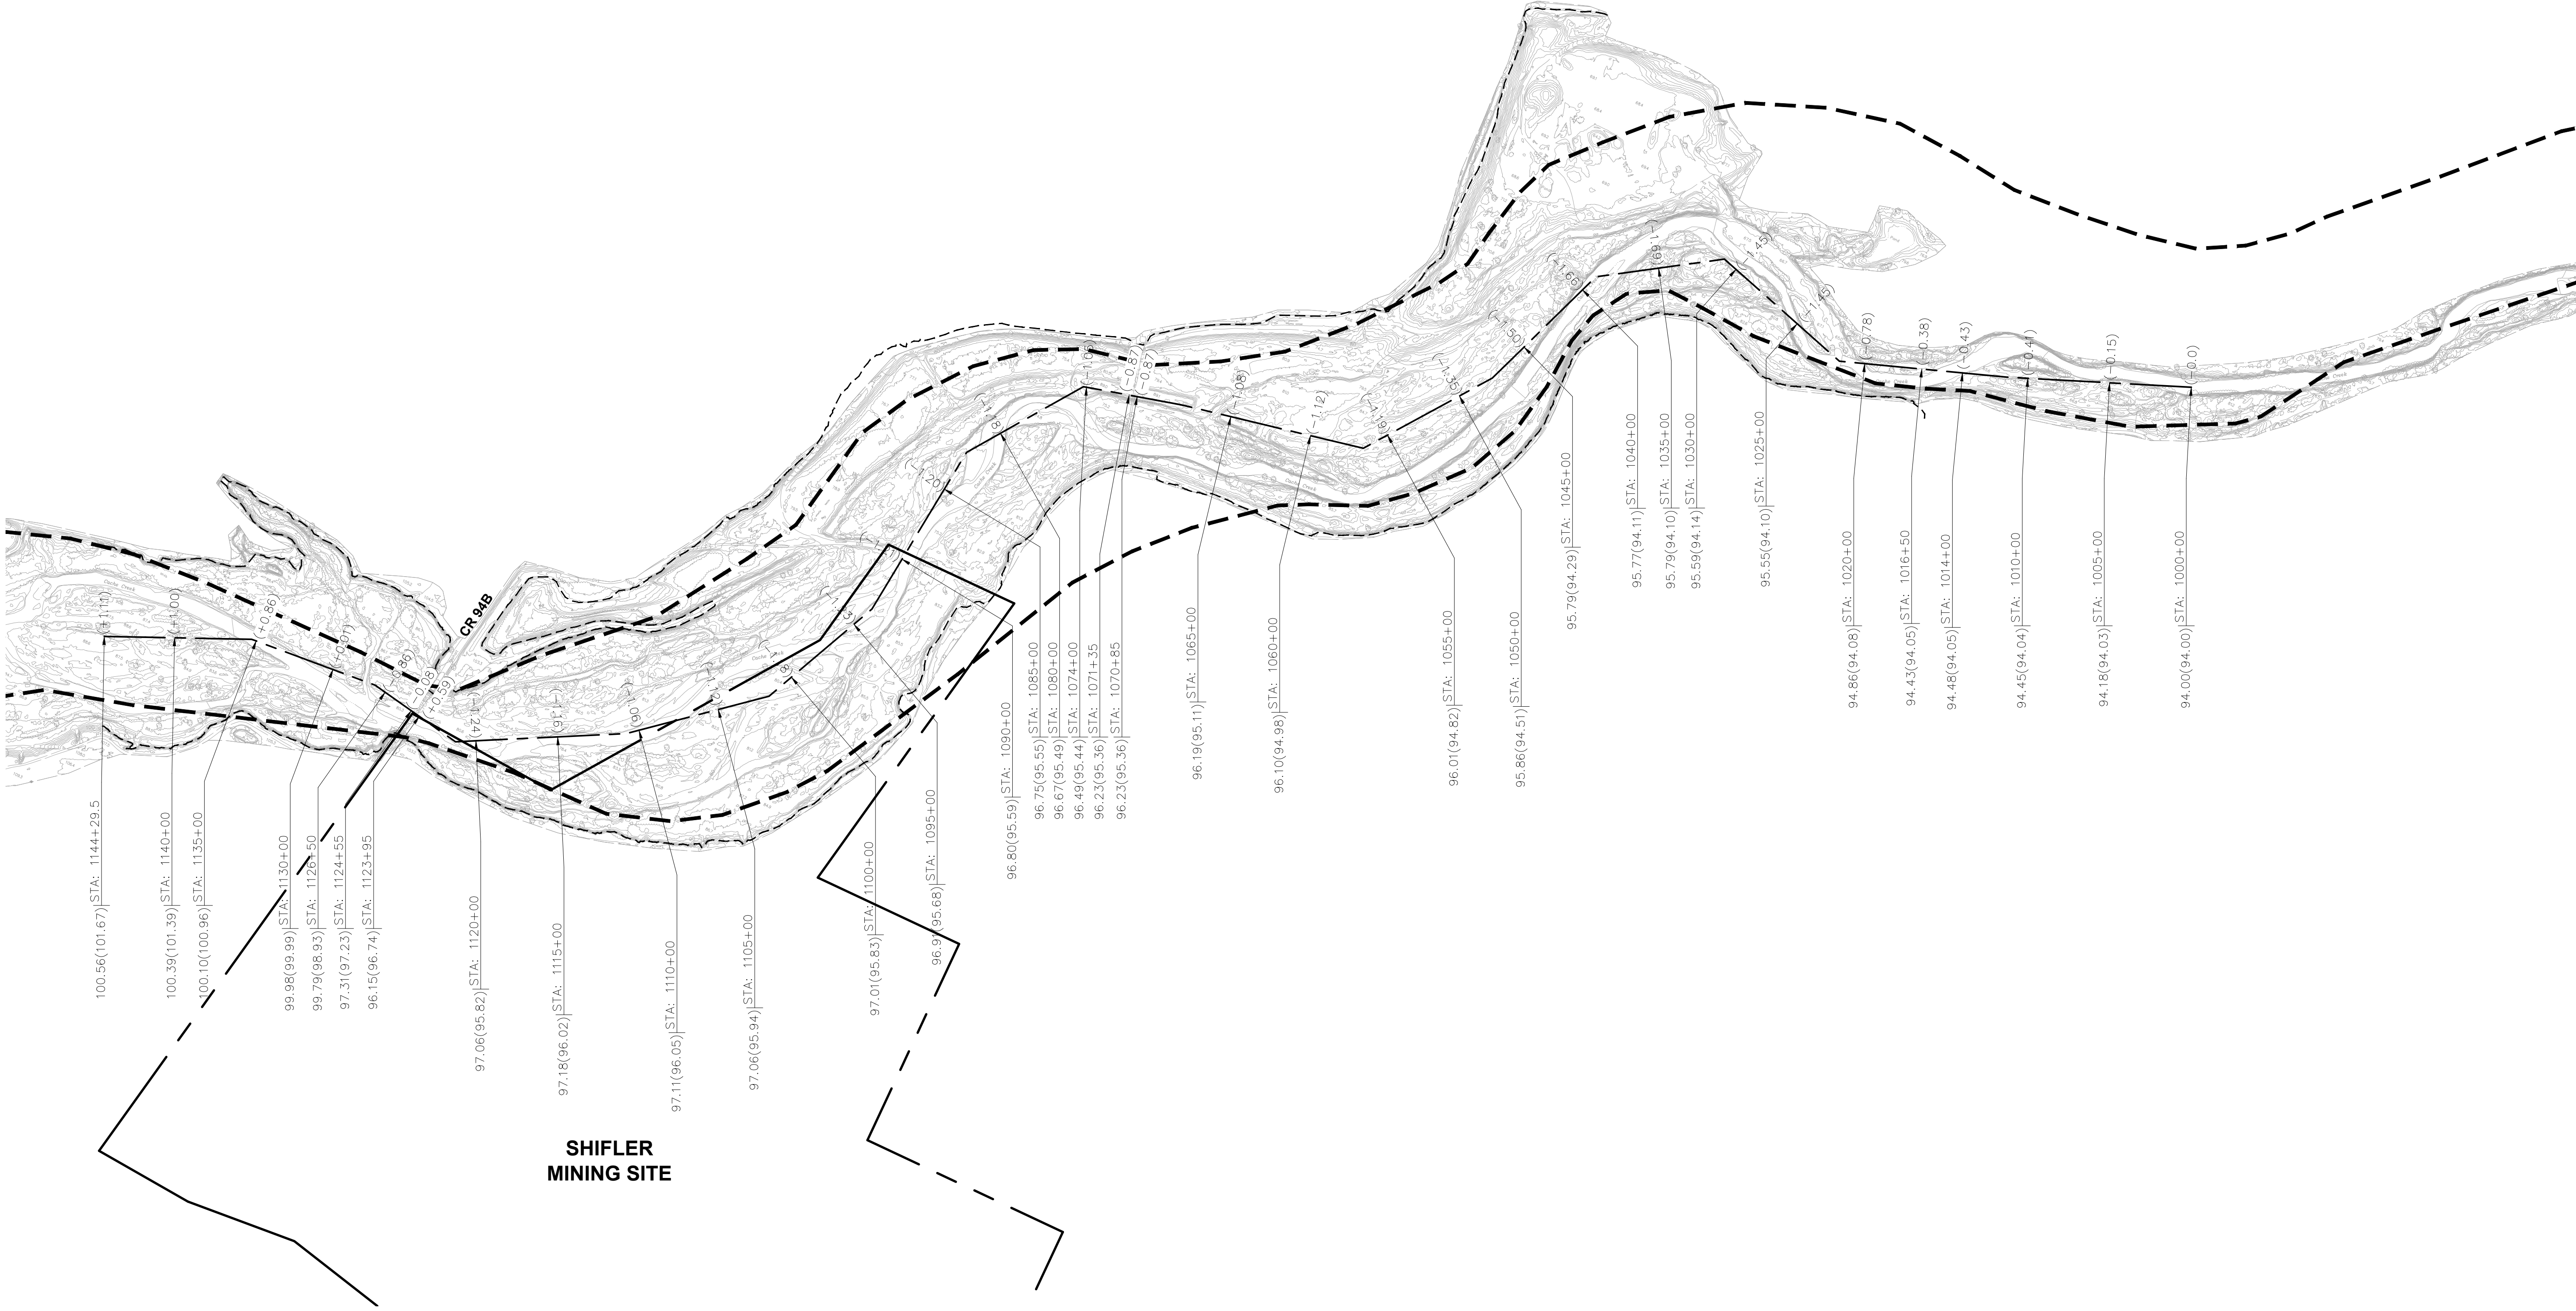
**TEICHERT AGGREGATES
CACHE CREEK HYDRAULICS STUDY
APPROXIMATE 100-YEAR FLOOD ELEVATIONS**

- 100-YR FLOOD ELEVATION DIFFERENCE IN FEET (-1.4')
CREEK STATION
100 YEAR FLOOD ELEVATIONS IN FEET
95.6: 2010 EXISTING GEOMETRY
(94.2): TEST 3 GEOMETRY
100-YR FLOOD EXTENTS (2010 EXISTING GEOMETRY)
CREEK MODEL CENTERLINE
PROPERTY LINE
TEST 3 LINE

- 100-YEAR WATER SURFACE ELEVATIONS CALCULATED USING 100-YEAR FLOW (Q_{100})=61,500 CUBIC FEET PER SECOND BASED ON U.S. ARMY CORPS OF ENGINEERS "LOWER CACHE CREEK, YOLO COUNTY, CA-CITY OF WOODLAND AND VICINITY FLOOD REDUCTION STUDY," MARCH 12, 2001.
- 100-YEAR FLOOD ELEVATIONS ANALYSIS BASED ON APRIL 2010 AERIAL TOPOGRAPHY AND AUGUST 2010 HEC-RAS HYDRAULIC MODEL.

Areas of storage that have no conveyance are represented on the cross-section plots as "ineffective flow areas" and the tops of banks are graphically represented on the cross section plots as "bank stations". The streamwise locations of the cross-sections are shown on the fold-out drawing (Sheet 1 of 1) in Appendix D, attached.

Appendix D – Fold-out drawing: Approximate 100-year Water Surface Elevations
