## Teichert Shifler Project

## Determination of Waters of the U.S.

December 5, 2019

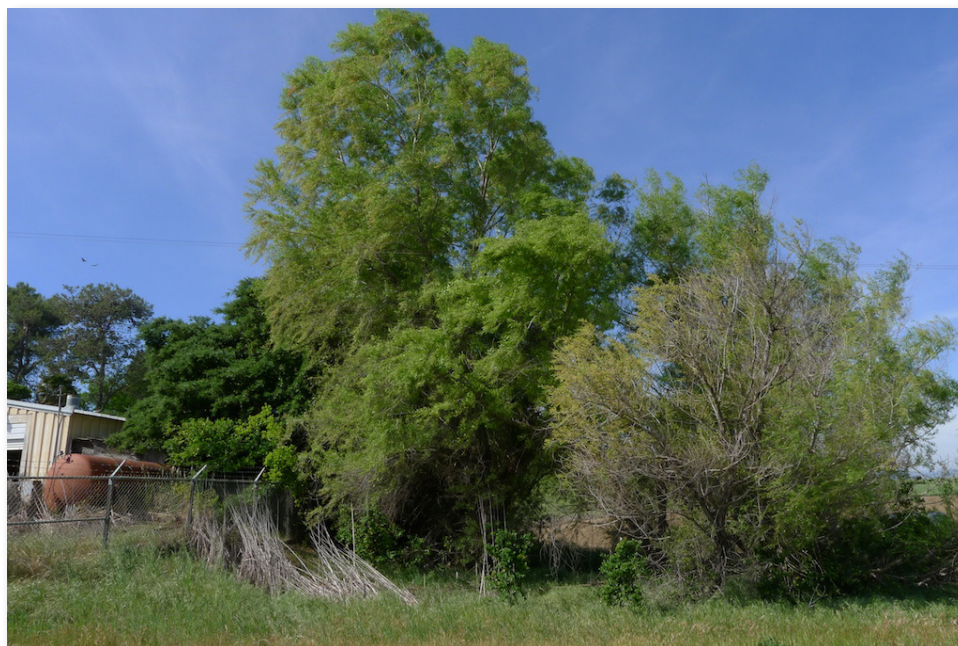
The setting of this area is shown in Photo 1 (Appendix A). Photo 2, Water leaks abundantly from irrigation works immediately outside the southern site boundary (Photo 2), supporting lush cattails (*Typha angustifolia*) on top of the hillside (Photo 3), then flowing under the fence and into the study site (Photo 4). This is the irrigation supply for the cemetery (marked on the USGS map as Monument Hill), so it is understandable that it would run frequently at all times that the turf would be under water stress. Though frequent, this irrigation leakage is intermittent; it (and the surface water downslope, within the site) is absent for long periods, during which the wetland vegetation it supports dries out and dies, and is replaced by an upland understory (DP-5). When the irrigation system is turned on, however, the flow is substantial (Photo 5) and attains the toe of the slope (Photo 6), where it infiltrates in the moderately permeable Yolo loam soils. In order to keep the farm perimeter road dry, a ditch is usually excavated at the toe of the slope (DP-4), which terminates in both directions, not far from the point where the irrigation leakage arrives at the toe of the slope. Observation of soils within a few feet of the surface water that was present on July 12, 2019 showed that no redoximorphic features or other hydric soils indicators were present on that date (Photo 4). Even under the ponded water, color difference between matrix and redox depletions was only between 2.5YR 3/2 and 2.5YR 3/1 (Photo 7; contrast is defined as "faint", insufficient to constitute a hydric soils indicator). Soils under the willows on the hillslope (DP-5) also lacked hydric field indicators. In both the herbaceous and the woody shrub layer, decidedly upland species (e.g., interior live oak, *Quercus wislizenii*) are mixed in with a FACW willow (*Salix gooddingii*), and no indicators of wetland hydrology are present either.

Photo 1. Setting of DP-2 through DP-5 at southern site boundary. Fence is at boundary; shed and tank are off site. Willow area is represented by DP-5; points DP-2 through -4 are behind vegetation at right edge of photo. Tall dead gray stems in center left foreground are *Typha* surrounded by live upland grasses (*Avena* and *Bromus diandrus*), which cannot survive prolonged saturation. Leakage discharge obviously used to go there, but now flows further behind (as seen from this viewpoint).

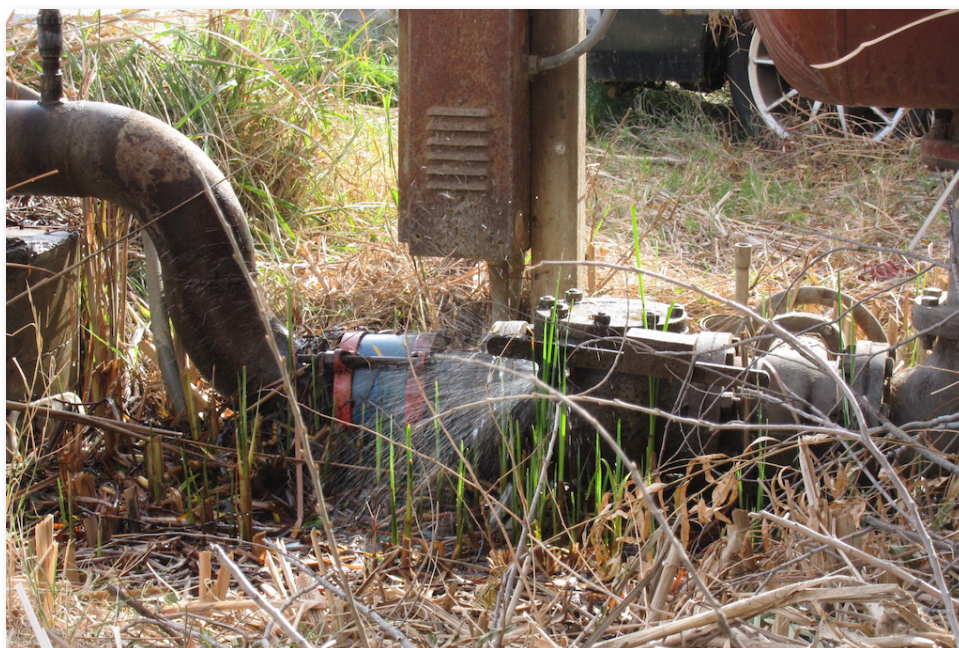
Photo 2. View through boundary fence to leaking irrigation works 10-20 feet away. Water spray is clearly visible. Corner of the tank in upper right corner of photo is the same tank that is seen behind the fence in Photo 1.

This combination of circumstances supports a conclusion that the hydrophytic species and intermittently inundated or moist soils are supported only and entirely by the non-normal circumstance of intermittent abundant leakage from off-site irrigation facilities.

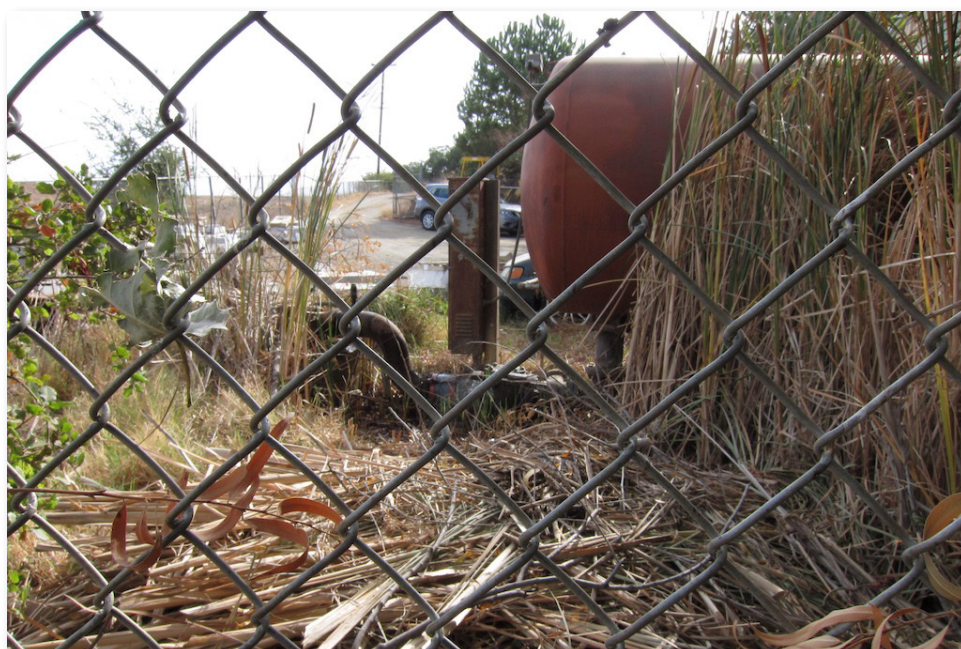
Photo 3. Abundant *Typha* off site, at top of hillside, supported by leakage from irrigation.

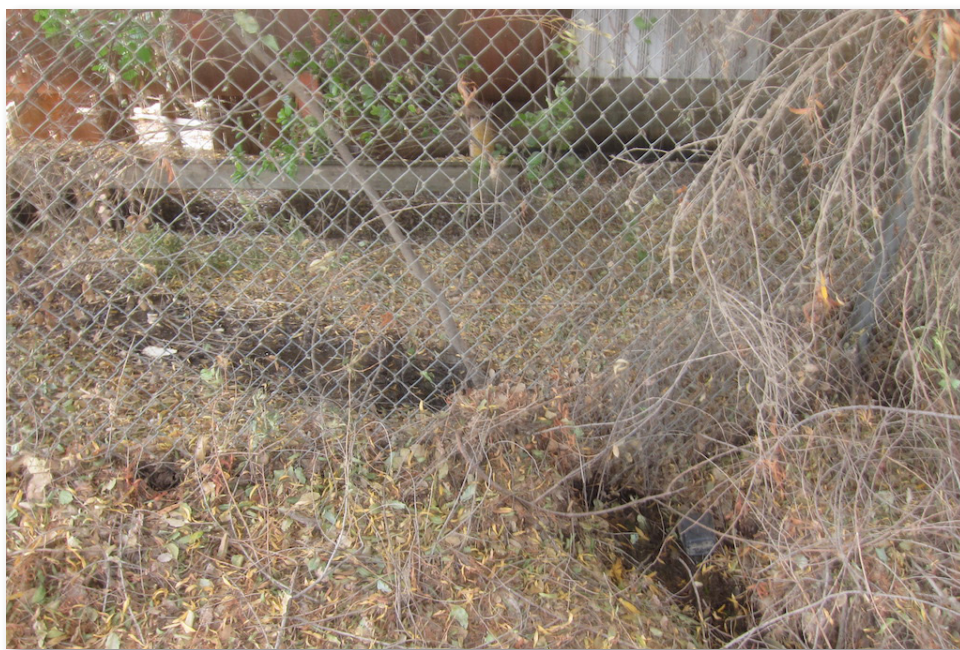
Photo 4. Leakage flow entering site under property boundary fence.

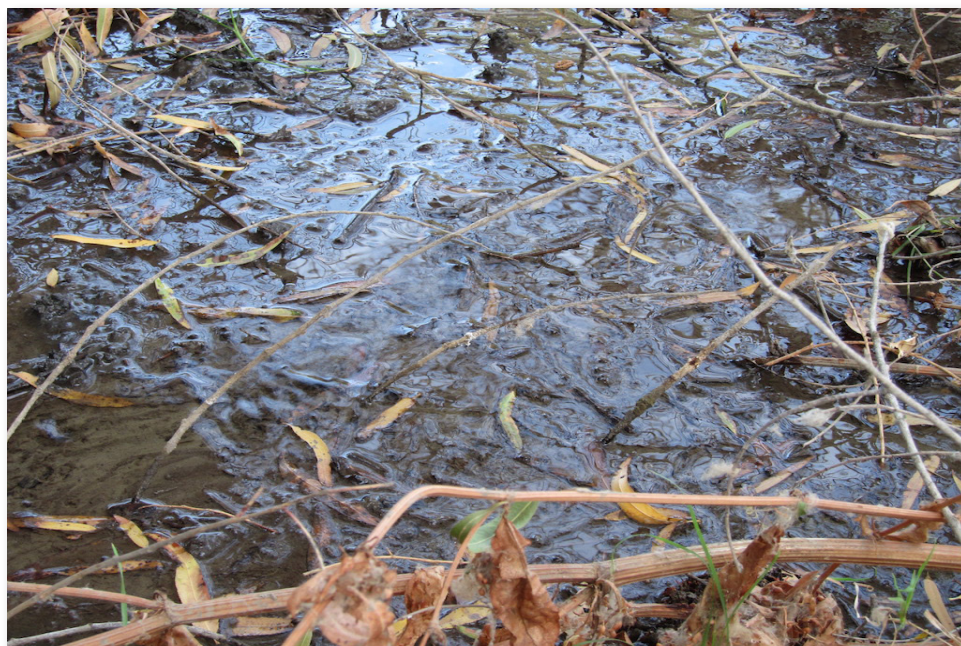
Photo 5. Ripples in flow down hillslope demonstrates that it's not just a small amount of seepage, instead, it's a substantial continuous flow whenever the off-site irrigation system is turned on.

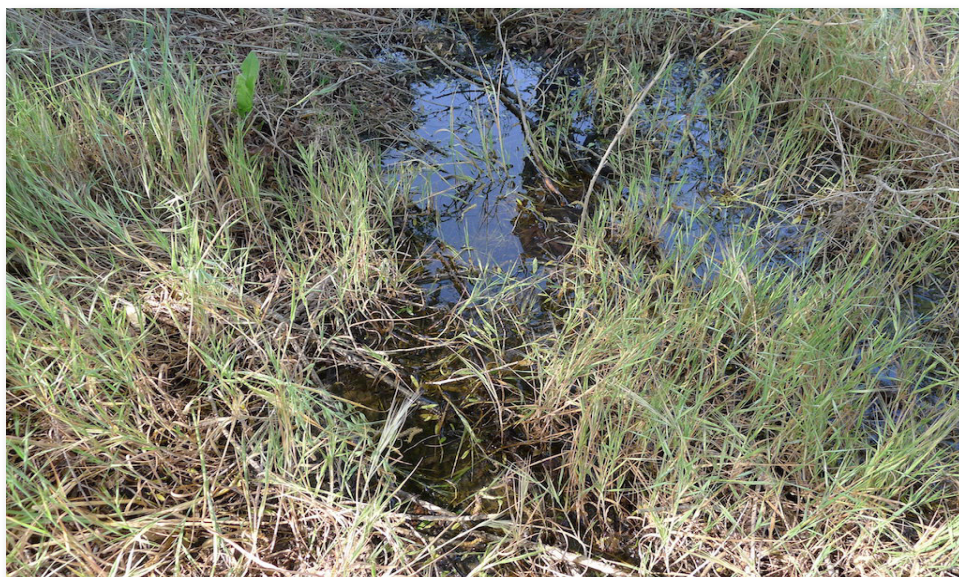
Photo 6. Leakage flow ponded at the toe of slope, on April 24, 2018. Grass is *Cynodon dactylon* (FACU). If surface water such as this had been present throughout the winter, vegetation would be dominated by FAC or wetter species. Instead, this is fresh leakage flow, with the irrigation system just having been activated as the weather warms up. DP-2 is located within a few feet of the standing water visible here.

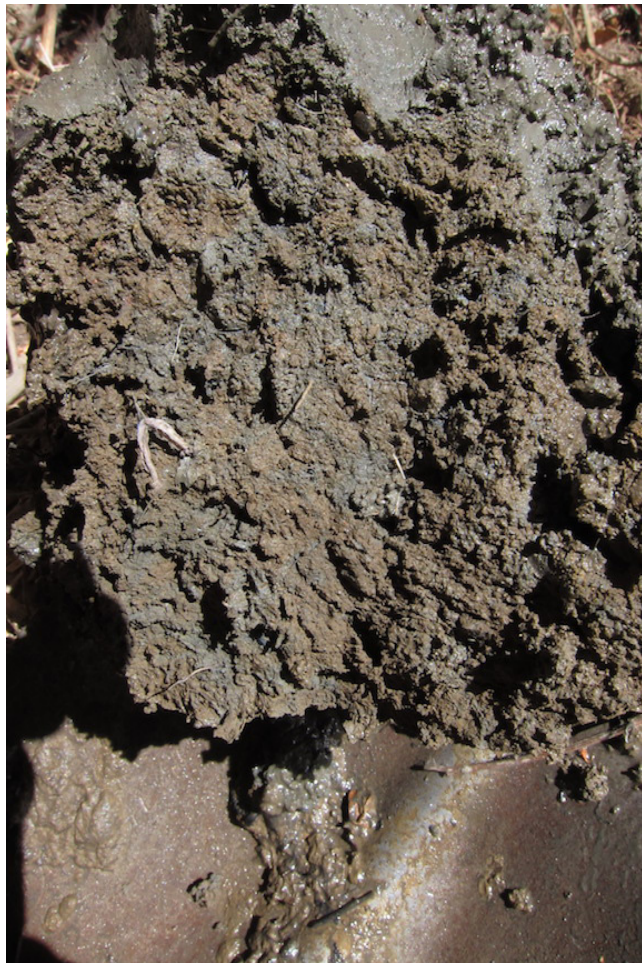
Photo 7. Saturated ped from soils under standing water near DP-2, showing faint redox contrast (2.5YR 3/2 vs. 3/1). Soil was drier below about 10" than it was at the surface. Both of these circumstances are consistent with the saturation having been present only for a short period of time. As indicated by previous photos, this hydrology is not a normal circumstance.

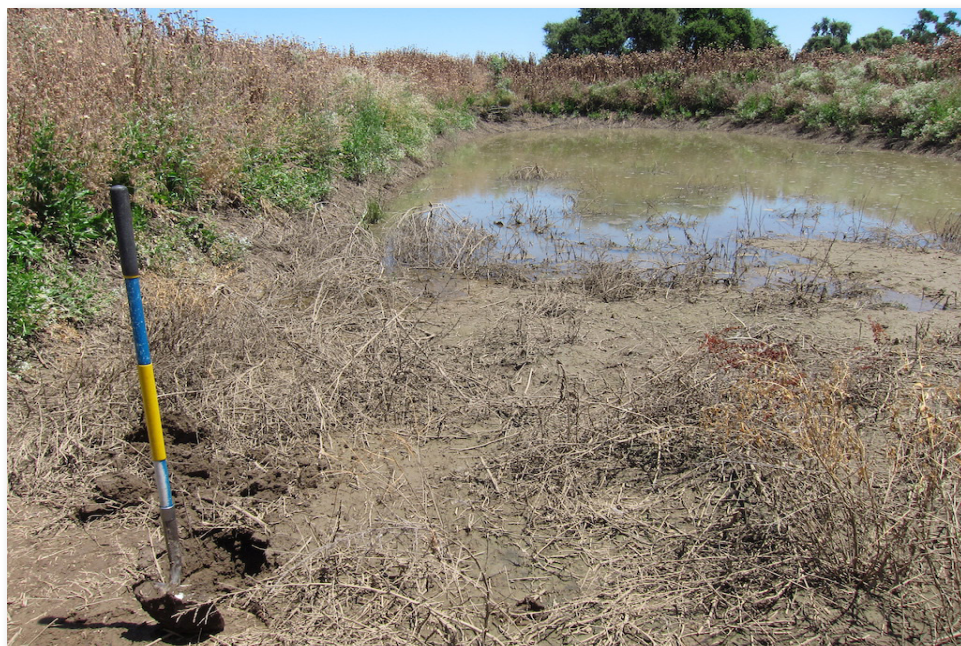
Two excavated basins are present in the northern part of the site (Photos 9, 10). These receive irrigation tailwater collected in row-end ditches and perhaps also rain runoff, although the permeability of Yolo loam is 4.5623 micrometers/second (0.647 inches/hour; NRCS, 2019), which means that only intense rainfall is likely to produce any runoff at all, and even under this circumstance, it would infiltrate into the basin floor within a short period of time. Even during the exceptional water year from October 1, 2018, to September 30, 2019, rainfall for an entire 24-hour period only exceeded two inches on five occasions. In many visits, I have never seen water or seemingly saturated soil in either basins except during active irrigation. Presence of sediment on plant debris at DP-8 (not within a basin) certainly indicates that depressions do fill with water at times, but not for long (as indicated by absence of hydric soils indicators). In July, living vegetation extending right to the basin floor at DP-1 was strongly dominated by UPL species (in other words, there was no OHWM above the basin floor indicated by physical markers or change in vegetation).

Photo 9. Setting of DP-1, in infiltration basin that had recently partially filled from irrigation tailwater (July). Inflow is behind photographer; there is no outflow other than infiltration into the basin floor. Though the soil surface is only a few inches above the water level, no water table or saturation was encountered in the test pit to its maximum depth of 20 inches. This feature is constructed on dry land and its hydrology (standing water) is artificial (derived from pumped and diverted irrigation flow). I have visited this feature multiple times in winter months and it is never ponded or even moist at those times, because there's no irrigation flow.

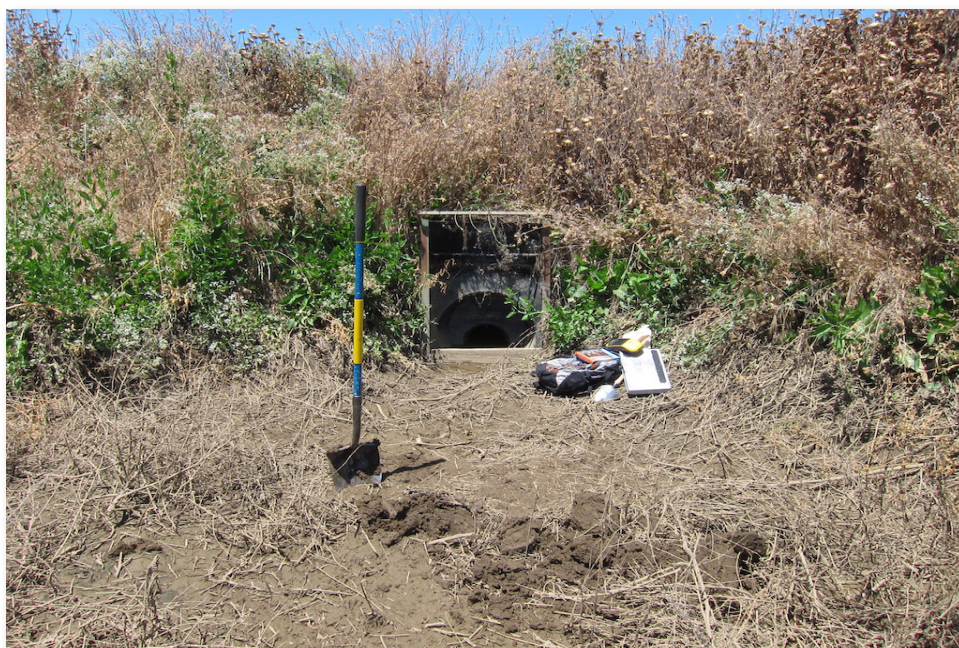
Photo 10. Inflow to infiltration basin. Shovel is in the same location as in Photo 9. Vegetation on berm includes *Lepidium latifolium* (FAC) but is dominated by UPL species.

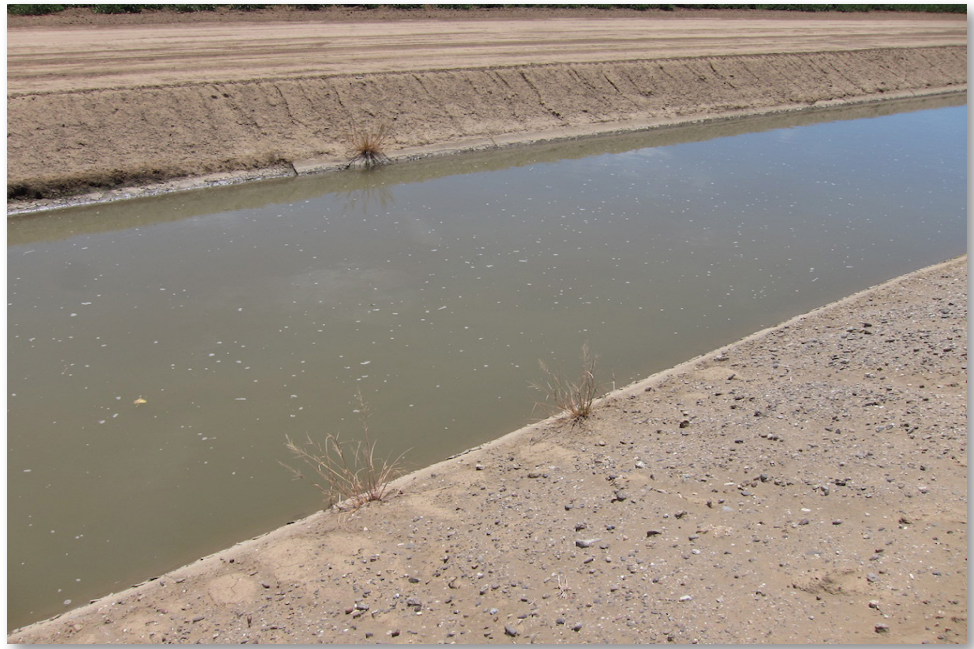
Photo 11. Moore Canal (feature IC-1), near the cross section OHWM-2. Canal is quite uniform throughout its length within the site: sideslopes are 1.5:1 to 2:1, and the canal is concrete lined nearly up to the maximum flow level. A slightly incised OHWM can be discerned in the soil just above the concrete, and, as seen in the photo, occasional plants of *Leptochloa* (*Diplachne*) *fusca* var. *uninervia* (Mexican sprangletop, FACW) grow exactly at that point, but not higher. Canal is flowing almost to maximum capacity, which is consistent with presence of irrigation tailwater in the basin shown in Photos 9-10 (taken on the same date).

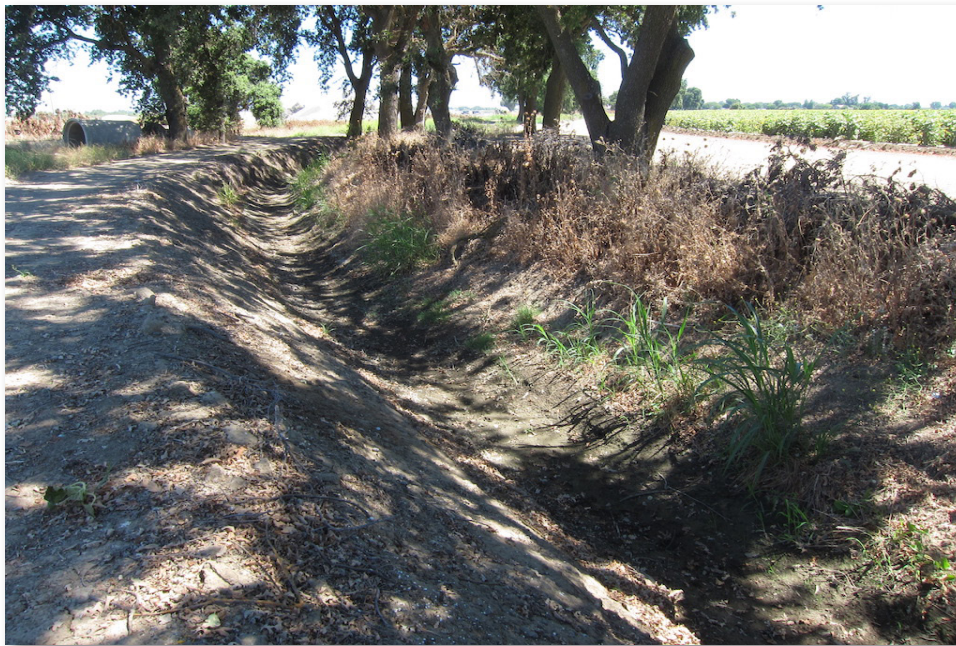
Photo 12. Magnolia Canal. Like Moore Canal, there is no floodplain or even a low terrace; flow is confined to the excavated channel under all possible conditions. This much smaller irrigation canal is unlined and supports FACU and UPL vegetation on its banks (*Quercus lobata*, *Brassica*, *Bromus diandrus*, *Carduus pycnocephala*, *Cynodon*, *Silybum*, *Sorghum*).

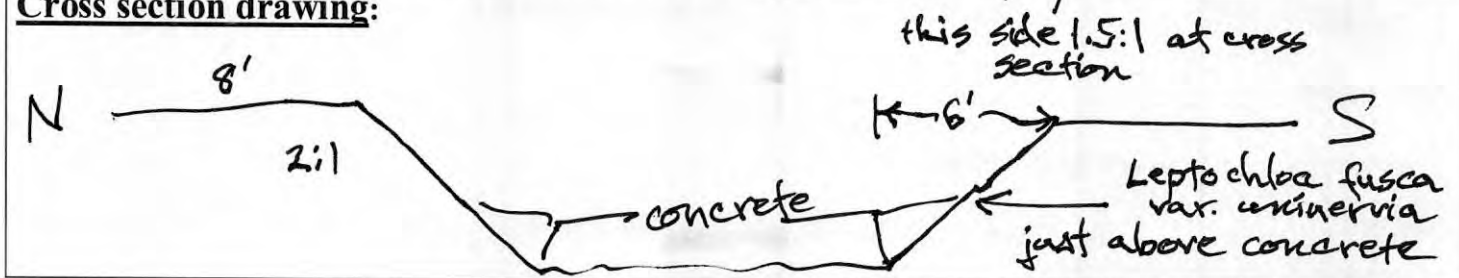
Cross section drawing:

Project ID: Teichert Shifler Cross section ID: OHWM-2 Date: 7/12/19 Time:

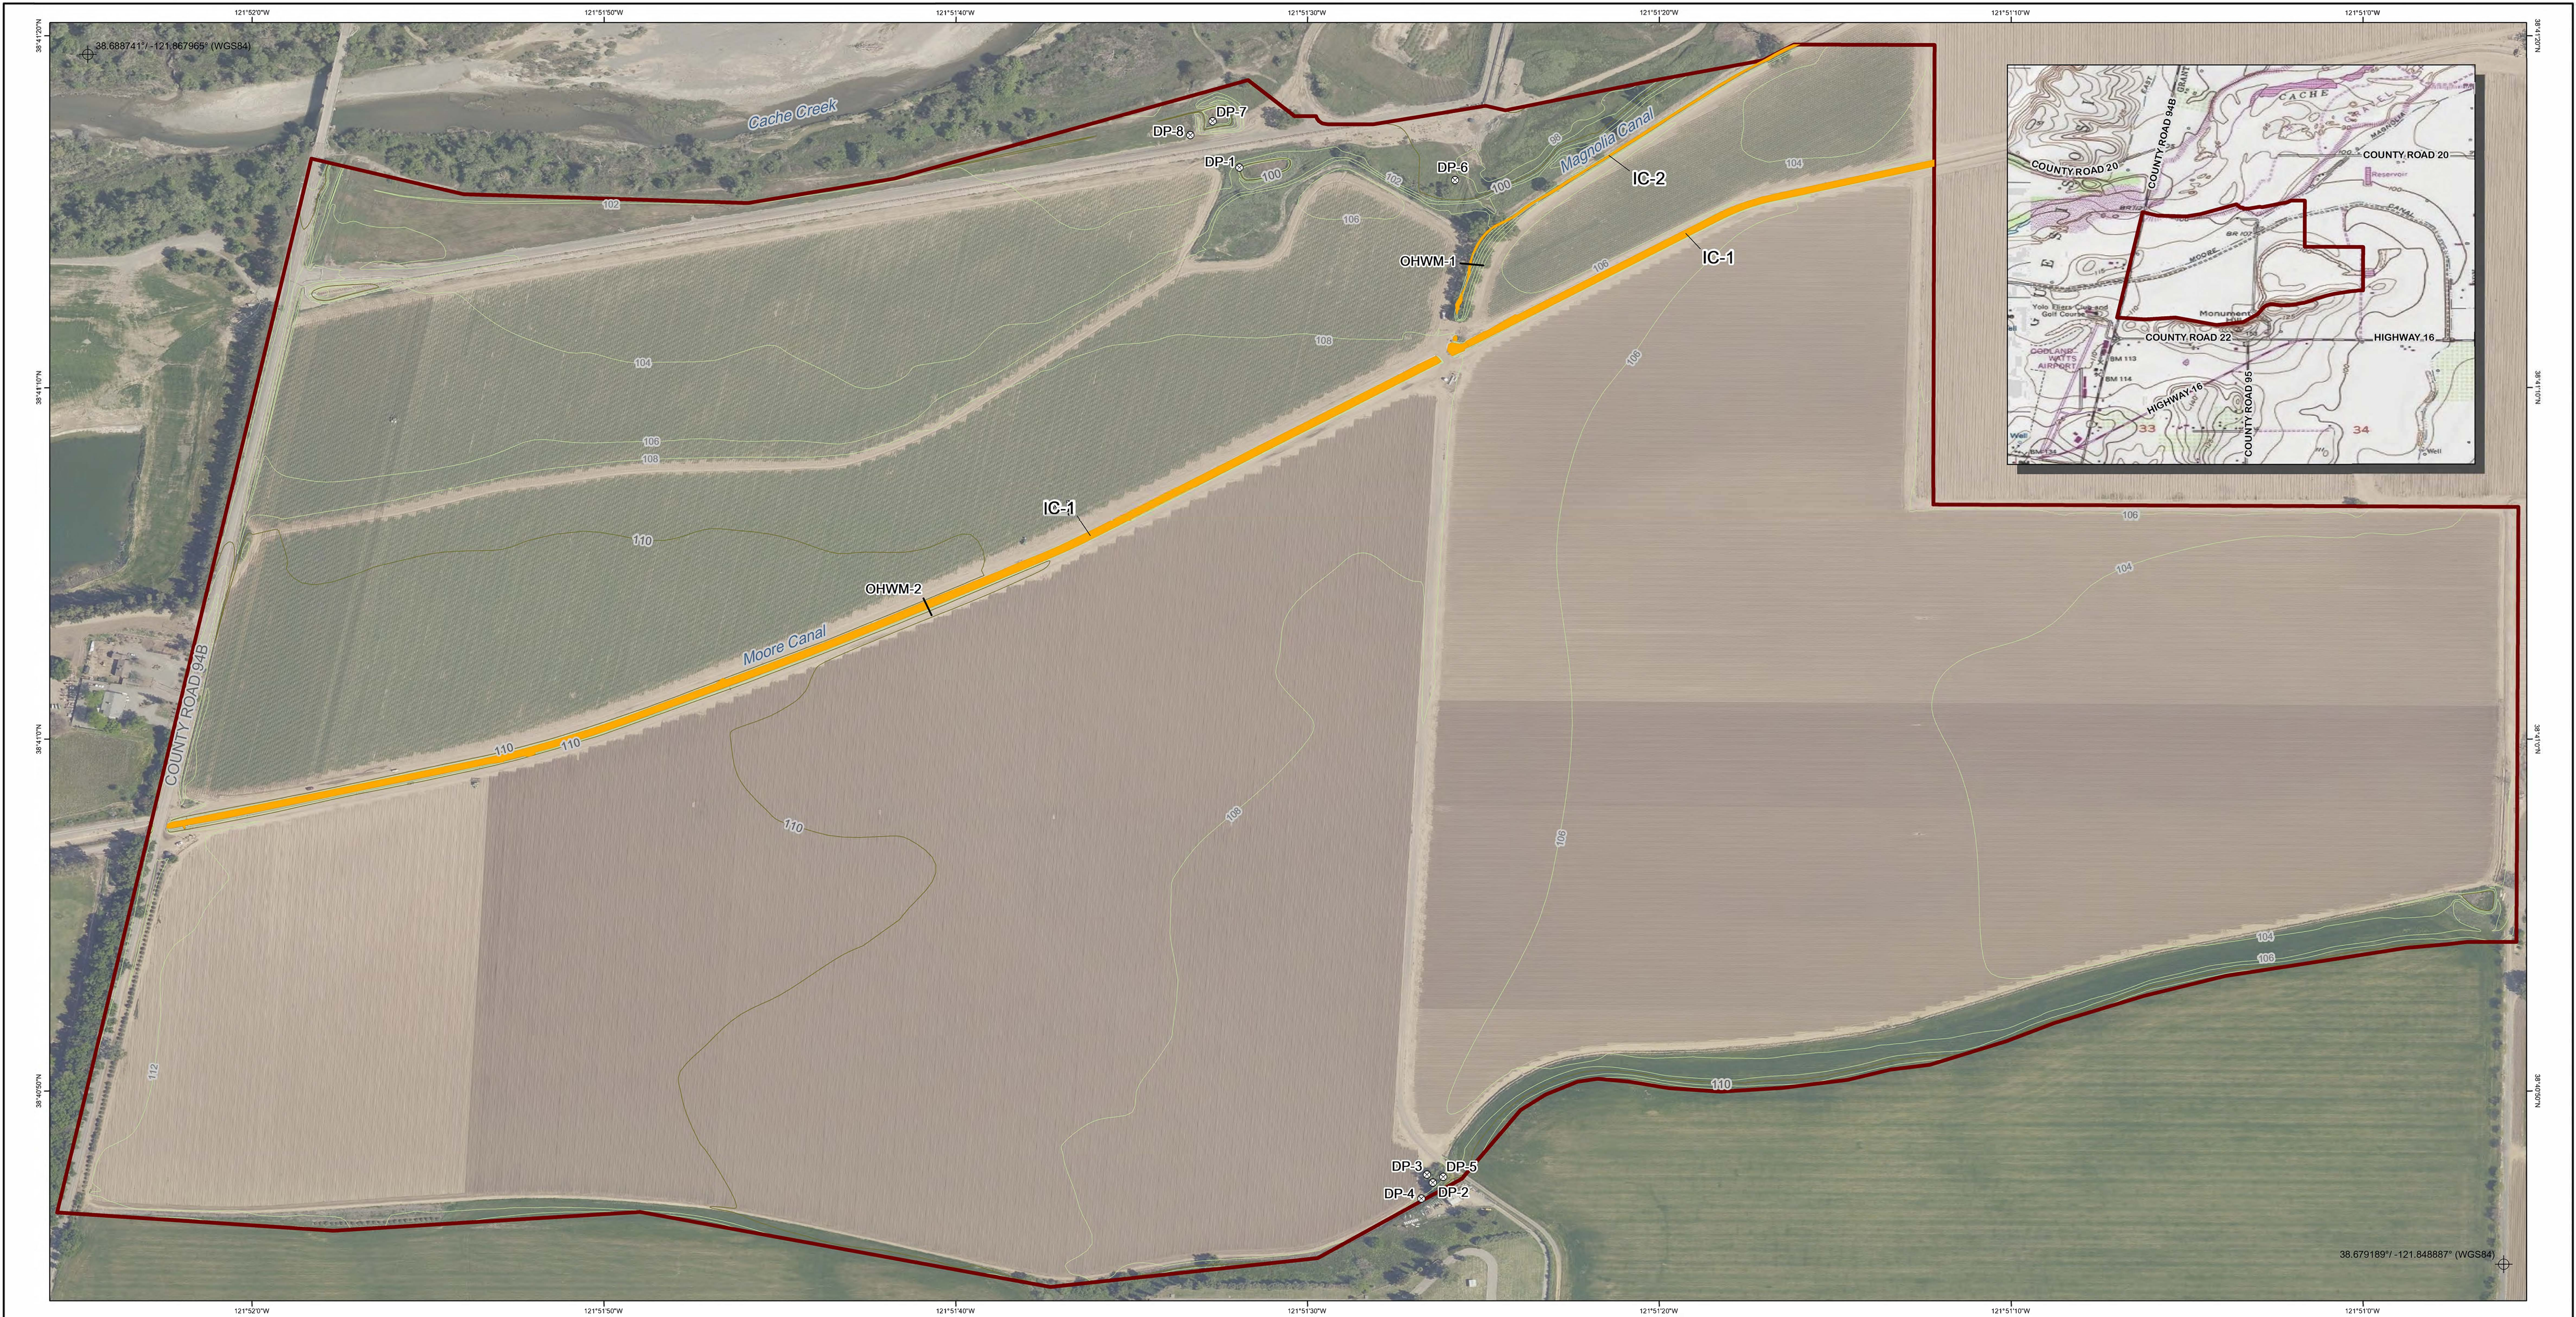
Three-parameter wetland determination data points were studied at eight locations (see Figure 4, Aquatic Resources Delineation Map). Five of these were in an area affected by run-on from an irrigation system leak just off site, and the remaining points were located in or near two sediment/infiltration basins near the northern site boundary. All of these non-wetland determinations are discussed below.
