## INITIAL STUDY

### **Housing Incentive Program Expansion and 788 San Antonio Road Mixed-Use Project**

April 2020

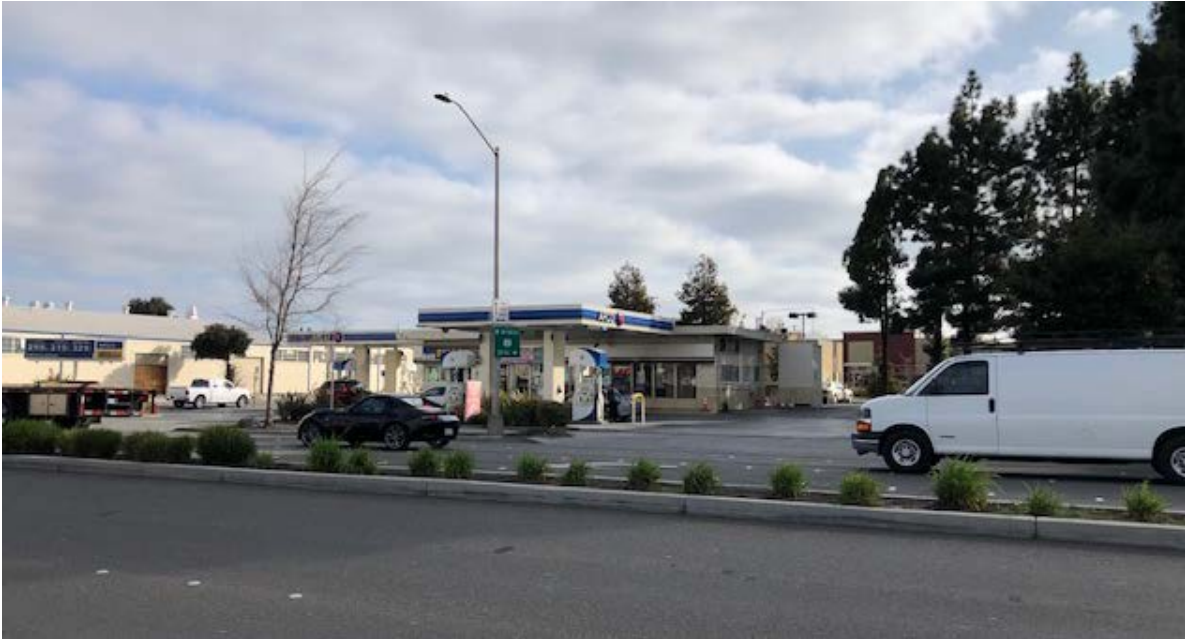
**Photo 1:** View of 840 San Antonio Road, taken from San Antonio Road looking northeast

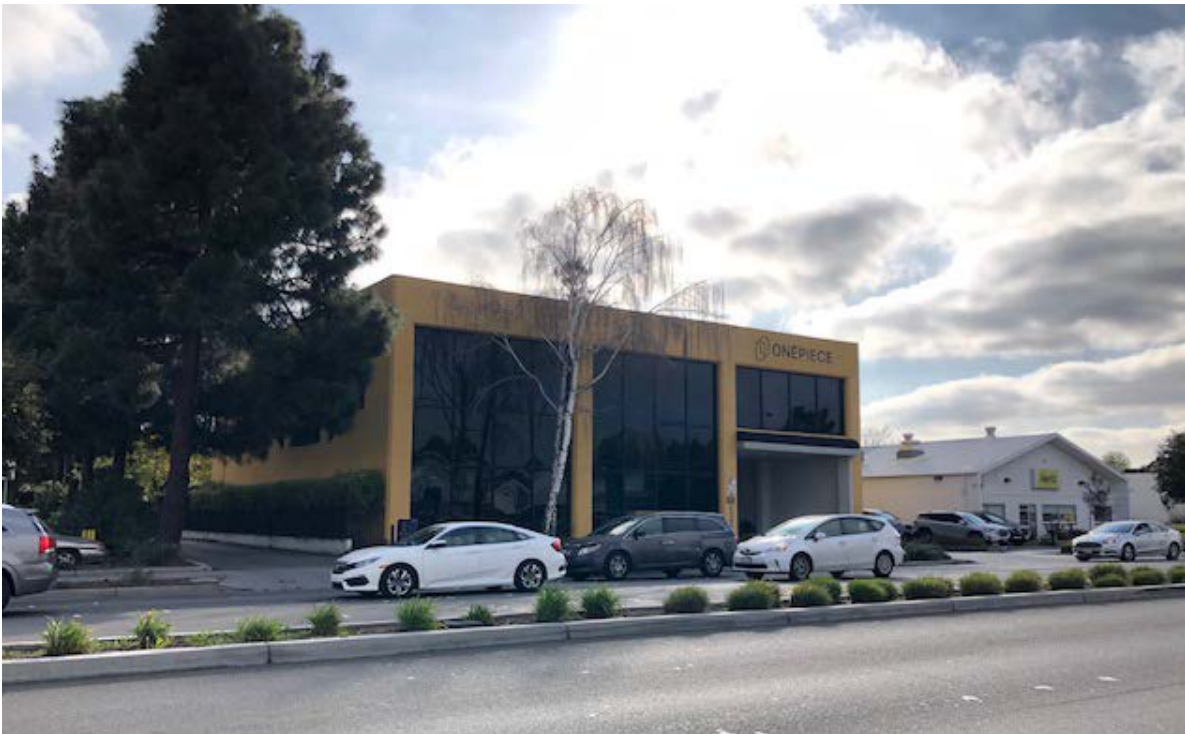
**Photo 2:** View of 824 and 816 San Antonio Road, taken from San Antonio Road looking southeast

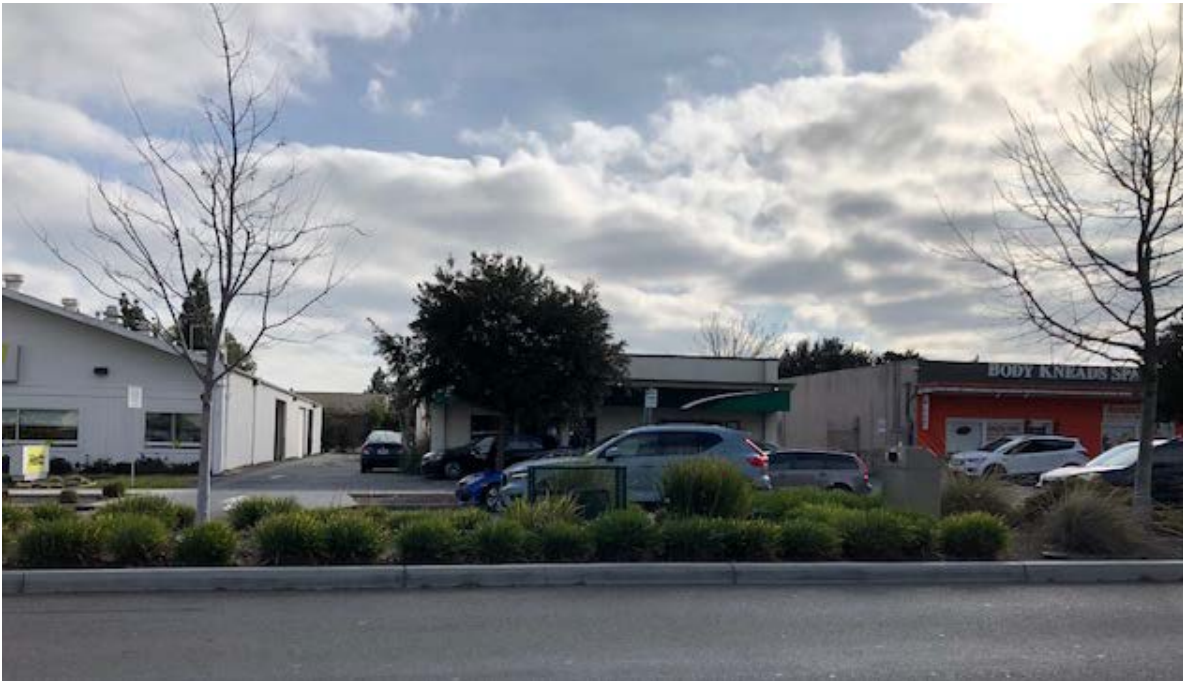
**Photo 3:** View of 816 San Antonio Road, taken from San Antonio Road looking east.

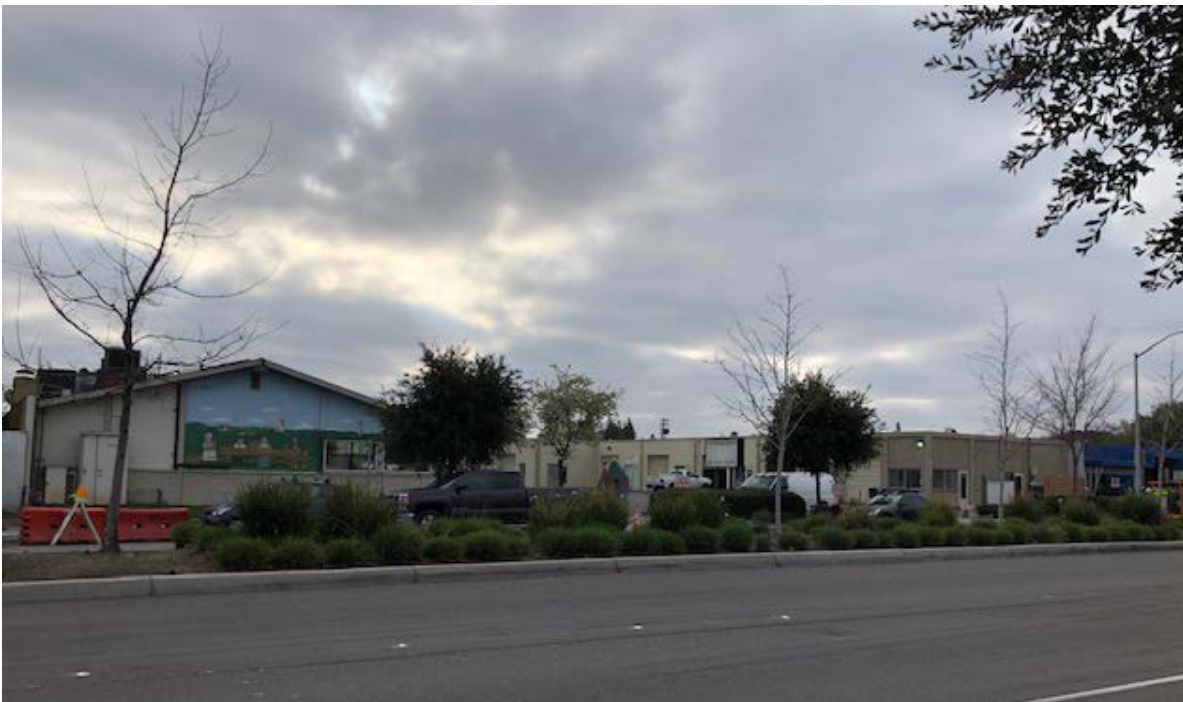
**Photo 4:** View of 728 and 720 San Antonio Road, taken from San Antonio Road looking southeast.

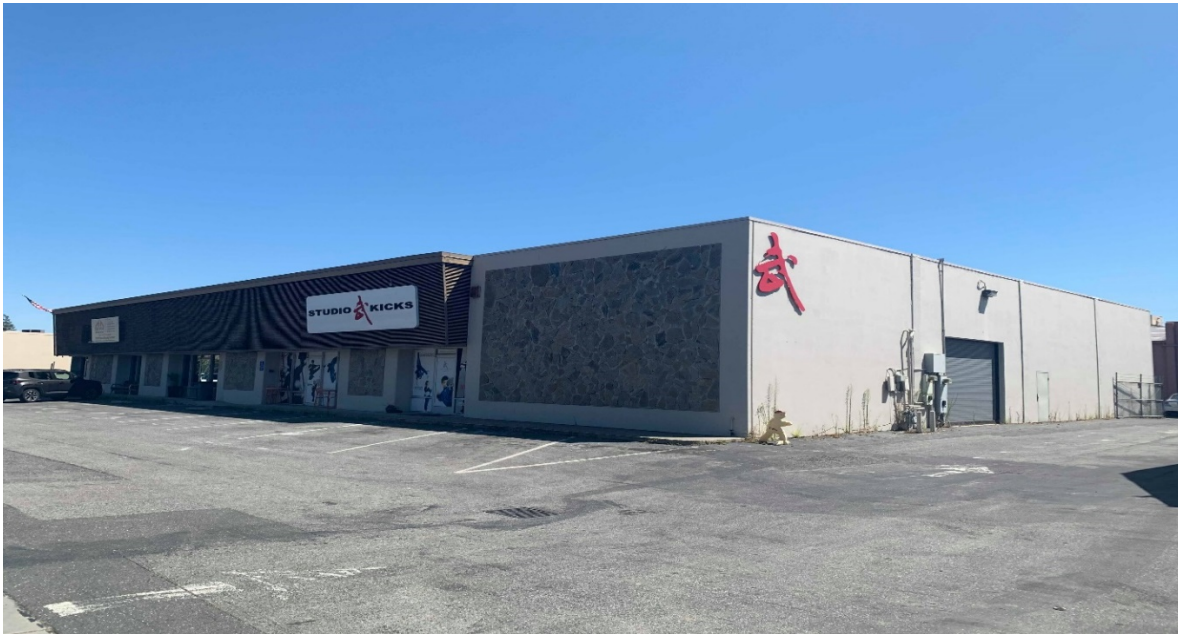
**Photo 5:** View of the 796 San Antonio Road, taken from San Antonio Road looking northeast

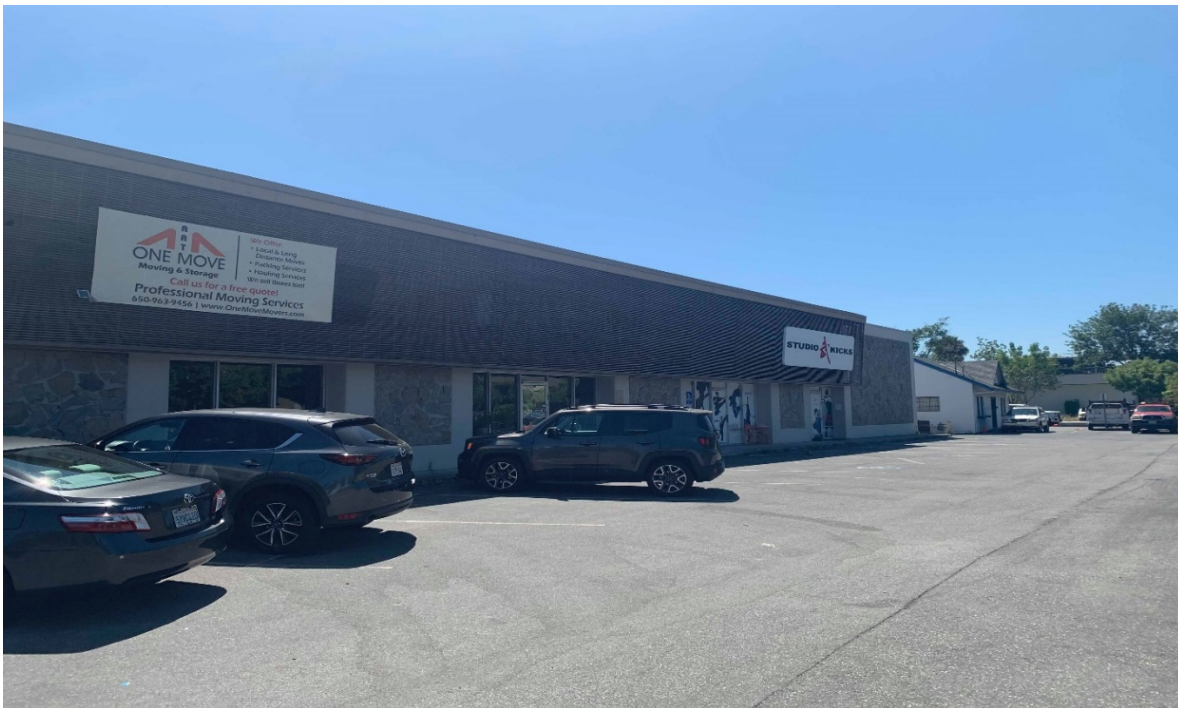
**Photo 6:** View of 796 and 788 San Antonio Road, taken from San Antonio Road looking southeast.

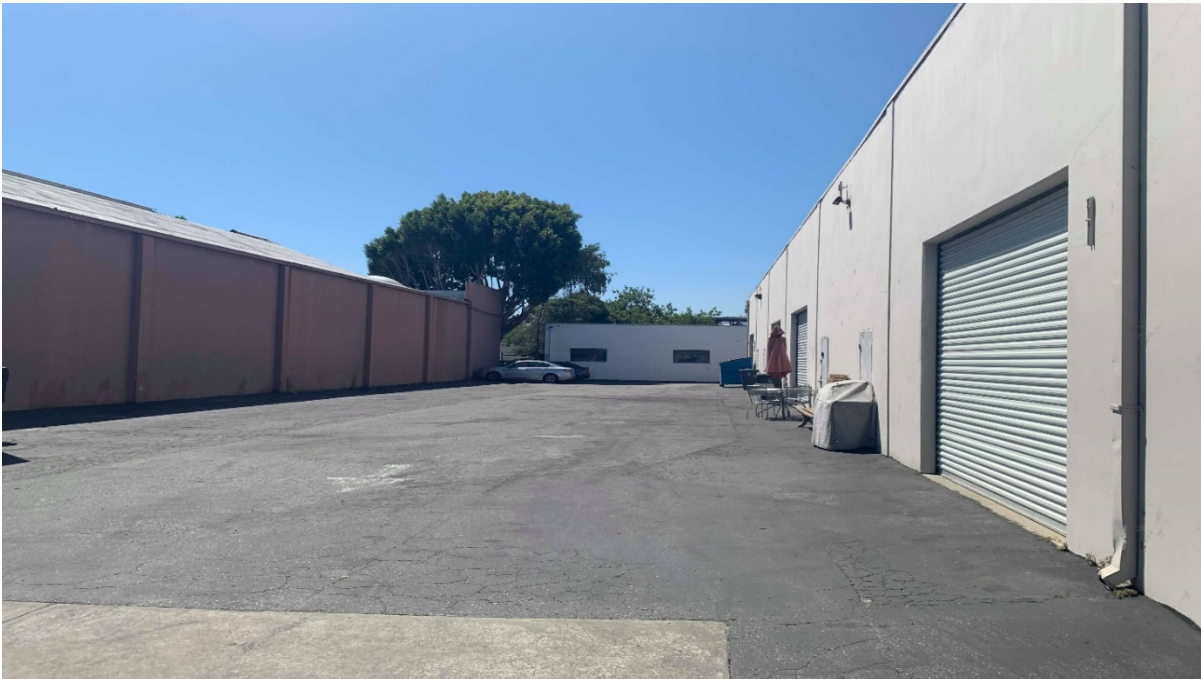
**Photo 8:** The eastern portion of 788 San Antonio Road, looking south.

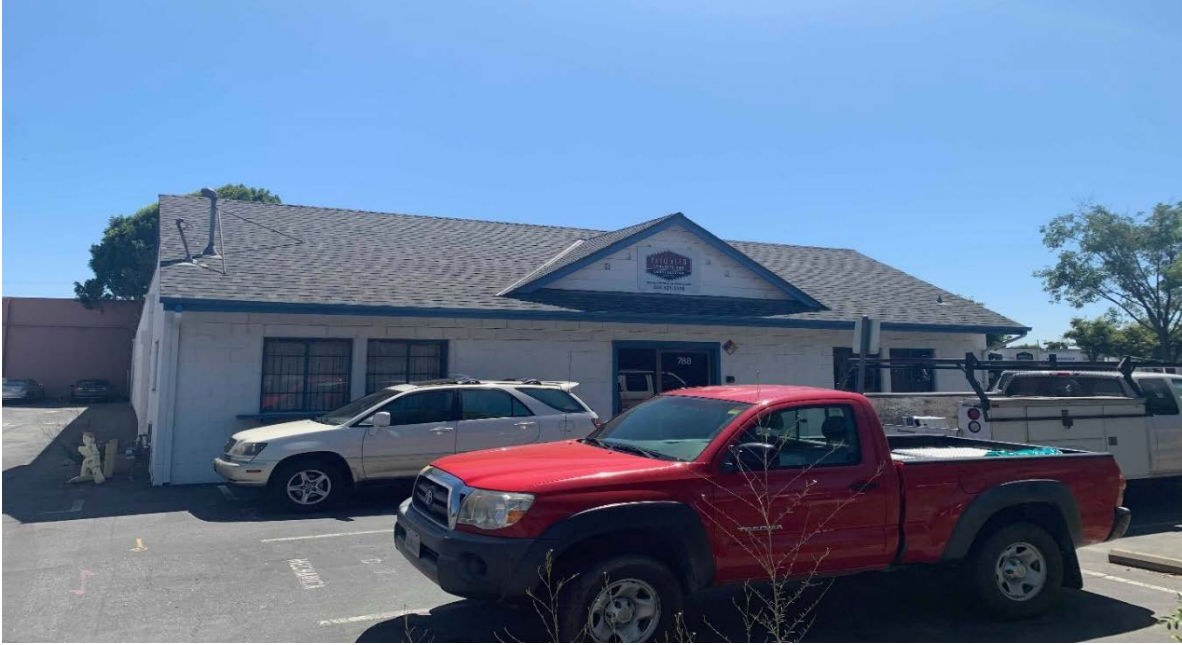
**Photo 9:** View of the existing concrete and construction building and parking lot at 788 San Antonio Road, taken from San Antonio Road looking southeast.

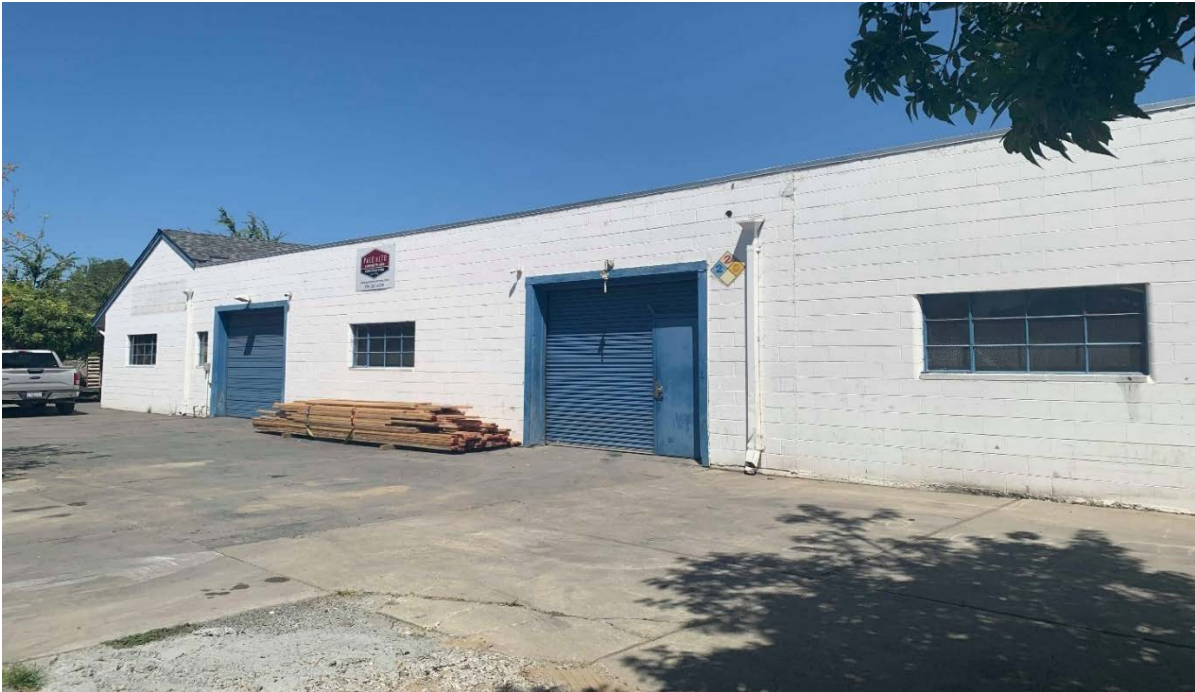
**Photo 10:** View of the existing concrete and construction building at 788 San Antonio Road, taken from Leghorn Street looking northwest.

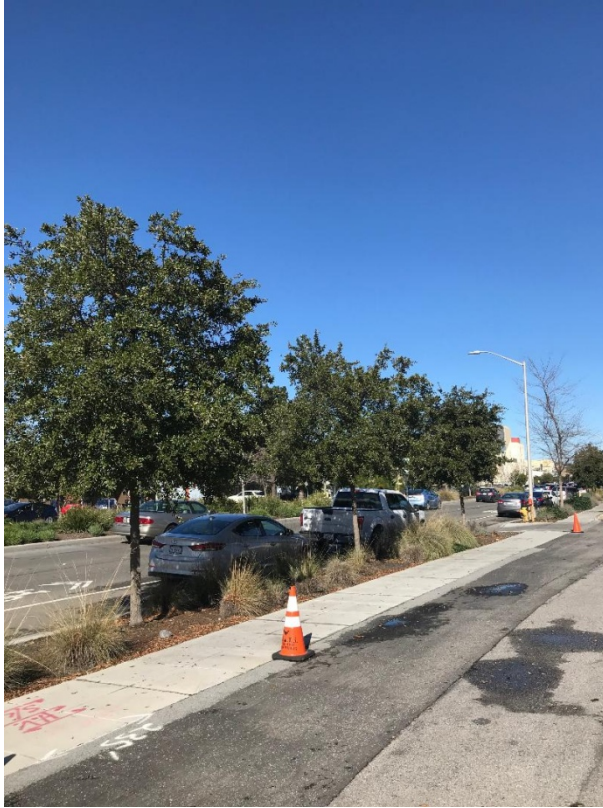
Showing tree locations

Raywood ash tree #2 is in poor condition. This tree is not a protected tree and is in significant decline, therefore removal is recommended regardless of the proposed construction. Other non-protected trees to be removed include trees #5, 8, and 9.

As described in the *Description of the Project*, sixteen trees are located on or adjacent to the project site. According to the Arborist Report prepared for the site as part of the project plans, ten of the existing trees are protected under the Tree Preservation and Management Ordinance (Appendix A). The project plans indicate that three of the protected trees near the southern boundary of the site would be removed and replaced. As described above, the Tree Preservation Management Ordinance requires that the project applicant obtain a Tree Removal Permit prior to removal and replace the removed trees.

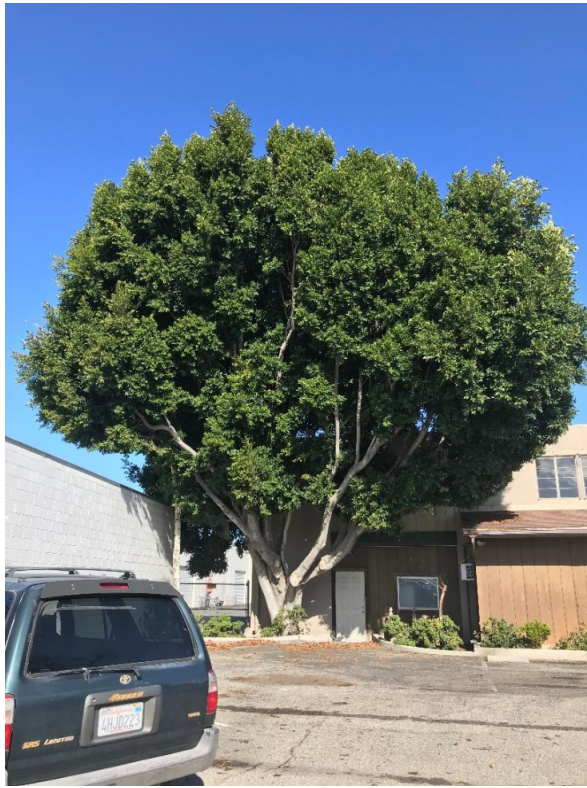
### Showing neighbor's Ficus tree #3

Ficus tree #3 is located on the neighboring property to the east. This tree is mature for the species. The proposed building foundation near this tree is pushed back further away from the existing. Impacts are expected to be nonexistent for this reason.

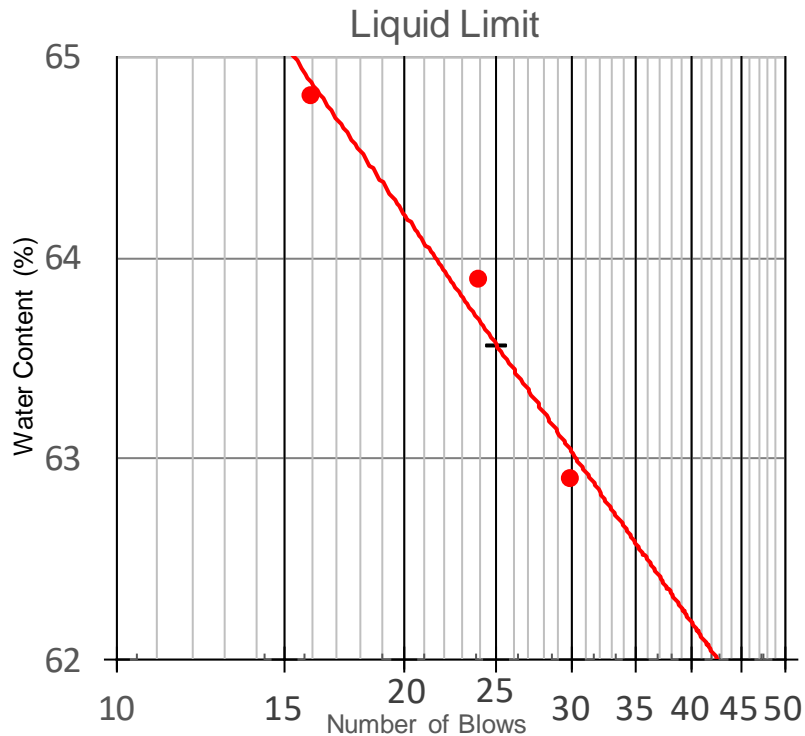
Plastic Limit Data			
Trial	1	2	Ave
Water Content (%)	26.2	25.8	26

Data Summary	
Liquid Limit	<b>64</b>
Plastic Limit	<b>26</b>
Plasticity Index	<b>38</b>
Natural Water Content	<b>28.8</b>
Liquidity Index	<b>0.074</b>
% Passing #200 Sieve	--

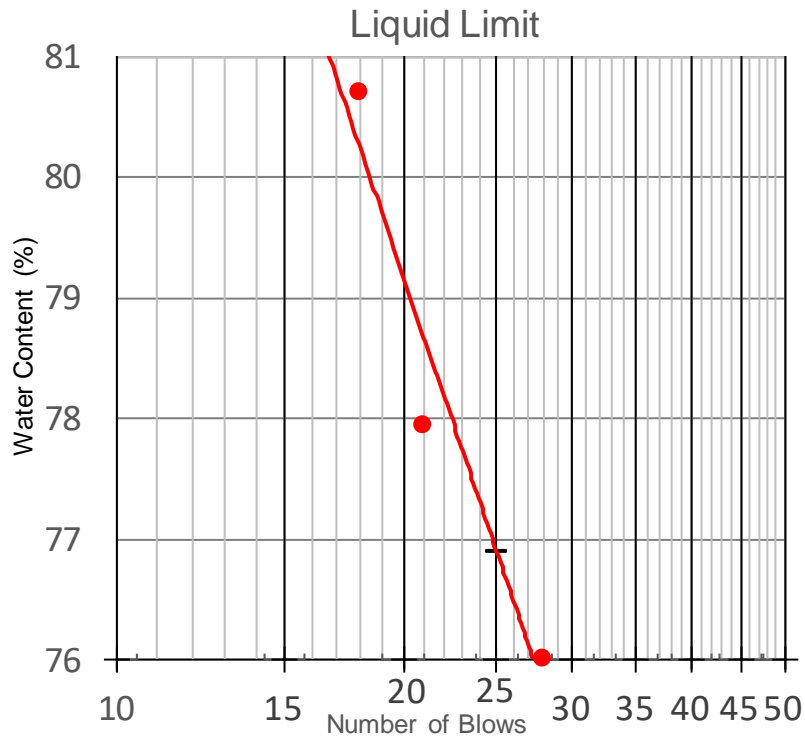
Plastic Limit Data			
Trial	1	2	Ave
Water Content (%)	25.4	24.9	25

Data Summary	
Liquid Limit	<b>77</b>
Plastic Limit	<b>25</b>
Plasticity Index	<b>52</b>
Natural Water Content	<b>31.2</b>
Liquidity Index	<b>0.119</b>
% Passing #200 Sieve	--

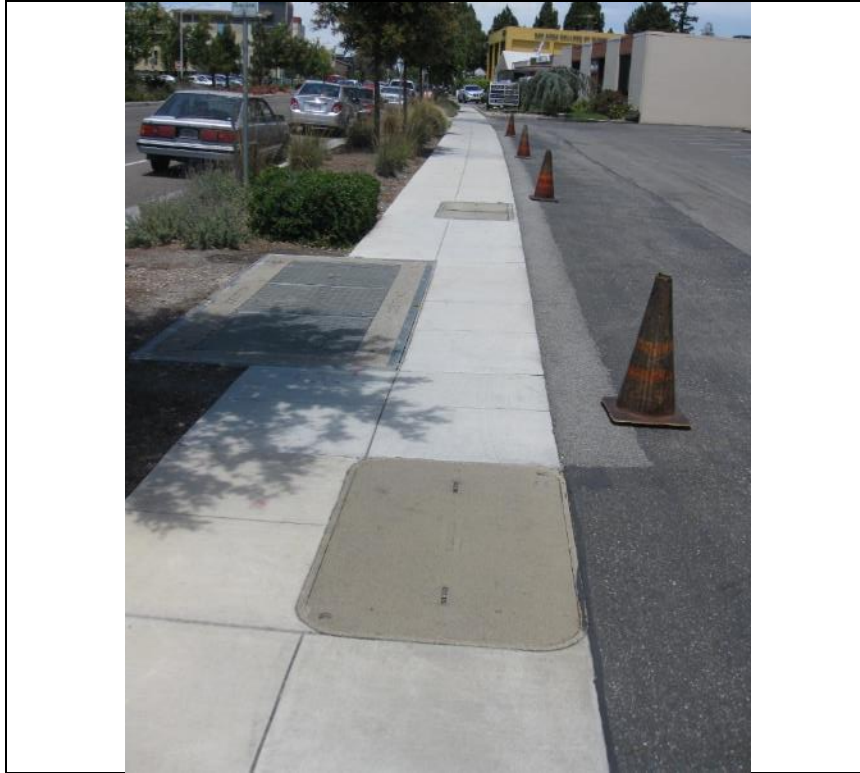
<b>Project No.</b> 17-0041.00	<b>Description</b>	Looking north along west property perimeter and utilities in sidewalk	<b>7</b>
	<b>Name</b>	788-796 San Antonio Road, Palo Alto, California	<b>Photo Date</b> July 5, 2017

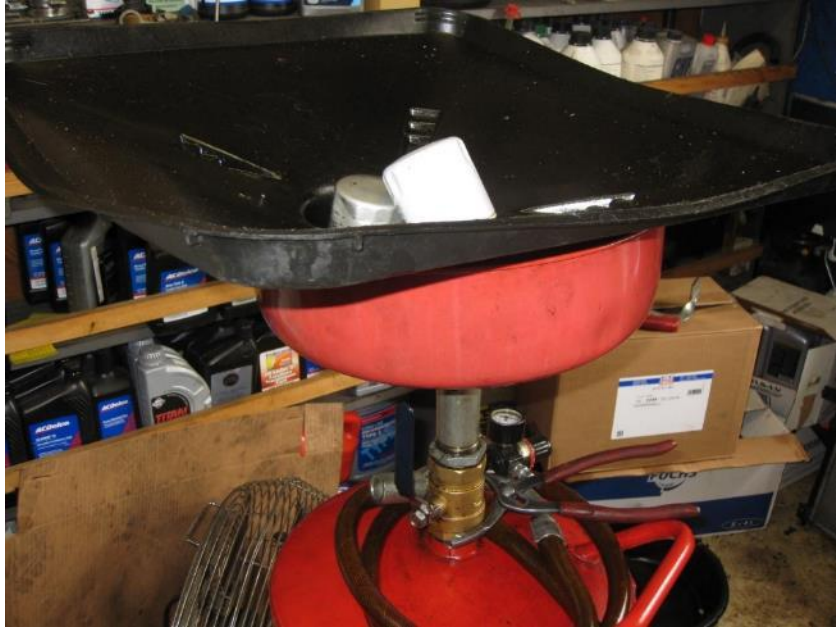
Project No. 17-0041.00	Description	Used oil collection at Mechanica Automotive	9
	Name	788-796 San Antonio Road, Palo Alto, California	Photo Date July 5, 2017

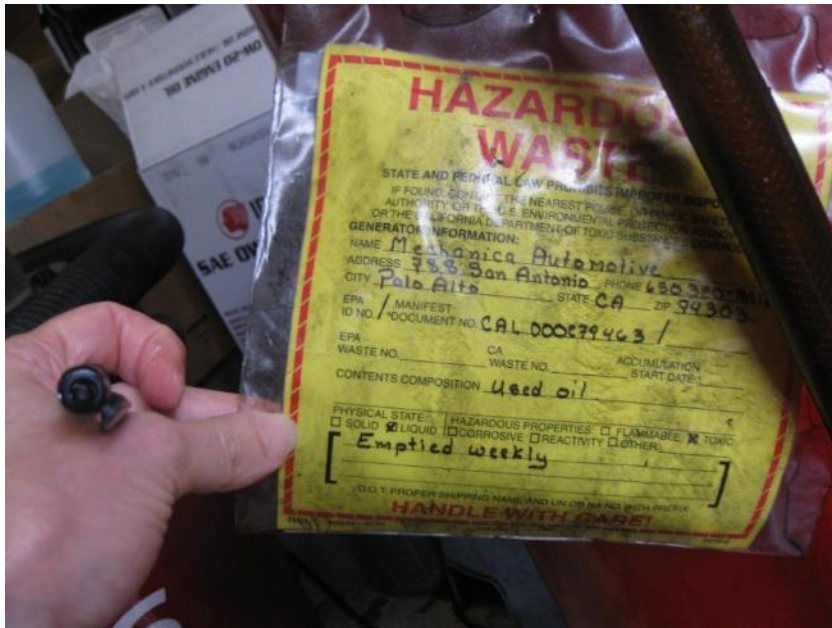
Project No. 17-0041.00	Description	Detail of used oil collection	10
	Name	788-796 San Antonio Road, Palo Alto, California	Photo Date July 5, 2017

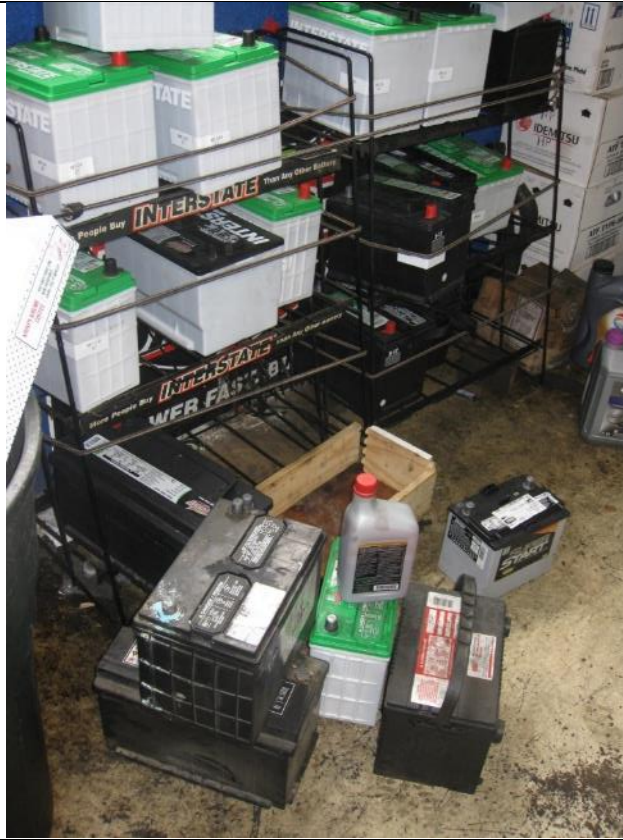
Project No. 17-0041.00	Description	New and used battery storage; bottle of used fluid	11
	Name	788-796 San Antonio Road, Palo Alto, California	Photo Date July 5, 2017

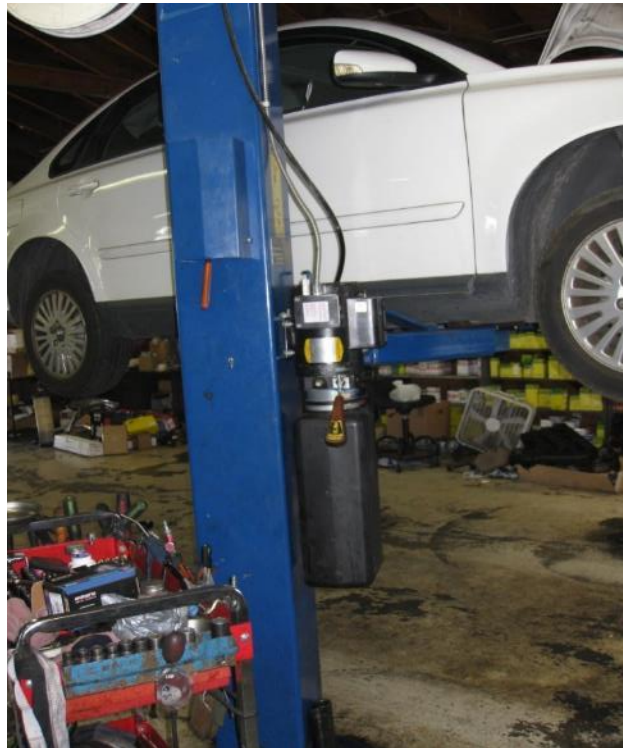
Project No. 17-0041.00	Description	Above ground vehicle lift with oil reservoir	12
	Name	788-796 San Antonio Road, Palo Alto, California	Photo Date July 5, 2017

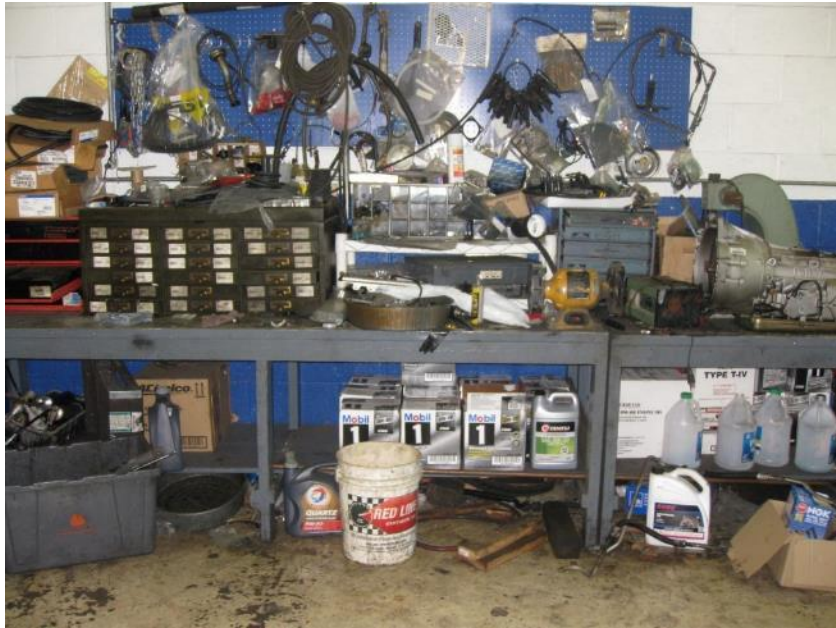
Project No. 17-0041.00	Description	Workbench, new oil storage	13
	Name	788-796 San Antonio Road, Palo Alto, California	Photo Date July 5, 2017

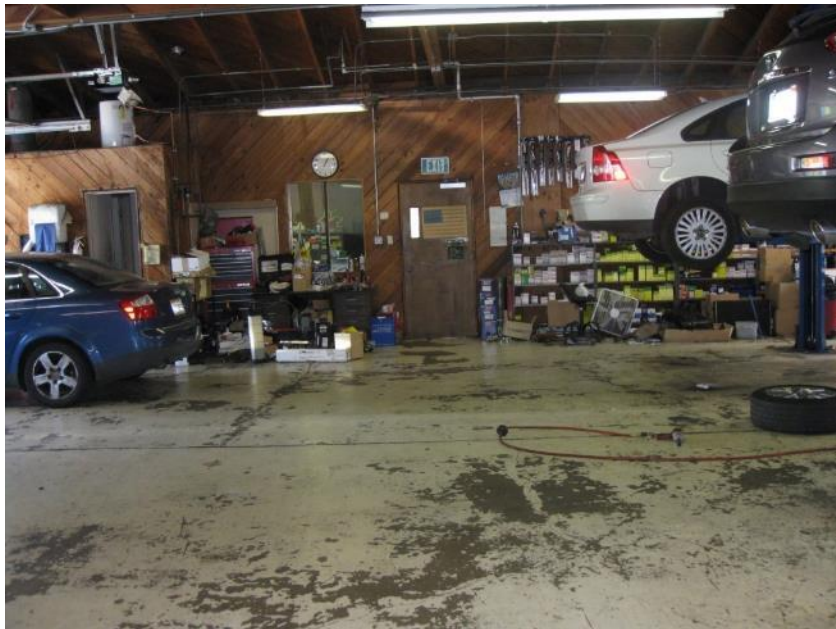
Project No. 17-0041.00	Description	Main shop area looking west; lifts have above ground oil reservoirs	14
	Name	788-796 San Antonio Road, Palo Alto, California	Photo Date July 5, 2017

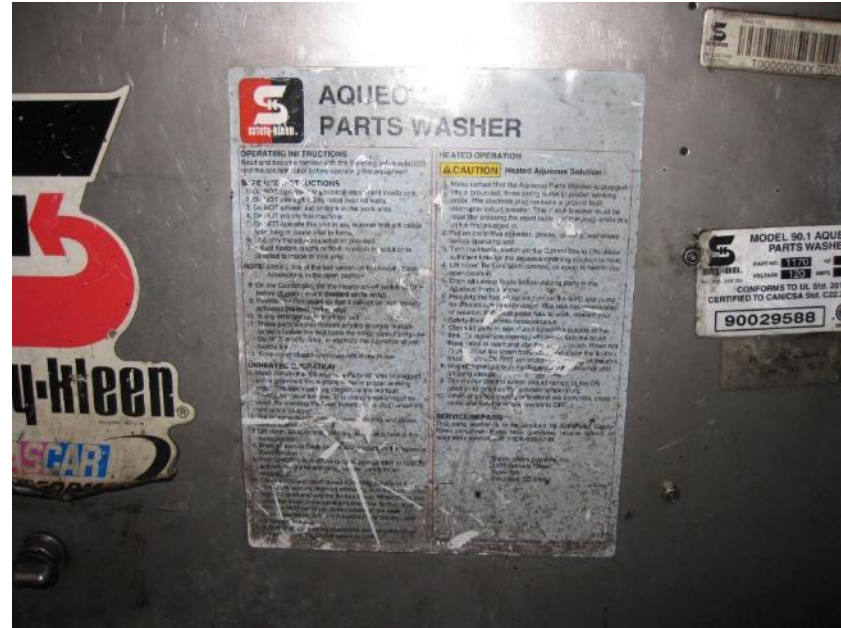
Project No. 17-0041.00	Description	Aqueous parts washer label; resulting oily water is removed by vendor	15
	Name	788-796 San Antonio Road, Palo Alto, California	Photo Date July 5, 2017

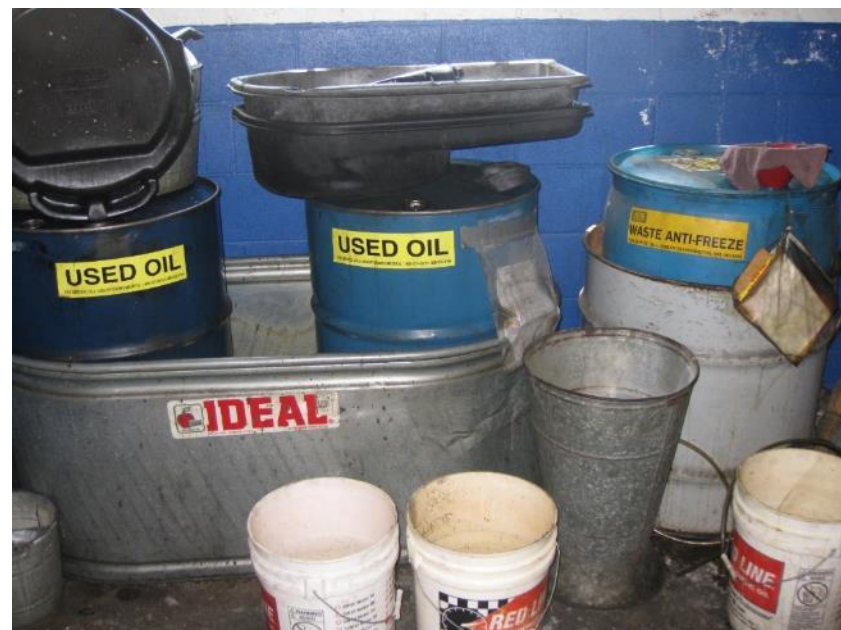
Project No. 17-0041.00	Description	Used oil and antifreeze storage (collected in shop); three drums	16
	Name	788-796 San Antonio Road, Palo Alto, California	Photo Date July 5, 2017

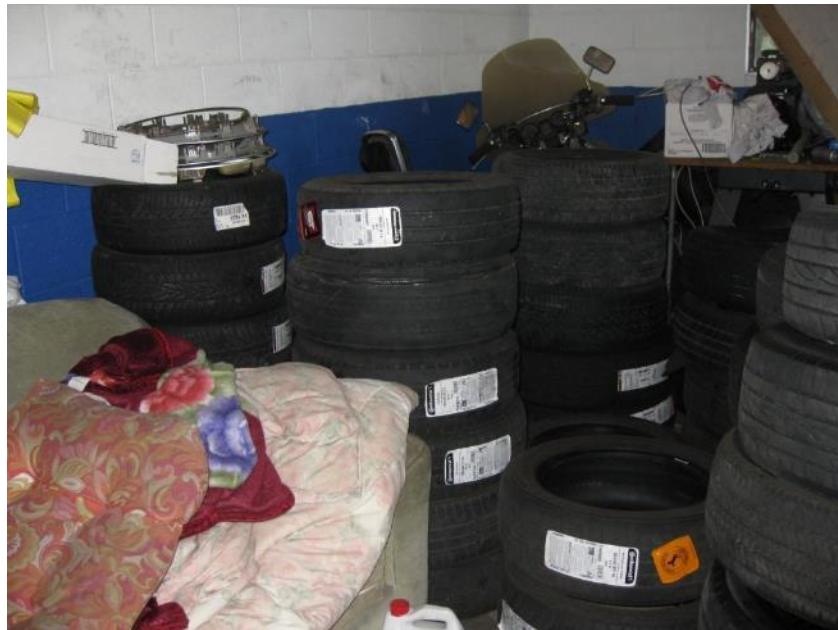
<b>Project No.</b> 17-0041.00	<b>Description</b>	Tire storage	<b>18</b>
	<b>Name</b>	788-796 San Antonio Road, Palo Alto, California	<b>Photo Date</b> July 5, 2017

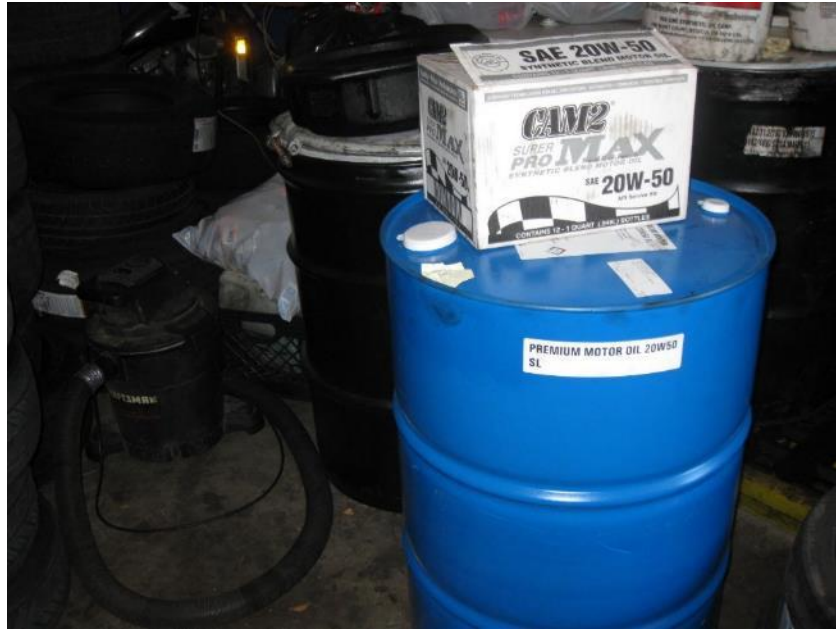
Project No. 17-0041.00	Description	Additional new oil storage	19
	Name	788-796 San Antonio Road, Palo Alto, California	Photo Date July 5, 2017

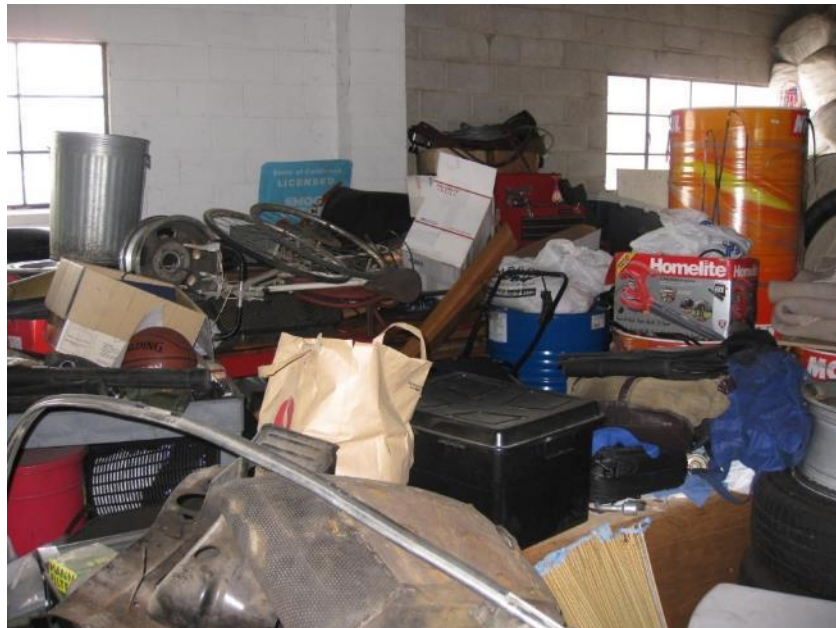
Project No. 17-0041.00	Description	Clutter in majority of rear room at Mechanica Automotive; floor inaccessible	20
	Name	788-796 San Antonio Road, Palo Alto, California	Photo Date July 5, 2017

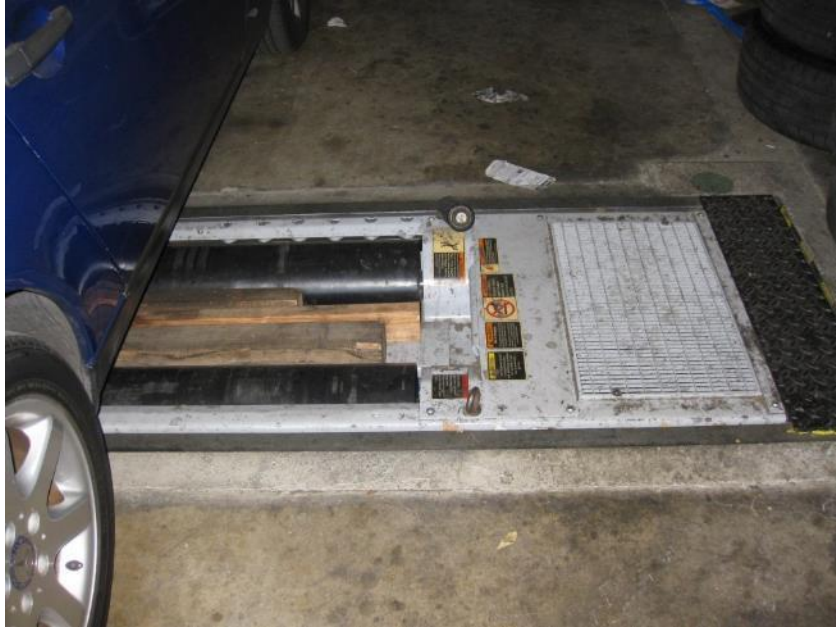
Project No. 17-0041.00	Description	In ground testing features with rollers, no longer in use	21
	Name	788-796 San Antonio Road, Palo Alto, California	Photo Date July 5, 2017

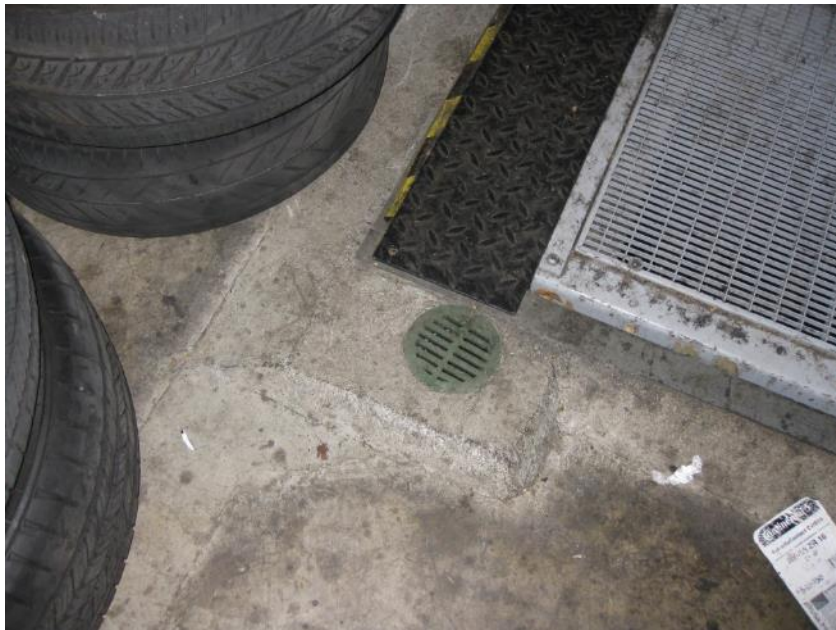
Project No. 17-0041.00	Description	Floor drain at testing features	22
	Name	788-796 San Antonio Road, Palo Alto, California	Photo Date July 5, 2017

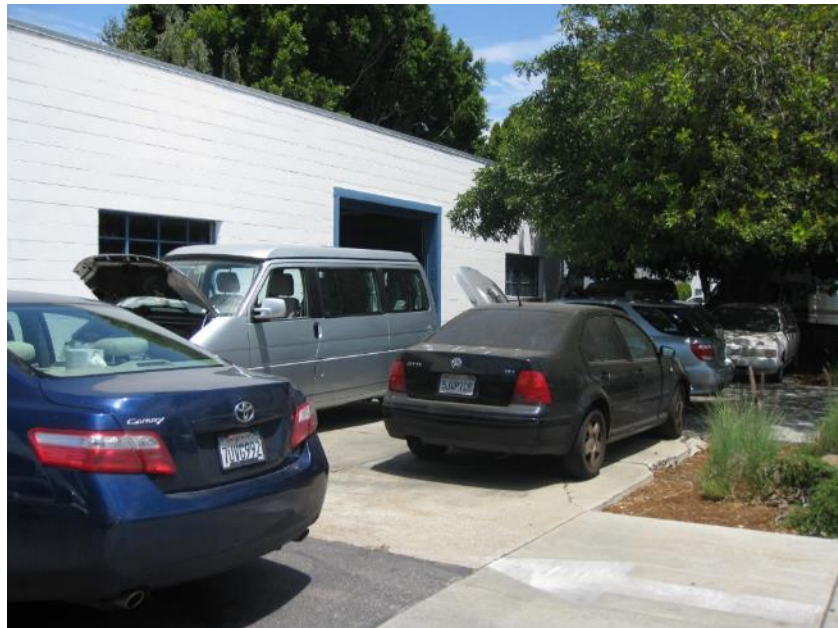
<b>Project No.</b> 17-0041.00	<b>Description</b>	Cars stored and being serviced outdoors south of Mechanica Automotive (pavement covered)	<b>24</b>
	<b>Name</b>	788-796 San Antonio Road, Palo Alto, California	<b>Photo Date</b> July 5, 2017
