# San Simeon Community Services District

## Community Water Tank Project

### Initial Study and Mitigated Negative Declaration

September 2019

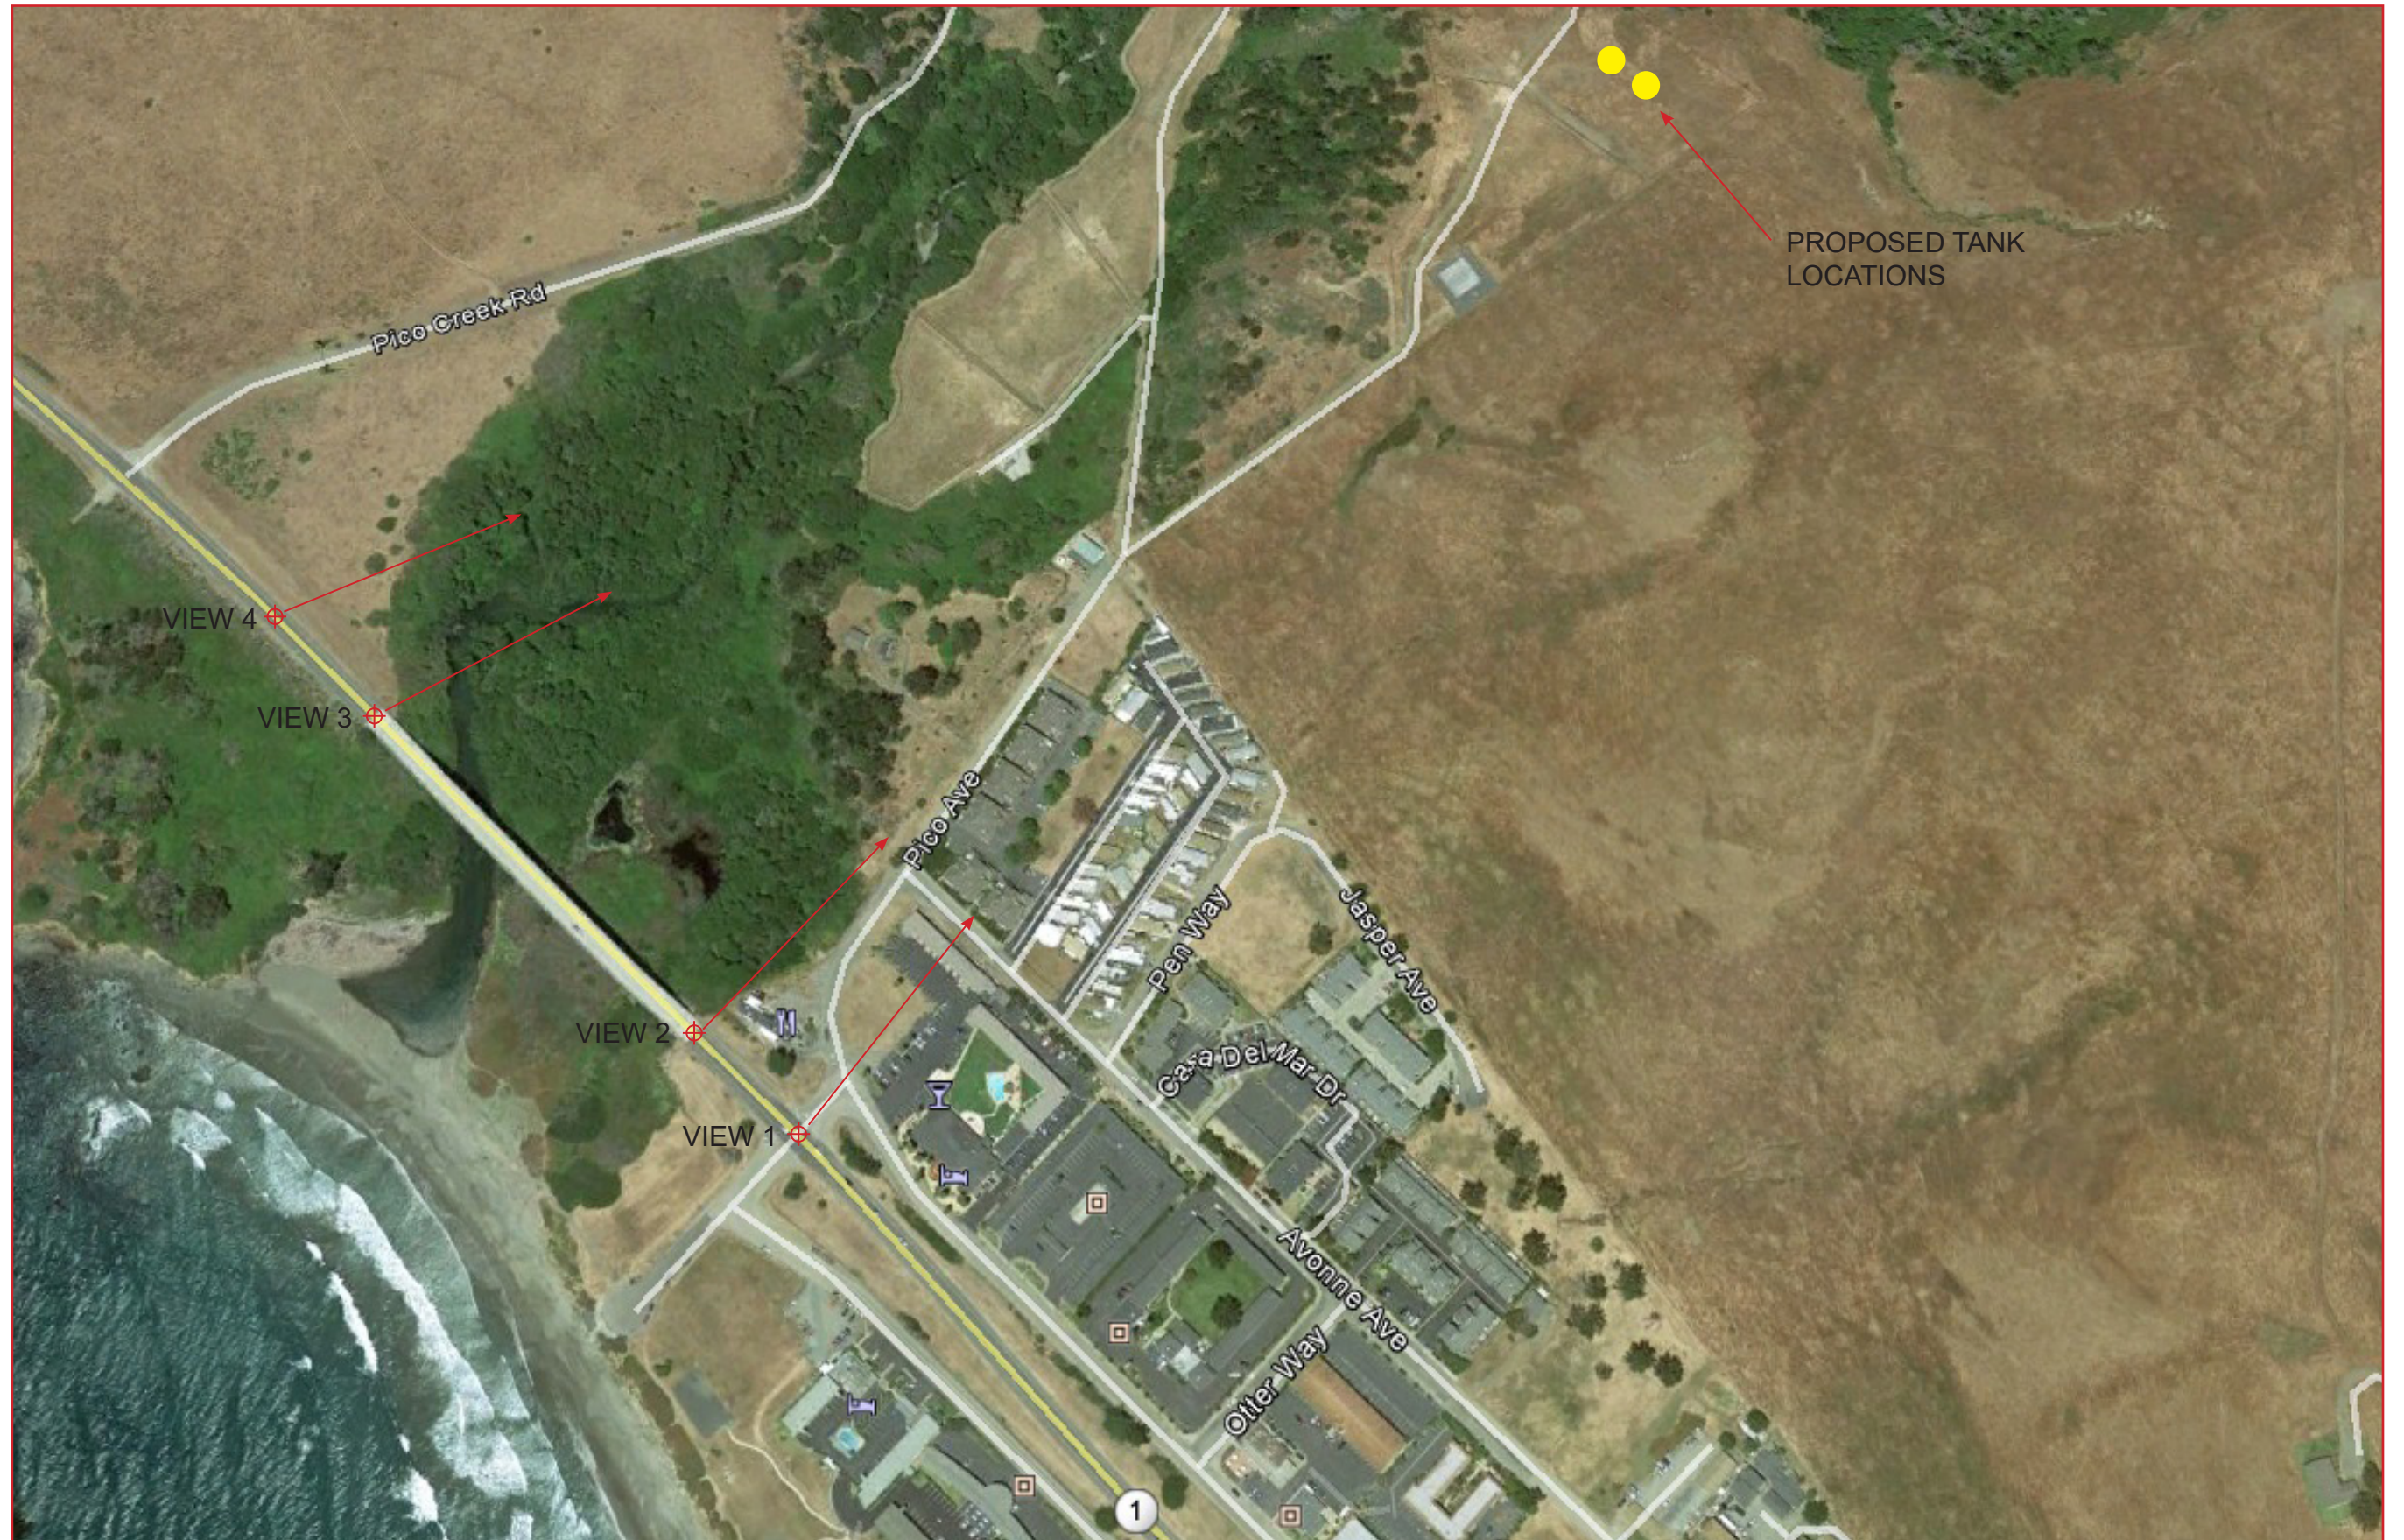
**Attachment B:**  
**Project Visual Simulations**

## SAN SIMEON WATER TANKS

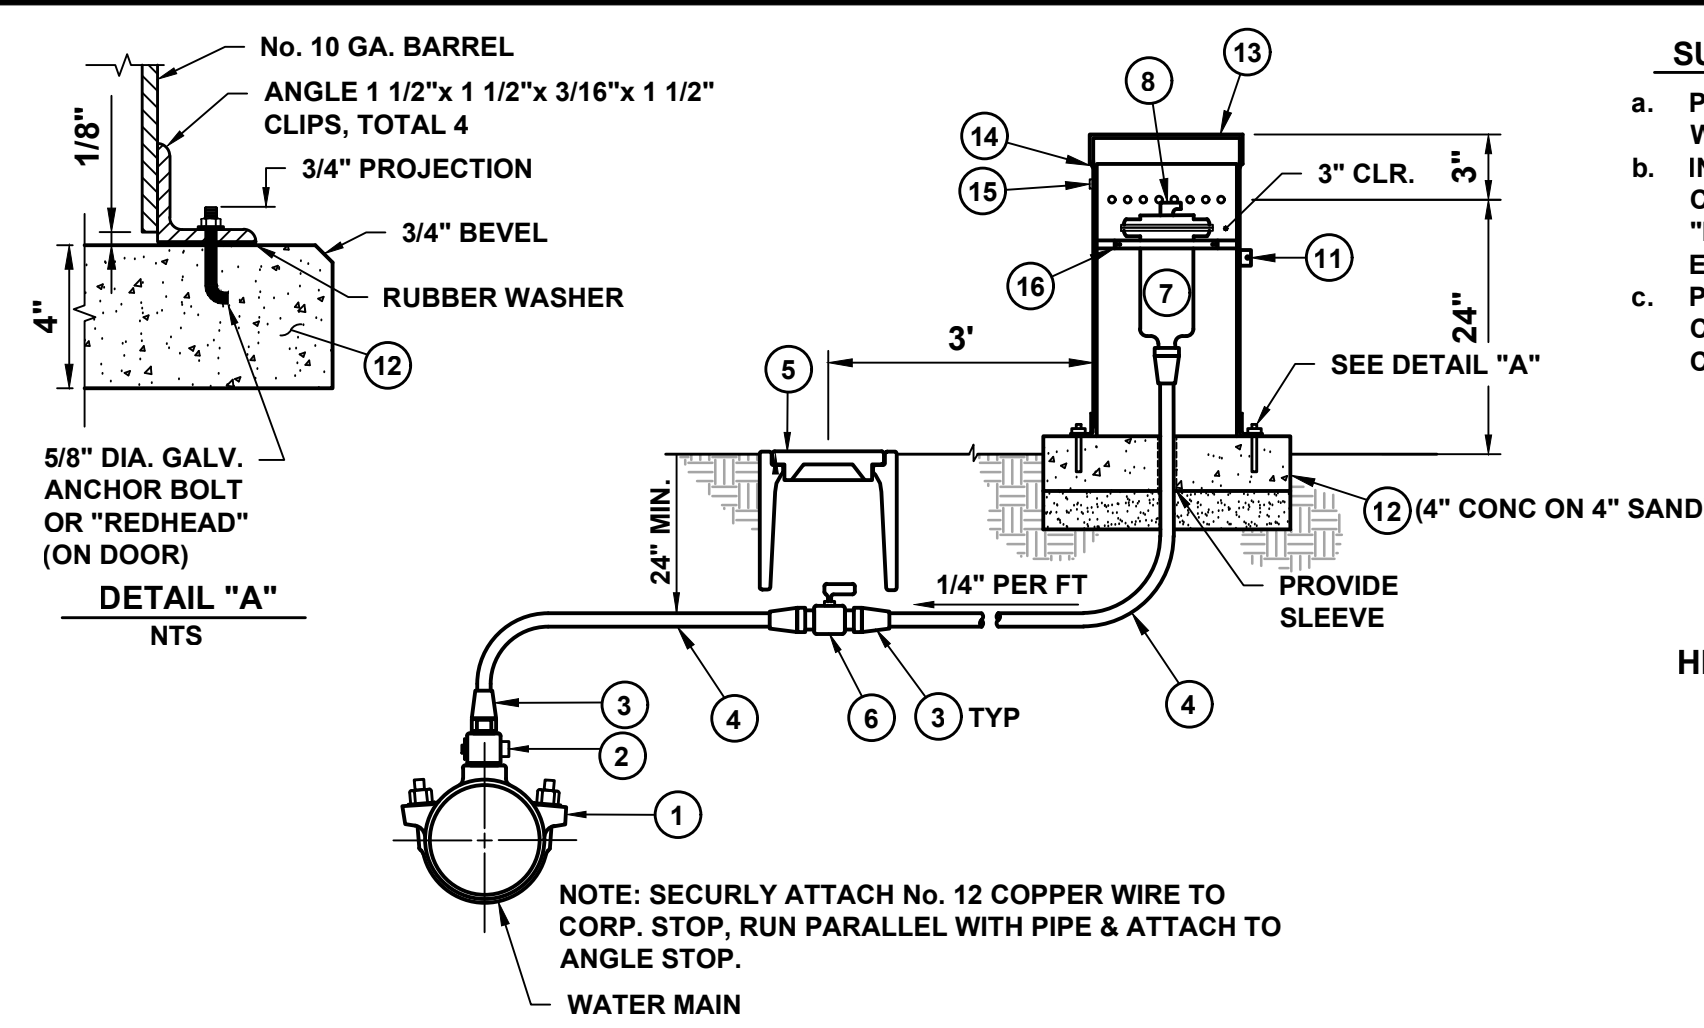
1. BRONZE SERVICE SADDLE, DOUBLE STRAP, WITH AWWA I.P. THREADS.
2. CORPORATION STOP WITH IP THREADS.
3. MUELLER INSTA-TITE CONNECTION.
4. POLYETHYLENE PIPE, PIPE SIZE SHOULD MATCH AIR & VACUUM RELIEF VALVE SIZE.

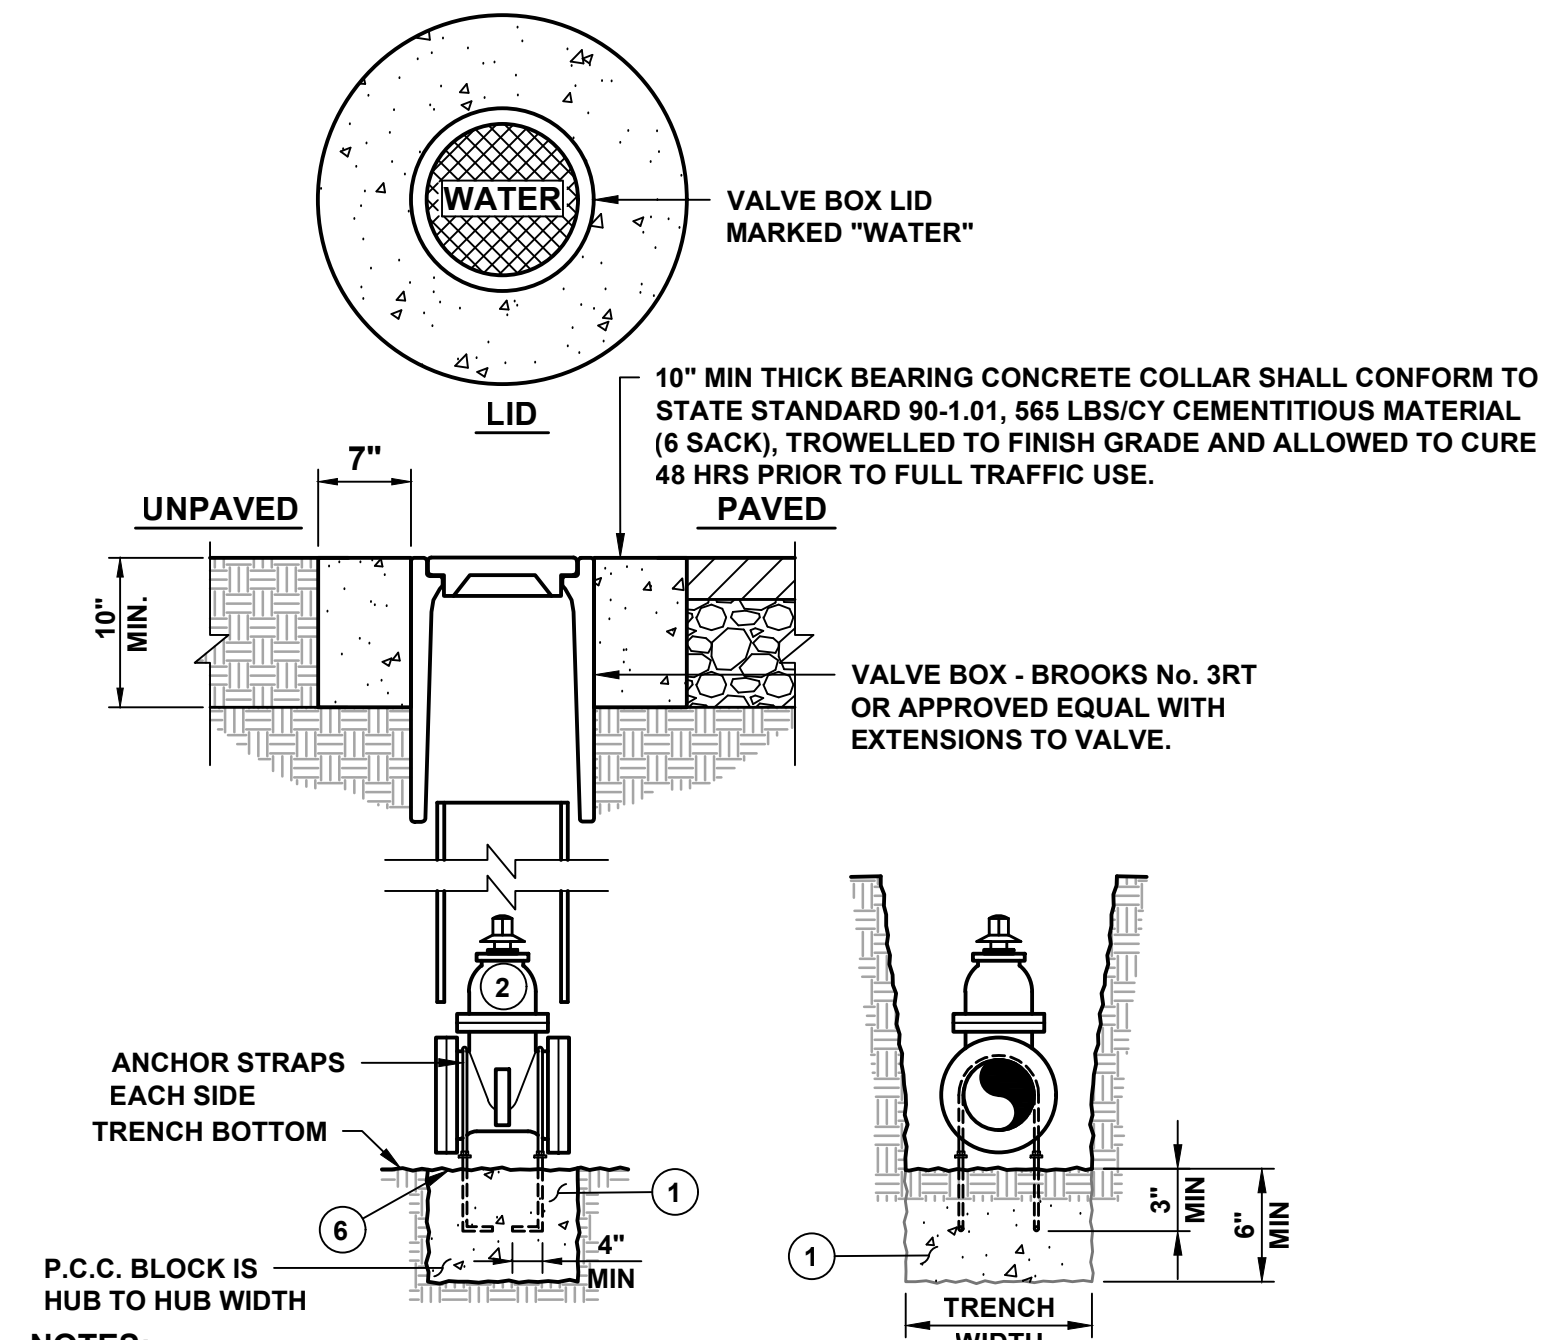
1. CONCRETE THRUST BLOCKS SHALL CONFORM TO STATE STANDARD 90-1.01, 470 LBS/CY CEMENTITIOUS MATERIAL (5 SACK), AND POURED AGAINST UNDISTURBED NATIVE SOIL.
2. VALVES SHALL HAVE NON-RISING STEM, RESILIENT WEDGE RESILIENT SEAT, AND BE EPOXY COATED.
3. ALL MATERIALS AND INSTALLATION SHALL CONFORM WITH THE APPLICABLE SECTIONS OF THE DESIGN STANDARDS.
4. ALL FITTINGS SHALL BE WRAPPED IN POLYETHYLENE SHEET AND ALL FLANGES AND BOLTS SHALL BE SHIELDED FROM CONCRETE PER THE DESIGN STANDARDS.
5. UNDER NO CIRCUMSTANCES SHALL UTILITY LIDS AND CONCRETE COLLARS BE LOCATED WITHIN CURBS, GUTTERS, SIDEWALKS, DRIVEWAYS, CURB APRONS OR CROSS GUTTERS.
6. VALVE ANCHOR SHALL BE POURED LEVEL WITH TRENCH BOTTOM. ANCHOR STRAPS SHALL BE FASTENED TO CONCRETE EMBEDDED ANCHOR BOLTS.

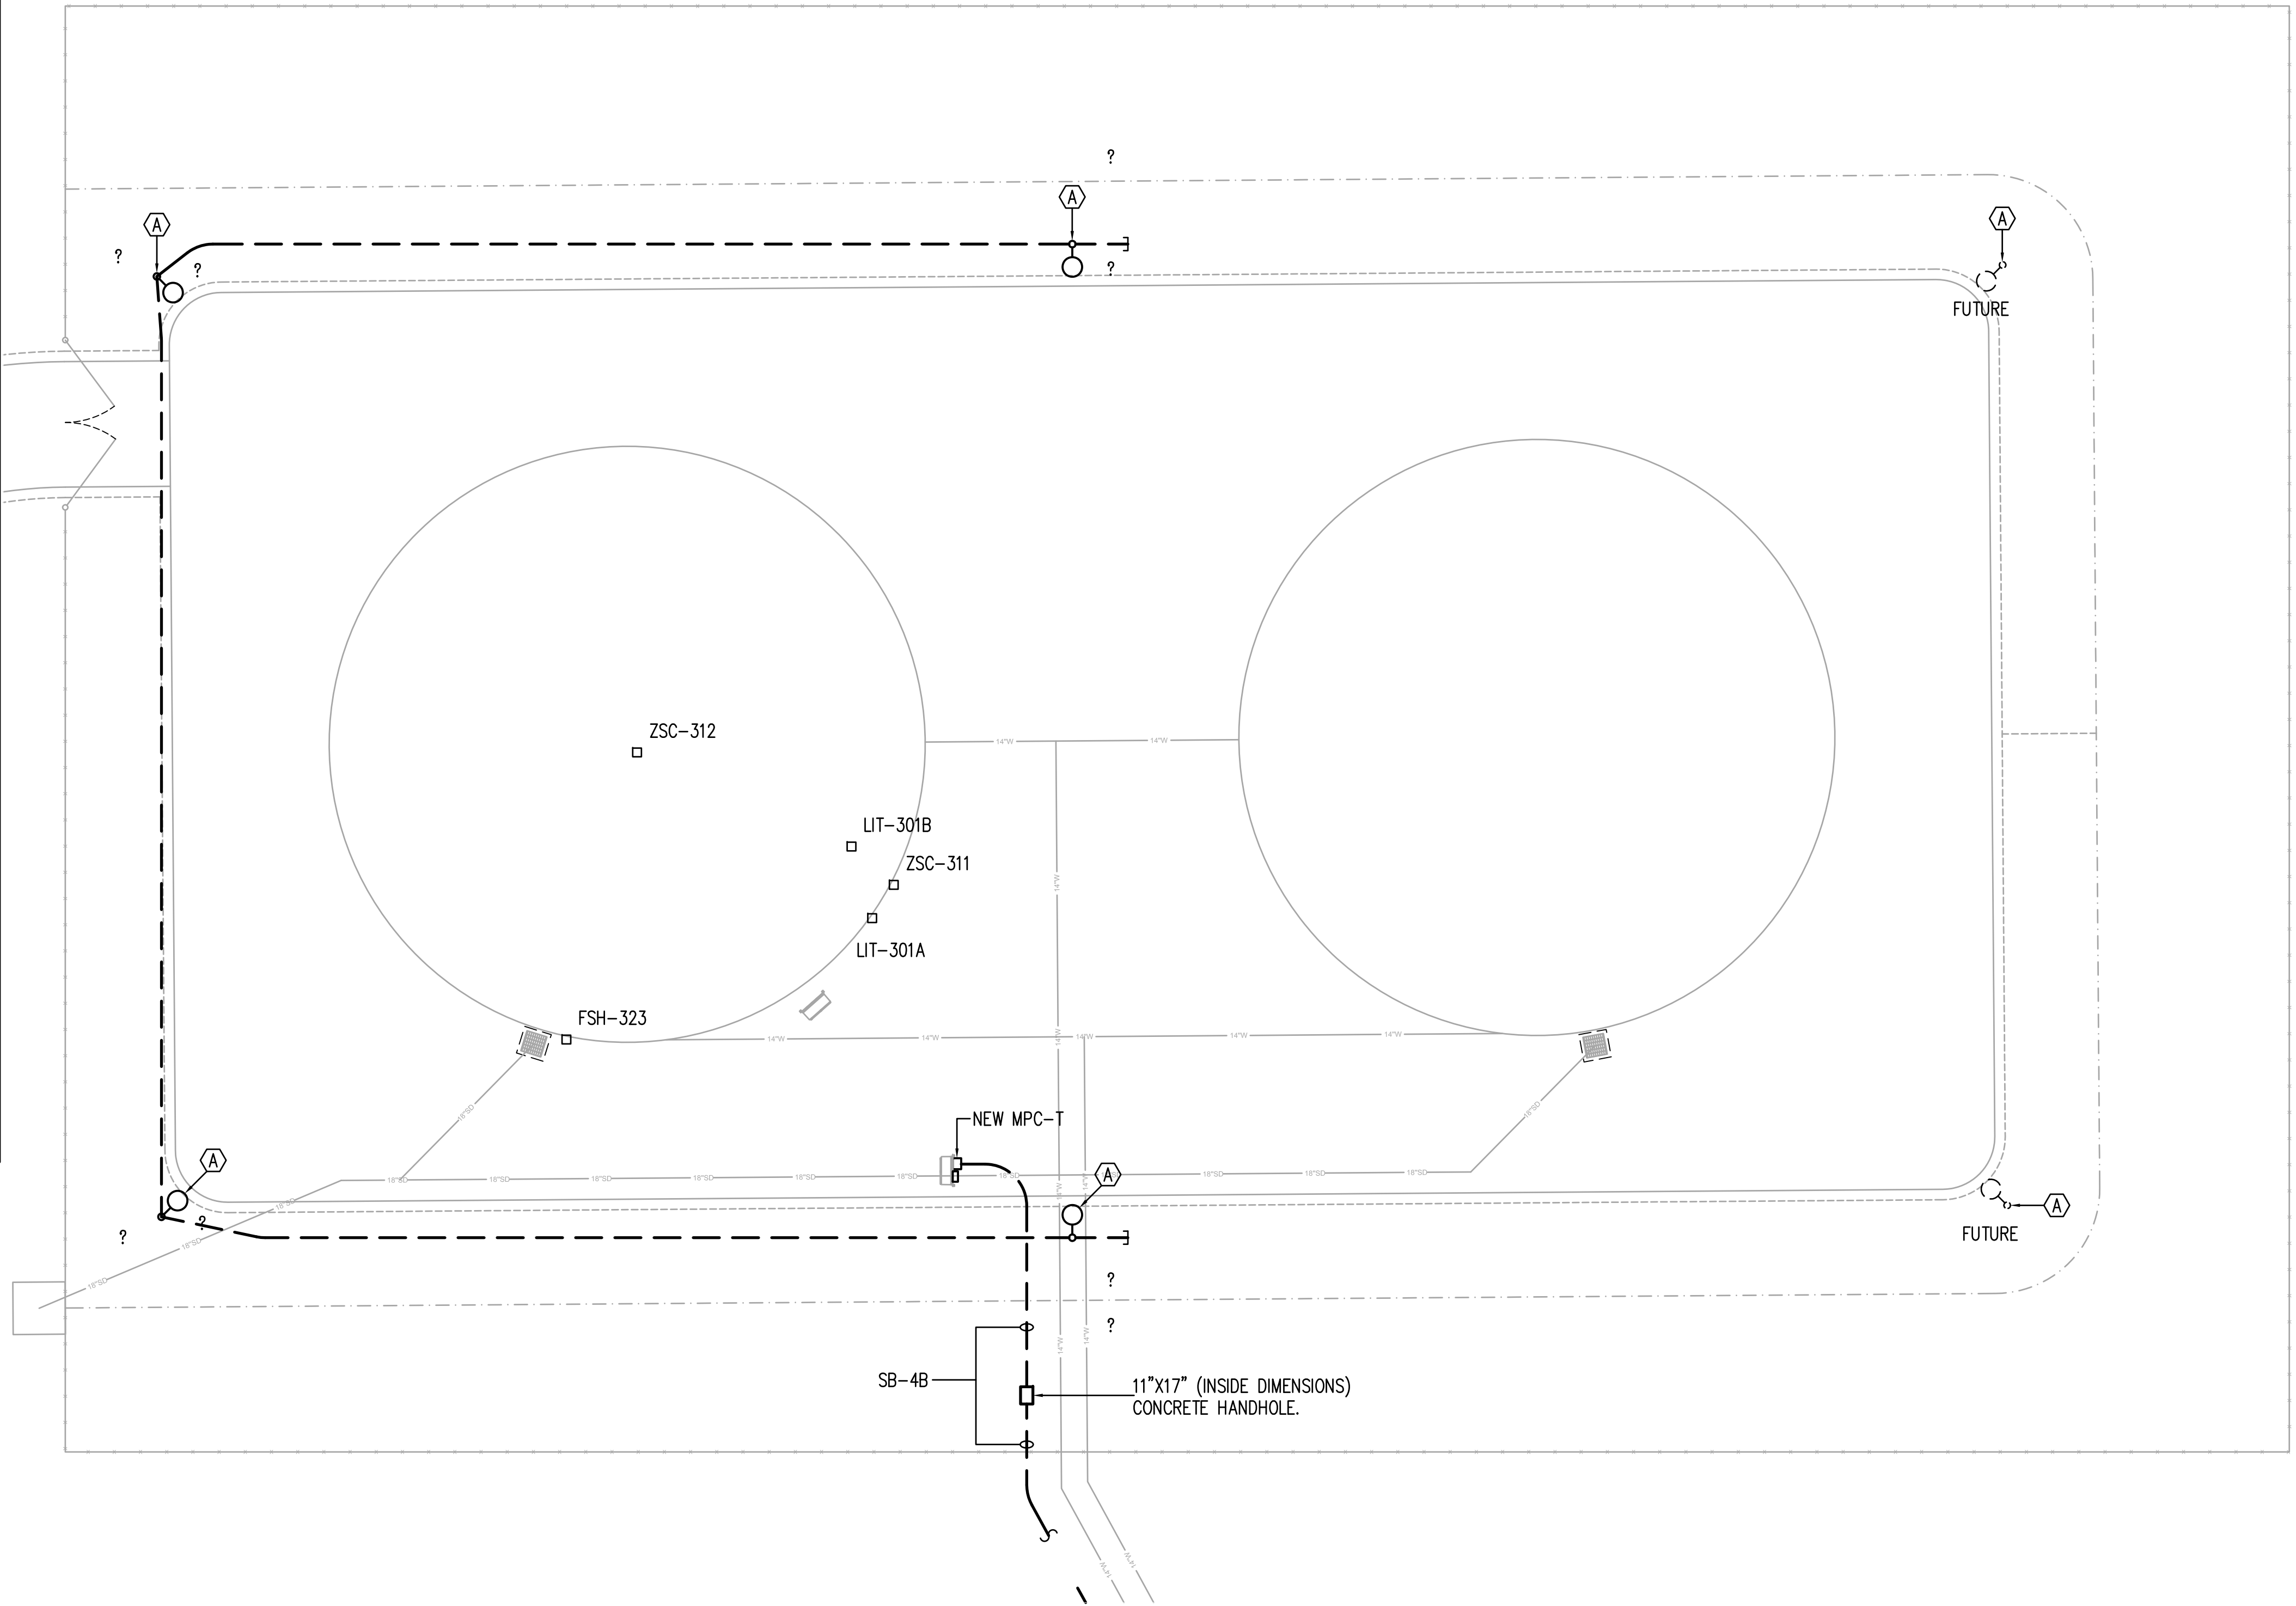
## 24 TANK SITE ELECTRICAL PLAN

- 1 ALL ELECTRICAL WORK SHOWN IS NEW UON.

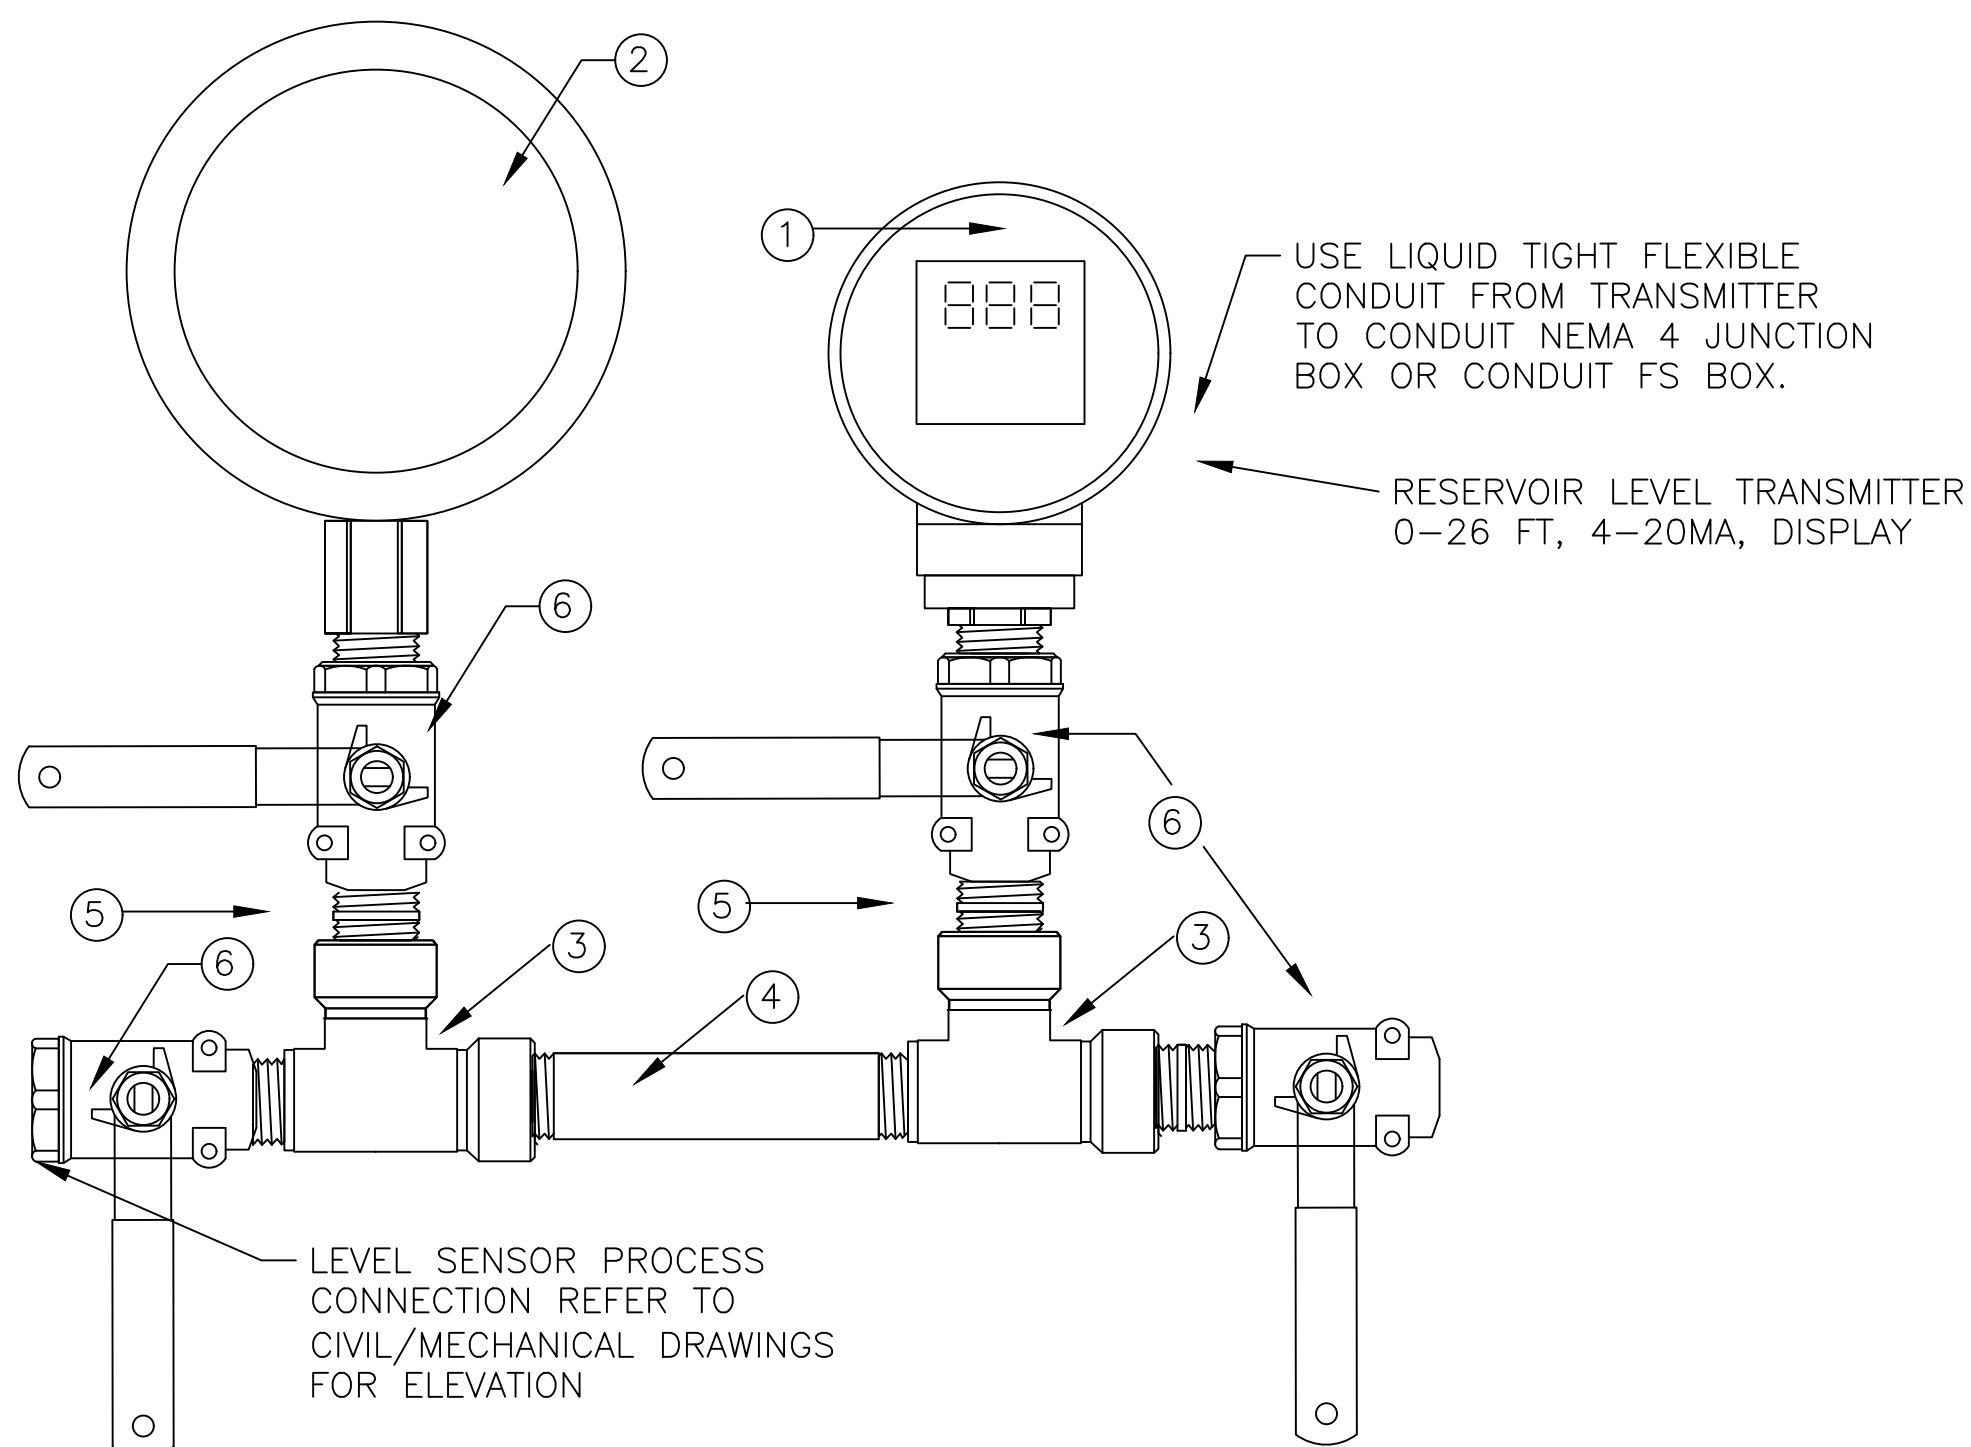
**(A)** PRESSURE/LEVEL TRANSMITTER ASSEMBLY

ITEM	QTY	DESCRIPTION	MANUFACTURER MODEL
1	1	PRESSURE TRANSMITTER, 0-26 FT, 4-20 MA, DISPLAY	SPECIFICATION SECTION 13801
2	1	PRESSURE GAUGE, 0-26 FT, 1/2" NPT	SPECIFICATION SECTION 13801
3	3	STREET TEE, 1/2" NPT, STAINLESS STEEL	SWAGelok SS-8-ST
4	1	NIPPLE, 1/2" NPT, STAINLESS STEEL	SWAGelok SS-8-HLN-4.00
5	2	CLOSE NIPPLE, 1/2" NPT, STAINLESS STEEL	SWAGelok SS-8-CN
6	4	BALL VALVE, 1/2" NPT, STAINLESS STEEL	APOLLO 76-103-01A

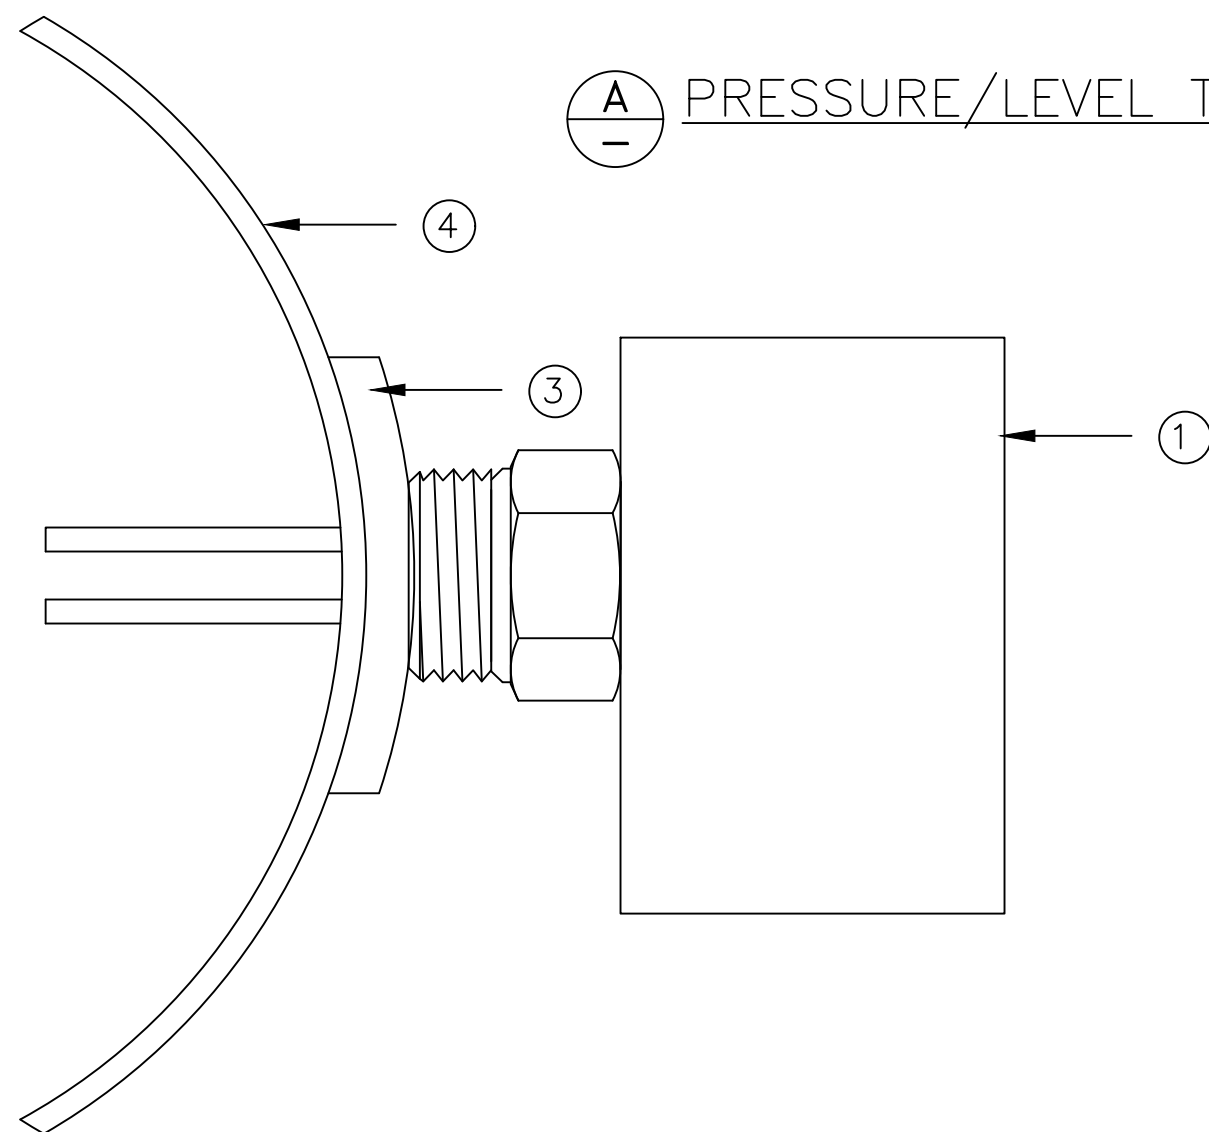
**(D)** RESERVOIR OVER FLOW SENSOR ASSEMBLY

ITEM	QTY	DESCRIPTION	MANUFACTURER MODEL
1	1	TANK OVER FLOW SENSOR, STAINLESS STEEL, 2 PROBE	SPECIFICATION SECTION 13801
2	1	LEVEL CONTROL RELAY, DC SERIES, 24 VDC, SPDT	SPECIFICATION SECTION 13801
3	1	2" NPT EXTRA HEAVY DUTY FITTING	
4	1	TANK OVER FLOW PIPE

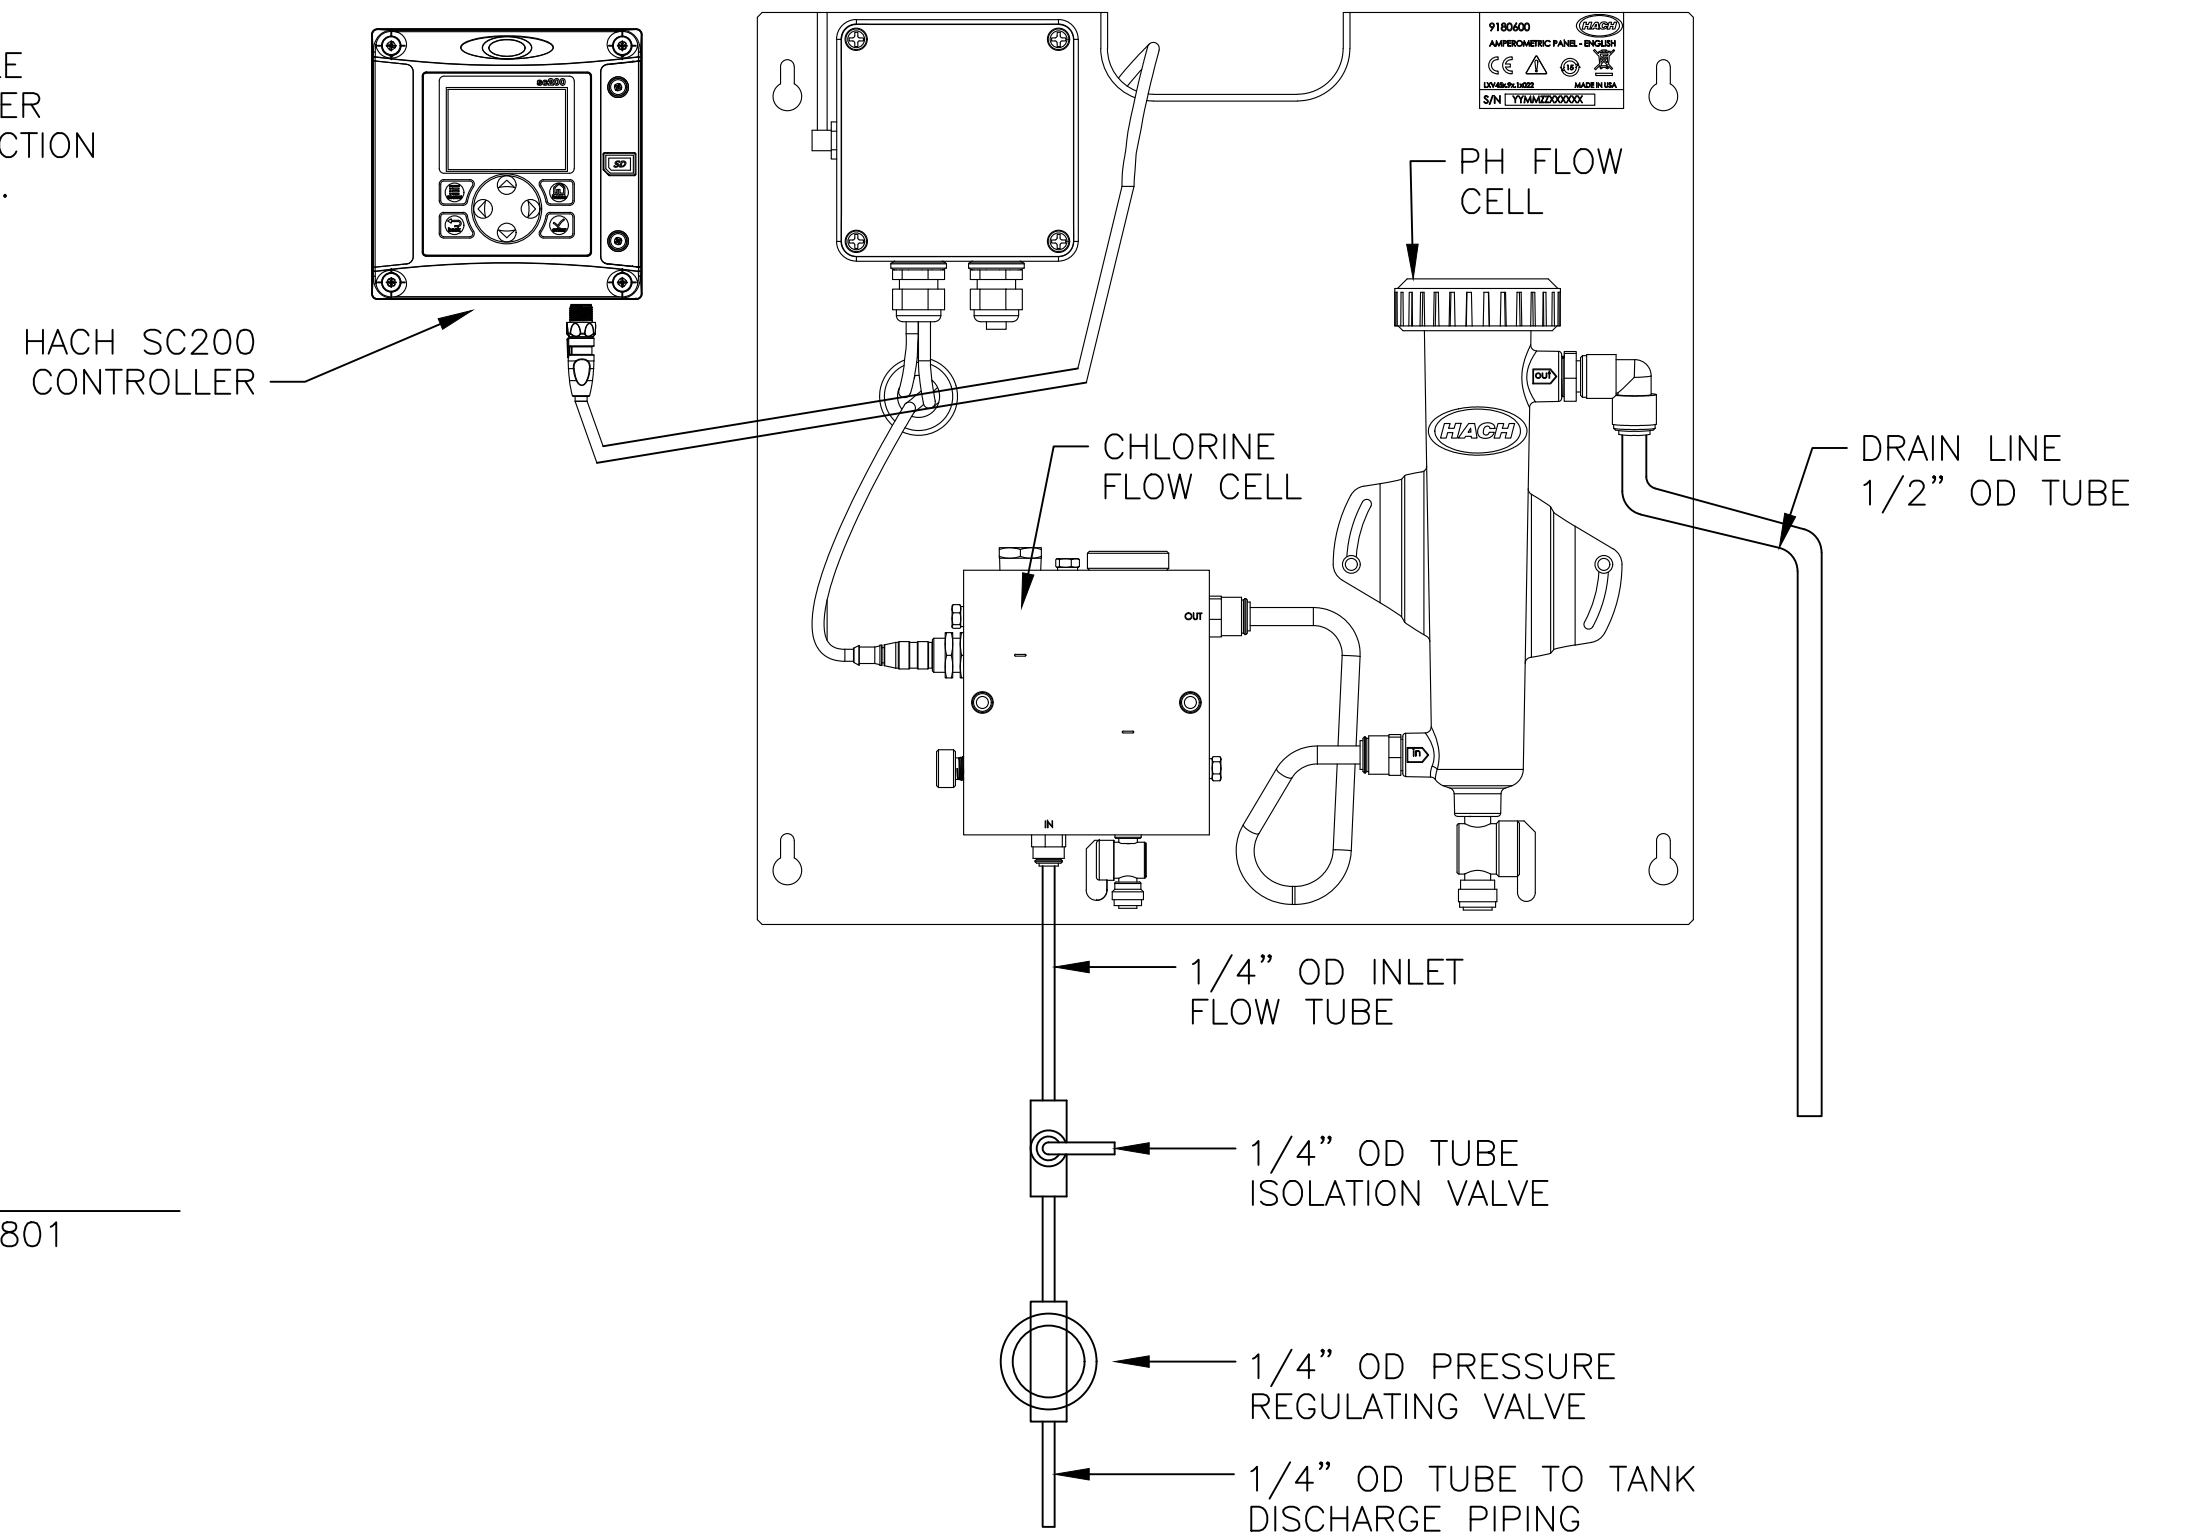
**(C)** CHLORINE RESIDUAL ANALYZER (TOTAL) ASSEMBLY

ITEM	QTY	DESCRIPTION	MANUFACTURER MODEL
1	1	CHLORINE RESIDUAL ANALYZER REAGENTLESS	SPECIFICATION SECTION 13801
2	1	CHLORINE RESIDUAL CONTROLLER	SPECIFICATION SECTION 13801
3	1	SUPPLY LINE 1/4" OD TUBING, LENGTH AS REQUIRED	
4	1	ISOLATION VALVE, 1/4" TUBE	
5	1	PRESSURE REGULATING VALVE, 1/4" TUBE

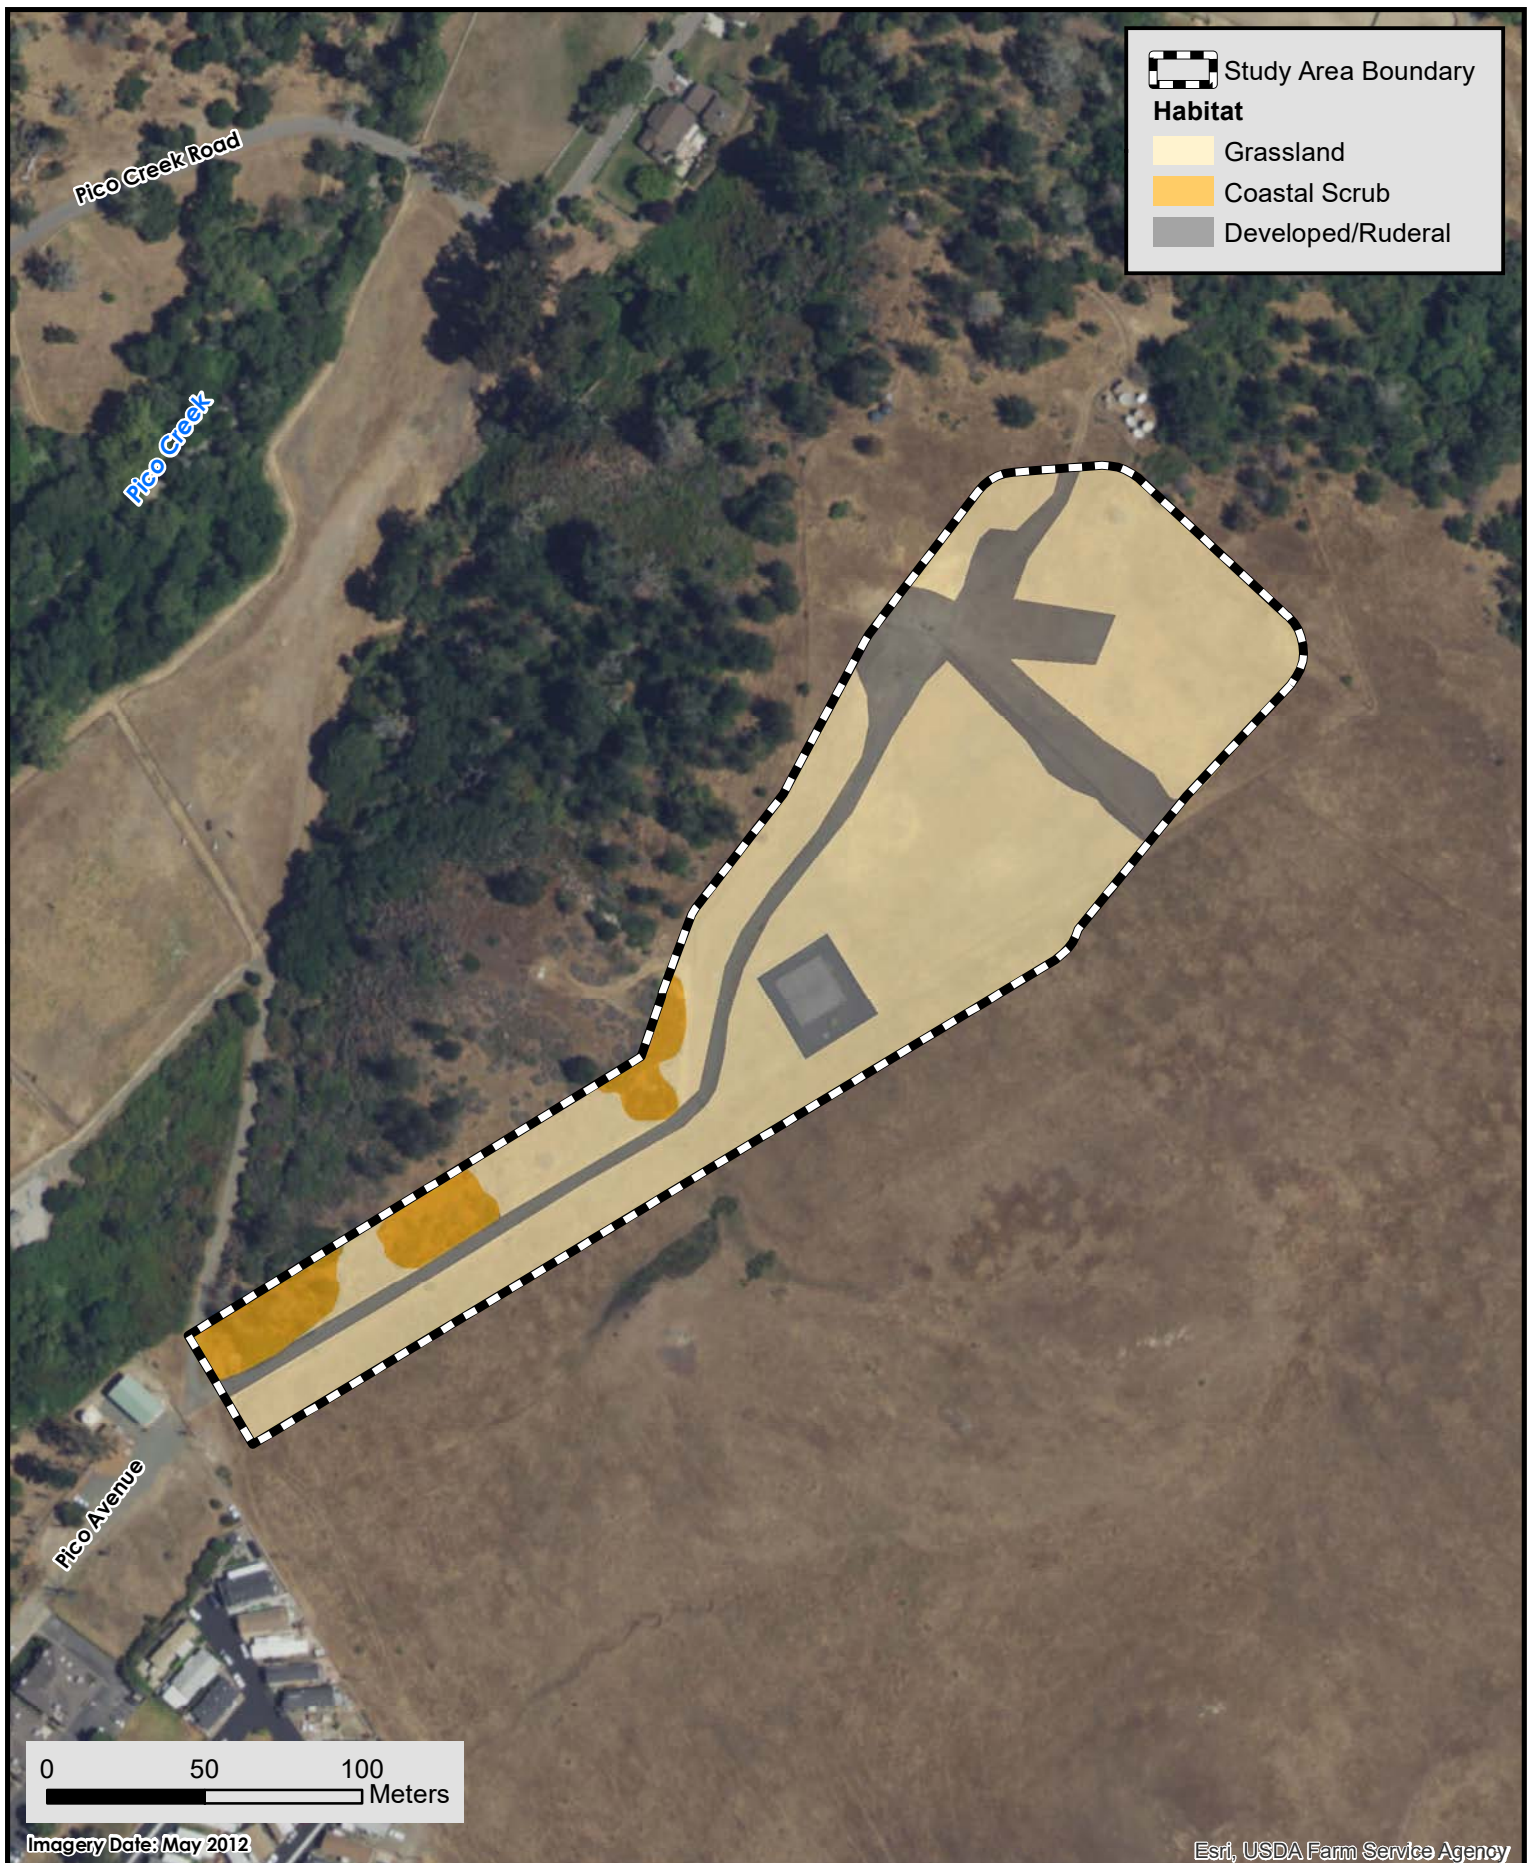
The grassland onsite consisted mainly of non-native species as described above for ruderal habitats, but there were also patches of native bunchgrasses with elements of coastal terrace prairie community, particularly along the northern and northeastern perimeter of the site where grazing impacts were reduced. In these areas, native grasses consisted of purple needle grass, California oatgrass (*Danthonia californica*), and blue wild rye (*Elymus glaucus*). Other native species were Santa

Ynez false lupine (*Thermopsis macrophylla*) and western rush (*Juncus occidentalis*). Near the edge of the study area and along the fence line in the northern and northeastern edges, were elements of the surrounding Monterey pine forest consisting of one isolated Monterey pine tree that was deceased from pitch canker, toyon (*Heteromeles arbutifolia*), and young coast live oaks (*Quercus agrifolia*), as well as a few coyote brush (*Baccharis pilularis*) shrubs.
