# San Simeon Community Services District

## Community Water Tank Project

### Initial Study and Mitigated Negative Declaration

September 2019

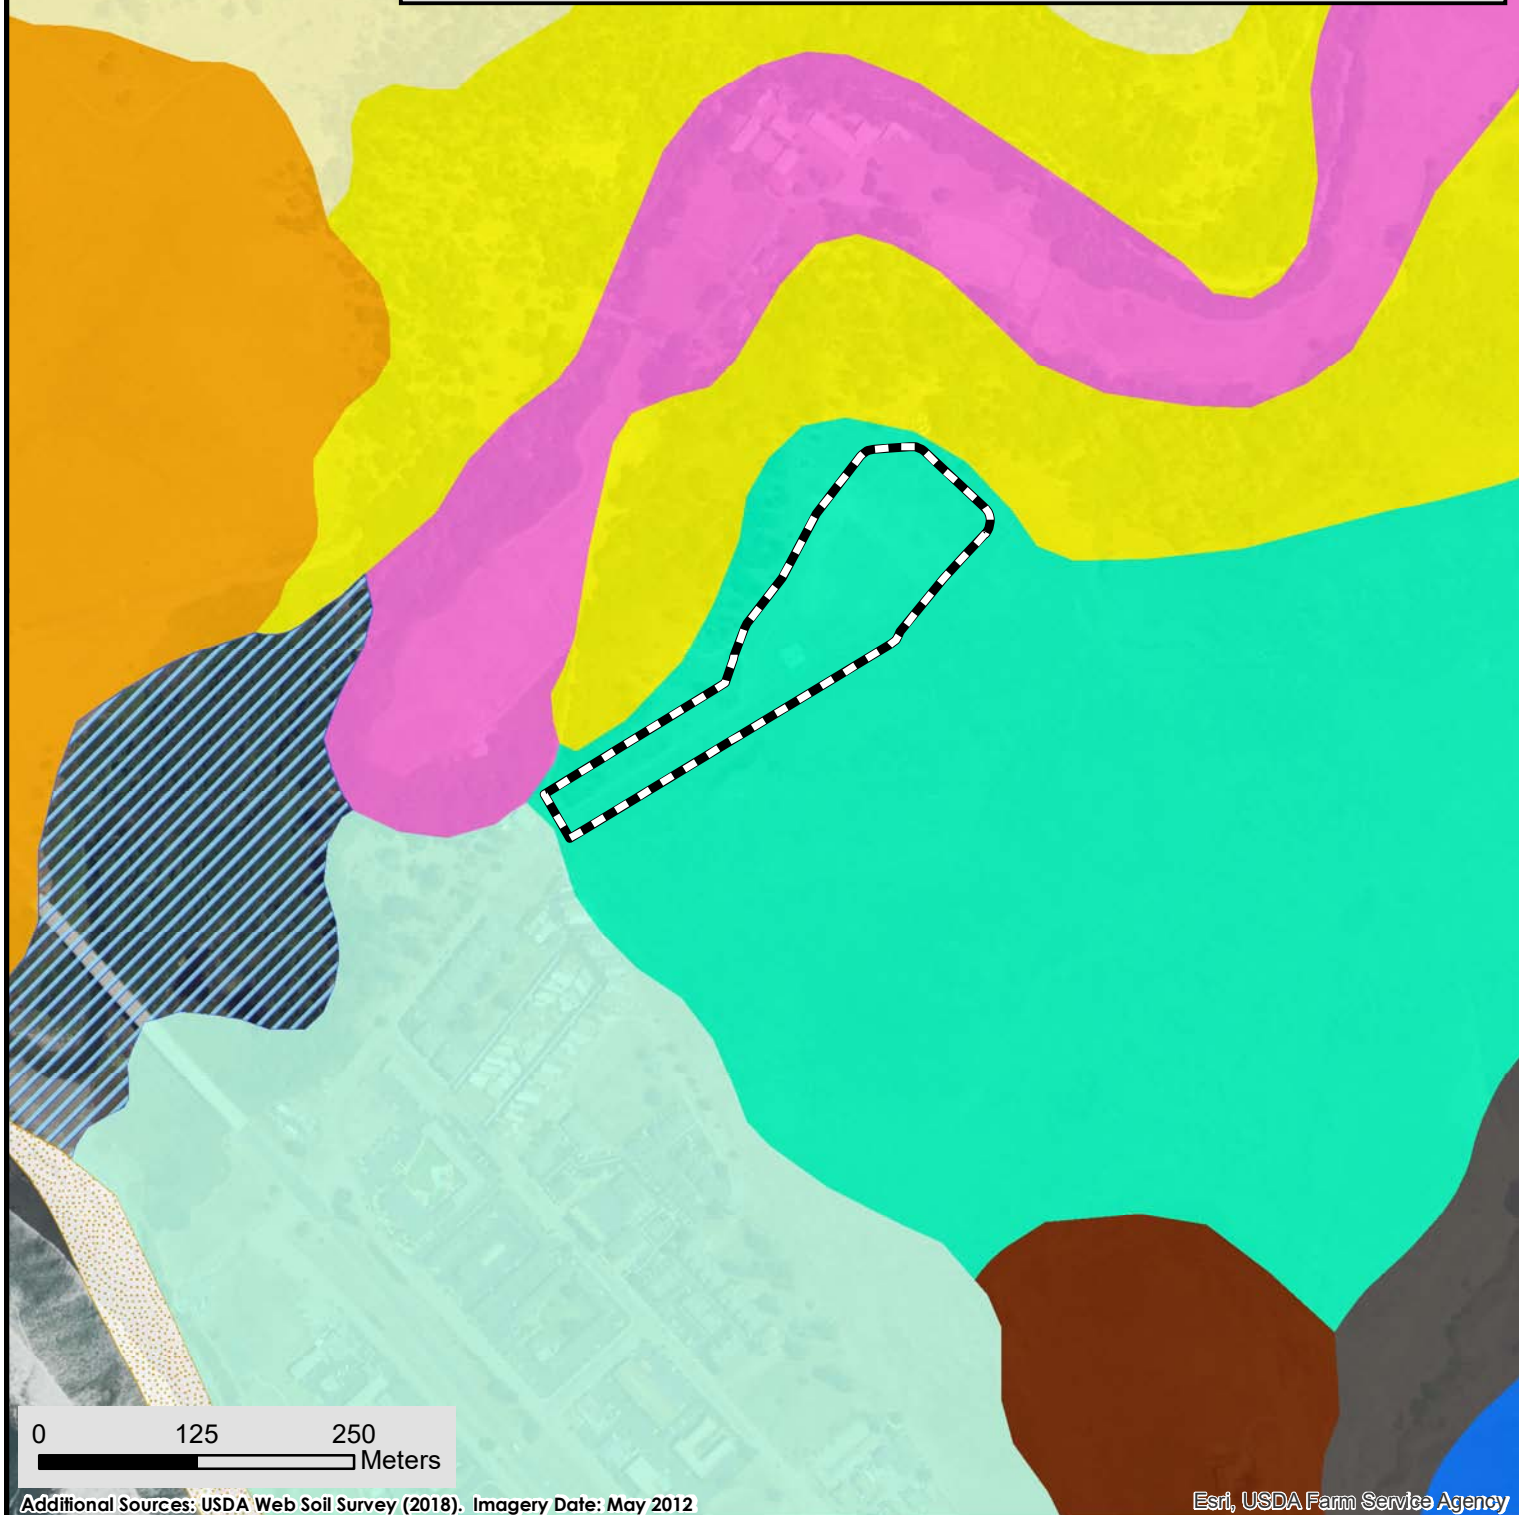
The Natural Resources Conservation Service (2018) identified only one soil type on the property, Concepcion loam 5-9% slopes, as shown on Figure 4. This soil occurs on the toeslope of terraces within 1 to 2 miles of the Pacific Ocean. It is alluvium derived from sedimentary rock and is moderately well-drained.

Additional Sources: USDA Web Soil Survey (2018). Imagery Date: May 2012

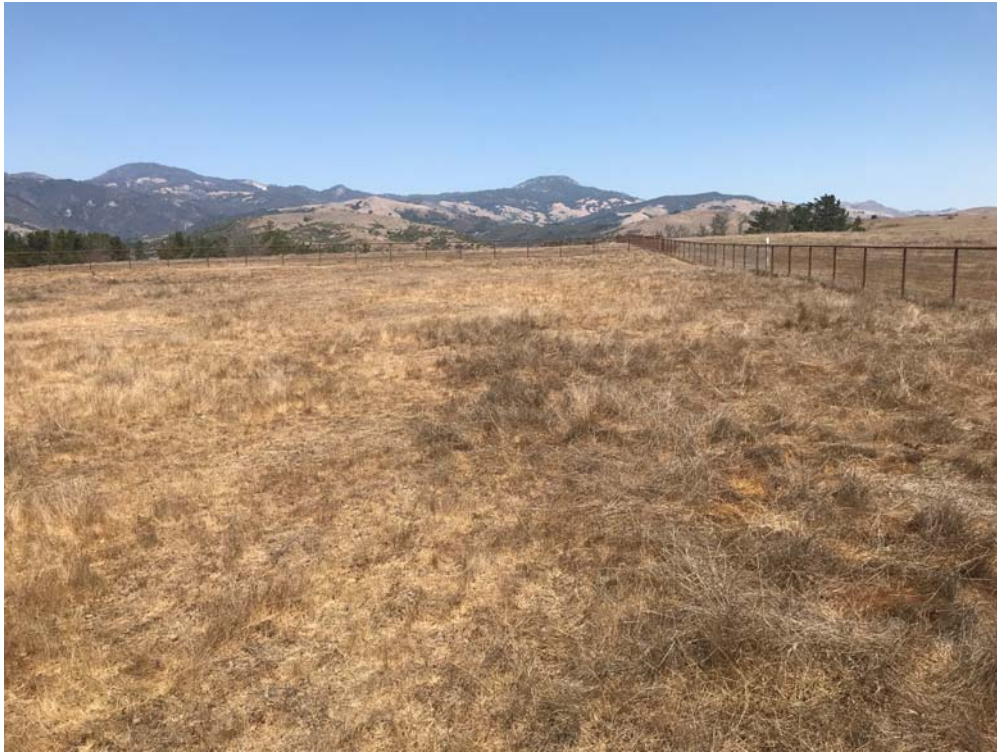
**Photo 1.** Grassland habitats in the project site that have been grazed by horses. Also shown is the perimeter fence.

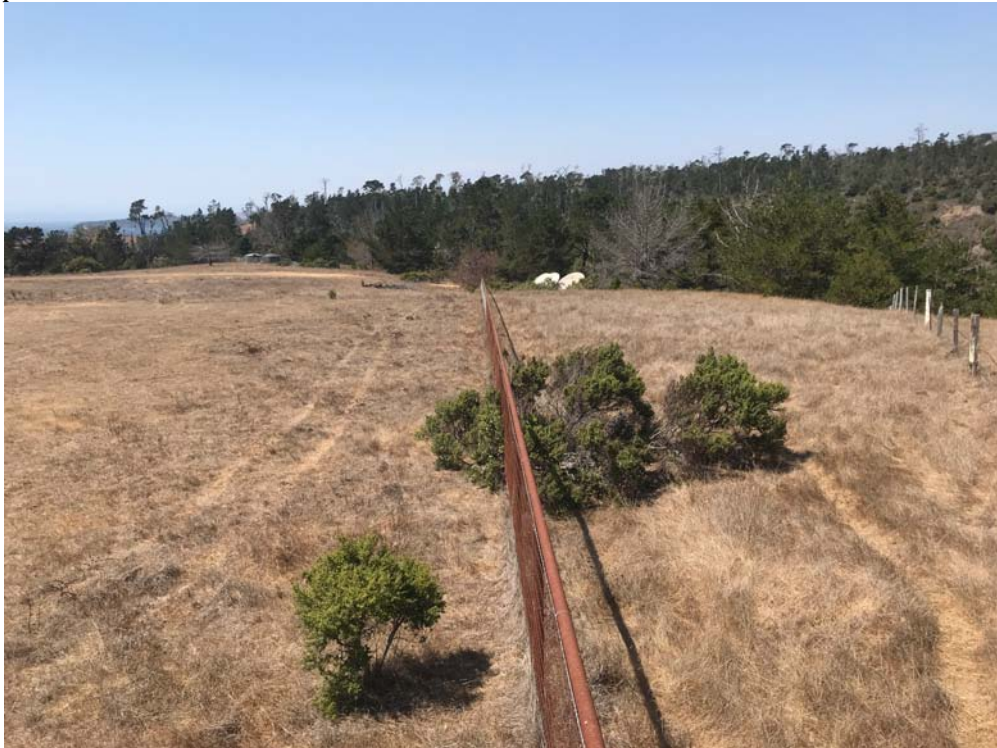
**Photo 2.** Grassland habitat with scattered coyote brush (*Baccharis pilularis*) shrubs along the study area perimeter. Monterey pine forest outside the boundary of the site is seen in the distance.

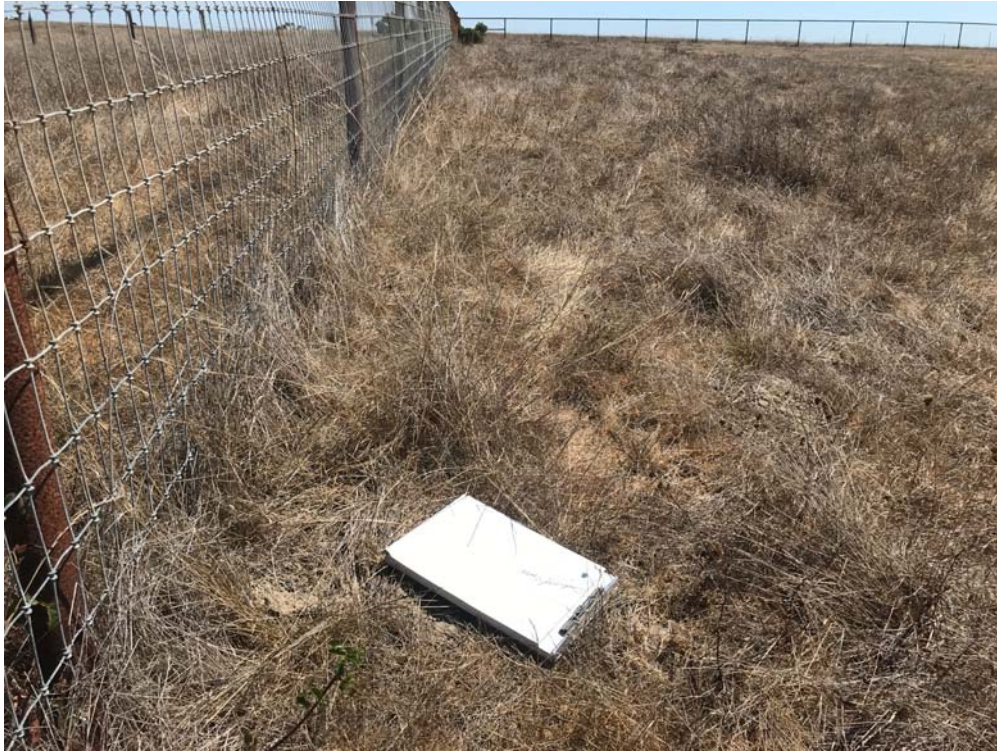
**Photo 3.** A native bunchgrass, purple needle grass (*Stipa pulchra*), occurred as a component of the grassland habitat in areas with lower disturbance.

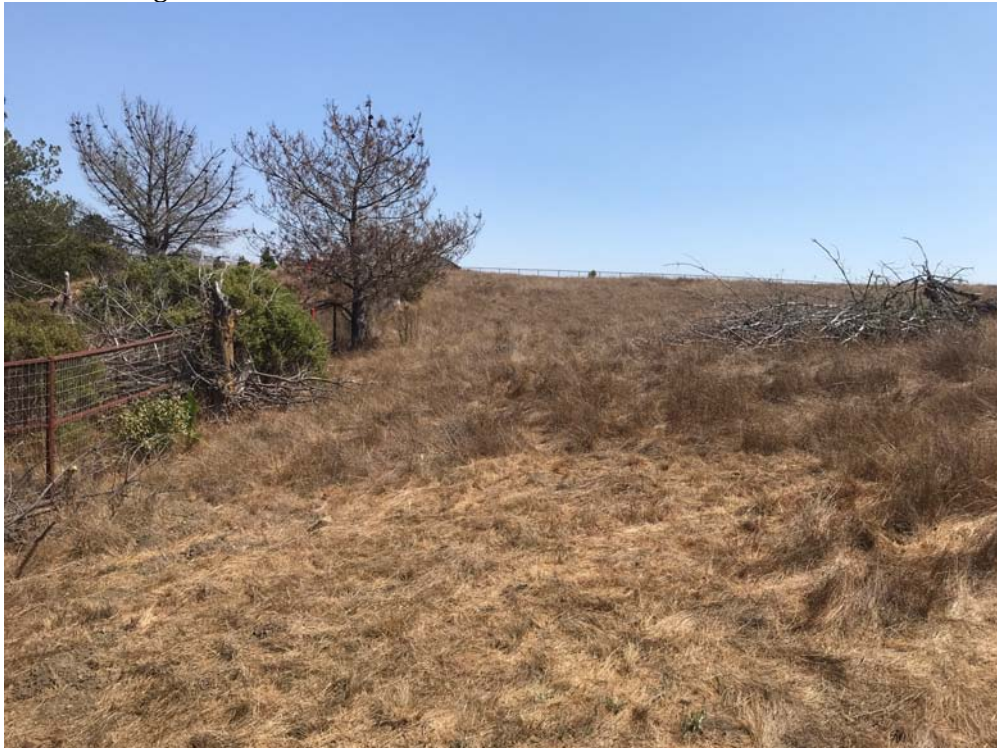
**Photo 4.** A deceased Monterey pine (*Pinus radiata*) along the edge of the study area was the only tree present.

Ynez false lupine (*Thermopsis macrophylla*) and western rush (*Juncus occidentalis*). Near the edge of the study area and along the fence line in the northern and northeastern edges, were elements of the surrounding Monterey pine forest consisting of one isolated Monterey pine tree that was deceased from pitch canker, toyon (*Heteromeles arbutifolia*), and young coast live oaks (*Quercus agrifolia*), as well as a few coyote brush (*Baccharis pilularis*) shrubs.

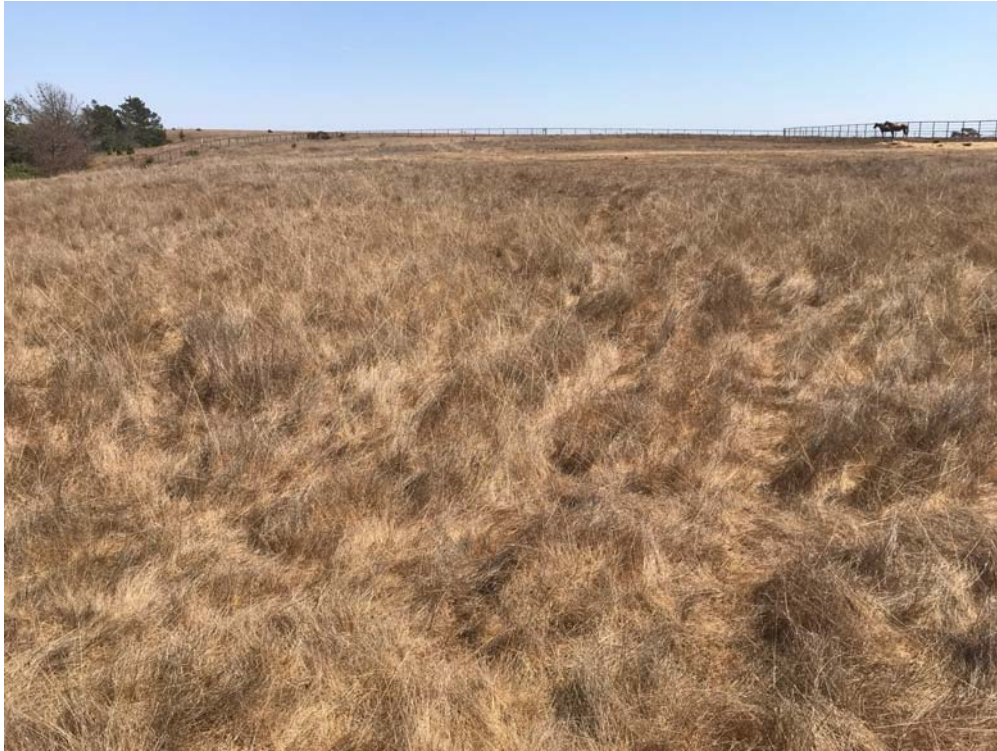
**Photo 5.** Grassland habitat had elements of coastal terrace prairie in areas with lower disturbance.

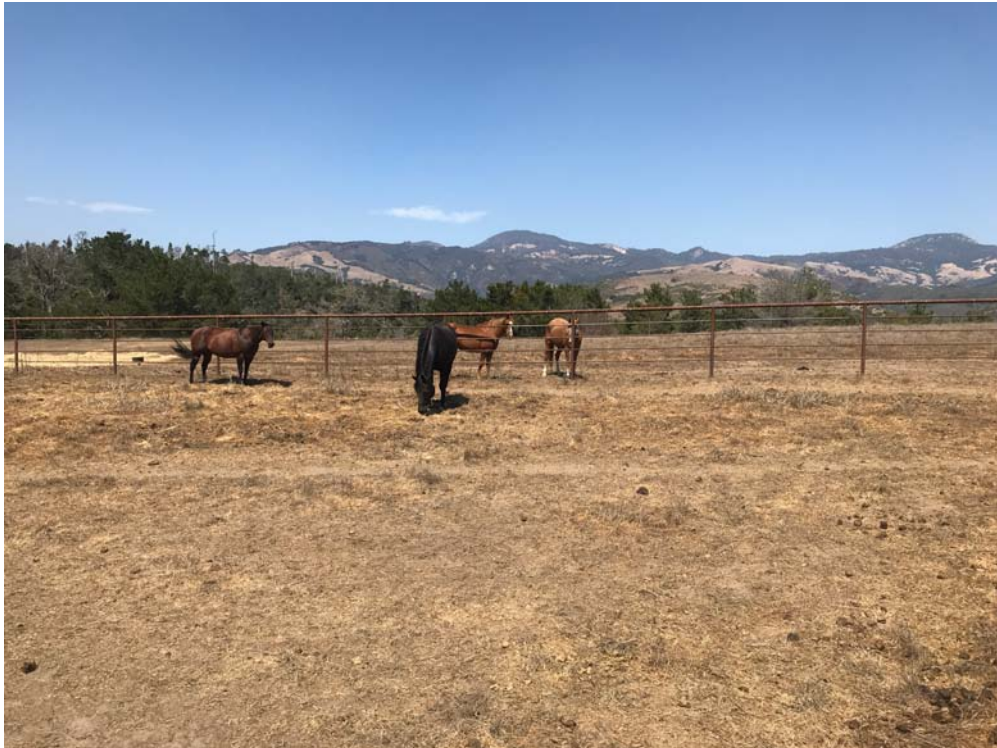
**Photo 6.** Ruderal areas along the interior pipe fence line where trampling and grazing effects were more pronounced.

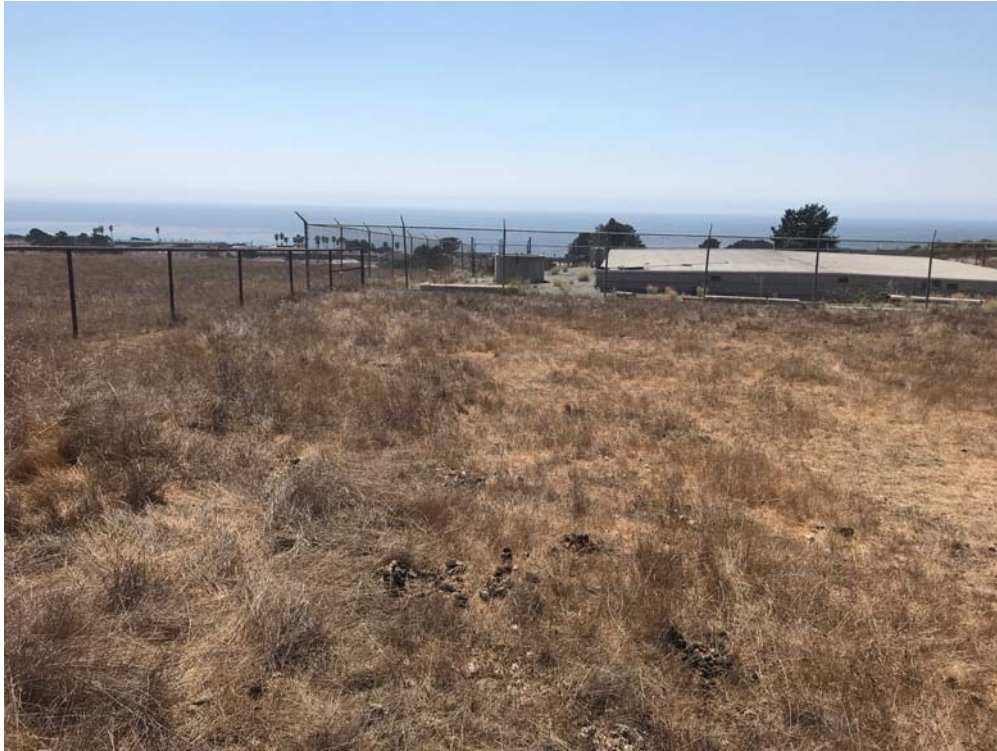
**Photo 7.** View from the southern perimeter fence looking southwest toward the existing reservoir. The new water line would run along the fence to the new tanks.

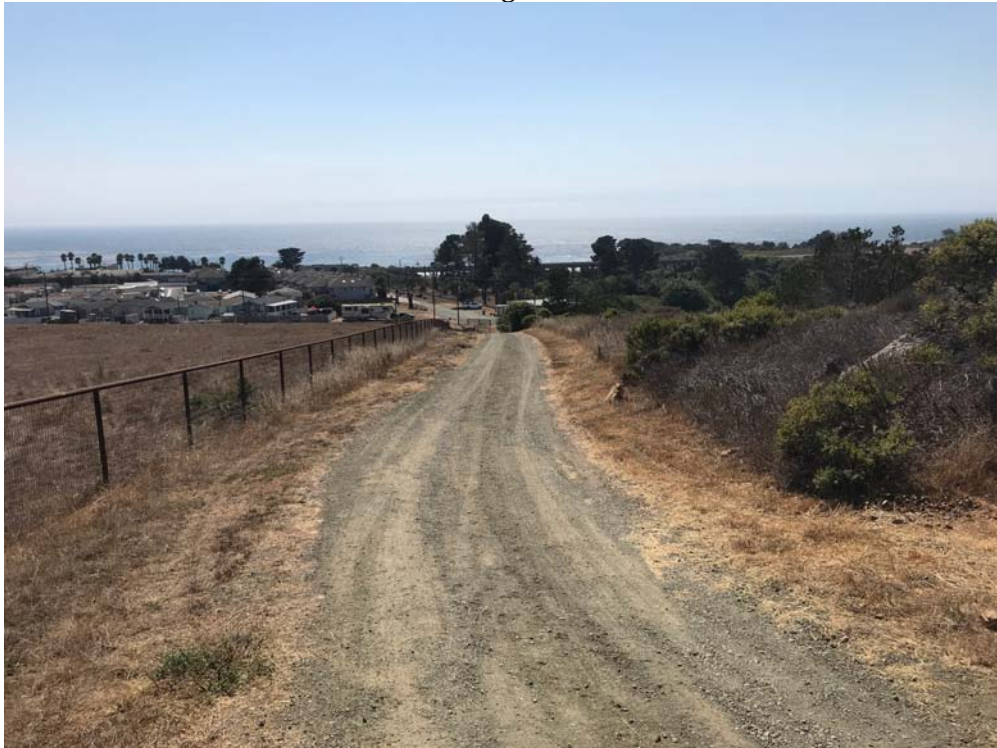
**Photo 8.** Coastal scrub habitat along the access road, looking toward the entrance of the site with the community of San Simeon in the distance. This road would be improved to 12 feet wide and surfaced with decomposed granite or crushed miscellaneous base.

B
1
- 12-FOOT WIDE DG (DECOMPOSED GRANITE) OR CMB (CRUSHED MISCELLANEOUS BASE) ACCESS ROADWAY. SEE

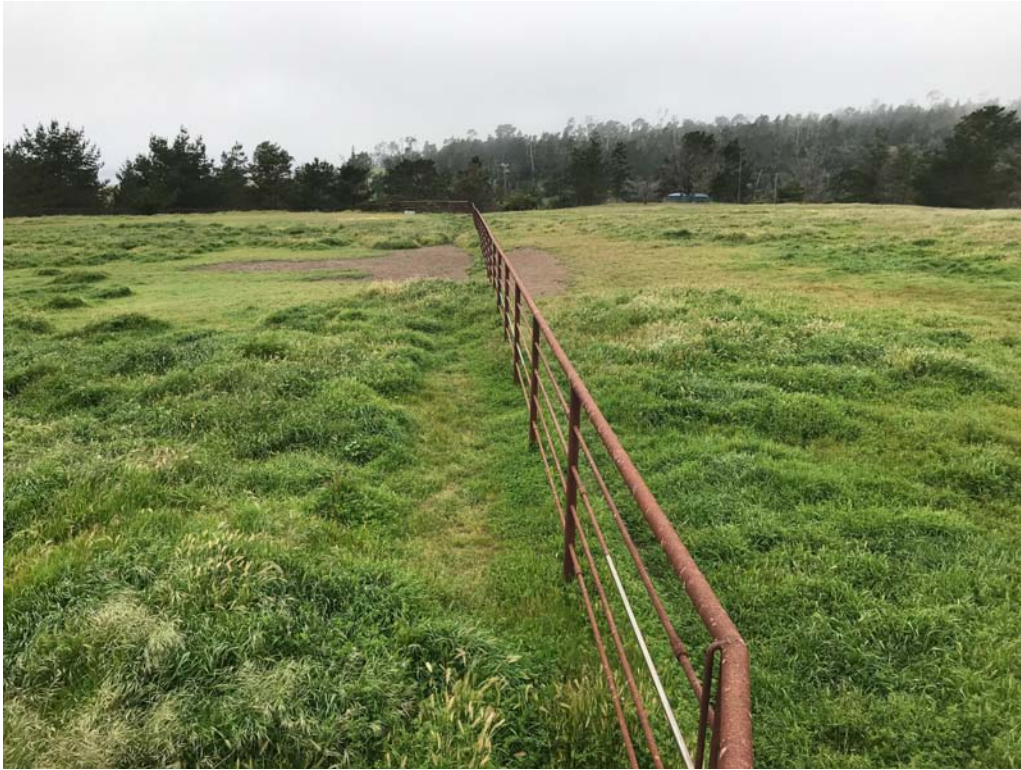
**Photo 3.** Site was actively grazed by horses and this photo shows central fence separating pastures. Note bare disturbed soils and dense non-native grasses.

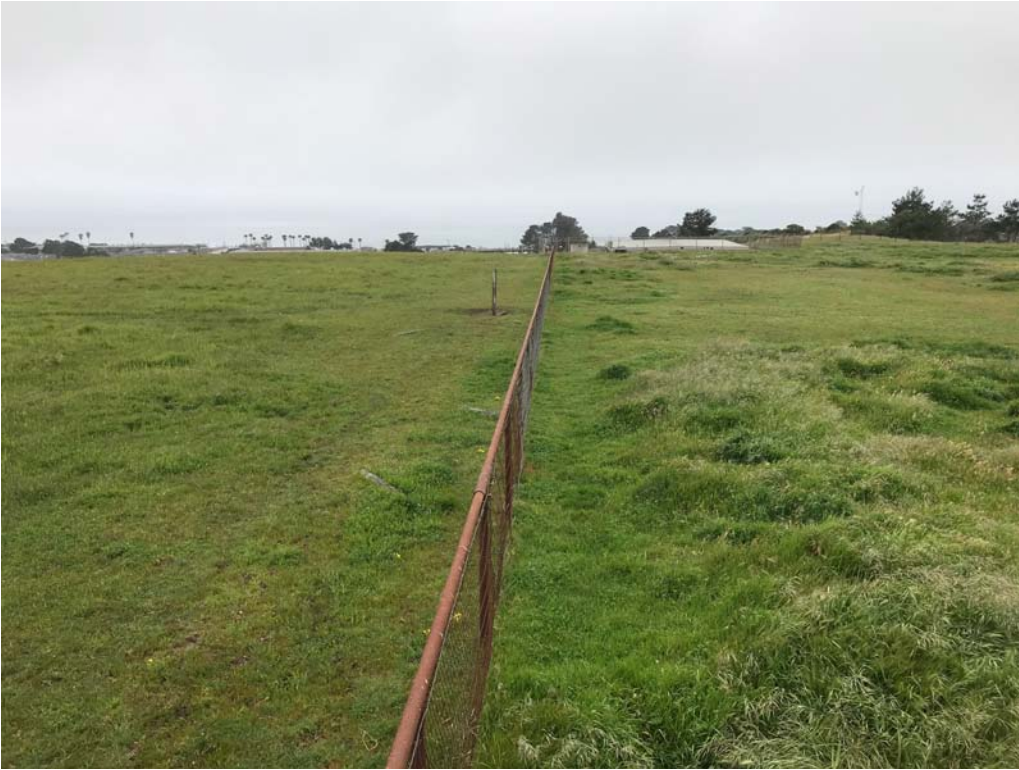
**Photo 5.** Eastern fenceline borders extensive grasslands on the neighboring property. Several Cambria morning glory plants were observed along the fence with higher density occurrences present further east offsite.

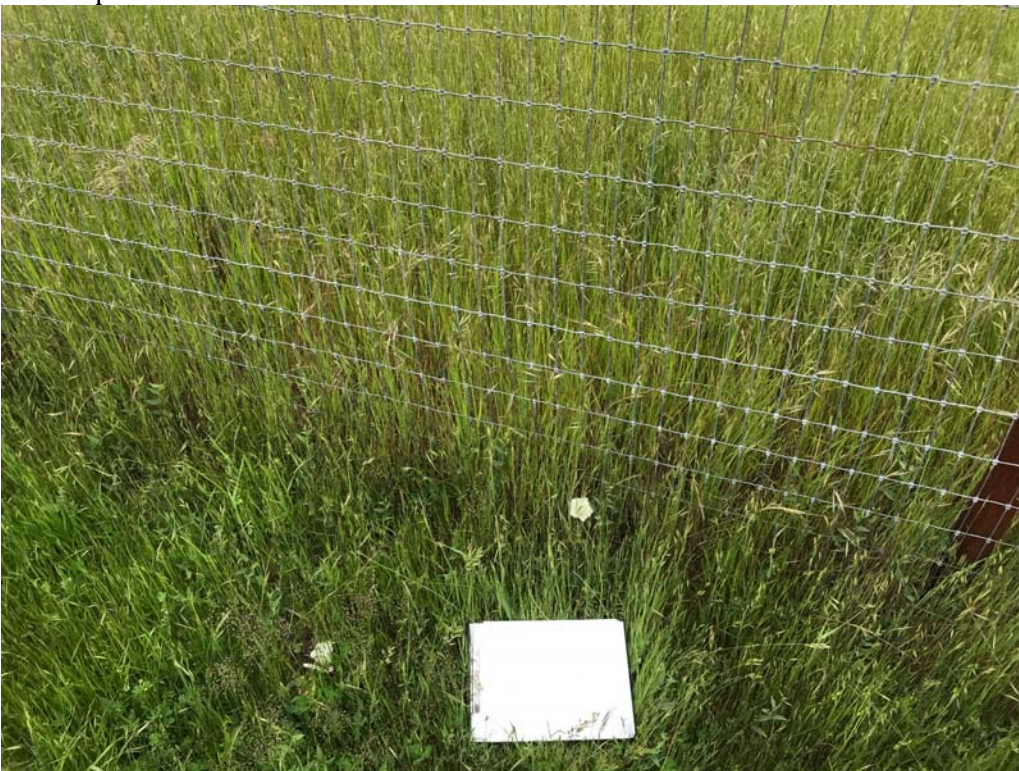
**Photo 6.** Photo of one Cambria morning glory plant growing along fenceline between existing reservoir and future tank site.

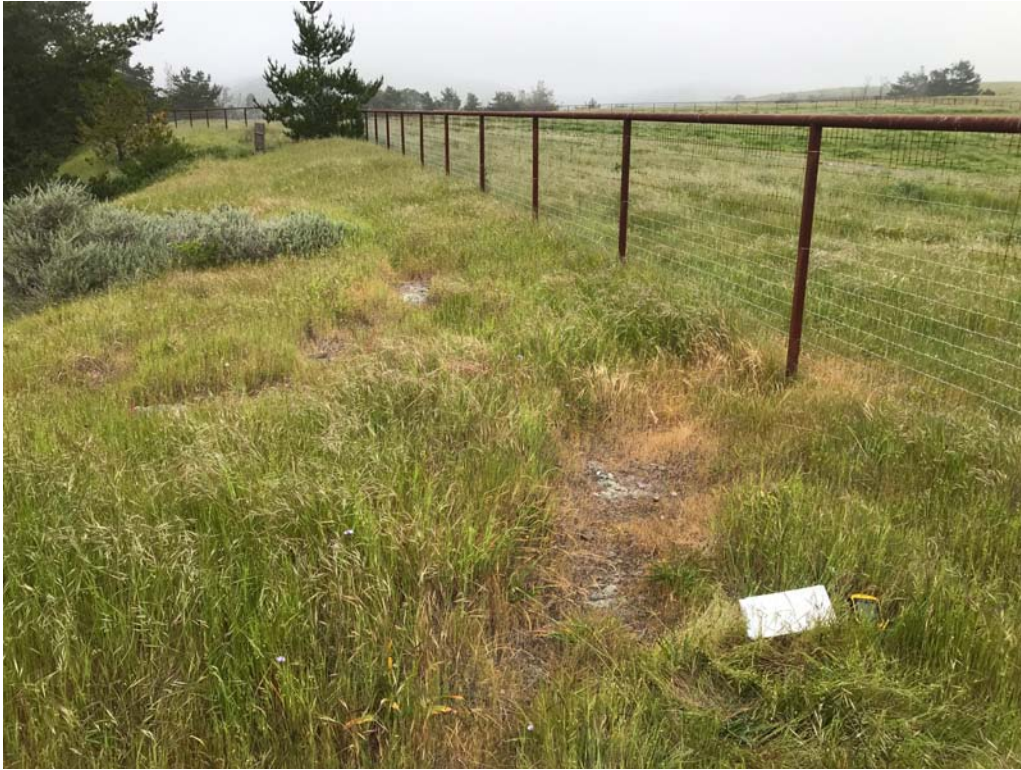
**Photo 7.** Several small rock outcroppings outside the western fenceline had occurrences of Blochman's Dudleya plants.

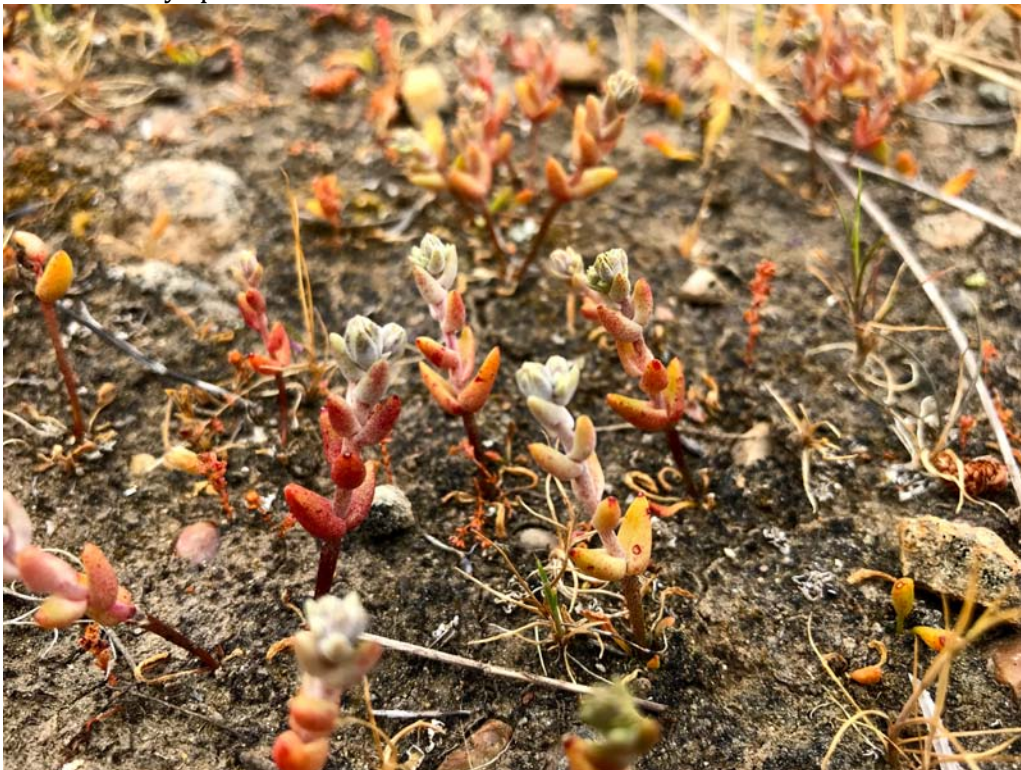
**Photo 8.** Close-up view of Blochman's Dudleya plants growing on exposed rock outside the western fenceline. These occurrences will not be impacted by the proposed project.
