**JURISDICTIONAL DELINEATION REPORT
FOR THE SUPERIOR AVENUE PEDESTRIAN
AND BICYCLE BRIDGE AND PARKING LOT
PROJECT
NEWPORT BEACH, CALIFORNIA**

September 2019

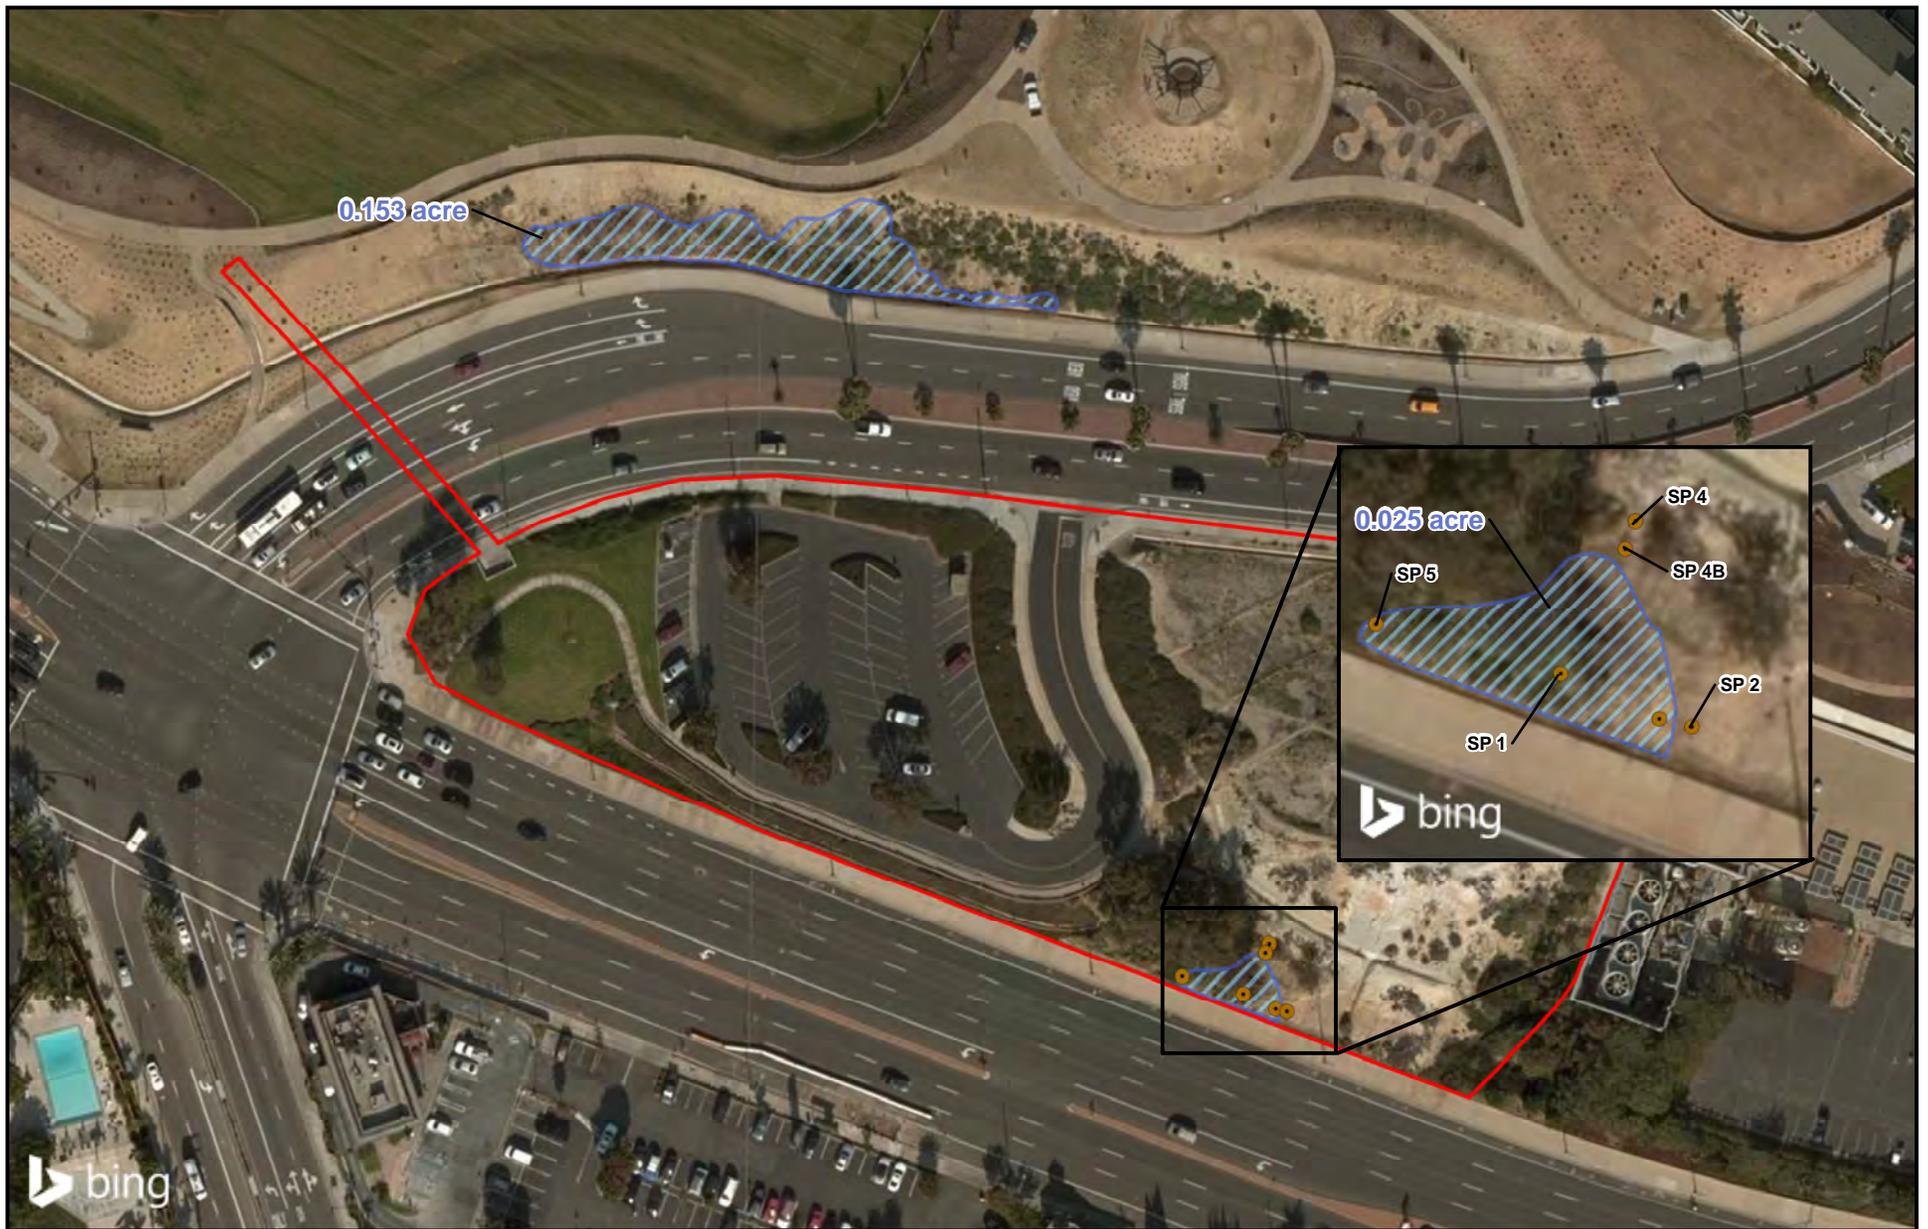
Figure 2
 Superior Avenue Pedestrian and Bicycle
 Bridge and Parking Lot Project
 Coastal Commission Jurisdictional Wetlands

Based on the observations and data collected during the fieldwork, Chambers Group identified and delineated areas both on site and off site that would meet the Commission’s criteria for jurisdictional wetlands (see Figure 2). There are no jurisdictional drainage courses or streams within the proposed Project area or immediately adjacent. The results of the delineation fieldwork, broken out into on-site wetlands and off-site wetlands respectively, are presented below.

As shown on Figure 2, there is one small area (approximately 1,090 square feet, or 0.025 acre) adjacent to the proposed Project site limits that exhibits sufficient hydrology to establish a prevalence of hydrophytic vegetation and/or the formation of hydric soils. This wetland is situated on a moderately steep slope facing West Coast Highway near the southeast corner of the proposed Project site. These wetlands are composed mostly of coastal freshwater (cattail) marsh vegetation having several strong wetland indicator plants, but some portions of the wetland area are completely unvegetated (bare ground), likely attributed to past disturbance (e.g., possible slope maintenance activities and impacts from transients who were observed camping just above the wetlands at the time of the fieldwork) or perhaps an allelopathic situation with unvegetated areas having a dense cover of Eucalyptus leaves, which often inhibit the germination of other plant species. In addition, the hydrology on the slope consists of an indeterminate source of groundwater seepage. Lastly, some marginal indicators of hydric soils exist, but the soil conditions fell short of satisfying the hydric indicators (e.g., gleyed matrix, depleted matrix). These wetland parameters are described in more detail below.

Soil pit 1 (SP1) is located near the center of the West Coast Highway wetland area, where freshwater marsh habitat occurs (see Figure 2). This soil pit was selected to confirm the presence of other wetland parameters (i.e., hydric soils and wetland hydrology). Interestingly, strong indicators of wetland hydrology were present, but the soils lack positive hydric soil indicators. Specifically, no redox features were present despite the low matrix chroma of 2, and although gleyed soils did exist, the matrix value of 2.5 was too low to be an indicator of hydric soils (i.e., gleyed matrix value must be 4 or higher) (USACE 2008). This could indicate a wetland area where the wetland hydrology is relatively new and hydric soil indicators, which often take years to establish, have not had time to develop.

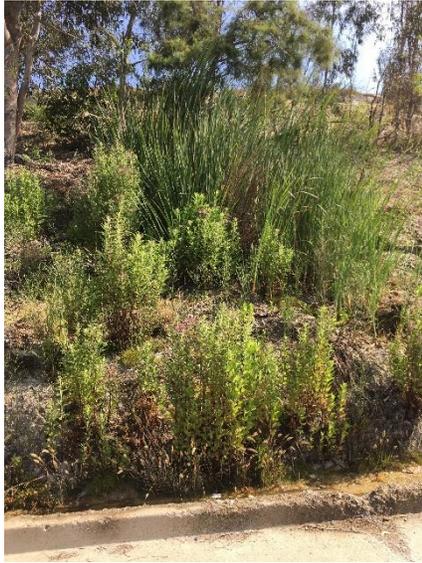
Photo 1: View of wetlands on north side of West Coast Highway. Assortment of wetland plants growing on wet slope above concrete-lined drainage ditch adjacent to sidewalk.

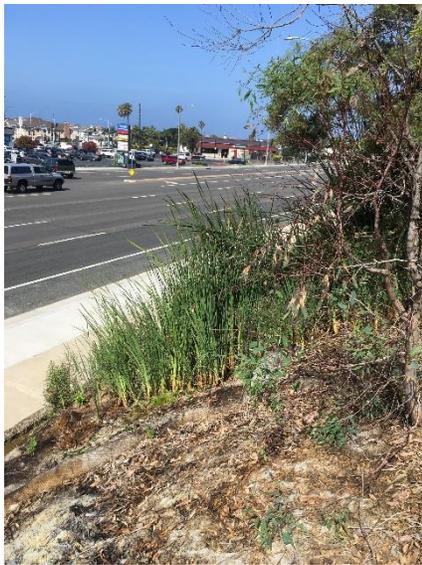
Photo 2: West Coast Highway wetlands. Note saturated soils in foreground adjacent to cattails and sparsely vegetated to unvegetated conditions there.

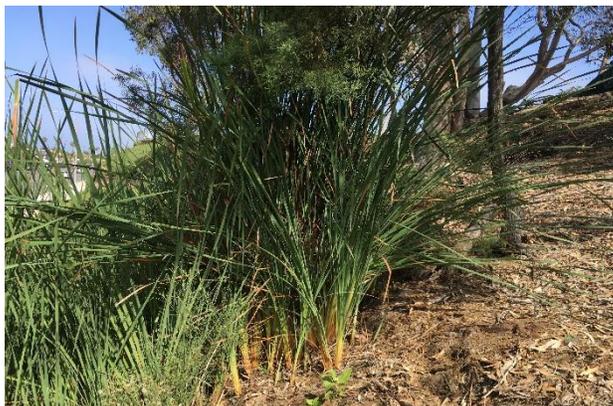
Photo 3: Close up of dense patch of cattails associated with on-site wetlands.

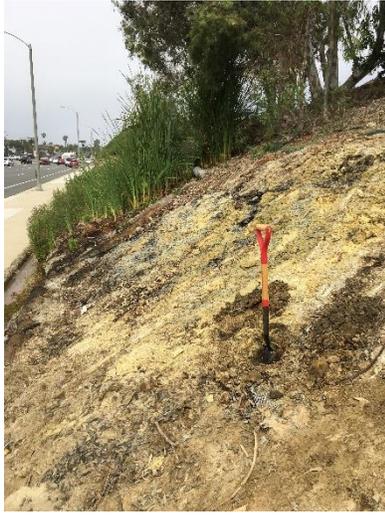
Photo 4: View of Sample Pit 2.
Note saturated soils and
unvegetated conditions on slope
next to Sample Pit 2. Cattails in
distance.

Soil pit 2 (SP2) was selected at a location that appeared to satisfy wetland hydrology but lacked any vegetation. This was to establish whether hydric soil indicators were present along with wetland hydrology. The soil pit revealed a multi-layered soil profile of primarily silty clay and sandy silt. Abundant redox concentrations were present within the sandy silt layers, but the matrix chroma of 4 was too high for it to be an indicator of hydric soils (USACE 2008). In addition, there were gleyed soils within 12 inches of the surface, but they only accounted for approximately 10 percent of the soil profile when at least 60 percent is required to qualify as a hydric soil indicator (USACE 2008). Consequently, the hydric soil parameter was not satisfied. Again, it could be indicating a recently established wetland where the hydric soil indicators have not had enough time to develop.

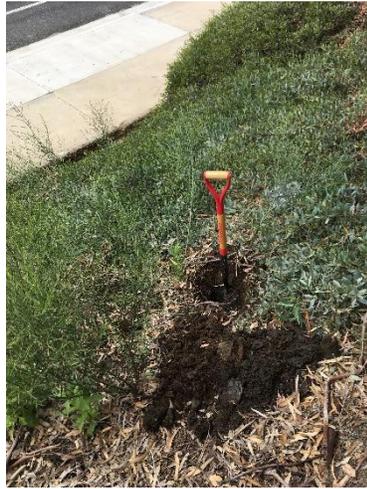
Photo 5: View of Sample Pit 5.
Note change in vegetation from
wetland vegetation on left and
upland vegetation on right.
Wetland margin.

Soil pit 5 (SP5) was selected at an on-site location that appeared to be just inside the wetland boundary. SP5 appeared to have some wetlands plants, but acacia (*Acacia* sp.), an upland plant used for landscaping, was dominant. This soil pit was excavated to determine if hydric soils and/or wetland hydrology were present. The soil consisted entirely of a very dark (10YR 2/1) silty clay but lacked any redox features. Some marginal indication of wetland hydrology existed (see SP5 data sheet, Appendix B). Therefore, this sample plot location was determined to be at the wetland boundary.

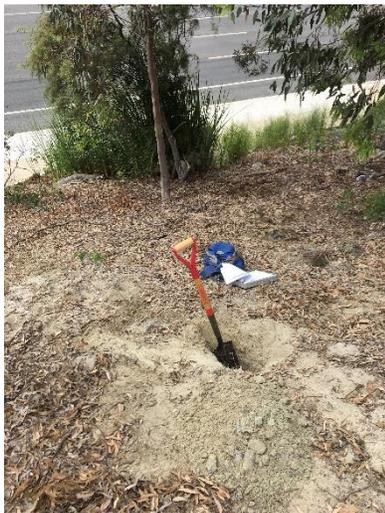
Photo 6: View of Sample Pit 4.
Note dry, sandy (non-hydric) soils.
Lacks vegetation and hydrology.

In examining the slope above the freshwater marsh habitat, soil pit 4 (SP4) appeared to have the same conditions as SP3. The soils had a different soil composition and soil colors, but no hydric soil indicators were present. Soil pit 4B (SP4B) was selected closer to the marsh habitat. Although there was no visible indicators of wetland plants or wetland hydrology, the soils at 18 inches from the surface were slightly damp. In addition, although the soils did not satisfy any of the conditions associated with hydric soils, gleyed soils again occurred within 12 inches of the surface. The gleyed soils accounted for approximately 95 percent of the soil profile from 5-18 inches, but the gleyed matrix value of 2.5 was too low to be an

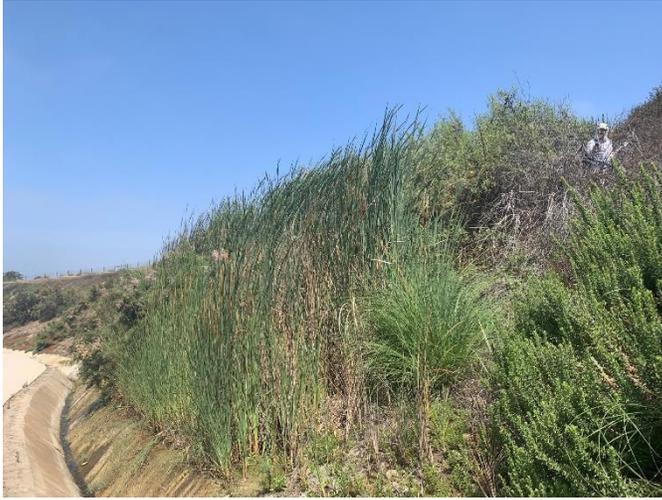
Photo 7: View of Superior Avenue wetlands on north side of Superior Avenue. Dense stand of cattails growing on wet slope above concrete-lined drainage ditch adjacent to sidewalk.

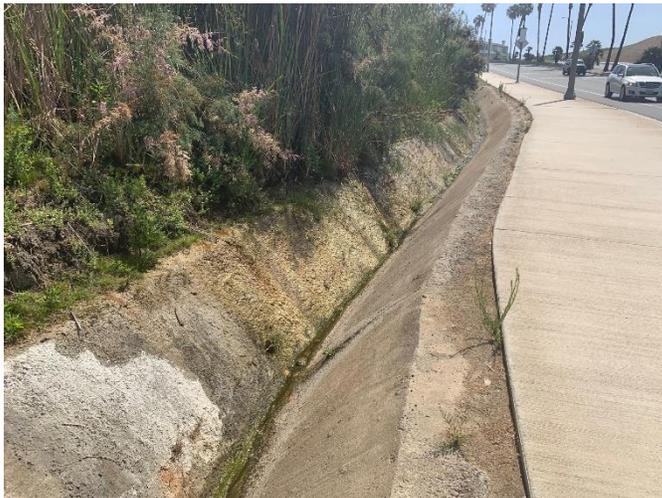
Photo 8: Superior Avenue wetlands. Note excess water draining off slope into the concrete-lined drainage ditch at toe of slope.

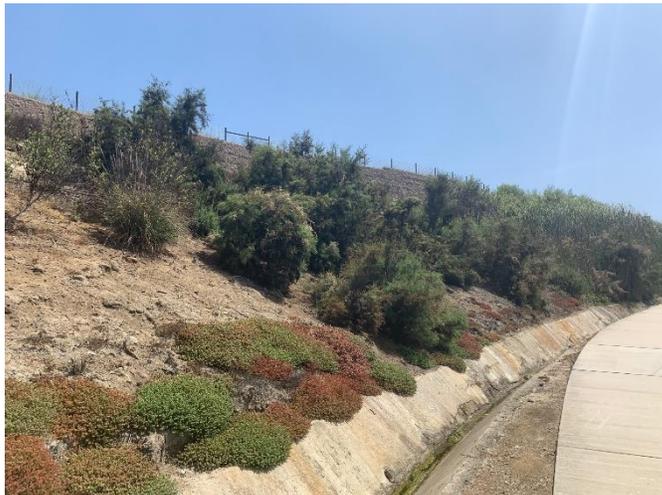
Photo 9: Superior Avenue wetlands. View of closest point of wetlands to proposed bridge. This is limit of wetlands on slope.
