**City of San Juan Capistrano
San Juan Creek at Rancho Mission Viejo Riding Park
Ordinary High Water Mark Delineation
Technical Report**

April 2018

Prepared by:
Amec Foster Wheeler
Environment & Infrastructure, Inc.
9177 Sky Park Court,
San Diego, CA 92123

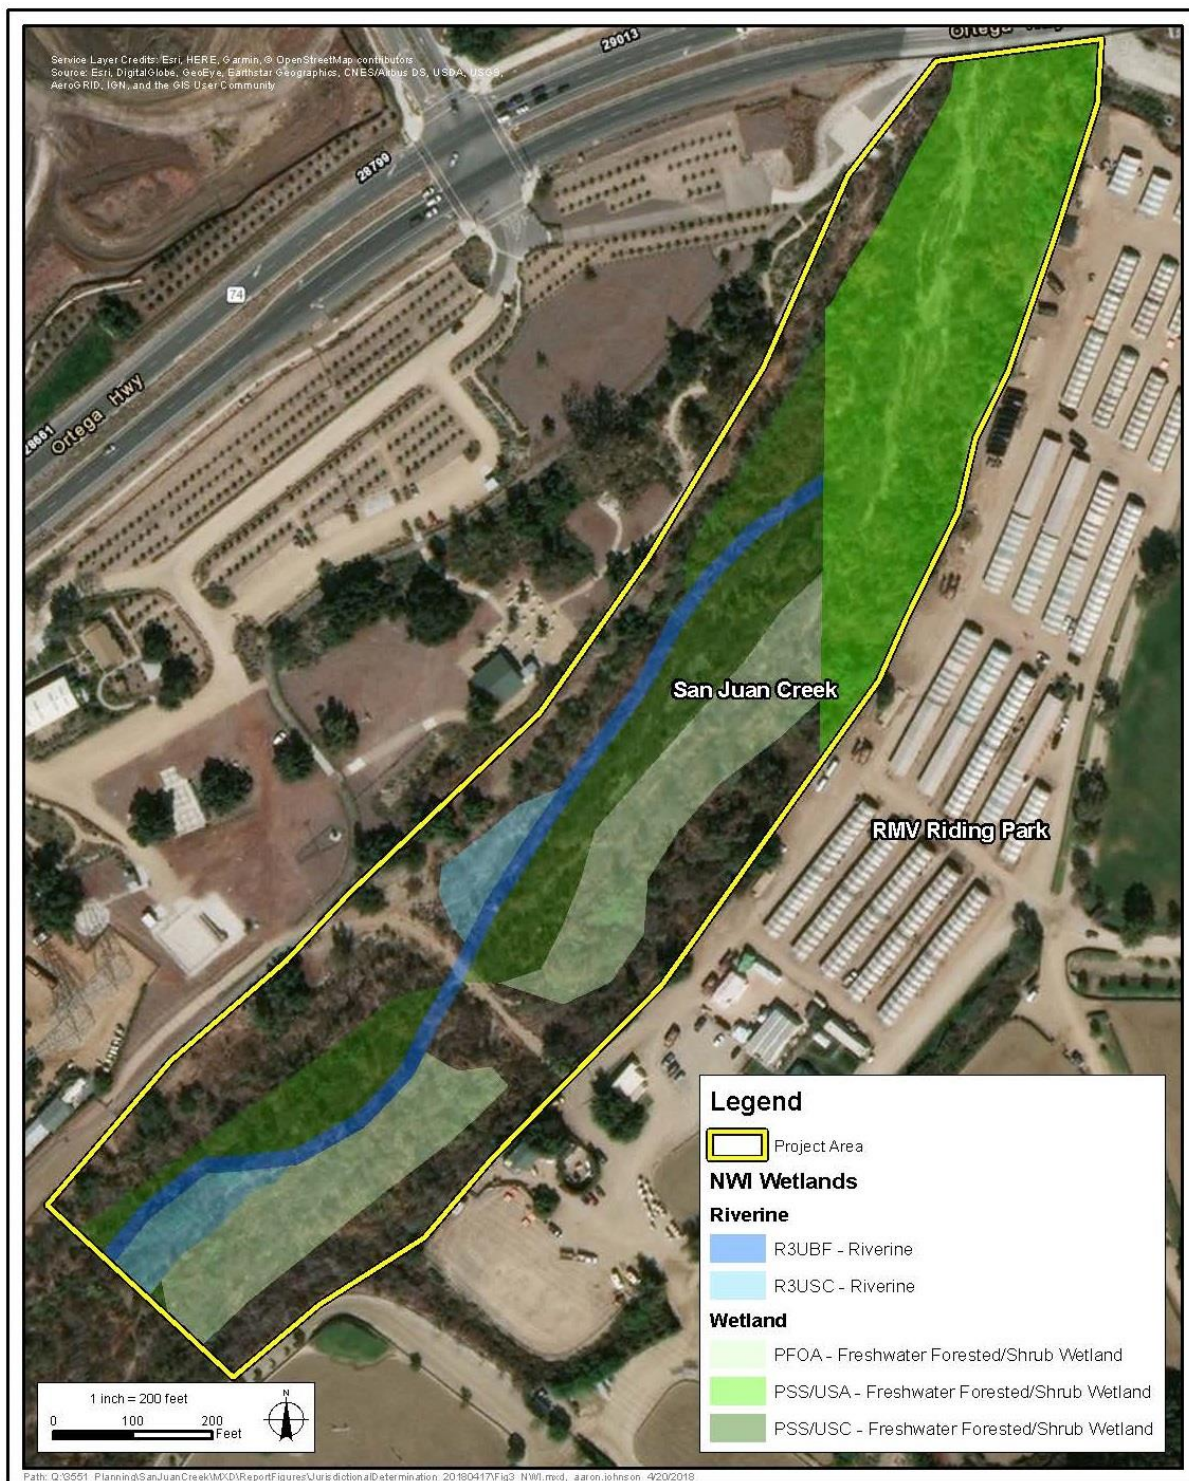
Figure 3. National Wetlands Inventory

NWI wetlands mapped in the project area are shown in Figure 3 (USFWS, 2018) and include:

- R3UBF – Riverine, Upper Perennial, Unconsolidated Bottom, Semi-permanently Flooded
- R3USC – Riverine, Upper Perennial, Unconsolidated Bottom, Seasonally Flooded
- PFOA - Palustrine, Forested, Temporarily Flooded
- PSS/USA - Palustrine, Scrub-Shrub/Unconsolidated Shore, Temporarily Flooded
- PSS/USC - Palustrine, Scrub-Shrub/Unconsolidated Shore, Seasonally Flooded

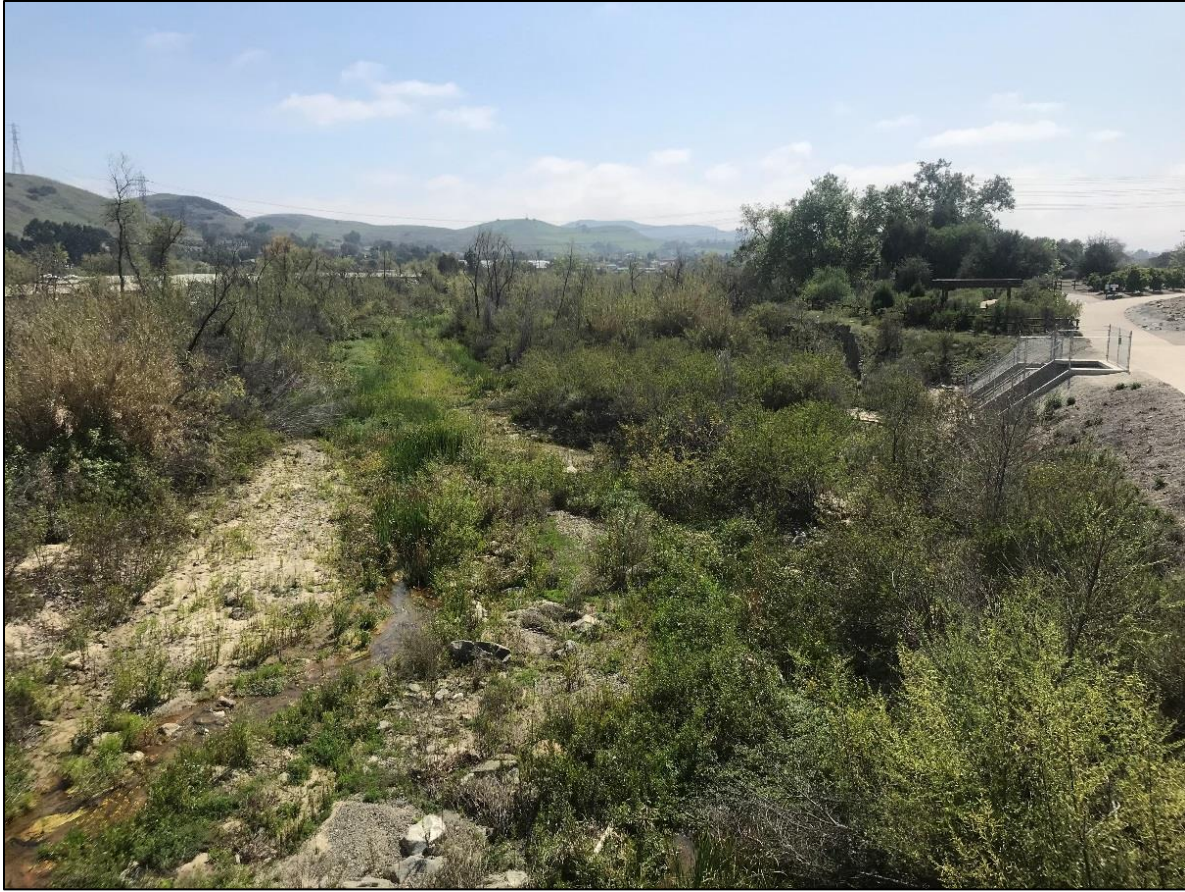
Photo 1 (4/4/18): San Juan Creek facing southwest from the Highway 74 Bridge showing hydrogeomorphic conditions of the project area. The Riding Park is on the east (left) bank of this photo. The Low-Flow Channel (with dense wetland vegetation) transitions to the Active Floodplain (sandy soils with sparse vegetation) then to the Low Terrace (with mature willow and large Arundo stands) further east.

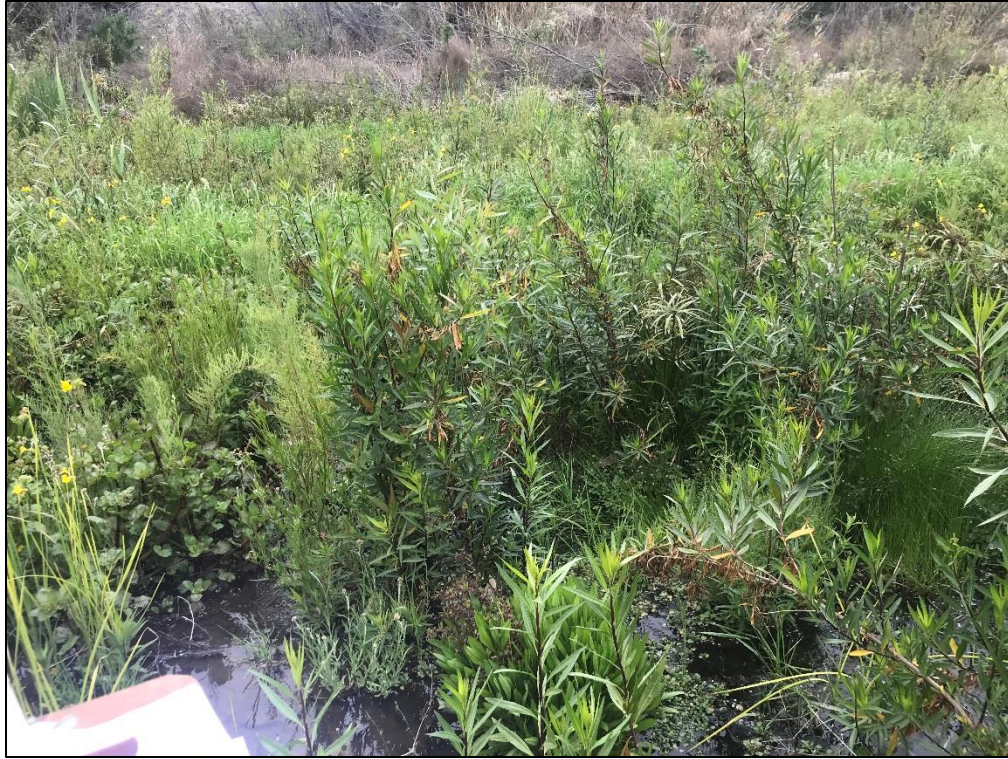
Photo 2 (4/4/18): Dense wetland vegetation and flowing water within the Low-Flow Channel at Transect (T) 2.

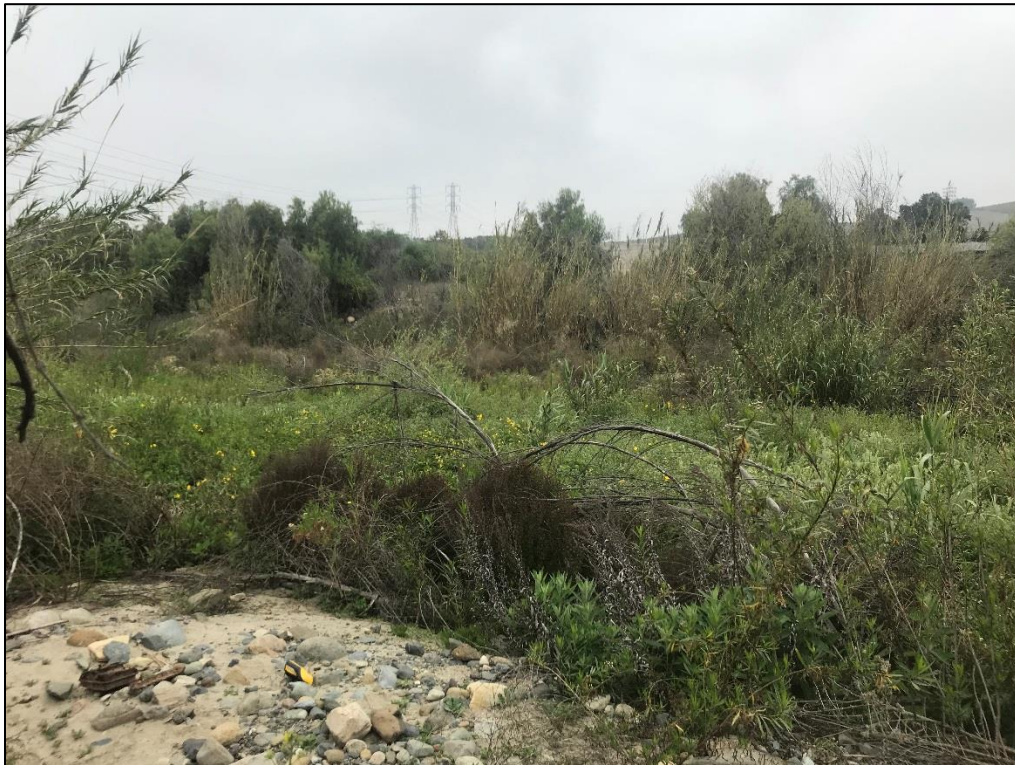
Photo 3 (4/4/18): Facing northwest along T2 showing the transition from the Active Floodplain (cobble and sandy soil) to the Low-Flow Channel (dense wetland vegetation).

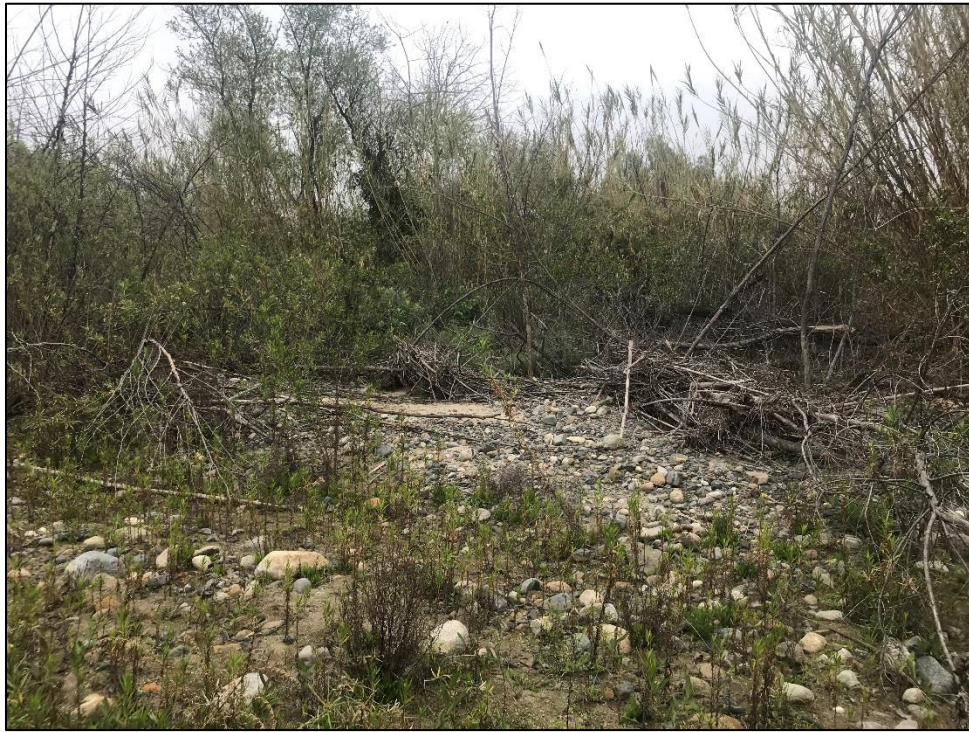
Photo 4 (4/4/18): Facing southeast along T2 showing the transition from the Low-Flow Channel (moist soil) to the Active Floodplain (cobble and sandy substrate) with the Low Terrace (dense mature willow and Arundo) in the background.

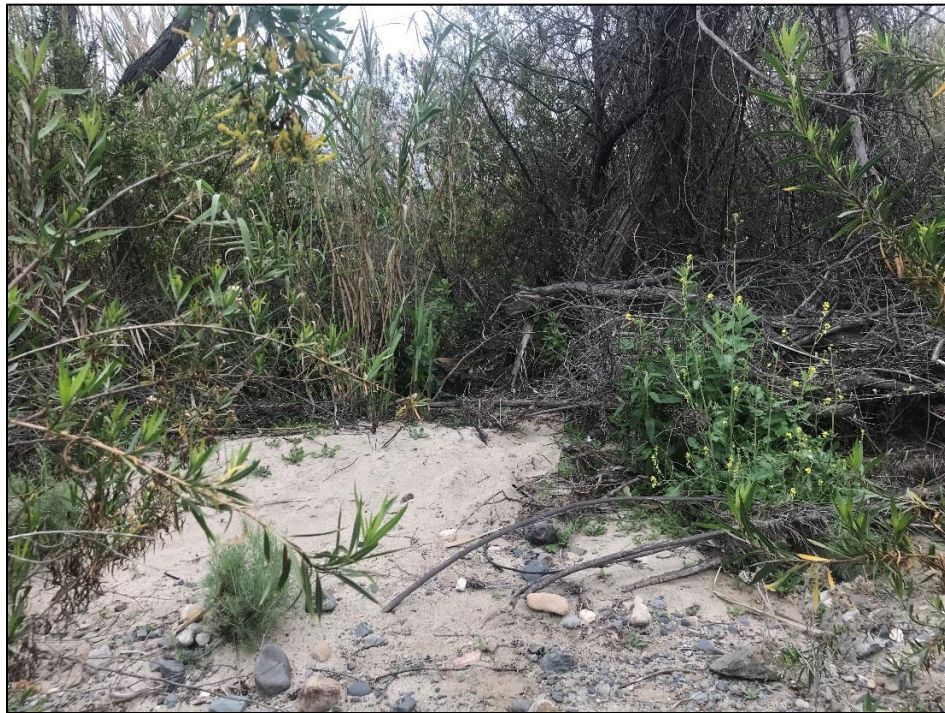
Photo 5 (4/4/18): Facing east along T2 showing the elevated sandy bench that transitions from Active Floodplain (sandy substrate) to Low Terrace (dense mature willow and Arundo in the background).

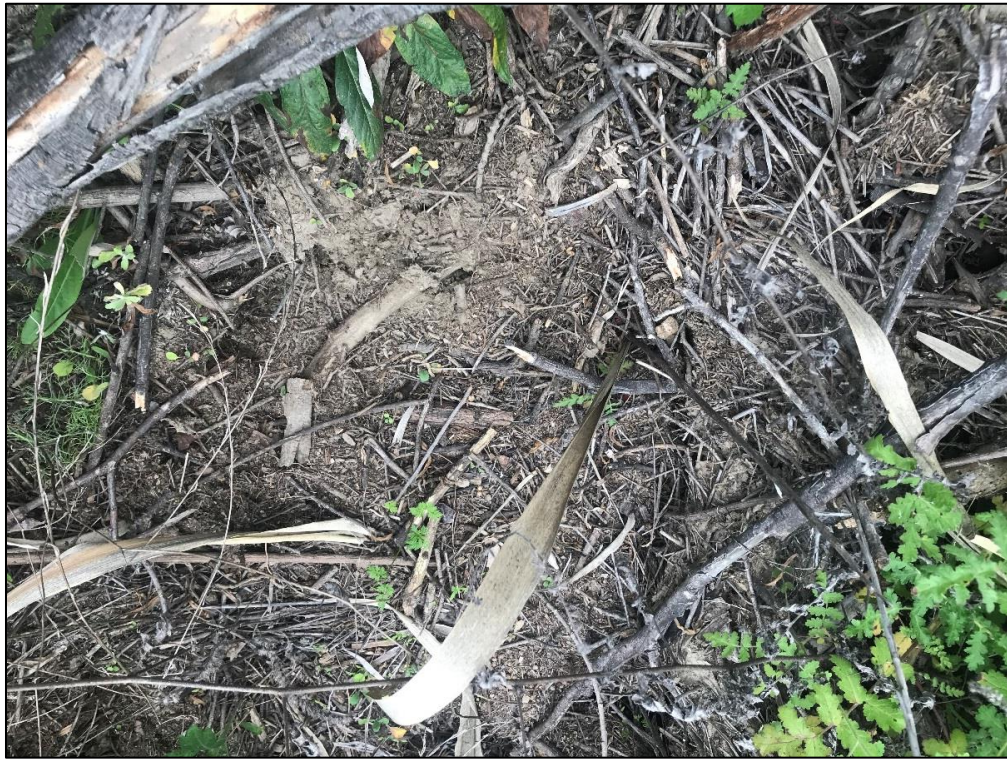
Photo 6 (4/4/18): Showing soil conditions within the Low Terrace at T2, showing silty sandy soil with leaf litter and decomposing vegetation occurring on the surface.

Silty sandy soils in the low terrace have no sign of redox features to a depth of 14". Presence of leaf litter + vegetation, appears that area was not disturbed during recent high flows in 2017. Conditions & topography are not likely to collect + hold water.

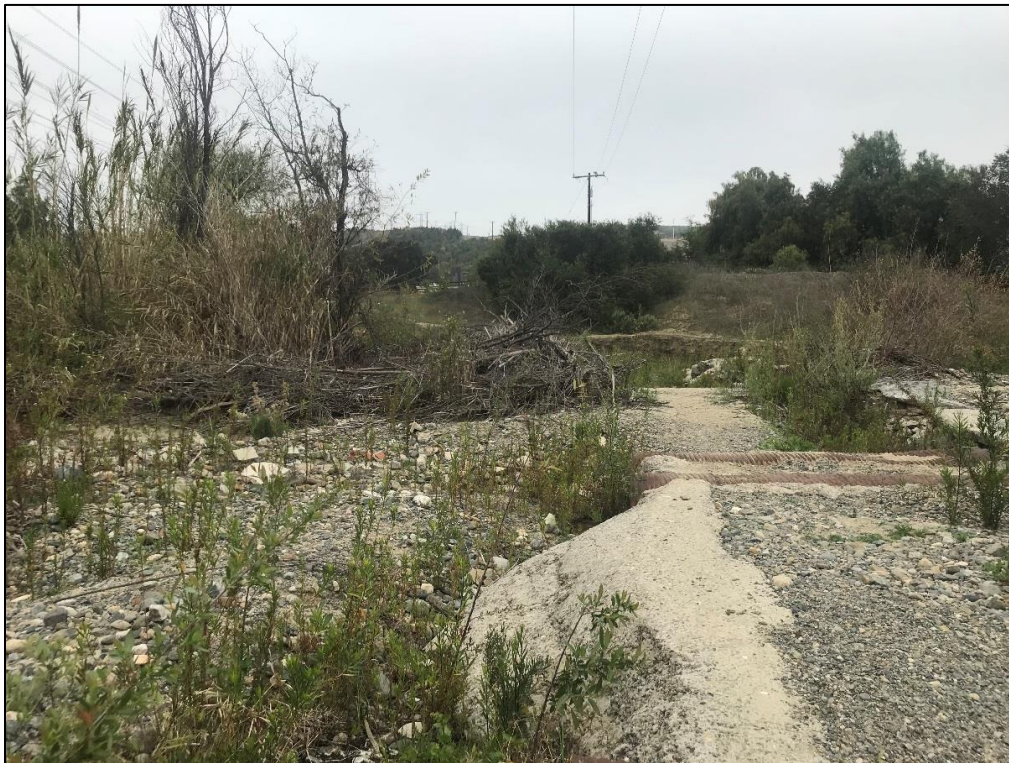
Photo 7 (4/4/18): Facing northwest along T3 showing culverted farm road crossing San Juan Creek.

*Channel has been modified historically for storm water (flooding) controls
 i.e. restricted channel reach, armoring stream banks
 Farm road constructed across channel with culverts, damaged in 2017 storm.*

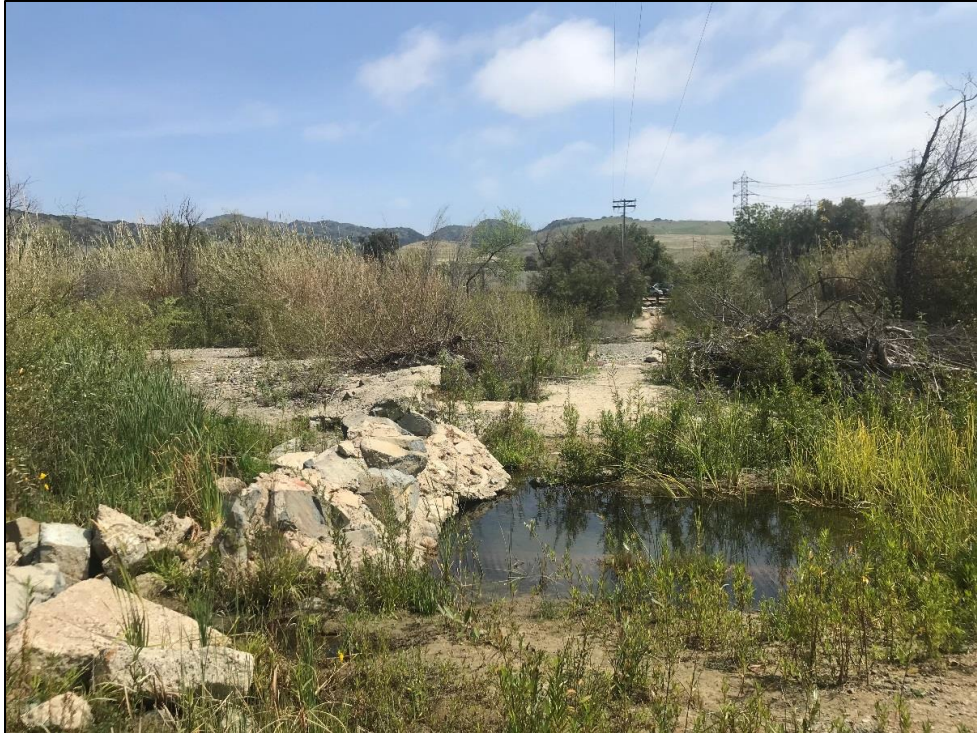
Photo 8 (4/4/18): Facing southeast along T3 showing culverted farm road crossing San Juan Creek.

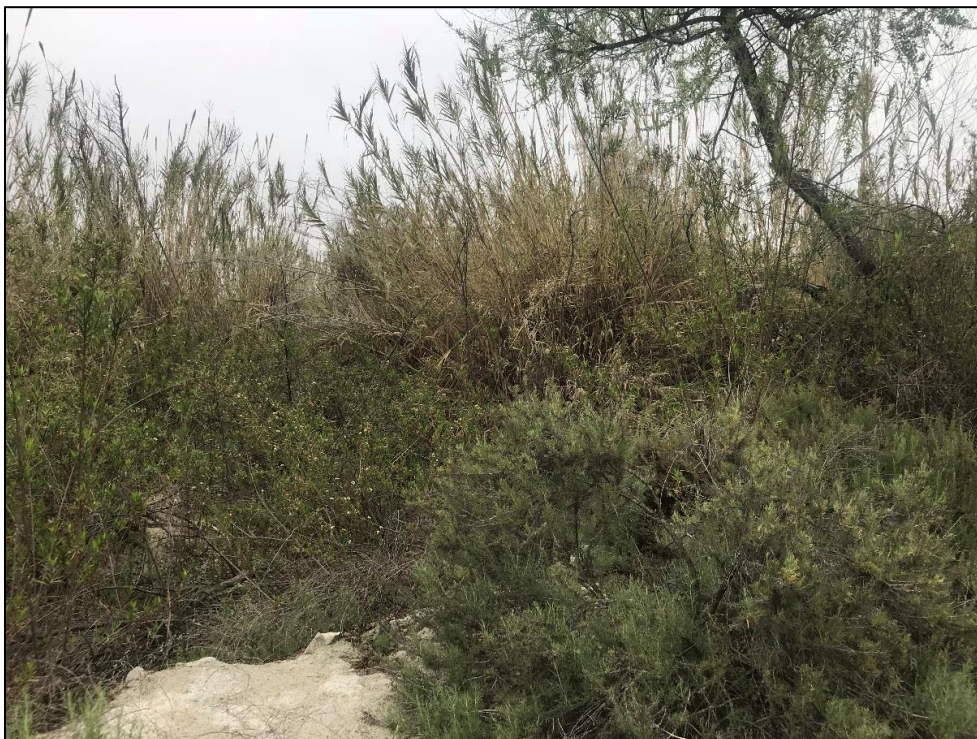
Photo 9 (4/4/18): Facing northeast at the OHWM at T3 with the transition between mulefat (*Baccharis salicifolia*) dominated riparian to *Artemesia californica* dominated upland communities along the farm road.

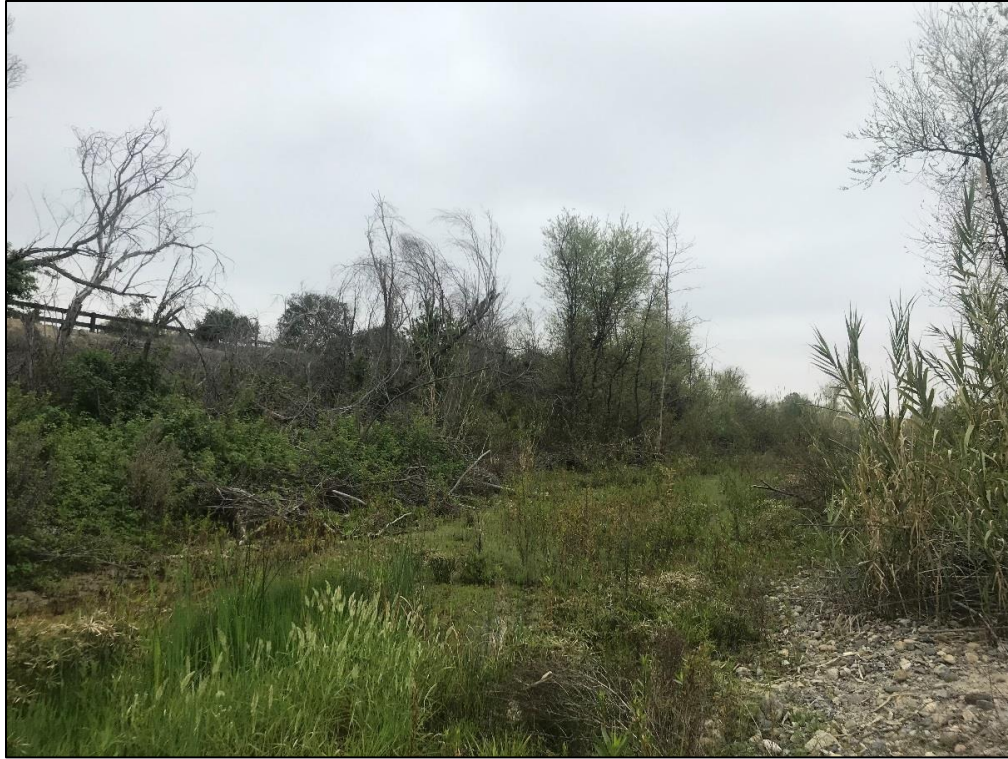
Photo 10 (4/4/18): Facing southwest showing the east (left) bank of the project area with the Low-Flow Channel rising steeply through the Active Floodplain and into the Low Terrace with mature willow along the bank.

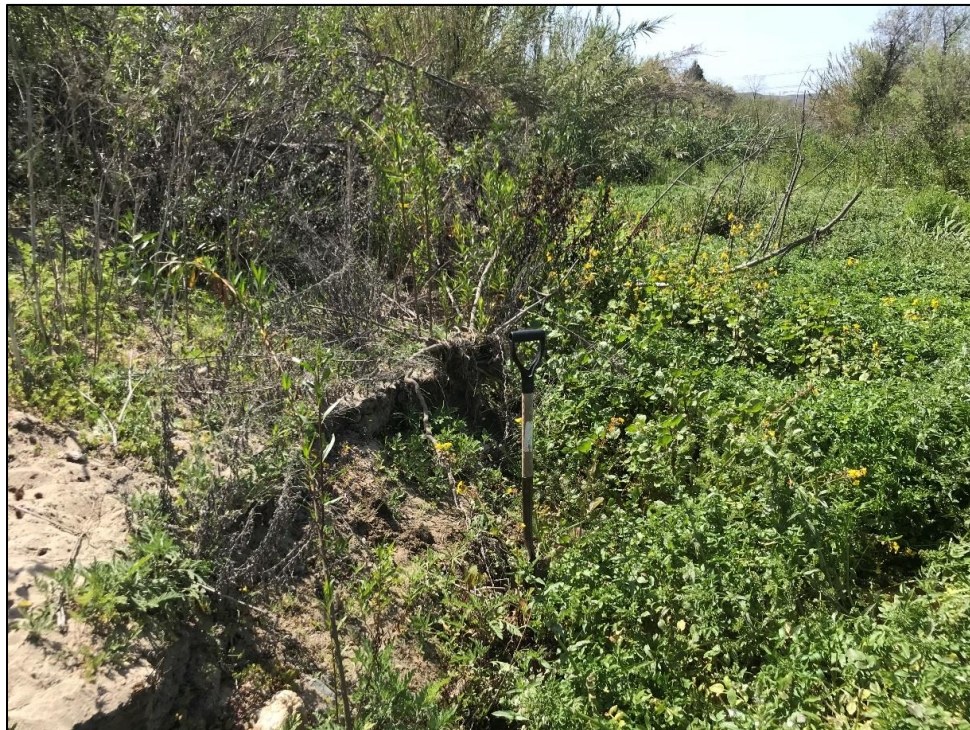
Photo 11 (4/13/18): Facing south-southwest along T5 showing the Low-Flow Channel with dense wetland vegetation rising steeply through the Active Floodplain to the east (left).

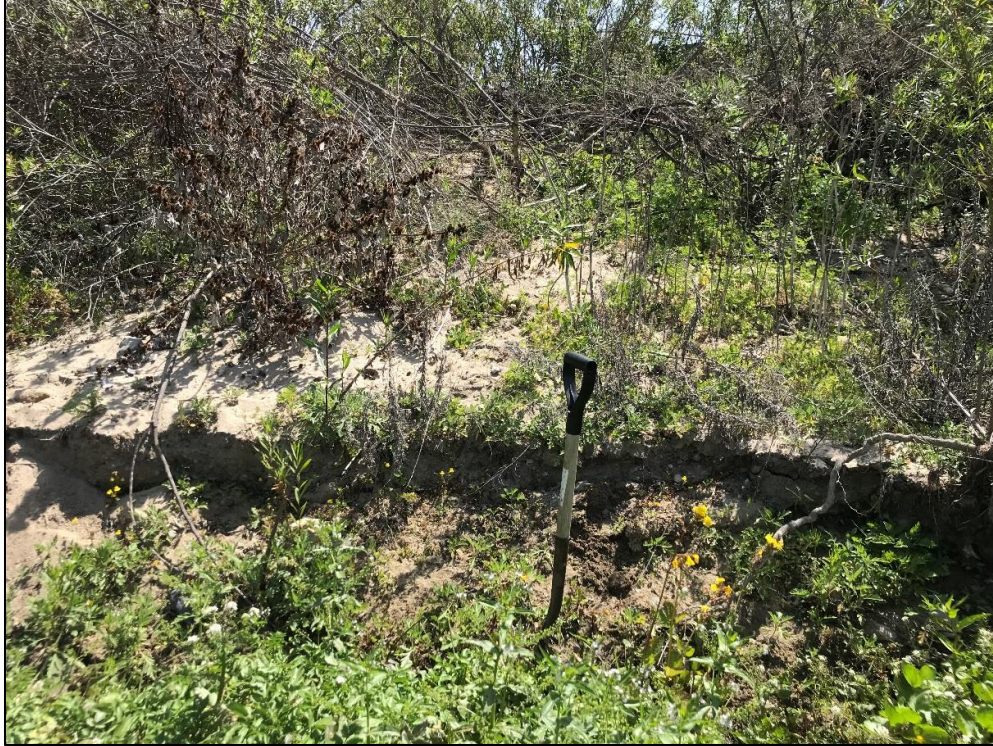
Photo 12 (4/13/18): Facing east along T5 showing the Low-Flow Channel with dense wetland vegetation rising steeply through the Active Floodplain to the east.

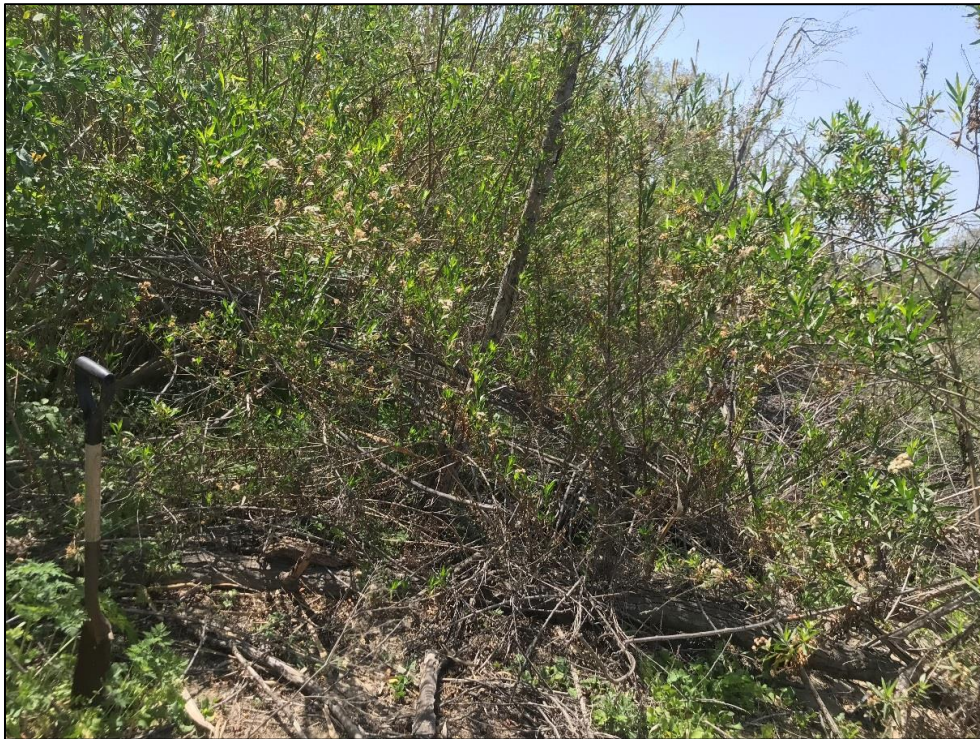
Photo 13 (4/13/18): Facing south along T5 showing the OHWM where the Active Floodplain transitions to the Low Terrace with dense mature willow riparian communities and silty soil.
