CULTURAL RESOURCES ASSESSMENT

LANCASTER 40 RESIDENTIAL PROJECT

COUNTY OF LOS ANGELES, CALIFORNIA

April 2015

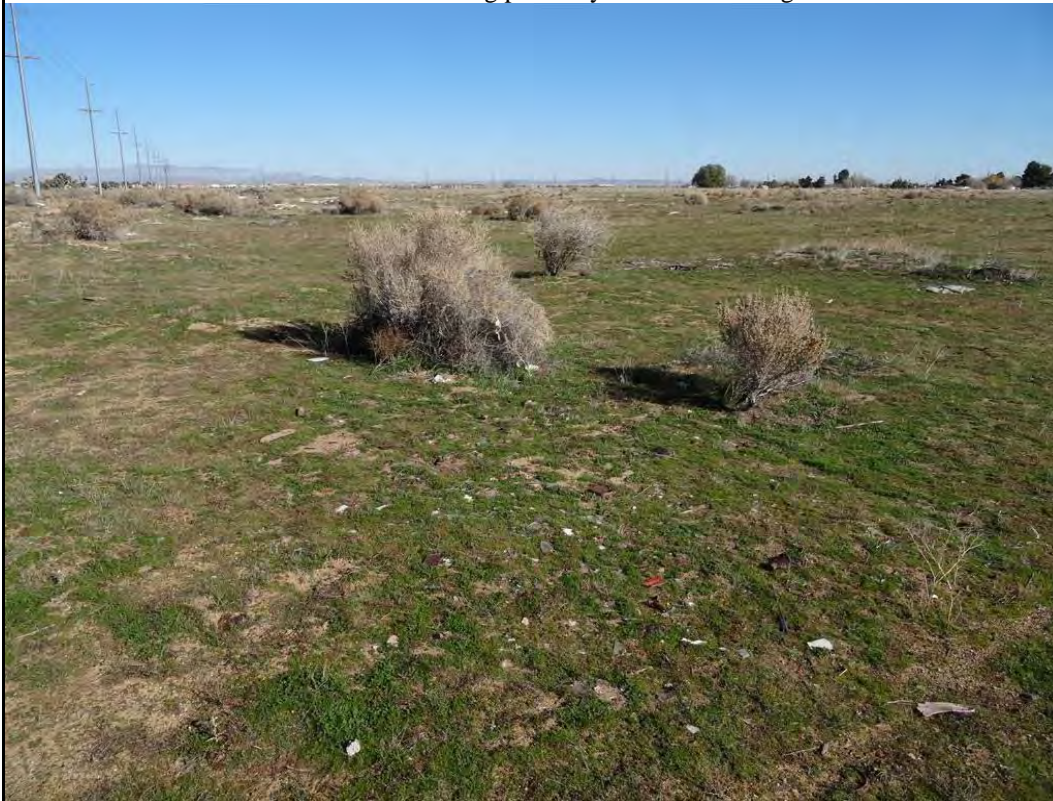
***P3a. Description:** (Describe resource and its major elements. Include design, materials, condition, alterations, size, setting, and boundaries) The site appears as originally recorded: It is a scatter of primarily rusted cans (beverage, sanitary food, and vacuum-sealed coffee) and glass pieces (clear, brown, and aqua) in an area measuring approx. 15x15 ft dating from the 1950s. The current survey also confirmed the presence of window glass, glazed ceramics (orange and green, flow-blue, and white), shoe pieces, a rubber hose, lumber and concrete fragments, as noted by (Norwood 2007), but not mentioned by Tsunoda (2007). Flat-topped cans are all church-key opened suggesting a 1950s deposition. Fewer cans exist at the site than were present in 2007 based on photos in Norwood (2007), and on the original site record by Tsunoda (2007).

P-19-003693: Historic trash scatter showing primarily rusted cans and glass. View to north.

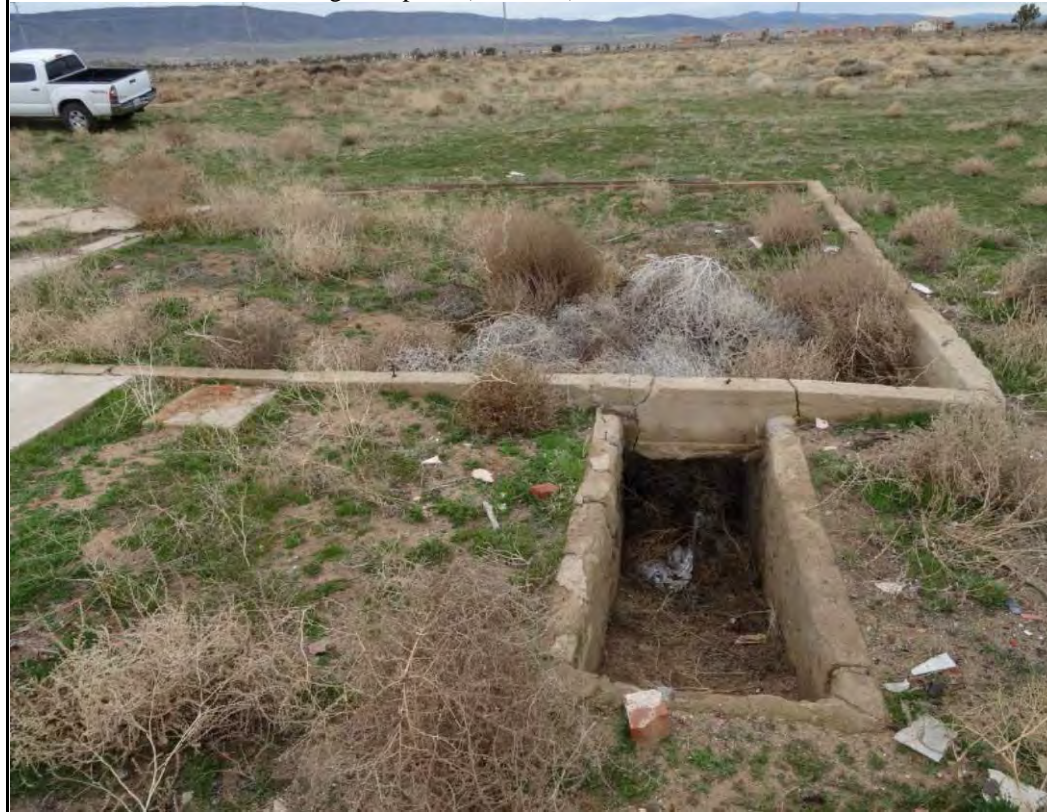
Farmstead: View of House Foundation (Feature A). Note basement entrance. Truck parked on side of earthen reservoir/irrigation pond (Feature J). View to the west.

Feature A is a 6 inch wide perimeter house foundation measuring approx. 20x20 ft square that represents the original residence. Feature A was tested using two 1x1 m units. A semi-basement in the northeastern corner of the foundation was also tested using a special larger feature excavation unit.

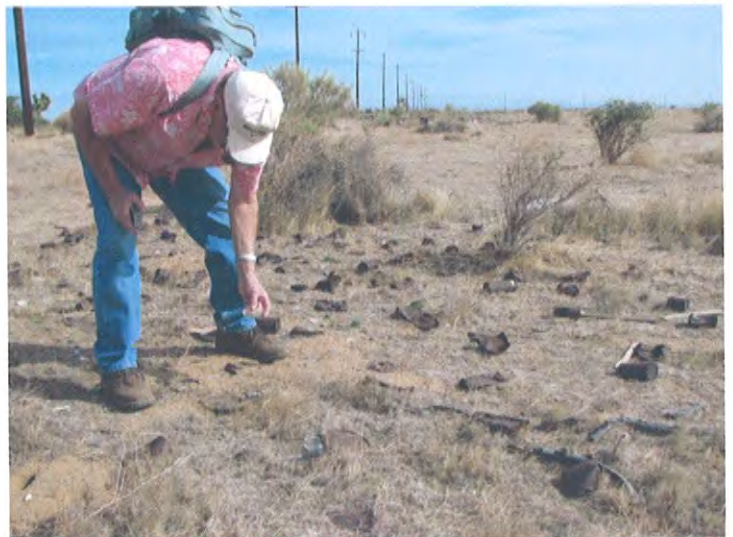
539-2 view N

Site 539-2: The site consists of a small, disturbed late period refuse deposit measuring approximately 5 meters north/south and 4 meters east/west. The deposit contains common household-related refuse. An inventory of artifacts noted is presented in Attachment 1. The site does not appear to have appreciable depth. Based on can types and bottle maker's marks the site dates to circa 1955-1957.

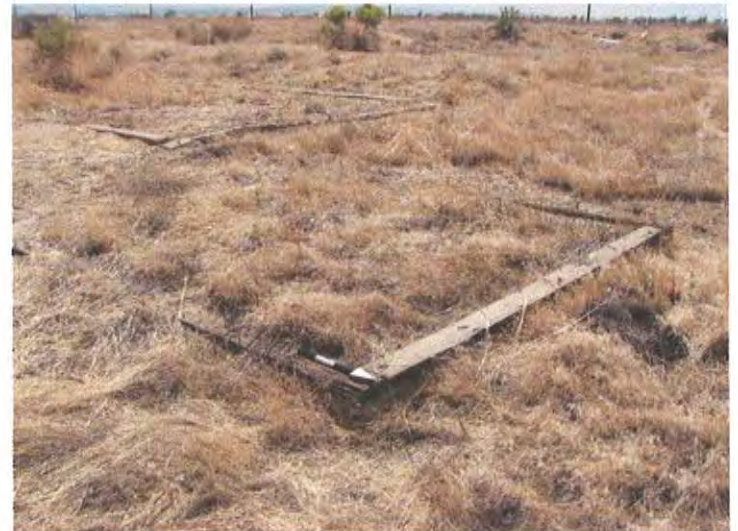
Feat F.JPG

Feature F is a 6 inch wide concrete perimeter foundation set in an area measuring 10x10 ft that appears to be a water tank foundation.

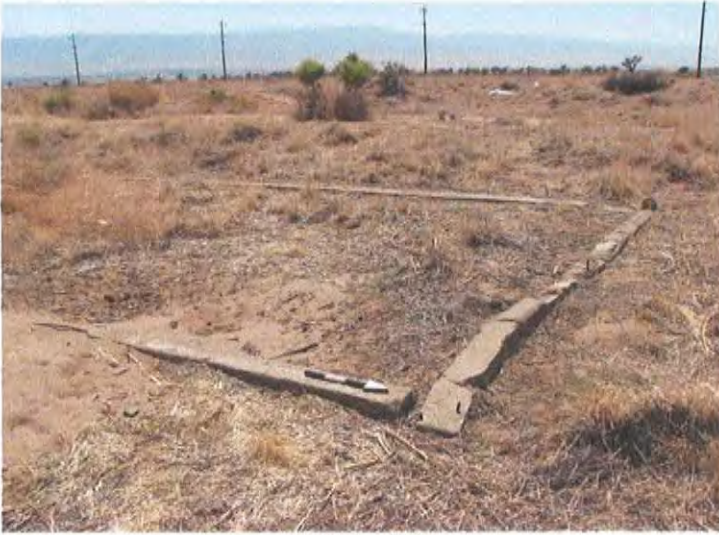
Feat G.JPG

Feature G is a 6 inch wide concrete strip set in an approx. 36x17 ft rectangular perimeter that was the foundation for a barn or workshop. The southernmost 25 ft of the eastern side does not contain the perimeter foundation, suggesting that it was the entrance to the structure. Two 1x1 m excavation units were placed along the northern end of the eastern side of this feature.

Feature G: The feature is a simple rectangular poured cement footing with wall mounting bolts. It may represent a foundation for a barn or workshop.

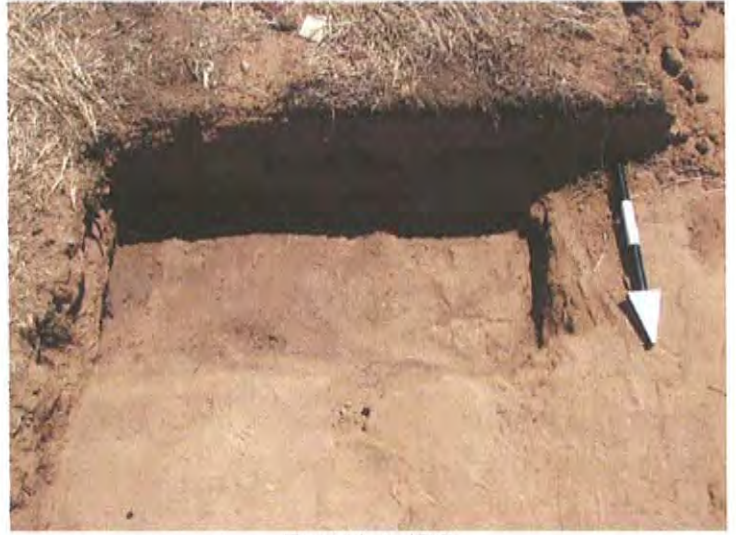
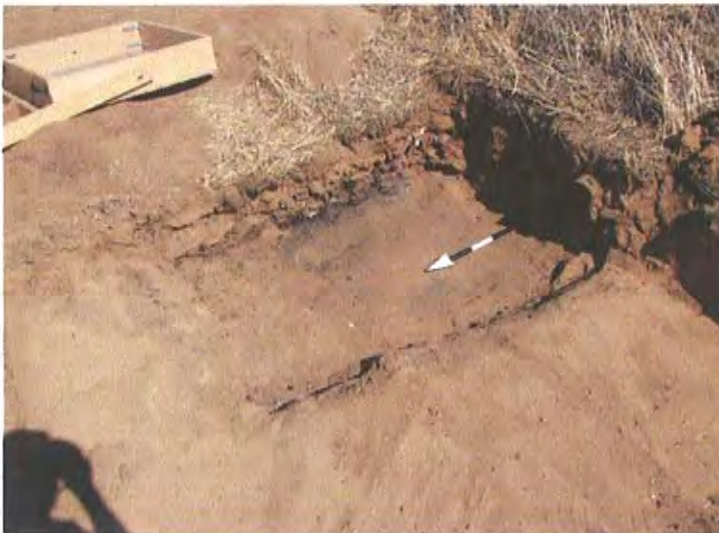
Feat H_1.JPG

Feature H is a circular refuse deposit or burn pit measuring 16.5 ft diameter. Five 1x1 m excavation units were placed at this feature.

Feature H: This feature is a small refuse deposit measuring about three meters in diameter. An earthenware made by Southern Potteries, Inc. between 1917-1957 (Lehner 1988:433, mark 1) is the only specifically datable artifact noted. The feature may date to the 1940s-1950s period.

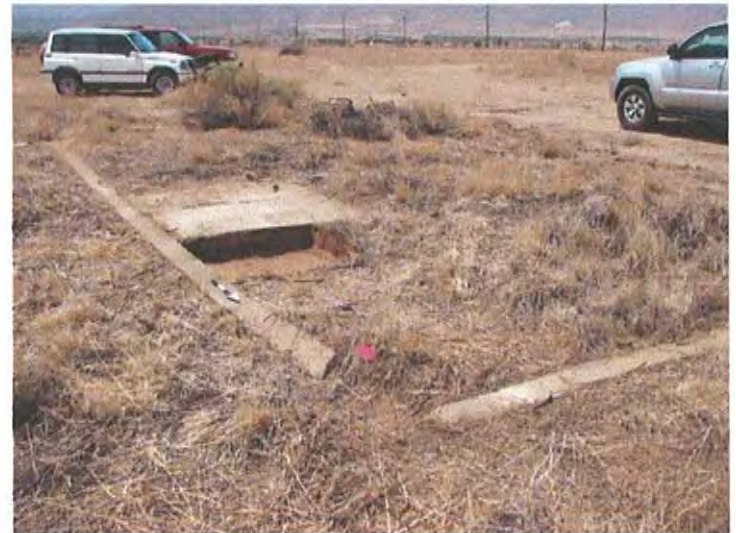
Feat I.JPG

Feature I is a 6 inch wide perimeter footing for an outbuilding foundation measuring approx. 16x32.5 ft. A concrete slab measuring approx. 5x6.5 ft is located at the eastern side within the larger foundation. One 1x1 m excavation unit was placed on the north side of the concrete slab within the larger foundation.

Feature I: This feature is another simple rectangular foundation. It is partially buried, but is similar to Feature G. It may represent another outbuilding.

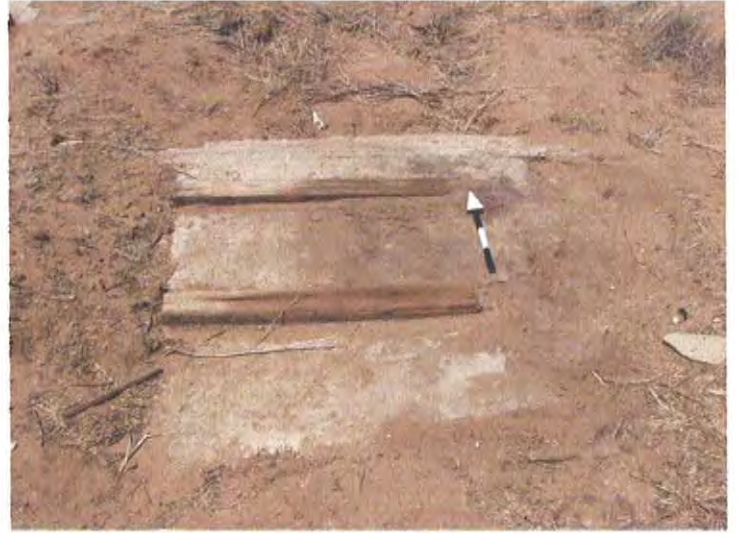
Feat M.JPG

Feature M is a concrete slab measuring 19.5x18.75 inches that contains brick impressions. Located on the eastern side of the house (Feature A) foundation, Feature M is probably the foundation of a brick-lined stove or heater vent.
