PHASE I ENVIRONMENTAL SITE ASSESSMENT & LIMITED PHASE II SUBSURFACE RECONNAISSANCE

November 3, 2016

**29960 Panoche Road
Paicines, San Benito County, California 95043
Assessor Parcel No's. (APN): 027280011000**

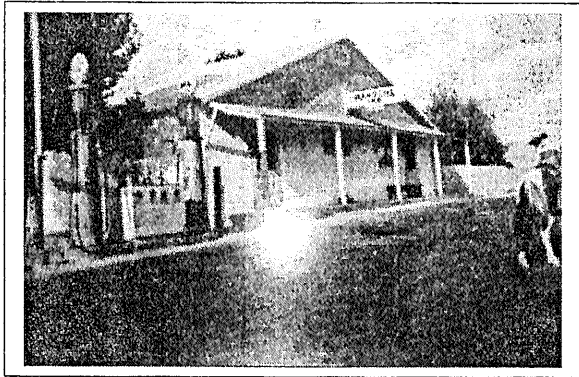
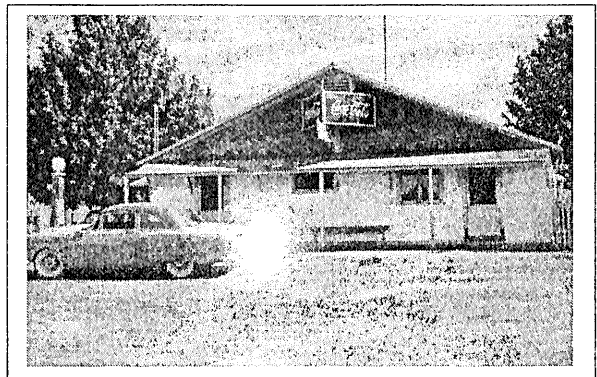
It was brought to our attention that beginning in the 1950s, the facility dispensed two grades of gasoline as well as motor oil to its patrons. The gasoline was contained in underground storage tanks, and pumped from two dispensers located at the front eastern side of the main restaurant building. The oil was contained in aboveground tanks positioned on the fueling island between the two dispensers. The Client found and provided Phase-1 ES with the photographs of this fueling system shown below.
