# ***Stony Creek Bridge (No. 11C-0245) Replacement Project*** **Natural Environment Study**

Glenn County, California  
Township 22N, Range 5W, Section 27  
USGS *Julian Rocks, California* 7.5-Minute Quadrangle  
Federal Aid Number: BHLO-5911(031)

**Natural Environment Study**

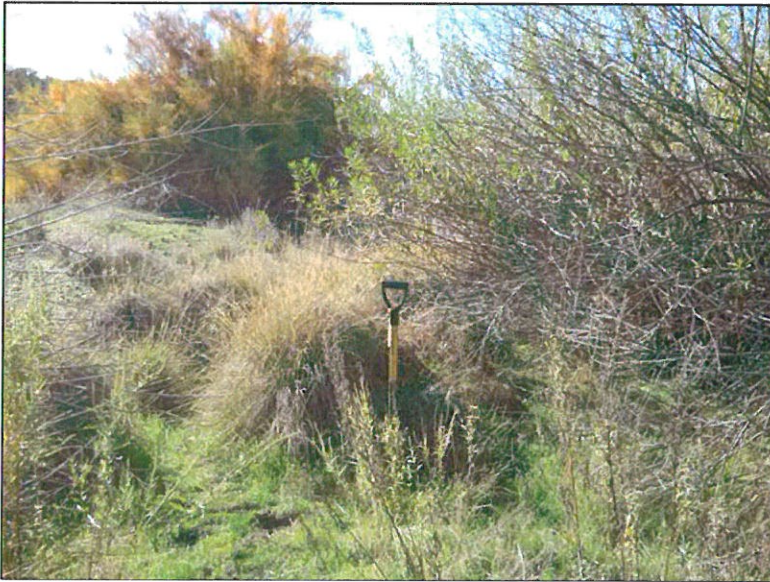
Photograph 3. Upland. DP3 (shovel) documents a suspect area that was determined to be upland.

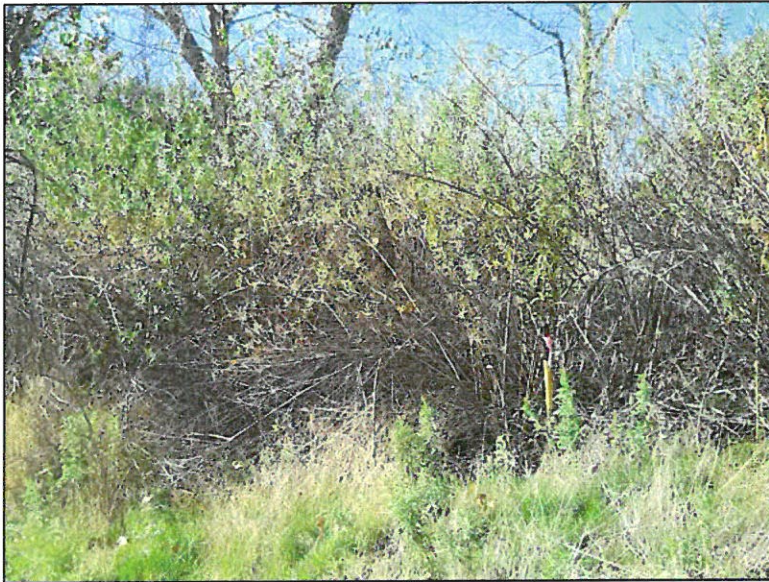
Photograph 5. Riparian Wetland. DP6 (shovel) documents the feature. Orientation: southwest.

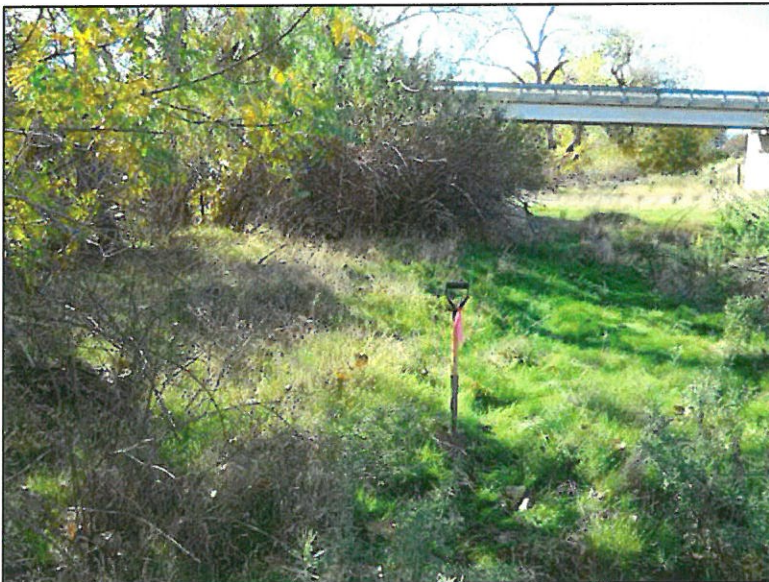
Photograph 6. Upland. DP7 (shovel) documents the upland pair point to DP5. Orientation: southwest.

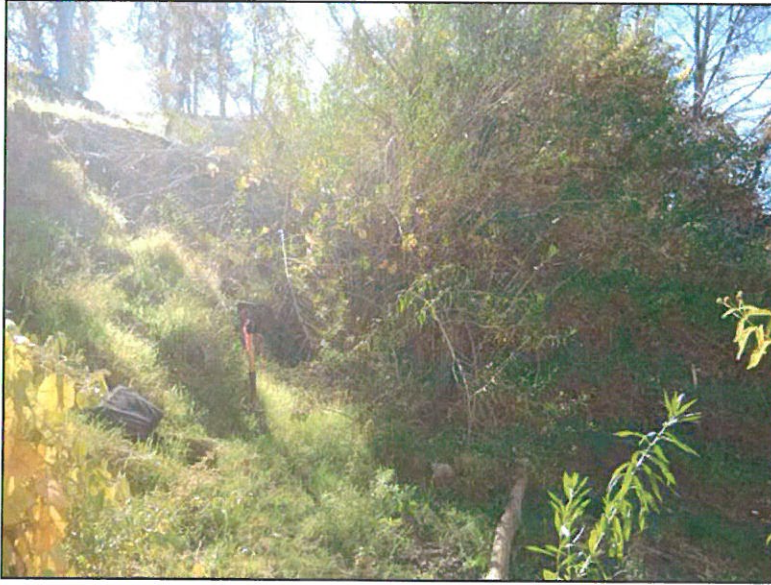
Photograph 7. Riparian wetland. DP10 (shovel) documents the feature.
