APPENDIX C

Historical Significance Diagrams

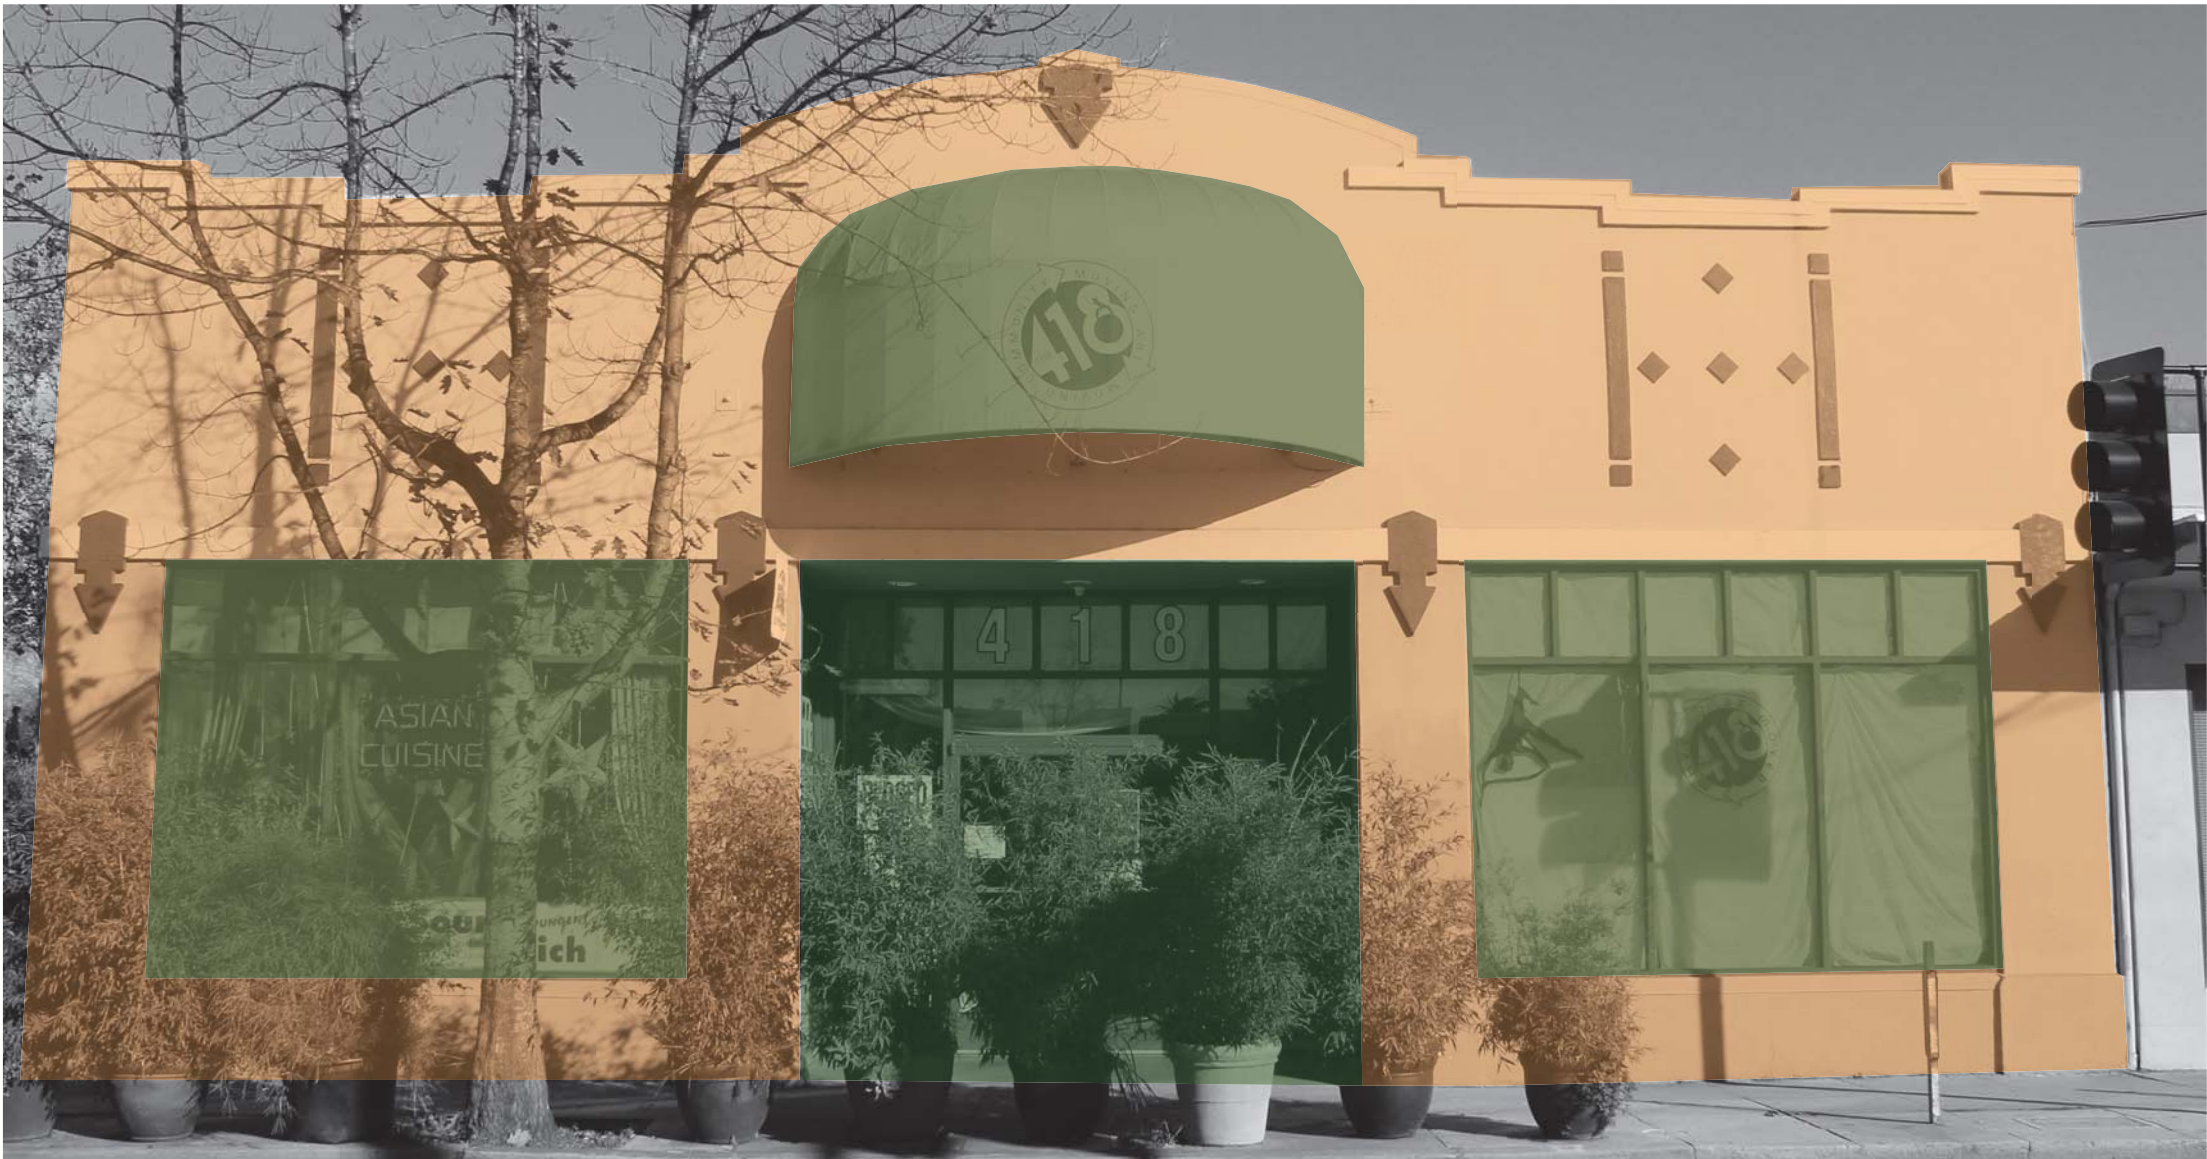
Significance Diagram: 418 Front Street-West Facade

- The primary (west) facade retains its Mission Revival style design and character-defining composition, despite replacement of original windows and main entry door.
- Fenestration contributes to the building's historic character, but components within the openings including muntins and glazing are non-contributing.
- The primary facade's stepped cornice and curved parapet are of primary significance.
- Art Deco detailing is of primary significance.

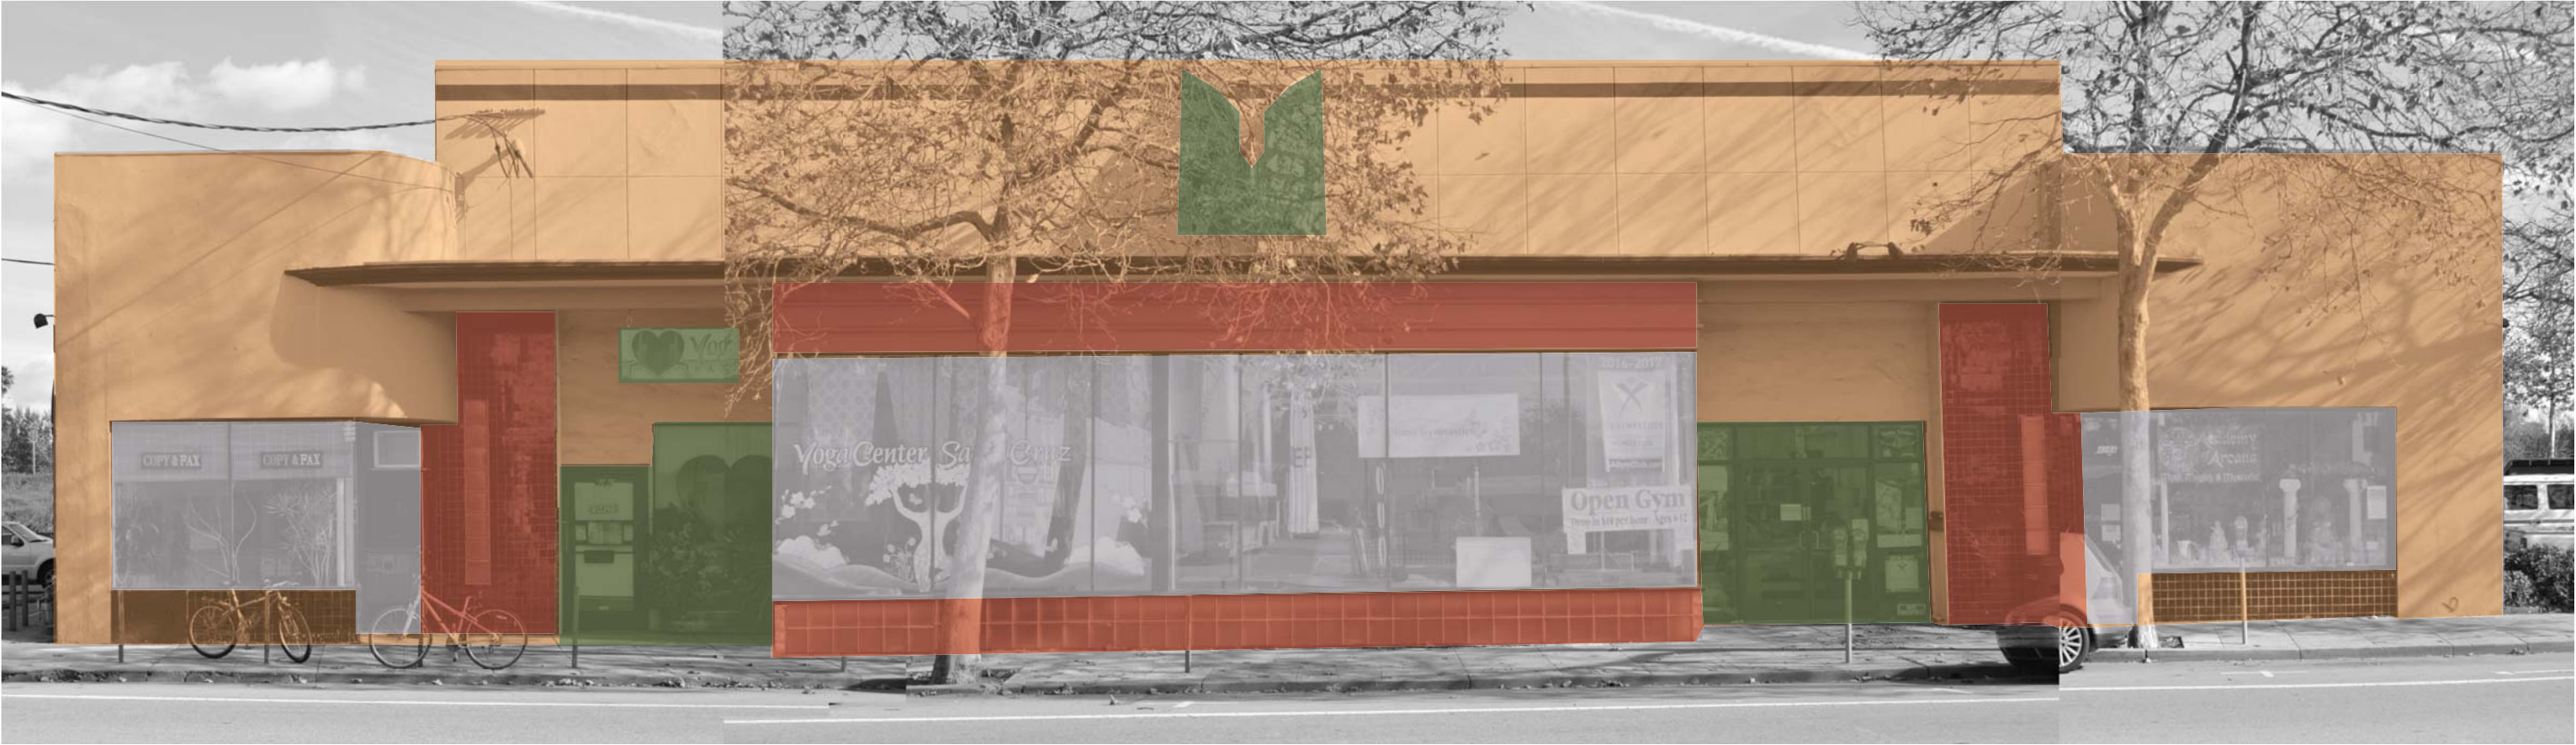
Significance Diagram: 428 Front Street-West Facade

- Articulation of the primary (west) facade's multiple surface planes is a primary, significant feature.
- Streamlined elements connect the primary facade's multiple surface planes and are of primary significance.
- Replacement display windows are contributing features.
- Recessed door ways and door components and signage at the top-center of the facade are non-contributing features.

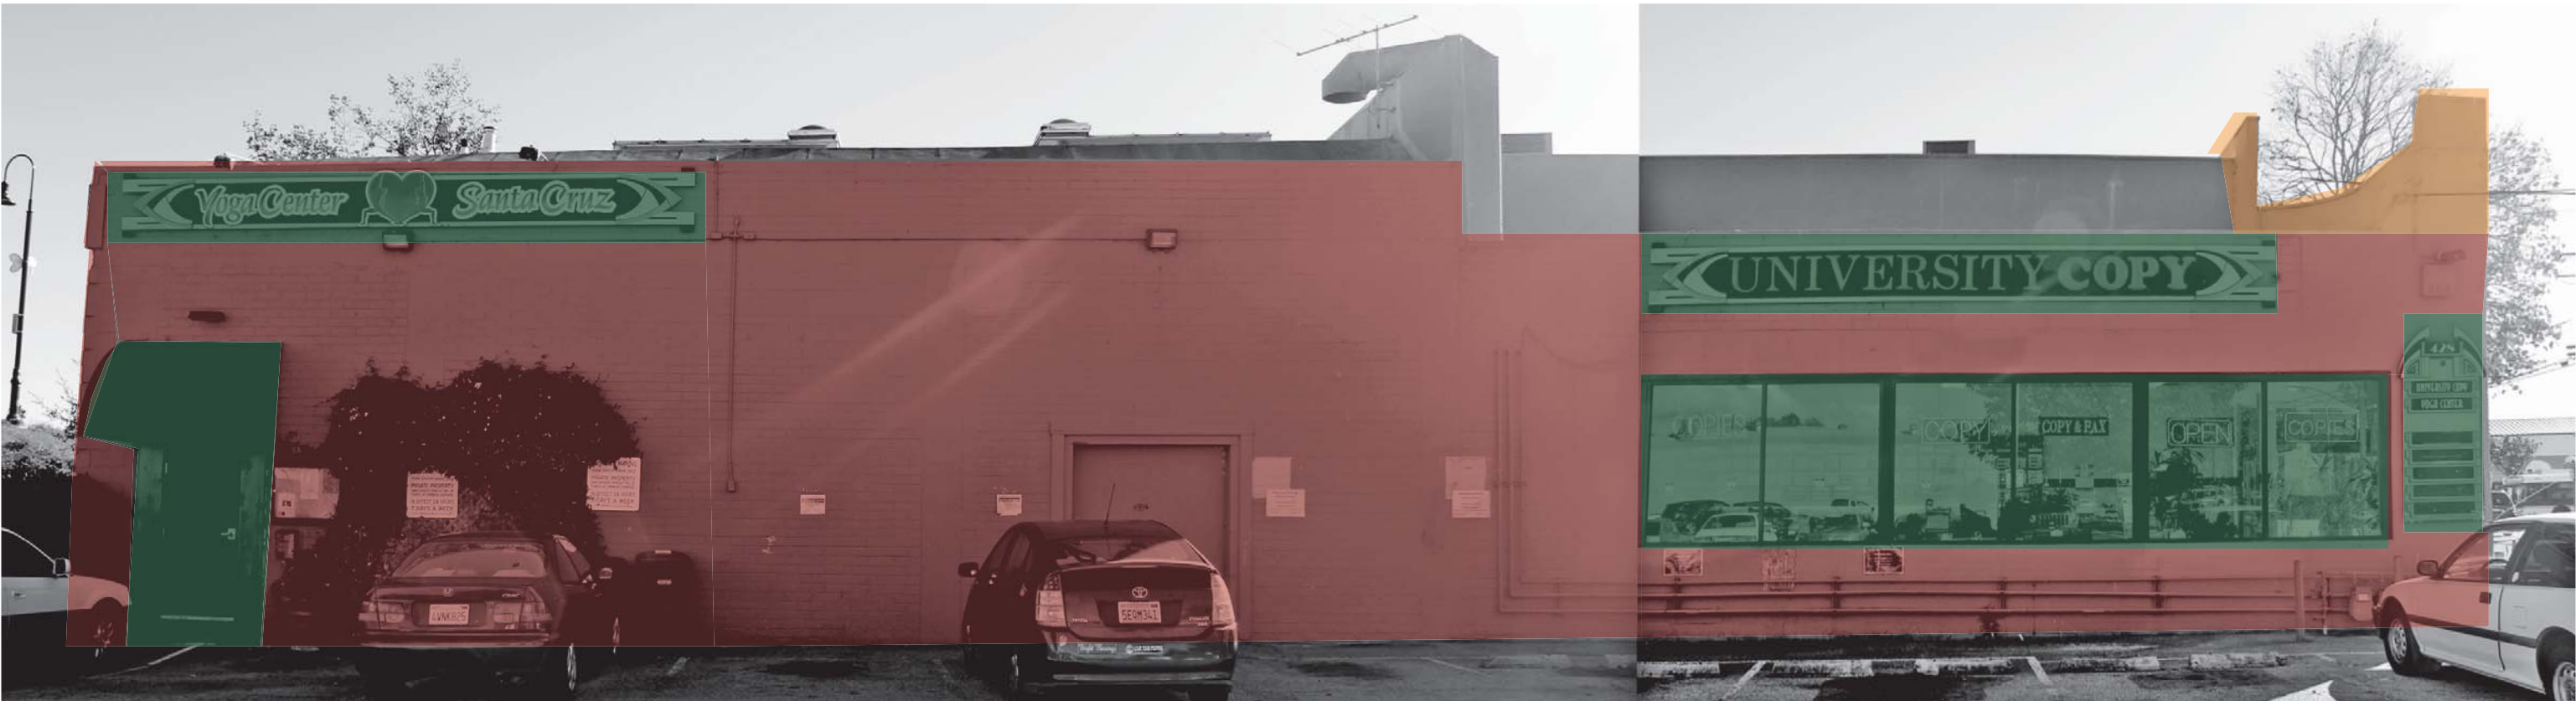
Significance Diagram: 428 Front Street-North Facade

- The north facade contributes to the building’s overall character, but has undergone notable alteration.
- Windows added in 1987 are non-contributing features.
- A portion of the primary facade’s significant parapet line is connected to the north facade.

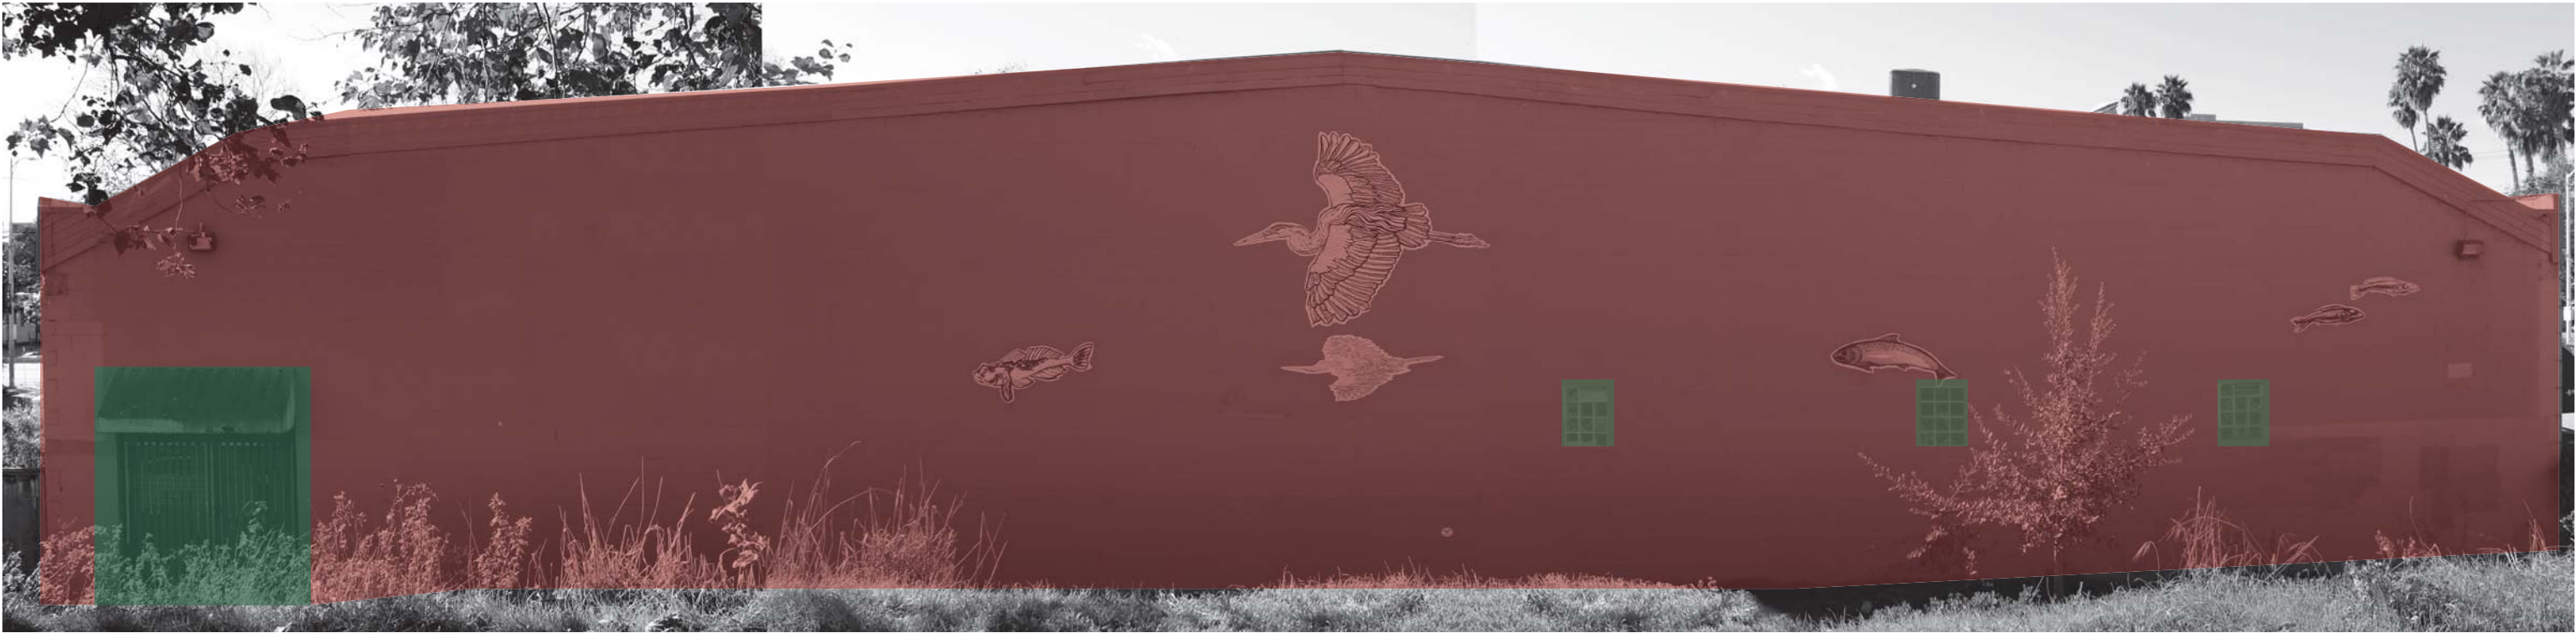
Significance Diagram: 428 Front Street-East Facade

- The rear (east) facade retains its original massing and roofline that corresponds to the building's framing.
- Glass block windows do not appear original and are non-contributing features.
- Door opening at southeast corner may be an original feature but does not contribute to building's character.
