Initial Study and  
***Mitigated Negative Declaration***  
for the  
600 Old La Honda Road Retaining Wall/Slope Repair Project  
Project # CUSE2019-0007 and CEQA2019-0007

1. Project title: 600 Old La Honda Road Retaining Wall/Slope Repair Project
2. Lead agency name and address: Town of Woodside  
Planning Department  
P.O. Box 620005 (Mail)  
2955 Woodside Road  
Woodside, CA 94062

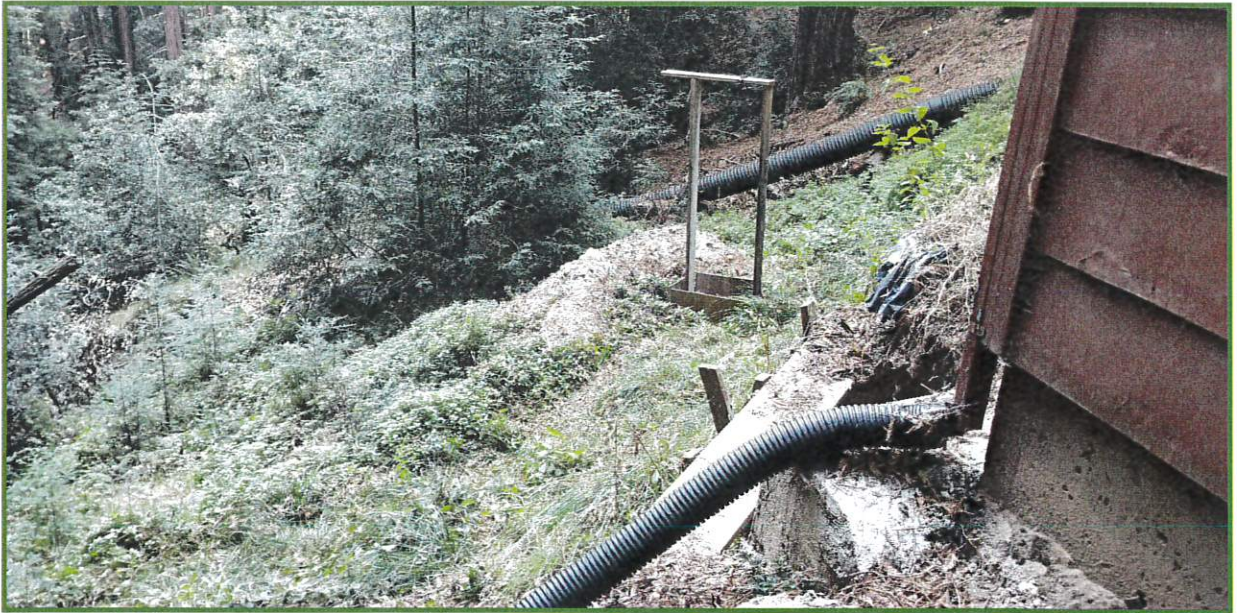
**Figure 3.** The northern corner of the garage where the proposed retaining wall is required for support (looking east).

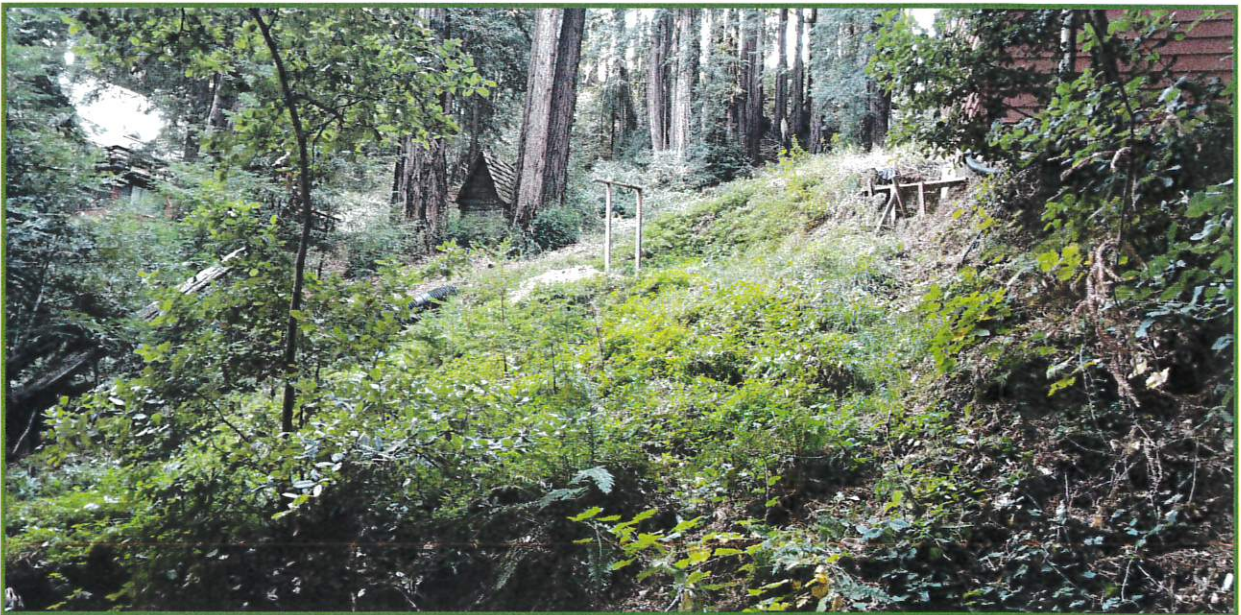
**Figure 4.** Looking uphill (southeast) towards the unstable slope.

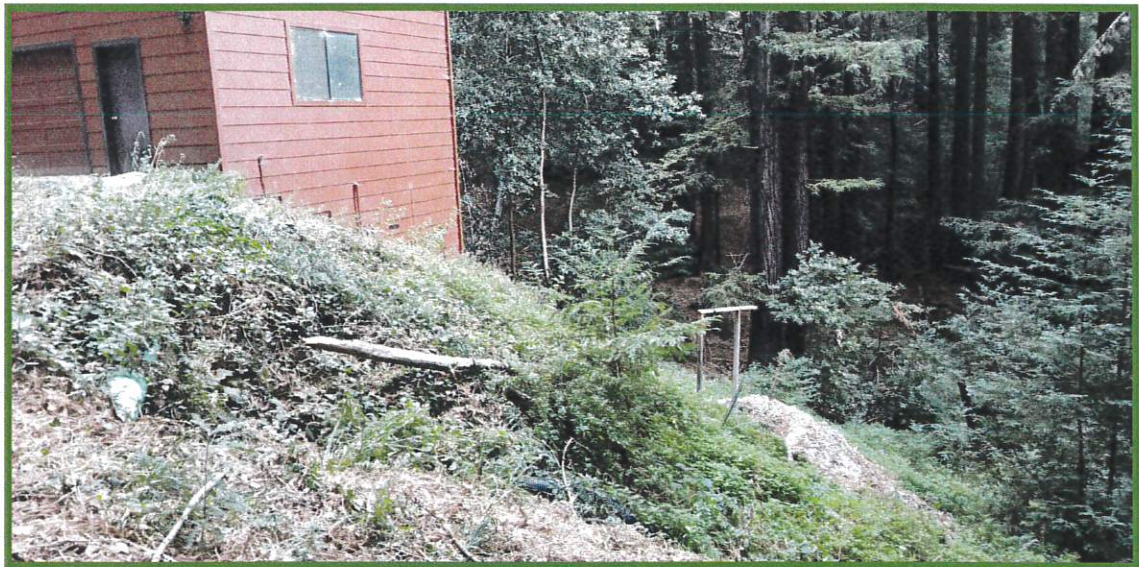
**Figure 5.** Looking north towards the location of the proposed retaining wall.

- **Retaining Wall:** A retaining wall would be located at the approximate location of the main scarp alignment. The retaining wall would be constructed about 5 feet downslope of the main scarp. The 74.8-foot long retaining wall would be  $\approx 8$  feet tall, above grade, with an additional 5 feet below the surface. Soldier beams and 24-inch wide piers would be installed to a depth of approximately 22-feet below the retaining wall (**Attachment 9, Sheet S2.0**). The end of the retaining wall would be located  $\approx 27$  feet from the flow line of Dennis Martin Creek, and above the top of bank by  $\approx 7$  feet. It would be located within the 50-foot Stream Corridor, as measured from the centerline, therefore requiring a Use Permit from the Town.

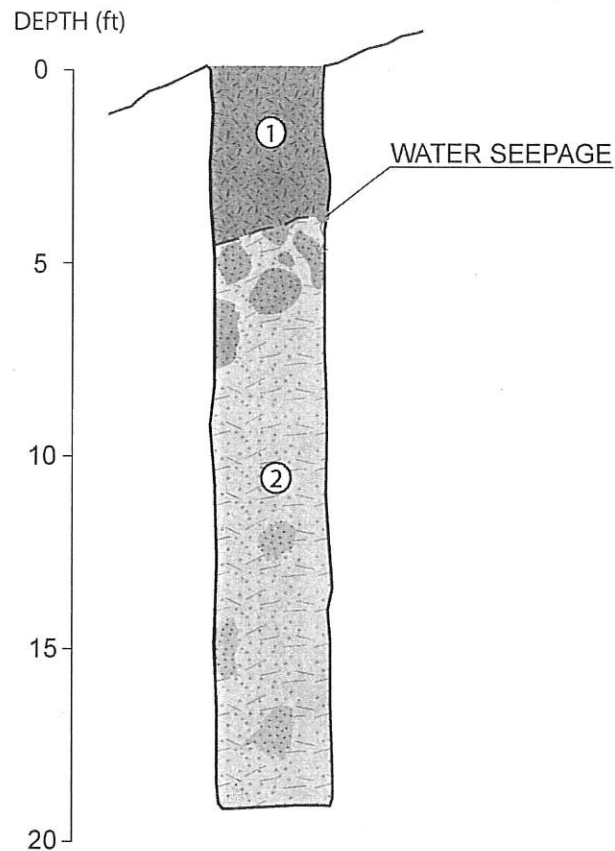
#### UNIT DESCRIPTIONS

- 1) **SANDY SILT (ML)**; dark yellowish brown (10YR 3/6); heterogeneous; subangular fine- to medium-grained sand; firm to stiff; low plasticity; saturated; scattered roots and rootlets (Landslide Deposits)
- 2) **SILTSTONE AND SANDSTONE**; greenish gray (GLEY 1 5/10Y) to very dark gray (GLEY 1 3/N); intermixed; sheared texture; highly weathered; highly fractured; low hardness; friable to weak; predominately siltstone with blocks of sandstone; upper 3 feet has blocks yellowish brown sandstone; oxidation staining in upper 3 feet of the unit; moist (Bedrock/ Displaced Bedrock)

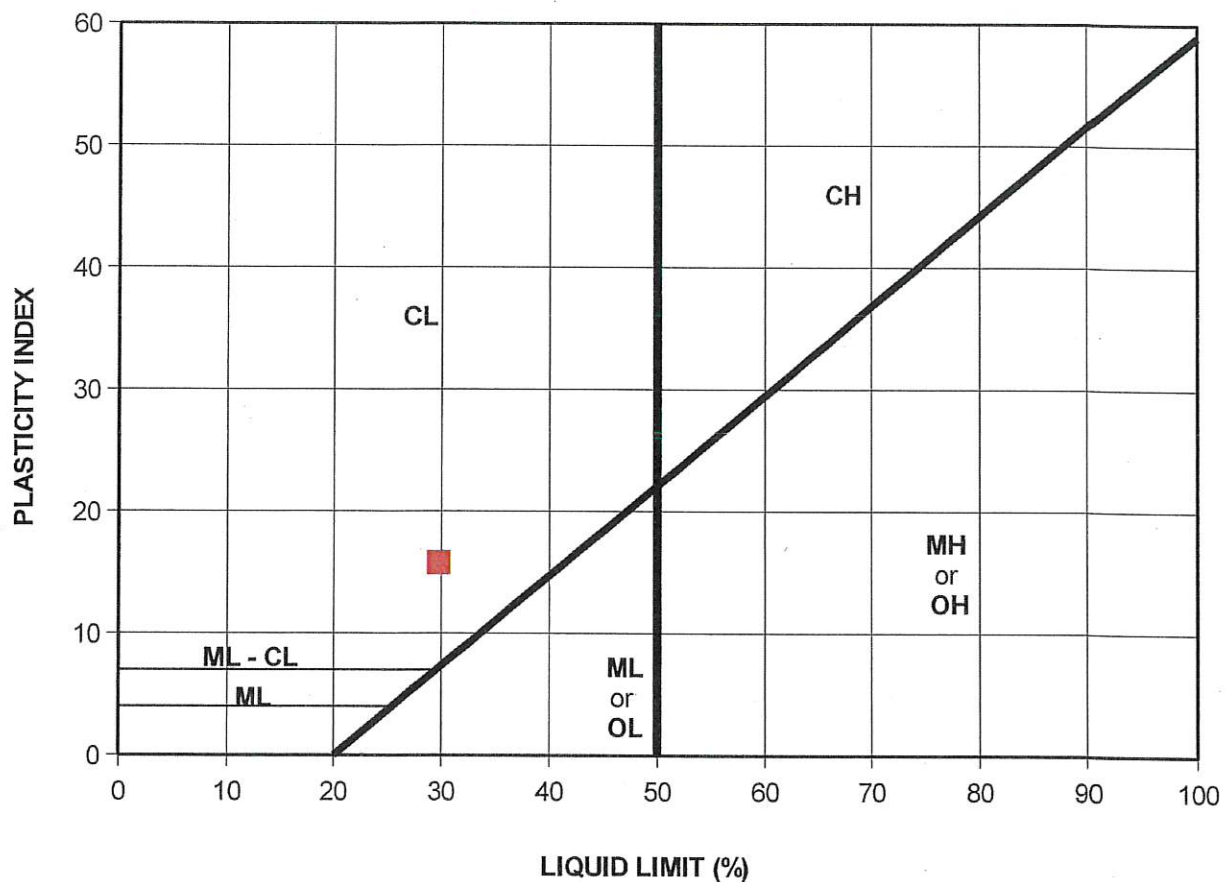
#### PLASTICITY CHART

KEY	SAMPLE NUMBER	SAMPLE DEPTH (ft)	WATER CONTENT (%)	LIQUID LIMIT (%)	PLASTICITY INDEX	PLASTIC LIMIT (%)	PASSING No. 200 SIEVE (%)	LIQUIDITY INDEX	UNIFIED SOIL CLASSIFICATION SYMBOL
<span style="color: red;">■</span>	P1-2	7	19	30	16	14	47	0.3	CL

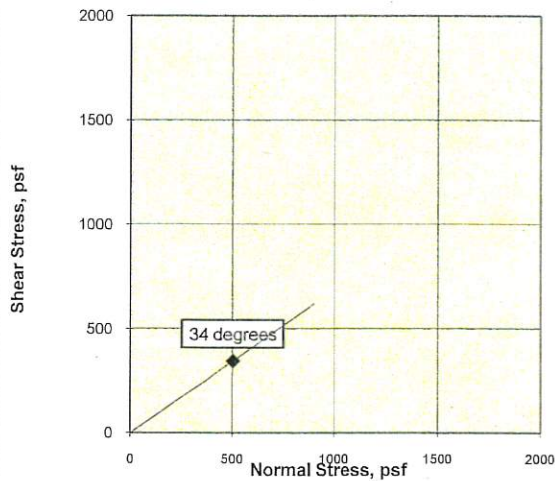
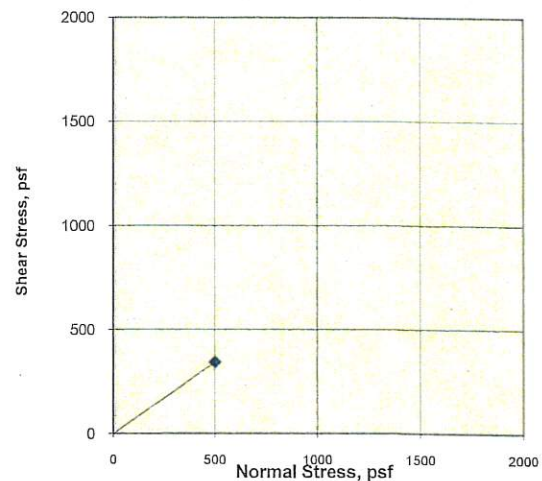
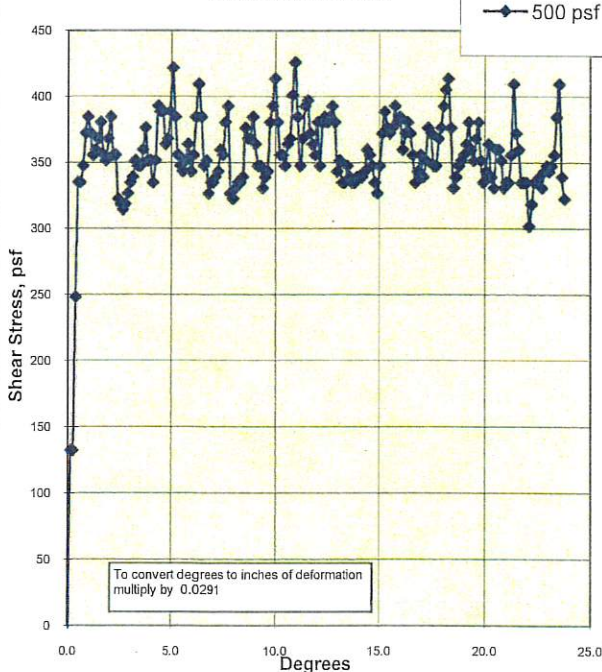
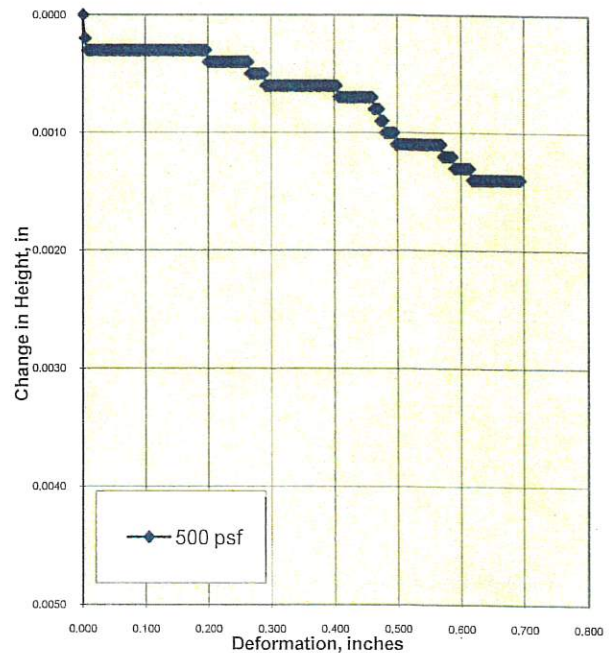
### SHEAR STRENGTH TEST RESULT NO. 1

Secant Residual Stress Friction Angles

Strength Envelope

Deformation Curves

Vertical Deformation

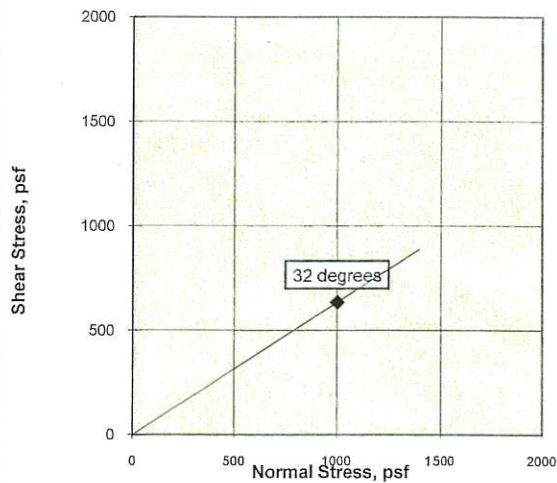
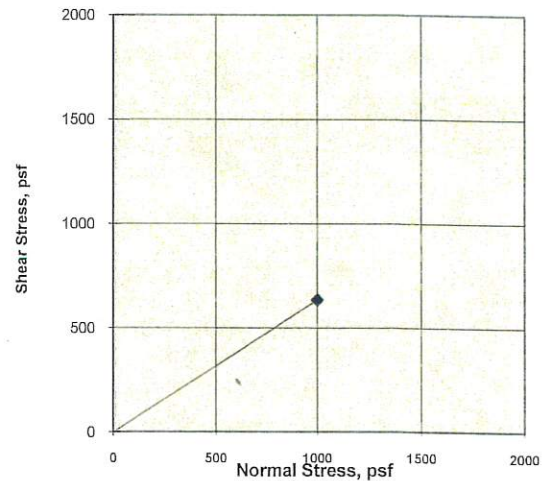
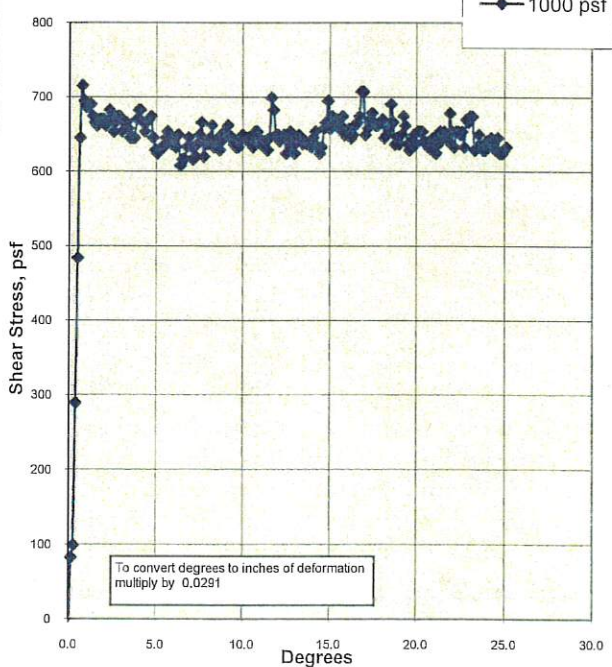
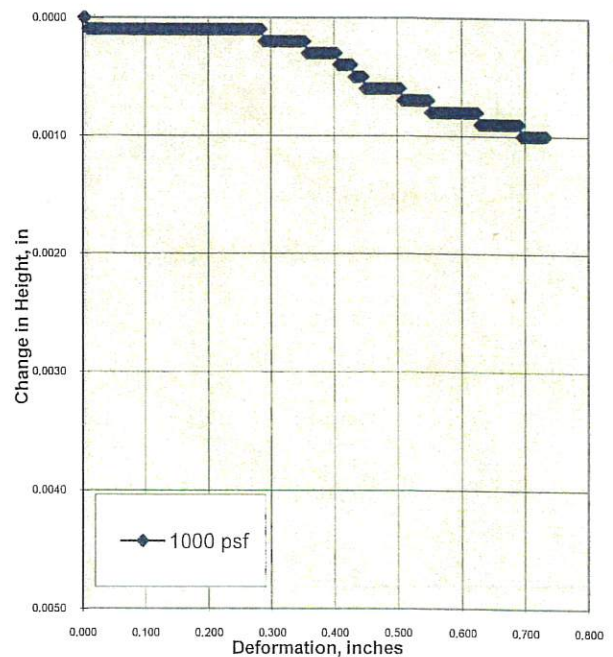
### SHEAR STRENGTH TEST RESULT NO. 2

Secant Residual Stress Friction Angles

Strength Envelope

Deformation Curves

Vertical Deformation

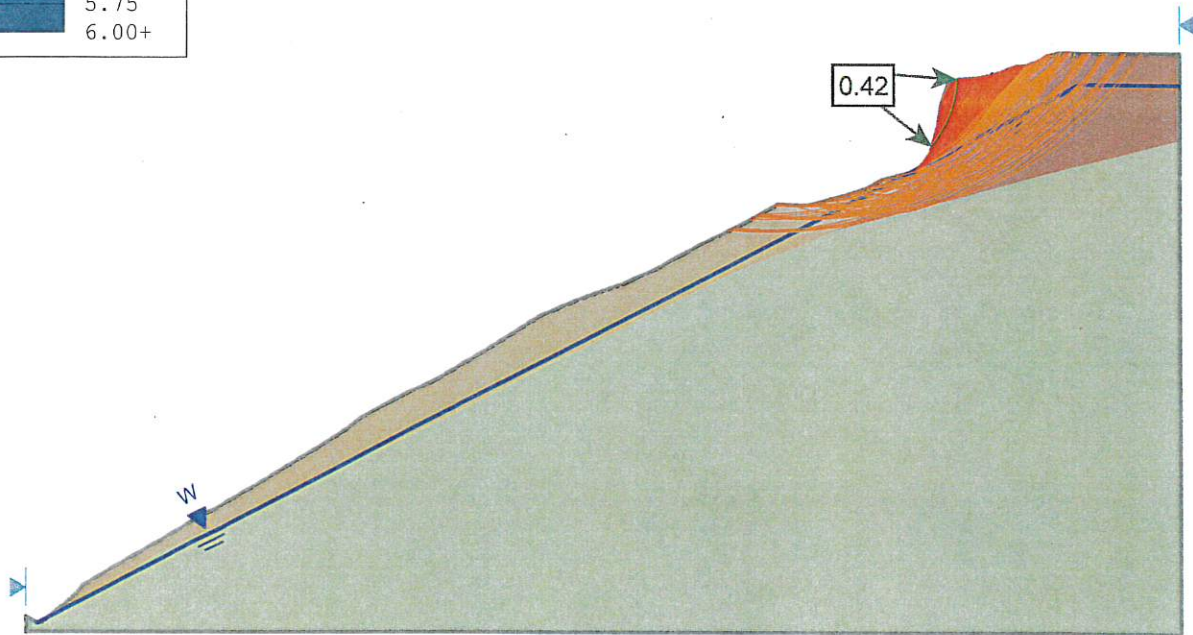
## GLUSS RESIDENCE CROSS-SECTION A-A' STATIC

EVALUATION OF LANDSLIDING INITIATING  
ANYWHERE ON THE SUBJECT SLOPE

- Fill and Colluvium
- Landslide Deposits
- Bedrock/ Displaced Bedrock

NOTE: THE POTENTIAL SLIDE SURFACES WITH A FACTOR OF  
SAFETY OF 1.0 OR LESS ARE SHOWN

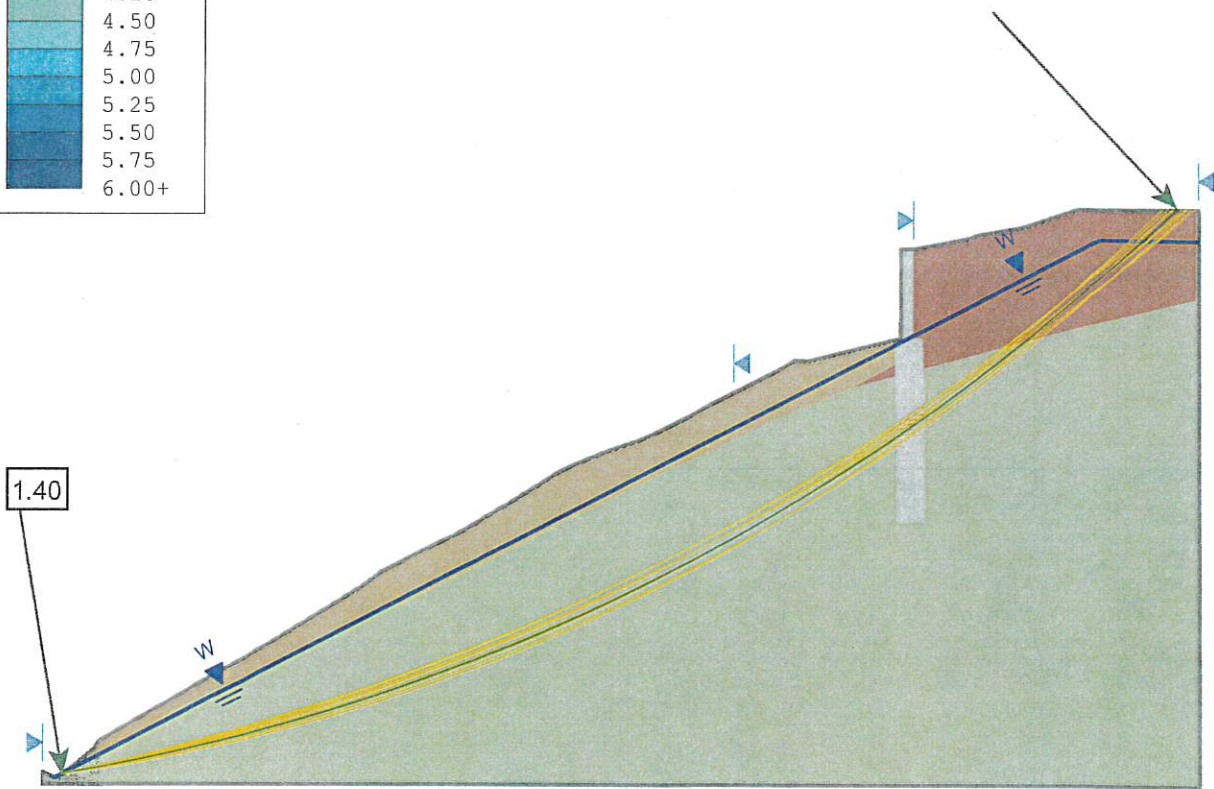
EVALUATION OF LANDSLIDING INITIATING  
UPSLOPE OF THE PROPOSED RETAINING WALL

- Fill and Colluvium
- Landslide Deposits
- Bedrock/ Displaced Bedrock

NOTE: THE TEN MOST CRITICAL POTENTIAL  
SLIDE SURFACES ARE SHOWN

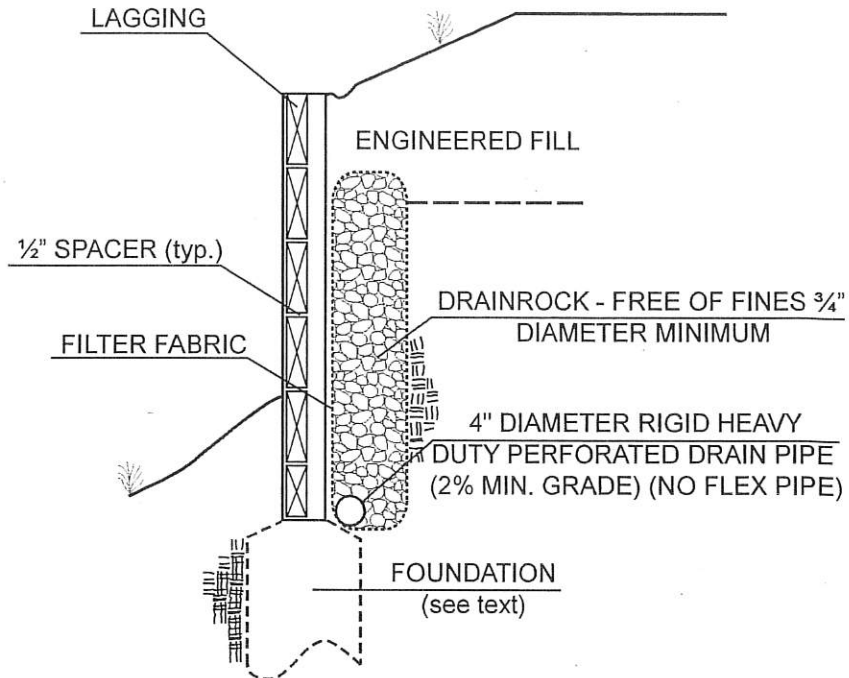
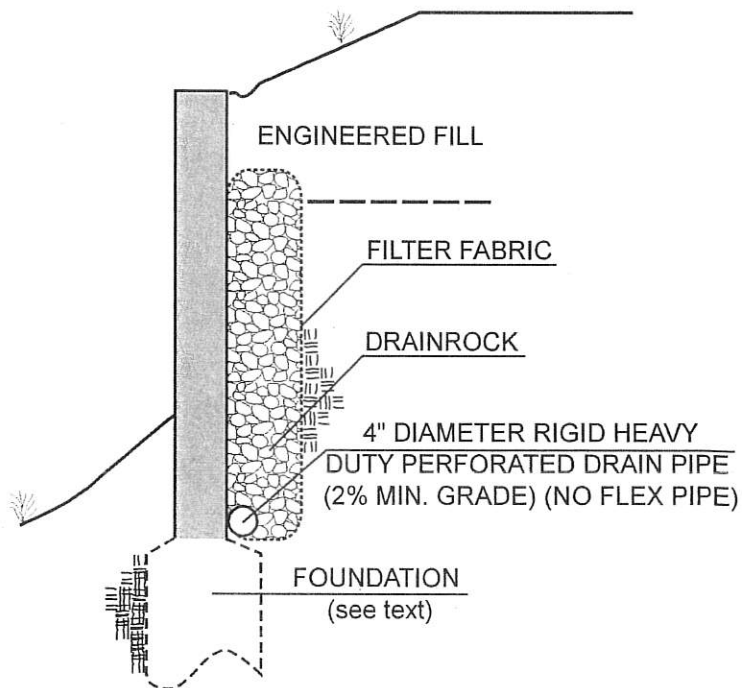
CONCEPTUAL RETAINING WALL BACKDRAIN DIAGRAM

## FOR LAGGING WALLS

## FOR CONCRETE WALLS

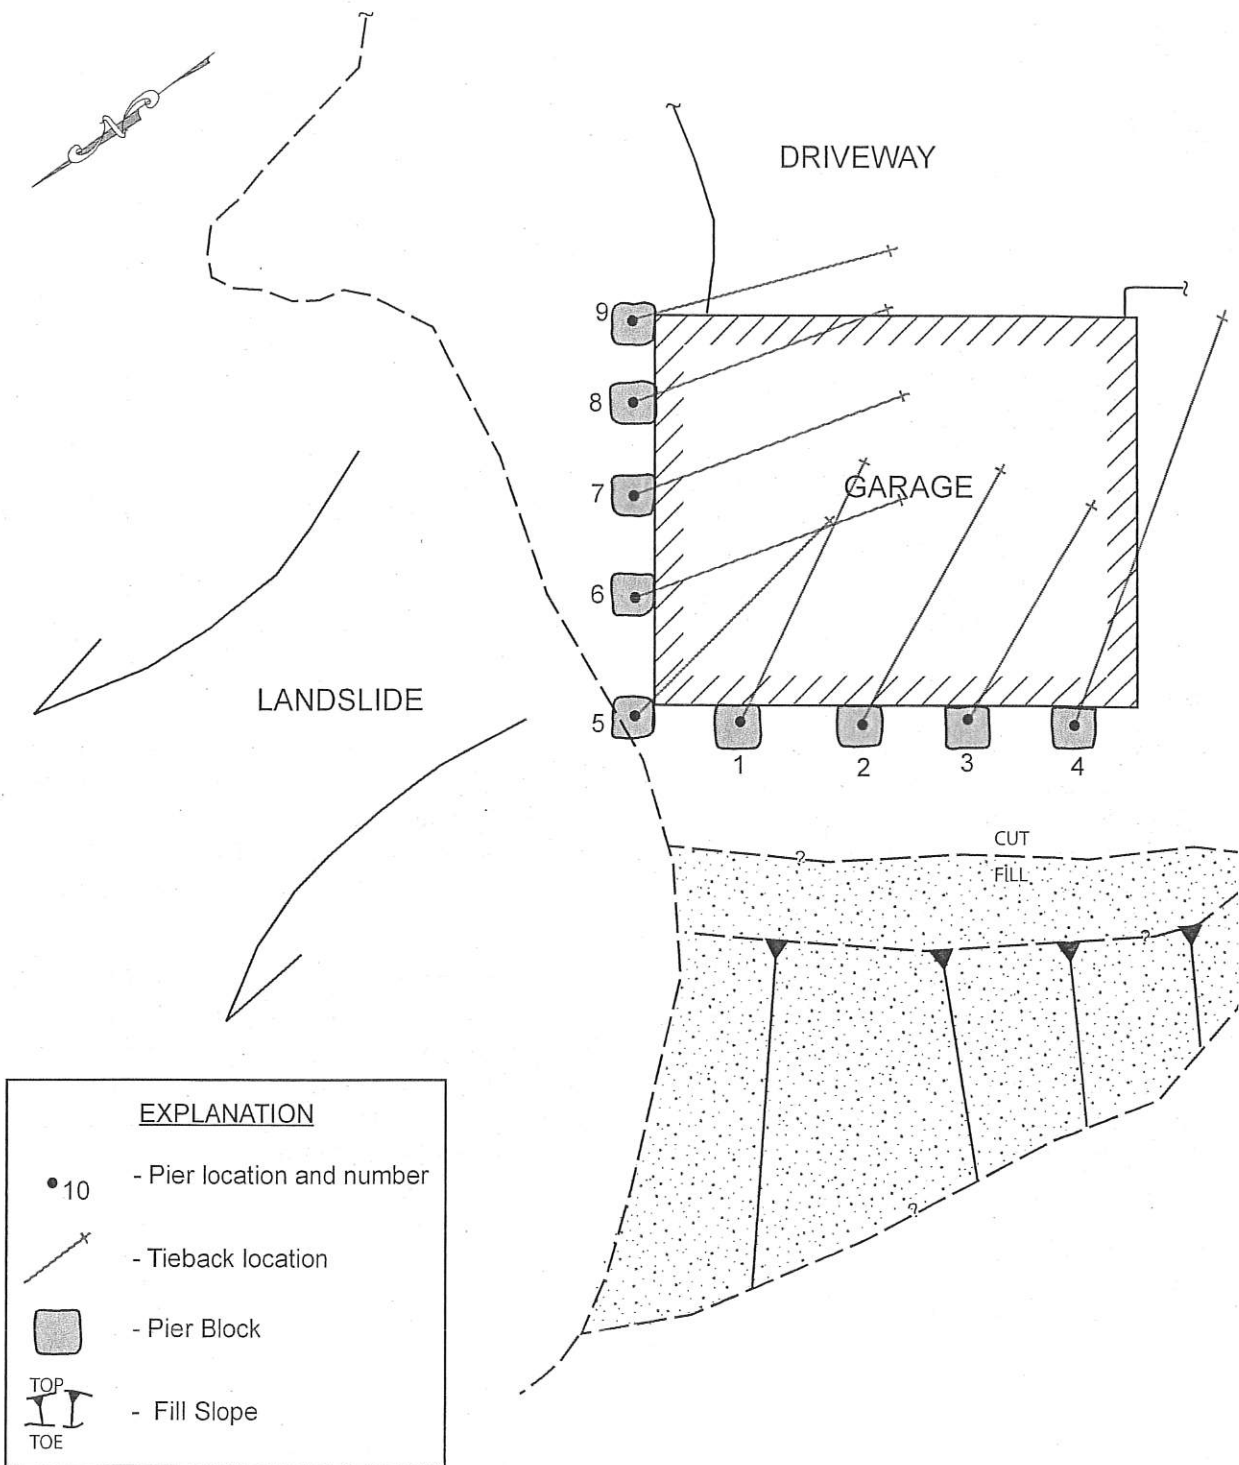
#### HELICAL PIER AND TIEBACK LOCATION PLAN

BASE: Partial site plan generated by C. Reid using tape and a compass; C2EARTH, INC.; 2-18-17

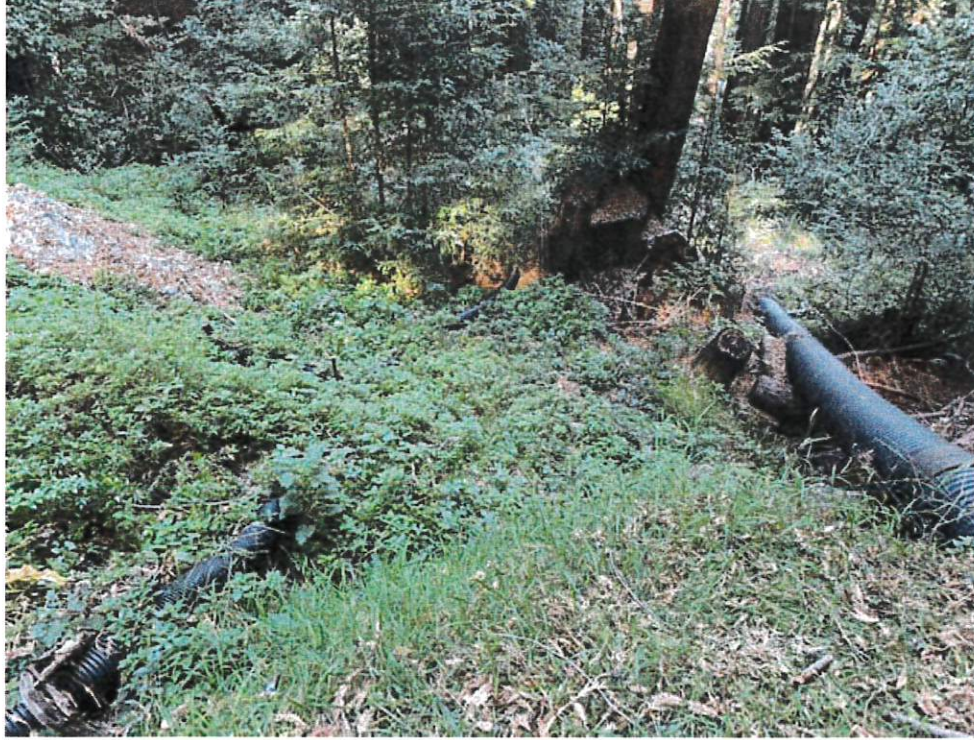
Appendix B-1. Failing slope, looking north, with hummocky topography, disturbed vegetation, and exposed culvert (right of photo).

The project site consists primarily of an eroding, hummocky slope below the garage and driveway that failed after heavy rains in the winter of 2017 (**Attachment 6**, Appendix B-1, B-2). Adjacent portions of the study area, outside the project site, consist of the garage, driveway, and residence in the southeastern

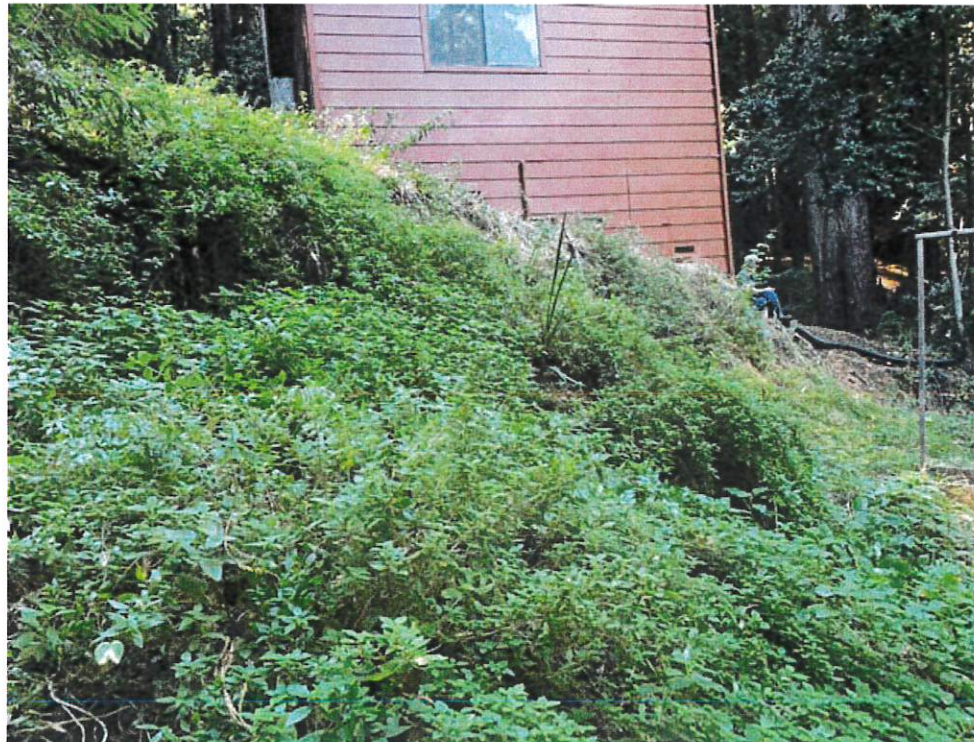
Appendix B-2. Failing slope, looking west toward garage, with Ruderal vegetation.

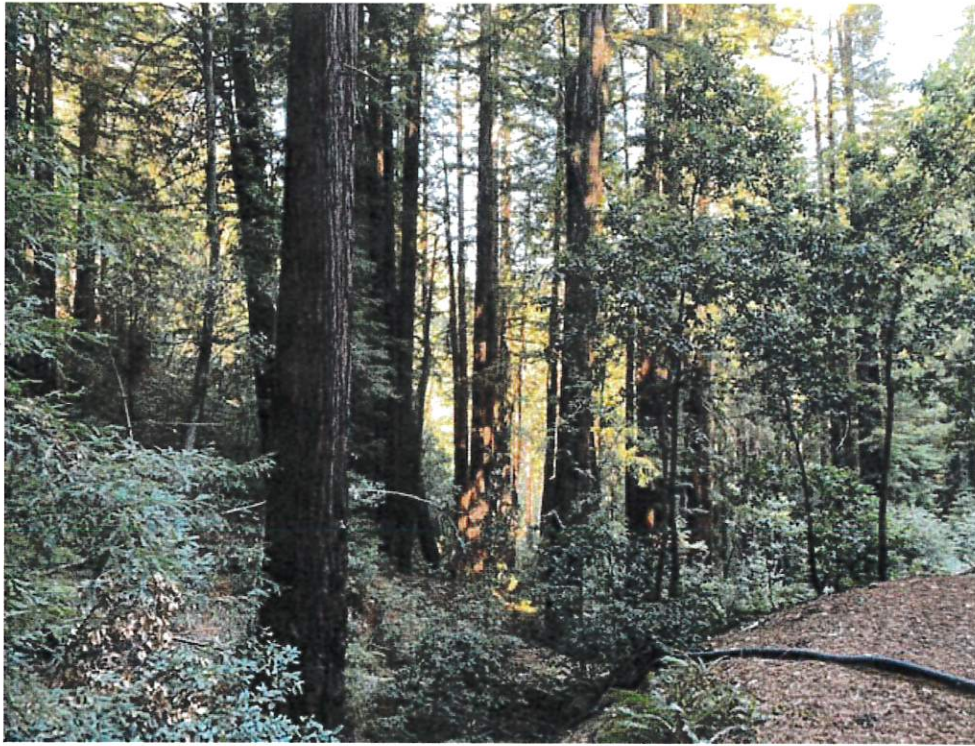
Appendix B-3. Redwood Forest along Martin Creek, looking downstream (north) with top-of-bank in lower right of photo and garage to the right, just outside photo.

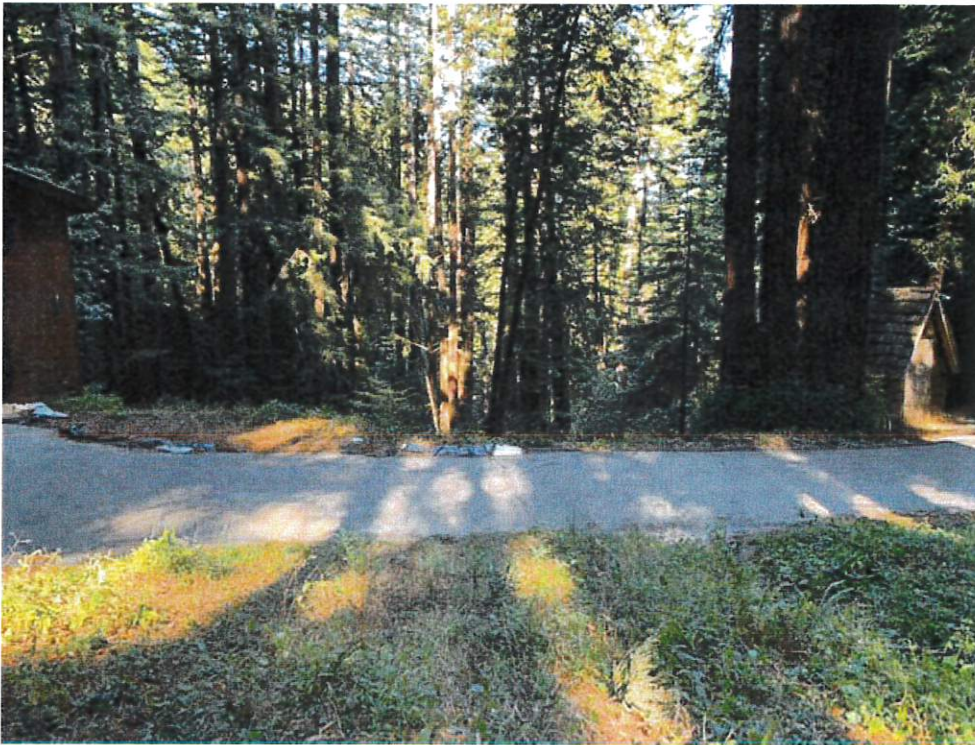
Appendix B-4. Developed/Ruderal habitat, showing the driveway and garage (left of photo), looking north, with the failing slope north of driveway and garage.

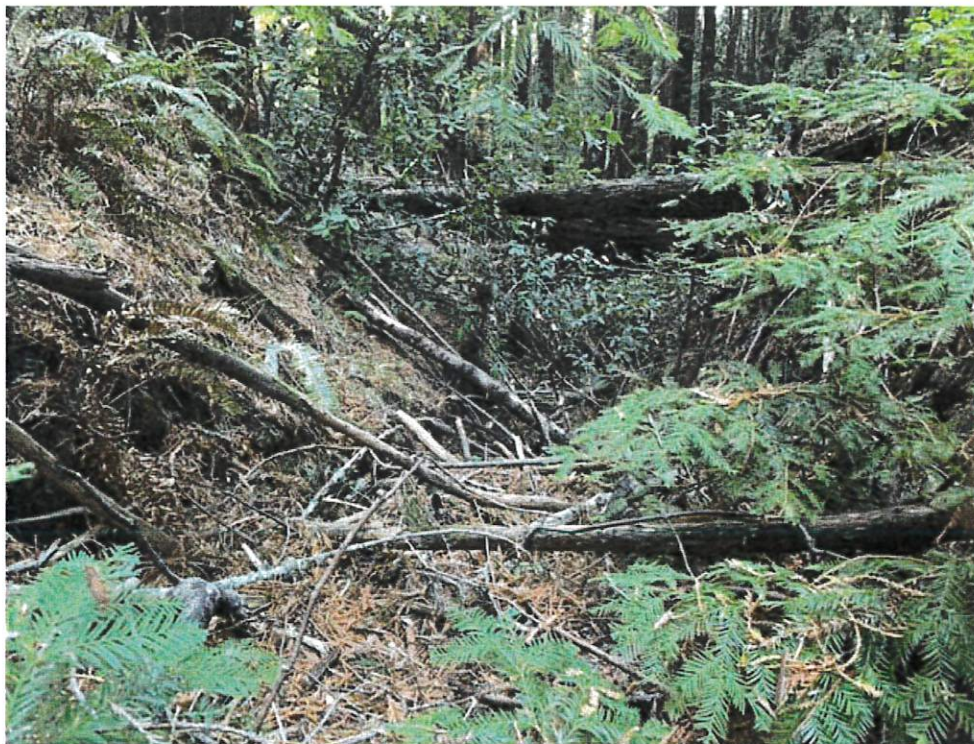
Appendix B-5. Martin Creek on the study area, looking downstream (north).

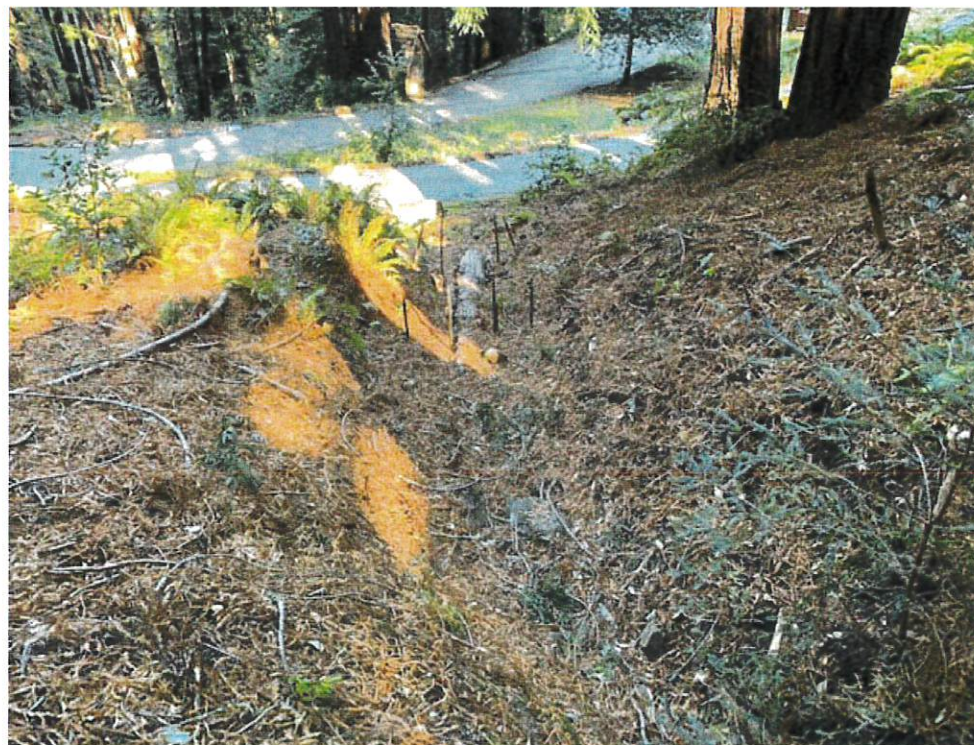
Appendix B-6. Ephemeral tributary, looking downstream (north), with driveway in upper portion of photo.

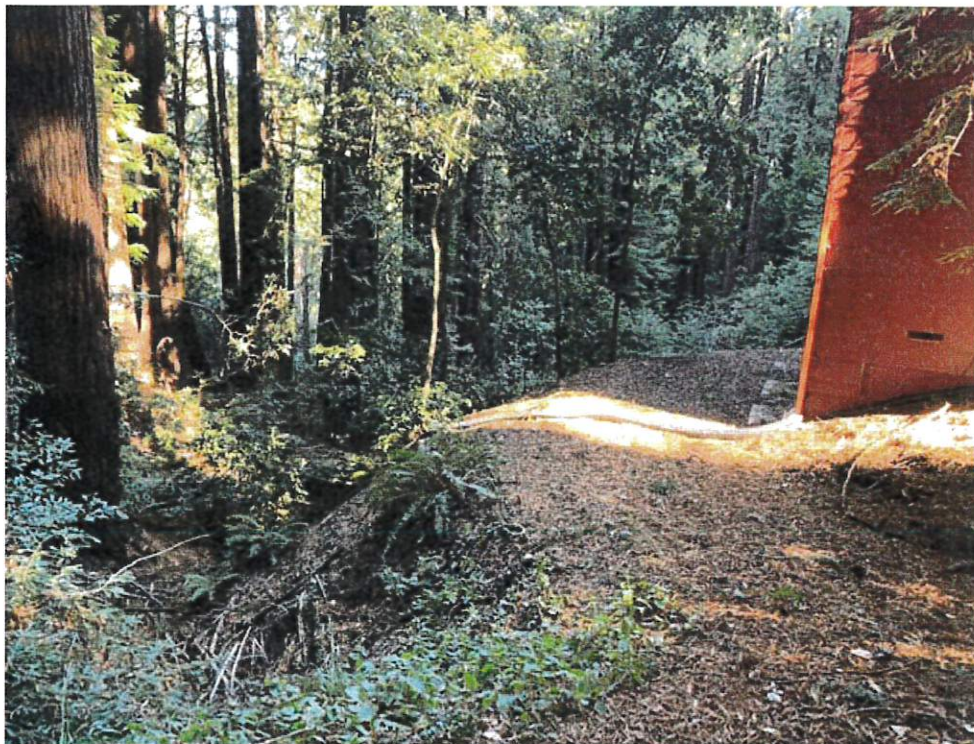
Appendix B-7. Martin Creek top-of-bank (center of photo), with garage to the right, looking downstream (north).

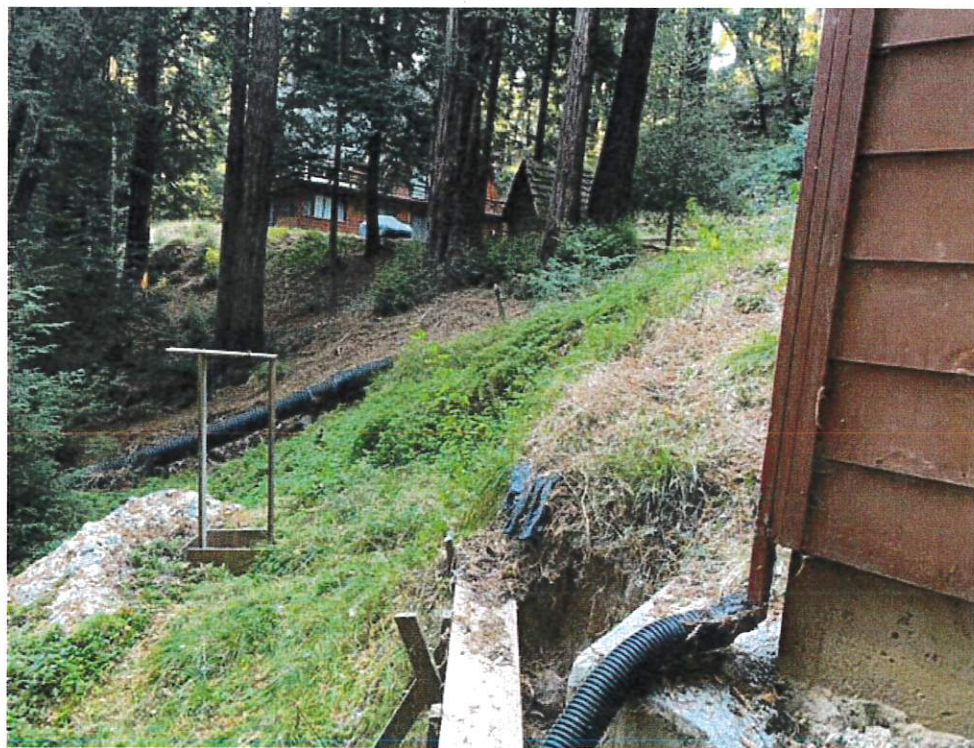
Appendix B-8. Project site, taken from northern corner of garage, looking east across failing slope at location of proposed retaining wall.
