APPENDIX B
ARCHITECTURAL AND HISTORICAL
EVALUATION

**Historical Evaluation of the
Buildings at 1400 Burbank Avenue
Santa Rosa, Sonoma County, California**

May 31, 2011

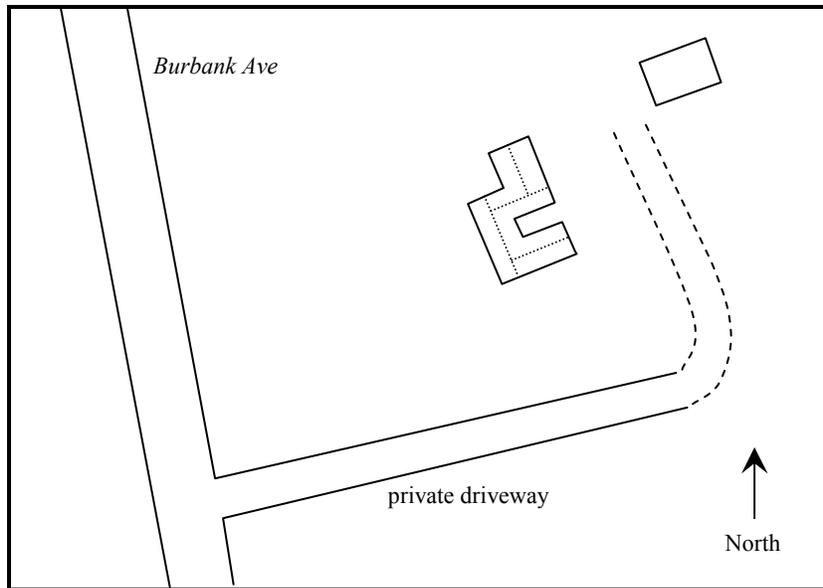
Figure 5. Sketch of the building layout.

The house at 1400 Burbank Avenue is on a long, narrow lot and sits 225 feet east of Burbank Avenue. It is a one-story, frame structure with a compound form (Figures 5 and 6). The front of the house is very simple and appears to have been used rarely, the rear entry serving as the main access point. The door and stoop are centered on the front façade, and are flanked by narrow, double-hung windows. Outward of these windows are larger, fixed windows.

Projecting to the rear are gabled wings that create a small, U-shaped courtyard at the rear of the building. Three doorways open on to the courtyard accessing different parts of the house. Two doorways are standard sized, and one consists of a pair of French doors. A third gabled wing extends north from the northern wing. It has its own entrance on the east elevation.

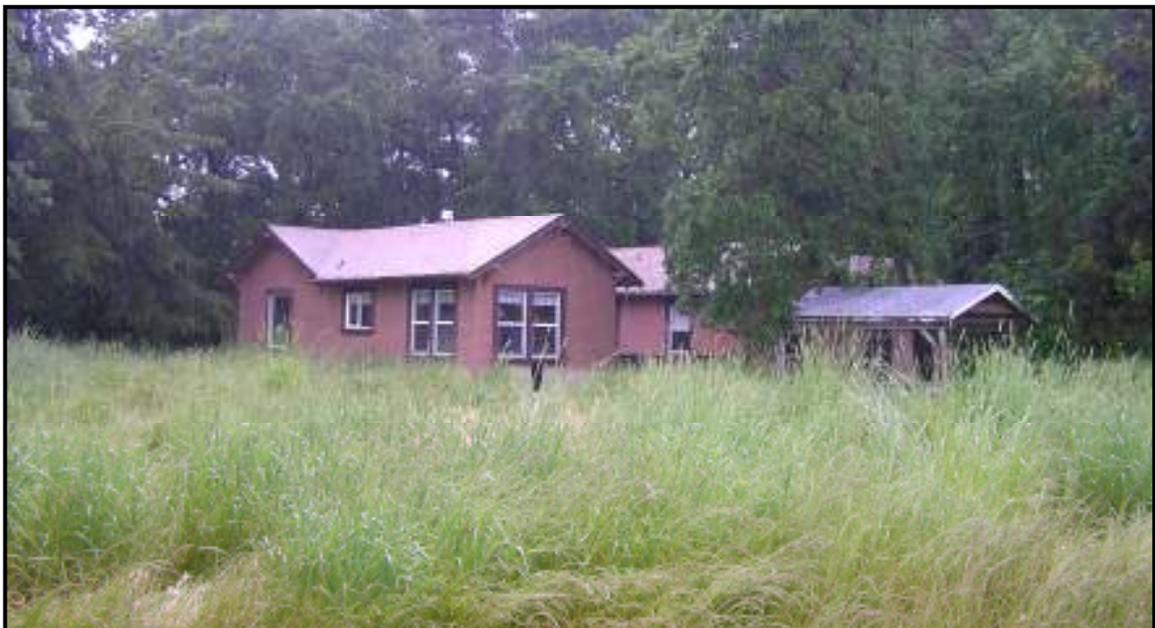
Figure 6. View of the south and east (rear) house elevations.

The house is clad with narrow, lapped siding except near the bottom of each wall where vinyl siding has been installed. Decorative brackets are found at the gable ends. Windows throughout the house have vinyl sashes. At the rear of the house is a small, gable-roofed barn (Figure 7). Original siding appears to be vertical boards and battens. The roof is covered with corrugated metal sheets, and the windows are a mix of multi-paned and fixed vinyl sashes.

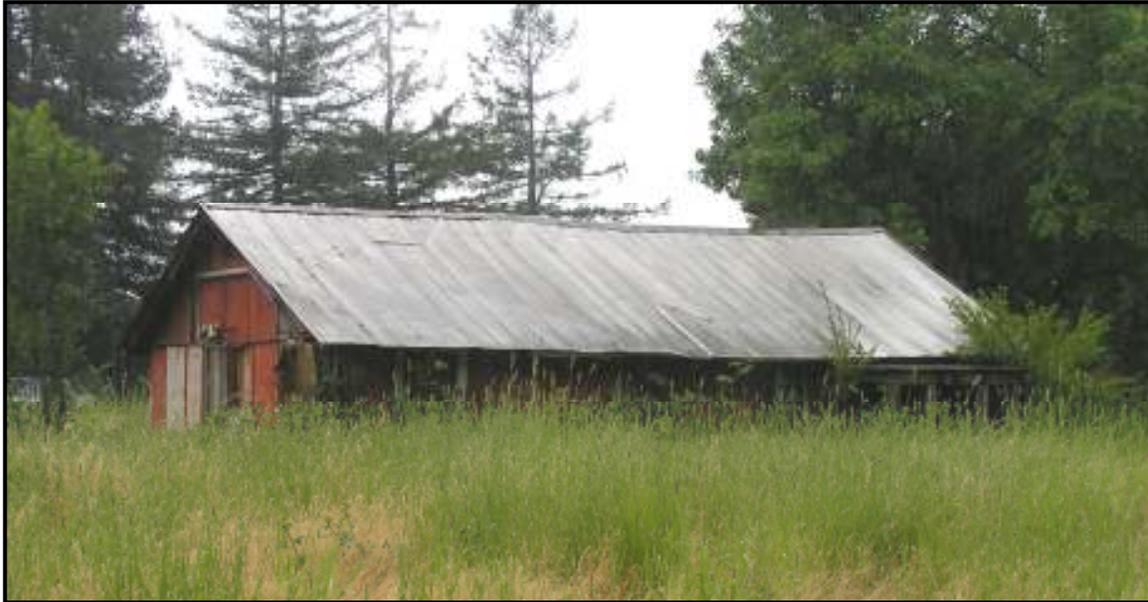
Figure 7. View of the barn, facing southwest.
