# Preliminary Jurisdictional Delineation Report

**201 Kimberly Lane, 161, 141, & 139 Miles Lane**

**Watsonville, Santa Cruz County, CA**

August 15, 2019

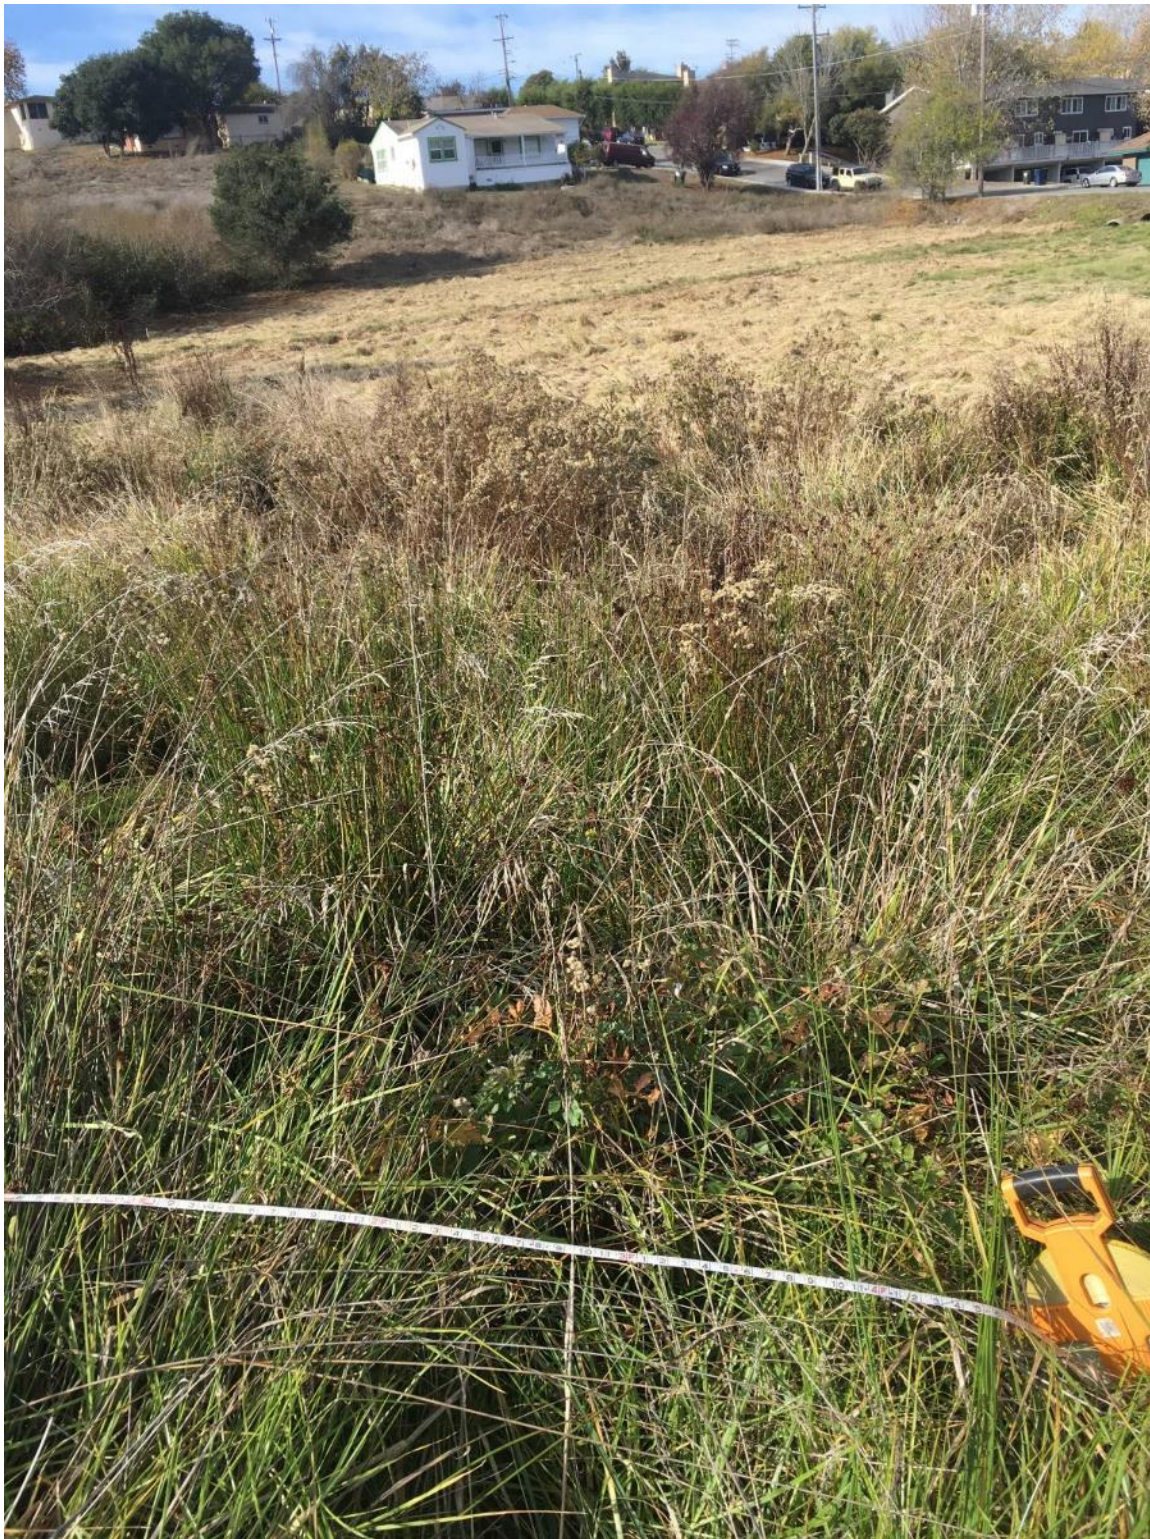
**Photo 1: Vegetation at ML01**

Table 3 summarizes the results of vegetation sampling at all sampling points. All vegetation observed is listed. Photos 1 and 2 show the vegetation at each sampling point. The Wetland Indicator Status was determined using the *Arid West 2016 Regional Wetland Plant List* (Lichvar *et. al.* 2016). Using the methods outlined by the Army Corps of Engineers, wetland vegetation indicators were observed at one sampling point – ML01.

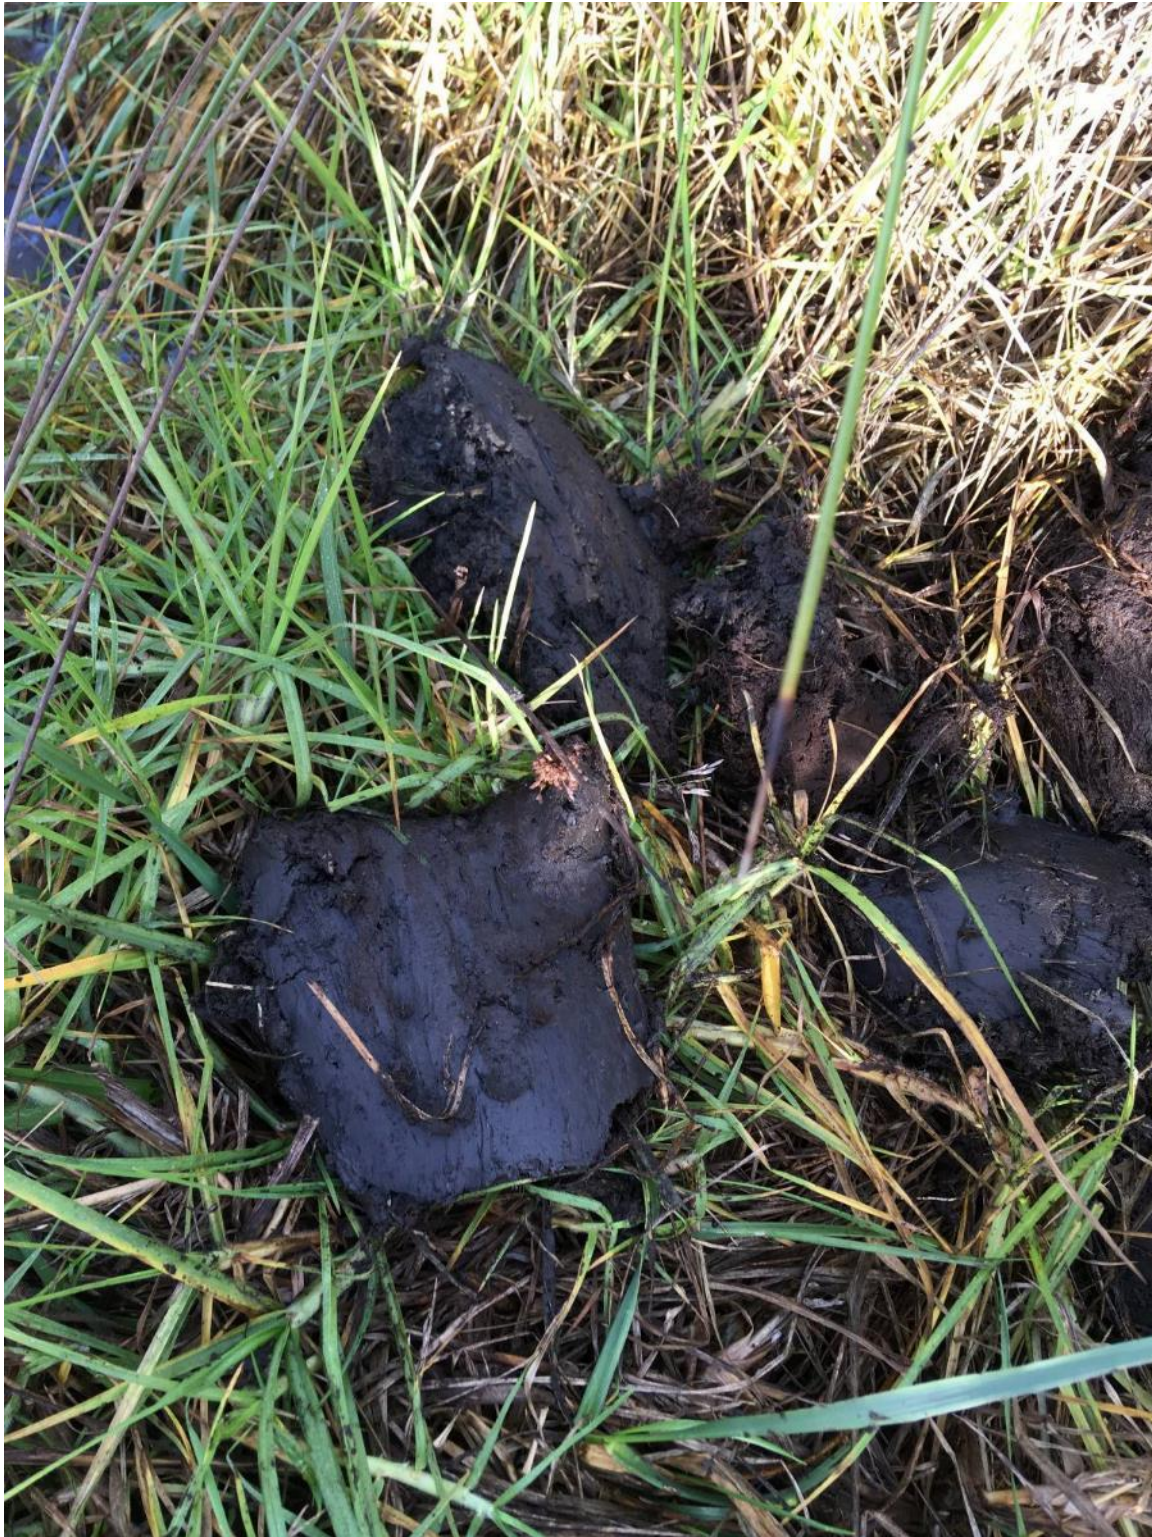
**Photo 11: Soil at ML01**

One series appears to occur at all the sampling points according to the soil survey: Tierra-Watsonville Complex, 15-30% slope. This soil is rated as hydric, in group D. Group D soils have high runoff potential when wet and are clayey in texture. Soils at ML01 below 8 inches are clayey, and so do conform to group D. The soils at ML02 were found to be sandy rather than clayey, and so do not conform to hydric soils in Group D. In addition, ML02 had gravelly material, indicating that it may be Pfeiffer soil type, a minor component of the Tierra-Watsonville Complex found in the soil survey.

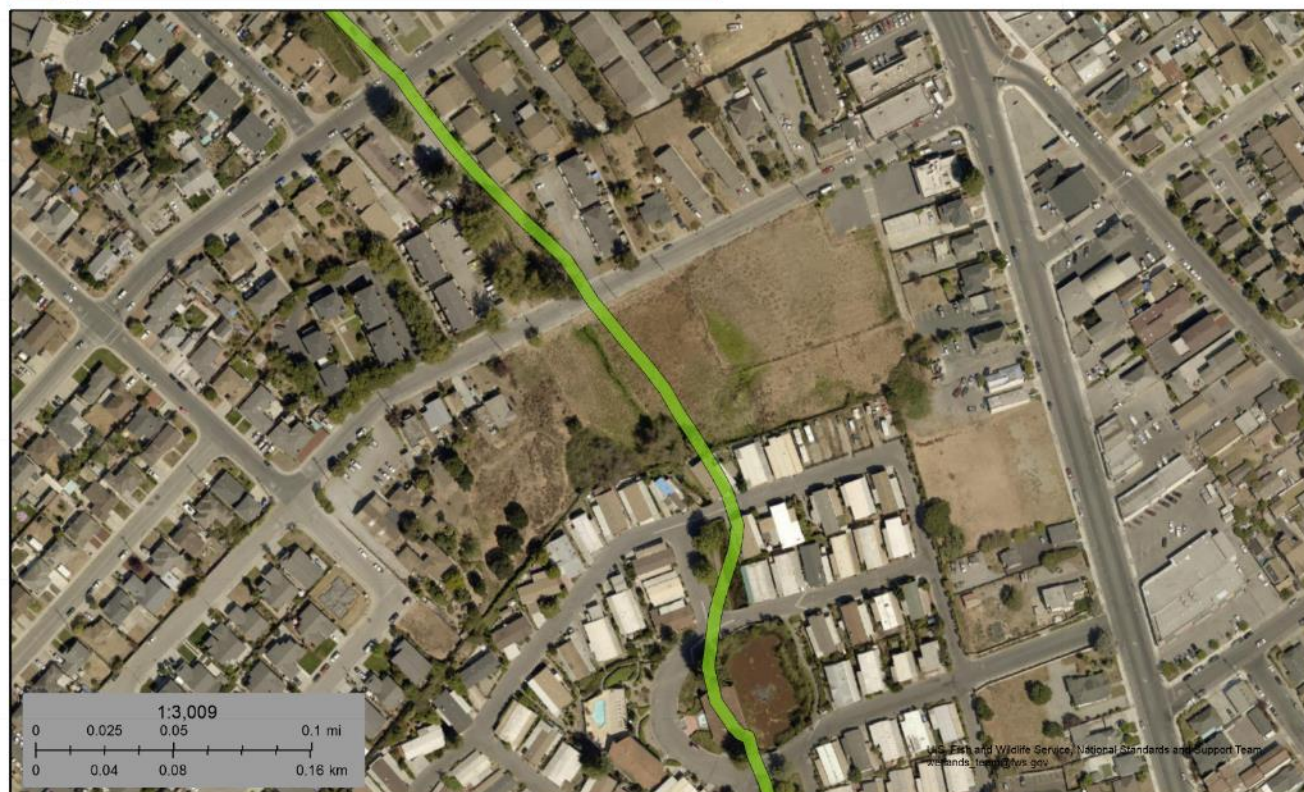
Field observations confirmed that such a feature occurs on the site, though the exact location is somewhat different than mapped by the NWI. This feature has a clear Ordinary High-Water Mark, and so is considered a Potential Water of the U.S. No wetland sampling occurred in this feature.

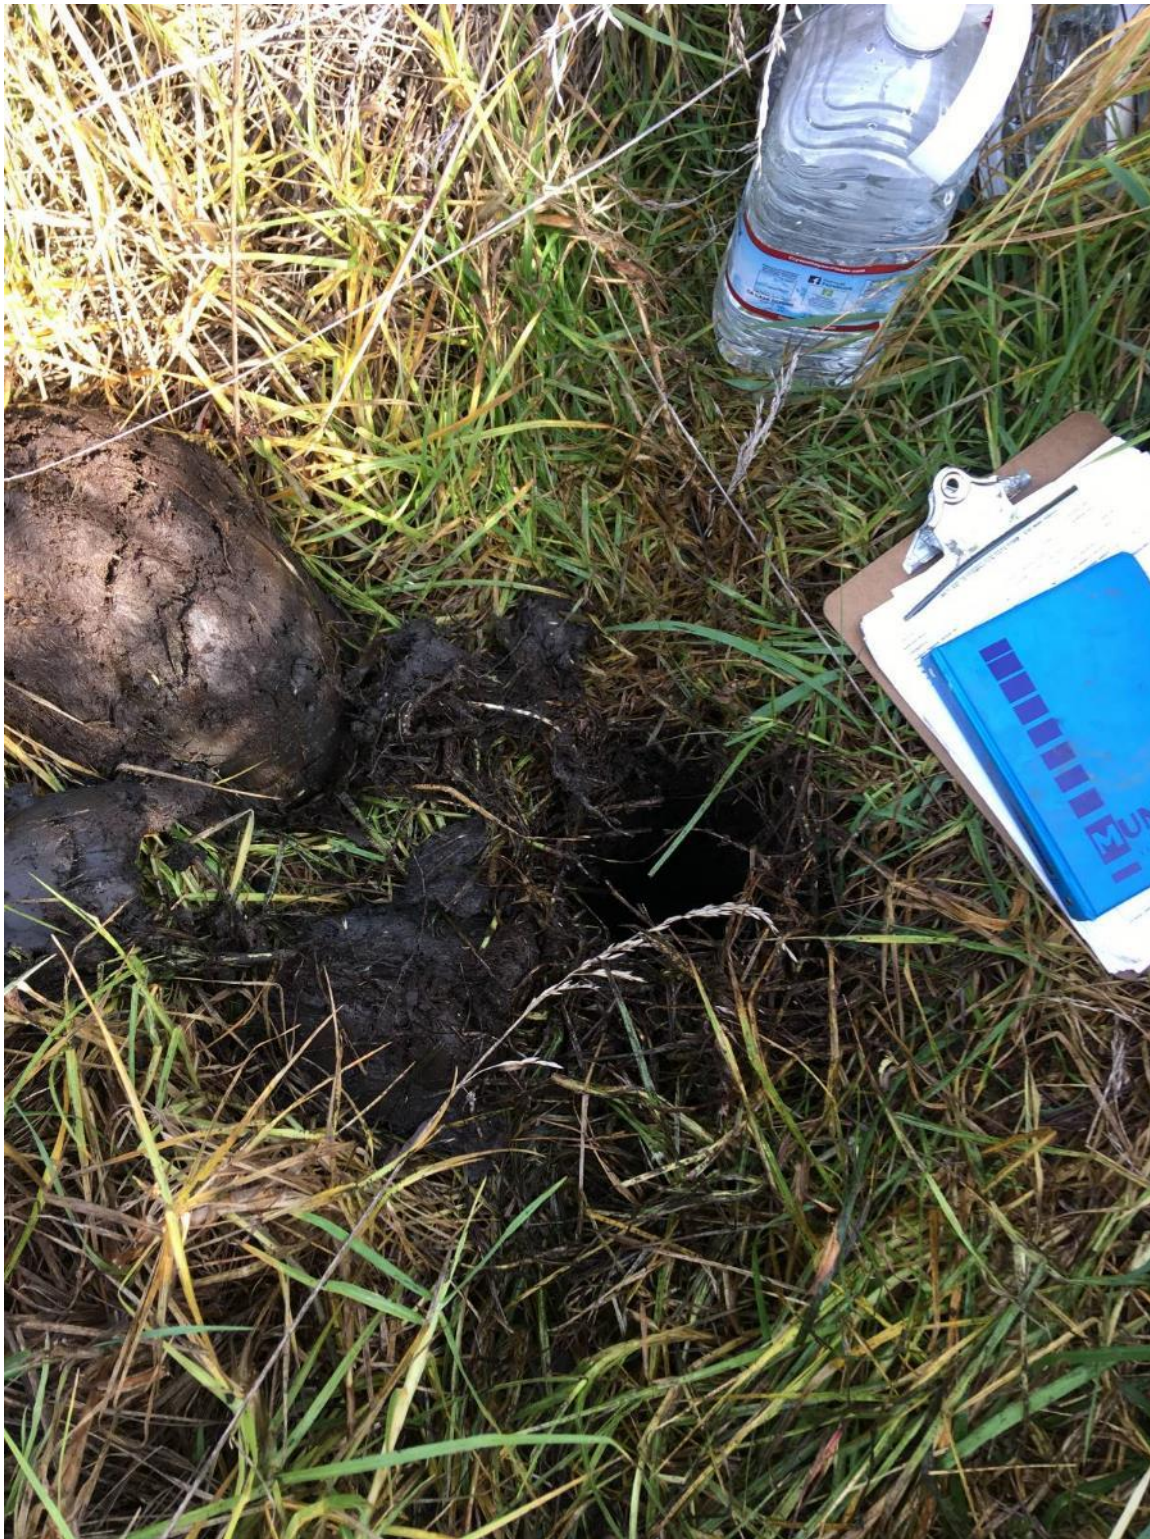
**Photo 20: Pit at ML01**

Table 6 provides a summary of wetland indicators observed at each sampling point. Only sampling point ML01 showed evidence of wetlands under the jurisdiction of ACOE

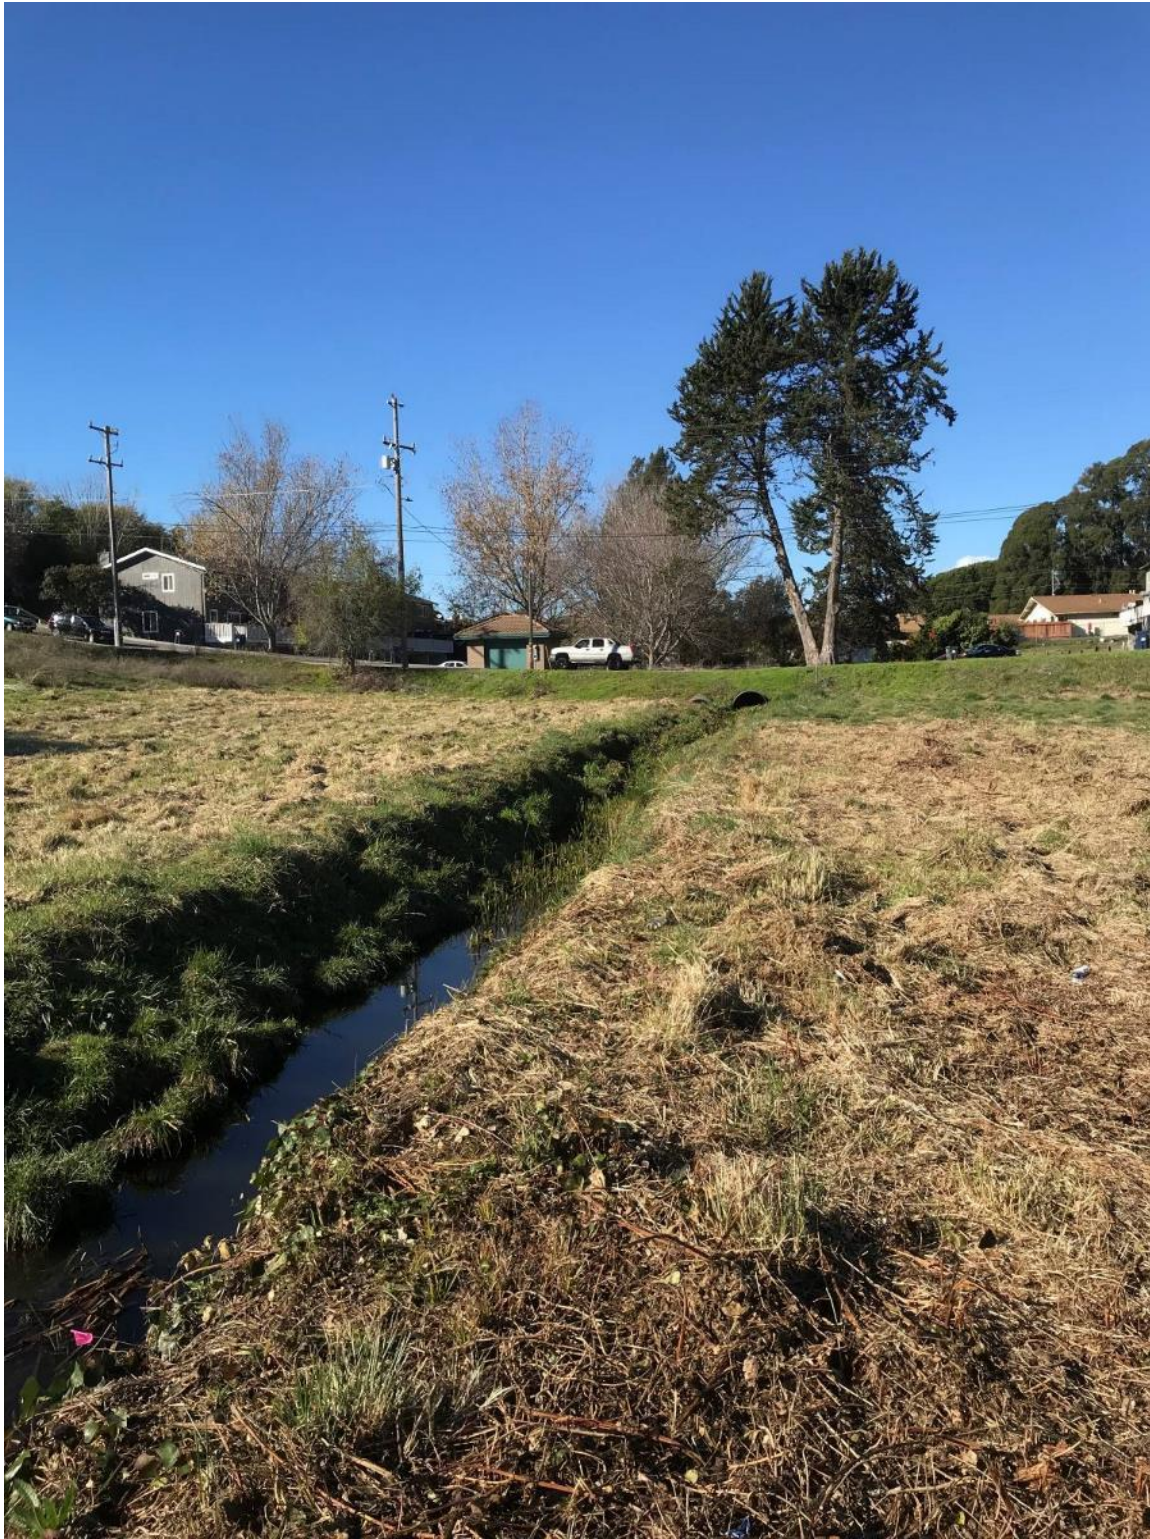
**Photo 32: Intermittent Stream, looking north**

The stream enters the property through a culvert that runs under Miles Ln. The first 183 l.f. is dominated by emergent obligate wetland vegetation such as *Typha* sp. (cat tail) and *Schoenoplectus* sp. (bull rush) (Photos 31 and 32). The final 70 l.f. is under *S. laevigata* and has *R. armeniacus* along the banks (Photos 33 and 34). The feature drains onto the adjacent property into a storm water structure (Photo 35). This structure acts as a small impoundment, causing the ditch to fill with water during the summer season.

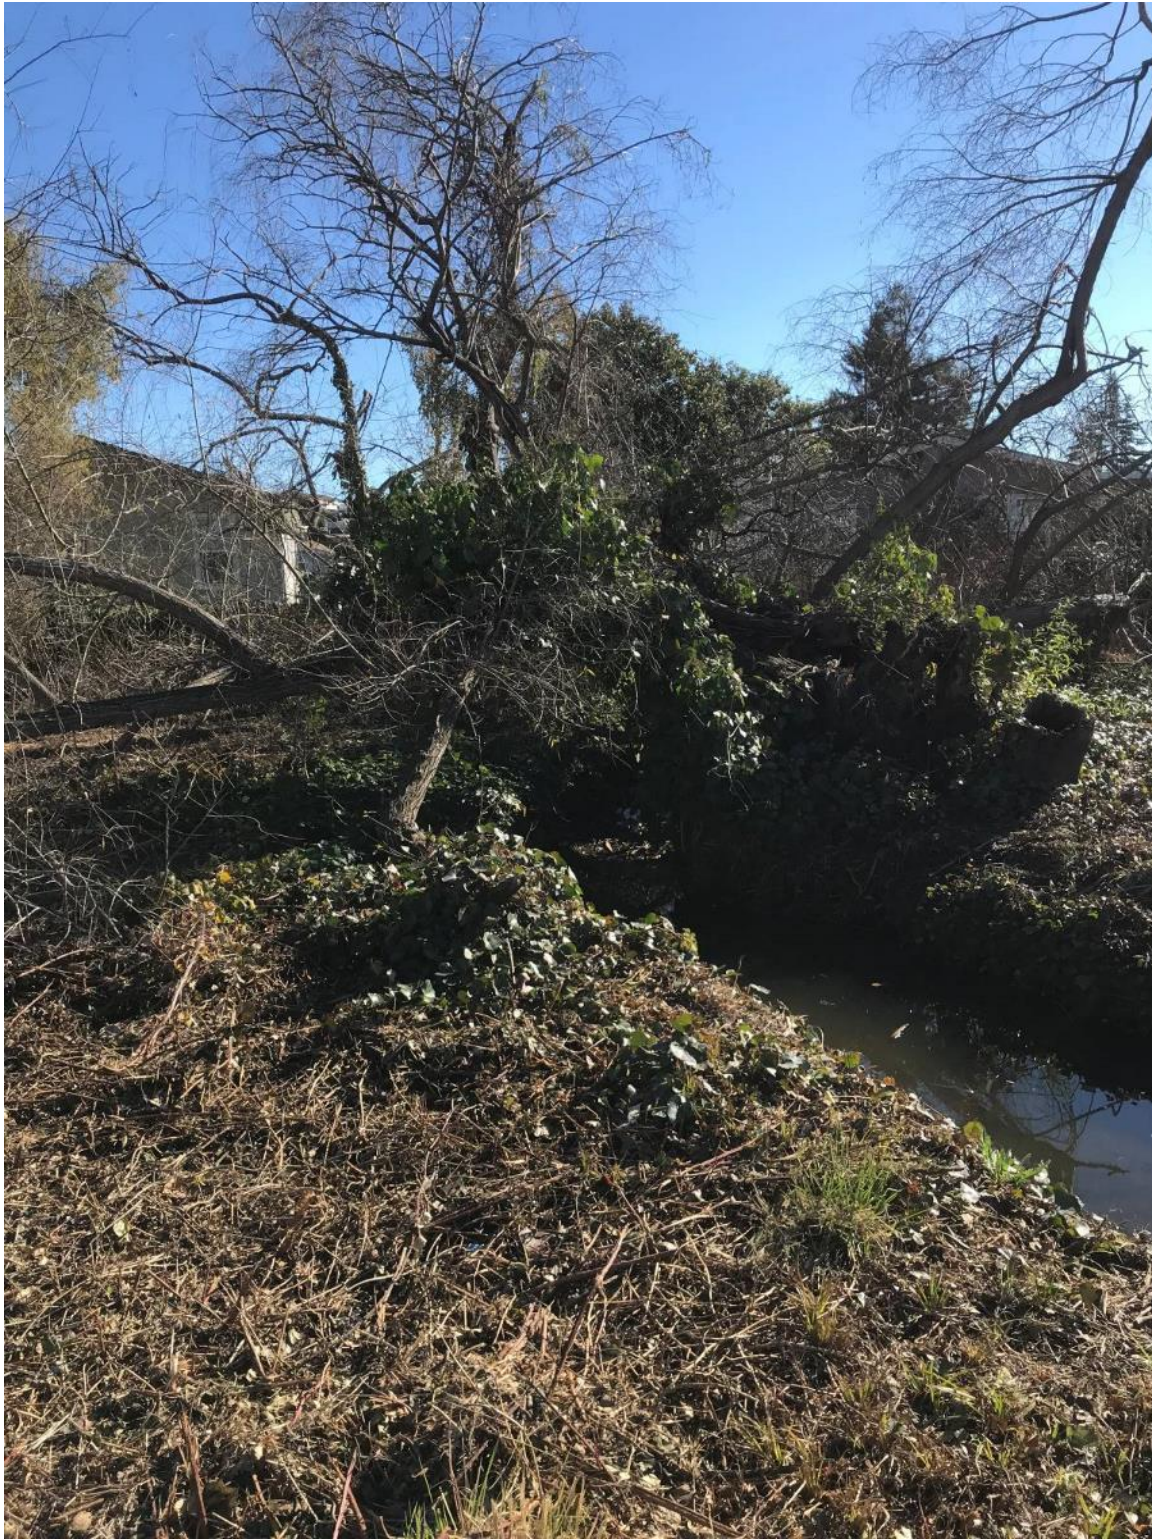
**Photo 33: Intermittent stream entering *S. laevigata* canopy**

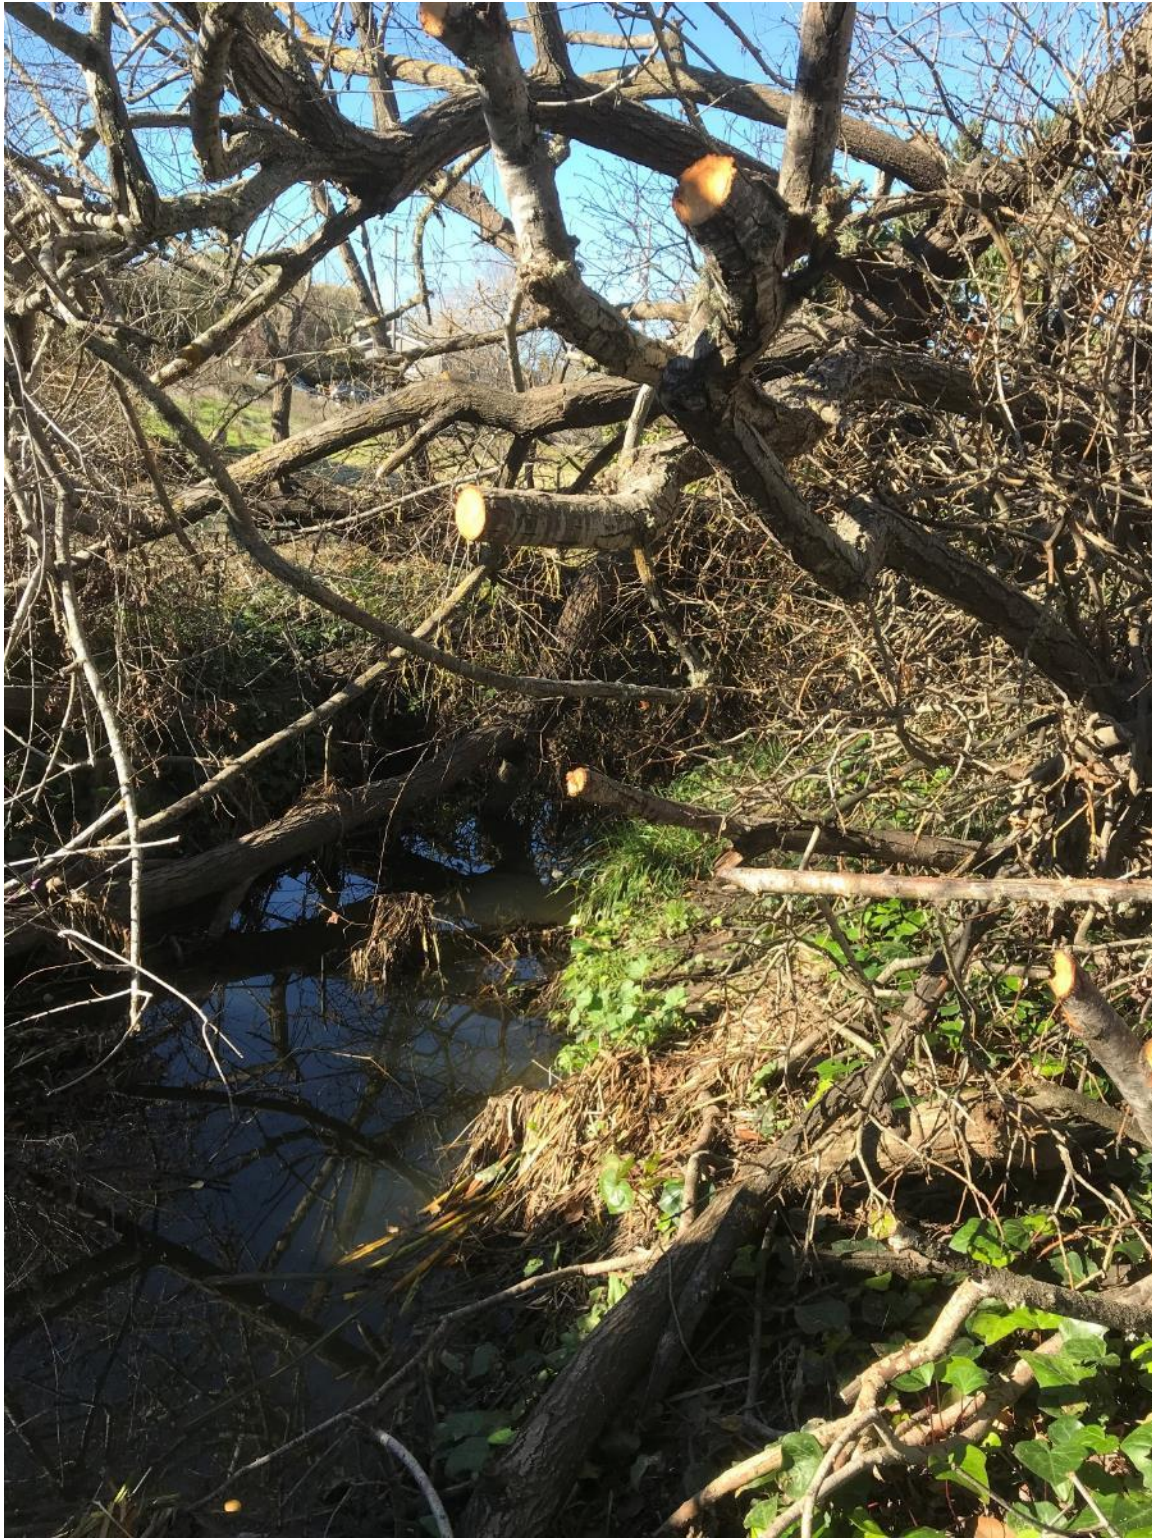
**Photo 34: Intermittent Stream under *S. laevigata***

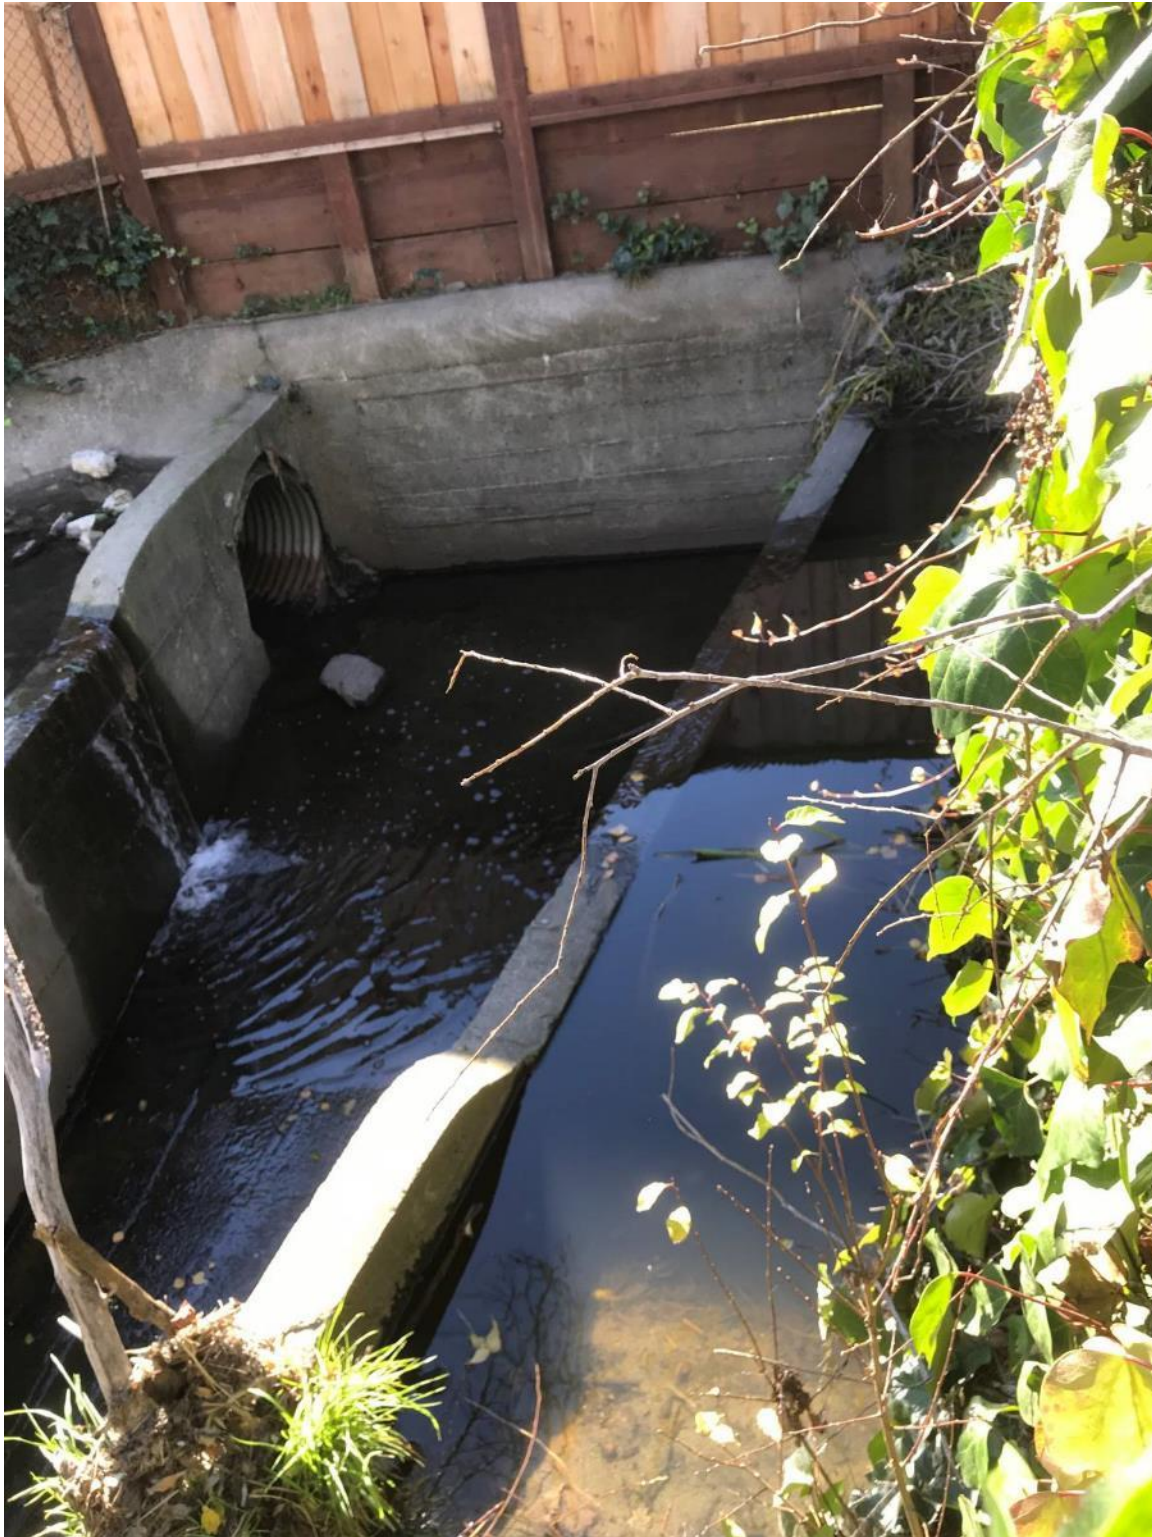
**Photo 35: Stormwater structure where intermittent stream drains**

ECI noted that the upper water source appeared to be intermittent, running primarily in the winter and spring. The lower section of the channel is impounded by a stormwater feature, which causes water to backup into the stream channel (Photo 35). This artificial structure may give the impression that the area is an arm of the slough, when in fact any standing water in the channel is caused by this structure, not by the hydrology of the slough.

Given that the feature is fed by an intermittent stream, and that the buildup of water, if present during the dry season, is due to an artificial structure, ECI determined that the best description of this feature is as an intermittent stream. It may be the case that the feature could equally be described as an "emergent wetland," however since these wetlands typically lack flowing water, and since water is clearly flowing through the system through much of the year, ECI believes intermittent stream is more appropriate a description than emergent wetland. It should be noted, however, that the results of this report would not change if the naming of this feature were changed in this way.

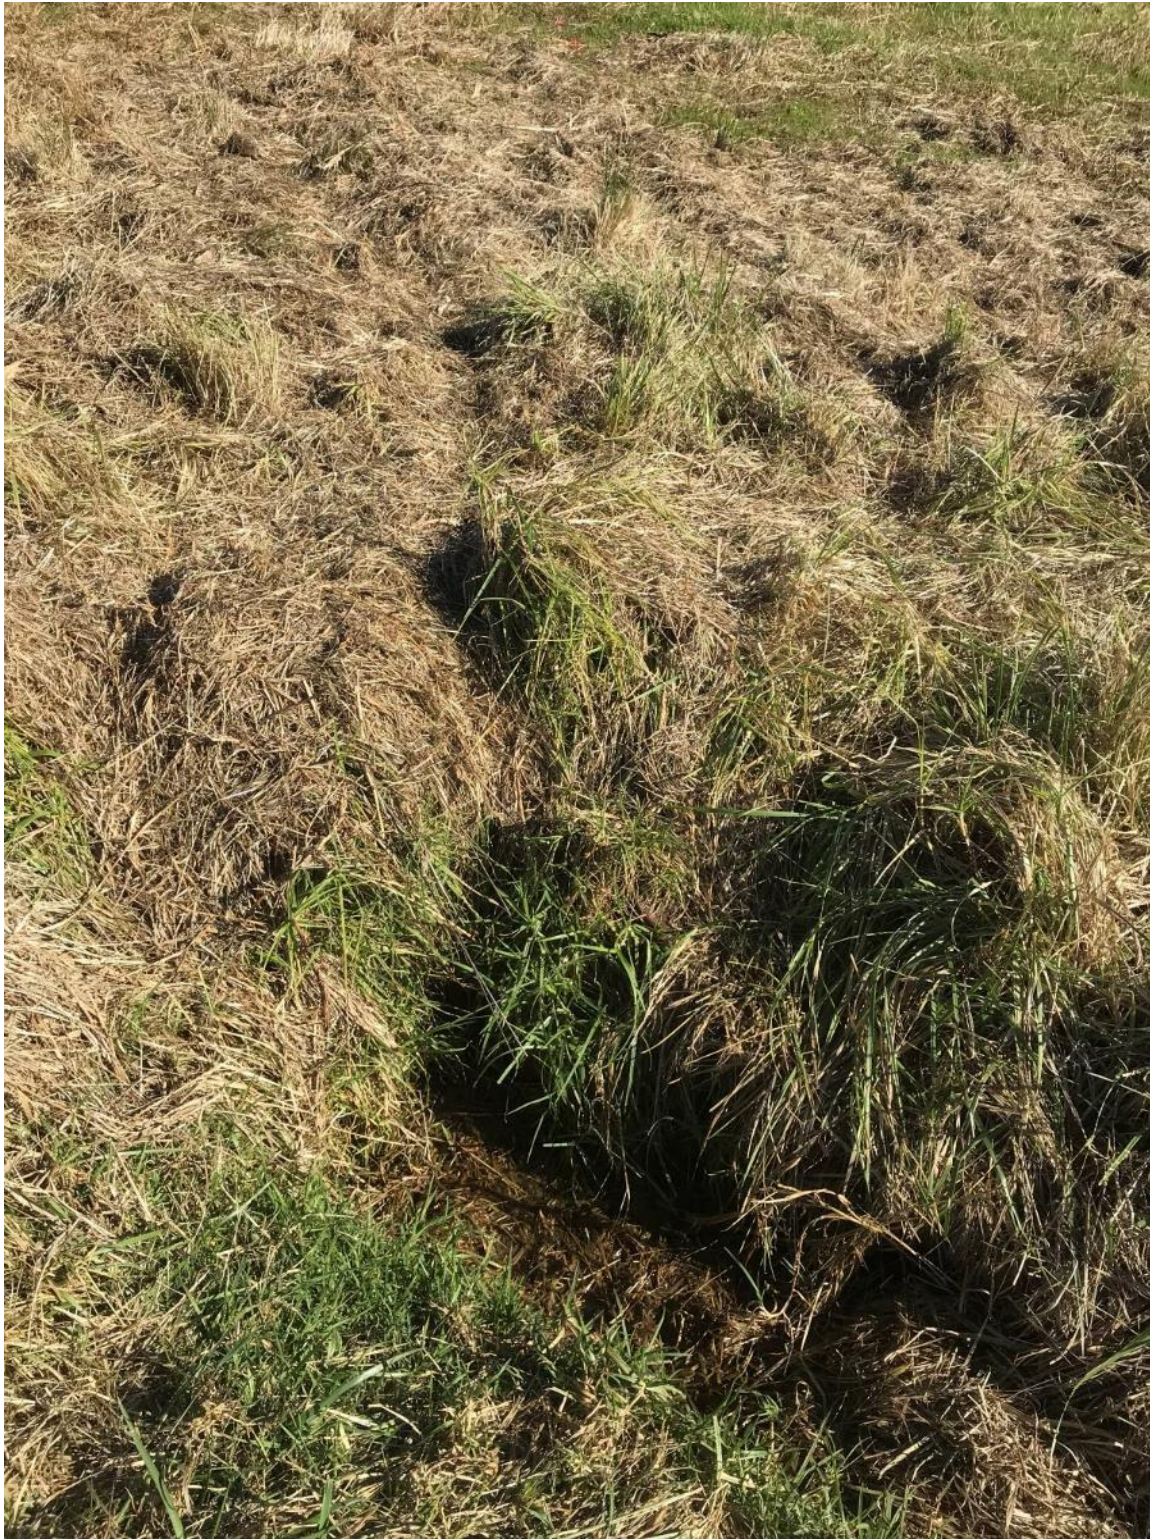
**Photo 36: Seep feeding seep wetland feature**

4. Seep wetland on the central, eastern section of the property. Field sampling, as described below, provided clear wetland indicators for this site, and so paired sampling points were analyzed in order to determine the boundary of this wetland feature. This feature is included on the Delineation Map provided in Figure 7.

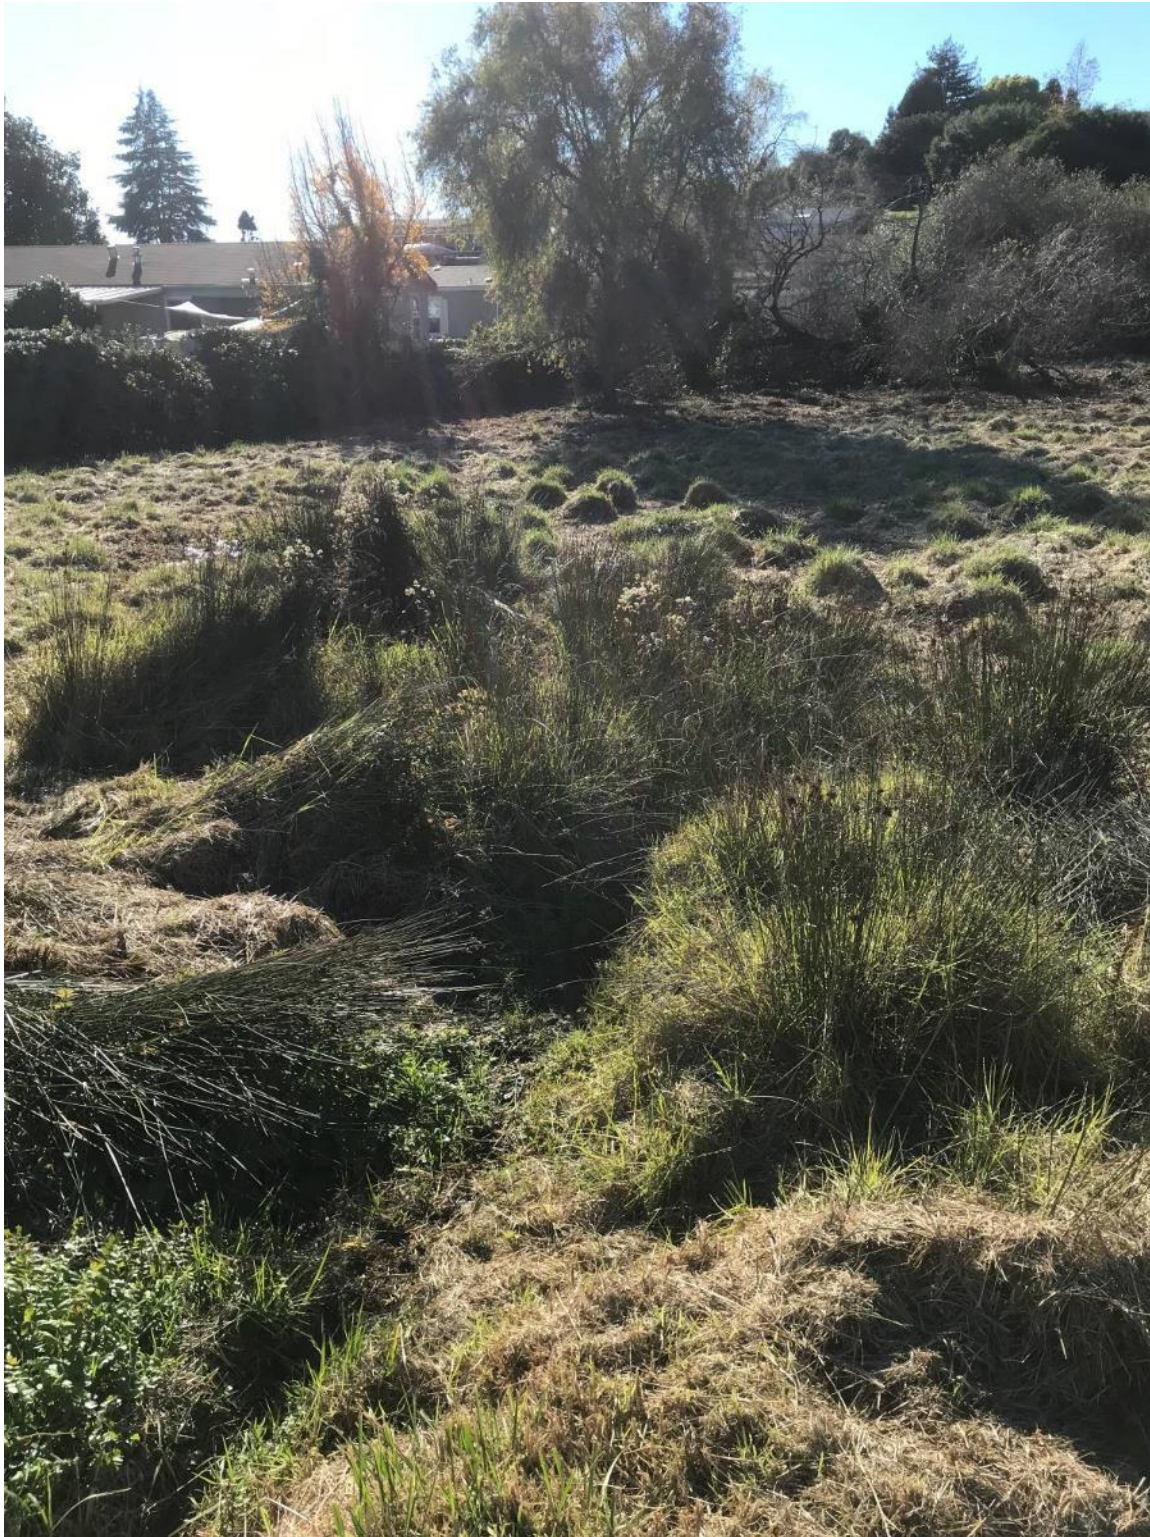
**Photo 37: Seep wetland**

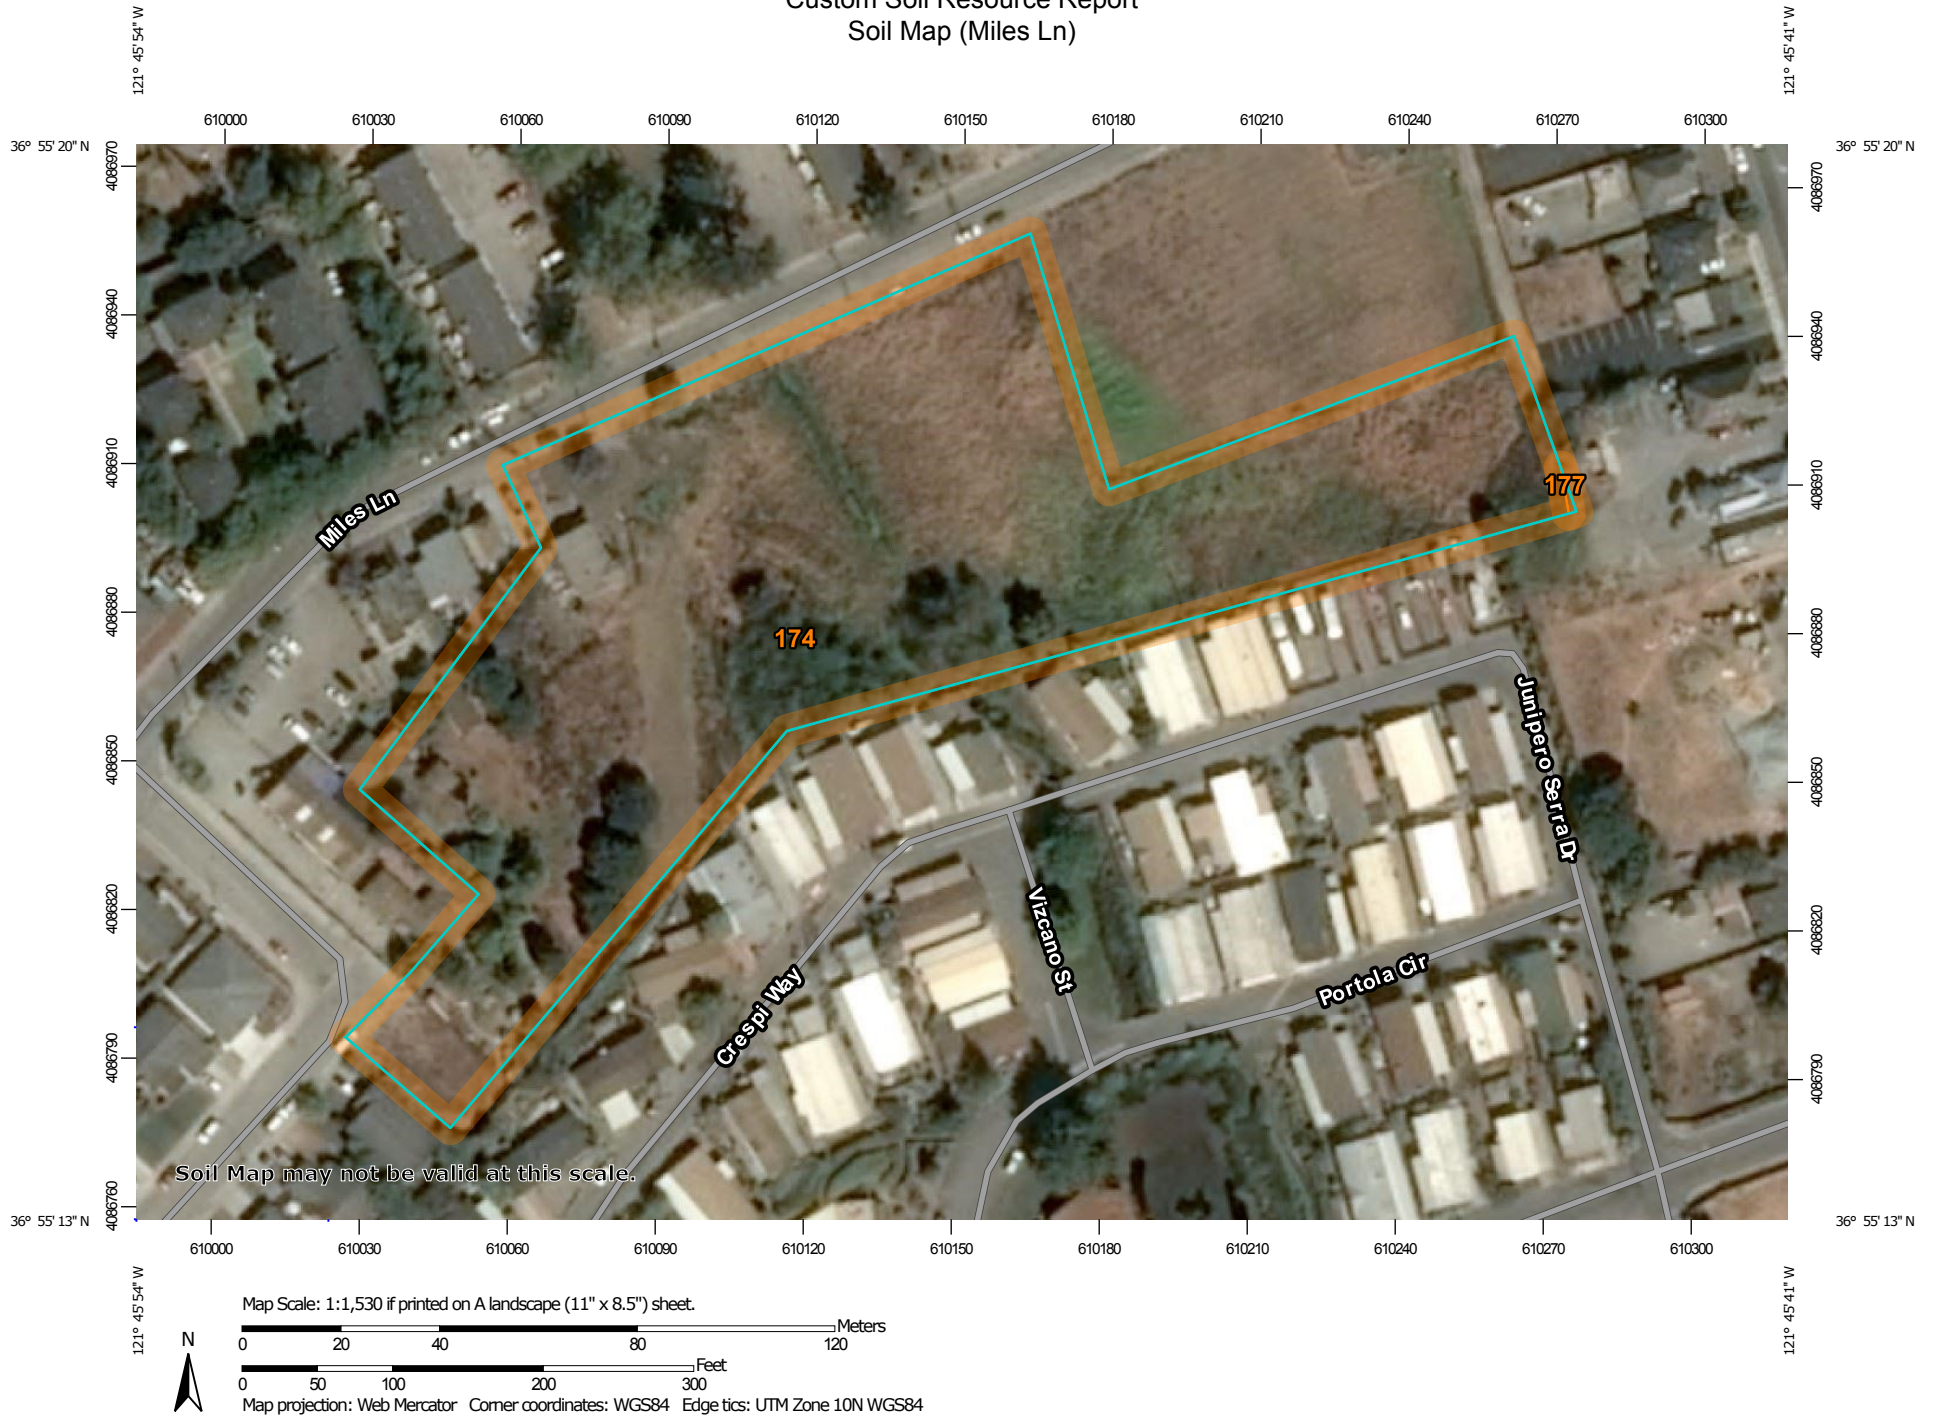
Custom Soil Resource Report  
Soil Map (Miles Ln)

The soil map section includes the soil map for the defined area of interest, a list of soil map units on the map and extent of each map unit, and cartographic symbols displayed on the map. Also presented are various metadata about data used to produce the map, and a description of each soil map unit.
