Biological Resources Report Preliminary Jurisdictional Wetlands Report

Biological Resources Technical Report

Vallecito SCE Moorpark LCR - BESS Project
Santa Barbara County

April 17, 2019

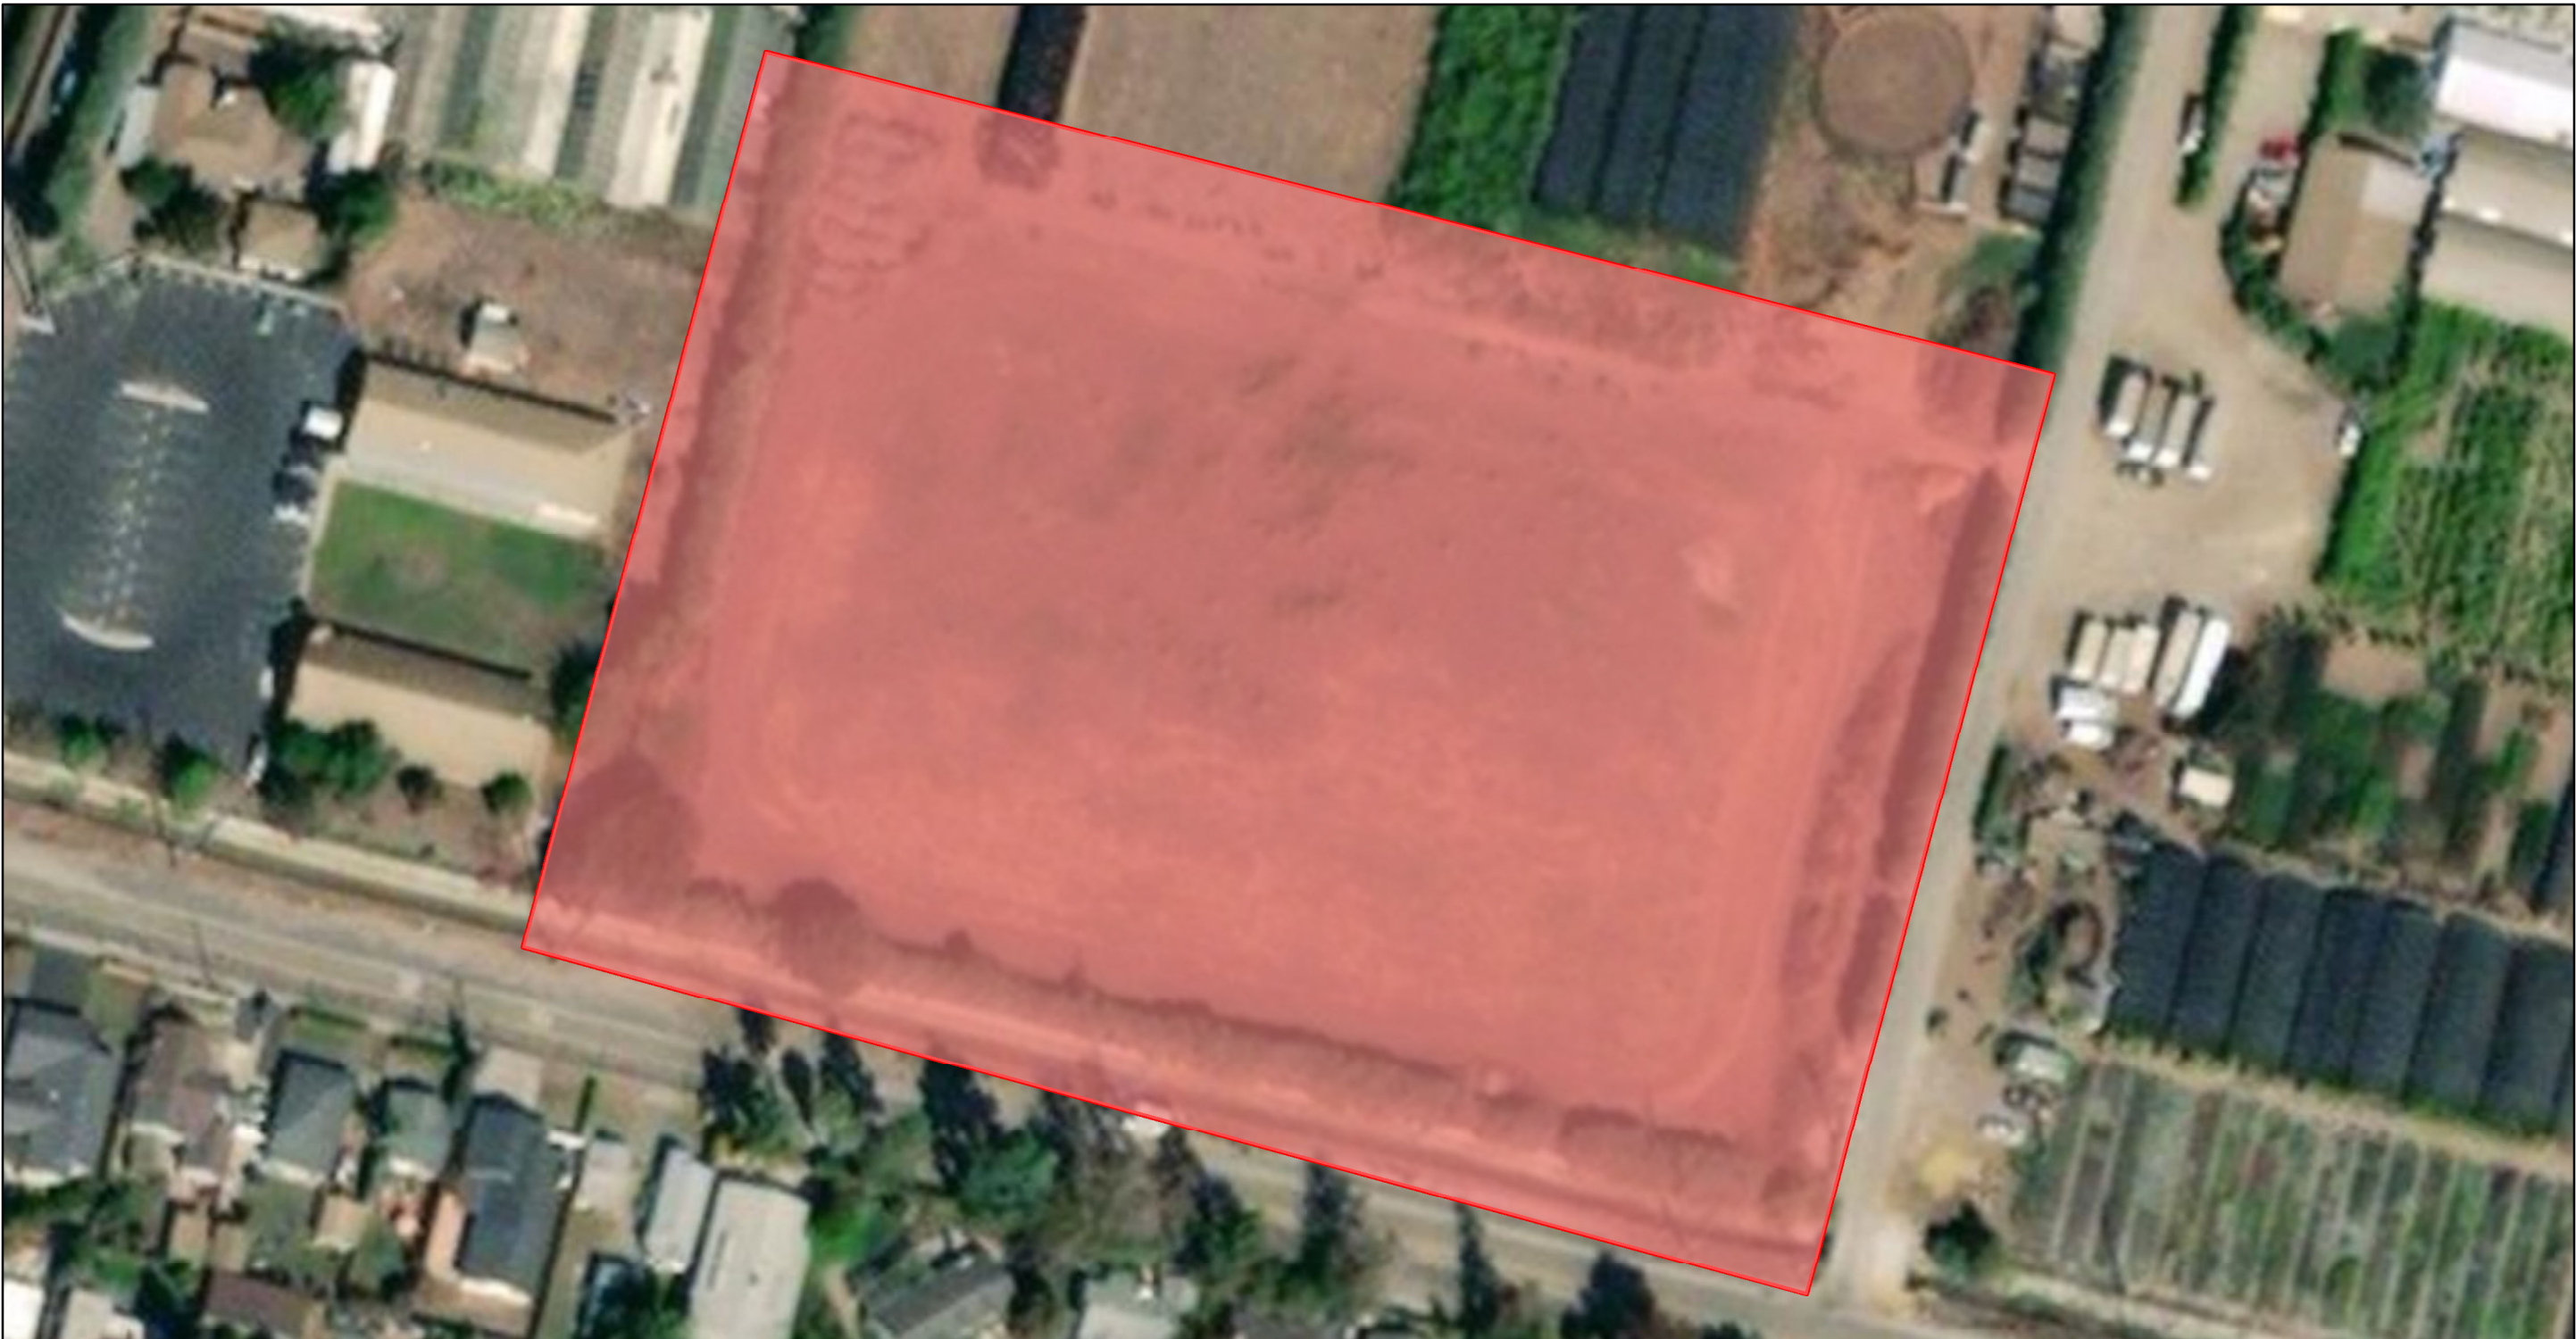
Vegetation Communities and Land Cover Types

The entire BSA has historically been developed appears to have been used in the past for agricultural purposes. The project site is currently fallow and appears to be disked regularly for weed control purposes. Vegetation observed during the field survey was comprised of common plant species characteristic of disturbed areas in the coastal ranges and valleys of southern California. Based on the lack of vegetation and absence of native plant communities, habitat conditions within the BSA were noted to be of generally poor quality. A well-established monoculture of non-native tree species dominates the existing tree canopy, where present, and lower strata are generally comprised of non-native grasses and non-native herbaceous plants. Within the BSA, Stantec biologists mapped one vegetation community and one additional land cover type. These are described further in Section 4.2.1 below. Figure 2 (Appendix A) illustrates the land cover types occurring in the BSA.

This classification was used primarily to map areas of fallow agriculture (which the majority of the BSA is comprised of) and unpaved access roads. The fallow field appears to be regularly disked for the purposes of weed control. Vegetation in these areas is sparse and comprised primarily of non-native annual forbs and grasses such as Bermuda grass (*Cynodon dactylon*), cheeseweed (*Malva parviflora*), and wild radish (*Raphanus sativus*). At the edges of the fallow field, other non-native species observed included spiny cocklebur (*Xanthium spinosum*) and a patch of iceplant (*Carpobrotus edulis*) along the western border of the BSA. The unpaved access road also includes other non-native grasses such as ripgut brome (*Bromus diandrus*), soft chess (*B. hordeaceus*), foxtail barley (*Hordeum murinum*), and wild oats (*Avena fatua*).

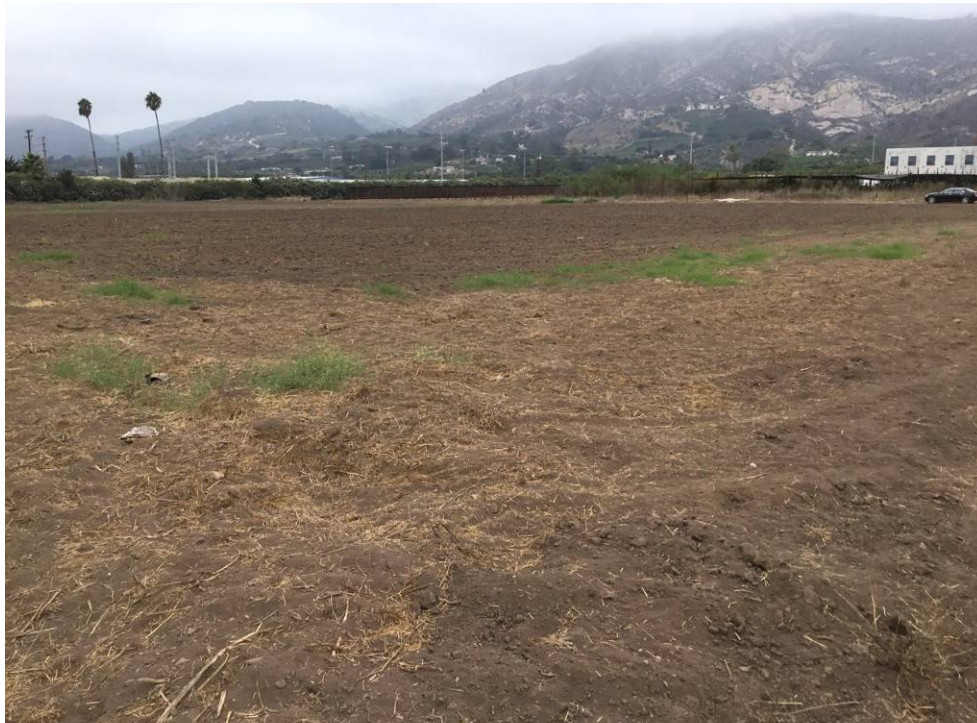
Photo 1: September 28, 2018

Representative site photo, looking northwest from the southeast corner of the BSA.

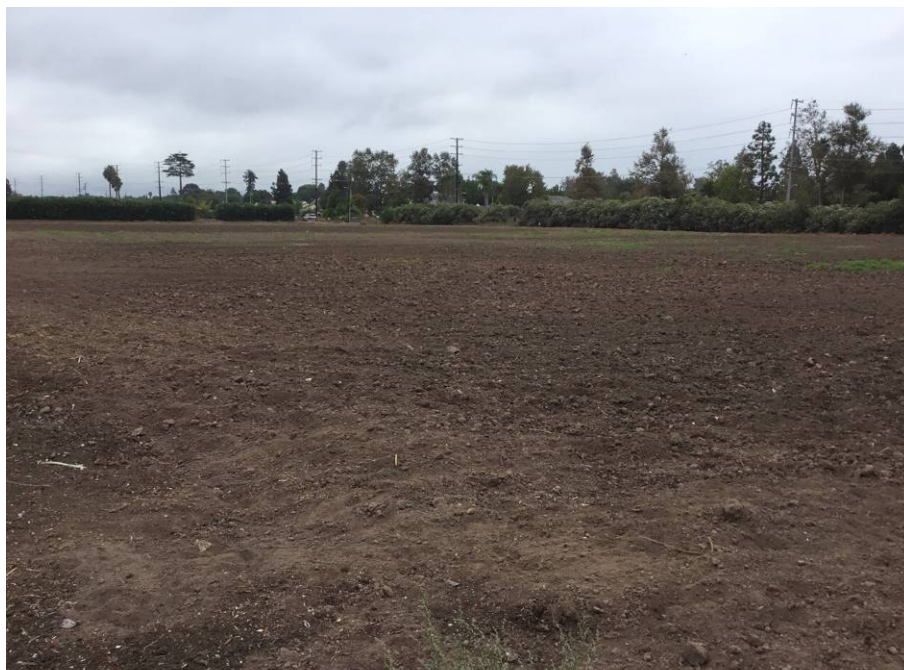
Photo 2: September 28, 2018

Representative site photo, looking southeast from the northwest corner of the BSA.

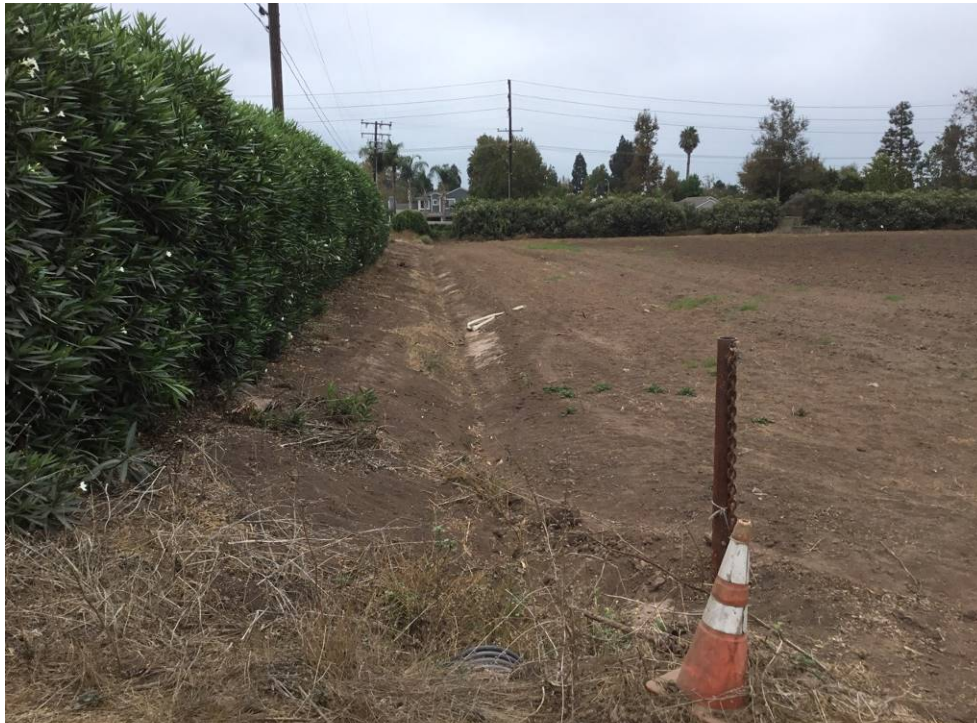
Photo 3: September 28, 2018

Photo taken from the northeast corner of the site illustrating oleander hedgerows and drainage channel cut into the field along the eastern edge of the property. Note: drainage does not have a direct connection to Franklin Creek.

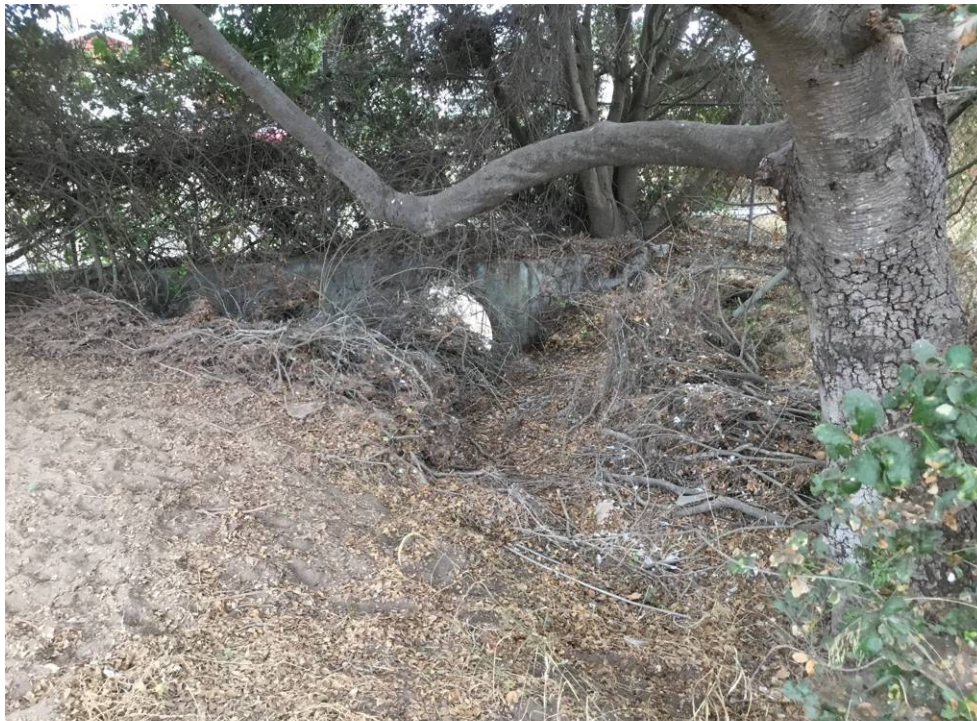
Photo 4: September 28, 2018

Photo taken at outlet of western site drain, at the southwest corner of the BSA, looking south. Culvert passes through concrete "bank" and enters Franklin Creek.

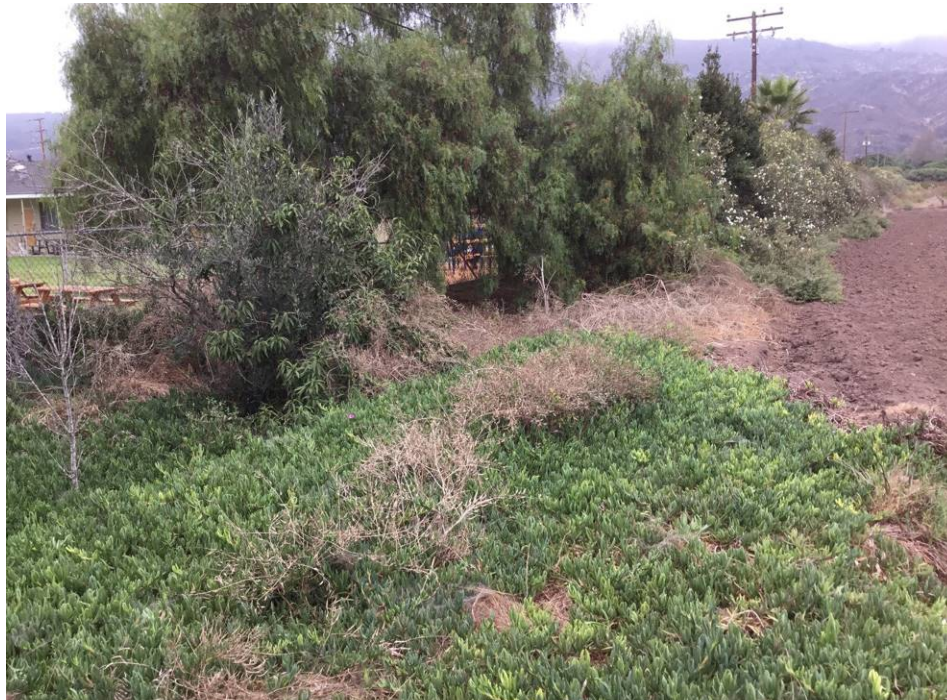
Photo 5: September 28, 2018

Photo taken near southwest corner of the site, looking north-northwest at “upstream” portion of western site drain. Note: lack of defined bed and bank, more so further upstream, and patch of iceplant.

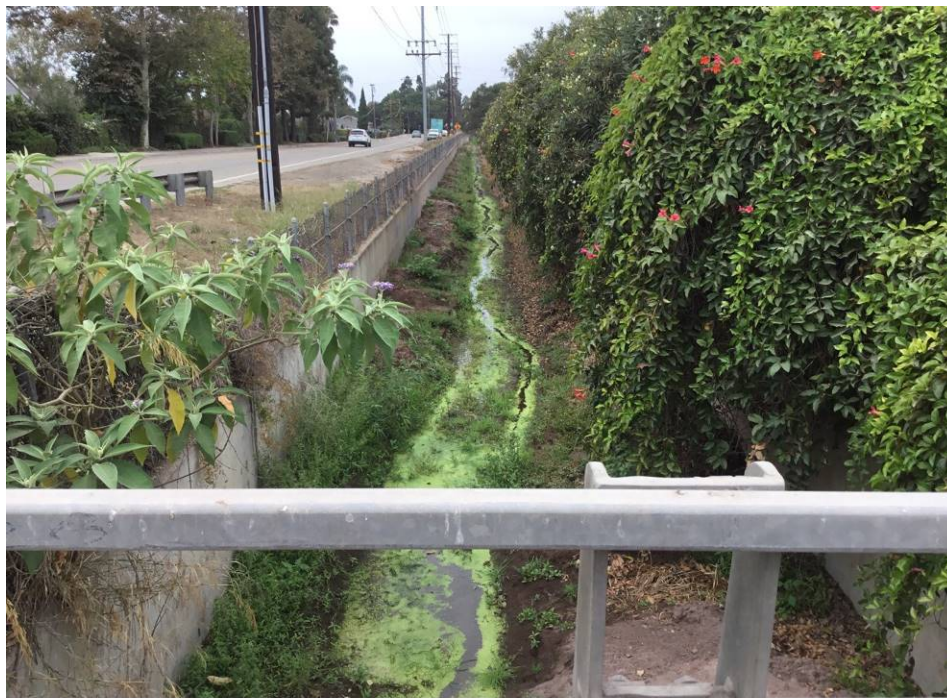
Photo 6: September 28, 2018

Franklin Creek, which travels east to west along the southern boundary of the BSA. Photo taken from near the southeast corner of the BSA, looking west. Note: lack of significant riparian vegetation.

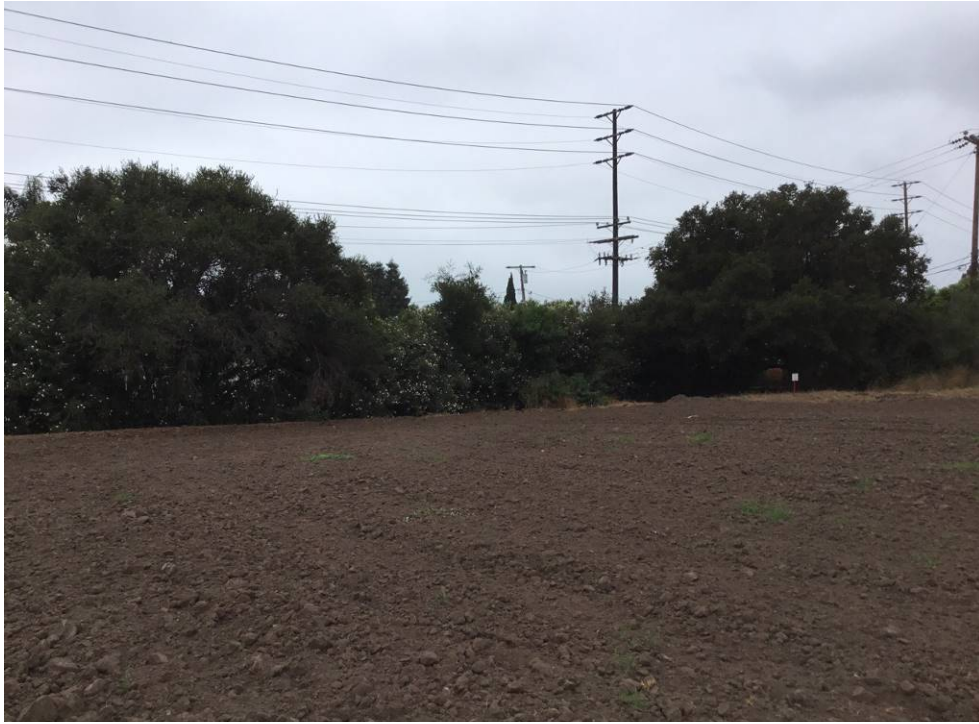
Photo 7: September 28, 2018

Photo depicts the assemblage of coast live oak trees along the edges of the southwest portion of the BSA. Photo taken looking southwest.

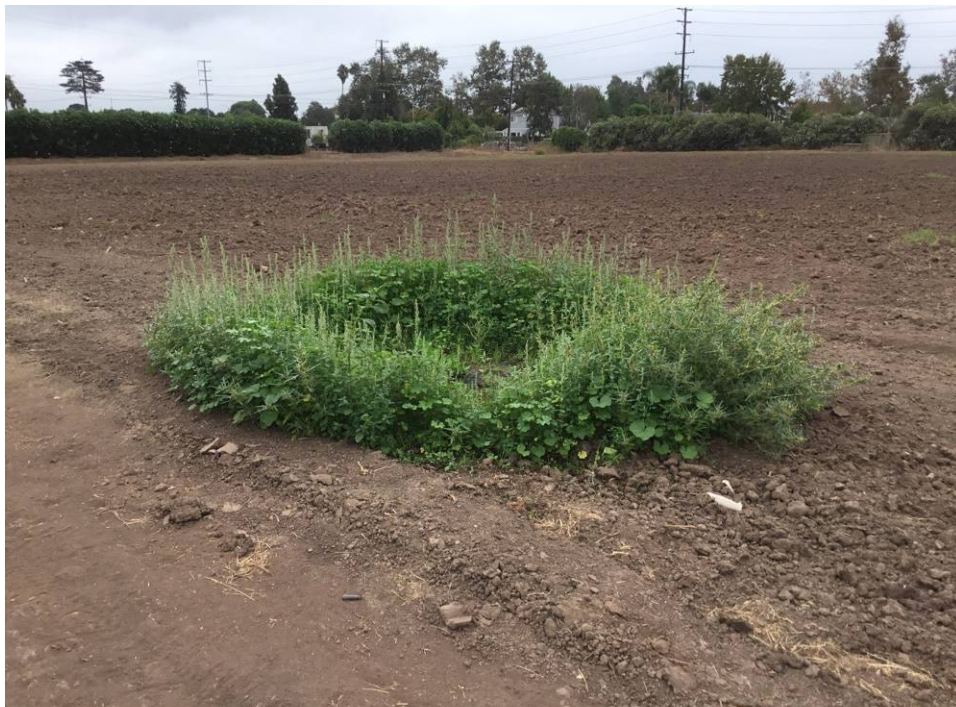
Photo 8: September 28, 2018

Patch of thicker herbaceous vegetation growth resulting from a leaking irrigation line; a small amount of standing water was present in the center. Photo taken along the northern BSA boundary, adjacent to the unpaved access road, looking southeast.

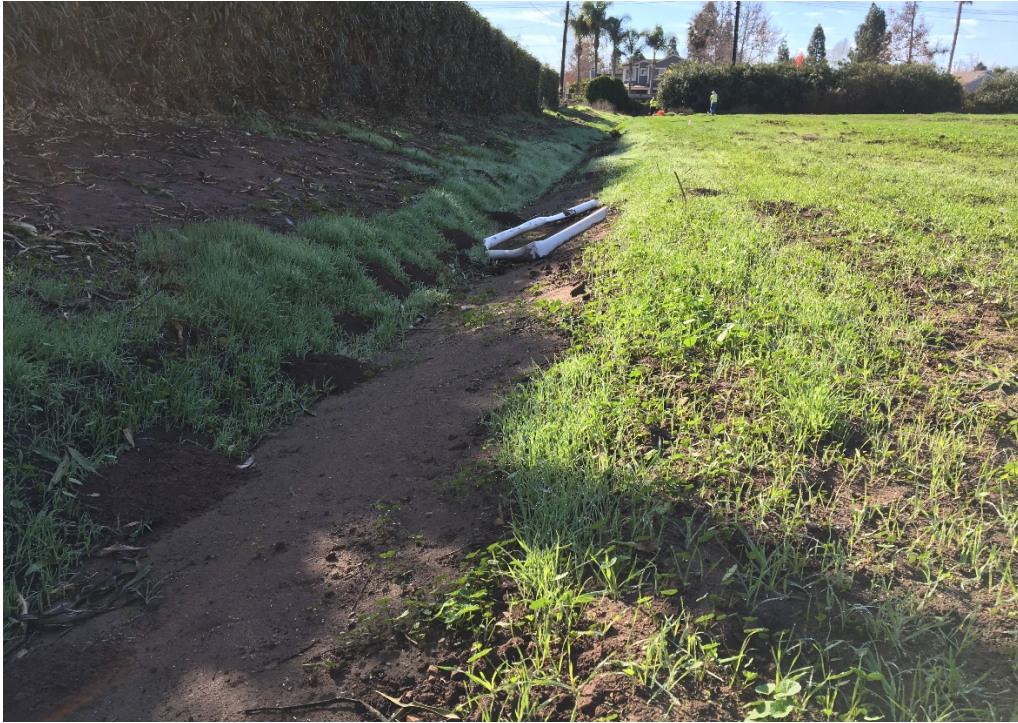
Photo 1: December 19, 2018

Ditch 1 – Adjacent to fallow agricultural field on the east side of the BSA, looking downstream (south).

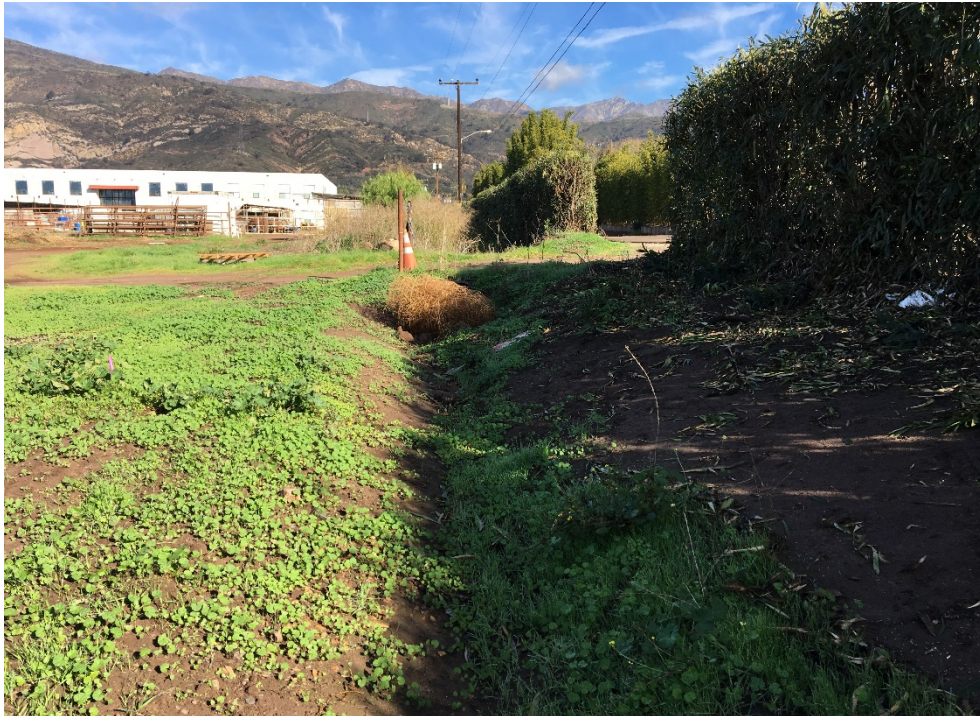
Photo 2: December 19, 2018

Ditch 1 – Looking upstream (north) toward the entrance to the site. Note: culvert under the unpaved entrance road is obscured by vegetation.

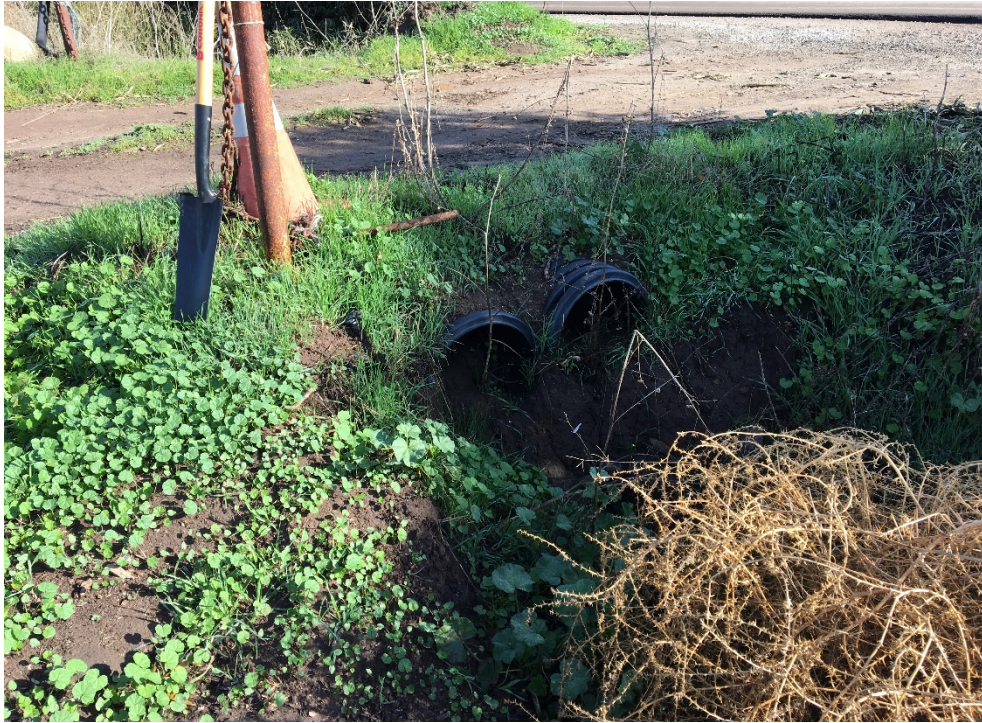
Photo 3: December 19, 2018

Ditch 1 – Close-up of culvert under the unpaved access road to the site.

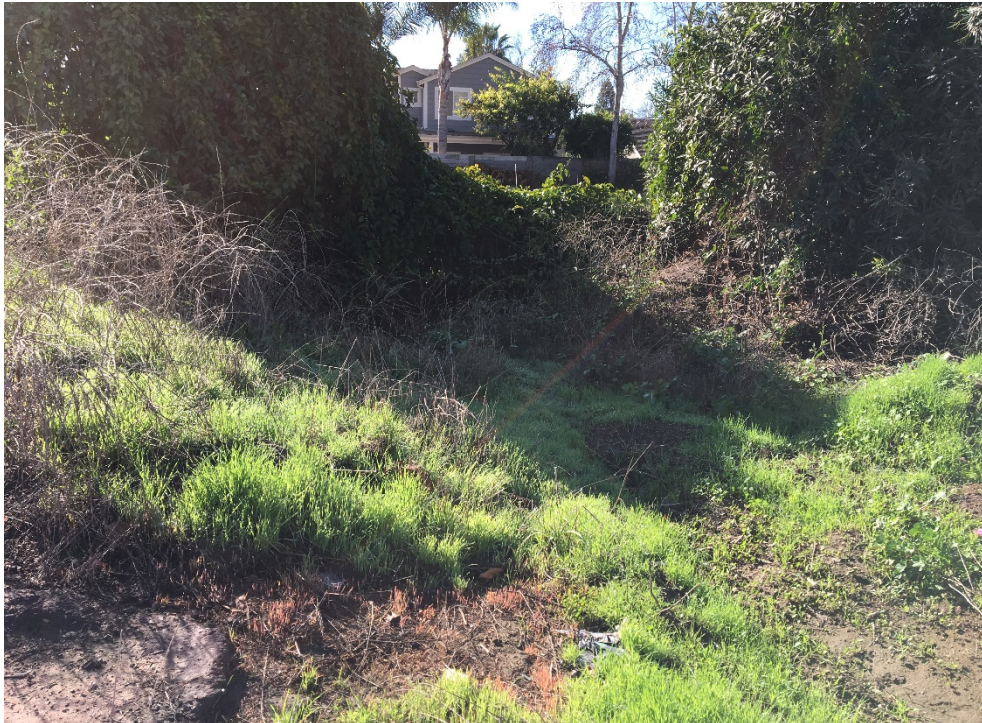
Photo 4: December 19, 2018

Ditch 1 – Downstream terminus of drainage. Note: lack of connectivity to Drain 1

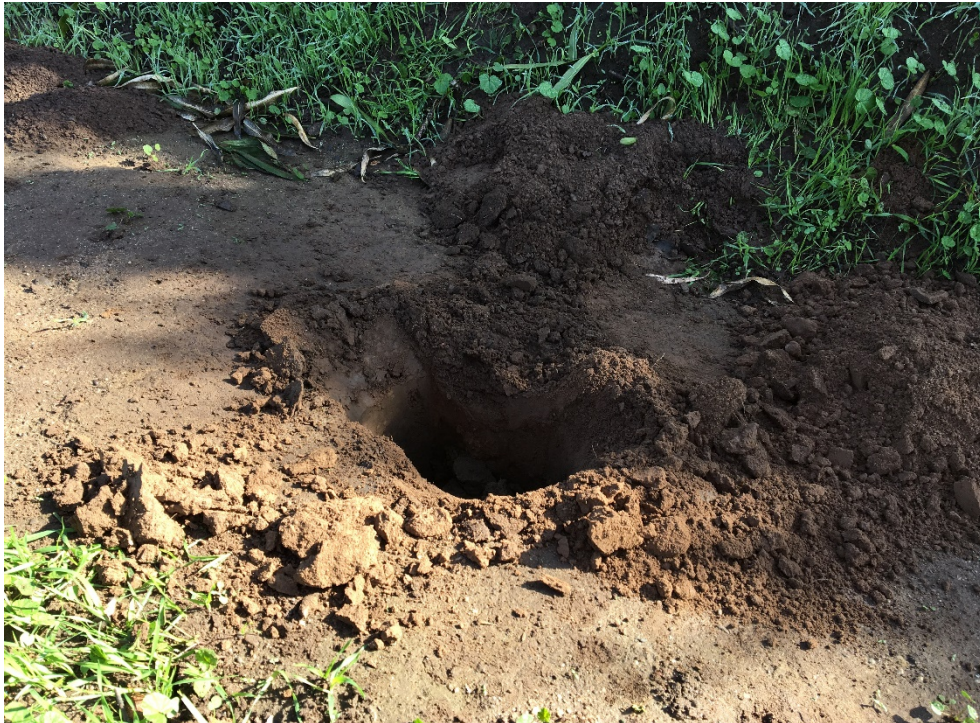
Photo 5: December 19, 2018

Ditch 1 – Soil Test Pit 1. Note: silty sand substrate at this location.

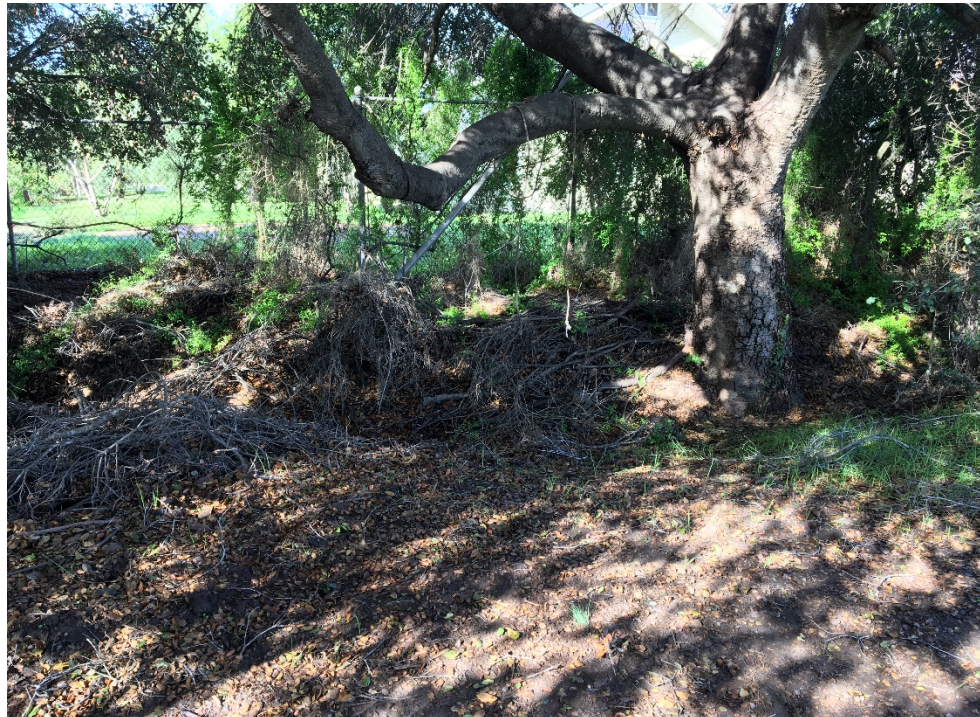
Photo 6: December 19, 2018

Ditch 2 – Looking west from adjacent to the southern terminus of the drainage. Note: this is the only portion of the drainage within the BSA that is not completely overgrown with vegetation.

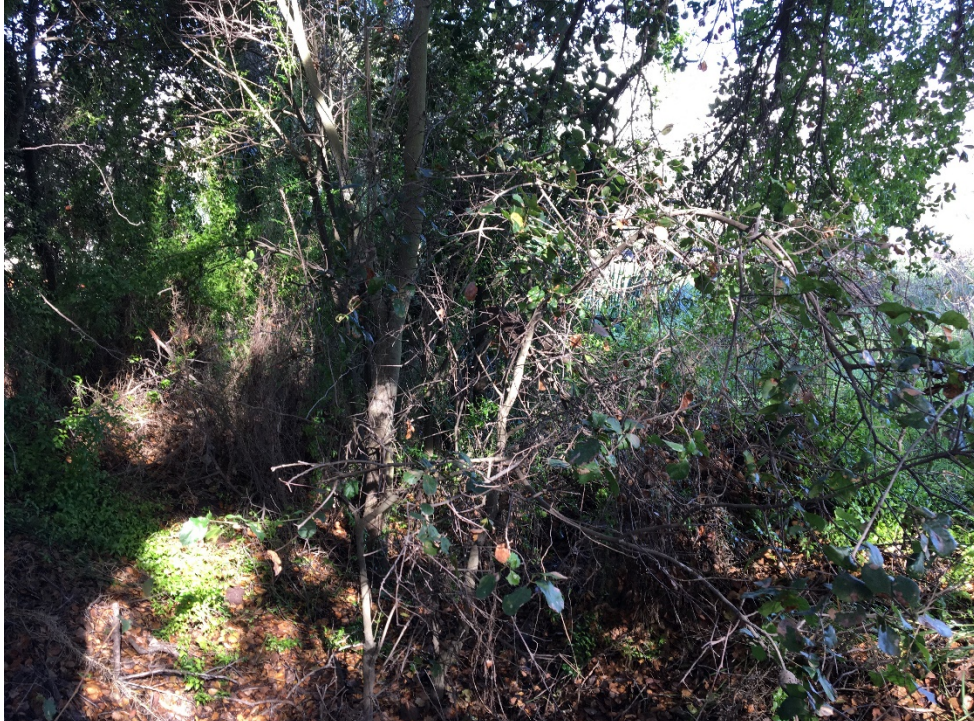
Photo 7: December 19, 2018

Ditch 2 – Looking upstream (north) from the southern end of the drainage.

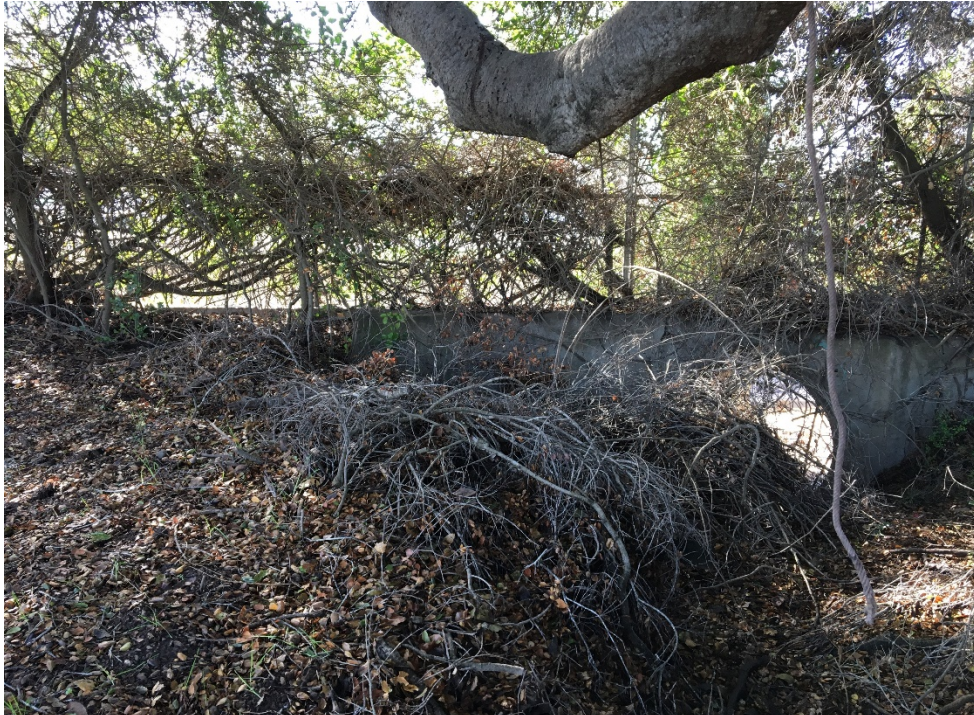
Photo 8: December 19, 2018

Ditch 2 – Looking downstream (south) from the southern end of the drainage toward the culvert through the concrete wall of Drain 1.

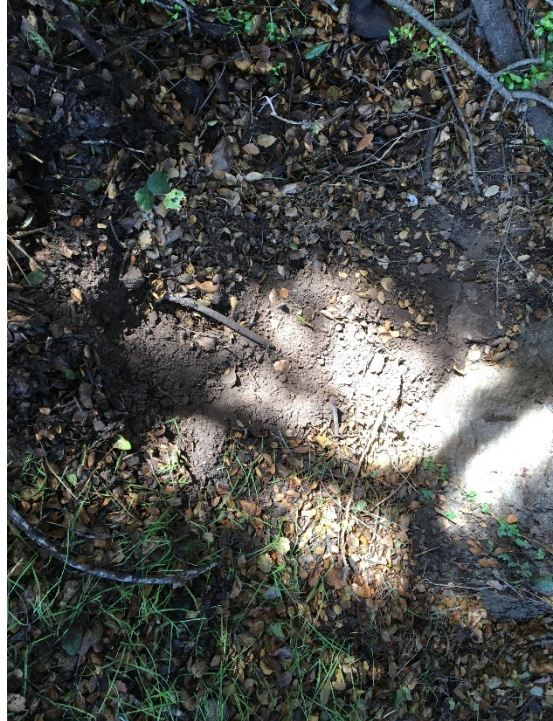
Photo 9: December 19, 2018

Ditch 2 – Soil Test Pit 2. Note: silty sand substrate at this location.

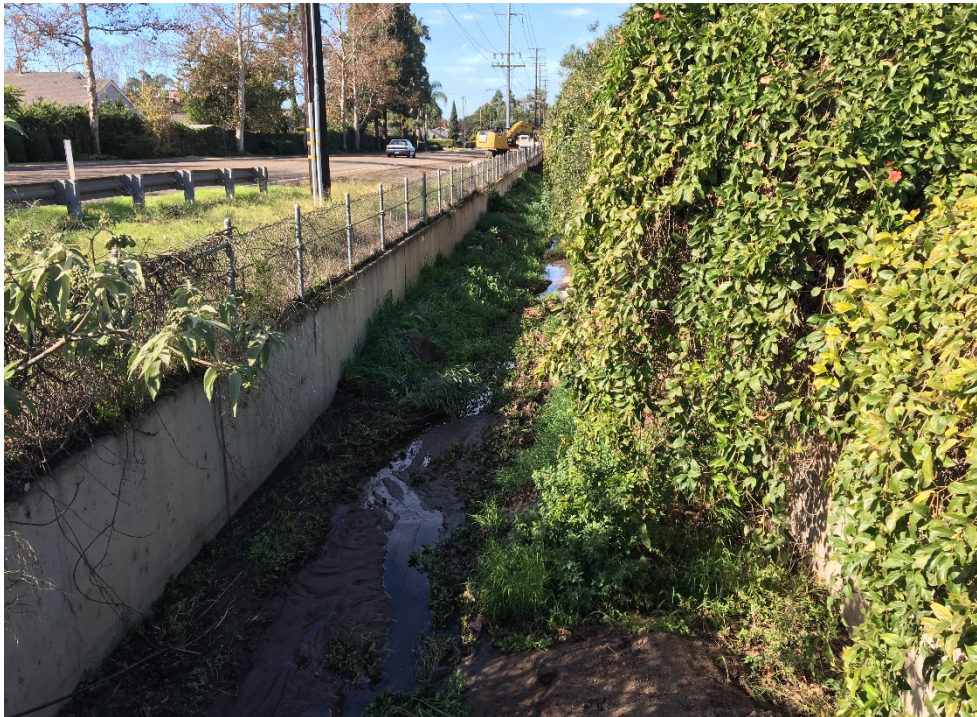
Photo 10: December 19, 2018

Drain 1 – Looking downstream (west) from the southeast corner of the BSA. Note: accumulated sediments along the bottom of the drainage and surface water (likely originating from irrigation runoff from nearby agricultural activities).
