CITY OF SCOTTS VALLEY

INITIAL STUDY

Mitigated Negative Declaration EA18-008

Creamer Two-Lot Minor Land Division - 33 Polo Heights
Assessor's Parcel Number 024-021-28

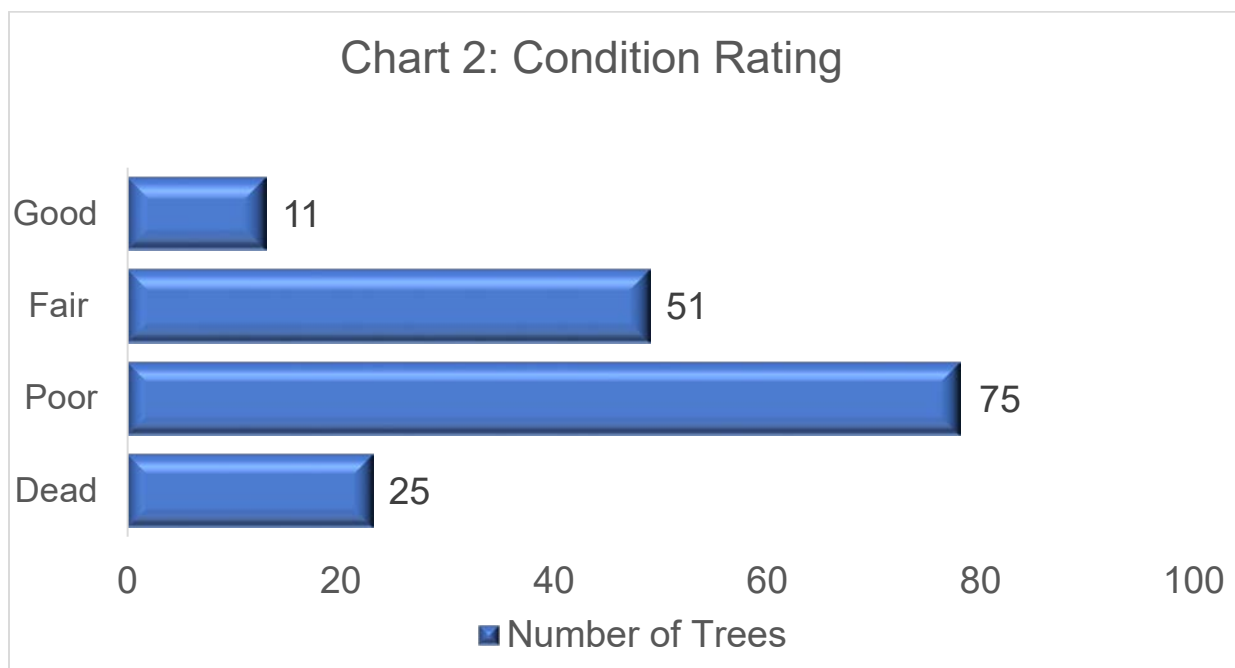
Condition Rating

A tree's condition is determined by assessing both the **health** and **structure**, then combining the two factors to reach a *condition rating*. Tree condition is rated as good, fair, poor, or dead. The quantity of trees assigned for each category (good, fair or poor, dead), is indicated below:

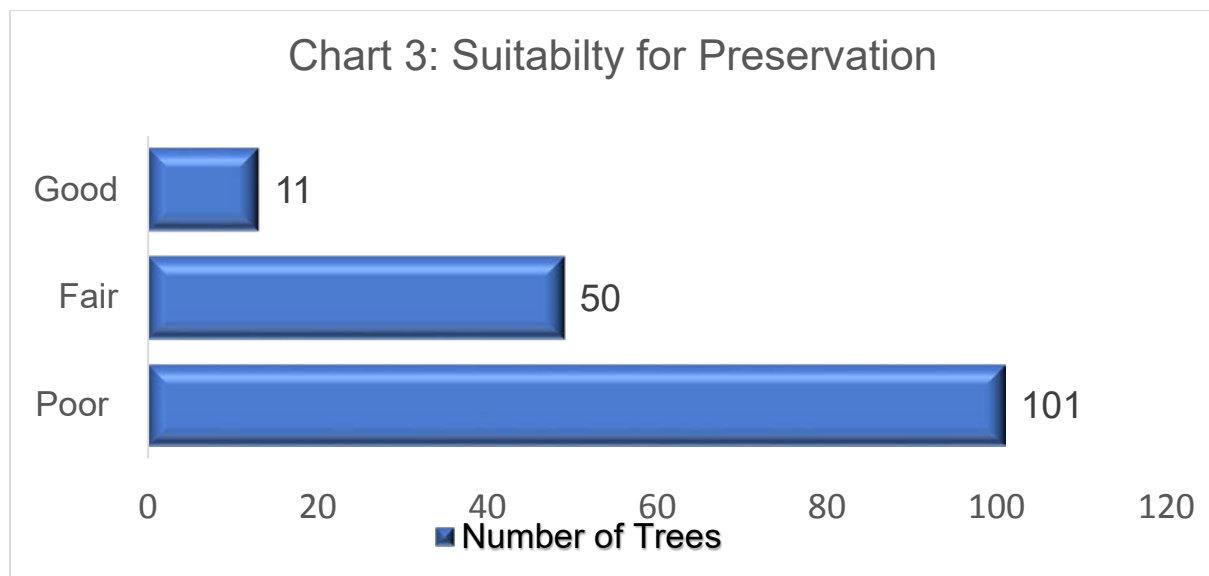
Suitability Rating

A tree's suitability for preservation is determined based on its health, structure, age, species characteristics and longevity using a scale of good, fair or poor. The quantity of trees assigned to each category (good, fair or poor), is listed below.

Sixty two percent of the trees evaluated were not suitable for preservation, due to either poor health, poor structure or the tree was dead.

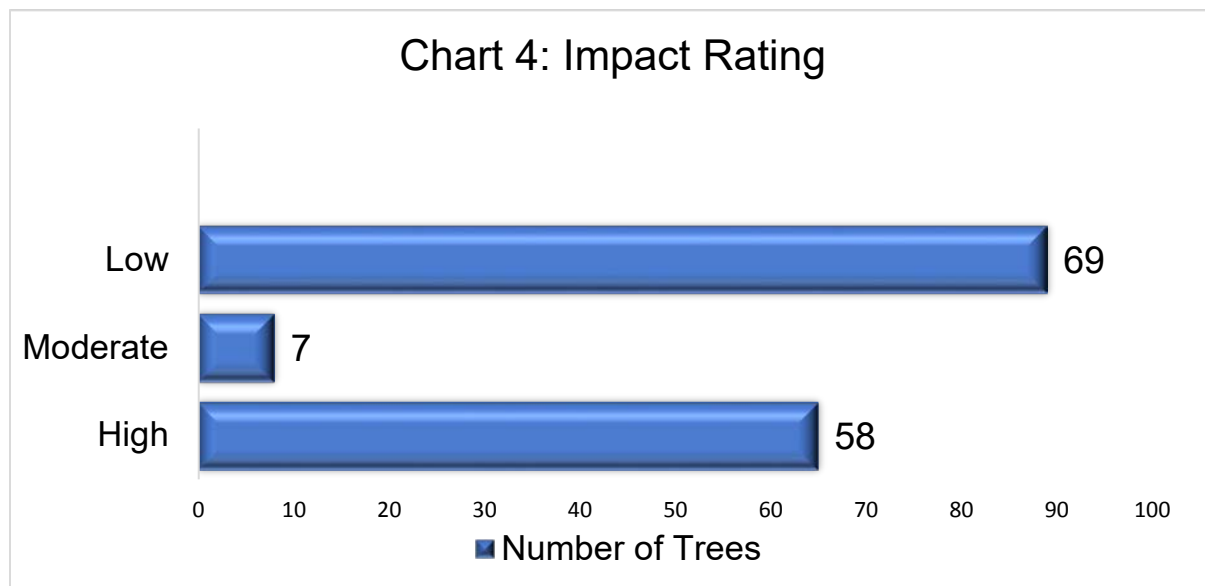
Impact Level

Impact level rates the degree a tree may be impacted by construction activity and is primarily determined by how close the construction procedures occur to the tree. Construction impacts are rated as low, moderate, high. The quantity of trees assigned for each category (low, moderate, high), is indicated below:

- Sixty-nine trees are in areas that are far enough away from proposed grading and excavation activities that they will not be affected.
- Seven trees are located close to grading limit or excavation areas but will only be moderately affected.
- Fifty-eight trees are in or *very close* to the proposed grading limits or excavation areas for parcel improvements and will be highly impacted by grading activities.
- Dead trees (25), were not included in impact rating evaluation.

Trees that are moderately affected can be retained and may require pre-construction treatments such as tree protection fencing, silt fencing and tree wells to reduce grade changes around the root zone areas.

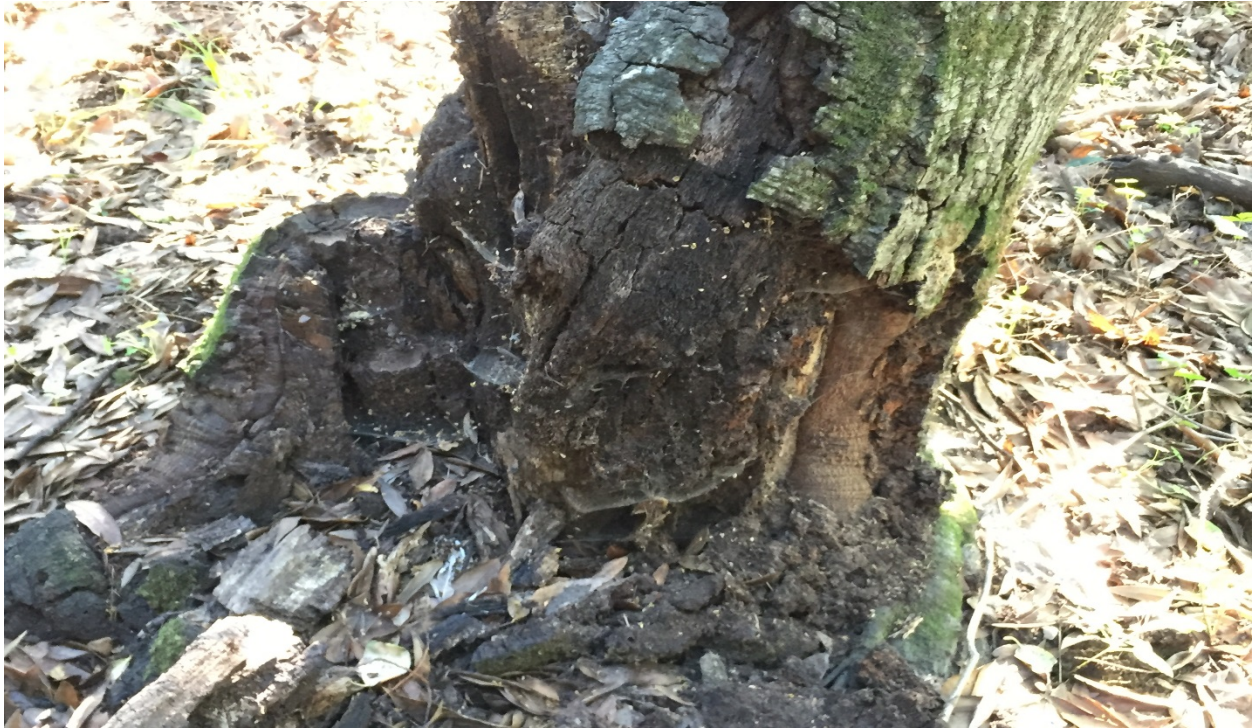
Image #1 – Tree #89 - Coast Live Oak - Note loss of bark and extensive dead wood due to wood decay fungi. The lack of sound wood and significant lean increases the chances of tree failure.

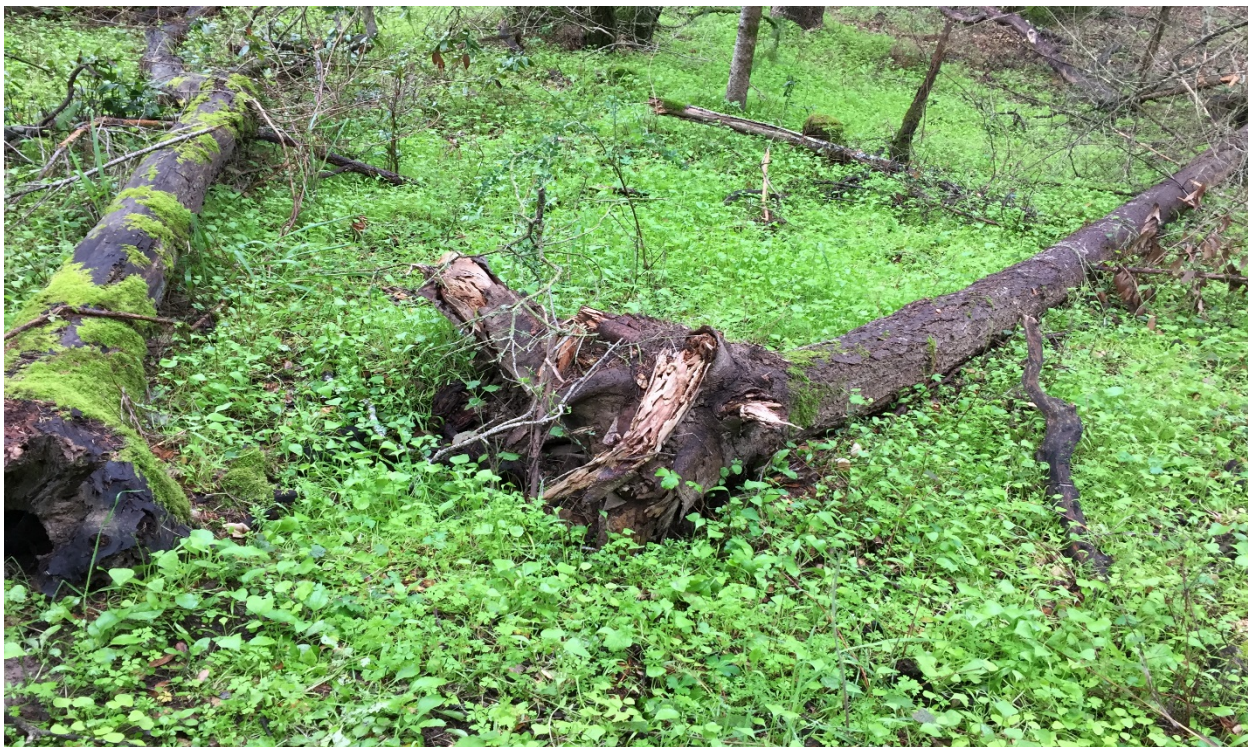
Image #2 – There were many trees on the property that had failed due to root and basal decay from fungal activity.

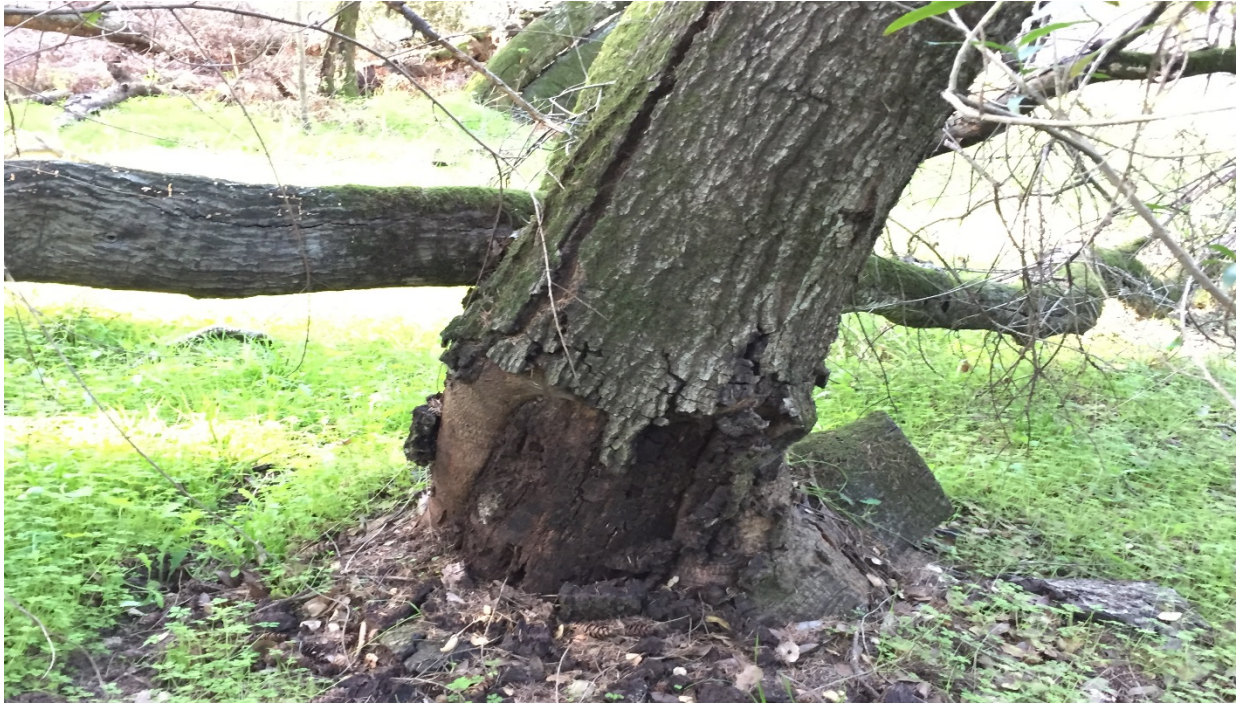
Image #3 – Tree #139 – Coast Live Oak – Note loss of bark, wood decay and significant lean.

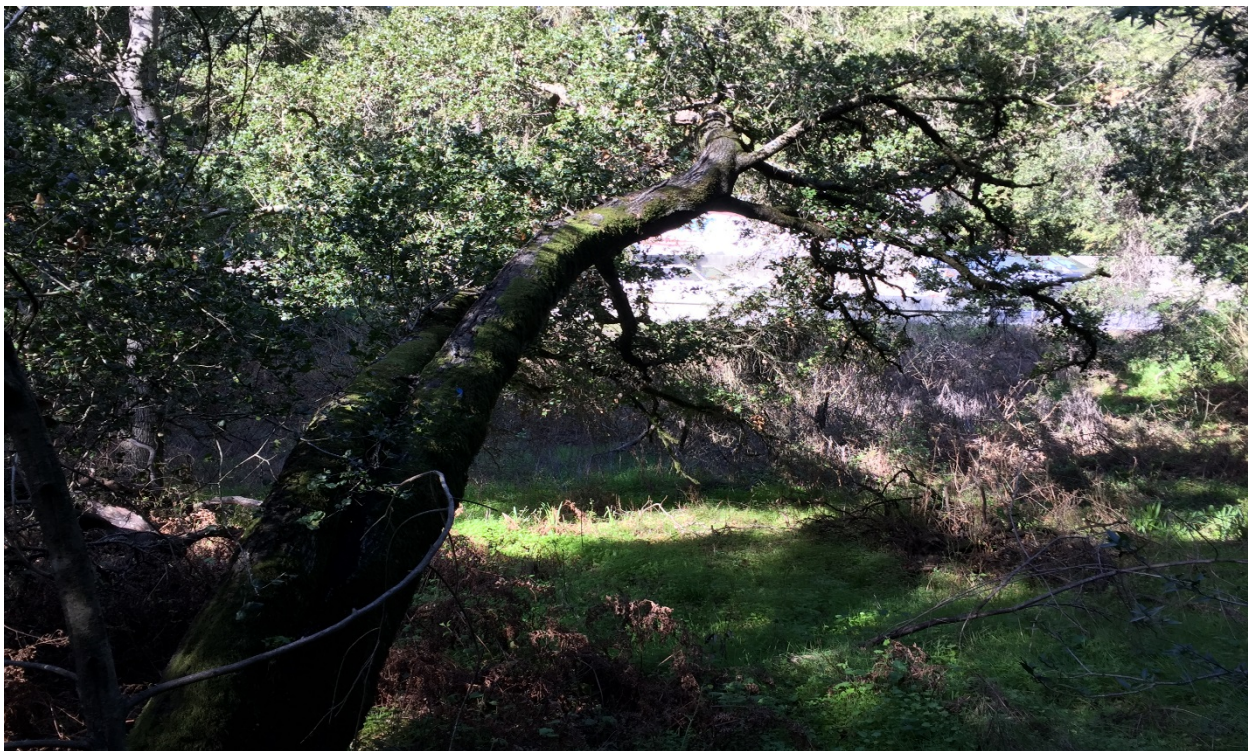
Image #4 – Tree #196 – Coast Live Oak – Note nearly horizontal growth pattern of main trunk.

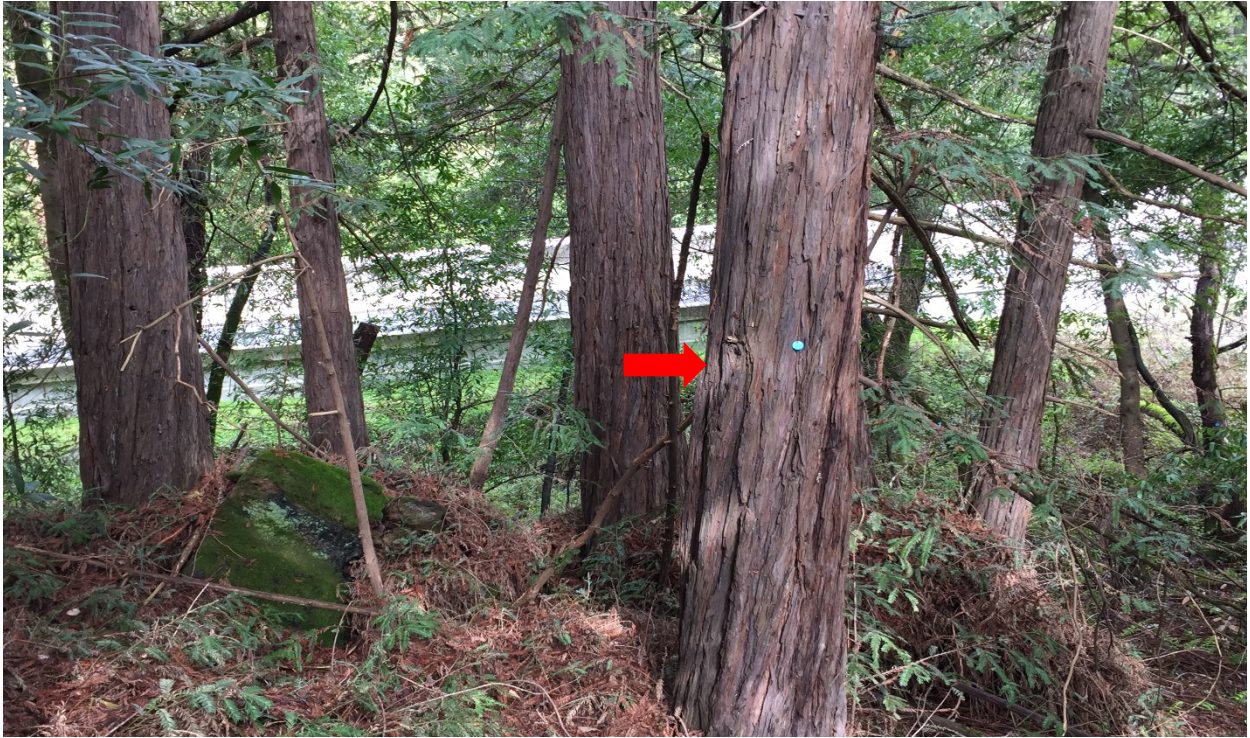
Image #5 – Tree #163 (arrow) – Coast Redwood – ‘Parent’ redwood (arrow), with smaller trees (‘sprouts’), growing around it.

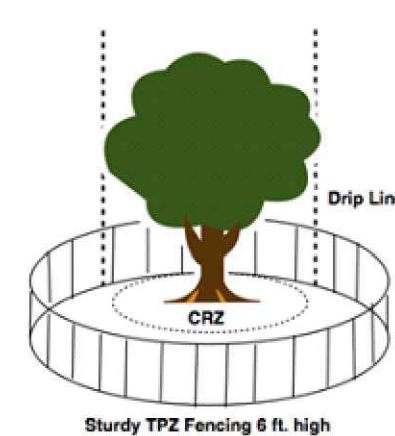
Figure 1: Tree protection distances

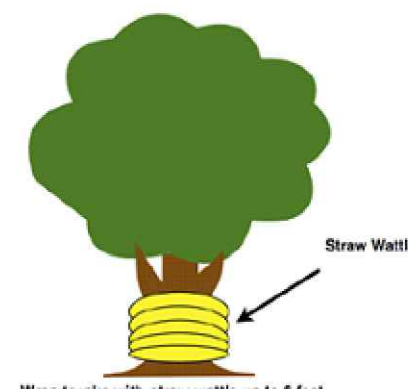
Figure 2: Trunk protection with straw wattle

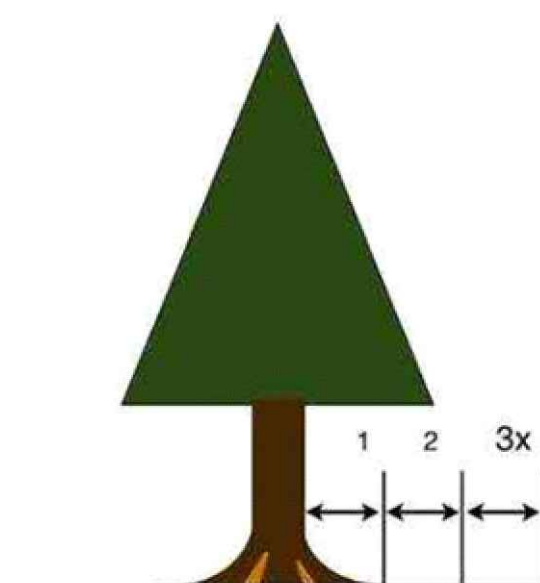
Figure 3: **Critical Root Zone (CRZ) = 3 to 5 times the trunk diameter on one side**
