Riparian Habitat Restoration Plan for Grayson Riverbend Preserve

*San Joaquin River Mile 76-77
Stanislaus County, California*

January 2020

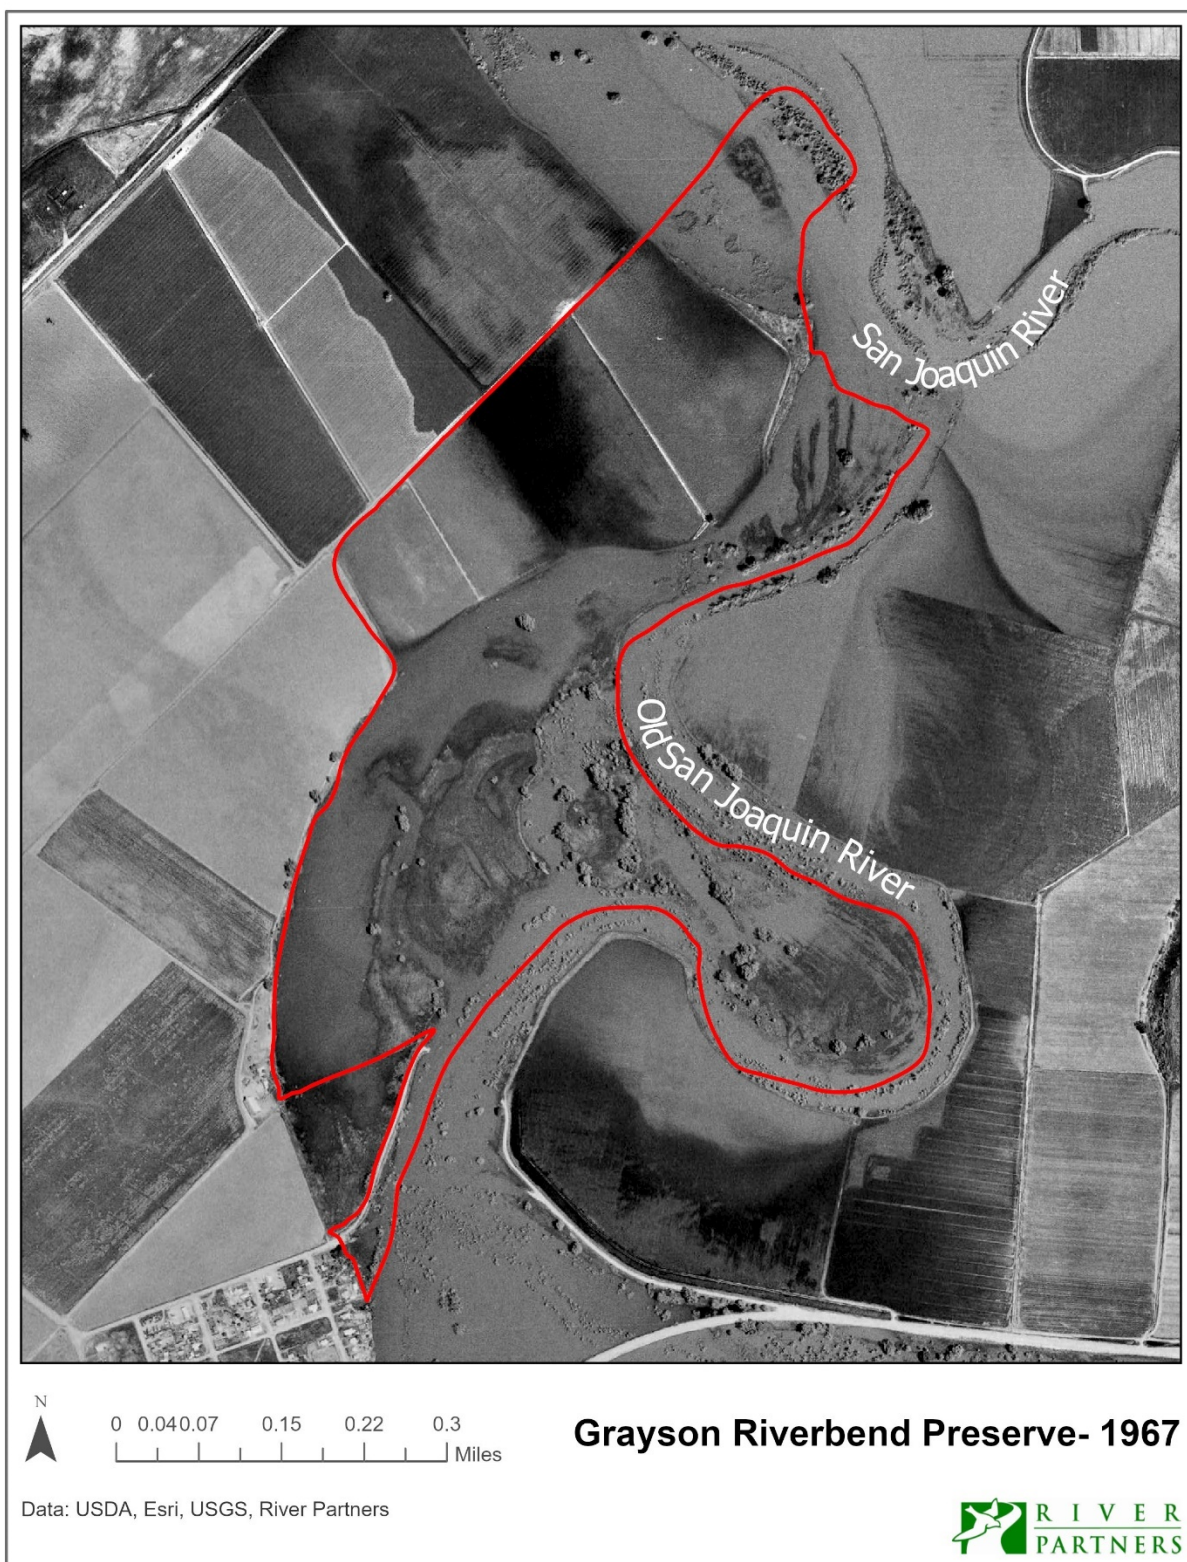
Figure 3. Aerial photo of Grayson Riverbend Preserve, 1967

The 1967 aerial photo (Figure 3) shows flooded conditions, resulting in a high level of inundation across GRP flowing from Laird Slough into the old channel and onto lower elevation agricultural fields. The Grayson Road Bridge was washed out and subsequently rebuilt in a location further upstream where it remains today. Breaches and deposition of sediment on-site and at neighboring lands are evident from this photo.

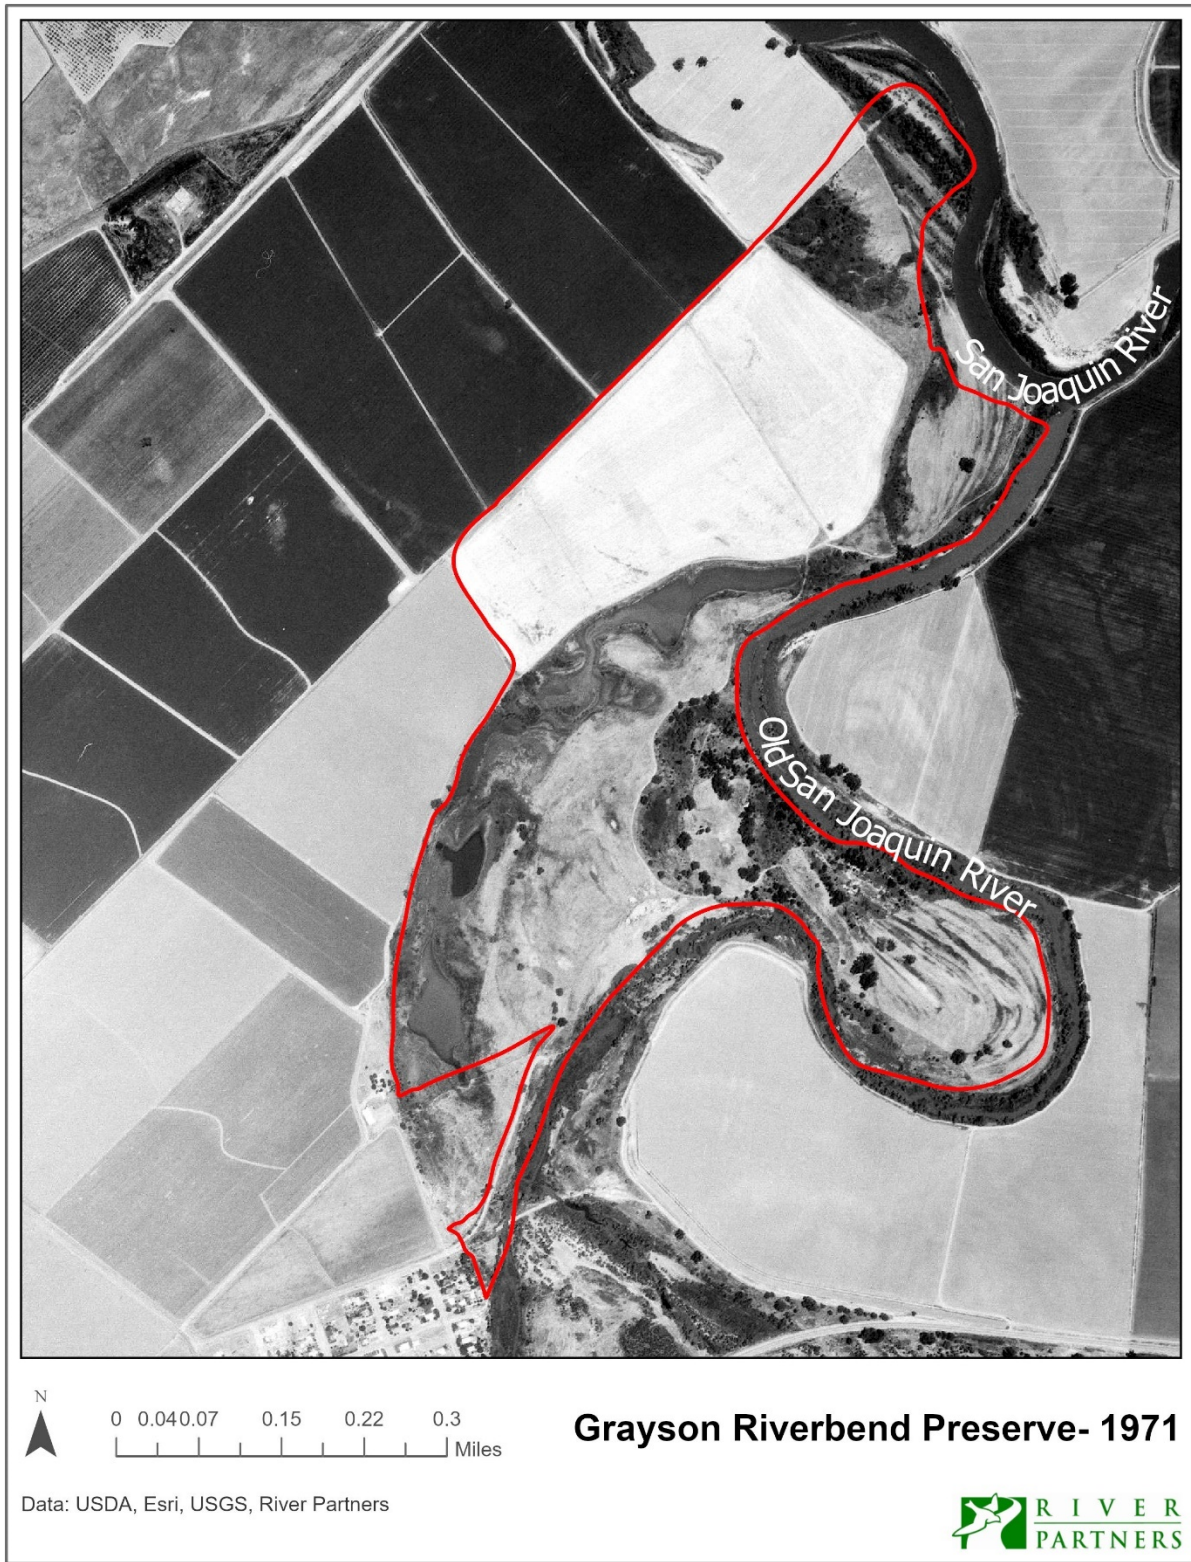
Figure 4. Aerial photo of Grayson Riverbend Preserve, 1971

The 1971 aerial photo (Figure 4) shows conditions during lower flows and it is clear that there is still a dynamic and intact off-channel wetland habitat mosaic along the western

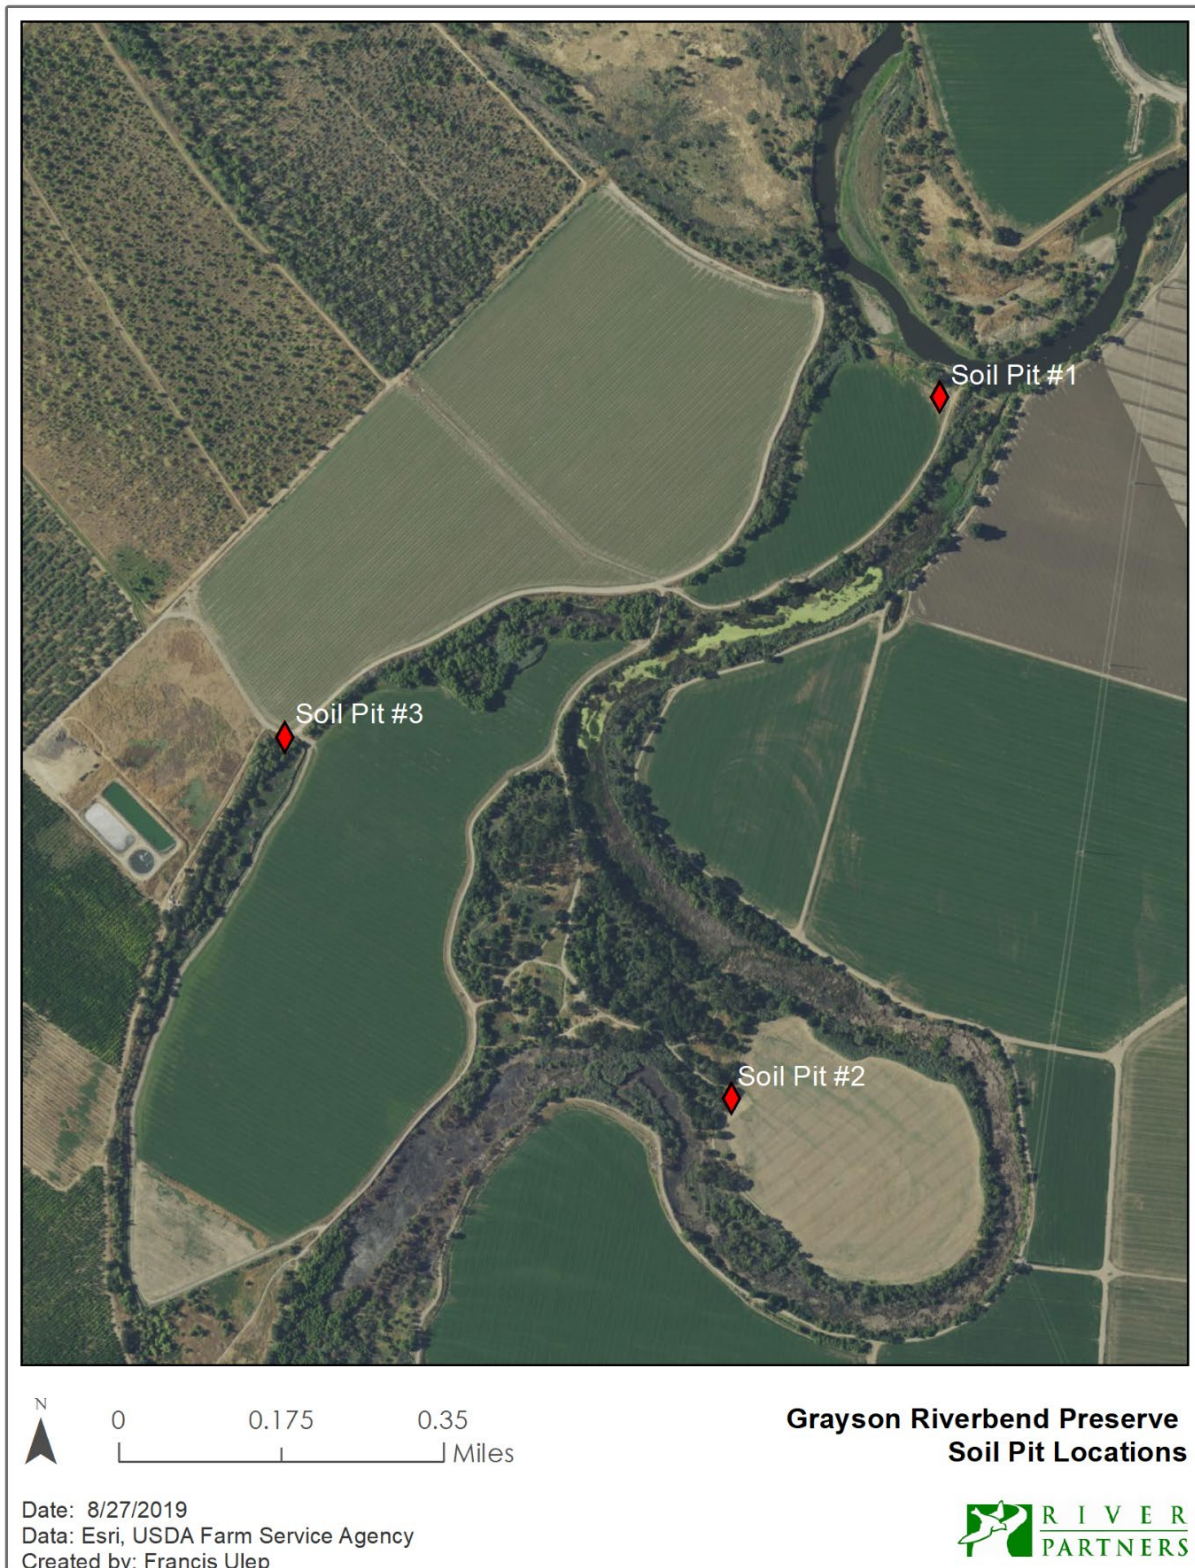
Figure 9. Soil pit locations at Grayson Riverbend Preserve

In addition to the information provided by the soil survey, three backhoe pits were excavated by River Partners on April 5, 2018 to further assess site conditions (Figure 9). Field observations are provided in Table 2.

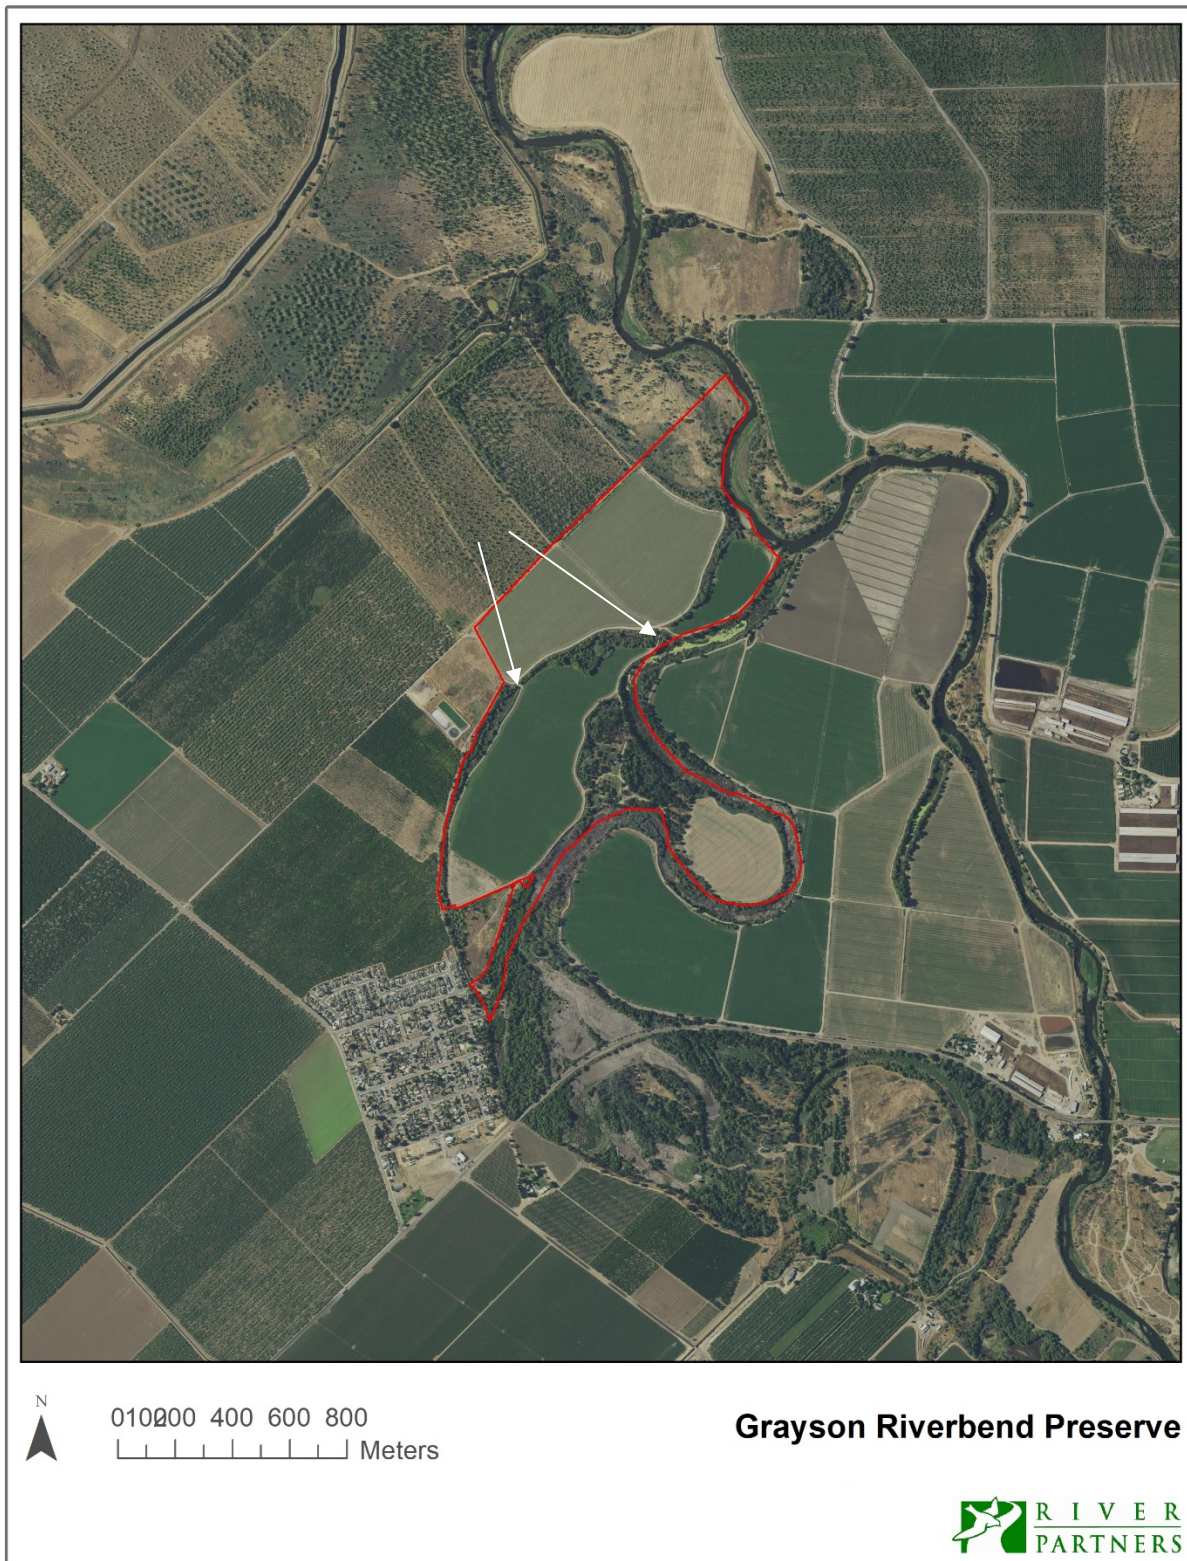
Figure 17. Location of the two field culverts in Field 4

Specifically, removing two field culverts and their associated embankments in Field 4 would likely provide additional frequently inundated floodplain habitat (Figure 17). As GRP floods up through a backwatering effect from the mainstem San Joaquin River, removal of these structures to adjacent grade would allow for inundation starting at the downstream end of Field 4 at much lower elevations (approximately 30 feet) compared to the berm degrade (which would start inundating the upstream end of Field 4 above 38 feet), providing inundation of Field 4 at a much larger range of flows. This action would also likely improve egress for juvenile salmon from the site

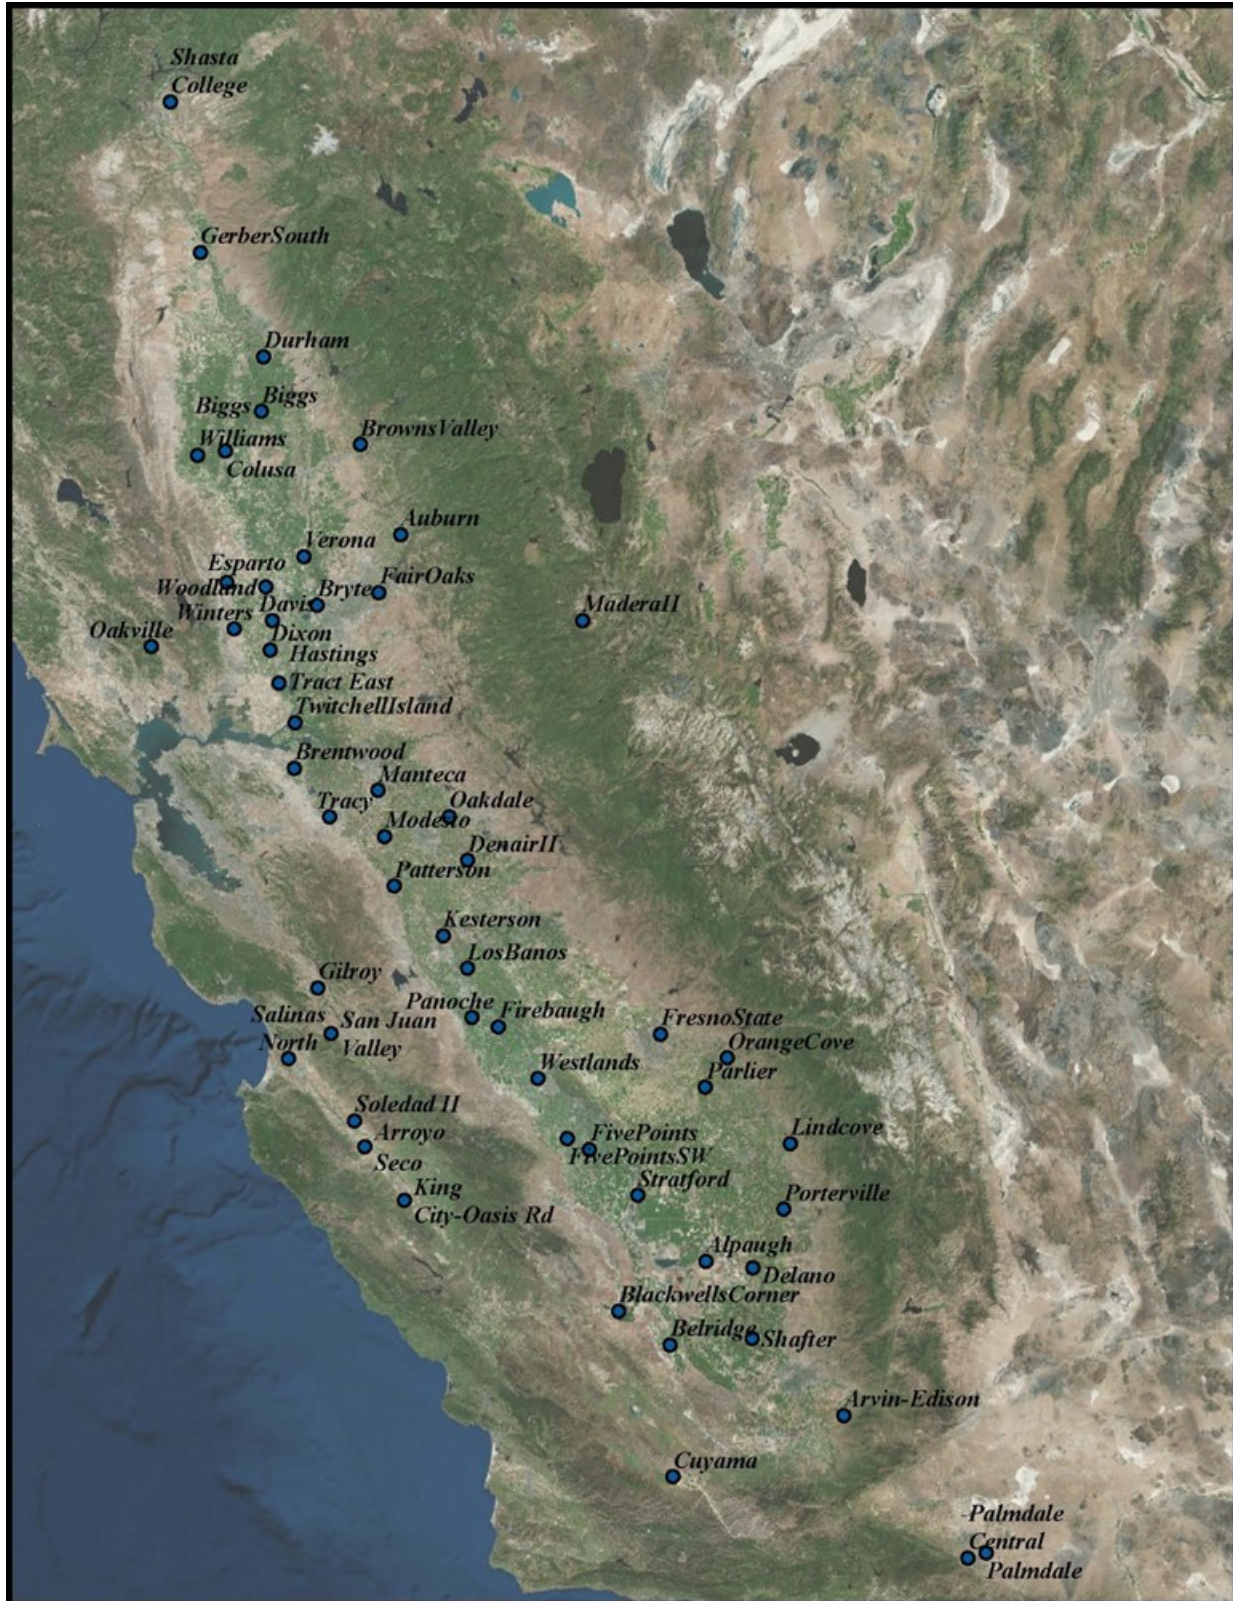
Figure 3. Locations of the CIMIS weather stations used in this evaluation

Hourly weather data for the project time frame was collected from California Irrigation Management Information System (CIMIS) weather stations located throughout the project area. Dozens of individual weather stations were used for the METRIC modeling process. Figure 3 shows the approximate locations of weather stations used in this project. Each station is listed in Table 3 showing the approximate range of time that the station was utilized. A station may have become active or inactive within this time frame.

The Los Banos #56 CIMIS station was utilized as the “primary” weather station. This station was selected because of its centralized location within the primary area of interest (see Figure 3). The same quality control procedure was used at all weather stations as will be described.
